Duke of Northumberland River - Isleworth

A Project Proposal by the Wild Trout Trust December 2015

1. Introduction

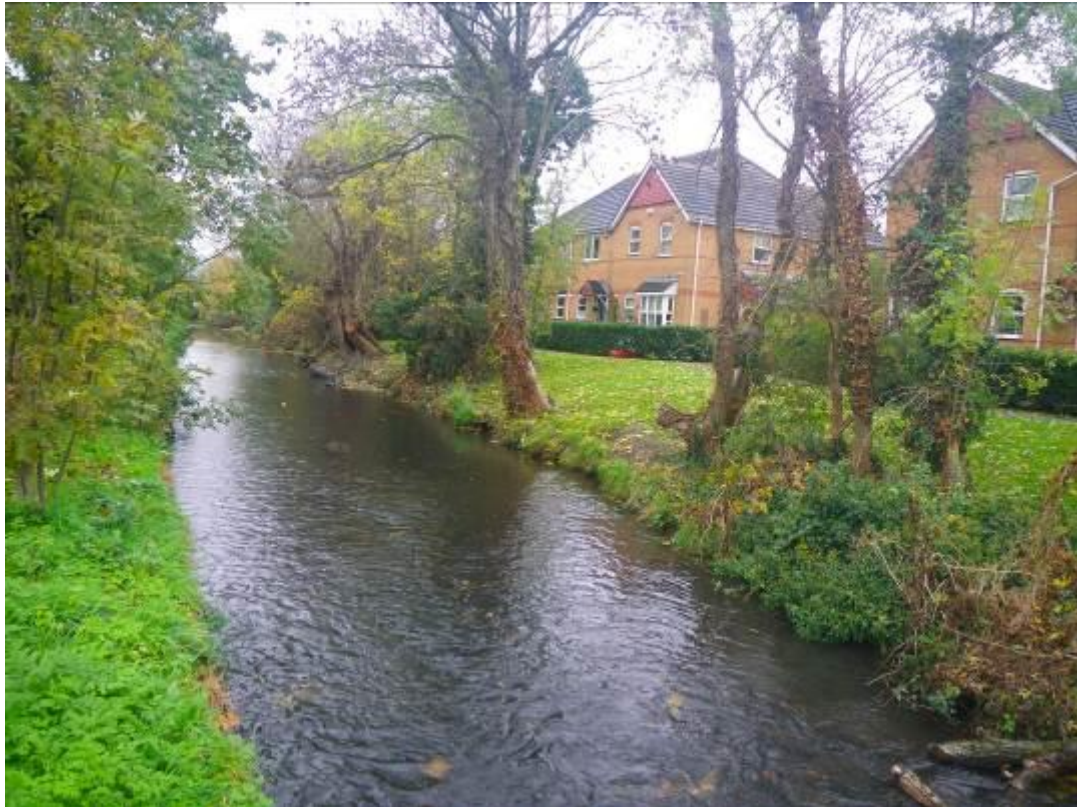
As a wholly man-made channel, the river here has a mainly straight channel planform and in the most part a uniform, largely shallow depth profile and uniform cross-section. A short section of the reach running downstream from Worton Bridge is slightly shallower than the remaining downstream section (photo 1), and as a result consisted of mainly riffle habitat, as opposed to the downstream section which is shallow glide. The river supports no deeper "pool" refuge habitat, with water depth greater than 0.5m virtually absent from the entire section.

Photo 1. Shallow riffle habitat running down from Worton Bridge. Potentially a good spawning site for gravel loving coarse fish species.

It is recommended to concentrate on pool and run creation on the flat shallow glide habitat found in the northern end of the reach and simply use woody debris on the shallow riffle habitat to help sort gravels and create micro habitats for small fish and aquatic bugs.

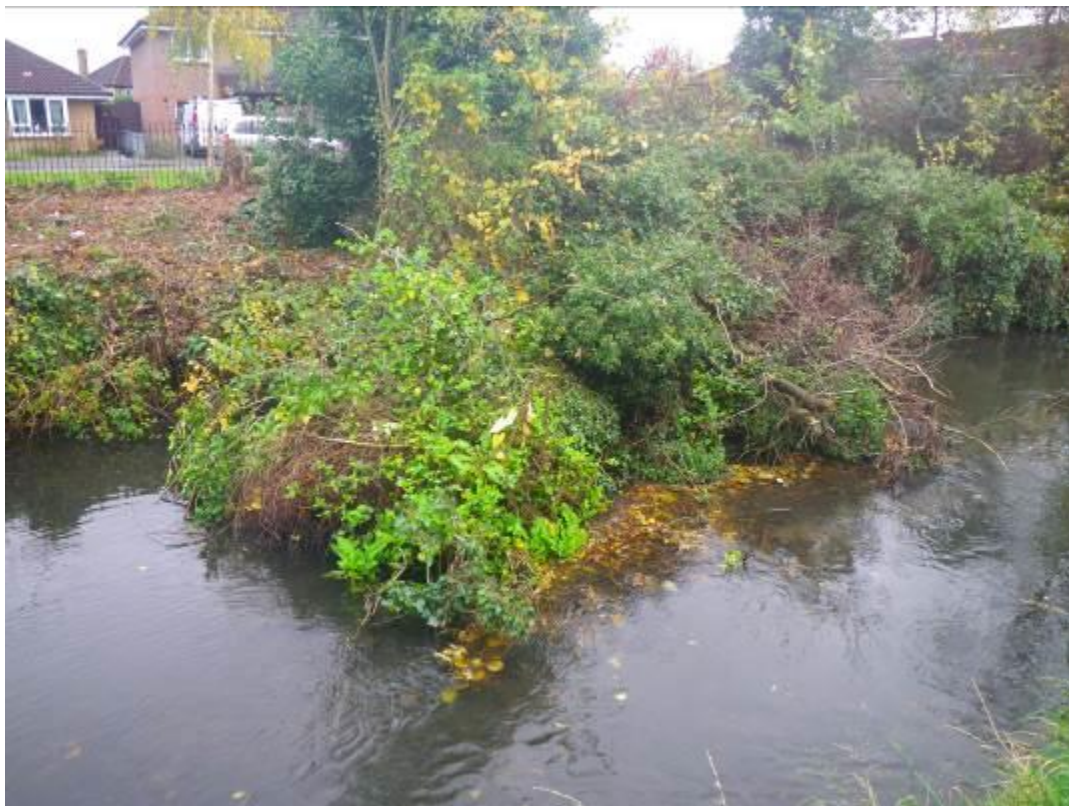
In one or two locations, in-channel variations in flow patterns are being promoted by the odd piece of woody debris that has been left in the channel following recent tree work carried out adjacent to the RB (photo 2). In addition some changes to flow patterns have also been promoted in the section just downstream of Worton Bridge through the positioning of some blocks of discarded concrete (photo 3). Not ideal, but nevertheless promoting some local sorting of fine river bed sediment and changes to the flow dynamics.

Photo 2. Woody debris left in the margins providing some excellent cover and promoting in-channel flow diversity.

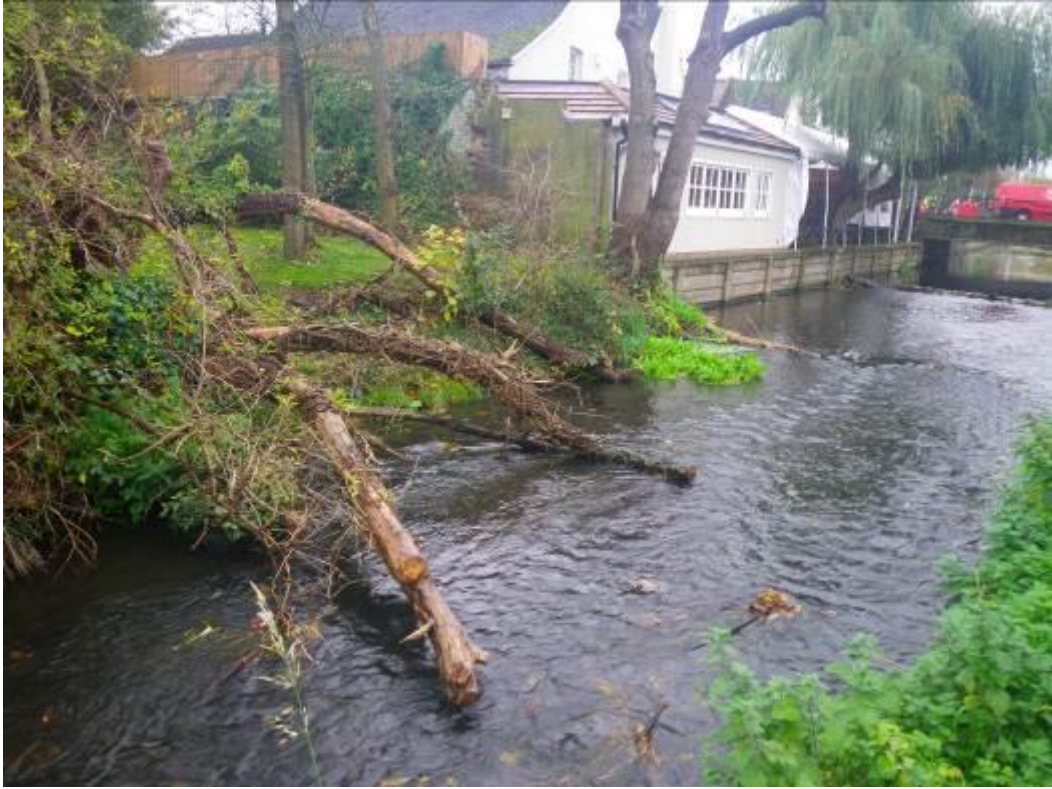
Photo 3. More woody debris and a line of stones/concrete promoting some diversity in flow patterns and providing micro habitats for small fish and invertebrates on the upper reaches.

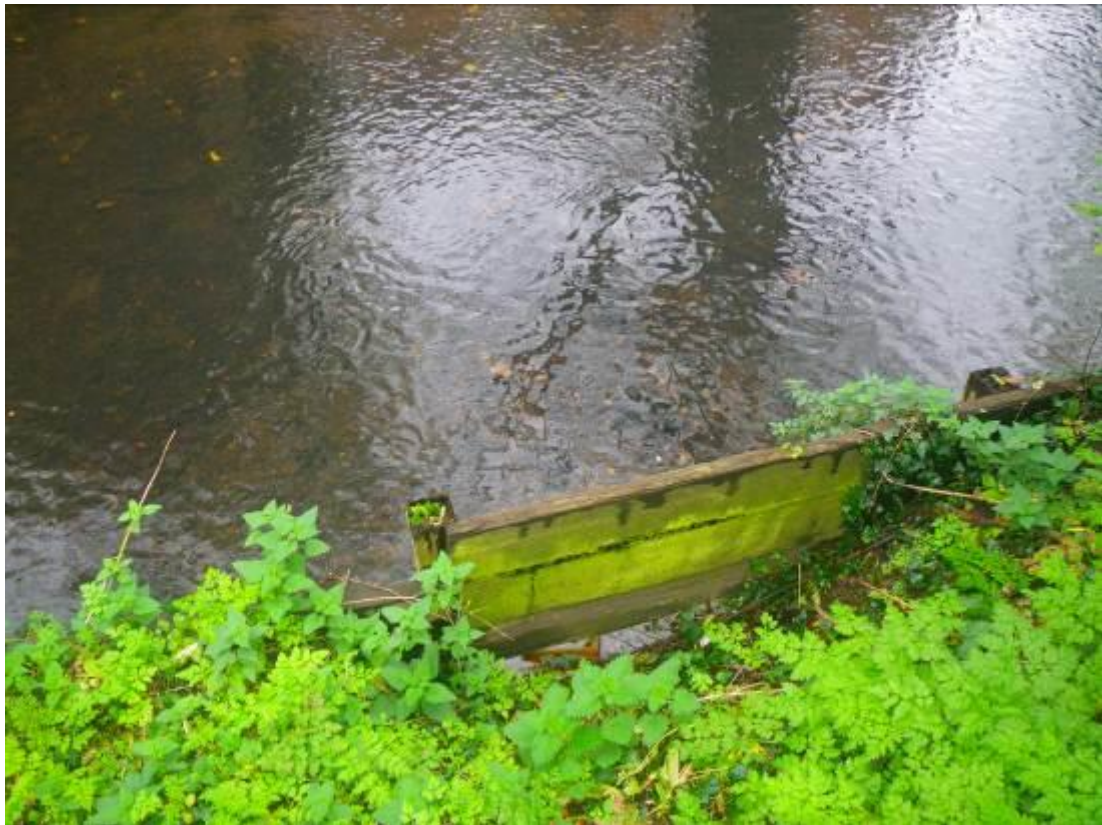
The river banks and margins are an *ad hoc* mix of vegetated earth banks, wooden toe-boarding, with concrete and sheet steel piling evident on the LB. In general, the RB was more stable and natural compared to the LB running adjacent to the Riverside Walk footpath. Here there was evidence of toe-board failure (photo 4) and sections of sterile vertical concrete revetment (photo 5).

Photo 4. Toe-board failure adjacent to the LB was evident in several locations.

Softening the concrete and toe-boarded margins with brushwood shelves and/or tree sweepers should be a priority action. It is recommended initially to try a range of these techniques and monitor their impact before embarking on a wide ranging enhancement project.

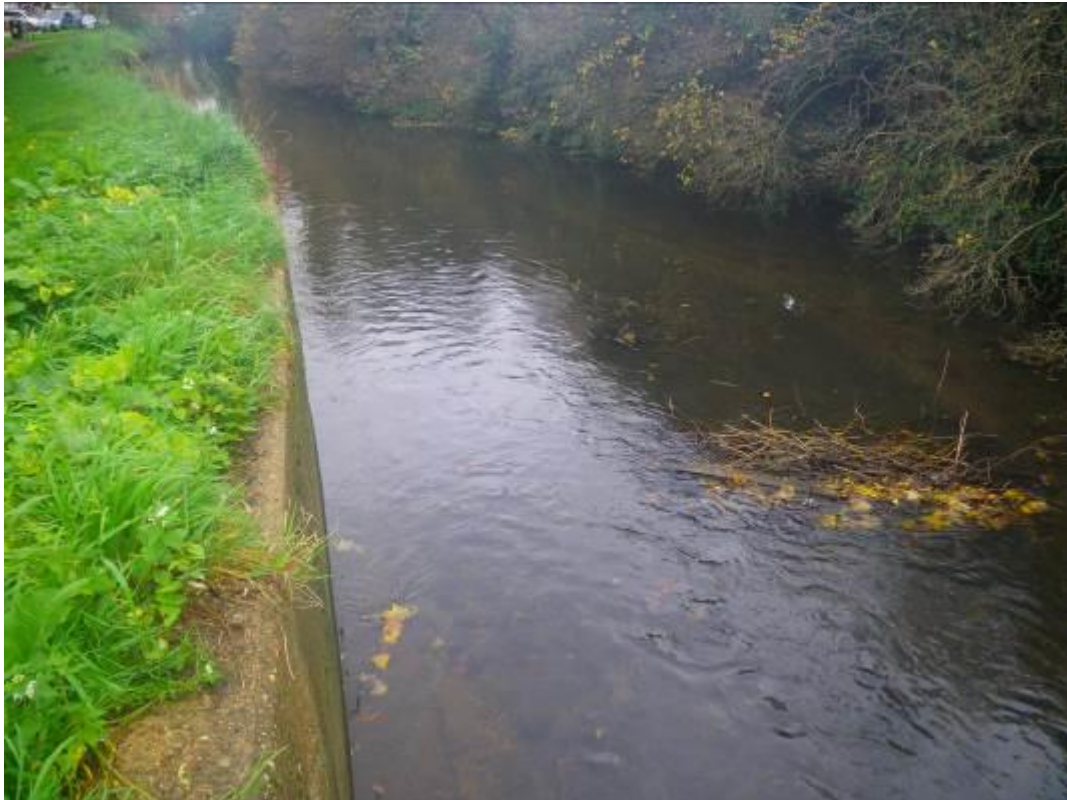
Photo 5. Biologically sterile concrete LB contrasts with the natural tree-lined RB, which provides some excellent habitat and resilient bank protection

Softening the areas of hard revetment adjacent the LB could be achieved by installing tree sweepers (fig. 2) won from the RB and cabled to the toe of the LB using expansion bolts secured into vertical concrete revetment. A combination of brushwood shelves (photo 7), woody debris flow deflectors and one or two modest sized pools could transform the reach and substantially boost its potential for increasing biodiversity.

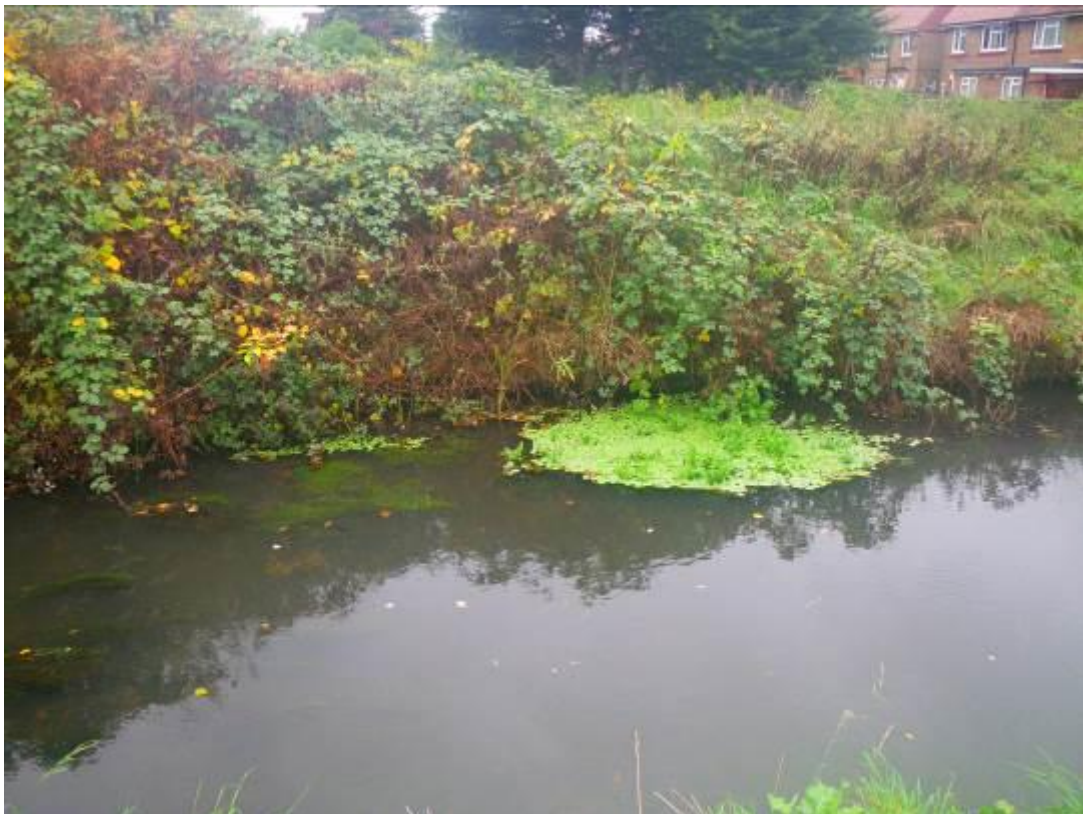
Photo 6. Small patch of the undesirable and highly invasive floating pennywort

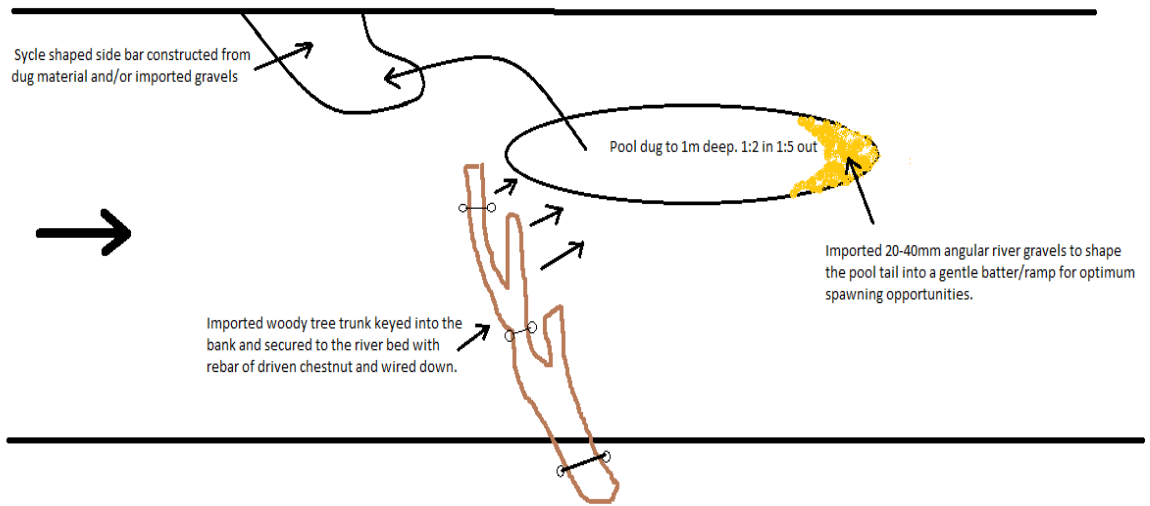
Fig 1. Schematic (not to scale) drawing depicting a typical dig and dump feature but with additional woody debris flow deflector to promote the flume required at the neck of the pool.

Using a combination of woody debris deflectors to promote a flume (to ensure sustainability) at the neck of the pool, hand digging modest sized, elliptical pools (1m maximum depth) and shaping pool tails and side bars with imported 20-40mm angular river gravels, could provide the much needed diversity in bed shape and flow patterns. Digging pools by hand will enable a soft approach to redistributing in-channel bed material. If pure clay is detected then hand digging would easily cease before any potentially damaging excavations are made. A schematic drawing is depicted in fig. 1.

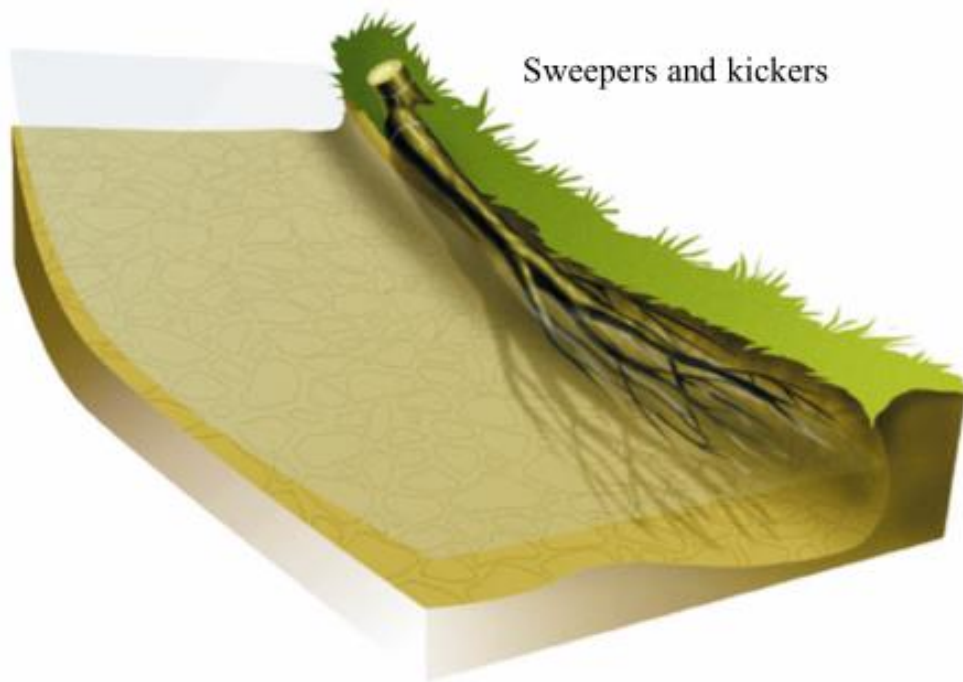
Figure 2. Tree sweeper with galvenised cable used to attache the trunk to a secure stump. Sweepers can easily be secured to a stout fixing eye drilled into concrete revetment.

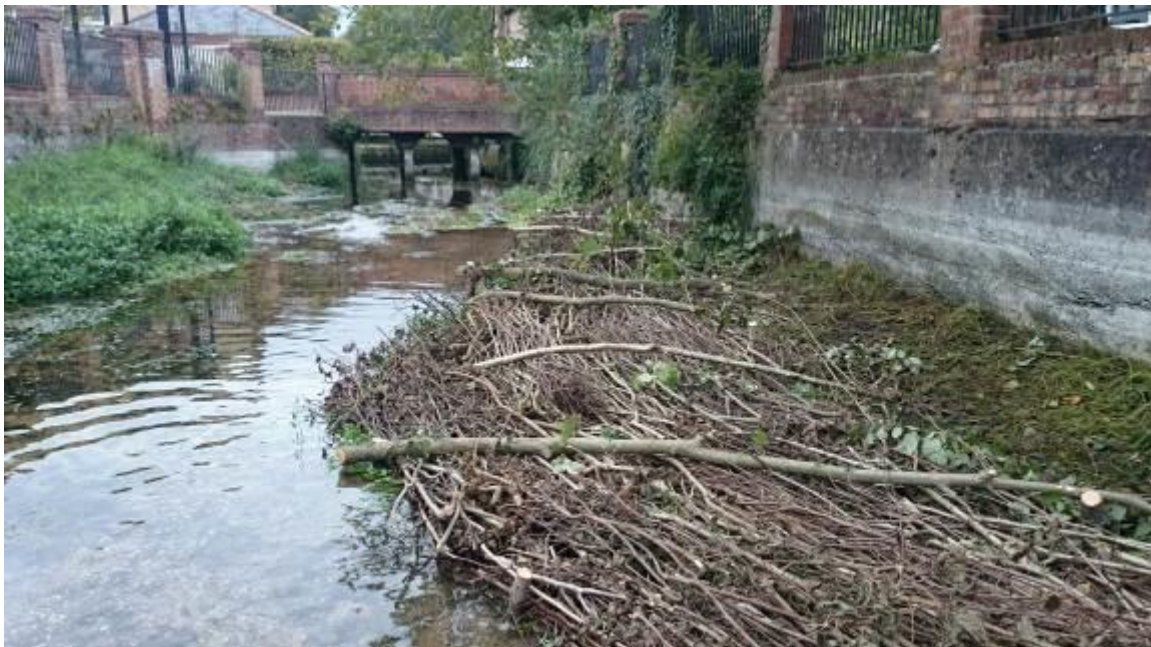
Photo 7. A brushwood shelf installed into the margins of a river in an urban environment.
