**Advisory Visit**  
**Eastburn Beck, R. Aire**  
**07/07/2015**

## **1.0 Introduction**

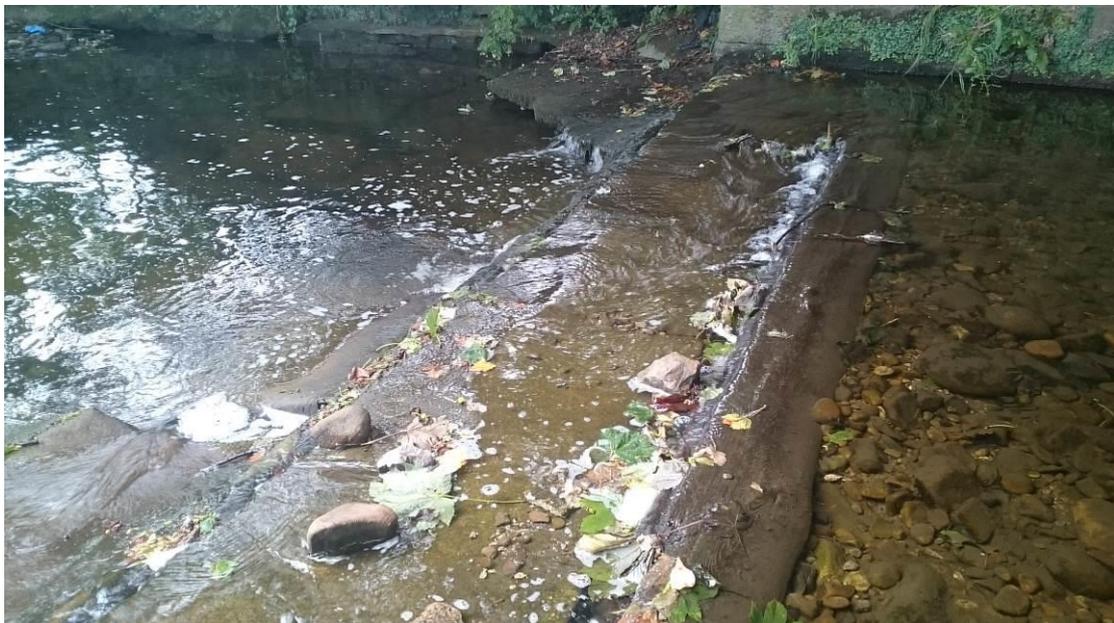
The starting point of the walked section was at a footbridge which spans a weir (SE0072144453) and is at the d/s limit of Lyndhurst Wood on the RB (Fig 1). The weir is a severe obstruction to fish passage as it has a substantial sill of concrete on the d/s side, but this is beginning to degrade and a deeper pool has formed immediately beneath where some of the blocks of stone (upon which the concrete was laid) have been displaced. The pool contained 6-10 trout of 10-20cm. At the u/s side of the weir, there is a wooden beam spanning the beck which has several shallow grooves eroded into its surface creating flow diversity.

**Fig 1. The weir beneath the footbridge spanning Eastburn Beck, below Lyndhurst Wood. Note the wooden lip u/s and the degrading concrete sill d/s. A scour pool where erosion has removed the concrete sill holds a water depth of >50cm, and trout were visible.**

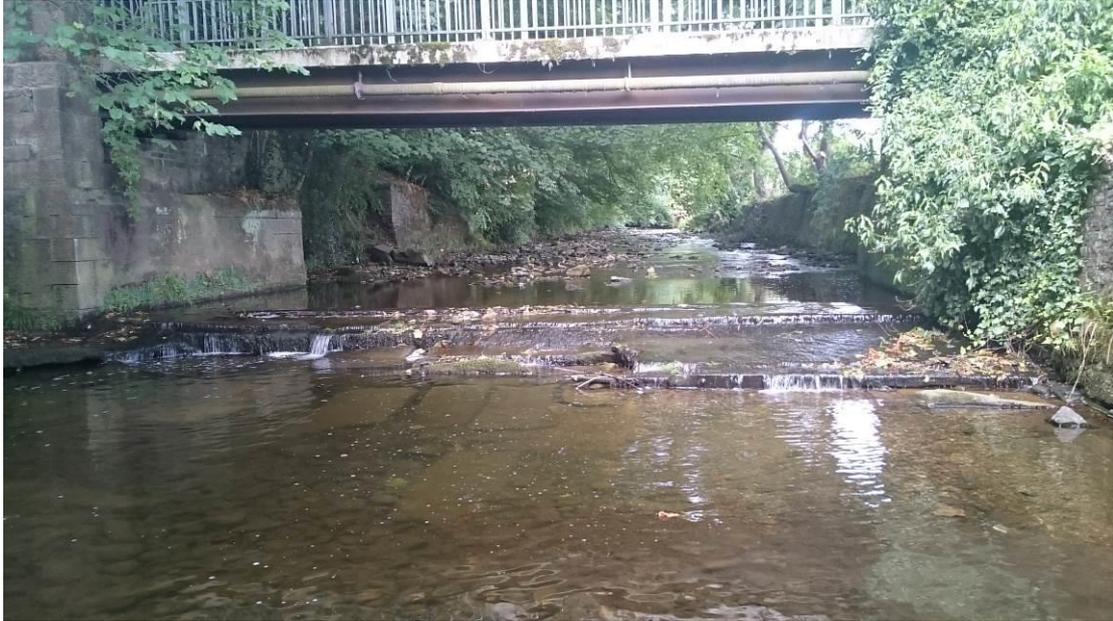
Immediately u/s of the weir, the impounded section inhibits the capacity of the beck to maintain natural alternating lateral scour and deposition processes. Consequently, the riffle-pool sequence is replaced by a single long, straight pool with a depth of only ~10cm as the bed above the weir has gradually built up with substrate. The beck is constrained on both banks by walling to a height of several metres in some places, and clearly has been straightened (Fig 2). Despite a variety of natural boulder, cobble and gravel sizes (along with some large hewn stone revetment blocks and irregular lumps of concrete comprising the bed), the channel is overly wide and water depth is shallow and uniform. There is a distinct lack of 'thalweg' (the line drawn between the lowest points of the stream bed; i.e. the

**Fig 2. The weir beneath the footbridge spanning Eastburn Beck below Lyndhurst Wood. Ponding is evident immediately u/s of the structure but only ~10cm depth. Note the walled banks, straightened course, and exposed substrate**

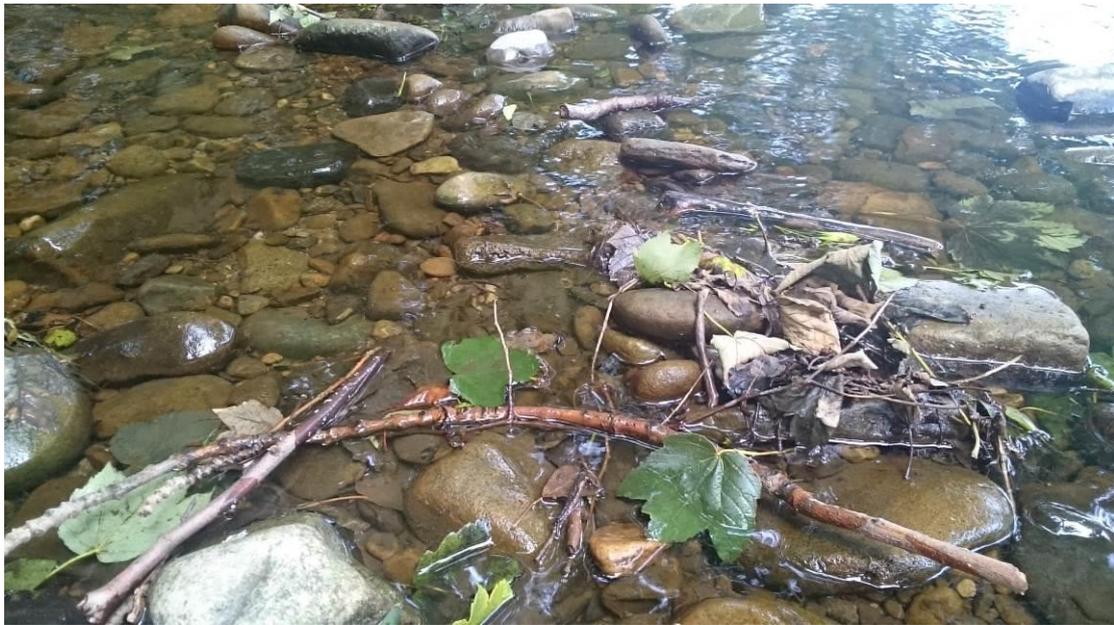
**Fig 3. Abundant leaf packs should provide food for shredding invertebrates such as *Gammarus pulex*. Note shallow water depth.**

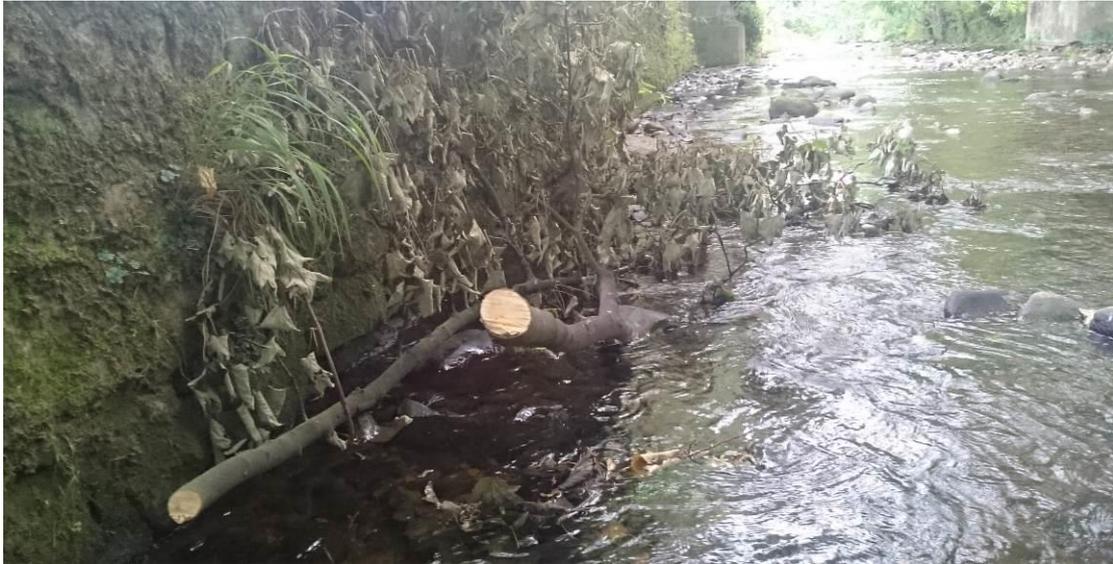
**Fig 4. Cut branches of sycamore left in the beck from the pruned tree on the LB. This woody debris could form a useful refuge feature and food for invertebrates if retained (pinned) in such a position but is likely to be removed by the next rise in water.**

The addition of woody debris, as in Fig 4, will greatly enhance the habitat both in terms of holding fish and invertebrates, but should be secured so it is not dislodged or removed by the next spate.

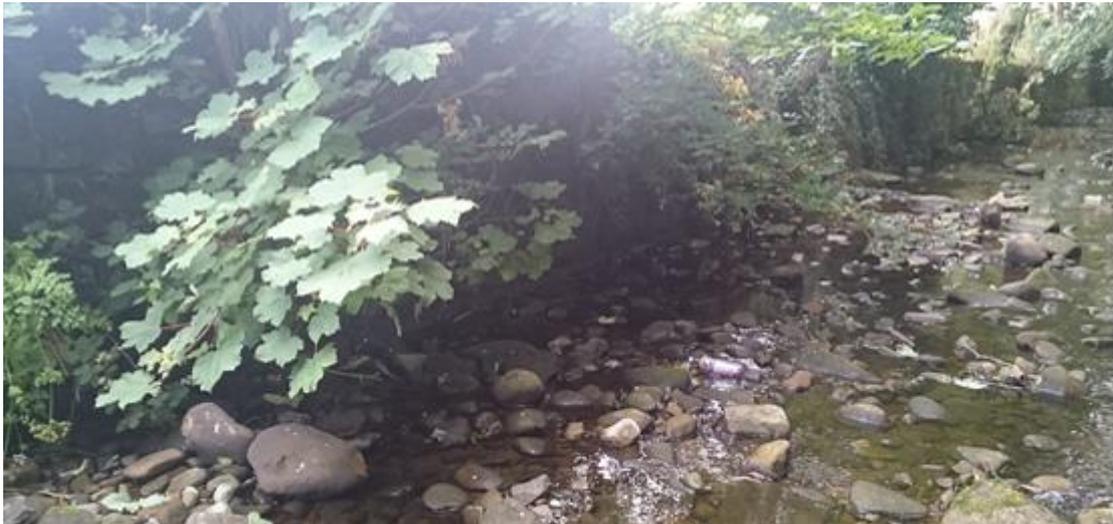
Despite the walled nature of the banks, self-set trees have established (Fig 5). It is important to encourage these as they provide valuable low level cover for fish, as well as their roots adding to the structural stability of the bank.

**Fig 5. Valuable, low-level cover provided by self-set trees but note insufficient depth of water with current channel form.**

The more pliant species, such as willow or hazel, should definitely be left *in situ* to provide this important habitat function. These species can be managed to 'lay' along the channel by hinging the trunks, thereby increasing their effectiveness (see Recommendations).

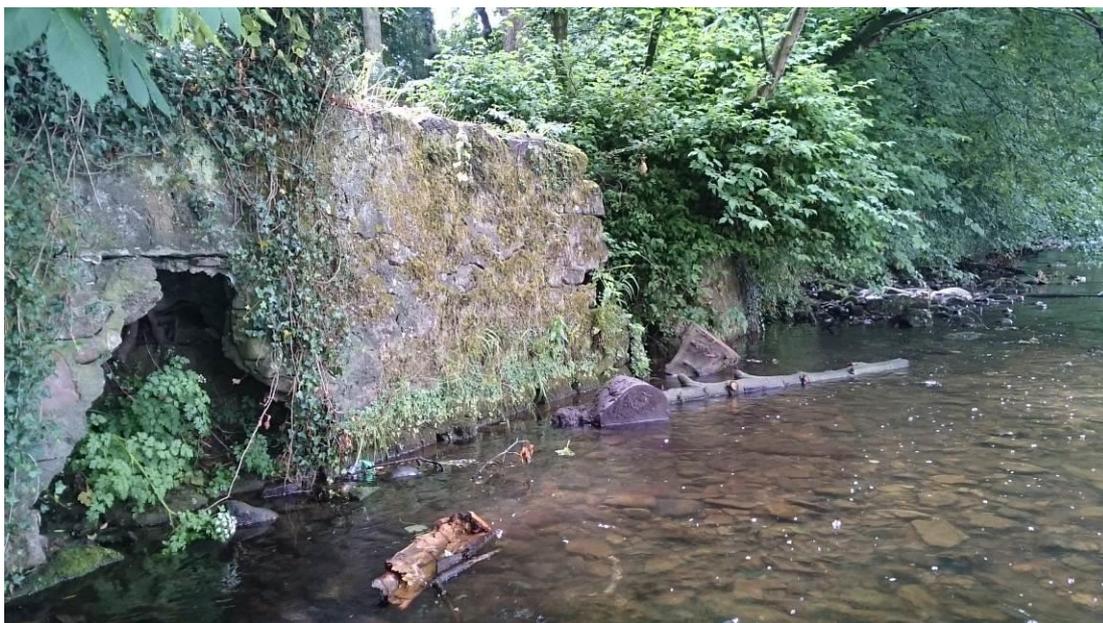
The walling of both banks is clearly failing in a number of areas (Fig 6). This is desirable, in that it breaks up the monotony of a walled edge into small embayments and scours, and the wall material that falls into the stream effectively acts as large boulders. However, it

**Fig 6. At various places on both banks (here the RB) erosion has led to partial or total failure of the wall, creating improvements to an otherwise uniform habitat. NB the cut log was not pinned.**

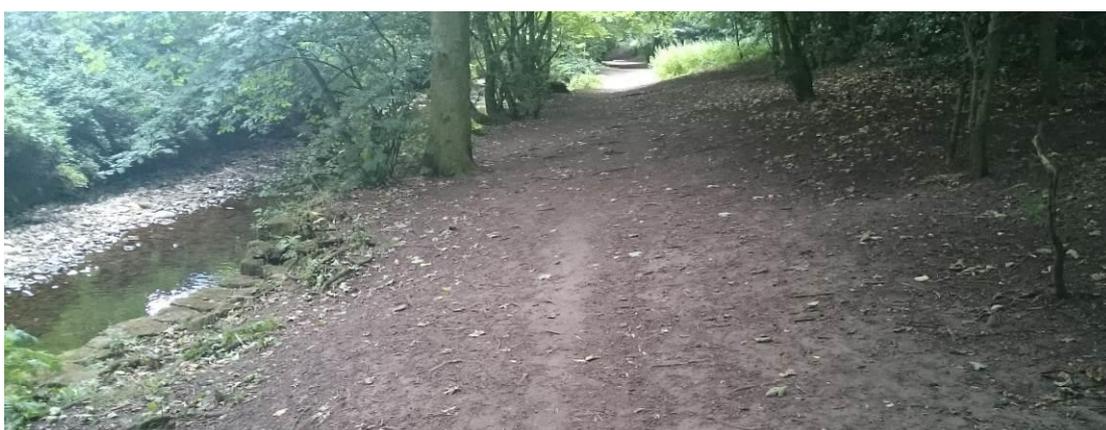
Such features are focal points for people / dogs to enter the water, but as a consequence they tend to be free of vegetation, heavily compacted when dry or a quagmire when wet, and will 'gutter' fine silt into the beck. Even without the influence of passers-by, these erosional points form small gullies for rainwater run-off; the slope through Lyndhurst Wood is quite substantial and as there is little understory vegetation (Fig 7), overland flow must be a considerable source of fine sediment.

**Fig 7. One of the numerous paths and denuded understory on a steep slope to the beck; a likely source of fine silt ingress during heavy or prolonged rain.**

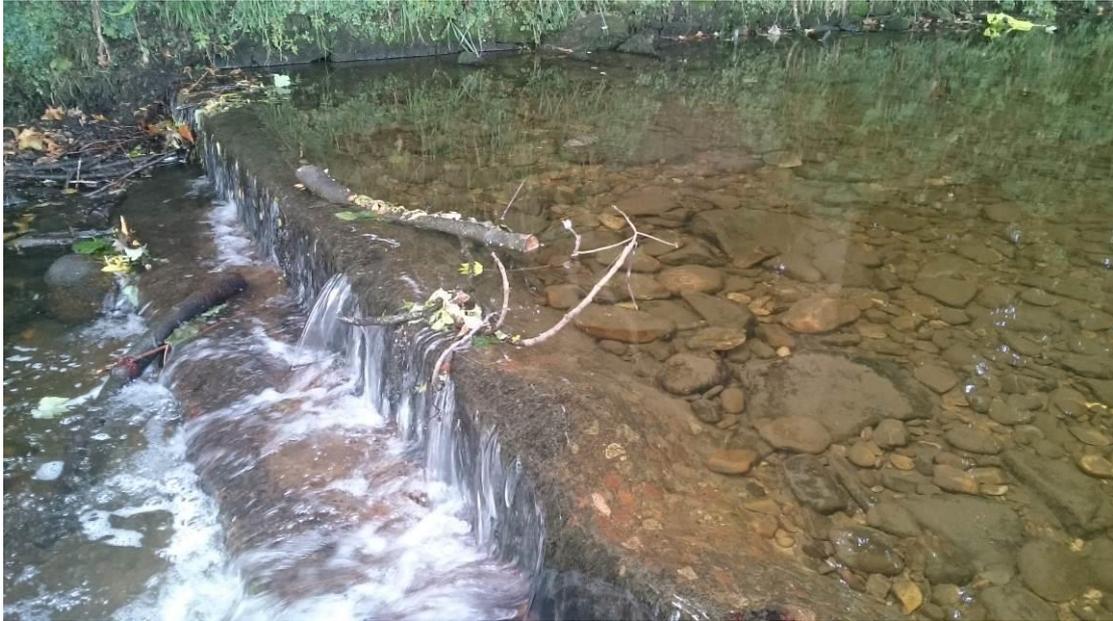
The first of a series of simple step weirs is found at SE0017544488 (Fig 8). It appears to be a single narrow span of concrete which impounds a section of water  $\sim 40\text{m}$  u/s. It is deeper than the previous section ( $\sim 30\text{-}40\text{cm}$ ) but is fairly uniform in depth across the width of

**Fig 8. A concrete step weir which ponds a section of  $\sim 40\text{m}$  u/s, reducing flow variation and causing the formation of a uniform bed (and water depth) as substrate cannot migrate d/s.**

If this is not feasible, then adapting the simplest solution Gaskell advocated in most cases, to cut a channel or slot 1 – 2m wide down to the current d/s bed level, would be highly beneficial. Each slot should be wide enough to largely remove the upstream impounding effect of each structure. As some of the weir lips are wooden, this should be relatively easy to achieve. A number of the concrete lipped weirs already have degraded notches which could be exploited and 'encouraged' to degrade further. Each slot should be sited anywhere within the central third of the structure so that it does not unduly influence bank (wall) erosion. Focussing of the flow within one area will aid bed scour to form deeper pools (for refuge and to hold larger fish) and gravel sorting (thereby augmenting spawning habitat). It should be noted that Gaskell also suggested the physical destruction of parts of the aprons to allow fish sufficient water depth to access the base of the weir.

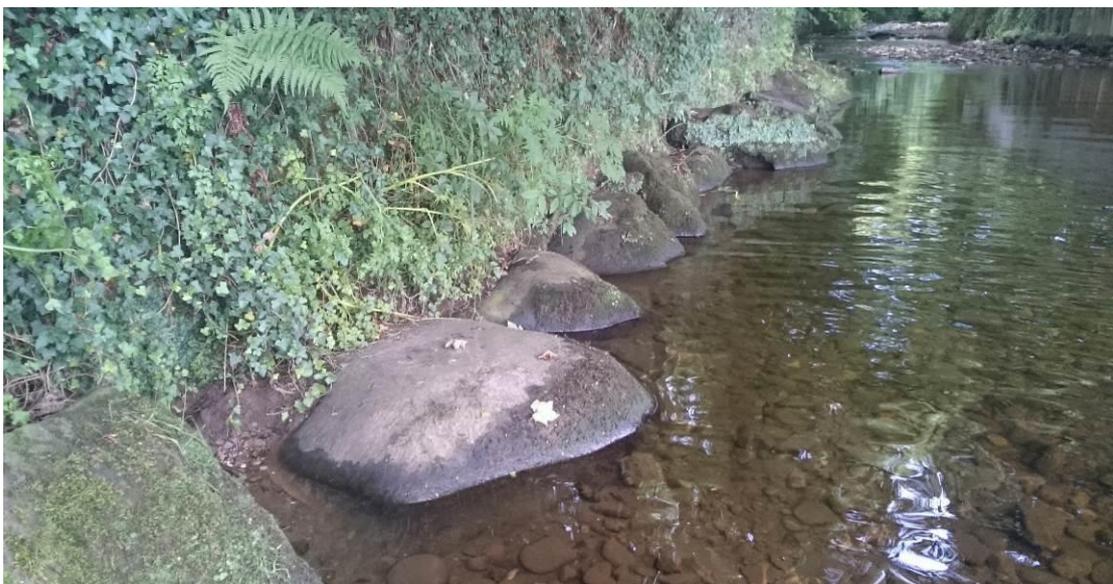
The toe of the RB has been lined with a row of large boulders which 'roughen' the effect of the straight wall (Fig 9). They probably provide some limited refuge for small fish. If this section were not impounded, then the energised flow passing this roughened boulder line would create some important turbulence and probably scour, helping to increase bed (and hence depth) diversity (see Fig 10), but only if the thalweg reached the feature. The lack of energy in these impounded sections u/s of the weirs is evident in Figs 8 & 9: a fine silt coats the larger substrates.

**Fig 9. Just u/s of a concrete weir, large boulders line the toe of the RB. Note the fine silt deposition on the cobbles and gravels, and the extent of the ponded reach.**

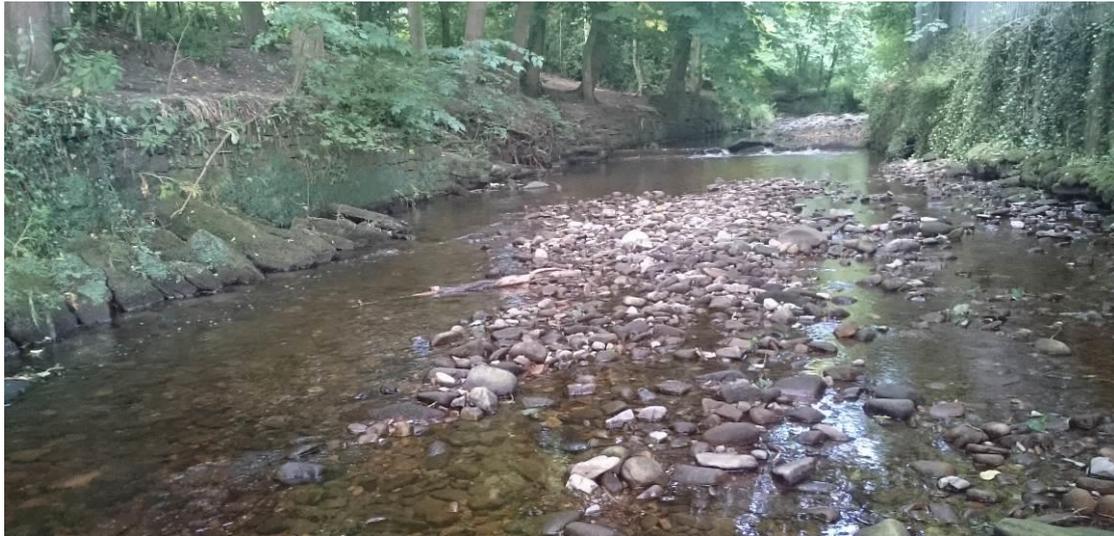
**Fig 10. A more energised section of the Eastburn Beck where sediment deposition constrains the flow (mostly) to the RB and creates valuable flow diversity; as a consequence, the channel is narrower and deeper and offers secure lies for fish amongst the larger boulders.**

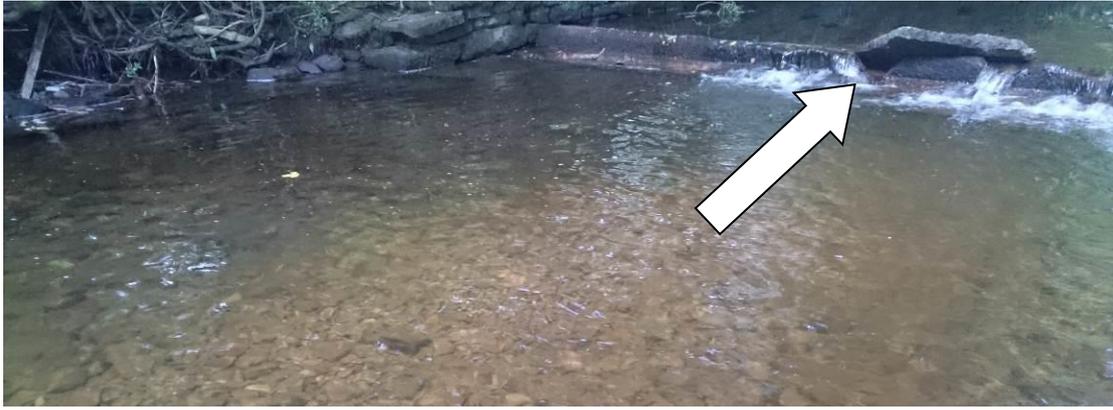
The next deeper pool spans the channel width, formed by another simple concrete lipped weir (at SE0011844470) which has started to degrade near to the centre (Fig 11). A slab of concrete has been wedged up against that point and has been bedded in by deposited cobbles and gravel u/s but is starting to be undershot (see arrow in Fig 11). This structural weakness can be readily exploited (see Recommendations). Bed material within the pool has been sorted by the flow and turbulence and are free of fine silts, providing better habitat for a wider diversity of invertebrates, and potentially some spawning gravels. However, as the energy of the flow is dissipated across the entire channel width, the pool is short as the beneficial effects of the turbulence are only effective within a few metres of the weir. Where the channel is a more natural width, the accelerated flows would create more beneficial pool dimensions and maintain the bed free from sediments that can smother incubating salmonid eggs.

**Fig 11. A scour pool, which spans the Eastburn Beck, caused by a simple concrete weir. The flow has sufficient energy to remove some fine silts and sort the substrate but only in the immediate plunge pool of the weir. Note the concrete slab wedged against a degradation in the sill, which is now being undershot (arrow).**

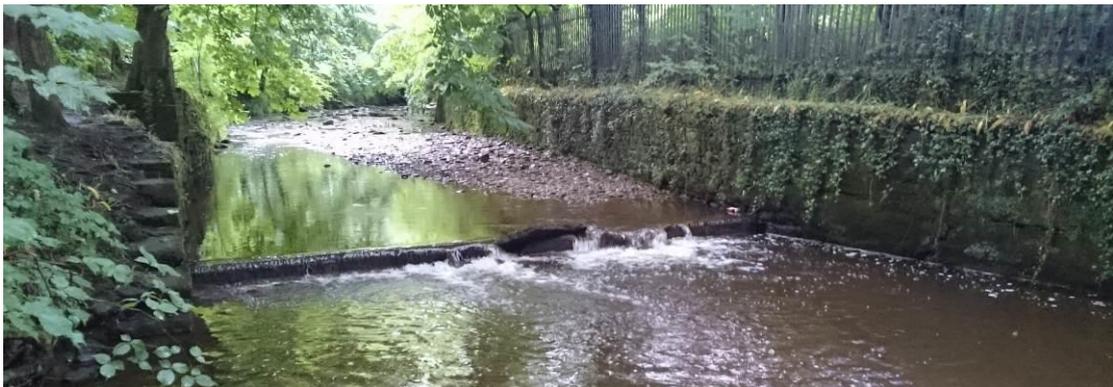
The weir is impounding water and retaining substrate but the distance u/s that these negative impacts are felt is reduced by a bend in the channel which has forced flow to the outside (RB). Here, being constrained by the wall, it has scoured downward to create a deeper channel and facilitated deposition of a gravel bar on the inside of the bend (Fig 12).

**Fig 12. A bend in Eastburn Beck has allowed geomorphology to regain some control of erosion and deposition of substrates above the weir, reducing the impact of impoundment.**

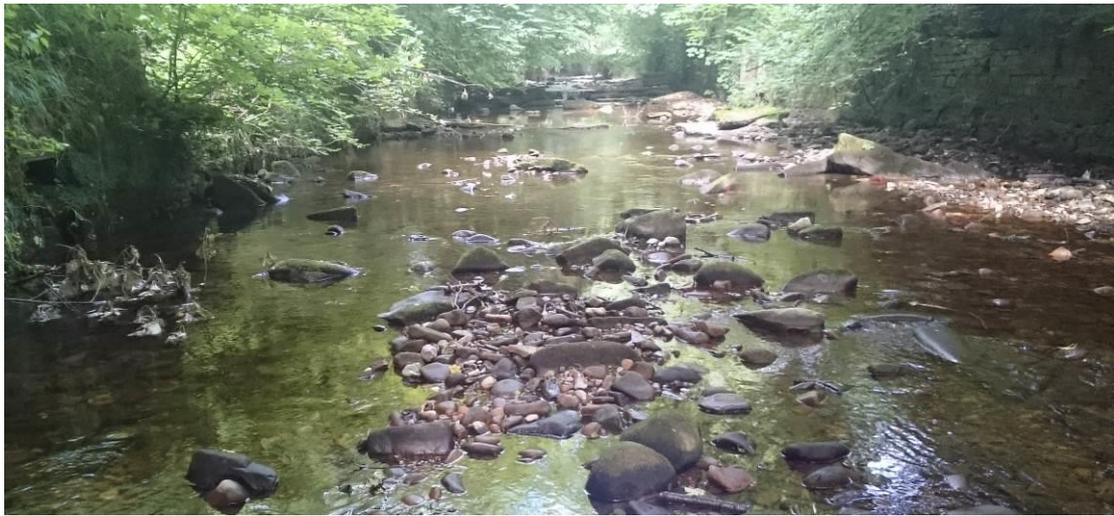
**Fig 13. A better mosaic of instream habitat and overhanging vegetation, but the water depth is still too uniform and shallow.**

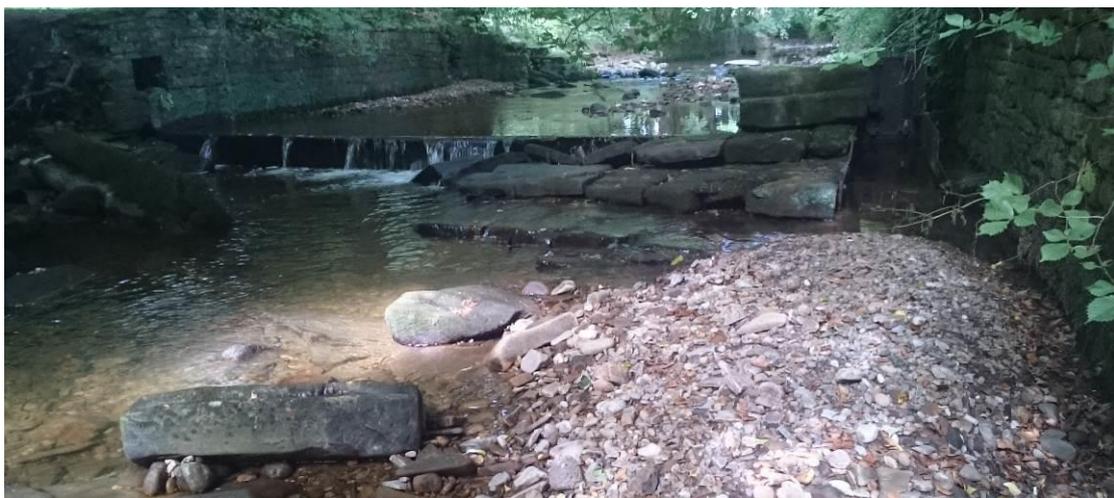
The weir (at SE0003744506) is narrower than the previous structures as there is a dilapidated mill sluice to the LB. A substantial bank of gravel has accumulated in what would be a back eddy from the mill sluice wall under higher flows. This currently helps to constrain the channel width for 3-4 metres.

**Fig 14. The weir and sluice. Large stone slabs provide instream features, and will diversify flow. Note the deposited gravel in the lee of the defunct mill race and sluice.**

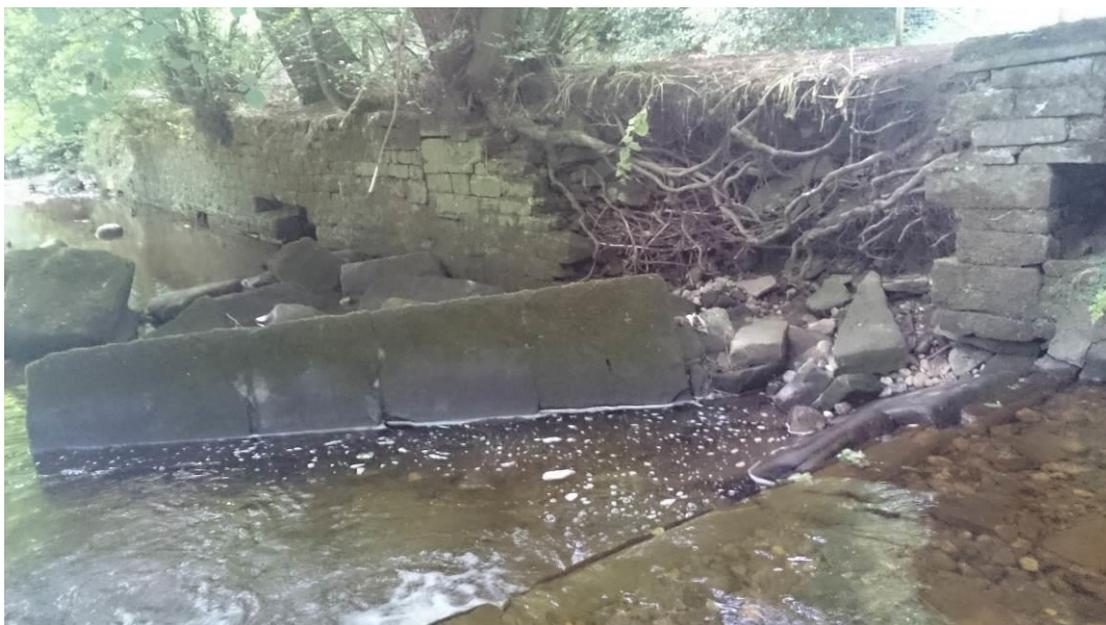
There is also a considerable number of concrete and stone slabs and blocks strewn about the pool which will provide refugia and cause turbulence around them when sufficient water is flowing. Indeed, so much so, that the wall on the RB appears to have succumbed to erosive power diverted by a particularly large slab; the hole would be much worse if it were not for the roots of the riparian trees (Fig 15). Similarl to the situation shown in Fig 6, this does not require repair, but the footpath should be diverted away from this point, or at least access from the bank side should be restricted with fencing. This would allow more understory vegetation to grow and stabilise the

**Fig 15. Erosion of the RB wall exposing the riparian tree roots. This is likely to have been caused by spate water deflected by the stone slabs centre shot.**

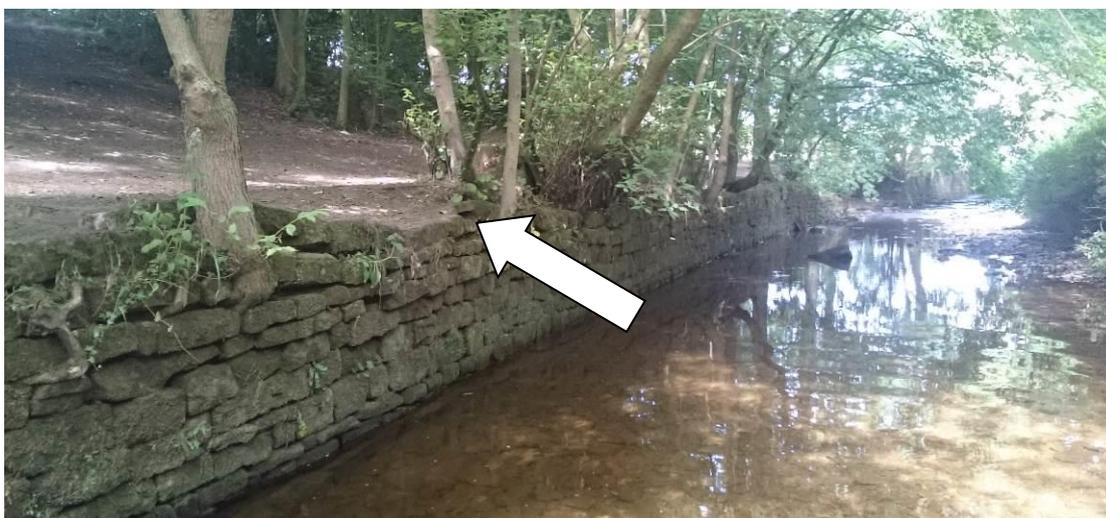
Again, such a simple weir has a dramatic effect u/s, impounding and levelling the bed substrate to a uniform depth (Fig 16). Combined with a lack of buffering on the RB, that bed substrate is smothered with a layer of fine silt, and there is no low hanging vegetation to provide cover or refuge for fish.

**Fig 16. The impounded section above the weir and sluice is essentially featureless. The arrow highlights the route of sediment ingress as there is no understory vegetation on the compacted earth beyond the wall, and the slope of the land is considerable at this point.**

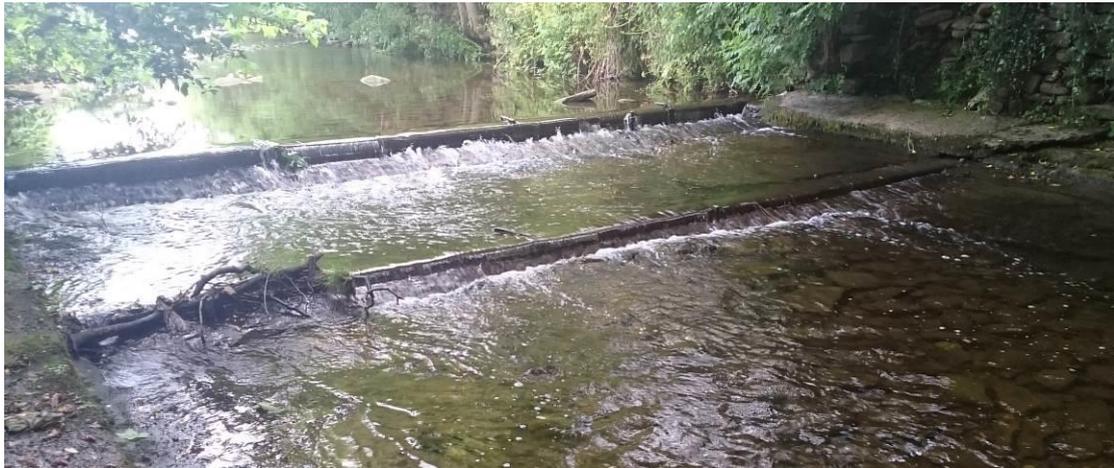
The u/s end of Lyndhurst Wood is marked by a two-stage weir comprising two single wooden beams spanning the channel and pinned onto concrete (Fig 17). The apron between these is probably concrete bed, but has some natural substrate on top. The water depth throughout the structure is very shallow at base-flow and hence it is

**Fig 17. The weir comprising two single wooden lips pinned to concrete at the u/s end of Lyndhurst Wood.**

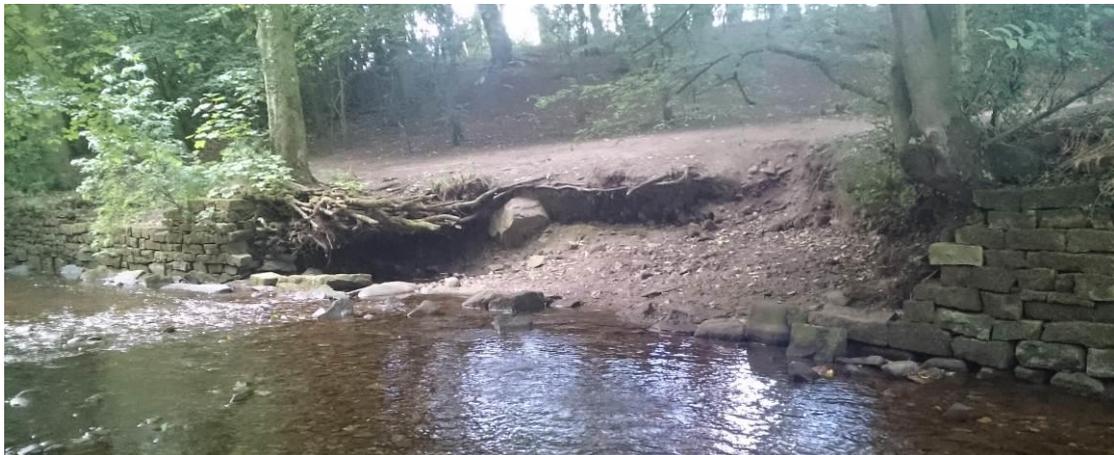
Immediately d/s on the RB, the wall has failed and a large embayment has formed. Erosion is occurring from both sides: spate flow is undermining the remaining walling and roots of the riparian trees (as in Fig 15), while people and dogs clearly use this breach to access the beck and their activities are leading to gullies and compaction from the landward side (Fig 18). Soil from the woodland paths are likely to be focussed here and enter the beck.

**Fig 18. A break in the wall (footings still visible) immediately d/s of Fig 17 on the RB. Erosion is being severely exacerbated by people and dogs entering the beck here.**

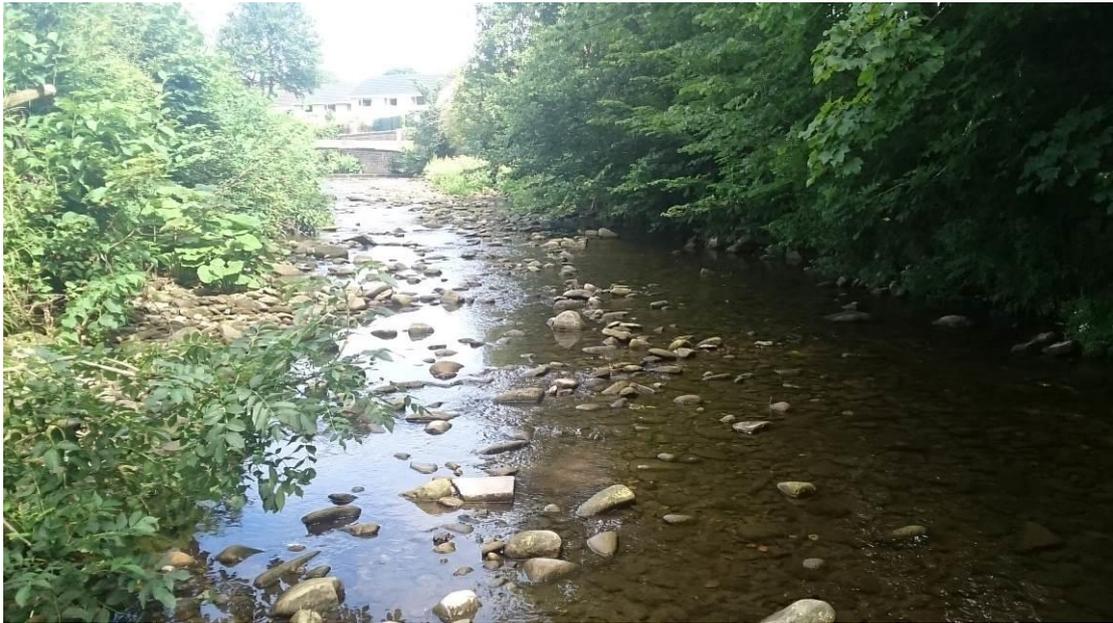
**Fig 19.** Looking u/s from the extent of Lyndhurst Wood. The RB (left of pic) is much more natural and the LB has lower vegetative cover probably because of light.

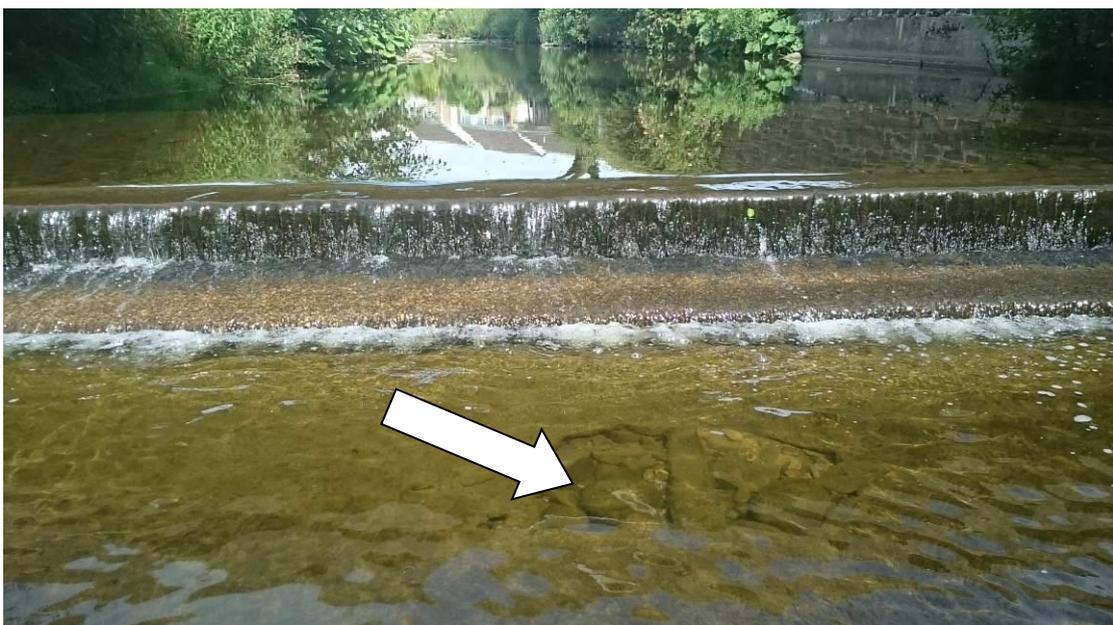
A defunct concrete bridge spans the beck at SD9991344610 and beneath it lies a concrete step weir, below which is a wide apron of >1m. One patch of erosion has occurred midstream, within the apron, and that feature was holding a small trout (Fig 20). The ponding u/s is considerable and clearly seen in Fig 20, and because of the lack of canopy and flow, the bed substrate was smothered in algae and silt, indicating that natural nutrient concentrations are being augmented by point or diffuse sources u/s.

**Fig 20.** The concrete step weir and apron at SD9991344610. The arrow points to the erosional feature where one small trout lay. Note the severe ponding u/s.

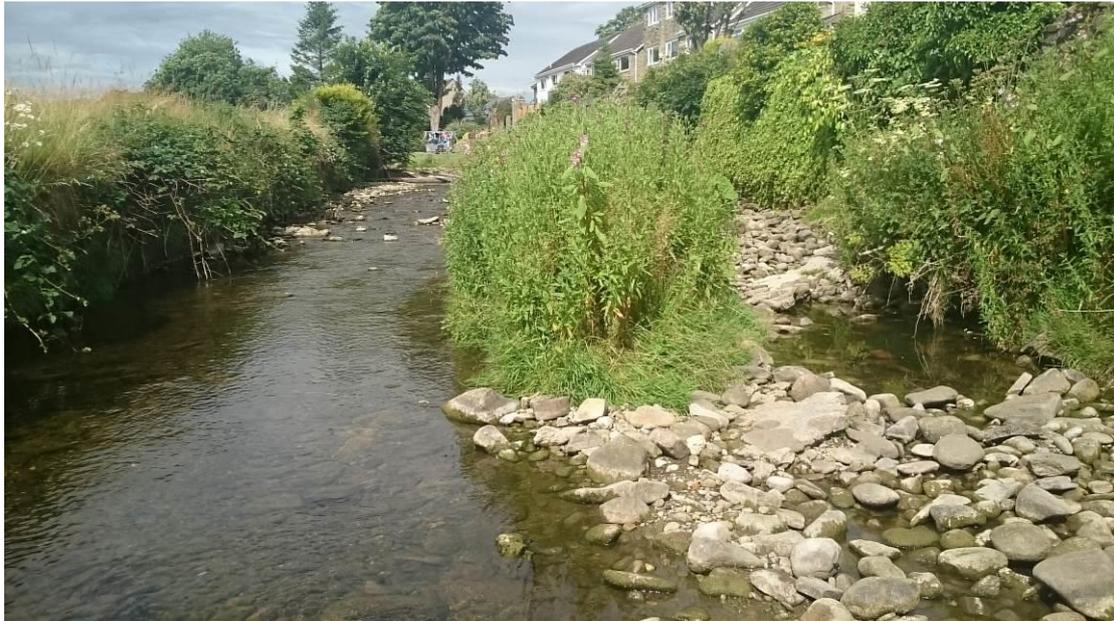
Approaching the final weir at SD9983144641 (the u/s limit that was walked), the beck takes on its most 'natural' proportions under the observed base-flow. A substantial deposition of bed substrate against the LB has become colonised by willowherb and other tall herbaceous vegetation which has helped to consolidate it (Fig 21). This feature may be as a result of the large undershot scour from the degraded weir u/s. Gaskell had previously noted the deposition of high quality spawning gravel habitat thrown up by the scour at the tail end of the weir pool. This is still in evidence.

**Fig 21. A consolidated bar of substrate has developed, constraining the base-flow to the LB at a more appropriate channel width. It also runs deeper under the bankside vegetation (cover).**

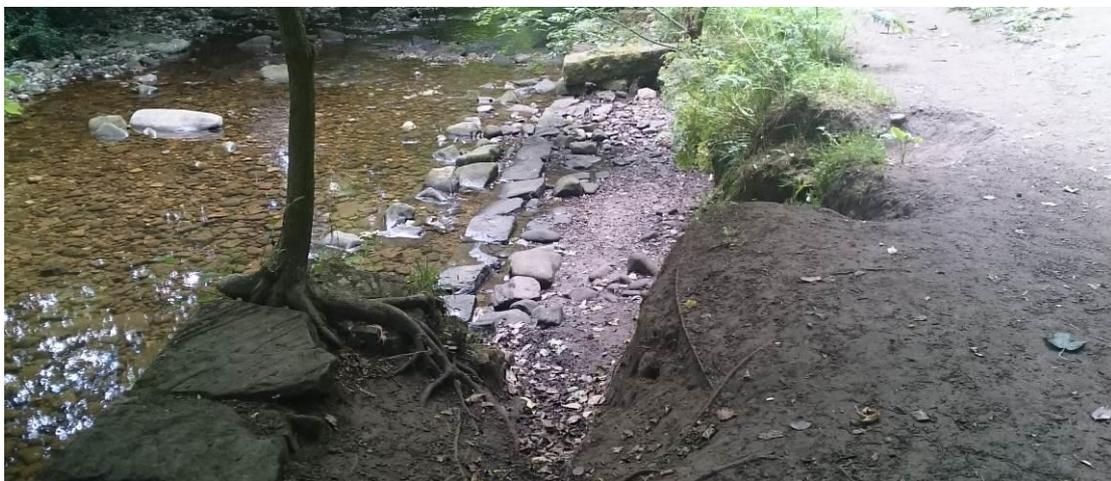
**Fig 23. A view of the beck from the path where the wall has been breached, and severe guttering and compaction of the bare soil is occurring. If this continues, the tree with exposed roots in the foreground will soon be lost.**

To promote the growth of an understory buffer strip, temporary fencing will be required to protect it from trampling by walkers and dogs. It is hoped that via prior consultation and engagement with the local community, e.g. a noticeboard of intended restorations and / or talks at local forums, then the benefits will be realised and such structures will be accepted. It is not intended that the buffer strip ultimately blocks the view of the beck, nor prevents access, but it will require some sensitive management to achieve the desired results, i.e. a more stable bank and a buffer that provides a) shelter and food for riparian animals, and b) protects the beck from soil ingress. Figs 23-25 exemplify the damage that is occurring and a small piece of buffer already in place.

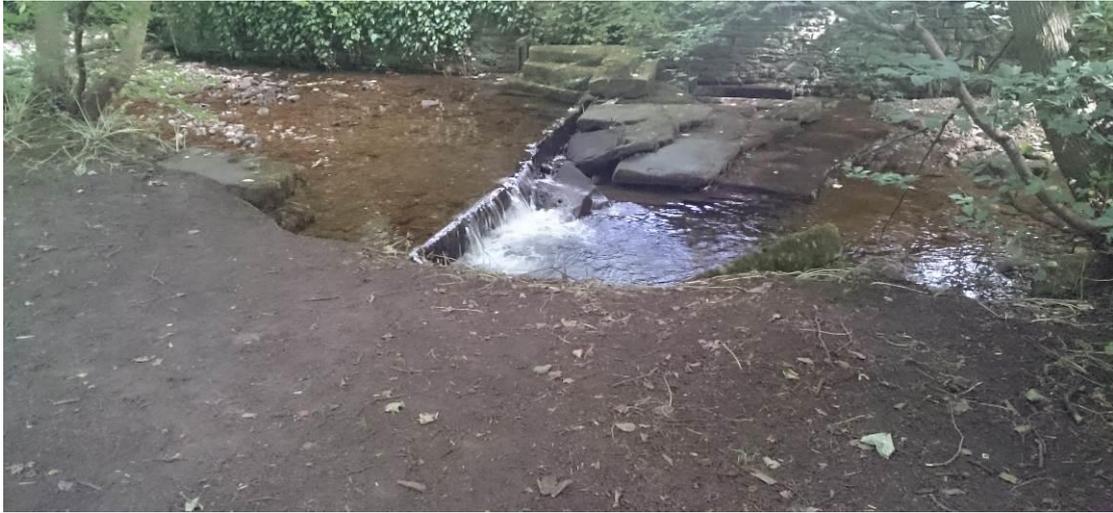
**Fig 24. The eroded bank viewed from the footpath that was previously viewed from the beck in Fig 15. The path is undercut, a danger in itself to walkers, and will continue to erode from both sides unless mitigation measures are put in place.**

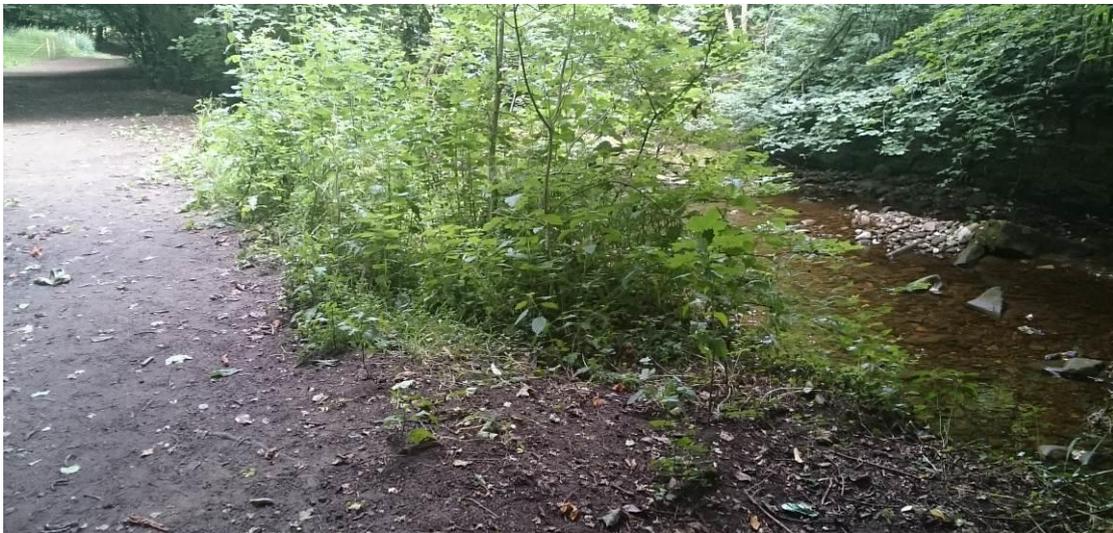
**Fig 25. A small parcel of riparian herbaceous vegetation and young ash and sycamore trees that have managed to establish where light from the mature canopy allows, and the path has not encroached to the bank wall. This should be encouraged along much more of the RB but requires management so it does not prevent views of, nor denies access (at certain points) to the beck.**

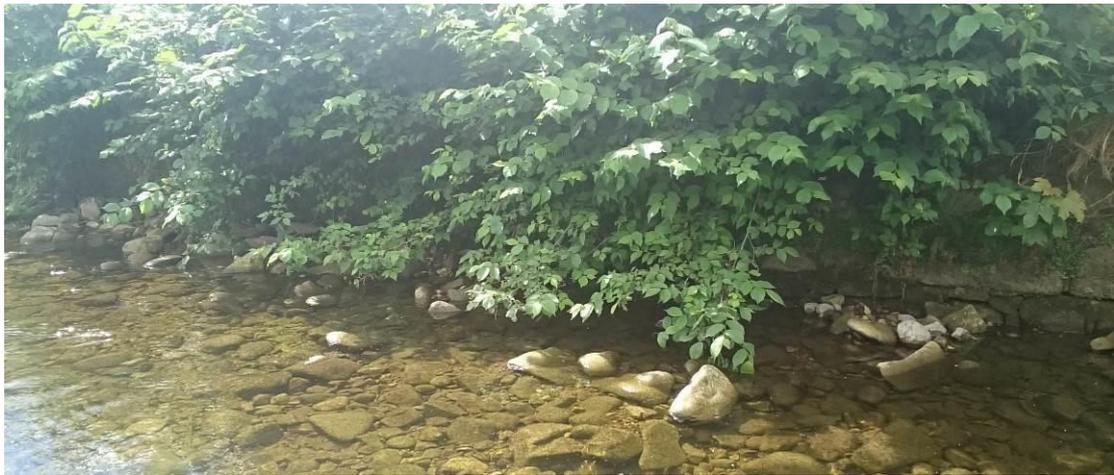
**Fig 26. Low overhanging vegetation with trailing branches are excellent holding habitat provided there is sufficient water depth beneath.**

Better light access to the toes of the walls will also encourage vegetation to grow as it does u/s of the shading influence of Lyndhurst Wood (e.g. Fig 26), thereby providing better cover for fish, especially emergent fry, and extending the safe feeding lies of larger individuals further into the channel. A simple adaptation of hedge laying techniques to 'hinge' bankside scrub vegetation into the margins of the stream where the depth is around 30 cm or less would quickly and easily achieve this.

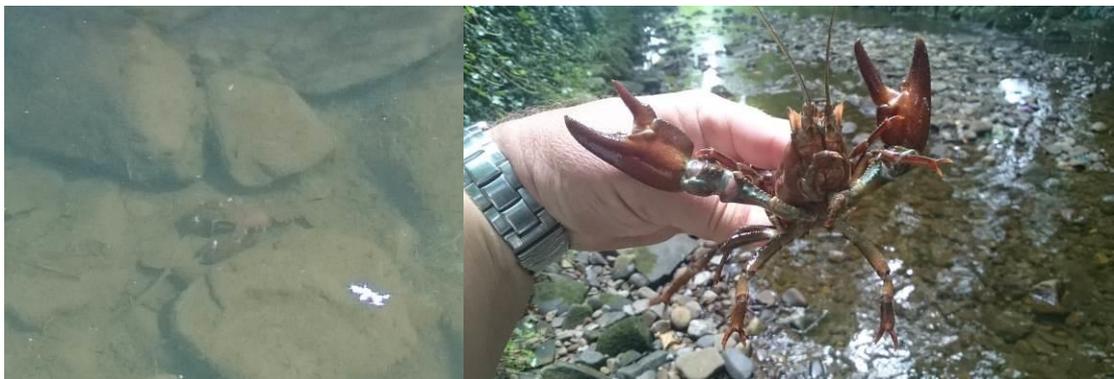
Signal crayfish were caught by hand when stone turning, and were observed walking around the deeper pools below weirs throughout the entire walked stretch (Fig 27). Clearly the weirs do not constitute any form of preventative barrier to their dispersal. There is currently no effective eradication method. It might be worthwhile placing signage, advising of the impacts of these crayfish, asking the public not to move them around the catchment and informing them that it is a criminal offence to do so.

**Fig 27. Mature and juvenile signal crayfish were observed throughout the walked stretch of Eastburn Beck.**
