Advisory Visit

River Elwy, Rhyl & St. Asaph Angling Association

May 2017

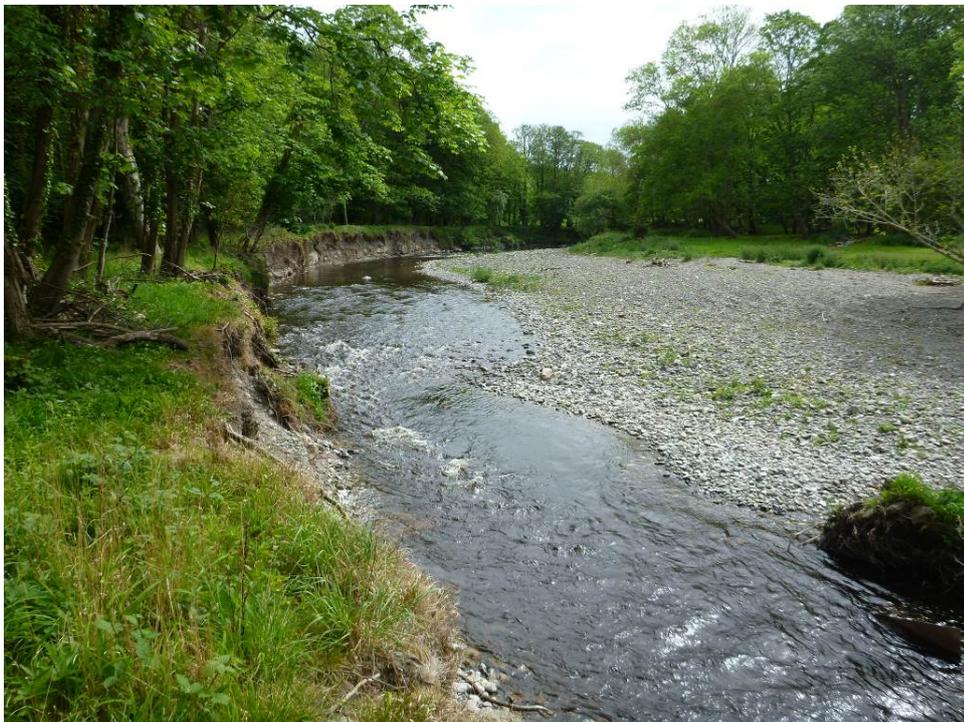
The actively eroding bank is on the right hand bank adjacent to the steeply sloping, wooded valley side leading down from Bryn-polyn Nurseries (Photos 1 & 2). RSAAA members and the landowner stated that the channel had been realigned here in the past and previously it had been further to the east, closer to the base of the valley slope. A relict channel is visible in the wood (and on Figure 1, the small pond on the RHB).

RSAAA are concerned at the accelerated rate of erosion taking place along this section of bank and the shallowing of pools downstream where sediment has accumulated (Photo 3). It was suggested that trees which had fallen in from the RHB (and subsequently been removed) may be responsible for the changes seen, but this is unlikely; the falling trees are a symptom of changes rather than its underlying cause.

A detailed assessment by a fluvial geomorphologist is required to identify the underlying cause(s) of the channel instability and accelerated bank erosion here. It is not possible to advise on what might be done practically without that understanding. Measures to protect the bank or divert the flow are not recommended in the meantime and are likely to fail in such a high-energy river environment, or even be counterproductive. Factors that could be contributing to the channel instability include:

Photo 1 Actively eroding bank, upstream view.

- Seek advice from a professional fluvial geomorphologist on the root causes of the bank erosion and downstream sediment accumulation at Bryn-polyn.
- Identify the conditions attached to the hydropower development and fish pass at Penucha-ro-fawr weir and check that they are being met. If enforcement of the conditions is required, request this in writing from the Local Planning Authority and NRW as appropriate.

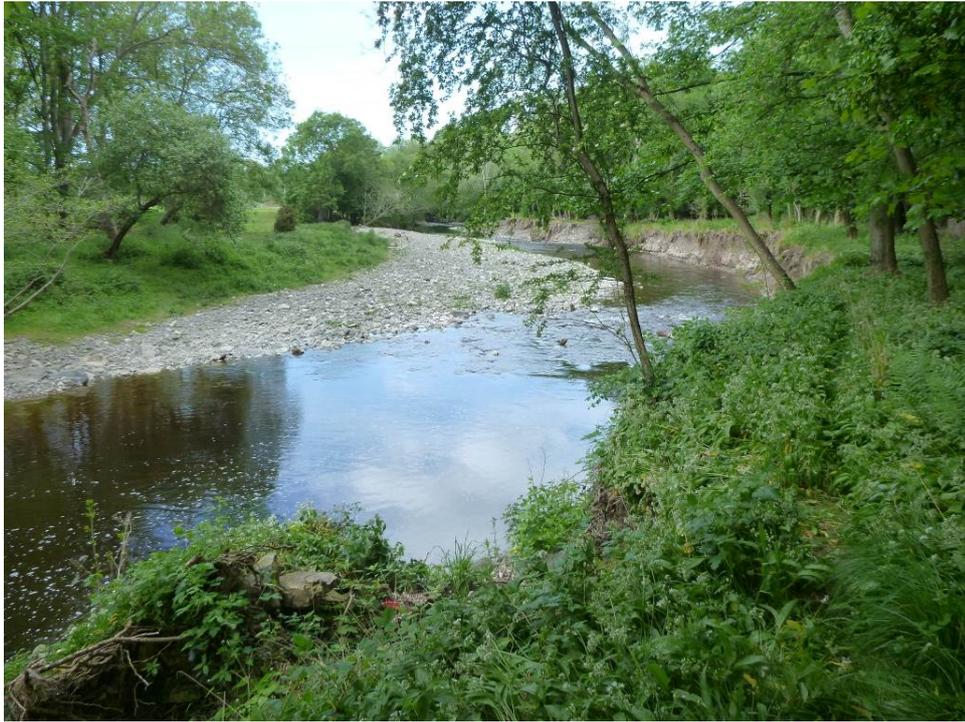
Photo 2 Actively eroding bank, downstream view.

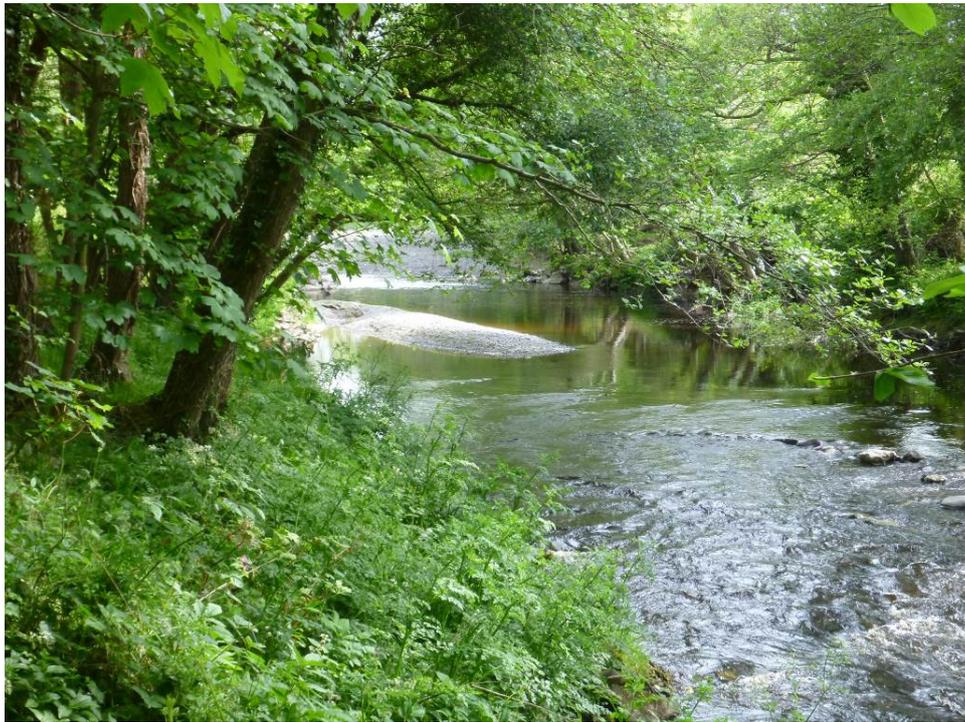
Photo 3 Pool immediately downstream of the reach shown in Photos 1 and 2, showing the gravel bar, a recently formed feature which is shallowing an established fishing pool.

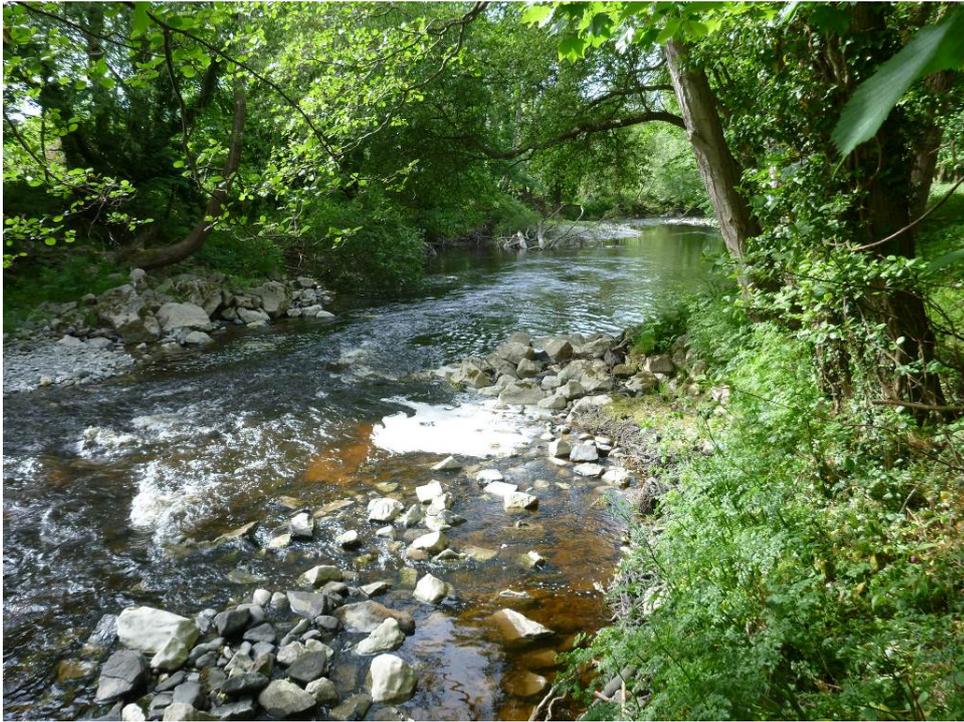
Subsequent research using old maps available online (www.old-maps.co.uk) gives an indication of the historic plan-form of the channel in this location. Figures 2 – 5 in the Appendix give examples of historic maps for this location and indicate that there was a weir and sluice here circa 1892, but it had disappeared by 1899. This weir is shown supplying water to a mill channel on the RHB leading to a hydraulic pump at Bryn-Elwy and returning to the main river just upstream of Bryn-Asaph. The river is shown following the course further east up until the mid-1960s, after which it is shown as straightened with four new weirs; the latter are presumably the blockstone channel constrictions seen on this visit (Photos 4 and 5).

Photo 4 Blockstone channel pinch points which are presumably the features described as weirs on the 1960s maps following the realignment of the river course.

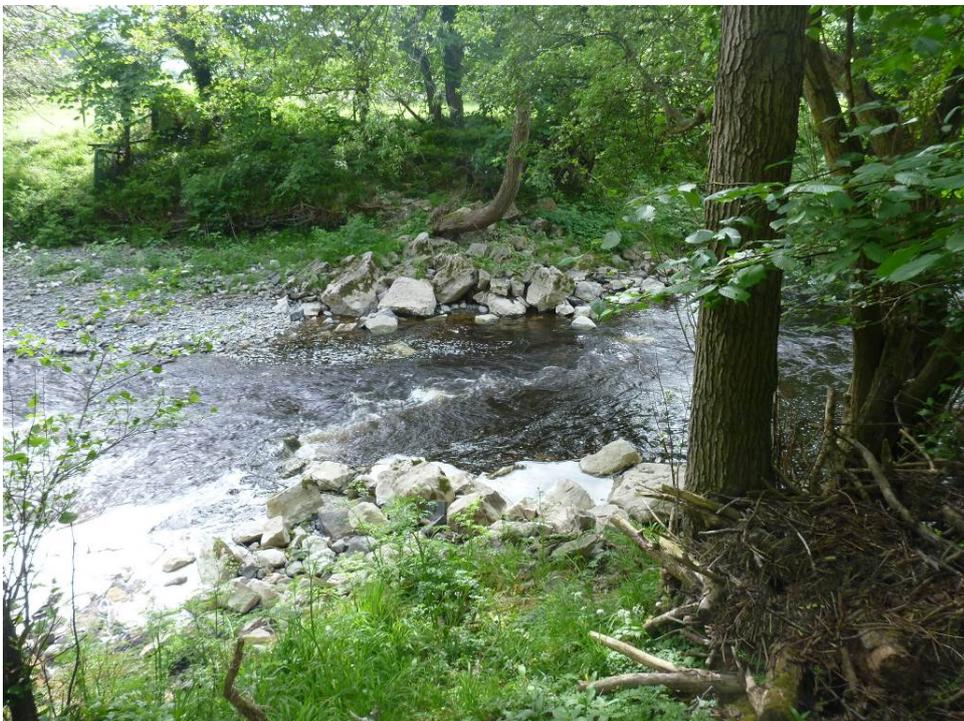
Photo 5 As above

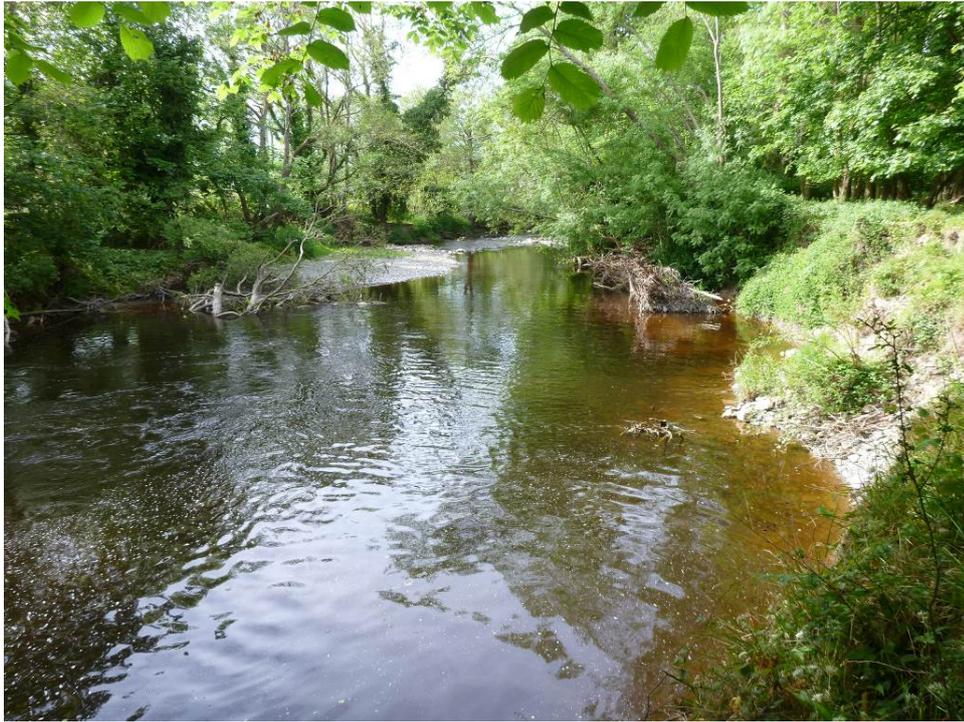
Photo 6 A deep pool downstream of the above flume.

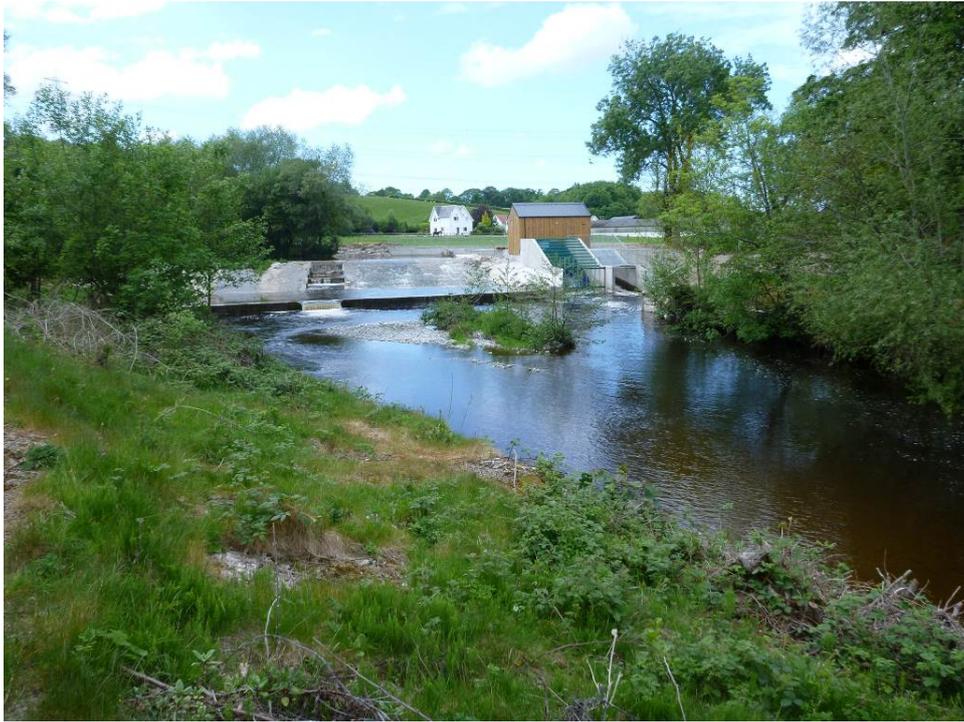
The scheme consists of a single large Archimedes screw turbine with a Larinier fish pass alongside it against the LHB (Photos 7 and 8). Prior to the construction of the scheme, fish passage was provided by a pool-traverse fish pass in the centre of the weir and a notched pre-barrage at the downstream extent of the weir structure; the pool-traverse channel remains, but the upstream end of the pass has been sealed (Photo 9) to concentrate the attraction flow for upstream migrants in the vicinity of the new fish pass entrance.

Photo 7 Upstream view towards the weir at Penucha-ro-fawr with recently installed hydropower facility.

It is recommended that RSAAA check what conditions apply to the hydropower development and that they are being met. As the development was the subject of a planning appeal, the Inspector may have attached relevant conditions to ensure the site operated in a proper way. The fish pass approval process operated via Natural Resources Wales (NRW) should have a condition for the operator to show that the fish pass is working effectively.

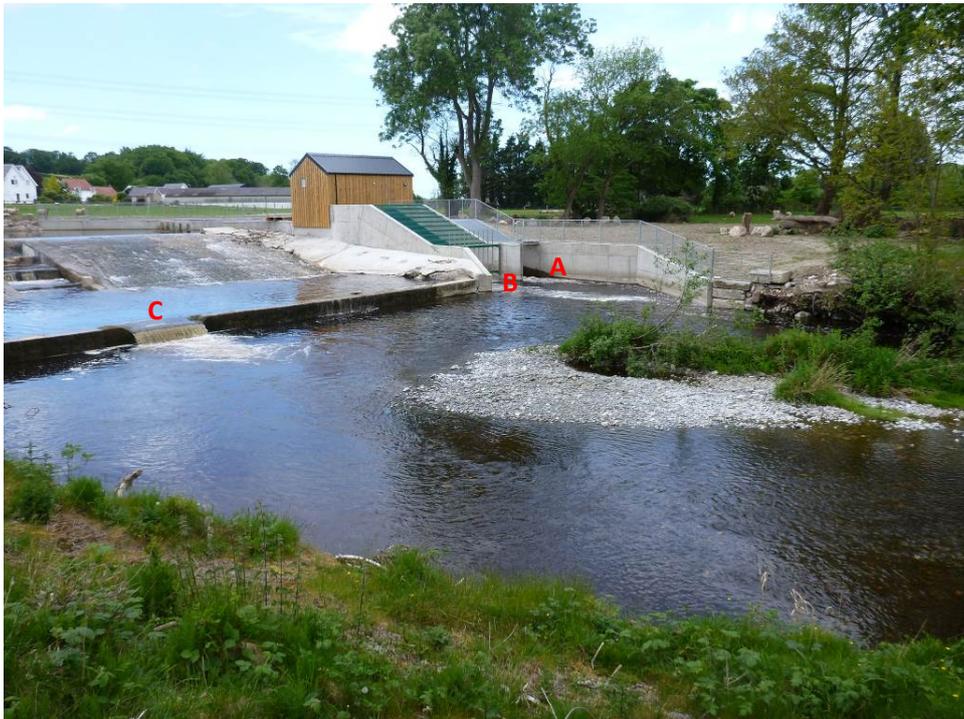
At the time of the visit, the turbine was not in use, presumably because the flow in the river was less than a hands-off flow condition. The flow across the structure was therefore split between the fish pass (against the left bank) and the central notch of the pre-barrage (Photo 8). This highlighted a

problem, i.e. when the turbine is not in use, there is a considerable attraction flow through the notch in the pre-barrage, potentially leading upstream migrants away from the entrance to the new Larinier fish pass and into a “blind alley”. Relocation of the notch in the pre-barrage closer to the left bank or removal of the entire pre-barrage may alleviate this issue.

Photo 8 Closer view of the above weir, showing location of fish pass entrance (A) (far side of the channel, against LHB), the adjacent Archimedes screw turbine (B) and the flow through the central notch of the weir pre-barrage (C). The turbine was not operating at the time of the visit, presumably because of a hands-off flow condition in lower flows.

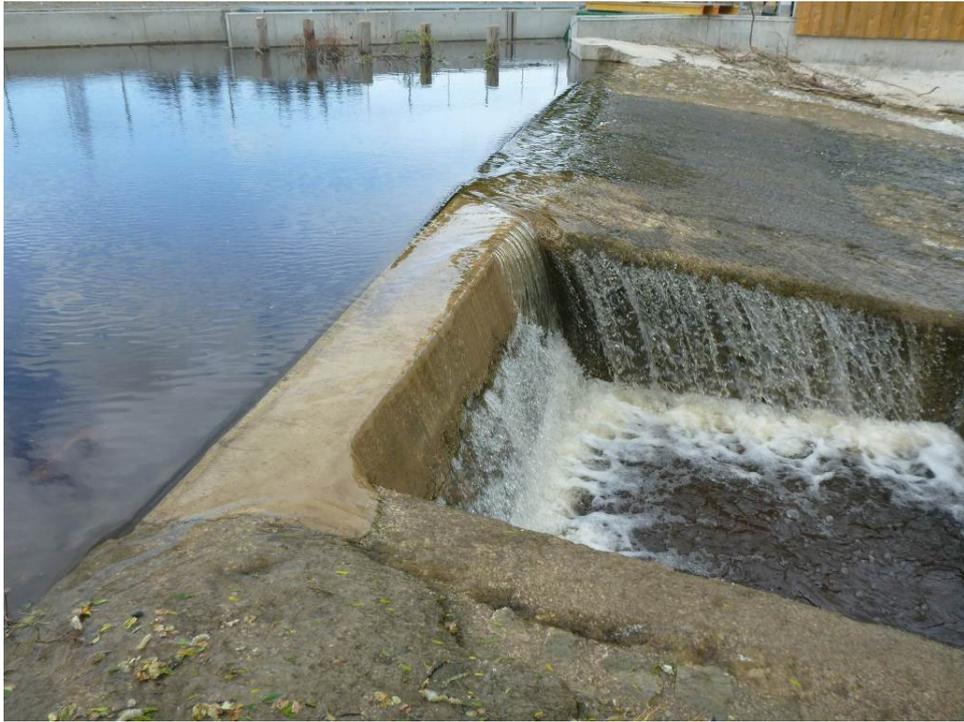
The sealing of the upstream end of the former pool-traverse pass has effectively raised the level of the weir crest, diverting more flow to the new fish pass and turbine. This has increased the impounding effect in the reach upstream of the weir, exacerbating the interruption of sediment transport caused by the weir, with potential impacts on the downstream reach (see comments above, pages 4 – 5). If gravel has been removed from upstream of the weir (Photo 16) this could also have reduced the rate of sediment transport across the weir.

Photo 9 Upstream end of the former pool-traverse fish pass in the centre of the weir, now sealed off.

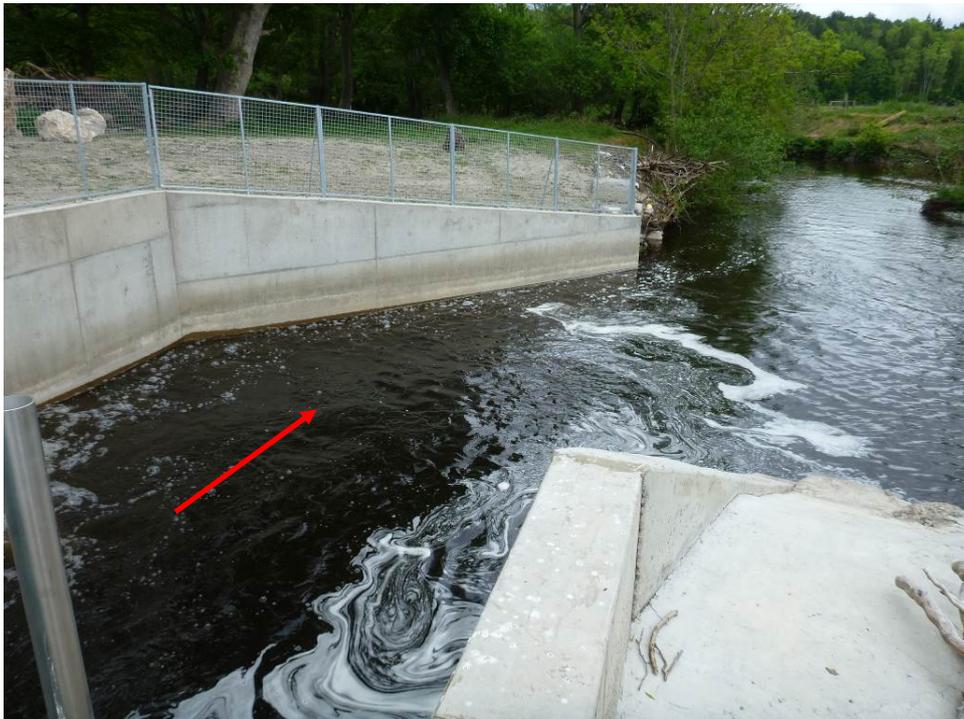
Presumably when the turbine is operating, the main flow is concentrated near the new fish pass, providing attraction flow. However, it is striking how large the screw turbine is for this location, which raises questions over whether it is appropriate (and the consented size?) for the prevailing flow regime in the Elwy. Another potential issue was illustrated in video footage taken by an RSAAA committee member of the turbine in operation (<https://youtu.be/EypXoDuMwbo>); this shows the turbine generating large waves which are reflecting off the concrete retaining wall opposite (Photo 10) and likely reducing the attraction for fish towards the fish pass entrance beyond.

Photo 10 Area downstream of the fish pass and turbine, showing how the wall opposite cuts across the flow (arrow), reflecting the large waves caused when the turbine is in operation and potentially impacting upon the effectiveness of the fish pass.

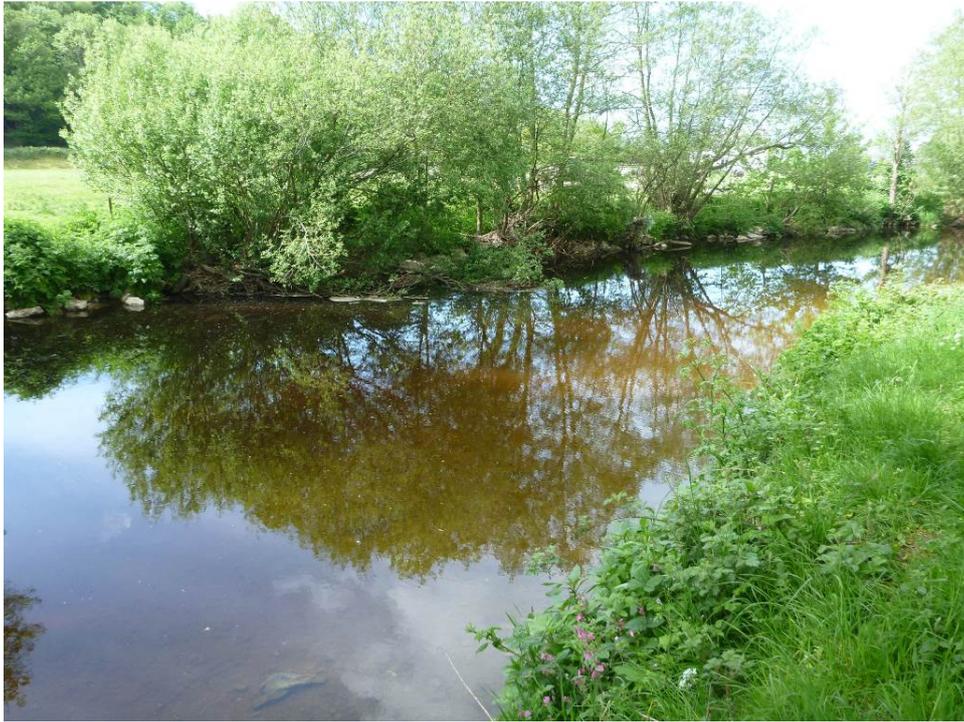
Photo 11 Impounded reach upstream of the weir.

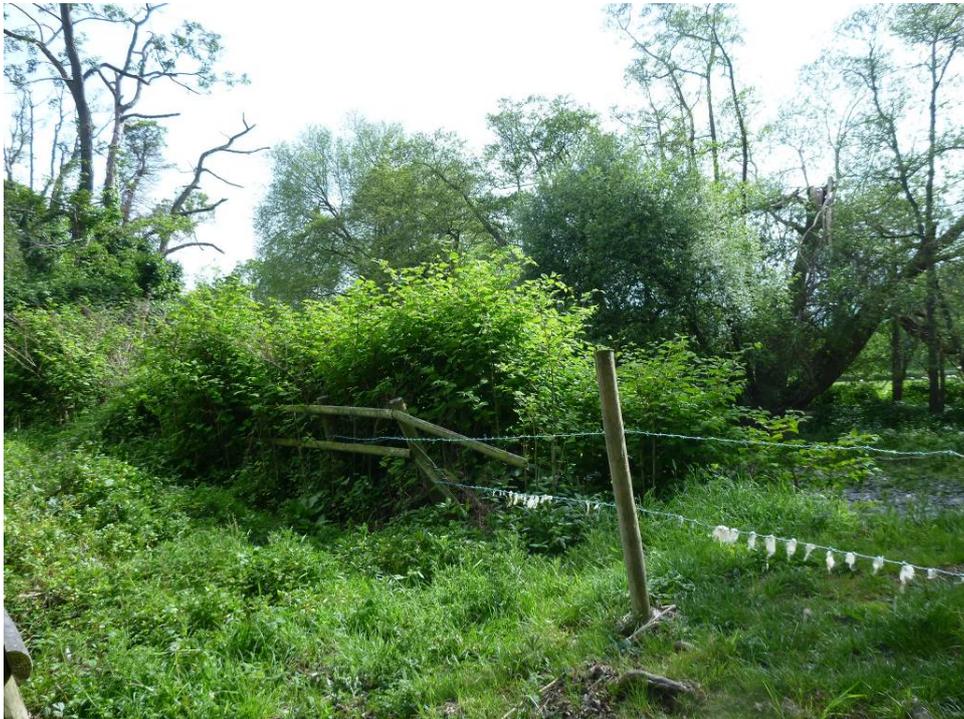
Photo 12 A stand of Japanese knotweed (*Fallopia japonica*) at grid reference SJ0381672288.

A stand of Japanese knotweed was observed during the visit (Photo 12). This should be treated appropriately to prevent its spread. Stem injection of herbicide by an appropriately trained person is the best method. It should on no account be strimmed or flailed, as this plant can propagate itself from small fragments.

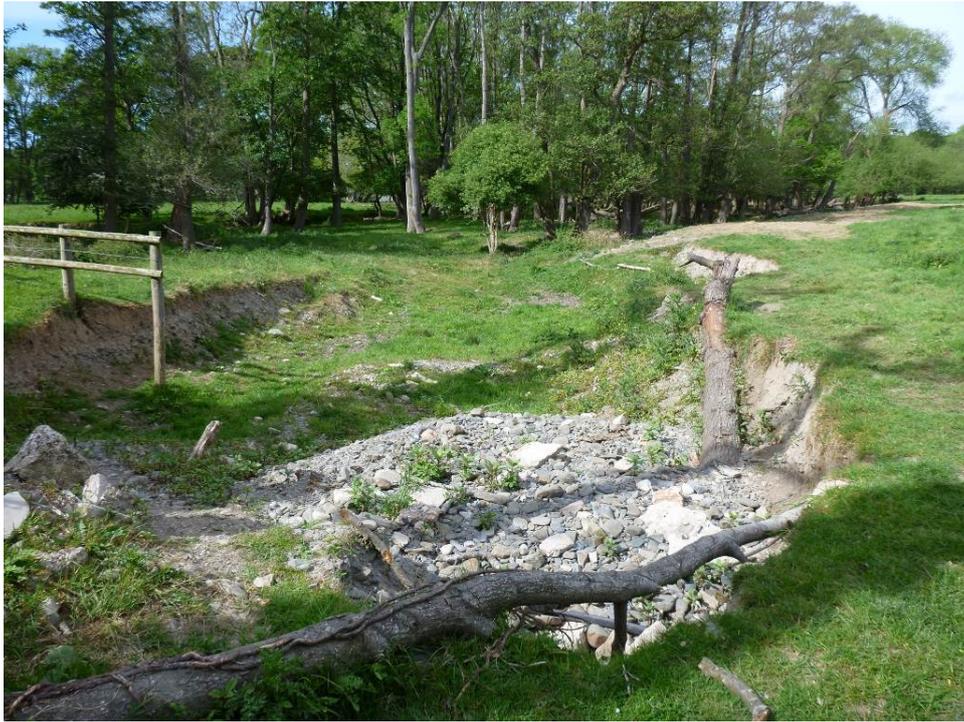
The effective increase in weir crest height may also have implications for flood flows circumventing the weir via a relict channel which bypasses the meander (Photos 13 – 15). The channel is visible on the 1874-92 map (Figure 3, Appendix), labelled COCR (Centre of Old Course of River). It is too straight to have been a former natural course and may have been a temporary flow diversion during original construction of the weir, which was subsequently back-filled. RSAAA report that during floods in recent years, mass slippage of material has occurred at the downstream end of this channel, caused by water seeping through and destabilising the ground (Photo 15). If flood flows and/or sub-surface flows are being diverted via this channel more regularly, there is the potential for the river to eventually break through and bypass the weir.

Photo 13 Former channel which cuts off the meander with Penucha-ro-fawr weir at its apex. This is visible on the 1874-92 map (Figure 3, Appendix), labelled COCR (Centre of Old Course of River). It is too straight to have been a former natural course and may have been a temporary flow diversion during weir construction that was subsequently back-filled.

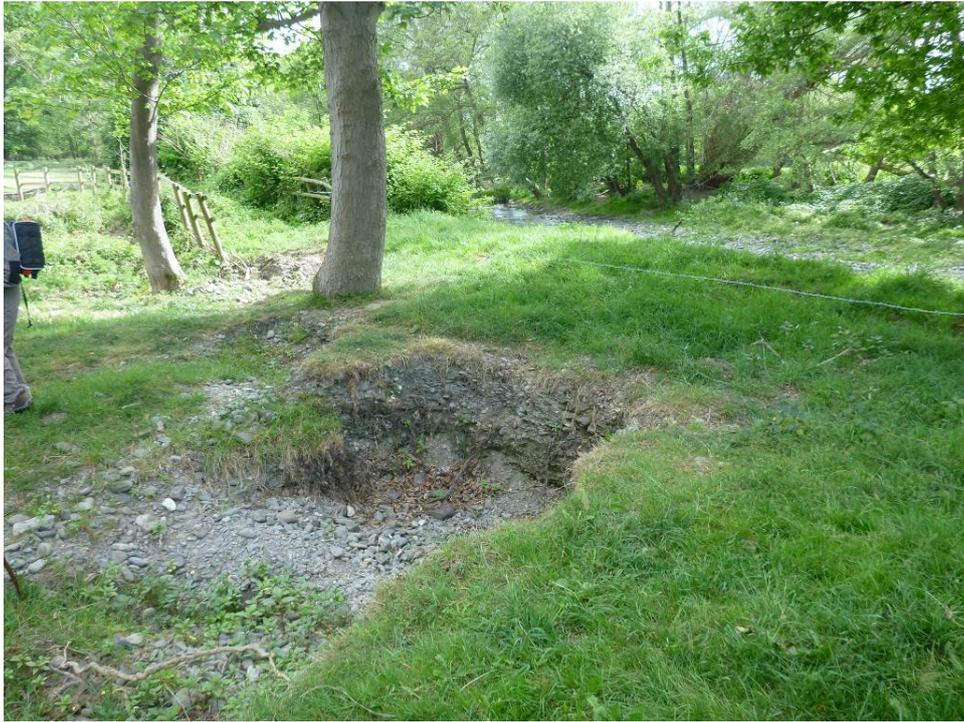
Photo 14 Upstream end of above channel with river in the background – a plug of made-up ground that is being eroded by successive floods weiring over the bank?

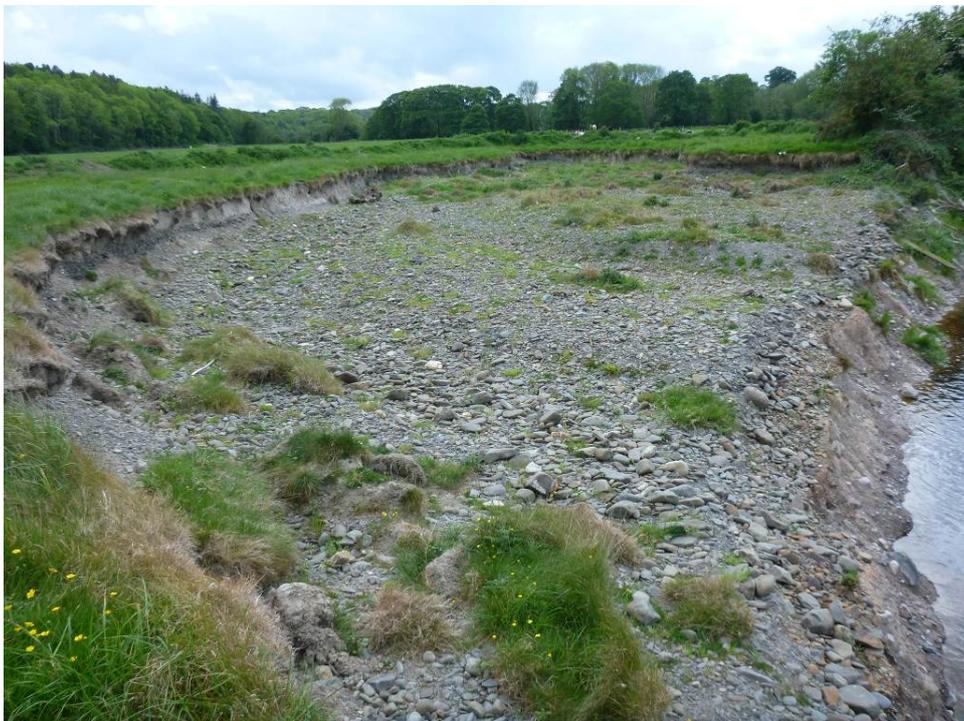
Photo 15 Downstream end of above channel, where mass slippage of ground has occurred during floods in recent years. This may be a symptom of it being made-up ground from when the channel was back-filled.

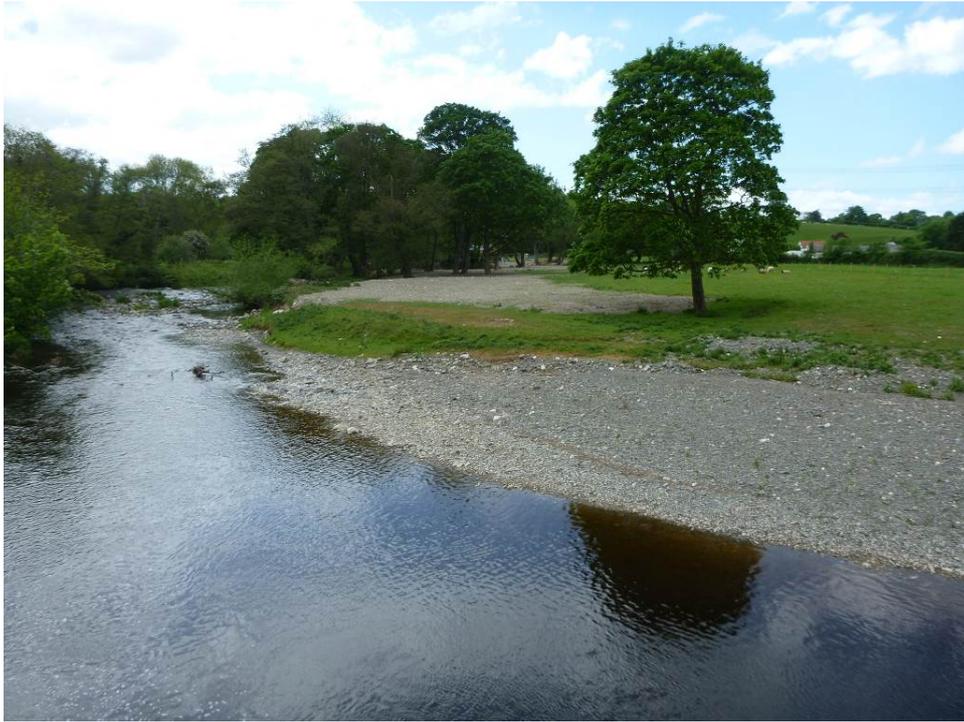
Photo 16 View across to the LHB opposite the location in Photo 14 (downstream of the weir). Note the gravel spread on the floodplain, possibly spoil from the hydropower construction.
