**Advisory Visit**

**River Elwy, Rhyl & St. Asaph Angling Association**

**May 2017**

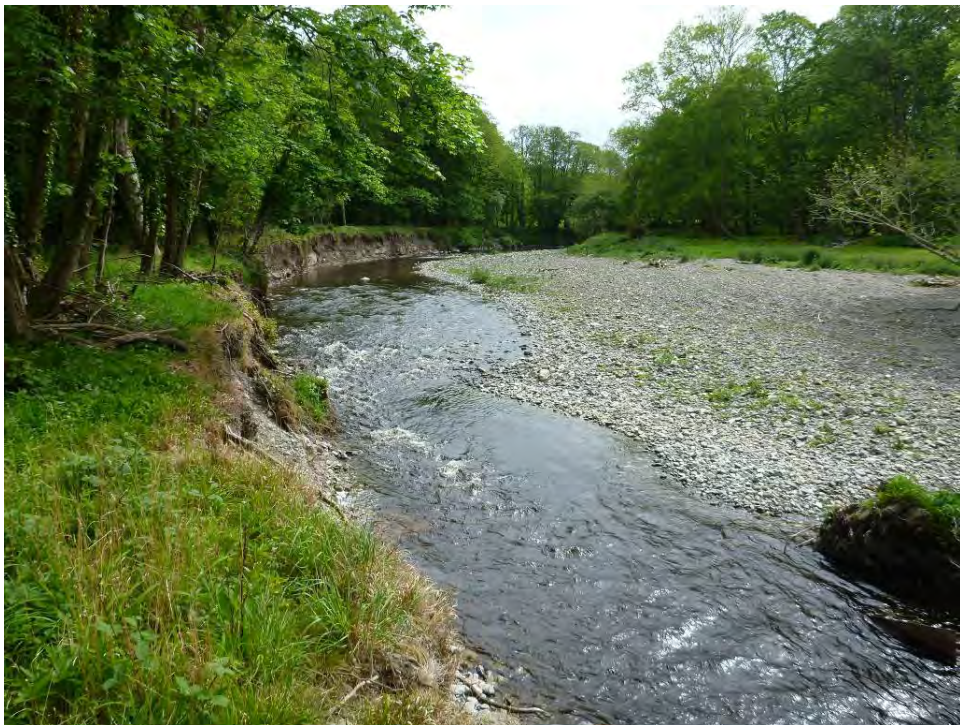
The actively eroding bank is on the right hand bank adjacent to the steeply sloping, wooded valley side leading down from Bryn-polyn Nurseries (Photos 1 & 2). RSAAA members and the landowner stated that the channel had been realigned here in the past and previously it had been further to the east, closer to the base of the valley slope. A relict channel is visible in the wood (and on Figure 1, the small pond on the RHB).

A detailed assessment by a fluvial geomorphologist is required to identify the underlying cause(s) of the channel instability and accelerated bank erosion here. It is not possible to advise on what might be done practically without that understanding. Measures to protect the bank or divert the flow are not recommended in the meantime and are likely to fail in such a high-energy river environment, or even be counterproductive. Factors that could be contributing to the channel instability include:

**Photo 1 Actively eroding bank, upstream view.**

- Seek advice from a professional fluvial geomorphologist on the root causes of the bank erosion and downstream sediment accumulation at Bryn-polyn.
- Identify the conditions attached to the hydropower development and fish pass at Penucha-ro-fawr weir and check that they are being met. If enforcement of the conditions is required, request this in writing from the Local Planning Authority and NRW as appropriate.

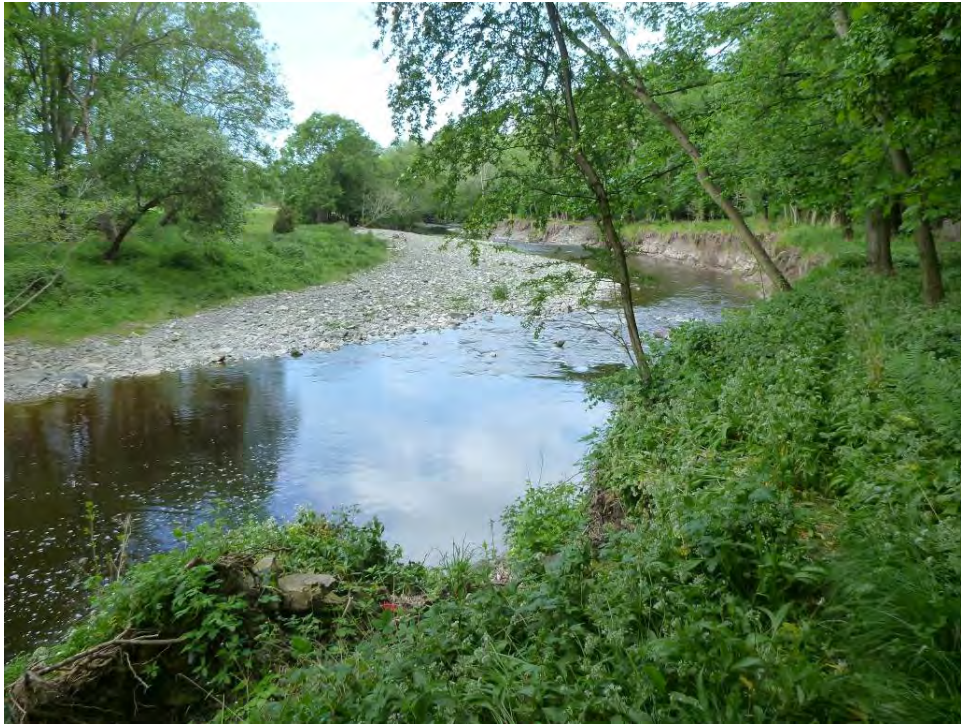
**Photo 2 Actively eroding bank, downstream view.**

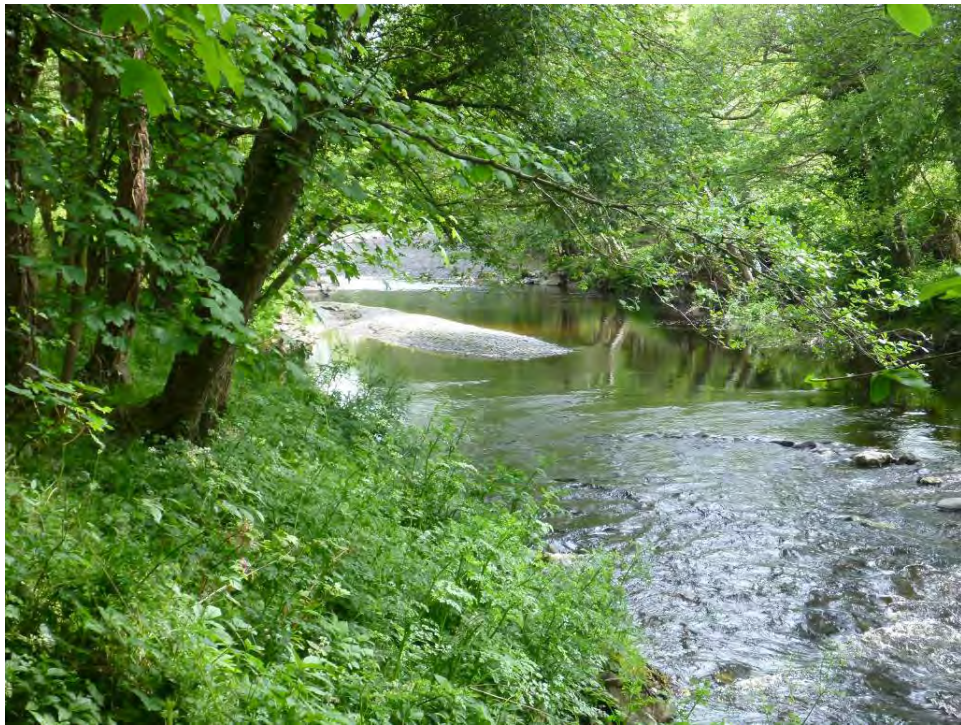
RSAAA are concerned at the accelerated rate of erosion taking place along this section of bank and the shallowing of pools downstream where sediment has accumulated (Photo 3). It was suggested that trees which had fallen in from the RHB (and subsequently been removed) may be responsible for the changes seen, but this is unlikely; the falling trees are a symptom of changes rather than its underlying cause.

**Photo 3 Pool immediately downstream of the reach shown in Photos 1 and 2, showing the gravel bar, a recently formed feature which is shallowing an established fishing pool.**

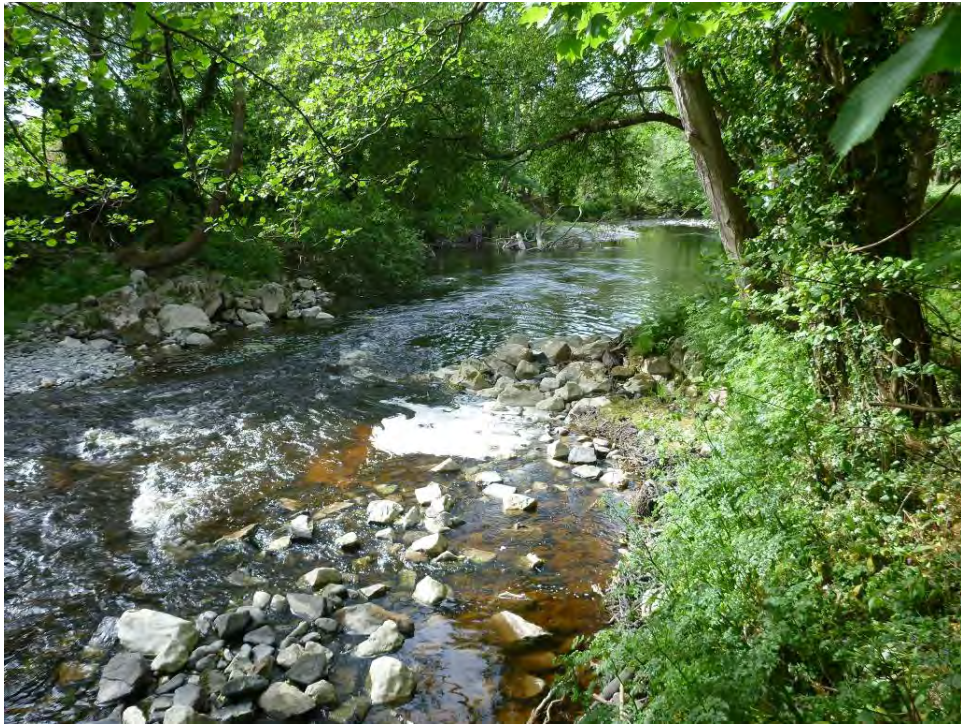
Subsequent research using old maps available online ([www.old-maps.co.uk](http://www.old-maps.co.uk)) gives an indication of the historic plan-form of the channel in this location. Figures 2 – 5 in the Appendix give examples of historic maps for this location and indicate that there was a weir and sluice here circa 1892, but it had disappeared by 1899. This weir is shown supplying water to a mill channel on the RHB leading to a hydraulic pump at Bryn-Elwy and returning to the main river just upstream of Bryn-Asaph. The river is shown following the course further east up until the mid-1960s, after which it is shown as straightened with four new weirs; the latter are presumably the blockstone channel constrictions seen on this visit (Photos 4 and 5).

**Photo 4 Blockstone channel pinch points which are presumably the features described as weirs on the 1960s maps following the realignment of the river course.**

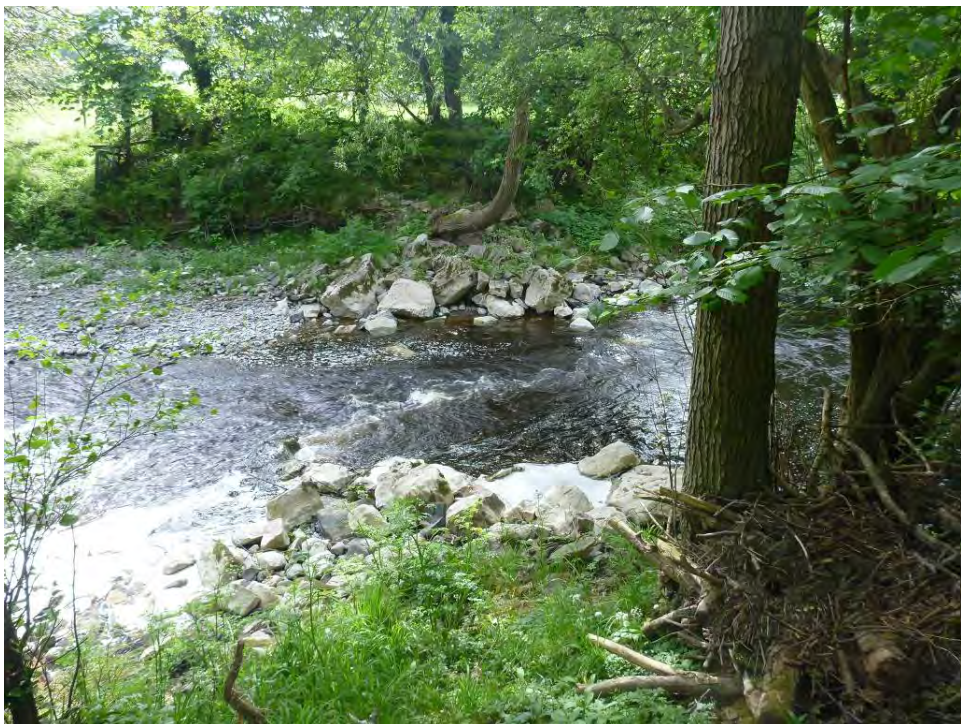
**Photo 5 As above**

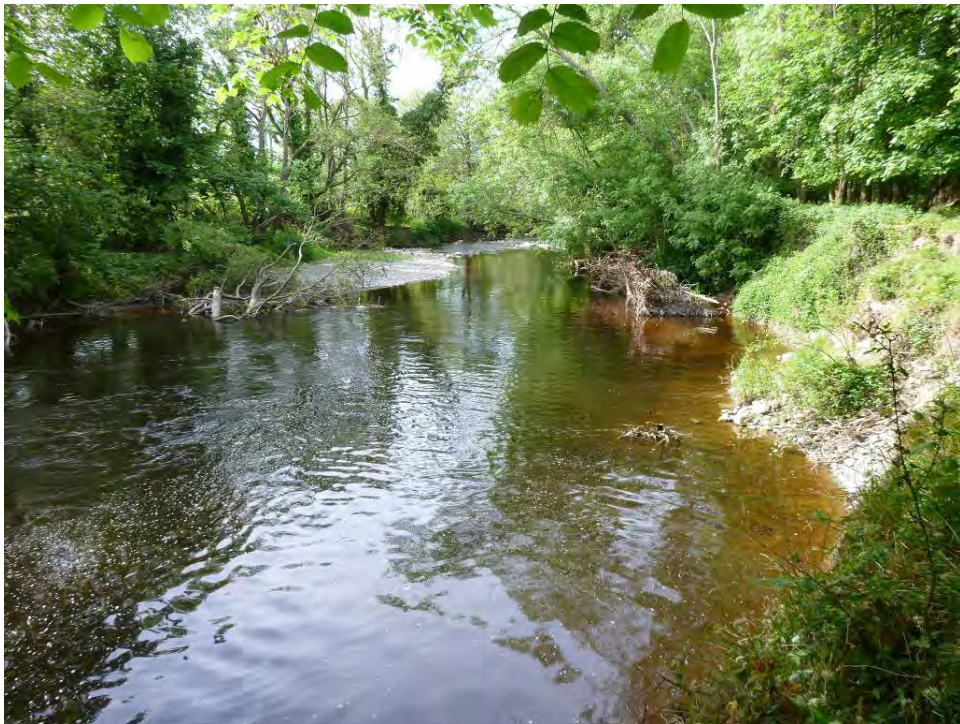
**Photo 6 A deep pool downstream of the above flume.**

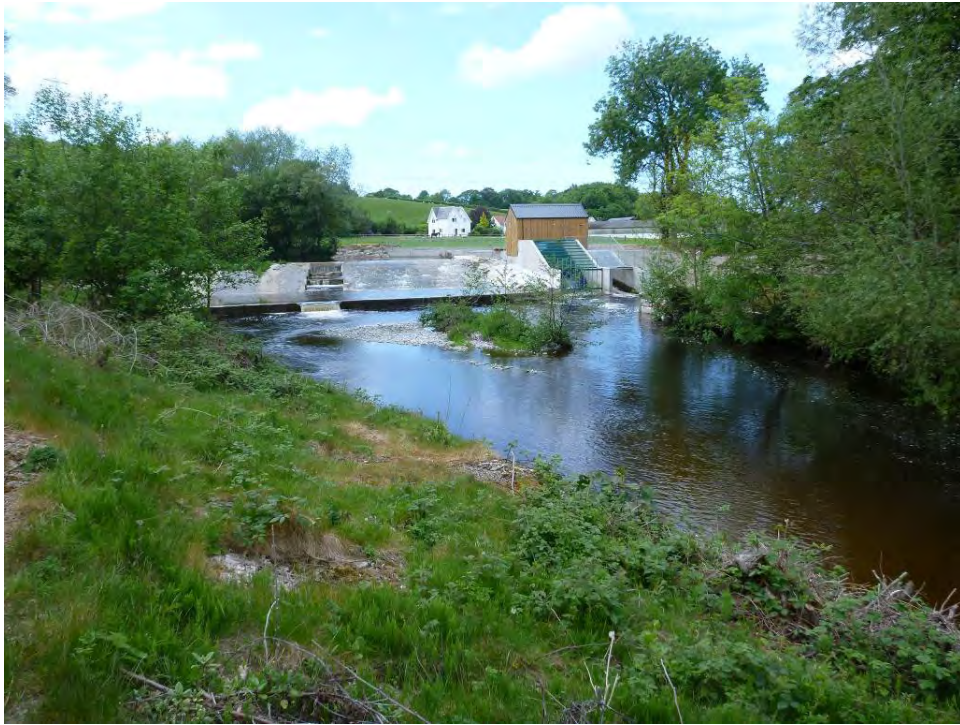
The scheme consists of a single large Archimedes screw turbine with a Larinier fish pass alongside it against the LHB (Photos 7 and 8). Prior to the construction of the scheme, fish passage was provided by a pool-traverse fish pass in the centre of the weir and a notched pre-barrage at the downstream extent of the weir structure; the pool-traverse channel remains, but the upstream end of the pass has been sealed (Photo 9) to concentrate the attraction flow for upstream migrants in the vicinity of the new fish pass entrance.

**Photo 7 Upstream view towards the weir at Penucha-ro-fawr with recently installed hydropower facility.**

It is recommended that RSAAA check what conditions apply to the hydropower development and that they are being met. As the development was the subject of a planning appeal, the Inspector may have attached relevant conditions to ensure the site operated in a proper way. The fish pass approval process operated via Natural Resources Wales (NRW) should have a condition for the operator to show that the fish pass is working effectively.

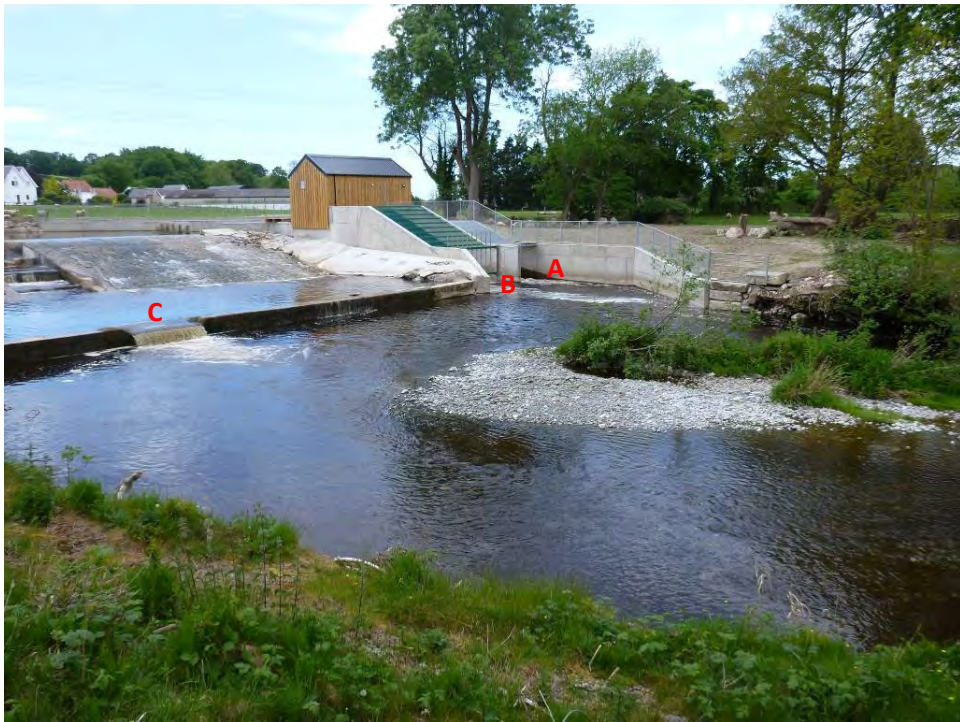
At the time of the visit, the turbine was not in use, presumably because the flow in the river was less than a hands-off flow condition. The flow across the structure was therefore split between the fish pass (against the left bank) and the central notch of the pre-barrage (Photo 8). This highlighted a

problem, i.e. when the turbine is not in use, there is a considerable attraction flow through the notch in the pre-barrage, potentially leading upstream migrants away from the entrance to the new Larinier fish pass and into a “blind alley”. Relocation of the notch in the pre-barrage closer to the left bank or removal of the entire pre-barrage may alleviate this issue.

**Photo 8 Closer view of the above weir, showing location of fish pass entrance (A) (far side of the channel, against LHB), the adjacent Archimedes screw turbine (B) and the flow through the central notch of the weir pre-barrage (C). The turbine was not operating at the time of the visit, presumably because of a hands-off flow condition in lower flows.**

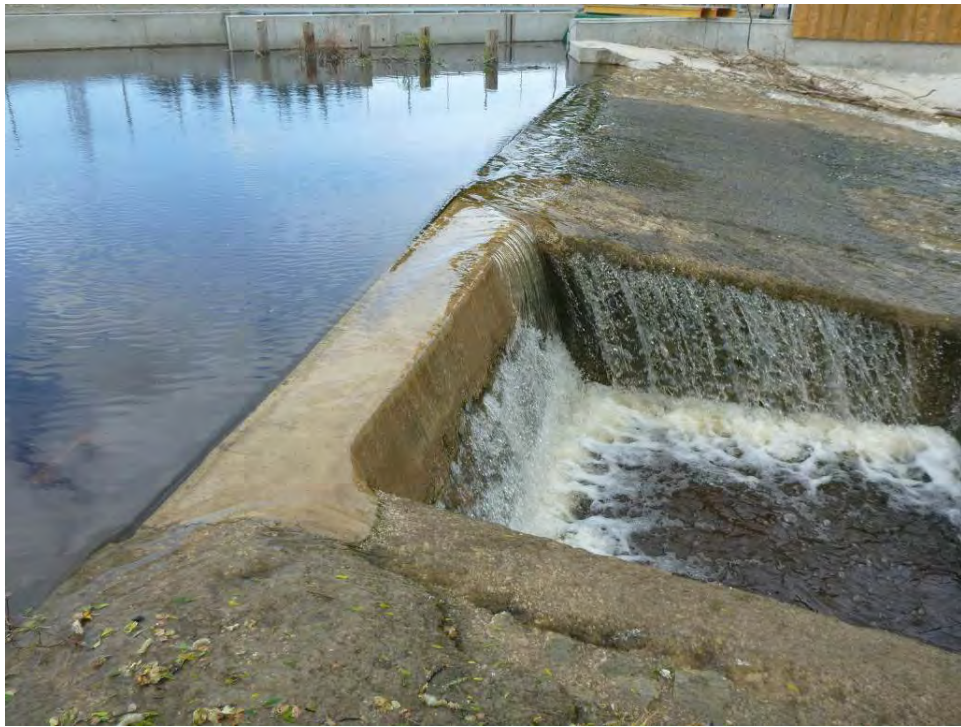
The sealing of the upstream end of the former pool-traverse pass has effectively raised the level of the weir crest, diverting more flow to the new fish pass and turbine. This has increased the impounding effect in the reach upstream of the weir, exacerbating the interruption of sediment transport caused by the weir, with potential impacts on the downstream reach (see comments above, pages 4 – 5). If gravel has been removed from upstream of the weir (Photo 16) this could also have reduced the rate of sediment transport across the weir.

**Photo 9 Upstream end of the former pool-traverse fish pass in the centre of the weir, now sealed off.**

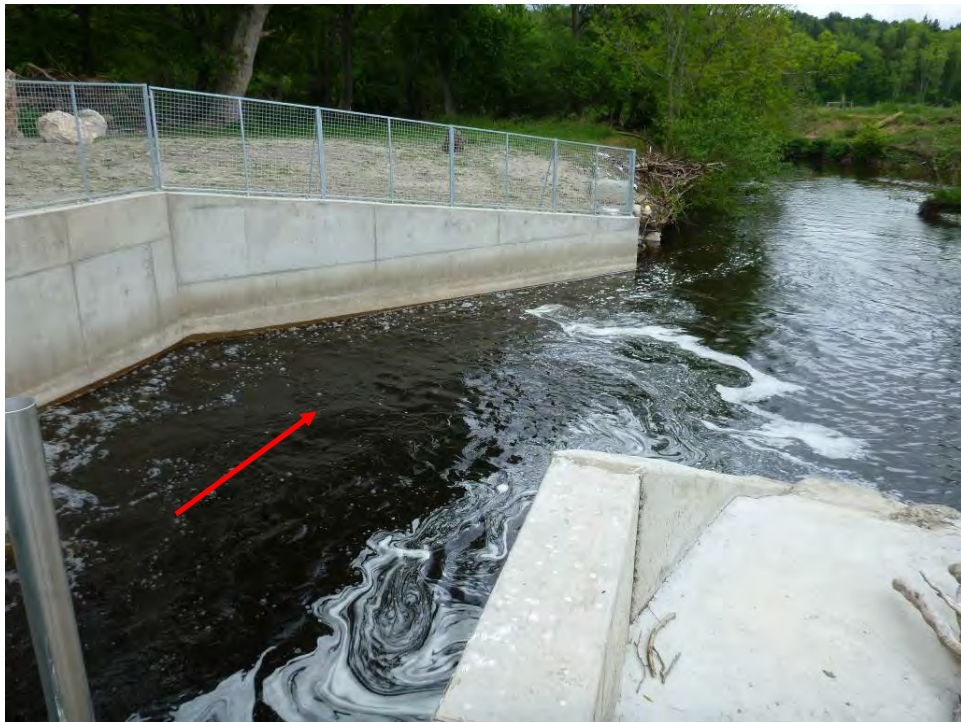
Presumably when the turbine is operating, the main flow is concentrated near the new fish pass, providing attraction flow. However, it is striking how large the screw turbine is for this location, which raises questions over whether it is appropriate (and the consented size?) for the prevailing flow regime in the Elwy. Another potential issue was illustrated in video footage taken by an RSAAA committee member of the turbine in operation (<https://youtu.be/EypXoDuMwbo>); this shows the turbine generating large waves which are reflecting off the concrete retaining wall opposite (Photo 10) and likely reducing the attraction for fish towards the fish pass entrance beyond.

**Photo 10 Area downstream of the fish pass and turbine, showing how the wall opposite cuts across the flow (arrow), reflecting the large waves caused when the turbine is in operation and potentially impacting upon the effectiveness of the fish pass.**

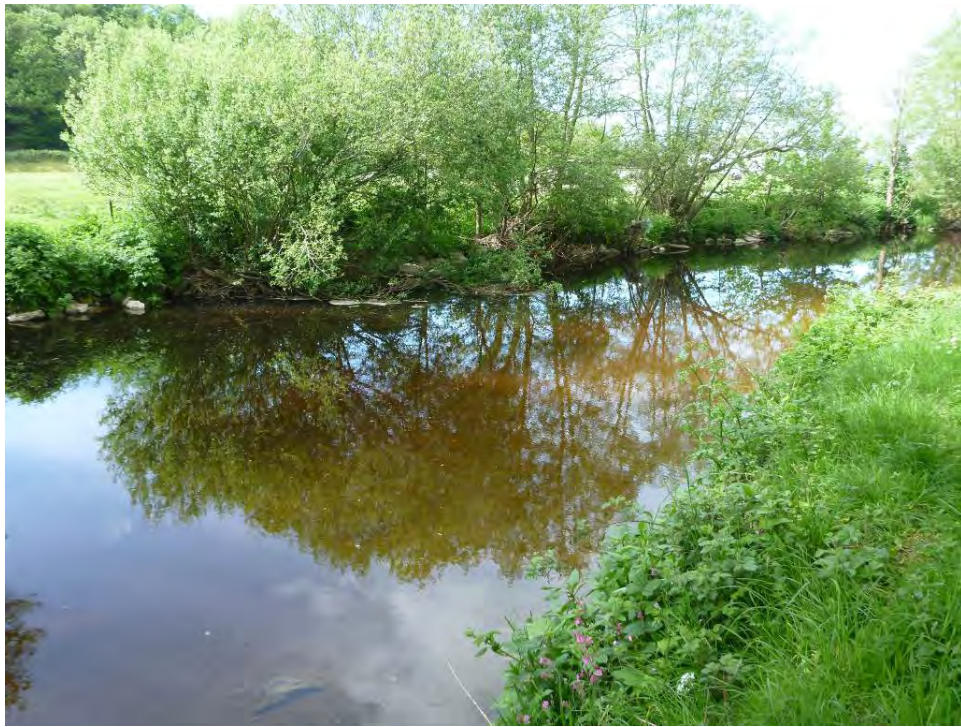
Photo 11 Impounded reach upstream of the weir.

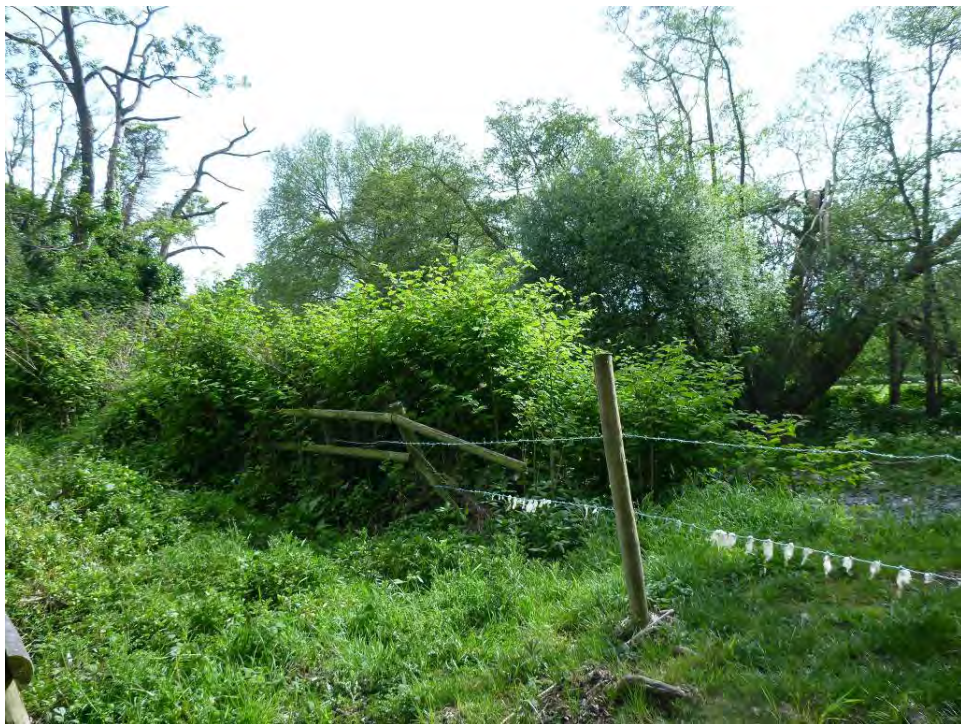
A stand of Japanese knotweed was observed during the visit (Photo 12). This should be treated appropriately to prevent its spread. Stem injection of herbicide by an appropriately trained person is the best method. It should on no account be strimmed or flailed, as this plant can propagate itself from small fragments.

Photo 12 A stand of Japanese knotweed (*Fallopia japonica*) at grid reference SJ0381672288.

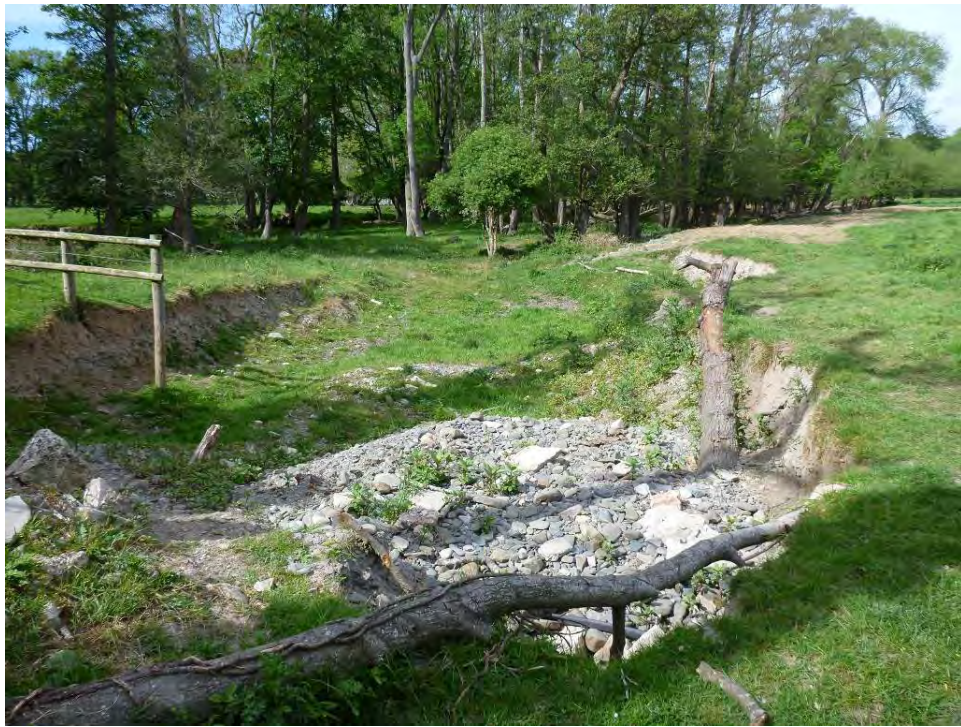
The effective increase in weir crest height may also have implications for flood flows circumventing the weir via a relict channel which bypasses the meander (Photos 13 – 15). The channel is visible on the 1874-92 map (Figure 3, Appendix), labelled COCR (Centre of Old Course of River). It is too straight to have been a former natural course and may have been a temporary flow diversion during original construction of the weir, which was subsequently back-filled. RSAAA report that during floods in recent years, mass slippage of material has occurred at the downstream end of this channel, caused by water seeping through and destabilising the ground (Photo 15). If flood flows and/or sub-surface flows are being diverted via this channel more regularly, there is the potential for the river to eventually break through and bypass the weir.

**Photo 13 Former channel which cuts off the meander with Penucha-ro-fawr weir at its apex. This is visible on the 1874-92 map (Figure 3, Appendix), labelled COCR (Centre of Old Course of River). It is too straight to have been a former natural course and may have been a temporary flow diversion during weir construction that was subsequently back-filled.**

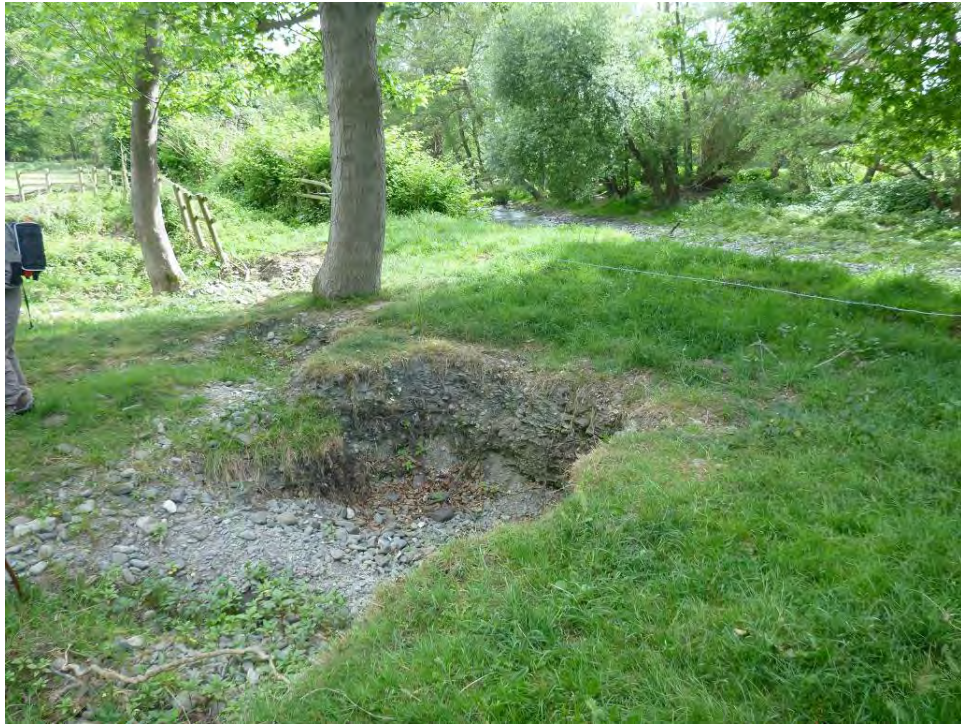
**Photo 14 Upstream end of above channel with river in the background – a plug of made-up ground that is being eroded by successive floods weiring over the bank?**

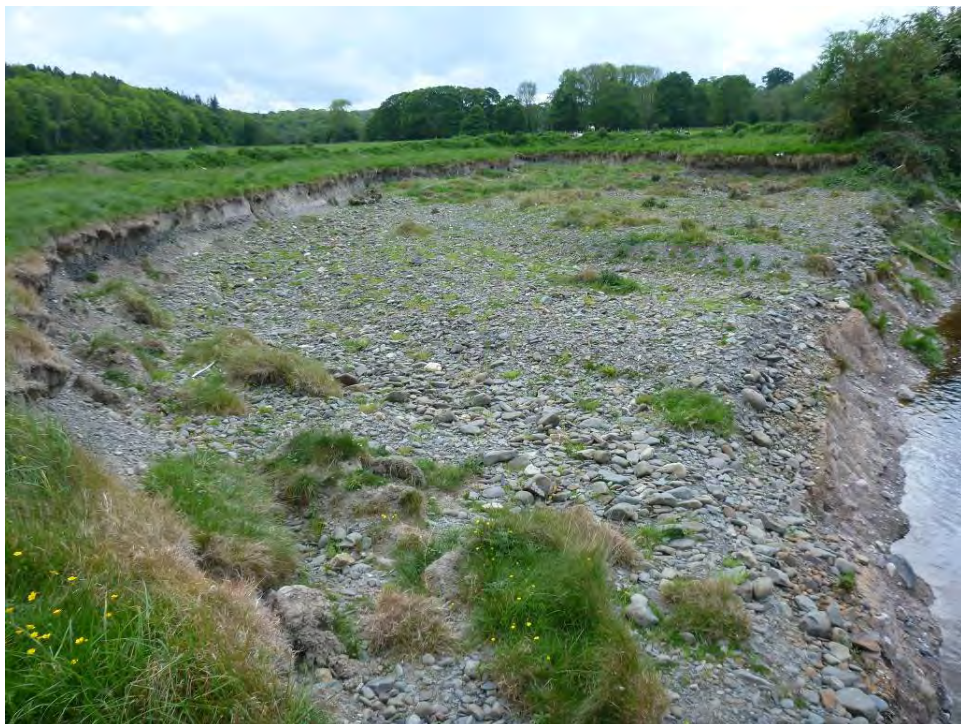
**Photo 15 Downstream end of above channel, where mass slippage of ground has occurred during floods in recent years. This may be a symptom of it being made-up ground from when the channel was back-filled.**

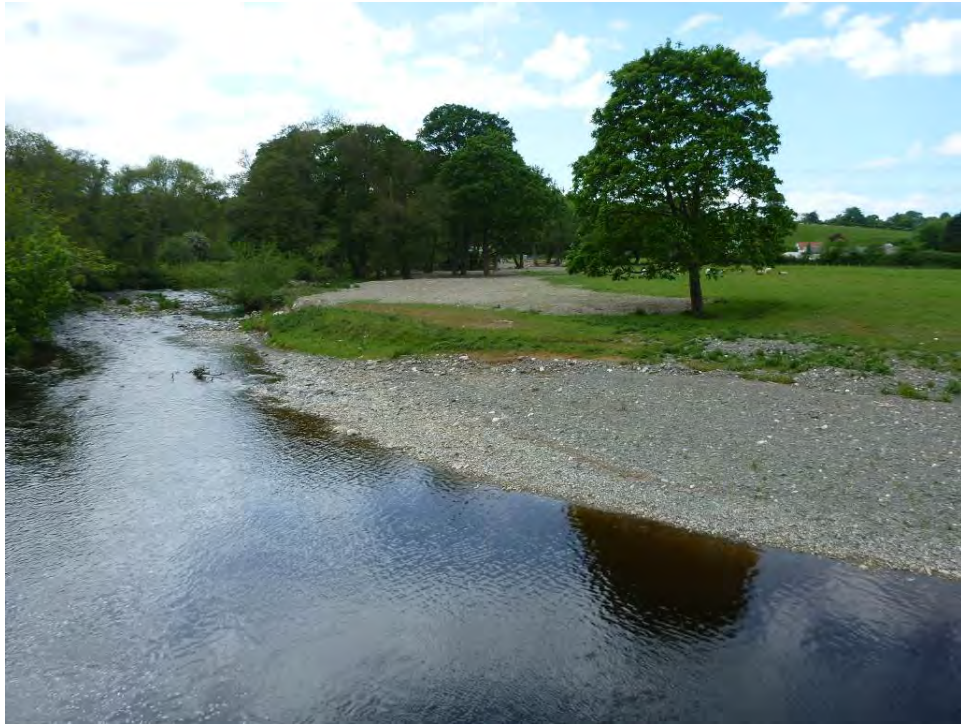
**Photo 16 View across to the LHB opposite the location in Photo 14 (downstream of the weir). Note the gravel spread on the floodplain, possibly spoil from the hydropower construction.**
