**Advisory Visit**  
**Endon Brook, Staffordshire**  
**January 2012**

## **1.0 Introduction**

This report is the output of a site visit undertaken by Tim Jacklin of the Wild Trout Trust to the Endon Brook, near Cheddleton, Staffordshire on 17<sup>th</sup> January, 2012. Comments in this report are based on observations on the day of the site visit and discussions with Mick Buxton (Fisheries Technical Officer), Carl Lea (Environment Officer) and Dan Griffiths (WFD Officer) of the Environment Agency.

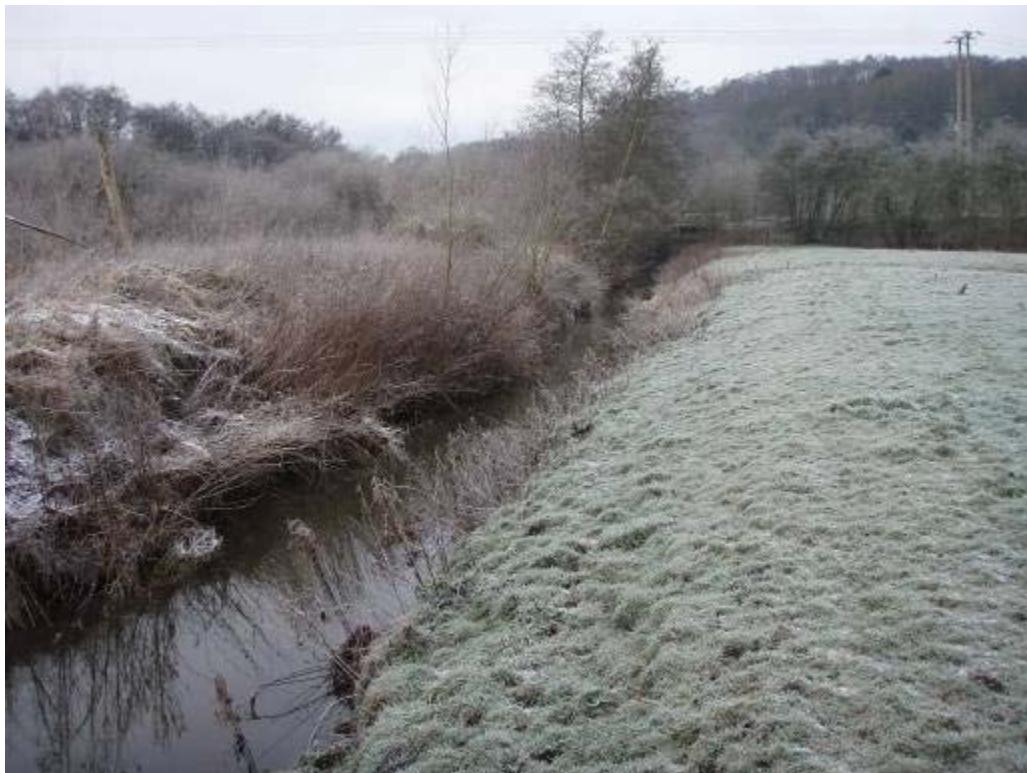
**Photo 1**

Immediately upstream of the Churnet confluence up to the disused railway bridge, the brook is in a straightened, incised channel with a trapezoidal cross-section; the flow pattern is a smooth glide with a fine sandy bed substrate. Channel dimensions are approximately 5 metres wet width and 10 metres bank-full width. The channel is open (few trees) with an unmanaged right bank and improved grazing on the left bank (Photo 1). Upstream of the railway bridge the channel is more shaded by willow and sallow trees (Photo 2); there is some evidence of a stone toe to the banks and the channel remains artificially straight (probably moved when the railway was built). There are two bed checks (possibly old weirs?) which create a localised riffle effect, but otherwise the flow pattern is smooth glide with a fine bed substrate, apart from a few cobbles (originating from eroded artificial stone toe).

In-stream habitat on this section is generally poor, because of historic channel modification (straightening) and impoundment by the gauging weir. The brook lacks a pool-riffle structure, being largely slow, uniform, shallow glide habitat with bed substrate dominated by sand and silt.

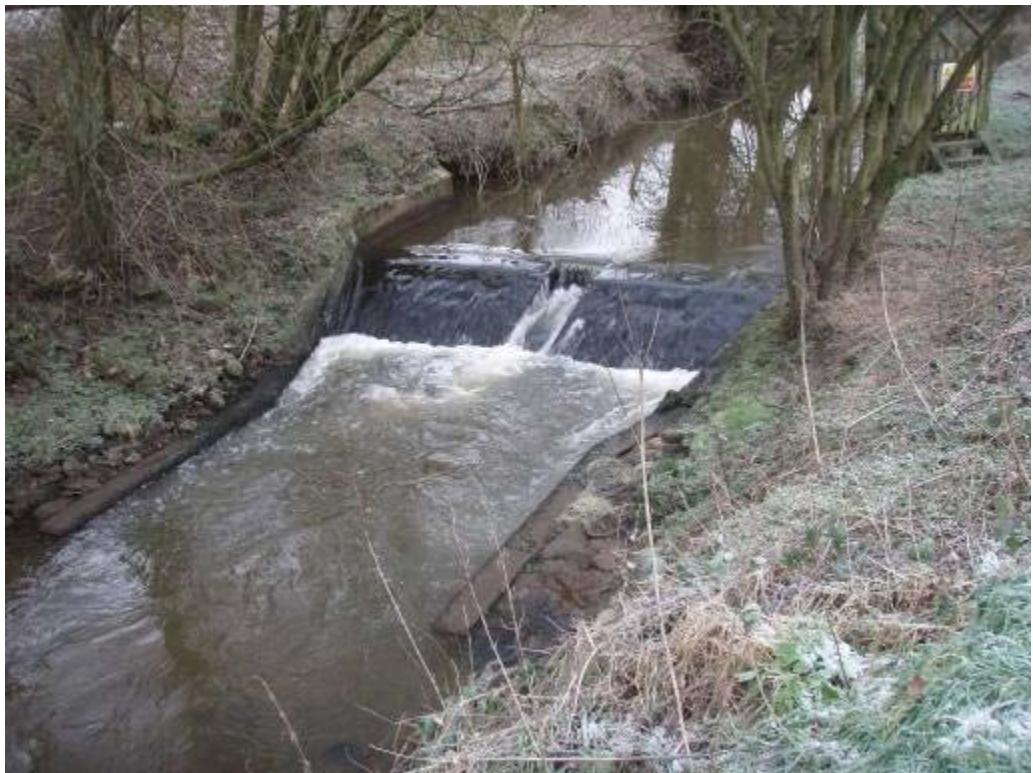
**Photo 3**

A flow gauging weir is present (SJ965535) with an approximate 0.8m head difference at the time of the visit (Photo 3). The fast flowing, steep face of the weir presents a moderate barrier to fish passage (probably impassable by smaller trout, most coarse fish and small species). There is a notch in the centre of the weir, currently blocked off at the upstream end. The impounding effect of the weir creates a slow glide upstream, becoming wide and shallow with progress upstream. The banks here are scrub / woodland up to the road culvert (Photo 4).

Improvement of fish passage at structures including the gauging weir (Photo 3) and A53 culvert (Photos 15, 16) are recommended, to improve connectivity with better habitats upstream (Horton Brook) and downstream (River Churnet). However, this work is a lower priority than tackling the instream habitat deficiencies and will not address the waterbody failure if carried out in isolation.

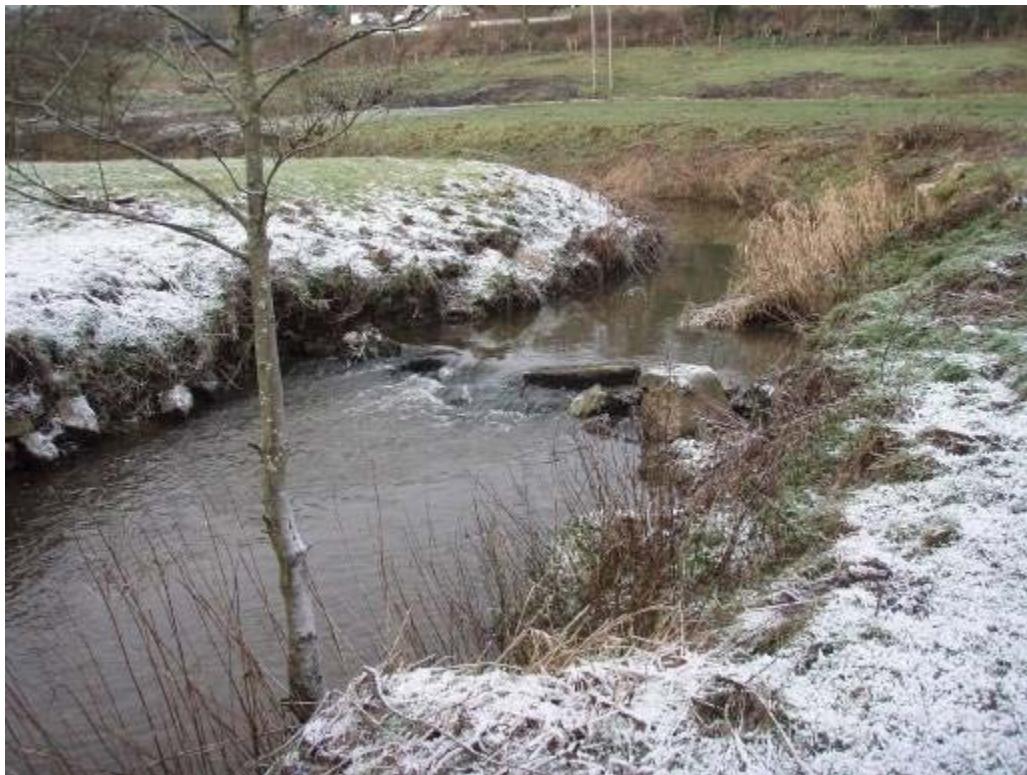
The culvert under the road does not present a barrier to fish movement and neither does the rough block-stone weir just upstream (Photo 5). The brook runs alongside a large pond on the left bank, much of which has been recently dredged; the spoil from this has been spread over the field between the pond and brook, with some pushed down the banks of the brook.

**Photo 5 Rough blockstone weir just upstream of Sutherland Road**

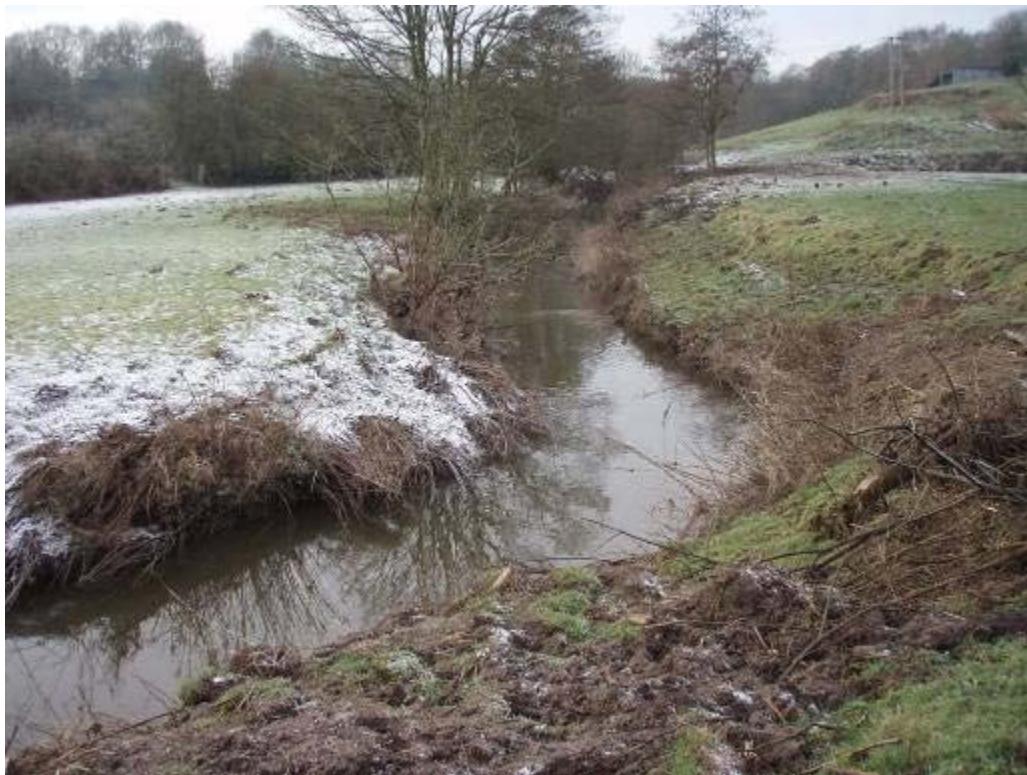
The brook has a meandering plan form throughout this section although the channel remains incised reflecting past bed lowering. There is some good tree cover on the downstream reach (below the railway bridge SJ959535) and reasonable in-stream fish habitat (Photo 6). Above the railway bridge the trees become fewer with progress up towards Denford where the channel is open alongside improved pasture. The flow pattern continues to be a smooth glide throughout, but with more pace than the downstream section. A small tributary from Deep Hayes Park joins on the right bank.

**Photo 6 Pond on left bank (right of picture)**

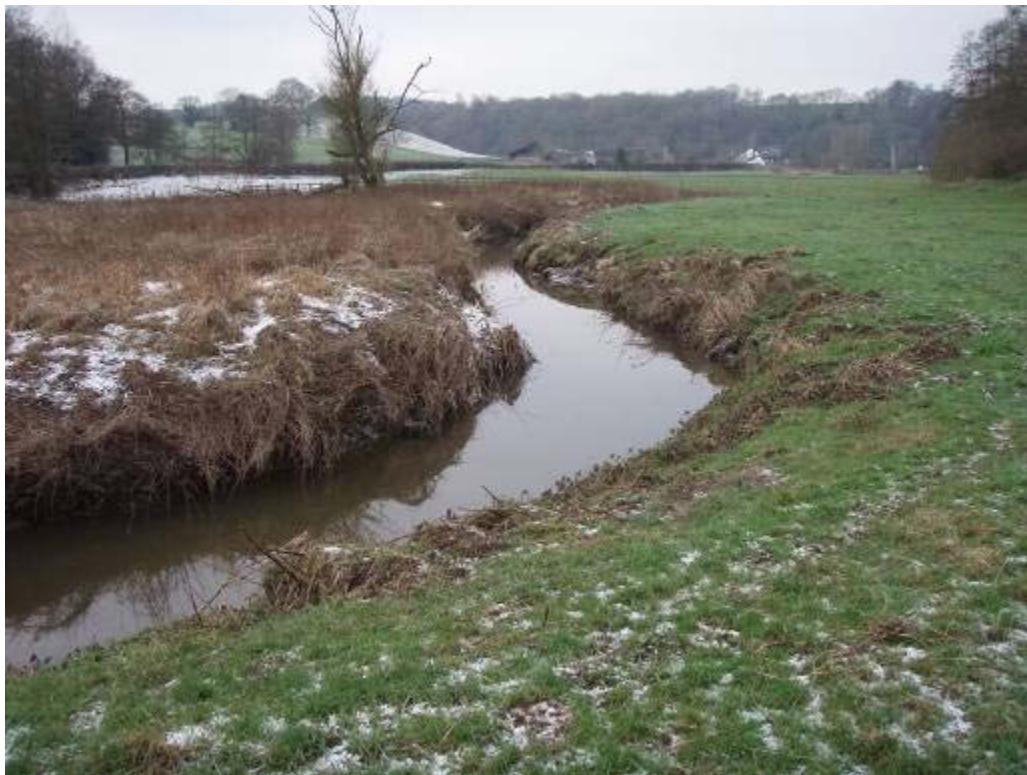
Marginal and in-stream emergent vegetation was evident between the railway bridge and Denford, but it has been recently dredged out of the downstream section (Photos 7, 8).

**Photo 7** Just upstream of Deep Hayes tributary; emergent vegetation had recently been dredged from this section

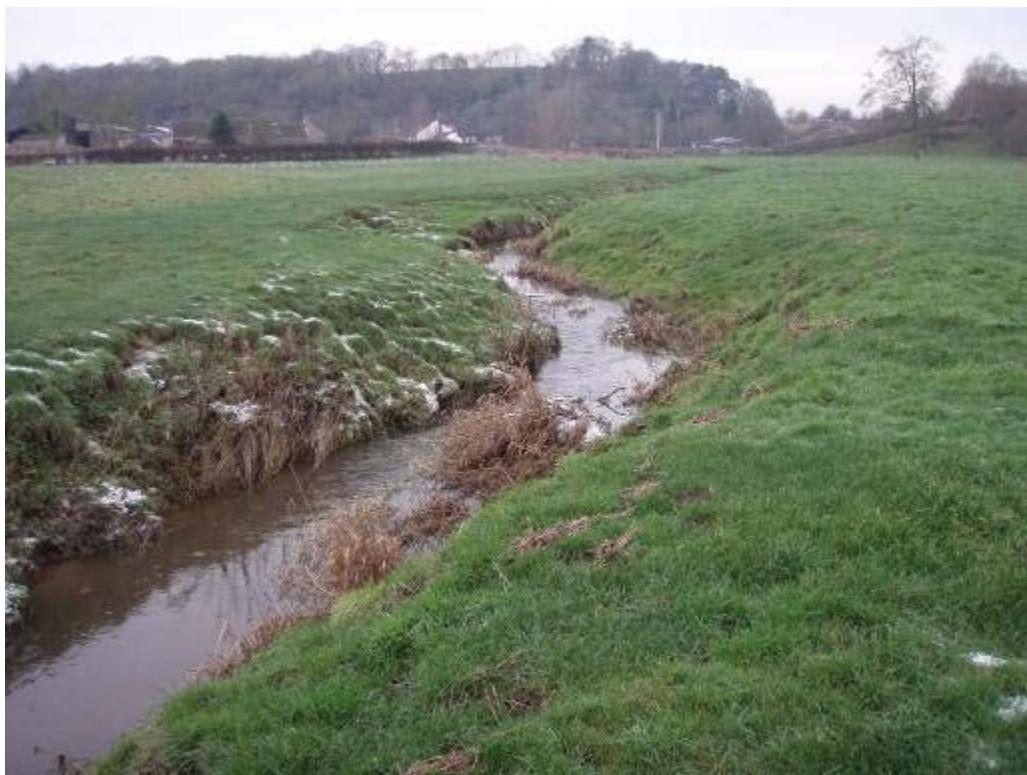
**Photo 8** Further upstream towards Denford; emergent vegetation is intact and providing some flow variation, although riparian habitat is poor

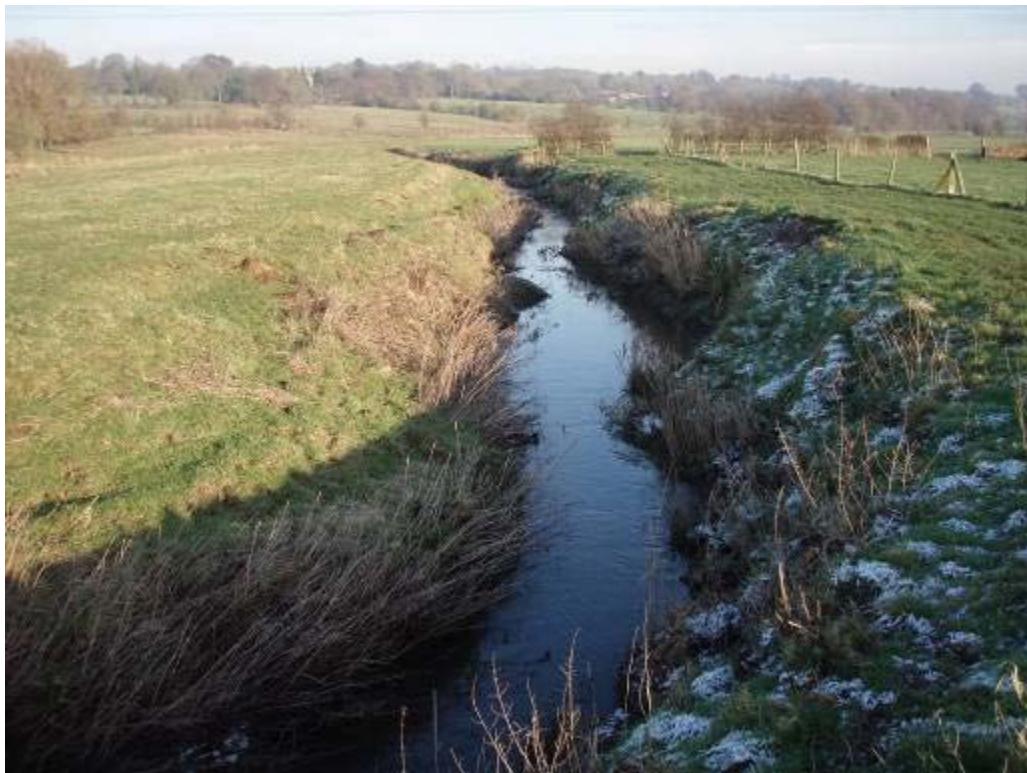
In-stream habitat was very poor throughout this section (Photo 9). The brook flows through a broad, flat valley bottom and has been the subject of a land drainage scheme (Endon Brook Improvement Scheme 1985). This has resulted in a deeply incised (3m below field level in some areas), very steep-sided, narrow channel completely disconnected from the floodplain. The flow pattern is a uniform, shallow glide with fine, sandy bed substrate. The channel is open, with no trees, and the banks are grazed by livestock to fall of bank.

**Photo 9** Typically poor in-stream habitat of this section

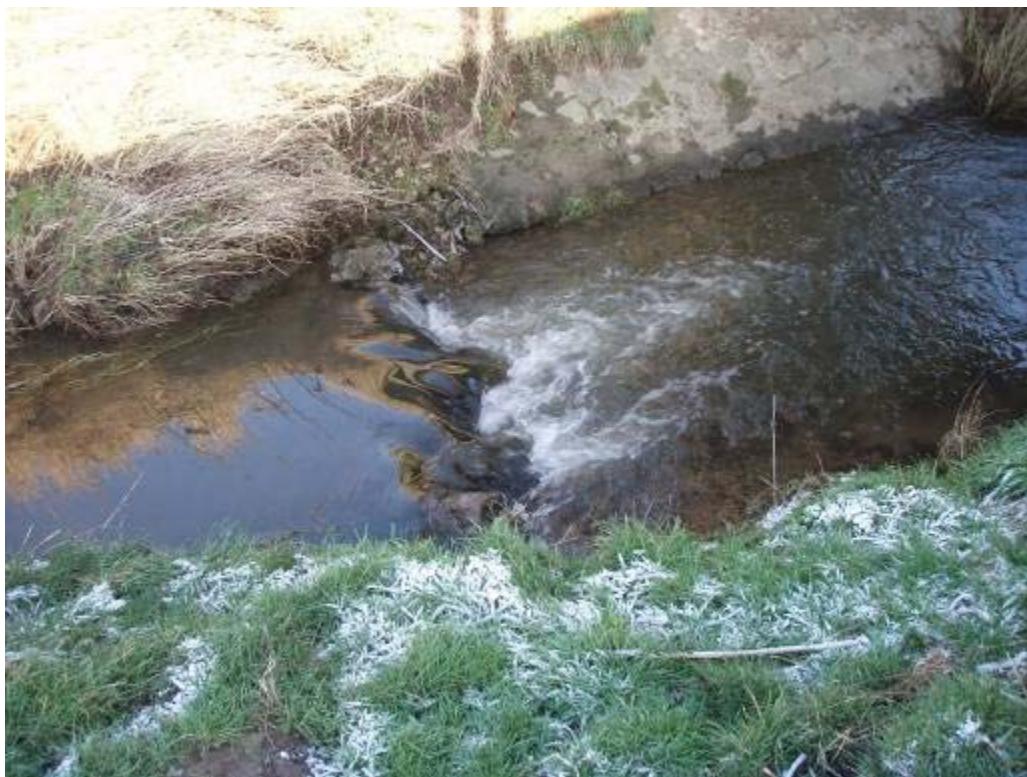
There is the occasional low block-stone weir, plus remnants of a stone toe to the bank in some areas, presumably installed when the land drainage scheme was carried out (Photos 10, 13). Just below a farm bridge near the sewage works, there is a section of faster flow and a gravel substrate (Photo 11), and immediately downstream a lateral scour pool and downstream riffle are starting to develop; these are however exceptional features in an otherwise barren channel for fish habitat.

**Photo 10** Low weir just upstream of farm bridge

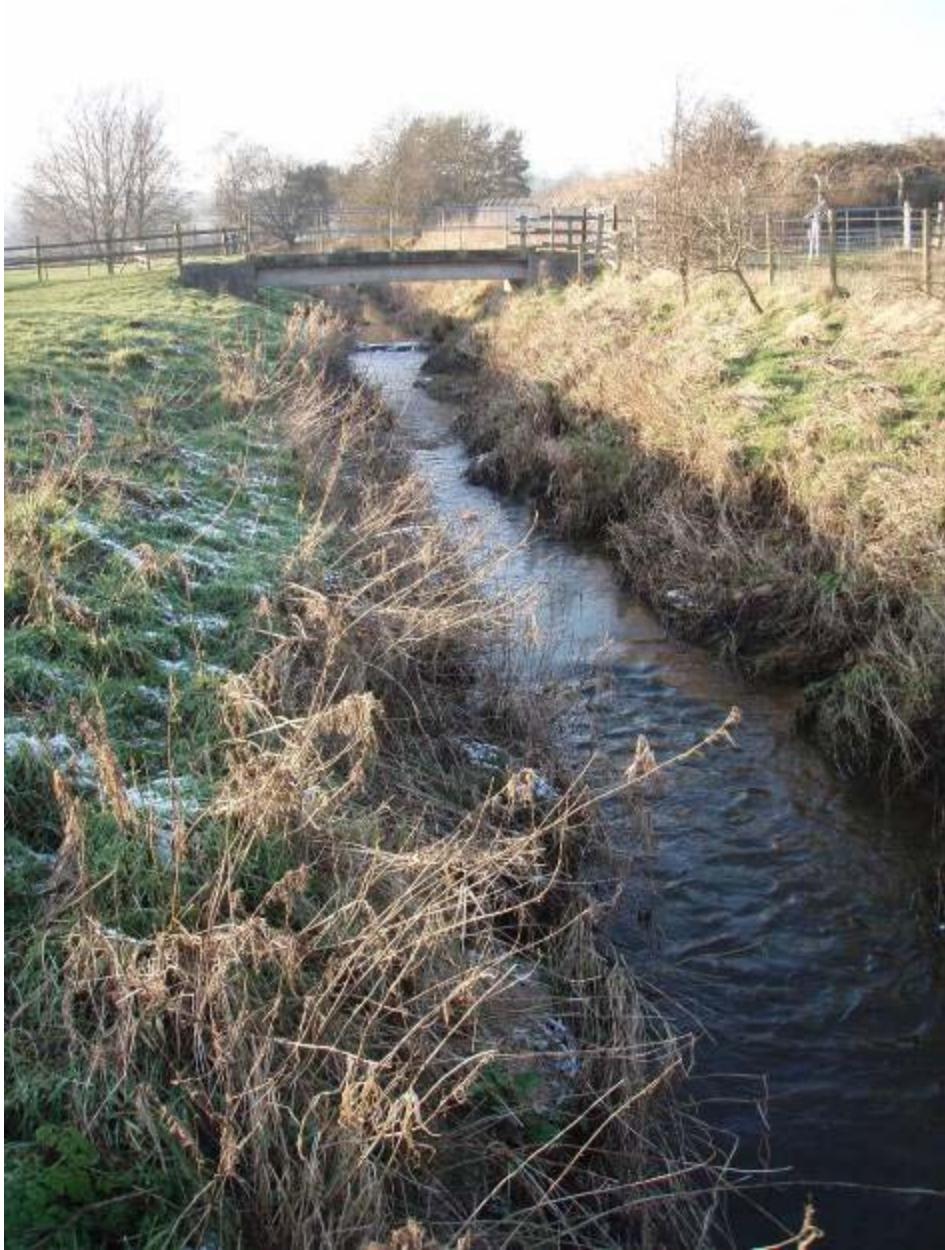
**Photo 11 Steeper, faster flowing section with a gravel bed**

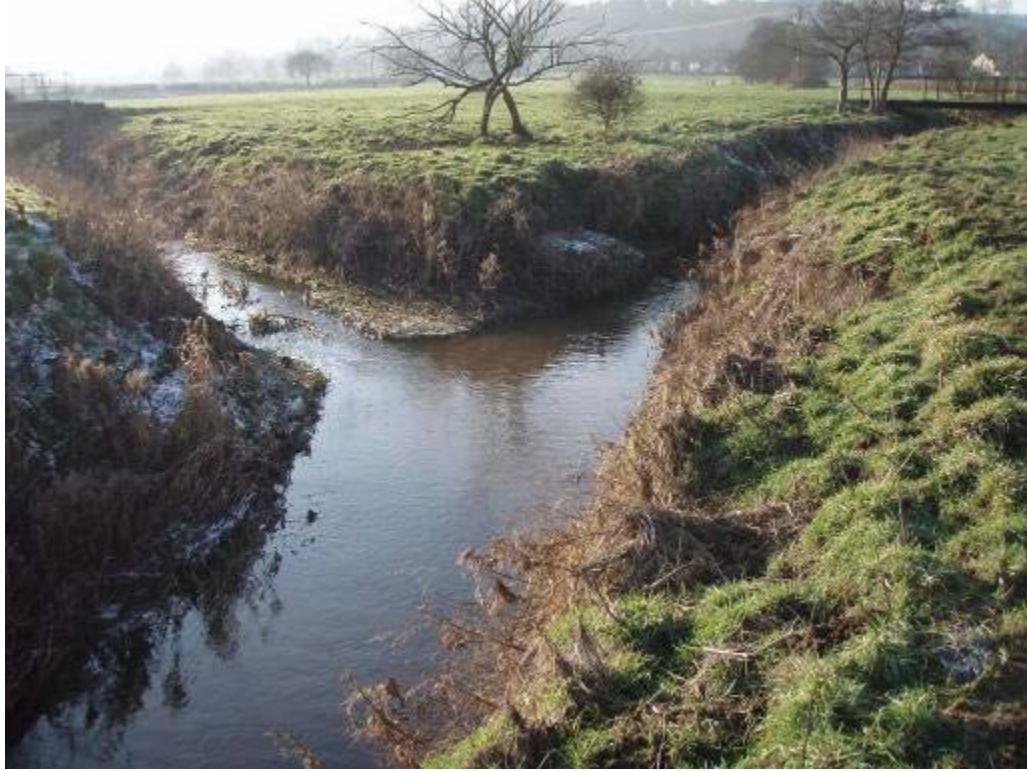
At the confluence of the Endon and Horton Brooks (Photo 12), it is evident that most flow originates from the latter. About 100m upstream from the confluence, on the Endon Brook, is a block stone cascade, presumably installed during the 1985 scheme. At the A53 crossing of the Horton Brook there is a potential barrier to upstream fish movement (see next section).

**Photo 12 Confluence of Endon (left of picture) and Horton Brook**

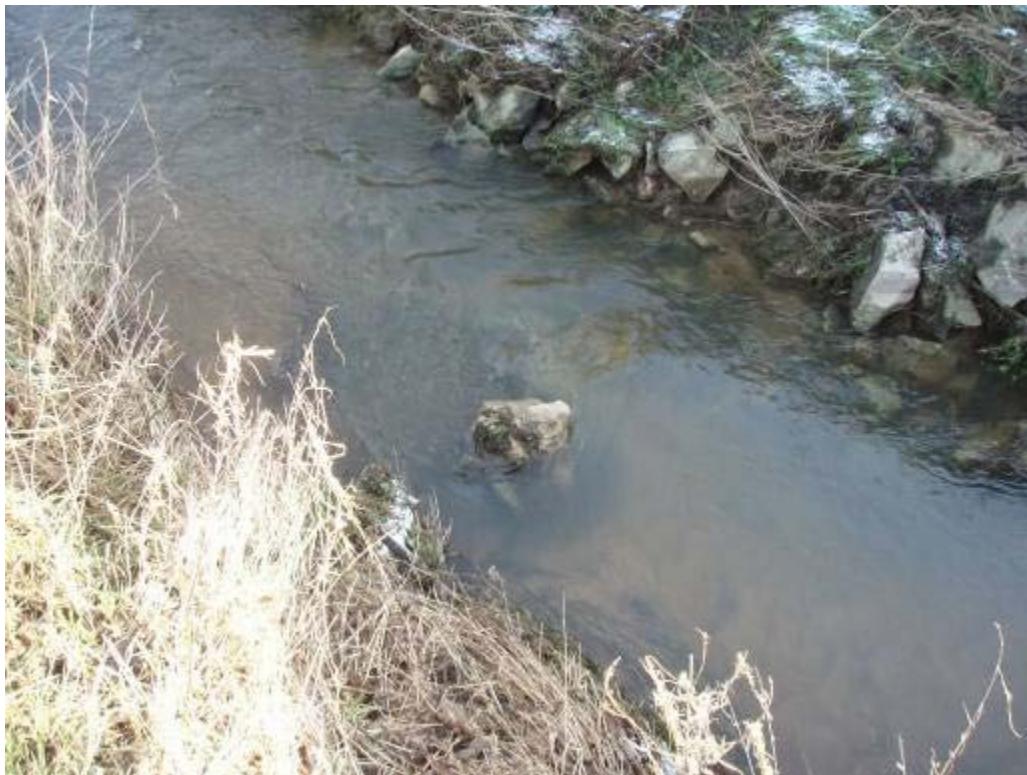
**Photo 13 Fine bed material, plus blockstone bank toe reinforcement.**

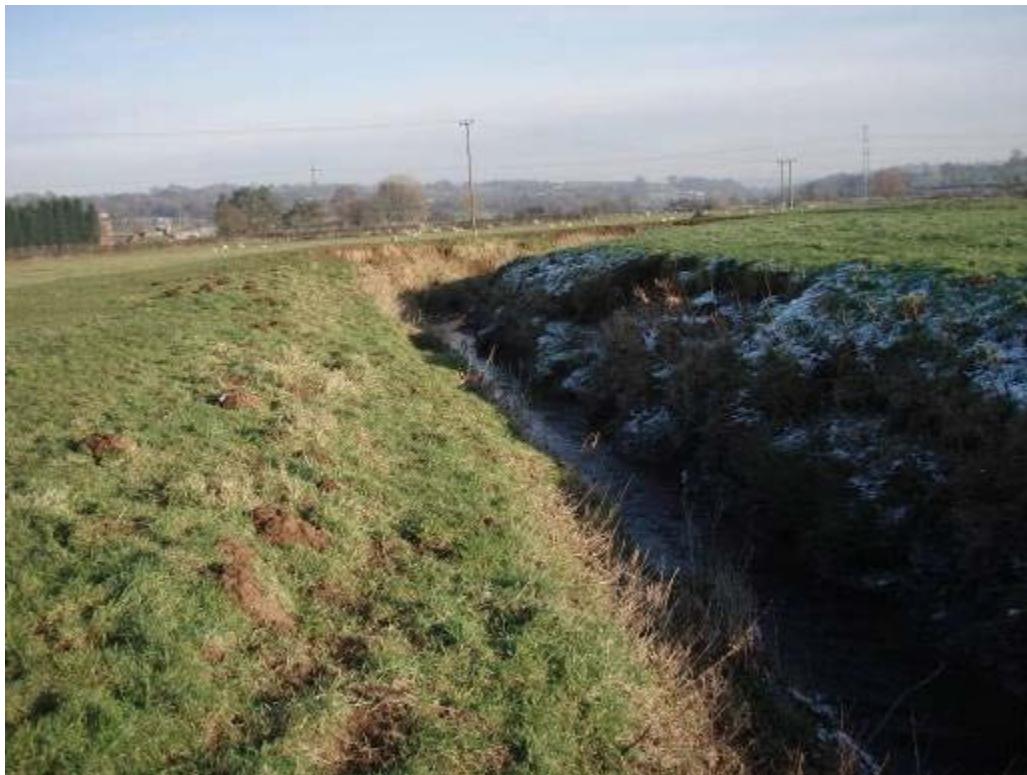
Although outside the waterbody under scrutiny, a couple of areas were inspected on the Horton Brook. At the A53 road bridge close to the Endon Brook confluence, the culvert presented a barrier to fish migration, having a step at both ends of the culvert bed under the road. In-stream habitat is very poor downstream of this point to the Endon confluence, for the same reasons as the above section (Photos 14-16).

**Photo 14** Horton Brook just upstream of Endon Brook confluence

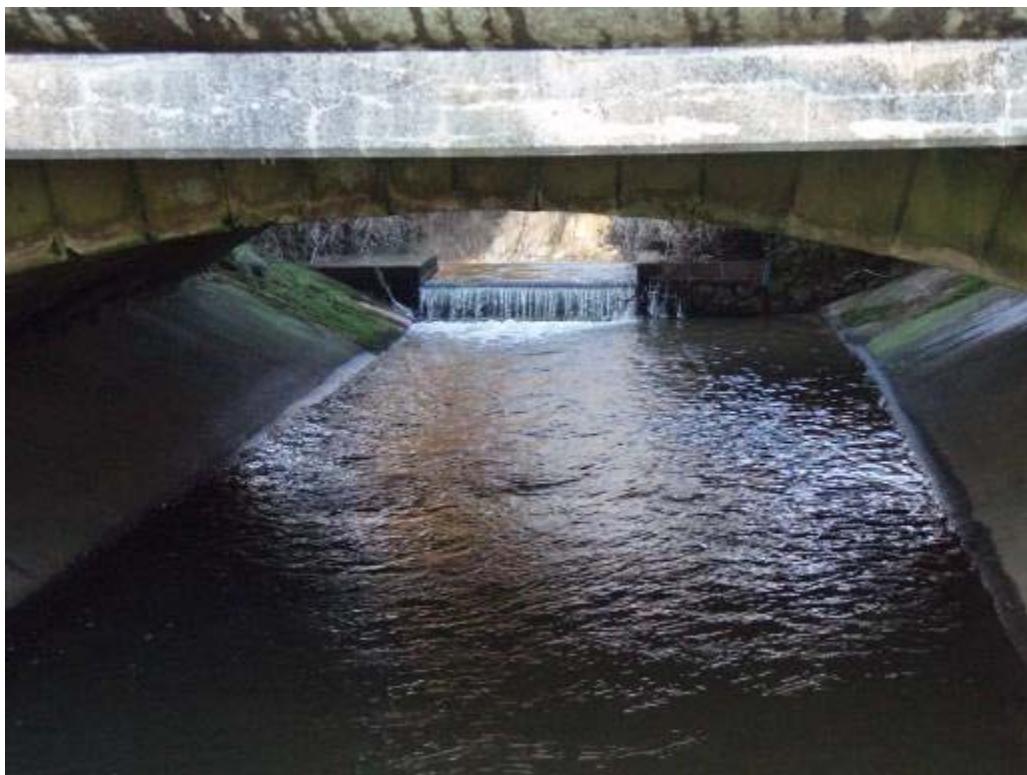
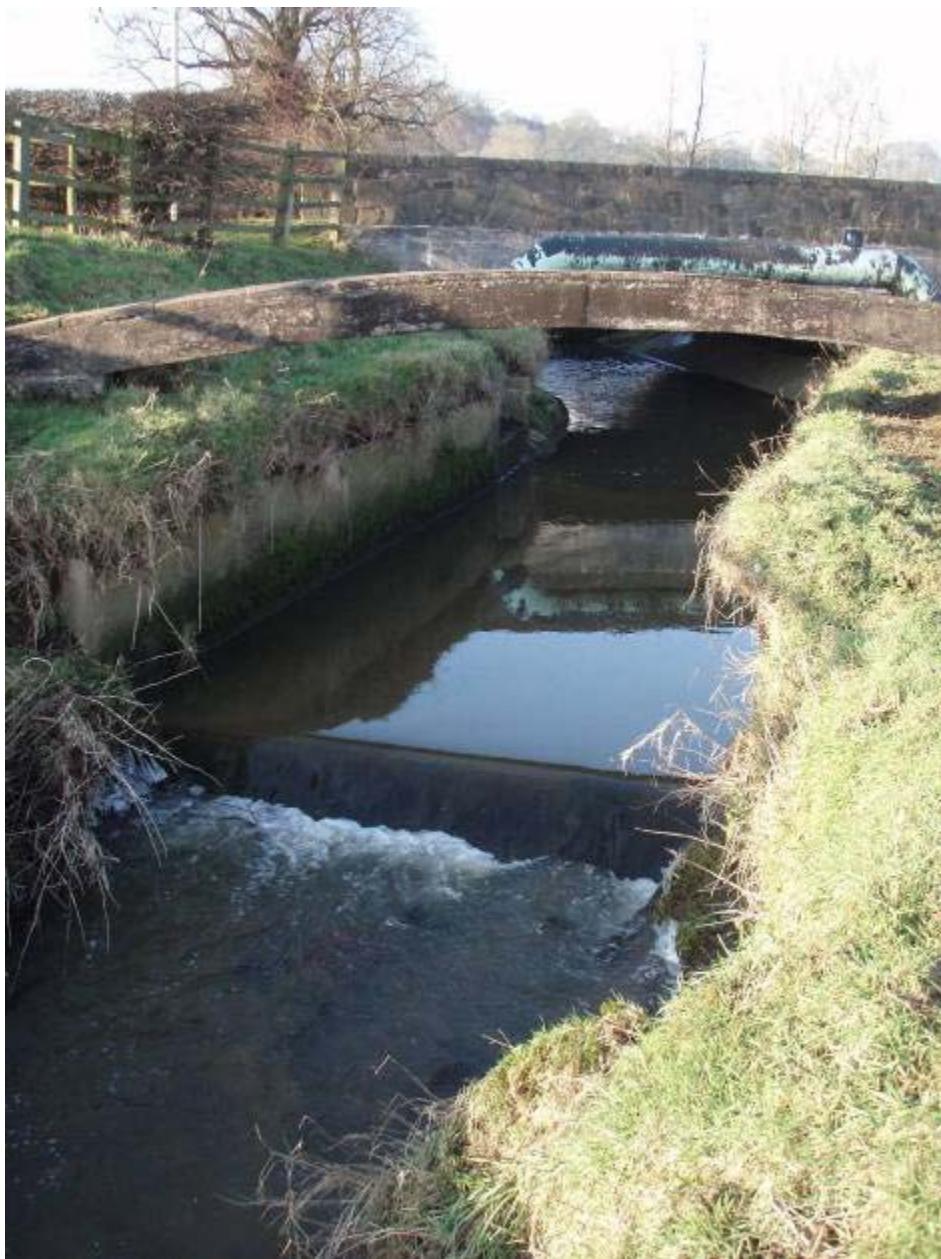
**Photo 15** A53 road culvert (Horton Brook), view upstream under bridge.

**Photo 16 A53 road culvert (Horton Brook), view from downstream.**

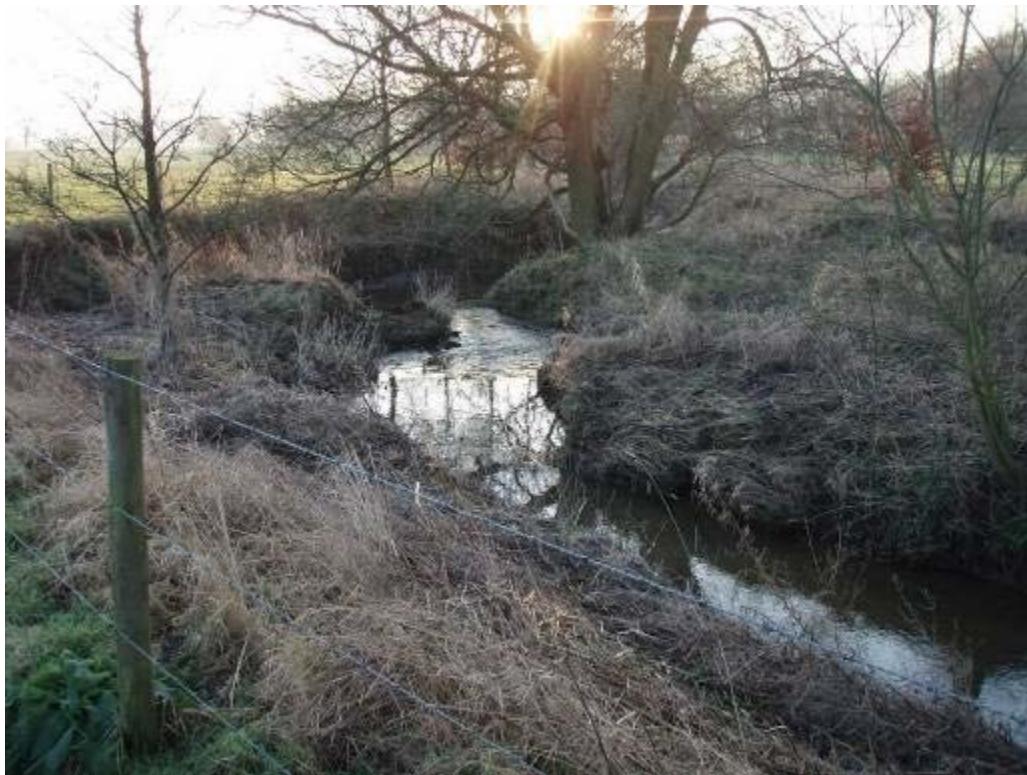
A short section at SJ938556 was inspected (Photos 17 – 19). Here the Horton Brook has reasonably good in-stream habitat, with a fenced 5-m ungrazed riparian zone which includes alder and willow trees. No past land drainage works are evident and there is a pool-riffle structure. The bed substrate still contains a high proportion of sand, and although coarser sediments are apparent, no suitable spawning gravel was observed. The road bridge culvert and a farm bridge (pipe culvert) just downstream are not ideal in terms of fish passage, but do not present major barriers.

**Photo 17** Horton Brook (near SJ938556). Good in-stream and riparian habitat.

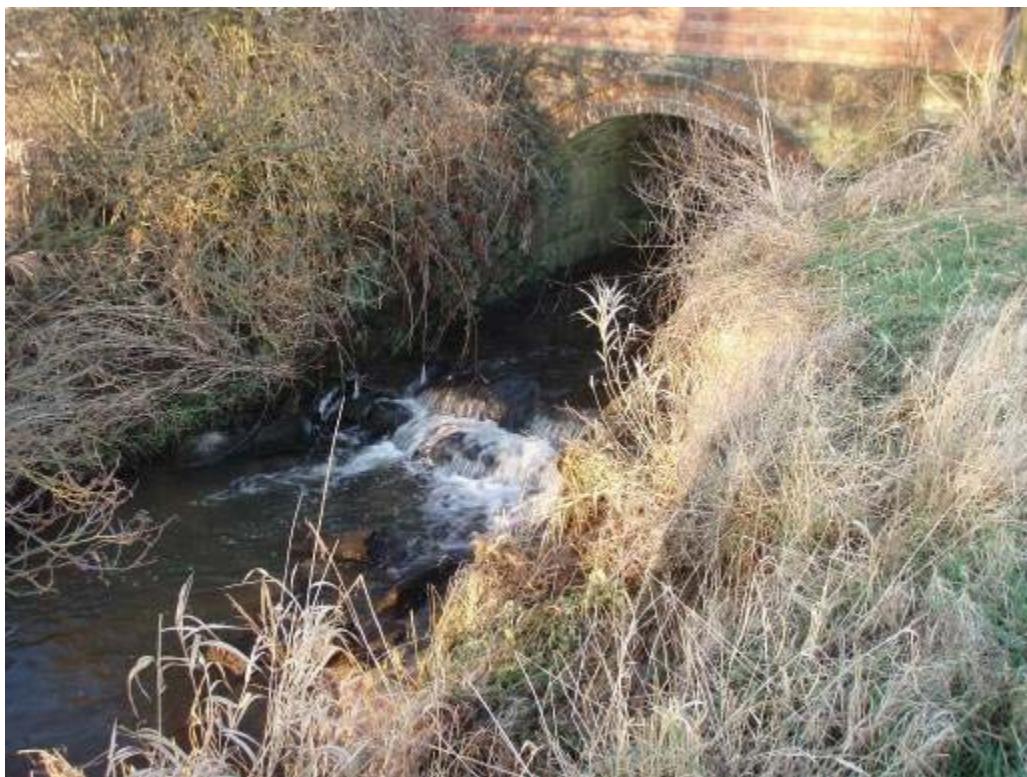
**Photo 18** Road bridge (Horton Brook, near SJ938556).

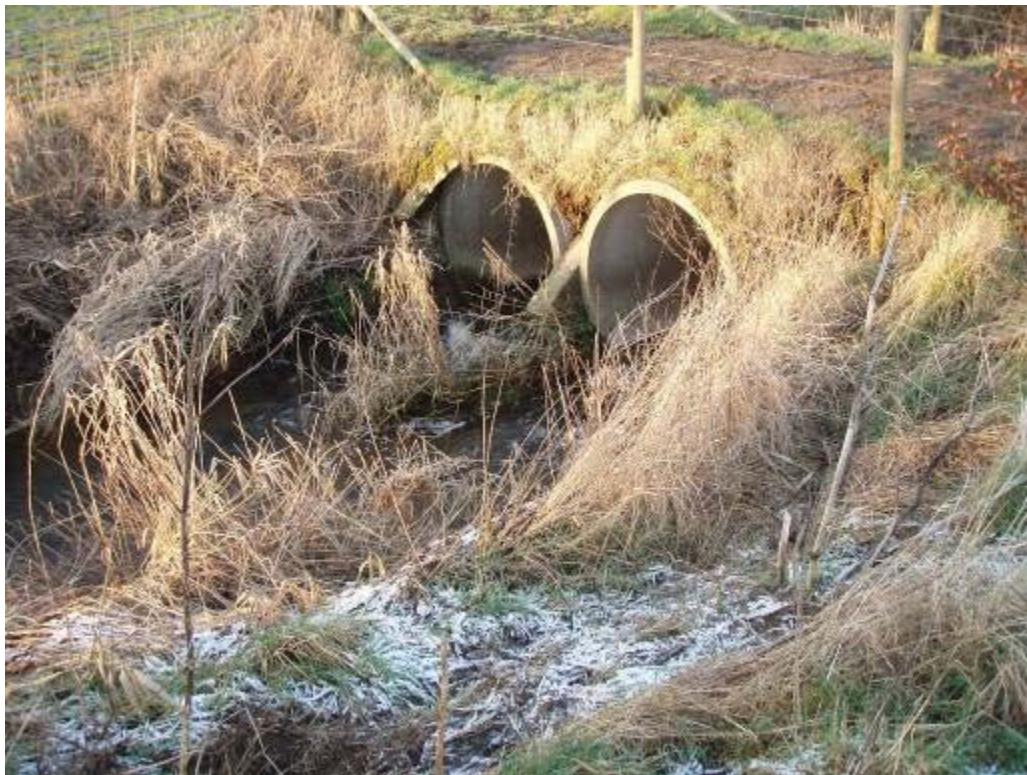
**Photo 19** Farm vehicle crossing and potential fish migration barrier, just downstream of Photo 18.

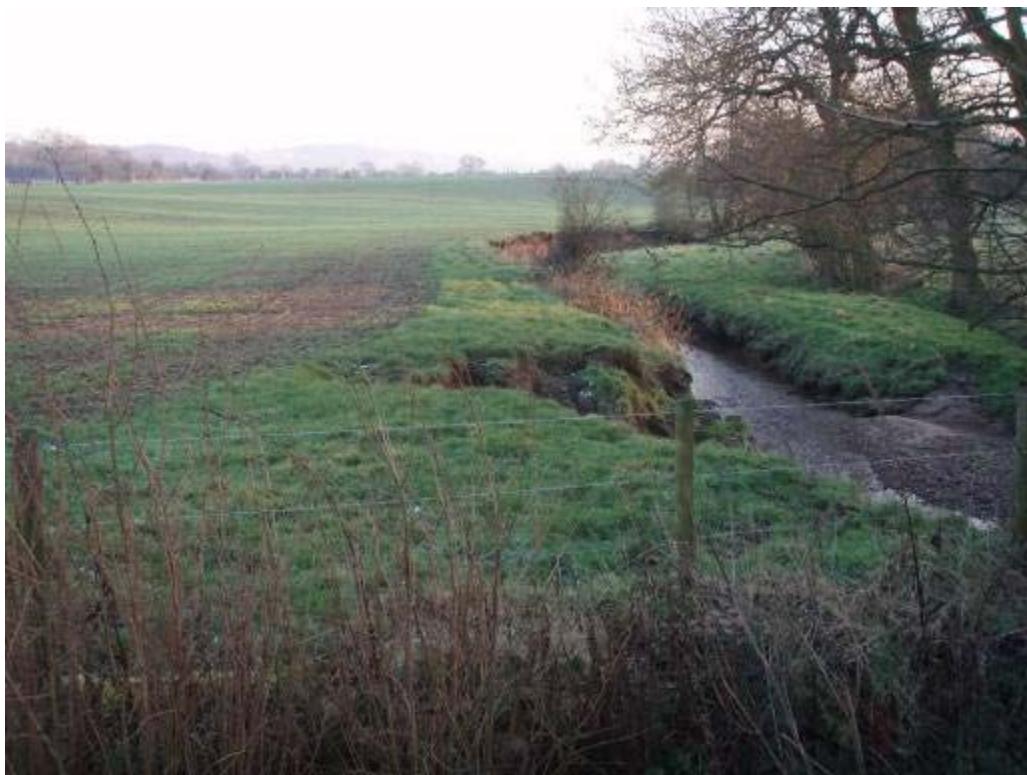
At SJ936576 near Boot Hall road bridge (Photos 20, 21). There is better bed substrate here comprising sizes suitable for trout spawning. In-stream habitat is good, but there are some land use issues; there is no buffer zone between the brook and fields, one of which had recently been ploughed and re-seeded. Excessive bank erosion was evident alongside this field.

**Photo 20** SJ936576 near Boot Hall road bridge – land use impacting riparian habitat on the left bank.

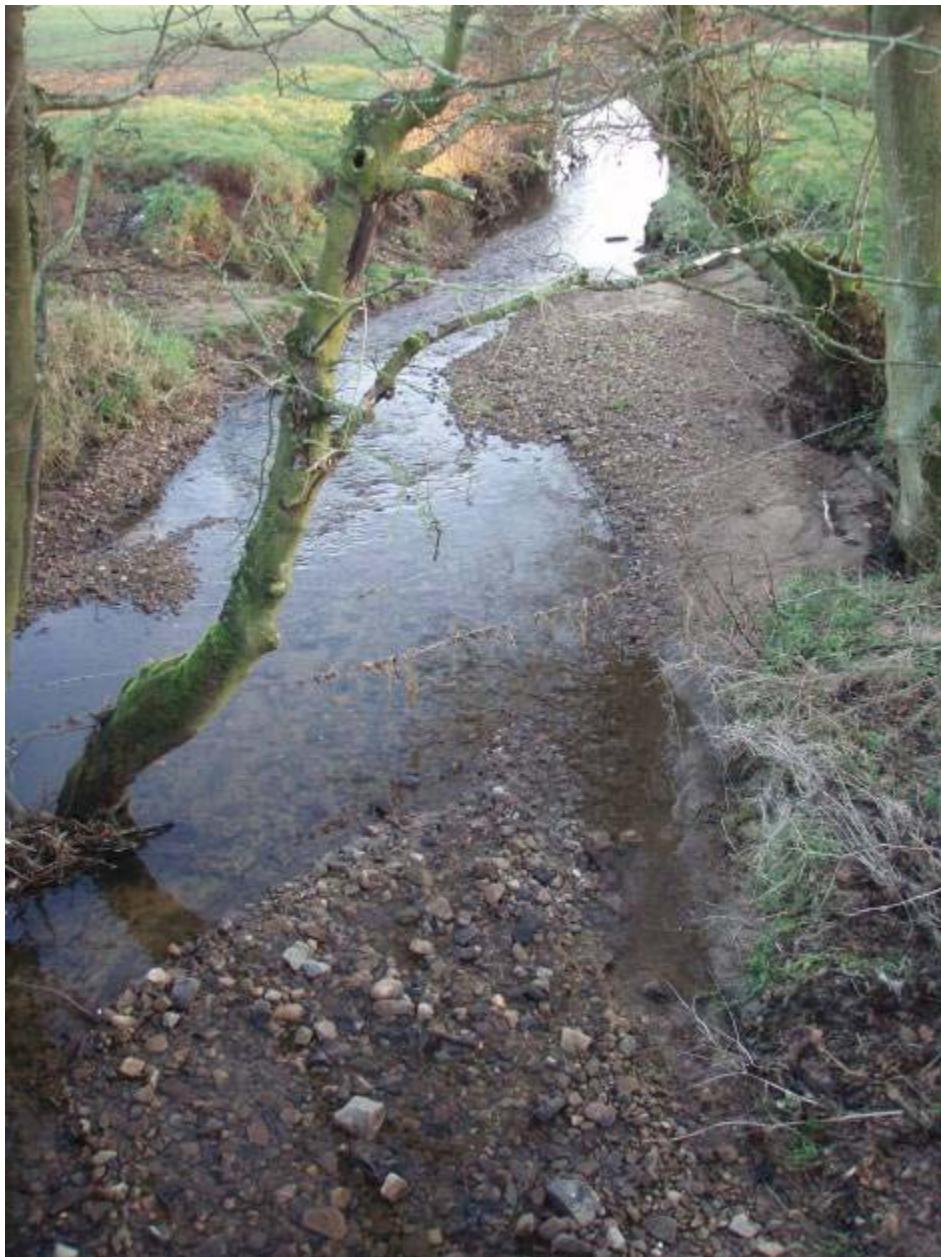
**Photo 21 SJ936576 near Boot Hall road bridge – better trout spawning substrate**
