Project Proposal

Forth Fisheries Trust

River Allan, Killandean Burn and Bog Burn

30th September 2015

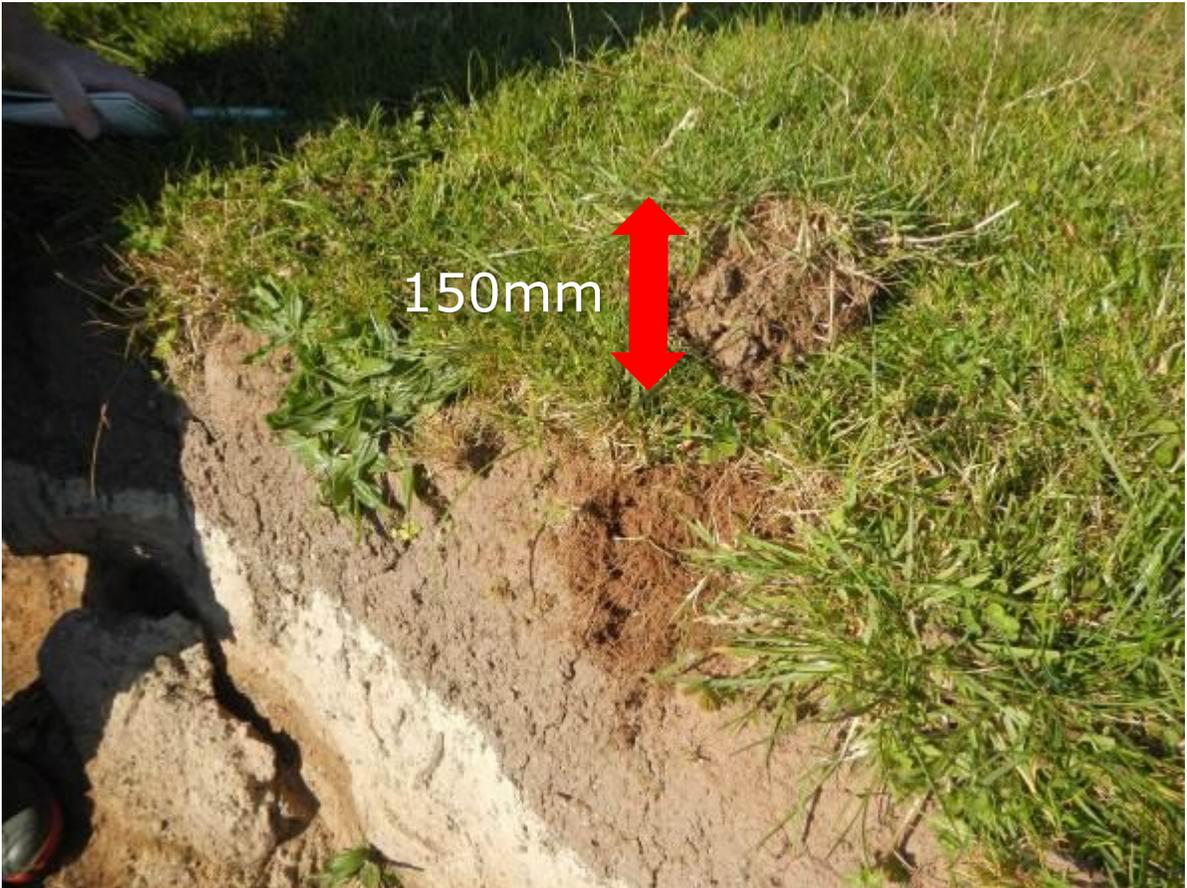
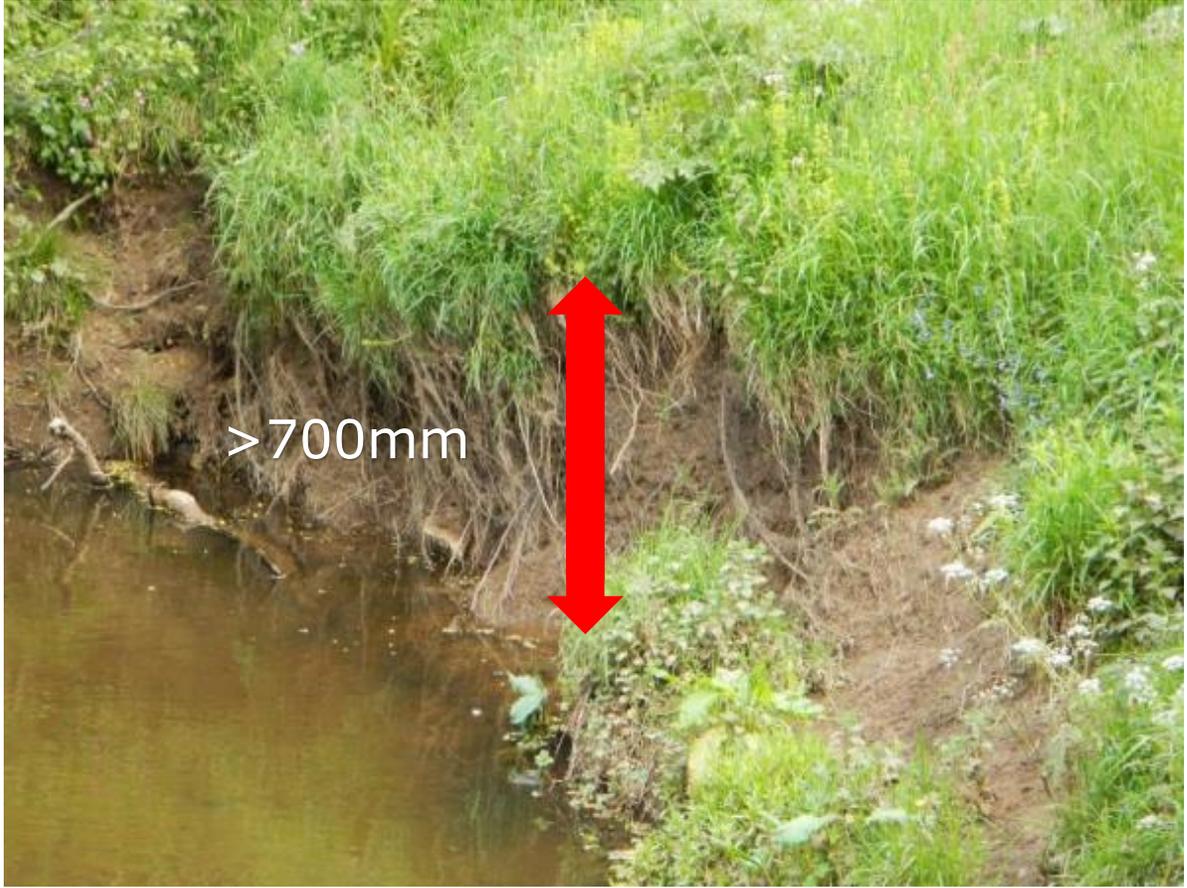
By preventing saplings and herbaceous vegetation from establishing, grazing also reduces the diversity of root systems contained within the bank; a diversity of trees and herbaceous vegetation, combined with grasses, provide much deeper and wider-ranging root structures than grass alone. Note the difference between the sparse root system (c.150mm depth) beneath the closely grazed grass banks on the River Allan (Fig. 1a) and the diverse root structure (>700mm depth) within an un-grazed bank (Fig. 1b).

Figure 1a (above) Shallow root system beneath the grazed river banks on the River Allan vs the deep, diverse root system of an un-grazed riverbank on another river in Figure 1b (below).

To improve riverbank stability long-term on the River Allan, buffer fencing to exclude livestock from the banks will be vital. This one measure will allow a healthy coverage of bankside vegetation to naturally colonise susceptible areas and prevent the physical damage that currently is being caused by livestock access. Light re-seeding with a wild grass and flower mix that is native to the area would also accelerate the rate at which protection is provided to the bank.

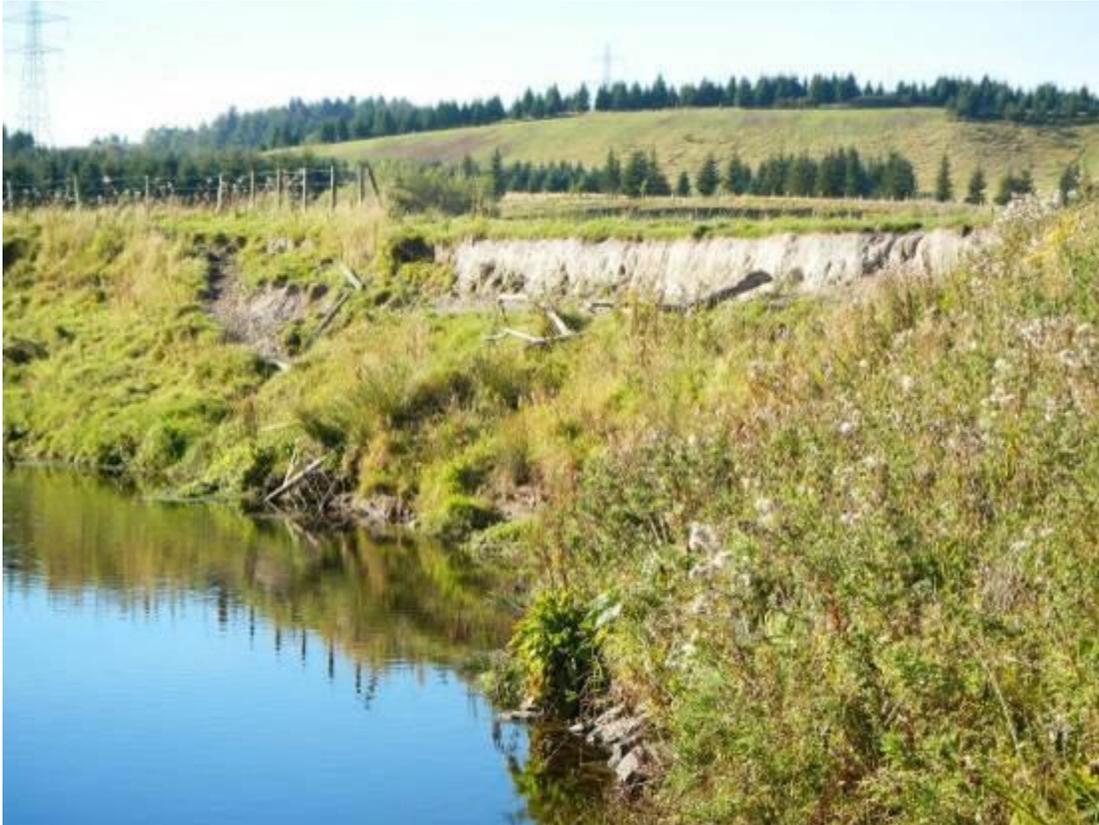
Trampling and poaching by cattle and / or sheep prevents even grass from re-growing in well-trodden areas, as well as physically breaking up the ground and allowing high river flows, rain and surface water to scour away the soil. This prevents the recolonisation of slumped bank material that would otherwise naturally revegetate and stabilise the bank at a shallower gradient (Fig. 2).

Figure 2. An area of bank that appears to have slumped and has stabilised somewhat but remains highly susceptible to further erosion due to the continued grazing and trampling that is occurring.

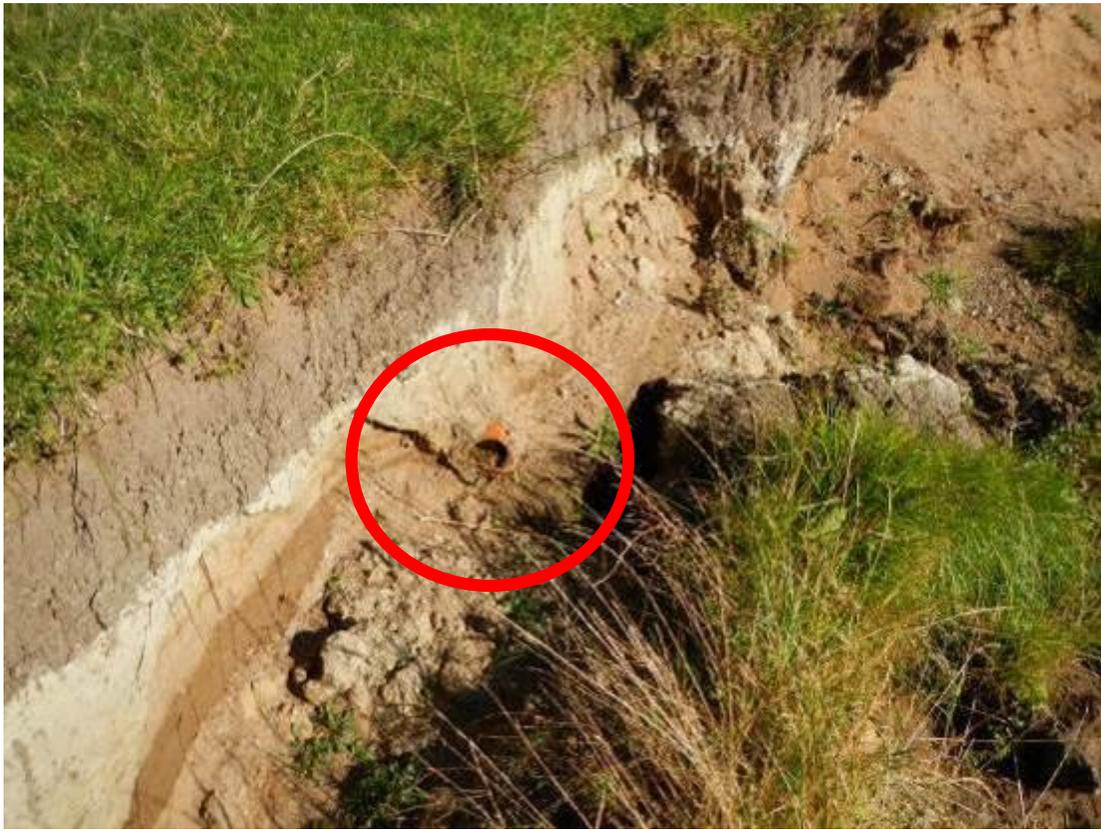
Several land drains discharging along the upper part of the bank, create localised wet areas that further increase bank susceptibility to slumping and erosion, and are probably causing direct scour when they discharge higher volumes of water in wet conditions (Fig. 3).

Figure 3. Clay pipe field drains discharge water drained from the neighbouring field directly onto the riverbank (red circle). In the absence of root structure to hold the banks together, this greatly increases erosion rates and allows what little turf there is to be undermined.

The field drains are not an easy issue to address, especially as they improve the workability of adjacent fields and so are unlikely to be removed. That said, significantly increasing the vegetation cover along the bank by excluding livestock will reduce the issue; the greater root structure within the ground will help bind soil together, and the foliage above the ground will provide direct protection to the soil and dissipate the energy of flows emanating from the pipes.

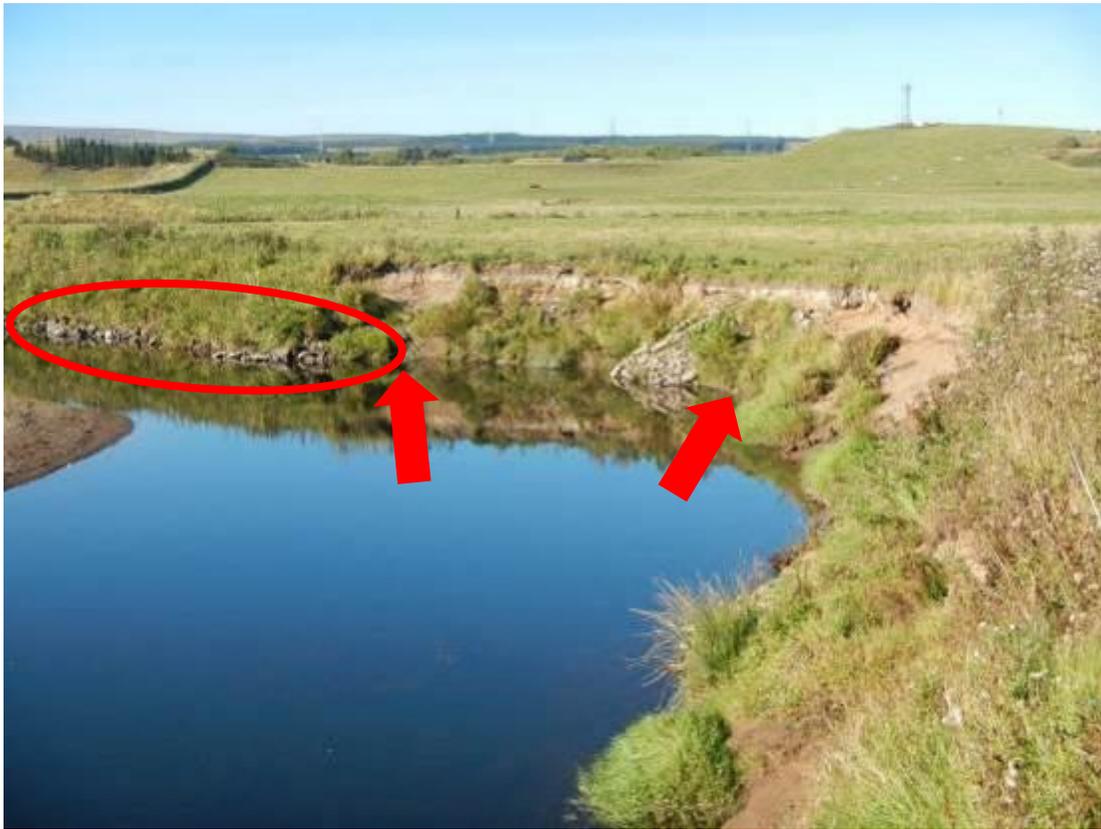
Figure 4. Rock armouring (red oval) has offered some protection to the base of the bank for long enough to allow it to vegetate but will always be susceptible to erosional scour at either end and below the waterline. Note that this is already apparent as flows deflected from the rock cut away at the softer material (red arrows).

It is strongly recommended that no further stone or hard structures are introduced along the bank as these will only serve to increase scour and erosion in other areas. If it is considered that greater bank protection is required, installation of brush, as described previously, should be undertaken.

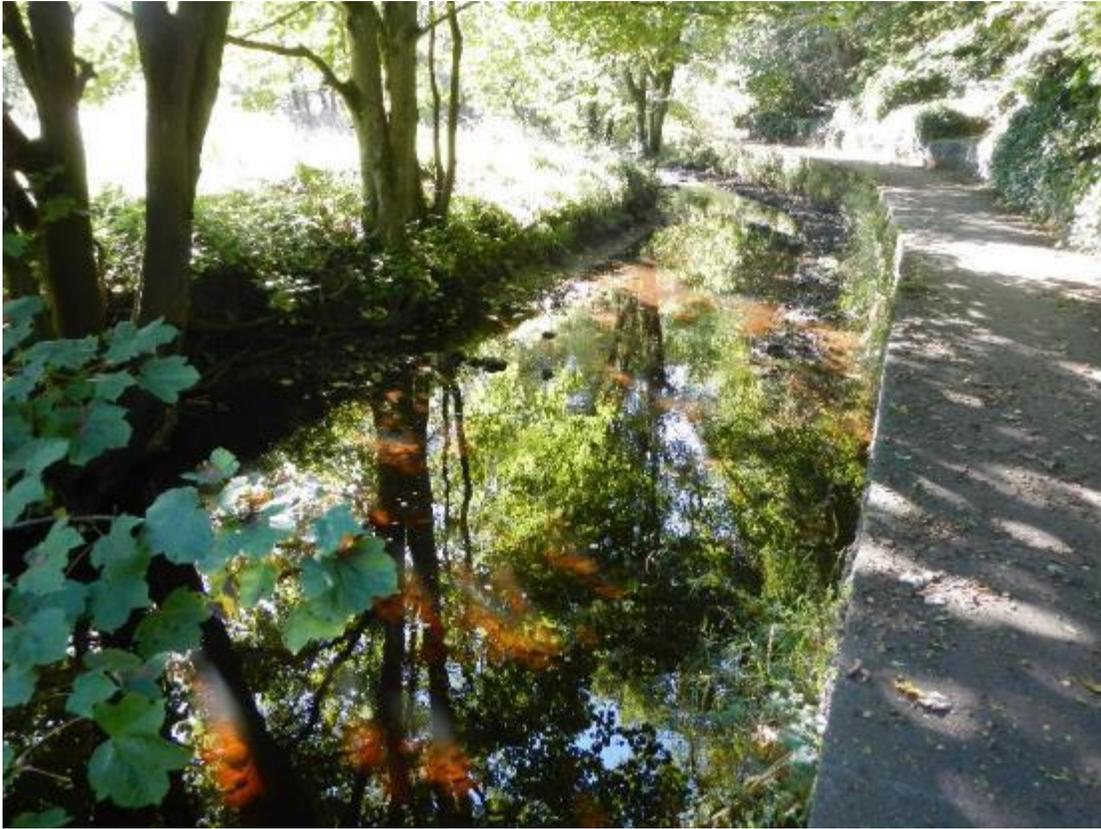
In some sections the revetment is clearly to protect the adjacent footpath (Fig. 7). In other areas, there is no obvious purpose for the revetment, other than constraining the Burn in its current course (Fig. 8), which is not advantageous to the habitat quality of the Burn. Scour along the edges of the gabions has produced some deep water but habitat would be of far higher quality without the gabions. The vegetation and trees present should be sufficient to provide natural bank protection (maintaining a natural, slow rate of erosion) and good habitat in most areas.

Figure 7. Hard engineered revetment in the form of a three-tier gabion wall. While not the most ecologically friendly method for protecting the bank, this structure does serve to protect the footpath along a confined section of bank (for the life of the foundation gabions).

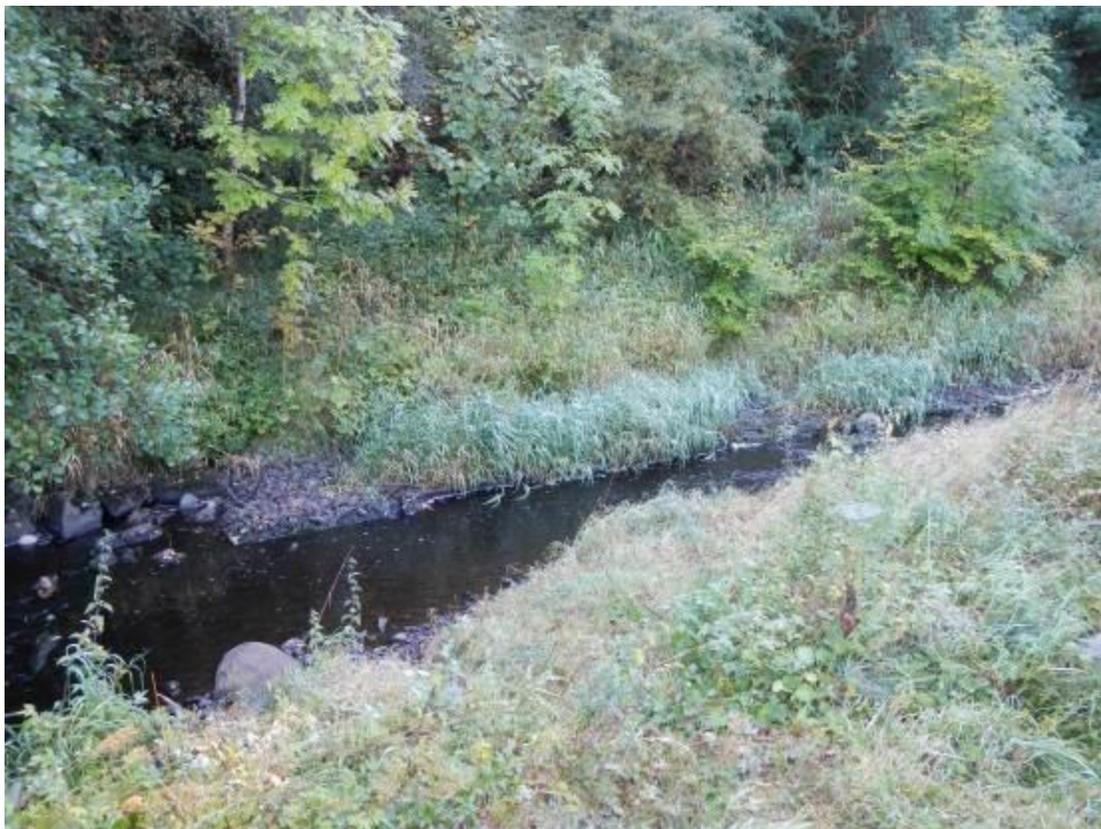
Figure 8. Unnecessary revetment along the far bank. Healthy vegetation and trees on the far bank could naturally maintain erosion rates at a low level. These gabions should not be replaced when they fail.

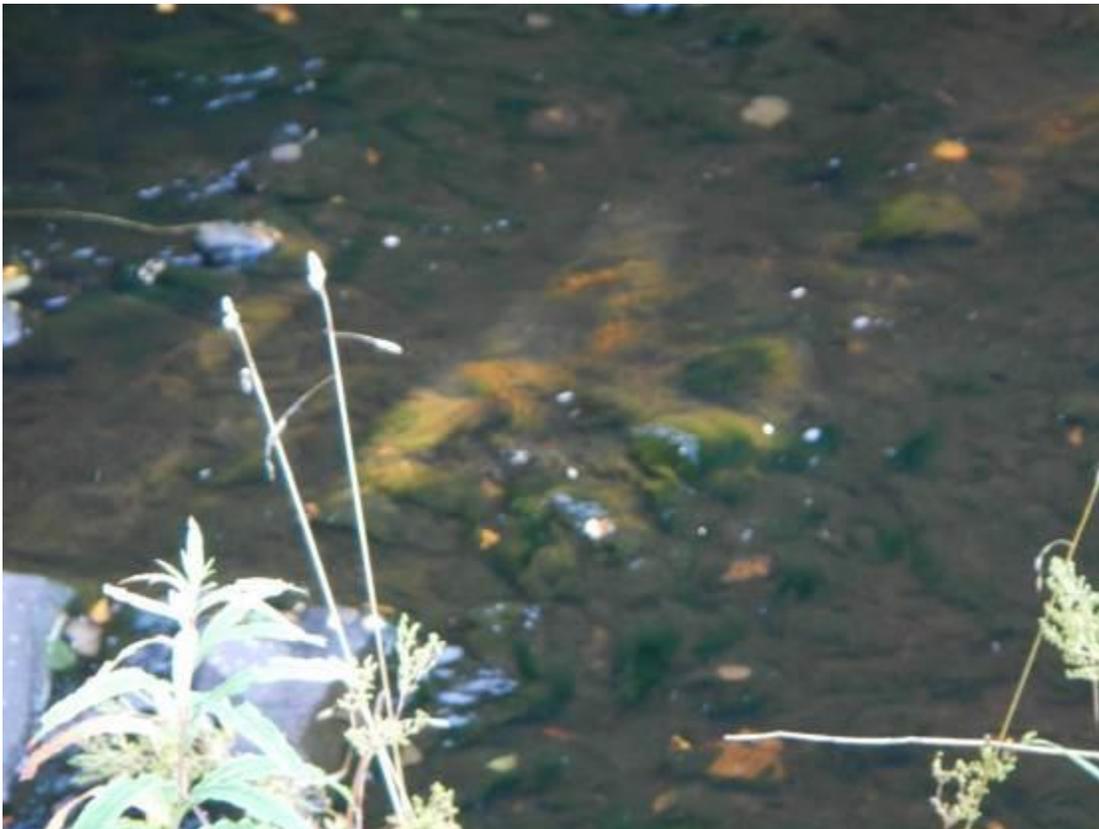
Excess sediment and nutrient inputs to the system are evident from siltation and heavy algal growth on the bed (Fig. 9), both of which can reduce oxygen levels within the gravels and reduce egg and alevin survival rates. Smothering of the substrate with fine sediment and algae, and the consequential loss of micro-habitats is also likely to have a detrimental impact upon many beneficial native invertebrate species that use those habitats. It is understood that the source of these inputs has been identified as a land holding that is currently for sale, and that RFFT has plans in place to try and address the problem with the new owners once the sale has occurred.

Figure 7. Excessive algal growth and siltation on the bed of the Burn.

It is recommended that the sediment issues identified by RFFT, upstream of the section visited, are addressed as soon as sale of the land in the problem areas is finalised and the new ownership established. Siltation of a watercourse has a significant negative impact upon salmonid and invertebrate habitat, greatly limiting their production, and is almost impossible to mitigate. Prevention is the only sustainable solution

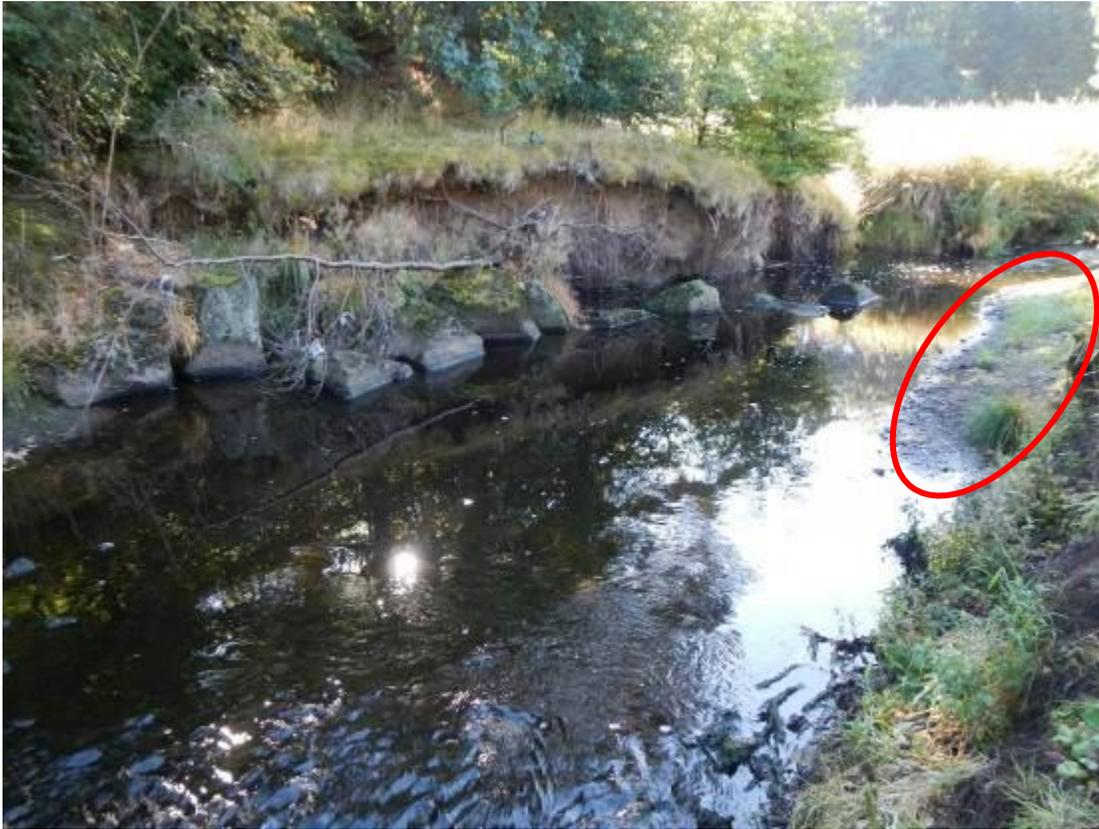
Where not protecting the footpath (or other important infrastructure), revetments should be left to degrade and eventually fail, and natural erosion allowed to develop. This will allow the Burn to naturally reinstate more channel sinuosity, enhancing substrate composition and features (Fig. 10).

Figure 10. A section of bank originally armoured with large block stone revetment that has now failed as erosion scours around and undercuts the stone and they slump forward, deflecting even higher erosive forces into the bank (see video - <https://youtu.be/q7zq1yxaPEA>). While a source of sediment, in this instance, the erosion is beneficial in reinstating natural features to the Burn and developing habitat. Note how the Burn with is already adapting to the increase in width by depositing finer substrate on the slower inside of the bend (red oval), thereby naturally maintaining an appropriate width for the flows received and increasing the sinuosity of the wetted channel.

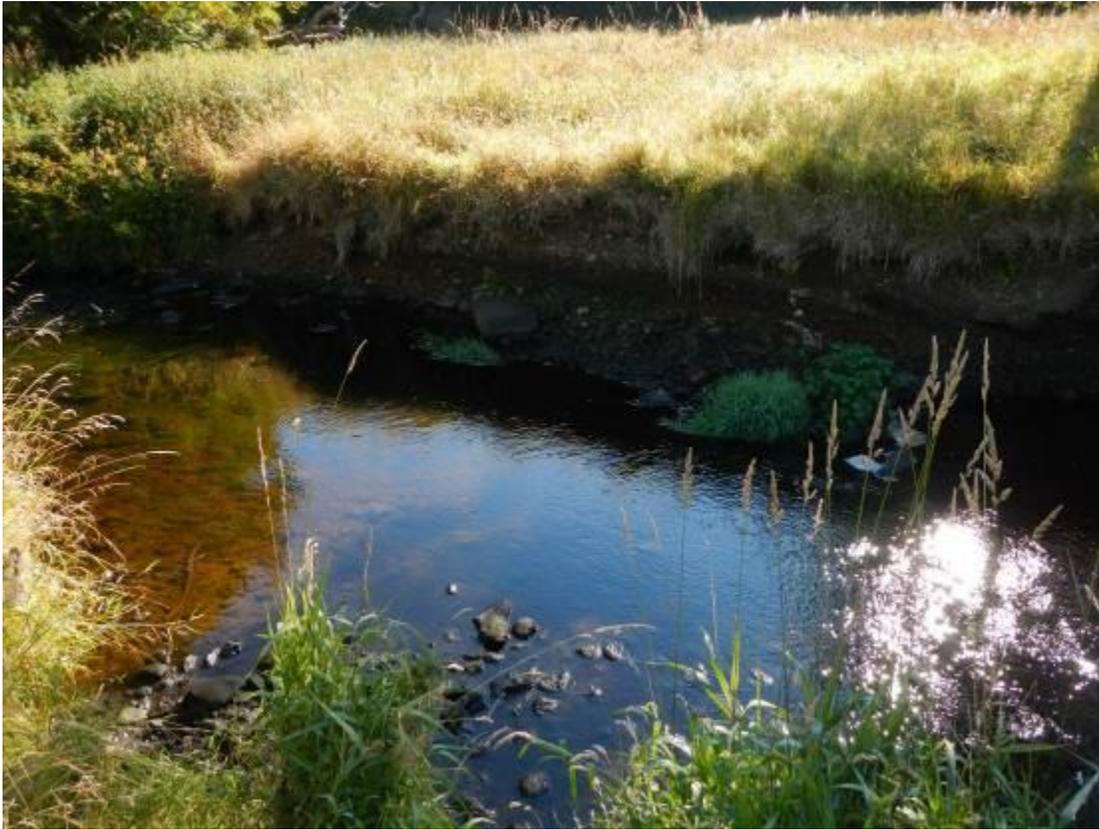
Figure 11. Some erosion is beneficial and vital as a source of new substrate to the Burn. Tree planting a few metres back from the Burn could help to control the rate of future erosion and provide valuable habitat as the channel migrates in that direction.

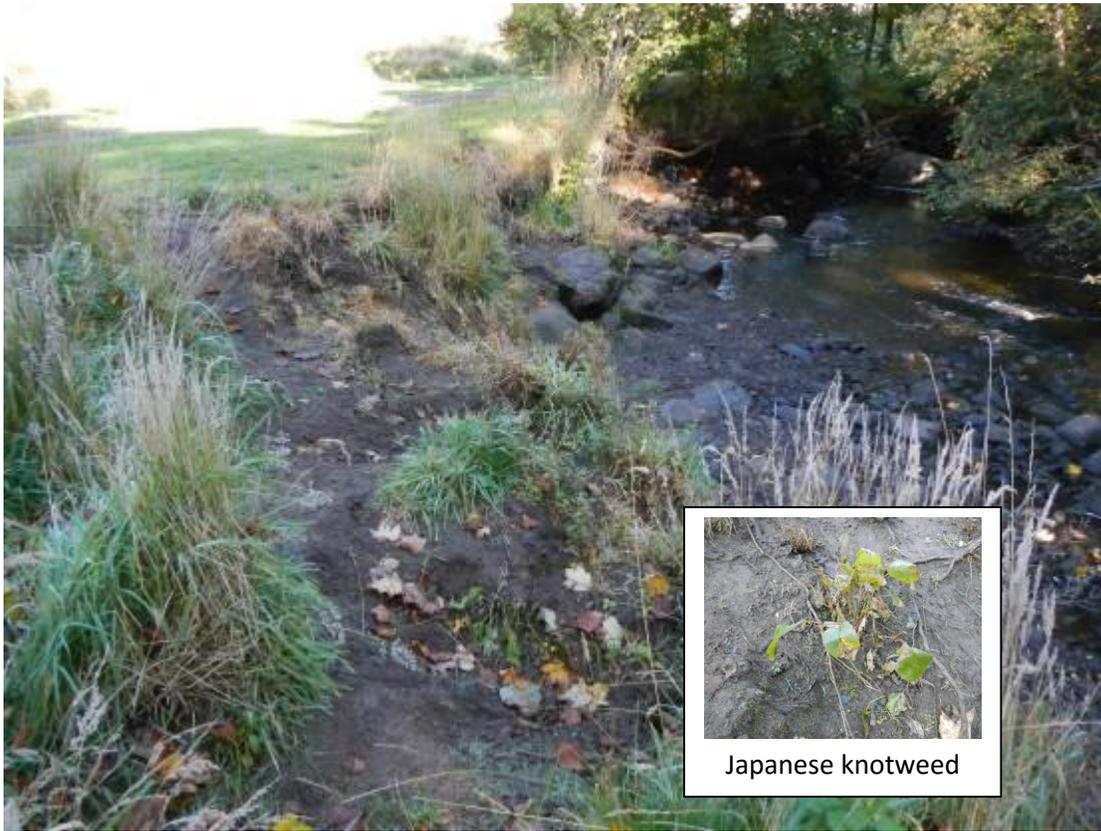
In many areas, accelerated rates of erosion jeopardise the banks (Fig. 12) and, in almost all of these areas, the remains of Japanese knotweed (*Fallopia japonica*) plants can be observed (Fig. 12 - inset). Knotweed is almost certainly the major contributing factor to the erosion, proliferating rapidly in the growing season and shading out all other vegetation, only to die back in the winter and leave exposed soils susceptible to erosion. RFFT have been administering a knotweed eradication programme along the Burn, which appears to be working; however, several further treatments will be required to fully control such a voracious species and the sites should be monitored for several years after all plants appear to have been eradicated to ensure that none persist.

Figure 12. Erosion and bare earth around the site of a Japanese knotweed stand. Chemical treatment of the knotweed appears to be working but small plants still remain (inset).

This brash technique could be extended along other areas of bare earth, such as immediately u/s (Fig. 12), to protect the bare earth and reduce erosion in the areas where knotweed has inhibited riverbank vegetation. It would protect the bank, encouraging bankside vegetation to re-establish, while also discouraging trampling of the area by visitors and dogs which appear to be increasing erosion by accessing the Burn at that point.

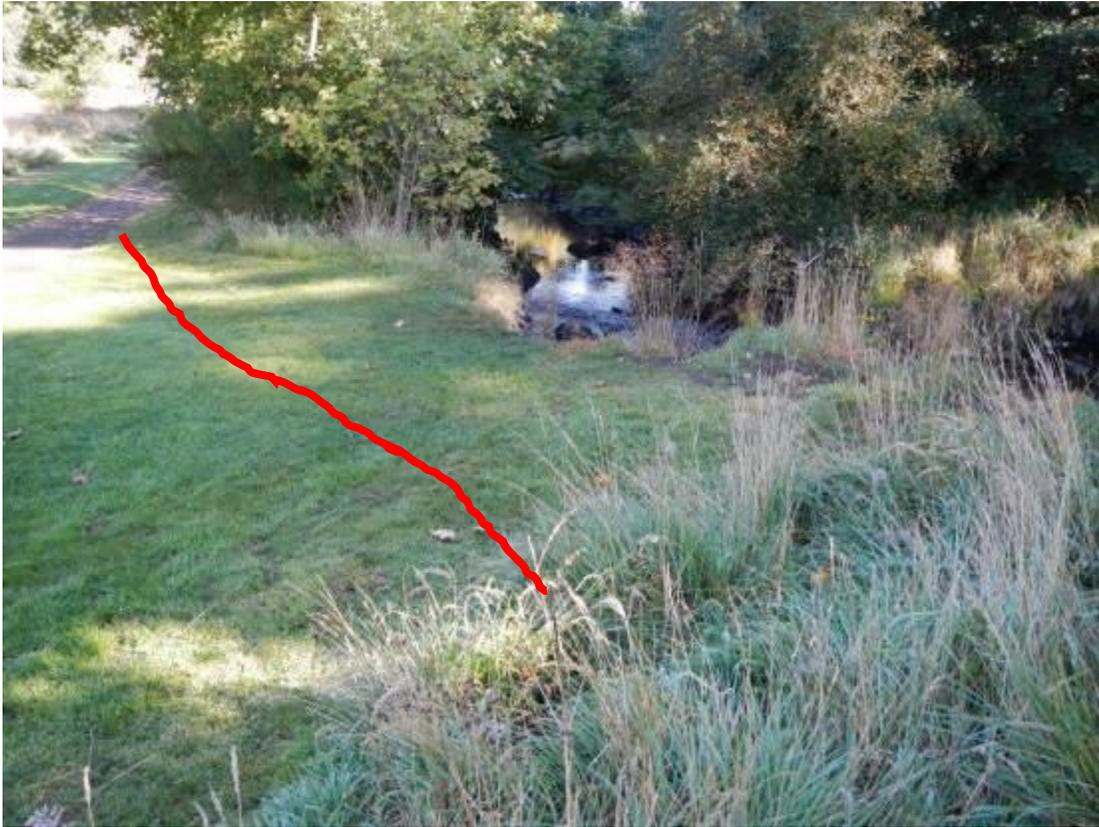
Where the footpath banks are at risk, soft bank protection may be beneficial to prevent the Burn eroding the path (see **Recommendations**), or the council from intervening with hard engineered revetment to protect the path. The areas that are experiencing erosion issues often correspond with locations where the grass has been mown closely to the river bank. While the mowing is not the primary cause of the erosion, closely cropping the grass (akin to grazing, as described earlier on the River Allan), and encouraging footfall and dog access in and out of the water on the closely cropped grass, places those areas of bank at increased risk of erosion. Maintaining a larger buffer strip between the mown path areas and the riverbank will increase the vegetation cover that will afford greater protection to the bank.

Figure 13. Mowing right up to the top of the eroding riverbank further destabilises it by reducing the foliage protection above and root structure within the bank. Creating a buffer strip here to at least the red line would be greatly beneficial.

To help stabilise the banks where unnaturally high rates of erosion are occurring, several simple measures would be beneficial. Continued treatment of the knotweed will be vital, as this is undoubtedly one of the major underlying causes. Reducing the access at those locations where the bank stability is already compromised would also be beneficial and could easily be achieved by allowing a larger, unmown buffer between the footpath and the river bank (minimum 3 metres). This could be aided by the installation of posts or boarding around the obvious access point to simply discourage further access to the river and prevent mowing of the grass past that point as depicted in Figure 23.

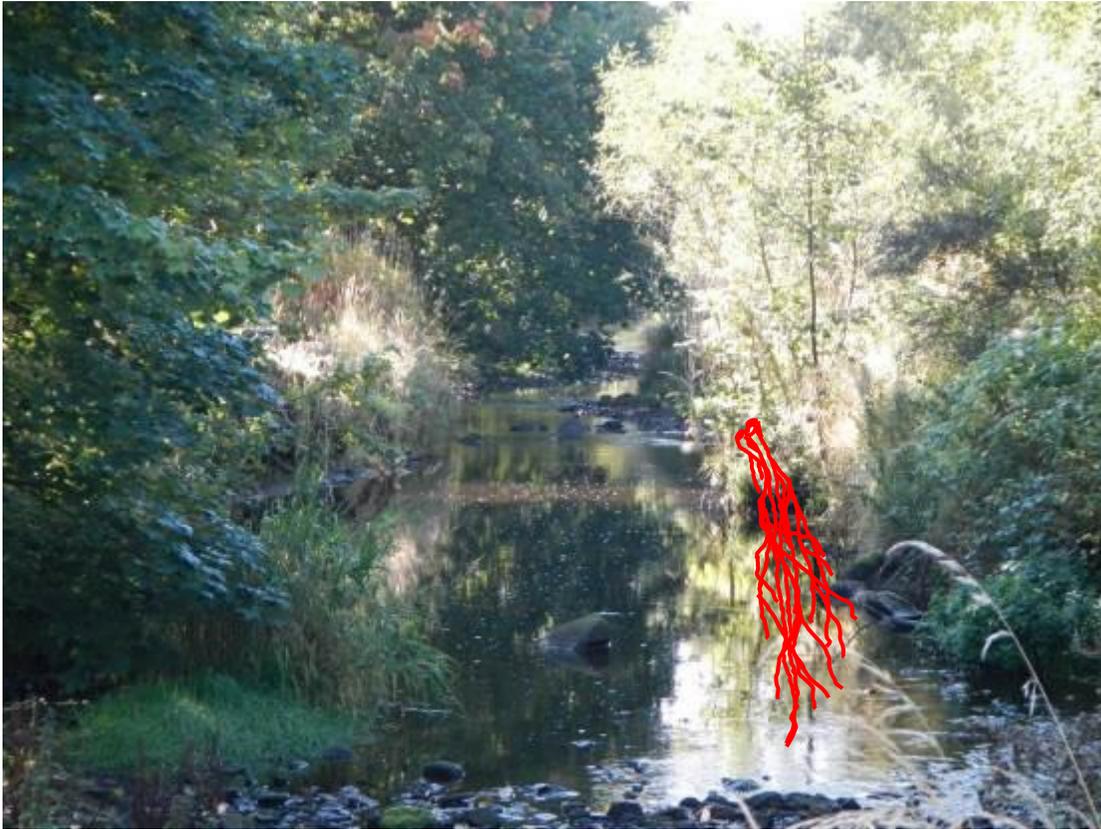
In other areas, although still subject to past human intervention, higher quality salmonid habitat is present. Some small measures to further enhance the habitat quality throughout would be beneficial. Where willow trees and shrubs are adjacent to the watercourse, they could be laid down along the bank side to trail into the water, providing cover and structure in the channel (as shown in Fig. 14). Planting of willow whips in bare or open sections would also increase the fish holding capacity and provide improved habitat for adult resident trout.

Figure 14. A relatively open pool that could be greatly enhanced with low and trailing cover by laying some of the bankside shrubs into the channel (as indicated by red outline).

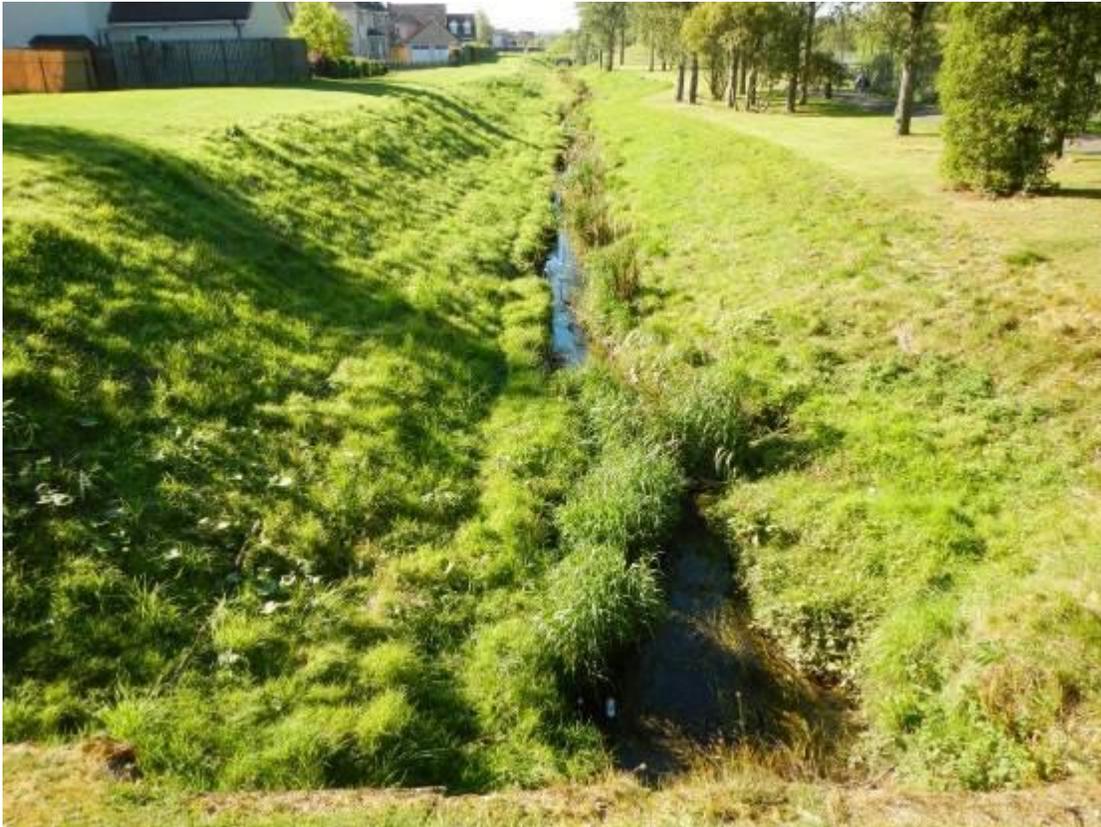
The current channel is almost completely straight and at a low gradient, which is unusual as straightening a watercourse almost invariably increases channel gradient by reducing the distance over which the gradient is lost. This suggests that the Burn may have been moved significantly from its original course. It now lies within a deep V-shaped trench (high flow channel), with the low-flow channel also being of a much narrower, deeper cross-section than would naturally occur on a watercourse of this size (Fig. 15). The uniform dimensions create a channel that lacks discrete areas of scour and deposition, and is subject to uniform bed scouring at high flows.

Figure 15. Straight, uniform width and depth, low-flow channel sitting within a straight V-shaped trench.

There are three potential recommendations for Bog Burn: completely restore a more natural, sinuous channel to the Burn; undertake a 'dig and dump' type restoration to the current channel; or install flow diversion structures that would help kick-start naturalisation of the channel. Of these options, complete restoration is the optimal solution to create a more natural watercourse and would be undertaken if significant funding were available. However, the site is constrained within its location and channel dimensions due to adjacent infrastructure, and in the current financial climate, it is unlikely that work on the required scale would be feasible. Installation of woody material and flow deflectors to introduce more natural features to an impacted channel can often be a cheap and easy option. However, in this instance, the extent of modification and lack of flow energy available mean that such techniques are unlikely to create significant habitat improvements. This leaves the most realistic option being 'dig and dump' type restoration to the current channel.

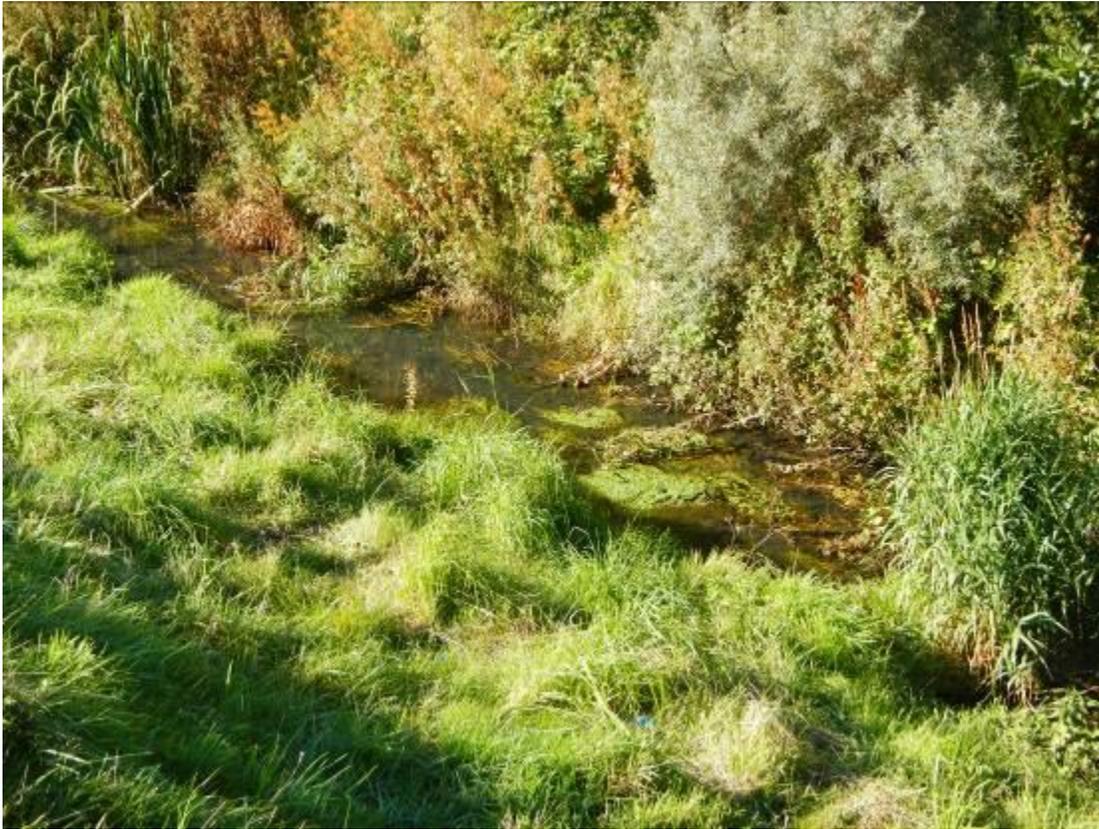
Some limited areas of shallower, faster flowing, higher quality habitat exist. However, where light is able to reach the bed, obvious nutrient issues are evident by excess algal growth which further degrades the habitat (Fig. 16). In many other areas, the uniform cross-section channel lacks shallow, wider, faster-flowing riffles and deeper, self-maintaining pools and allows unimpeded encroachment of emergent and aquatic vegetation. This results in vegetation choking the channel and impoundment and slowing of the flows upstream (Fig. 17). The issue would be far less pronounced in a channel with more natural dimensions that could adapt to the high flows it receives and maintain greater variation in flow direction and velocities. Natural shading from increased tree cover would also limit the encroachment of vegetation.

Figure 16. Shallower, faster flowing areas provide some higher quality riverine habitat but excess algae in the areas with higher light penetration to the bed reveal elevated nutrient inputs upstream.

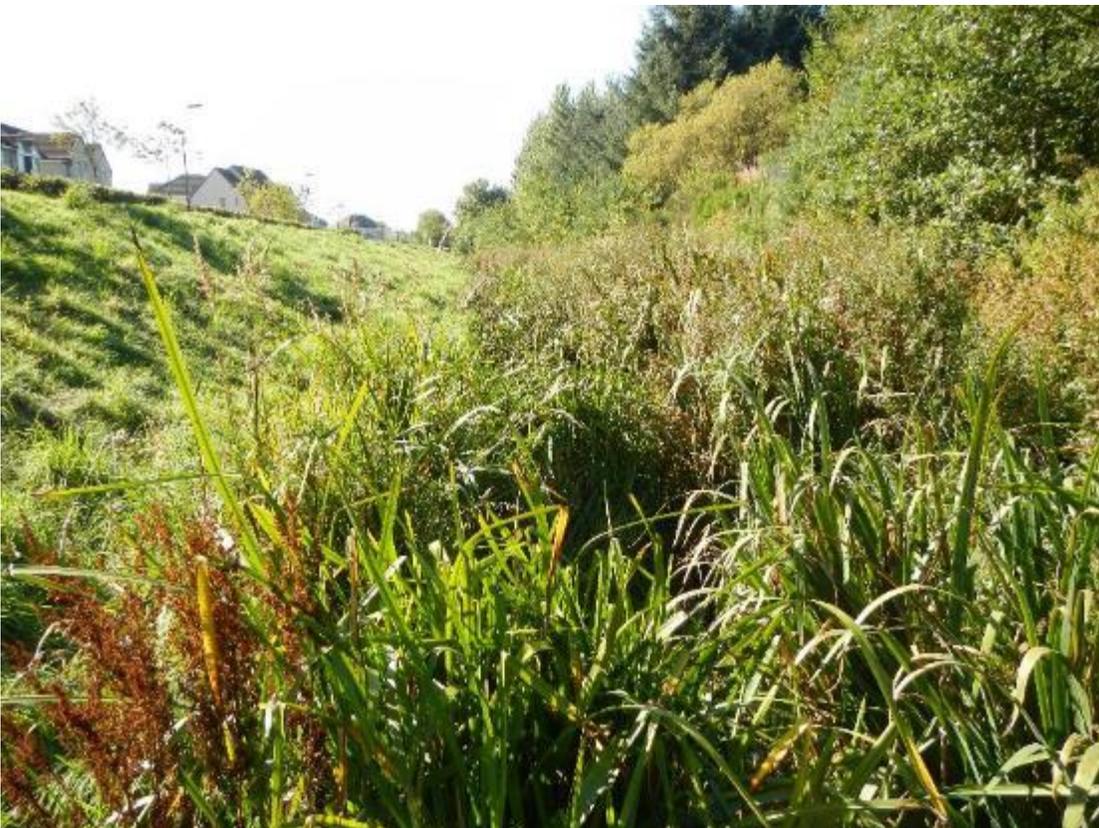
Figure 17. Uniform flows and depths allow uniform encroachment of vegetation, leading to choking of the channel and impoundment of flows.

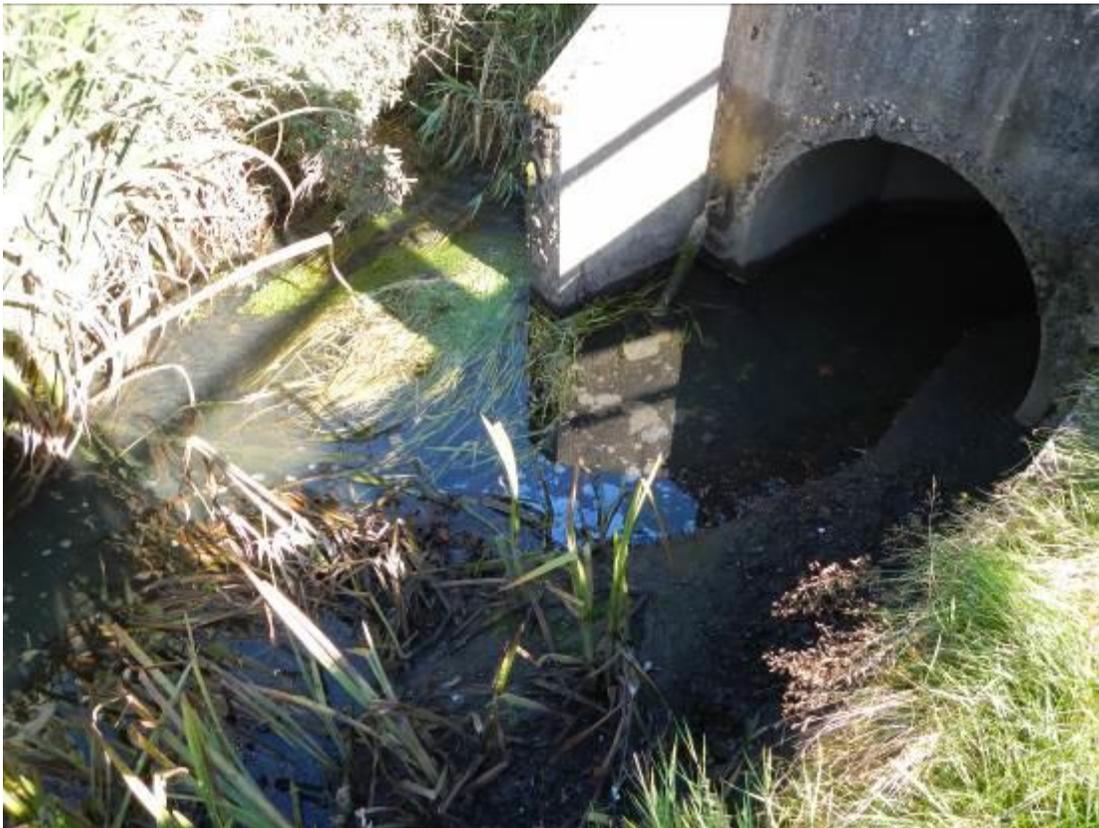
Inspection of a culvert entering the Burn, approximately halfway along the reach inspected, revealed a shiny, likely oil-based film on the water surface and a surface boom in disrepair (Fig. 18). The issue is probably linked to misconnections within the drain system and / or surface water (road washings), and the boom an attempt to deal with the problem. It would be worth monitoring the Burn to see if any pollution events can be more accurately identified (see **Recommendations**).

Figure 18. Culvert outflow entering the Burn with a now defunct surface boom. Note the oily film on the water.

In addition to the habitat restoration measures, it is recommended that a programme of invertebrate sampling be initiated on the Bog Burn, which would, ideally, be undertaken by the local community if their support can be gained. Assessing the size and diversity of species within the invertebrate populations of the Burn can provide an indication of the long-term water quality, rather than just the snap-shots possible through water sampling. Changes to the invertebrate populations can then be used to help identify pollution incidents, especially if sites are located up and d/s of the suspected pollution sources.
