Water Framework Directive Advisory Visit

River Frome, Gloucestershire

December 2012

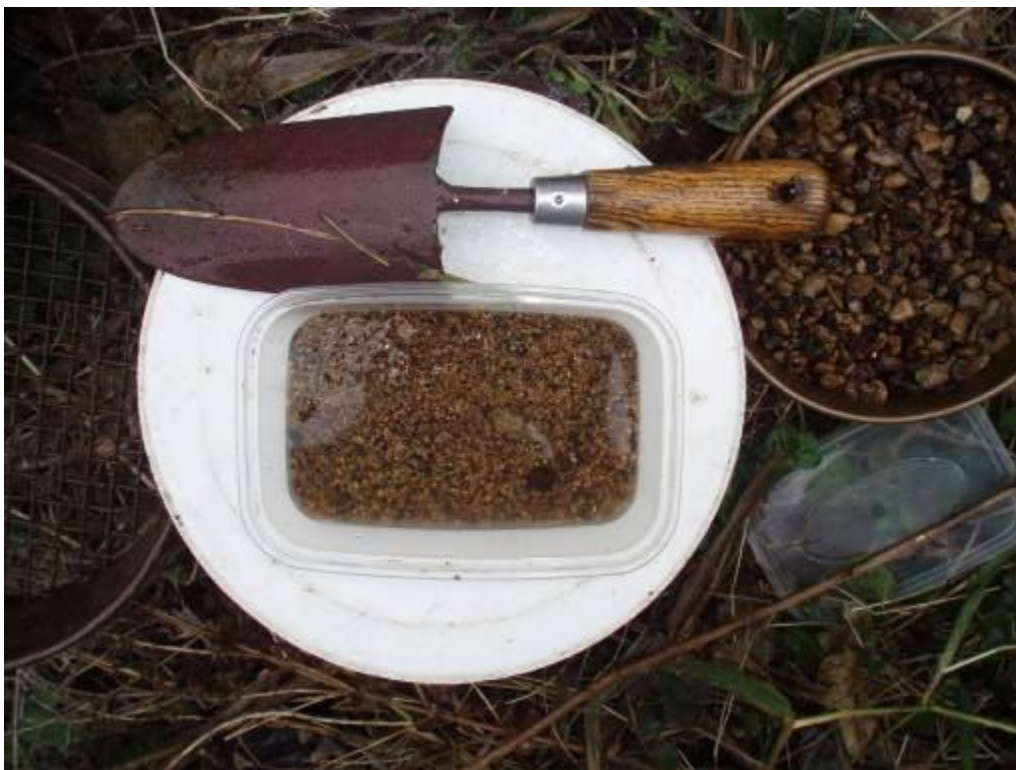
A gravel sample was taken from immediately downstream of the road bridge at this location, to the left of centre channel. The gravel was clean and well-sorted (probably as a result of localised scour caused by the bridge) and suitable for salmonid spawning. There was a small component of fines (<2.0mm) and that present was coarse sand, with very little fine sand or silt (Photos 1, 2).

Photo 1 Gravel sample showing fines (<2.0mm) component (left) and larger gravel (right).

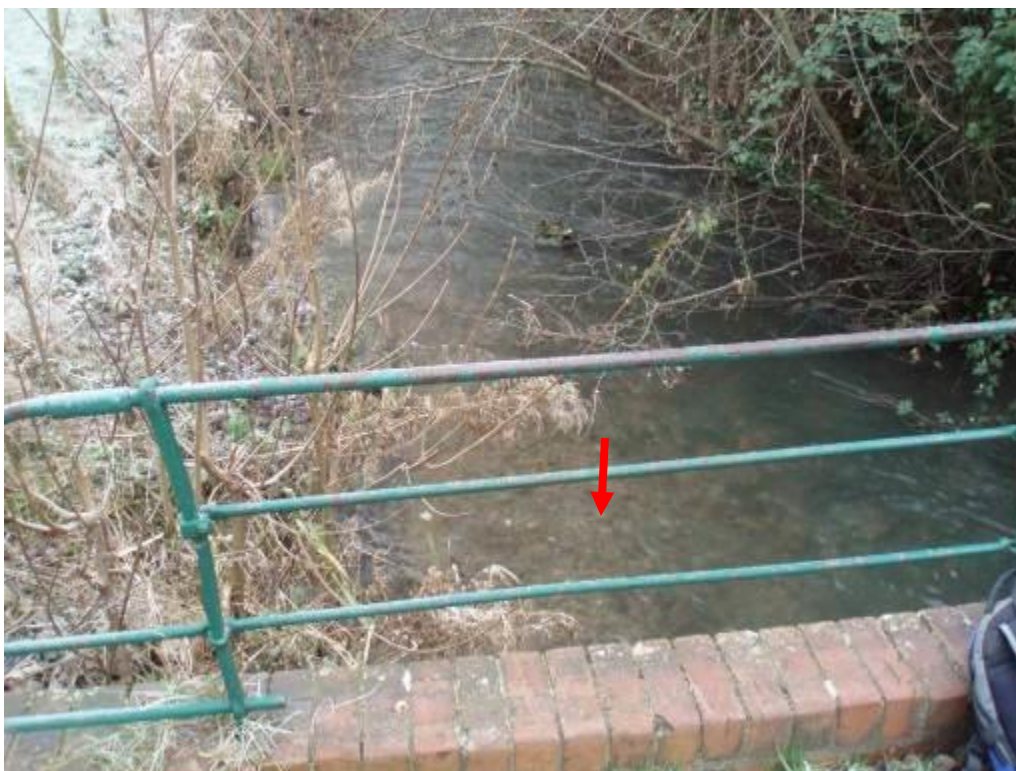
Photo 2 Area of gravel sampling downstream of bridge

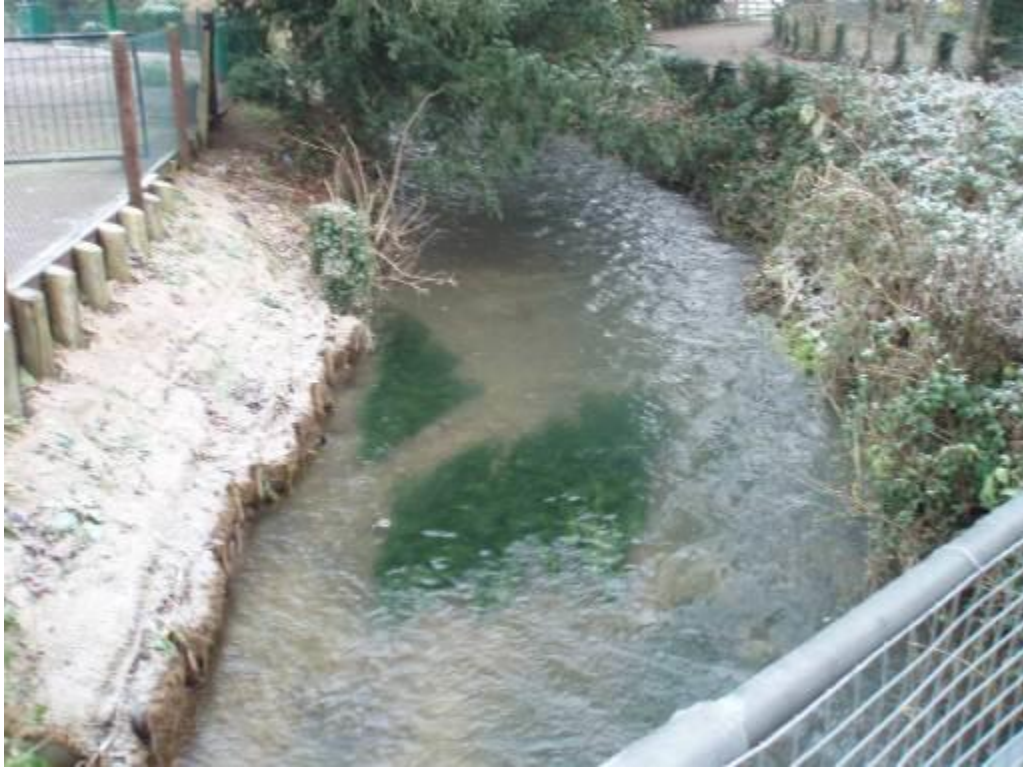
Riparian habitat was reasonably good, with fencing alongside a grazed field on the left bank and overhanging trees, roots and scrub on the right bank. Some water crowfoot (*Ranunculus* sp.) was present in the more open section upstream of the bridge (Photo 3).

Photo 3 Upstream of road bridge

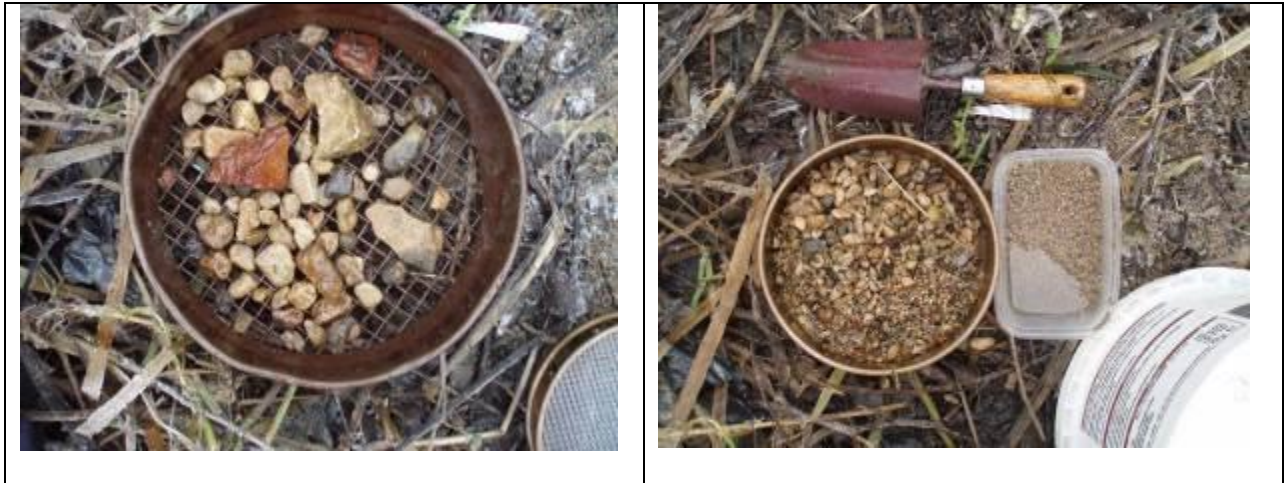
Photo 4

The river here emerges in two channels from under the bridge, confluent downstream of a vegetated sediment bar (Photo 5). Gravel was sampled from the point indicated on Photo 5 (red arrow). The substrate was similar in composition to the previous site (Photo 4), but a greater proportion of silt was observed during sampling. Despite this, the substrate was suitable for salmonid spawning in terms of size and being well-sorted. Beyond the immediate sampling point, substrate appeared to have a larger component (cobble and broken brick) in the faster flowing mid-channel areas.

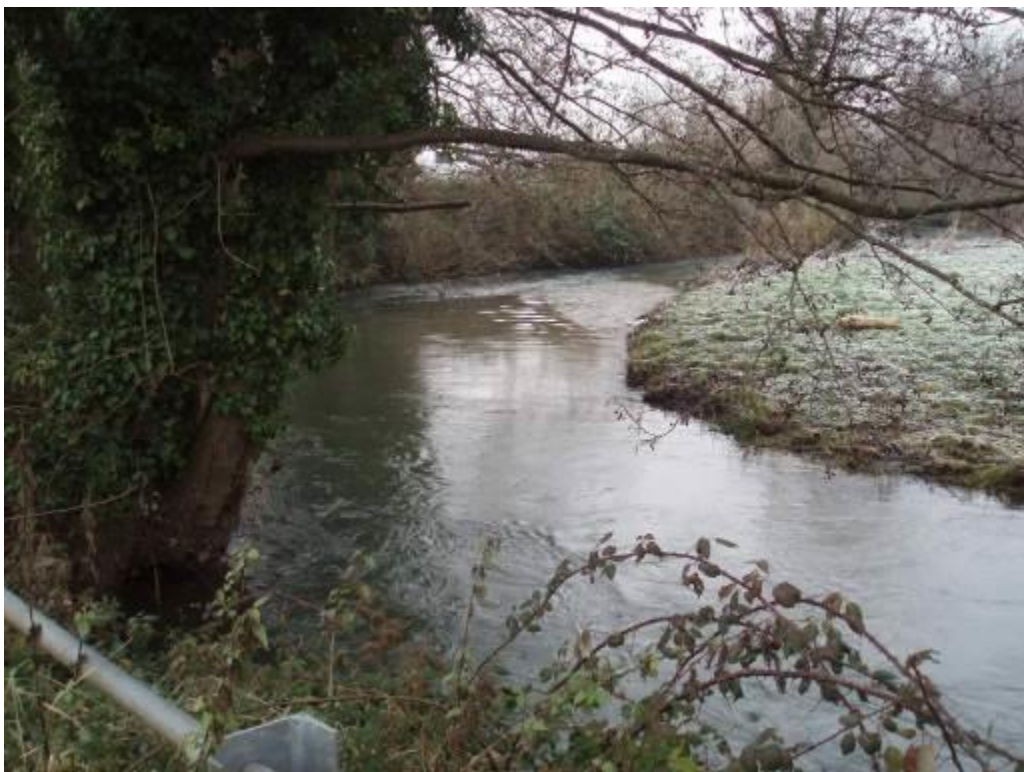
The river channel through this section is relatively straight apart from an S-bend under Downton Road bridge. There are some good habitat features associated with this localised sinuosity, namely a pool-riffle sequence with its associated variety of depth, flow velocities and well-sorted substrate (Photo 6). The bank height on the inside of the bends is low, providing good lateral connectivity to the floodplain and hence marginal refuge areas for fish during high water.

Photo 6 Looking downstream from Downton Rd. (north channel)

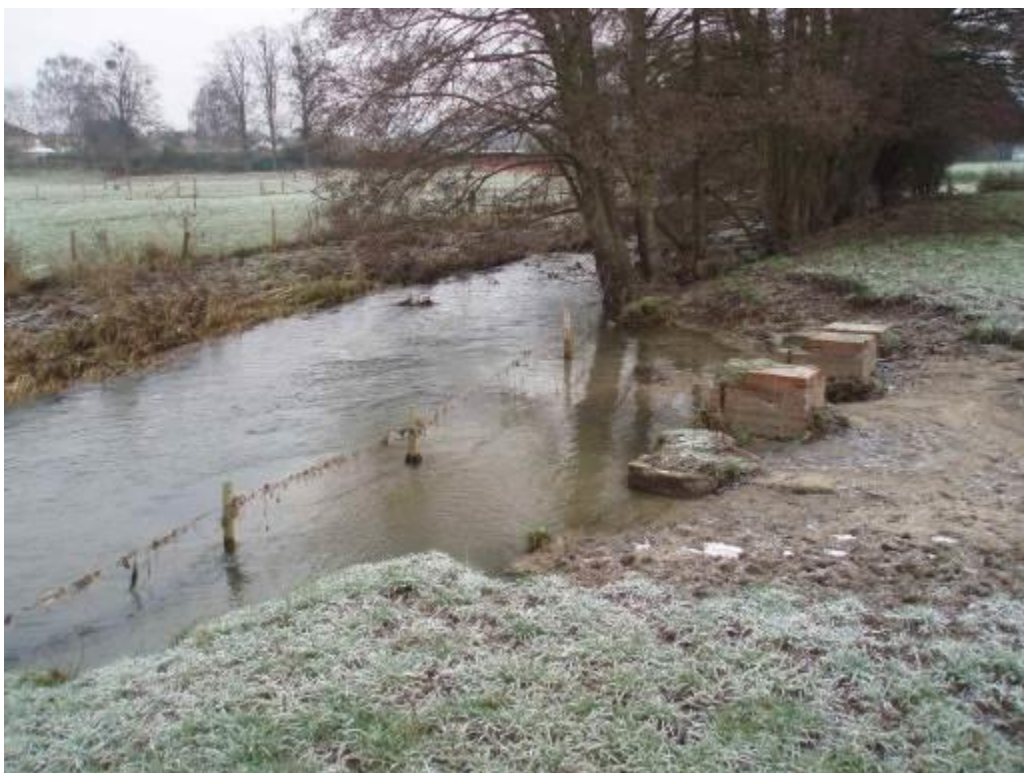
An old sluice structure is present on the left bank, with the remains of a channel leading away from it across the field (Photos 7, 8). Just upstream of the railway, extensive civil engineering works were taking place to lay a pipeline. This appeared to be taking place with due regard to the river, with minor impact at a machinery crossing point.

Photo 7 Former sluice, now livestock drinking area (SO 79853 04863)

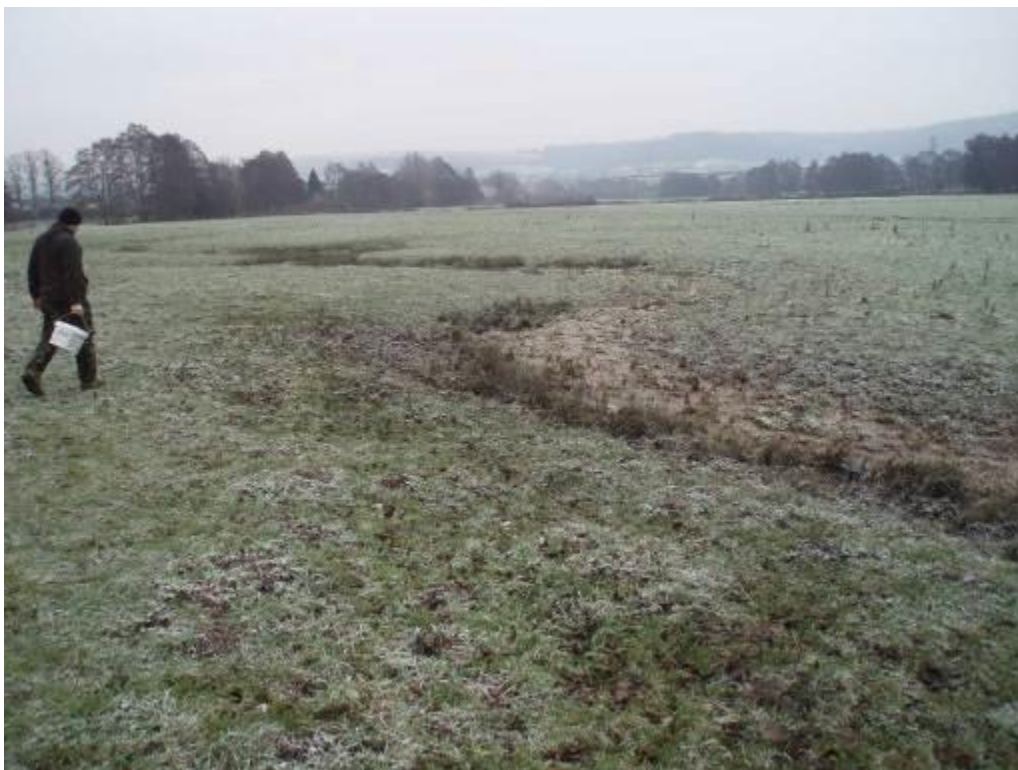
Photo 8 Former channel associated with above sluice

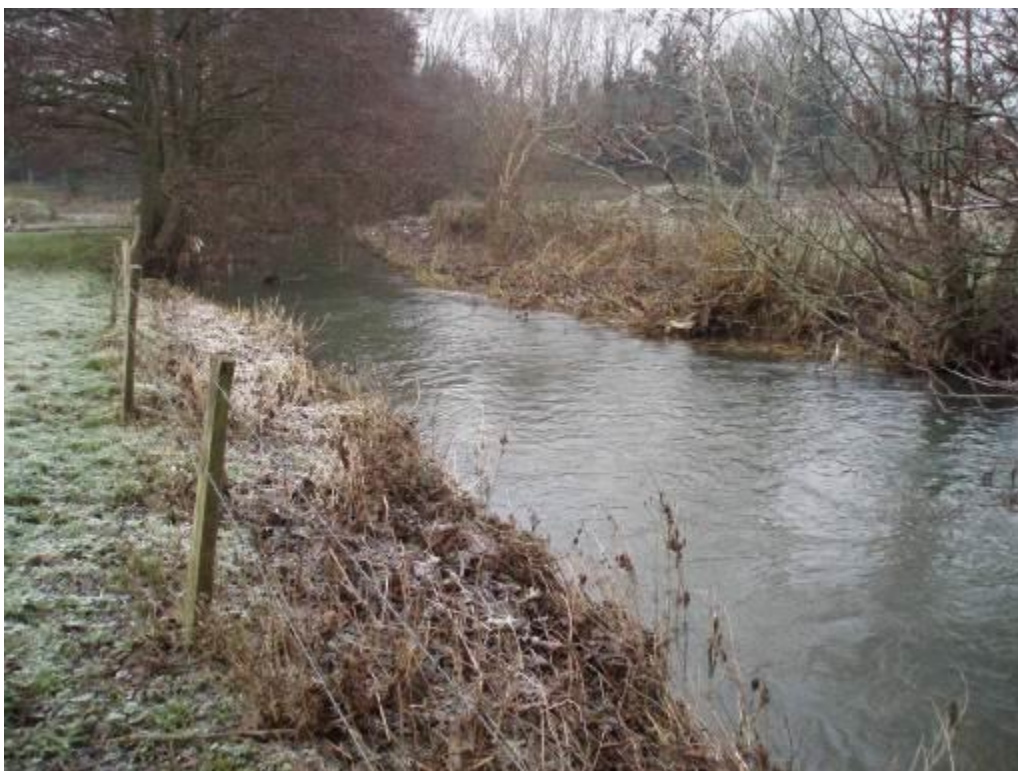
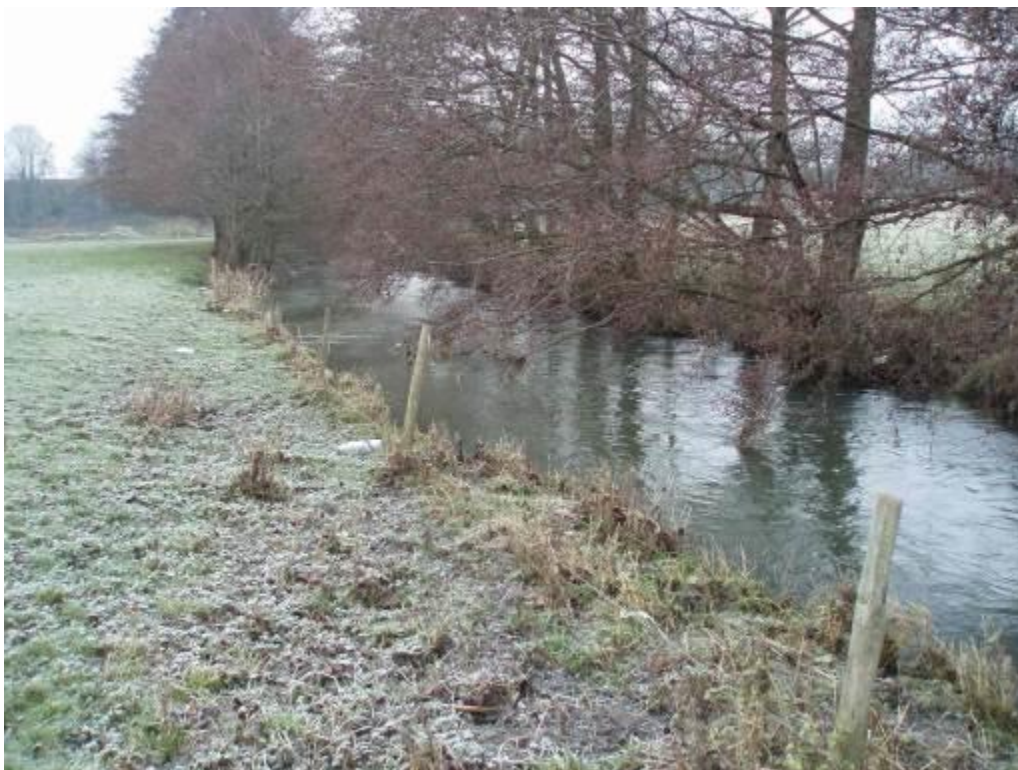
The remainder of the channel is straight (probably man-made) and as a result lacks depth variation. There is however good riparian habitat in the form of 'shaggy' marginal vegetation and mature trees, mostly alder (Photos 7 – 10), protected from grazing by fencing on both banks. The substrate is gravel and water crowfoot is abundant in the less shaded areas; this provides some variety of flow velocity and a degree of substrate sorting. Gravel sorting could be improved by the introduction of large woody debris structures. In general, the habitat appears favourable for salmonids and it would be surprising if this section did not support a wild trout population.

Photo 9 North channel near railway, downstream view

Photo 10 North channel (railway embankment visible in background), downstream view

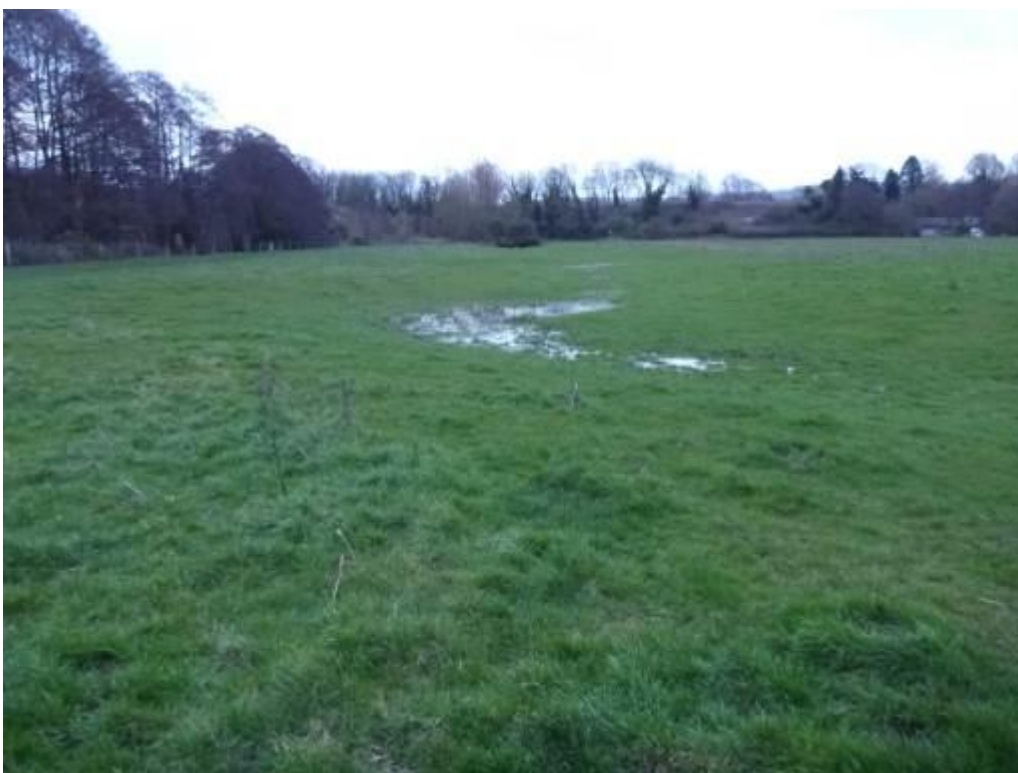
Downstream of the railway the habitat is similar, but the river becomes impounded as it approaches Bonds Mill. Between the railway line and Bonds Mill it is clear this reach of river is in a perched channel above the level of the land on the left (south) bank. The remains of a former channel (with bridge) can be seen in the field here and this appears to be a route for floodwater (Photo 11).

Photo 11 Low-lying field on true left (south) bank downstream of railway.

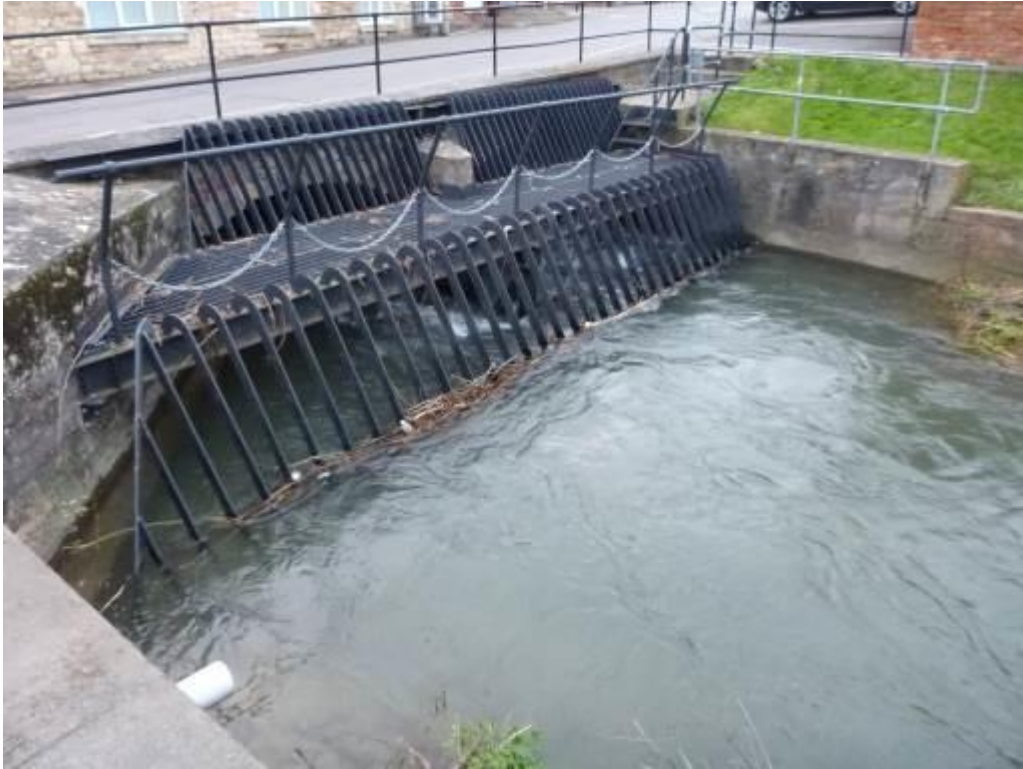
At Bonds Mill, the river is split into two channels, one flowing over a weir at the head of a culvert under the mill site (Photo 12), the other over an overspill weir on the left bank and south of the mill site (Photo 13). The channel to the south of the mill has a gravel substrate suitable for salmonid spawning in many areas; the installation of small log flow deflectors would assist in sorting this and improving spawning habitat (Photo 14). The channels re-join about 200m downstream of the mill, then the habitat is similar to that described upstream of the railway line, with similar opportunities for introducing woody debris.

Photo 12 Weir at head of the culvert under Bonds Mill

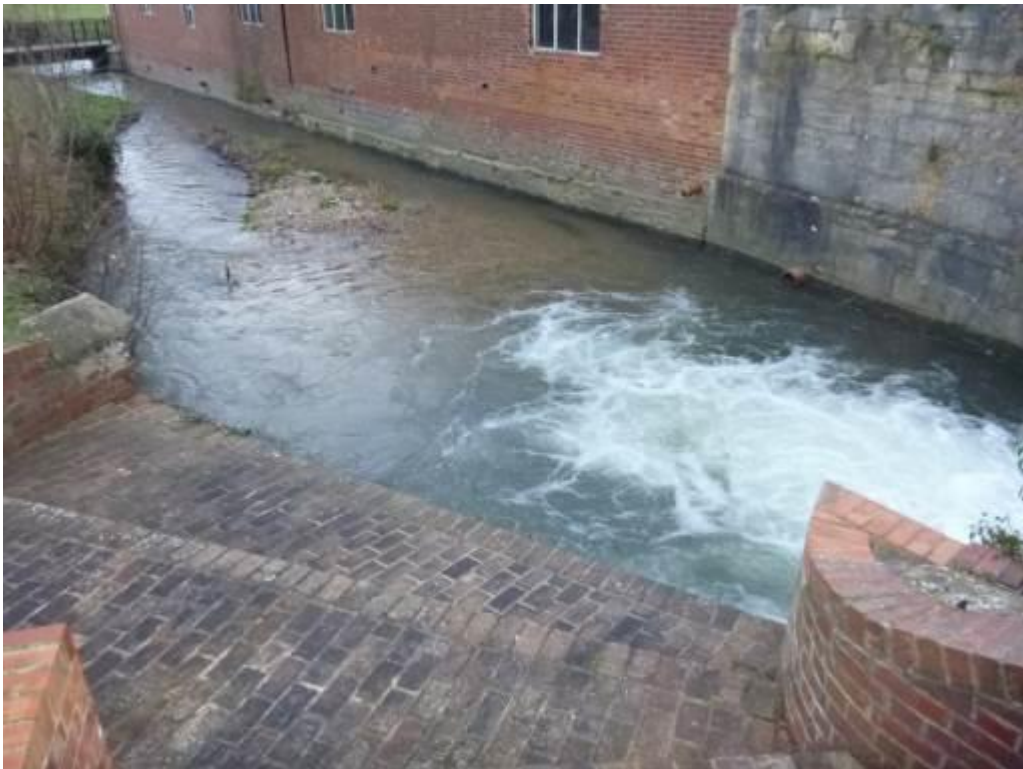
Photo 13 Weir into south channel adjacent to structure in Photo 12. Note gravel bed substrate.

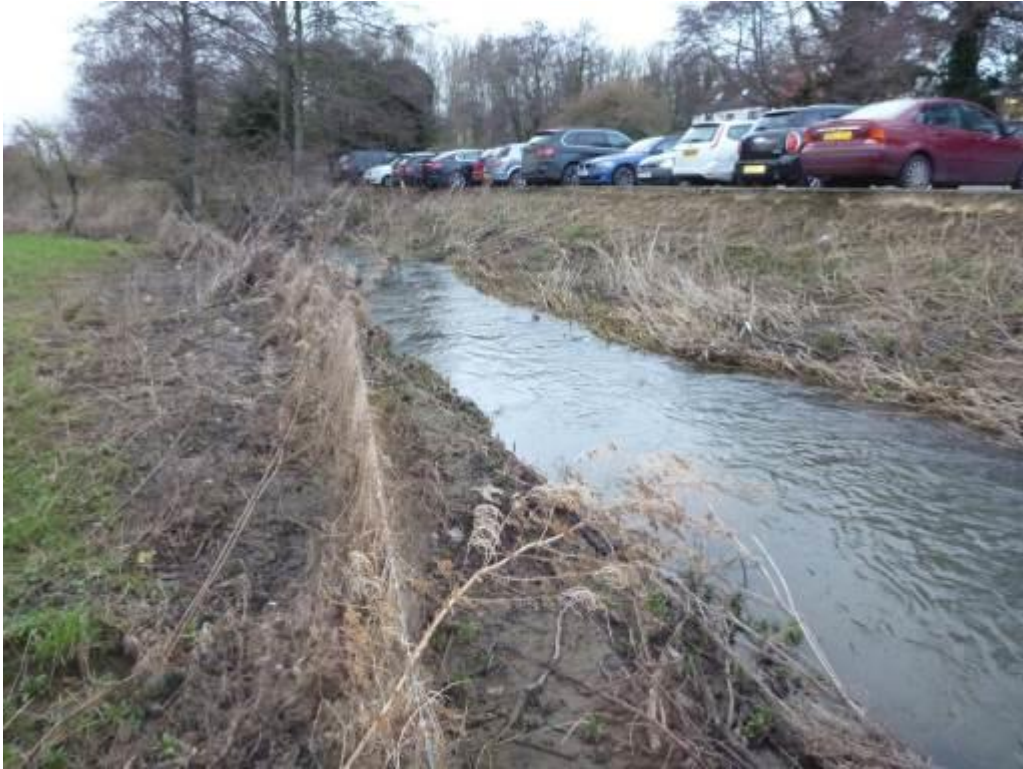
Photo 14 Channel to south of Bonds Mill

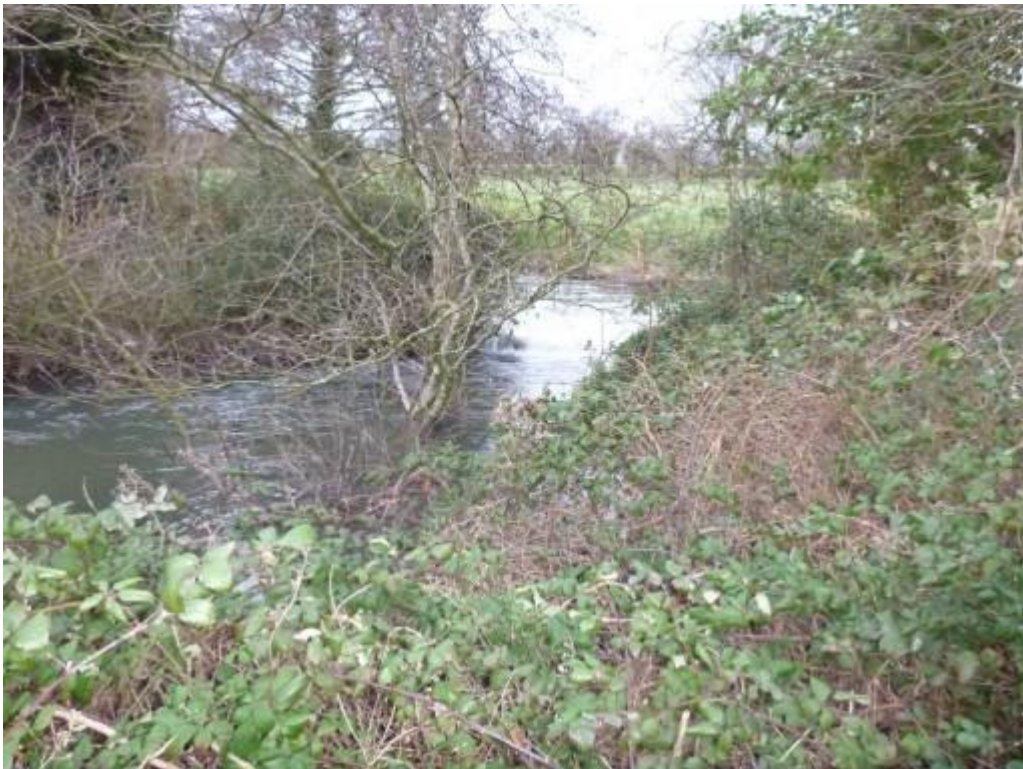
Near Eastington Park Farm the river is split again by a small weir (SO 78338 05559) which was drowned out at the time of the visit, but diverting water from the main channel into a small channel on the left (south) bank (Photo 15).

Photo 15 Site of weir splitting flow near Eastington Park.

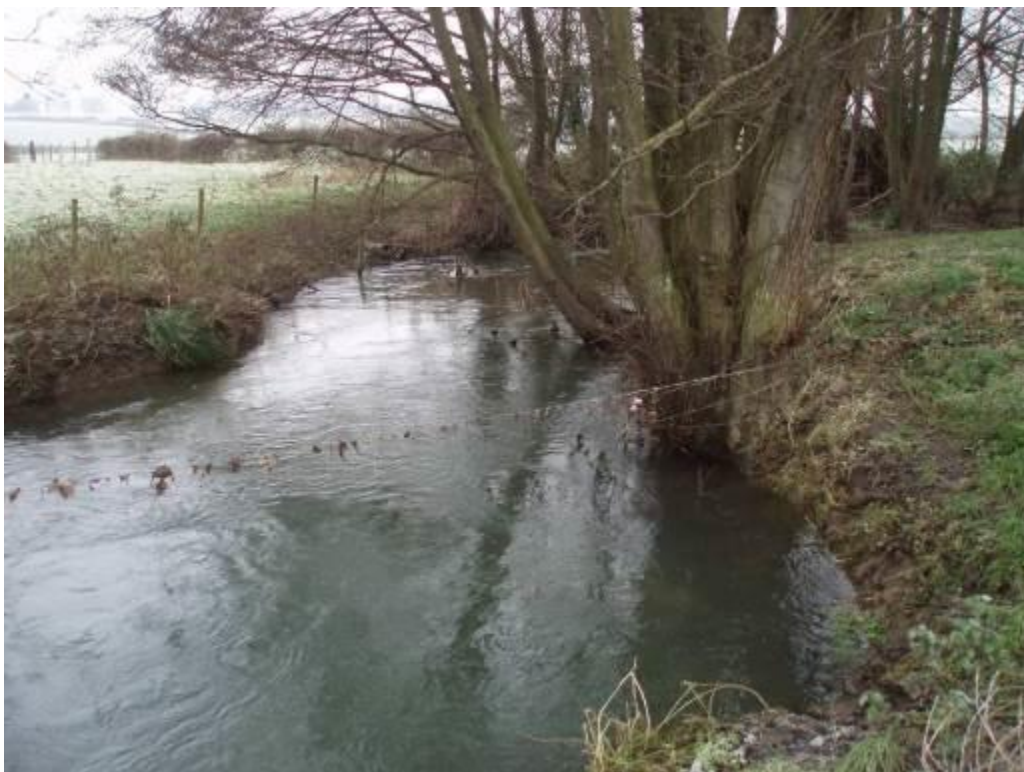
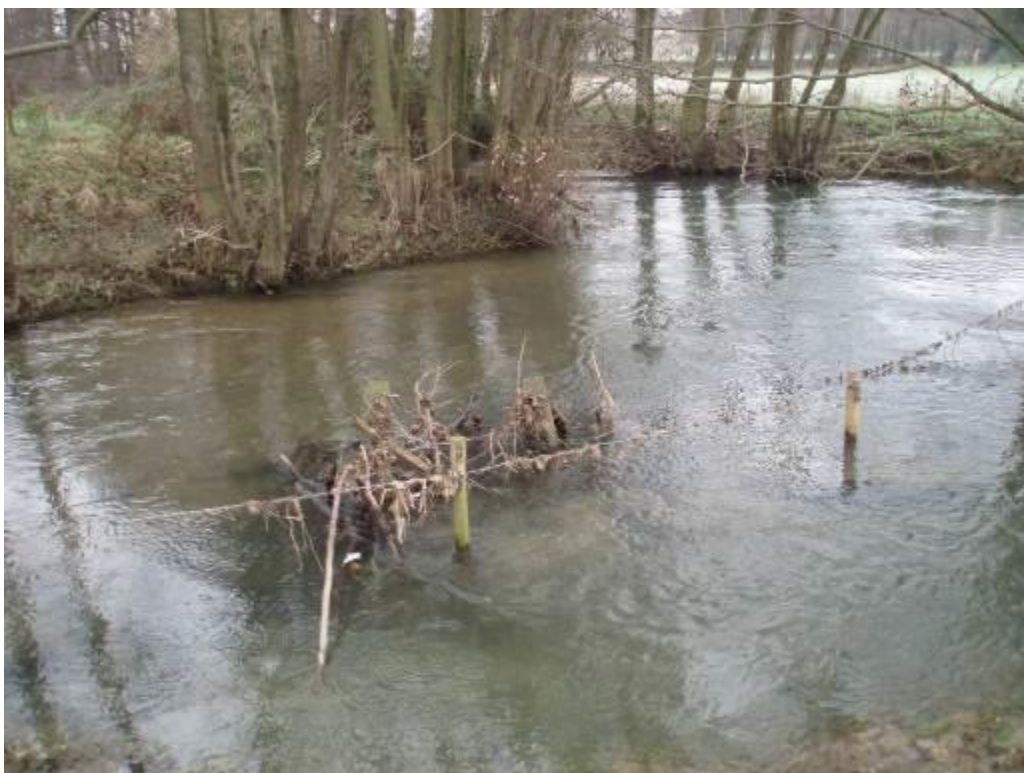
Running parallel to the north channel described above, this channel appears to be much more natural and could be, at least partly, the original river course. It is sinuous, has a pool-riffle sequence and good quality in-stream habitat throughout. Deep lateral scour pools associated with riparian tree roots provide excellent cover, and banks of well-sorted gravel good spawning opportunity (Photos 16, 17).

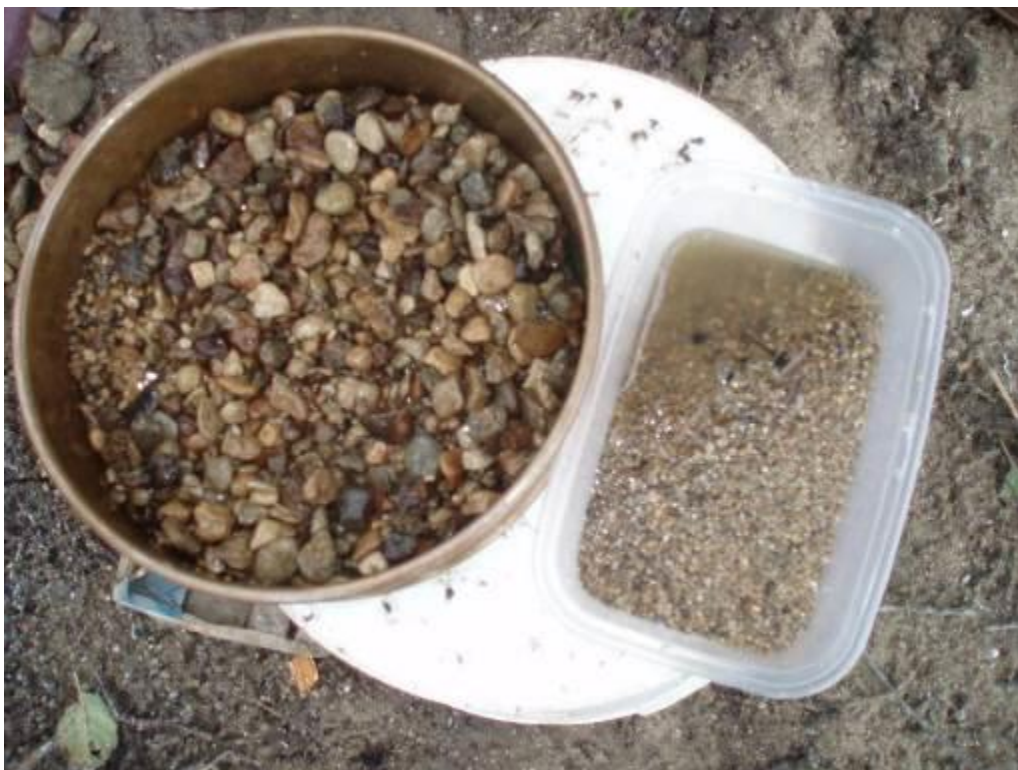
Photo 18

A gravel sample was taken at SO 79815 04667 which showed a good size for trout spawning, with a low proportion of fine sediment (Photo 18). This section of river should support a good fish population, although there is a barrier to fish movement (weir) at Beard's Mill just downstream of the railway (Photos 19). A small leat exits the channel upstream of the weir (Photo 20), through the Beard's Mill site (now private residences) and rejoins a short distance downstream.

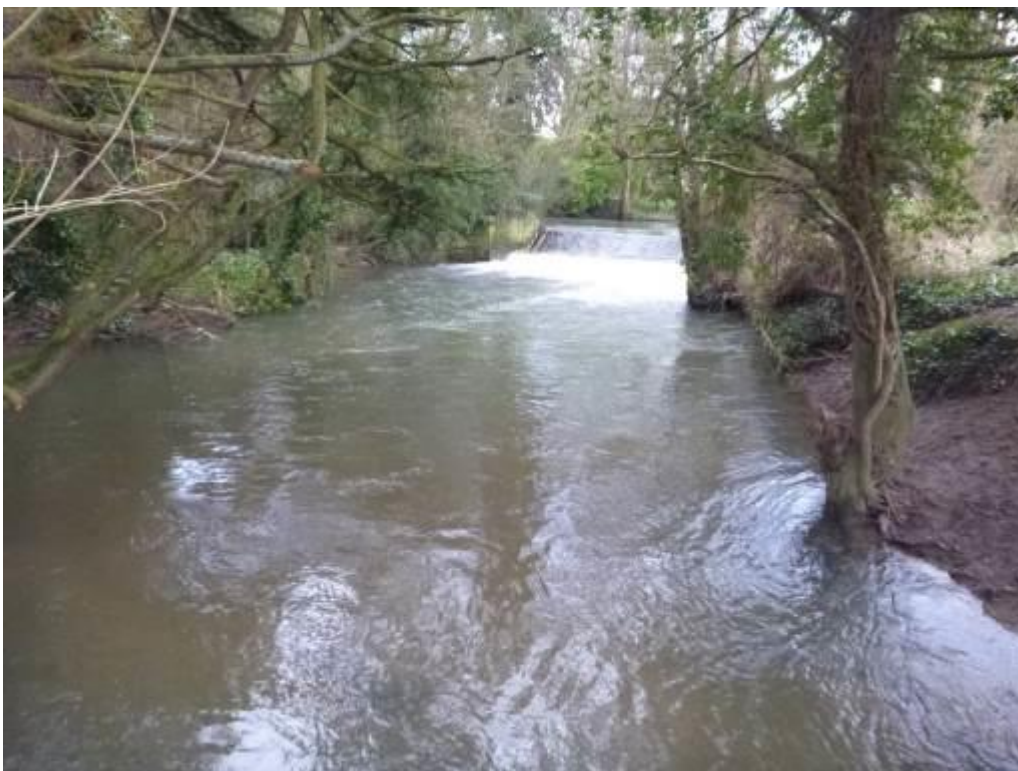
Photo 19 Weir at Beards Mill (SO7954104857)

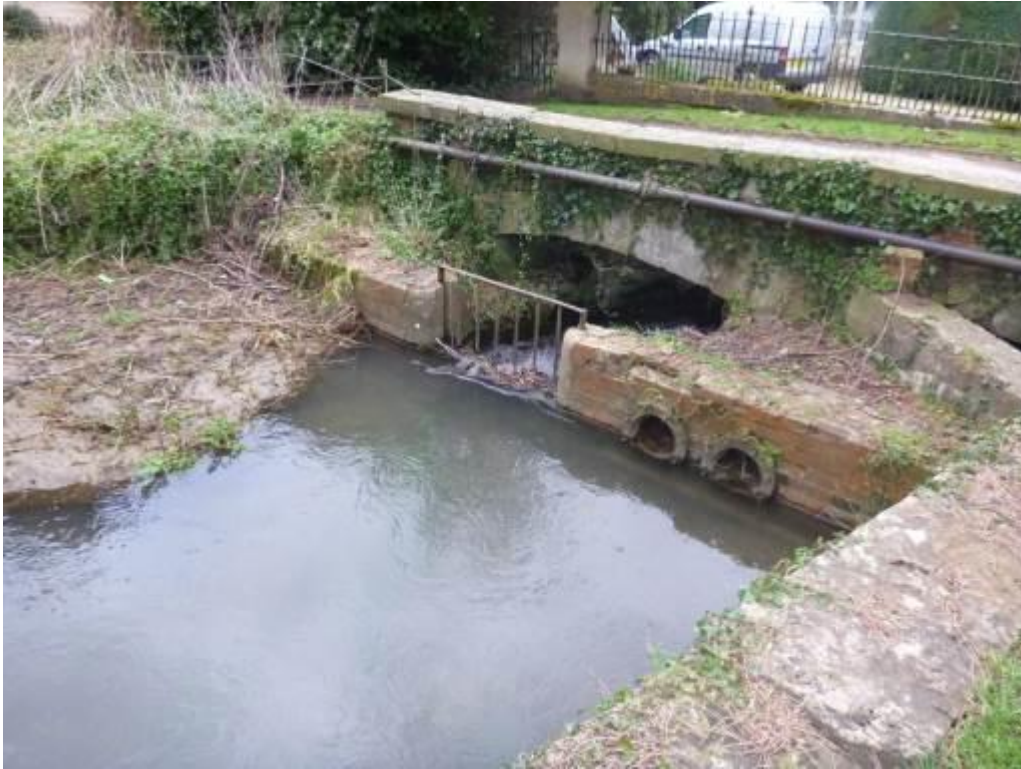
Photo 20 Head of the mill leat channel at Beards Mill

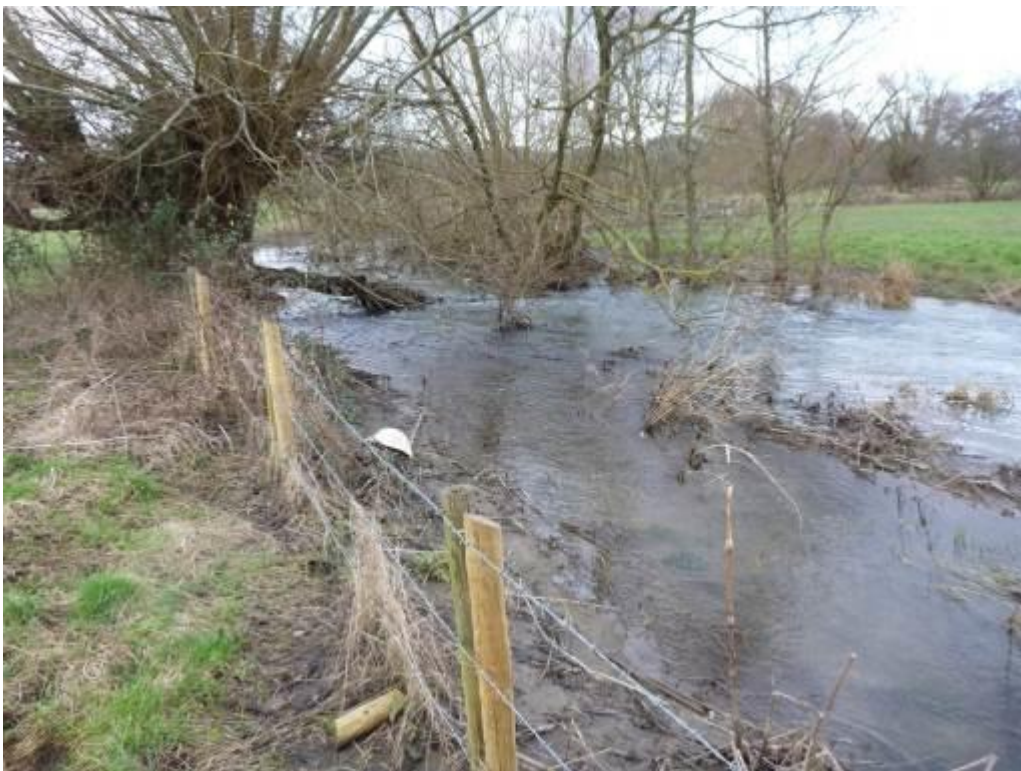
Below Beard's Mill the channel is straightened for about 250m then enters a short meandering section. The latter has good in-stream habitat including woody debris (Photo 21). The discharge from Stroud Sewage works enters the channel on the left bank and from this point downstream the river is artificially straight (Photo 22). The field on the right bank is low lying with evidence of former channels, suggesting this may have been (at least partly) the route of the river prior to the split into the present north and south channels of the Frome.

Photo 21 Meandering section downstream of Beard's Mill

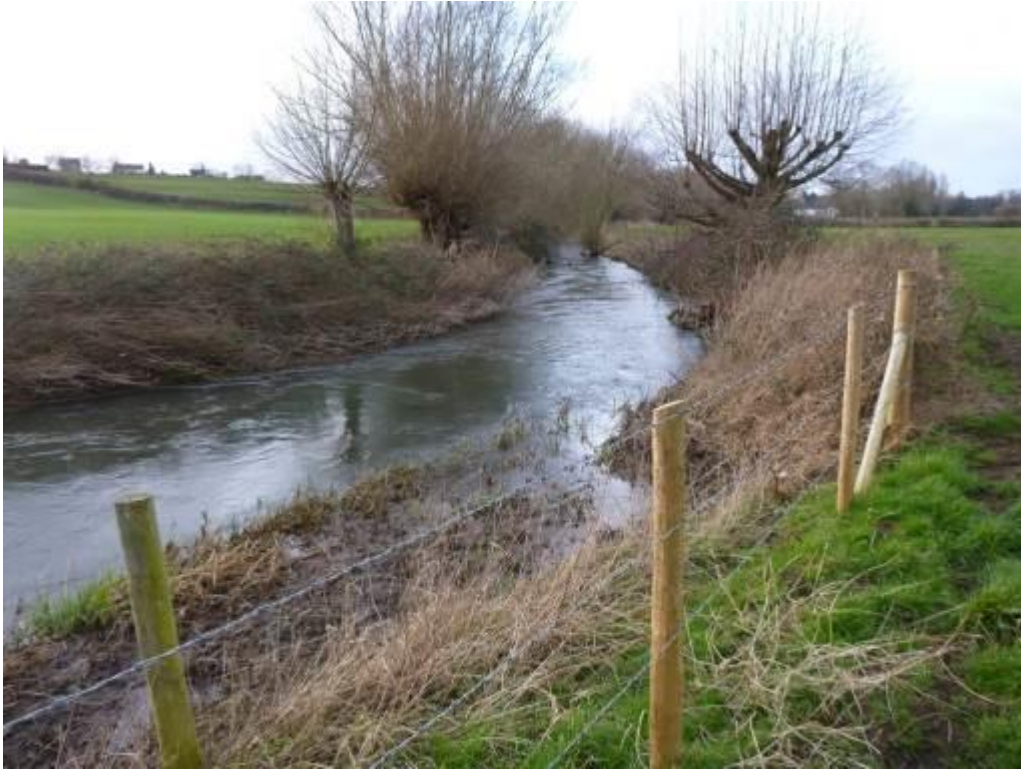
Photo 22 Downstream of sewage works discharge

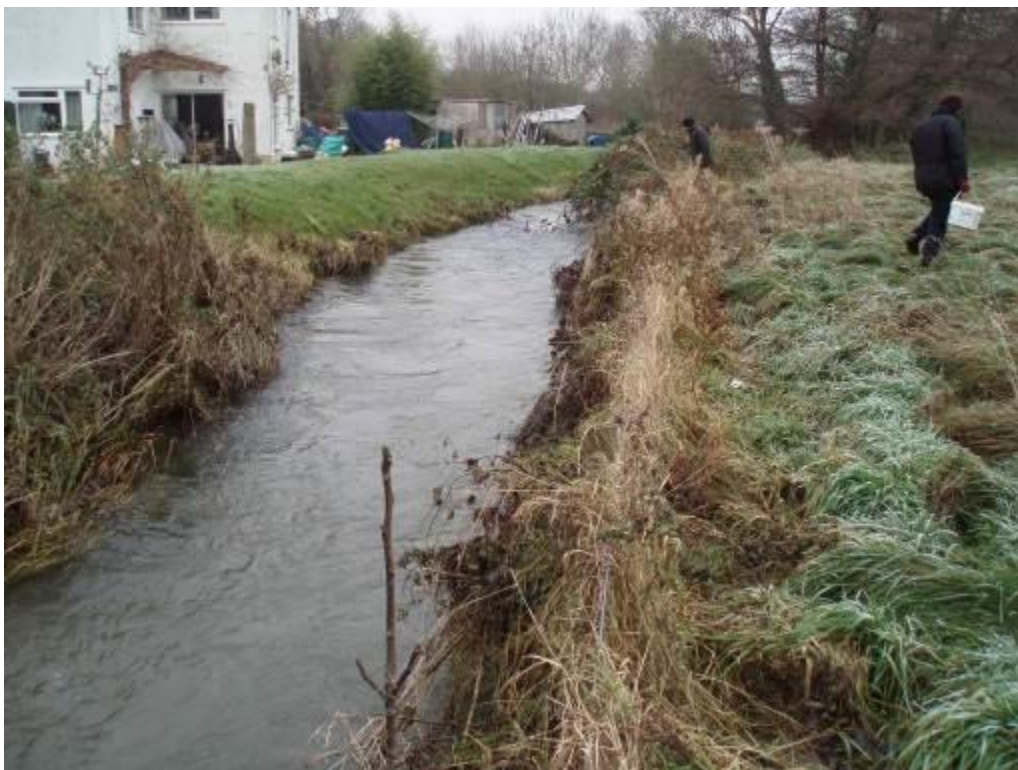
The north channel here is further divided into two channels which diverge upstream of the A419 and converge just upstream of Downton Road; the more southerly is narrow, deep and incised where it runs close to houses on the right bank. The channel is generally straight and flow through this section is swift and there are few areas of slacker water (Photo 23).

Photo 23 Uniform, fast flowing section.

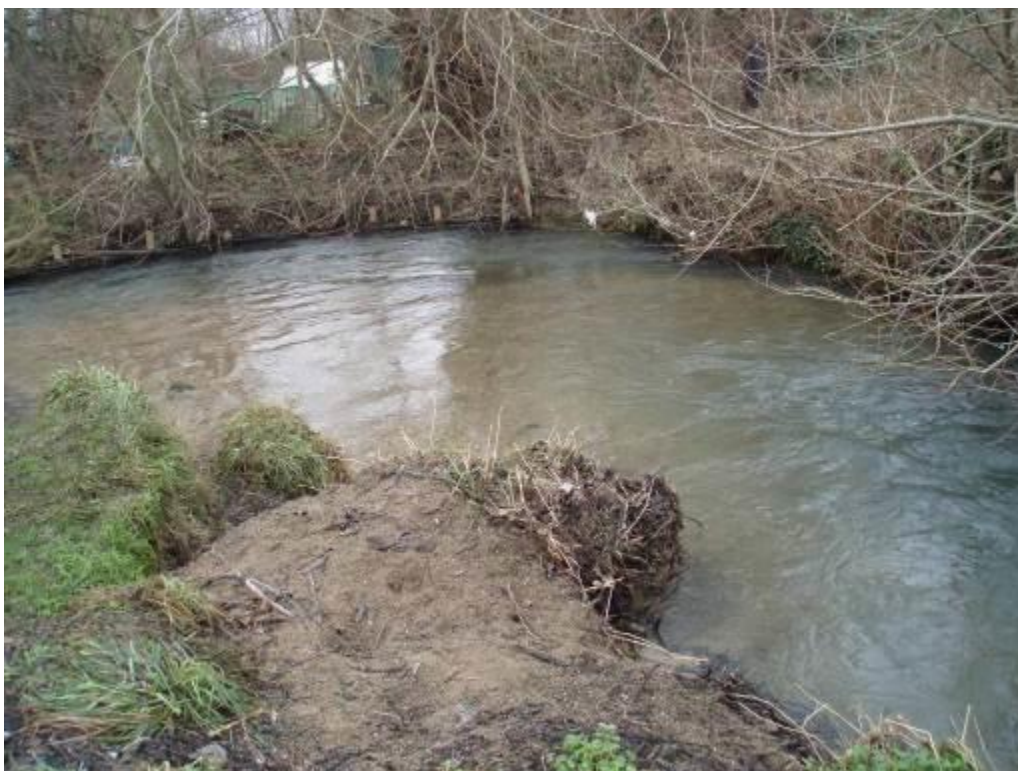
At SO 80597 04531 there is a bend in the channel which has produced a lateral scour pool and a bank of sorted gravel which is good quality for salmonids spawning (Photo 24). A gravel sample was taken here (Photo 25).

Photo 24 Lateral scour pool and gravel ramp

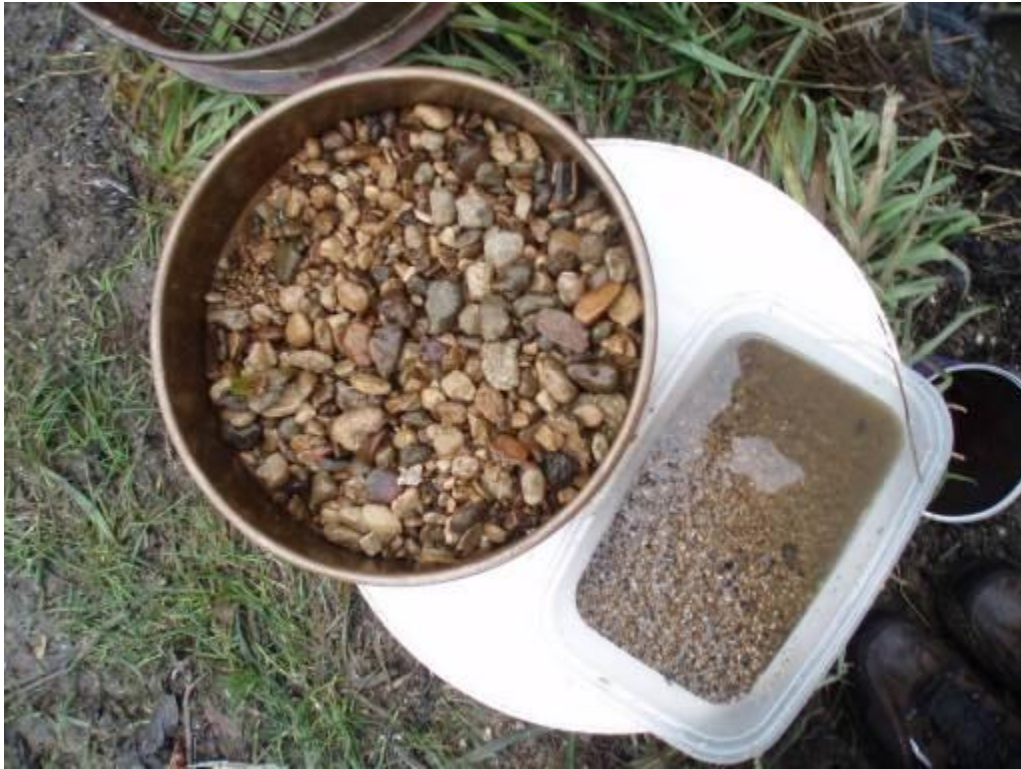
Photo 25 Gravel sample from SO 80597 04531

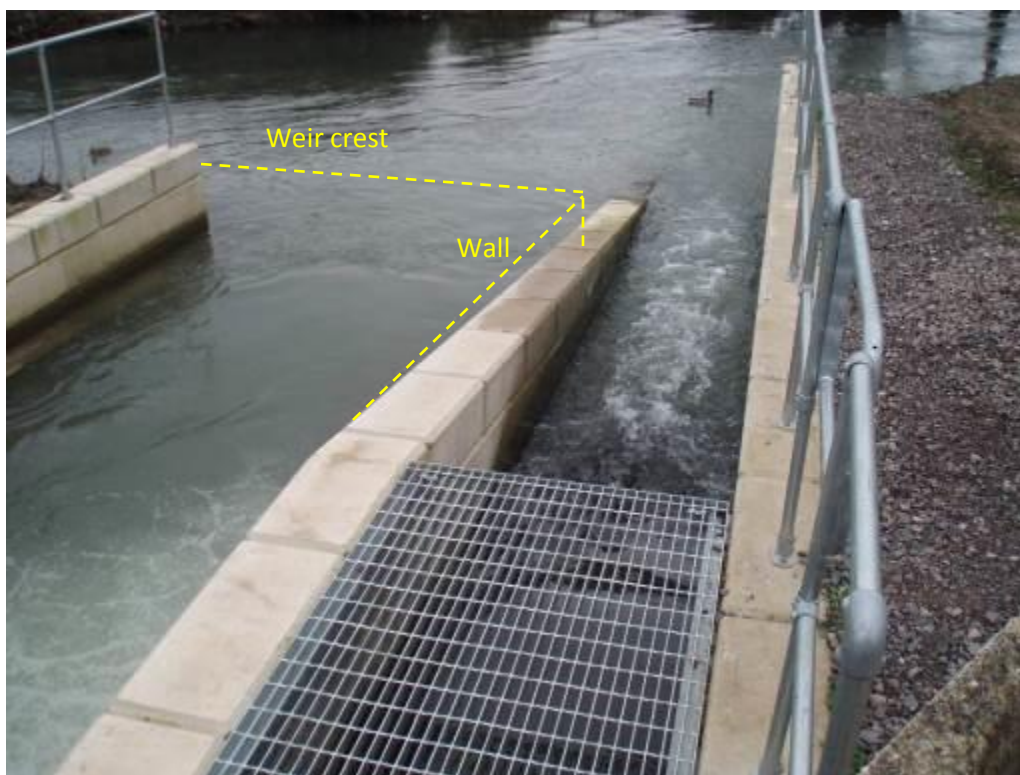
Photo 26 Locating the downstream end of the pass alongside the weir face, with a suitable retaining wall (as indicated by yellow lines) greatly improves pass efficiency. This should be considered at other sites.

If similar passes are planned elsewhere as part of the regeneration project, an improvement to the design would be to locate the downstream end of the pass in line with the toe of the weir (Photo 26).

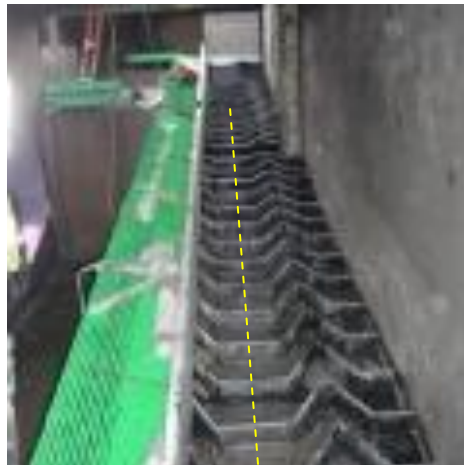
Photo 28 Example of one-and-a-half Larinier units plus angled bristle mat for eels (NB there should be a separator between the Larinier units in the position of the yellow line – as in Photo 18). Water flow towards camera.

It would be worth considering installing one-and-a-half Larinier units (which would occupy 0.9m of the channel width) and including an angled bristle mat for eels in the remaining 0.3m (Photo 28). This would improve the opportunity for eel passage by providing a pass on both sides of the channel, whilst detracting little from passage opportunities for other species.
