Water Framework Directive Advisory Visit

River Frome, Gloucestershire

December 2012

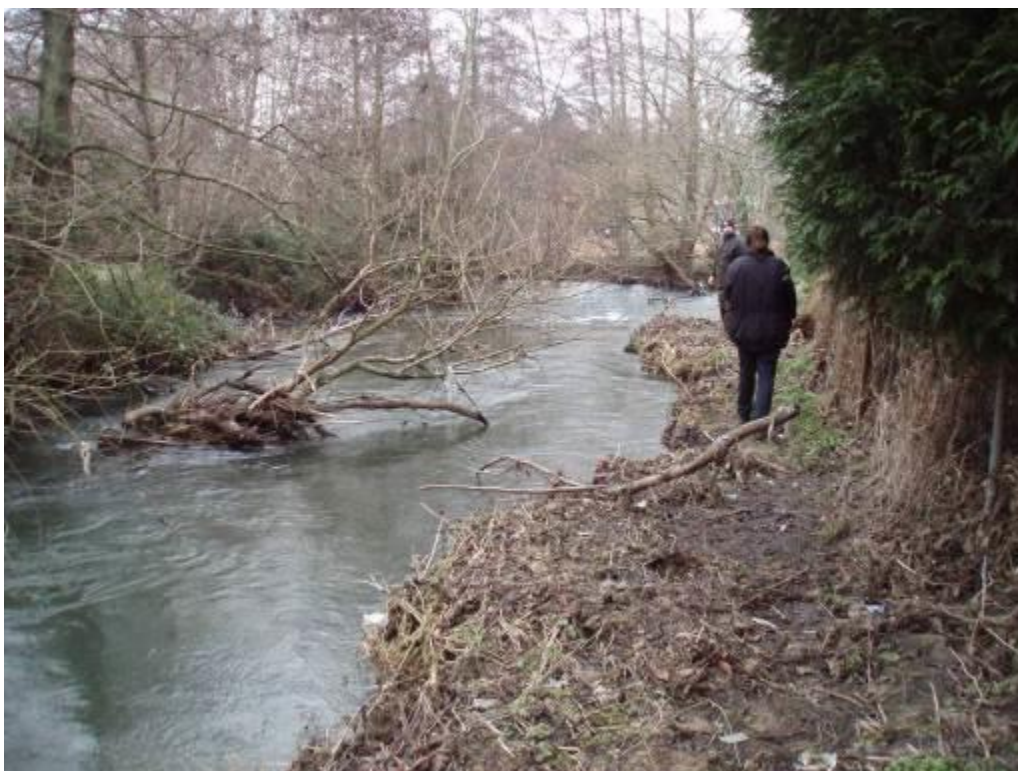
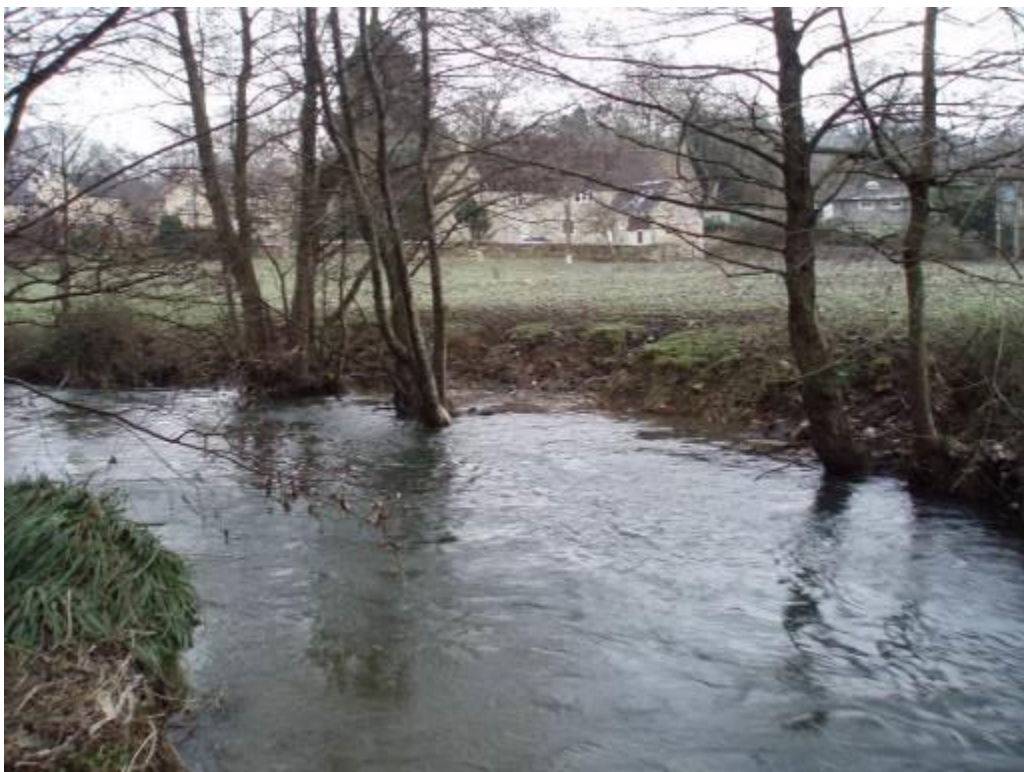
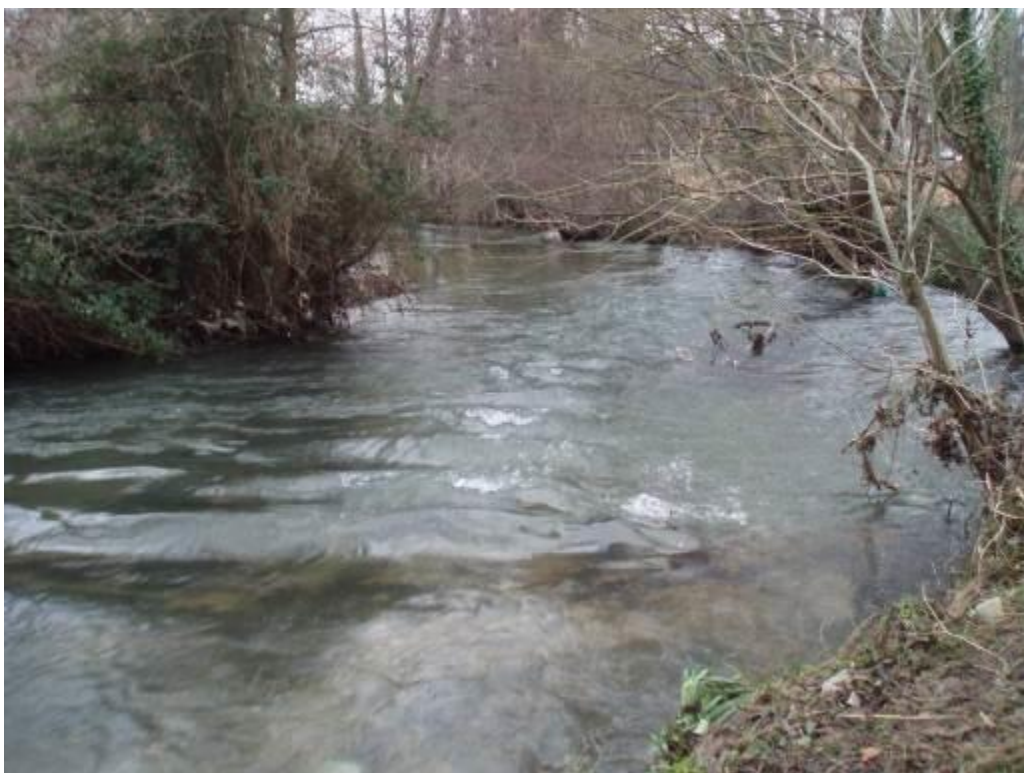
The river at this site has generally good in-stream habitat, with a meandering planform, variety of depths, gravel substrate and some large woody debris (Photos 30 – 32). The banks are tree-lined (predominantly alder). There is a grazed field on the left bank and some bank poaching alongside the river here (Photo 31).

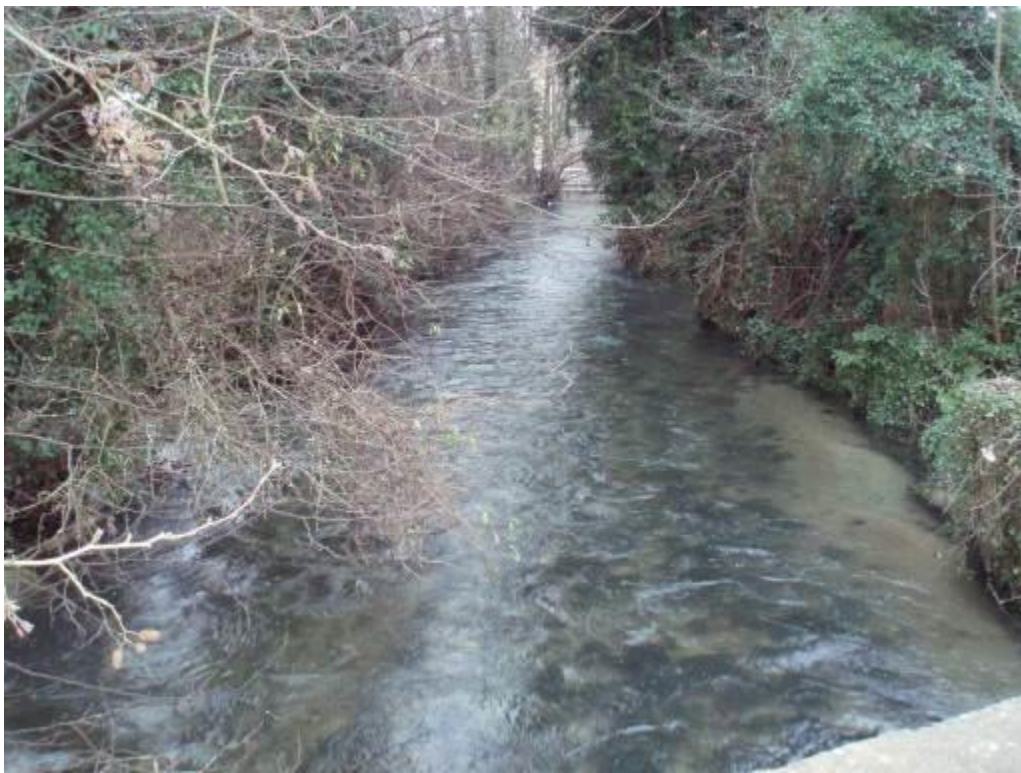
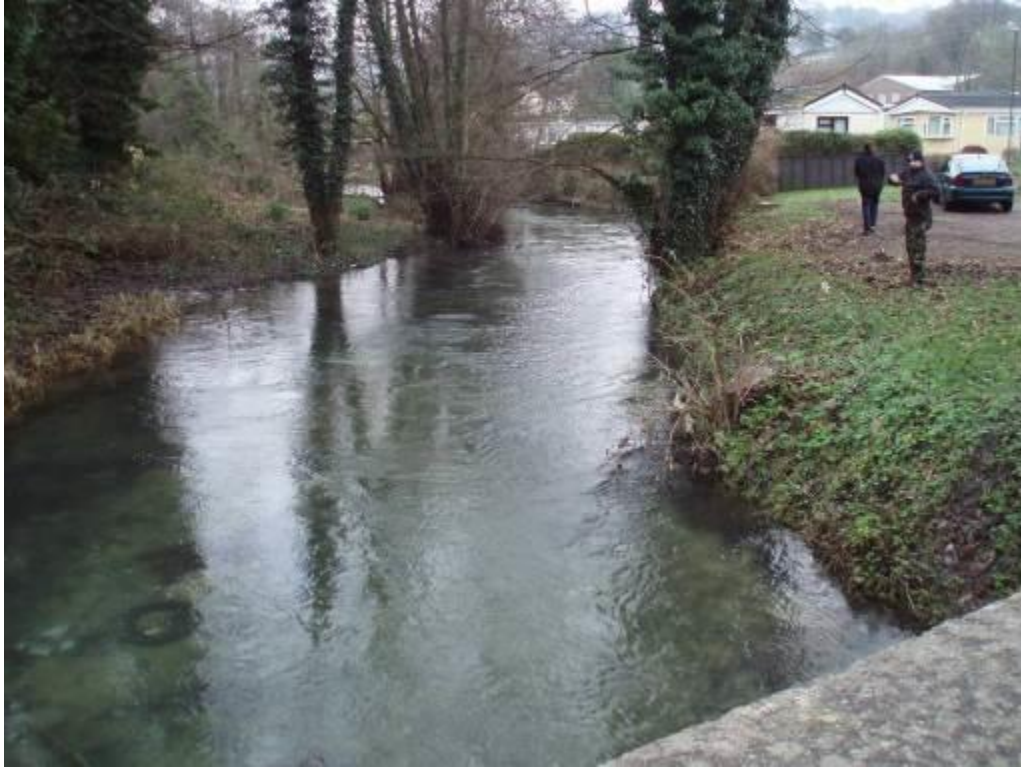
The river here is swiftly flowing in a single channel in a steep-sided valley. The bed substrate comprises a range of particle sizes from cobble to sand and silt and is unsorted and not good spawning habitat. In-stream structure such as large woody debris or flow deflectors would create localised scour and improve gravel quality. Habitat for juvenile and adult life-stages of salmonids is reasonably good, with plentiful marginal cover and a good depth of water (Photos 33, 34).

Photo 33 View downstream from Hope Mill Lane

Photo 34 View upstream from Hope Mill Lane

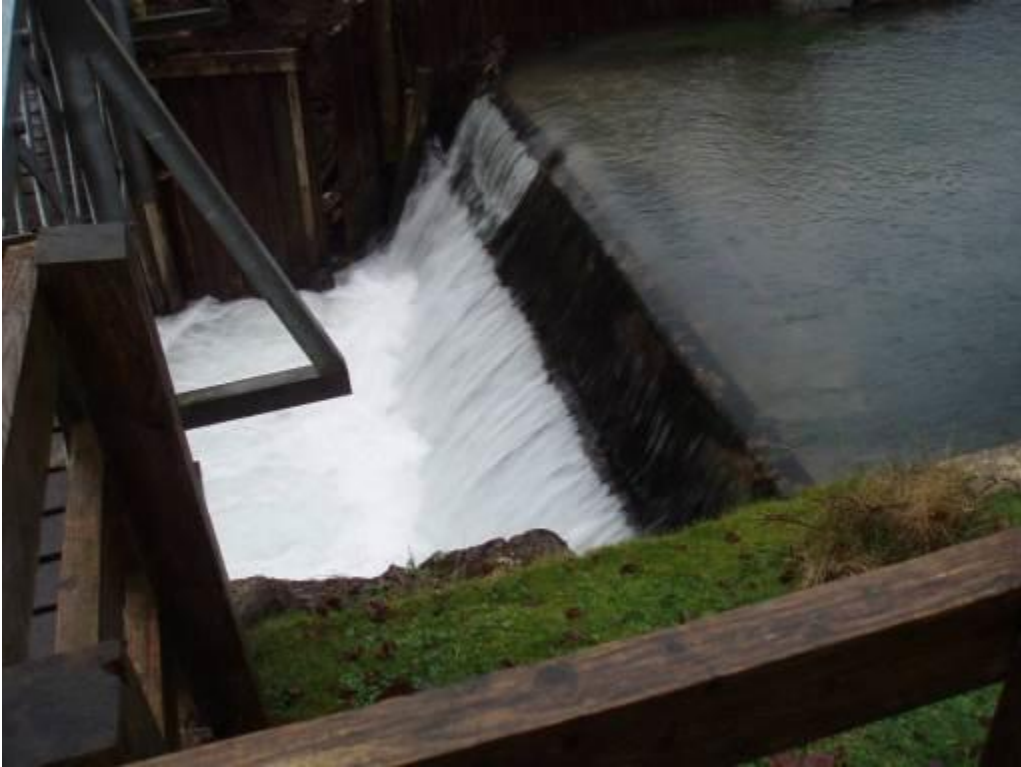
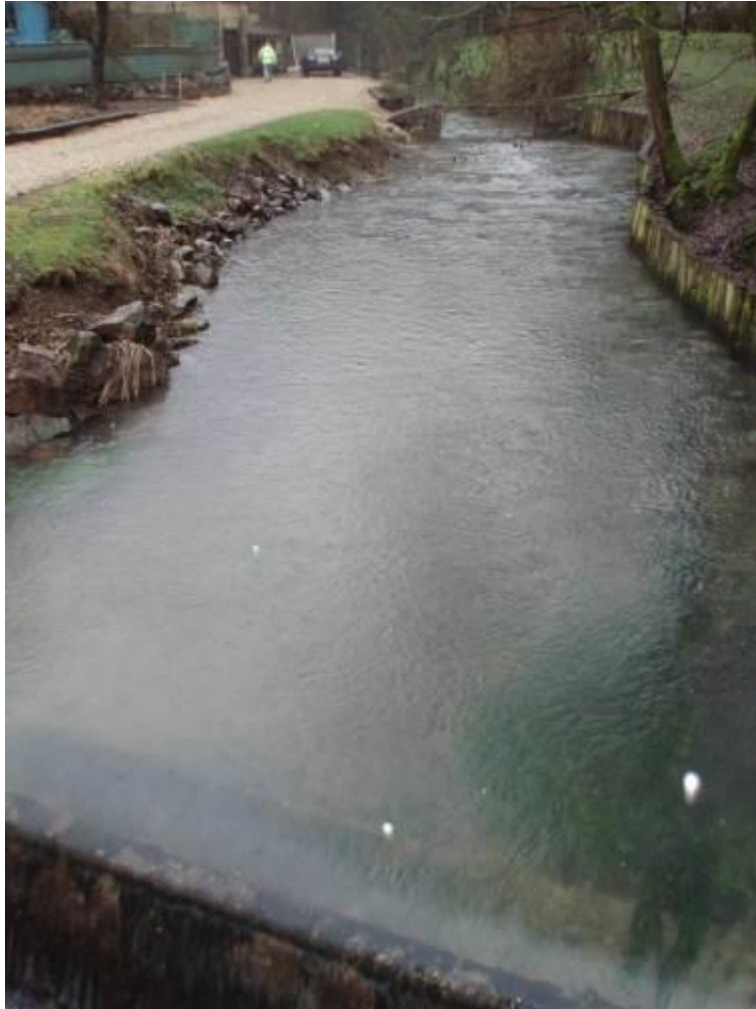
Upstream of the steep-fast flowing section is a weir (and barrier to fish migration) and footbridge at approximately SO8981602515; this impounds the river for only a short distance upstream because of the channel gradient here (Photos 36, 37). Progressing further upstream, the river flows through the village, bordered by gardens, houses and the road (Photos 38-40); in-stream habitat is good here with a gravel substrate and good marginal cover.

Photo 36 Weir and footbridge in Chalford (SO8981602515)

Photo 37 Impounded section upstream of weir in Photo 27

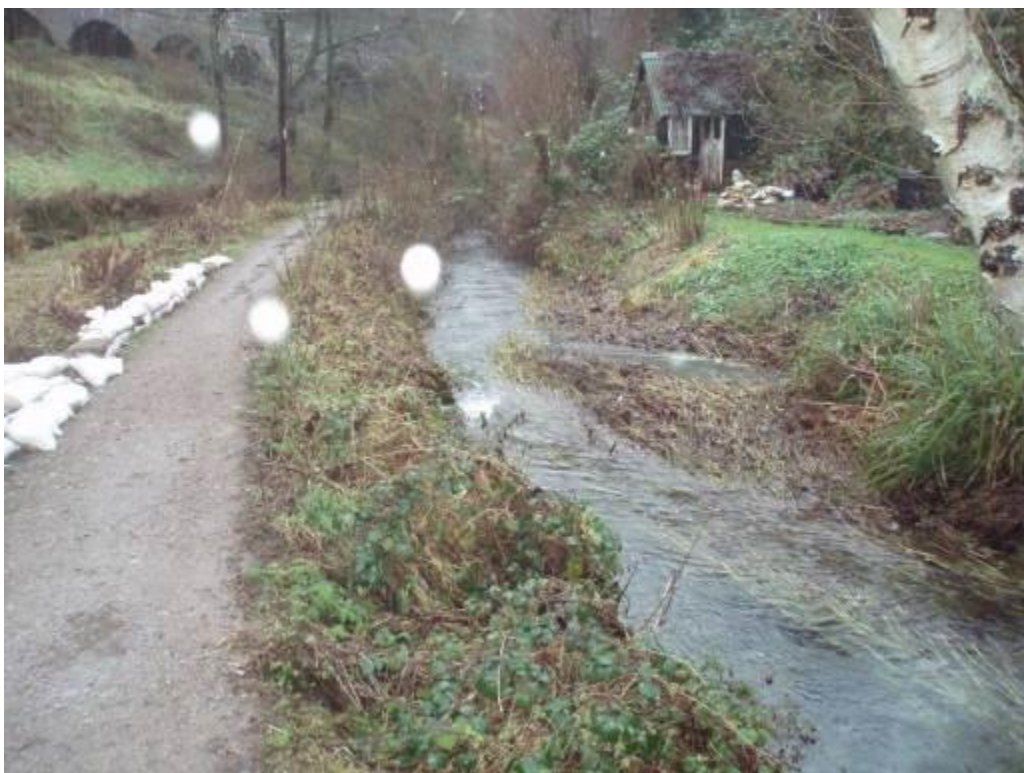
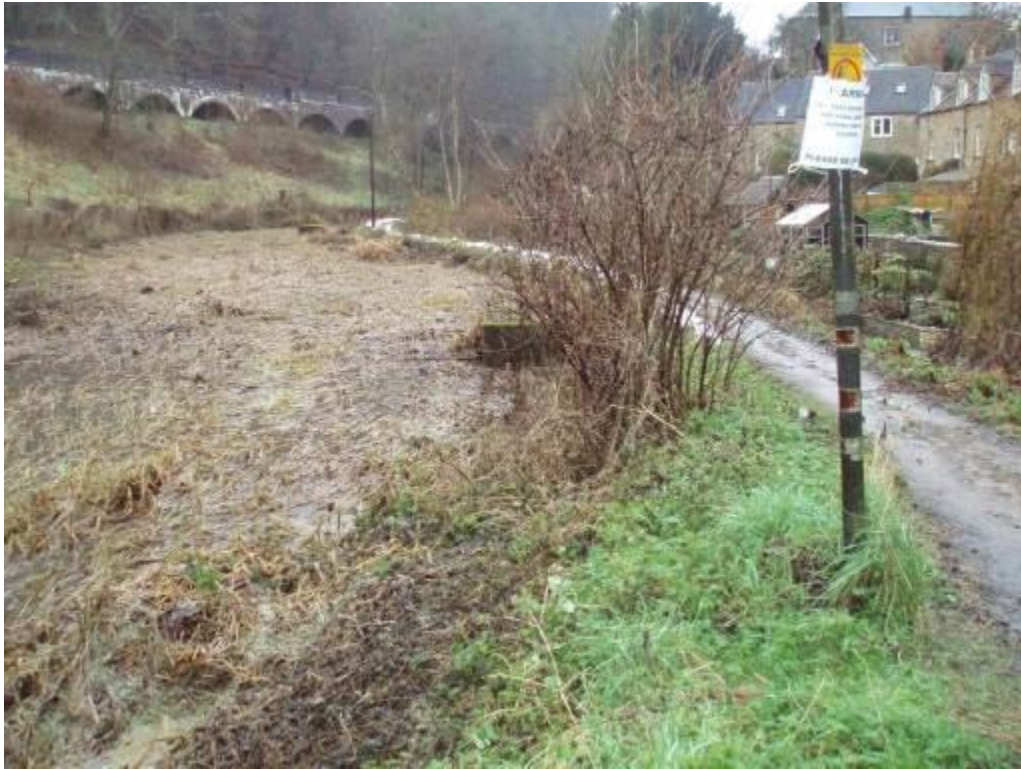
Just downstream of this point the river is straight and narrow and has abundant growth of water crowfoot (Photo 41); the channel is separated from the disused canal on the left bank by a footpath (Photo 42).

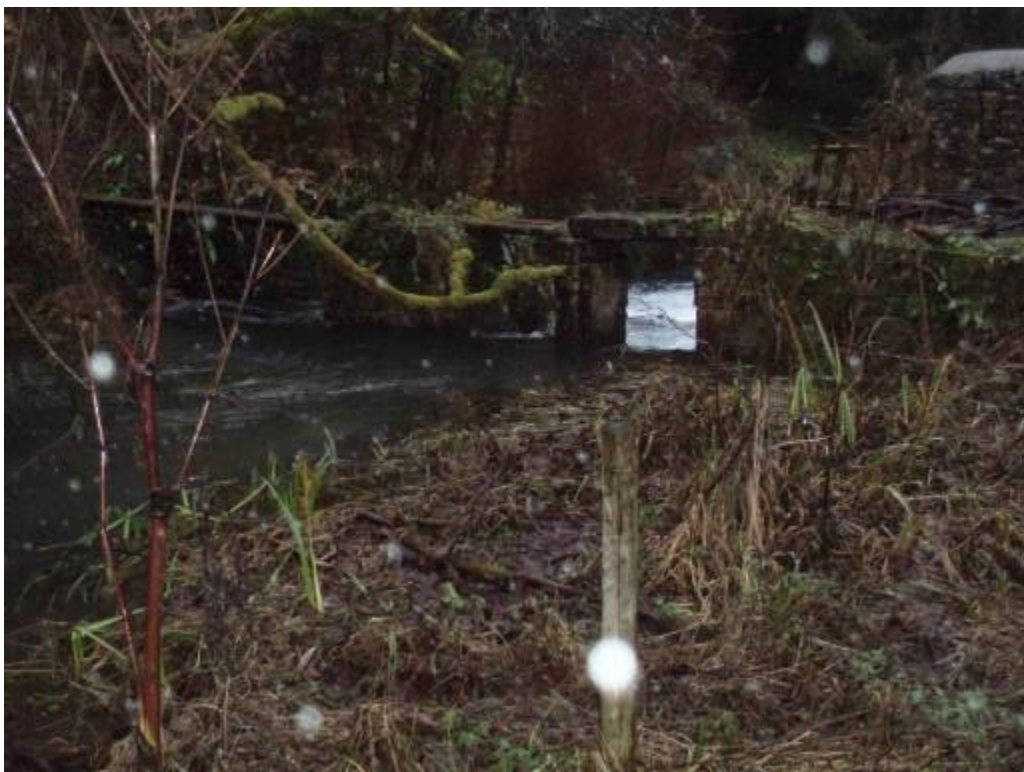
Photo 43

The river here was inspected from two fields on the right bank. The channel is straight (alongside the canal and railway) and uniform in width and depth. The downstream limit was at a private house and garden where an old sluice structure impounded the river (Photo 43). Immediately upstream of this structure the river bed is dominated by fine sediment which has settled out (Photo 44). Marginal habitat on the right bank is good here – soft, shaggy edges - whereas the left bank is a steep embankment (alongside the adjacent canal) dominated by young trees of a similar size.

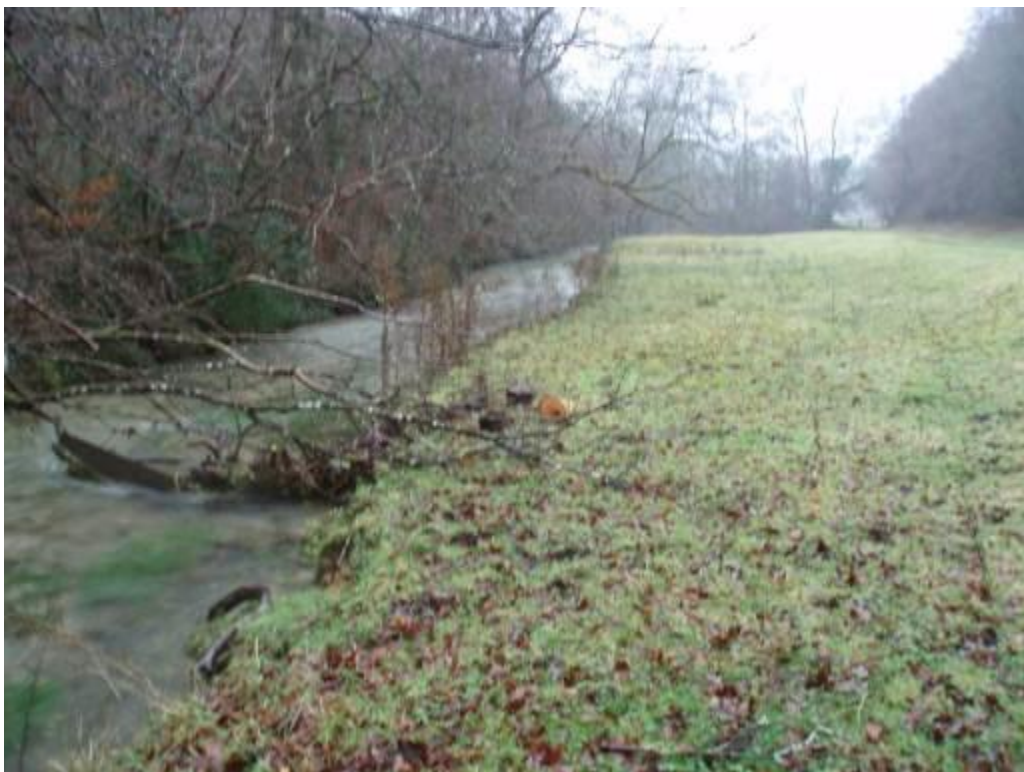
Photo 45

In the middle of this section is a flow gauging weir. Downstream and upstream of this, the river is fast flowing and predominantly shallow. Marginal habitat on the right bank is poorer than downstream due to grazing, and it would benefit from fencing (Photo 45). Although the bed substrate comprises gravel of a good size for trout spawning, it is poorly sorted. Two or three notable exceptions are where woody debris has created localised scour, depth variation and gravel sorting (Photos 46, 47).

Installation of flow deflectors and woody debris would greatly improve in-stream habitat along this section for a relatively low cost. A more ambitious project could involve creating a more sinuous channel using the fields on the right bank.

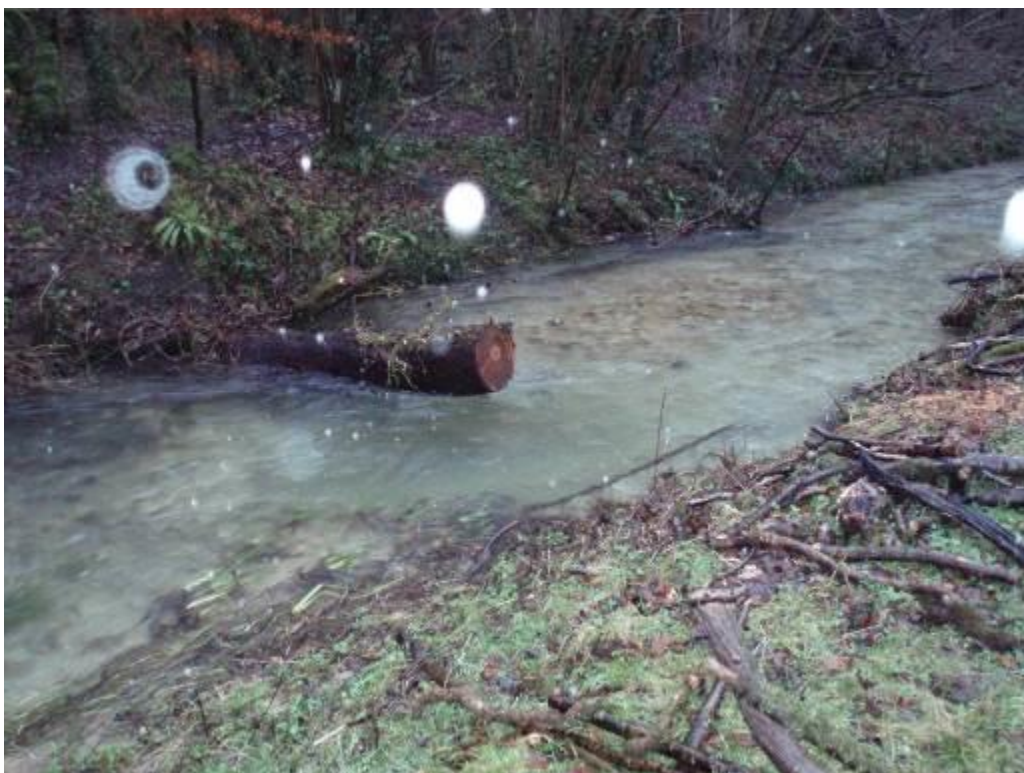
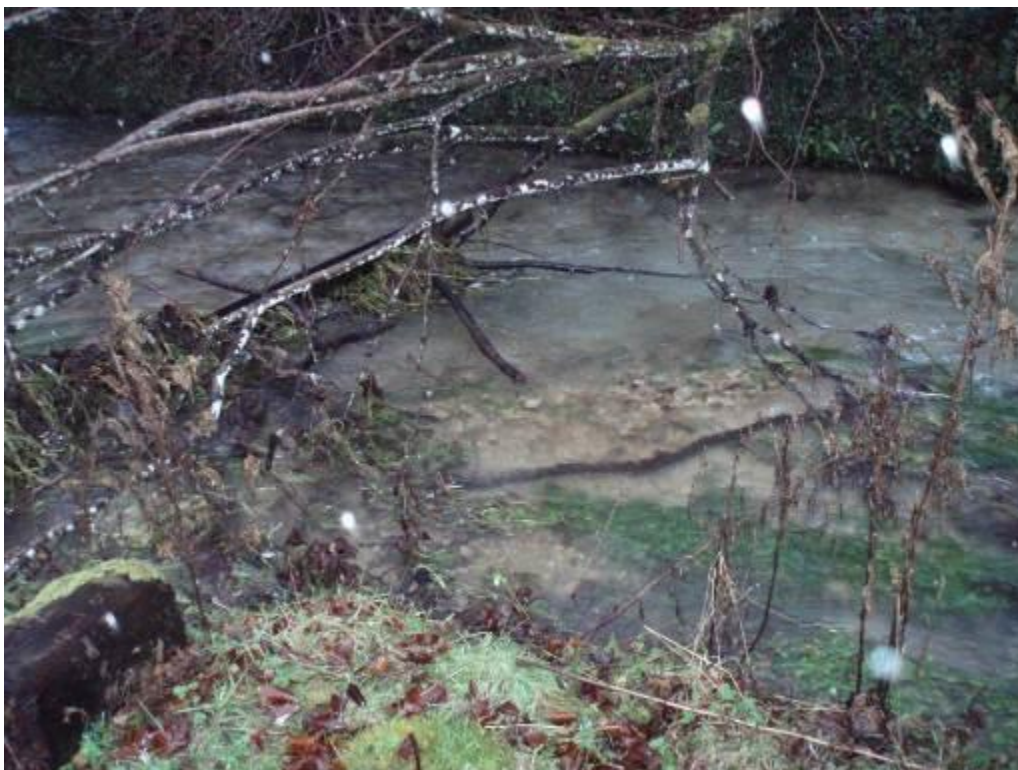
Photo 46 Scour beneath this log has created a deeper pool and ramp of clean gravel

Photo 47 Further bed scour and gravel sorting by large woody debris

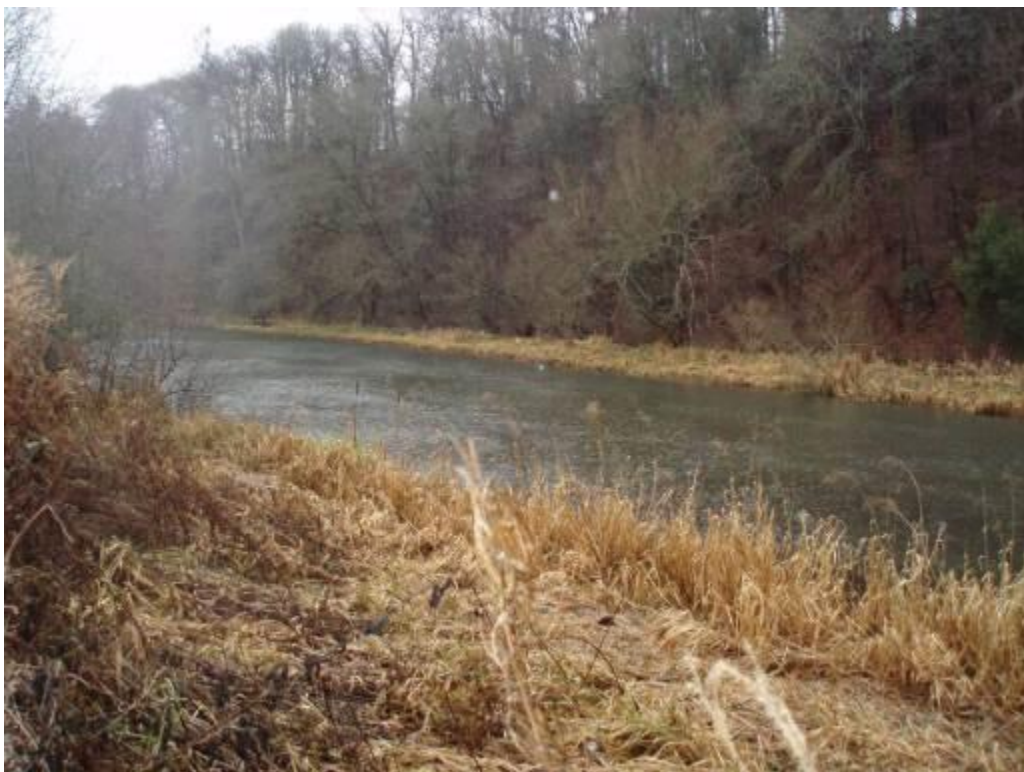
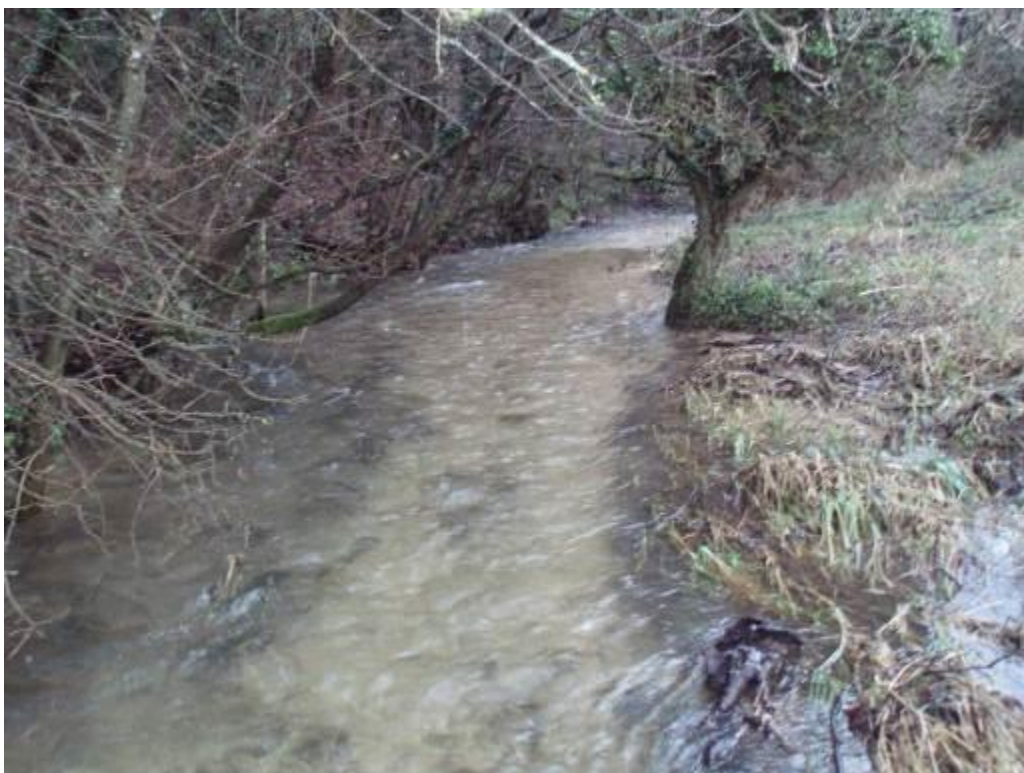
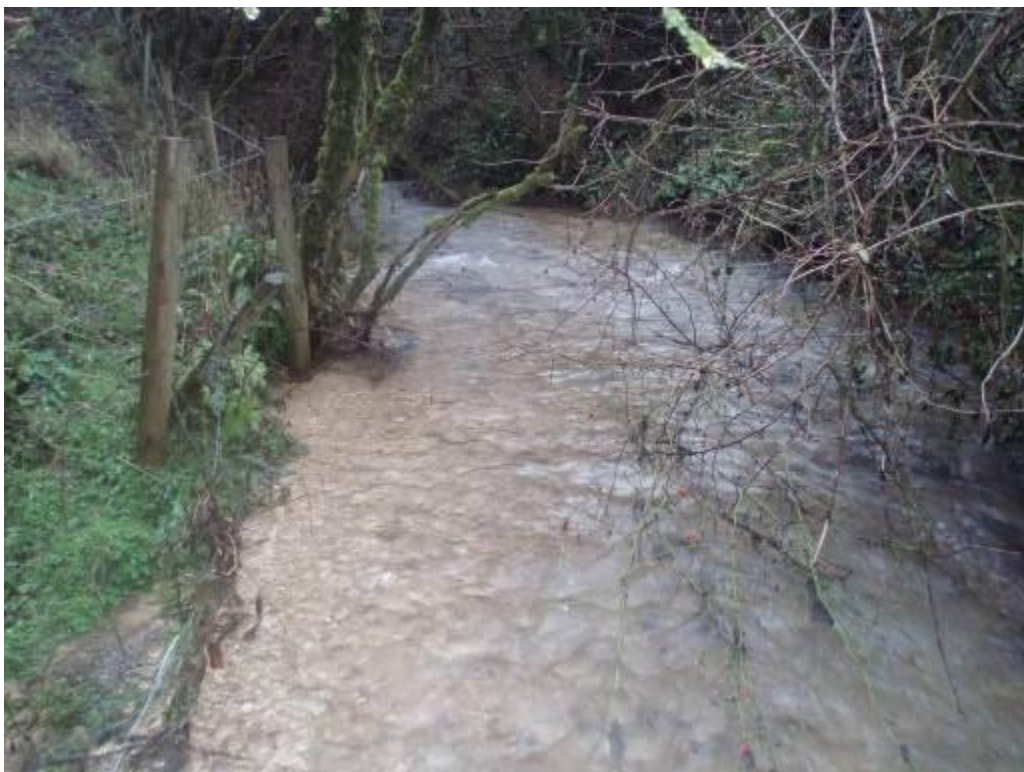
The downstream end of this section is bounded by a reservoir (Photo 48), the dam of which is an obvious barrier to fish movement. There is a short section of river upstream of the reservoir to Puck Mill Upper Lock, which has some good quality gravels suitable for spawning (Photos 49, 50). However, the gravels appear to be very clean and recently deposited, suggesting they may be the result of a recent flood event and not typical; evidence of this was seen at several sites upstream of this point. From Puck Mill Upper Lock, the river is culverted underneath the canal for approximately 150m creating another impediment to fish movement.

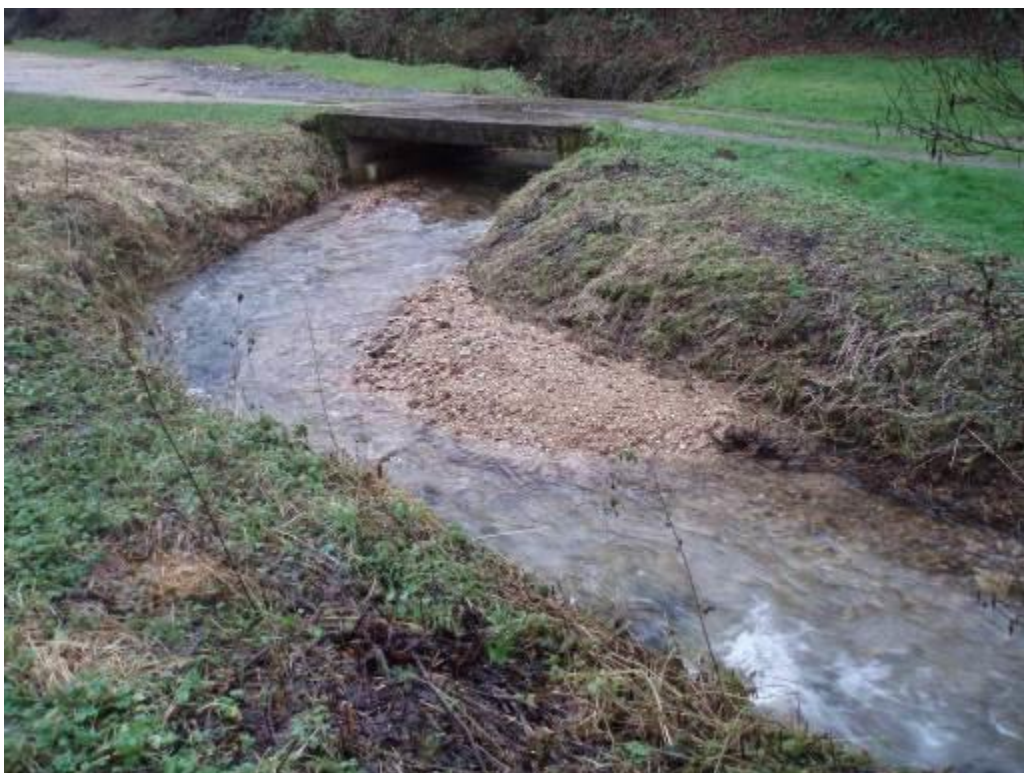
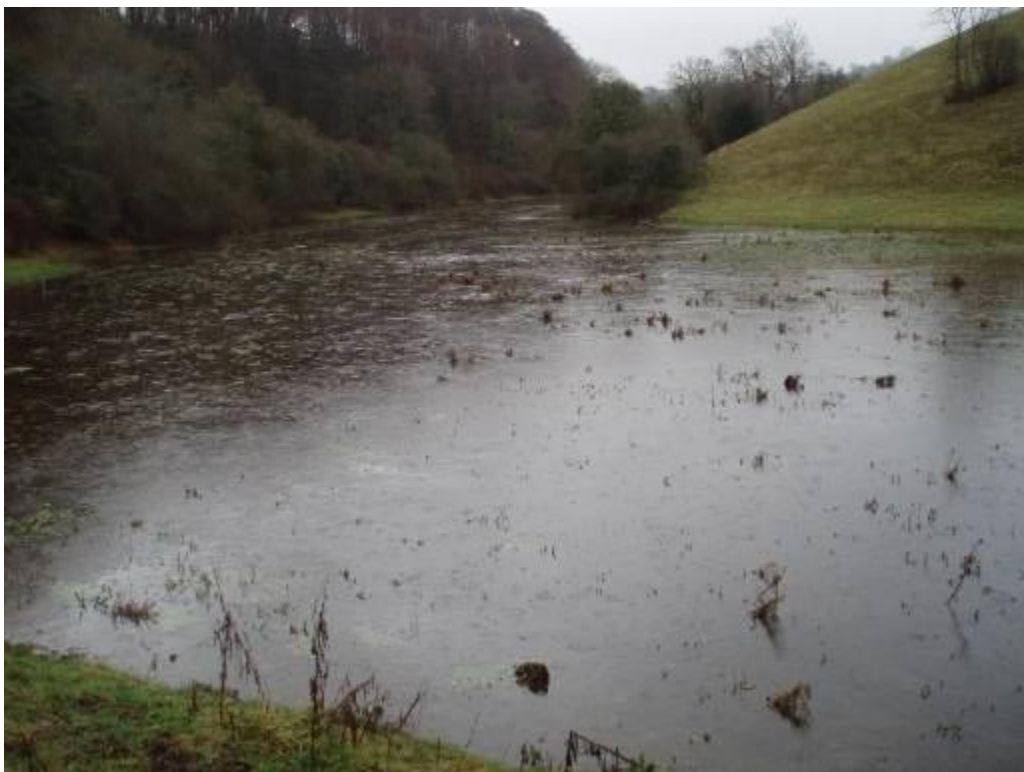
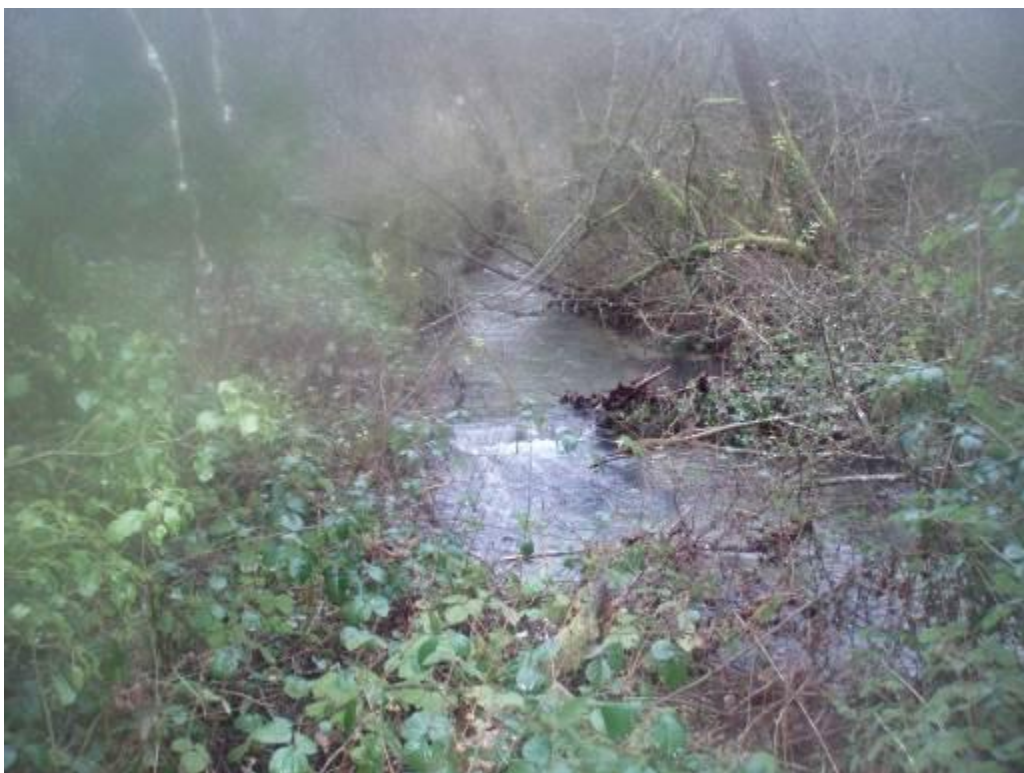
Alongside the property near Whitehall Lower Lock there was further evidence of recently deposited gravel as a result of high water (Photo 51). Upstream of this point, the river habitat transformed in a completely unexpected way, becoming a flat, inundated valley bottom with no discernible river channel (Photo 52); this continued for about 750m upstream to Whitehall Bridge. Beyond this point the river flows through a Gloucestershire Wildlife Trust nature reserve (Siccaridge and Sapperton Woods) and appears to have good in-stream habitat (Photo 53).

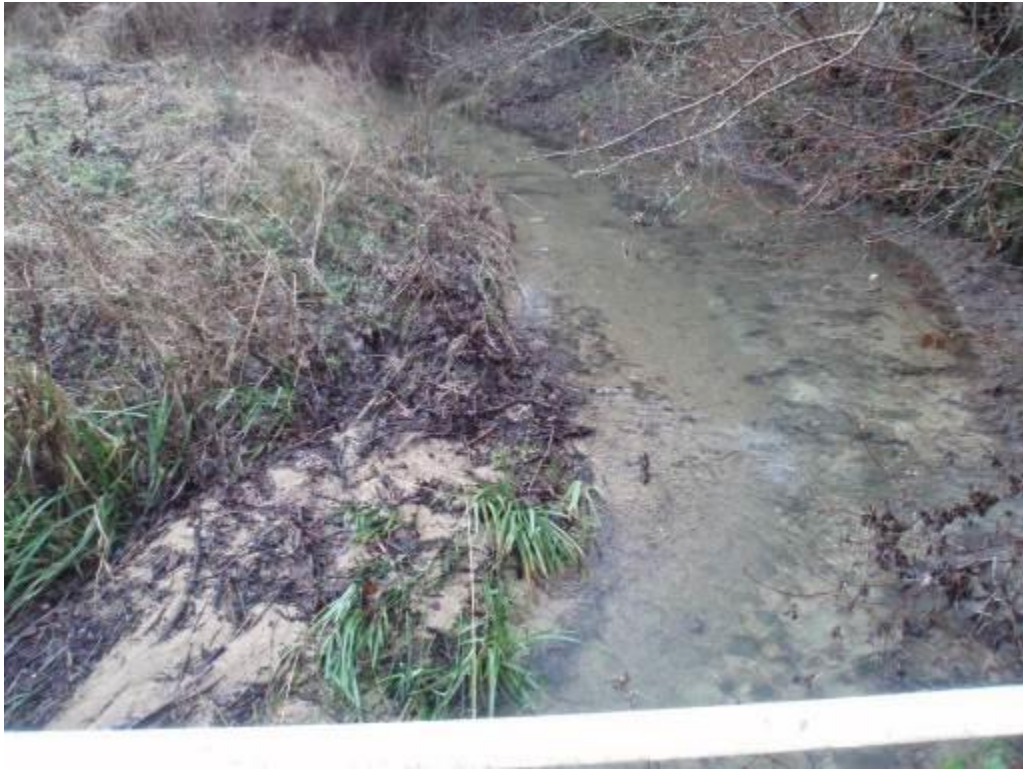
Photo 54

Located on the upper reaches of the river, this section displayed more evidence of a recent, significant flood having moved the bed load of the river. Upstream of the road the river appears to have been impounded by the throttling effect of the culvert, causing fine sediment to settle out (Photo 54).

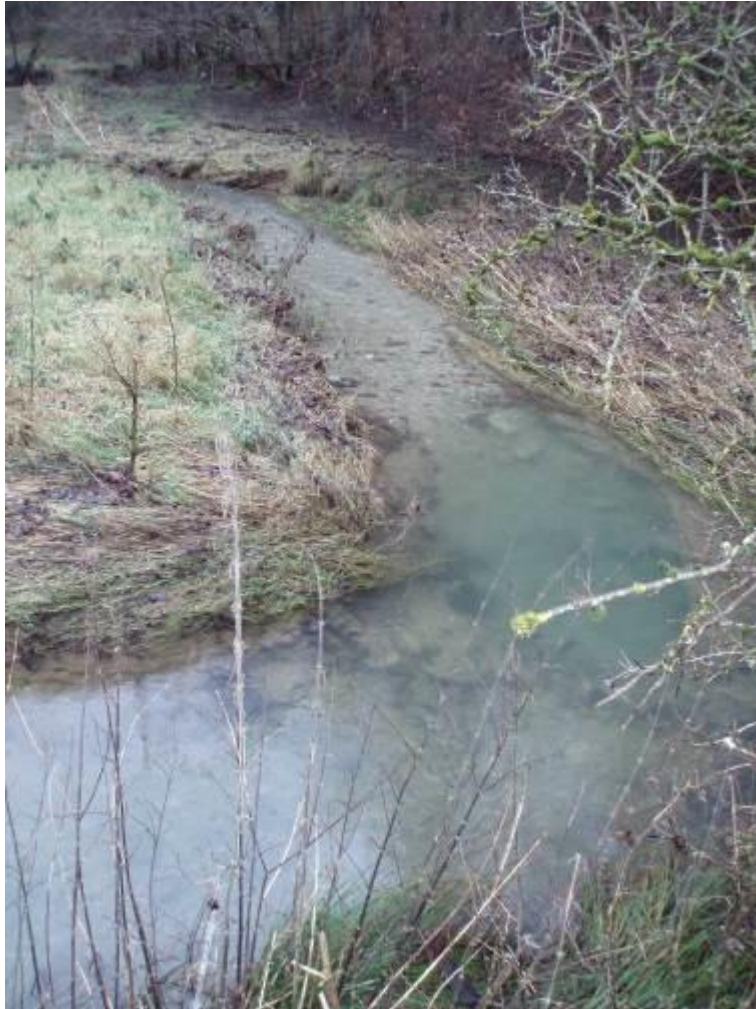
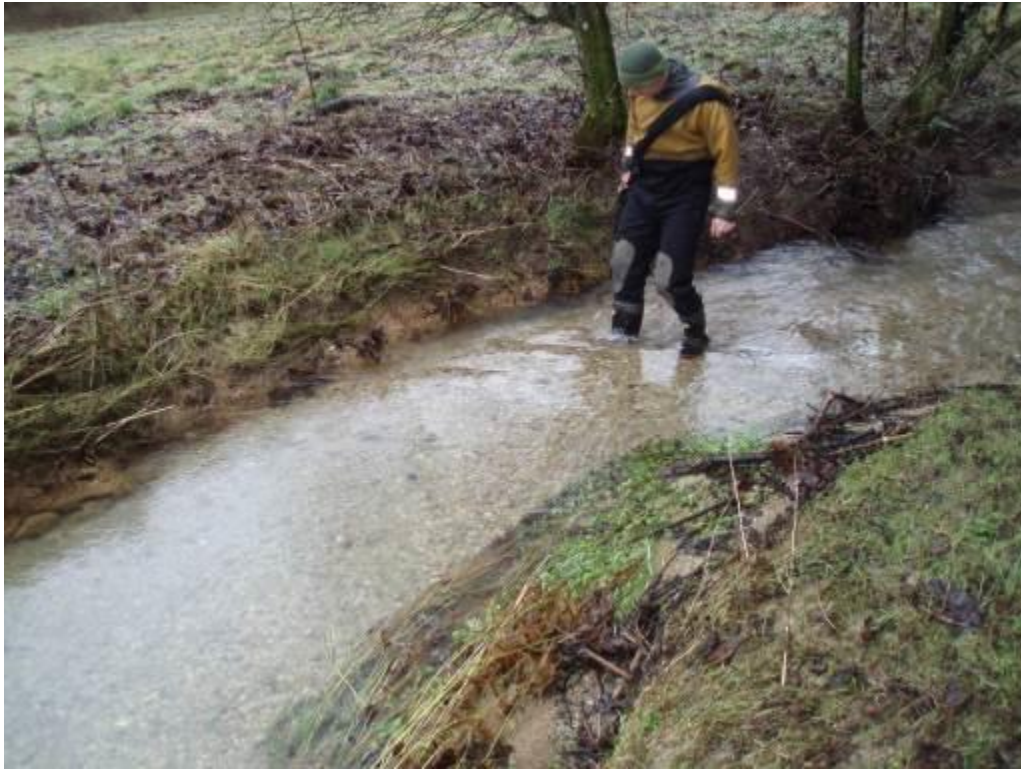
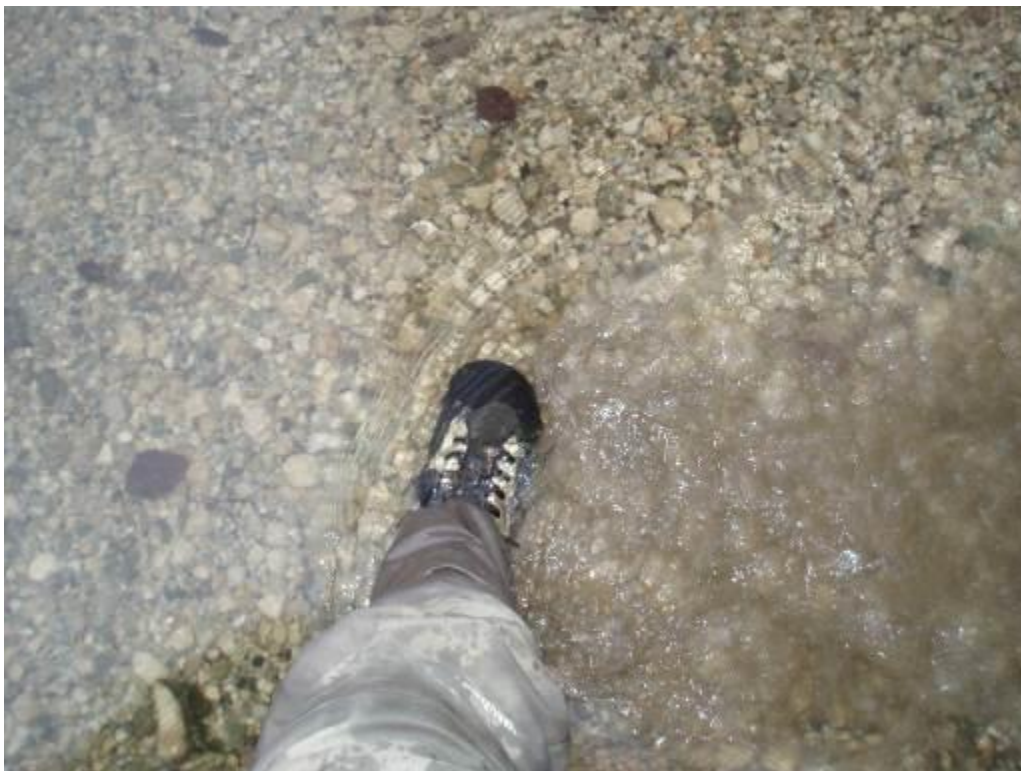
Downstream of the road, deep pools had been scoured out on bends in the channel and clean, well-sorted gravel deposited in riffles downstream (Photos 55 – 57). The in-stream habitat appeared very good as a result of this, but it raises the question of how frequently this occurs and its impact on fish spawning and invertebrates. If it is a relatively rare event, then the effect is likely to be beneficial; if it occurs frequently, washout of fish eggs and invertebrates could limit populations.

Photo 55 A deep scour pool on a bend and clean gravel deposits downstream. The flattened marginal vegetation indicates recent high water.

Photo 57 Clean, well-sorted gravel, ideal for trout spawning...as long as it stays put.

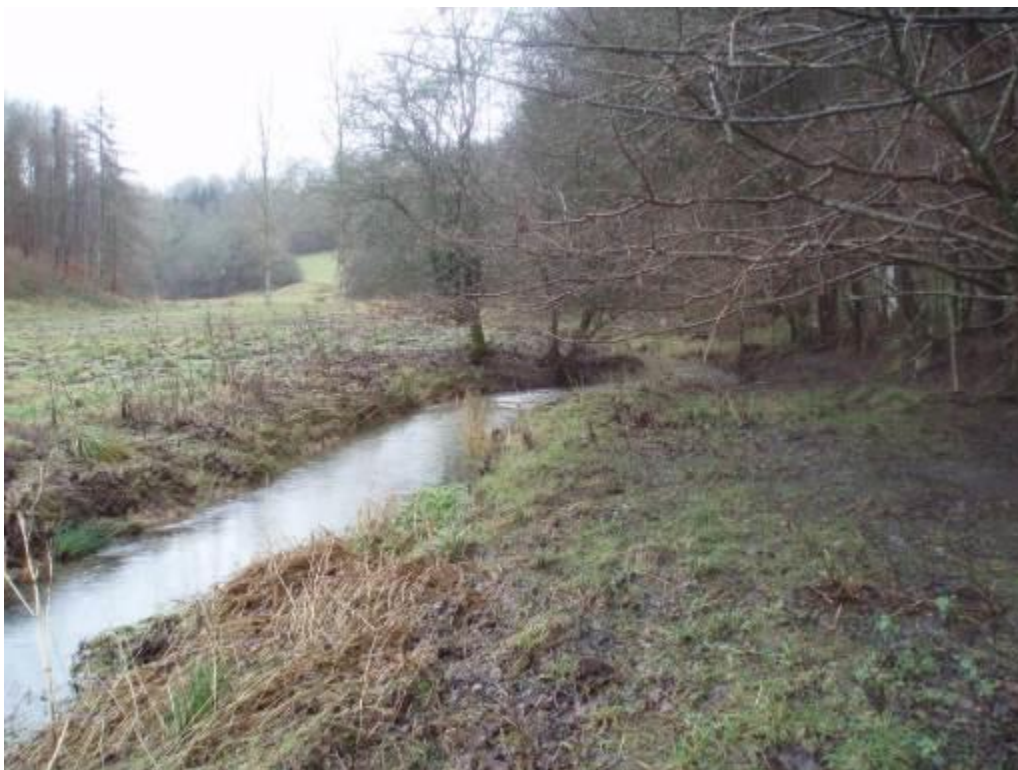
Photo 58

Other aspects of river habitat at this site are good, including low intensity adjacent land-use, mixed shading and channel form and level relative to the floodplain (Photo 58).

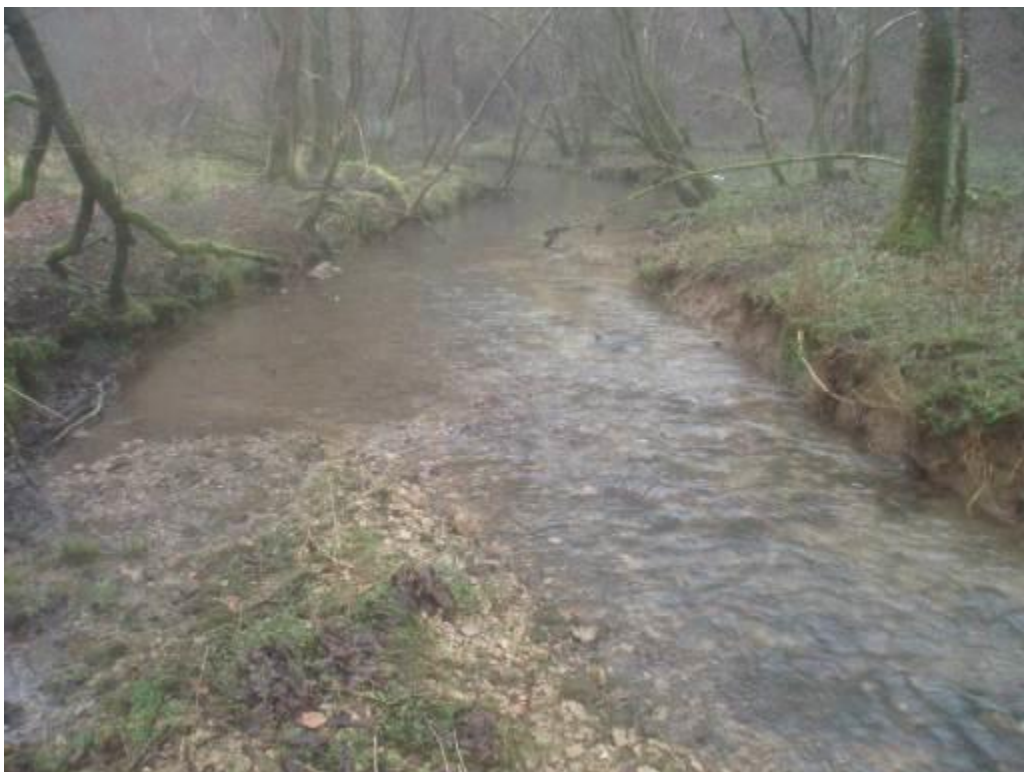
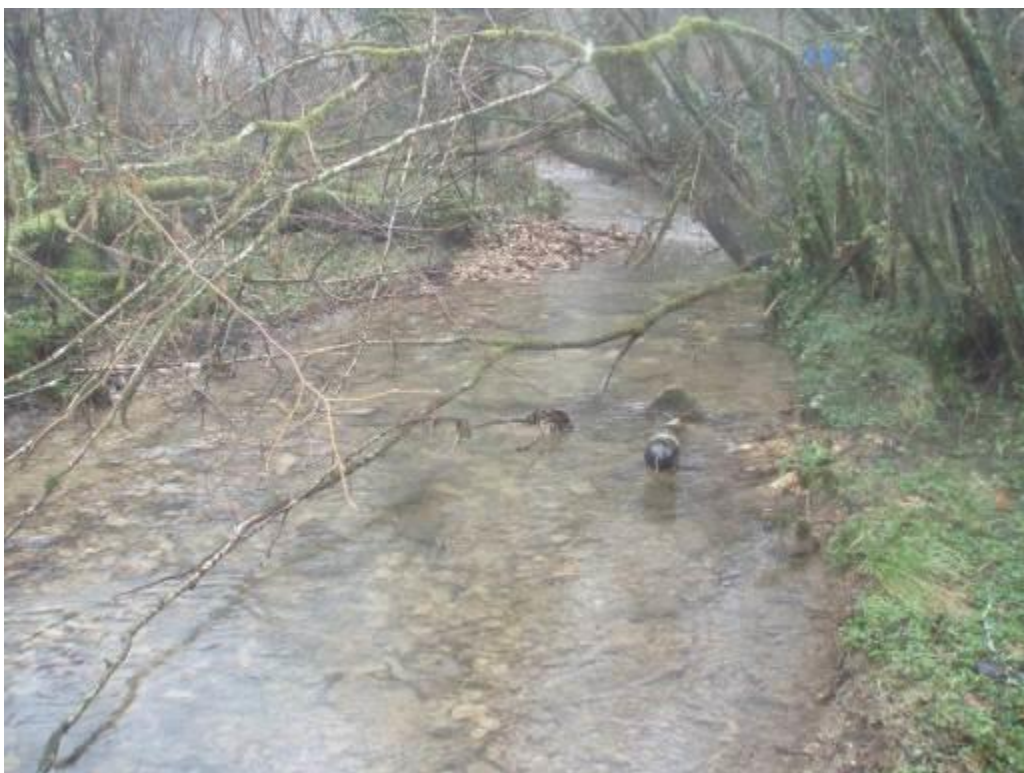
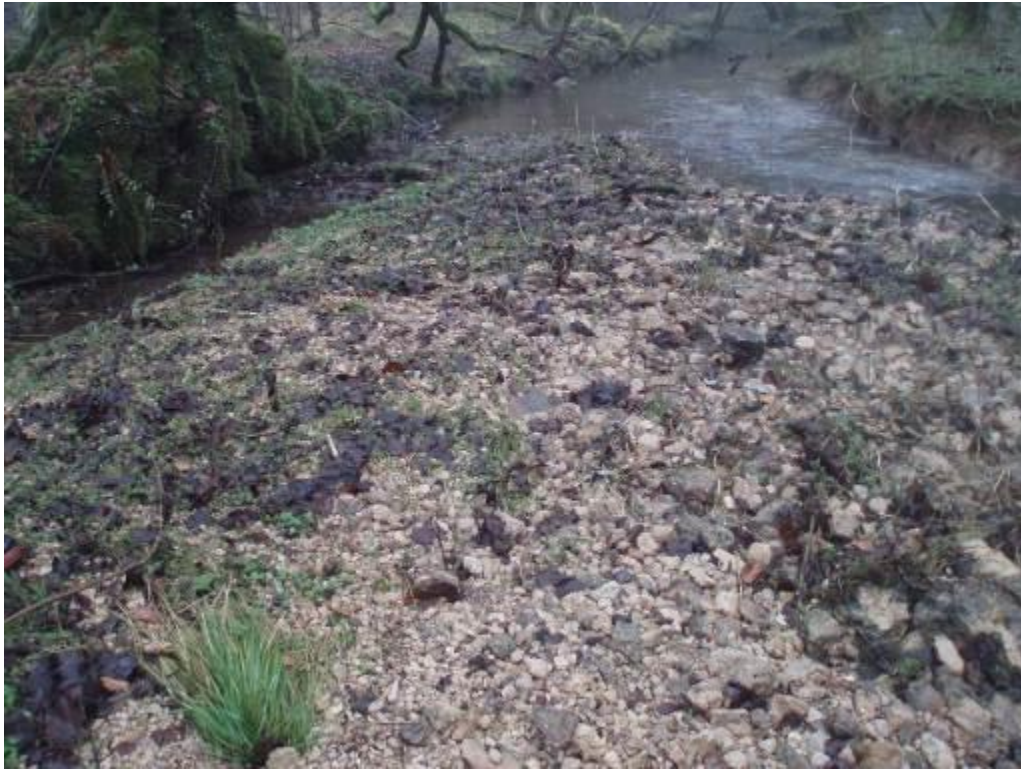
A wooded section of river in the headwaters of the Frome. Again evidence of recent significant bed load movement, with large deposits of fresh gravel in side bars. Generally good in-stream habitat (Photos 59 – 61).
