Dorset Frome – Notton to Southover

An advisory visit carried out by the Wild Trout Trust – June 2008

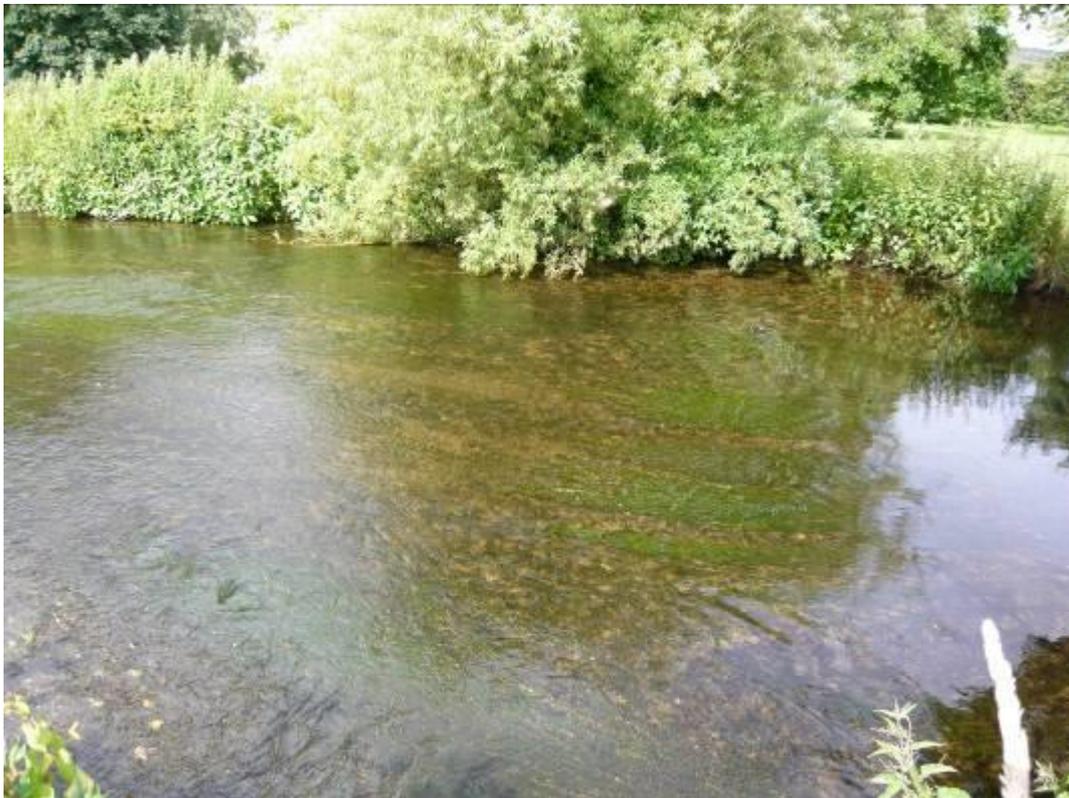
Excellent trout nursery habitat below Notton bridge

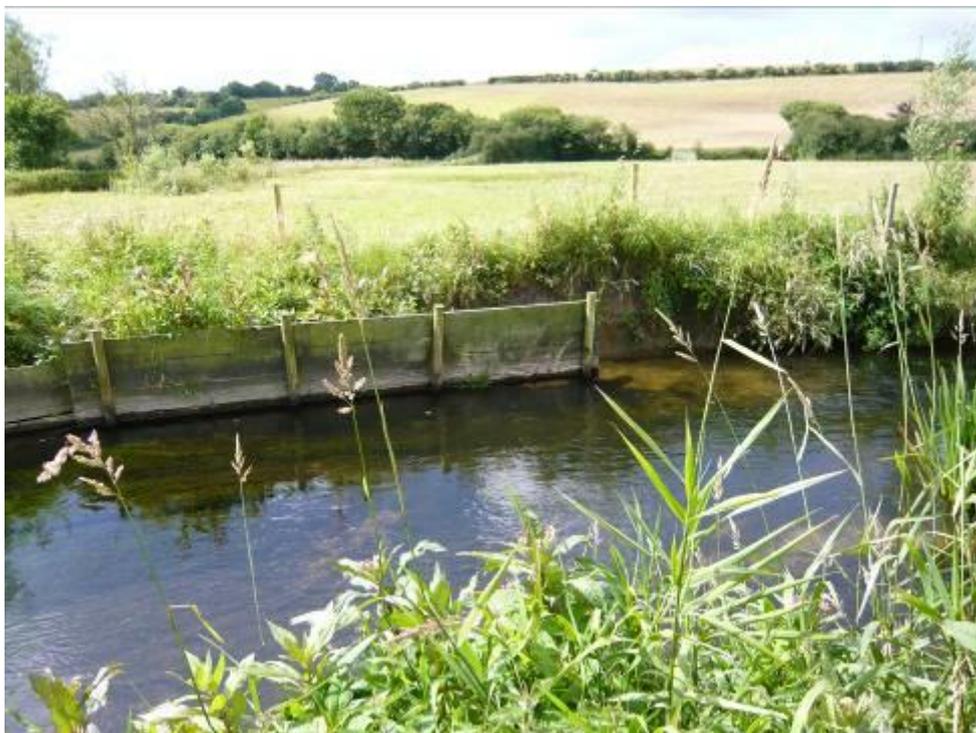
Most of the margins and banks throughout the fishery were in good condition with a nice mix of shallow shelves and deep marginal pools. Some active erosion was evident in a few areas where the bank was not defended with marginal root systems. Provided no serious loss to property is threatened there is often no need to actively intervene. Sometimes a small realignment or managed retreat of an access path is better and more beneficial to the river and its inhabitants than any attempt to harden the bank. New gravels won from such events are crucial to the condition of many trout habitats. On one section of RHB near the top of the section a land owner has attempted to defend the bank using wooden toe-boarding. This has already started to fail and as well as being a biologically sterile habitat, it is also failing to prevent the river from moving sideways.

Ineffective bank erosion control measures

The margins of any well managed chalkstream are potentially the biologically richest part of the stream. An eroded bend, if left unmanaged, will usually find a naturally equilibrium and eventually create excellent habitat. As the bank nibbles back, the rate of erosion slows and the bare bank slumps down to form a natural batter to be rapidly colonised with a herb rich margin. The main problem is that few owners have a relaxed approach to losing their property to the river. Where a managed retreat is deemed impossible, then soft engineering techniques using planted faggot bundles to protect the toe of the bank, or live willow spilling will usually halt the process. Simple current deflectors using tree trunks can also be deployed and anchored to divert the erosive flows towards the centre of the channel rather than the toe of the bank.

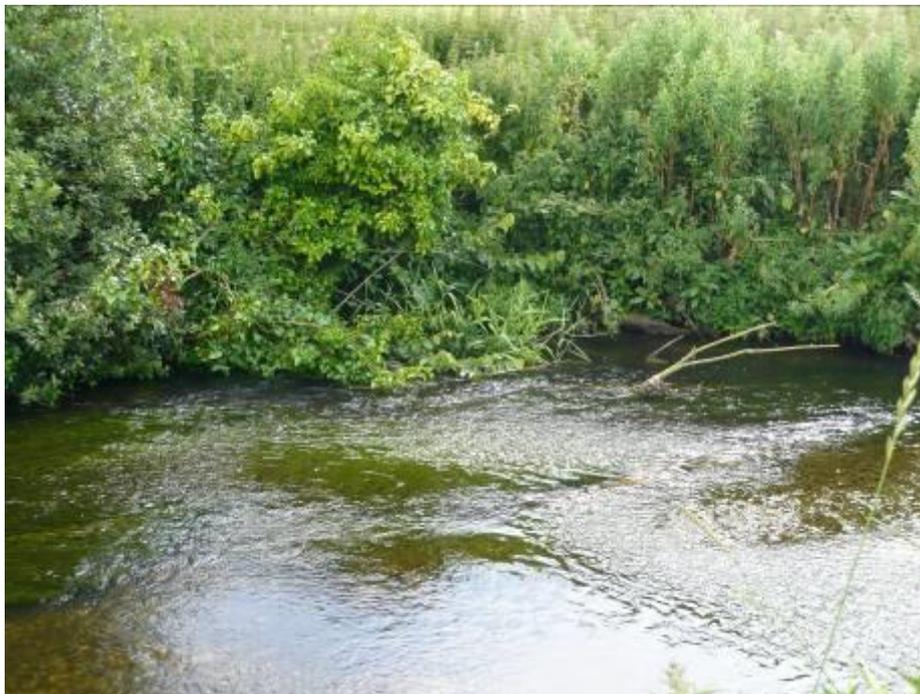
A low scrubby margin – trout heaven!

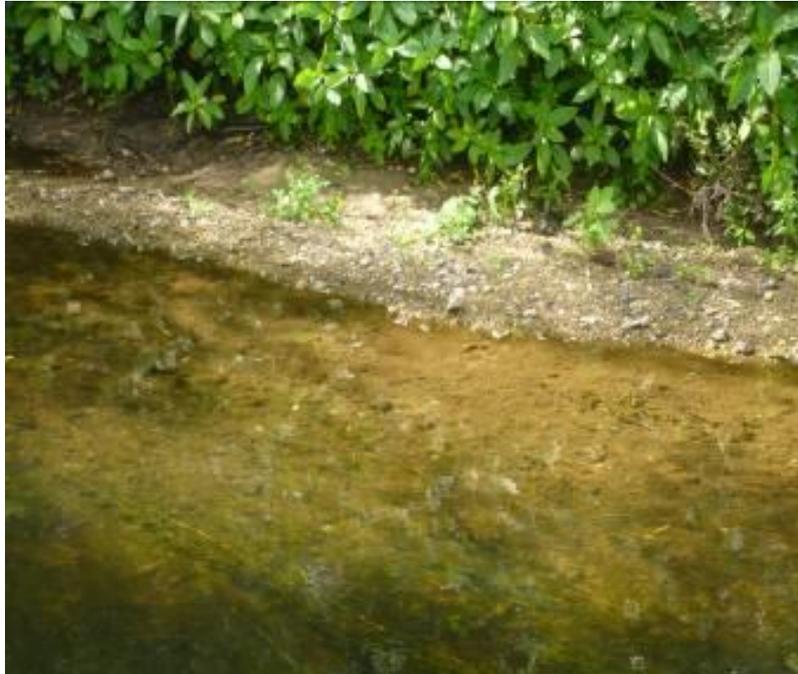
This plant was observed on numerous sections of the beat and there was evidence on how damaging it can be for trout habitats, where it has the capacity to outcompete and shade other native plants and prevent the establishment of those crucially important marginal fringes. It is recommended that efforts are made to eradicate the plant, especially where it is found adjacent to potentially high quality marginal habitat.

A backdrop of Himalayan balsam which has compromised the establishment of a vegetated fringe of ecotone plants. A gently battered margin like this is usually brilliant habitat for trout fry but cover is essential.

Control measures are required to prevent flowering and if this is achieved before seeds are set, eradication is possible in two to three years. Options for control include:

- **Chemical control:** can use glyphosate or 2,4-D amine. Need to be used whilst plant is actively growing in early spring for best effect.
- **Cutting/mowing/strimming:** cut at ground level, before the flowering stage in June. Do not cut earlier as this promotes greater seed production in any plants that regrow. Cutting should be repeated annually until no more growth occurs.
- **Pulling:** shallow-rooted plants can be pulled up very easily and disposed of by burning or composting, unless seeds are present.
- **Grazing:** Grazing by cattle and sheep is effective from April throughout the growing season. It should be continued until no new growth occurs.

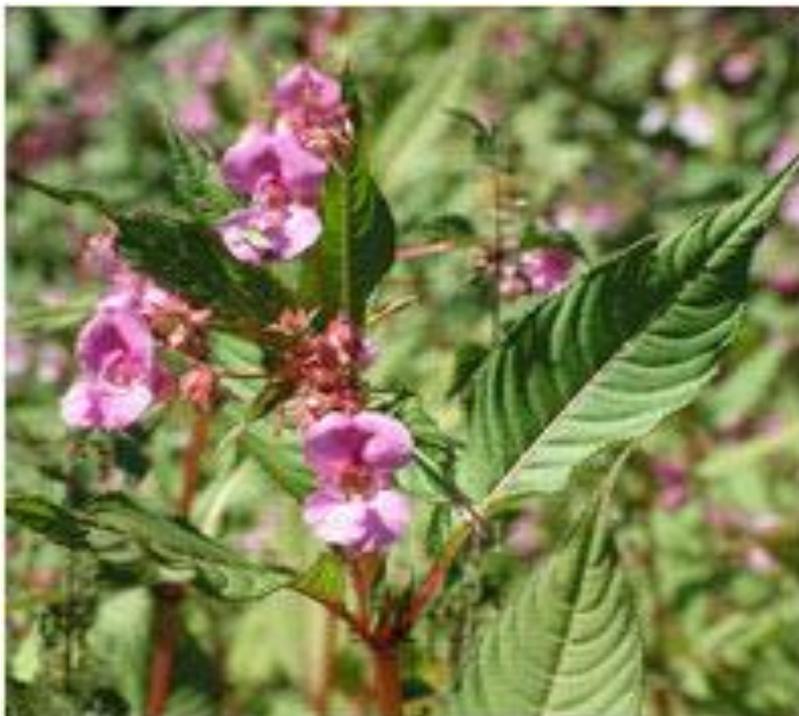
Himalayan balsam in flower

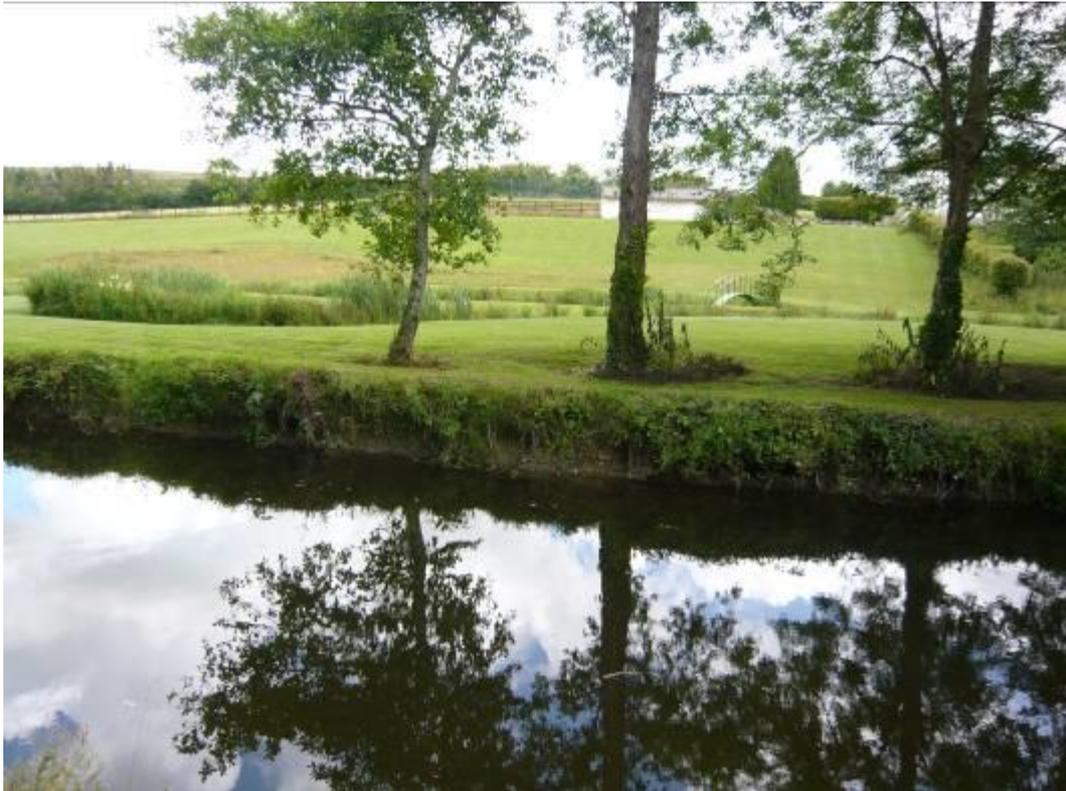
Formal garden with a bank vulnerable to erosion and devoid of marginal scrubby cover

A real improvement could be made through a change in marginal management on the LHB and the provision of some low cover via planted goat willow or sallow *Salix caprea*.

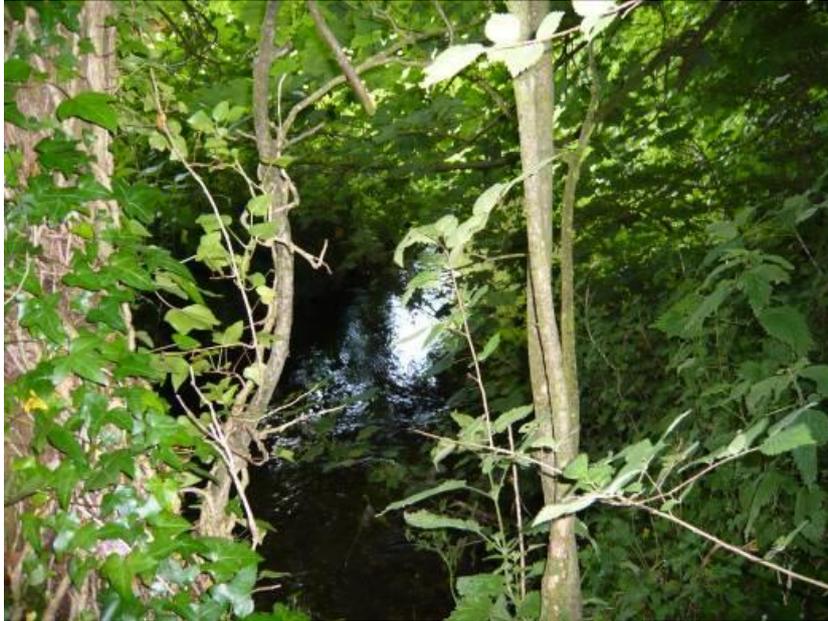
Side carrier fed from the sluice – good refuge for young trout from predators

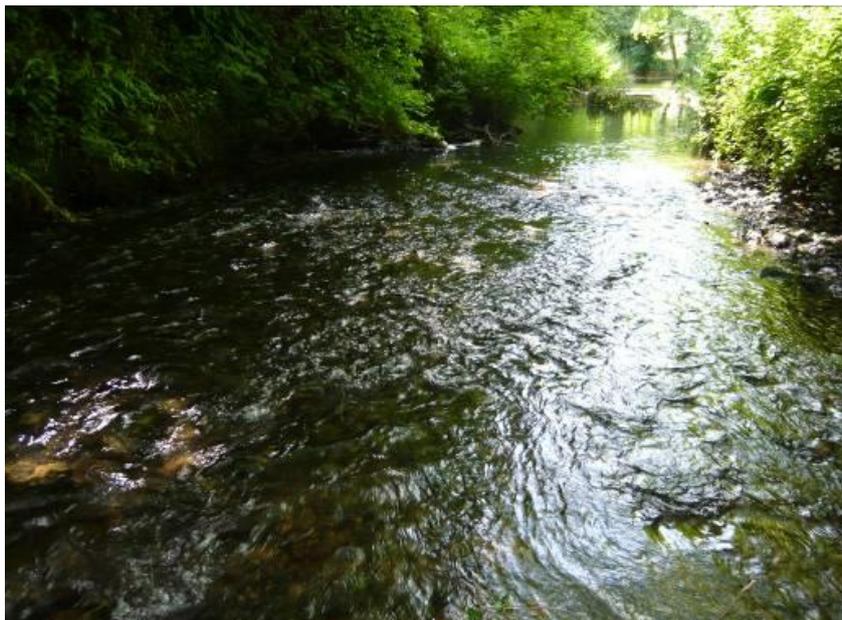
Downstream of the hatches the river takes on a very different and unusual look. Here a very steep, natural looking slope rises up above the left bank giving the river the characteristics of an upland wooded stream rather than classic chalkstream. The channel is very heavily shaded by mainly dense stands of sycamore *Acer pseudoplatanus*. Significant improvements to in-channel and marginal habitats could be achieved through some selected thinning of the sycamore canopy. Material won from the operation could be used to improve in-channel habitats by either “hinging” live trees or pegging down cut trunks to promote local scour and provide much needed refuges for fish.

Not a stream on Dartmoor but the Dorset Frome

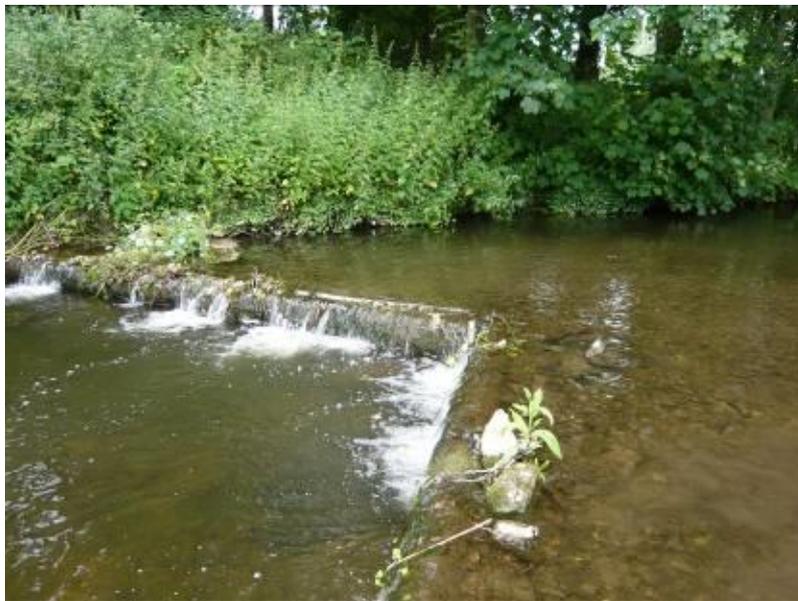
Flat V weir possibly on the site of an old stone structure

Upstream of the weir in the photograph above, the bed of the river has actually re-profiled with the bed level having risen to the top of the structure. Very little soft silt was present above the structure indicating the considerable gradient and power this particular reach has in heavy water conditions. Unfortunately the flat,

parallel nature of the structure has not enabled it to focus the erosive power of the river to form any decent sized central scour. Lowering the central part of the structure would potentially focus the scour over a range of different flow conditions.

Some of the structures constructed in attempt to improve trout habitat are not working very well. These should be removed or possibly modified to concentrate and promote in-channel scour over a range of flow conditions.

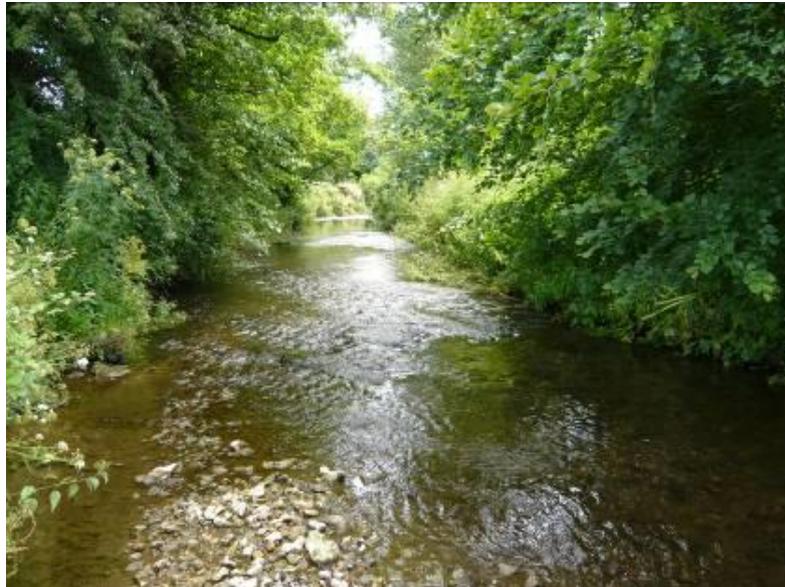
The straight shallow channel downstream of the Hydlands Farm

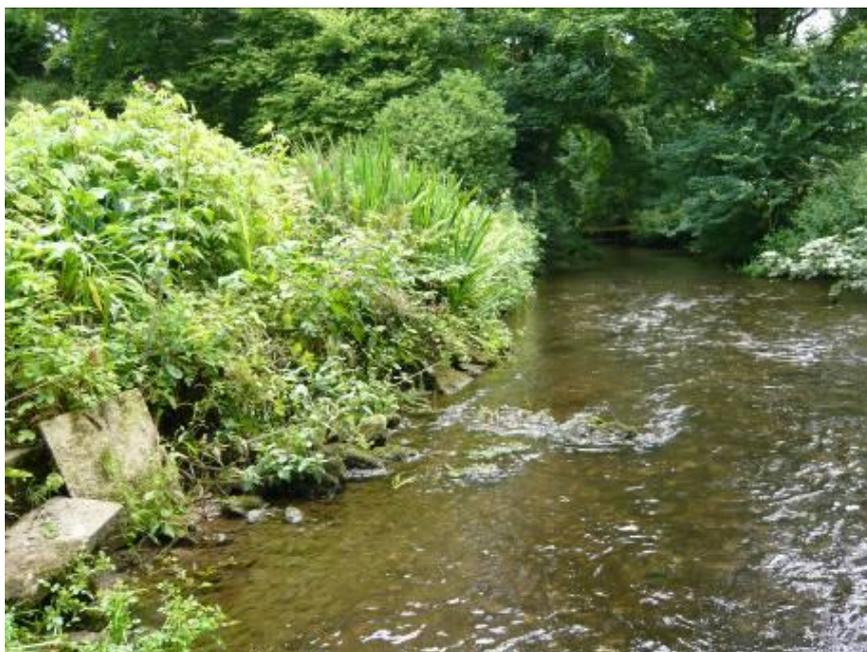
Inappropriate planting adjacent to the LHB may leave this section vulnerable to erosion
