## **Galmington Stream, Taunton**

**An Advisory Visit Report by the Wild Trout Trust**

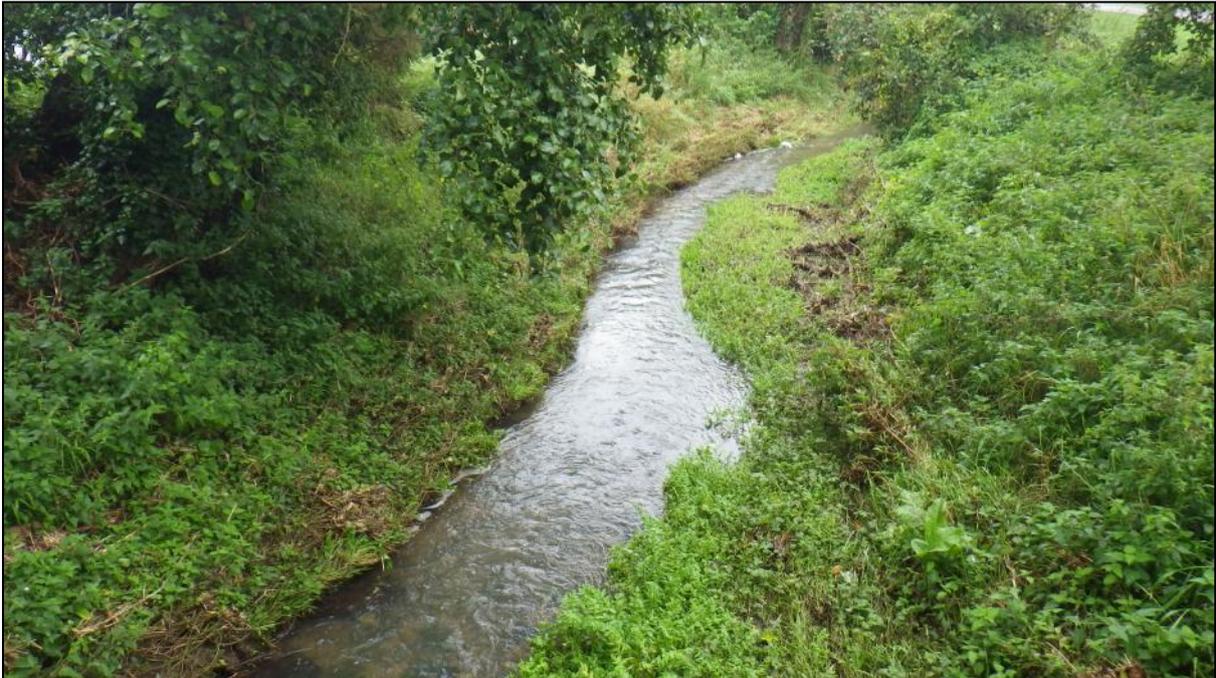
On the outside bank of meanders in the stream, natural erosion has led to undercutting of the banks, causing rotational slumps. As a result, grassy sections of upper bank have slid into the river and been transported a short distance before being deposited on the inside bends of meanders downstream. This has in places created small, grassy shelves at the toe of the bank. In other places, depositional processes have created small, muddy gravel shoals that have become colonised by beds of fools watercress (*Apium nodiflorum*).

**Figure 2: Fools cress growing in-channel**

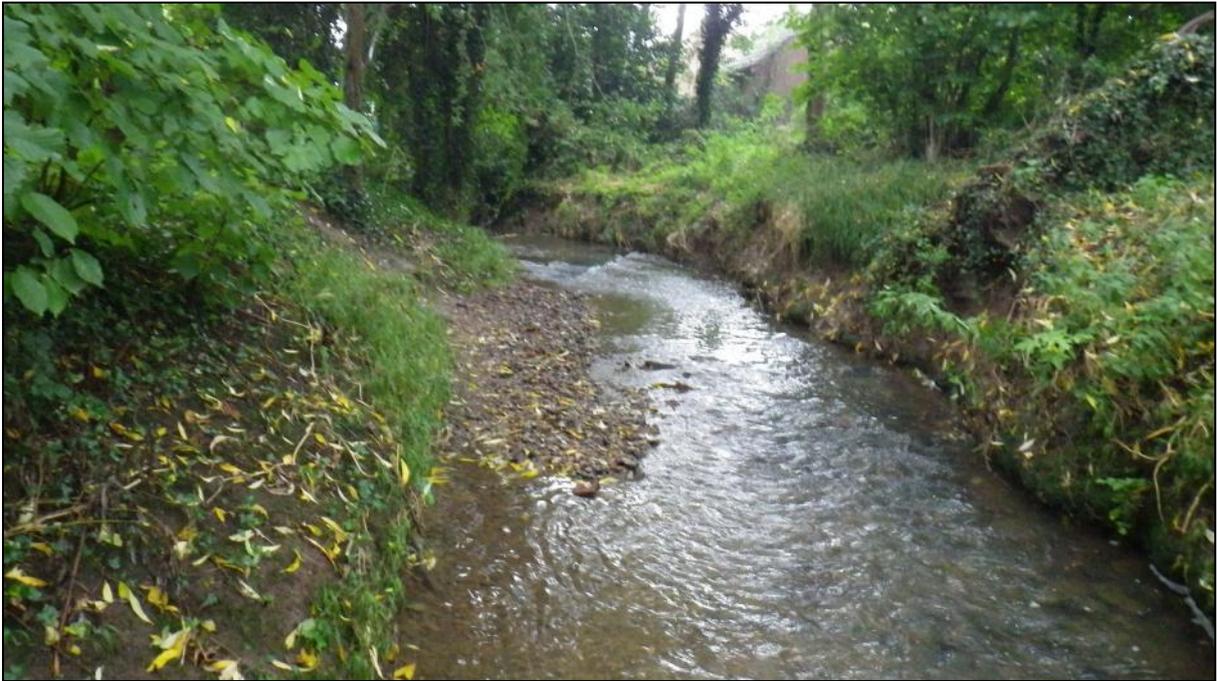
**Figure 3: A balance of erosion and deposition maintain channel width**

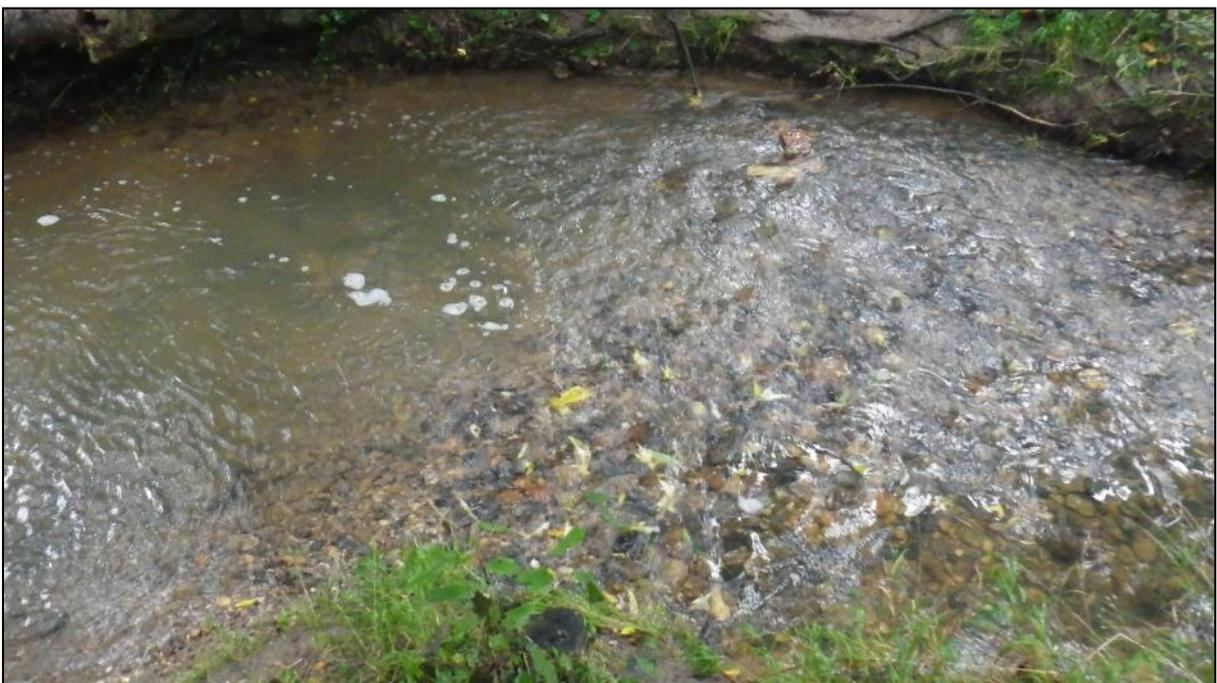
**Figure 4: Pool and riffle habitat**

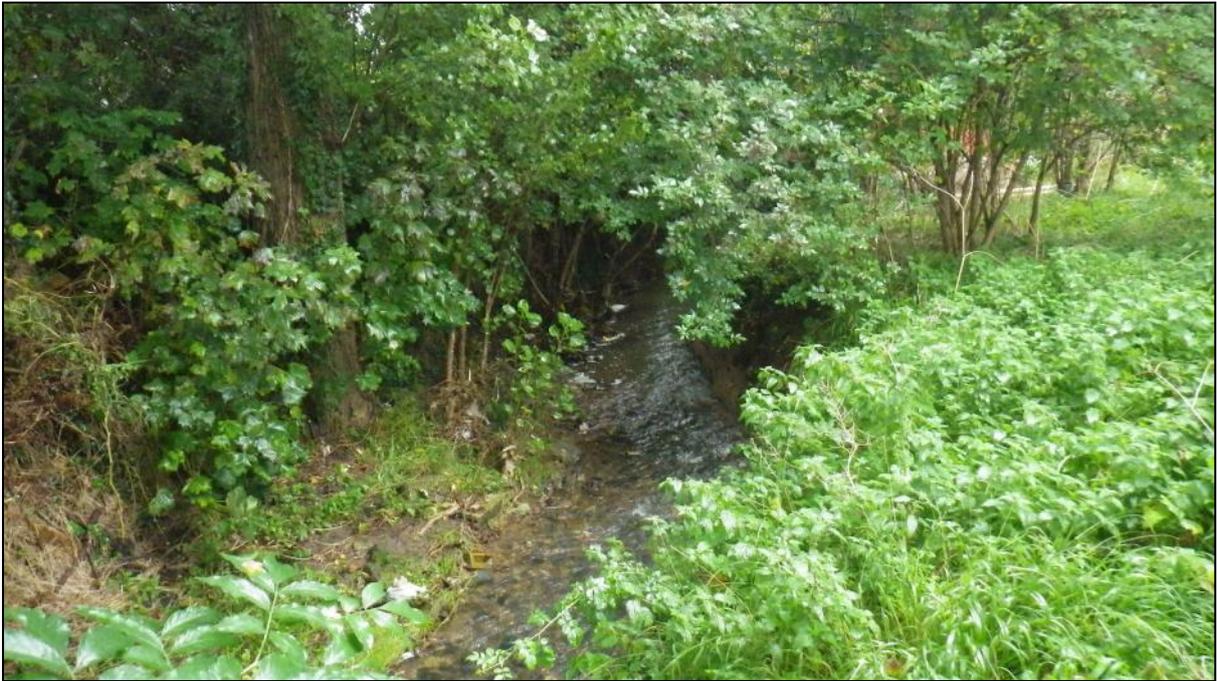
The root systems of bankside trees play an important role in forming meanders and have helped to protect steeper sections of bank from lateral erosional forces and promoting locally-increased depth via vertical scour. The bankside trees also shade the channel, keeping the stream cool and protecting its inhabitants from overheating in summer months.

**Figure 5: Shade from riparian trees**

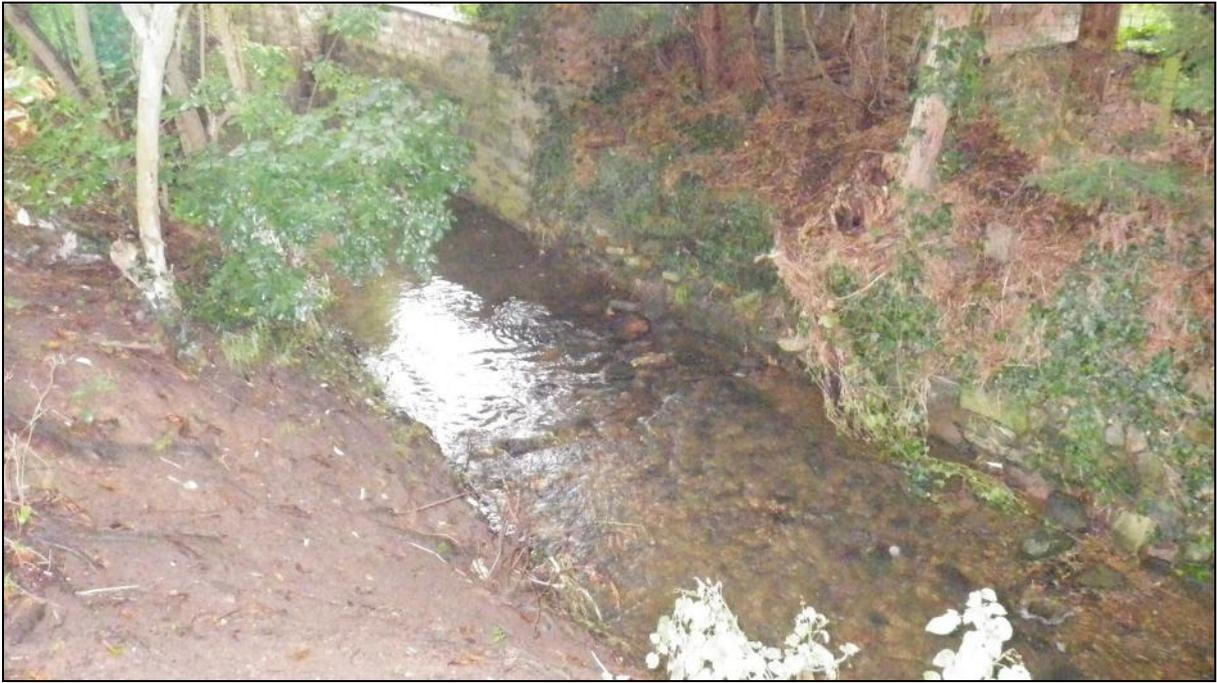
Throughout much of the stream corridor, the canopies of trees on either bank have grown across the narrow channel to form an almost unbroken tunnel of shade. This *tunnelling* is inhibiting the growth of aquatic and marginal plants and has resulted in bare soil banks in many locations. Banks deprived of vegetation are prone to increased rates of erosion.

**Figure 6: Too much shade can lead to bare soil and increased rates of erosion**

- 4.** Fish passage over French Weir may have an impact on fish passage into the Mill Stream if fish can drop down through the hatches at the 'barrier wall'. The current operational status of the French Weir fish pass should be investigated with the Environment Agency.
- 5.** Through the over-shaded sections of the stream, selective tree works should be undertaken to create a dappled mosaic of light conditions with an approximate 50:50 ratio of shade to direct sunlight.

Tunnelling tree branches should be cut back in a few spot locations to create occasional south-facing skylights and selected riparian trees should be coppiced or pollarded to create occasional areas of sunlit bank. Sunlight should be focussed over shallow riffles and shallow-gradient banks in order to encourage aquatic and marginal plant growth.

Creating and maintaining optimum light conditions over a small stream can be a challenge. It is important not to be overzealous with tree works and to resist the temptation to pollard bankside trees to a uniform height. A rotational programme of tree management should be established whereby an uneven age and size structure is maintained throughout the river corridor in order to maintain variation in light conditions throughout the day.

A 5 year rotational programme of tree works is recommended with the aim of maintaining a diverse range of light conditions over the water.
- 6.** Some of the heavily-engineered sections of the stream would benefit from the introduction of some fixed LWD to introduce some physical diversity into the homogenous habitat. Thick branches from the proposed tree works could be pinned to the bed to promote localised scour and create a more sinuous channel form.

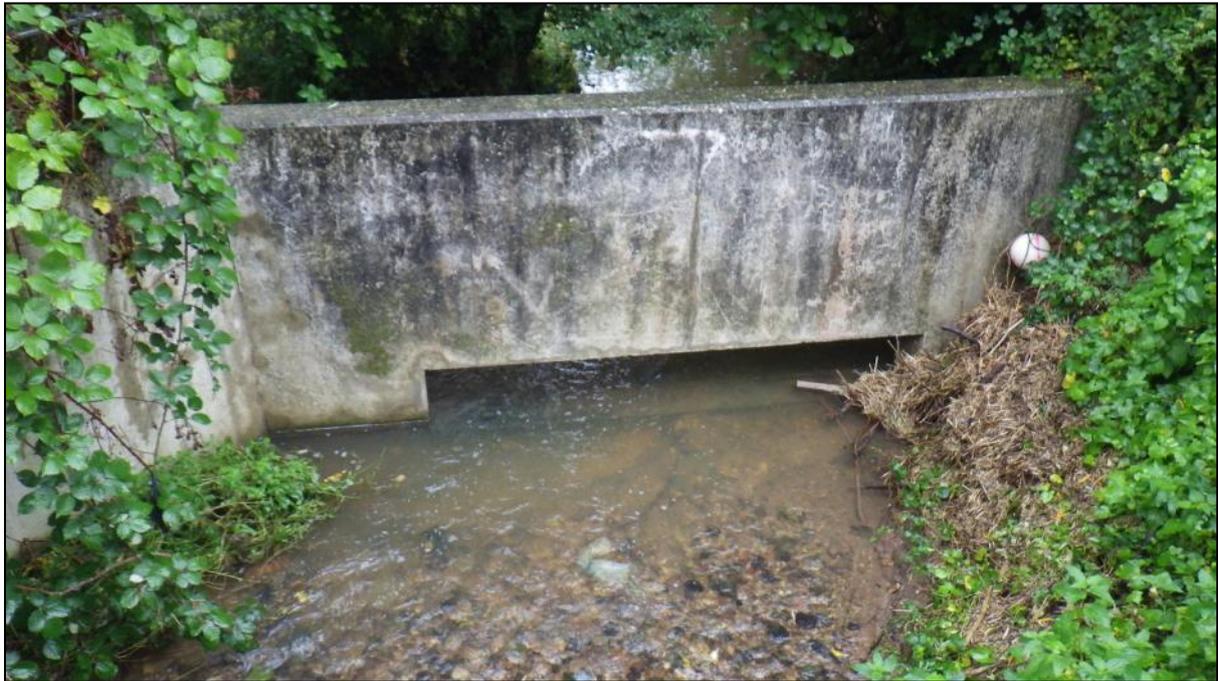
At ST207234, a concrete throttle structure controls peak flows downstream and acts to temporarily store floodwater within the stream corridor. This flood management technique requires riparian land upstream to remain undeveloped. The LNR designation has also helped ensure that the stream and its banks are protected for the benefit of wildlife.

**Figure 7: A throttle structure holds excess flood water upstream**

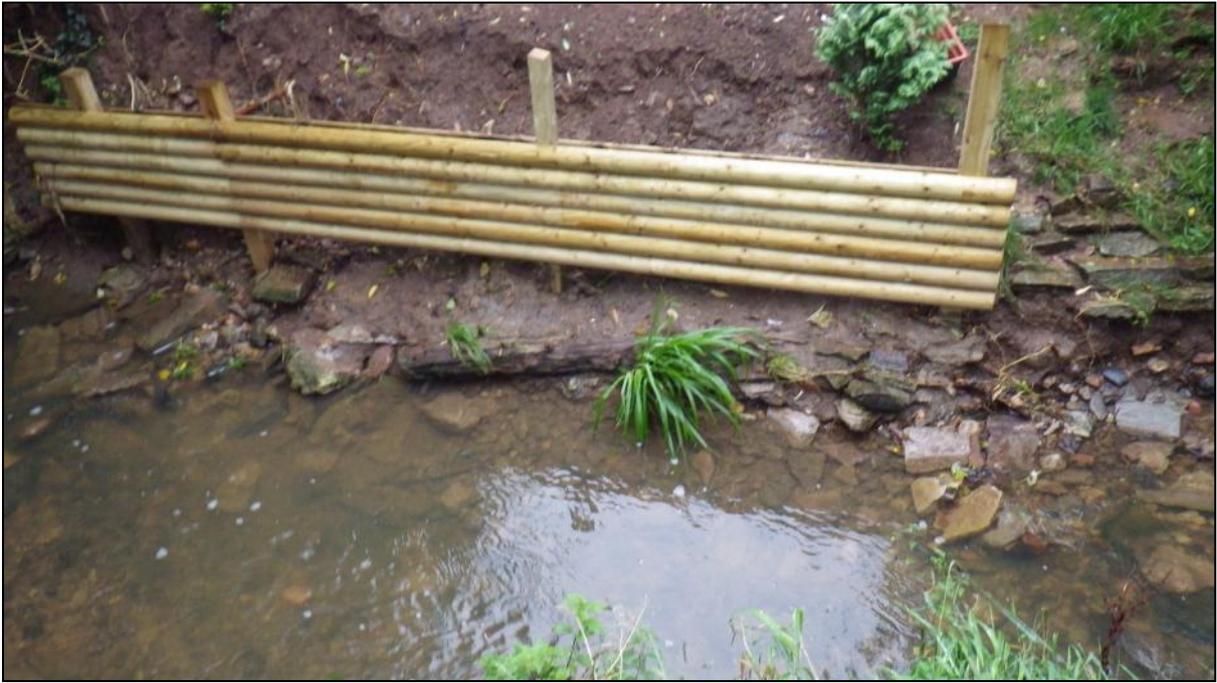
As the stream flows alongside residential properties, some residents have attempted their own make-shift erosion repairs. These mostly consist of vertical structures that not only fail to abate the erosion but may actually be accelerating the process by further reducing opportunities for marginal plants to establish and increasing scour by focussing flows. Consequently, the exposed soil is washed away at the toe and behind the structure, and the banks continue to slip into the river.

**Figure 8: a DIY revetment may actually be accelerating erosion**

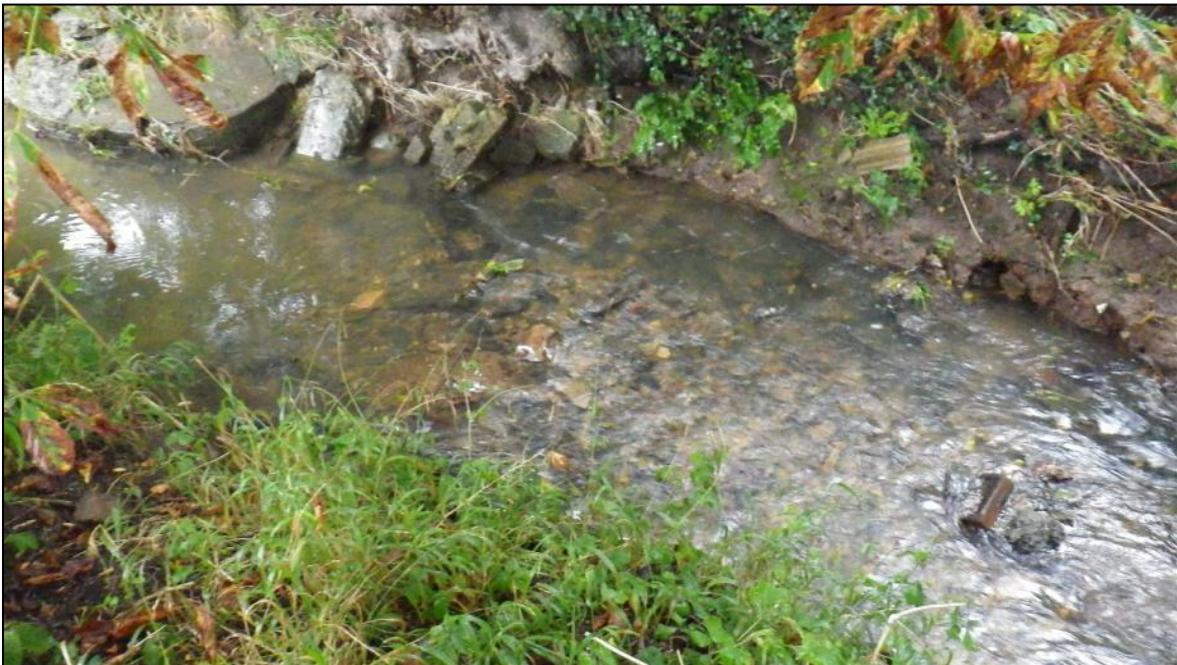
Along the back of properties on Galmington Drive, erosional processes that have helped shape the natural channel form upstream are halted by concrete and stone revetments on the LB. Fortunately, large stones/blocks have rolled into the channel and deflected flows to scour a pool-riffle sequence along the bed.

**Figure 9: Rubble from dilapidated hard-engineered bank revetments helping to scour a pool and riffle**

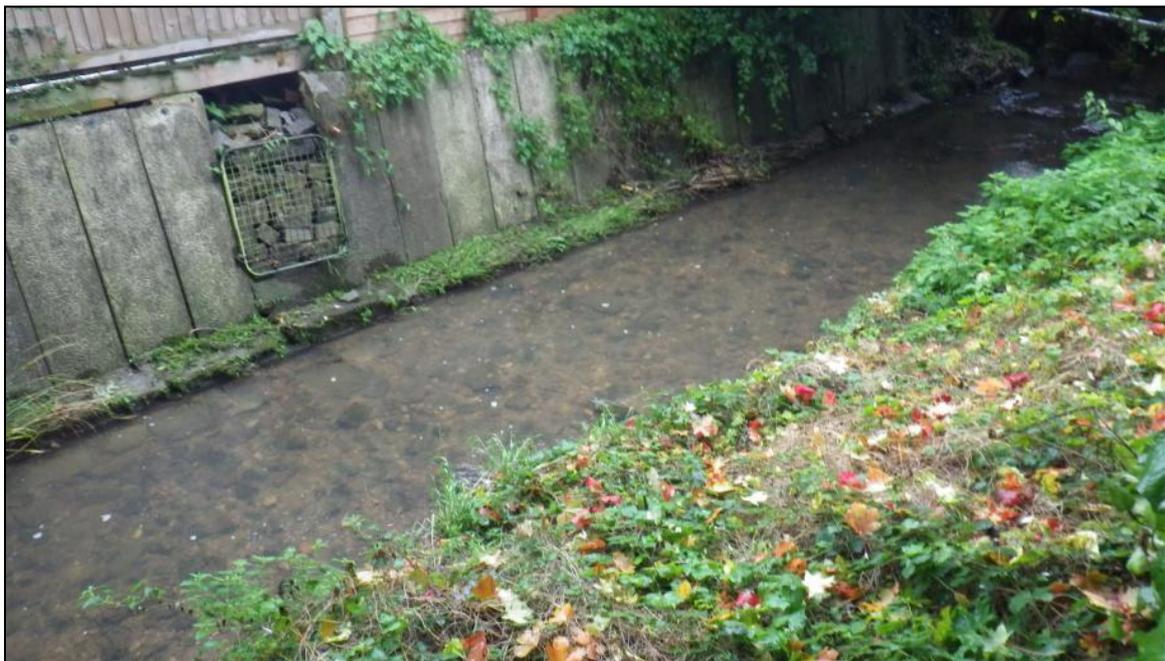
However, some sections of hard engineering have straightened the channel to such an extent that the habitat has become homogenous. Here the stream would benefit from the introduction of some simple in-stream structure (i.e. woody debris, tree kickers or flow deflectors) to help diversify habitat conditions.

**Figure 10: Straightened, engineered banks result in homogenous habitat conditions and poor biodiversity**

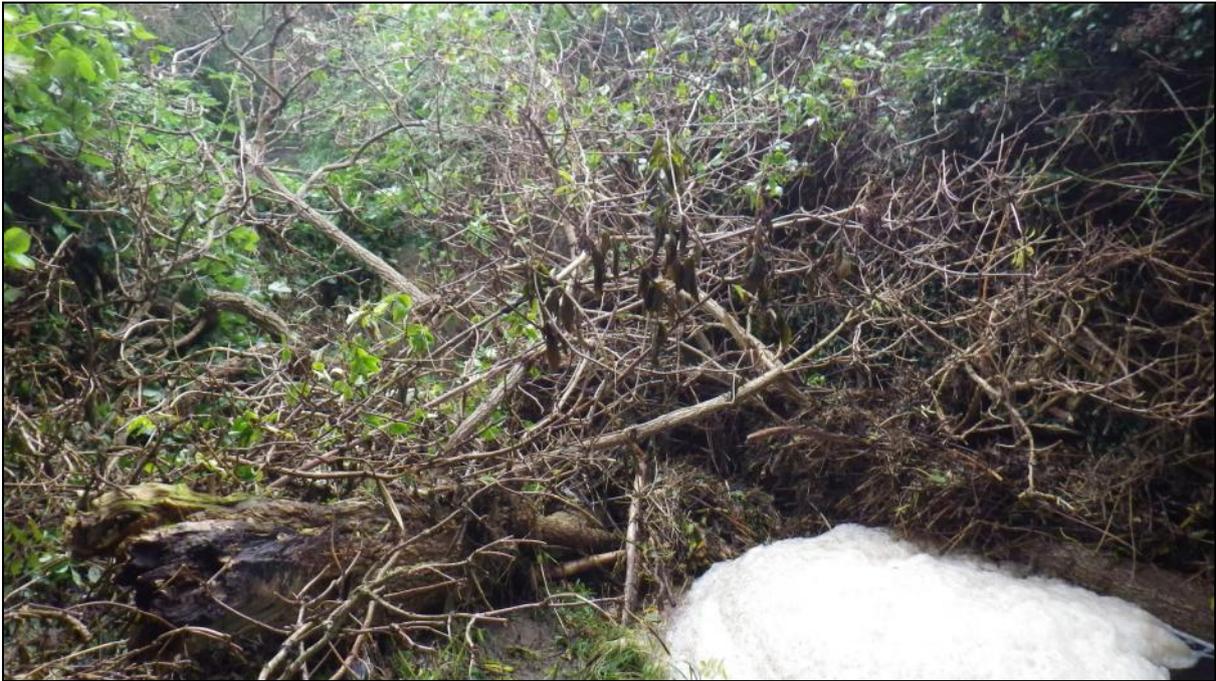
Near Bishop Henderson's Primary School, a large tree branch was observed wedged across the channel and collecting smaller pieces of woody debris to form a 'debris dam'. The river appears to have scoured a pool under the dam and the dam does not appear to be impounding flows. The volume of trapped woody material suggests that the stream receives a significant steady supply of woody debris from the bankside trees upstream. Woody debris is a vital component of the river ecosystem. It is an important food source for invertebrates and helps to increase flow diversity, which in turn improves the geomorphology for the stream, leading to increased habitat diversity.

**Figure 11: A 'debris dam' highlights the volume of woody debris entering the stream**

On the upstream side of the debris dam, a mass of white foam had accumulated. Foam on the water can occur entirely naturally as organic compounds from decaying debris break the surface tension allowing bubbles to form. However, accumulations of foam could also be indicative of elevated phosphate concentrations, possibly from sewerage effluent.

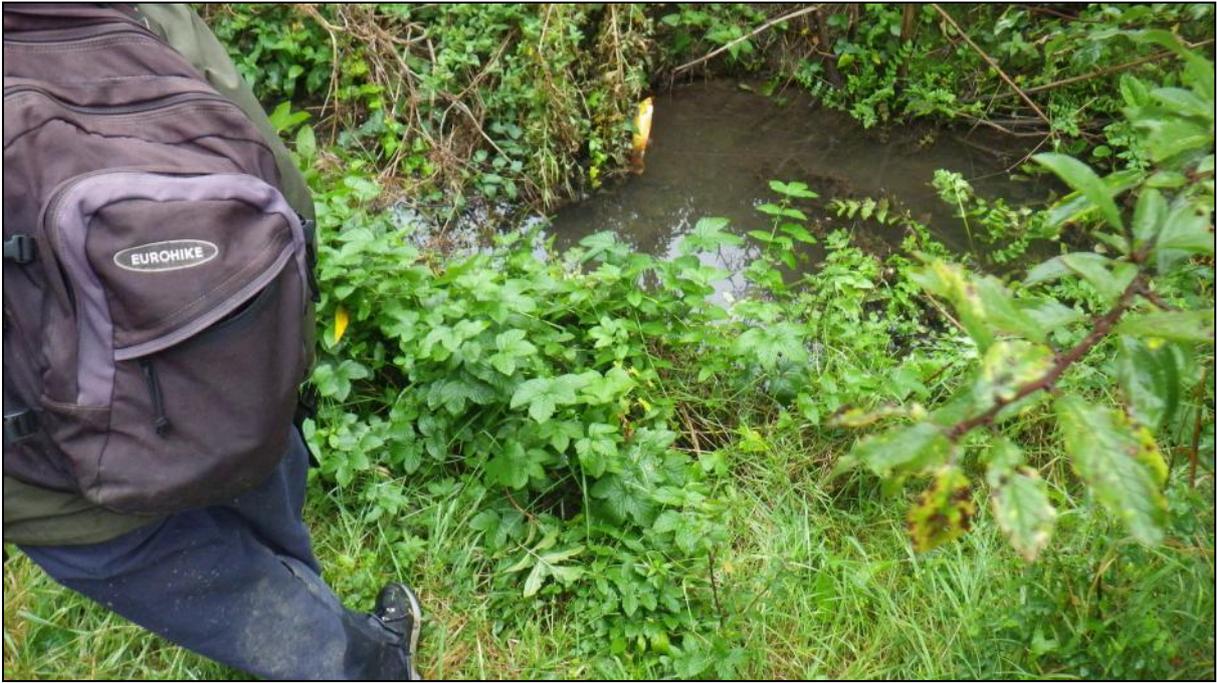
Nearby, a small drainage ditch runs through Comeytrove Neighbourhood Park. Emergent and marginal plants including meadowsweet (*Filipendula ulmaria*), branched bur-reed (*Sparganium erectum*), and water mint (*Mentha aquatica*) are present in abundance where the banks are exposed to direct sunlight. This highlights the potential for marginal plants to establish where bank gradient and light conditions are suitable.

**Figure 12: Meadowseet (*Filipendula ulmaria*) growing in open sunlight**

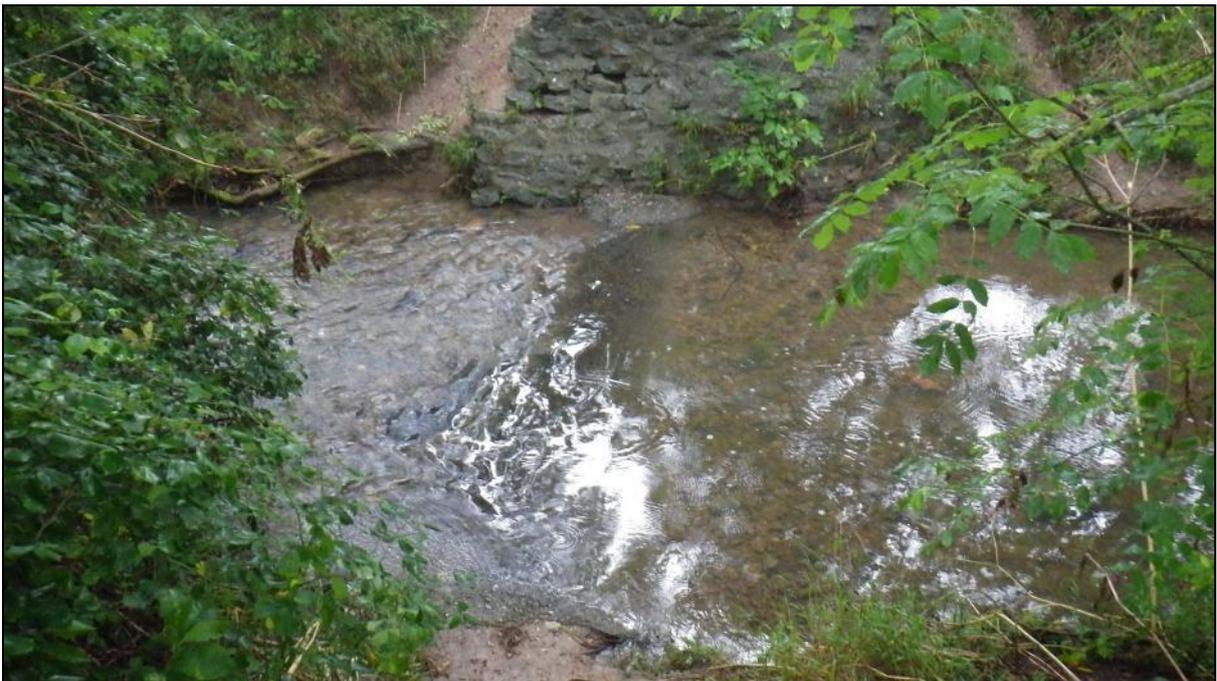
Near Musgrove Park Hospital, a water main runs below the stream bed. The exposed surface of the main was not a barrier to fish passage on the day of the visit but could be an obstruction during exceptionally low-flow conditions.

**Figure 13: Water main running through the riverbed**

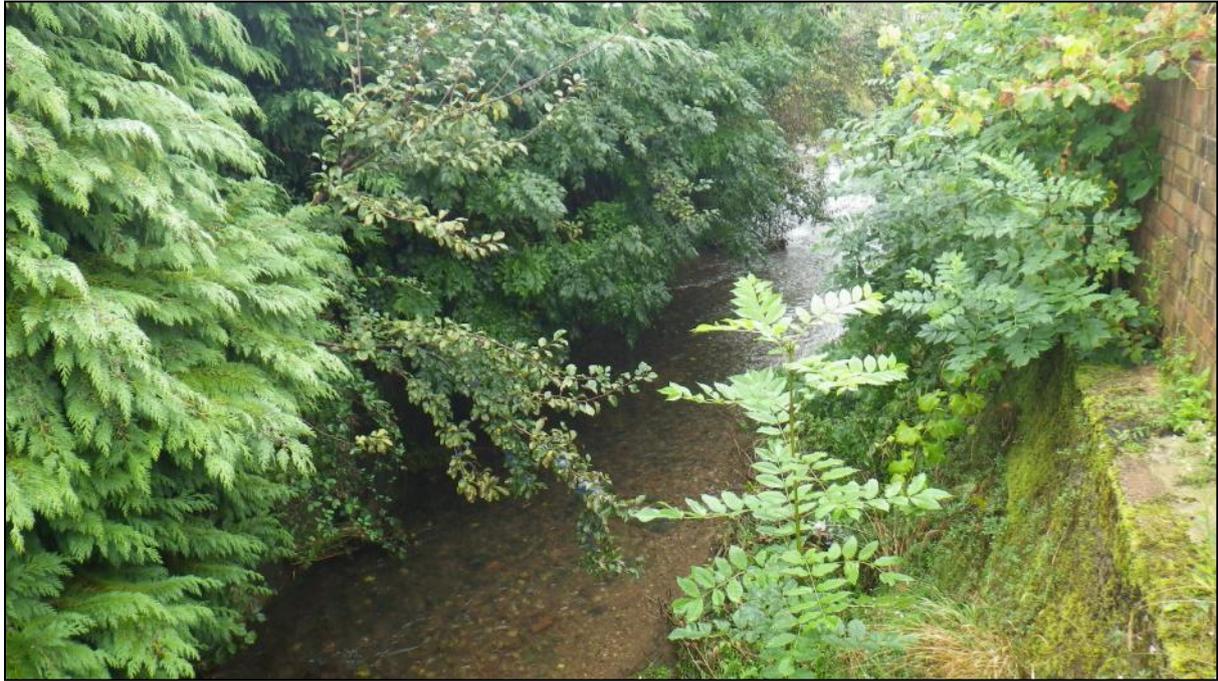
Downstream of the hospital, the stream banks appear to be walled. Much of the stream is heavily over-shaded but where sunlight is able to penetrate, some marginal plants are growing in depositional areas.

**Figure 14: Tall and steep banks**

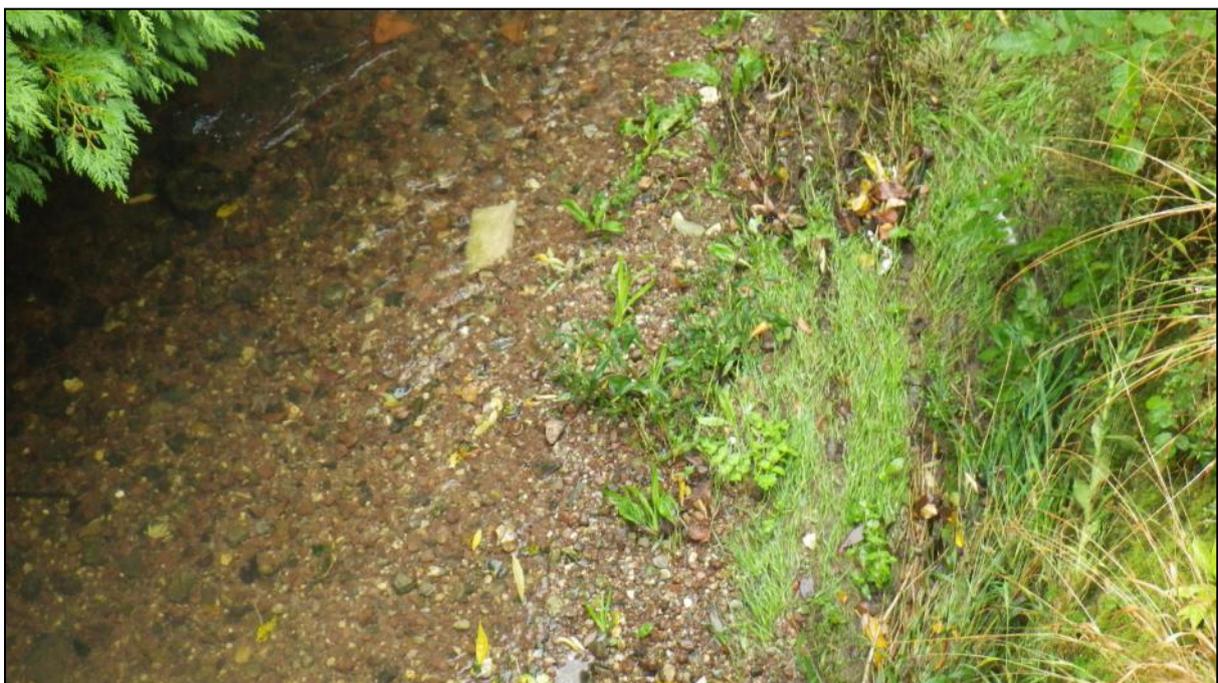
**Figure 15: Growth in the margins where sunlight penetrates through to the bed**

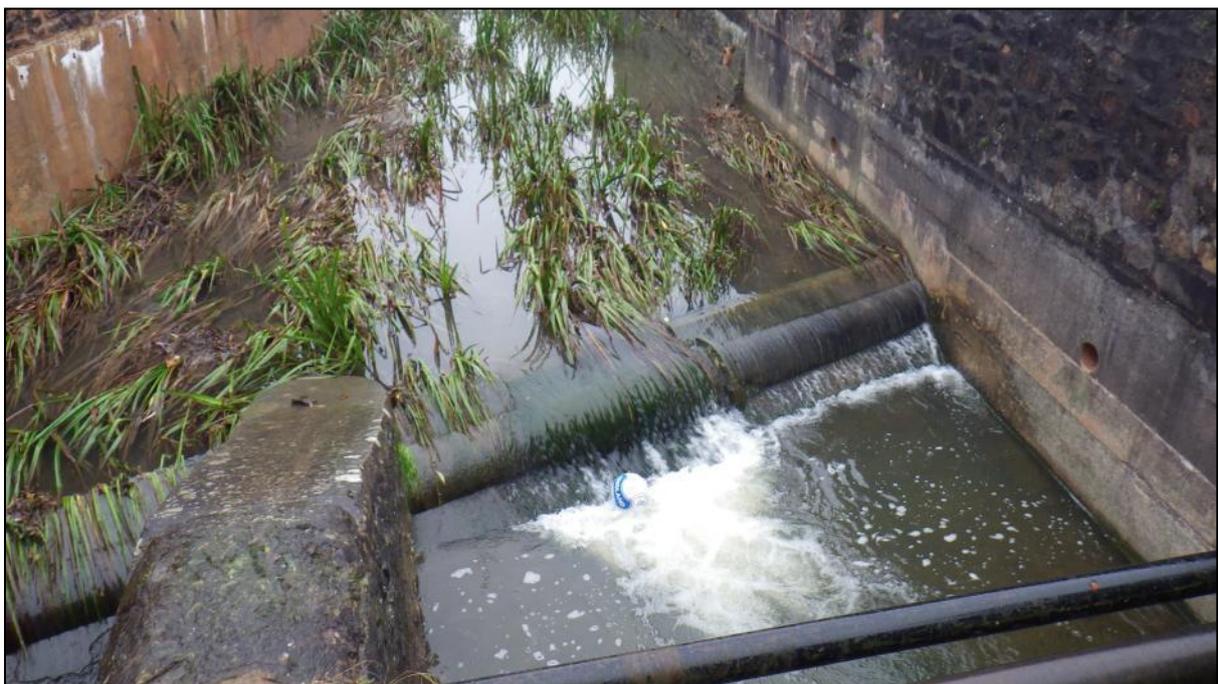
The stream runs between private residential properties and is inaccessible until it re-emerges alongside Parkfield Drive, at the junction of Parkfield Road. Here the stream is impounded by a pipeline set into a concrete weir. Upstream of the structure the habitat is degraded and the bed has become smothered with sediment as flows are backed-up and solids drop out of suspension. A dense bed of bur-reed (*Sparganium sp.*) has established and the stream resembles a still-water habitat, as opposed to a fast-flowing stream. The weir is a complete barrier to fish passage, preventing fish in the River Tone downstream from accessing the Galmington Stream upstream of this location.

Figure 16: A ~~complete~~ barrier to fish passage fragments the stream habitat

2. The major barrier to fish passage near the junction of Parkfield Drive and Parkfield Road needs to be addressed. Options to re-route the pipeline and remove the weir, or to at least ease fish passage over the obstruction should be explored with the Environment Agency. The free passage of fish is a key requirement of the Water Framework Directive (WFD).

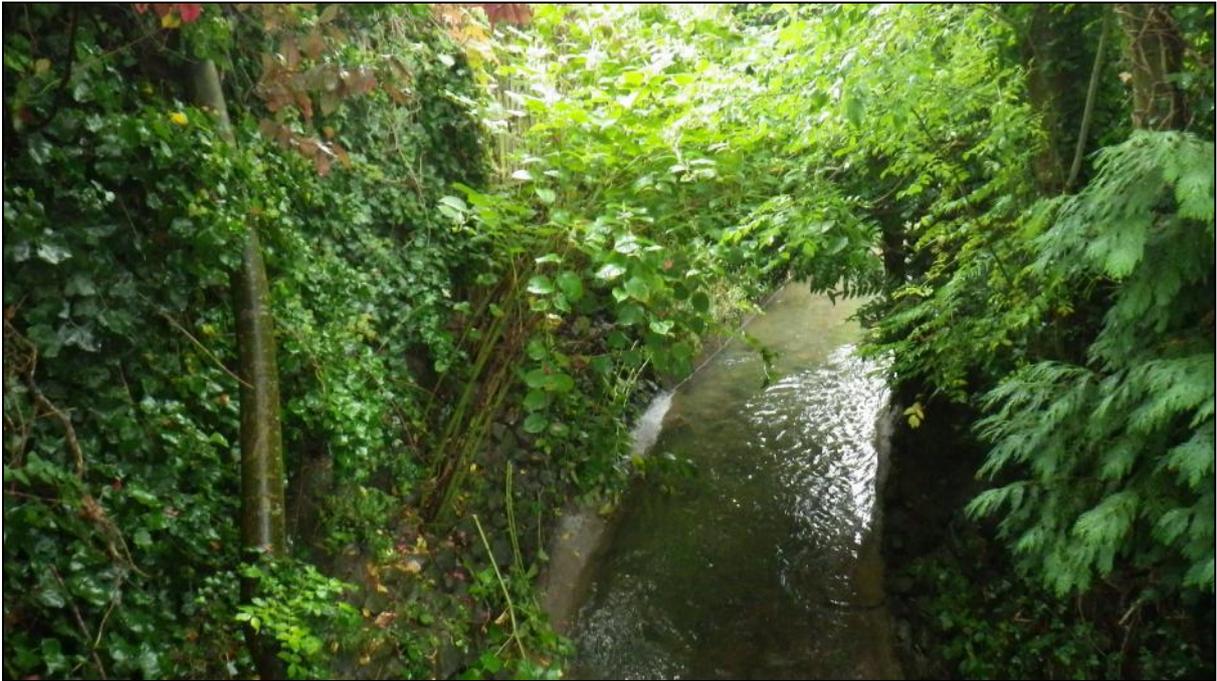
Just upstream of the A38 stream crossing, a patch of Japanese knotweed (*Fallopia japonica*) has sprouted from the stone wall on the LB. This was the only alien invasive species observed on the Galmington Stream on the day of the visit. Options should be explored to remove it in order to prevent it spreading.

**Figure 17: Japanese knotweed will need to be controlled**

7. The Japanese knotweed should be treated in order to prevent it spreading. JK is sensitive to a range of herbicides and the most effective time to apply herbicides is in late summer. The best method of treatment is stem injection by an NPTC qualified person. Permission will be required from the Environment Agency to use herbicides near the stream.

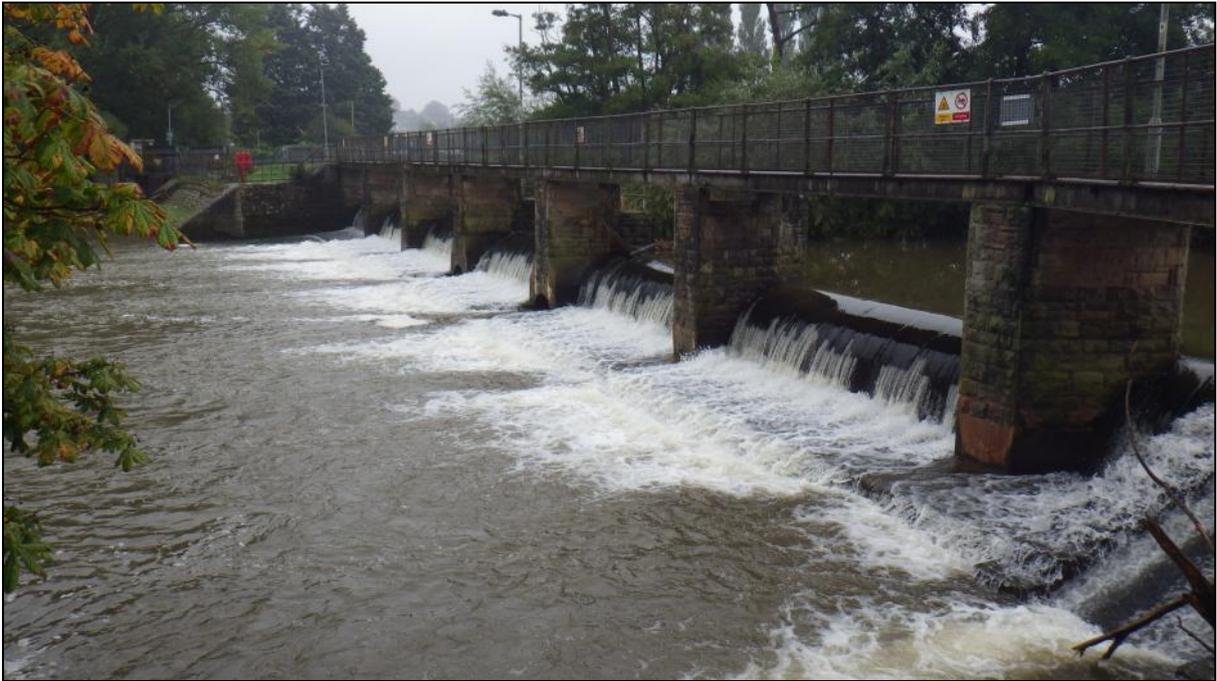
French Weir is impassable for fish. A stepped fish pass structure has been constructed on the left hand side of the weir but was not operational. The fish pass functions when boards are dropped into position to raise water level in a series of steps. None of the boards were in position on the day of the visit.

**Figure 18: French Weir is impassable to fish**

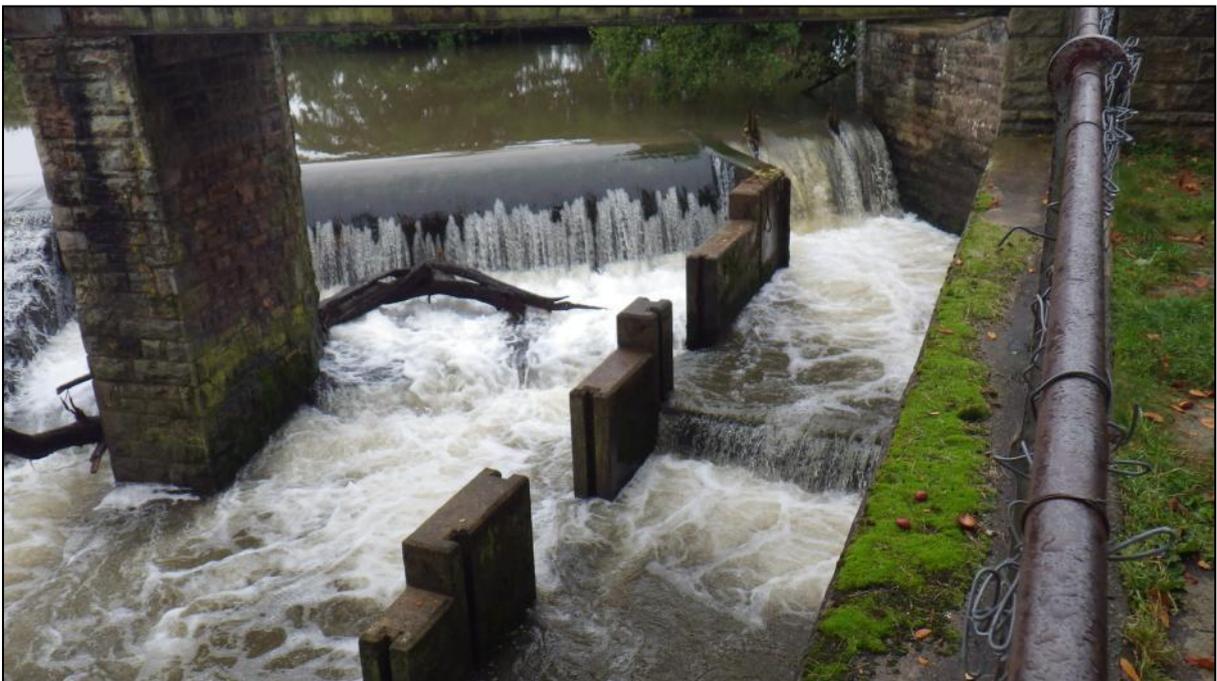
**Figure 19: Fish pass not in operation**

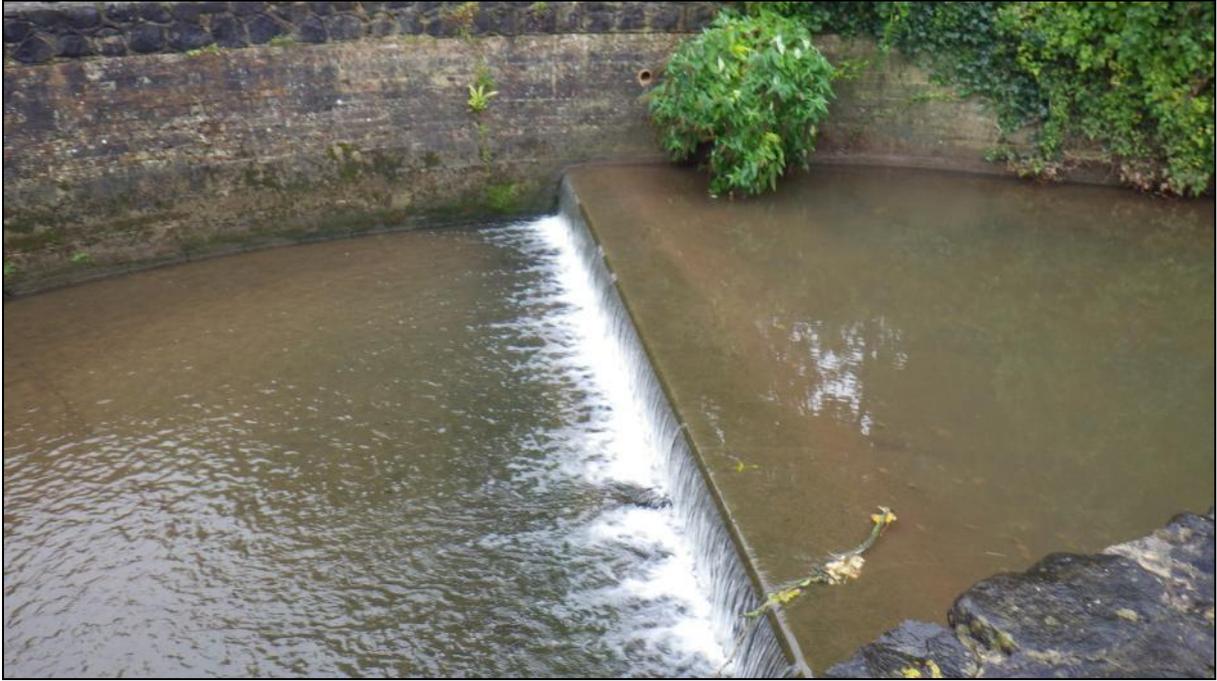
At the downstream confluence, a series of small weirs are major barriers to fish passage in most flow conditions, but may be passable during high flows. Fish passage into the Mill Stream from the Tone could be improved by the removal or alteration of the weirs.

**Figure 20: One in a series of weirs at the downstream confluence of the Mill Stream and Tone**

3. The downstream confluence of the Mill Stream and the River Tone should also be improved for fish passage as this appears to be the main access to the Mill Stream for fish populations in the River Tone. The ideal solution would involve the complete removal of the weirs. If however, this option proves impractical (for flood defence purposes etc.); it may be possible to remove approximately ¼ of each weir at alternating ends, using the remnants of the weirs as mid-points for rocky point-bar berms that would improve channel structure between the weirs (Figure 23).

At the very least, the option of cutting deep notches into the weirs should be explored in order to improve fish passage without affecting the flow regime of the Mill Stream (Figure 24). Notches should be cut as low as possible so as to avoid the requirement for a jump and with an appropriate width to maintain a suitable depth of water and flow velocity for fish passage.

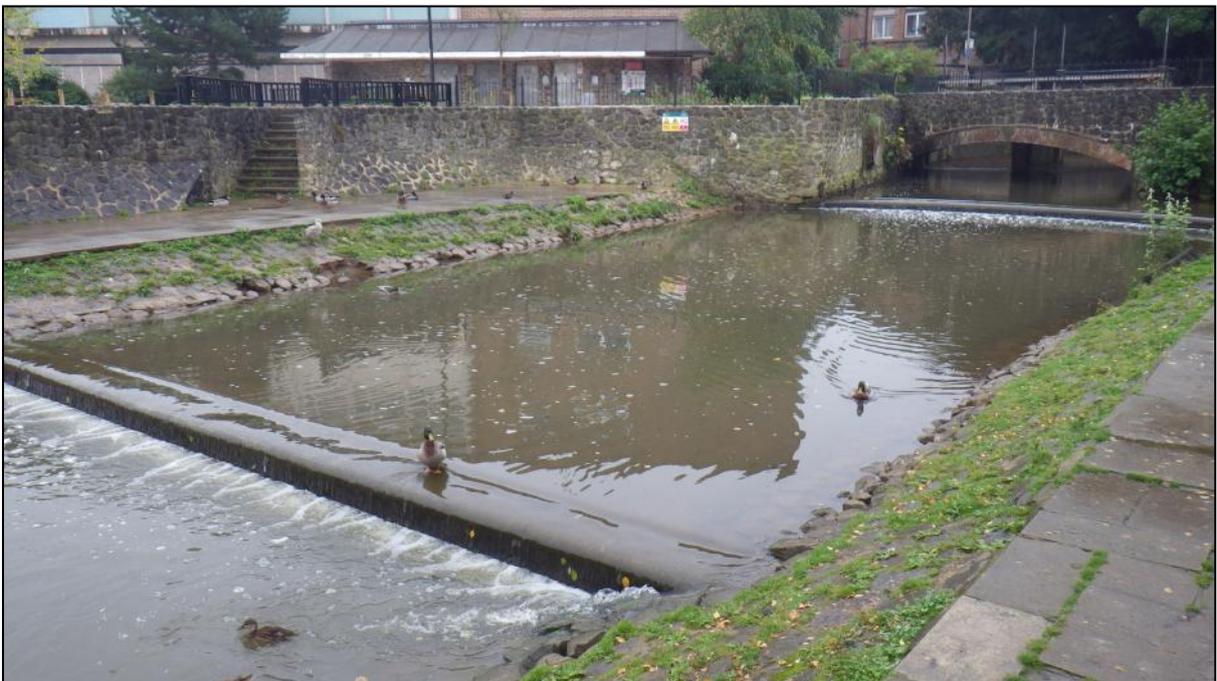
**Figure 21: A series of small weirs can be a serious energy drain for fish**
