Gatwick Stream – Riverside Garden Park, Horley

An Advisory Visit by the Wild Trout Trust – January 2014

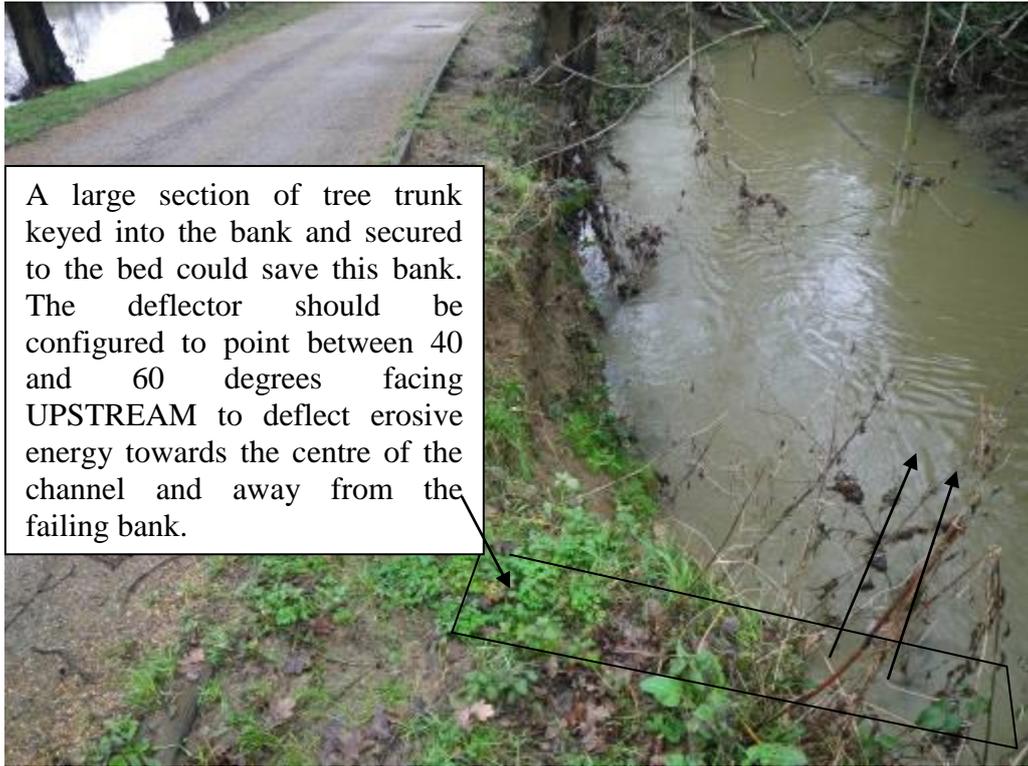
1. A significant issue is the proximity of the footpath running adjacent to the LB in several locations. The channel is deeply incised, comparatively high and steep. In several locations the bank is actively eroding (photo 1 and 2) and without intervention the footpath is likely to be severely damaged.

Photo 1. Steep bank on the outside of the bend will lead to bank failure and damage to the footpath.

Several options are available. Measures to slow down the high energy, erosive flow can be undertaken using simple techniques using materials won from riverside trees. For the site depicted in photo 1 a stub flow deflector made from a tree trunk or thick branch section could be keyed into the bank and configured to kick the flow away from the margin and towards the centre of the channel. The bare eroded bank faces at both sites can be protected by installing a brushwood mattress against the face to flow down water velocity and trap sediment (example depicted in photo 4). Ideally there should also be a managed retreated and the formal path should be either moved back, or narrowed to make space for defensive planting between the path and the top of the bank.

- Consider pegging in brushwood against the eroding bank face adjacent to the footpath.
- Coppice out any tree trunk which exacerbates bank erosion.
- Install a “tree trunk” stub flow deflector, keyed into the bank and extending a third of the way across the existing channel width to reduce erosion of the footpath.

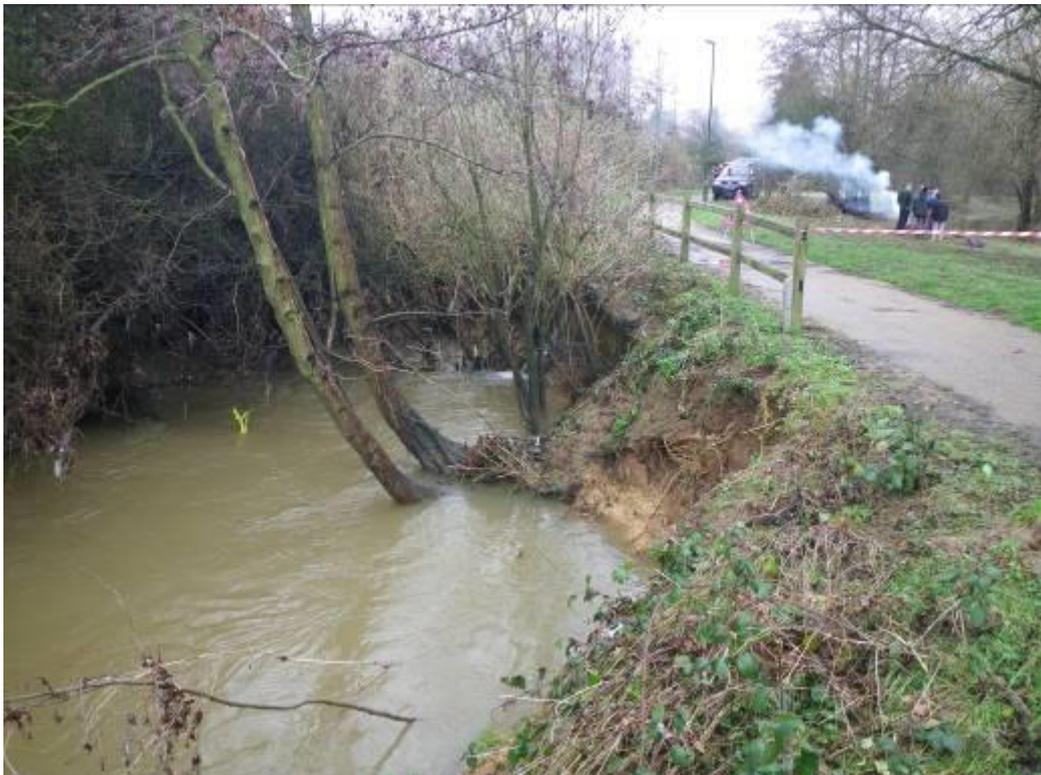
Photo 2 Another area where the path is in danger. Unfortunately the shape of the alders is forcing water into the bank under high flow conditions.

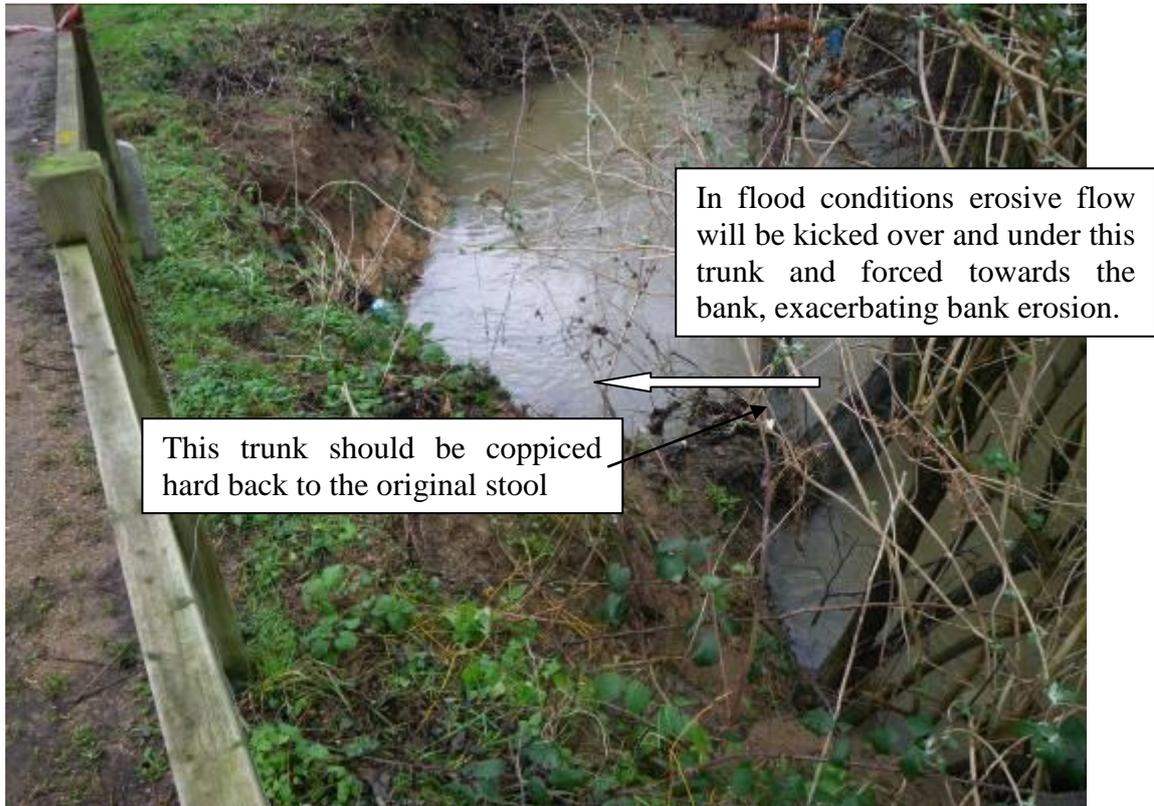
Photo 3. View from upstream looking down highlights the angle of the left hand trunk promoting the bank erosion.

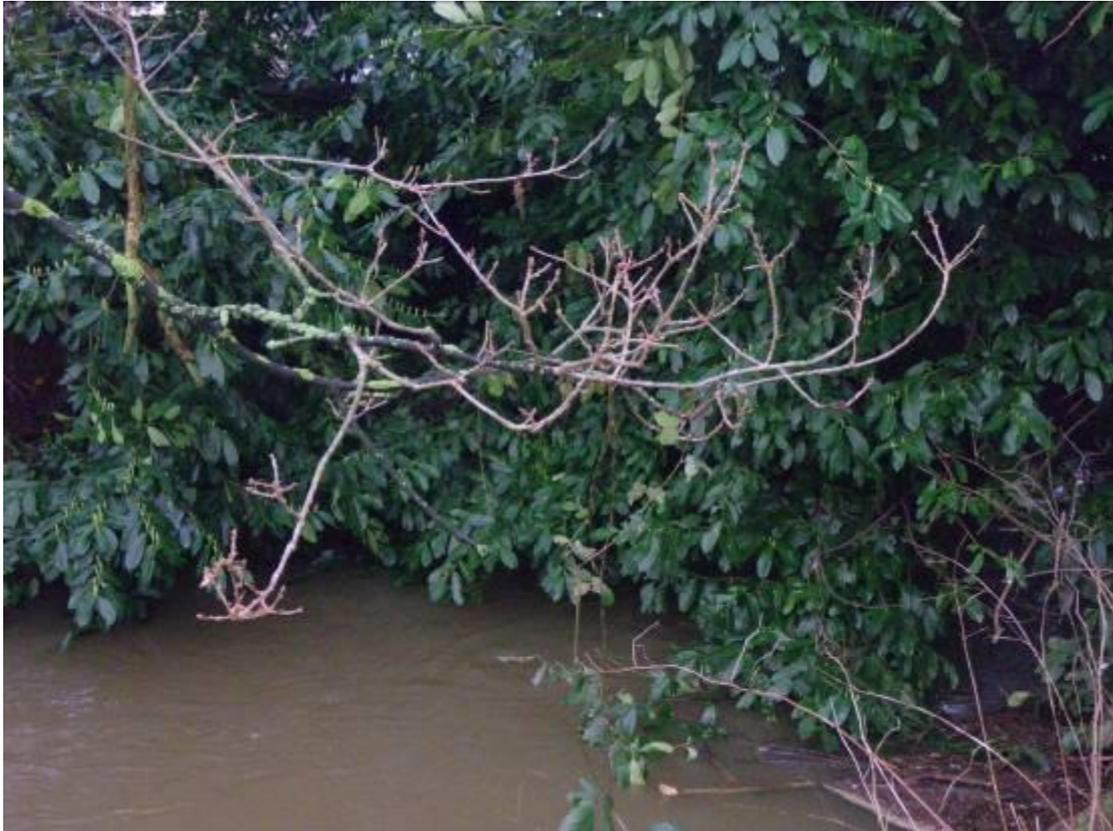
Currently the channel is quite heavily shaded. Some tree work would be desirable to provide a 50:50 dappled light and shade regime. Retaining low, overhanging cover is important, particularly over the outside of bends and over deeper pool habitat. There were some undesirable non native laurel or rhododendron trees which were blocking out all light and ideally they should be removed (photo 5).

Photo 5. Laurel trees completely shading the channel should be removed.

- Remove non native trees shading the channel.
- Highlight the importance of sensitive use of the river bank with garden owners adjacent to the RB.
- Coordinate and implement a Practical Habitat Workshop, led by the WTT, where interested groups can be trained with the simple techniques required to maintain and improve in-channel and riparian habitats.
