## **River Glyme – Woodstock Meadows**

**An Advisory Visit by the Wild Trout Trust December 2014**

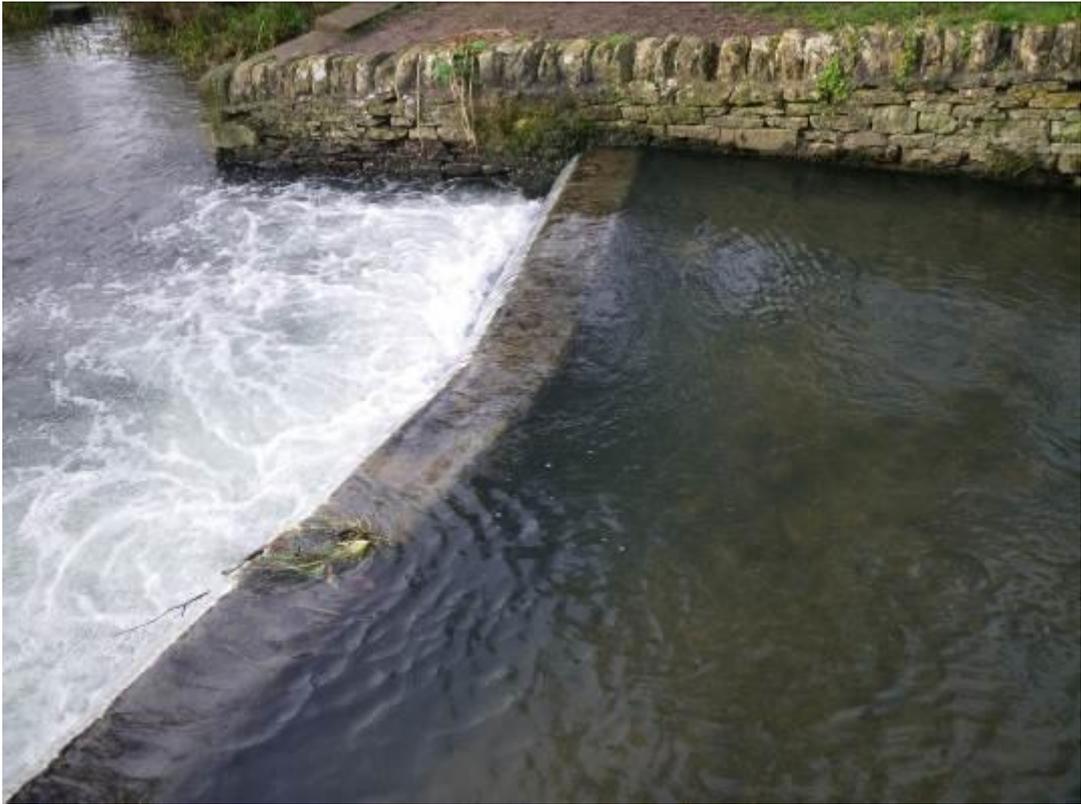
The section of main channel through Woodstock Meadows is perched and raised above the valley floor. The river channel may have been diverted to create a head of water for agricultural irrigation for the meadows, or perhaps to provide a head of water for milling power near the top of the Queen Pool. A low weir (photo 1) still exists at the head of the Queen Pool, which may replaced an older structure. Although this weir will restrict upstream fish migration, it has not significantly drowned out the upstream reach, where the flow velocities are vigorous, generated by the significant slope in the river bed.

Photo 1 The weir at the inlet to Queen's Pool (Blenheim Lake)

Conversely, active migration for fish out of the Queen Pool and into the main river is made virtually impossible, due to the flat crested weir on the entrance to the lake. It is not known if fish in the lower Glyme are able to migrate from below and up and into Blenheim Lake. If they can, then it would seem sensible to create improved opportunities for migrating up and out of the lake via the main channel. Simply cutting a low level notch, or removing sections of block or

brick to create a low level gap of at least 300mm wide would significantly help with connectivity issues.

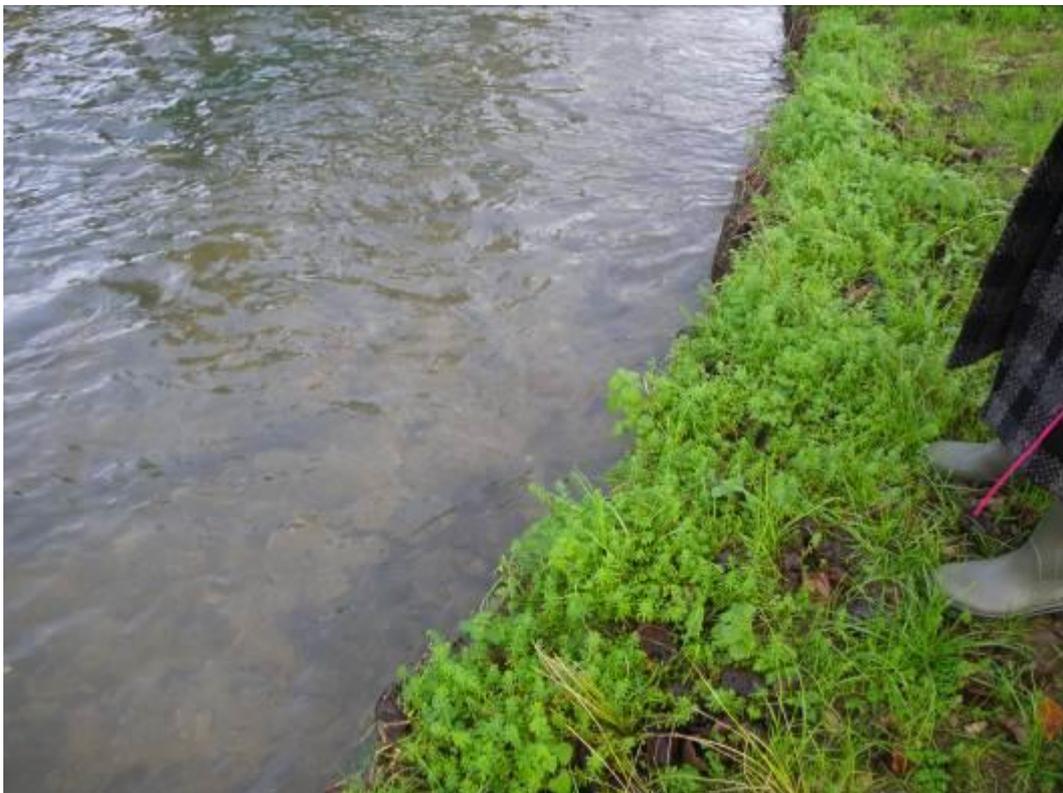
This section of main river channel has recently been the subject of extensive bank repairs (photo 2) where the river was in danger of breaching through the left bank. It is thought that the presence of burrowing signal crayfish *Pacifastacus leniusculus* is weakening the bank along this raised section of channel by burrowing into the bank and creating a pathway for leaks. Further repairs may be required to sections further upstream where the width of the raised bund/path is much narrower than in the lower sections. If leaks are detected, urgent action will be required to avoid a serious bank failure. Photo 3 depicts the perched nature of the stream.

Photo 2. Hazel faggot revetment supports the recently repaired LB.

Where the path is narrow between the main channel and the meadows, a close eye must be kept to ensure that no significant bank breach develops. The presence of burrowing crayfish will be of concern and a low thick fringe of marginally planted sedge may help to deter them, as would a shallow batter of imported gravels. Vertical clay or earth banks are sites where crayfish can inflict the most damage.

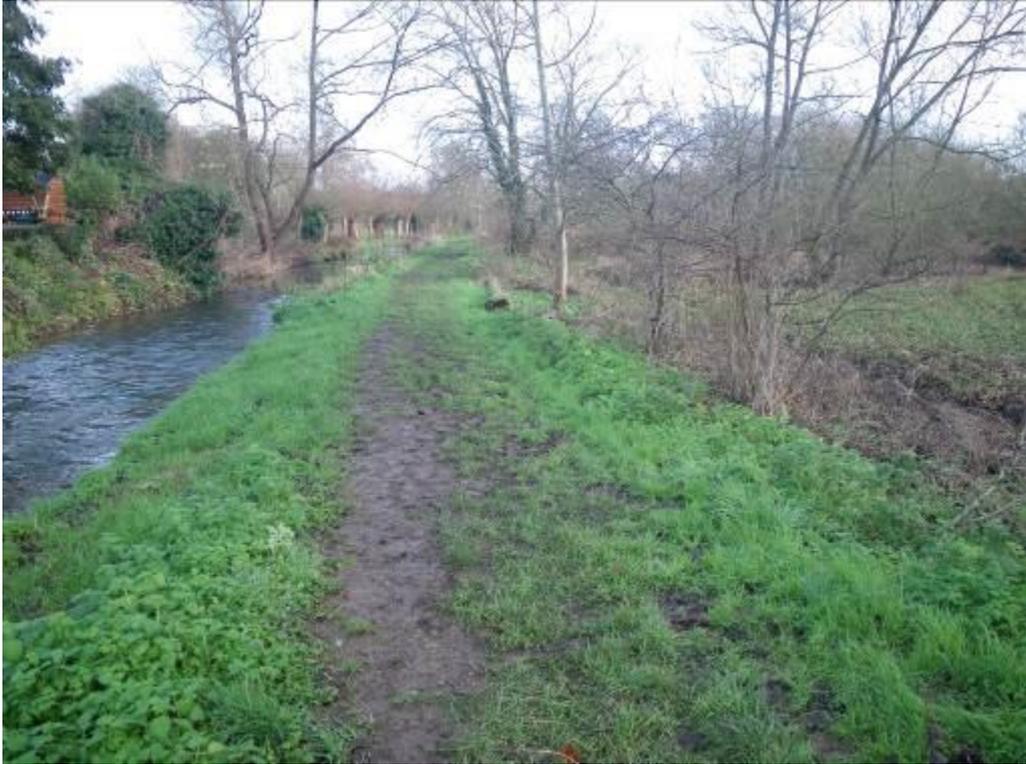
Photo 3 . View looking upstream adjacent to the repaired bank.

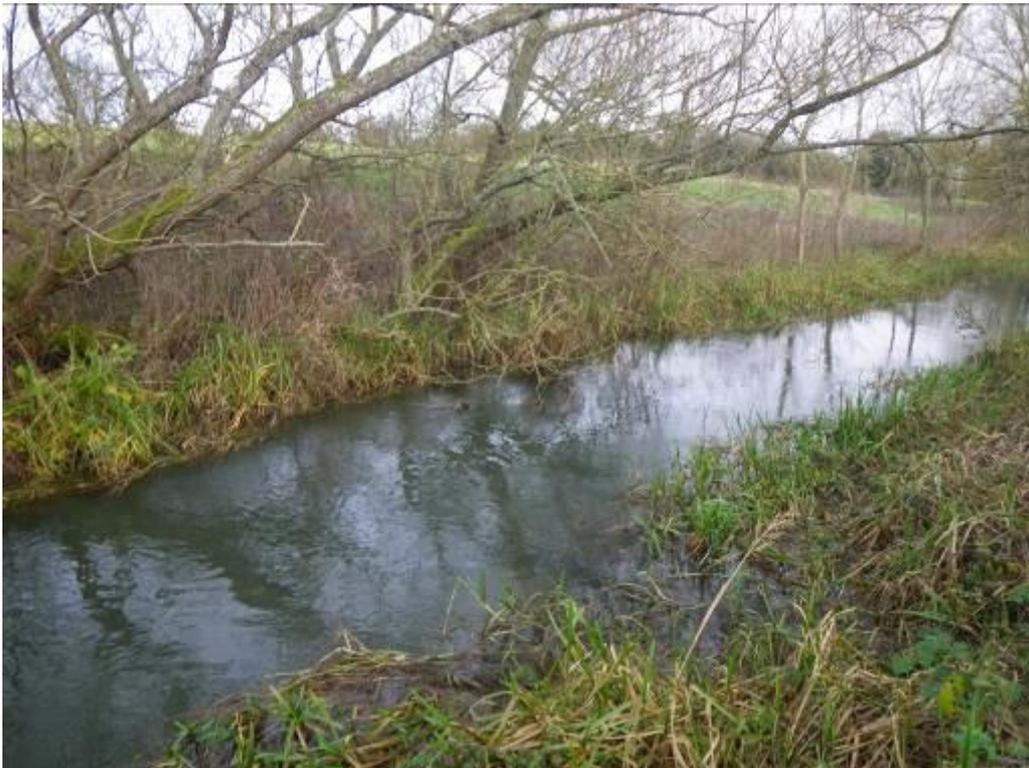
Photo 4. Good habitat provided by some low tree shading and soft, reed lined margins.

Some high level tree shading was provided by mature crack willows, *Salix fragilis*. As the name suggests, these trees are very brittle when mature and

some large willows along this section (photo 4) would benefit from pollarding to preserve the trees and to promote low level shading, which is considered to be much more ecologically valuable for river side trees. Any low branches that kiss the water surface, or hang low in marginal zones, provide ideal cover for a range of fish species and offer connectivity between aquatic and terrestrial ecosystems for a number of invertebrate species. Some local overhanging thorn bushes provide this type of habitat and should be retained where possible.

This section of channel would benefit from some sensitive tree work. Pollarding the leggy willows and trimming back some of the extensive thorn but still retaining some cover-hang would allow more light into the channel and promote improved submerged weed growth and channel productivity.

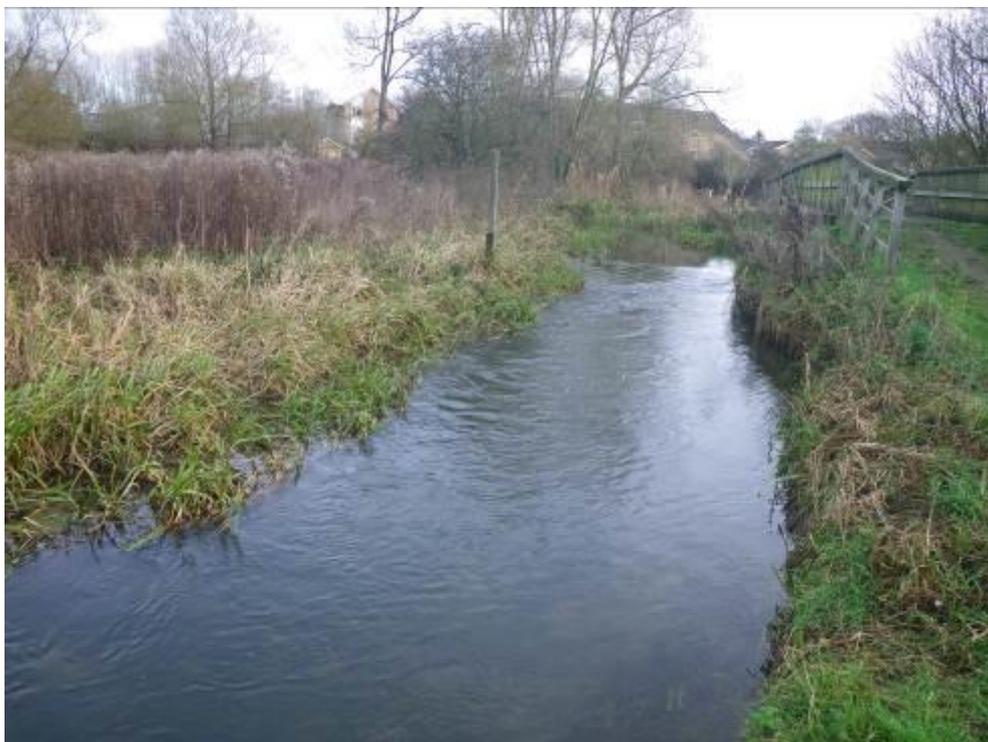
Some clearing of marginal reed has taken place adjacent to the LB near the very top of the reach. This is a particularly vulnerable section and it is recommended that a soft toe and planting is re-established along this section (photo 5).

Photo 5. Section of LB (right of photo) on the outside of the bend is vulnerable to erosion. Efforts to keep an established soft margin of energy absorbing plants is essential.

At the top end of the reach, the marginal emergent reeds should be left to protect the LB. If some work is needed to open up the channel during a low flow year, then reed should be peeled back from the RB and not the left. If clumps of emergent reeds become established in central channel locations then grub them out in favour of managing a pinched channel with a dense fringe protecting both margins.

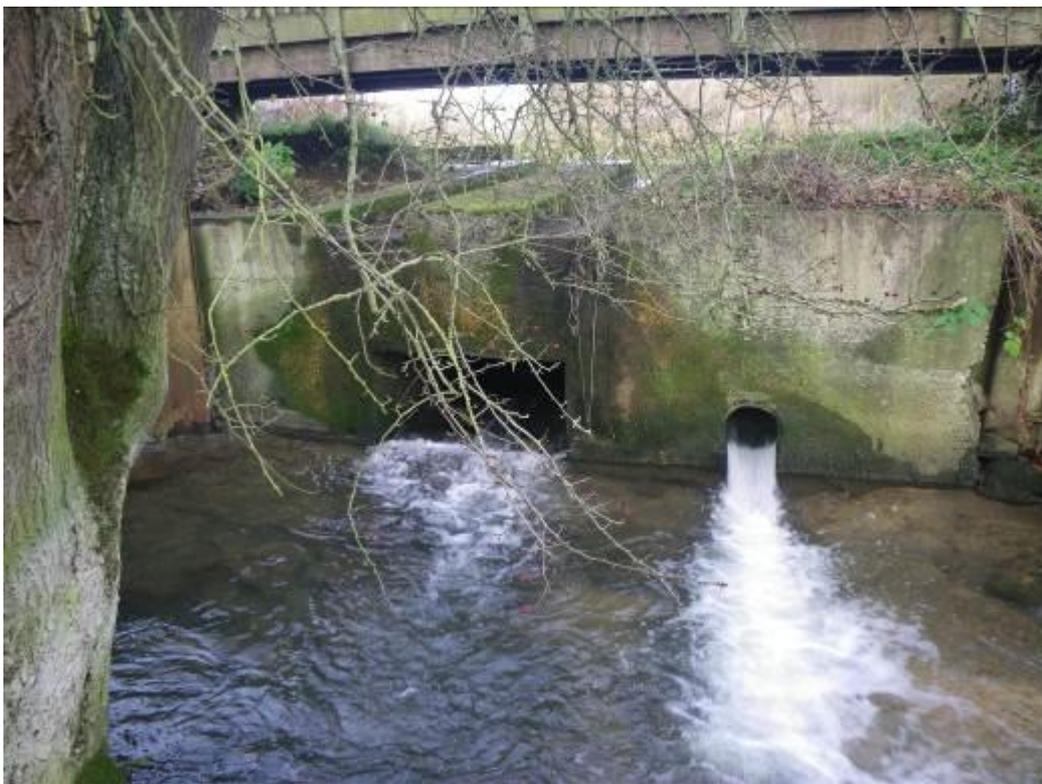
The structure itself consists of a box-culverted hatch and a perched culvert tube set in a huge concrete block. The structure is poorly designed, both for river ecology and flood defence purposes and is in very poor condition. Any fish flushed down into the carrier will find migration back up into the main channel extremely difficult. It was not possible to view any water throttling control on the upstream side of the box but there might be opportunities to block the pipe culvert and ease out capacity in the main culvert to consolidate flow which might help to improve opportunities for fish migration. A complete redesign and rebuild of this structure would be expensive but is highly recommended to provide increased flood capacity and improved connectivity.

Photo 6. Off-take structure feeding water into the carrier.

The large concrete structure which regulates flow into the carrier is a carbuncle. Replacing this structure with a controllable, fish friendly structure to determine flow splits should be planned for. Work of this nature will require a capital project, significant funding and a detailed consultation with the Environment Agency.

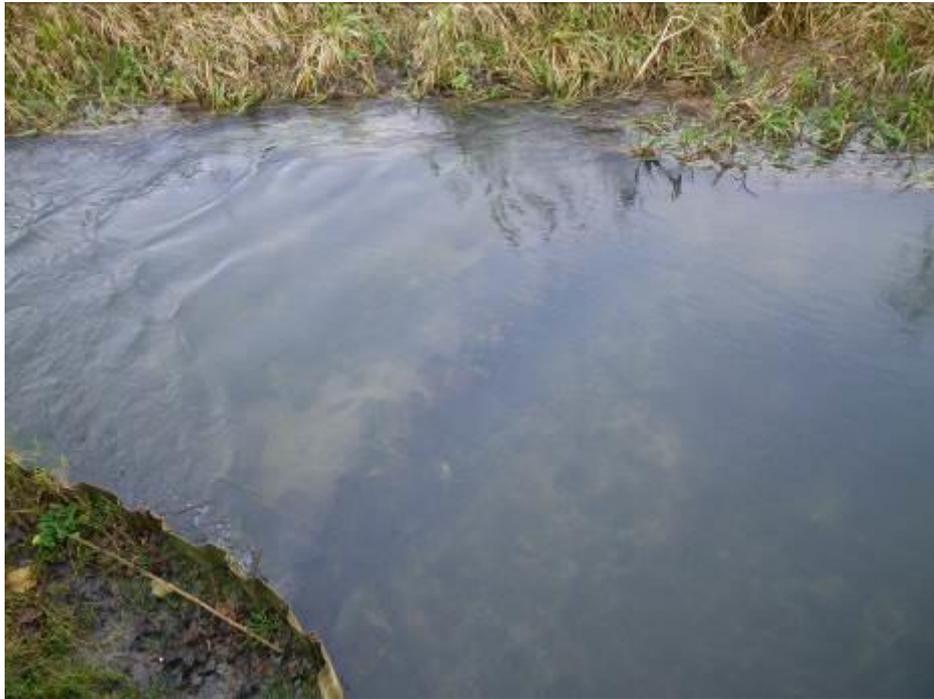
Just downstream of the structure on the main river channel there is a submerged stone weir (photo 7) which presumably was installed to hold up water levels and divert more flow via the carrier. This bed impoundment is having an adverse impact on habitat quality in the reach of main river running upstream of the Woodstock Meadows and a modification to secure more flow by increasing capacity at the structure would be a much better method for securing flow into the carrier. Running the main channel at a slightly lower level by

Photo 8. Line of in-channel stones forming a submerged weir. This was installed to either hold up water levels upstream, or secure more flow for the carrier. In-channel habitat upstream would benefit, as would vulnerable banks located immediately downstream of the steel piling, from its removal.

removing the stone weir would also take the pressure off the vulnerable banks which have been defended with sheet steel piling in this location.

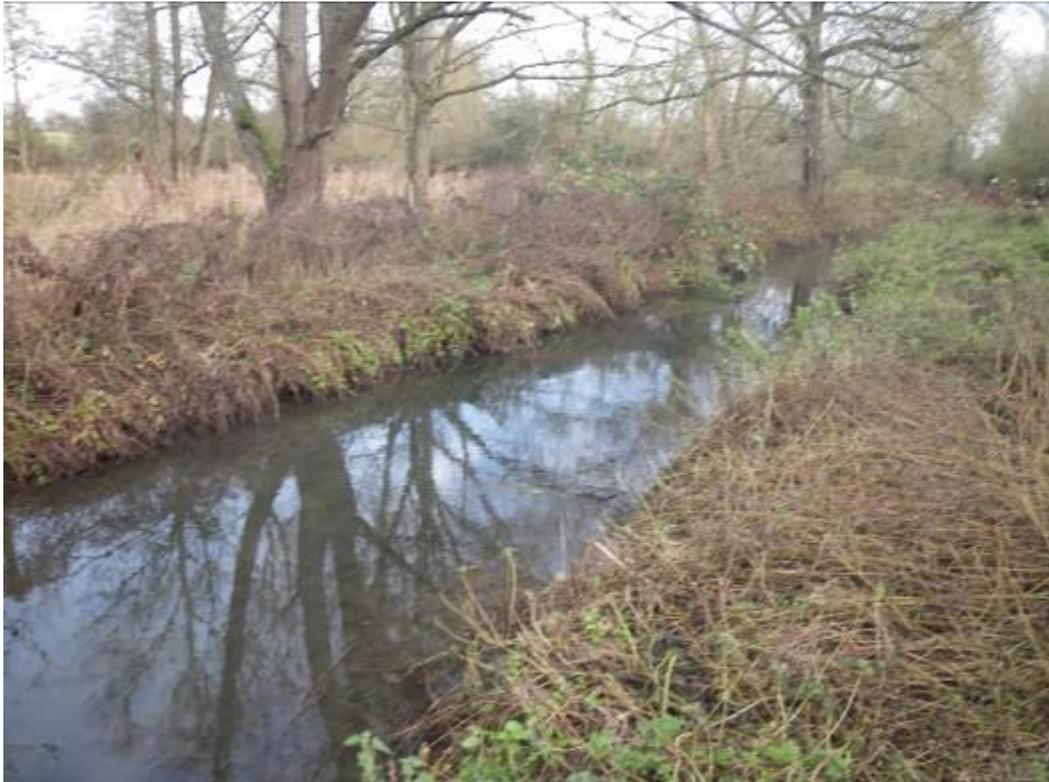
The carrier itself, has a very uniform morphology. The drop in bed level at the structure coupled with the right angled dog-leg route of the channel has in effect flattened out any gradient that might otherwise help to promote natural in-channel features such as pool and riffle. As a result the whole reach is made up of shallow glide habitat. Interestingly, the north-south section appears to have had very little maintenance work and is quite heavily over-grown and shaded, whereas the east-west section (photo 9) is relatively open, with only the odd clump of low overhanging shade. An ideal scenario would be a combination of both regimes where a dappled light and shade was maintained via sensitive bank and tree maintenance.

Photo 9. A straight and featureless section of carrier. Note the trailing bramble lying in the margins which provides some cover for resident fish populations.

On long sections of straight, uniform glide, improved habitat quality could be achieved via the introduction of large sections of woody debris, firmly secured to the bank and bed. By pinching the channel width with woody debris, local bed scour could be encouraged to provide some much needed variety in the shape of the river bed.

The long, straight sections of carrier would benefit from pegging in LWD flow deflectors to promote bed scour and bundles of brushwood pegged in parallel to the banks would provide habitat and food for invertebrates and cover for small fish.

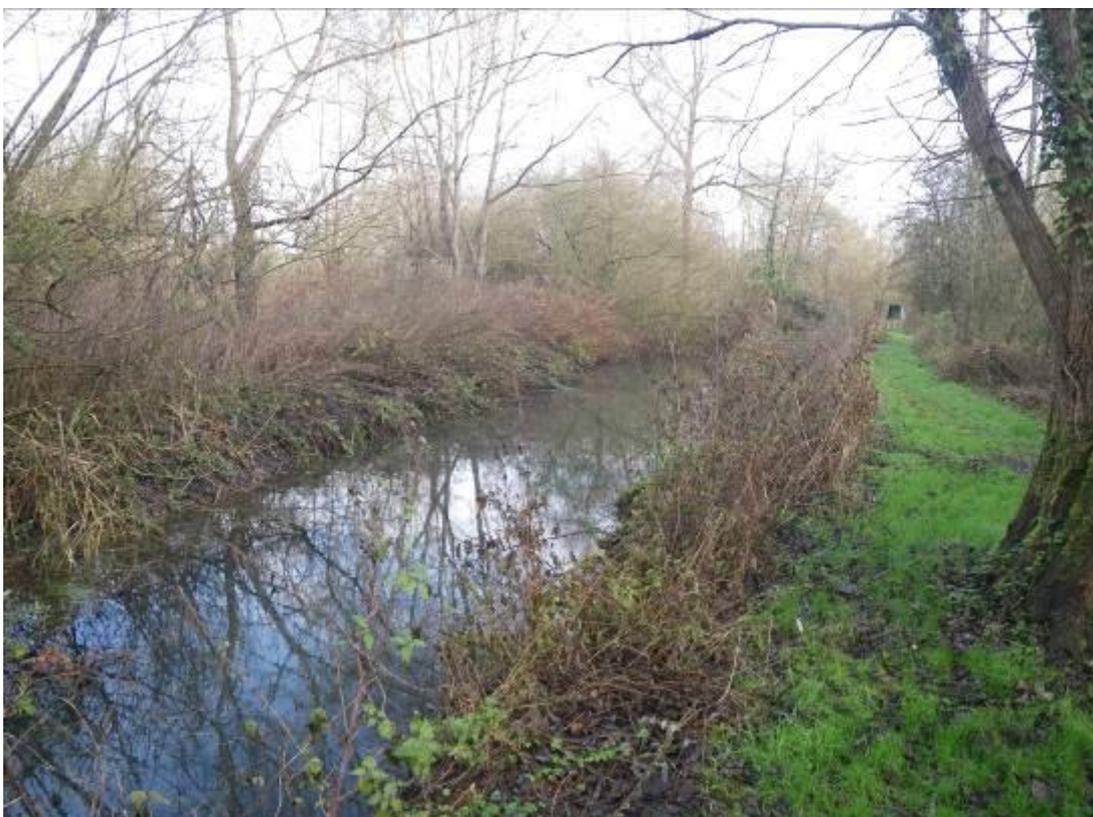
Photo 10. Scuffy margins providing good cover and bank protection on a section further downstream.

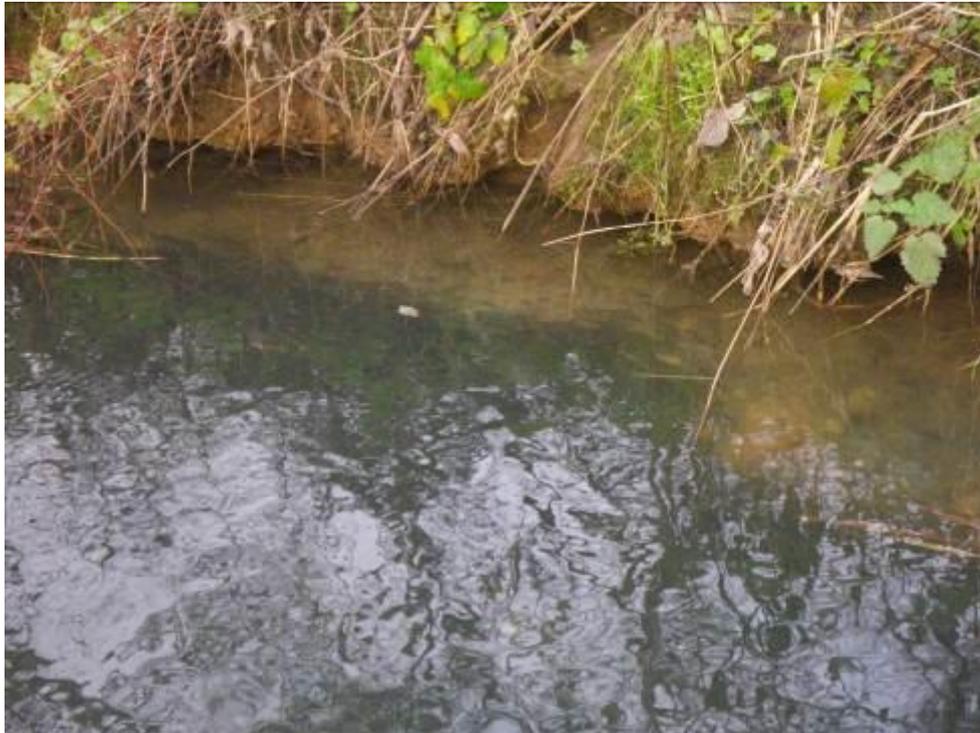
Unlike the main channel, the carrier drops down into the Queen Pool via a screened culvert which flows under the road and joins the top end of the lake. There is no weir, or impoundment on the carrier and as a result, huge numbers of juvenile coarse fish fry, thought to be either roach *Rutilus rutilus* or bream *Abramis brama* have migrated up out of the lake to take residence in incredibly large, dense shoals within the carrier, particularly in sections where there is any overhanging tree cover (photo 11).

Photo 11. The black stream bed is in fact thousands of small coarse fish that have migrated up out of the lake, probably in response to bird predation pressures within the lake itself.

It is understood that the winter migration of vast numbers of juvenile coarse fish out of the lake and up and into the carrier is a concern for the local Environment Agency, who have undertaken fish rescue work at this site to try and minimise fish mortalities. One possible option worth discussing with the EA and Blenheim Estate is to create habitat in the margins of the Queen Pool area that might act as a refuge and deter fish from making the migration up into the stream searching for cover from fish-eating birds.

Laying in a matrix of brushwood into the shallow lake margins might at least intercept some of the fish destined for the stream.
