Advisory Visit

River Great Ouse

June 2019

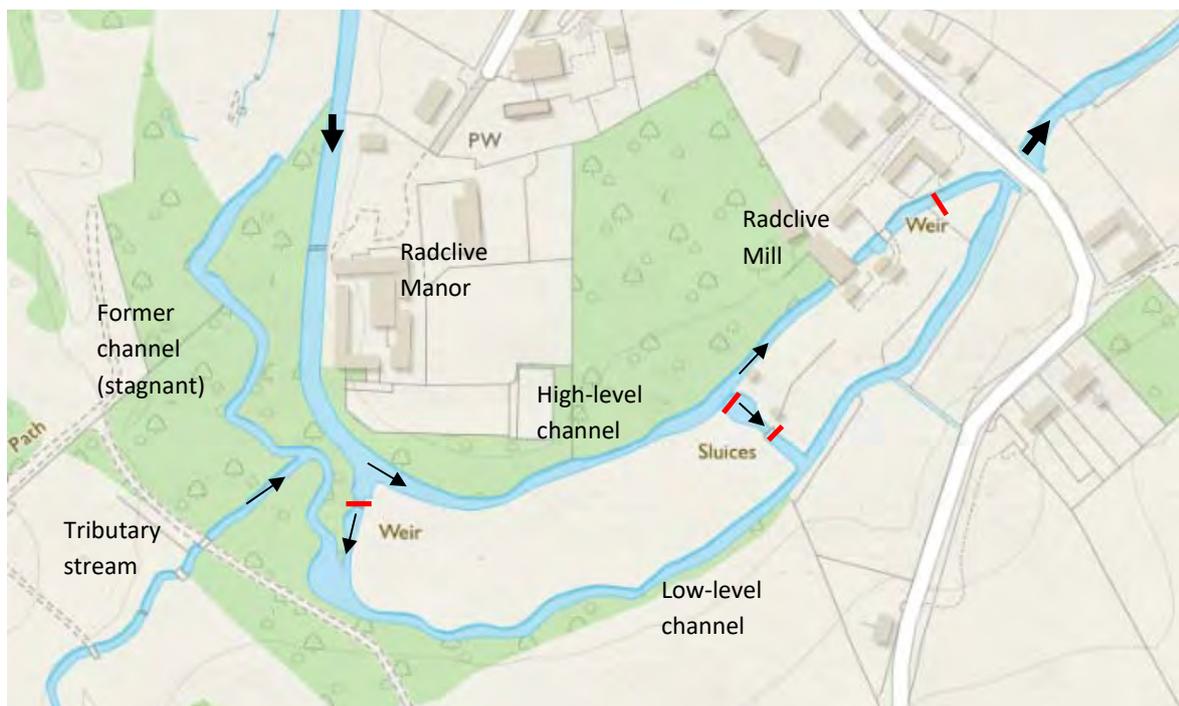
The overriding negative impact upon river habitat at Radclive (and the wider upper Ouse) is the effect of the flow control structures which impound the river and prevent fish access across the site (Figure 1).

Figure 1 Showing the main flow into and out of the site (bold arrows), the flow splits, a tributary stream (smaller arrows) and the flow control structures (red lines).

The river channel is divided into a high-level channel, in which the water level is controlled by impounding structure(s) at Radclive Mill (Photos 35 – 36), and a low-level channel which receives water from a tributary stream (Photos 13 – 16) and at two points where the high-level channel overflows

(Photos 17-18 and 27-31). The high and low-level channel converge below Radclive Mill, just upstream of the road bridge; any fish seeking to move upstream from this point will quickly reach a dead-end whichever route is chosen.

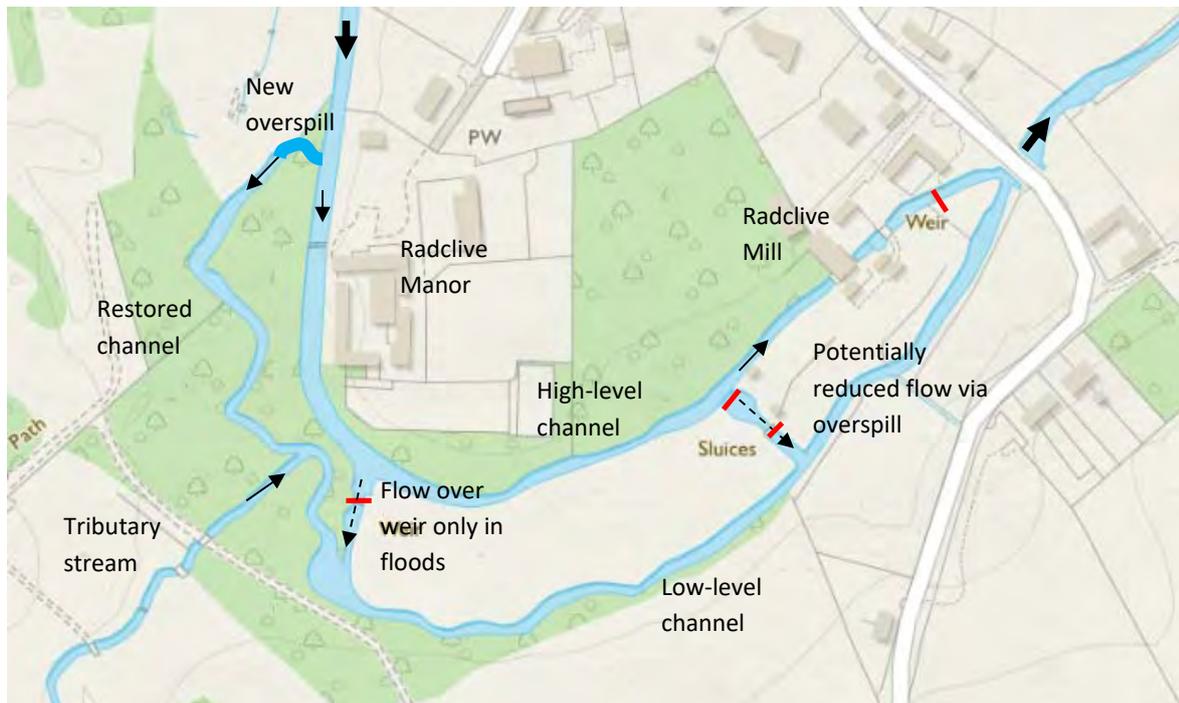
Figure 2 Indicative diagram of re-prioritisation of flows presently following the existing overflow(s) via a new, fish-friendly overflow into a restored channel, whilst maintaining existing flows under Radclive Mill. Subject to detailed flow modelling and design.

- Construction of a new overflow from the RH bank of the main river channel into the head of the abandoned channel (Figure 2). This overflow could be engineered to take a fixed range of flows (according to river flow) and allow fish passage across it.

- Re-modelling of the abandoned channel into a nature-like channel, suitable to accommodate the fixed range of flows.
- Modification of the existing overflow(s) from the high-level channel to prioritise flows over the new overflow sited upstream. In effect the existing weir overflow (d/s of Radclive Manor) would become a flood relief overflow, only coming into play during high flows. Modification of flows via the second overflow (u/s of Radclive Mill) could also be considered. Existing flows under the mill could be preserved.

Detailed flow modelling* is required to inform potential options and it is recommended that an options and feasibility study is undertaken by a suitably qualified contractor (*check whether any flow models already exist which could be used).

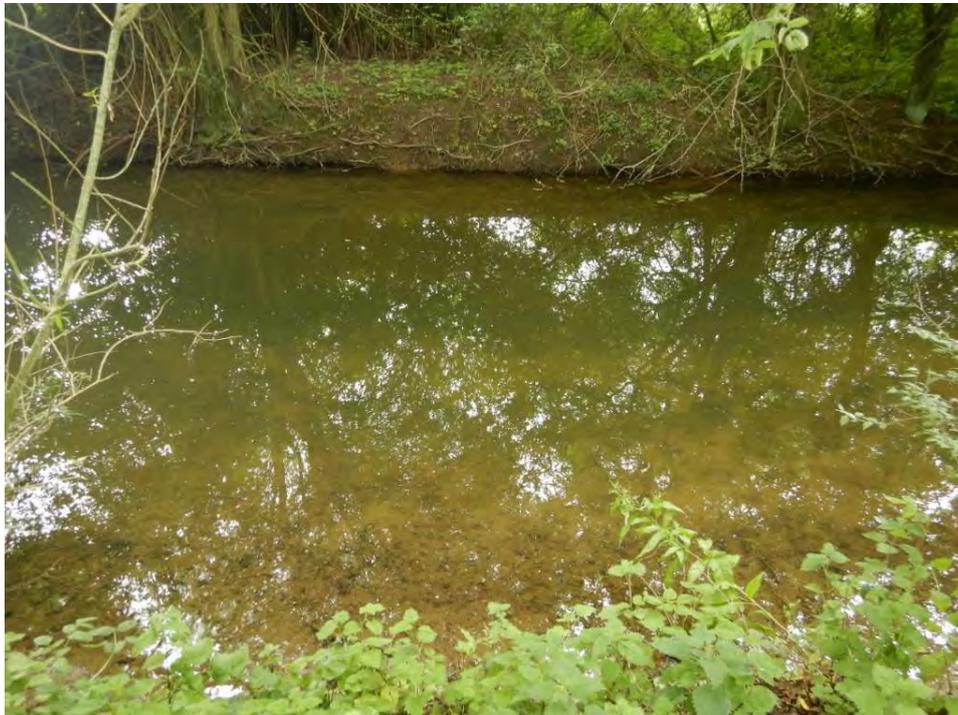
The shade provided by the higher canopy of bankside trees helps to keep water temperatures down in summer (important for coldwater species such as trout), but can also prevent the growth of aquatic vegetation (Photos 1 – 2). Banks of reeds and rushes pinch the channel width and provide variety to flow patterns and depths (through scour) in an otherwise uniform channel. Striking a balance between light and shade will provide the best of both worlds and there are opportunities to 'hinge' some trees into the river margins to enhance low cover and reduce shading (Photos 4 and 7). Dead trees should be left standing for biodiversity benefits (woodpeckers, etc.).

Photo 1 Deep silt with little marginal vegetation due to shade.

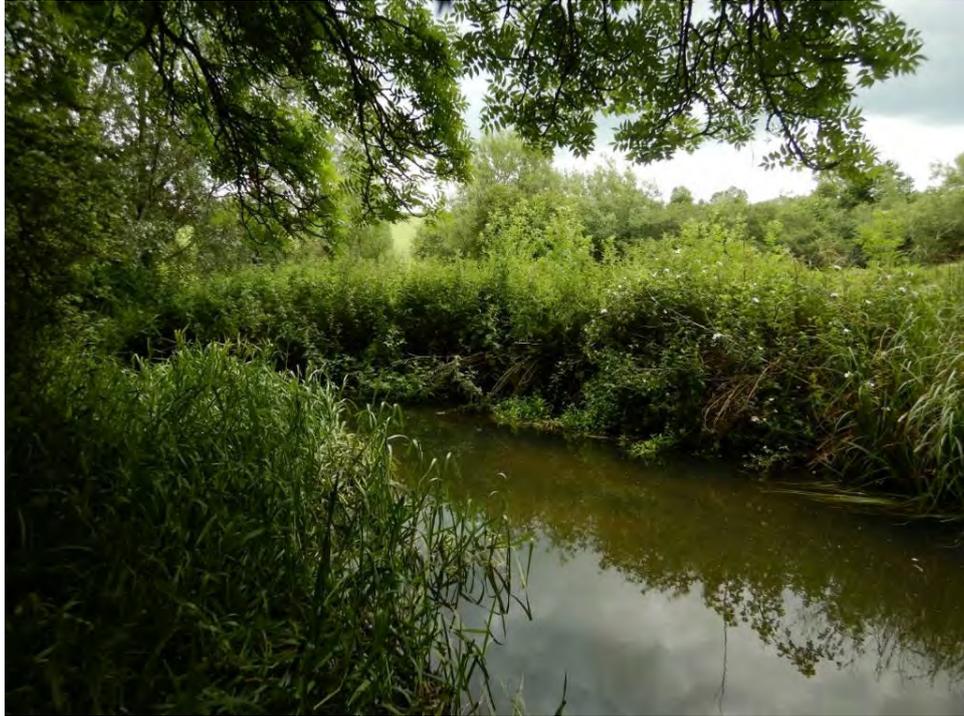
Photo 2 Marginal vegetation was present where light penetrated through canopy.

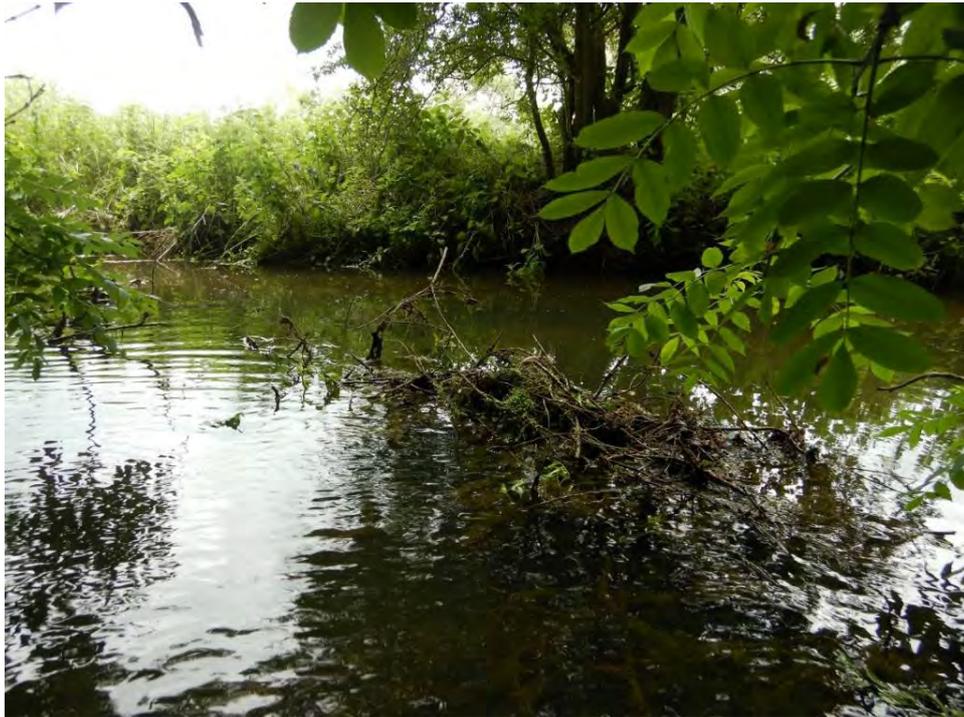
Photo 3 Accumulated coarse woody material retained silt in the margins and deflected the flow against the opposite bank adding a little flow diversity.

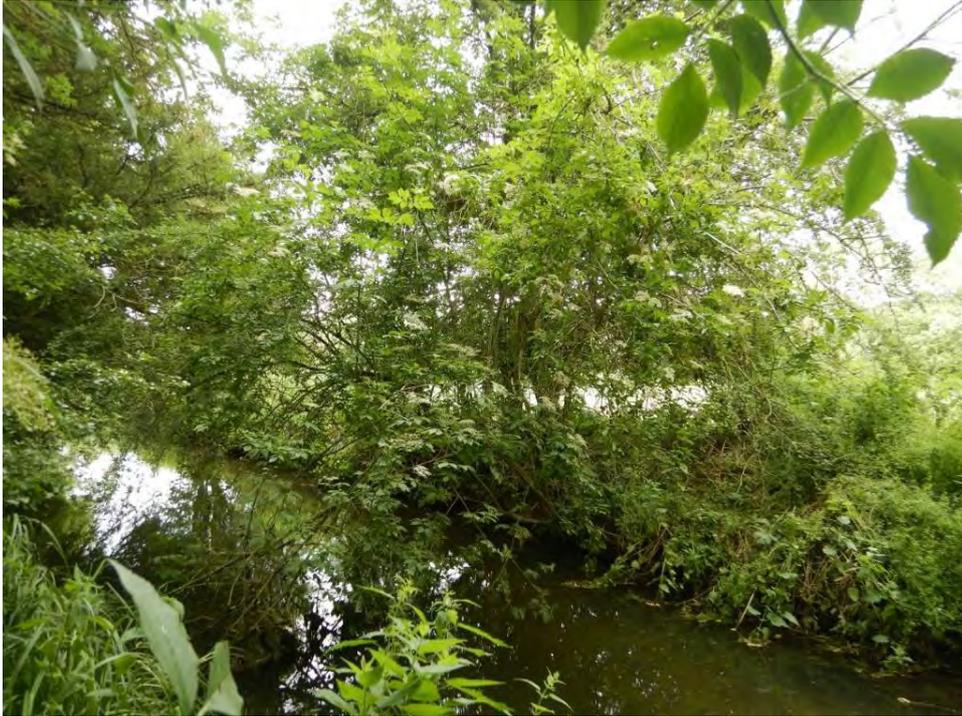
Photo 4 Riparian trees provided shade to the water, reducing temperatures. Terrestrial invertebrates will fall into the river from the canopy providing food for fish. Some trees here could be laid over into the water to improve low cover.

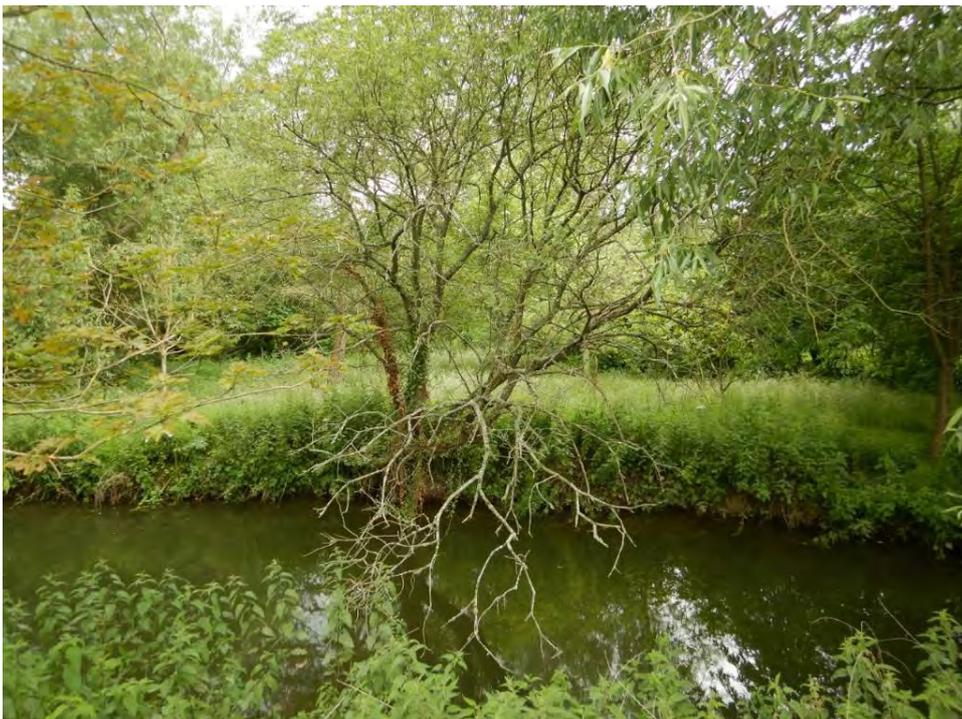
Photo 5 Dead (or dying) trees should not be removed. They are valuable habitats and provide a source of large woody material (LWM) for the river which can initiate geomorphic processes such as scour. LWM can also provide cover to fish from high flows and predators.

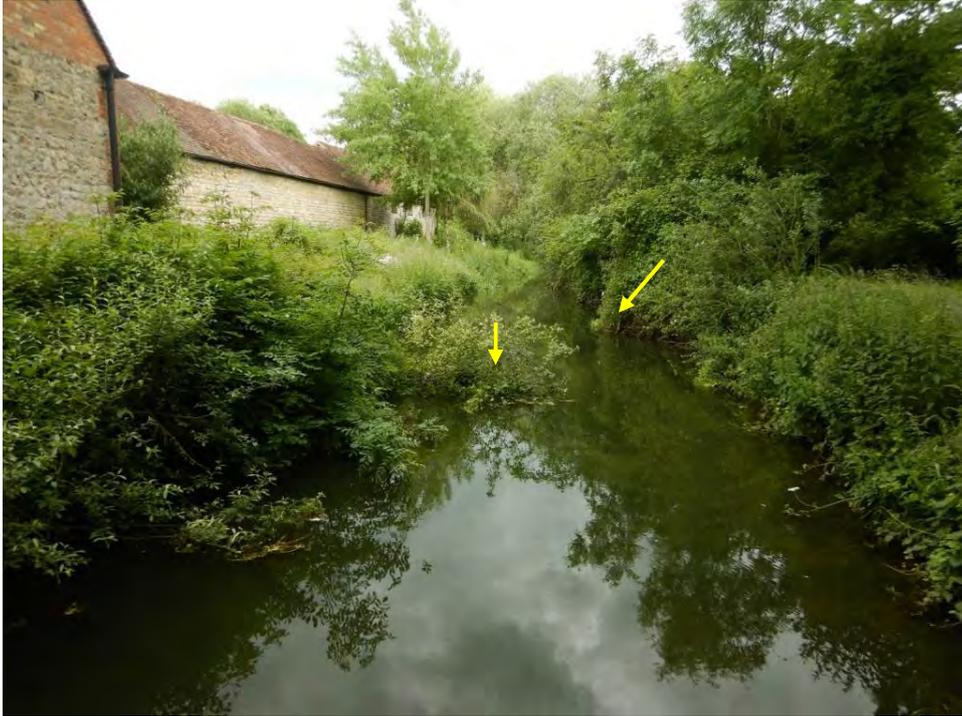
Features which enhance the potential to hold fish include low cover over (and trailing into) the water provided by bushes and trees alongside the river (Photo 6). Fish feel secure beneath the cover provided by the trailing vegetation and rafts of debris which collect against them; these should be retained.

Photo 6 View from bridge looking downstream, the river was almost 2m deep. Trees trailing down to water level provide overhead cover for fish (arrows) – leave it in place.

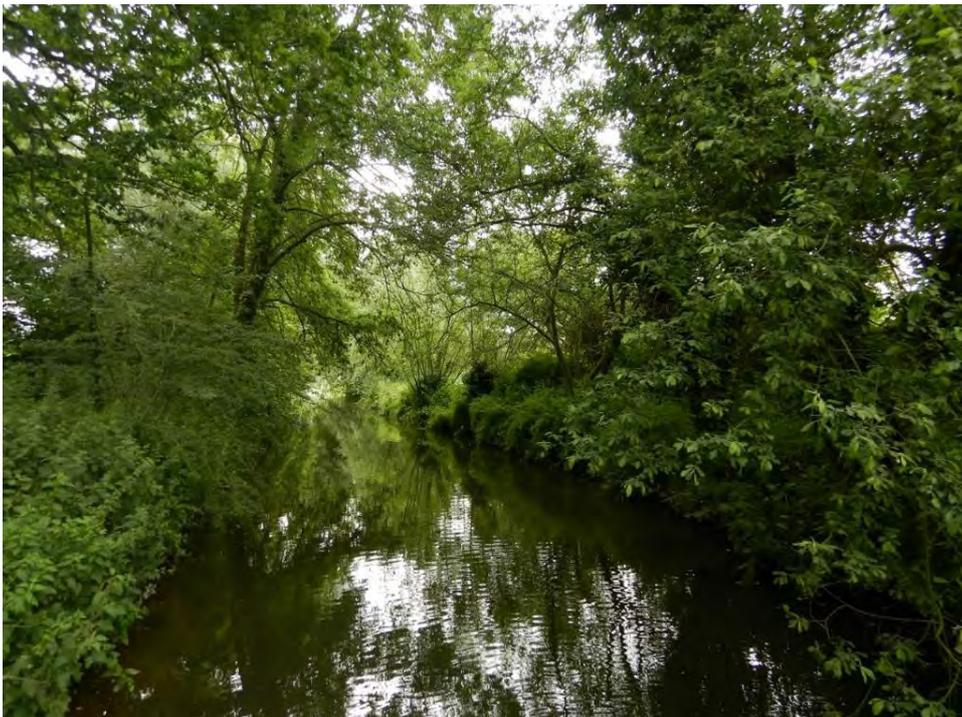
Photo 7 View from bridge looking upstream. The dense tree cover here could be reduced and some trees ‘hinged’ into the river margins to provide cover. Aim for a ratio of 60:40 shade-light.

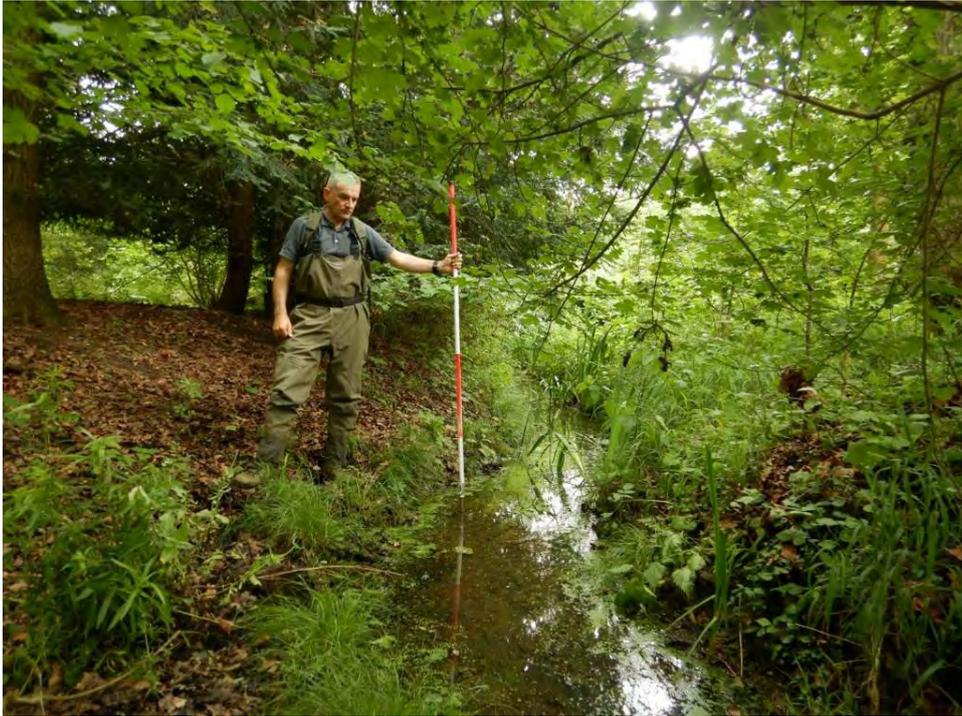
Photo 8 An historic channel was found leading away from the river (looking downstream). The channel could be engineered to provide a by-pass channel around the mill and weir structures. A by-pass channel would aid the river's natural recovery of its fish populations.

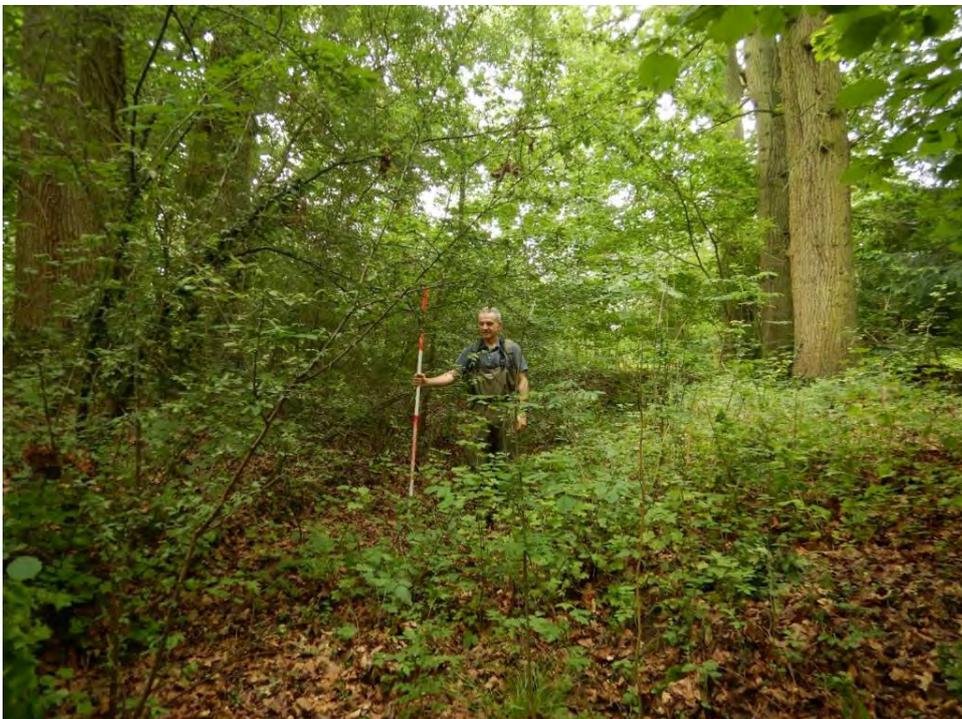
Photo 9 The abandoned channel almost cuts back to the River Great Ouse.

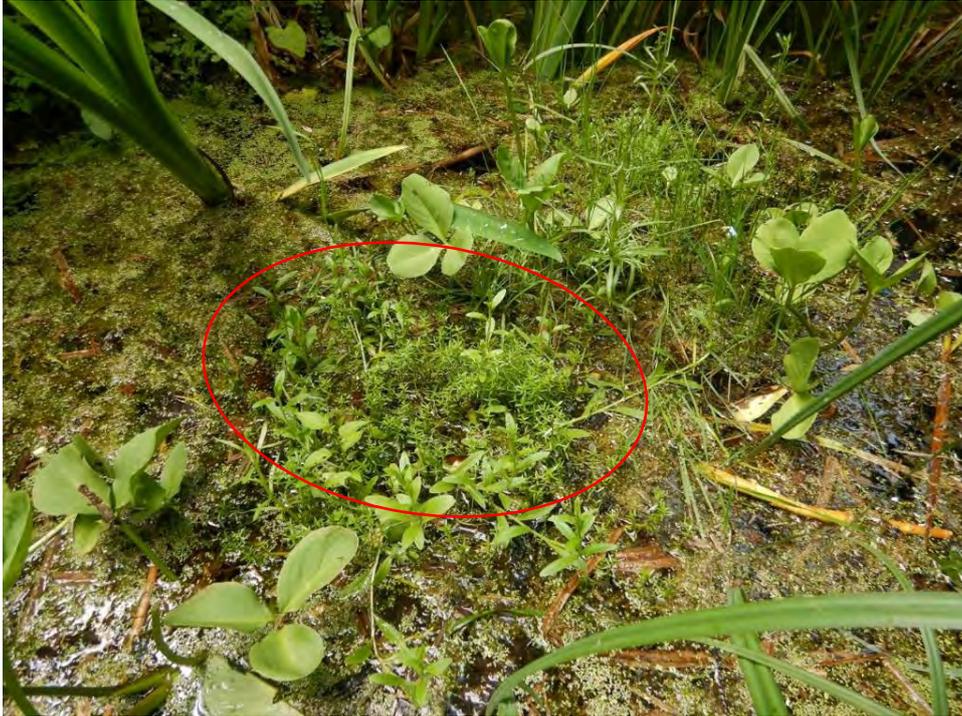
Photo 10 Parts of the abandoned channel had been widened to create pond habitats. This area contained the non-native invasive plant New Zealand pigmyweed (*Crassula helmsii*). Extreme care must be taken not to spread it, it would be wise to remove it whilst it is only a small amount.

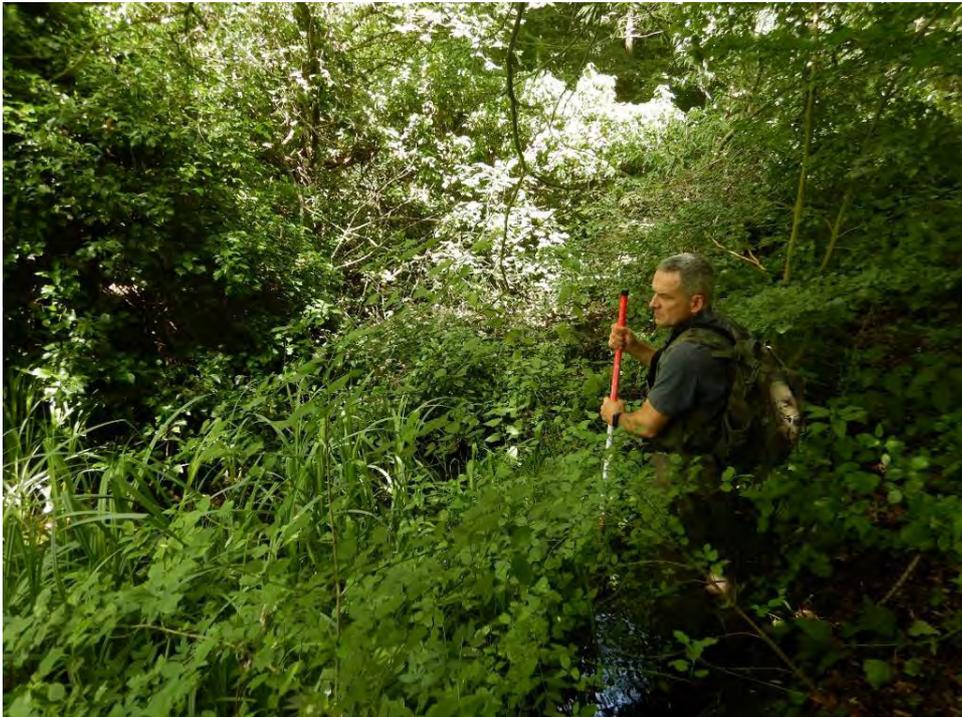
Photo 11 The abandoned channel was clearly wide at some point in its past, now it is little more than a marshy depression.

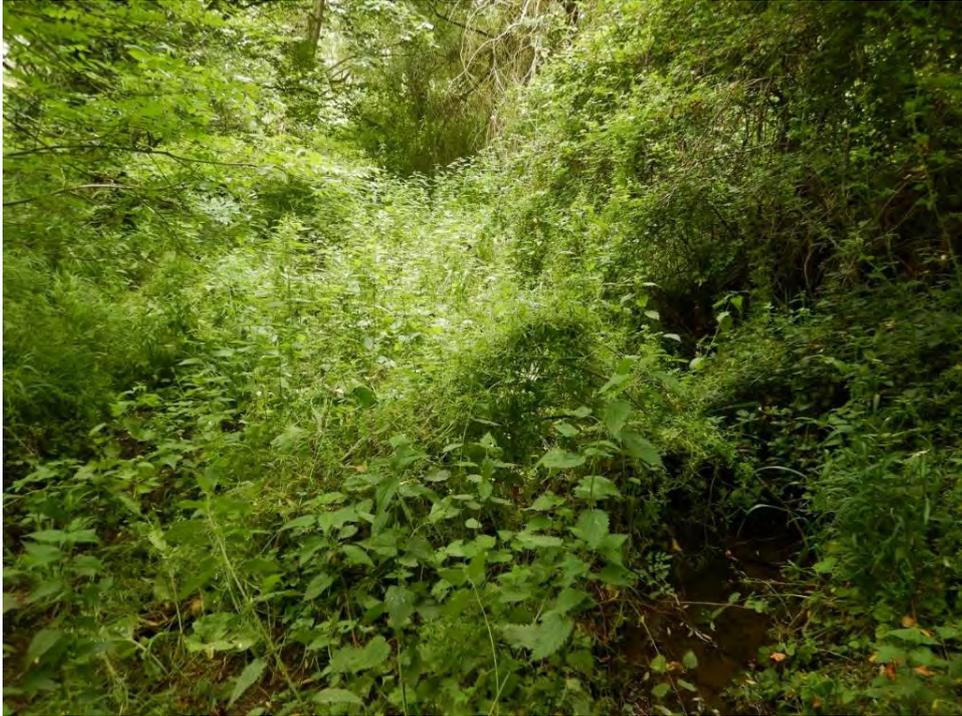
Photo 12 The abandoned channel was almost lost to vegetation where it met with the golf course stream. However, beneath the vegetation a wide sediment-filled channel was still evident.

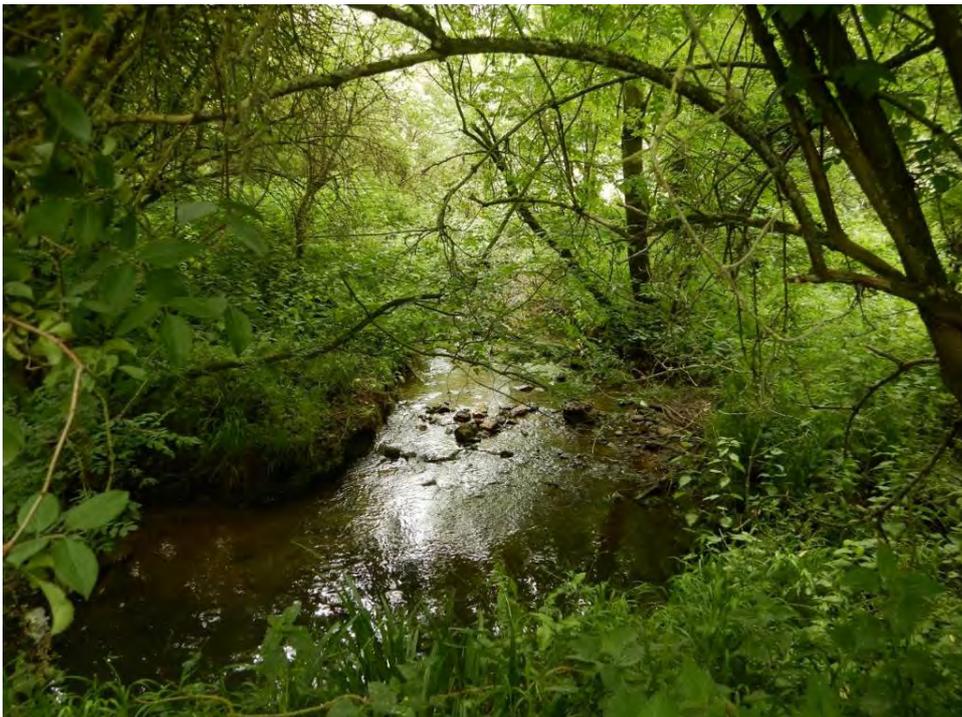
Photo 13 A tributary stream emerging from the Buckingham Golf Club had much potential as a nursery stream for the Gt Ouse. The coarse substrate could provide spawning opportunities for fish such as brown trout, minnow, dace and chub – especially if enhanced with further gravel ranging in size from 10-40mm.

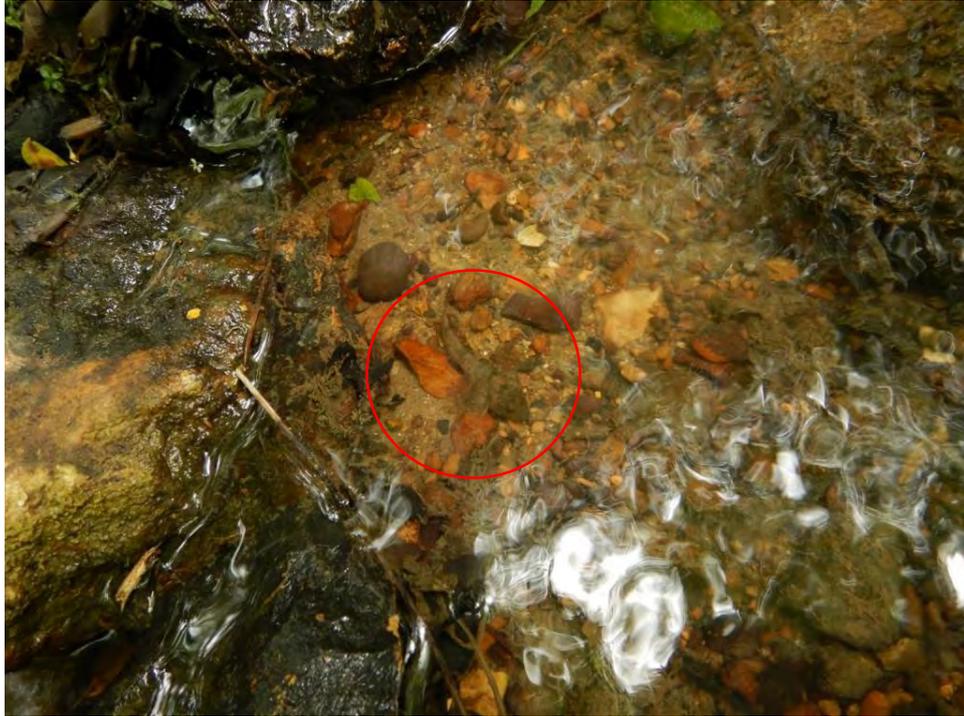
The golf course tributary has some reasonably good habitat for a short section, with coarse gravel substrate present. Stone-turning here revealed live bullhead (*Cottus gobio*) and a variety of invertebrates which may be an important source for recolonising the river downstream.

Photo 14 Stone turning confirmed a reasonable diversity of aquatic invertebrates and a bullhead fish (red circle). The discovery of fish and invertebrates is critical to the river's natural re-population following the pollution events.

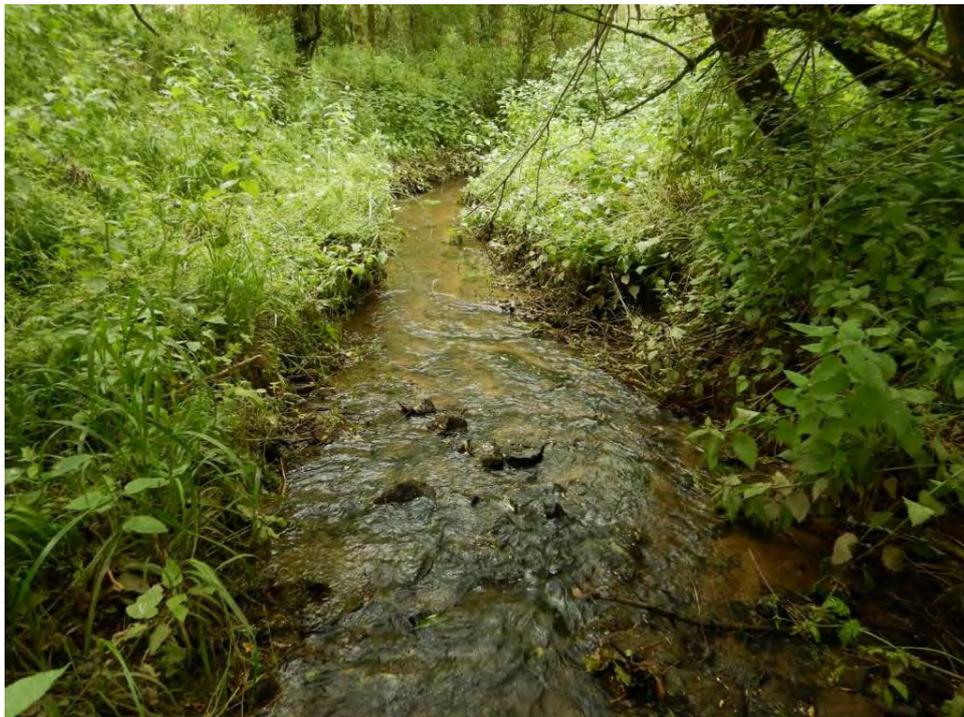
Photo 15 The golf course stream had surprisingly good habitat but only for a short distance.

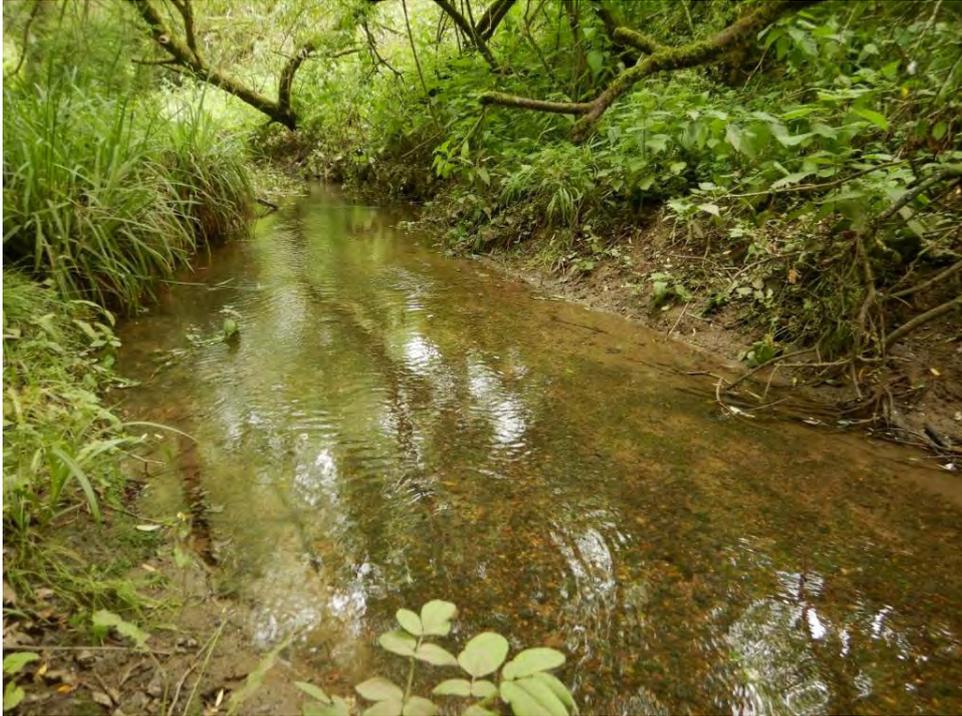
Photo 16 The golf course stream became silty as its gradient dropped, and it has almost certainly been dredged at some point in its past thus removing the coarse substrate that is important for cover and fish spawning.

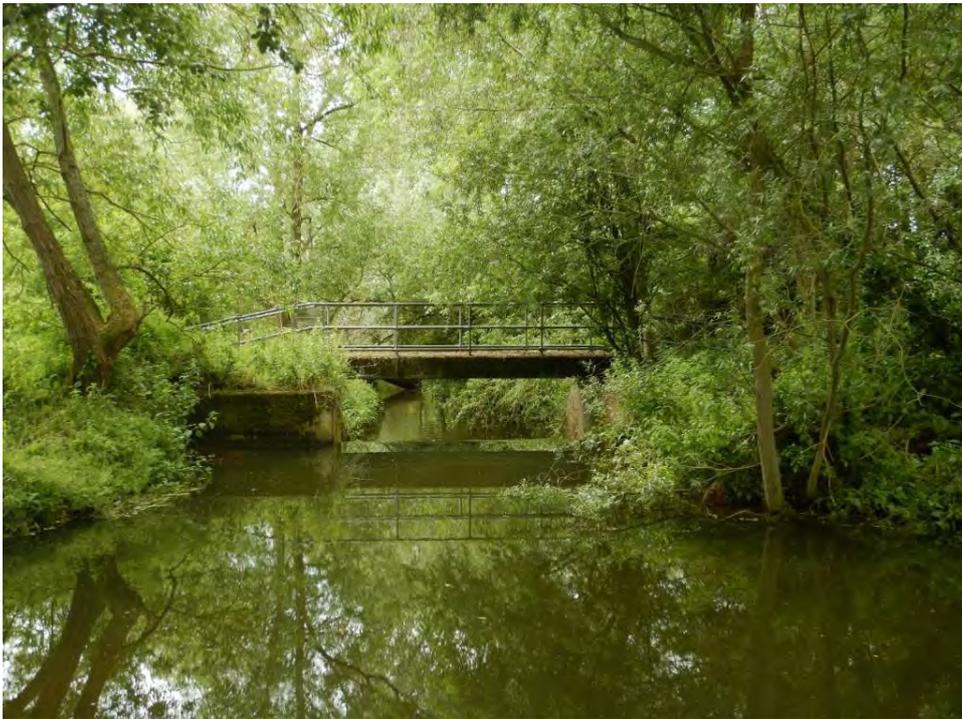
Photo 17 The side weir (viewed from upstream) splits the river channel downstream of Radclive Manor. The weir is a relatively recent construction and its purpose is to move flood flow away from the mill down the low-level channel. It was hard to assess the proportion of flow that is split but it appeared to be 50:50 at low-flow.

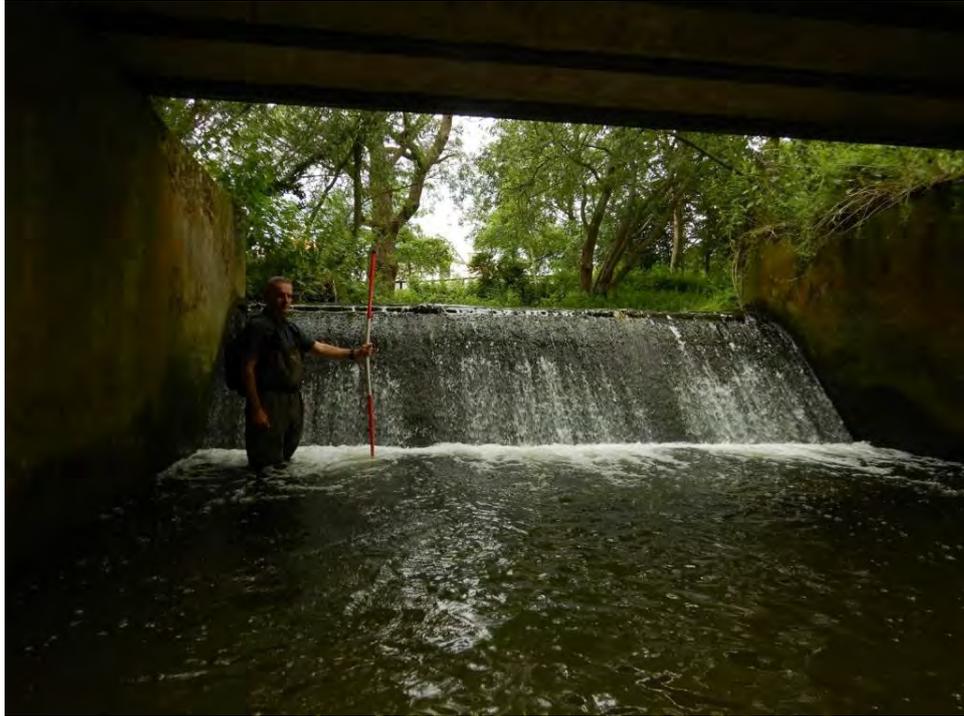
The overflow downstream of Radclive Manor consists of a concrete weir structure (EA-owned) with a 5-m wide crest approximately 1.6m above downstream bed level. Downstream of the weir face are a series of concrete block flow breakers and a concrete base extending a total of 11m downstream. A bridge crosses the channel a short distance downstream of the weir. The structure is a totally impassable barrier to upstream fish movement and a very significant barrier to downstream movement.

Photo 18 The weir viewed from below. This EA structure poses a complete barrier to the natural movement of fish and other riverine wildlife.

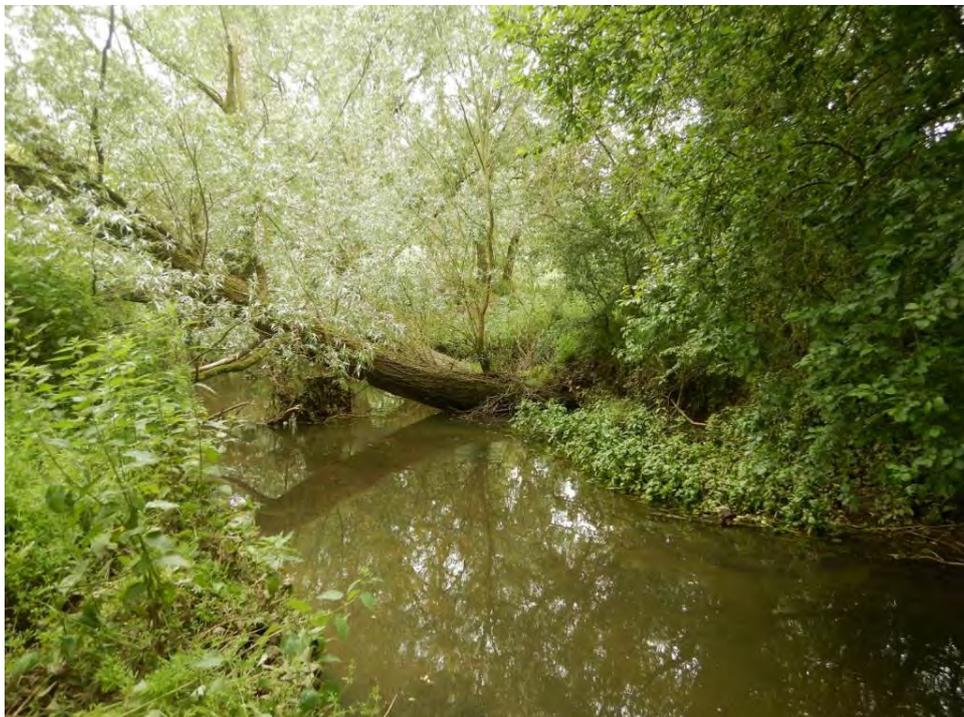
Photo 19 The low-level channel was too large for the flow that it conveyed, consequently the bed contained a high volume of fine sediment.

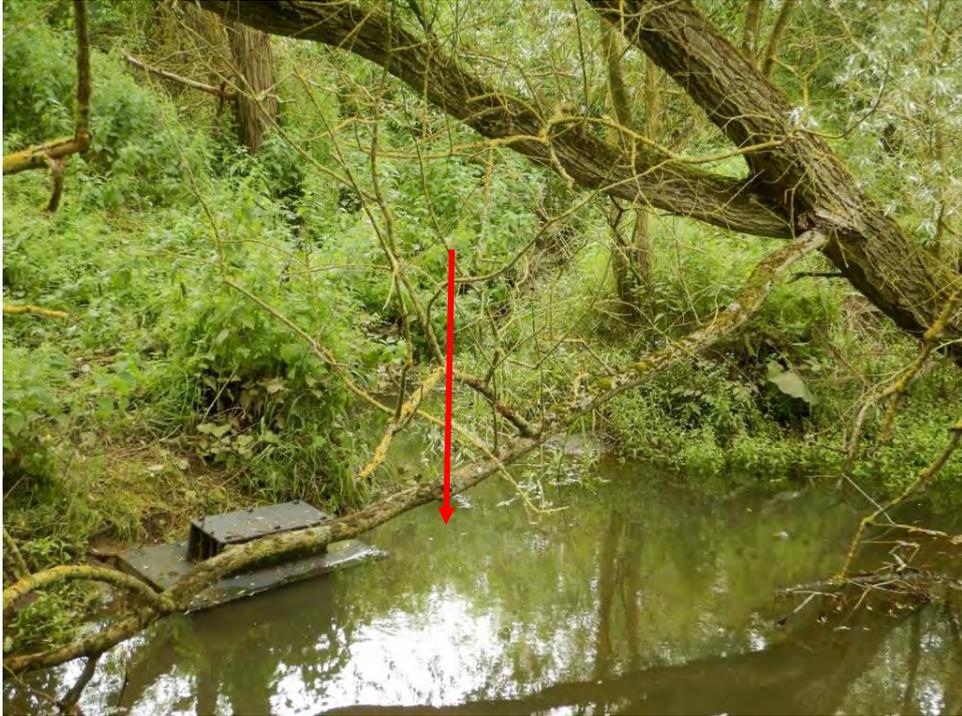
Photo 20 The confluence of the golf course stream (arrow), showing the relatively small volume of water currently contributed from this source to the low-level channel.

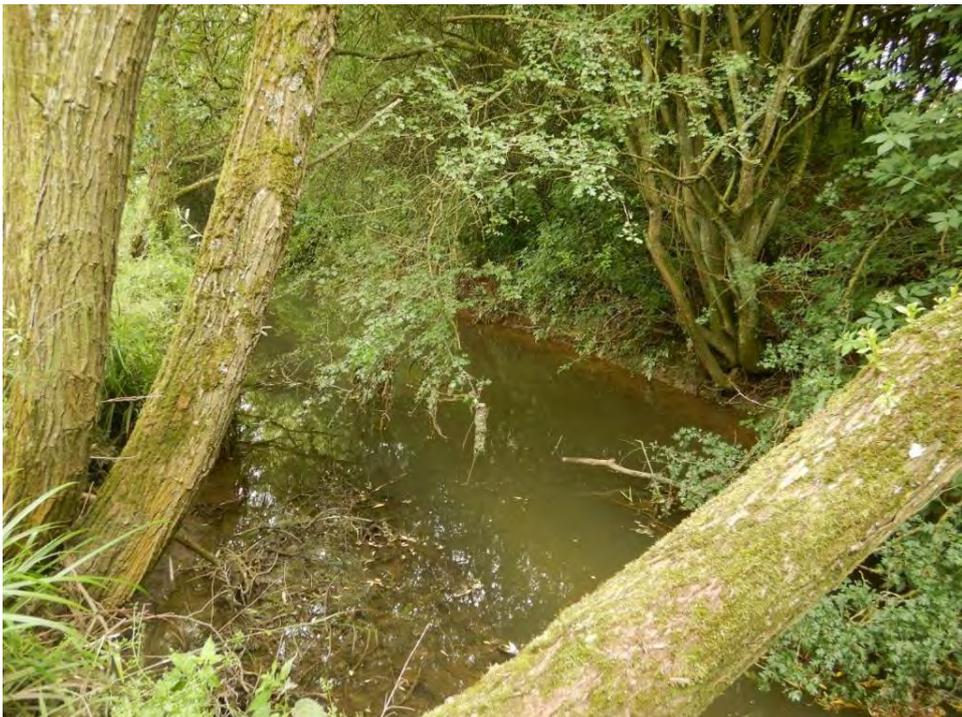
Photo 21 Riparian tree could be managed to increase light to encourage marginal growth, which would stabilise silt beds.

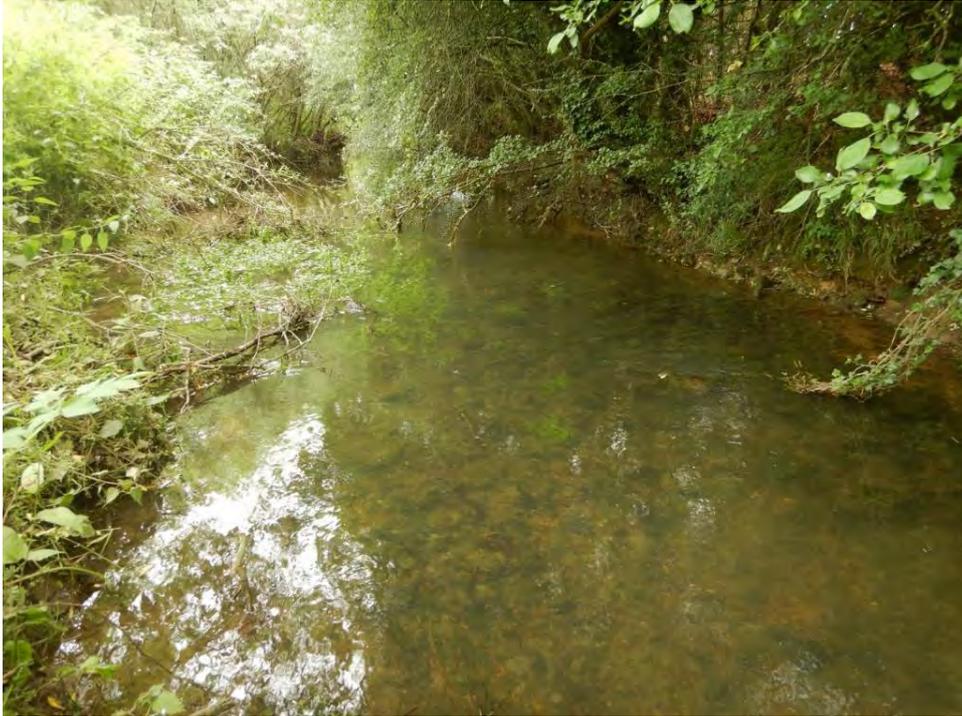
Photo 22 An outcrop of coarse substrate was found providing a valuable habitat. Unfortunately, the channel was wide, so the velocity was not too high, this was allowing fine sediment to settle over the stones. Simple habitat enhancement techniques using adjacent woody material could be deployed to increase cover and to speed up the velocity.

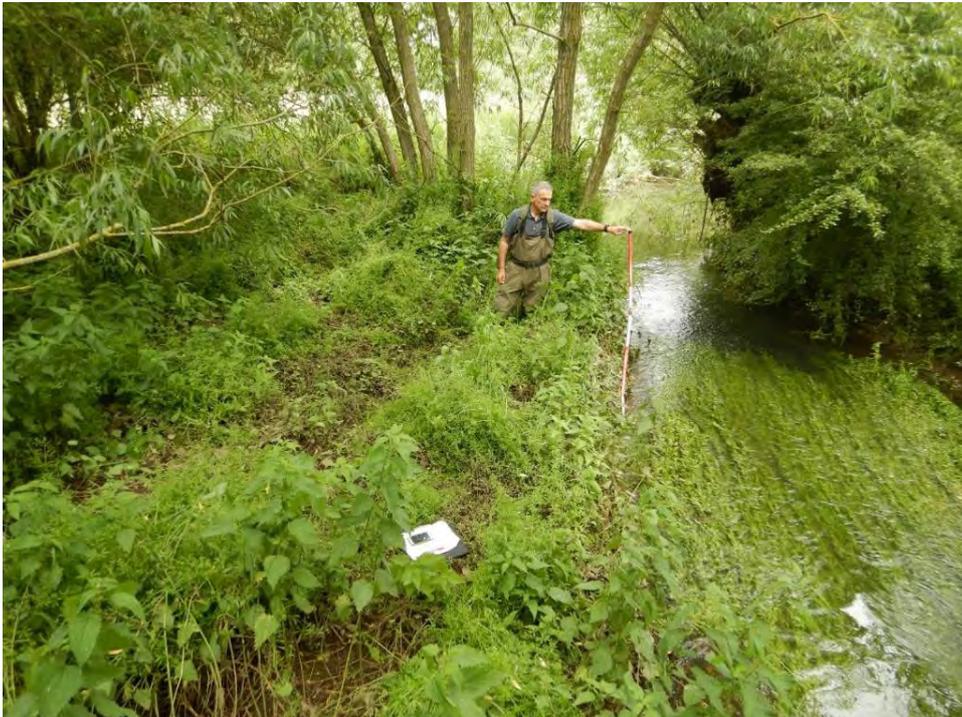
Photo 23 Where light reached the river and the bed was shallower aquatic plants diversified in-river habitat. The left bank shelved gently down to the river. Other parts of the bank could be reshaped to provide a better grade to the water's edge and to increase the river's inundation zone (a two-stage channel could be created).

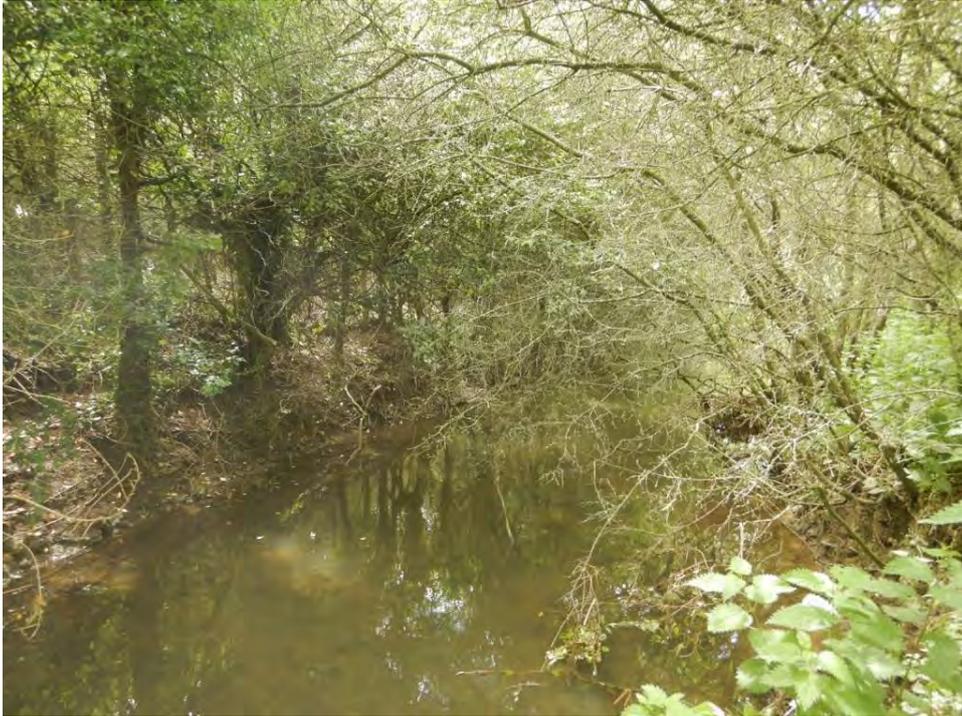
Photo 24 River looking upstream, note the shade suppressing plant growth.

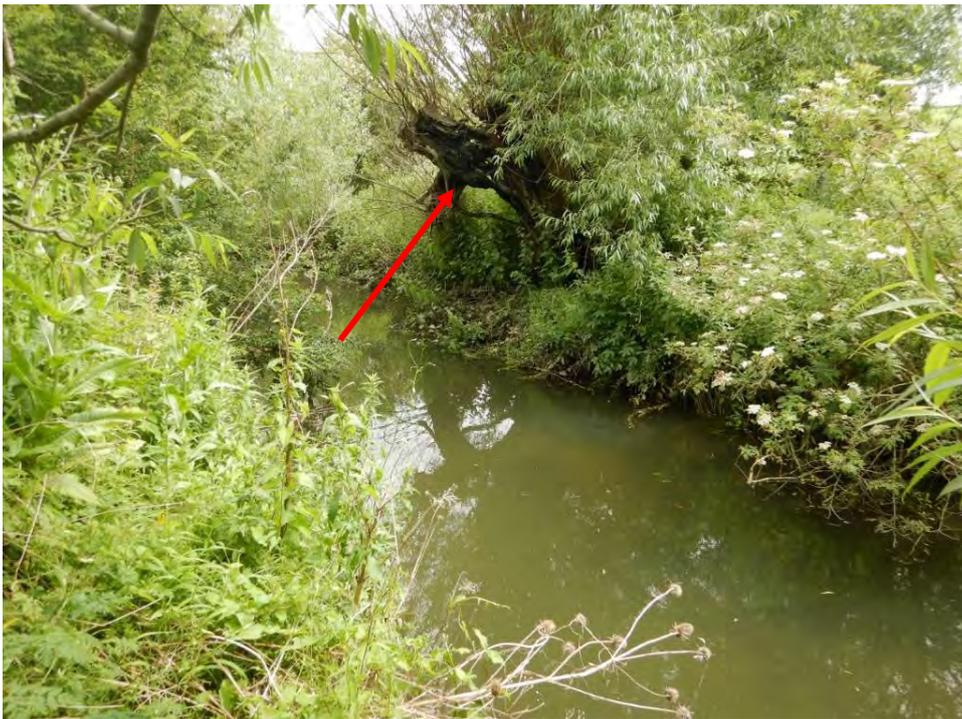
Photo 25 River viewed downstream, note the dense plant growth. This part of the low-level channel had a number of veteran pollard willows along it (red arrow).

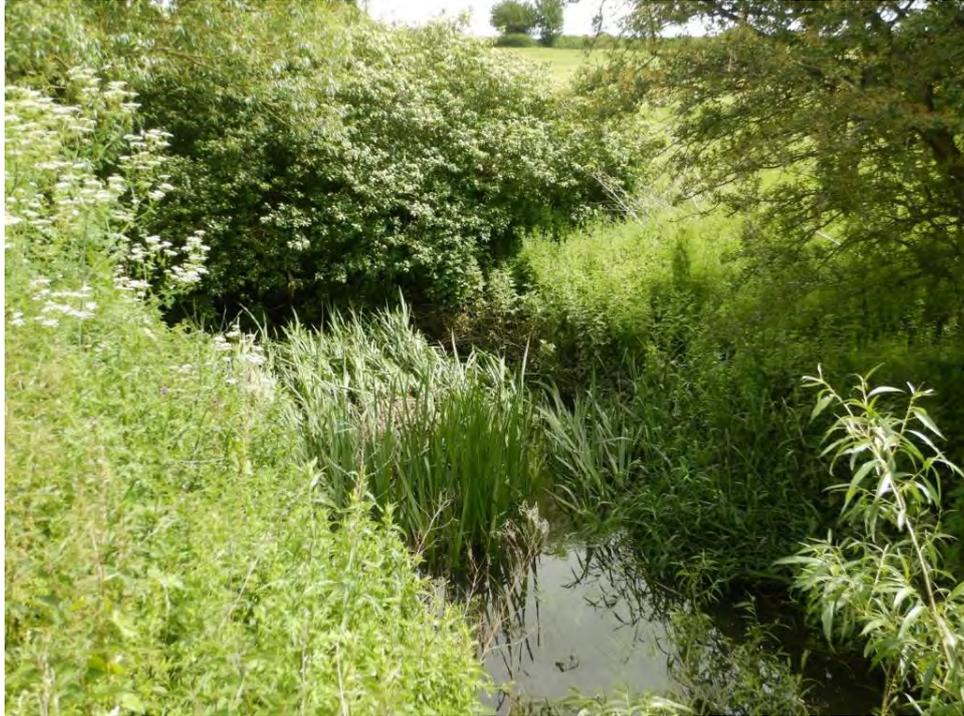
Photo 26 A dense stand of branched bur reed indicates where fine sediment is accumulating. It could be possible to replace the bur reed with stone and gravel to shallow river, creating a riffle. Riffles provide important spawning areas for a range of fish.

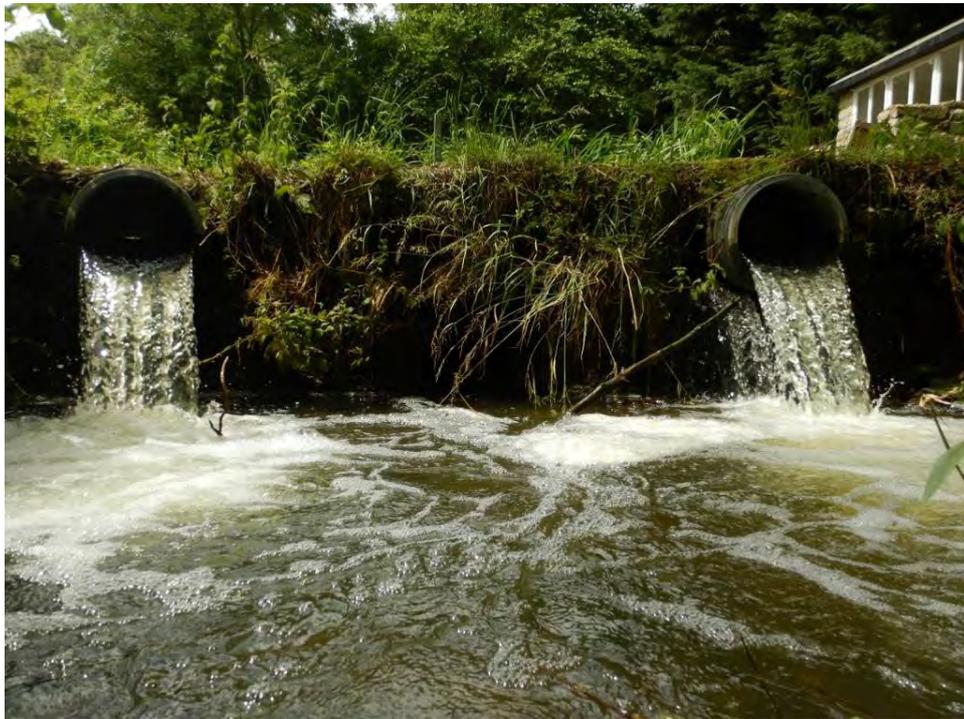
Photo 27 A channel remained which was probably the original side-channel around the mill allowing the miller to adjust flows. The channel had been dammed to create an ornamental feature with two 45mm pipes conveying the majority of flow. However, a third, lower pipe was present in the middle.
