Advisory Visit

River Great Ouse

June 2019

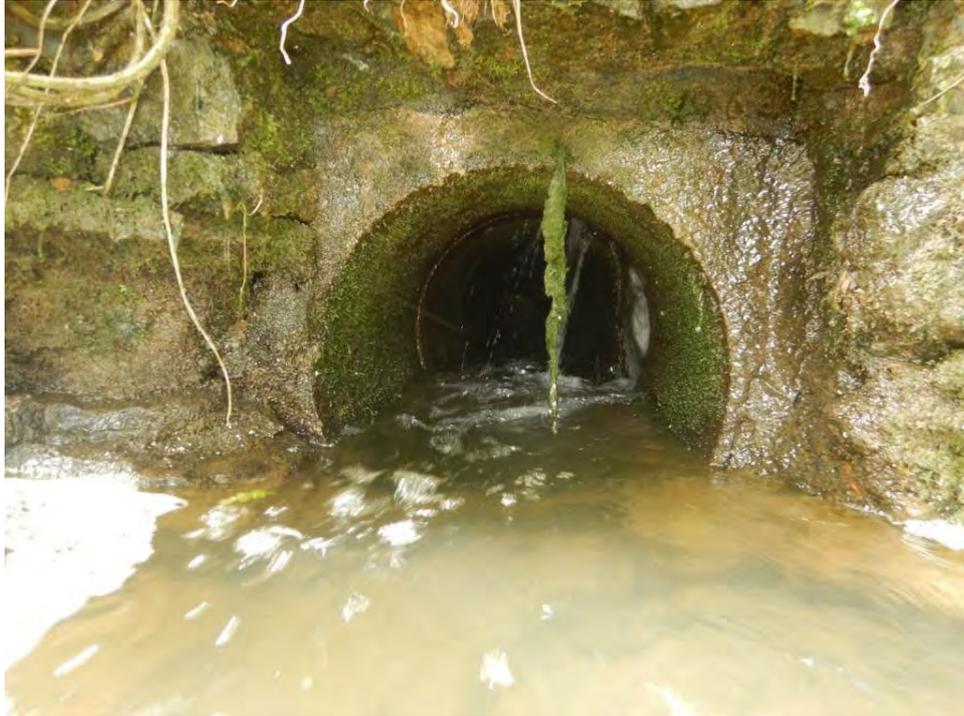
Photo 28 Close-up of the third pipe.

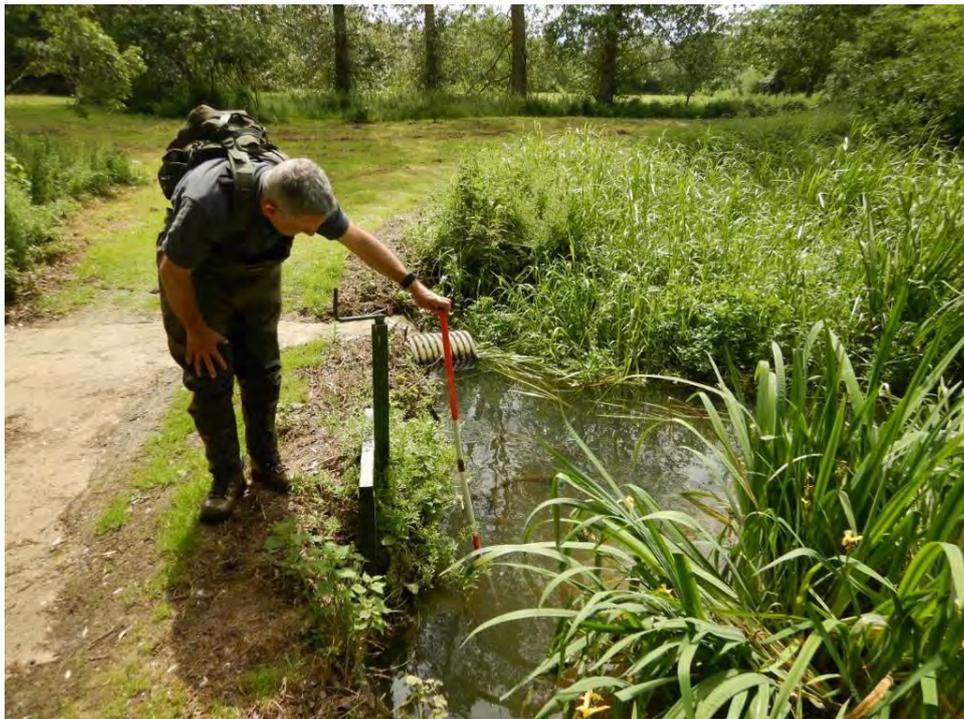
Photo 29 The pipe arrangement had a control structure for the 3rd pipe (it was unknown if it could be adjusted). The whole structure currently provides access to the land beyond (which is effectively an island).

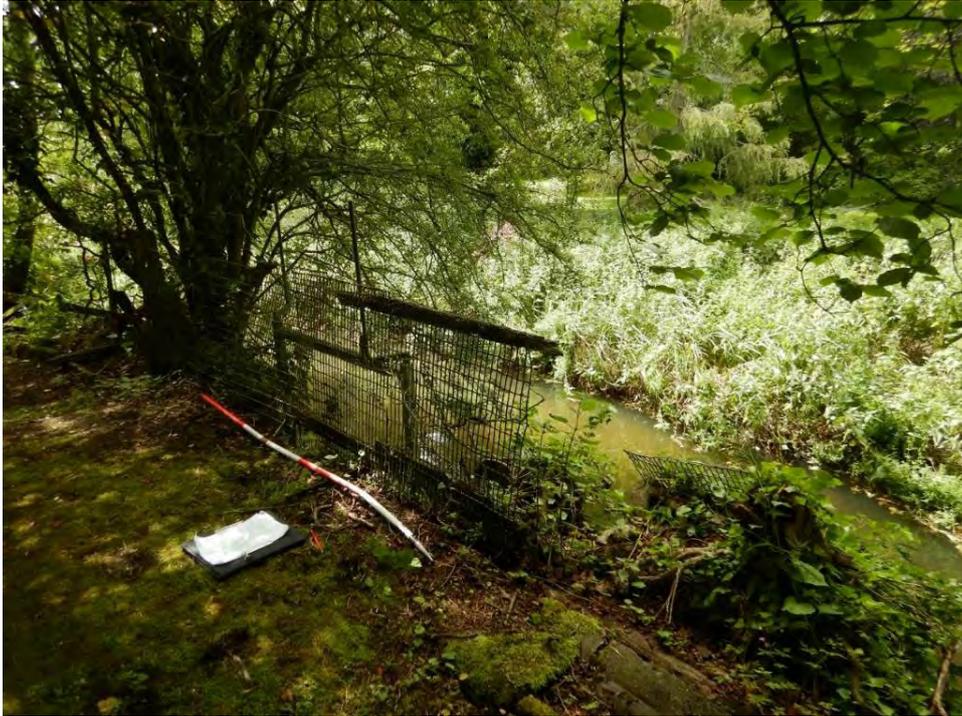
The second overflow from the high-level channel (upstream of Radclive Mill) consists of a dilapidated penstock sluice at the exit from the high-level channel which appeared to be stuck at a fixed aperture/flow (Photos 30 - 31). Approximately 25m downstream of the penstock is a ford consisting of three pipes set into a concrete crossing (Photo 27 – 29). These structures are impassable to fish moving between the high and low-level channels.

Photo 30 A penstock sluice controls the volume of flow into the overspill channel above Radclive Mill. The structure presented an impassable barrier to the movement of fish.

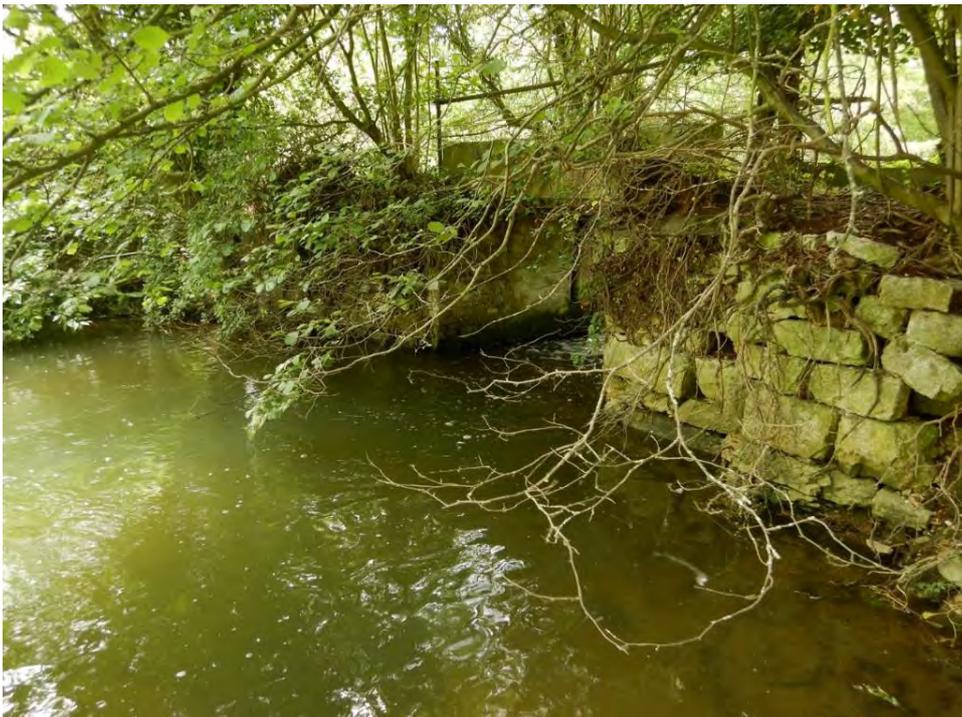
Photo 31 The downstream view of the penstock structure showing dilapidated blockwork.

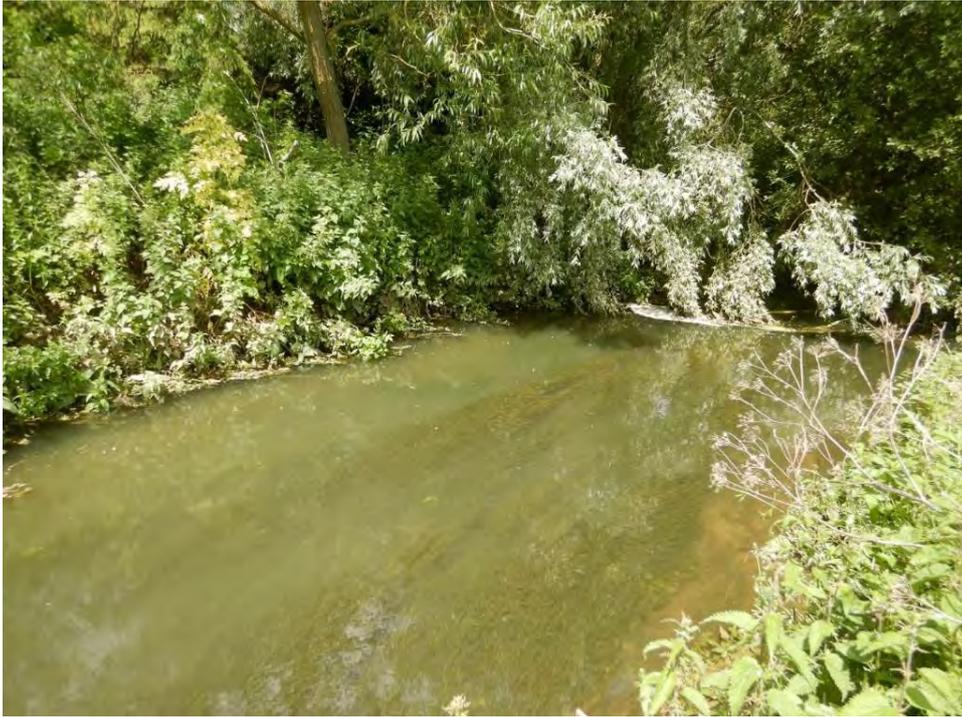
Photo 32 The river became wide and relatively shallow and contained dense beds of aquatic plants (*Potamogeton* sp). This area could be possibly be enhanced through the addition of stone and gravel to the bed to create riffle habitat.

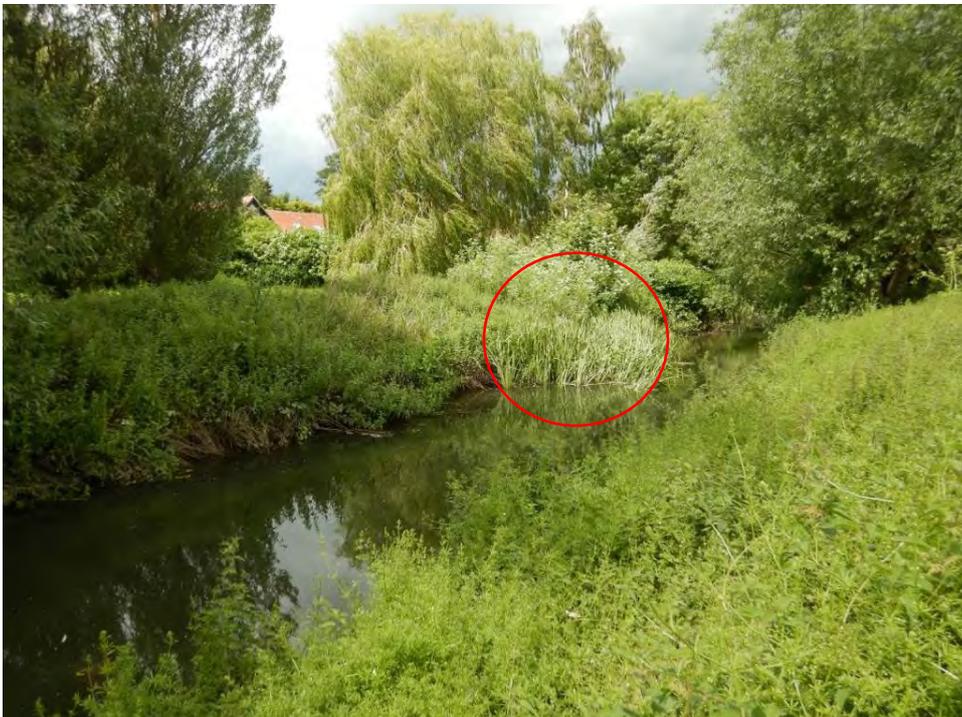
Photo 33 A dense stand of marginal bur reed (red circle) suggested a channel with an accumulation of fine sediment at its margins but depth mid channel.

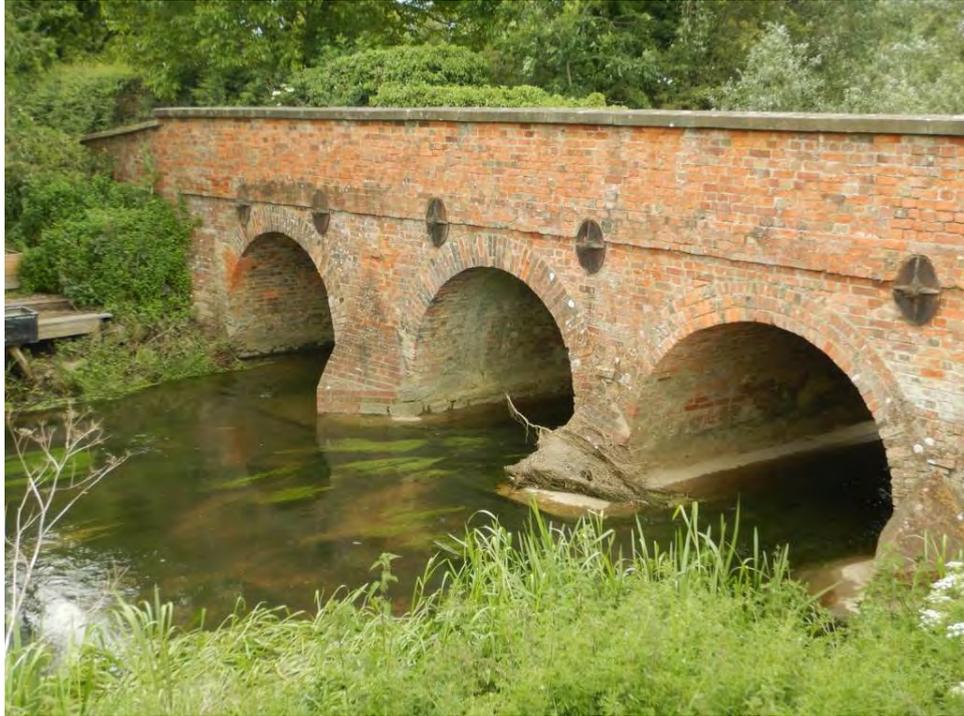
Radclive Bridge could be improved for fish passage as noted in Photo 34, although this is a lower priority compared to restoring fish passage across the wider site.

Photo 34 Radclive bridge presented a potential barrier to the movement of fish. In high flows the arches would convey fast water, in low-flow the concrete sill of the arches becomes too shallow. A series of simple baffles could be installed to increase the low-flow depth through the middle arch, or baffles could be installed to push the entire low-flow down the central arch.

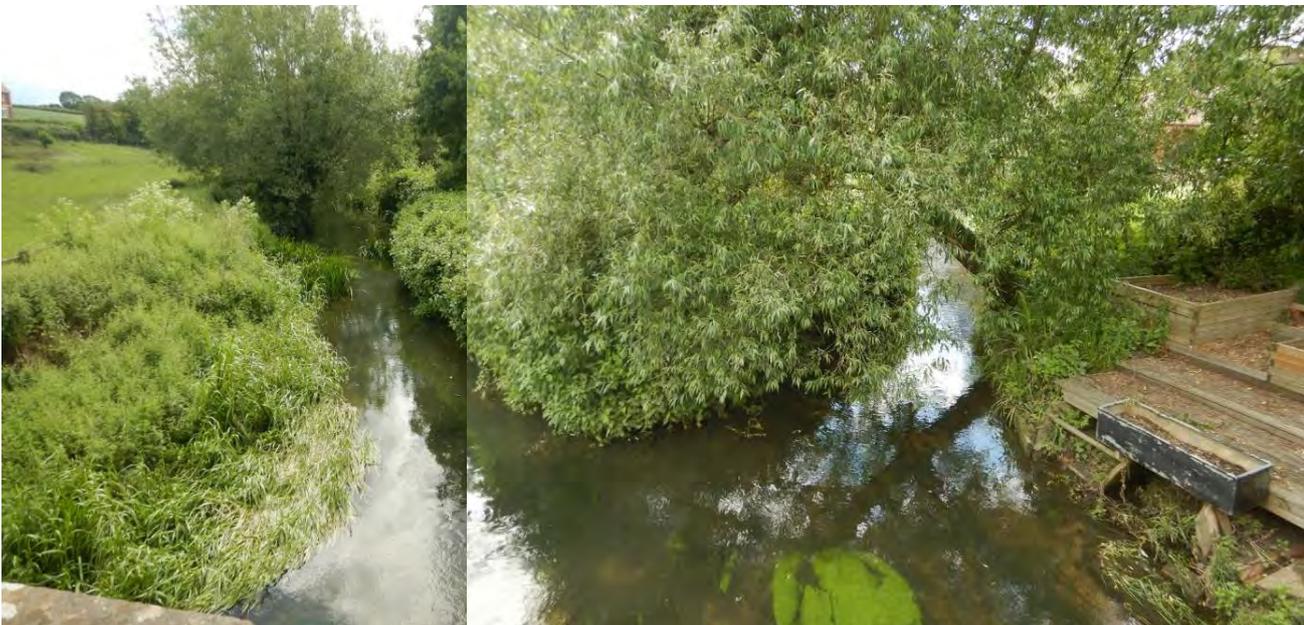
Photo 35 The view from the bridge looking upstream. The low-level channel (left) converges with the high-level (mill) channel (right). A short distance up the mill channel was a simple weir with a height estimated to be 0.4m (not seen).

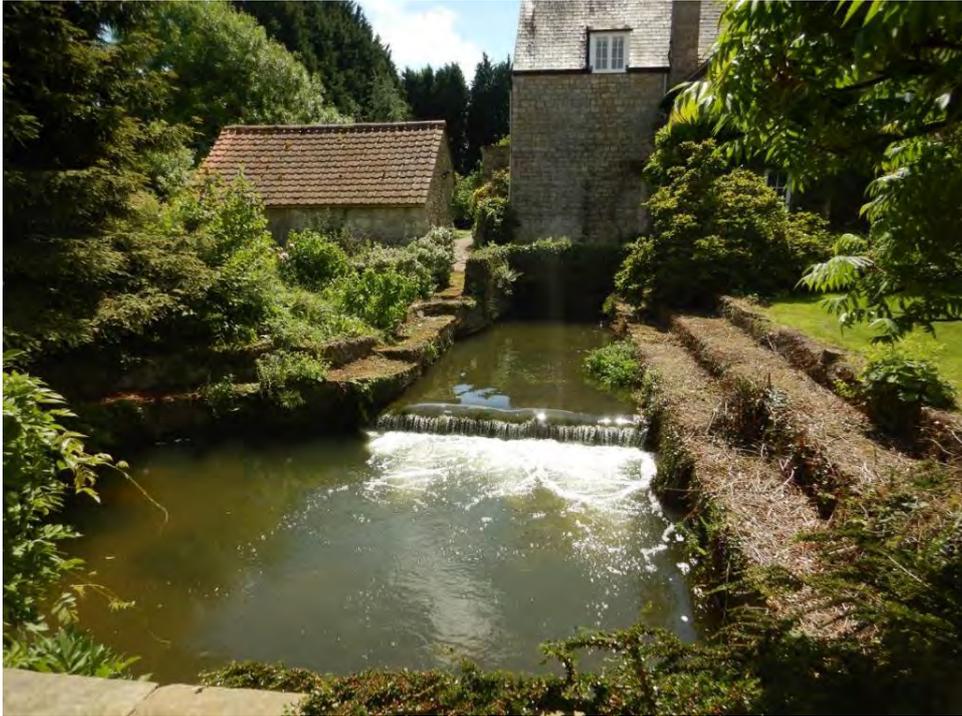
At Radclive Mill it was not possible to fully inspect the river as nobody was at home. Observations from the road and driveway revealed two weirs downstream of the mill and there may be more underneath or upstream of the mill building.

Photo 36 Another small weir was present in front of the mill. A full inspection of the channel arrangements at the mill was not possible as nobody was at home.

recommended that the flow control structures at Radclive Mill are inspected in more detail and considered as part of any fish passage improvement project.
