Advisory Visit
River Greet, Nottinghamshire
March 2014

1.0 Introduction

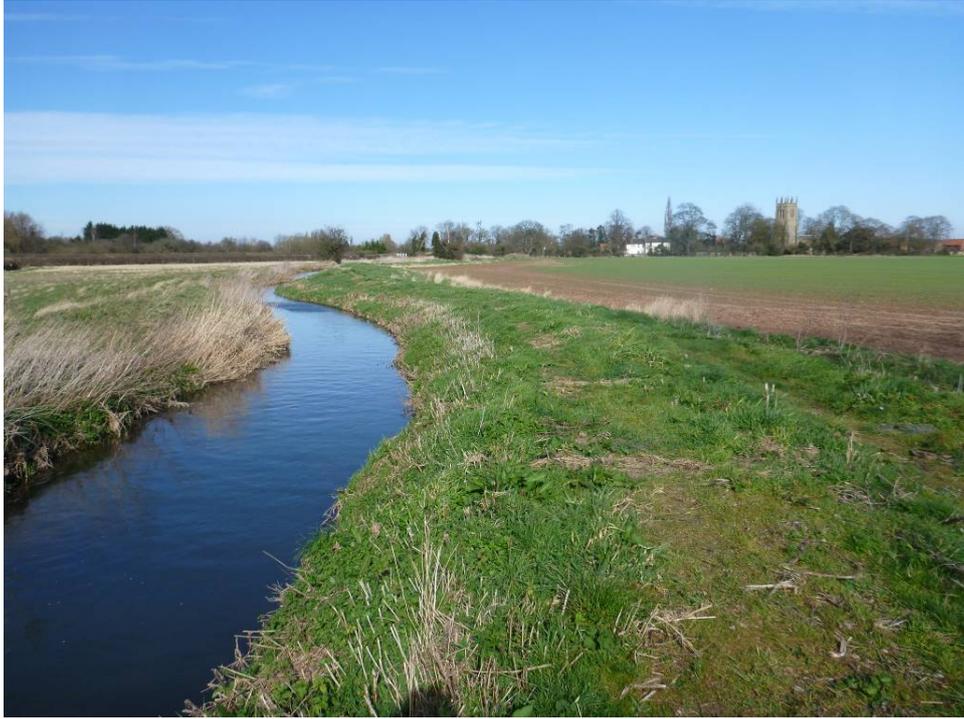
The channel has been engineered for flood defence and land drainage purposes and undergoes regular maintenance including dredging. Rolleston village has been flooded previously leading to the local community initiating and funding a project to construct a new flood defence bund. The photographs below show the generally uniform, embanked, steep-sided nature of the channel. The trapezoid-shaped channel cross-section means there is very little shallow, marginal habitat to provide refuge for juvenile fish during high flows.

Photo 1 View upstream towards road bridge and Rolleston church. Little in the way of cover for holding fish.

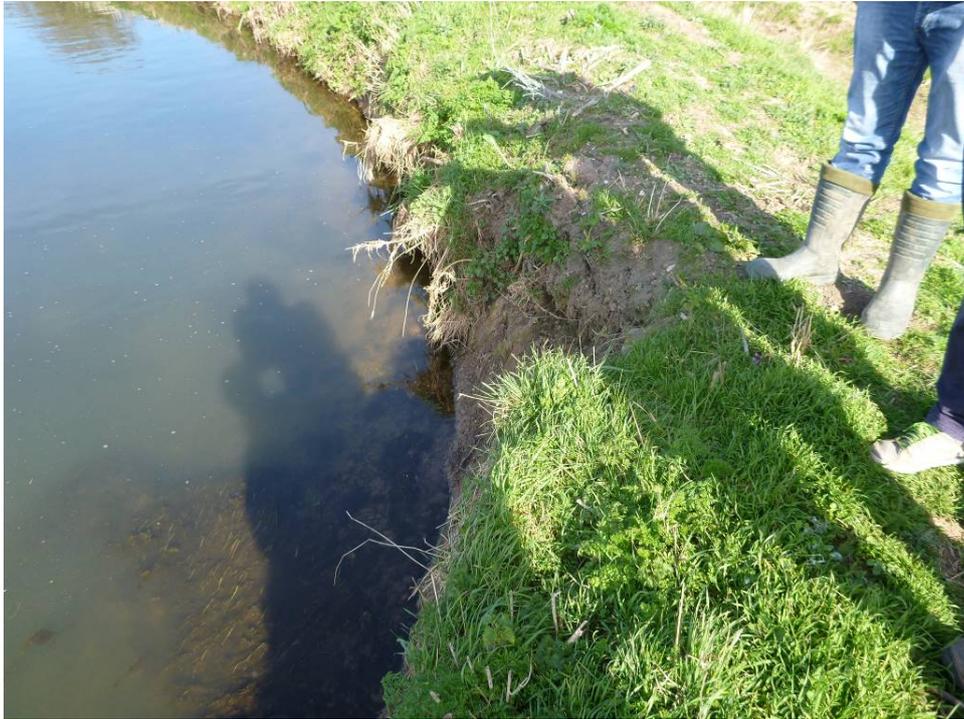
The channel is very open for much of its length, with few bankside trees or bushes. Where there are riparian trees (Photo 3), these provide good cover in and over the watercourse and greatly improve habitat quality. The trees also provide bank stability which prevents erosion. On bends without trees, some limited bank erosion was noted (Photo 2); this could be repaired with

Photo 2 Bank erosion on the outside of a bend. Soft revetment would protect such areas and provide some valuable cover for fish.

- Install brushwood bundles on the outside of bends which are experiencing erosion (Photo 2). These will take up minimal channel capacity and provide protection to the toe of the bank, plus some fish shelter (Photo 14).
- On straighter sections of channel, create a submerged berm that can colonise with emergent plants, providing improved marginal habitat for fish fry, invertebrates, etc. (Figure 4). Liaison with the body which carries out routine channel maintenance may allow this to be incorporated into their programme of works, i.e. bank works carried out by machine, re-planting carried out by NPS.

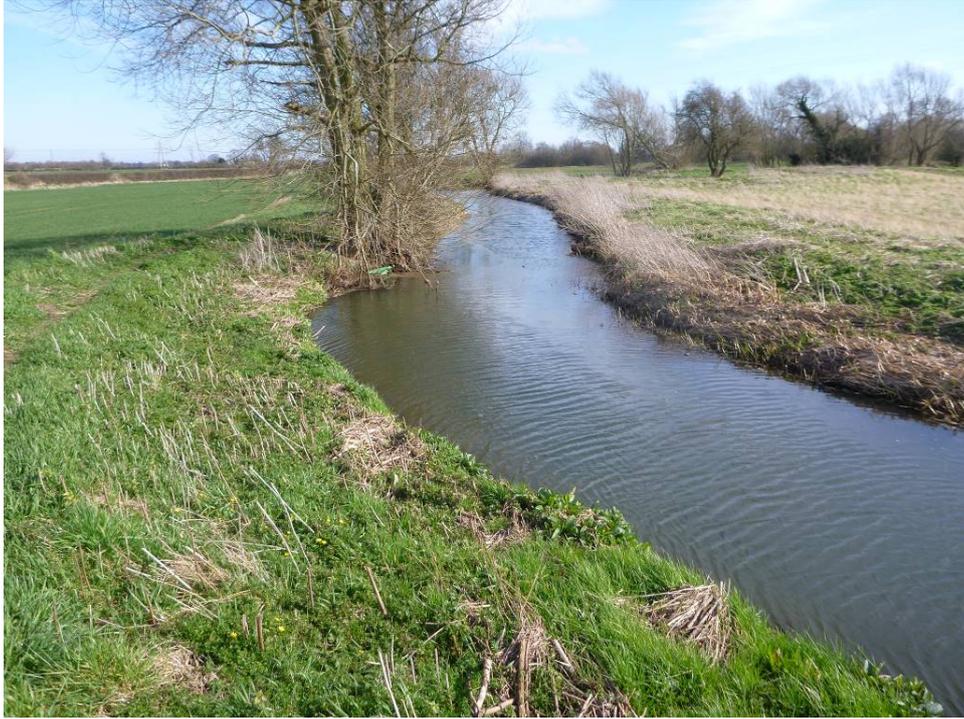
Photo 3 Trees on the left bank provide some low cover and a holding area for fish – areas like this are rare on this section of river

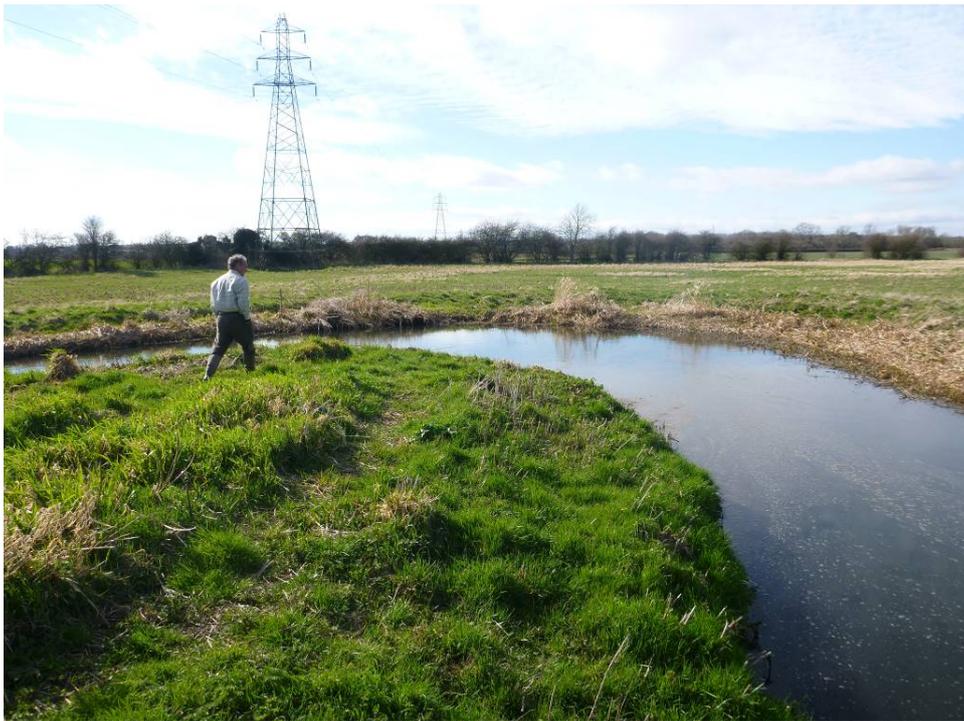
Although the river channel has been engineered, giving it very uniform dimensions, the channel has not been straightened and retains its natural, sinuous planform. This means there is some variety in depth, with deeper areas occurring on the outside of bends (Photos 4, 7). The deep water is valuable habitat for adult fish but could be greatly improved by planting trees on the outside of the bends. Also, if land levels allow, the bank on the inside of bends could be re-profiled, pulling back the embankment and creating shallow marginal areas; these would be valuable refuge areas for juvenile fish (see Recommendations).

Photo 4 A sharp bend in the river provides some valuable depth variation in the channel, but this could be greatly enhanced by establishing low-growing, bushy trees on the far bank to provide cover and shade

- Plant trees, particularly on the outside of meanders where deeper water is present. These should be native trees species, preferably of local provenance. Most suitable would be low-growing species with a bushy habit that could be coppiced; these include willow (*Salix caprea*, *S. cinerea*), hawthorn, blackthorn, hazel, and field maple. Willows are common along the Trent and could easily be transplanted from cuttings.
- Re-profile the river banks on the inside of bends to create low-level, wet margins alongside the river. This may require the re-alignment of existing embankments (Photos 12, 13, Figure 3). Liaison with the body responsible for channel maintenance may provide the opportunity for partnership working to achieve this, as it would also improve channel capacity and flood conveyance.

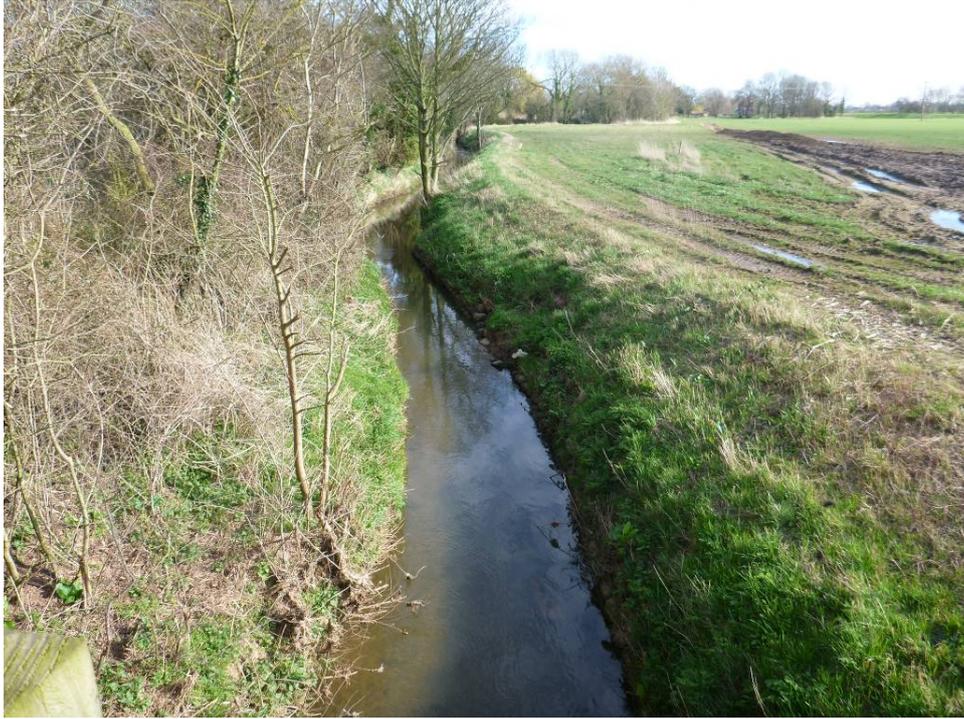
Photo 5 The Marlock Dyke runs parallel to the river on the right bank, but at a lower level, joining the Greet downstream of Fiskerton Mill (Photo 8)

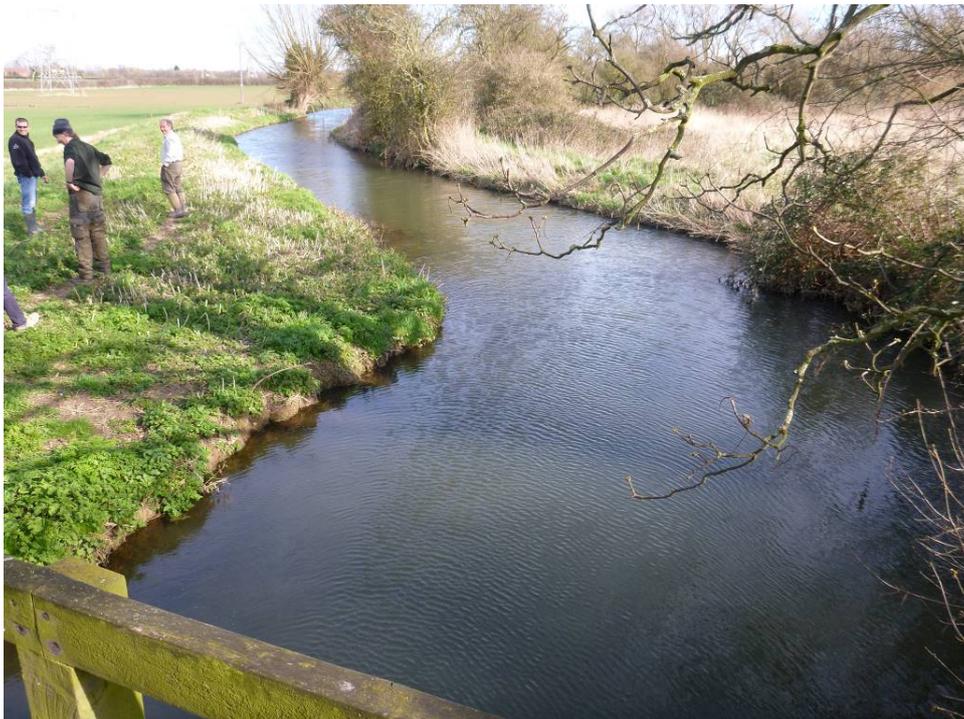
Fiskerton Mill impounds the river for much of the downstream part of this section, slowing the flow and encouraging deposition of fine sediment (Photo 6). The impoundment means the river has little energy; hence introducing structures which rely on scour to create or improve habitat features would not have the desired effect in the lower reach. With progress downstream towards the mill, the channel becomes perched above the level of the adjacent land, particularly the land on the left bank. Dykes adjacent to the river are at a lower level than the river; one is culverted underneath the river channel. Another, the Marlock Dyke, joins the Greet downstream of Fiskerton Mill, below the impoundment (Photos 5, 8). The perched channel limits the opportunity to connect the river to the adjacent land and create wet marginal areas suitable for fish fry; there may however be some limited scope (see Recommendations).

Photo 6 View downstream from the footbridge, showing impounded nature of the river above Fiskerton Mill

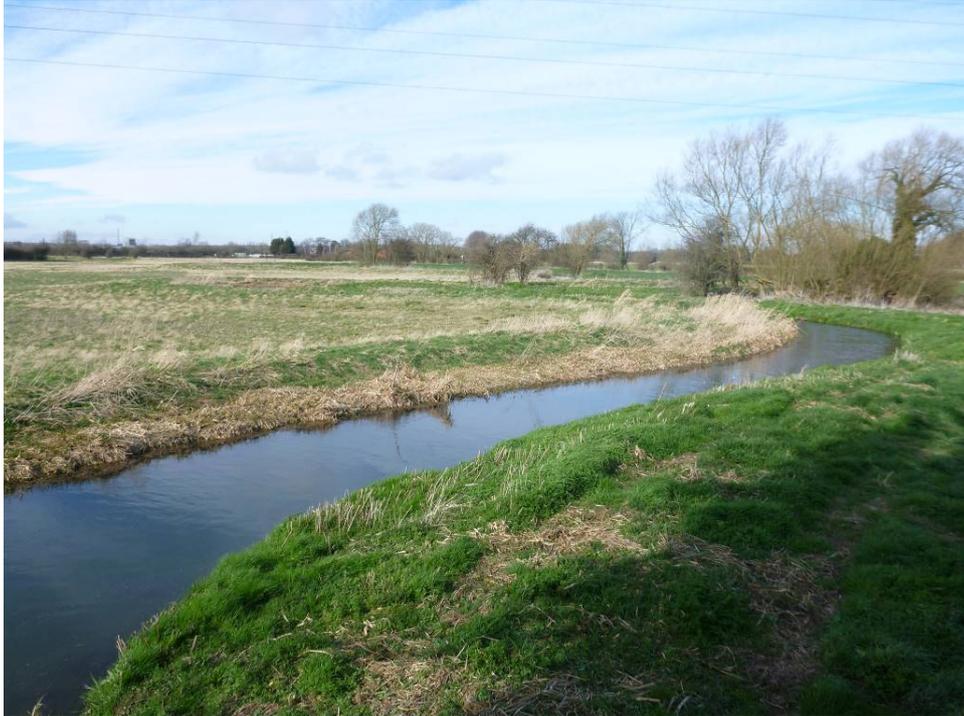
Photo 7 View upstream from the footbridge. There may be scope to move the embankment on the true right (far) bank back from the river edge to create some wet marginal habitat.

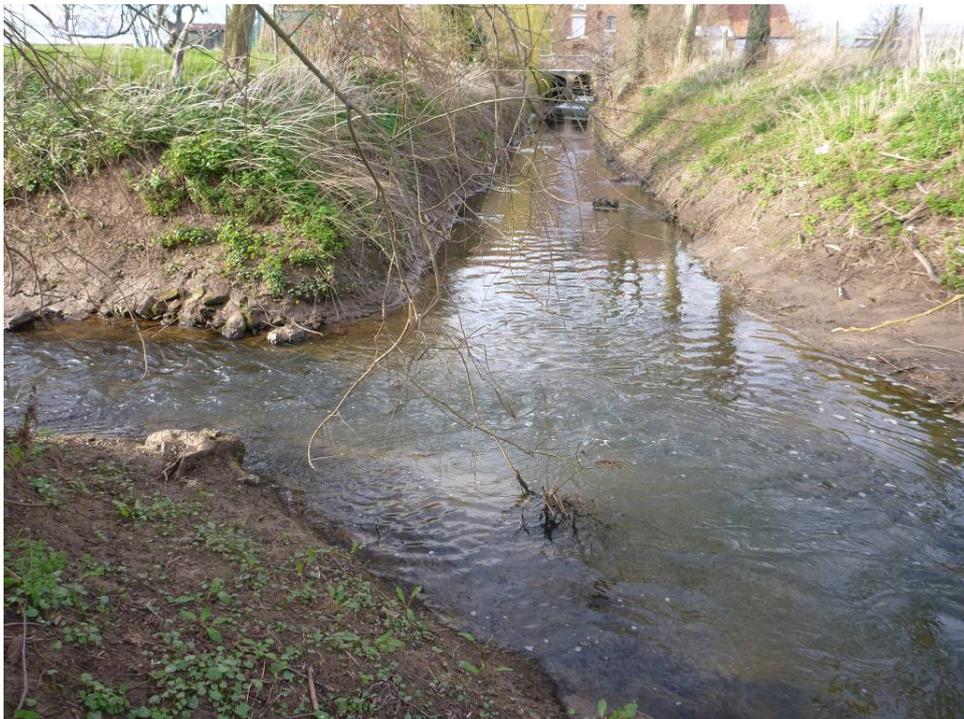
In addition to the NPS section, the river was inspected downstream at Fiskerton Mill (Photos 8, 9) and upstream alongside Southwell racecourse (Photos 10, 11). The culvert and impoundment under Fiskerton Mill is an obstacle to fish passage that prevents access for fish from the River Trent into the Greet. This lack of connection between the main river and its tributary limits the diversity and abundance of fish, not just for recognised migratory species like eels, lampreys and sea-trout but also for coarse fish which move considerable distances to breed. The habitat on the Trent is adversely affected by navigation weirs, so having well-connected tributary habitats is important for fish stocks in the main river. For these reasons it would be desirable to improve fish passage at Fiskerton Mill; a similar project was completed recently at Glandford Mill on the River Glaven in Norfolk (www.aquaticcontrol.co.uk/news/288/how-do-you-get-fish-swim-under-house).

Photo 8 View upstream towards Fiskerton Mill from the Marlock Dyke confluence.

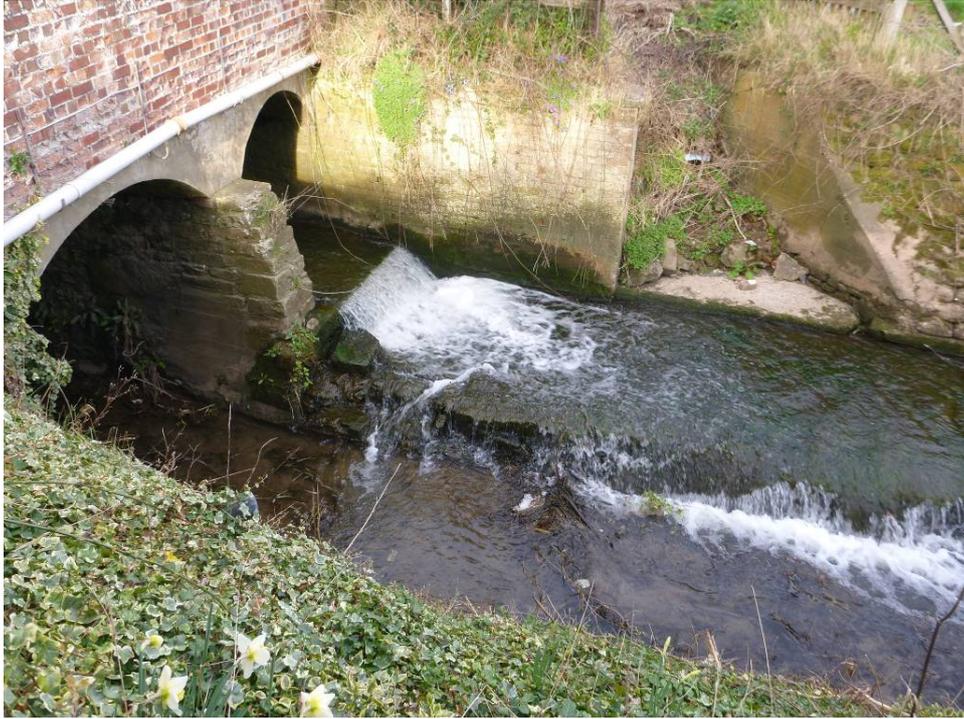
Photo 9 The culvert under Fiskerton Mill is a barrier to fish passage.

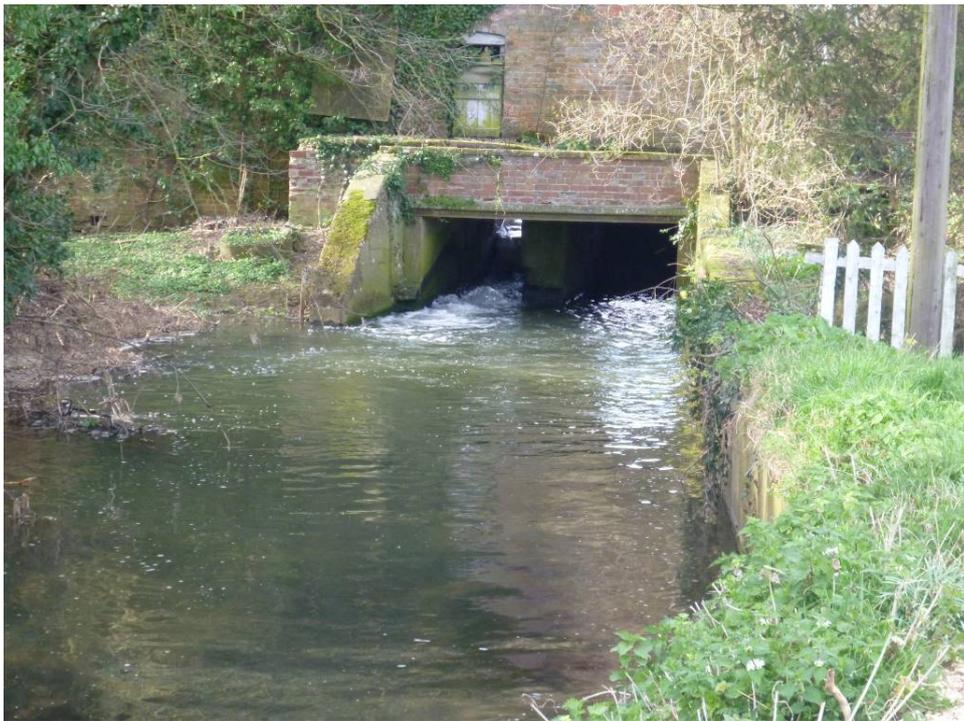
Upstream of the NPS section, another former mill is present alongside Southwell racecourse. This is also a barrier to fish migration, although the head loss across the structure appears much smaller. The river habitat upstream of the mill is poor, the channel having been straightened in addition to the factors affecting the NPS stretch.

Photo 10 Upstream of the NPS section is another mill at Mill Farm. This is also a barrier to fish migration.

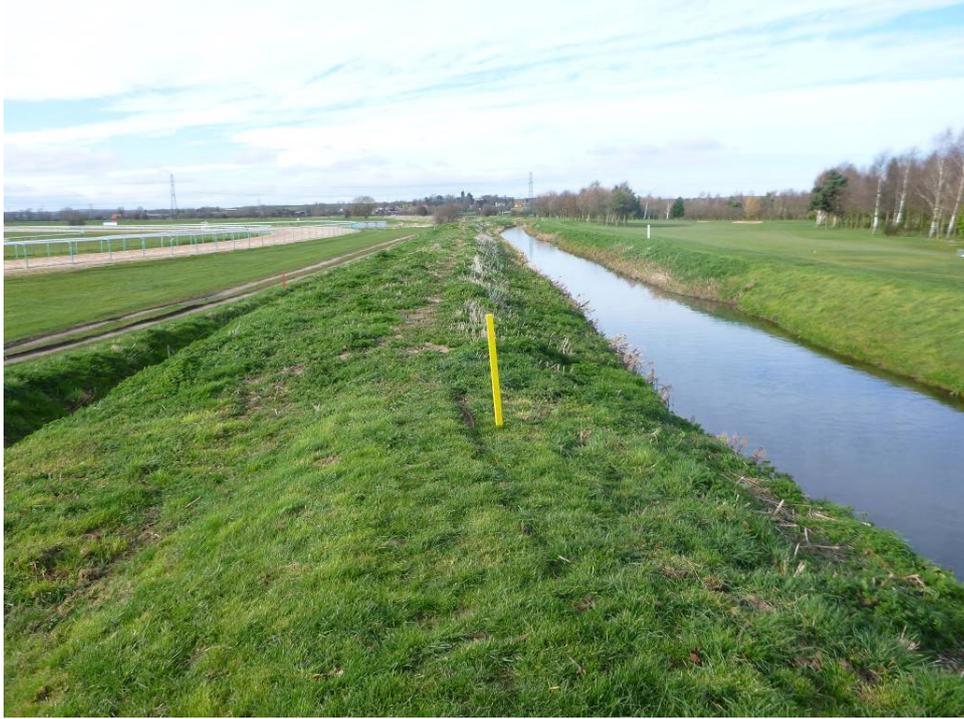
Photo 11 The Greet alongside Southwell racecourse – very poor in-stream habitat, lacking riparian vegetation, cover and shade.

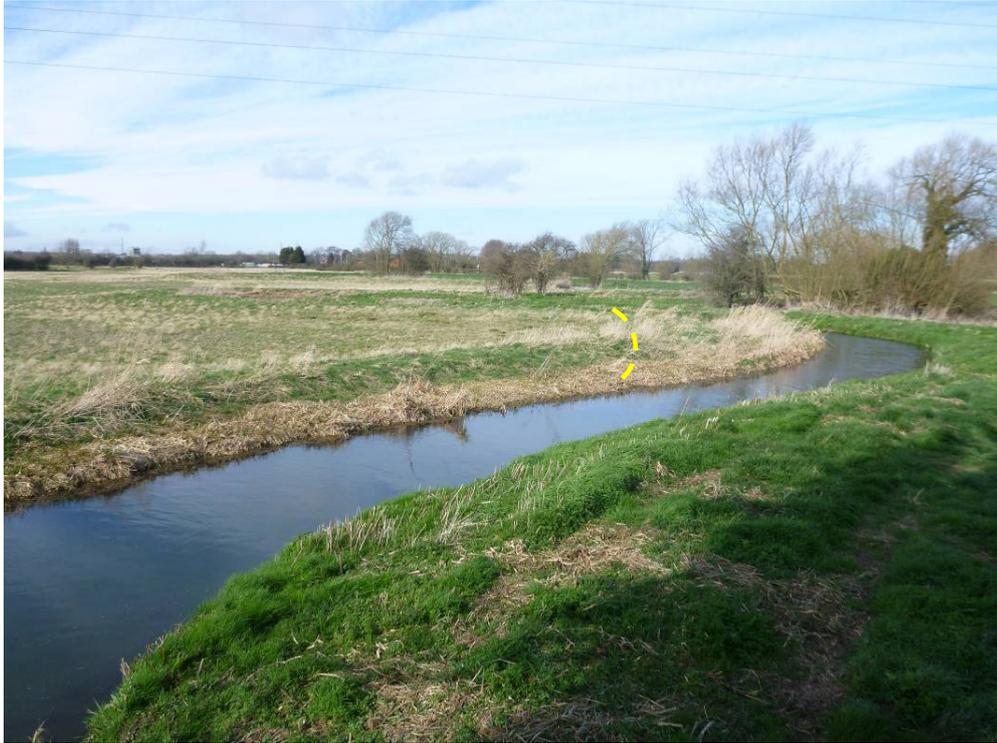
Photo 12 Possible area for re-aligning embankment, along the line indicated
