Halse Water, Norton Fitzwarren, Somerset

An Advisory Visit by the Wild Trout Trust November 2014

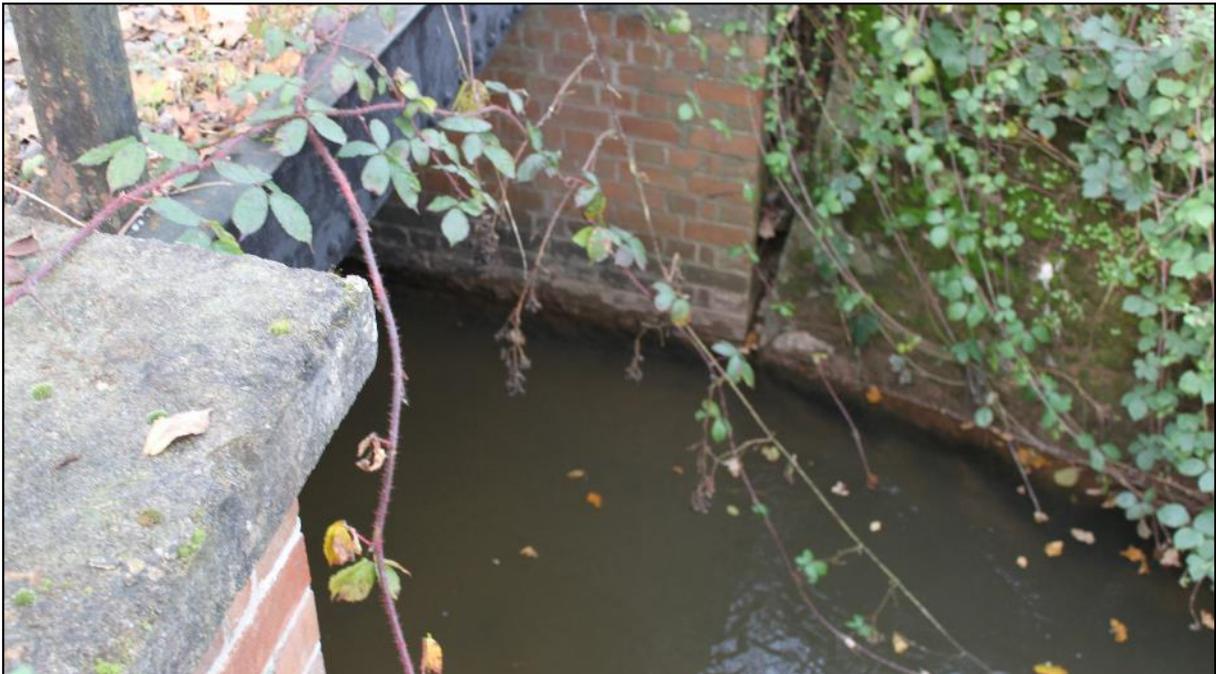
The Halse Water flows under the West Somerset Railway Line via a clear-span bridge (Figure 2) at the top of the reach inspected. Bridges are usually more favourable to river habitat than culverts as they allow for a greater free movement of river sediment (stone, gravel and fine sand and silt) as well as posing no physical or behavioural barriers to fish and other river wildlife.

Figure 2: The Halse Water flows under the West Somerset Railway line

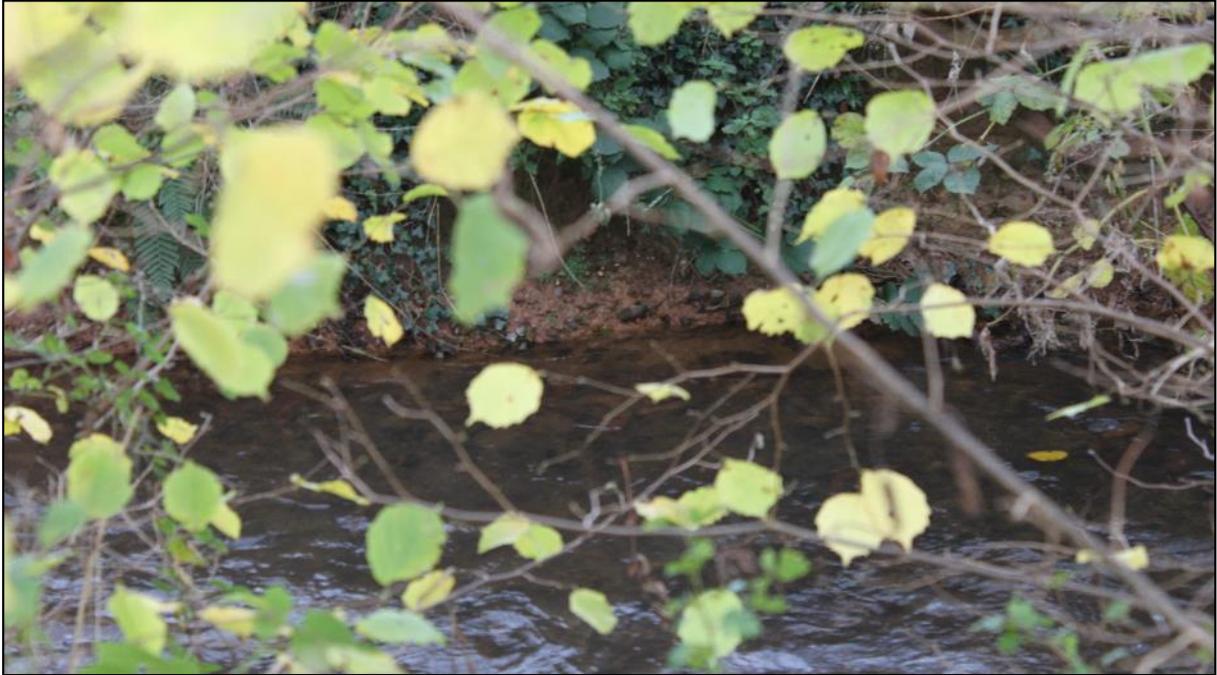
From the bridge the stream flows in a south-easterly direction towards Norton Fitzwarren. The river was clear-flowing on the day of the visit and a relatively clean gravel bed was visible. The stream is slightly incised (cut down into a steep-sided channel) which is sometimes an indication of previous dredging works. However, areas with an underlying alluvial geology can have relatively mobile soils, suggesting that the river may naturally form such a channel. The steep and relatively friable banks are susceptible to erosion which, depending on circumstances, can have both positive and negative impacts on river ecology. Bank erosion is a natural component of river morphology, helping to maintain habitat diversity and introducing new gravel into the system. As a river slowly meanders across the floodplain, bank erosion exposes the gravel seam deposited hundreds or even thousands of years ago, often by the same river (Figure 3).

Figure 3: Natural bank erosion exposes the floodplain's gravel seam (centre of image). This introduces fresh gravel into the river system

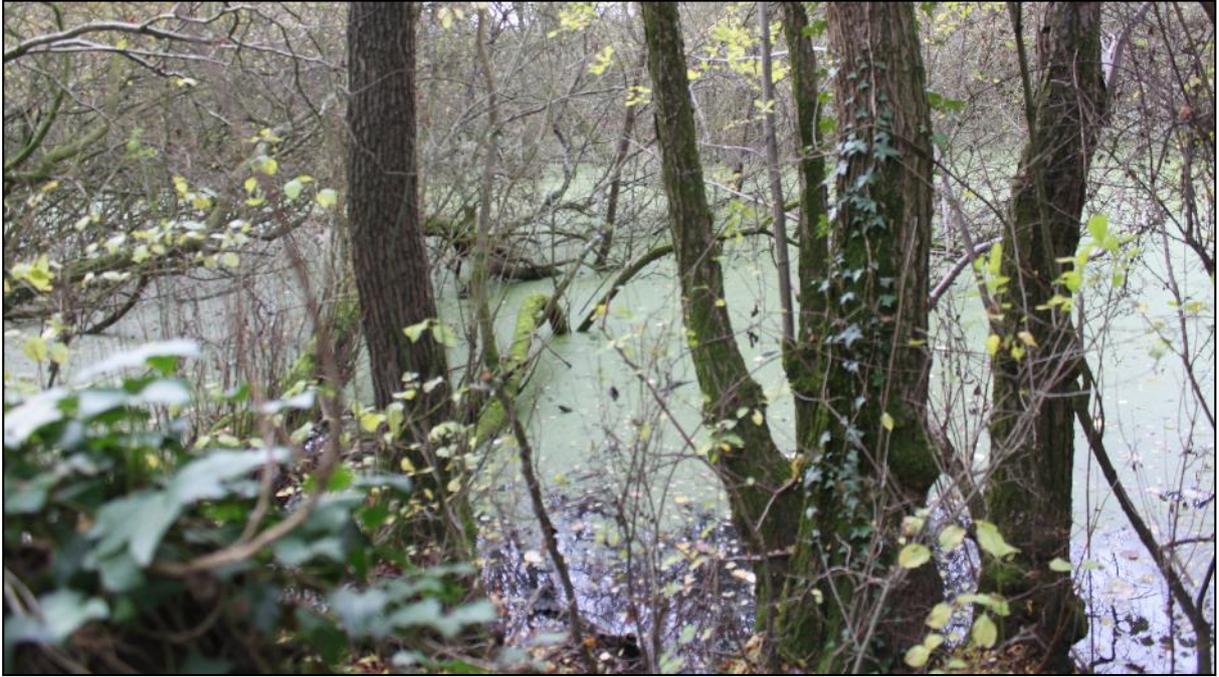
Alongside the river, at the rear of the footpath on the right-hand bank (RB) is a pond surrounded by unmanaged and over-grown willows (*Salix* spp.) (Figure 4). The pond was difficult to access and it was not clear how (or indeed *if*) the pond was connected to the stream.

Figure 4: The pond is overgrown and covered with duckweed (*Lemna* sp.) which could cause anoxic conditions. With some maintenance could be a valuable wildlife and community amenity

With some maintenance work, this pond could become a valuable local amenity that could help to connect the wider Norton Fitzwarren community with local wildlife.

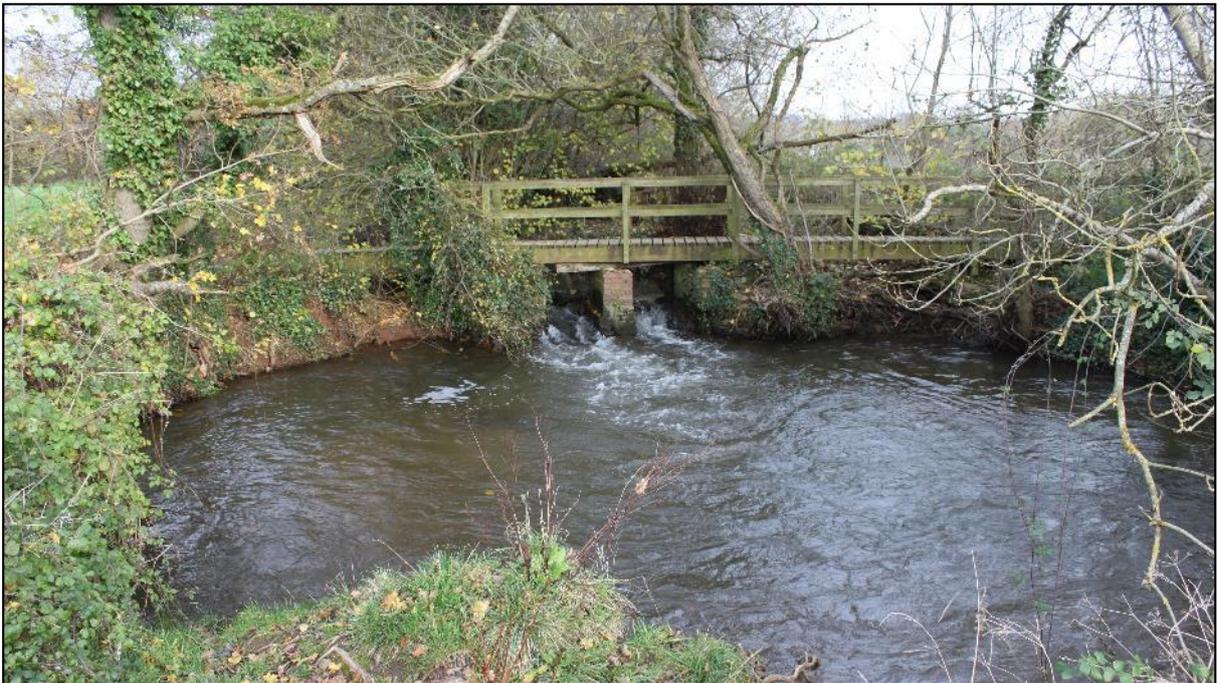
At NGR ST 18707 26254, the river flows under a small footbridge and bends sharply to the left. Flow is pinched as it passes through the narrow footings of the bridge (Figure 5) which causes the flow to be accelerated towards the opposite bank (Figure 6). The faster flow combined with the back-eddy effect that occurs when a river channel becomes abruptly wider after a pinch-point (Figure 7) has contributed to bank erosion.

Figure 5: At ST 18707 26254 the Halse Water is pinched between the narrow footings of a footbridge

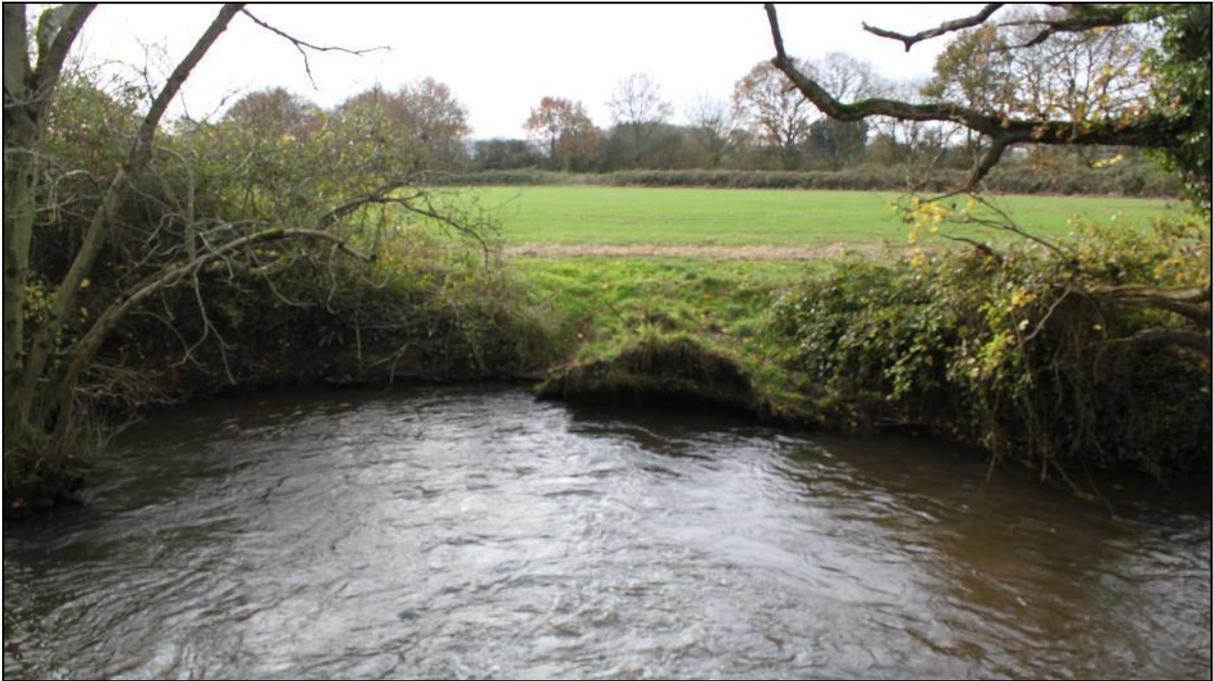
Figure 6: Flow is accelerated towards the opposite bank, exacerbating erosion.

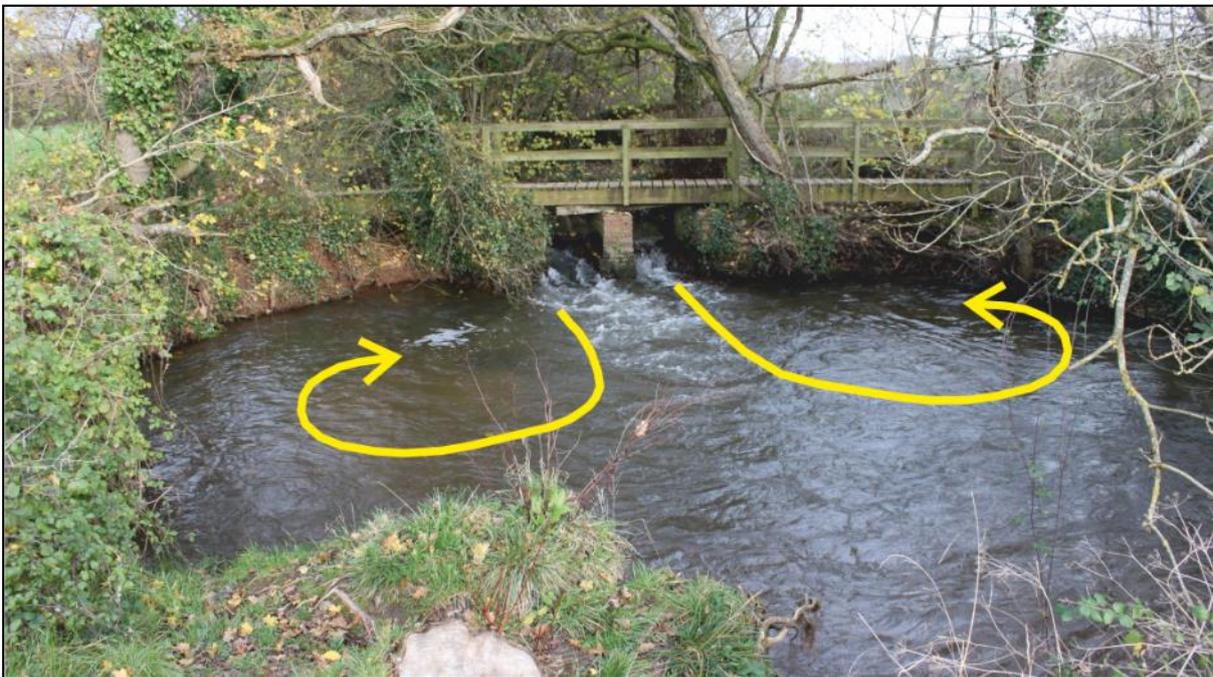
Figure 7: Back eddies form as the channel abruptly widens after a narrow 'pinch point'

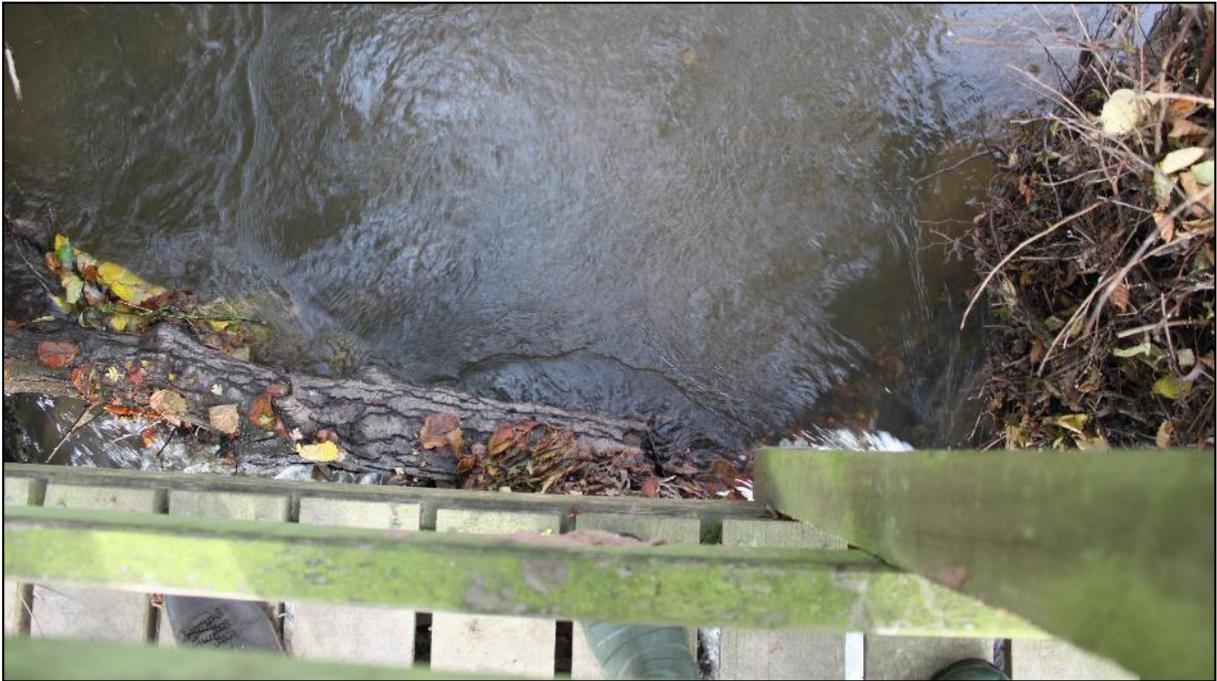
The narrow aperture of the bridge footings, which may have once been part of a sluice structure, was blocked by a loose piece of woody debris on the day of the visit (Figure 8).

Figure 8: A small log was trapped against the bridge footings, slightly impounding the river upstream

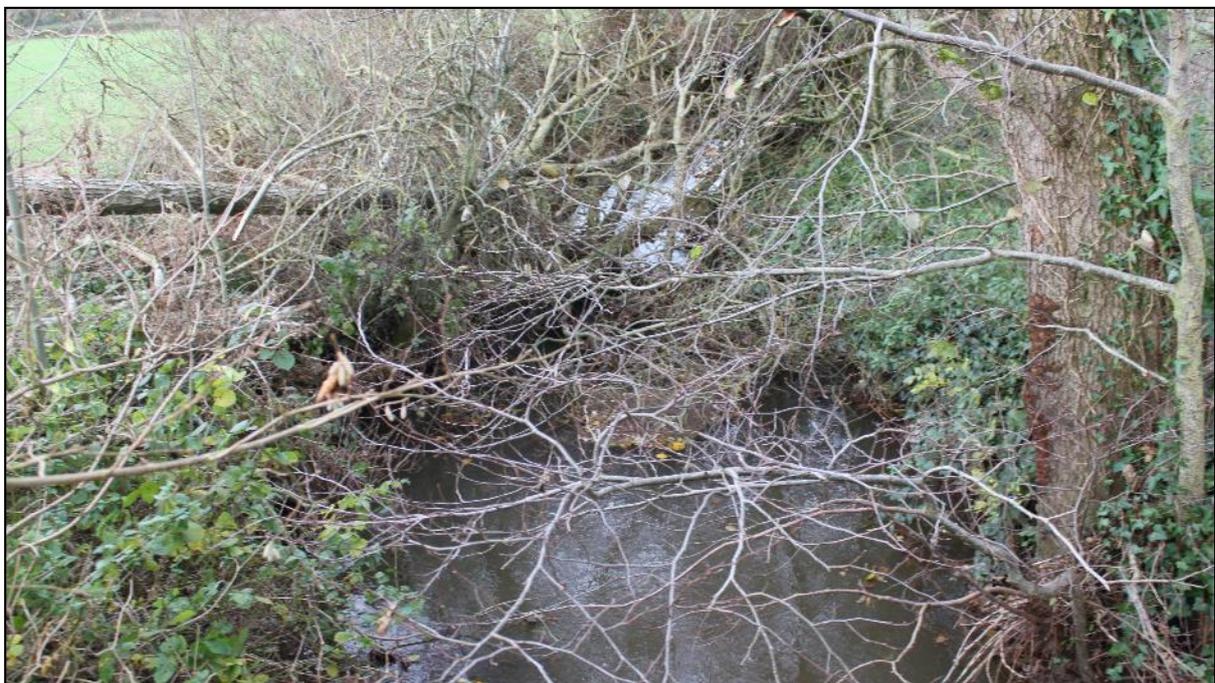
On the day of the visit, a large tree had fallen across the stream (Figure 10). This was collecting leaf litter and other debris. In this particular incidence the tree poses an increased flood risk and should be removed.

Figure 10: A fallen tree has significantly blocked the channel

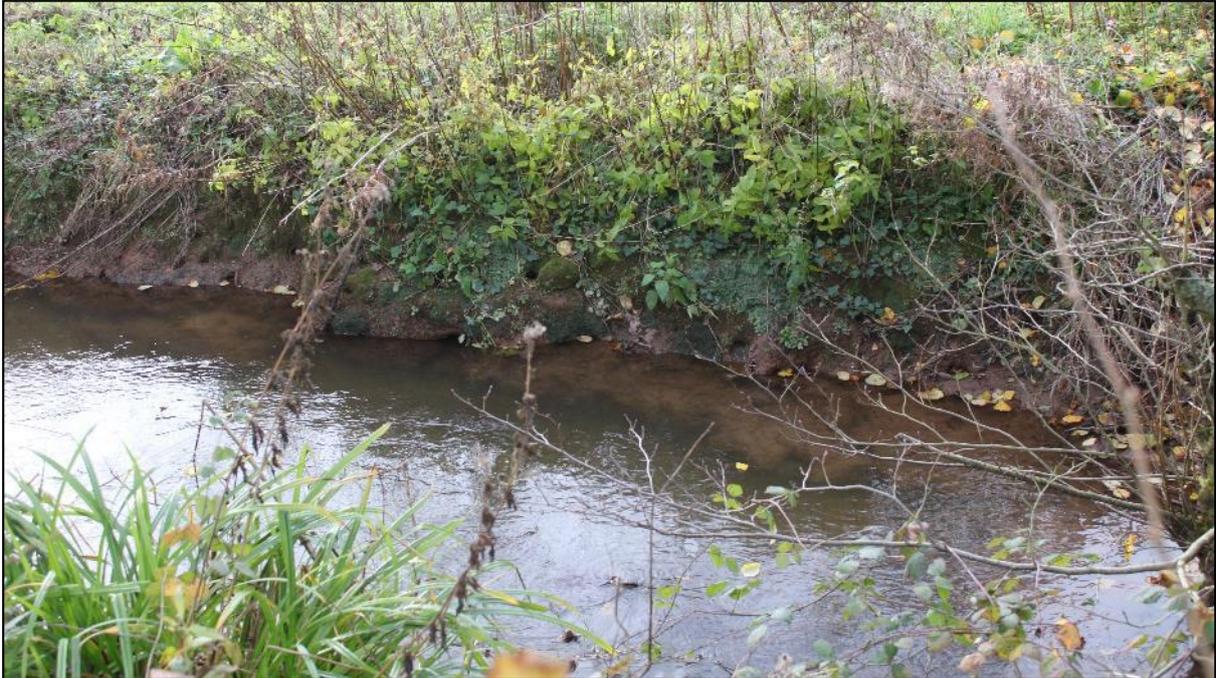
Whilst the channelised stream limits habitat diversity, the steep banks provide an abundance of burrowing habitat for water voles (*Arvicola amphibius*) (Figure 11). Water voles are a protected species and Britain's fastest declining wild mammal. Water voles, like many river species, need an abundance of marginal vegetation for food and cover. The wide buffer strip between the stream and the ploughed field on the RB will help with the abundance of cover but the uniform canopy height

Figure 11: Burrows in the bank appear to be those of the Water vole

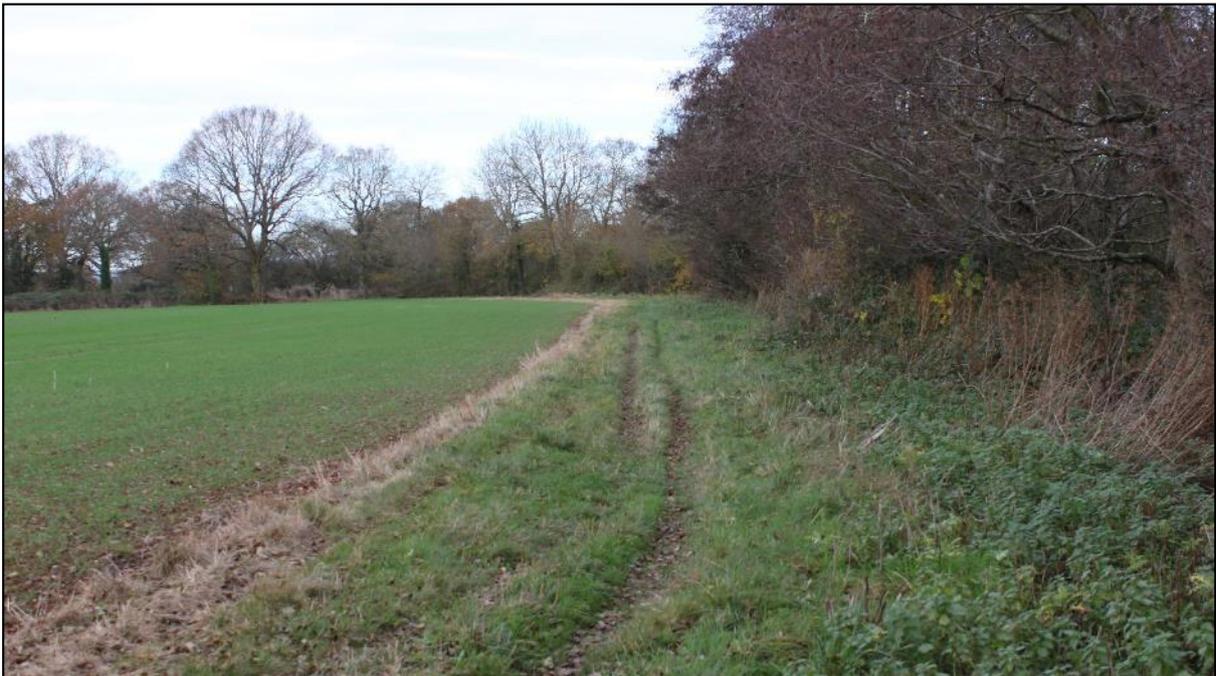
and density of the alders (*Alnus glutinosa*) along the LB casts uniform shade over both banks, possibly limiting marginal plant diversity (Figure 12).

Figure 12: A view (facing upstream) of the wide buffer strip and uniform tree cover over the straightened reach

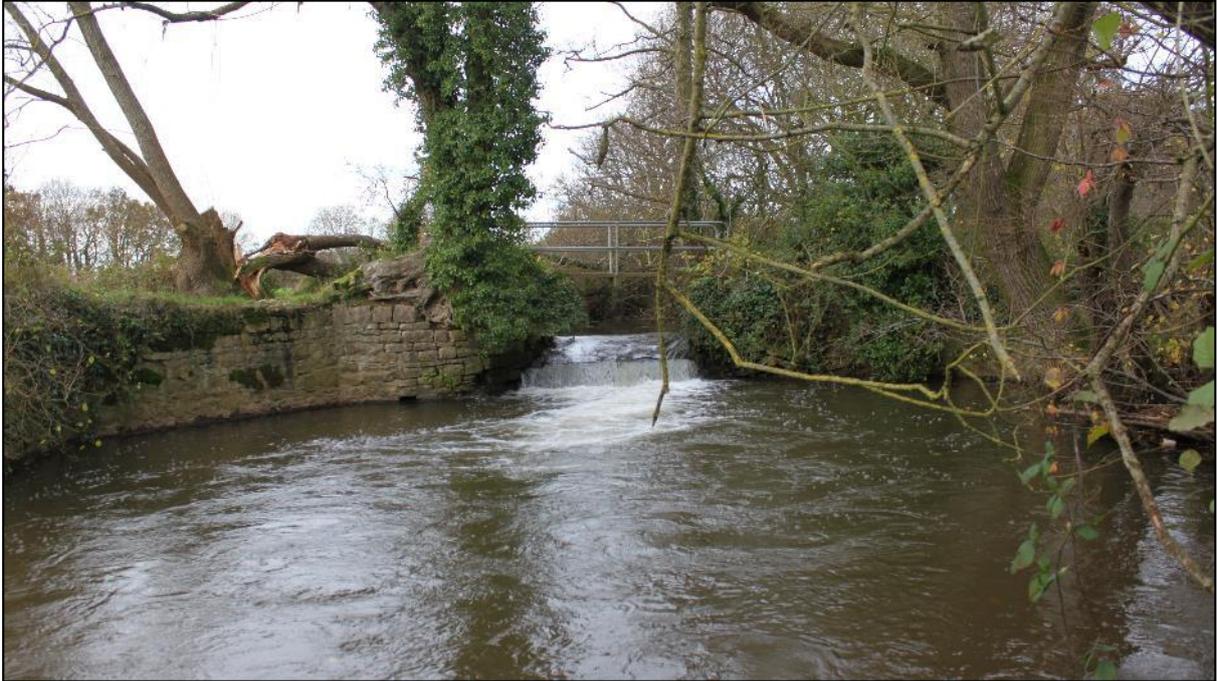
At ST 18846 26126, the river is impounded by a weir which forms the footings of a small footbridge (Figure 13). The original purpose of the weir is unclear but a study of maps from 1887 (old-maps.co.uk) show that sluices were once positioned

in several locations along this part of the Halse Water and the block-stone revetments either side of the weir hint at an industrial past.

Figure 13: A weir now forms the footings of a footbridge but probably had a more industrial purpose originally

3. The weir at ST 18846 26126 (Figure 13) is a major limiting factor affecting the quality of the river habitat. The original purpose of the weir is unclear and it is likely that the weir presently provides no useful function. Ideally it should be removed or a significant portion of it should be lowered to bed level.

Whilst this option will provide the best outcomes for the river as a habitat and for biodiversity in general, the removal of a weir on an artificially straightened channel is not necessarily a straight forward undertaking. A sudden drop in bed and water level can potentially lead to head-cut erosion (erosion of the bed) or reduced bank stability. Whilst these risks are relatively low on such a small weir, advice should be sought from the area Environment Agency geomorphologist, John Phillips (john.phillips@environment-agency.gov.uk)

If the removal or lowering of the weir proves unfeasible in the short term, other options to improve fish passage and habitat connectivity should be explored. For example, a stepped, retained riffle could be installed to replace the weir whilst retaining the water level upstream. This technique has been successfully used on other rivers to improve fish passage by spreading out the head loss of an impoundment (Figures 22 and 23).

Another option could be to install a technical fish pass on the weir. A number of engineering firms specialise in bespoke and pre-fabricated fish and eel passes that can be attached to existing structures. As a minimum, fish passage over the weir should be eased by installing timber baulk pre-barrages to create a 'pool and traverse' passage easement (Figure 24).

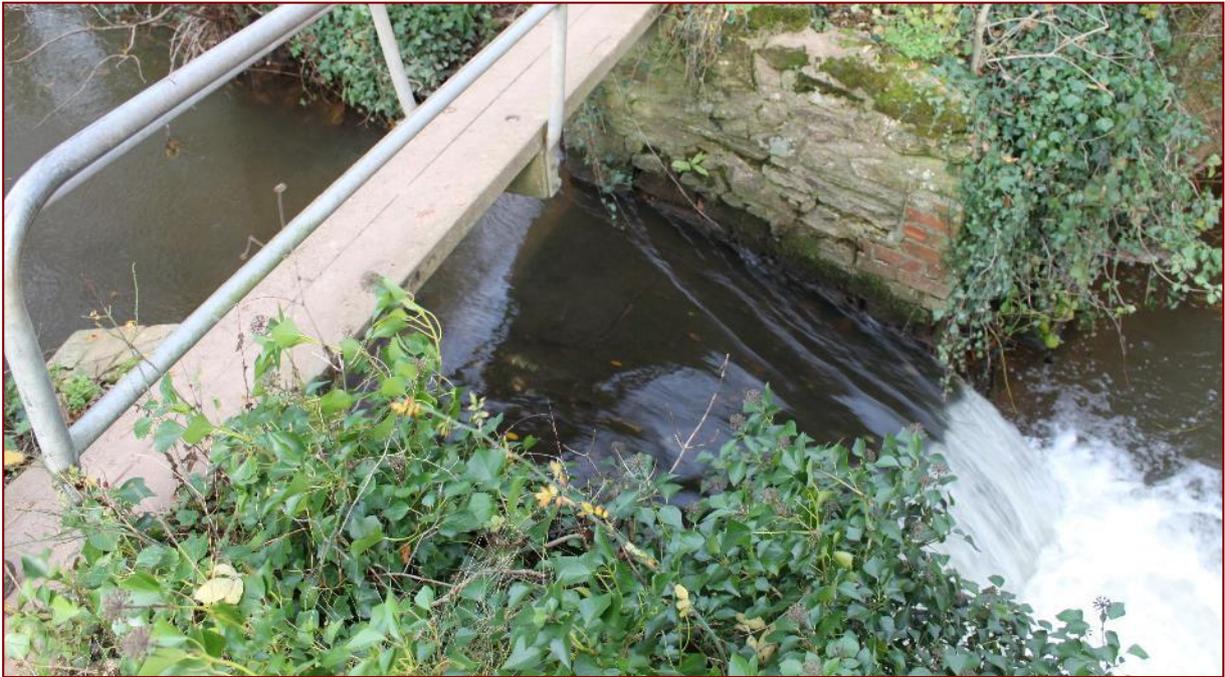
The wide crest of the weir (Figure 14) makes it a complete barrier to fish passage under most flow conditions. However, the weir may be passable to large adult trout under spate conditions when the head loss (the difference between the water level above and below the weir) is reduced.

Figure 14: The wide crest makes the weir a complete barrier for most fish species

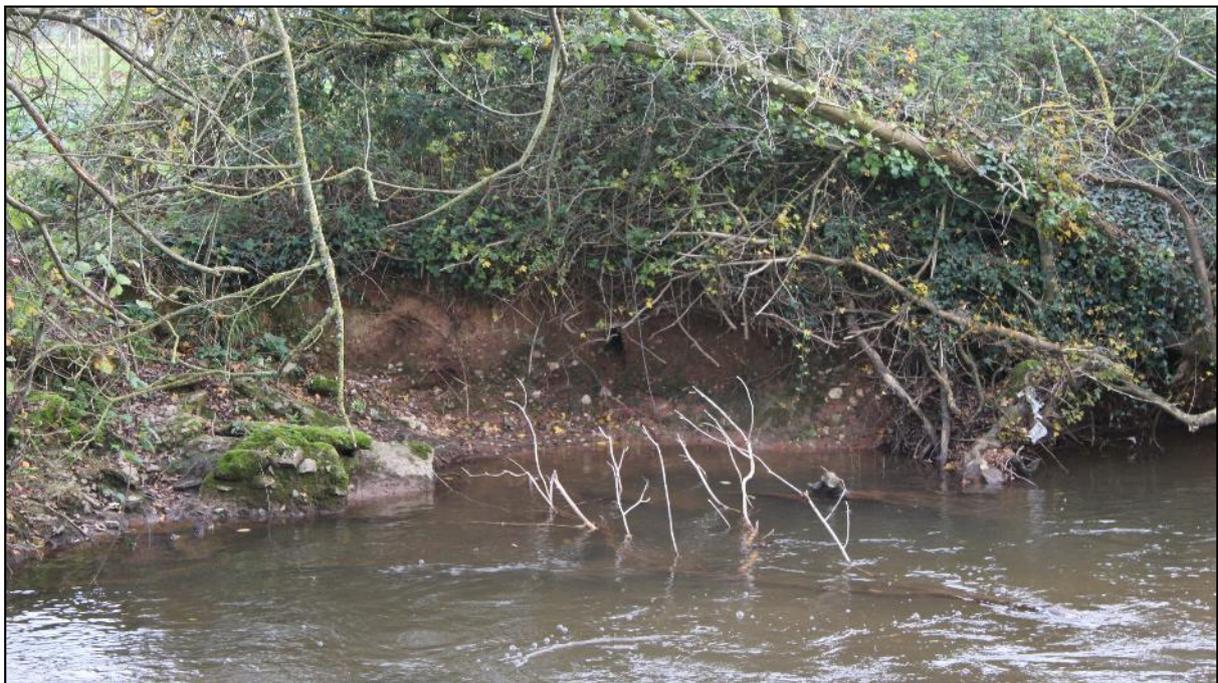
Below the weir the channel abruptly widens out in a similar scenario to the footbridge upstream (see Figure 6). The eddying flows during spate conditions have led to bank erosion on the left bank (Figures 16) which appears to have been exacerbated by dense shade inhibiting vegetation growth and by dogs scrambling up and down the bank.

Figure 16: An eroded bay on the left-hand bank on the weir pool

Fortunately, the bankside trees that are presently casting shade over the banks also give rise to a cost-effective solution to repair the erosion. Coppicing the surrounding hazel (*Corylus avellana*) will allow direct sunlight onto the banks and will also give rise to coarse woody material which can be used to create a brushwood 'marginal mattress' to patch up the erosion and provide a growth medium for marginal plants (Figure 17).

1. The hazel and small trees around the eroded bay should be coppiced to allow more sunlight onto the banks. Arising brushwood should be retained and used to repair the erosion.

2. Repair the eroded bay by installing a brushwood marginal mattress via the following methodology:
 - Drive wooden (ideally sweet chestnut) stakes securely into the bed at approximately 800mm centres to form the outer edge of the mattress.
 - Densely back-fill behind the stakes with the coppiced brushwood to approximately average summer water level.
 - Drive a second row of stakes through the brushwood and into the bed to form an upper terrace at the rear of the structure
 - Back-fill the upper terrace with coppiced brushwood.
 - Lay straight rods of hazel across the structure and secure to the stakes with galvanised fencing wire and staples.
 - Drive the stakes further into the bed to compact and secure the brushwood (Figure 21).

This solution should require no more than one or two days work, should cost no more than £500 - £1000 and will be significantly more sensitive to the river ecosystem than a hard-engineered solution. This type of solution is also likely to be more successful as the brush absorbs and slows flow against the banks, rather than deflecting erosive forces downstream.

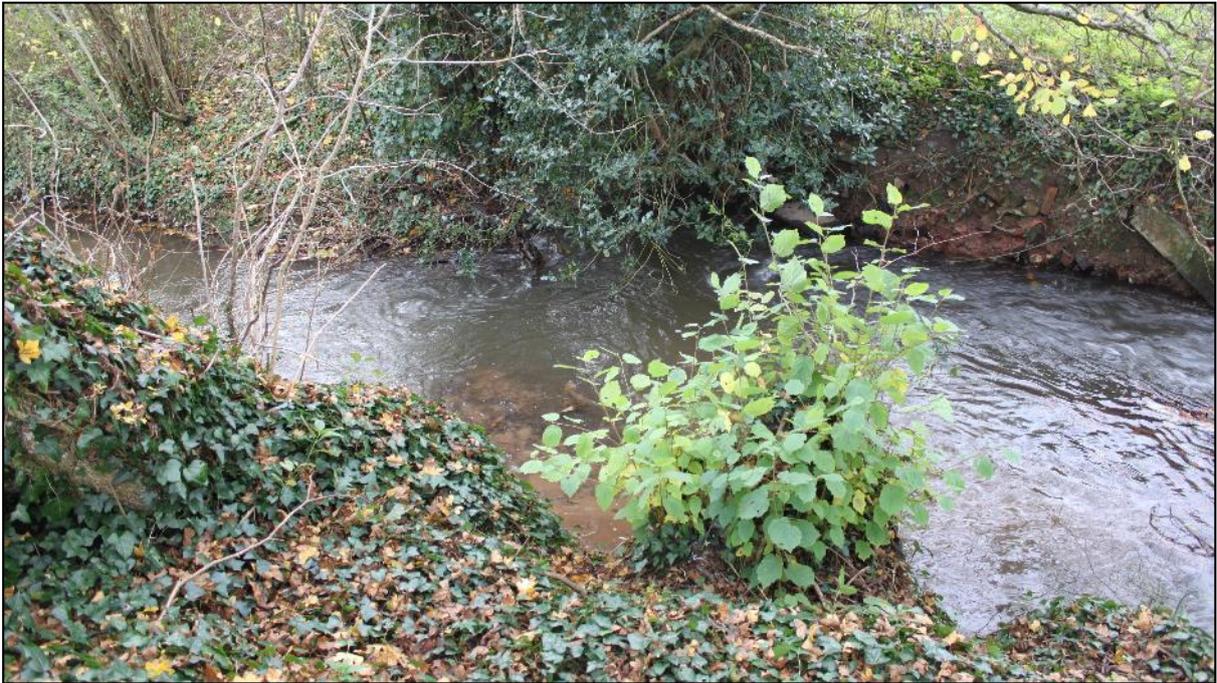
Downstream of the weir the river is free-flowing, allowing natural morphological processes to take place. As a result the channel becomes more sinuous and forms a natural sequence of pools and riffles (Figures 18 & 19).

Figure 18: The river downstream of the weir has a greater diversity of depth, width and flow conditions.

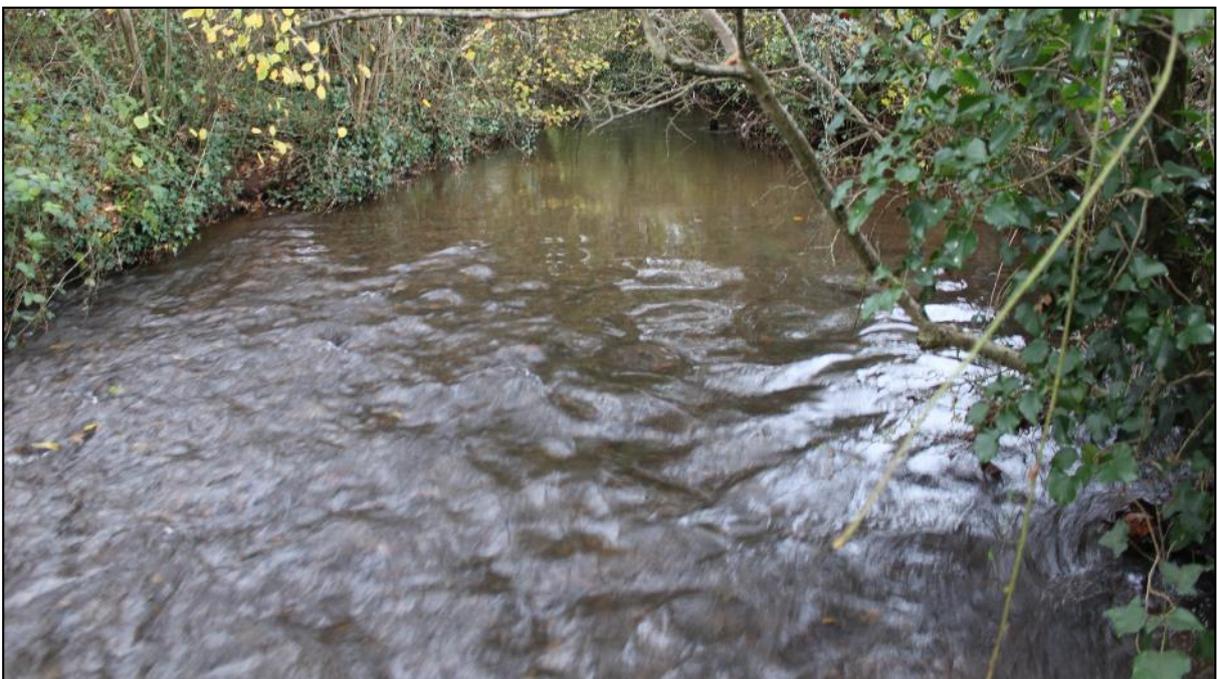
Figure 19: A natural pool and riffle sequence is important for providing habitat for different fish species and life stages

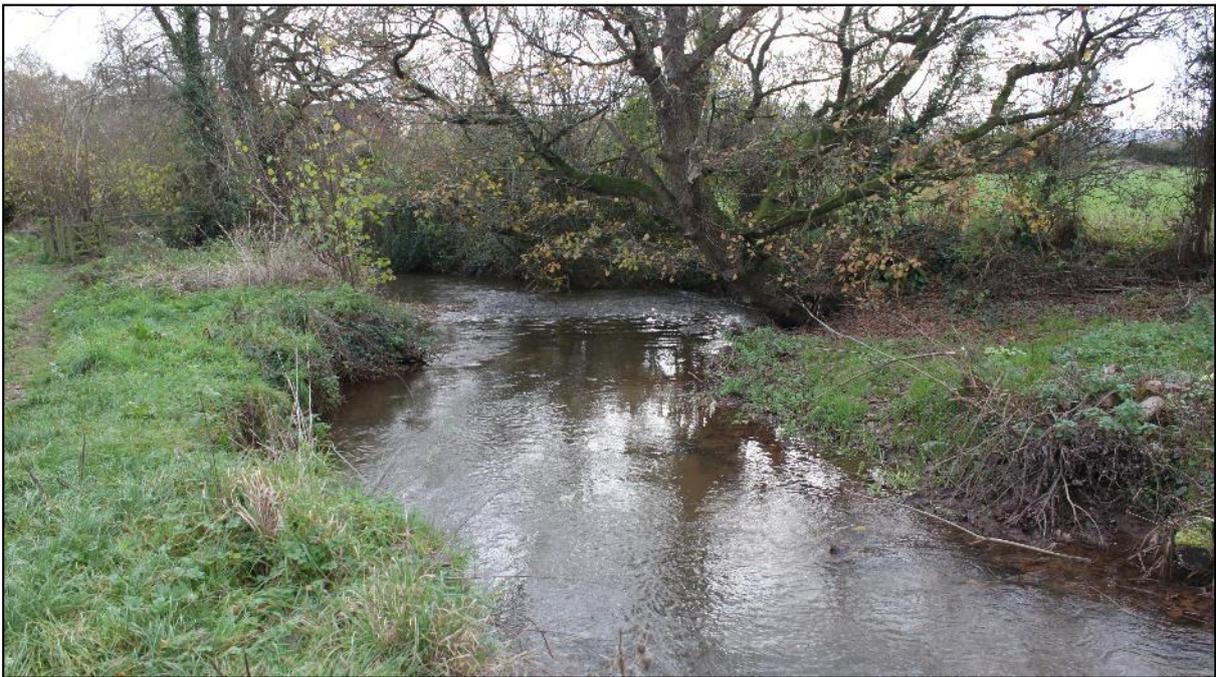
The full extent of the river visited was accessible via a footpath along the bank and parts of the river towards Stembridge Way are especially attractive (Figure 20). This could provide an opportunity to undertake a community-driven project that would improve the river for wildlife and also as a public amenity to be enjoyed by the local community.

Figure 20: The Halse Water near Stembridge Way is an attractive landscape feature which should be enjoyed by local people

4. Engage with the local community and gauge what interest there might be in a WTT River Habitat Workshop as a means of galvanising interest in the river and its wildlife. A small team of regular volunteers to undertake simple litter picks and perhaps even conduct monthly invertebrate samples will benefit the river and will also reduce the time between potential blockages, such as the log at the upper footbridge (Figure 8) and the large fallen tree (Figure 10), occurring and being reported and dealt with. A WTT Habitat Workshop will also provide an opportunity to educate local people about the difference between beneficial 'woody habitat' features and scenarios where woody material could potentially raise the risk of flooding. Details of the Anglers Riverfly Monitoring Initiative, a method for assessing water quality through the invertebrate fauna, can be found at the Riverfly Partnership website www.riverflies.org/.
