Advisory Visit

Harper's Brook, Northamptonshire

January 2018

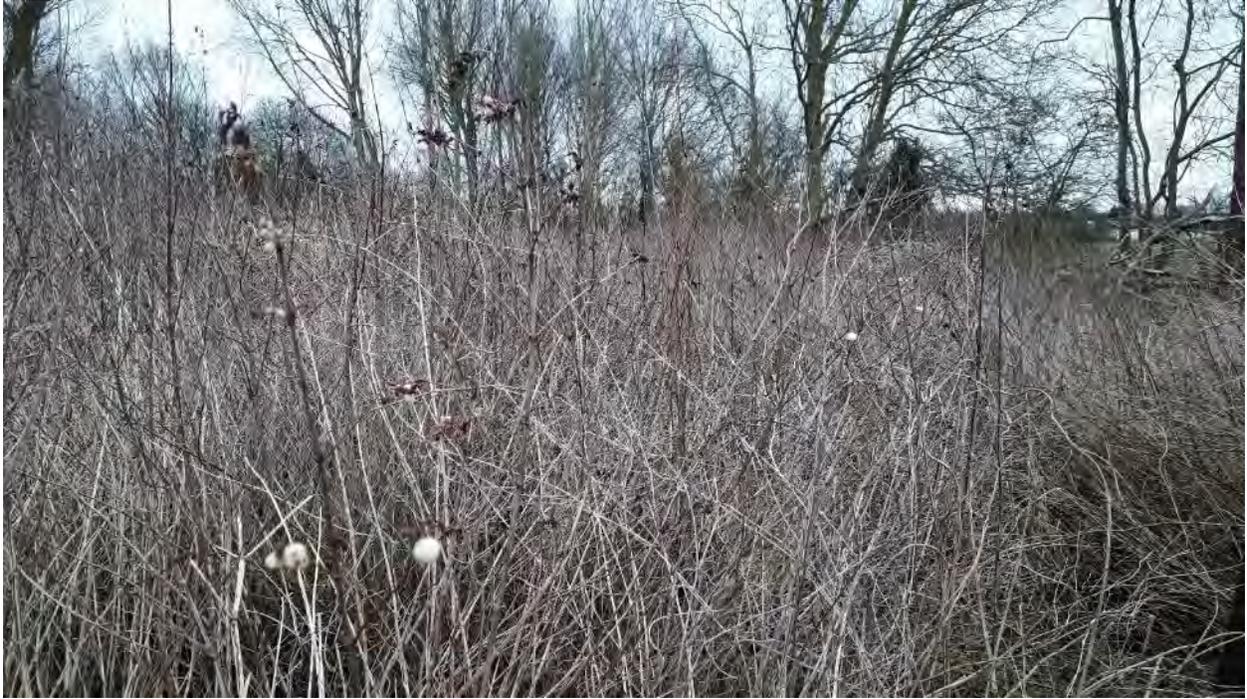
Picture 2 – Following clearance of trees from the mill island the non-native plant snowberry has become dominant to the point where it is out-competing much of the native flora. Its control and eventual eradication should be undertaken.

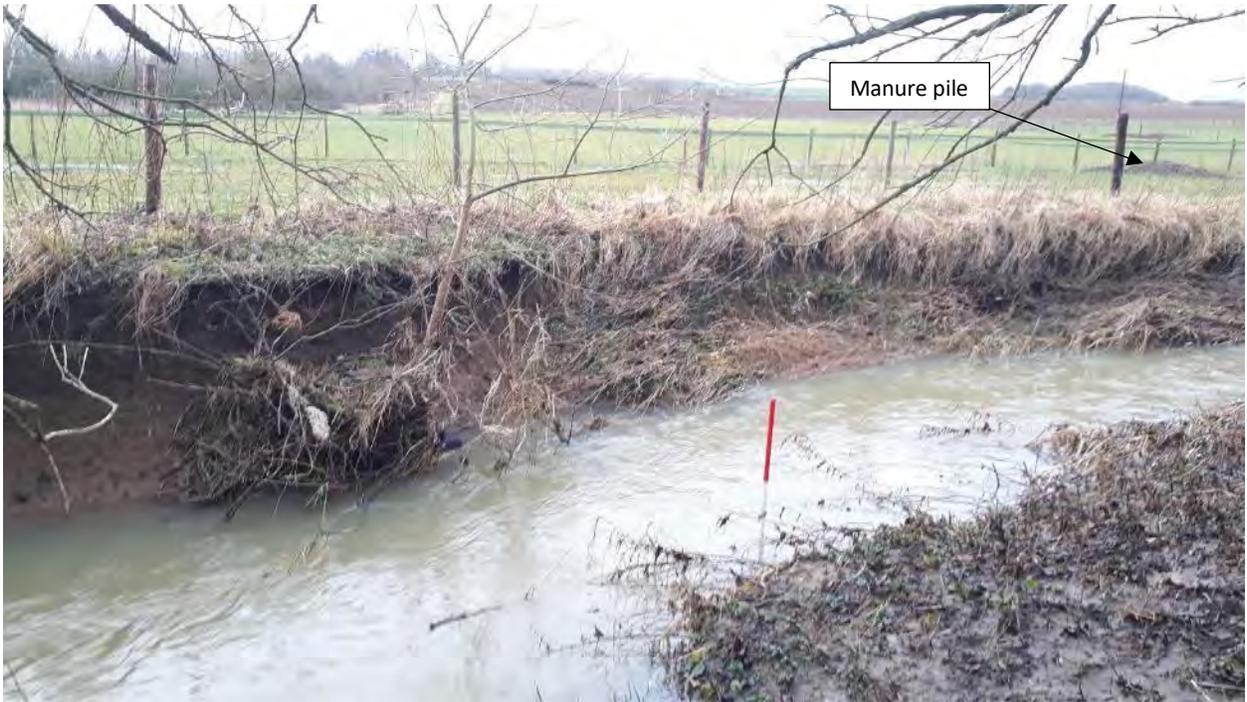
Picture 3 – The by-pass channel showing the proximity of the fence to the watercourse and the undercut bank that is developing. Note the manure pile in the field.

The grazed pasture was very short with no buffer zone between it and the by-pass channel. The grazing had acted to suppress and remove young trees and consequently the RHB was suffering from erosion and was being undercut.

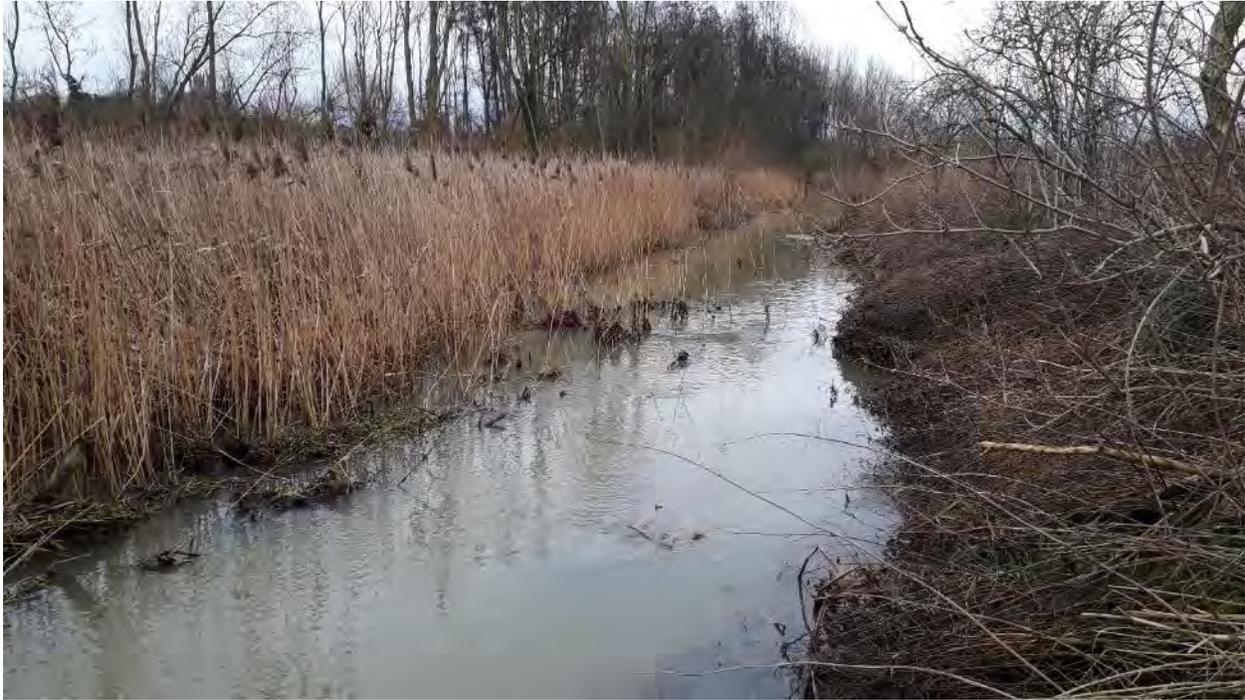
Picture 4 – The mill channel with encroachment by common reed.

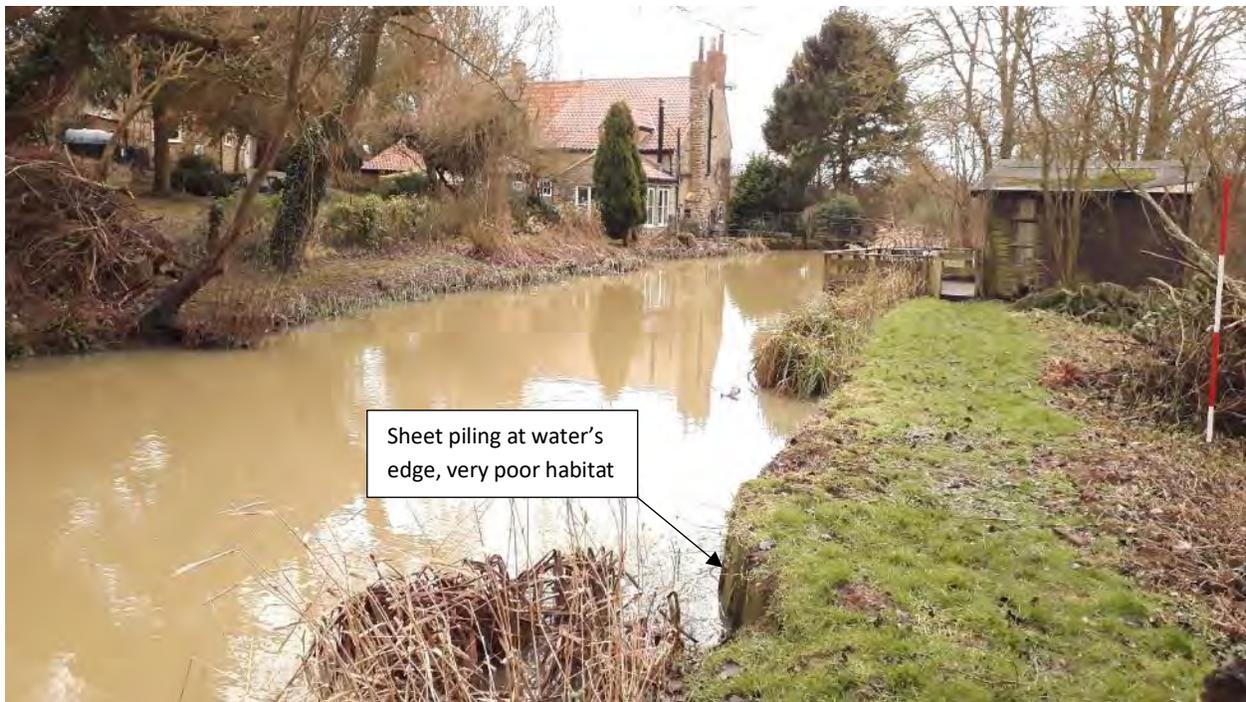
It would appear that the mill channel is suffering from siltation as a result of the impounding mill sluices and a lack of gradient. Furthermore, flow entering the mill channel reduces its velocity as a consequence of the leakages through the embankment.

Picture 8 – A view of the mill channel looking to where Lowick Mill would have once stood.

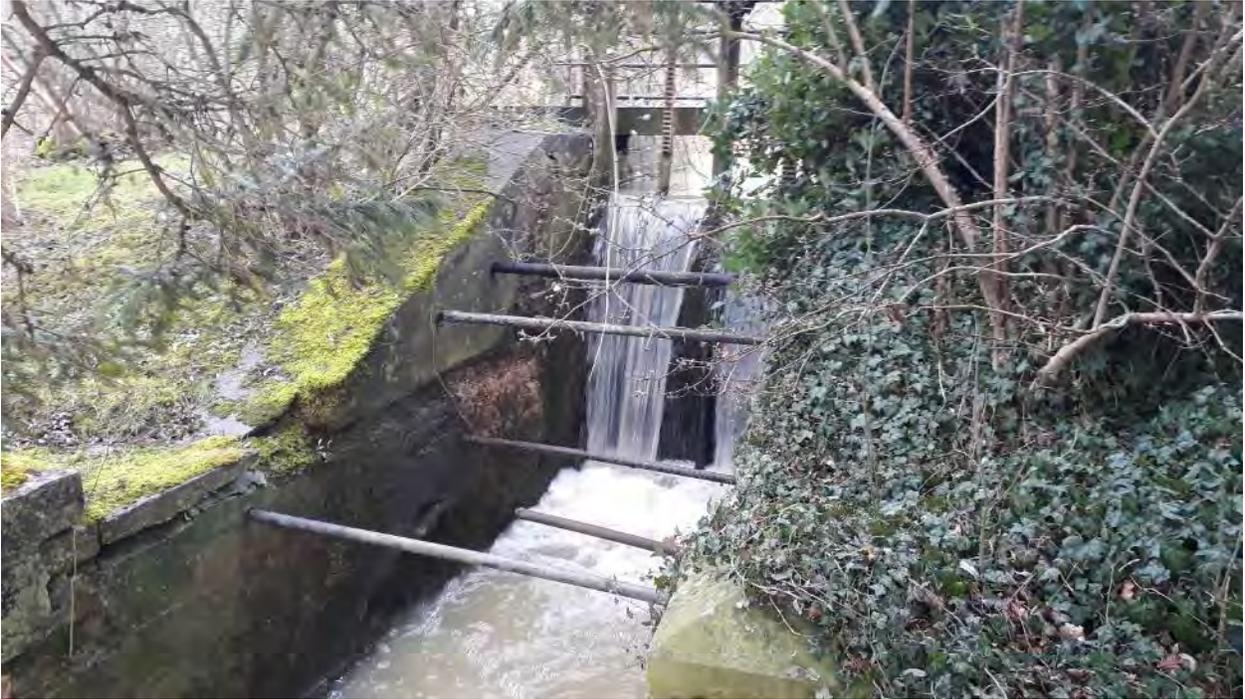
Picture 9 – The sluice gates viewed from downstream. Note that once closed from the bottom the flow moves over the top of the gates creating a fixed height within the mill channel.

It is very doubtful that fish would be able to traverse the sluice gates when initially opened due to the velocity of water over the smooth stone plinth, and its lack of cover and roughness to aid fish passage. However, once the mill channel has discharged its stored water and conveys only the river flow, the velocity may be less, thus enabling fish to traverse the sluice gates.

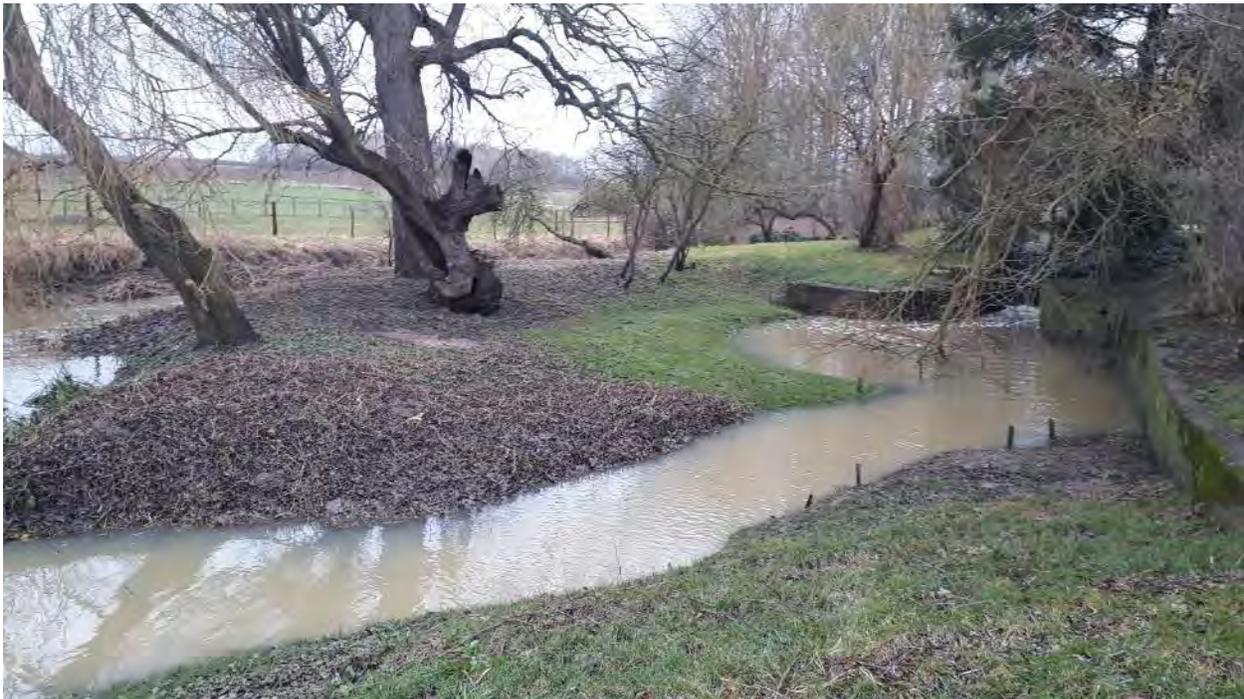
It would appear that in recent years the overall flow through the sluice gates has reduced, resulting in a reduction in scour of the mill pool. Deposition within the mill pool has enabled vegetated berms to extend out leading to a natural reduction of the pool.

Picture 11 – The mill channel and the mil pool. The small size of the pool relative to the head of water suggests that main scouring flows have been directed down the by-pass channel for many years resulting in natural encroachment of vegetated berms into the pool.

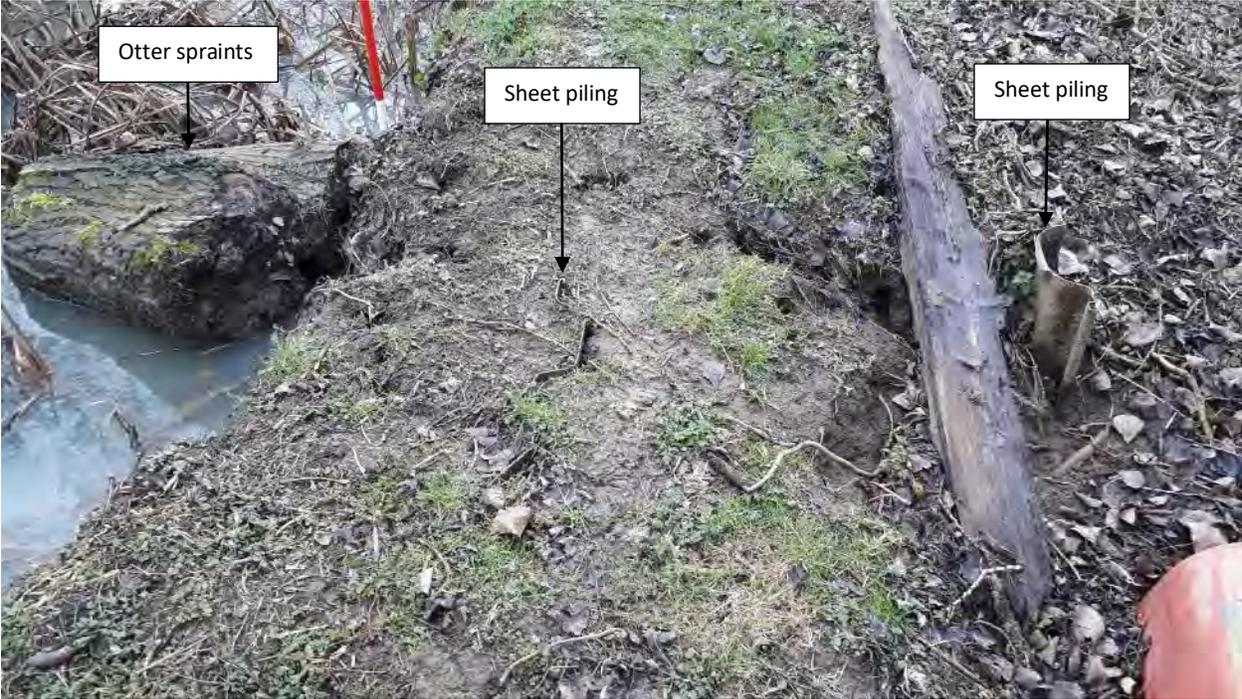
The mill channel is a particular point of concern for the landowner as its embankment is starting to fall into a state of disrepair. There was a significant amount of water flowing from the elevated mill channel to the lower over-flow channel. In places the flow was following the path of tree roots which had rotted away to enable pipeflow, but it was also evident that in high flow periods the mill channel embankment had been overtopped resulting in scour breaches forming. These breaches have now caused low spots which continue to act as water pathways in flood periods. It was reported that during the time of tree felling upon the island, a large number

of tree stems blocked the mill channel, causing the over-topping of the embankment, and that the situation has continued to decline since then.

Picture 12 – A leak point from the mill channel. Note that sheet piling has previously been used in a manner where it is set within the bank (and behind it) rather than fronting the water where it would remove habitat. If sheet piling is to be used this approach should be adopted.

The mill channel embankment was repaired in 2004 by the Environment Agency who used sheet steel piling (see pictures 8 & 12), and the work is still considered satisfactory. The landowner reports that the Agency are not in a position to undertake such work. The use of sheet piling to fix the leak points would appear to be the most sensible approach as it would give a durable and watertight finish and piling could be driven into the centre of the embankment (subject to detailed engineering survey) so that the natural frontage of the banks are retained. If sheet piling had to be delivered near **the water's edge** then it would be possible to mitigate its harm through the

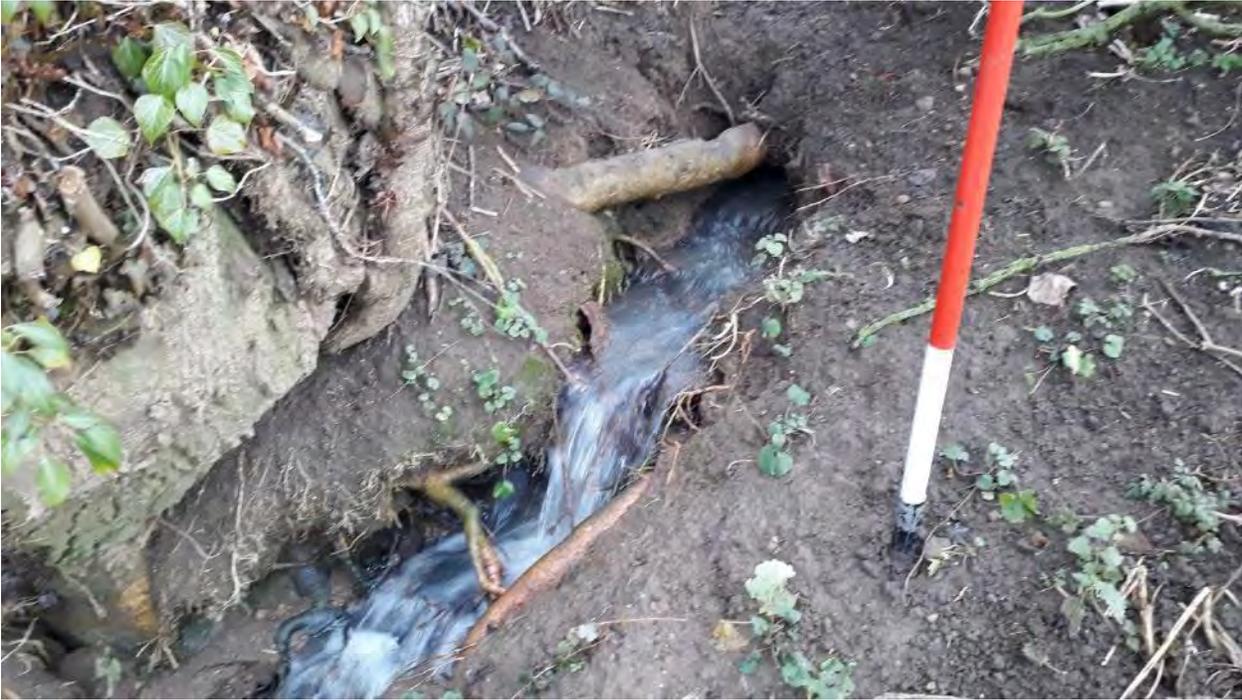
Picture 13 – Significant pipeflow originating from the mill channel.

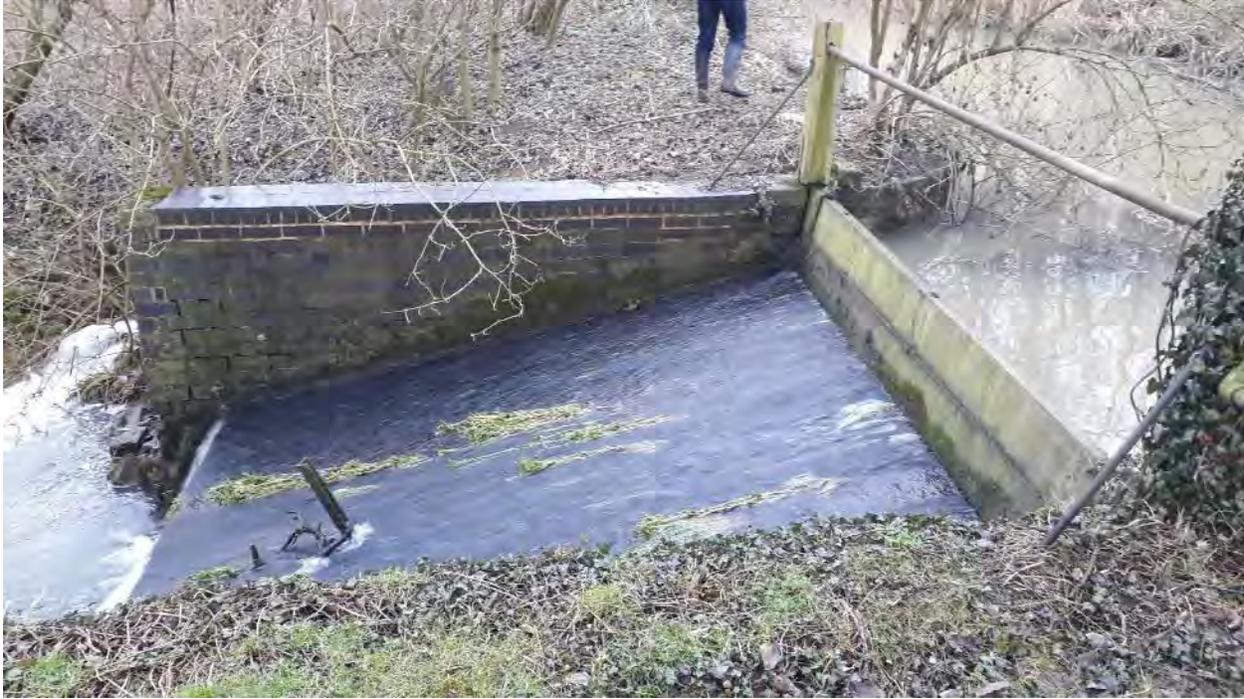
At the upper end of the over flow channel was a weir which had a width of ~3.5m and a fall of ~1.7m. Whilst its crest and face appeared in good order, the brick work supporting it was failing. The weir is shown on historical maps dating back to **1800's** and would have taken the over-flow from the mill channel diverting flow around the mill.

Picture 16 – The weir with little flow going over it. The boards could be lifted to allow a greater flow over it.

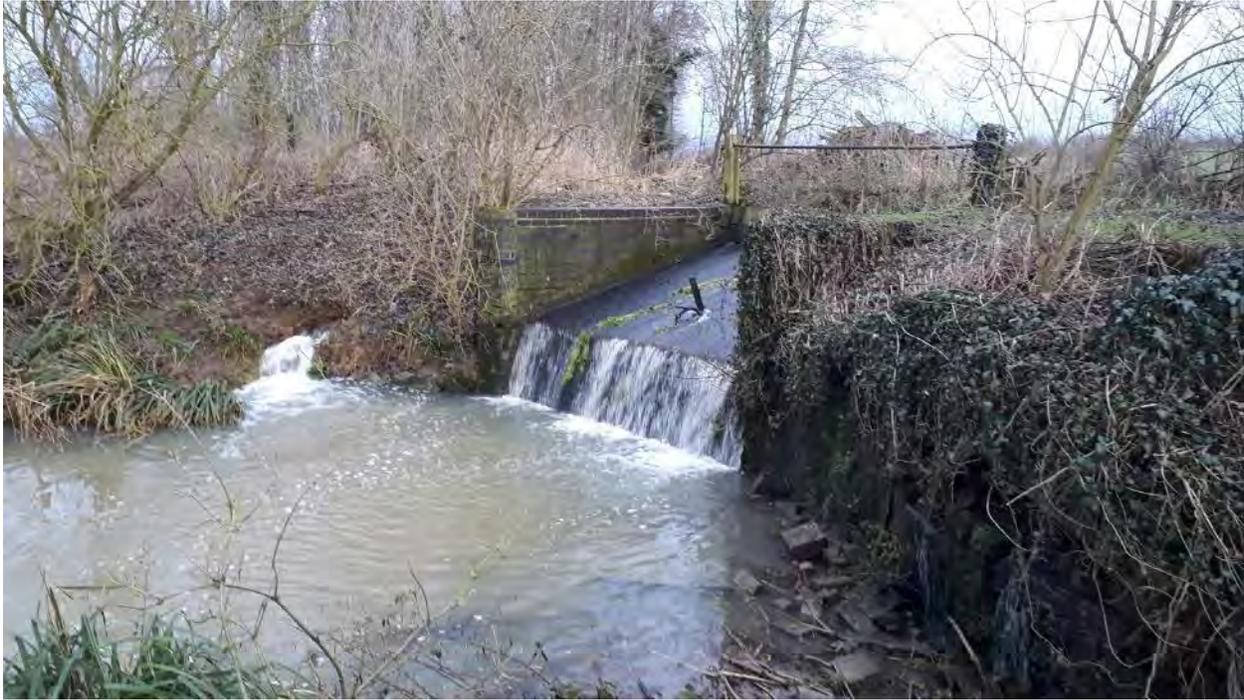
The weir showed a lot of pipeflow as a result of tree roots having penetrating into the brick work. On the RHB of the weir was a very large hole that was passing a large volume of water (but not in a manner to facilitate fish passage). Consequently flow over the weir was reduced. The weir presented a total barrier to fish passage at all levels of flow.

Picture 17 – Note the large volume of water emerging from the RHB of the weir.

The weir at the start of this channel is in a poor state of repair (see pictures 17 & 18) and it is possible that its supporting walls could collapse leading to a total loss of water in the mill channel. Only by dropping the level in the mill channel can the hydraulic pressure be reduced on the weir structure.

If costly repairs are to be avoided then removal of the weir might be worthy of consideration. With the weir removed the over-flow channel could take the place of the by-pass channel but the fall of ~1.7m at the weir would need to be overcome. That could be addressed by raising the bed level of the over-flow channel to bring it up by ~1.7m over a suitable length (most probably the full ~110m) so that an acceptable gradient is achieved. By

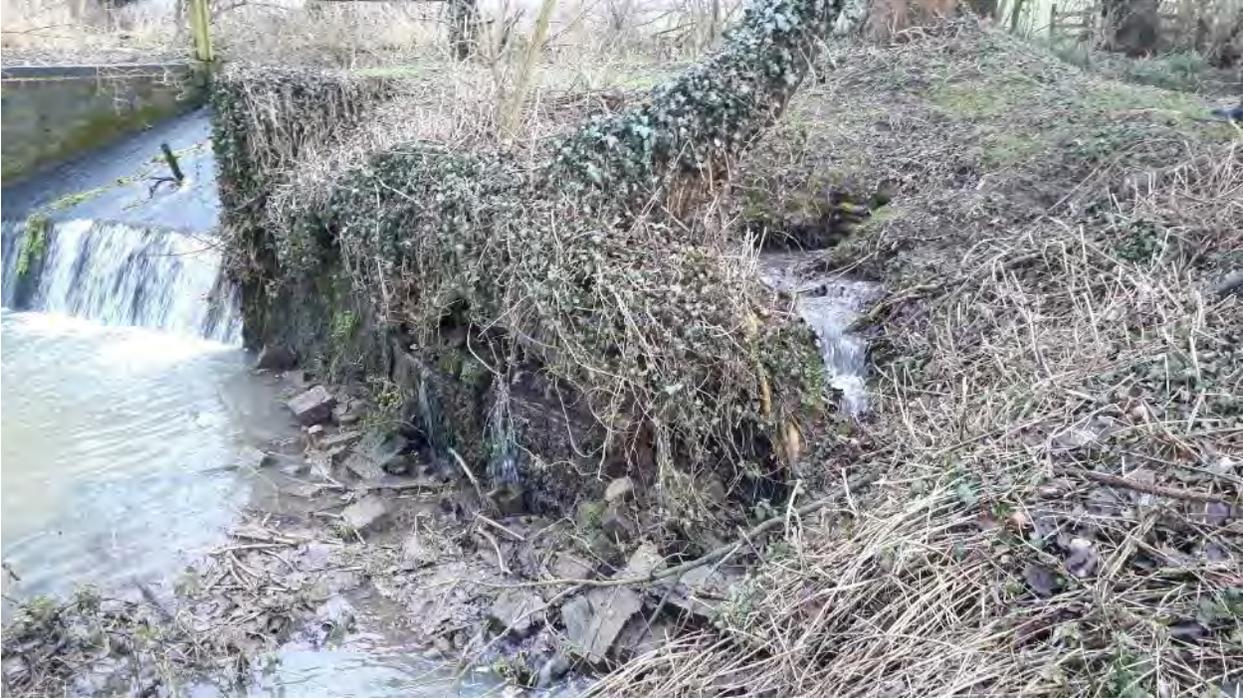
Picture 18 – Note the failing brickwork of the weir support walls and the significant pipeflow emerging from behind it.

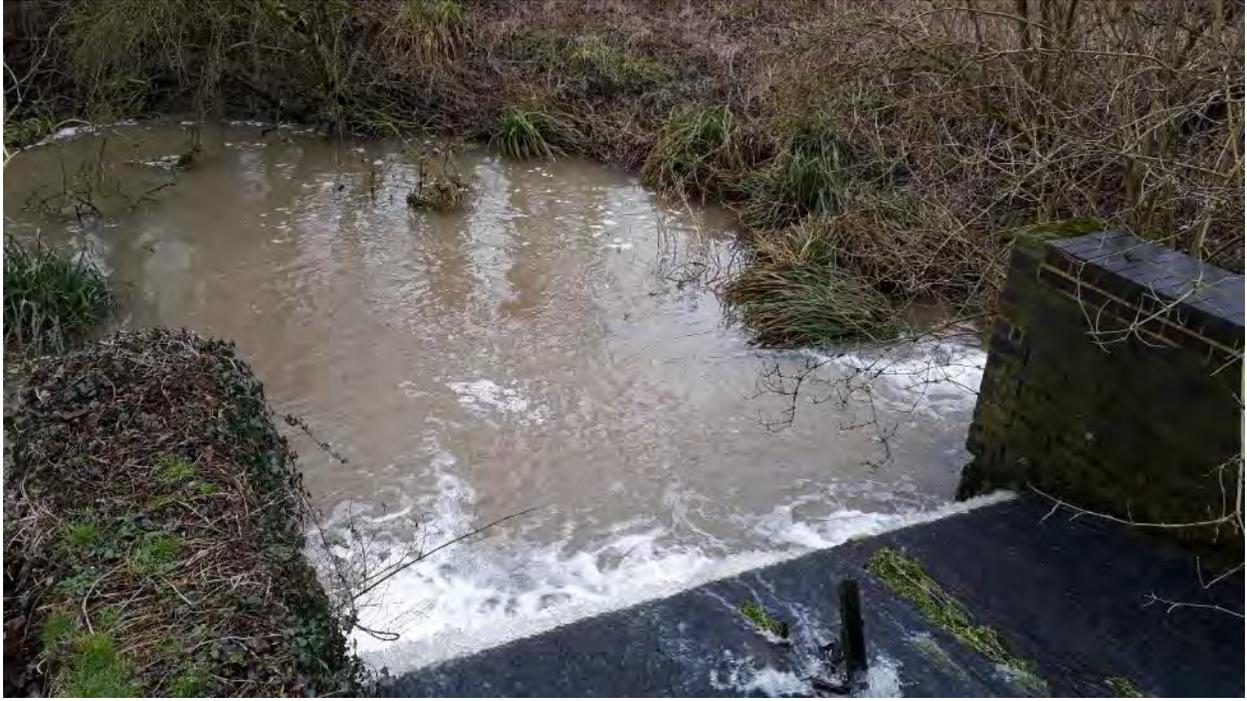
Downstream of the weir was a relatively large scour pool which would provide depth cover for various species of fish particularly adult brown trout. However, flow entering the weir pool was dispersed as a result of leakages through the embankment. The weir no longer conveyed the total flow that enters the weir pool. Consequently, it is doubtful that the weir pool receives the same scouring flow that it formerly did.

Picture 19 – The weir pool which currently receives little flow direct from the weir. It was not possible to assess the depth of the pool but if it were still receiving scouring flows then it may provide important depth cover for fish.

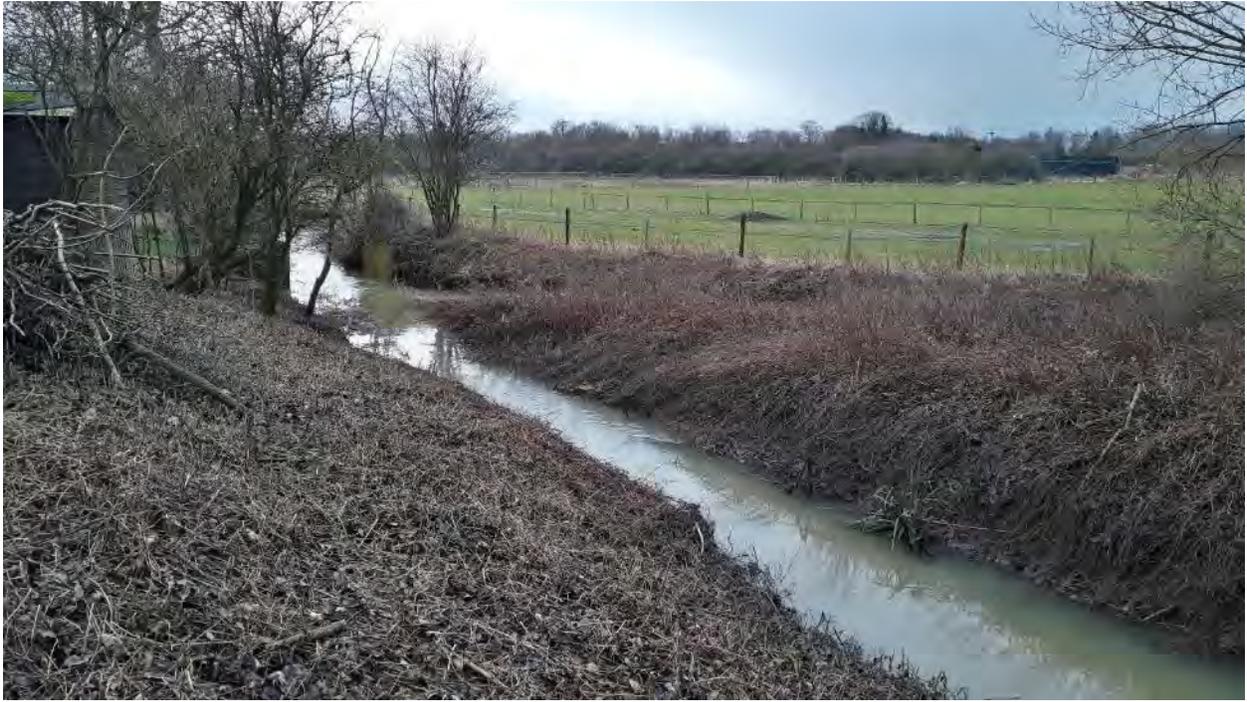
Habitat in the over-flow channel was poor with little flow diversity. Marginal vegetation had been pushed flat by the recent flood but the ruderal vegetation suggested that in mid-summer the growth is such that it suppresses any true marginal plants and creates a partially shaded channel with little complex habitat at water level.

Picture 20 – The poor habitat of the over-flow channel.

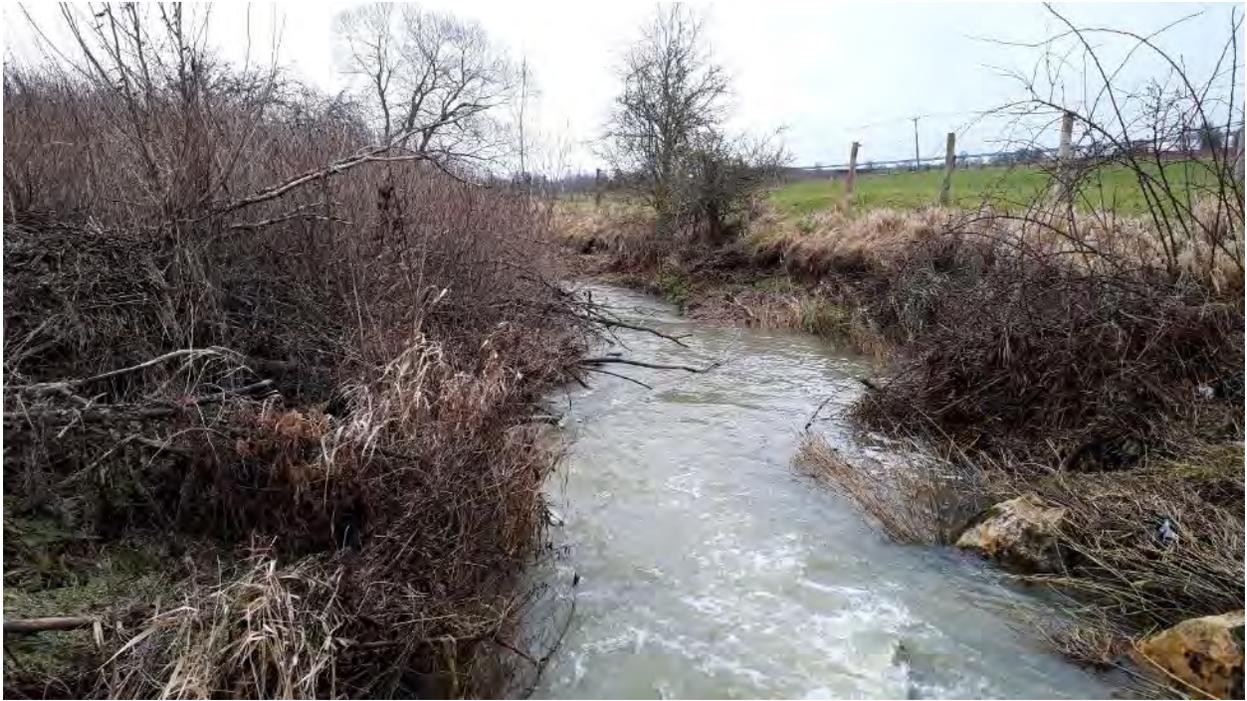
Picture 22 – The by-pass channel as it leaves the rock revetment reach. Note that rock revetments do little to absorb and subsequently slow flow, thus the energy is moved directly on to the reach downstream. This may lead to increased scour (which in this case is illustrated by a widening of the channel).

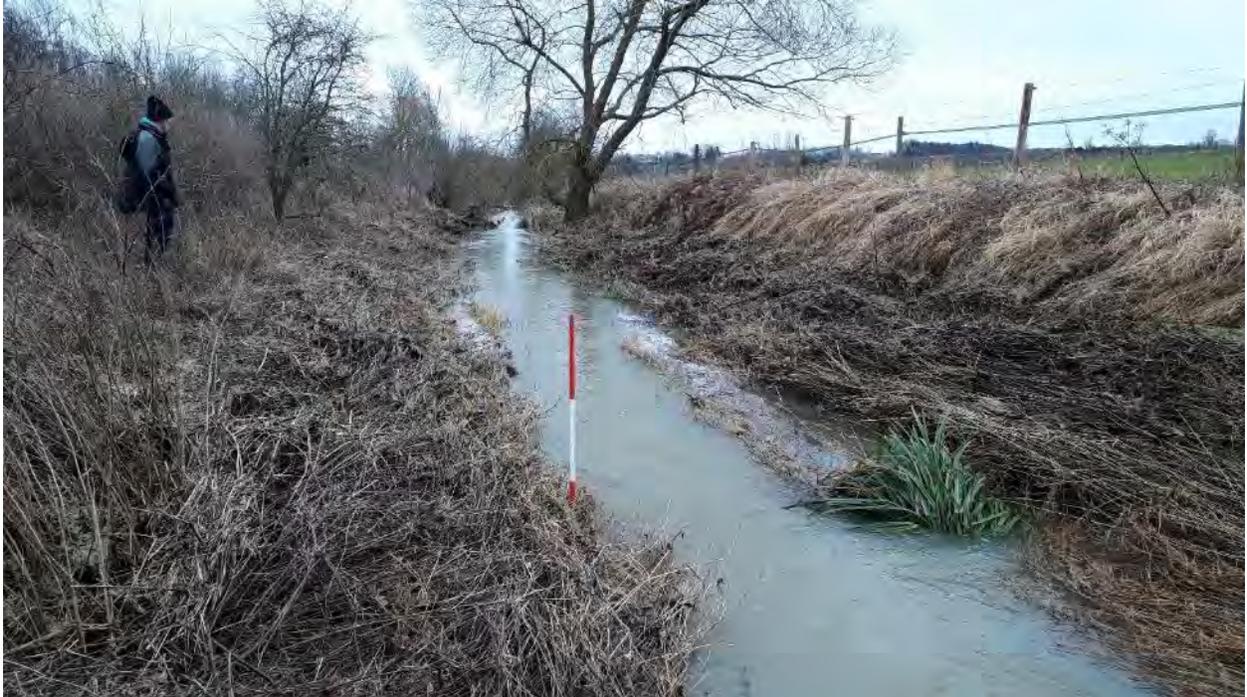
Picture 23 – Note how the flood flow has caused the marginal vegetation to be flattened. Grasses and reeds cannot hold back flow in a river with gradient; the weight of water will always push its way through. The vegetation will entrain fine sediment which is then colonised by plants (such as the pendulous sedge).

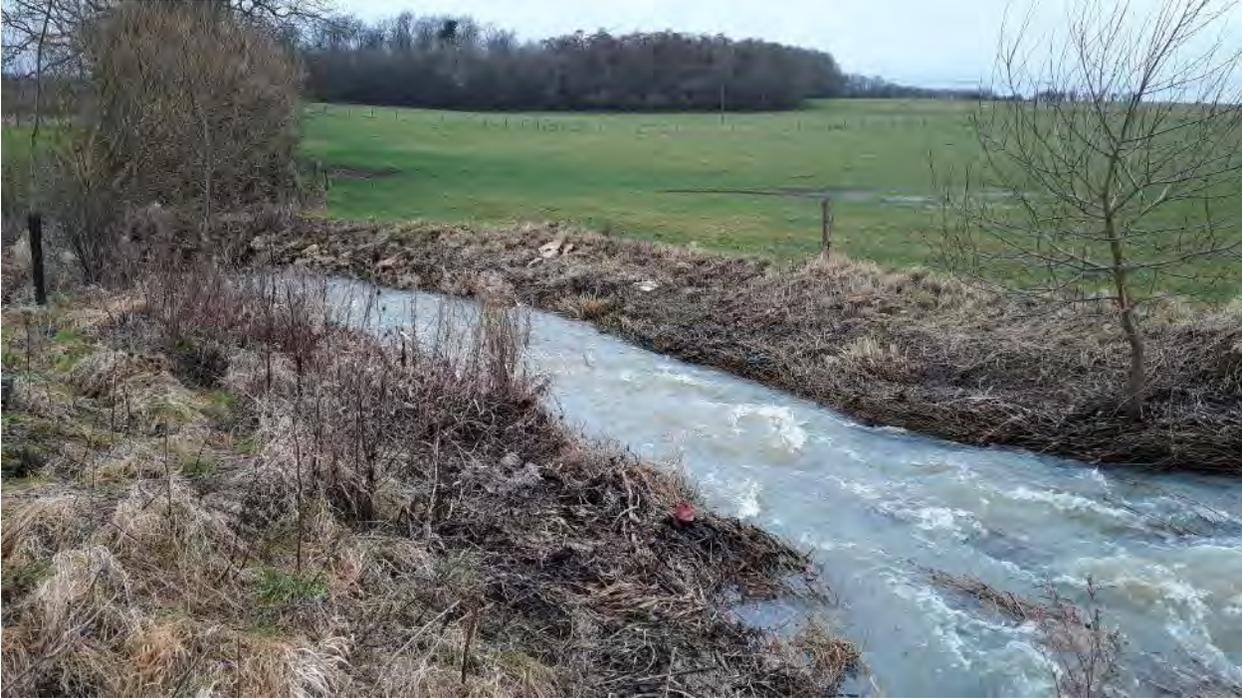
The stone weir caused a rapid flow to cascade down the by-pass channel. At the time of the visit the cascade was considered passable to brown trout, whether it would be passable to coarse fish species is not clear. The rapid water continued for ~10m and there were limestone blocks armouring the banks to reduce scour and prevent any channel movement. The limestone blocks offered little in the way of marginal habitat, but where some blocks had fallen (or may have been strategically placed) within the channel they had created small areas of pocket water which could ease the passage of many fish species. Due to the water colour and level it was hard to fully evaluate this impact; it is possible that low flow periods could pose problems to fish passage. **In terms of a full assessment of the structure's** passability a return visit would be required in low flow conditions.

Picture 24 – The start of the by-pass channel. The flow was turbulent but considered passable to adult brown trout.

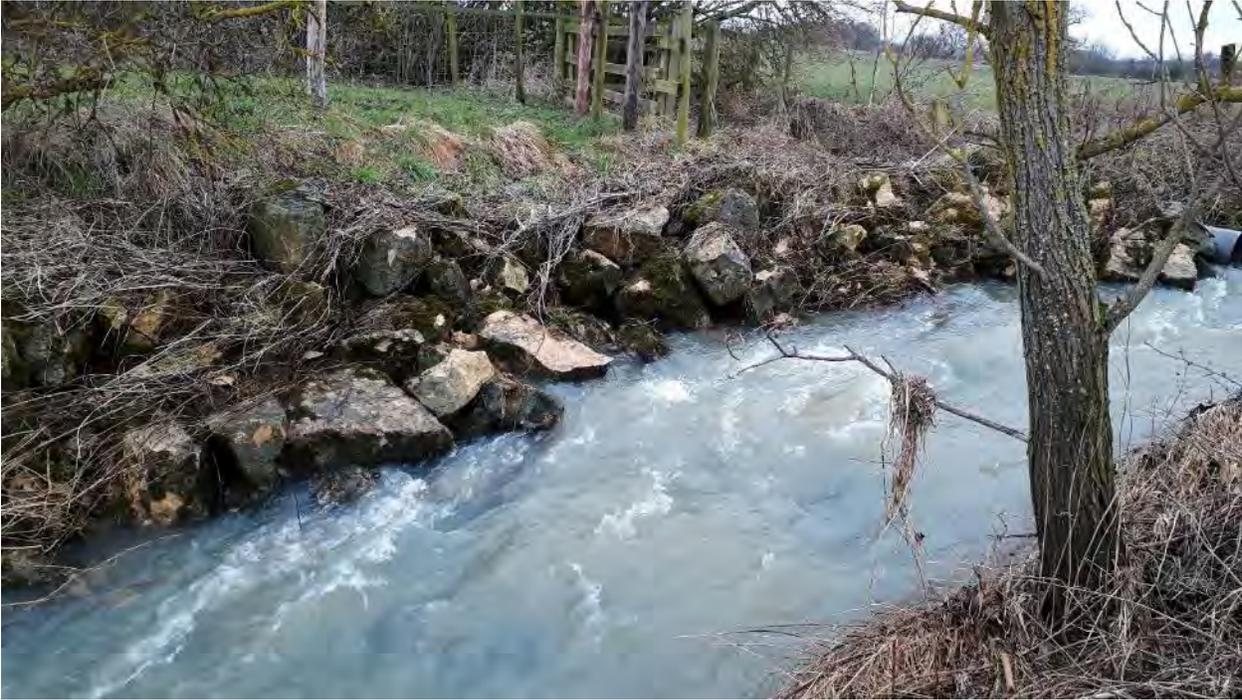
Picture 25 – Rock revetments used to protect the bank from scour, these actually pass the turbulent flow downstream. In-channel cover was provided by the occasional large rock.

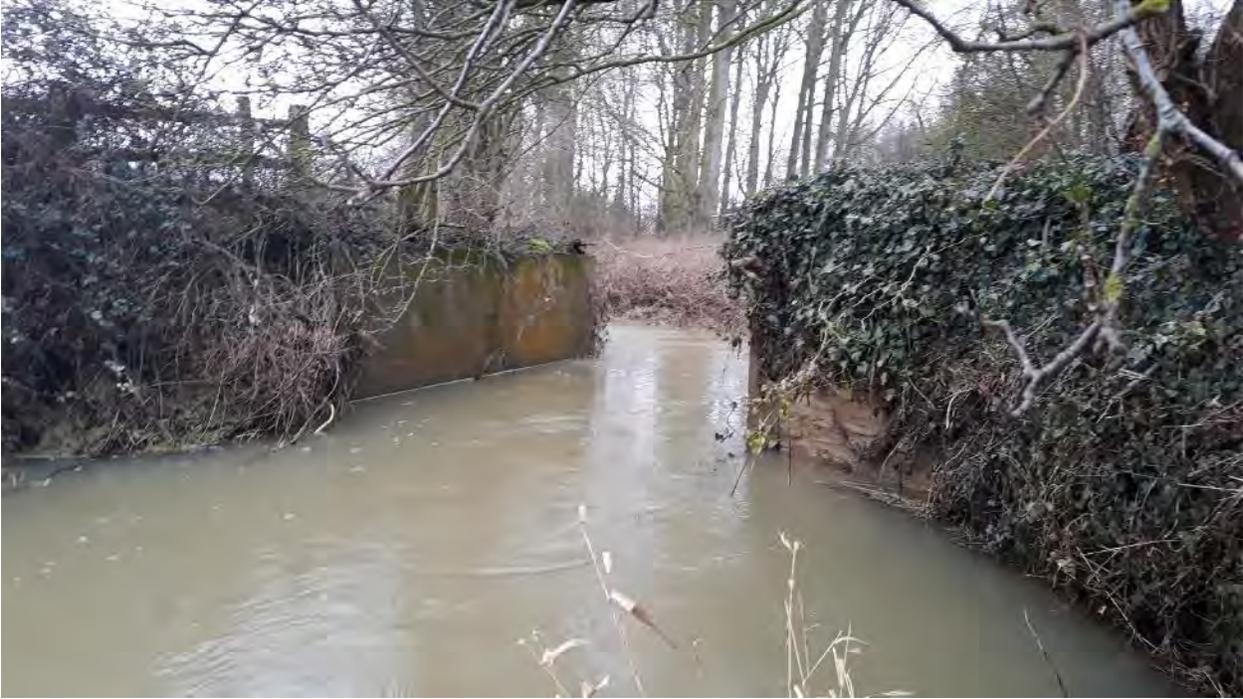
Near to the end of the by-pass channel was a defunct weir. Its purpose was believed to have been associated with a hydraulic ram for water supply. The weir structure no longer held back a head of water but its brick side walls remained and a smooth concrete bed ~3m was present. The defunct weir was not thought to present a barrier to fish except in very low periods when the level over the concrete may become an issue.

Picture 29 – The defunct weir which did not appear impound flow at the time of the visit.
