Advisory Visit

Harper's Brook, Sudborough, Northamptonshire

September 2018

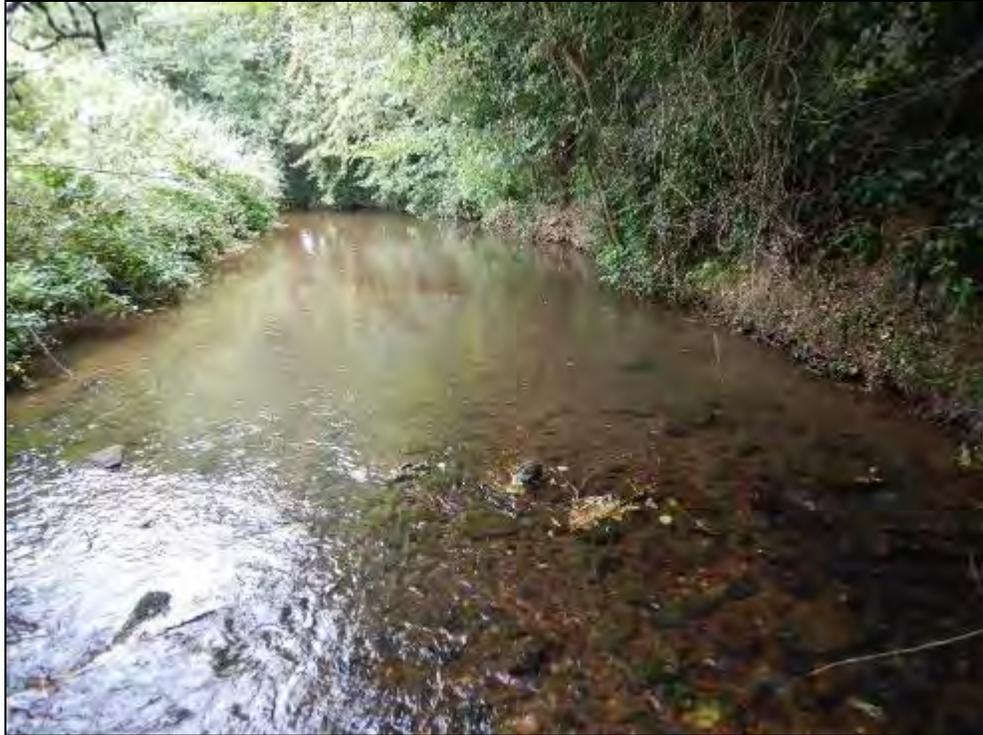
Pic 2 – The bed of the brook is dominated by coarse to very coarse substrates (16mm to 64mm) which can be utilised by gravel spawning fish such as brown trout, dace and minnow.

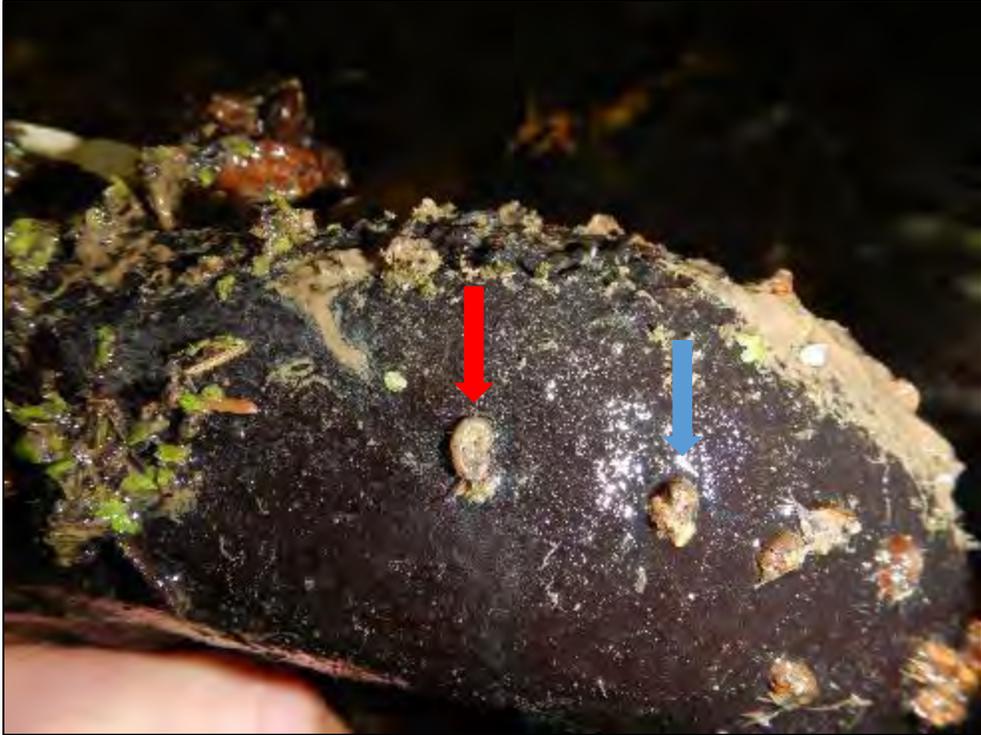
Pic 3 – Stone turning revealed a low number of both caseless (red arrow) and cased caddis (blue arrow).

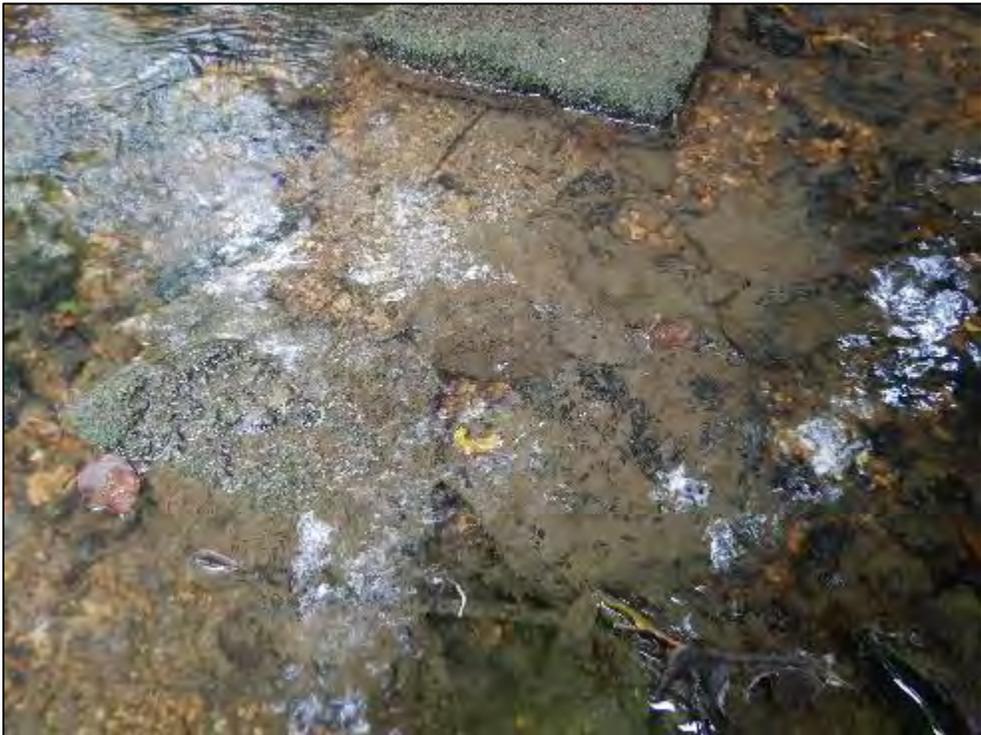
The bed level undulated as a result of a pool and riffle sequence interspersed with deeper (~0.6m) glides. A few large stones within the upper most riffle were turned to investigate the occurrence of aquatic invertebrates. Stone turning revealed an impoverished invertebrate community. For example, one would expect to find a high number of freshwater shrimp (*Gammarus* spp.) feeding on the leaf litter falling from riparian trees, but they were largely absent. No larvae of upwing mayflies (*Baetis* spp.) were observed. However, it was encouraging to observe some caseless caddis (*Hydropsyche* spp.) and cased caddis (*Agapetus* spp.; pic 3). Hoglouse (*Asellus aquaticus*) was observed, a species that is indicative of poorer water quality. Interestingly, the stone turning released a high volume of fine silt which was trapped in voids beneath stones. It is these voids that are usually occupied by a range aquatic invertebrates. It is also of concern that no bullhead or stone loach fish were found. The silt is degrading to the river environment (pic 4).

Pic 4 - Fine silt was found beneath all stones turned. Silt has to ability to smother and infiltrate the river bed reducing the available niches for invertebrates and small fish.

The gravel was found to contain high amounts of fine sediment. The approach of gravel jetting (where a water pump is used to deliver water into the gravel at high pressure using a metal lance) could be deployed to wash out the fines. However, this only delivers a quick fix and does not address the source of the sediment. It would be better to instigate the approaches detailed above to see if they bring about natural gravel sorting and fine sediment transfer prior to deploying gravel jetting. Following such works, it would be necessary to identify the original **cause of the gravel's deterioration so a sustainable solution can be found.**

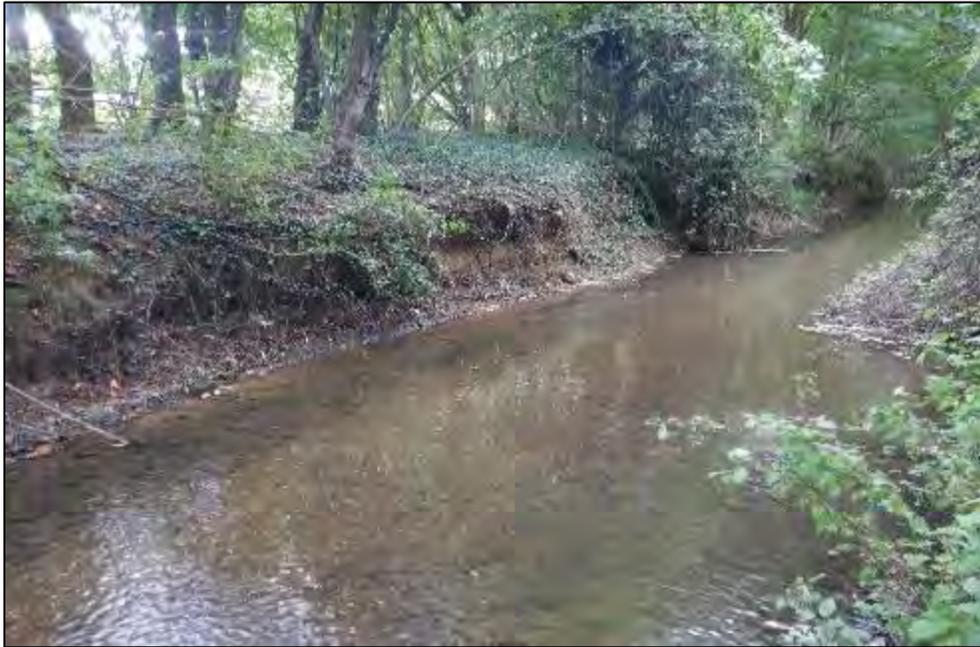
Pic 5 – Note how the clay banks are able to sustain a steep angle without slumping. The majority of the river bank within the reach is stable and not inputting fine sediment through collapse.

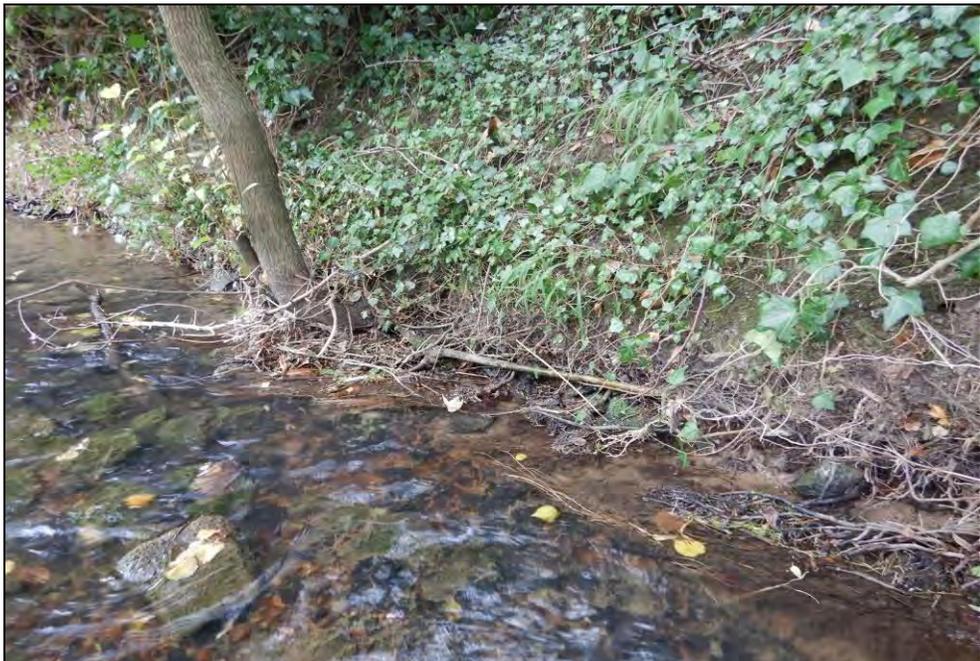
Pic 6 – Tree roots (even when fine and fibrous) increase bank stability and provide cover at water level.

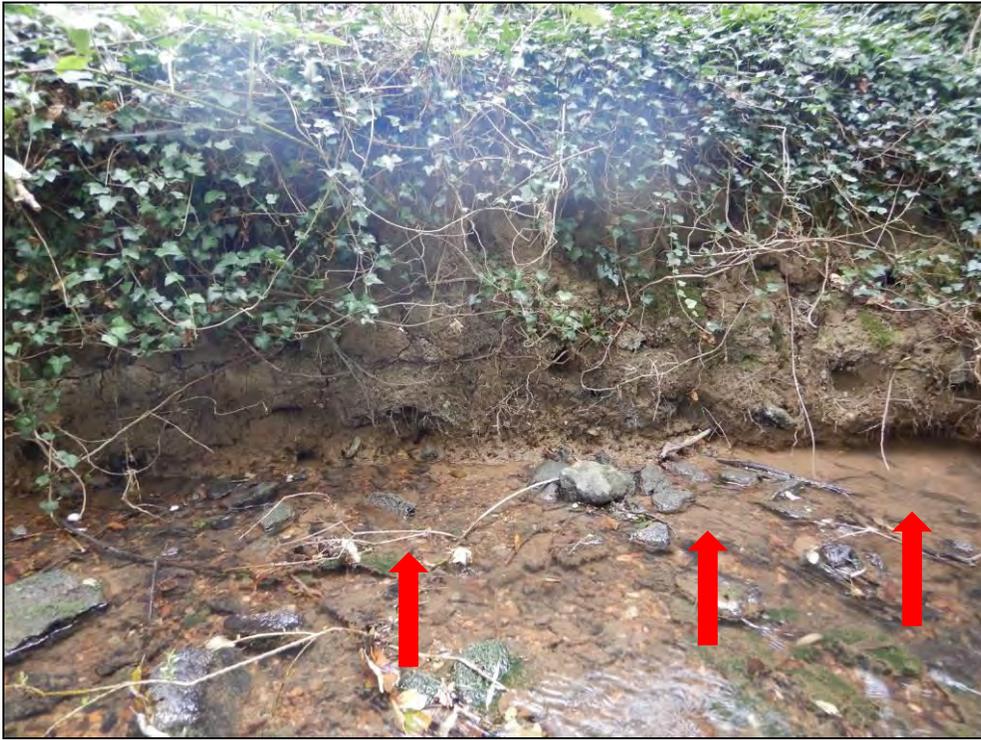
Interestingly, at one location, a number of holes were observed in the bank at water level. First thoughts turned to the invasive non-native American signal crayfish but none were found during the stone turning investigation. The holes are thought to be from bank voles (not being big enough for water voles).

Pic 7 – A number of small burrows were observed, in this case they are suspected to be bank voles. Note the accumulation of fine sediment amongst the marginal stones (red arrows).

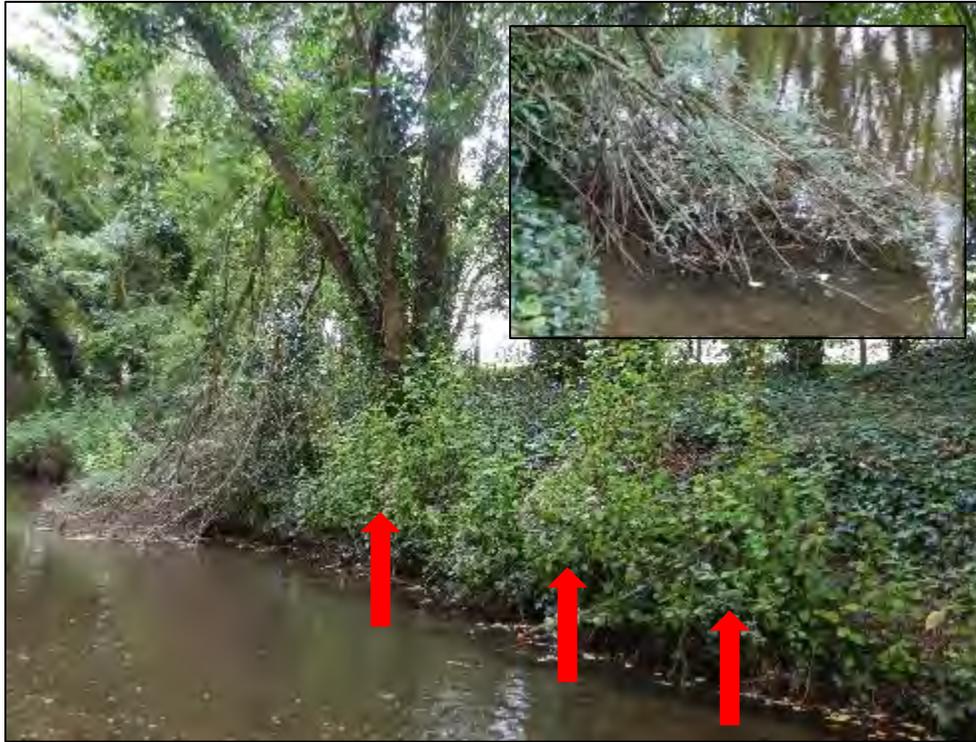
Pic 8 – Trailing branches provide the only cover at water level through much of the reach and should be retained. The new sapling growth (red arrows) is coming from alder suckers and should be encouraged.

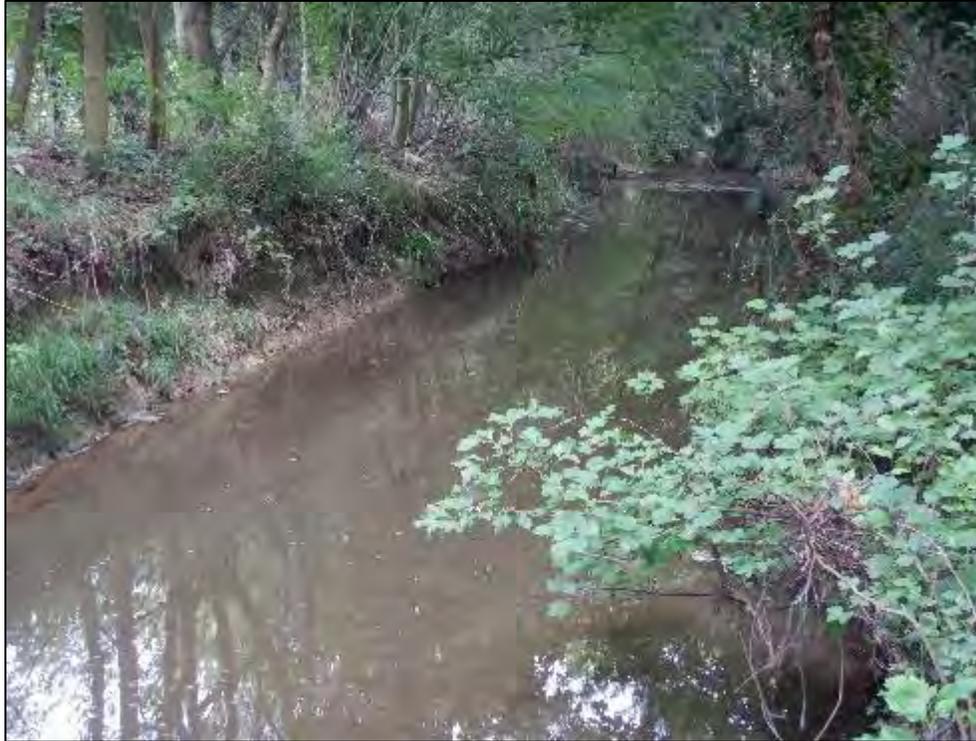
There was a lack of in-channel large woody material (LWM) and lush marginal cover at water level. These two elements are important constituents of a diverse and healthy river. The presence of LWM is extremely important within a river. It increases the available surface area on to which a biofilm (algae, bacteria and other microbes) can grow, thus starting off nutrient cycling. In turn, the biofilm may become a source of food for invertebrates, thus increasing the total biomass that a river can support. LWM also provides underwater cover, offering protection for fish against otters or fish-eating birds.

Pic 9 – Note the lack of in-channel LWM and a resulting uniform profile to the river bed. Marginal vegetation is very sparse, with its growth limited by shade and a lack of rooting substrates (such as accumulated LWM).

The brook is surprisingly clear of LWM. LWM material should be retained in-channel where it does not pose a flood risk (such as at and below water level). Where concern exists regarding the stability of LWM, it can be fixed in place through staking and/or using wire rope anchored to the banks and/or existing trees. Dialogue with the EA flood risk management team would be useful to establish the extent of flood risk to Sudborough and what habitat enhancement measures would be acceptable for the brook.

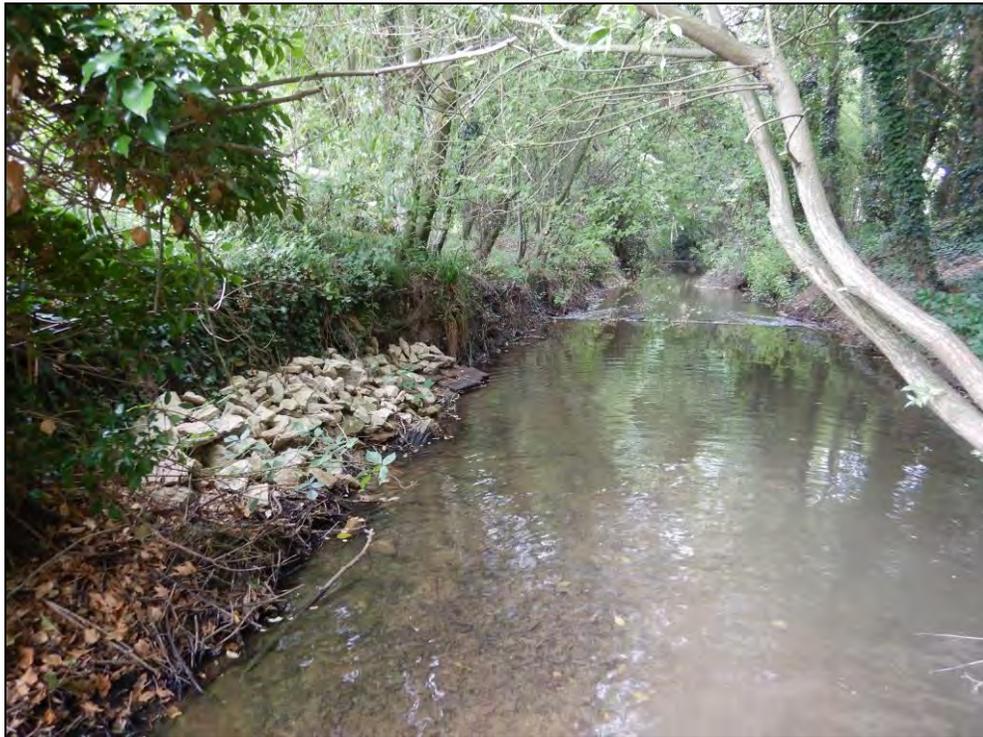
Moving downstream, a discrete area of the LB (not in control of the Old Rectory) has been protected using stone rip-rap (pic 10). This type of bank armoureding may initially prevent erosion at the site of its use, but the force of

water is simply moved elsewhere rather than dissipated, often resulting in downstream erosion, or the voids between the stones erode-out, leading to instability and ultimately their collapse into the brook. Furthermore, the occurrence of a significant stone outcrop is not in keeping with the landscape character of the brook. A much better approach to controlling bank erosion would be to use a brushwood ledge combined with tree-thinning to let light to the toe of bank. The brushwood ledge would act to provide erosion control whilst the fine lattice work of the fixed brushwood would encourage silt entrainment and consolidation, leading to a rooting substrate for marginal vegetation to establish, providing further bank protection. Another approach would be to use tree-hinging to provide instant bank protection and flow deflection. Examples of these techniques are provided at the end of this report, in the recommendations.

Pic 10 – Stone rip-rap used to protect the bank is not in keeping with the landscape of the brook and offers minimal habitat.

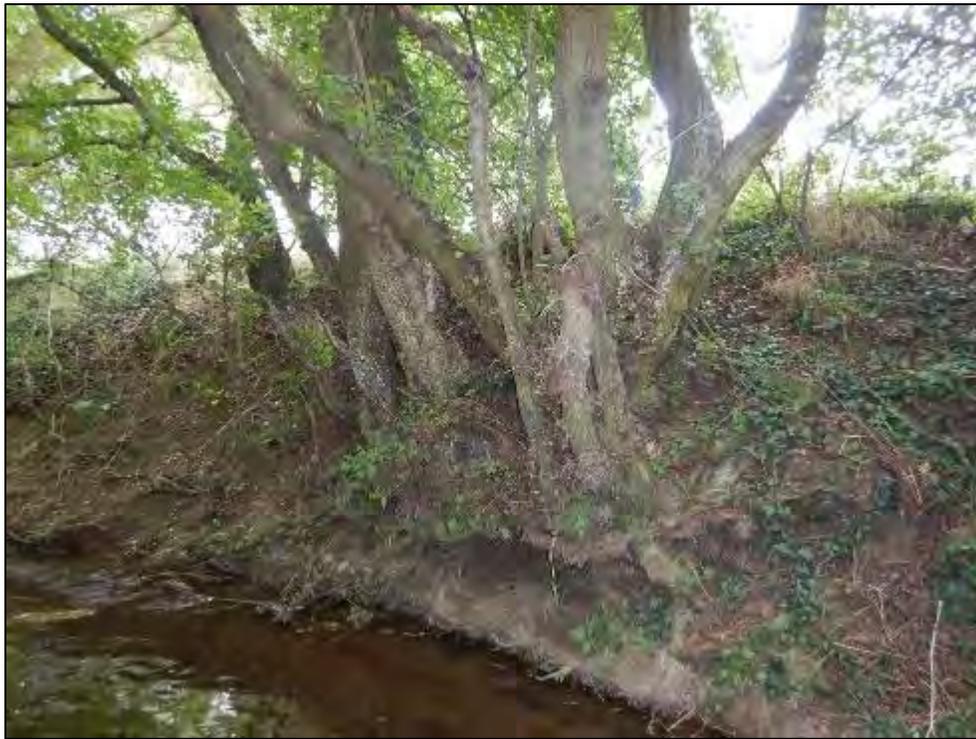
Pic 11 – At least four veteran coppice field maples were observed growing from the bank. Their age suggests a lack of mechanical maintenance (at least from the RB).

to the retention of important trees such as the veteran field maples. Trees should also be retained over pools for their shading to aid summer cooling and for controlling vegetation growth. Trailing branches at water level ideally should not be removed.

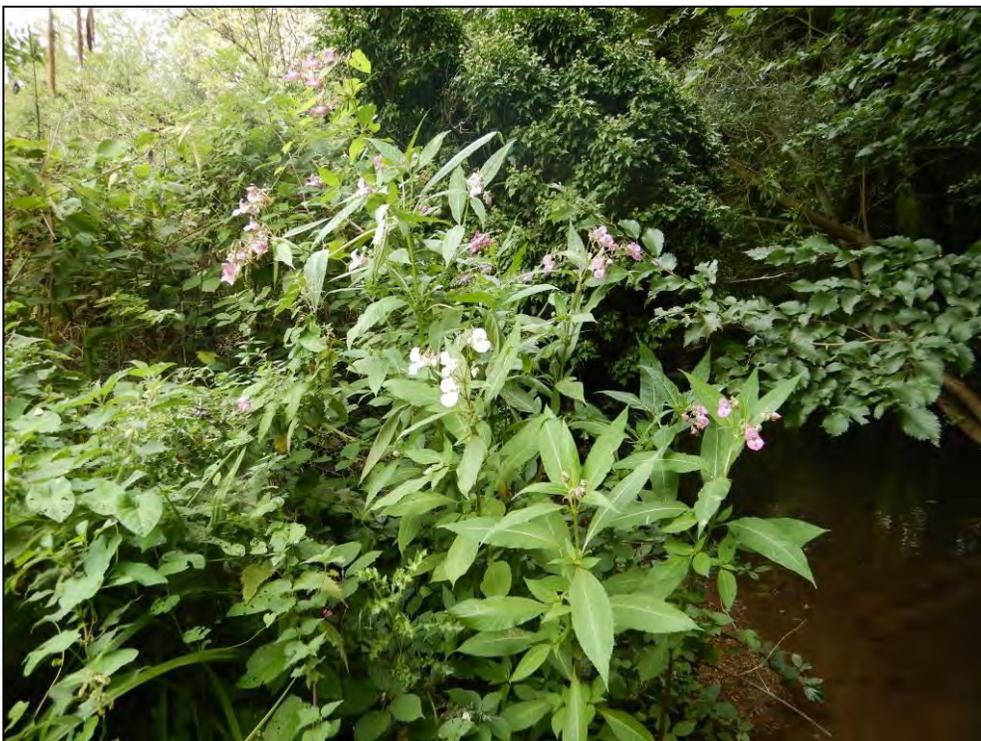
Where light reaches the channel, tall and vigorous plant species such as nettles, hops, bindweed and Himalayan balsam grew. The dominance of these plants is preventing the establishment of true marginal plants (if they were able to find wet margins to colonise). The only marginal plant present was pendulous sedge (being shade tolerant). As an invasive non-native plant, the occurrence of Himalayan balsam is not desirable (pic 13). It has the ability to colonise extensive tracts of marginal habitat through the production of **high numbers of seeds which are dispersed through 'explosive' seed capsules**. Once balsam is present, it tends to grow tall and outcompete native marginal plants. This then leads to a monoculture of balsam which creates two main problems. Firstly, native invertebrates are not well suited to exploiting non-native plants for food or shelter. Secondly, the roots of balsam are shallow **and don't provide**

bank stability particularly given that balsam is an annual and dies-back entirely in winter, leaving banks exposed to erosion.

Pic 13 – Himalayan balsam is an invasive non-native species and should be eradicated from the site.

The Himalayan balsam should be eradicated through pulling or strimming (below the first growth nodule) in order to prevent it from forming further extensive monocultures. The local Wildlife Trust is undertaking control of the plant in the Nene valley, more information can be found at www.wildlifebcn.org/wildlife/wider-countryside/water-wildlife/himalayan-balsam

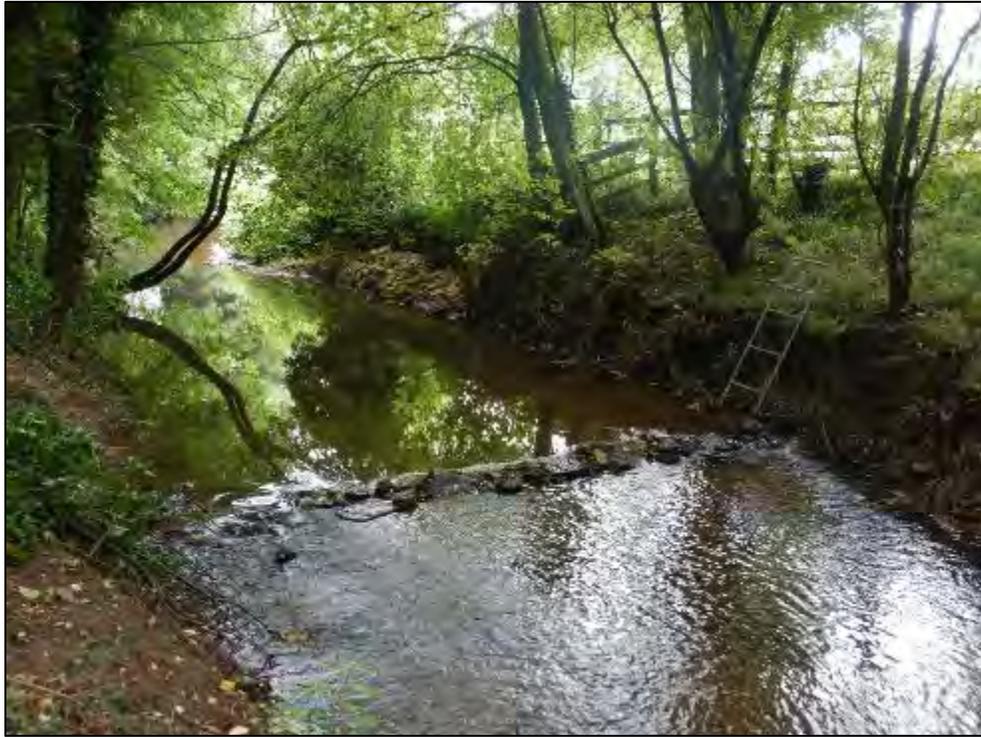
A low stone weir (pic 14) was encountered and its purpose is not known. It is believed to have been constructed by the opposing landowner. The current arrangement of the weir is likely to increase scour of the banks.

Pic 14 – A low stone weir has been created across the brook. Even small weirs interrupt sediment transfer and can prevent the movement of fish.

The low stone weir should be removed. However, as the Old Rectory only owns half of the river bed at that point, it would be best to engage the opposite landowner in dialogue about its removal. That being said, it would be fair to undertake half removal of the weir. Particularly in view of the fact that any person wishing to erect a structure within or across a Main River requires the written permission of the EA prior to undertaking such work. In determining the application (now referred to as an Environmental Permit) the EA would assess the proposal's impact upon flood risk and biodiversity before deciding if it should be allowed.

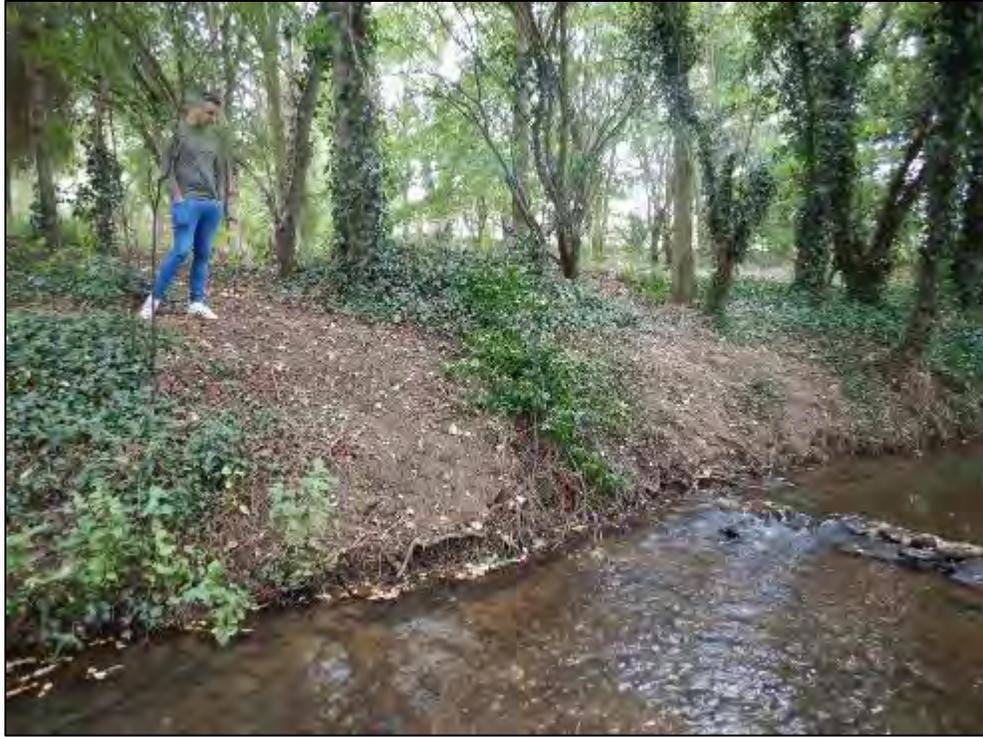
The weir is also acting as a focal point on the brook. Bank erosion to the true RB is being caused by animals (most probably dogs) repeatedly traversing the bank (pic 15). The owner of the Old Rectory does not have dogs and is not sure of the source of the bank erosion.

Pic 15 – The bank adjacent to the weir is being eroded by animals (most probably dogs). As the banks become degraded they become a source of fine sediment input to the brook.

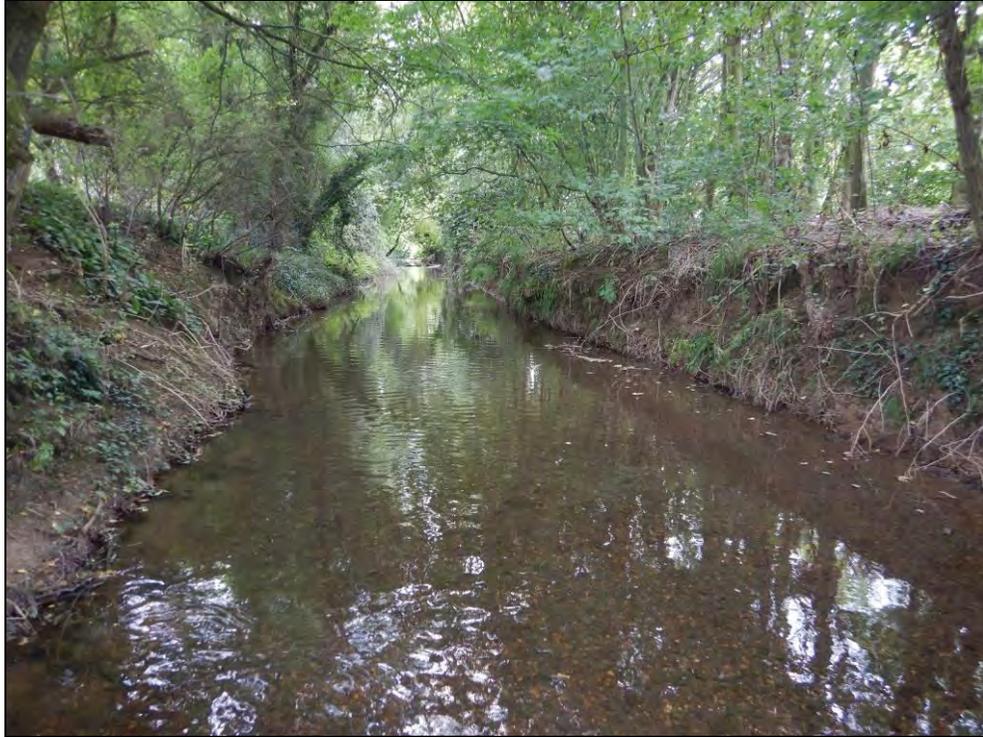
With much of the channel tree-lined, one would have expected to find a greater amount of LWM within the channel, such as fallen trees, large tree limbs and branches, yet there was no significant accumulation suggesting it has been cleared. This activity may be the result of EA flood risk management. Through dialogue with the EA team, it may be possible to ease-back on some of this clearance work.

Pic 16 – Much of the tree-lined channel is surprisingly devoid of LWM.

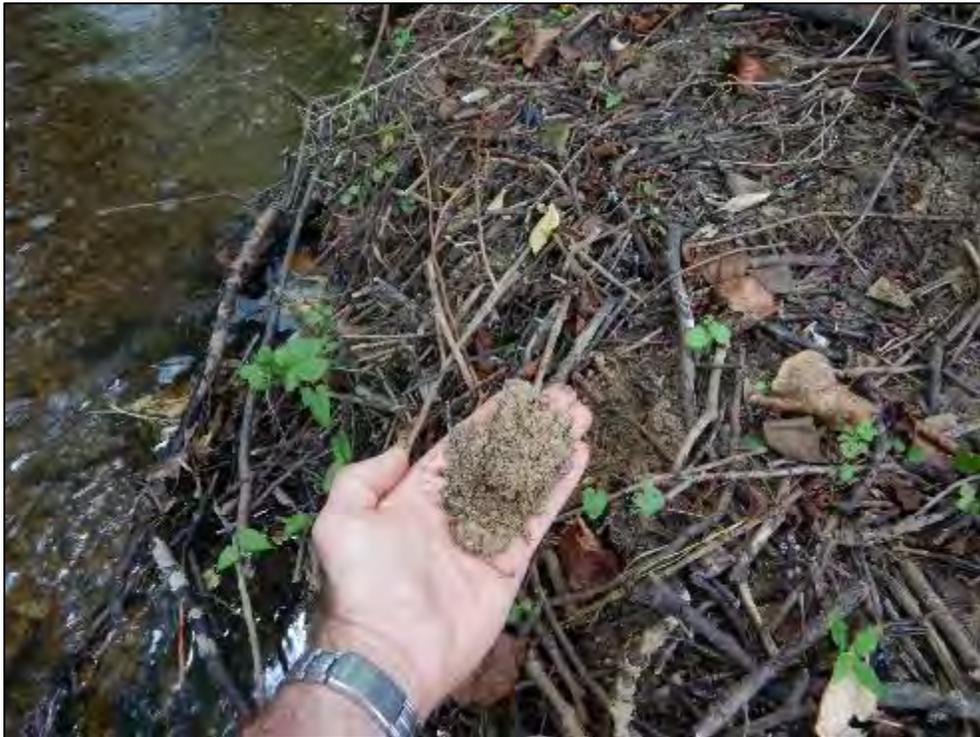
Pic 18 – The accumulation of woody material is aiding retention of fine sediment. Marginal vegetation would colonise this habitat if stable and unshaded.

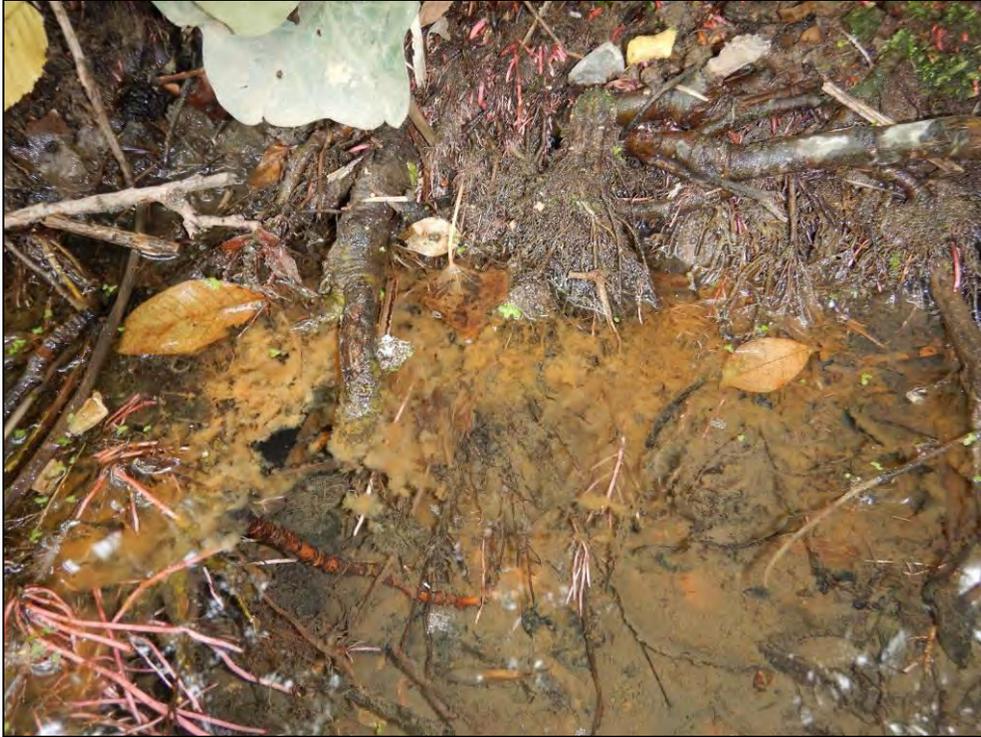
Pic 20 – Seepages of iron oxide were observed emerging from the bank. This is a natural occurrence and in volumes that don't discolour the water or lead to a lowering of the pH it is not considered a problem. This natural occurrence is not surprising given the geology of the area which in turn lead to its iron and steel industry.

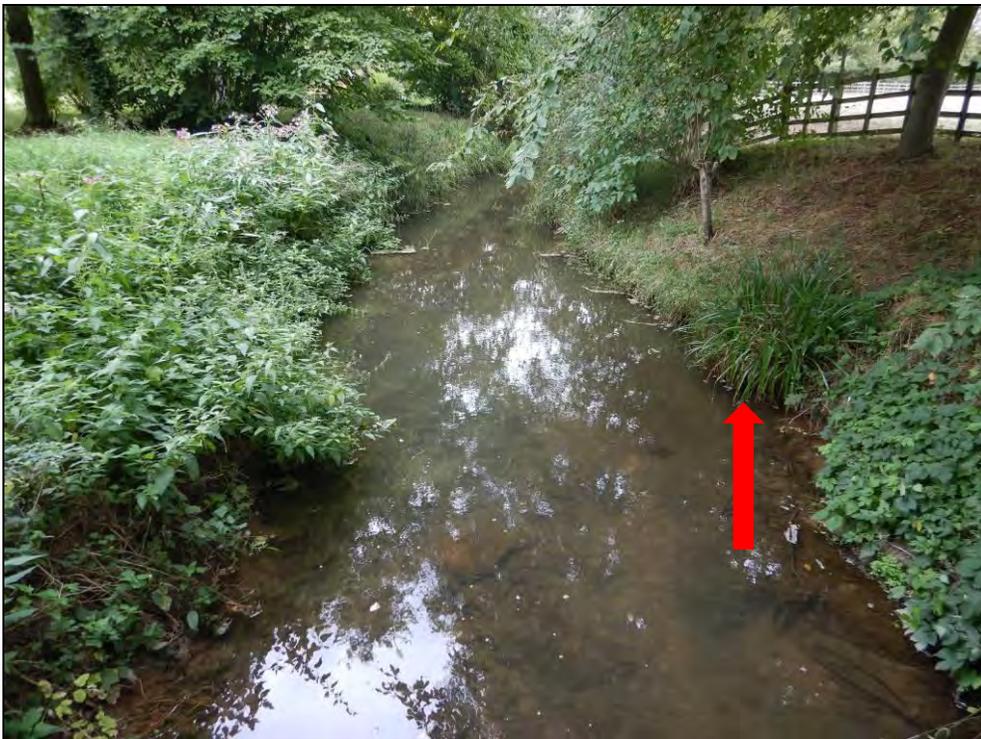
Pic 21 – Only one true marginal plant is present (red arrow), pendulous sedge.

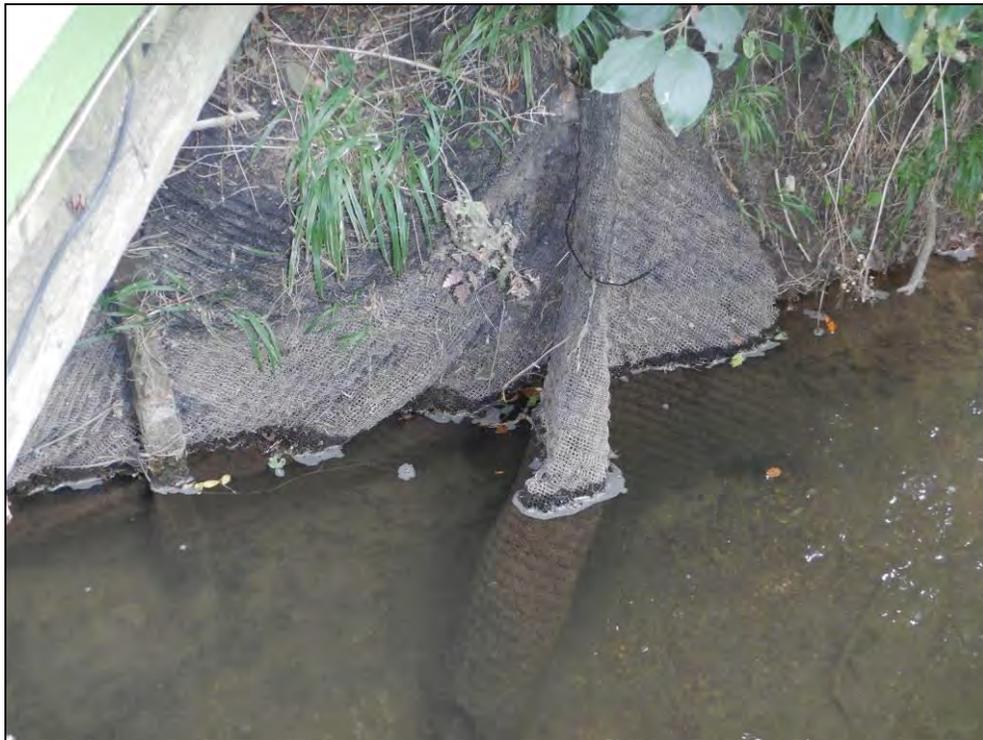
A footbridge was encountered and its banks have been stabilised using a non-degradable plastic mesh (pic 22). Plastic meshes pose a risk to wildlife with birds and small mammals becoming trapped. The banks are quite sound and it is probable that the mesh is serving no purpose. However, if the mesh is removed it could be replaced with a brushwood structure to provide bank protection and flow deflection away from the bridge footings.

Pic 22 – The bank beneath the bridge has been strengthened with a non-degradable plastic mesh. It is a hazard for wildlife and is unsightly.

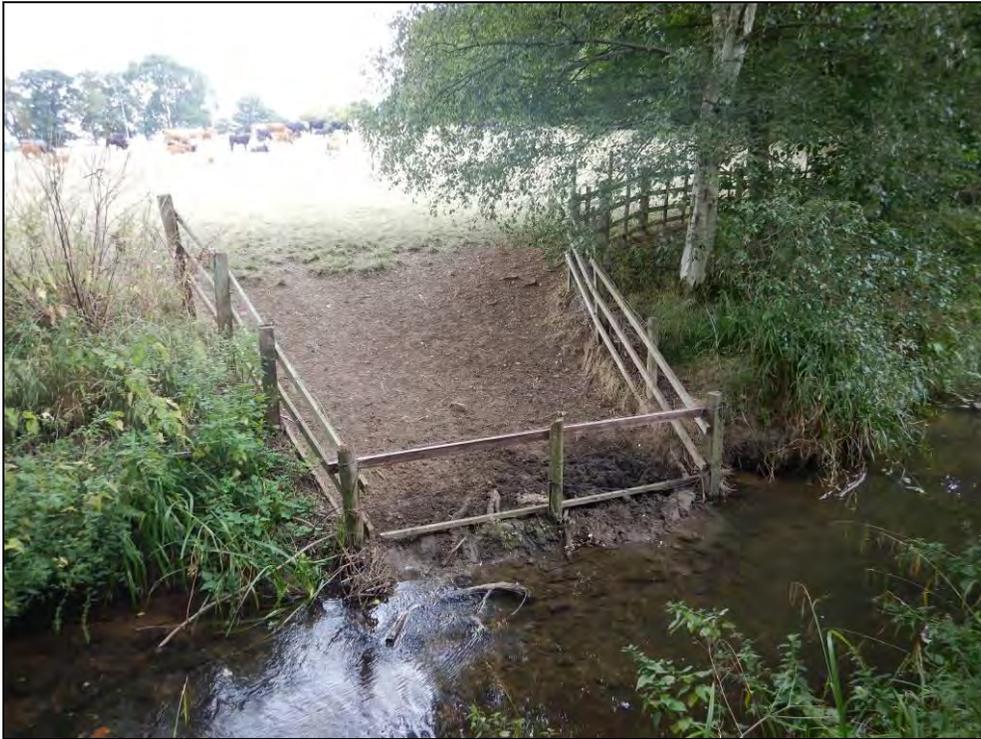
Animals are able to access the brook through a cattle drinker present on the RB (not in the control of the Old Rectory). The cattle drinker is in a poor state and is a source of sediment and nutrient input to the brook. The best approach would be to exclude cattle from watering in the brook and to use an alternative water supply such as mains water to a trough or a cattle pasture pump. If cattle have to water from the brook, then stone should be added to the drinker to reduce the input of soil resulting from bank erosion but this will do nothing to prevent nutrient pollution from faecal matter.

Pic 23 – the cattle drinker is a source of fine sediment and nutrient input to the brook.

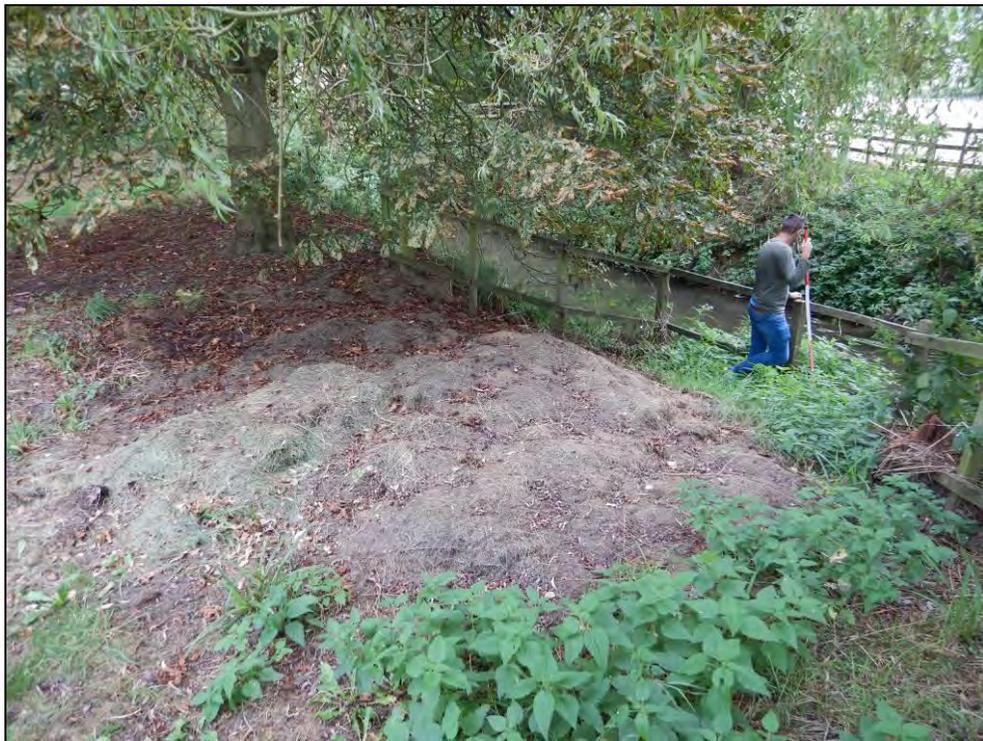
An old grass cuttings pile was located immediately adjacent to the brook (pic 25). It is unadvisable to add further grass cuttings to the pile as the leachate will add nutrients to the brook.

Pic 25 – An old large grass pile, a good egg incubation site for grass snakes.

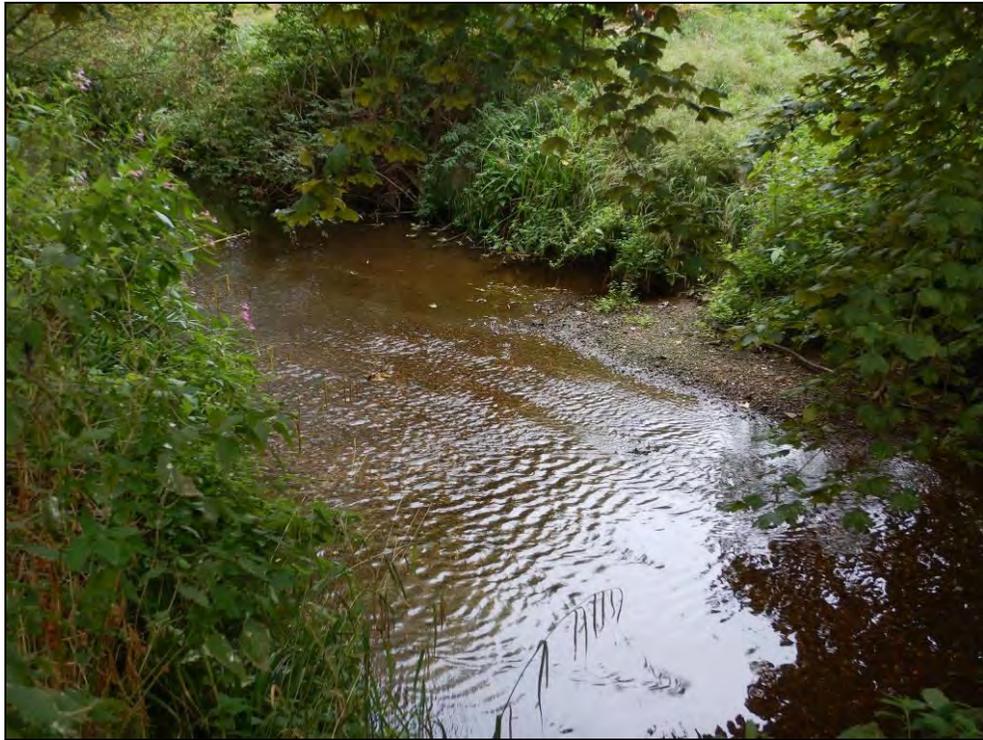
At the limit of the Old Rectory's control is a shallow riffle (pic 26). The riffle appears to be formed from well-sorted material but due to the steep banks it

was not possible to access it. The riffle is a potential spawning area for brown trout and habitat enhancement work to increase cover for adult fish during spawning and marginal cover for fry emerging from the gravel in early spring would be beneficial.

Pic 26 – At the downstream limit of the Old Rectory a shallow riffle is present. The riffle presents a potential spawning site for brown trout but it lacks habitat cover for both adult fish and emerging fry.
