**Walkover Report
Harsondale Burn
(River Tyne Catchment)
15/02/2017**

Undertaken by Gareth Pedley, Wild Trout Trust

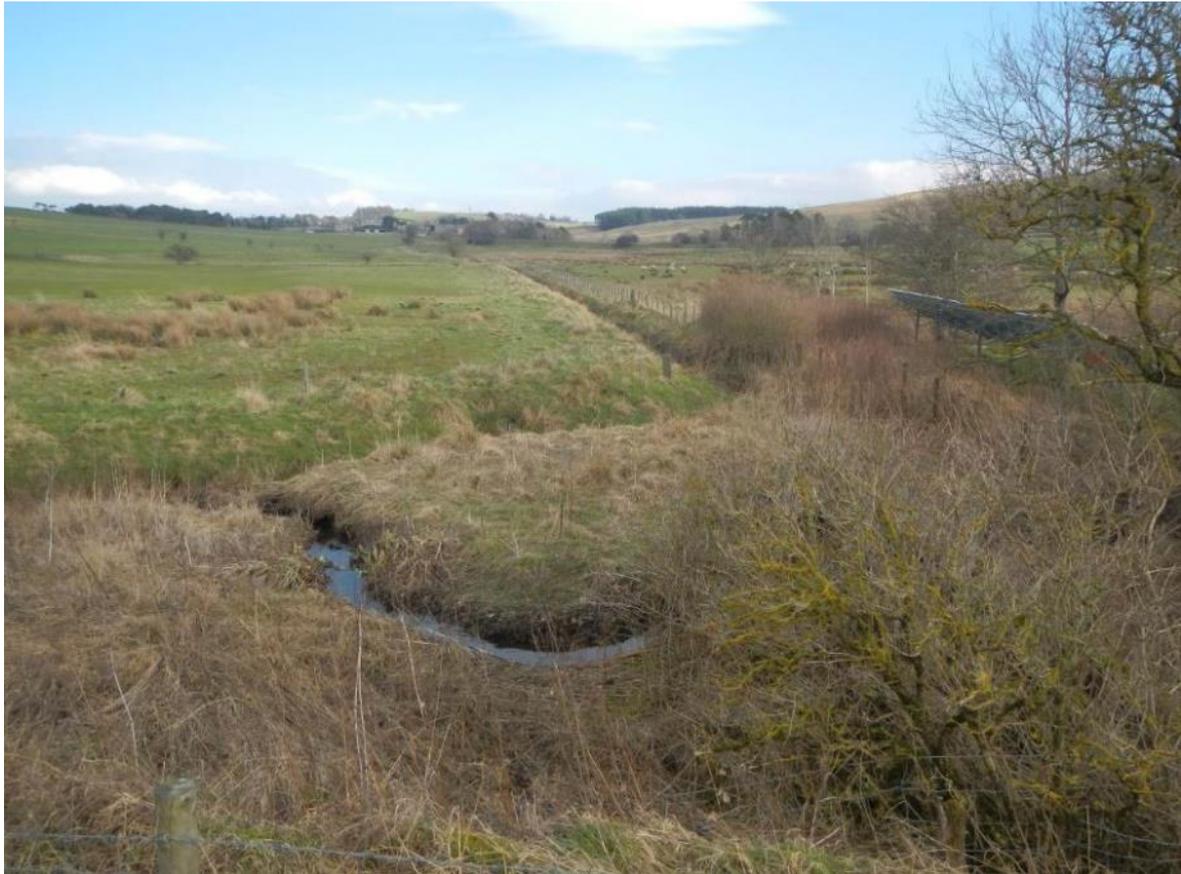
Photo DSCN5894. The upstream extent of the walkover. Here, the channel u/s extends into the distance as a straightened ditch, flowing through reasonably lightly grazed land; however the grazing is preventing re-colonisation by herbaceous vegetation and shrubs. The confluence with a small tributary, which flows past the Carts Bog Inn, can be seen in the foreground.

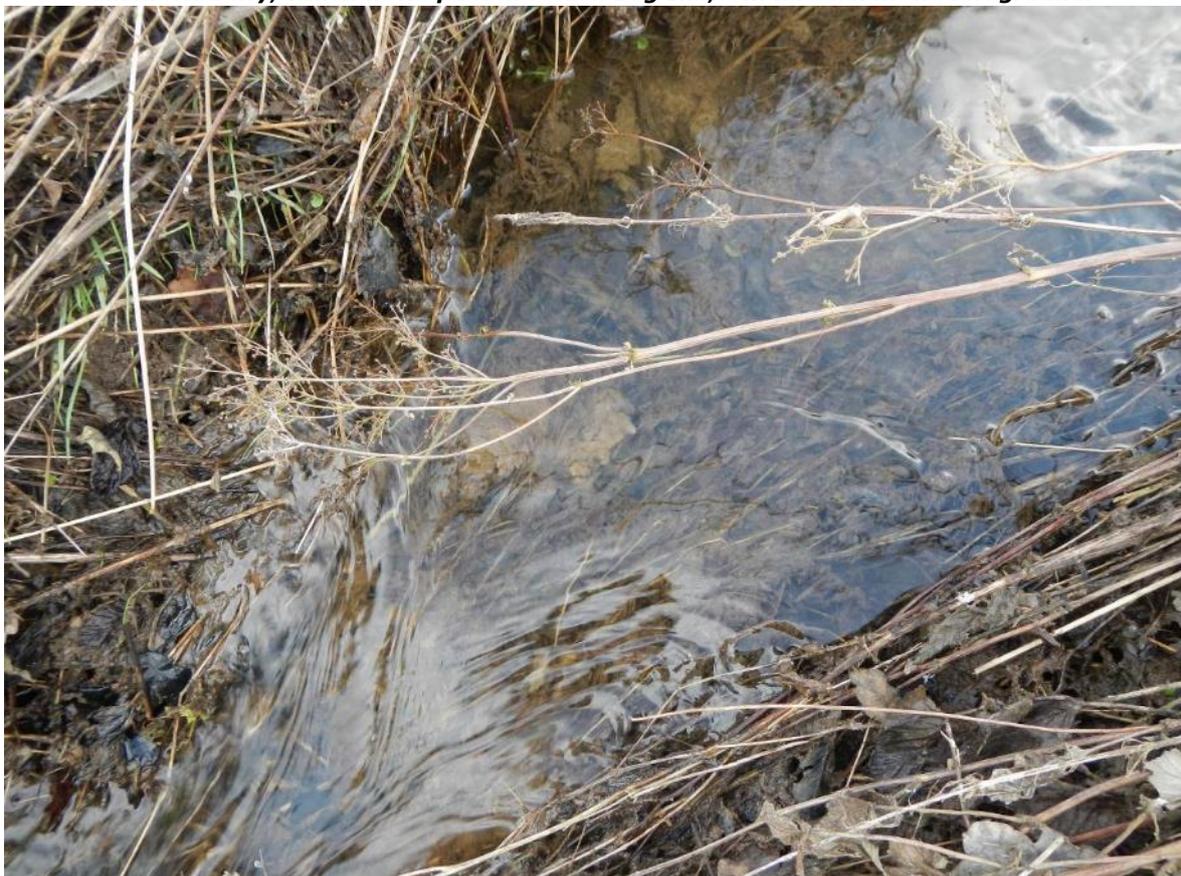
Photo DSCN5899. The tributary flowing past Carts Bog Inn exhibits signs of particularly high nutrient and sewage fungus, indicative of a likely septic tank issue from the inn (NY 81839 60677).

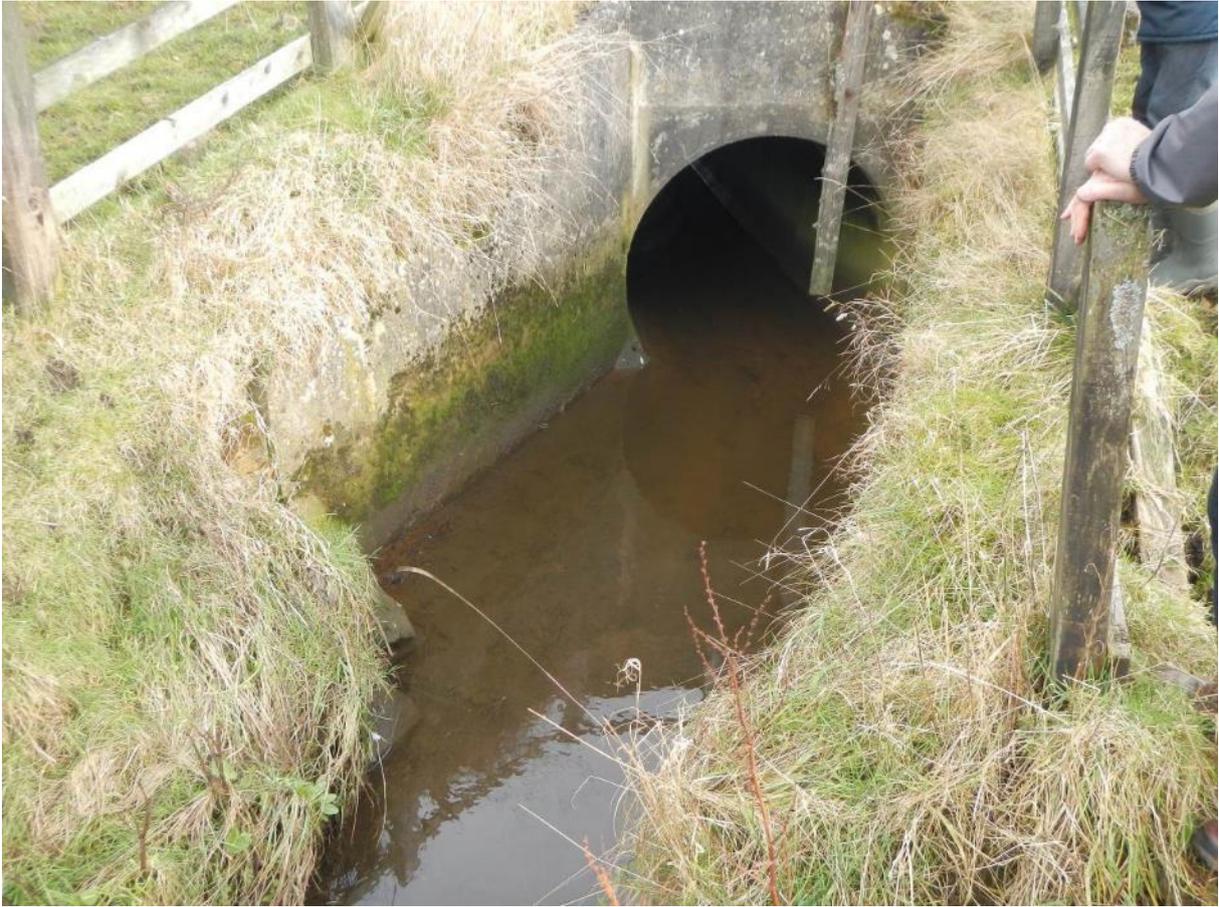
Photo DSCN5895. The A686 road culvert poses no real issues for fish passage or sediment transport (except possibly at very high flows through fluming) but the slightly wider channel in that area clearly demonstrates excess fine sediment issues. Ditch dredging/maintenance u/s is a likely cause.

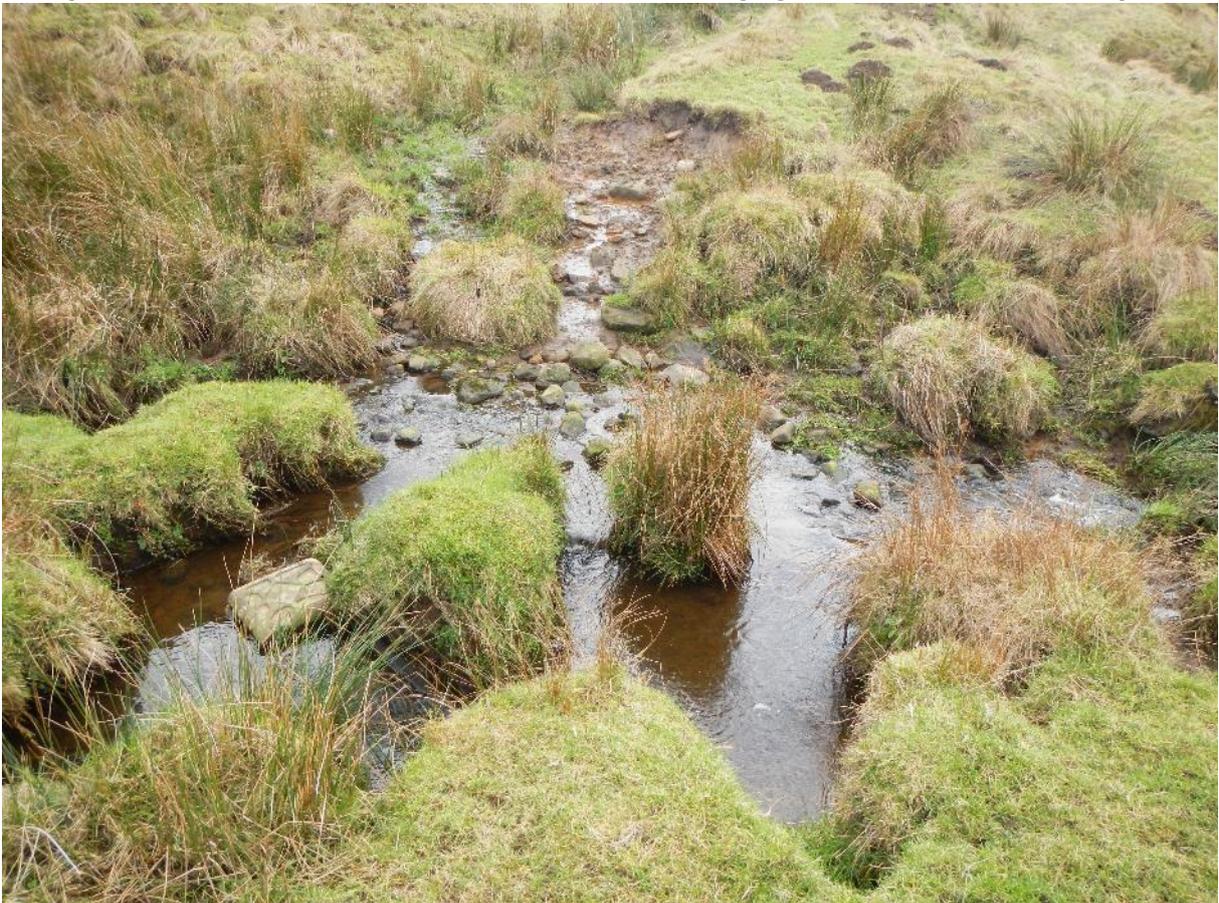
Photo DSCN5906. Grazing intensity, and its impact, increase in the field d/s of A686 road, exacerbating bank erosion and adding to the fine sediment problems.

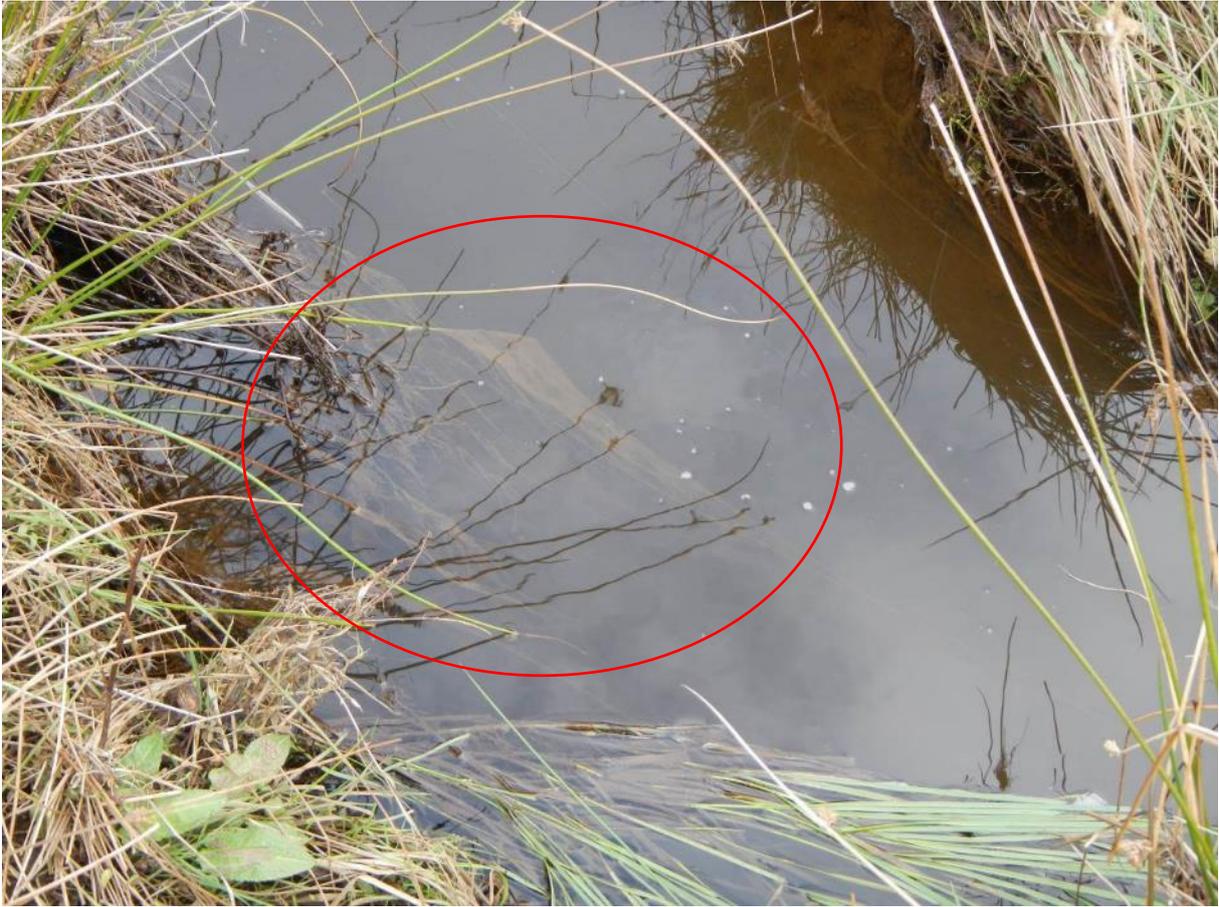
Photo DSCN5907. The nutrient issues emanating from the tributary u/s remain evident for some distance (photo taken 200m d/s of the confluence). Note the trailing, slimy biofilm.

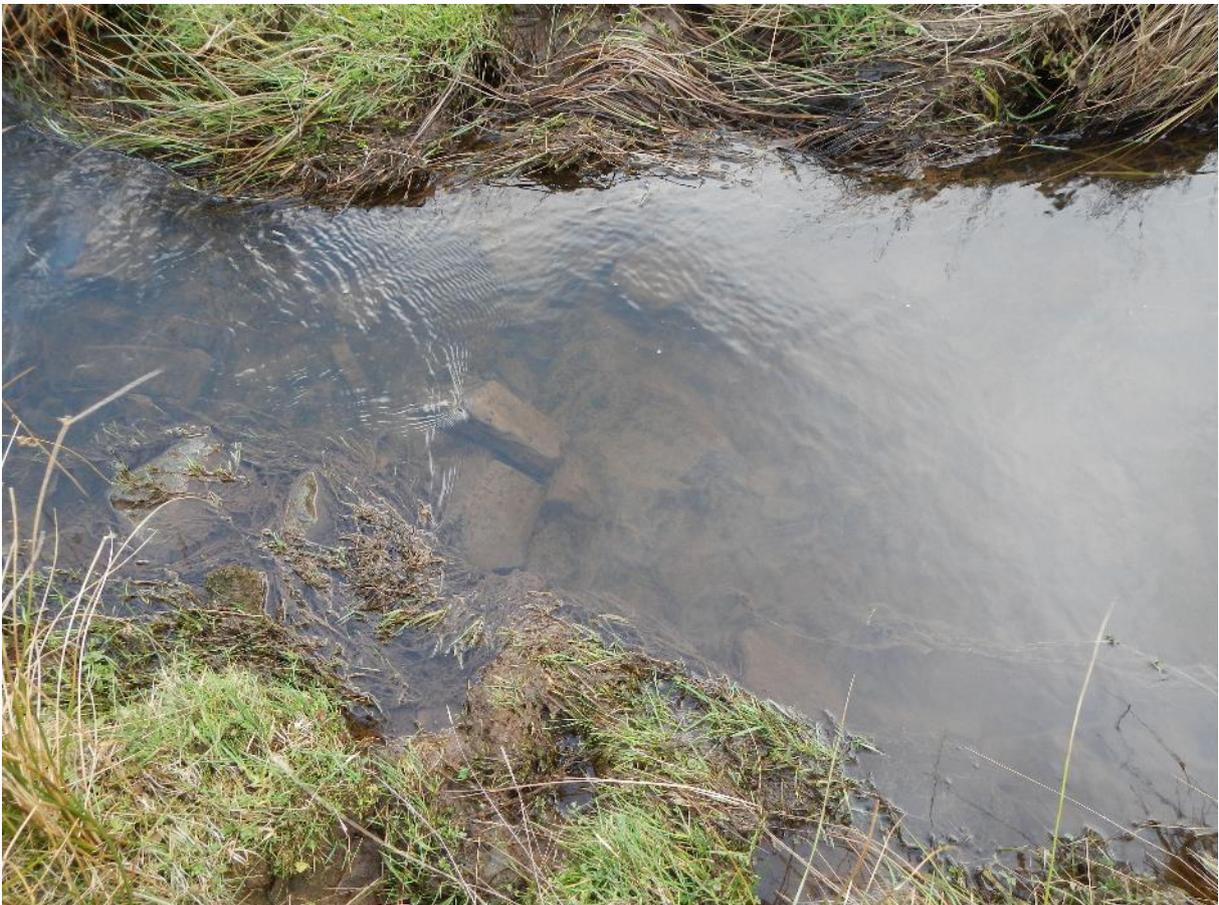
Photo DSCN5911. The increased biofilm on the in-channel vegetation and substrate also traps fine sediment, highlighting the over-supply.

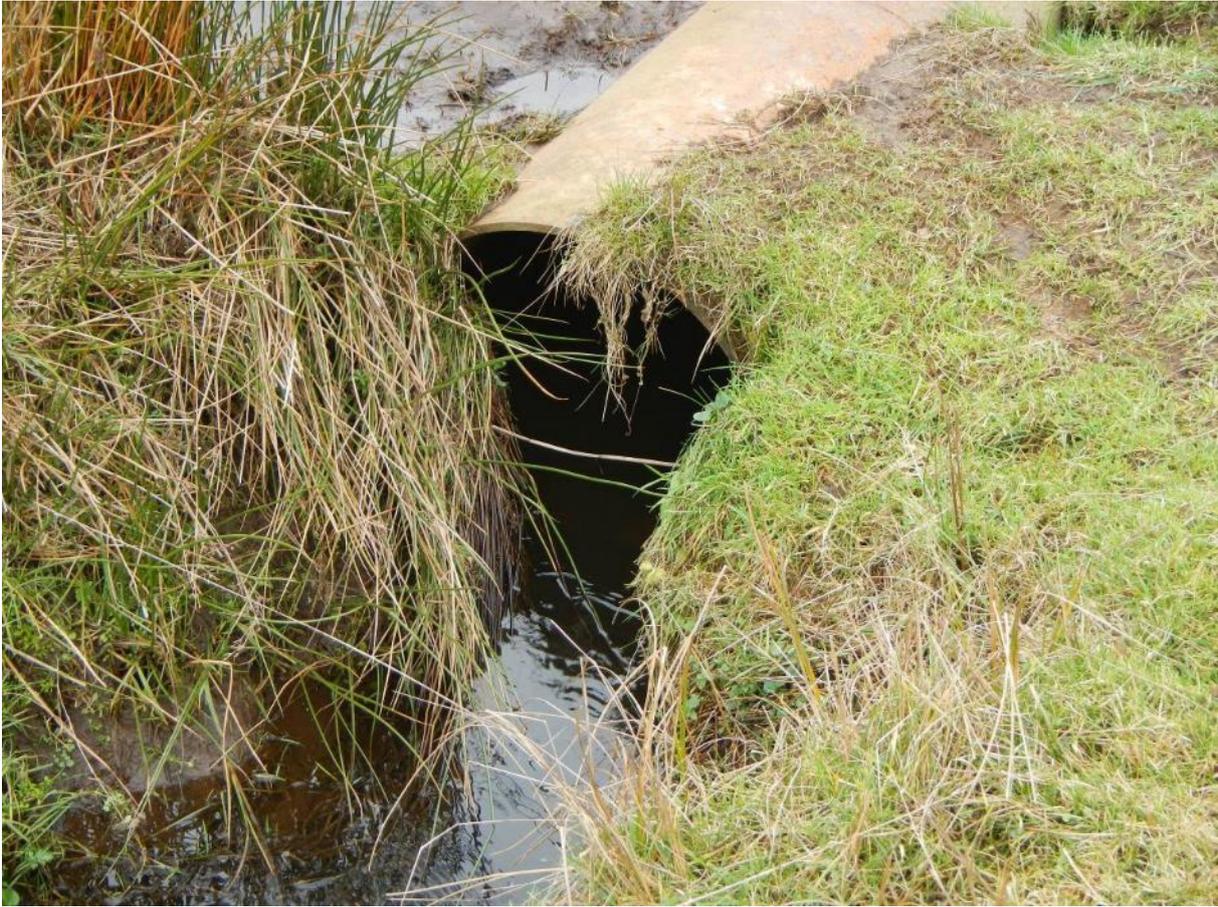
Photo DSCN5908. A small pipe enclosed the burn at a crossing point but poses no major impediment to fish or sediment movement.

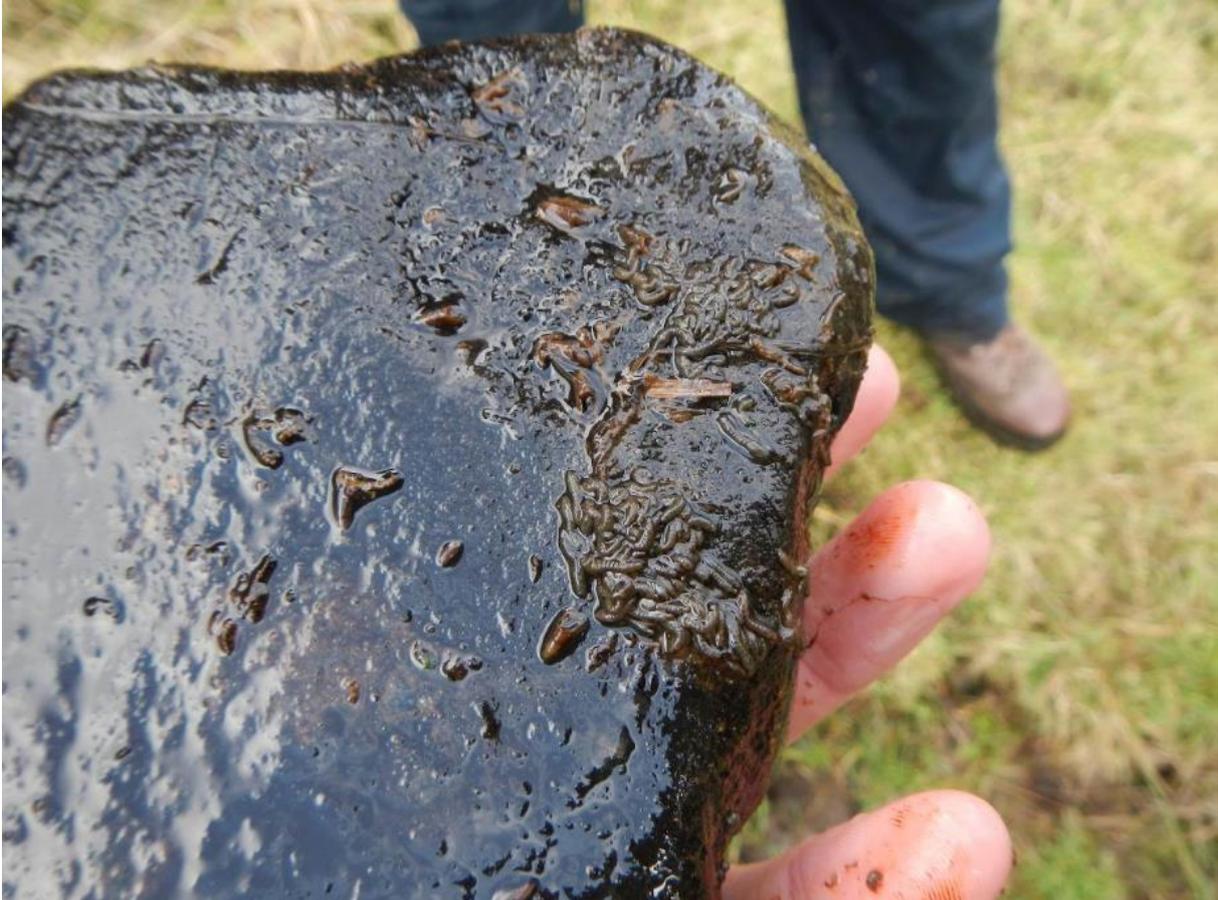
Photo DSCN5910. Stone turning revealed excessive numbers of black flies (*Simulium* sp.) and a general absence of the ephemeroptera and trichoptera that would be expected in a tributary of this order and location. An overabundance of simuliids is also indicative of excess sediment and pollution/nutrients.

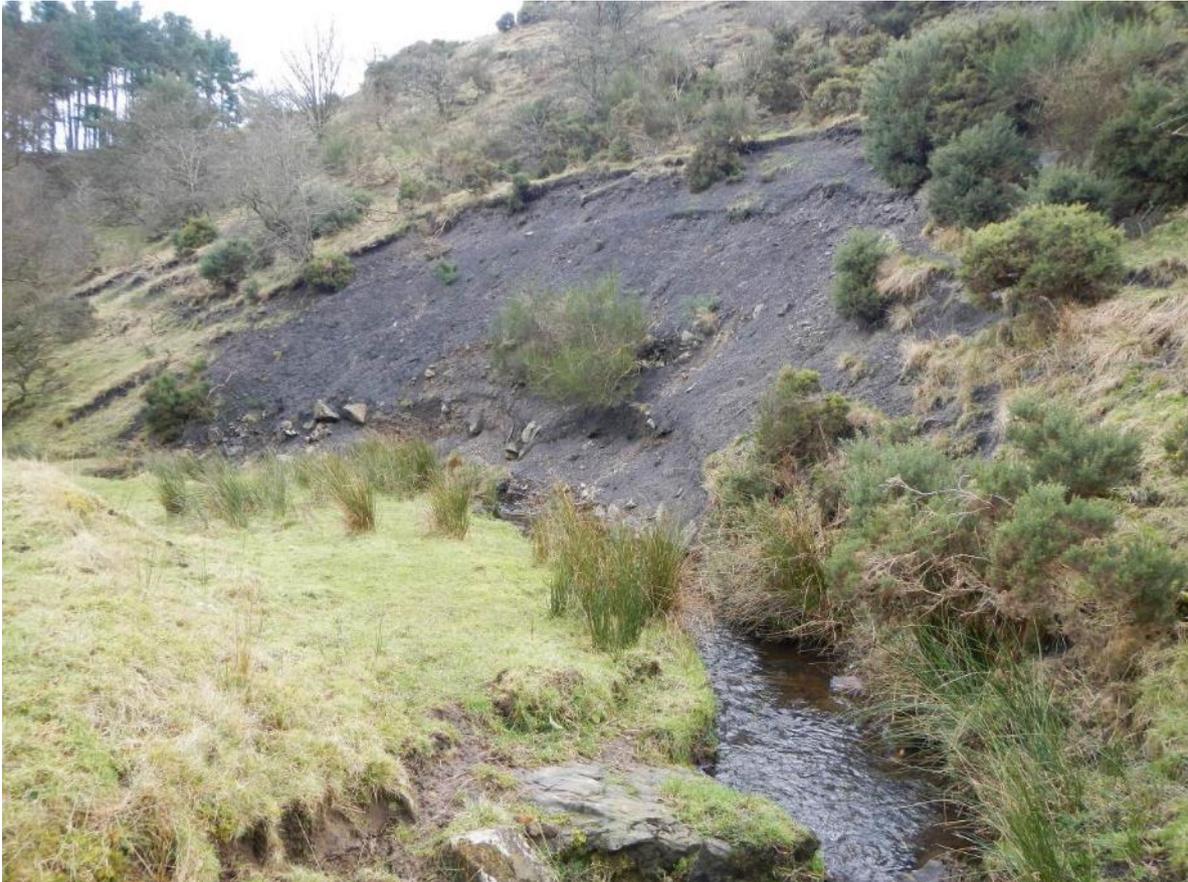
Photo DSCN5912. A bare bank face exposes mine spoil and clear signs of past mining activity in the area. The poor growing media limits root penetration into the ground and the topsoil protection root matrices provide, making the turf susceptible to slippage. This is particularly problematic where sheep tracks compromise the integrity of the sward.

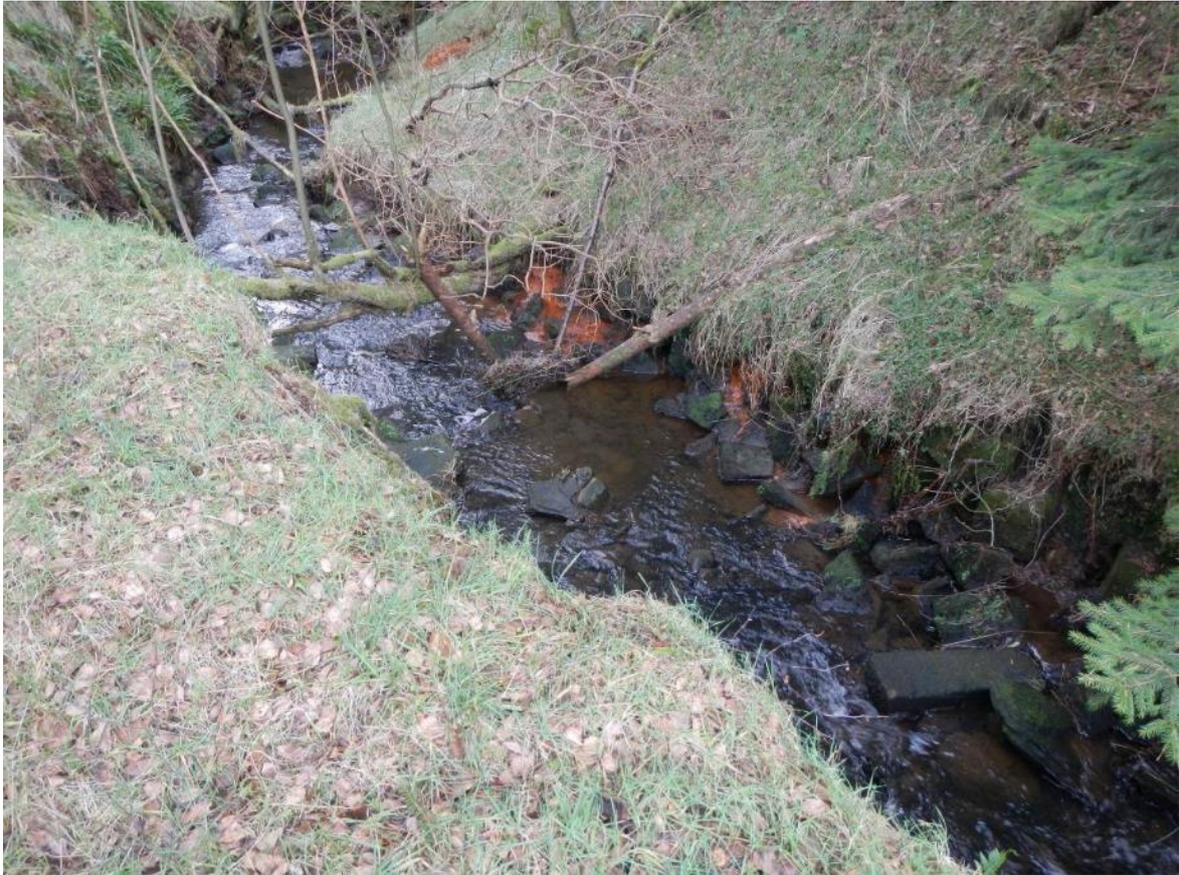
Photo DSCN5916. Water containing high levels of iron was observed to be seeping out of the bank in several locations throughout the woodland, where upon contact with the oxygenated water at the surface it oxidises, precipitating out of solution to leave an ochreous residue. This process also causes flocculation of very fine particles from suspension in the water, creating further coating of the bed with fine sediment; however, the mine water itself is not considered to be in great enough volumes to be causing a major issue (water sampling could clarify this).

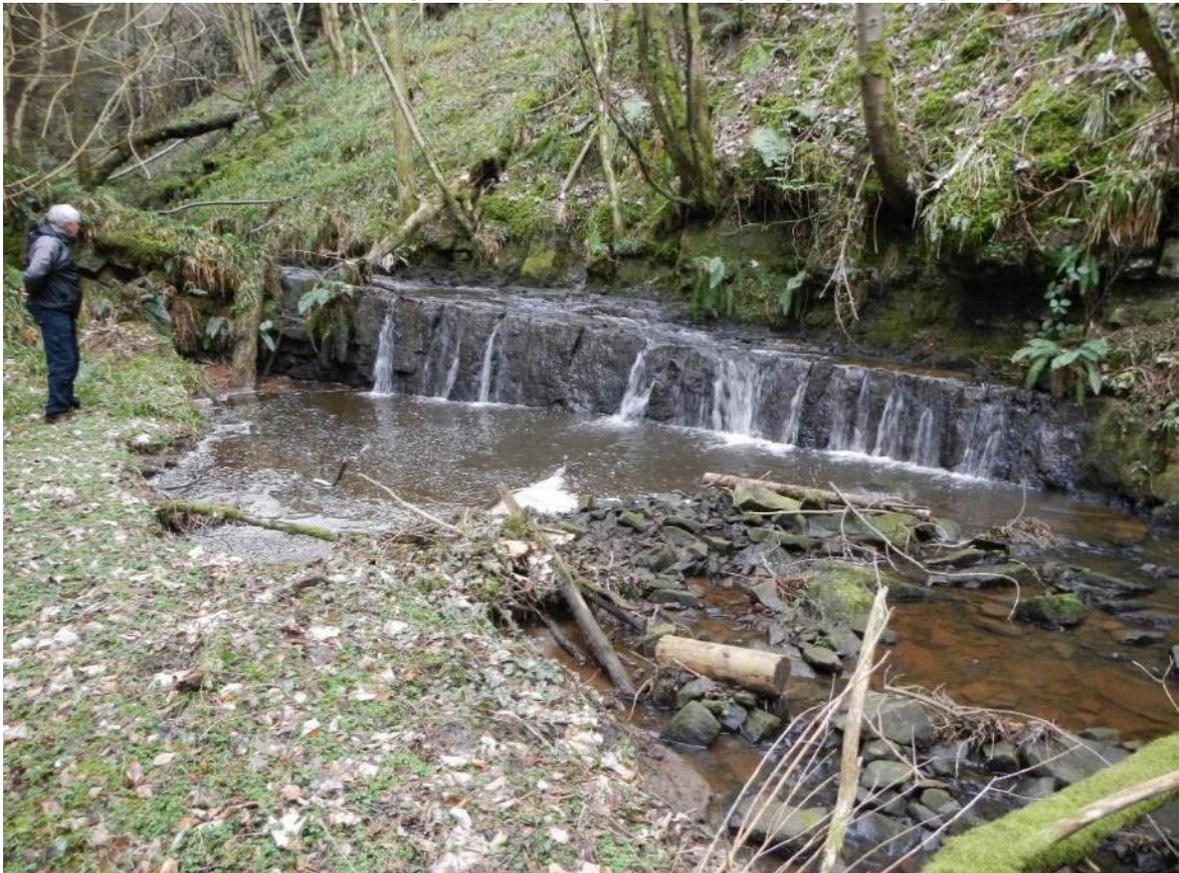
Photo DSCN5926. The steep and bedrocky nature of the valley creates numerous obstructions to fish passage. A bedrock ledge at NY 81255 60589 creates a complete barrier at low-medium flows.

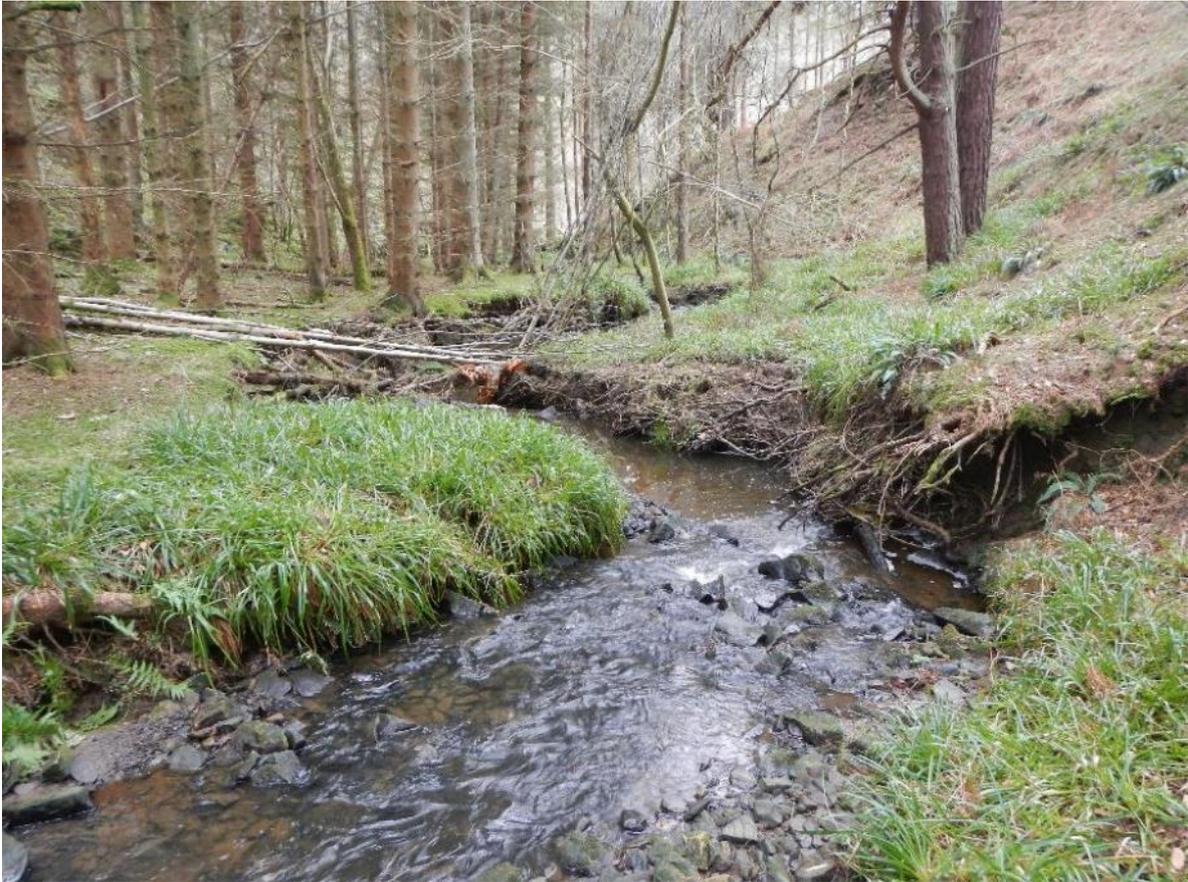
Photo DSCN5927. Shading from the coniferous canopy limits the extent of ground cover from vegetation and the shallow roots of the trees are susceptible to undercutting. Which creating some increase to the fine sediment loading of the burn, this erosion does allow habitat features to develop, like meanders and undercuts, and provides a source of woody material to the channel.

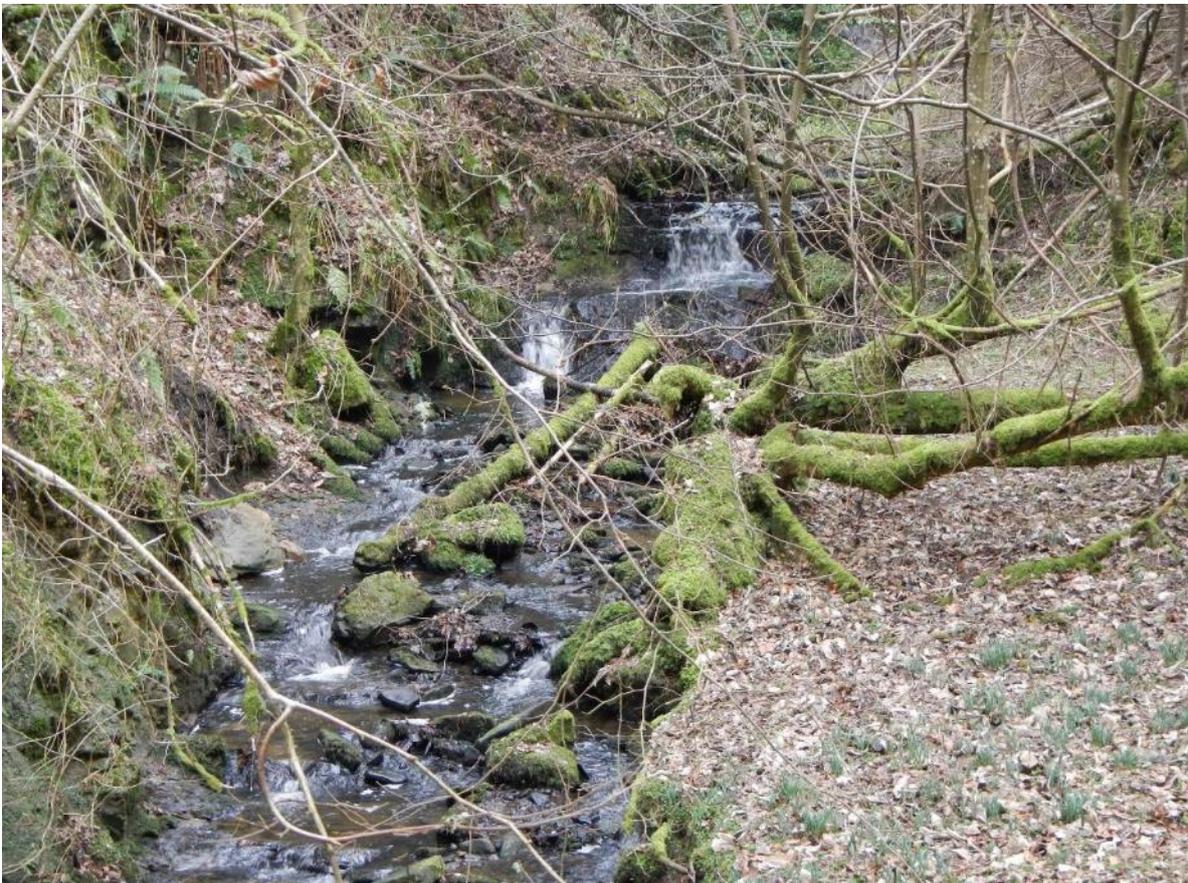
Photo DSCN5931. A further major bedrock obstruction was observed at NY 81132 60571.

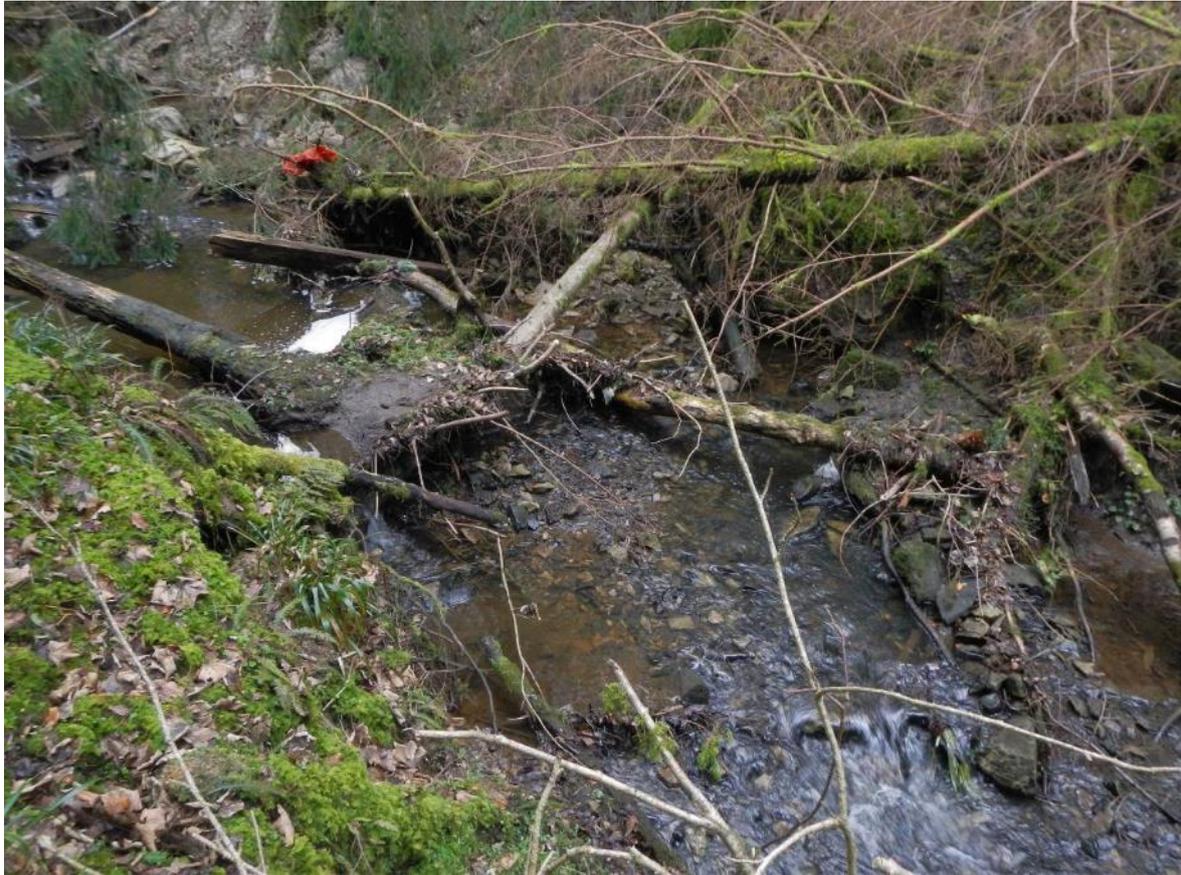
Photo DSCN5941. With the input of large trees and woody material also comes some potential issues, with blockages being created that impede fish passage. This issue of complete blockages occurring tends to be worse (less natural) with long, straight conifers (with areas of dense side branches), rather than naturally complex deciduous branches/trunks. Benefit is derived from the gravel and cobble (potential spawning) substrate they retain, but deciduous woody material usually achieves these benefits with less chance of complete blockage.

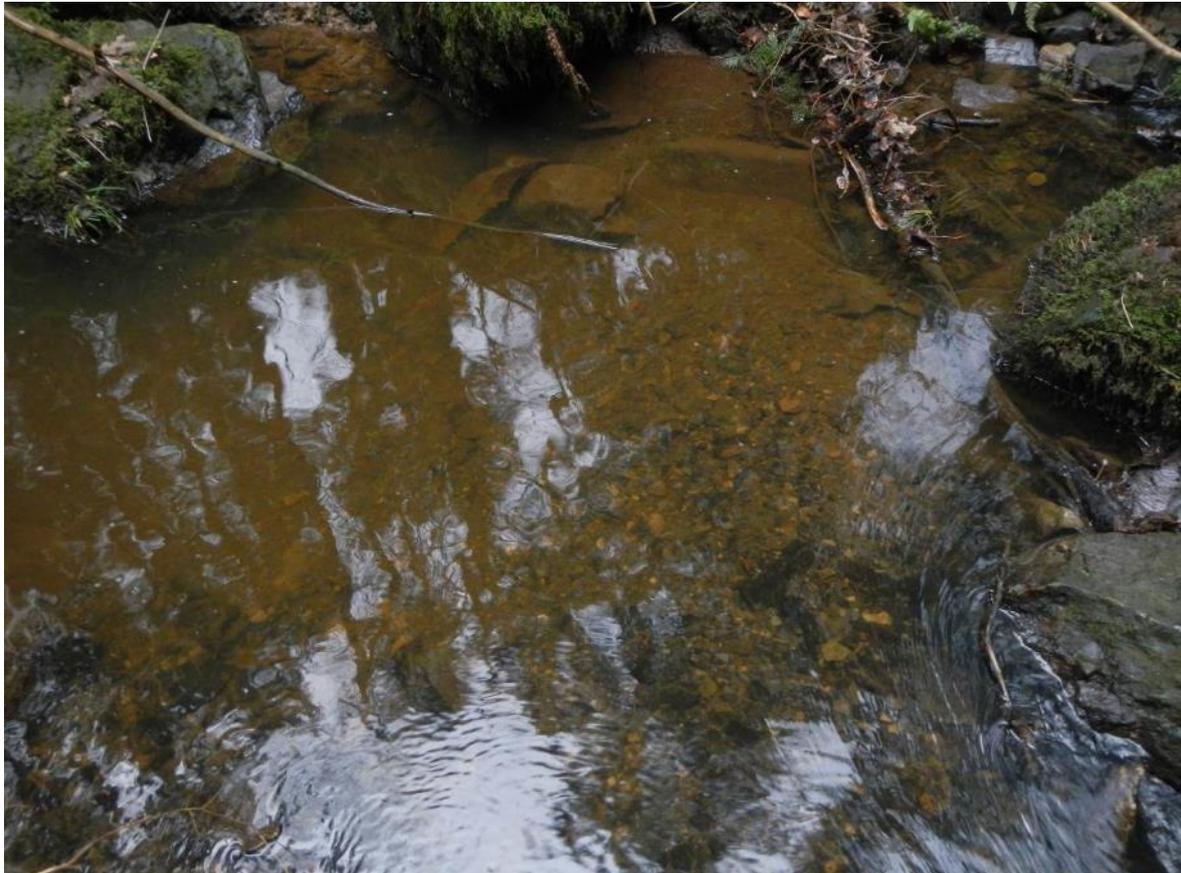
Photo DSCN5942. Some of the pools do naturally retain potential salmonid spawning substrate but its viability for that use and invertebrate habitat remains greatly compromised by fine sediment.

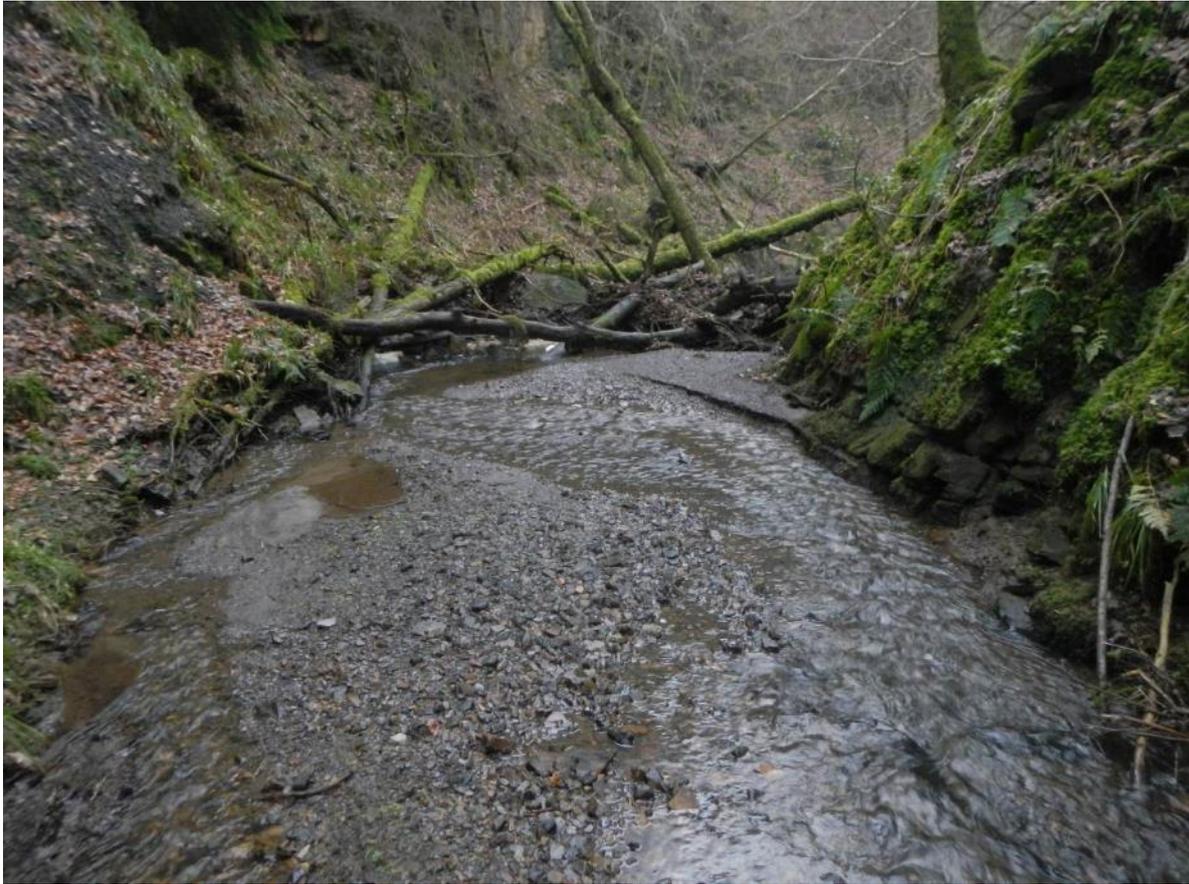
Photo DSCN5977. Several major >1500mm high (near complete) obstructions were noted throughout the middle and lower burn, particularly in the gorgy sections, where this would be more natural occurrence, irrespective of the constituent material. Valuable coarse substrate is retained by them which will benefit invertebrates and resident trout (if present) but some may obstruct migratory salmonid access at certain flows.

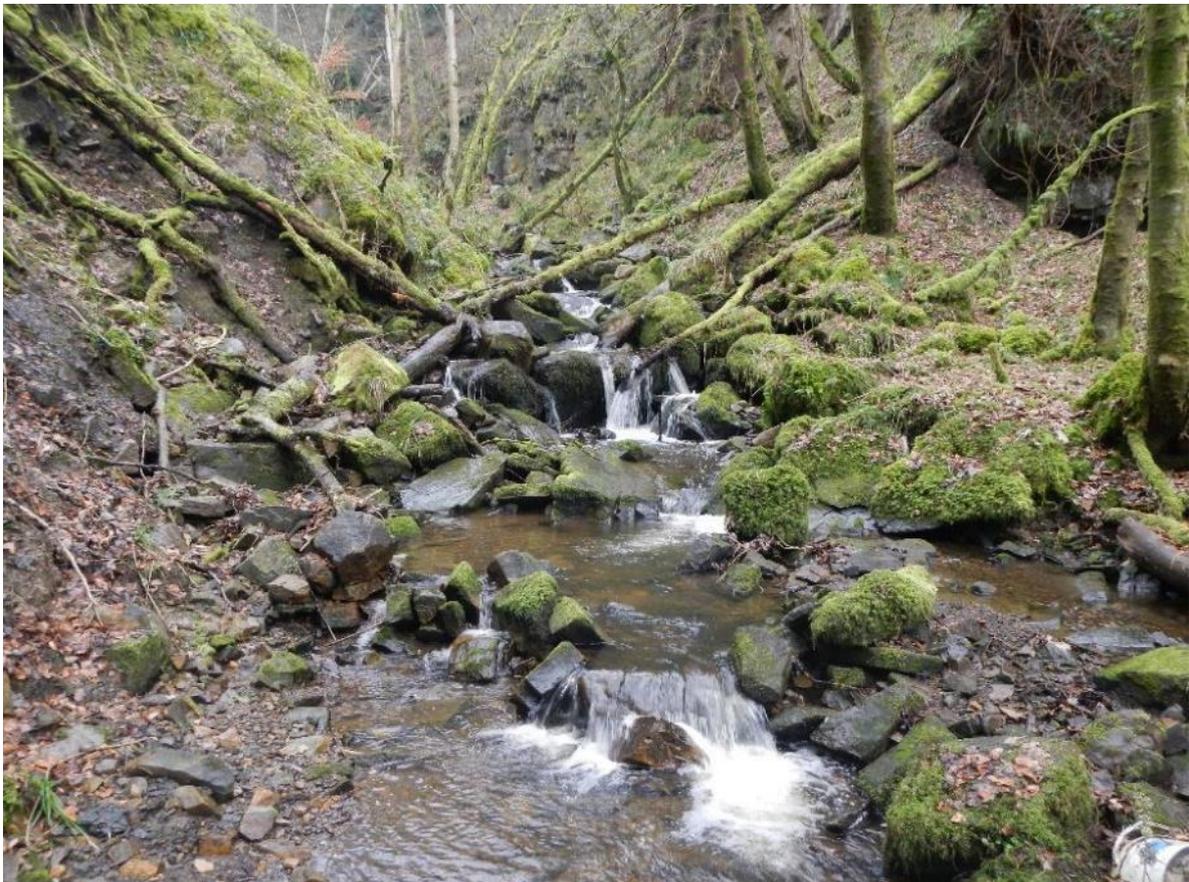
Photo DSCN5985. Natural, large boulder cascades also inhibit fish passage but are natural features of the rugged gorge.

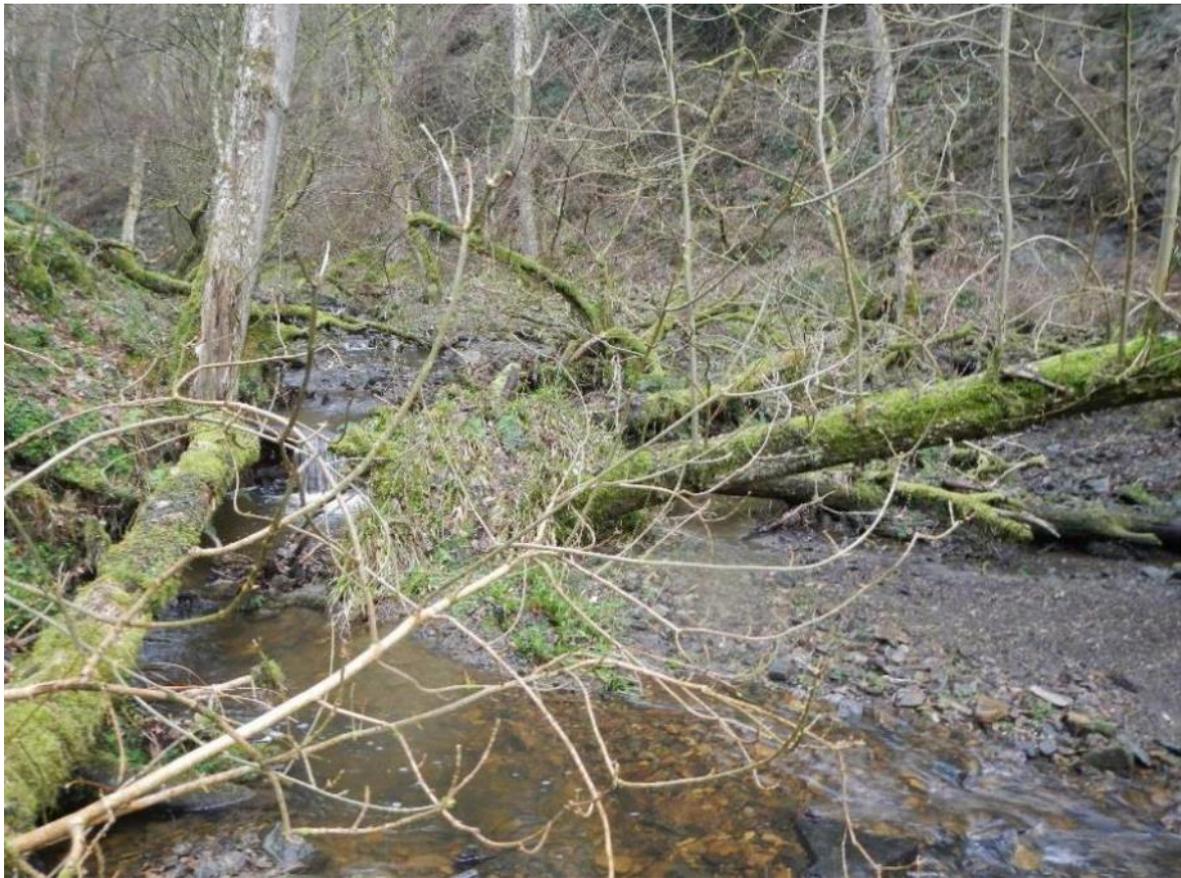
Photo DSCN5990. Towards the d/s end of the burn the channel begins to reduce in gradient, naturally retaining more gravel and cobble sediment and creating greater opportunities for salmonid spawning (fine sediment still an issue). Deciduous trees and a wider valley profile (mini-floodplain) further assist the retention of gravels and naturally enhance the habitat provided.

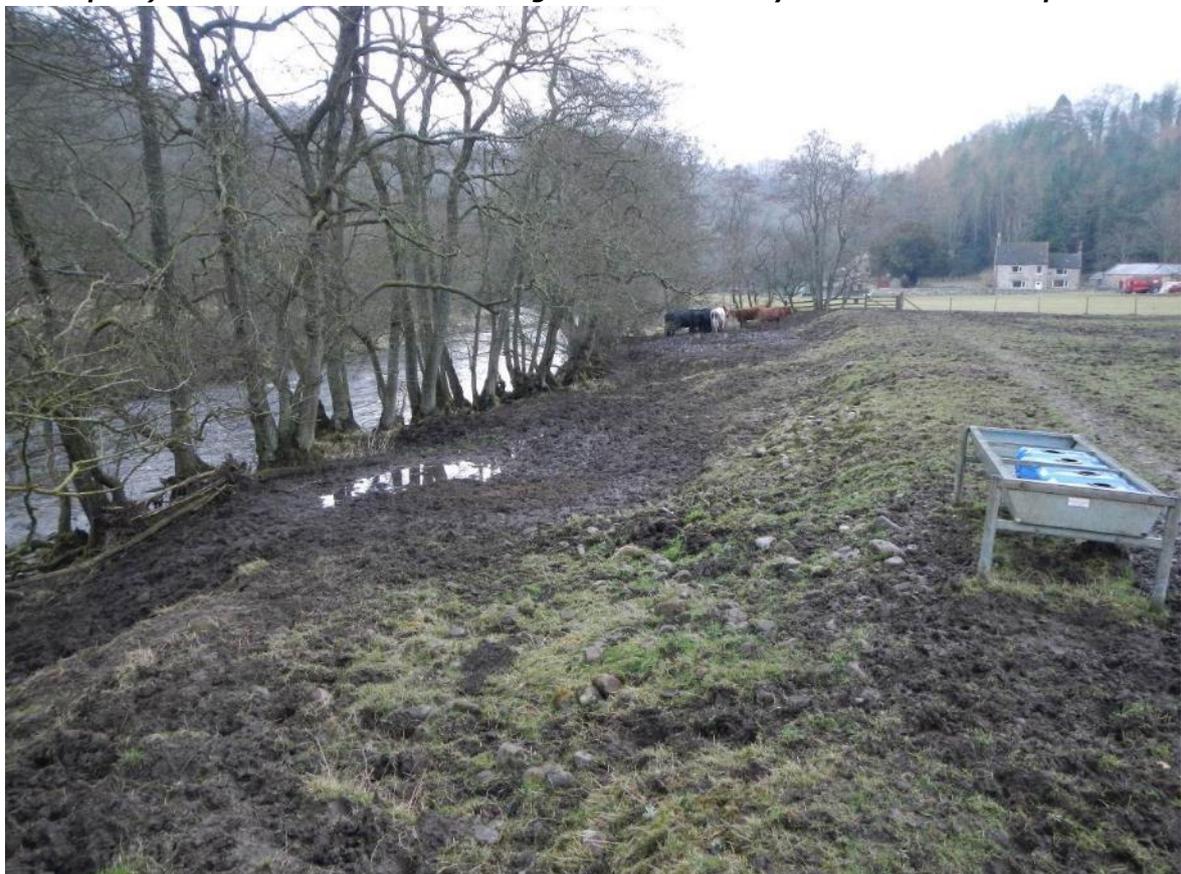
Photo DSCN6008. Although not part of the walkover, a section of the River Allen was walked at Plankey Mill to get back to the vehicle. Here the farming practice is very poor, with heavily overgrazed and poached banks, exacerbated by a feed ring being located on the bank, immediately adjacent to the river (NY 79614 61994).

Issue	Proposed action	Photos	Priority (1-3)
Fine sediment inputs u/s of the walkover section / u/s of Carts Bog Inn (NY 81842 60603).	Undertake further investigation of the sources. If ditch dredging, enter discussion with landowner/tenant about ways to limit the impact (work in the dry/work at very low flow when sediment can be controlled, avoid fish spawning period, only undertake work if absolutely necessary).	DSCN5899 & DSCN5907	1
High nutrient levels/sewage fungus in tributary (NY 81839 60677).	The pub is the only likely source so discussion with the owners/tenants about the issue would be beneficial. If no improvement, report to EA.	DSCN5899	1
Livestock access to burn and erosion (NY 81818 60694 - NY 81456 60673).	Buffer fencing to exclude livestock.	DSCN5906	2
River Allen			
Severe livestock poaching and feed ring adjacent to watercourse (NY 79614 61994).	Undertake farm advisory visit to discuss the issues highlighted. Remediation would include buffer fencing and better general farm management. As a minimum, the feed ring should be relocated away from watercourse.	DSCN6008	1

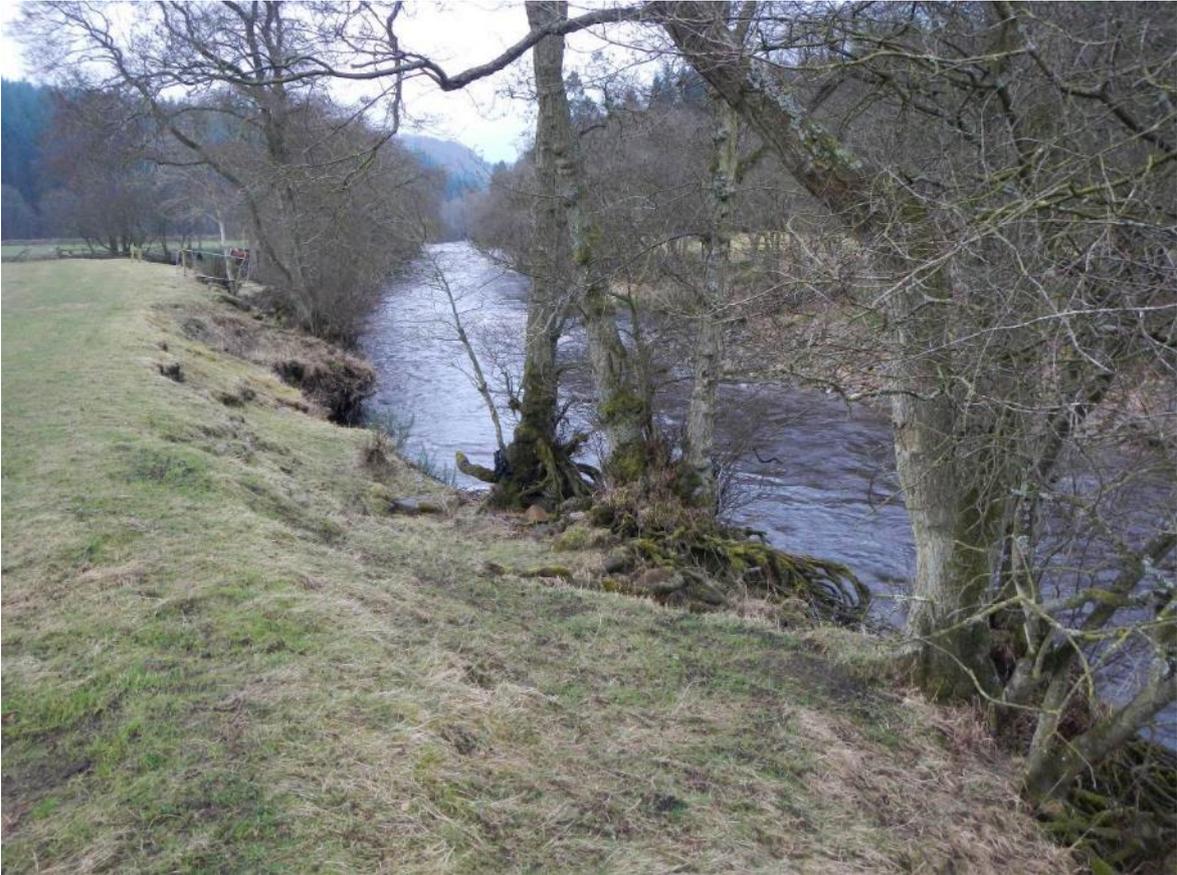
Photo DSCN6005. Grazing of the banks, in conjunction with past straightening and channel incision is also jeopardising the bankside alder trees (*Alnus glutinosa*). Ironically, this erosion and increase to channelled sinuosity that will almost certainly result will be an improvement to the morphology of the river, although it is highly unlikely that that the tenant, who is contributing to the problem, will agree.
