**Walkover Report
Harsondale Burn
(River Tyne Catchment)
15/02/2017**

Undertaken by Gareth Pedley, Wild Trout Trust

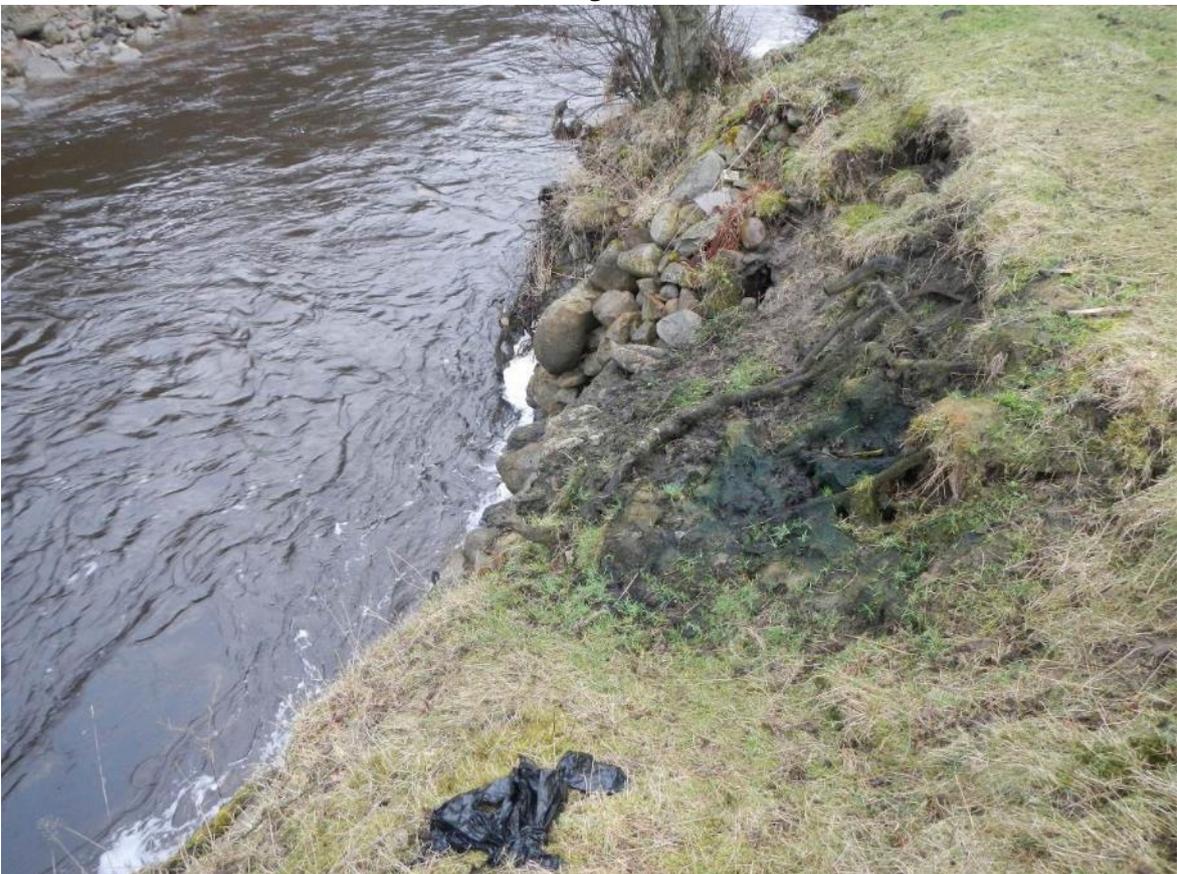
Photo DSCN66002. On the same section of bank, evidence of what appears to be the direct discharge of slurry/farmyard waste to the watercourse, down the river bank, was observed. If this is the case it would constitute a pollution event and is highly illegal

Suspected slurry/yard waste discharge direct to watercourse (NY 79586 62021).		DSCN66002	1
