## Holly Wood Local Nature Reserve Brook

### Advisory Visit

**Wild Trout Trust Report – Following a Site Visit on 28/11/2017**

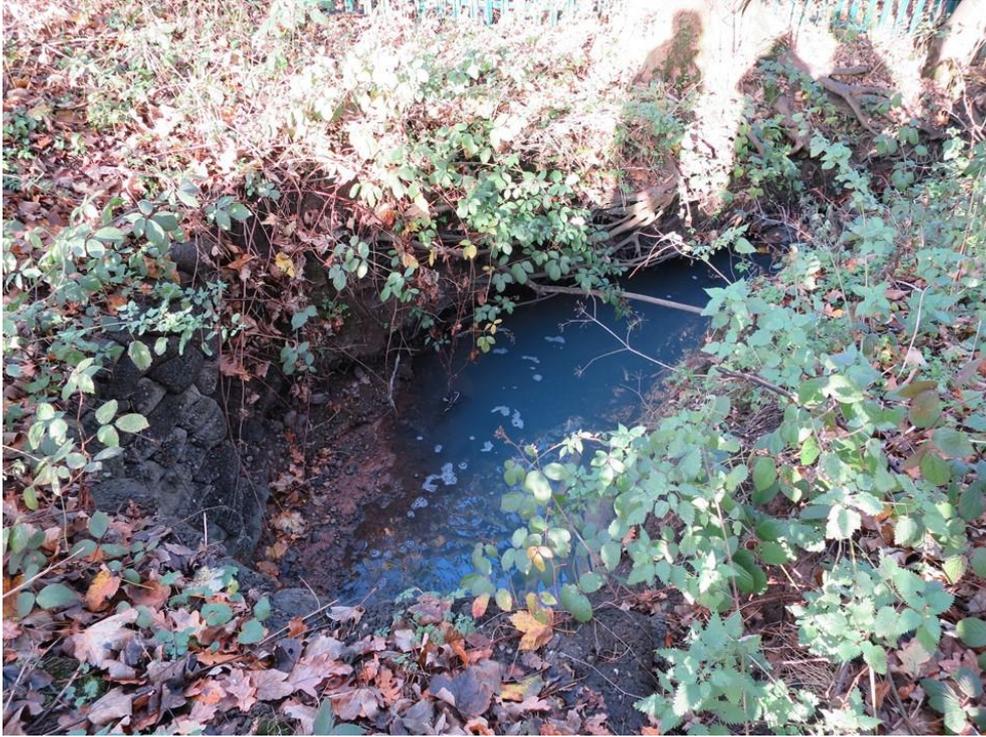
At the upstream limit of the visit, there appeared to be a problem caused either by misconnection or perhaps a blockage of the Combined Sewer system. Grey water was entering the brook under low-flow conditions via an outfall at SP05115 94521 (Fig. 6).

**Figure 6: Grey water in the Brook directly below an outfall pipe at the upstream limit of the visit at SP05115 94521**

Since the outfall from which the grey water is issuing is readily identifiable, continuing to report this issue (as is already being done) and potentially bringing the issue to the attention of local councillors may speed the response to this issue. A few metres downstream of this discharge the brook runs into an on-line pond at SP05243 94504 (Fig. 7).

The pond and its associated vegetation may be acting to mitigate some of the poor water quality arising from the grey-water discharges of the outfall. However, to continue to allow that greywater discharge to occur without remedial action to the combined sewer itself is not acceptable.

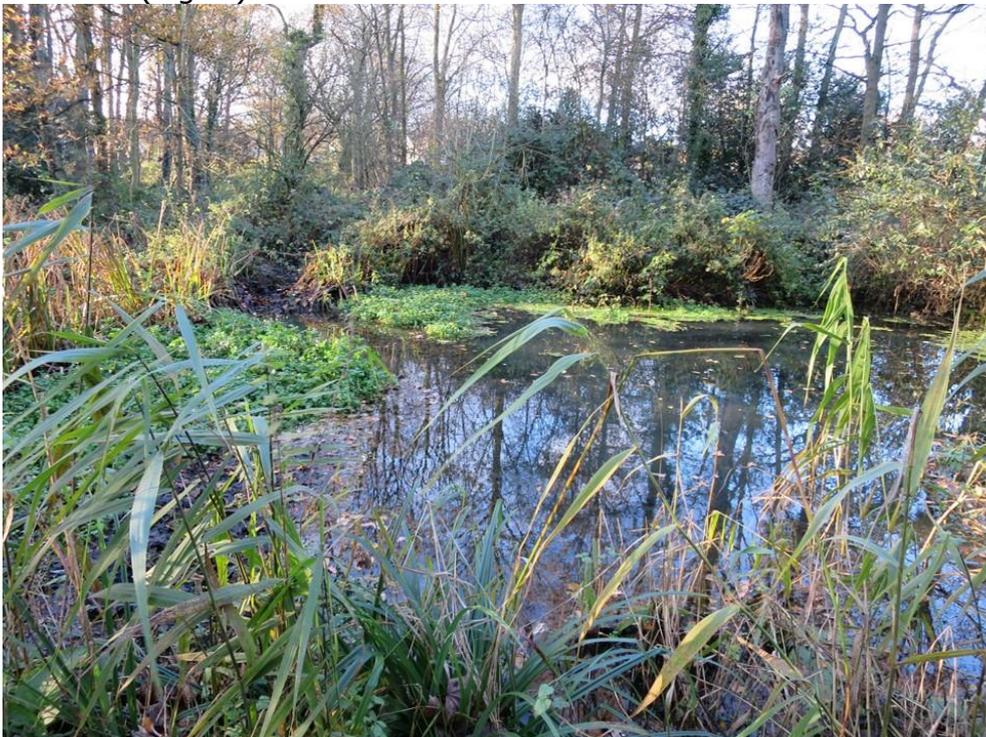
**Figure 7: Photograph of on-stream pond from close to the outflowing point (outside of frame), looking back up towards the inflow of the brook (upper left of frame).**

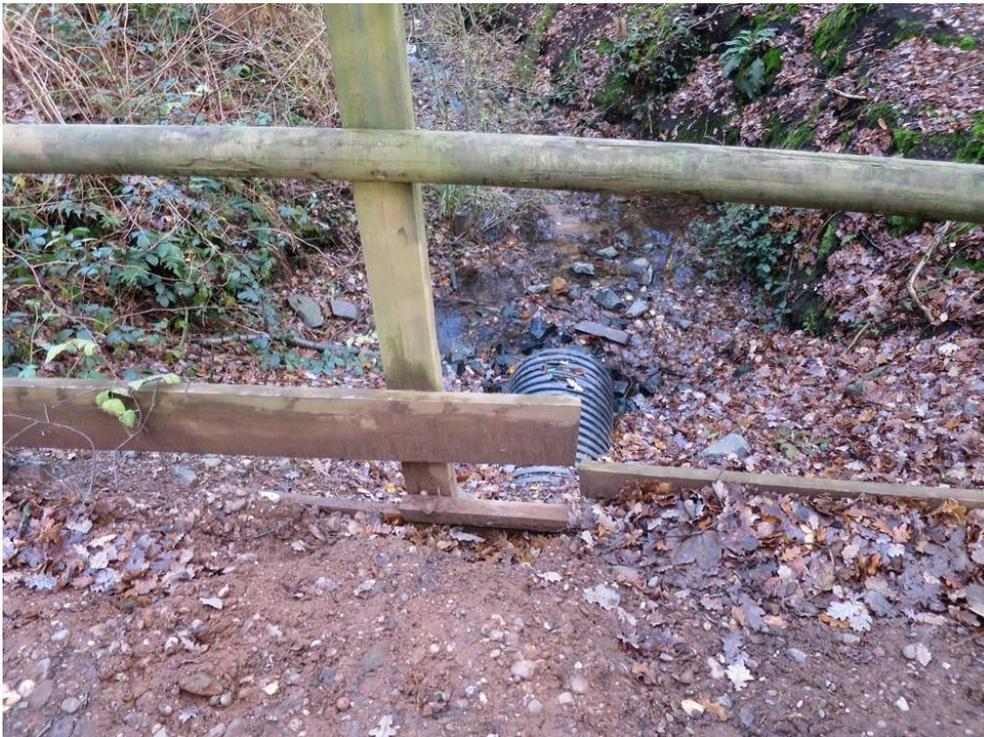
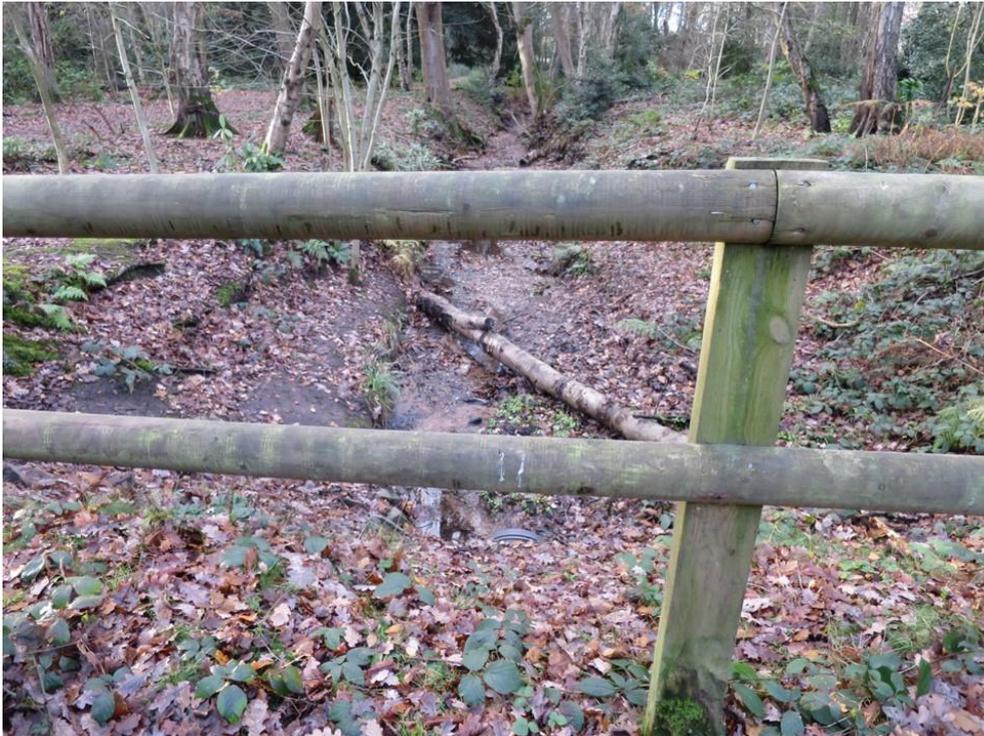
The brook continues downstream after the outflowing discharge from the pond into a steep gradient as it passes below the main footpath (pictured in Fig. 5) and flows down a steep, narrow valley. The brook is piped through a small plastic culvert, embedded into the footpath that forms a bridge over the brook (Figs. 8 and 9).

This, along with the on-line pond (and especially culverted brook at the upstream and downstream visit limits) is one of multiple examples of the habitat being split into inaccessible fragments for many aquatic species. As well as the existence of the specific habitat types outlined in Figs. 2-4, the ability for species to move between each type of habitat throughout their lifecycle is also vital.

**Figure 8: Upstream/inlet of the plastic-pipe culvert that carries the brook beneath the footpath at SP05375 94463**

**Figure 9: Looking downstream from the bridge and culvert through the footpath**

To significantly improve the freedom of movement (or "connectivity") would require a significant investment – particularly given that the downstream culvert is buried within the embankment carrying the M6 motorway. Therefore a judgement must be made as to whether tackling the barrier posed by the footbridge culvert would be cost-effective within the 400-m reach within the boundaries of Holly Wood. With that said, the culvert could be replaced by a clear-span bridge at relatively little cost.

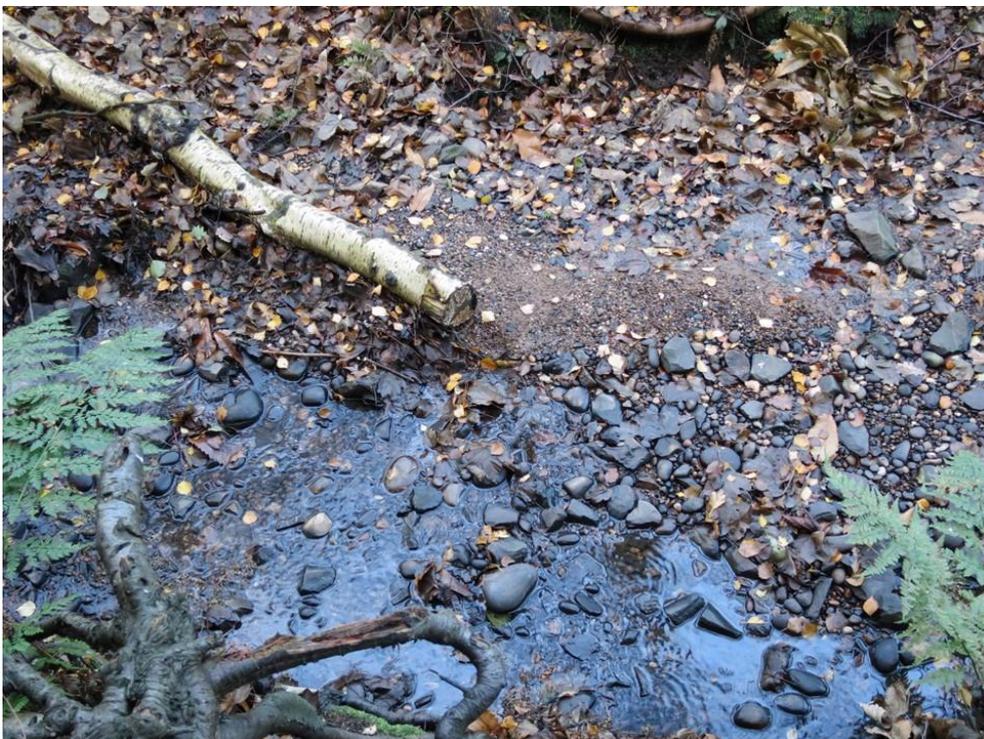
The steep gradient and presence of natural, fallen woody material within the channel creates valuable variation in the structure of the habitat. As well as creating different depths and flows over the cross-section of the channel, the process of "sorting" or "grading" substrate is very valuable (e.g. Fig. 10).

**Figure 10: Substrate material of different particle-size "fractions" is separated out into discrete patches by the scouring and deposition processes promoted by the presence of fallen woody material. Notice how the finer material has been deposited around this tree limb, while the coarse cobbles are exposed by faster flows being focused towards the lower edge of the frame.**

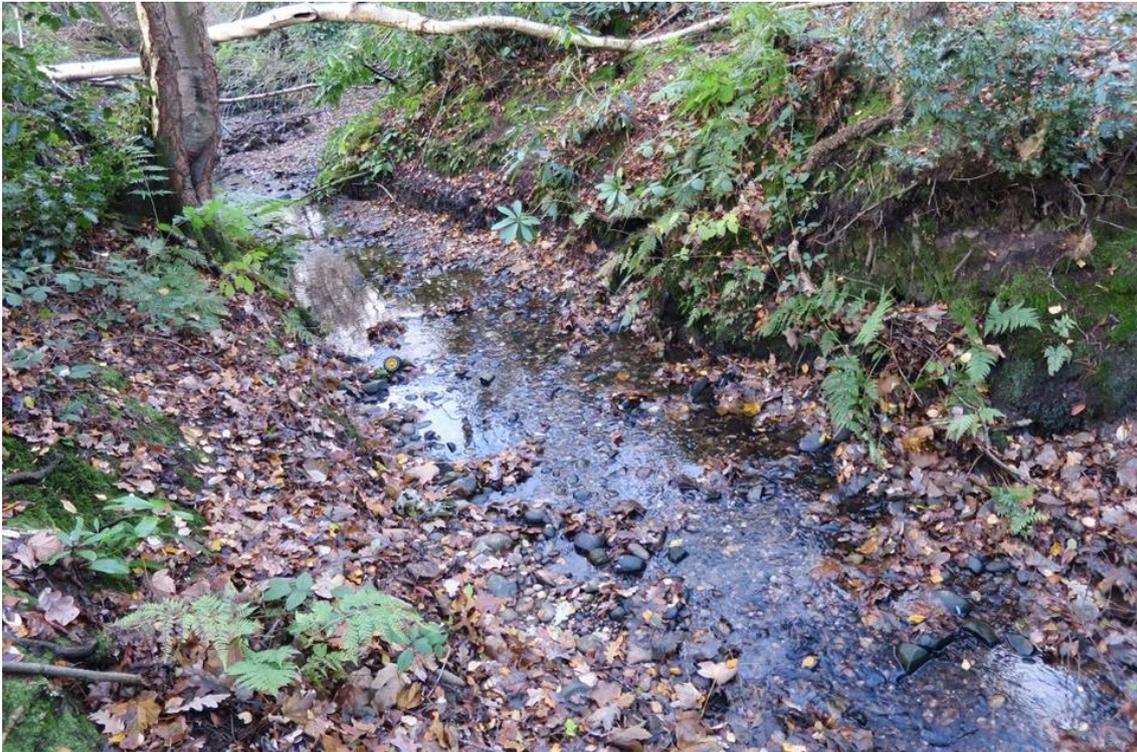
**Figure 11: Relatively uniform cross-sectional depth, flow and substrate. The steep gradient would readily promote extra structural diversity following the introduction of stable, large woody material.**

Introduction and secure anchoring of woody material within the channel could focus spate flows to create localised scour and deposition. In turn, this would result in a greater range of physical conditions that could make a broader range of habitat niche conditions available for colonisation.

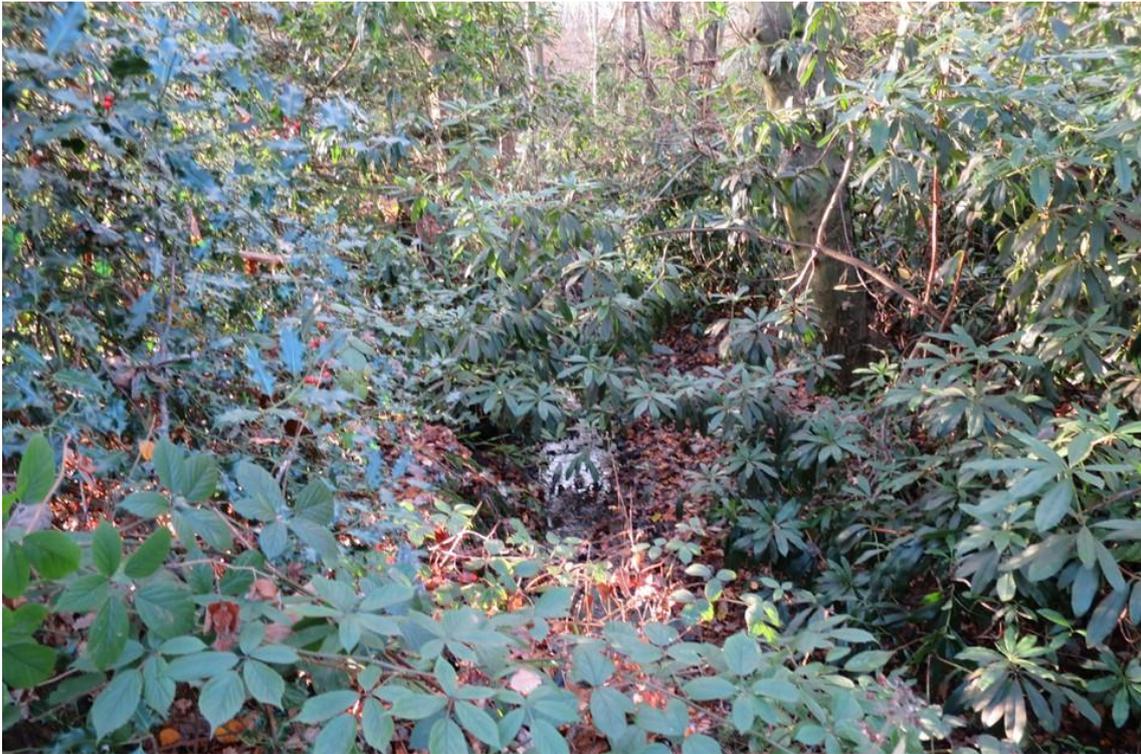
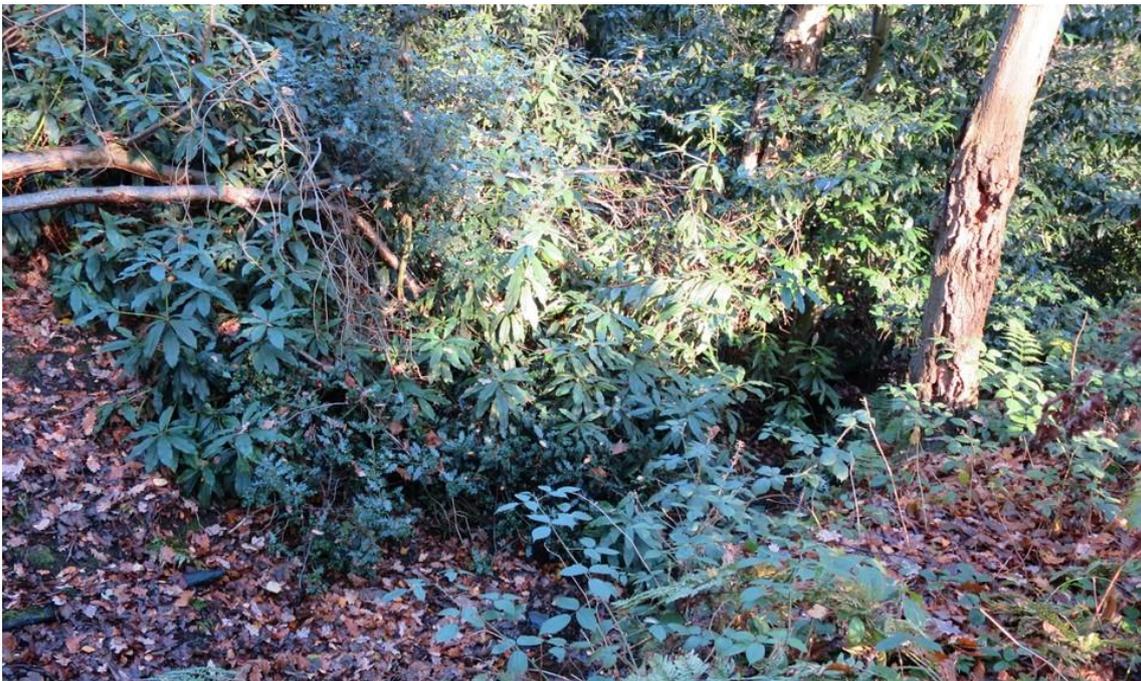
Although no Himalayan balsam or Japanese knotweed plants (typical non-native, invasive plant species associated with watercourses) were encountered during the visit, Rhododendron growth was extensive. As well as creating dense, uniform shade (e.g. Figs. 12 and 13) which limits the diversity of understory species; Rhododendron is also a host to fungal pathogens that can adversely affect native woodland tree species in the UK.

**Figure 12: Dense Rhododendron overgrowth competing with holly to produce a uniformly-shaded watercourse at SP05436 94456**

**Figure 13: Photograph from the same location as Fig. 12, facing downstream**

For these reasons, a programme of Rhododendron control (a notoriously physically difficult task) would be valuable to introduce and maintain. Just as physical variety stemming from the redistribution of riverbed material creates a wider range of opportunities for increasing species diversity, so too does reducing the dominance of competitively-dominant Rhododendron bushes. Their removal also greatly reduces the reservoir of fungal spores that can cause serious diseases of our native woodland trees. A significant proportion of the ground cover within the whole of the Holly Wood Local Nature Reserve woodland was noted to be Rhododendron.

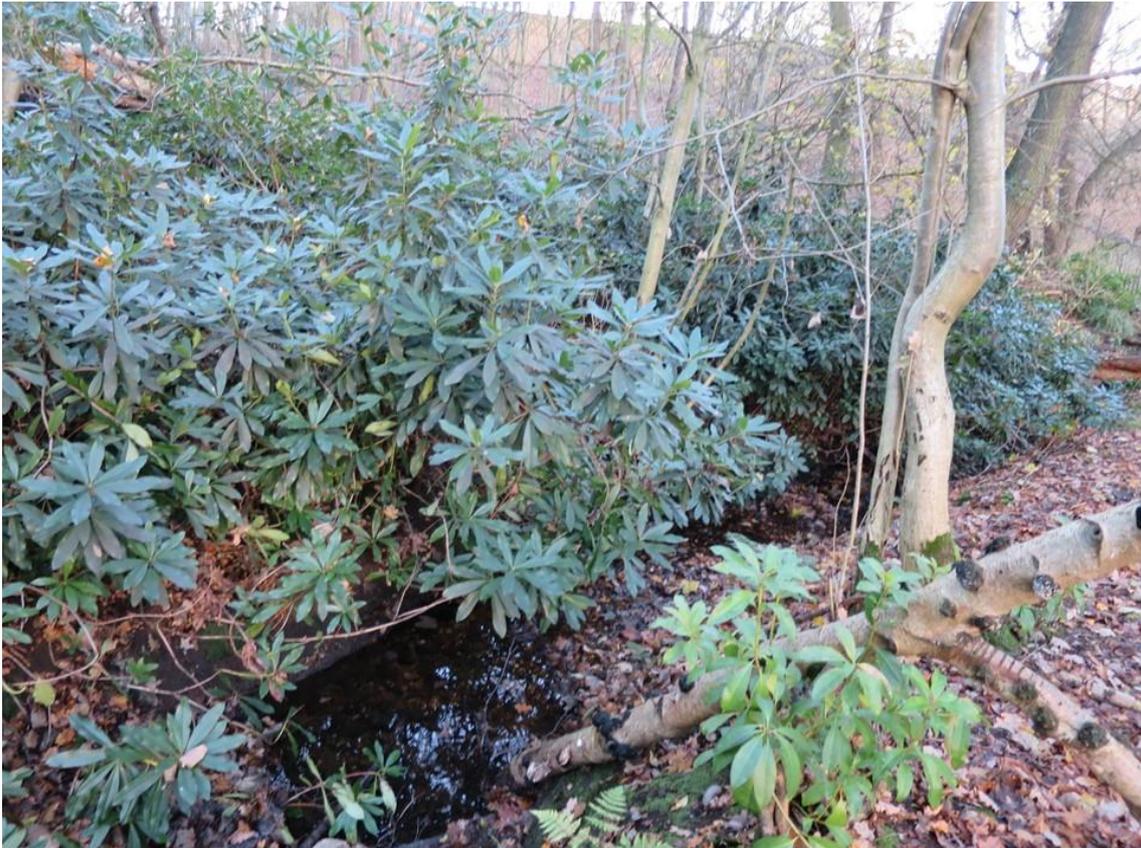
**Figure 14: Further examples of extensive Rhododendron overshadowing of the channel just above the downstream visit-limit**

At the same time, this is not an argument to create entirely open canopy throughout the whole visited reach. Again the guiding principle should be variety. A broad rule of thumb for canopy management (as well as promoting a diverse range of herbaceous and woody species) is to aim for an approximate mix of 60% dappled shade to 40% light.

While not an absolutely rigid formula – it gives a useful starting point. To this end, light, rotational coppicing of the mature trees can greatly enhance woodland biodiversity – and the biodiversity of their associated streams. Creating a staggered range of canopy heights - rather than a flat single-height – allows a more diverse understory to develop.

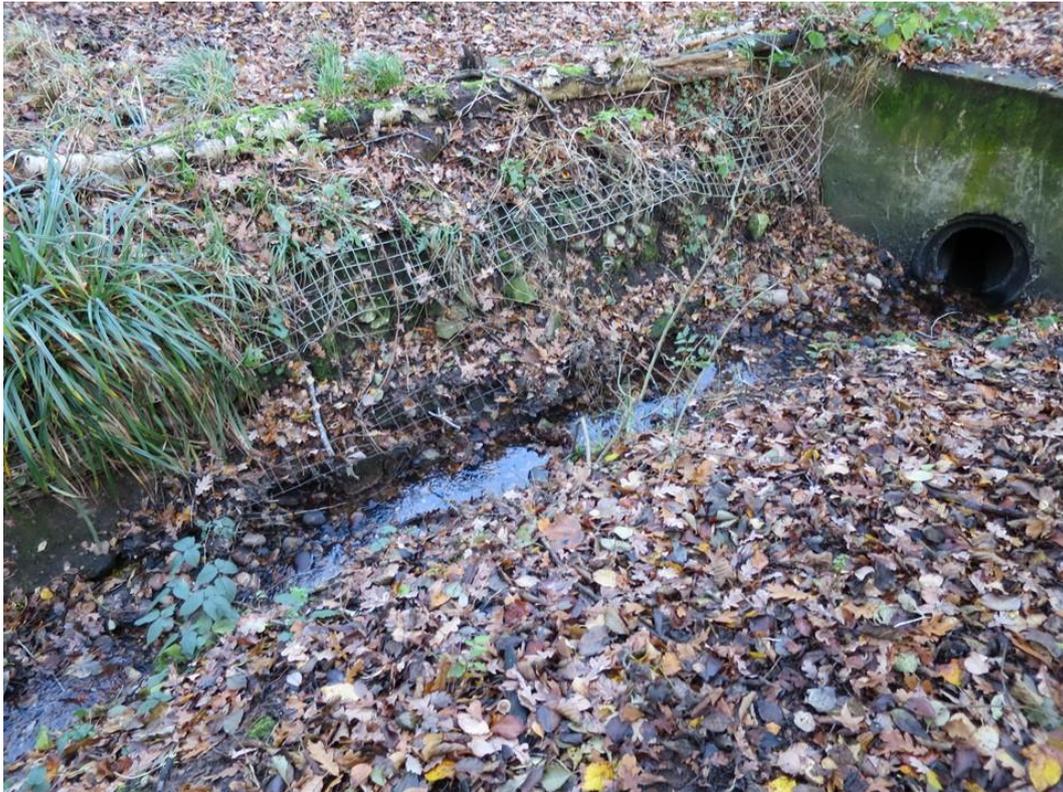
Finally, the small culvert that carries the brook beneath the M6 was located at SP0549294454 (Fig. 15). This is another significant barrier to migration that, together with the upstream-limit culvert and on-stream pond, effectively isolates the reach within the Holly Wood Local Nature Reserve.

**Figure 15: Tiny culvert that carries the brook underneath the M6.**
