Advisory Visit

Hoo Brook, Worcestershire

April 2018

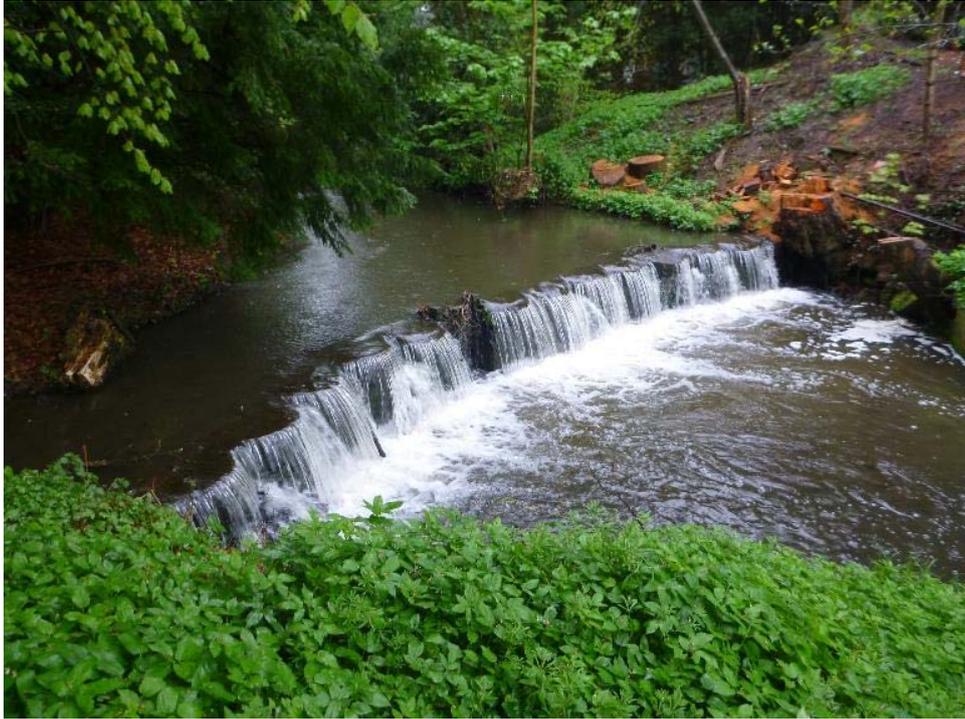
Photo 1 The weir at the upstream end of the reach. Note the slow, impounded water and poor quality habitat upstream in contrast to the free-flowing nature of the brook in the pictures below. Weirs like this drown out natural habitat features and cause fine sediment to settle out which smothers the gravel bed. Weirs are also obstacles to the free movement of fish, restricting their access to the different habitats required to complete their lifecycle.

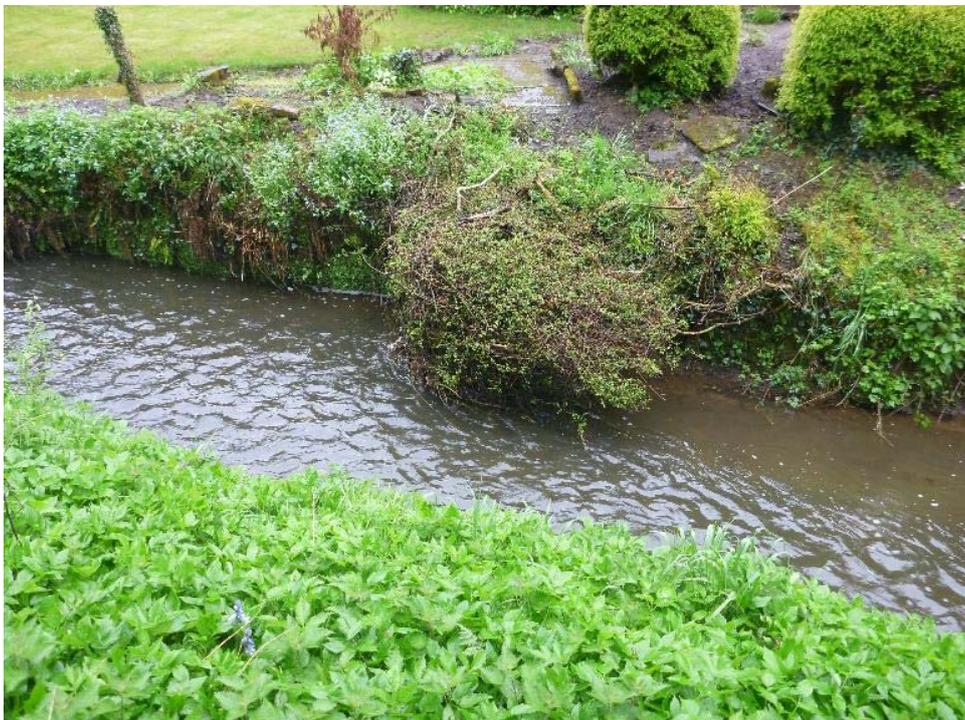
Photo 2 The walled bank of the garden does not provide good habitat because there is little cover for fish to shelter and feel safe. Overhanging cover like the bush (pictured) could make the difference between a fish occupying this area or not, so should be retained. Encouraging plants which overhang the water could improve the fish-holding capacity of this section.

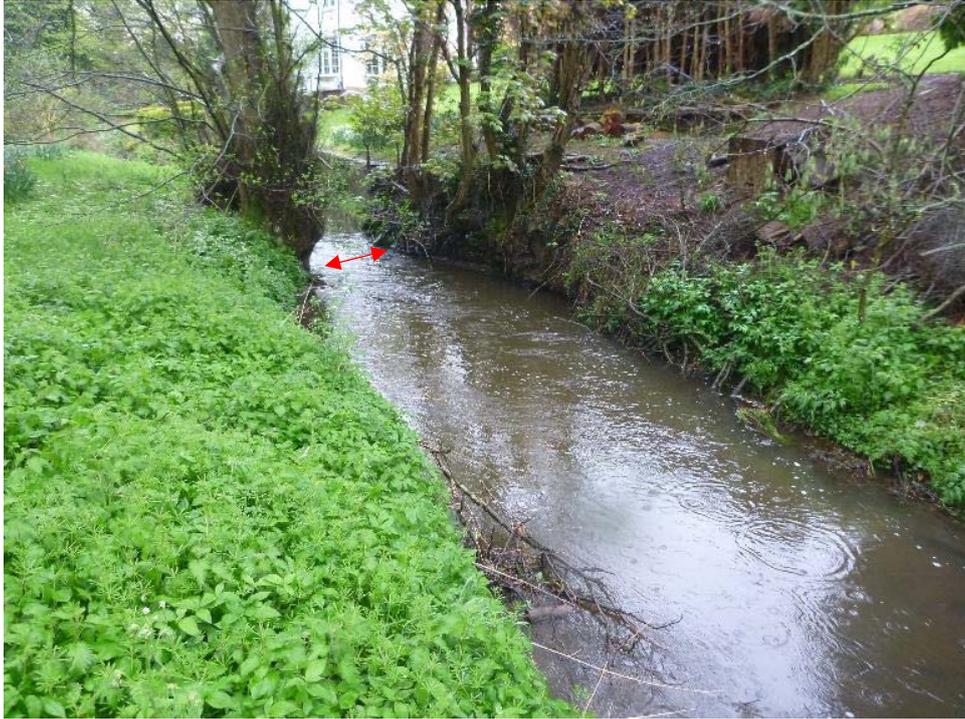
Photo 3 For the majority of the reach, mature trees and their root masses provide good bank stability and pinch the channel (arrow); this helps create deeper pool areas immediately downstream, where the increased flow scours the river bed. This is particularly valuable habitat for larger trout – a deeper pool with cover (submerged tree roots).

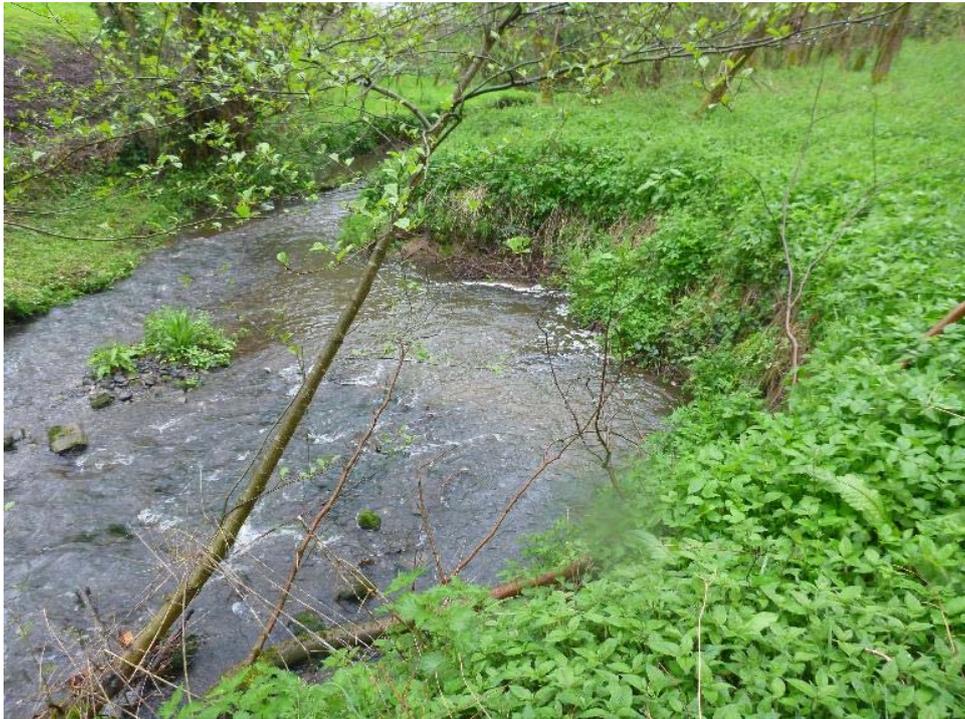
Photo 4 Some bank erosion is evident (right bank) at the downstream end of the garden section. This is not causing a problem and will eventually create a deeper pool on a meander, so should be allowed to continue.

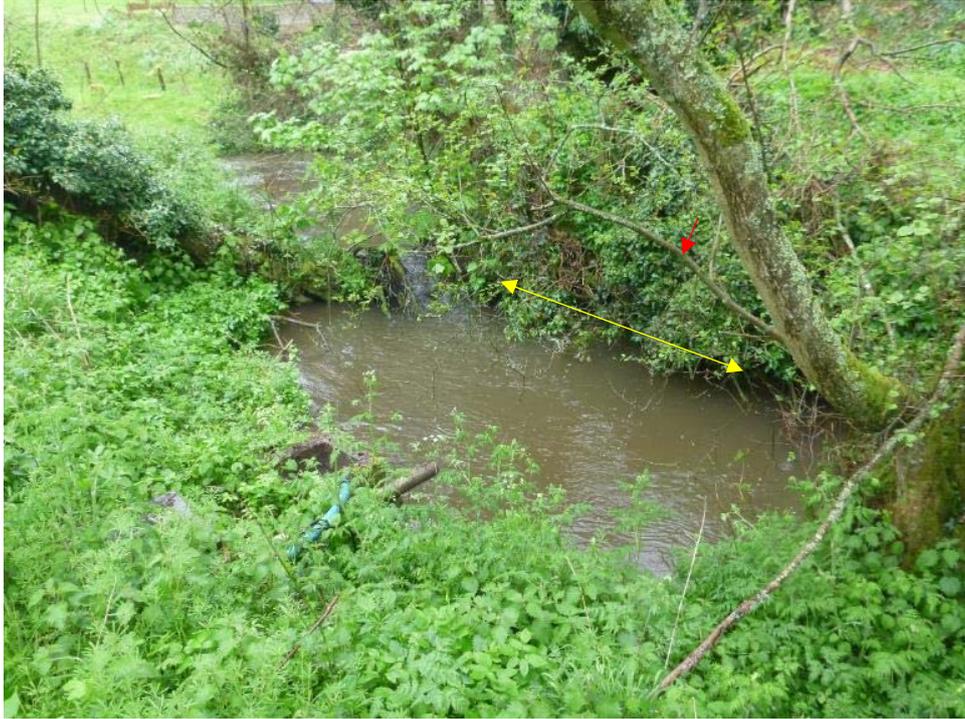
Photo 5 A good example of fallen timber pinching the flow and creating a scour pool, good for holding fish. Fallen trunks extending into the channel like this one should be retained. If this area was being improved for angling access, it would be important to retain the cover on the far bank (yellow arrow) which helps to hold fish; trimming higher level branches to facilitate a cast (e.g. red arrow) is less critical.

- Introduce more woody material to the channel, to mimic the natural features shown in the photographs above (e.g. Photos 5, 7 & 8). Larger trees could be positioned extending into the channel (with the majority of their weight on the bank, to prevent them washing away). Smaller trees in suitable areas can be hinged and laid into (or over) the channel, in a similar way to hedge laying (Photo 12). Targeting areas which are currently quite “bare” would be beneficial (e.g. Photo 6).

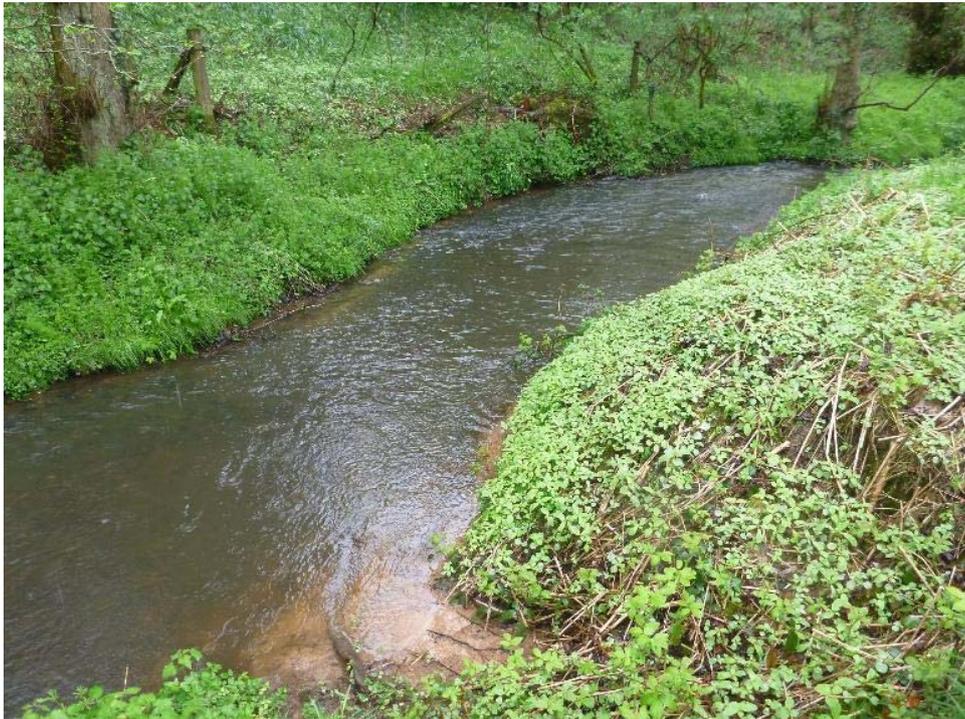
Photo 6 A shallow, faster flowing riffle area with a gravel bed. This is where trout would typically spawn, depositing their eggs in gravel during the autumn. The eggs incubate until the following spring, so are vulnerable to smothering with fine sediment. Unfortunately, the Hoo Brook appears to have a significant problem with fine sediment ingress which could be causing a bottleneck in trout production by reducing spawning success (the weir also inhibits the use of other spawning areas upstream). Tackling the source of the fine sediment is the best, but most difficult, solution (see Recommendations); in the meantime, measures to sort and scour the gravels can be implemented/ encouraged (Photos 7-9). Note also the presence of the invasive plant, Himalayan balsam on the banks – this should be controlled.

- The non-native, invasive plant, Himalayan balsam should be controlled, otherwise it smothers out native bankside vegetation. This leaves banks bare in winter and vulnerable to excessive erosion. A monoculture of balsam also leads to a lower diversity of insects, etc. which reduces the availability of bankside food sources that drop into the water. Balsam can be controlled by hand-pulling or cutting/strimming to ground level (below the first node on the stem of the plant, to prevent re-growth), well before the plant flowers and sets seed (normally late June). It is an annual plant, with a seed life of approximately three years, so a drop in plant numbers should take place with regular control. Seeds are washed

- Riffle areas where the gravel has high levels of fine sediment could be raked in anticipation of the trout spawning season (however, the development of more natural in-channel structure will do the job more sustainably in the long term). If raking is undertaken, early October would be the best time to attempt this. Further guidance can be found in this video on the WTT website:

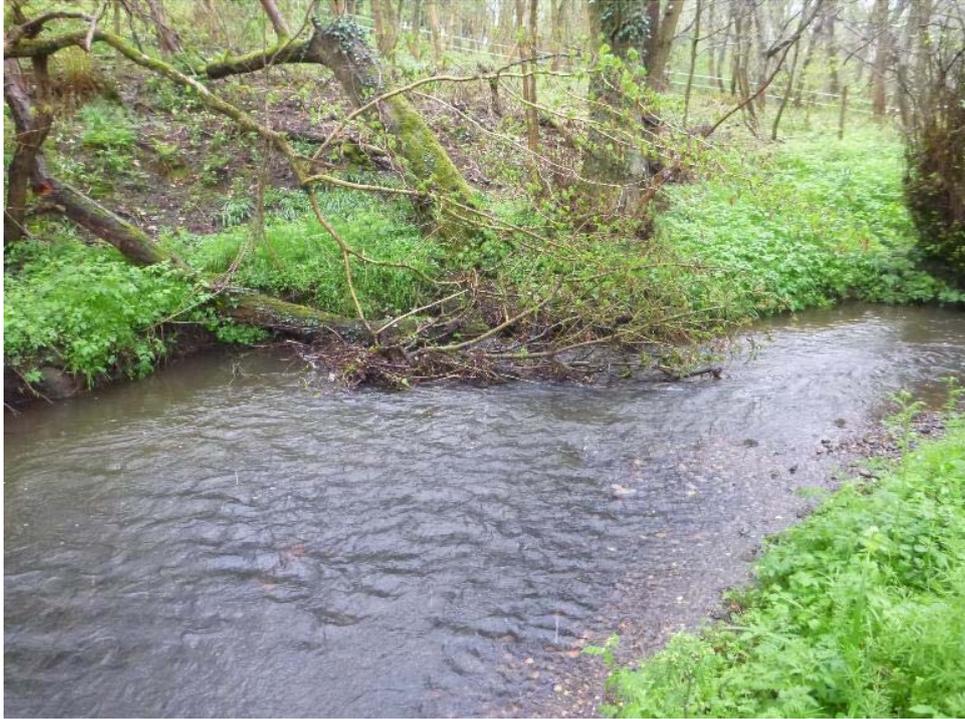
Photo 7 Woody structure in the brook course is very valuable habitat. In this case, it is causing scour on a gravel riffle which helps to sort the gravel and shift fine sediment, improving the chances of trout spawning success. Naturally occurring features like this should be retained.

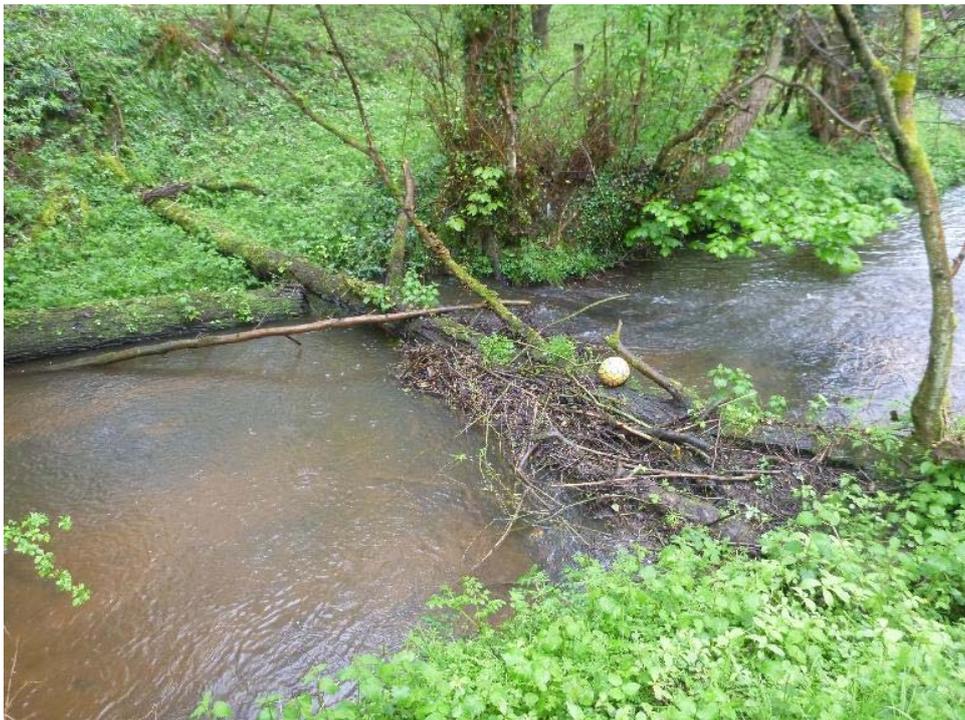
Photo 8 Another example of woody structure, formed by a fallen tree which has gathered debris. Although this may appear superficially “untidy” it is providing excellent habitat. The flow is being pinched and flumed through a narrow gap against the left bank, creating a series of beneficial features highlighted in Photo 9 below.

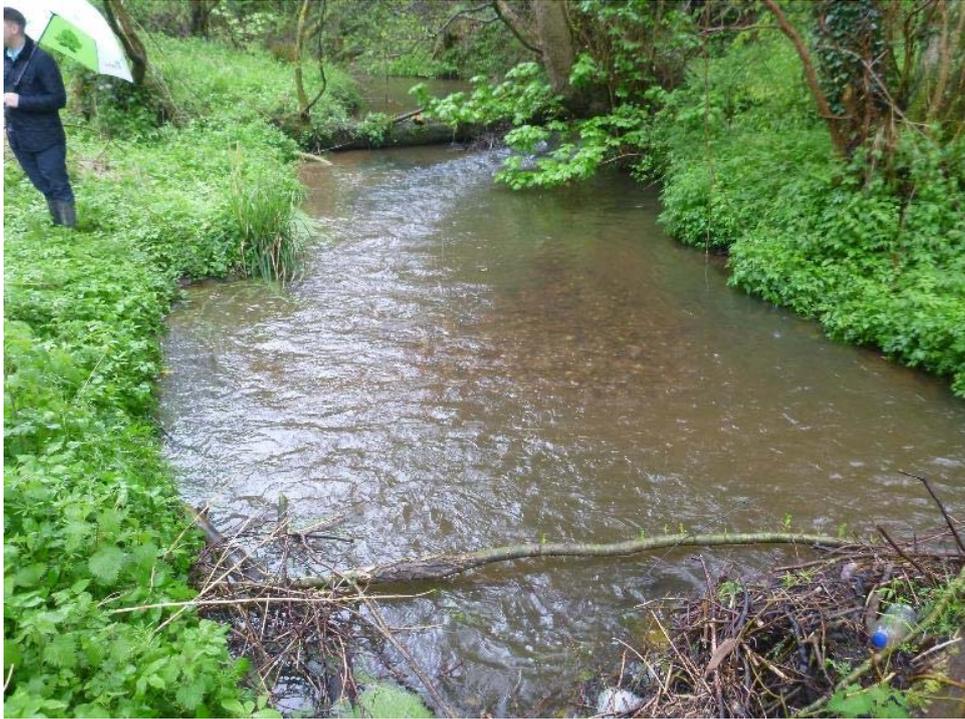
Photo 9 The same feature as Photo 8, viewed looking upstream, showing the pile of clean, well-sorted gravel which has been scoured by the pinched flow and deposited at the tail of the pool – ideal for trout spawning. In addition, the deep area with overhanging cover closer to the log provides a good lie for larger trout.

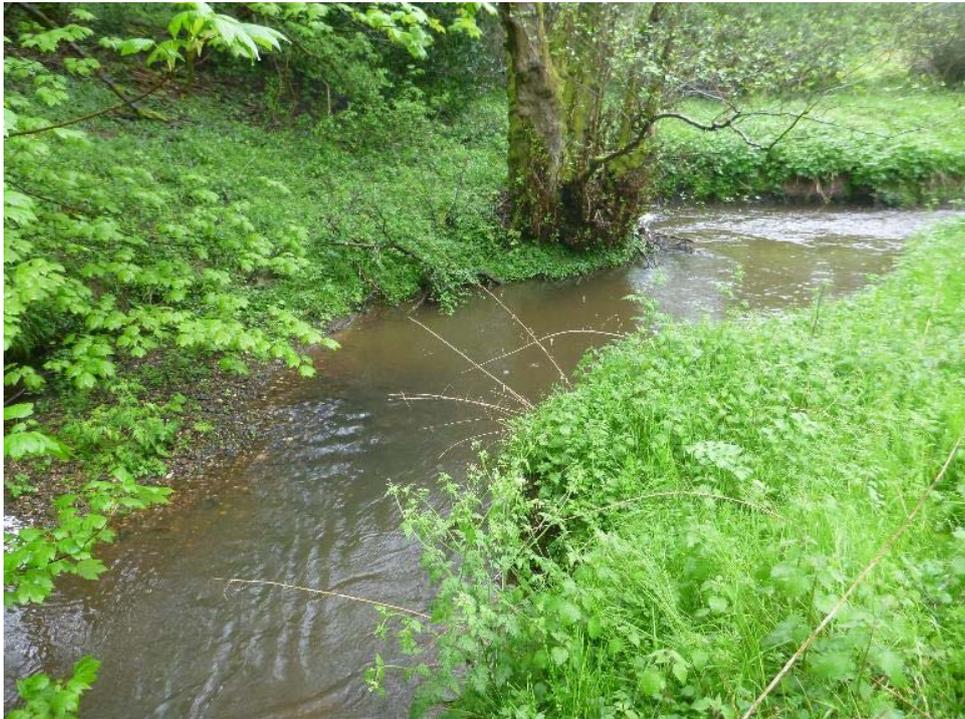
Photo 10 A good example of the high quality, in-stream habitat present on this reach: a deep pool, bordered by an alder tree provides excellent cover for adult trout; the run out from the pool provides the right flow and substrate for spawning; the bankside vegetation is a good balance of light and shade, trees and understorey vegetation, which will provide an input of insects, etc. to supplement the trout's aquatic food.

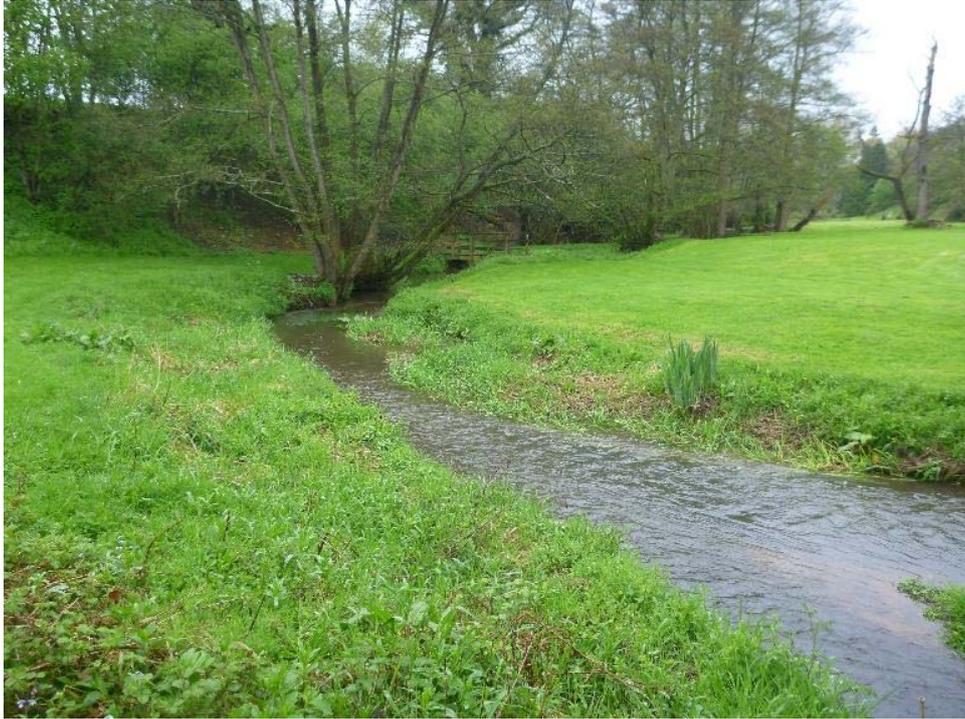
Photo 11 At the downstream end of the reach is a more open area where bankside vegetation is more managed. Although there is some water crowfoot present here (because of increased light reaching the channel), the in-stream habitat is generally simpler (and therefore poorer quality) than upstream (in contrast with the previous picture). Allowing a wider un-managed buffer along the watercourse (>2m wide) would be beneficial.

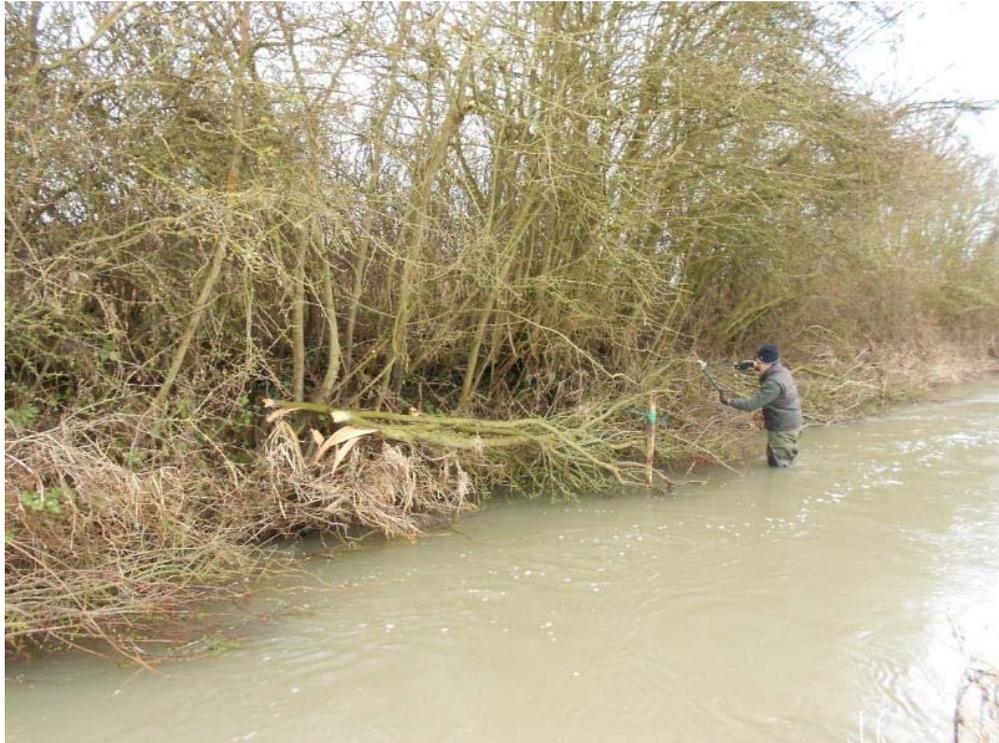
Photo 12 Hinging and laying trees to create trout holding cover.
