Advisory Visit

River Leven

Hutton Rudby Fly Fishing Club

25/03/2019

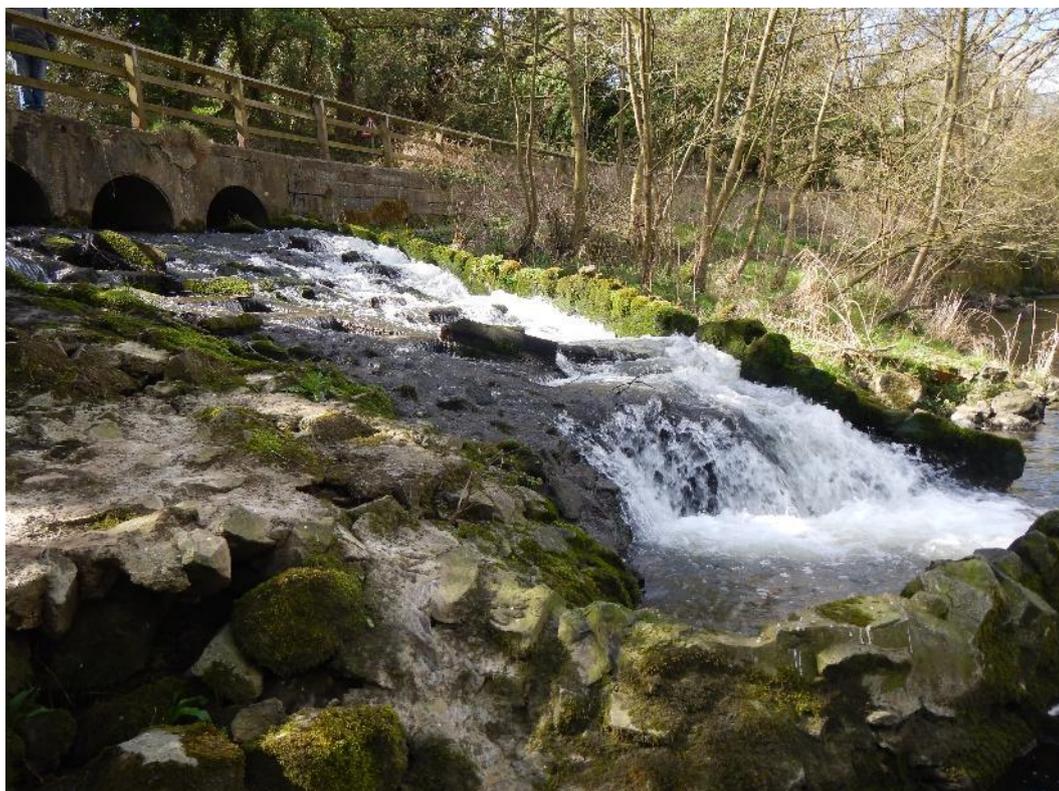
Towards the upstream end of the fishery, the barrier at the downstream end of Potto Beck remains a major issue, disconnecting what should be a valuable spawning tributary (Fig. 1: NZ 47311 06068). Some of the previous easements installed have degraded, with passability reverting to a very poor state. Since the last WFD assessment (2015), the classification of fish populations on the beck has dropped from Good to Moderate; poor access for fish from the main river and an associated reduction in spawning on the beck is almost certainly a contributing factor, along with recognised fine sediment issues. Resistance from the owner of the structure to undertake or even allow significant fish passage improvements has been an ongoing issue. The current *Failure* of the beck for *Fish* under the WFD classification system may bring more weight to the case for real fish passage improvements at the structure; something which should be followed up with the Environment Agency (EA).

Photo 1. Culvert at the downstream limit of Potto Beck: still a major barrier to fish access.

There are clear easement-type improvement works that could be undertaken on the structure, and the WTT is very happy to assist with this, but the first course of action should be to seek more major improvements through the EA and owner of the structure. It's a 'catch 22': if easements are successful, they can provide an improvement to the rivers and fishery, but it could again reduce the impetus (and potential funding options) for a proper solution to the fish passage issue, so it is best to keep the easement option in reserve in the short-term.

First and foremost, investigate options for a proper solution to the fish passage issues on the beck with the EA. As it is currently failing under WFD, there is a far greater driver for initiating improvements.

Lower cost options for Potto Beck could be looked at if the push for a more formal solution fails again. The exact solution would require more detailed site inspection but might include:

- Installing alternating baffles to deflect the flow from side to side across the apron, thereby decreasing the gradient and creating resting areas of lower flow velocity in the lee of the baffles where fish can rest. This could be achieved with additional baffles installed onto the apron.
- An alternative and potentially even more effective option could be to use more of the reinforced apron/bank area to one or both sides of the current easement, again lowering the overall gradient of the migration route through the easement.

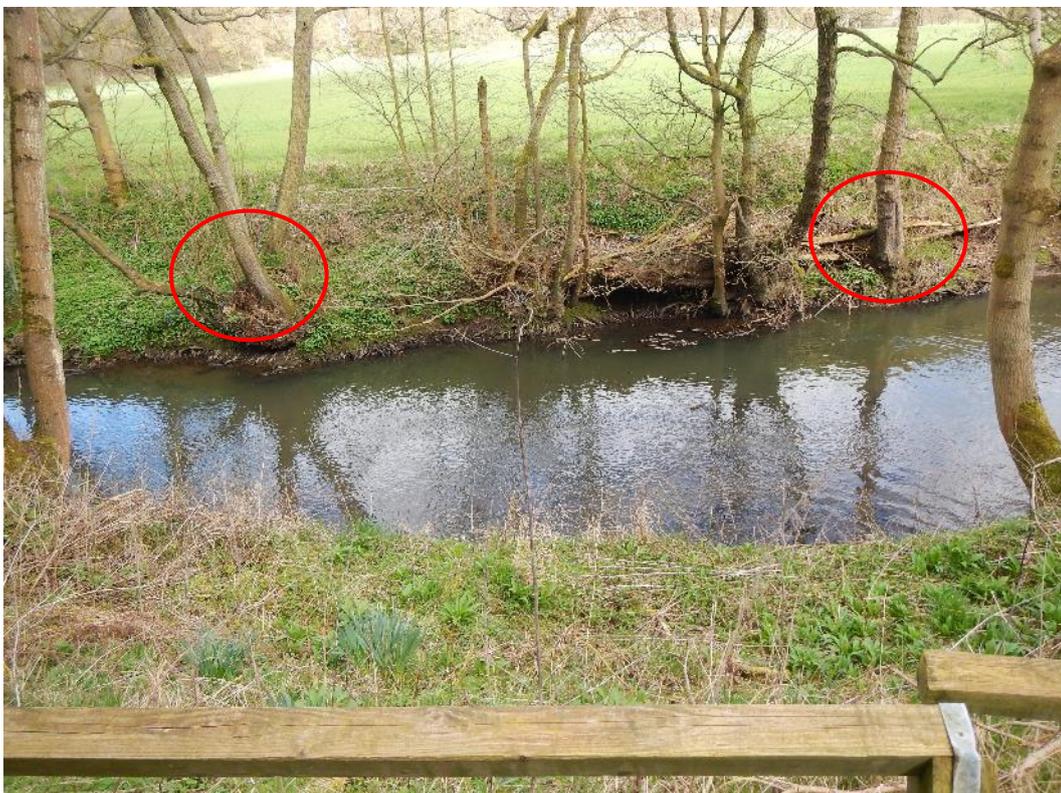
Photo 2. Alder roots provide valuable structure but there is a general lack of low/trailing cover. It is suspected this is partly due to the spatey nature of the beck that will break off some low branches, but likely also past maintenance. Coppicing *one/two* of the many trunks on the far bank would encourage low-level regrowth (red circle - NZ 47299 06087).

One or two (max) of the several trees along the RB in Fig. 2 (NZ 47299 06087) could be coppiced to reinvigorate low-level bush regrowth. This should ideally be undertaken within the dormant season to greatly reduce the potential for killing the tree – one of the trees is a multiple stem, which does limit the risk.

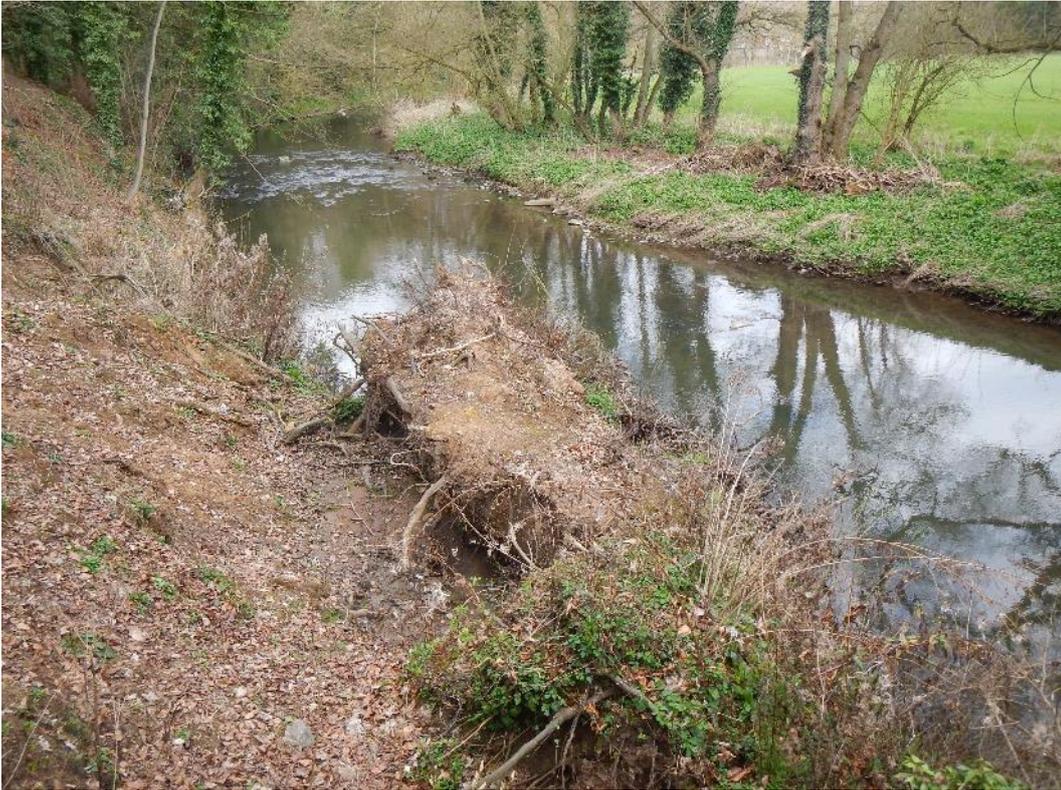
Photo 3. A large fallen tree that would otherwise have provided great habitat enhancement to the area has been largely removed from the channel. The tree is upstream of Hutton Ruddy village but had minimal chance of moving if left alone. If anything, the remaining rootball is now more likely to move, but even that is unlikely. The lack of cover and structure in this area could be improved by planting a few clumps of willow shrubs (goat willow ideally) in open areas along the waterline (NZ 47218 06134).

Willow whip planting would be beneficial along the bankline in the area around NZ 47218 06134 (Fig. 3). Goat willow would be the best species to use as being a smaller species it will provide good, low-level cover.

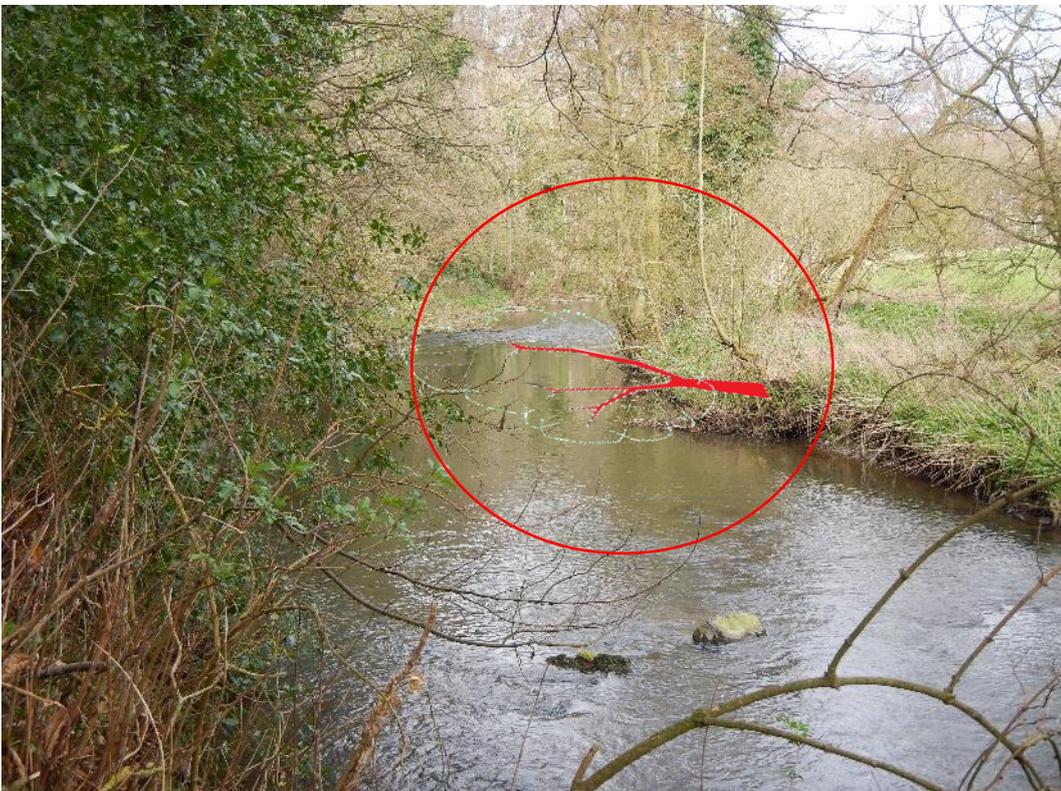
Photo 4. Almost immediately downstream of the rootball, a tall crack willow on the inside of the bend (NZ 47171 06229) could be laid down into the channel (as shown in red), to complement the existing natural tangle at its base and contribute to the development of structure.

- Lay the crack willow tree highlighted in Fig. 4 (NZ 47171 06229) down into the river channel.

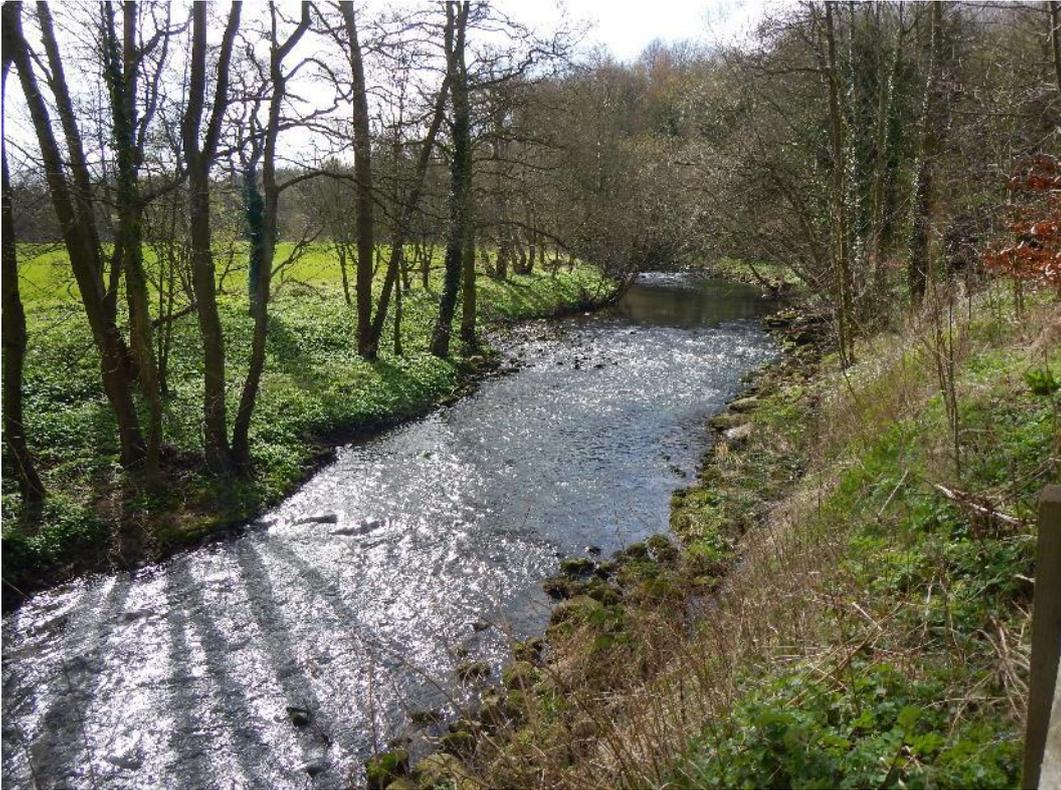
Photo 5. Riffle areas should provide ample habitat for juvenile salmonids, providing that recruitment is sufficient to supply them. Angler catch data for older juveniles and adult fish would suggest it is, on average, but this is no reason for complacency and fish passage improvements should be sought at all structures to increase the sustainability of fish population.

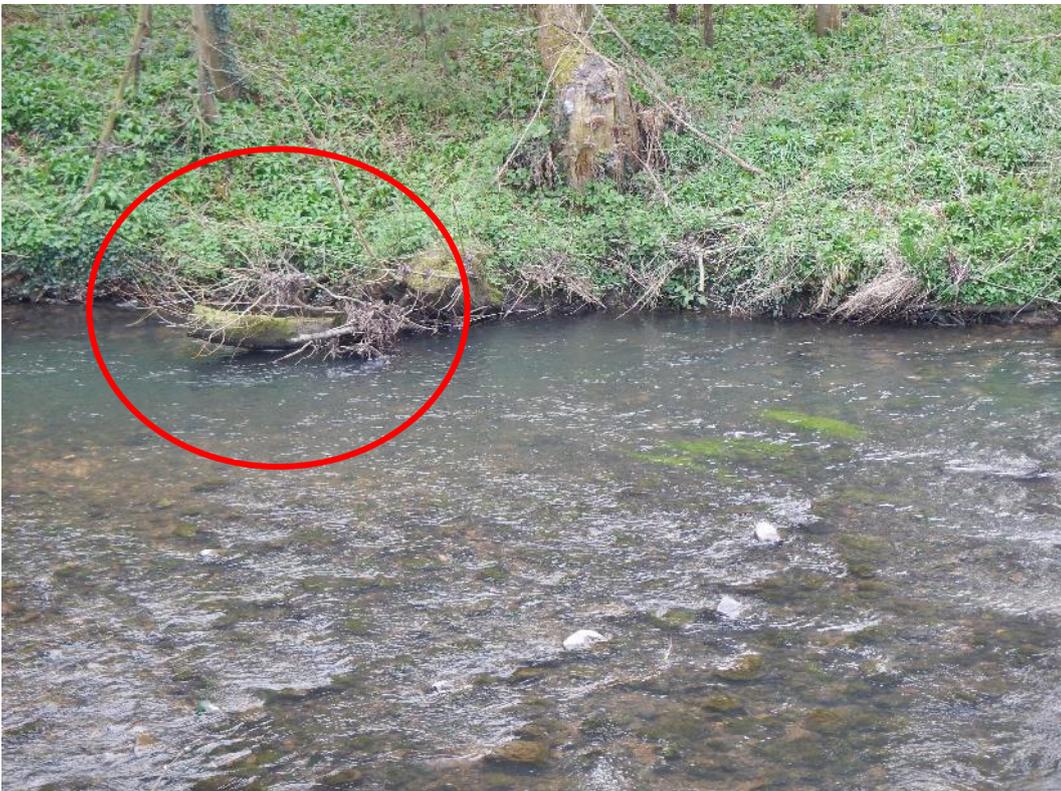
Photo 6. Evidence of valuable in-channel cover and structure being removed through maintenance (red circle). Water crowfoot is also present in some of the shallower areas, and where there is greater light penetration to the bed. As highlighted in the 2011 WTT report, the generally low occurrence of the aquatic macrophytes is not a major issue on a naturally well tree-lined upland watercourse such as the Leven.

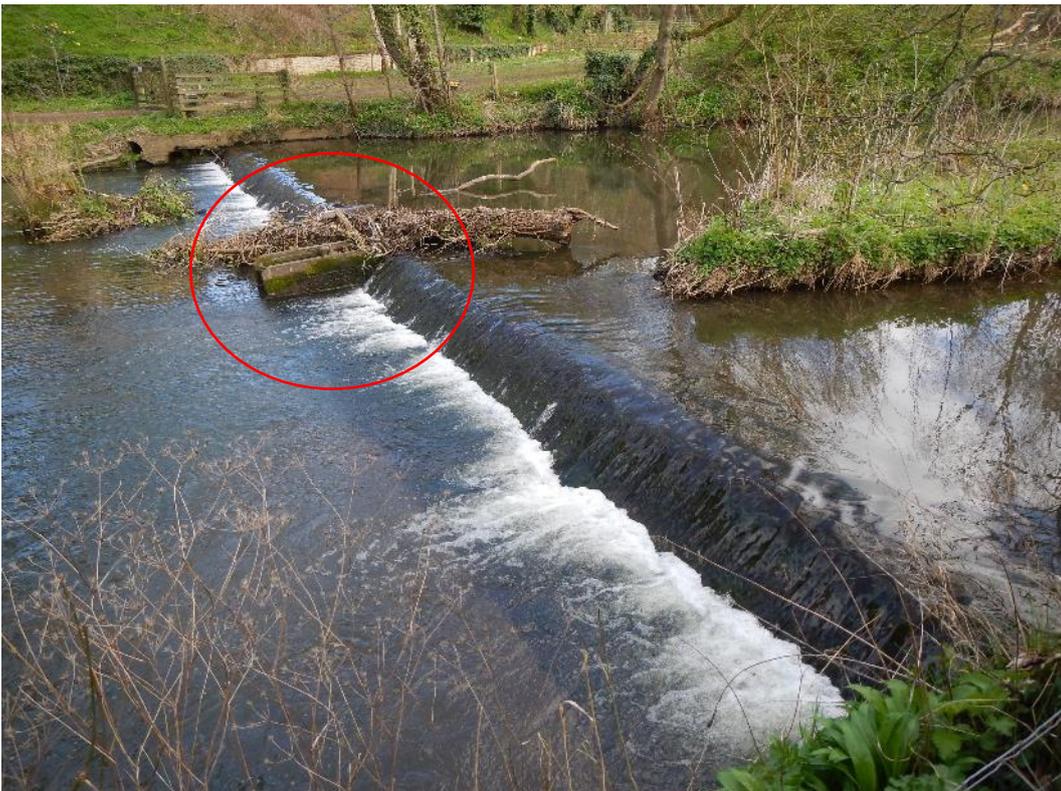
The weir immediately upstream of the bridge in Hutton Rudby poses another obstacle for fish ascending the river and its purpose should be ascertained to identify whether it can be removed (Fig. 6). The benefits of reducing the impoundment and lowering water levels upstream alongside the houses may add even greater weight to the case for removal (and potentially funding). Even aside from flood risk benefits, the improvements to fish and invertebrate habitat upstream within the impounded reach would make removal a very worthwhile exercise. Unlike the situation on Potto Beck, there is no potential conflict from local improvements here impacting upon future funding opportunities.

Photo 7. The weir immediately upstream of the road bridge in Hutton Rudby (NZ47190661). Service checks for the area around this structure would be worthwhile to ascertain whether it can be removed. The small easement mid channel (red circle) provides some improvement, but there is no substitute for full weir removal. The woody material that has accumulated on the weir should ideally be simply eased off into the channel downstream where it will provide a valuable habitat.

The first step should be to undertake service checks for the area to identify whether the weir serves a purpose and if so, what. The multiple benefits of removing for fish passage, habitat improvement and flood risk reduction should make removal a very favourable option. Even if services are present, it would be useful to know what, and whether there could be a longer-term strategy to have it removed through infrastructure improvements. Failing all of that, it may be worth revisiting to look at larger easement options.

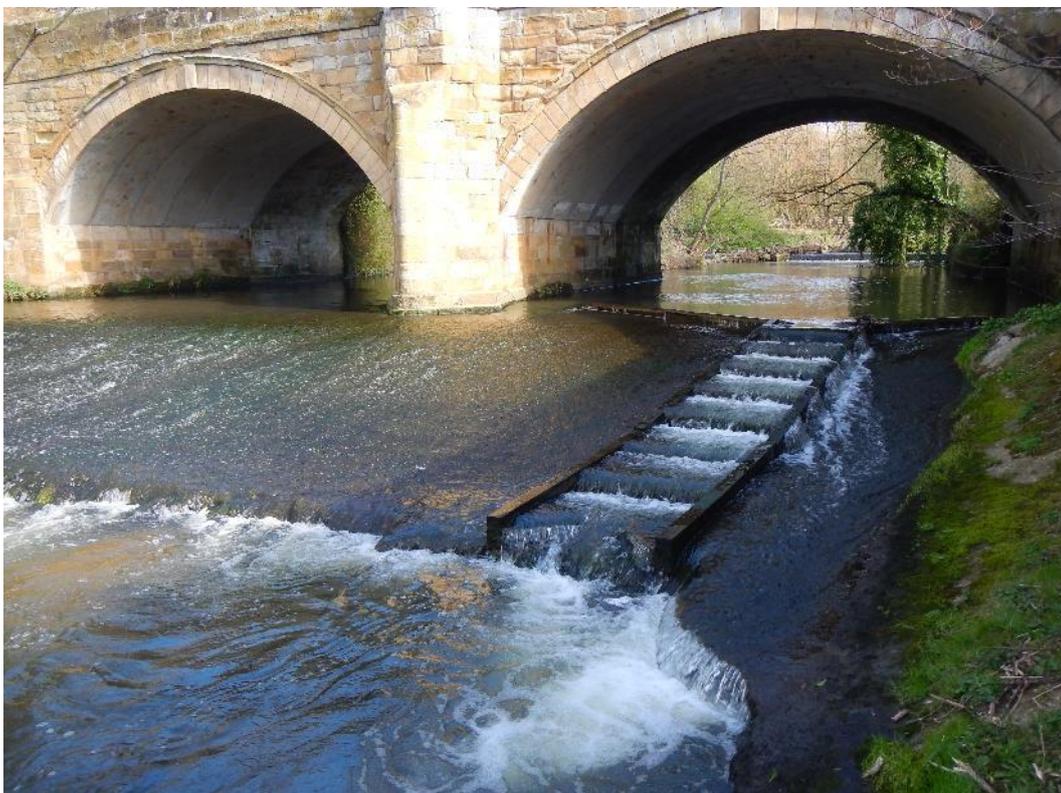
An easement has been installed to the road bridge footings and long sloping apron downstream in Hutton Rudby (Fig. 8). Again, this work is a very commendable effort, particularly in light of reluctance from the owners of the structure. The easement works well to capture sufficient water to fill the boxes while also raising water levels under the bridge arch upstream, so improving passage there too. Ending the baulk short of the full width of the arch also facilitates fish ascending the apron alongside the easement if they choose to do so. The easement has clearly been designed to accommodate smaller fish like resident trout, in a range of flows, which is a refreshing change as many easements only cater for larger salmonids in high flows.

Photo 8. The road bridge footings and apron create an obstruction to fish passage, but the previously installed easement provides a notable improvement (NZ 47155 06605). Further modifications could be undertaken to improve fish passage, particularly if permission could be obtained for a more extensive easement.

Improvements that could be made with this kind of easement include reducing the physical step between the boxes and increasing the width of the boxes (across the gradient). On a structure like this, there would ideally be no solid barrier to flow or fish between each of the boxes, with full bed depth notches at alternating ends of the transverse baffles. This would allow swim-through conditions, rather than a requirement to jump between the boxes. Increasing the width of the boxes would increase the distance the water has to flow across the apron (reducing the effective gradient and increasing channel roughness), increasing the transit time and slowing the overall flow velocity from the upstream to downstream side of the apron. The slowed flow in each pool helps to back up the water level in the adjacent box upstream, without the need for a full width 'weir' to create each pool.

Long-term, the best course of action would be to seek proper approval for a larger, more passable easement on the bridge apron, as described in the **Habitat assessment**. Similar work is regularly undertaken all around the country on other structures and there seems no reason for the owner of this structure to be resistant to the installation of a more effective easement. If there is continued resistance, support from the EA (with their additional powers under the Salmon and Freshwater Fisheries Act 1975) should hopefully facilitate the improvements. Even alongside the existing baffle array, there is the possibility to install another, bed-depth notch easement which might look something like Fig. 27, or could even potentially be located beneath the other arch (although the RB side could be more susceptible to flood debris).

There are also potentially options to improve the ease of passage at the existing easement through notching the baffles/downstream walls of the boxes, either partially or down to bed level (assuming the current installation of the structure permits). Further specific assessment of all the obstructions would be required to ascertain the best fish passage/easement options.

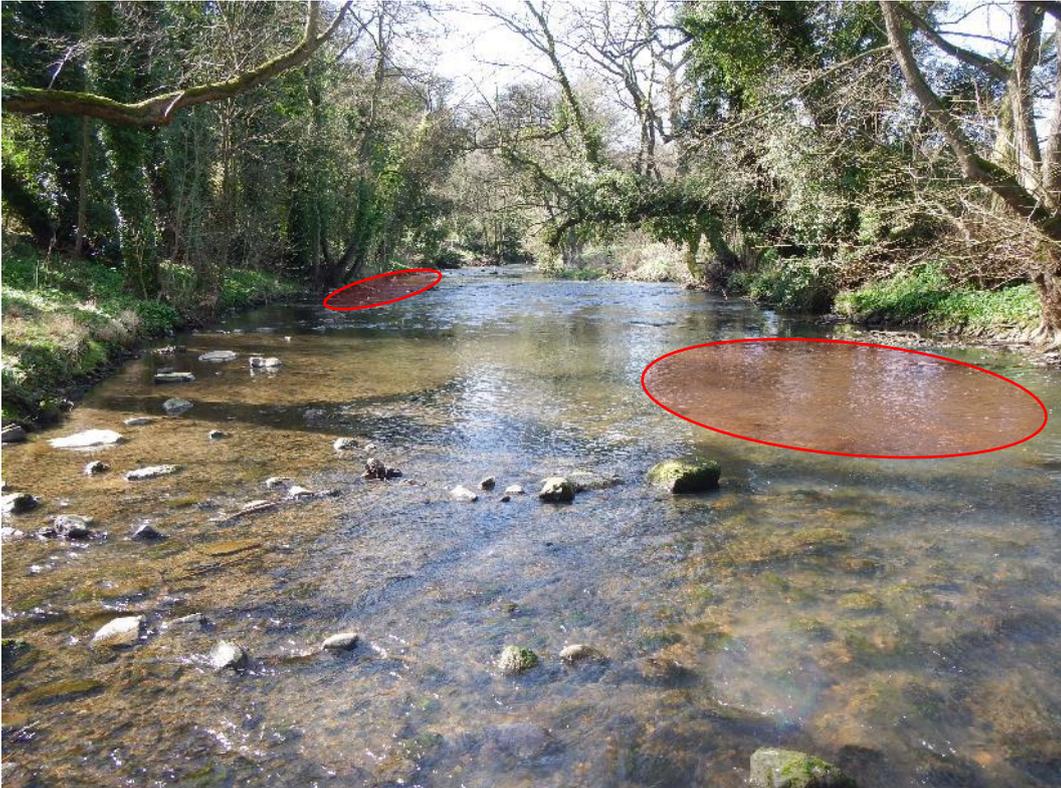
Downstream of the bridge, the physical habitat provides good potential for fish and invertebrates, although wider, low-velocity sections highlight the issues from fine sediment inputs upstream (Fig. 9). In addition to suitable flow and light, water crowfoot also requires relatively silt-free conditions. Flow dissipation around the plants can increase the deposition of silt and nutrients, causing smothering by the silt and/or associated excess algal growth.

Photo 9. Good potential invertebrate and juvenile salmonid habitat with areas for adult trout where the predominant flow pathway favours one side of the channel or the other, focussing bed scour to create deeper areas (red shading). This natural flow (moving from one bank side to the other) is vital in maintaining good quality pool, riffle and riffle features, even in straighter sections. Note the smothering of algae and fine sediment over the bed.

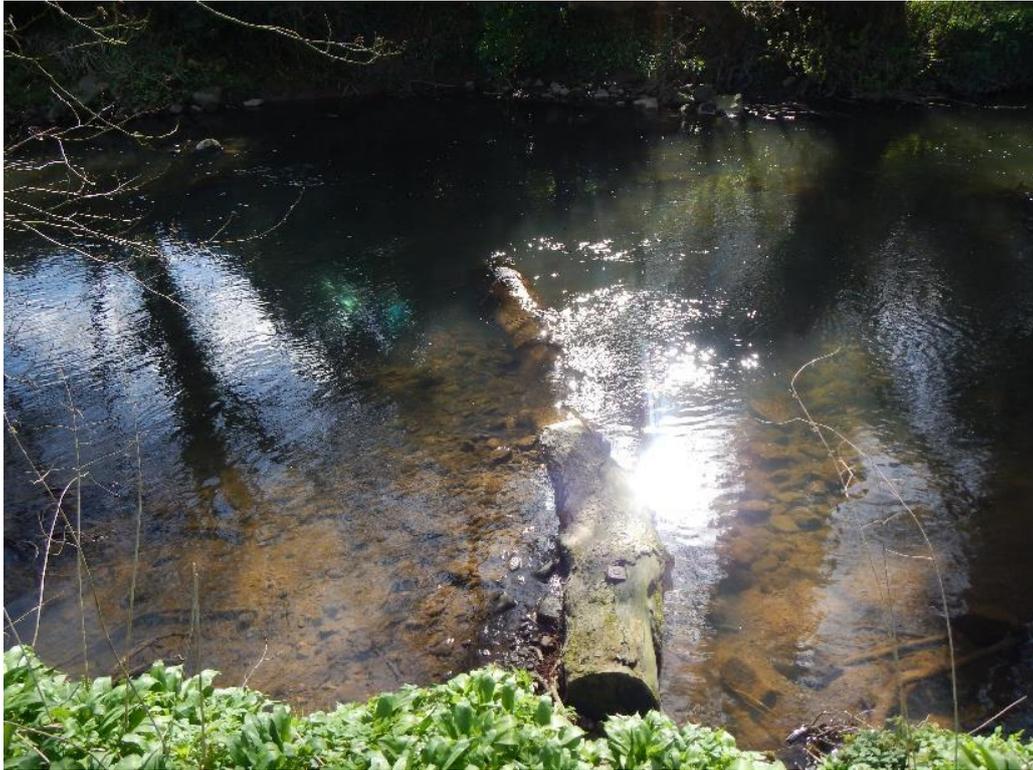
Photo 10. Past habitat improvements are creating features within the river, but are they simply fighting the river processes at that location, rather than encouraging more natural features?

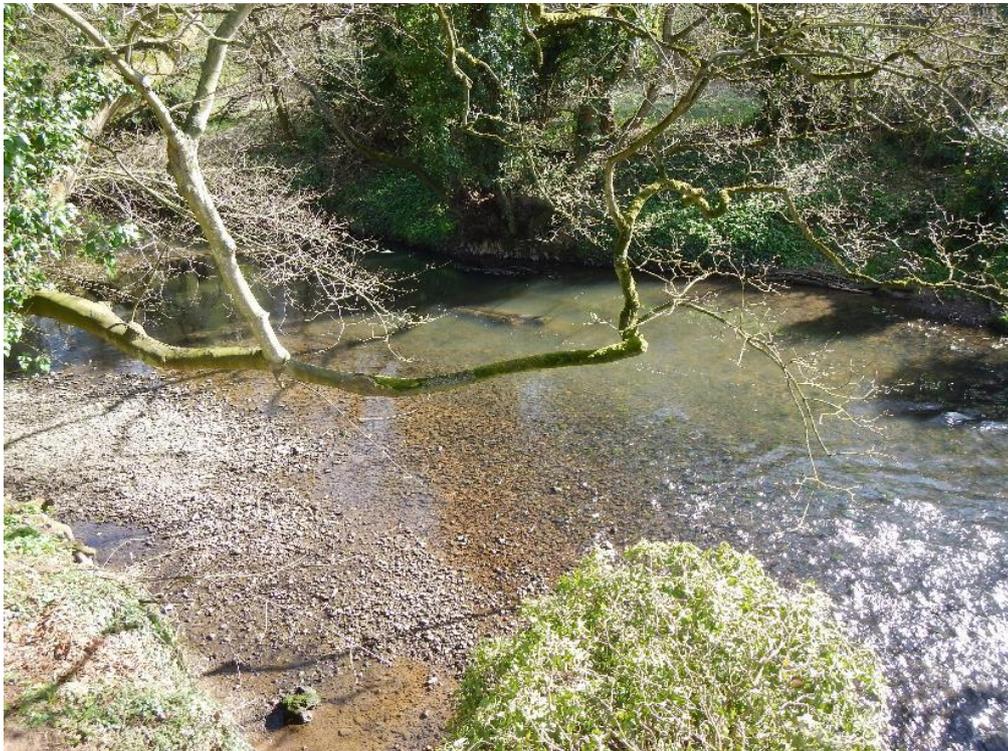
Photo 11. A valuable and relatively scarce area of wider channel, facilitating the retention of finer gravel substrate (when compared to the generally cobble bed). This area is important to the invertebrate and fish populations of the river as a gravel feature. Sadly, the potential is compromised somewhat by the fine sediment deposition but that is a catchment land management issue and not something that can be effectively tackled at this location.

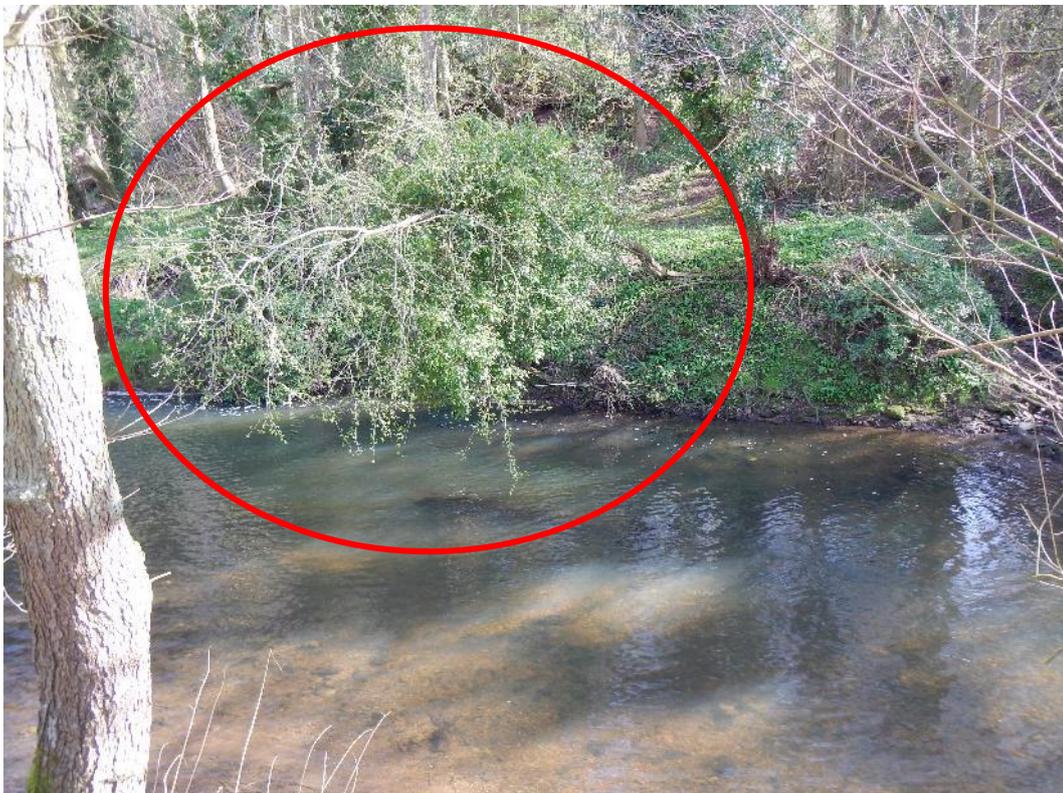
Photo 12. A valuable low-hanging branch that will provide a wide range of valuable features over time if left alone (red circle). Removing it, as would occur on many fisheries, removes those benefits, simply to allow an easy cast to an area that will then support fewer fish.

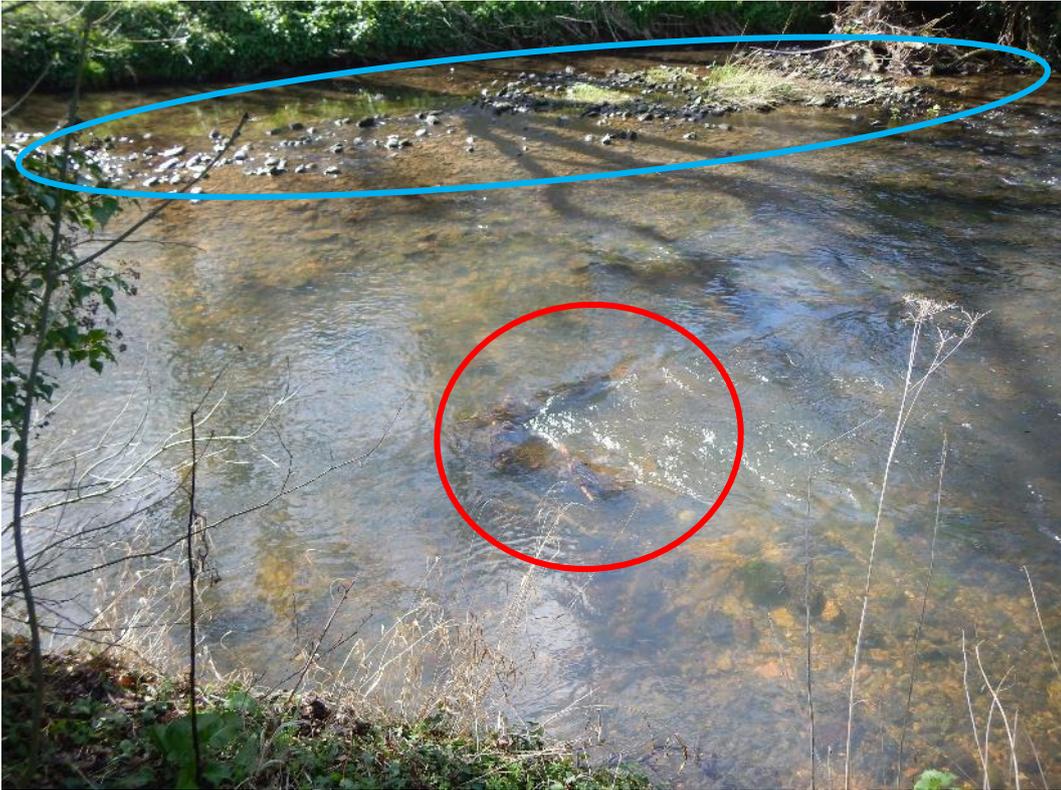
Figure 13 shows in-channel deflectors creating a feature but fighting the river's natural hydromorphology. By taking up space in the deeper channel, it is forcing more flow energy into the natural depositional area (red circle) on the far side that would otherwise almost certainly increase in size naturally to provide narrowing, deepening and bed sorting through natural scour, without the need for the deflector.

Photo 13. A deflector (red circle) somewhat fighting natural process that would otherwise encourage a similar effect as the deflector is intended to.

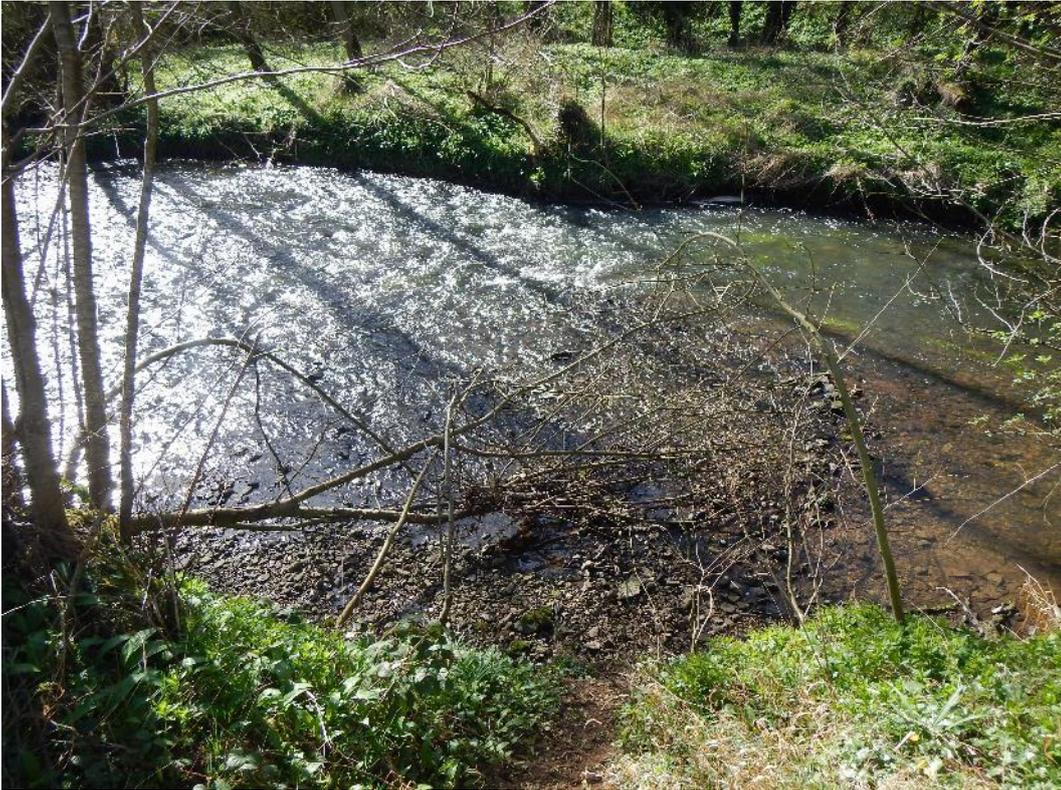
A fallen tree just downstream provides another great example of how natural processes (and working with them) can create far better results than some other more artificial interventions (Fig. 14). Note how the roughness and dissipation of flow energy created by the tree has reduced the ability of the river to transport the gravel in that area and encouraged the deposition of a raised bar feature within the channel. That feature then helps to focus flow along the far bank to increase velocities and create and maintain the deeper area downstream. Where channel diversity is lacking, this kind of feature could be replicated elsewhere to potentially develop more natural features, rather than forcing artificial ones; however, allowing features to develop naturally is often the preferable option.

Photo 14. A fallen tree/woody material in the channel naturally enhancing the river's hydromorphology to develop a gravel bar that focusses flow to the far bank and maintains the deeper area (and water crowfoot beds) downstream.

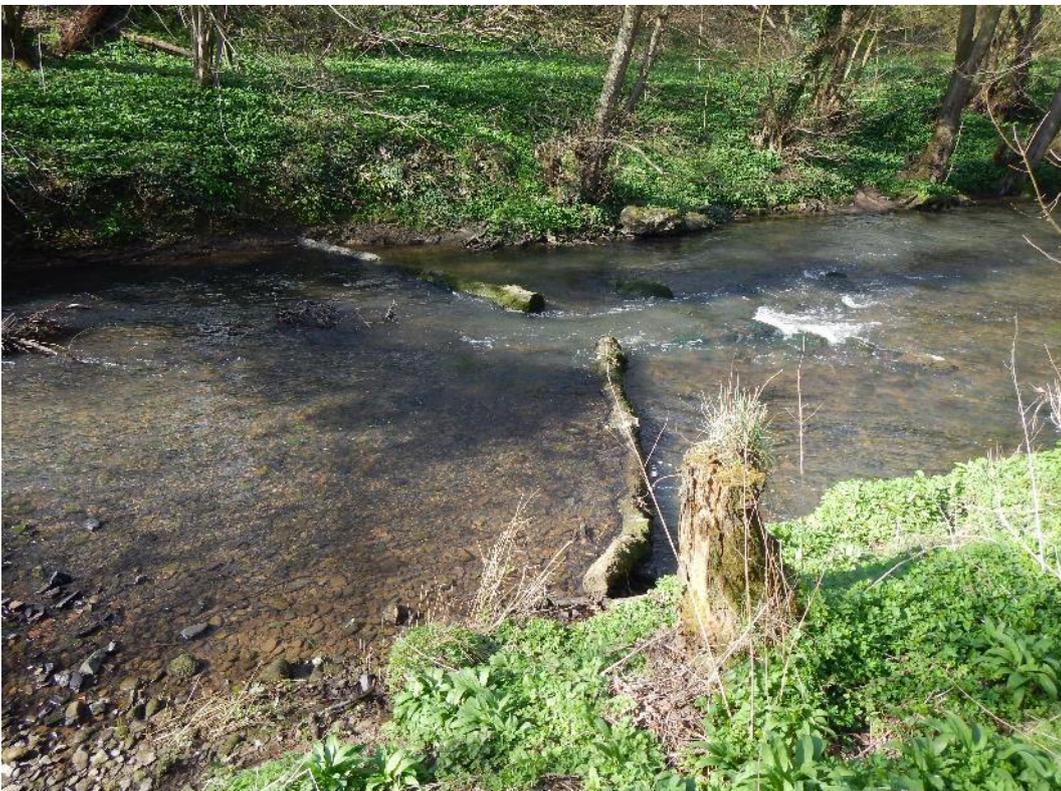
In contrast, a downstream facing paired deflector a short distance downstream artificially focusses flow to the centre of the channel (Fig. 15). Very occasionally this can be beneficial but preventing the natural transition of flow from one bankside to the other is usually detrimental to the development of natural riffles and side bars, as are so evidently beneficial in Fig. 14. Paired deflectors (usually upstream facing to turn overtopping flows in to the centre of the channel, encourage deposition in the channel margins and prevent issues with bank erosion downstream) are better employed on artificially straight or steep channels to create depth in areas where lateral erosion and the development of sinuous flow pathways are not possible: this is not the case on the relatively meandering River Leven.

Photo 15. A downstream facing paired flow deflector that is prohibitive to the kind of feature depicted in Figure 14. One or two are unlikely to create significant detriment to the overall river section but it is far better to employ more natural techniques where possible.

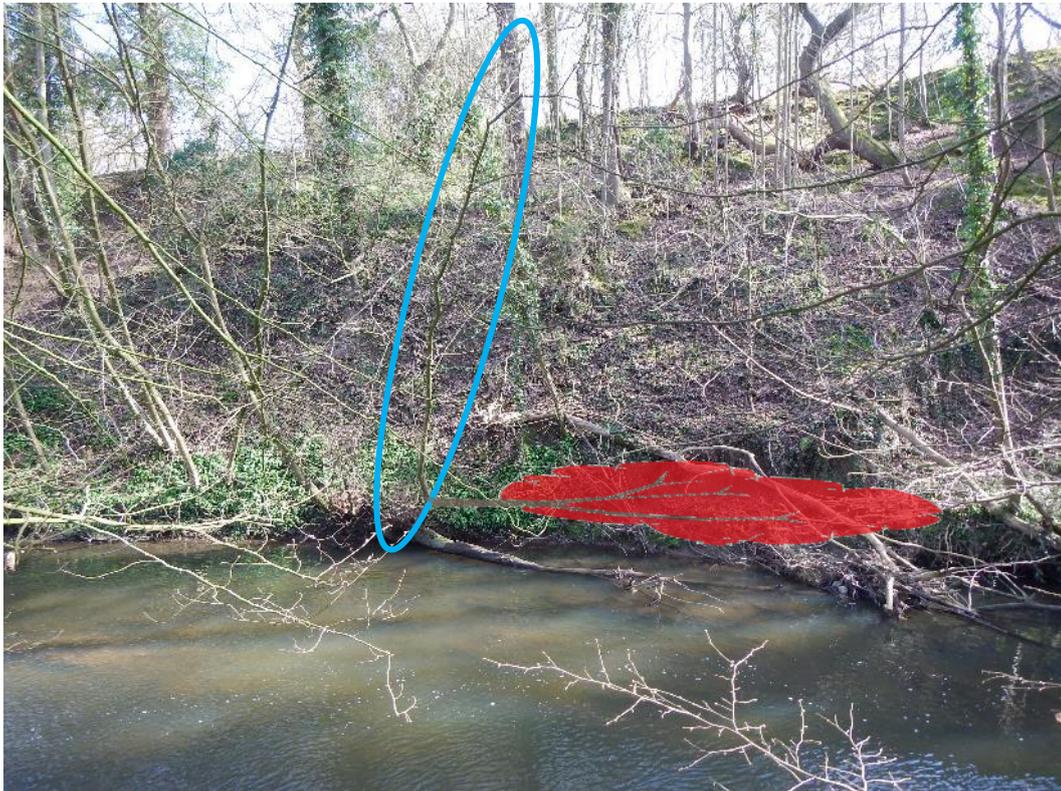
Photo 16. The valuable habitat provided by the submerged log (centre of shot) could be complemented by laying one of the elm trunks (red ellipse) alongside it and over the debris downstream (NZ 46236 07129).

- Lay the elm tree highlighted in Fig. 16 (NZ 46236 07129) down into the river channel.

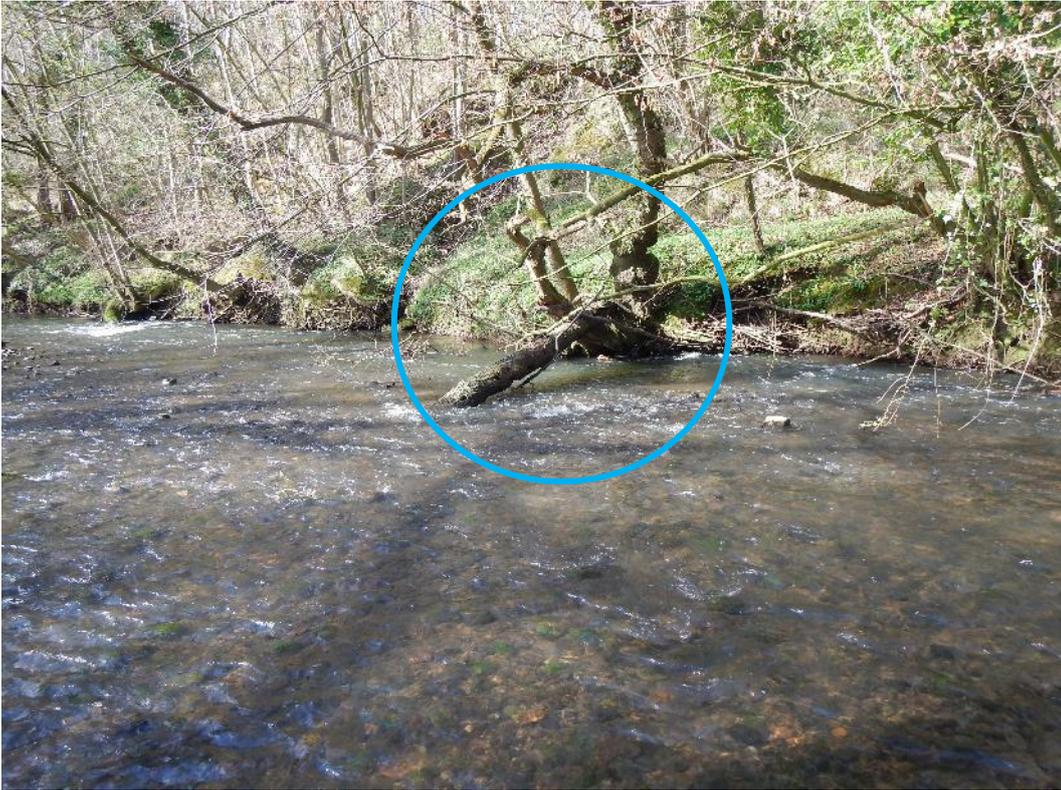
Figure 17 shows how the accumulation of naturally lodged woody material has created a range of different benefits over time. Currently, the flood debris caught on a live tree provides structure, some shade and cover but at higher water (probably with additional debris accumulation), flow has been driven into the bed alongside the tree, scouring a deeper-water feature and an excellent adult trout lie. Figure 18 shows a similarly beneficial logjam structure that creates localised channel narrowing, with an associated deeper channel immediately alongside and incredibly diverse structure within. These features provide vital areas where fish can evade high flows and predators, the latter being particularly pertinent as mink tracks were observed at the bend downstream (Fig. 19).

Photo 17. A great example of the benefits of lodged woody material (blue circle) that will provide a range of benefits and features over time.

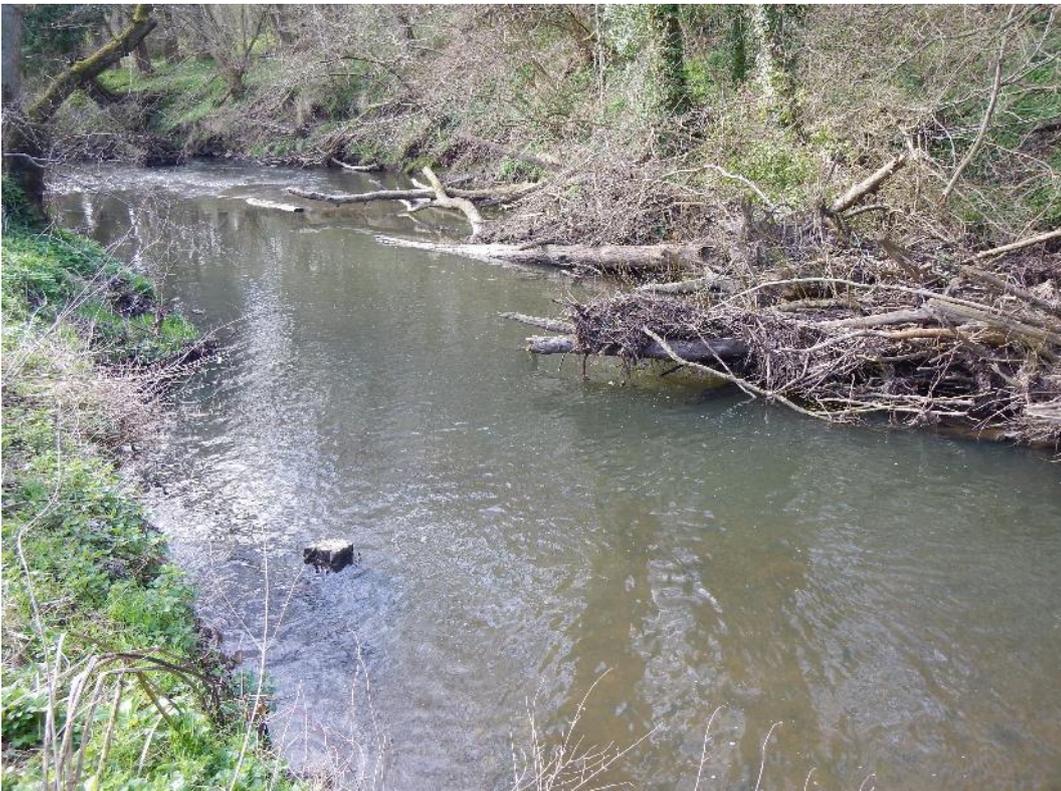
Photo 18. The structure and cover provided by logjams creates food and shelter for a range of wildlife, including trout.

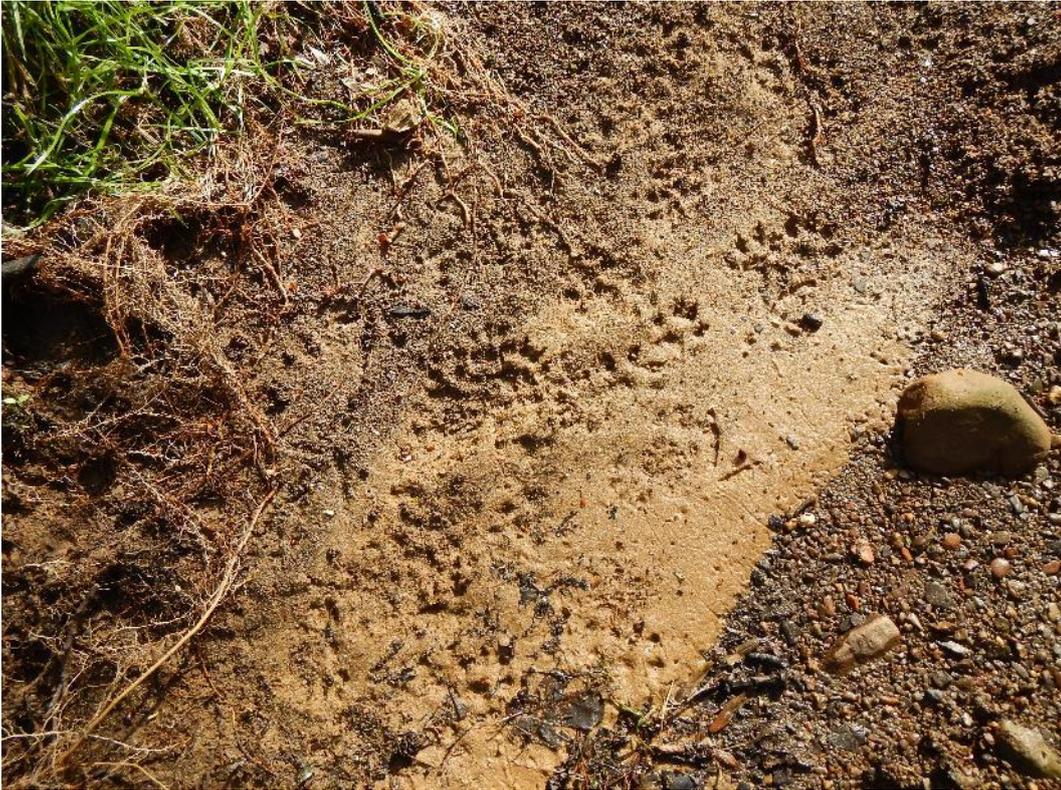
Photo 19. Mink tracks observed at NZ 46044 07138. It would be well worth HRFFC undertaking a mink trapping programme on the river.

- It would be beneficial if the club initiated a mink trapping programme. The best way to do this is with rafts (<https://www.gwct.org.uk/wildlife/research/mammals/american-mink/the-gwct-mink-raft/>).

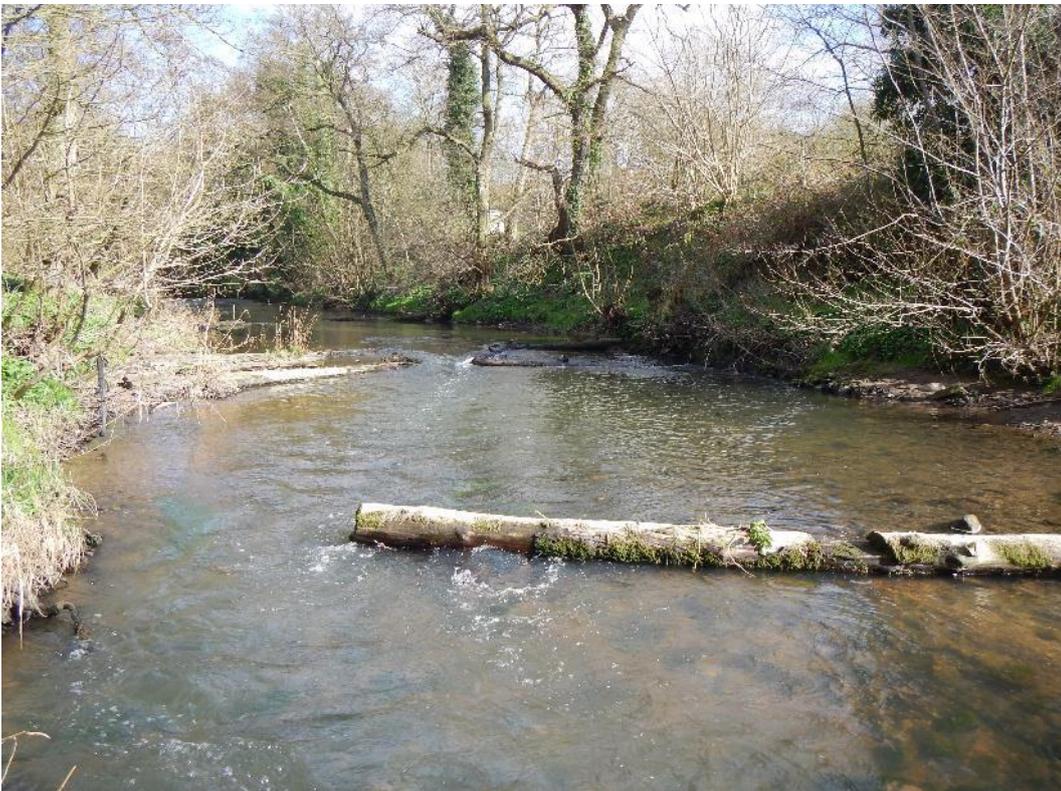
Photo 21. Somewhat conflicting deflector features: the upstream structure constrains flow to the centre of the channel; almost immediately downstream, the next deflector pushes flow to the RB, with little distance for beneficial erosion or deposition to take place. Deflectors are better utilised to move flows from one bank to the other over a more natural pool-riffle spacing (as occurs elsewhere), thereby reducing the channel gradient and increasing the potential for discrete areas of deposition and deeper pool development.

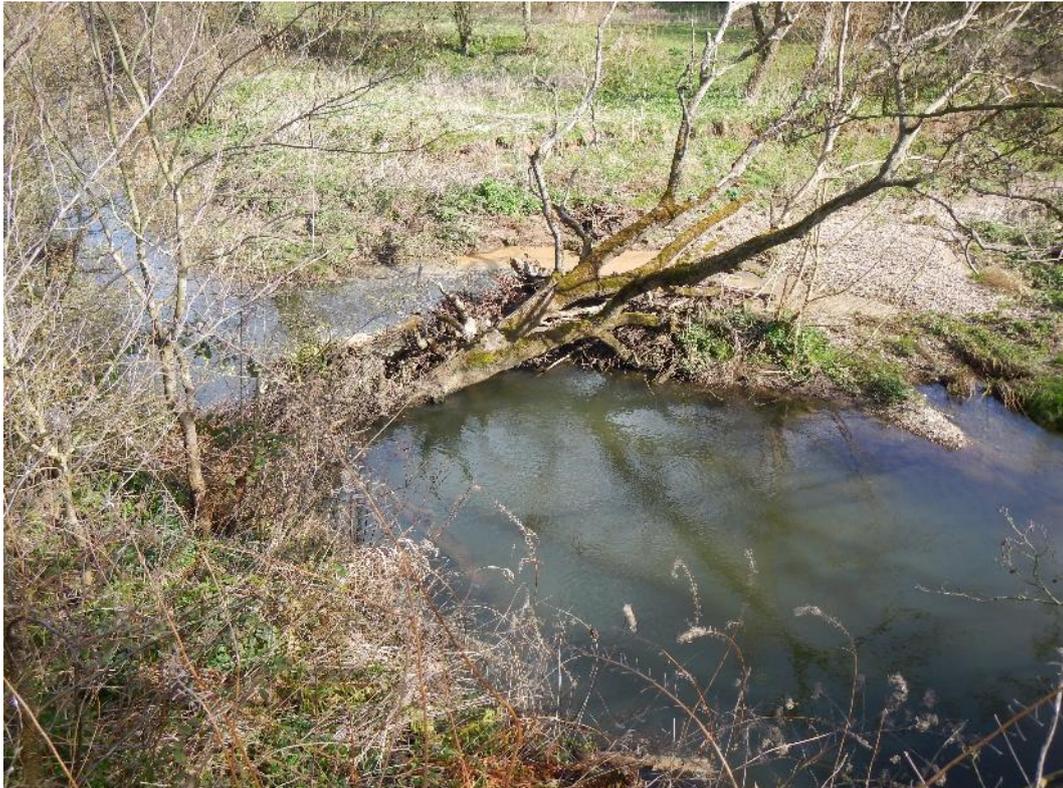
The occurrence of natural in-channel features downstream is testament to the beneficial hands-off management in the lower fishery. The large fallen tree highlighted in the previous WTT report still remains in place and creates a rare full-width logjam feature with associated benefits of bed scouring and substrate mobilisation that can be observed locally and for some distance downstream. The fact it remains in place many years on demonstrates the stability of large tree structures (when the rootball and trunk are left connected) and provides more support to the case for leaving such features *in situ*.

Photo 22. The large tree highlighted in the previous WTT report remains in place and continues to provide a valuable habitat feature.
