Advisory Visit

River Leven

Hutton Rudby Fly Fishing Club

25/03/2019

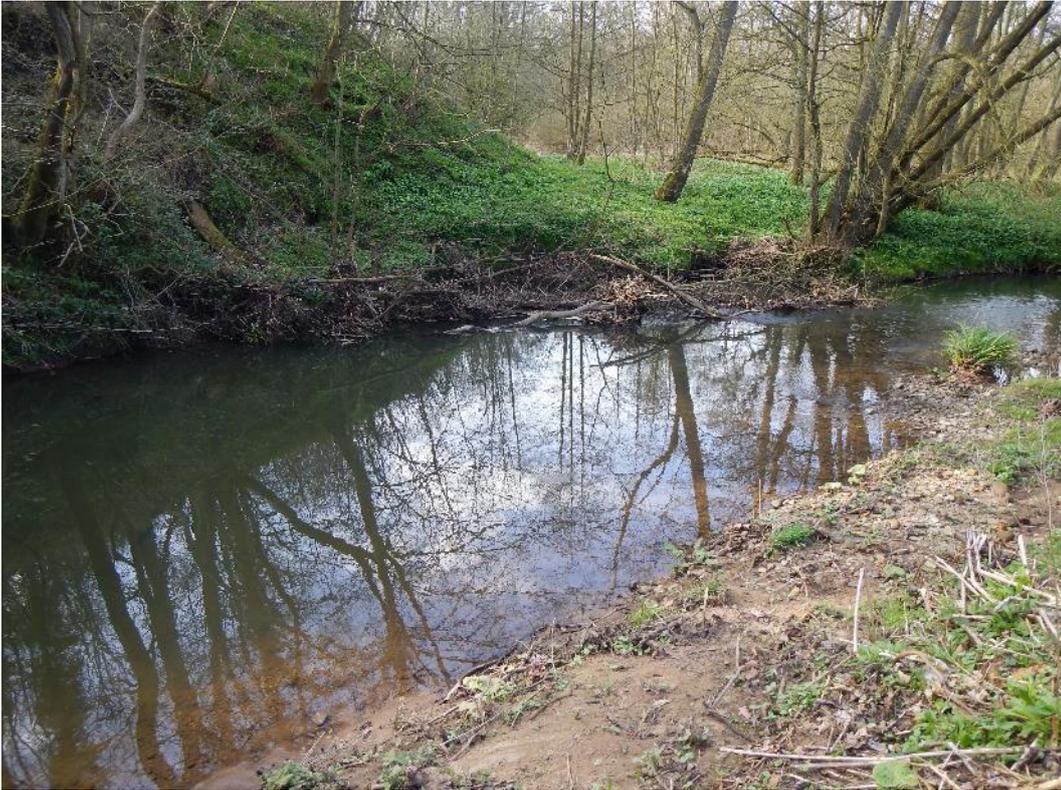
Photo 23. More valuable logjam structure.

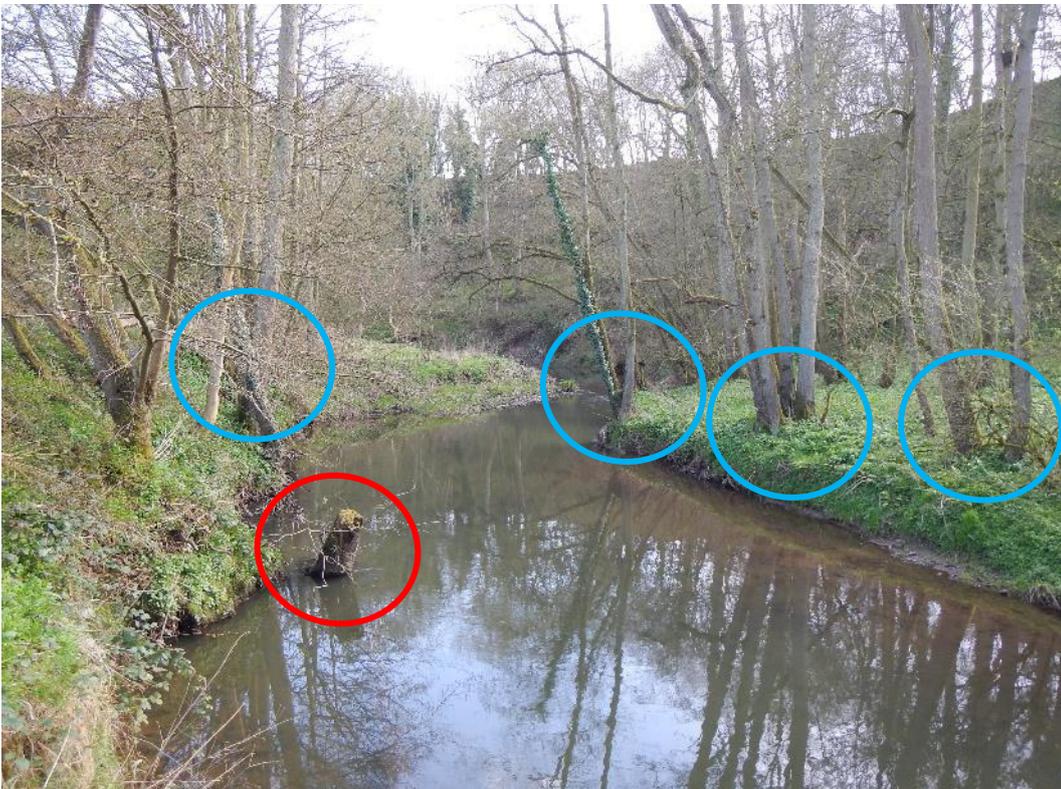
Photo 24. An area lacking low cover and in-channel structure – possibly exacerbated by historical tree maintenance (red circle)? Installing lodged woody material between some of the live, standing tree stems (blue circles) could be an easy way of introducing more structure to the channel and / or encouraging more logjam habitat.

As highlighted in Fig. 24, there are multiple stems of alder from which one could be cut (with no significant detriment to the overall canopy or other habitats) and lodged between two or more the remaining stems, closely mimicking the natural occurrence in Fig. 17. The technique is also shown in Fig. 25.

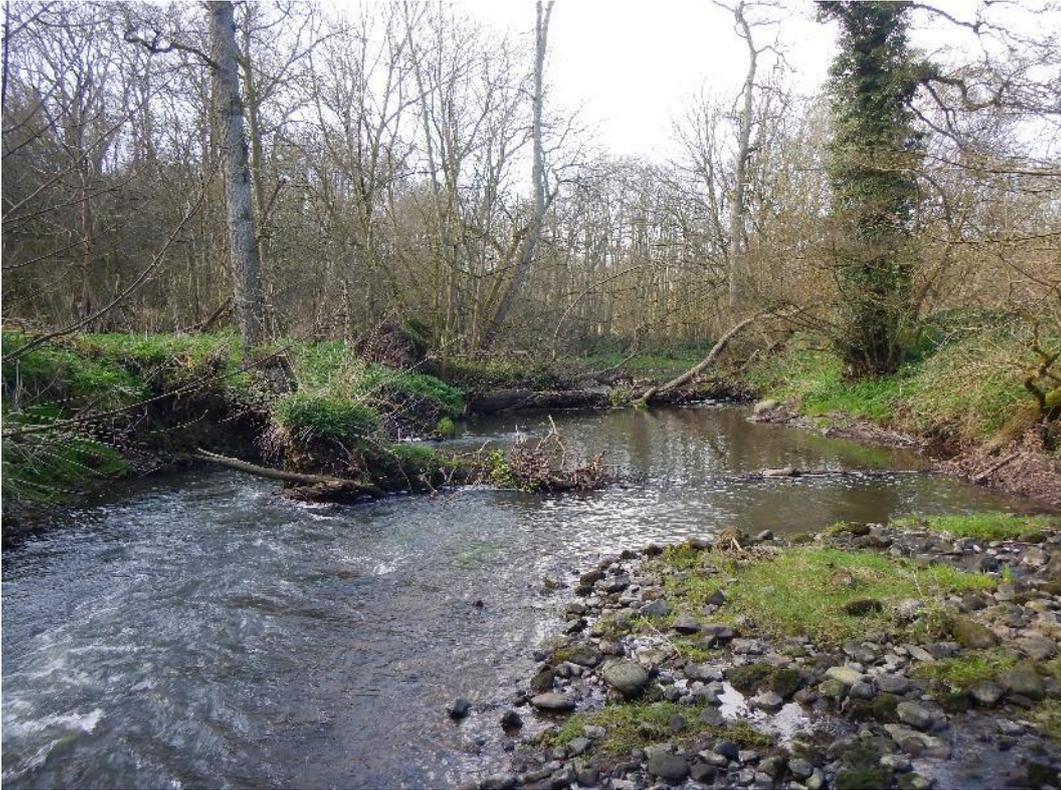
Photo 25. The highest quality habitat observed during the visit, where numerous trees have accumulated within the channel, creating a wide array of habitat.
