**ADVISORY VISIT TO THE RIVER IRVINE,  
GALSTON ANGLING CLUB, 13/14 MARCH 2007**

**By Dr Andy Walker, Ellwyn, Moulin, Pitlochry PH16 5ER  
(Tel: 01796 472743; E-mail: [Libisandy@aol.com](mailto:Libisandy@aol.com))**

**On behalf of Windrush AEC Ltd, The Cottage, Fordwells, Witney,  
Oxon OX29 9PP**

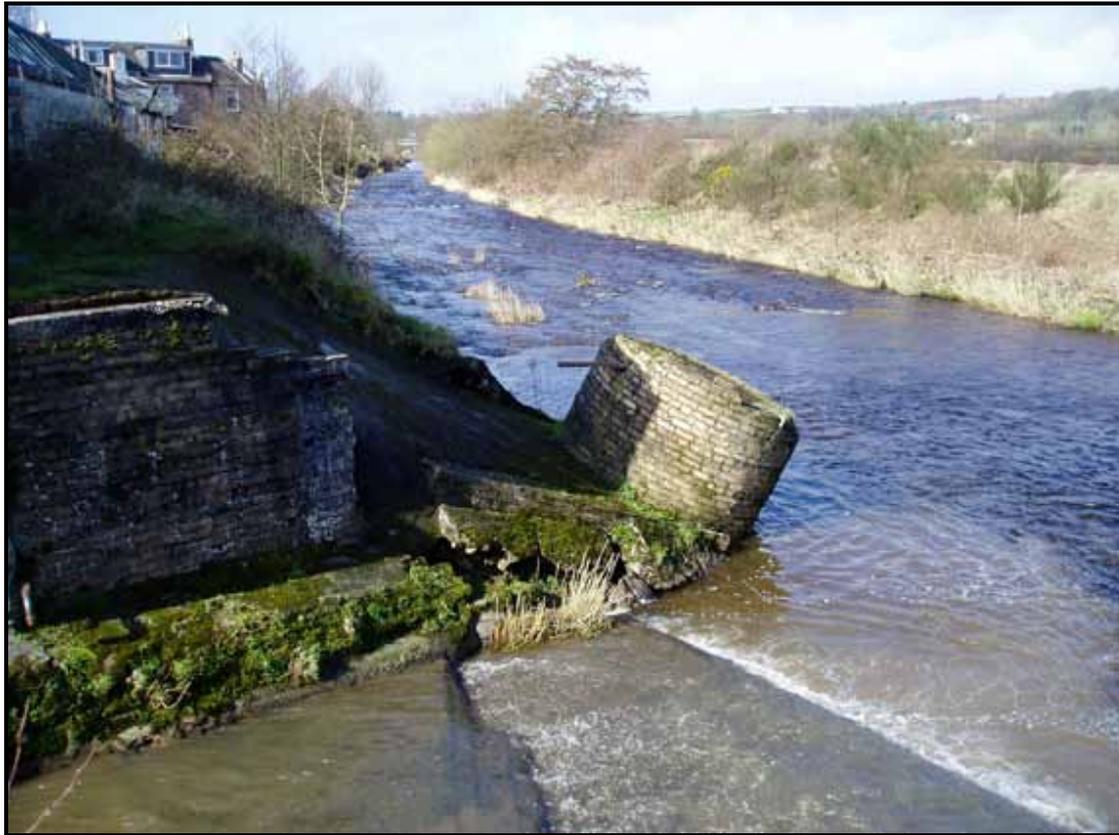
**Plate I: Burnawn confluence with River Irvine at Galston.**

The Burnawn was carrying a heavy silt load as it joined the River Irvine due to the civil engineering work involving heavy plant underway within the town. The banks and bed of the stream are being extensively modified for flood defence. The Ayrshire Rivers Trust (ART), in making comments about the proposals for this work in a letter written by Alistair Duguid, Principal Biologist, in 2004, pointed out that the opportunity should be taken to improve access for salmonid fish in the lower reaches of the burn, which contained a flat bridge apron/chute (Plate I) and a sizeable weir above Galston. It is unclear from information available at the time of the visit whether this opportunity to improving access for upstream passage of spawning stocks of salmon and trout has been taken, or indeed whether any consideration has been made for the retention of natural stream bed characteristics that would provide adequate juvenile habitat in the reconstructed section. An Environmental Statement (Final Report, 2005) by East Ayrshire Council describes mitigation to be implemented to reduce environmental effects including the canalisation of the burn, but does not comment on measures to protect or assist fish stocks. However, temporary diversion of the burn flow past the major in-channel works was at least reducing the level of siltation carried down to the main river (Plate II). The Burnawn would be a serious loss to the River Irvine if spawning access is denied by the flood defences. It is highly recommended that the Galston AC and the River Irvine Angling Improvement Association (RIAIA), probably through the ART in conjunction with SEPA, obtain electro-fishing data to monitor the development work and provide a basis for any mitigating action. [It is understood from a note from RIAIA that SEPA will be monitoring the recovery of the burn for the next five years]

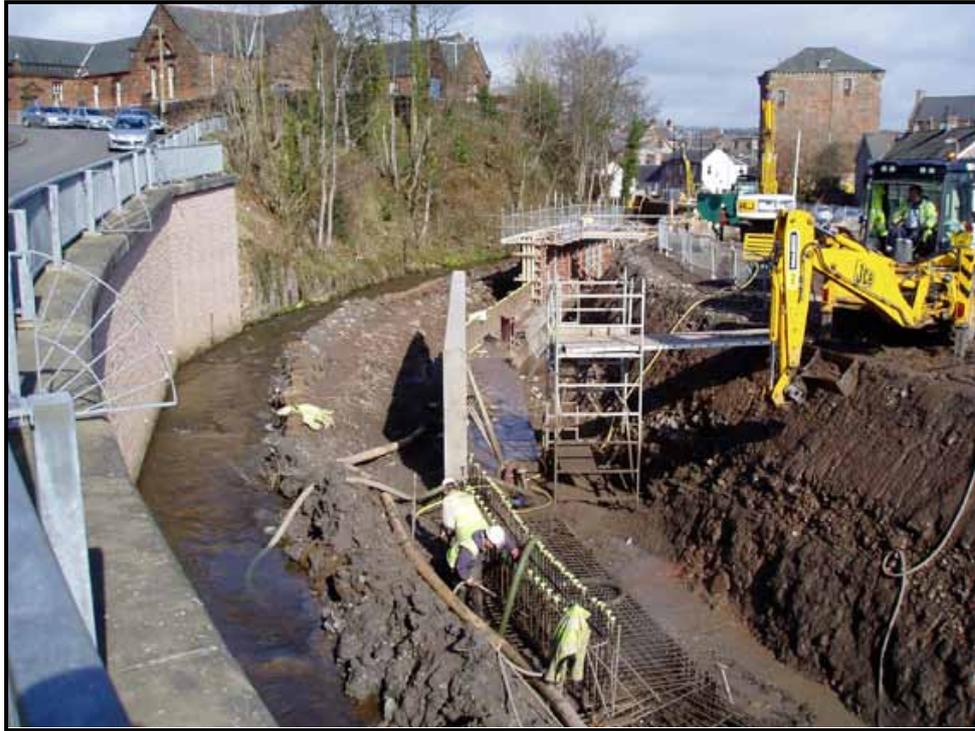
**Plate II: Burnawn flood prevention works in Galston**

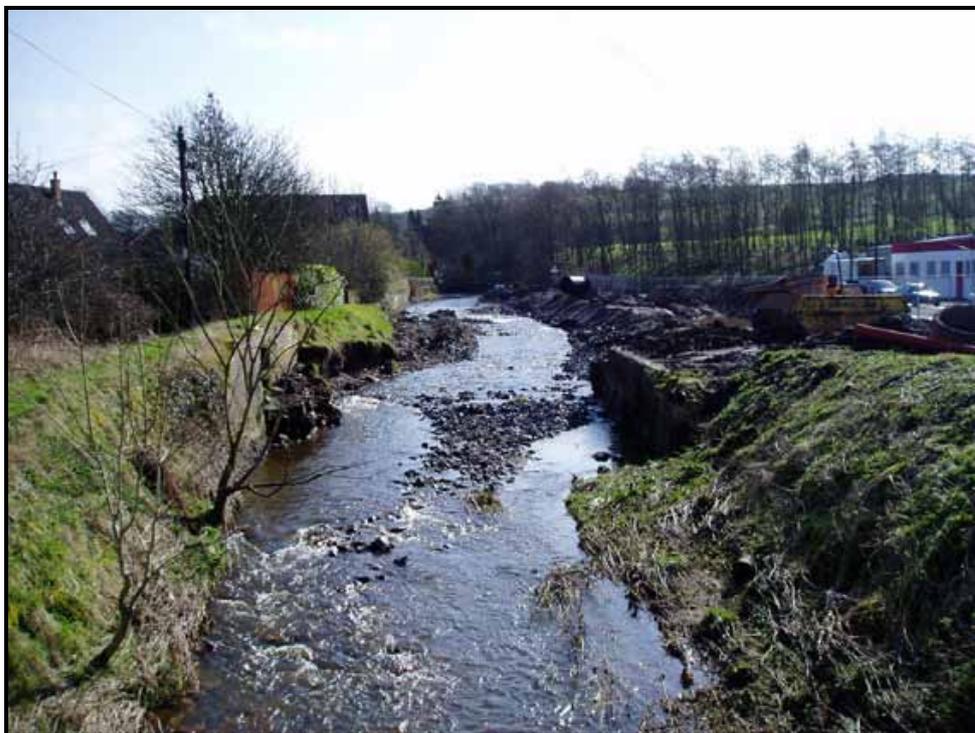
**Plate III: Burnawn immediately above Galston**

The Burnawn was still subject to extensive modification immediately above the town. According to local knowledge, this section used to be noted for large caddis fly larvae popular as bait for trout, but they are less commonly found now. Their absence is thought to be due to stream bed erosion caused by recent severe spates rather than overexploitation by bait-gathering anglers, or man-made alterations to the banks or bed (pers. comm.G. Anderson).

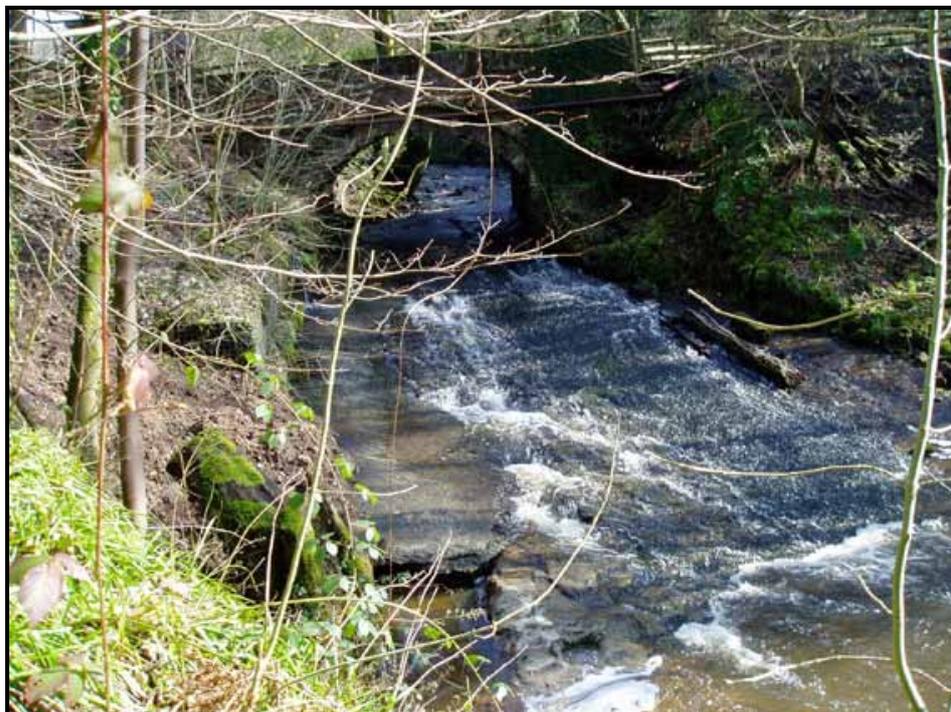
**Plate IV: Ramped section under bridge in upper Burnawn**

Further upstream is a steeper, wooded area where a broken, ramped bridge apron could be difficult for upstream migration of salmon and trout, although passable in moderately high water conditions, but possibly not in full spate. A number of cracks in the concrete probably assist fish passage by breaking up the flow. Any repairs that may be carried out in future should be designed with a rough substrate in order to minimise laminar flow velocity. Alternatively, consideration could be given to the installation of a simple fish ladder. Providing spawning adults can still reach this point in the burn, juvenile densities obtained above and below the bridge would provide an indication of whether or not there is a problem of access further upstream.

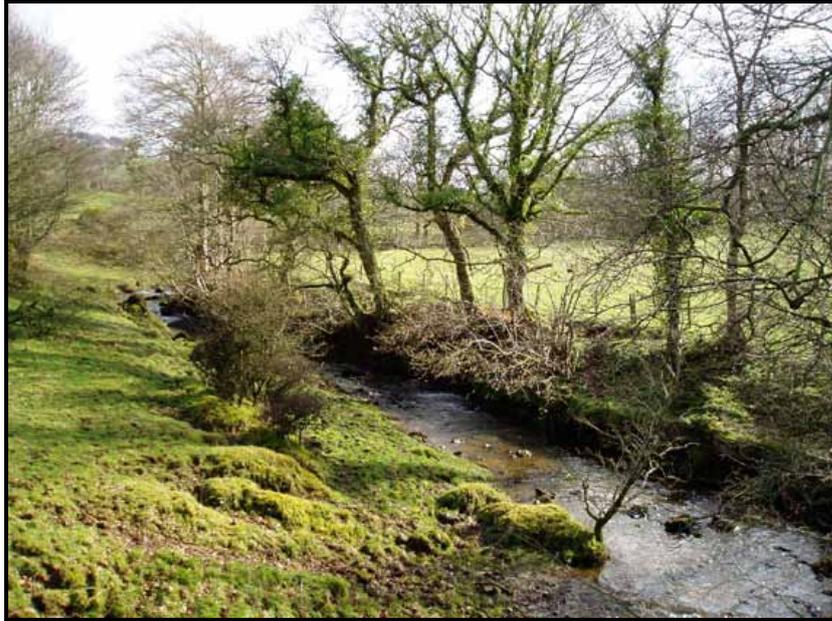
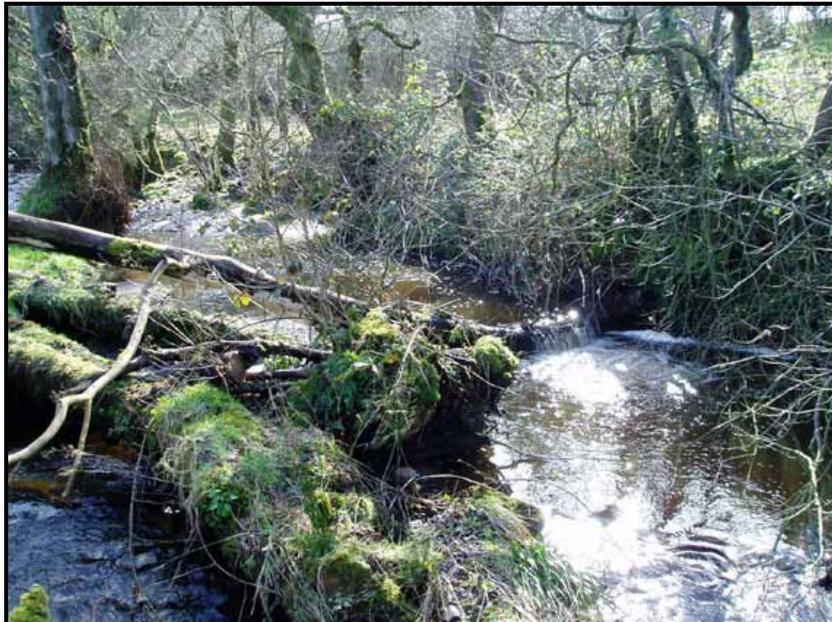
Many attractive pools and gravelly runs occur in the upper areas of the burn, some in dappled shaded woodland and others in more open grazed hillside. Juvenile habitat appeared to be very good, although there were some log jams caused by fallen timber. Galston AC has already done a lot of valuable clearance of fallen trees and accumulated debris to reduce the number of potential barriers to upstream migration. It will be important to plan this work carefully, bearing in mind that the retention in streams and rivers of some large woody debris can be very advantageous for larger fish, including resident brown trout by providing hiding and resting cover and wintering refugia.

**Plates V & VI: Upper Burnawn showing good habitat and occasional log jams**

Deep cover of this sort also is very valuable for adult salmon and sea trout awaiting spawning time. Each log jam needs to be assessed to see whether it is actually a barrier to fish movement before full-scale removal is enacted. Of course, the extent of blockage will change with time according to gales and spates, requiring that the situation in the burn is constantly reviewed. For further advice on large woody debris, consult the excellent article by Vaughan Lewis, 'Two limbs good, four limbs better', published in the latest edition of the WTT magazine *Salmo Trutta*, Vol. 10, which I have just seen. The magazine also contains several other articles with sound advice for tackling habitat improvements. Of course, the manual of the WTT, *The Wild Trout Survival Guide*, which will be supplied with the final AV report, shows the full background picture and lots of these practical techniques in action.

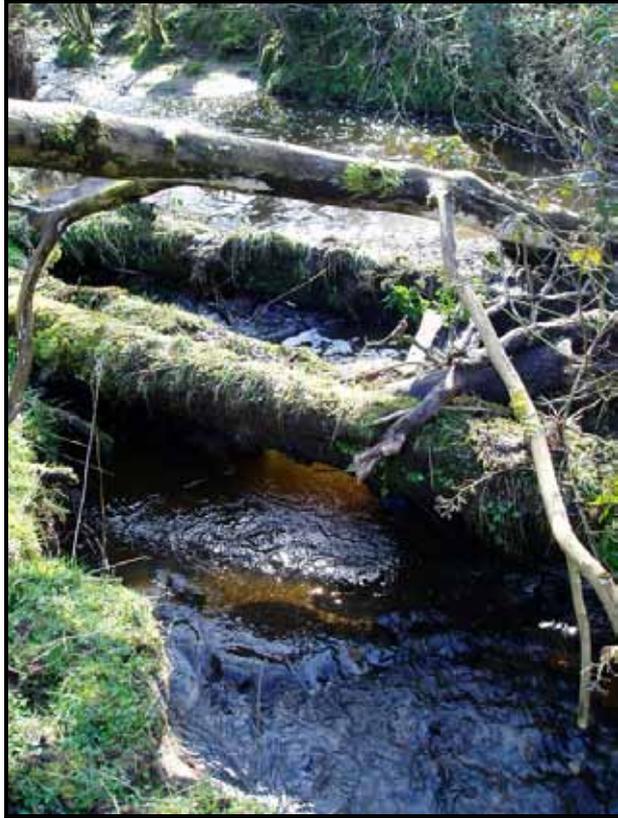
**Plate VII: Fallen timber can build into barriers to fish movements, but can also provide deep cover for larger fish**

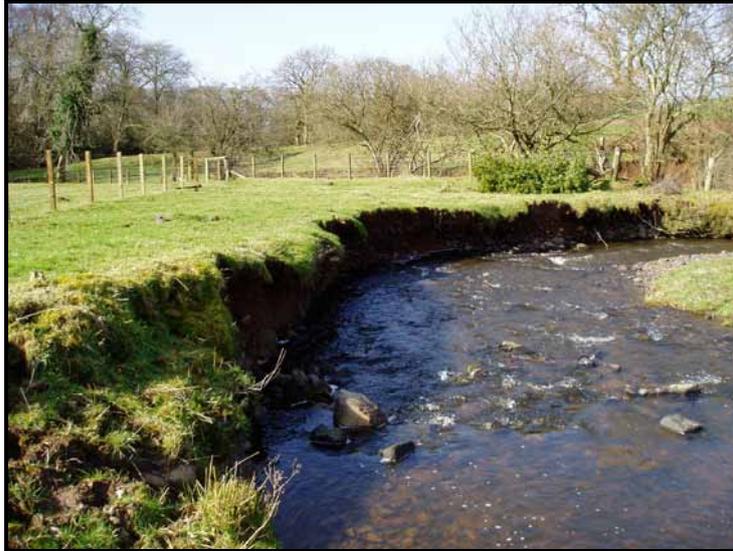
A few open sections of the burn had some bank erosion, as shown in Plate VIII. Here one bank is fenced to retain grazing livestock, but the other is only partially fenced. Farmers are encouraged as far as possible to install adequate fencing to create buffer zones along stream margins that will help to bind the banks while providing cover for wildlife. Unprotected, over-grazed, stream banks can erode away rapidly, widening and shallowing the wetted channel and allowing large amounts of substrate to be transported downstream. However, it is possible that some of the erosion that was seen occurred during unusually severe spates. Meteorological experts advise us to expect more summer droughts and milder, wetter winters, with an increasing prevalence of localised deluges and flooding. Banks protected by fencing typically grow long grasses and become bushed. They are much more durable in spates and provide very valuable overhead cover for larger fish, especially trout. Unfortunately, grants for farmers to install fencing, plant native deciduous trees and bushes and set aside land through the Rural Stewardship Scheme are believed to be restricted at present because of national budget shortfalls.

**Plate VIII: Severe bank erosion in a section of the upper Burnawn**

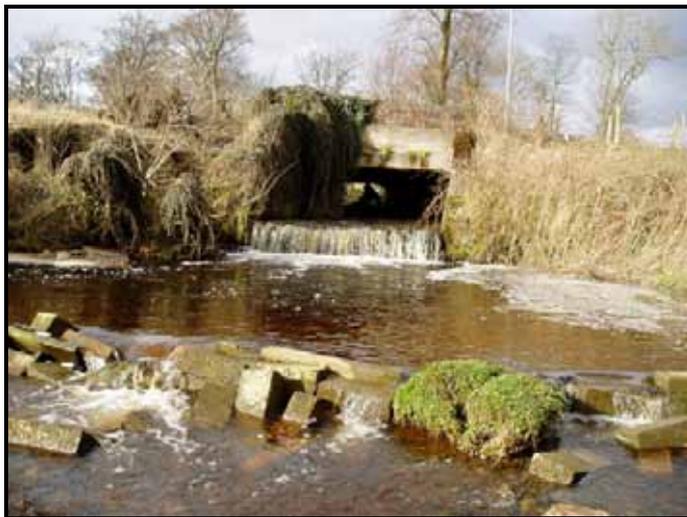
The second burn visited was the small Hags Burn which enters the River Irvine on the right bank between Galston and the village of Newmilns. About 100 metres up the burn from the river is a low weir (c. 1.5 metres) below the bridge over the A71. Because the wide pool below this weir carries away flood water without allowing the burn level to rise much, upstream passage of migrating fish is likely to be difficult into the shallow, rapidly flowing channel below the bridge. Galston AC members have constructed a simple secondary weir from concrete blocks to raise the normal level of the pool to reduce the height that fish need to leap and ease their passage. The blocks lie loosely and some are washed downstream in high flows, but are easily found and replaced.

**Plate IX: Hags Burn road culvert and raised weir**

The rubble weir looks unsightly but seems to be effective. The provision of a more permanent one could be thwarted by erosion of the soft alluvial stream banks and the gravel bed. A notch could be cut in the weir immediately below the culvert and perhaps also in the culvert floor in order to concentrate the flow and potentially

provide access at a great range of stream flows. However, specialised engineering advice should be sought before proceeding.

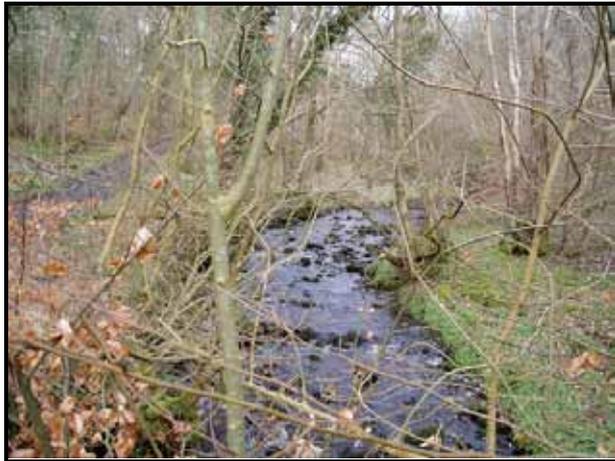
Above the main A71 roadway, the burn is a pebble and cobble channel, with mixed gravel, passing through quite dense woodland. It is likely to be over-shaded in summer when the leaf canopy is at full stretch and may lose nursery potential in consequence. Shading is more of an issue for smaller streams and in extreme case results in 'tunnelling'. This darkening effect constrains the growth of algae on the wetted stones and the growth of binding streamside vegetation. There are many dead trees, especially mature elms and, consequently, the channel of the Hags Burn is very prone to log jams. Some long-standing ones have already been sawn and cleared through the efforts of Galston Club members and more work is planned. As in the Burnawn, some large woody debris is beneficial and only that which causes genuine obstructions to migration should be removed. A watch should then be maintained for fresh falls of timber and blockages that need to be dealt with, working in conjunction with the local riparian estate owners, with the obvious proviso that some live or fallen tree removal will require specialist help. Hags Burn is probably an important spawning burn for trout.

**Plate X: Hags Burn in woodland**

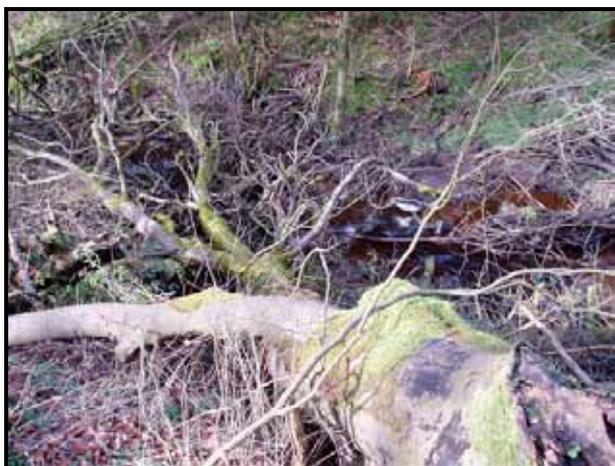
**Plate XI: Hags Burn showing fallen tree**

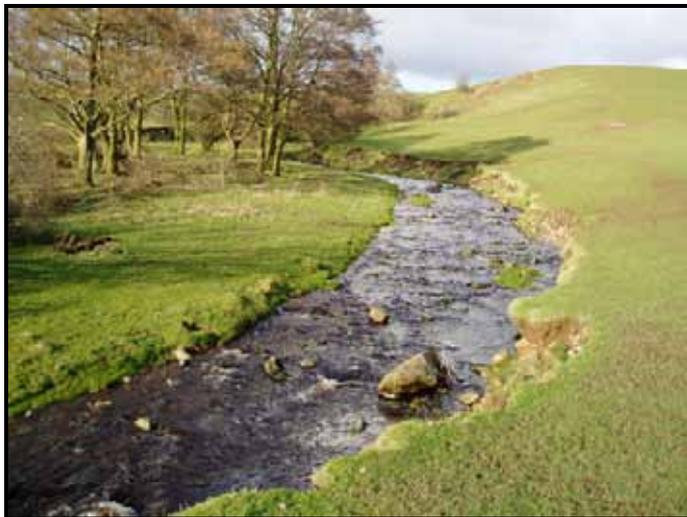
**Plate XII: Unfenced middle reaches of the Polbaith Burn in heavily-grazed grassland**

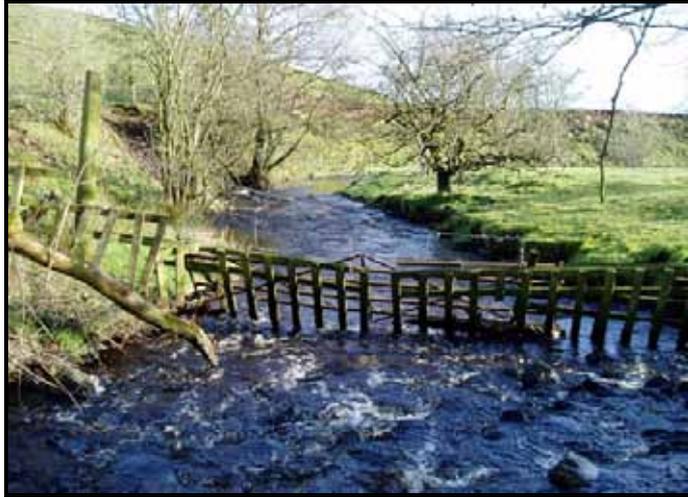
**Plate XIII: Polbaith further upstream**

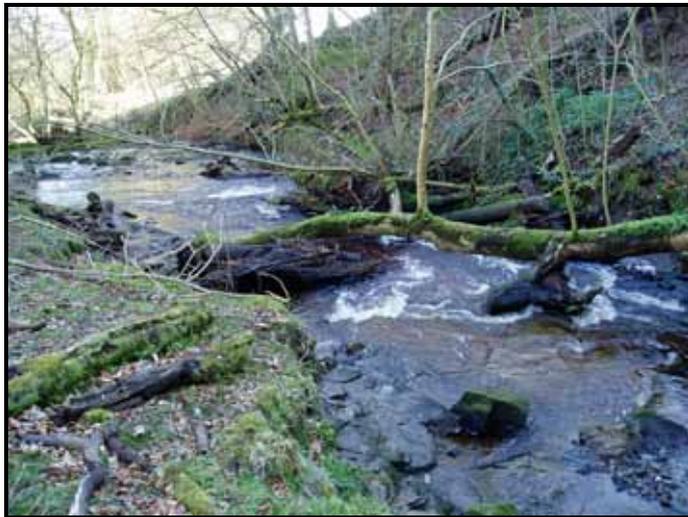
**Plate XIV: Polbaith showing bedrock pools near waterfalls**

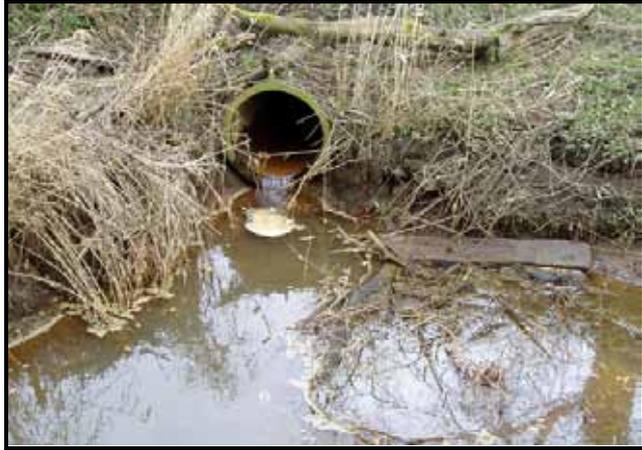
The lower Polbaith ie. below the minor road (Loudoun Kirk/Milton) is flatter and runs through fields and past an old covered landfill dump, material from which is emerging at points along the banks and entering the burn. Also, there are seepage channels that are both very unsightly and contain polluted water, although the volume reaching the burn was small and the dilution appeared to be sufficient to remove any gross signs of pollution downstream of the points of entry. However, this opinion was only based on a superficial examination and SEPA should be asked for technical advice on the chemical and biological status of the burn, especially in this area.

**Plate XV: Seepage pipe from covered landfill site**

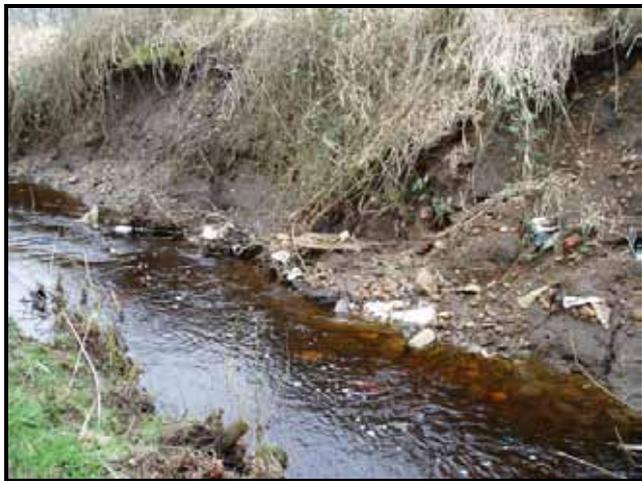
**Plate XVI: Landfill material eroding into the burn**

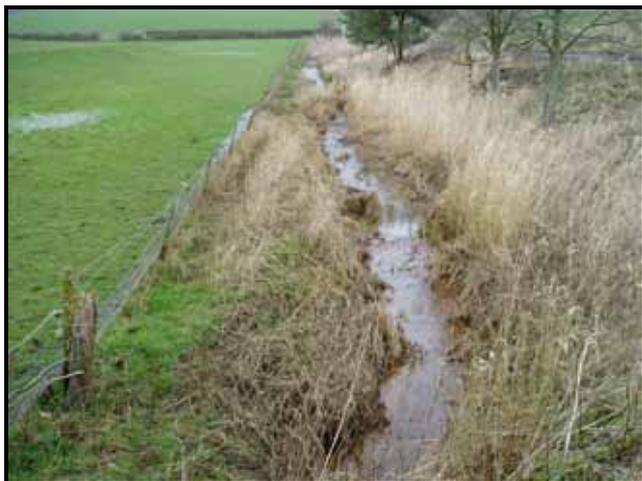
**Plate XVII: Seepage channel from landfill site**

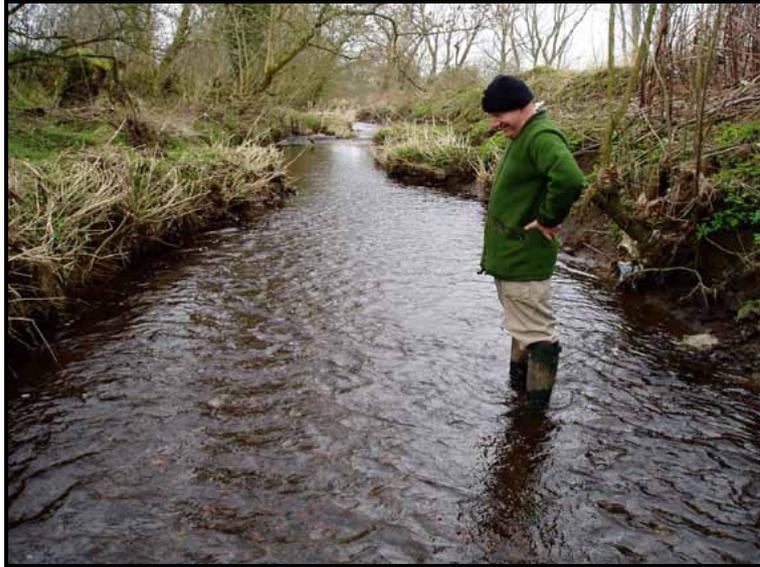
**Plate XVIII: Good gravel stretches in lower Polbaith**

On the credit side, stretches of the lower Polbaith contain clean gravel (Plate XVIII) and there is no indication of a physical barrier, although there could be judicious clearance of some woody and other debris. A stretch is fenced near the confluence with the main River Irvine and the habitats within and outwith are contrasted in Plate XIX (above). The stream banks are well-vegetated and sounder inside the fencing and show signs of overgrazing and general breakdown outside it. The water still looks quite darkly stained in this area.

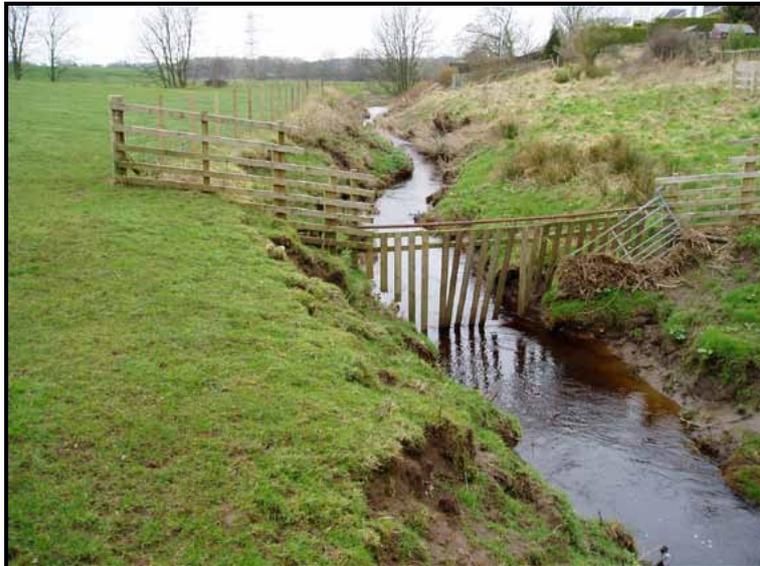
**Plate XIX: Lower Polbaith with some fencing**
