**Advisory Visit**

**River Isla**

**October 2014**

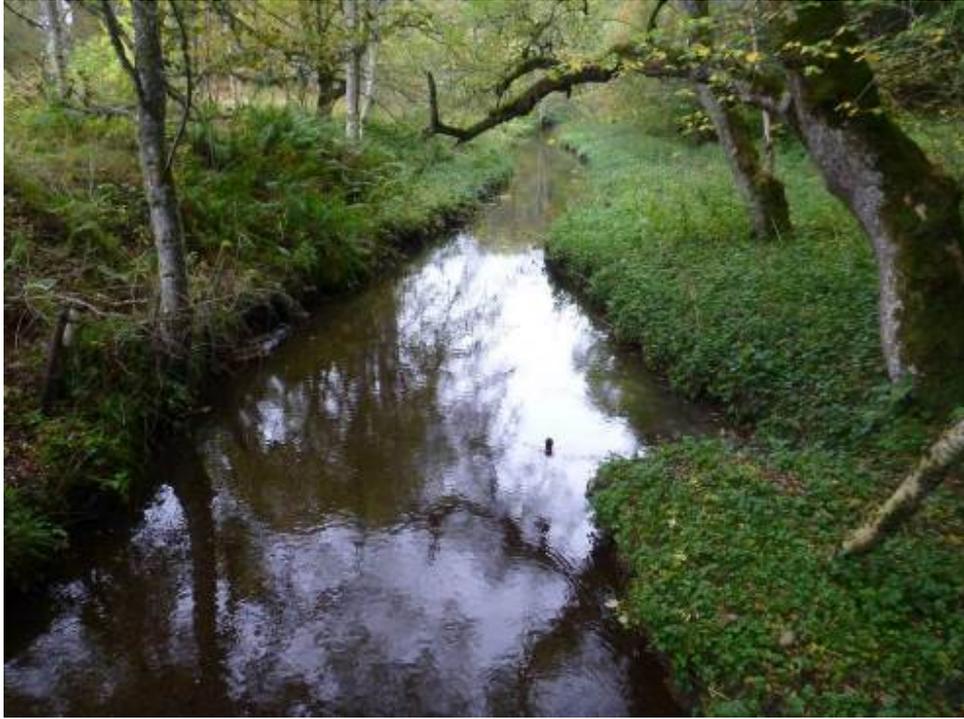
The river channel here has been straightened at some point in the past, possibly when the railway line was constructed (Figure 1). The river has a uniform width and depth profile and is predominantly shallow (Photo 1). There is no pool-and-riffle sequence, the in-stream habitat being largely shallow glide with an un-sorted riverbed substrate (Photo 2). The banks are stable, with mature trees present along both banks.

**Photo 1 Straight, uniform channel of the River Isla, Drummuir station**

Small salmonids were observed rising here, but the impoverished habitat as a result of channel modification is likely to restrict their density and size range. Introducing features to promote bed scour and sorting of the substrate would be likely to increase the number of fish this reach would hold. Such features could include woody debris tree kickers in the pattern of alternate D-shaped groynes. Features such as cross channel logs and log flow deflectors may be possible in sections where the gradient is greater (see recommendations section).

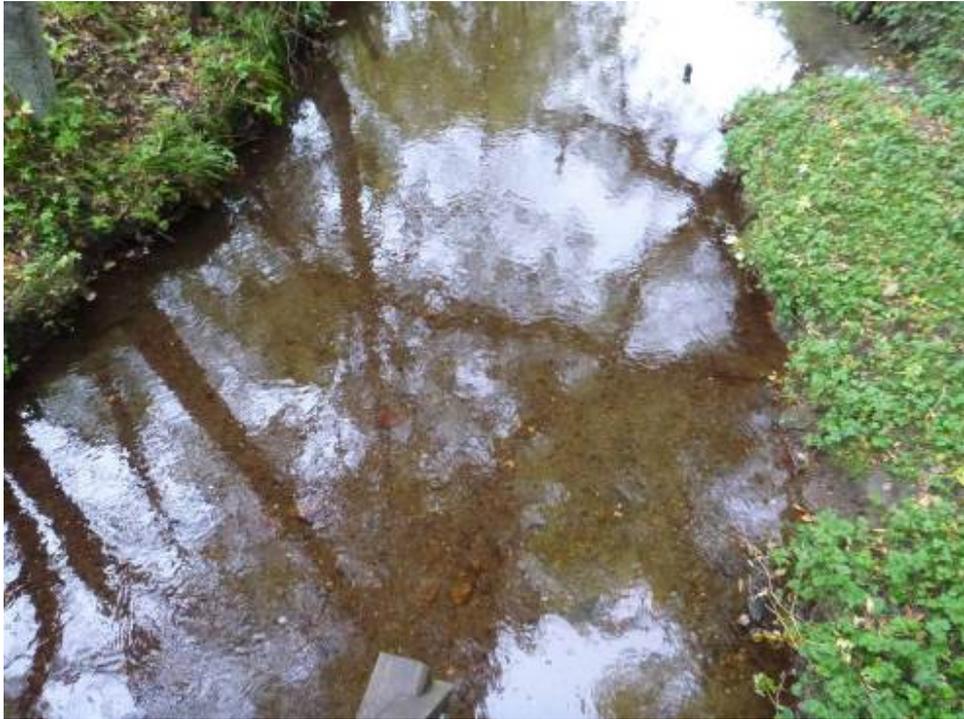
**Photo 2 Poorly sorted river bed sediments, River Isla, Drummuir station**

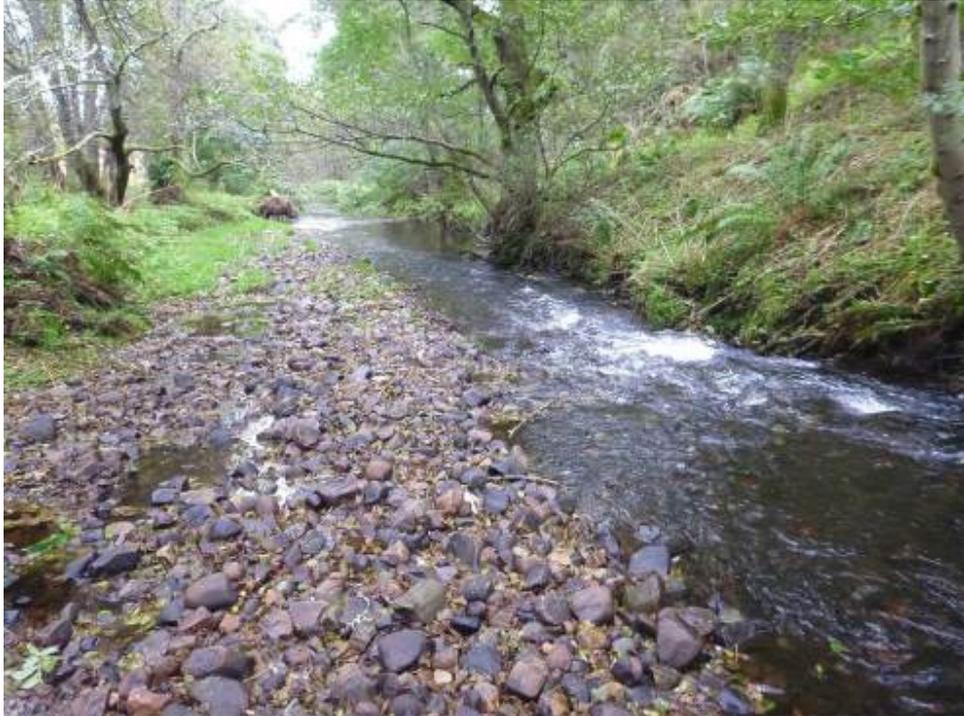
The section of the Isla downstream of the Towie Burn has obviously been straightened, possibly when the adjacent railway line was constructed (Figure 1) along the left bank. The river here has a moderate gradient (apparently steeper than the upstream Drummuir section) and tree-lined banks which promote bank stability; these factors have combined to produce reasonably good in-stream habitat despite the very straight channel (Photos 3, 4).

**Photo 3** Immediately downstream of the Towie Burn confluence – evidence of active bed load transport

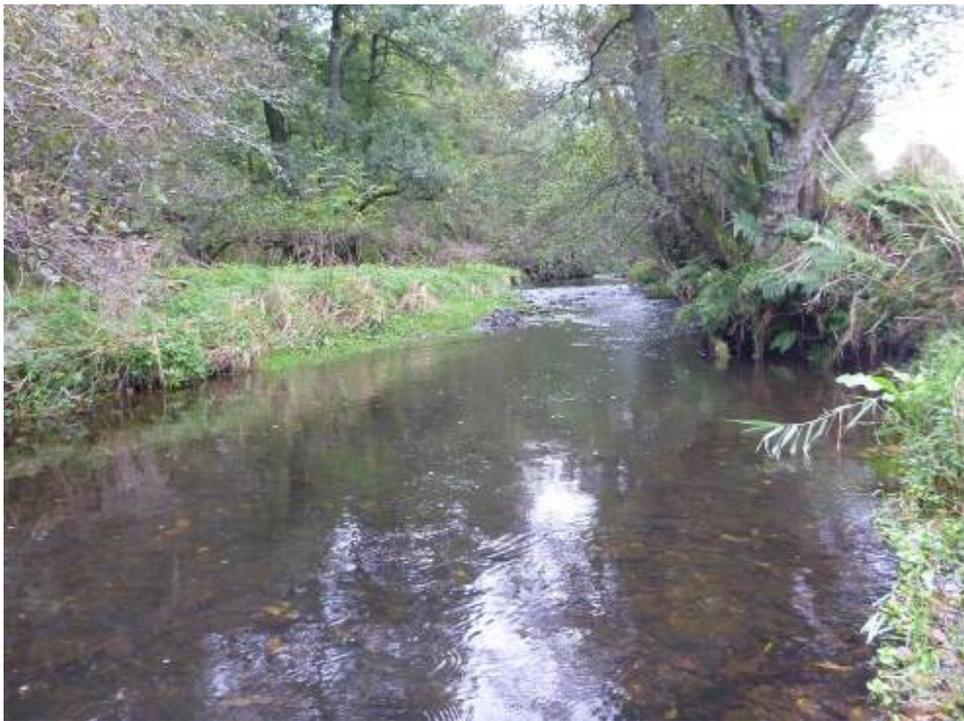
**Photo 4** Typical character of the reach downstream of Towie Burn – riffle and glide habitat in-stream, with excellent riparian habitat.

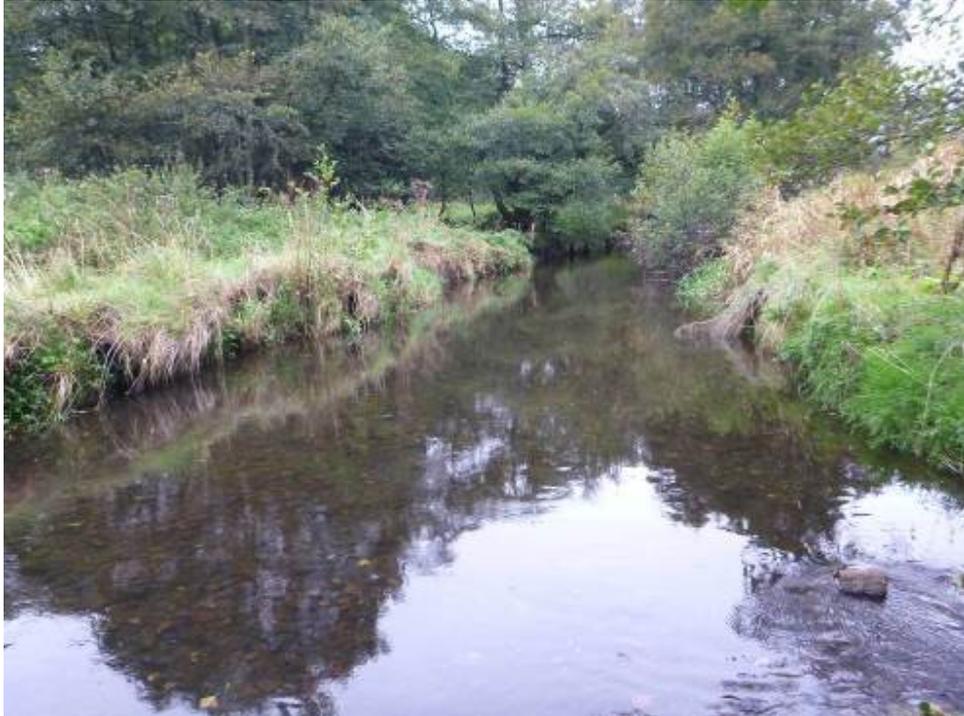
**Photo 5 The straightened nature of the channel means deep pool habitat is scarce, with shallow glides such as this present instead.**

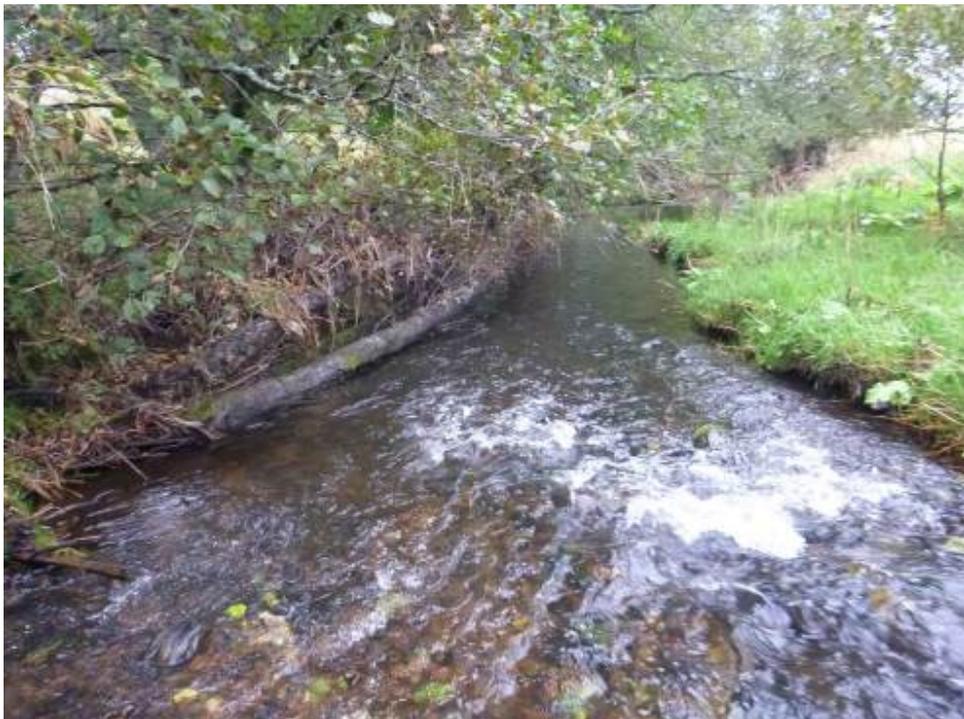
Both banks of the river are fenced preventing livestock access and allowing tree growth and succession (Photo 11). This provides a healthy riparian zone alongside the river with good bank stability and shade to prevent excessive water temperatures. It has also promoted the occurrence of large woody debris (LWD) features at regular intervals which are invariably enriching the in-stream habitat. Because of the good bank stability along this reach, the presence of LWD is promoting bed scour, much-needed depth variation and the sorting of river bed gravels (improving spawning conditions). Some examples are shown in Photos 6, 9 and 10.

**Photo 6 Woody debris in the channel provides excellent habitat diversity via increased cover, scour and depth variation**

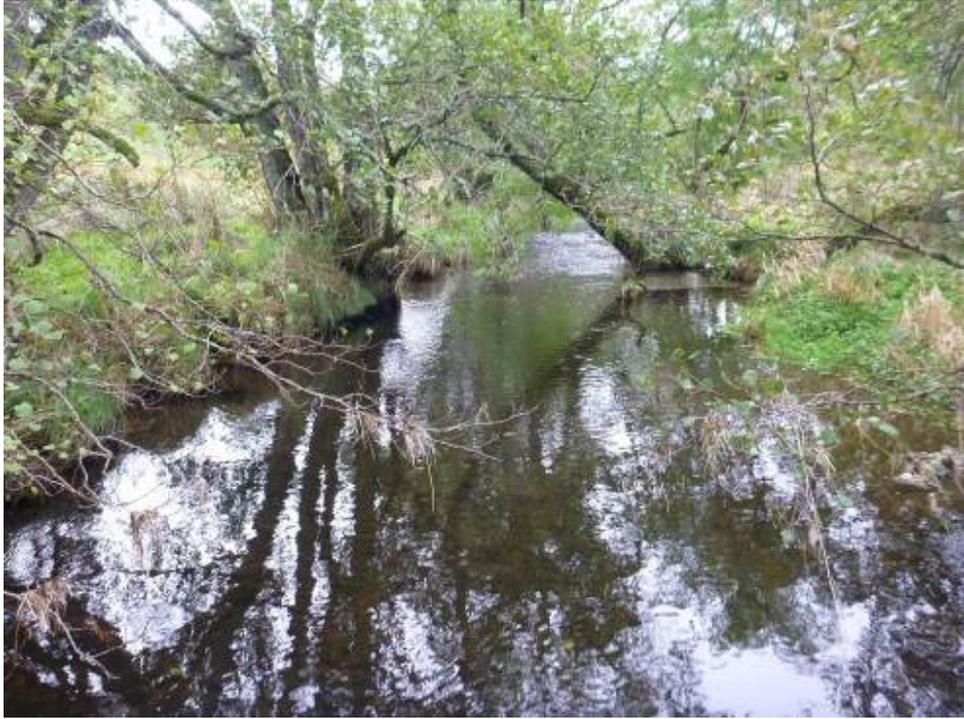
**Photo 7 Pinch points like this one created by trees on opposite banks create scour and deeper pools**

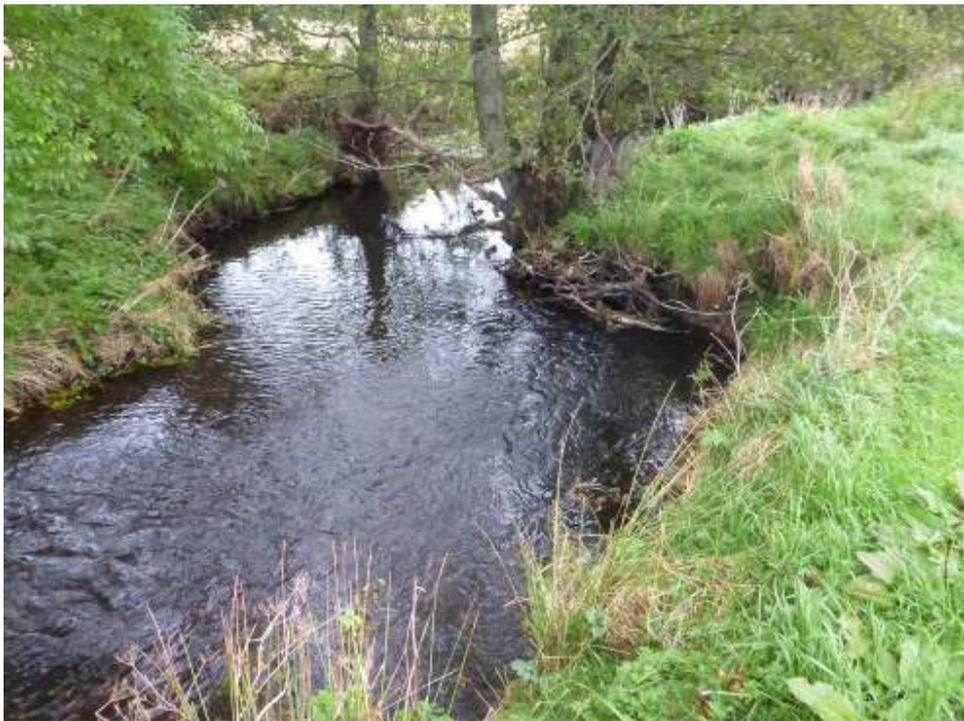
**Photo 8 As above – resilient tree roots causing flow deflection, scour and deep pool habitat**

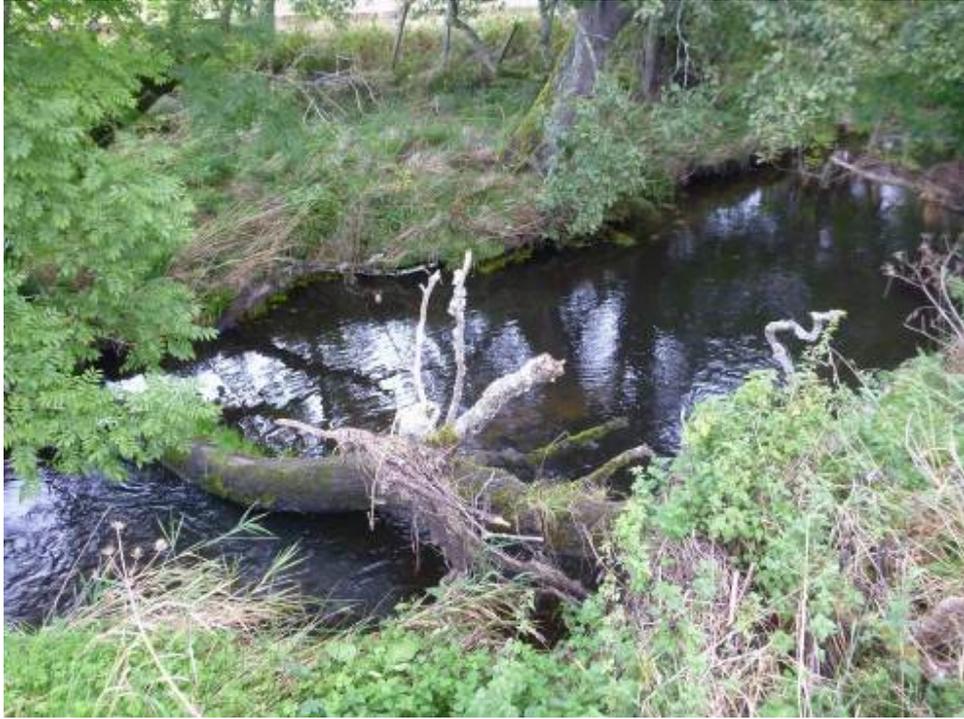
**Photo 9 Large woody debris creating scour and cover**

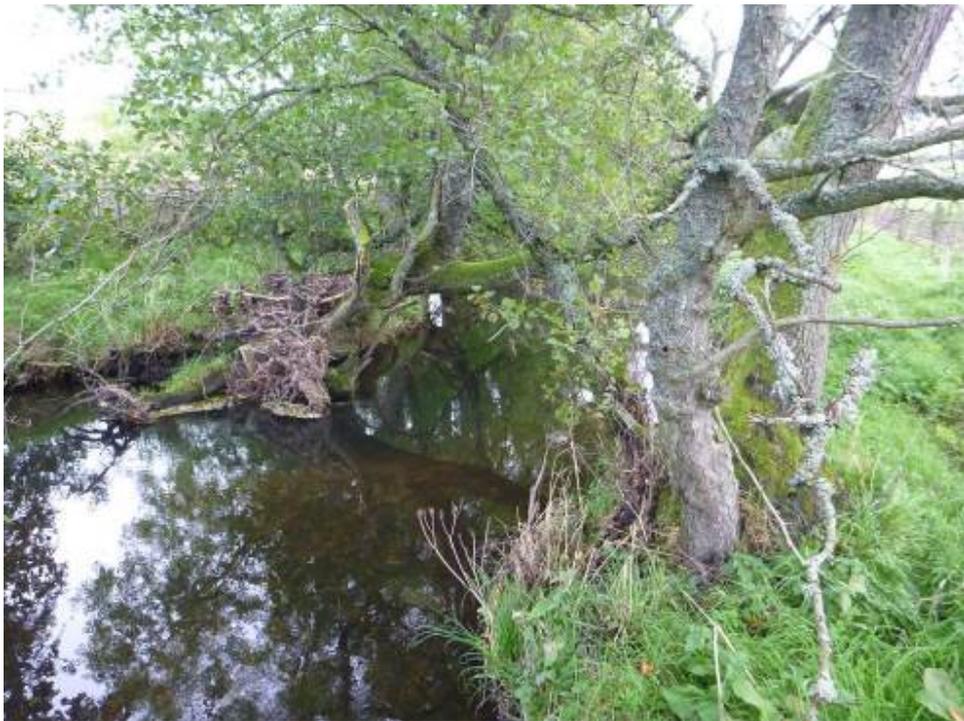
**Photo 10 As above**

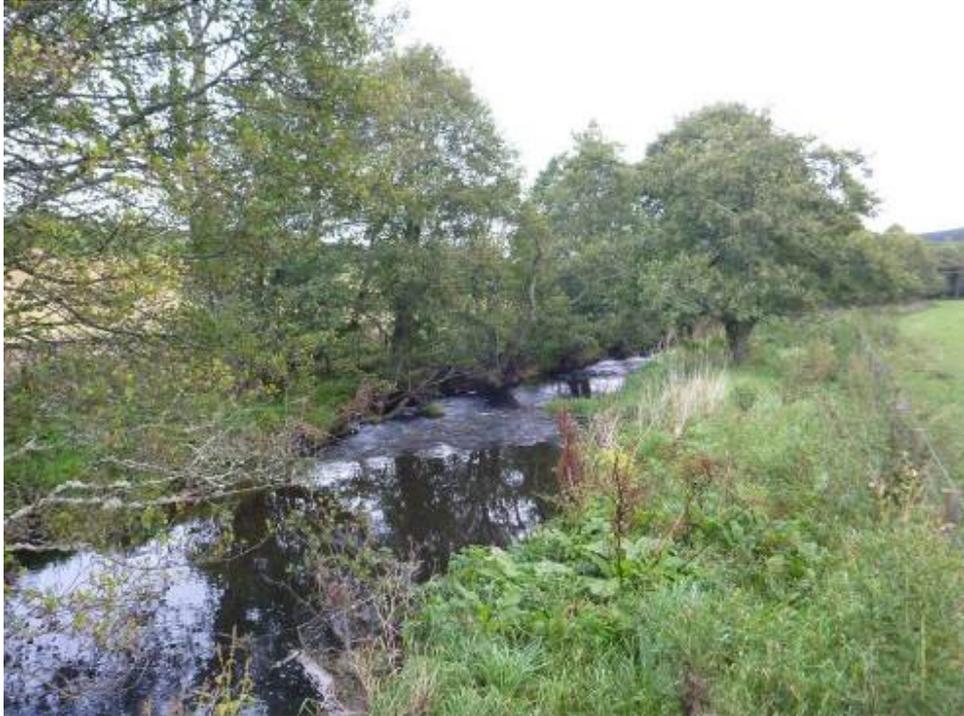
**Photo 11** The fenced buffer on the right bank has allowed good riparian habitat to develop

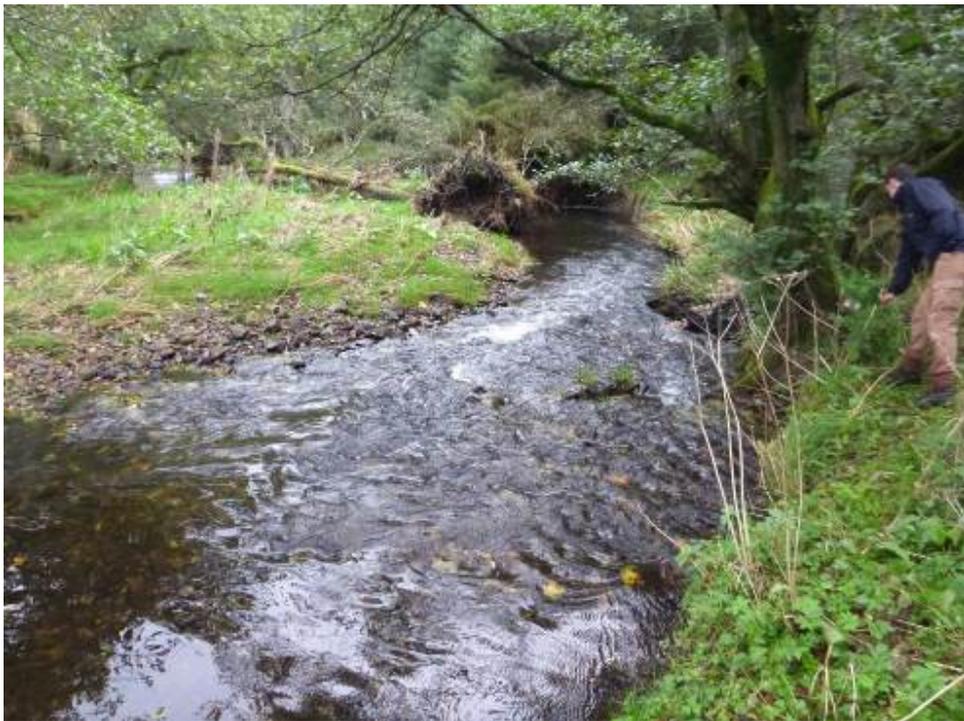
Downstream of a burn/field drain confluence on the LHB (approximate NGR NJ4018546255) the river channel widens, probably as a result of active erosion of the right bank (Photo 12). There is a small conifer plantation on the RHB here, the moderate size of the trees suggesting it was planted relatively recently (10 – 20 years ago?) compared with the more mature deciduous trees present. Loss of bank stability when this area was cleared and planted probably lead to increased rates of bank erosion, widening the channel; coarse sediment has been deposited in the wider channel in the form of a gravel shoal, in turn promoting more bank erosion. The overall effect is by no means detrimental *per se*, as it has re-introduced some natural sinuosity and depth variation to the channel, but it indicates how the artificially straight river reacts when the bank stability provided by the mature riparian trees is removed.

**Photo 12** More dynamic erosion and deposition at the conifer plantation on the RHB

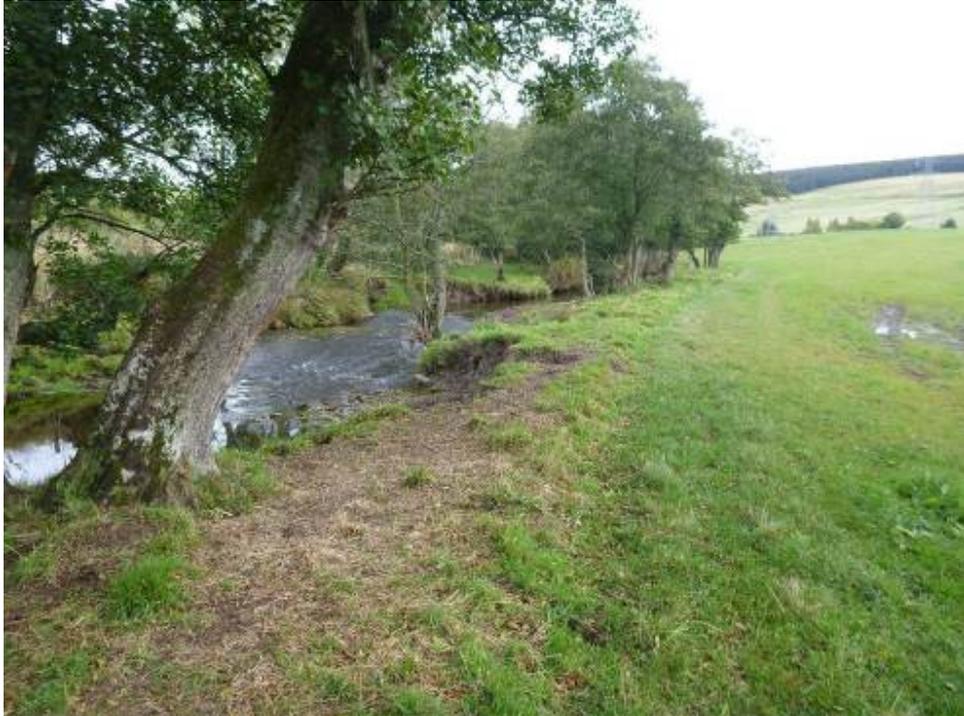
In the field downstream of the conifer plantation, the character of the river changes again, this time as a result of riparian land use (NGR NJ4041246479). The fenced buffer strip on the right bank ceases at this point and grazing has reduced the quality of the riparian habitat considerably (Photo 13). Closely grazed grass is present right up to the water's edge and bank poaching is evident in places (Photo 14); whilst grass is currently present it appears this may be part of a crop rotation with the field being a ploughed arable field previously. Tree succession and under-storey vegetation is absent, limiting the input of terrestrial invertebrates to the aquatic food web. In-channel habitat is generally shallow riffle with fewer pools than upstream.

**Photo 13 Unfenced field downstream of the conifer plantation**

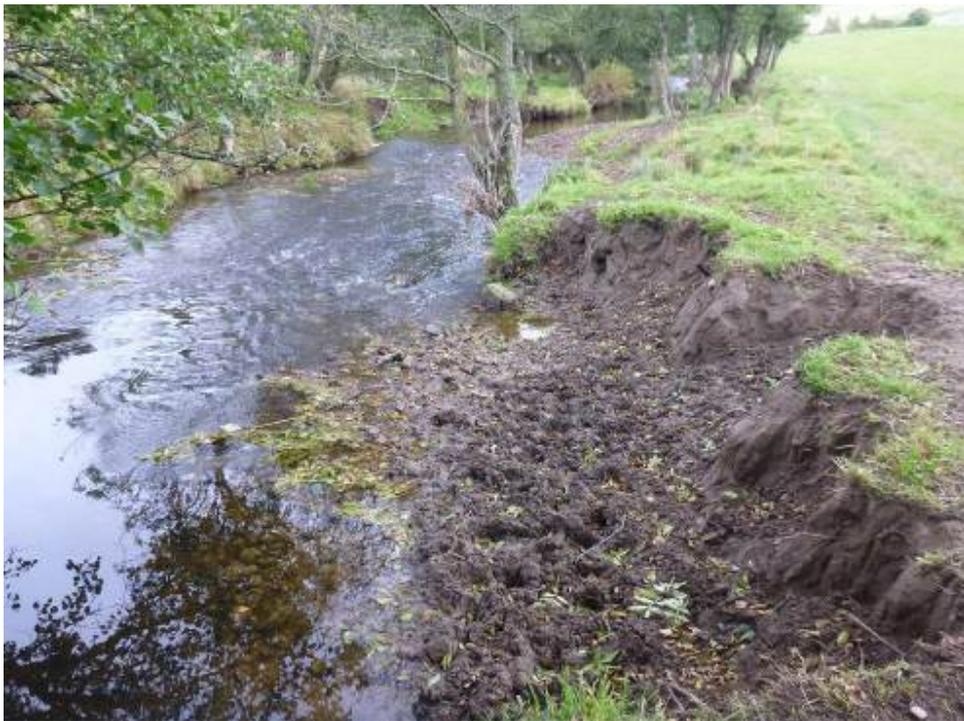
The next field downstream (NGR NJ4053746626) is fenced off but the fence is in poor repair, allowing livestock access. There are mature trees present on the bank here, but "scalloping" of the bank is occurring between them as

a result of livestock trampling. This could easily be rectified by mending the fence.

**Photo 14 Poached banks in the above field which will ultimately lead to loss of valuable trees and increased bank erosion**

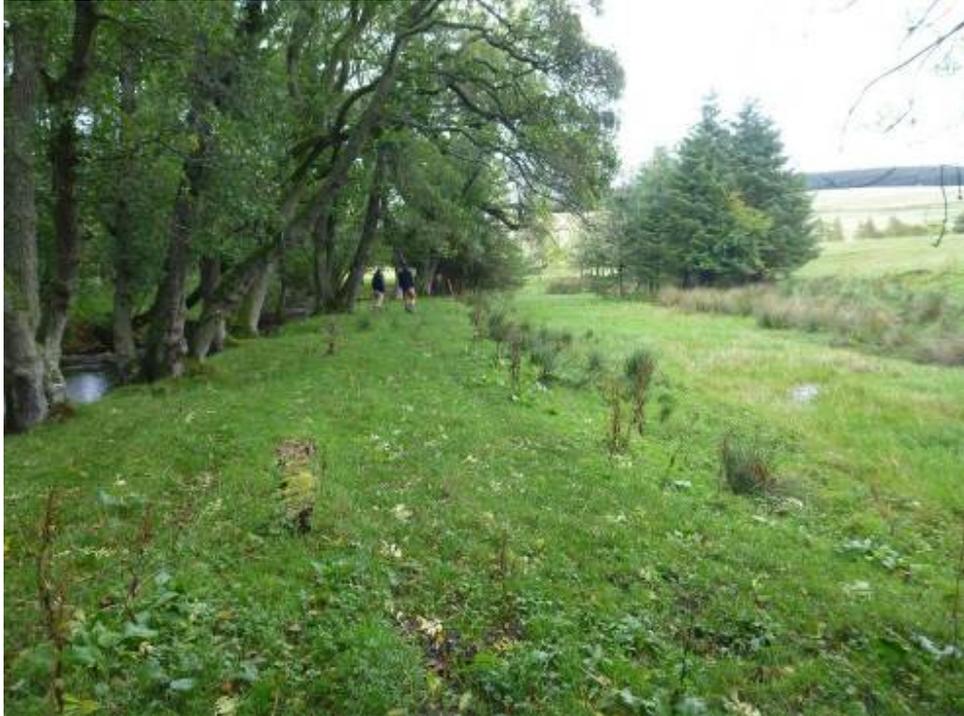
There is a low-lying boggy strip of land alongside the river here on the RHB (Photo 15) and the railway line is further away from the river on the LHB; there is also a flat meadow on the RHB downstream to the road bridge alongside the Davidson Burn confluence (Photo 16). This could provide an opportunity for introducing some sinuosity to the river channel, by re-meandering it across the wider corridor available here. Professional advice from a fluvial geomorphologist would be required. The invert of the minor road bridge at the downstream end of this reach would be a fixed level, to which a channel of appropriate gradient, length and bank-full discharge could be designed.

**Photo 15 Low-lying area on the RHB where channel re-meandering may be possible**

- Consideration should be given to re-meandering the section of the Isla upstream of the Bridge of Howdoup (Davidson Burn confluence), making use of the low-lying area on the RHB. Professional fluvial geomorphology advice would be required. Further advice on this topic can be provided by Wild Trout Trust (contacts Tim Jacklin, Gareth Pedley) and The Tweed Forum may be able to help given their experience with the Eddleston Water project [www.tweedforum.org/projects/current-projects/eddeleston](http://www.tweedforum.org/projects/current-projects/eddeleston) .

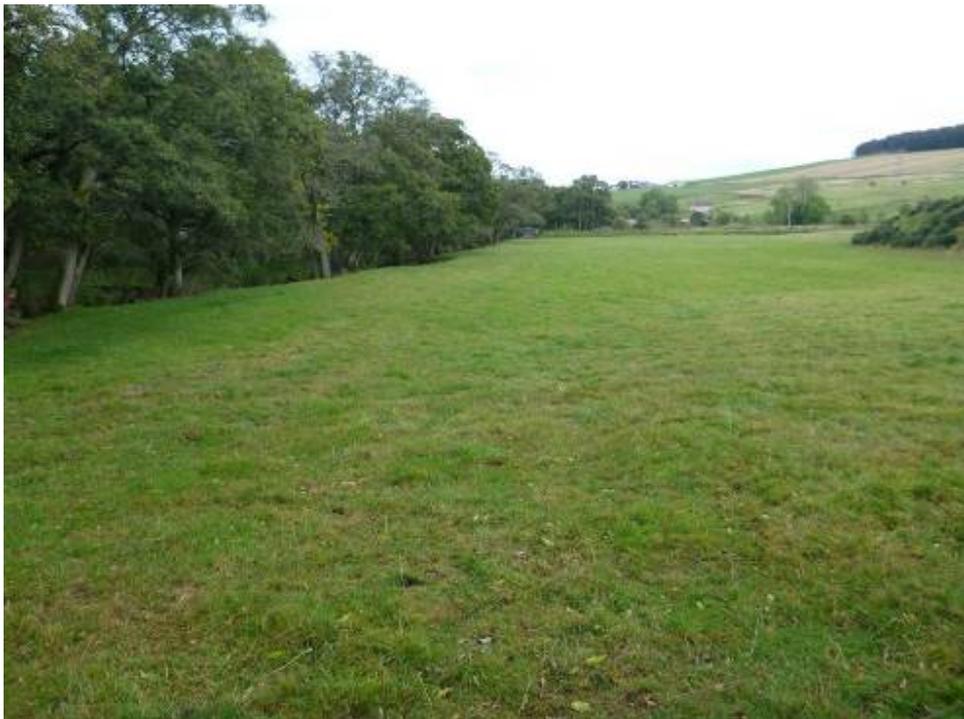
**Photo 16 Field looking downstream to the road at Davidson Burn confluence**

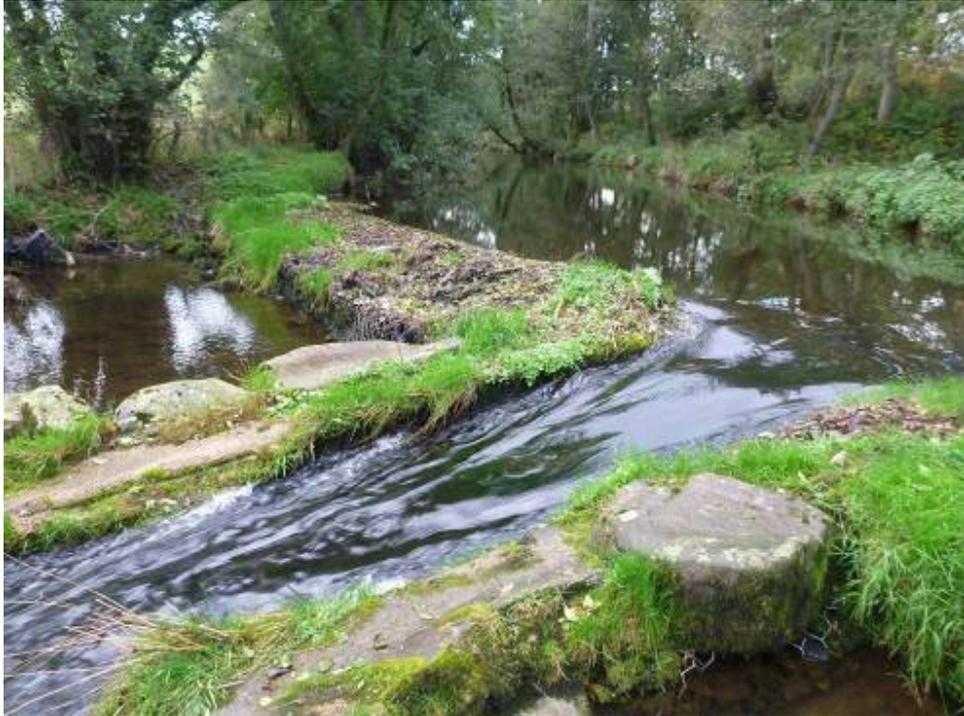
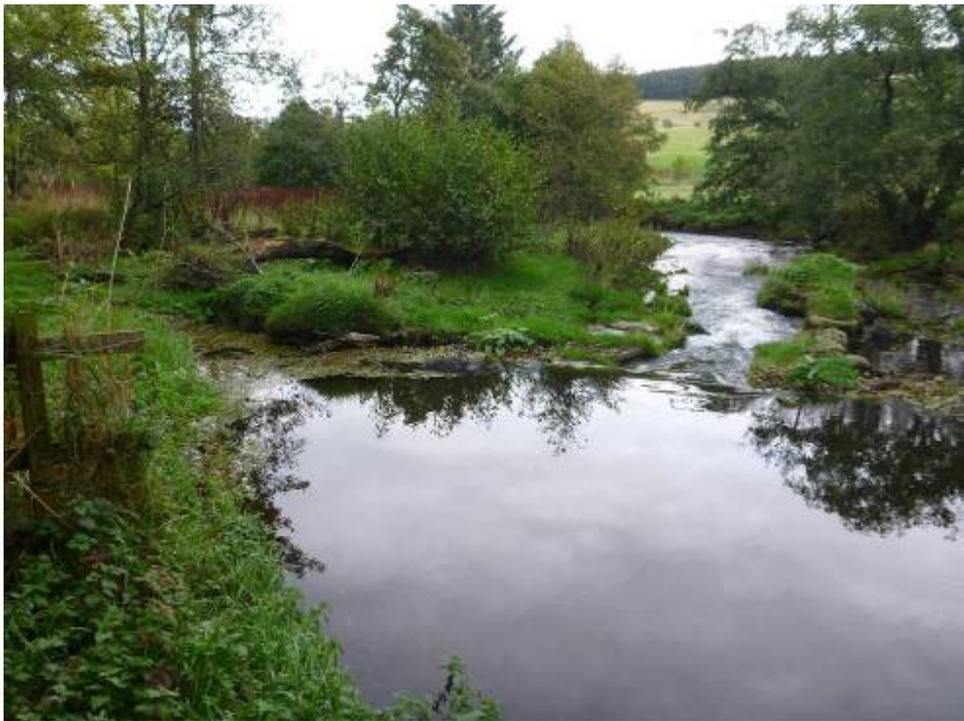
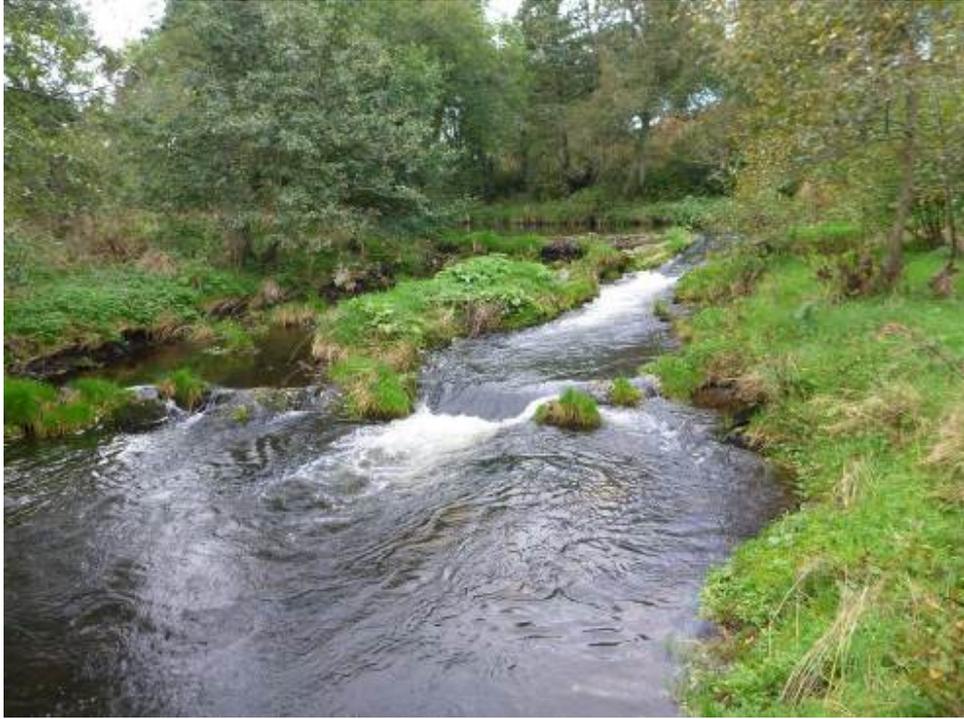
The Burn of Davidson joins the Isla on the RHB immediately downstream of the minor road bridge. Downstream of the confluence there is a long slow pool/glide impounded above a weir (Photos 17 – 19). The purpose of the weir is to divert water into a leat on the LHB which runs down to the Mill of Towie (NJ4073147242) and beyond, re-joining the Isla downstream of the Bridge of Auchindachy (NJ4068447503). There did not appear to be much flow down the leat on the day of the visit and it is not known if there is still extant water power at the mill. However, the weir structure comprised relatively modern gabion baskets suggesting recent repair or modification.

The flow over the weir was concentrated into a flume on the left side. The flow in the flume was very fast and laminar. Overall head loss across the structure was approximately 1 metre, although there is a step down at the downstream side (possibly a deliberate pre-barrage to aid fish passage). The structure is probably passable by adult salmon, sea trout and larger brown trout; however this is unlikely to be the case for juvenile and smaller adult trout. Opportunities to improve fish passage should be explored, the ideal solution being removal of the weir if the water supply to the mill is no longer required.

**Photo 17 Weir and impounded reach near Davidson Burn confluence**

**Photo 18 As above, downstream view with leat on LHB**

**Photo 19 Wider upstream view of the weir**

- Investigate the possibility of removing the weir downstream of the Davidson Burn confluence, or providing improved fish passage at this site.
- Retain large woody debris within the river channel. LWD is promoting good habitat in the Towiemore section of the Isla in a section which has been extensively straightened; the stable, tree-lined banks there mean the LWD creates scour of the river bed and depth variation. In sections of river with fewer trees and less stable banks, LWD may be more prone to causing bank erosion; in these cases, each structure should be assessed on its habitat merits weighed against effort to stabilise the banks by brushwood revetment, fencing and tree planting.

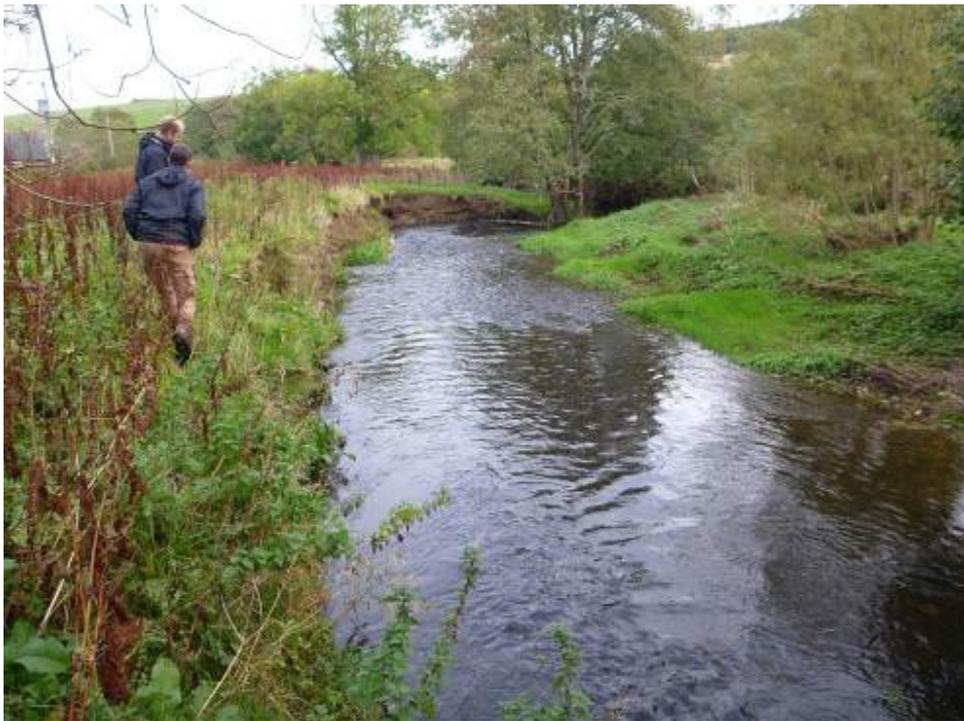
Downstream of the weir the plan-form of the river is more sinuous than the upstream section, although still has signs of past channel straightening in places. Bank erosion is more evident here, especially where mature trees are absent from the banks, for example between the weir and Mill of Towie (Photo 20). Where livestock are excluded from the banks, the riparian zone habitat is much better (Photo 21). Stone rip-rap has been used to reinforce the LHB just upstream of the Bridge of Auchindachy (Photos 22, 23), but this has failed; a more effective way to reduce erosion and improve habitat would be brushwood revetment (see recommendations) combined with setting back the fence line to allow trees to colonise the banks. A fenced buffer on the RHB here would also be of benefit.

**Photo 20 Upstream of Mill of Towie. LHB erosion in the absence of trees.**

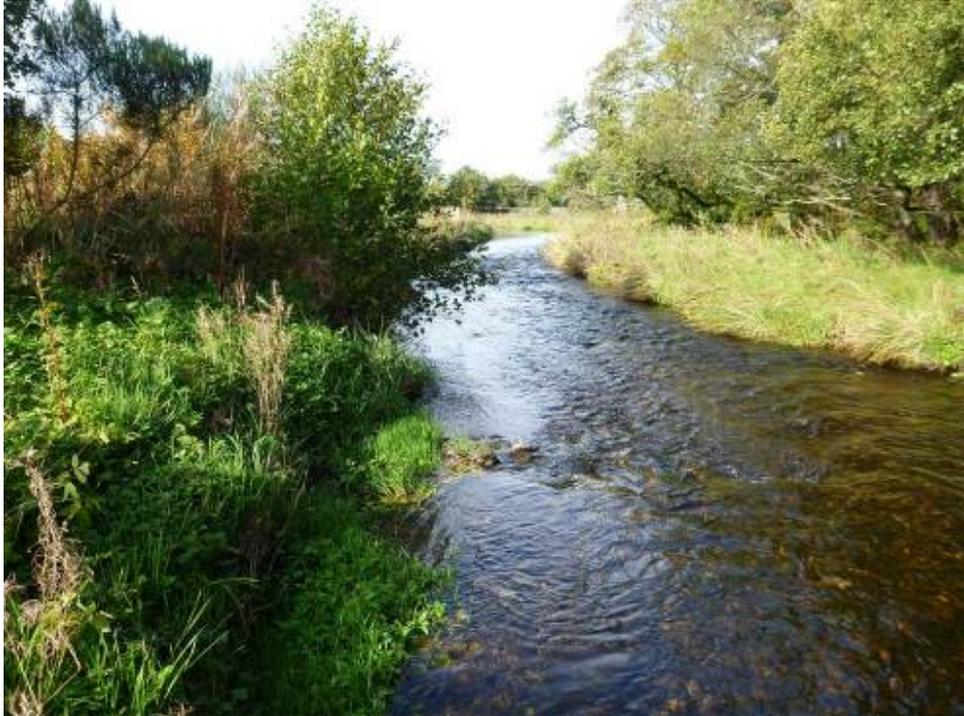
**Photo 21** An un-grazed section of river just downstream of Mill of Towie with good riparian habitat

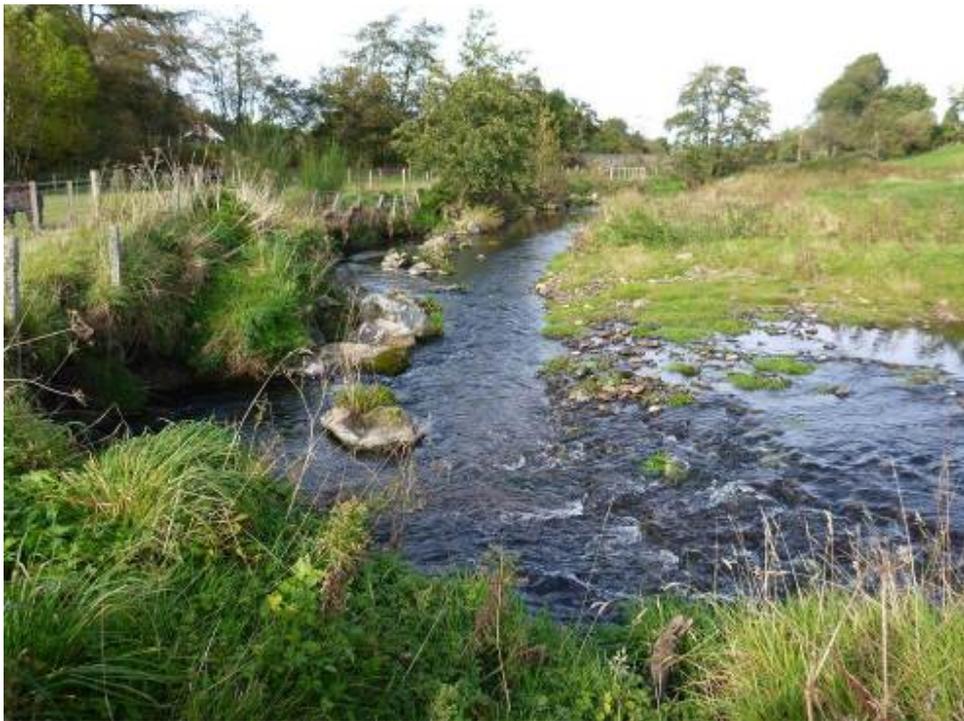
**Photo 22** Failed stone rip-rap bank reinforcement along the LHB

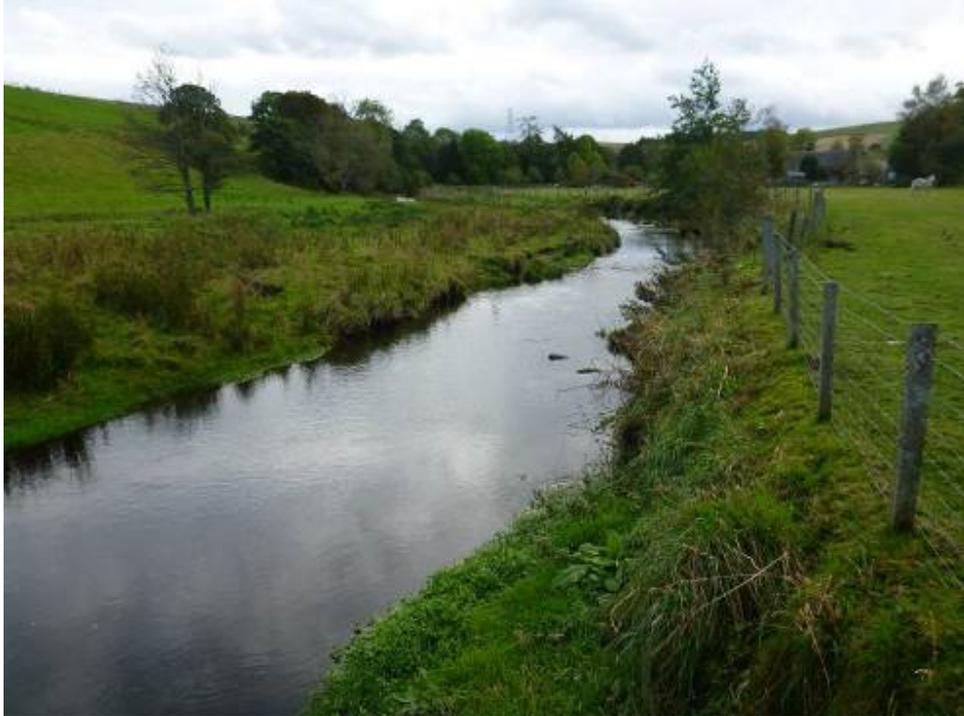
**Photo 23** Upstream view of the reach shown in Photos 21 and 22. Brushwood revetment and setting back the fence on the true LHB (right of picture) would arrest the erosion and improve riparian habitat here. The opposite bank would also benefit from a fenced buffer strip.

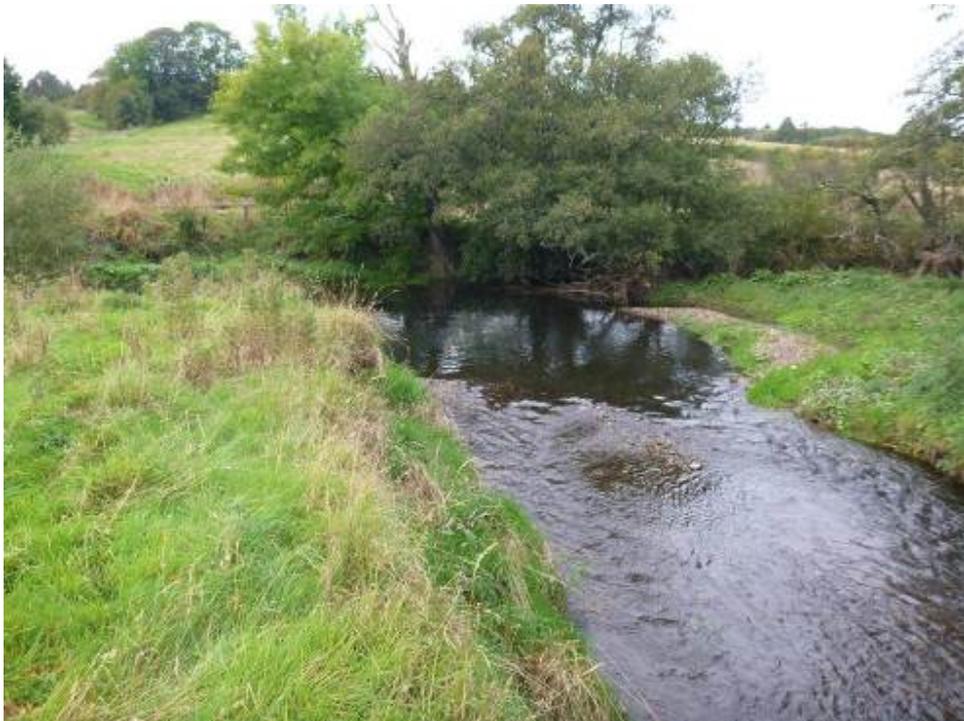
Downstream of the Bridge of Auchindachy the increased sinuosity of the river creates some deep lateral scour pools on the outside of meanders (Photo 24) which are good habitat for adult fish. It is important to note that the presence of trees and associated bank stability play an important part in

this process. Where trees are present and the bank is stable (as in Photo 24) the scour produces a deep holding pool. Where trees are absent, the less stable bank is prone to accelerated rates of erosion, producing poor habitat and inputs of sediment into the river (Photo 25). Areas like the latter are candidates for brushwood revetment and fencing/tree planting to stabilise the banks.

**Photo 24** A deep lateral scour pool.

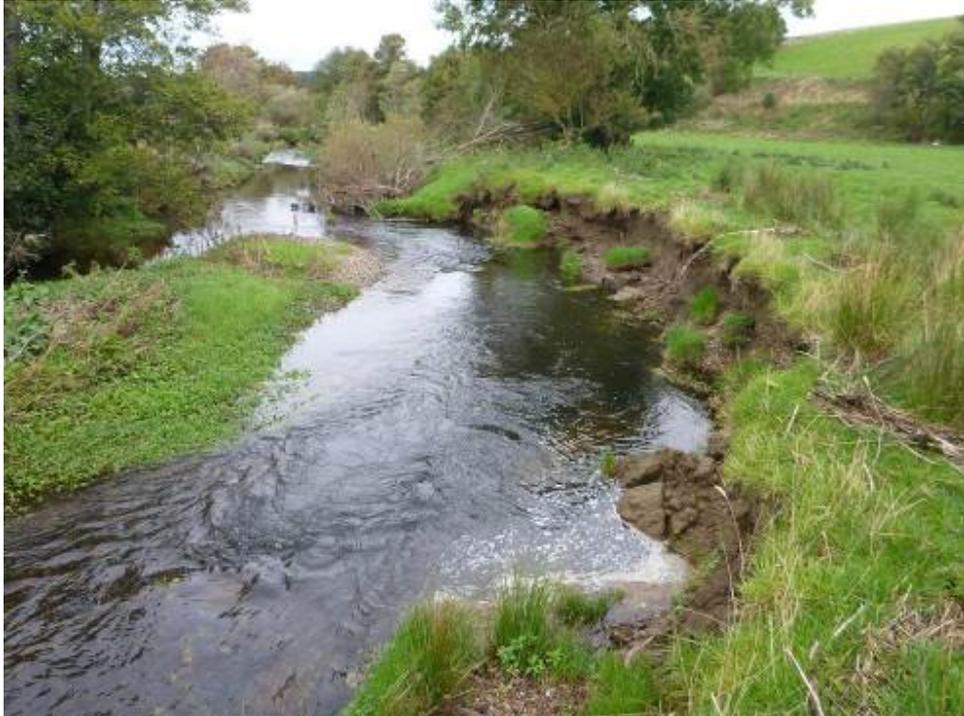
**Photo 25 Accelerated rates of bank erosion**

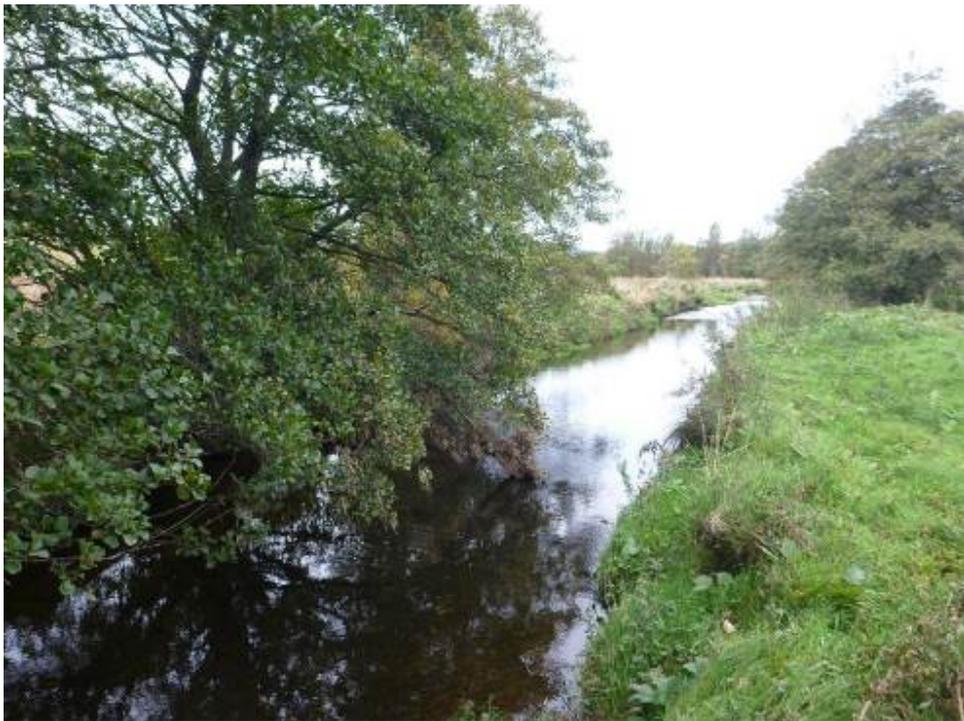
**Photo 26 Straightened section of river (NGR NJ4055447910)**

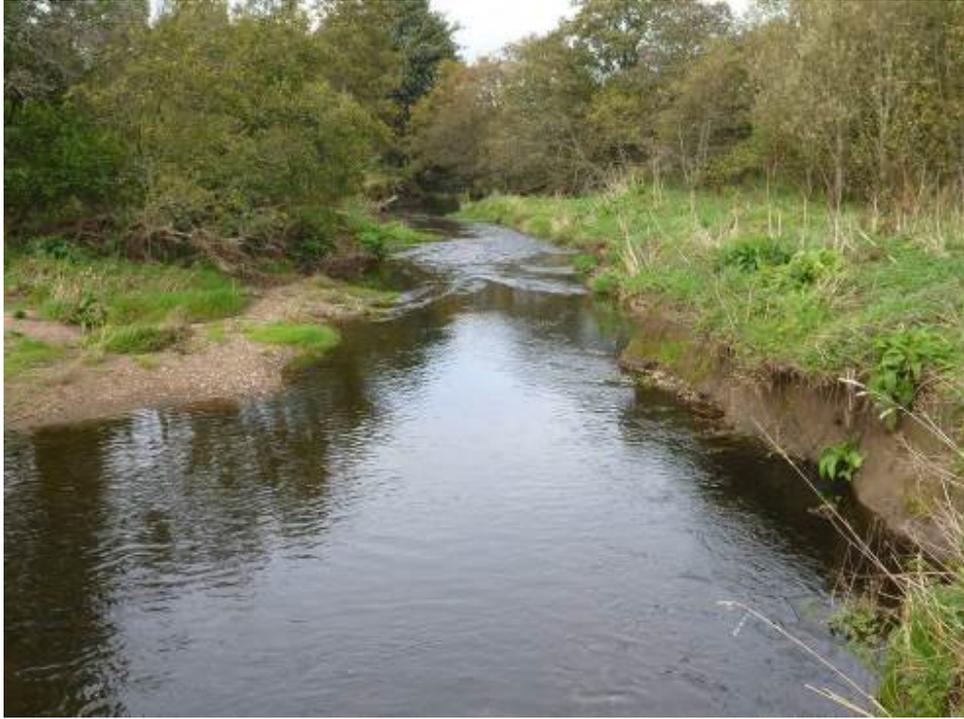
A good example of riparian land management can be seen in Photo 27 where it appears that land alongside the river has been set aside from agriculture and either planted or allowed to colonise with native trees. As these mature, they will stabilise the river banks and reduce the rate of erosion, producing a healthy riparian habitat, shade and inputs of woody debris. In contrast, Photos 25 and 26 show a straightened section of river with little depth variation and a section with few riparian trees and increased rates of erosion.

**Photo 27 Developing woodland produces a healthy riparian habitat**

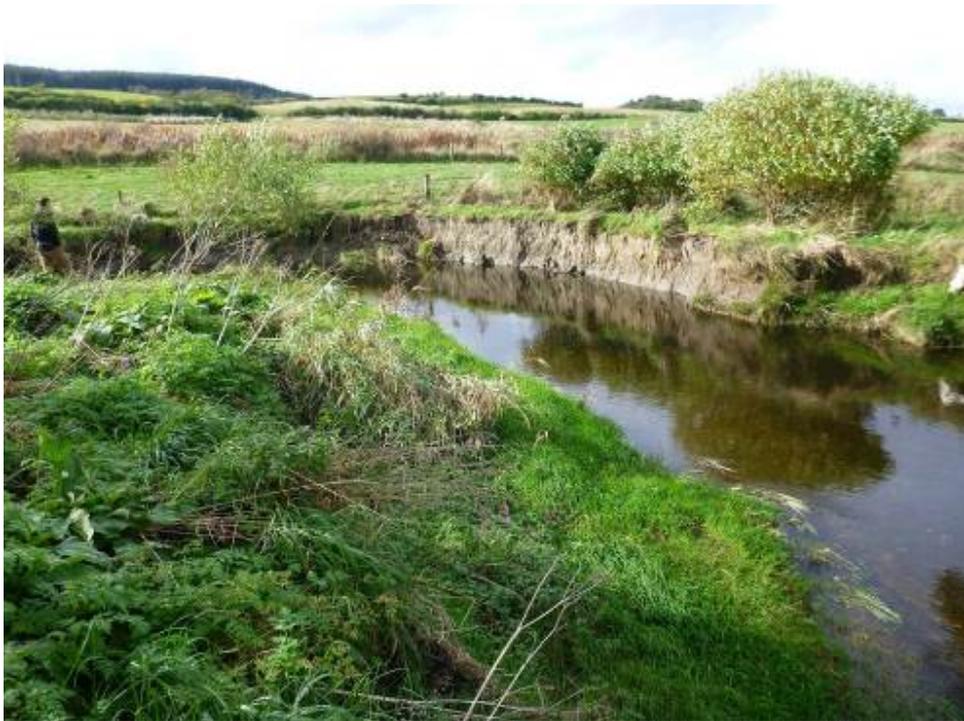
**Photo 28 Open, treeless banks are prone to accelerated rates of erosion**
