**Advisory Visit**

**River Isla**

**October 2014**

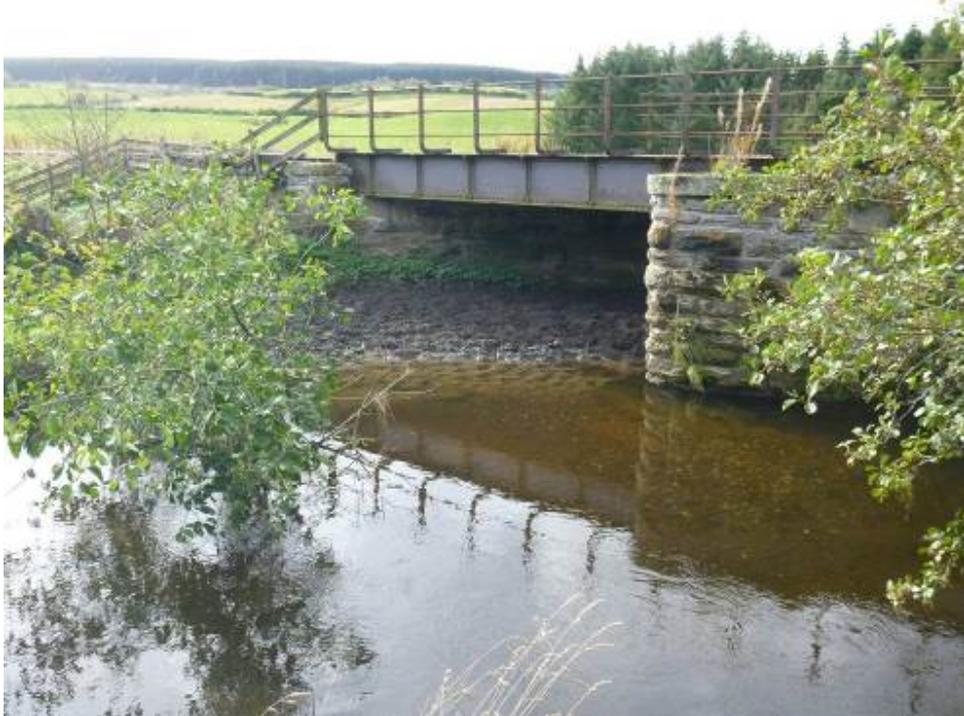
At the railway bridge NGR NJ4044648457, livestock access is creating a fine sediment input to the river (Photo 28). The river reach downstream of the bridge is relatively open and treeless and has numerous areas of accelerated bank erosion. Livestock appear to have unfettered access to the upstream section of this reach, with electric fencing appearing with progress towards the next bridge. Brushwood revetment, fenced buffer strips and tree planting would benefit the river here. At the downstream end of this reach towards the Bridge of Maisley, finer gravel is evident on the river bed (probably sourced from the active bank erosion just upstream). Rooted, submerged plants such as water crowfoot (*Ranunculus* sp.) and starwort (*Callitriche* sp.) are present in these areas.

**Photo 29** Railway bridge at NGR NJ4044648457. Livestock access is creating a fine sediment input here.

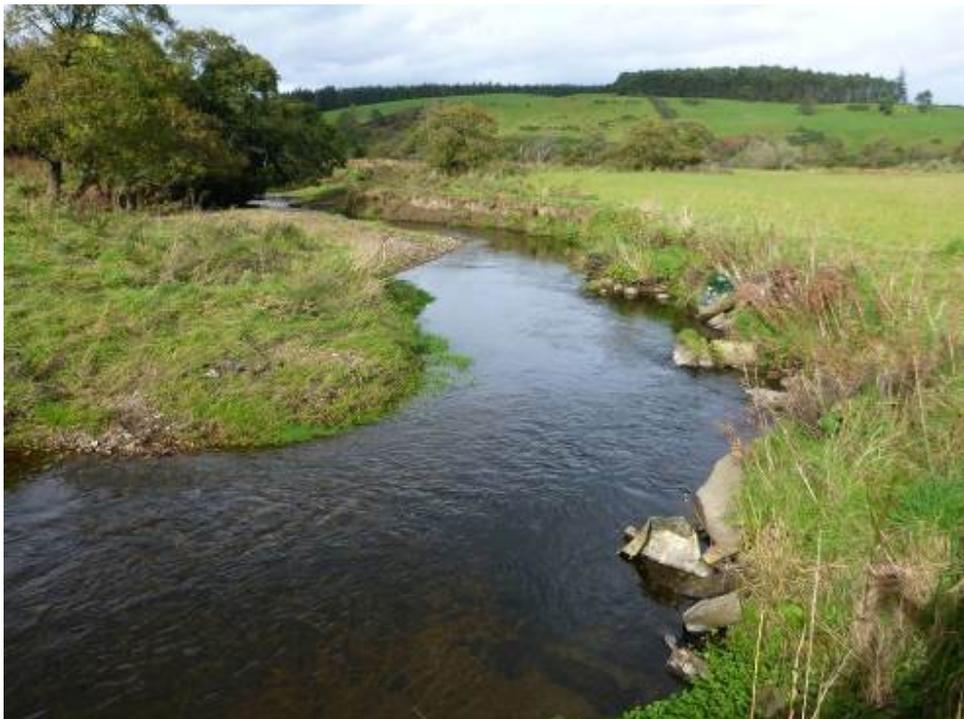
**Photo 30** View downstream from the above railway bridge. Absence of trees and accelerated rates of erosion occur in this reach.

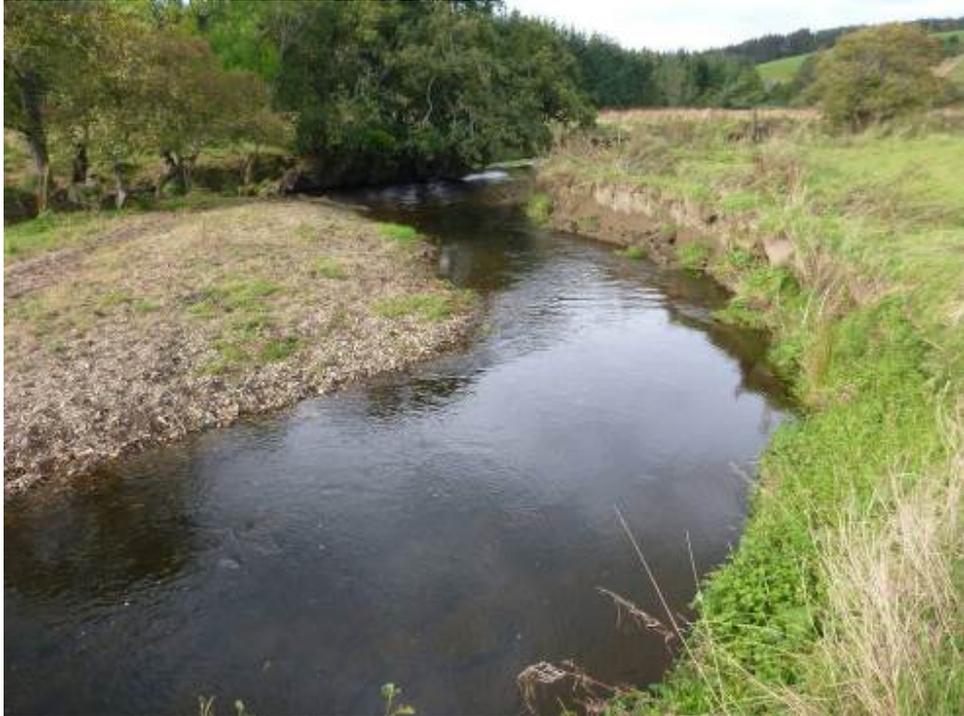
**Photo 31 An area that would benefit from brushwood revetment and fencing**

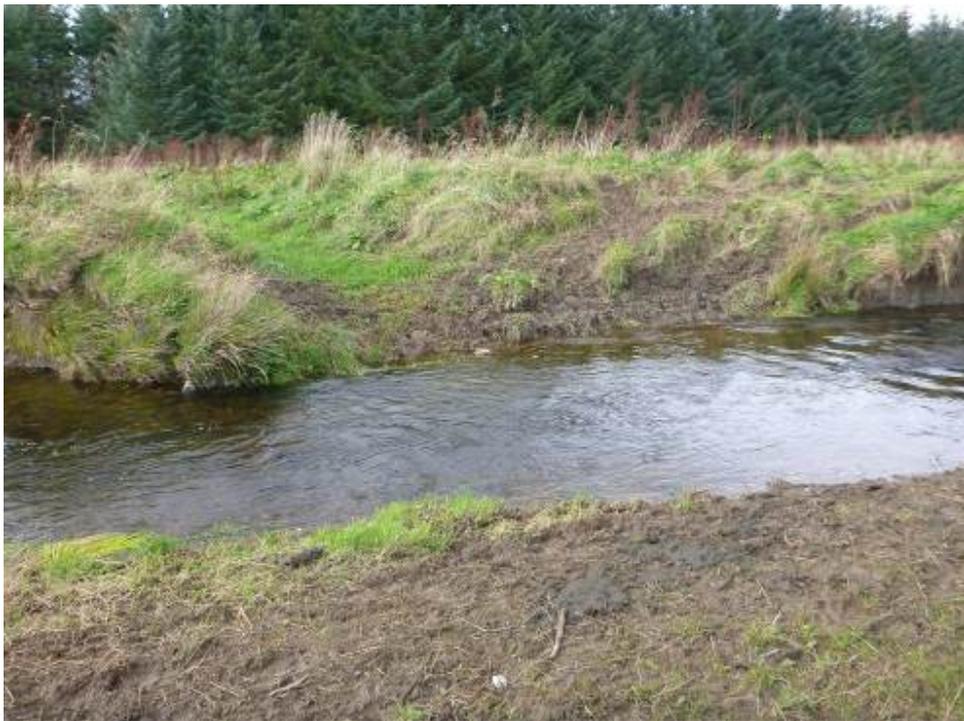
**Photo 32 Livestock access creating fine sediment and faecal input to the river**

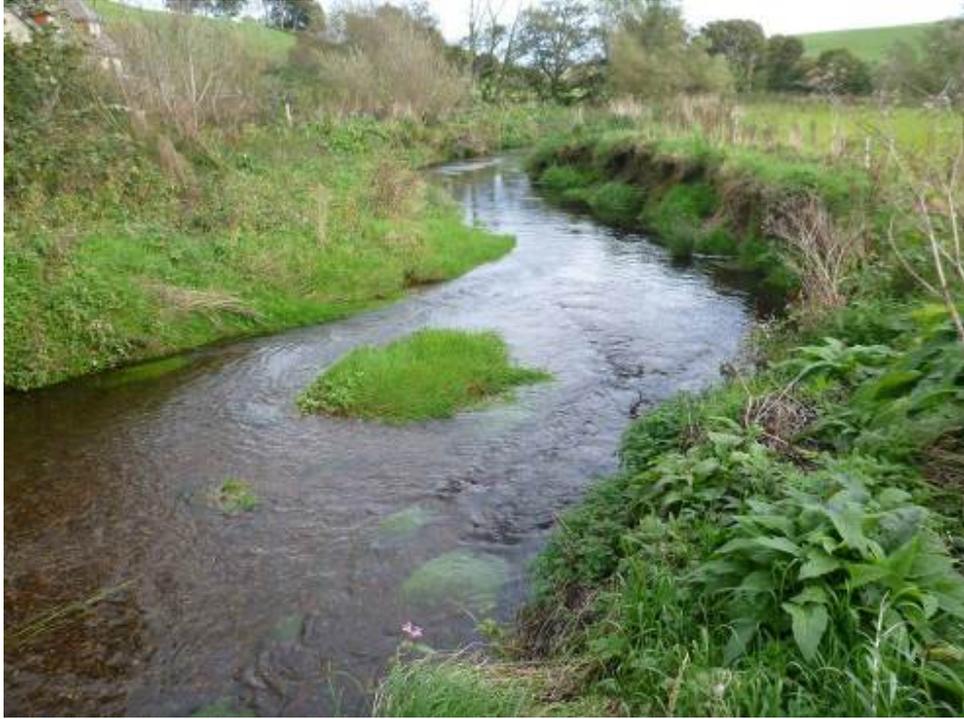
**Photo 33** Finer gravel and rooted, submerged plants such as *Callitriche* sp. and *Ranunculus* sp. are present around the Bridge of Maisley area NGR NJ4064348812.

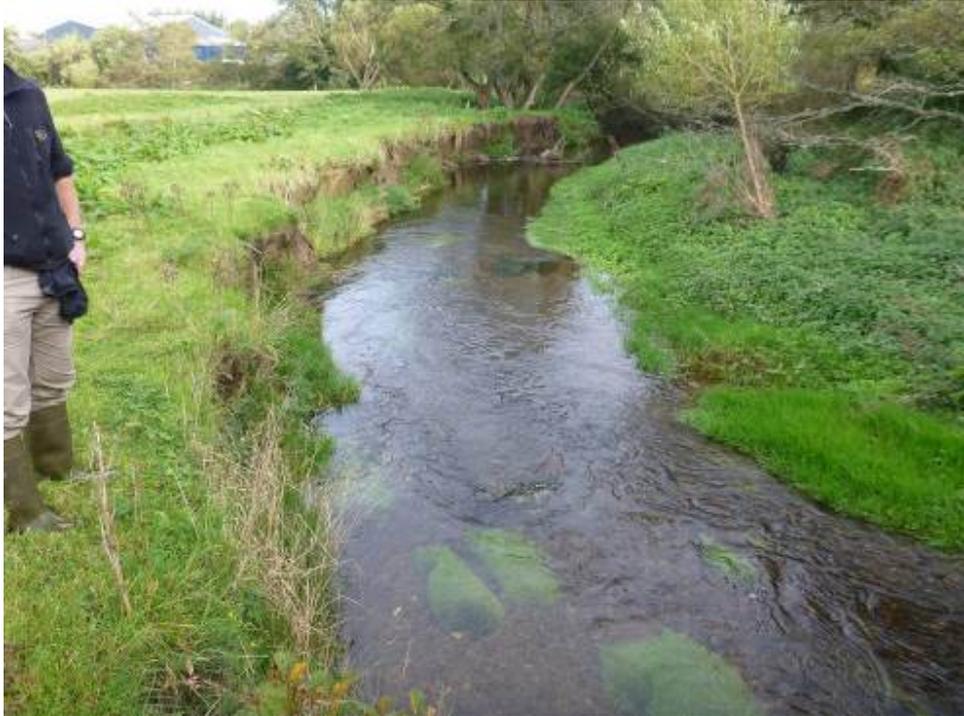
**Photo 34 Minor bank erosion could be tackled with brushwood revetment and fencing**

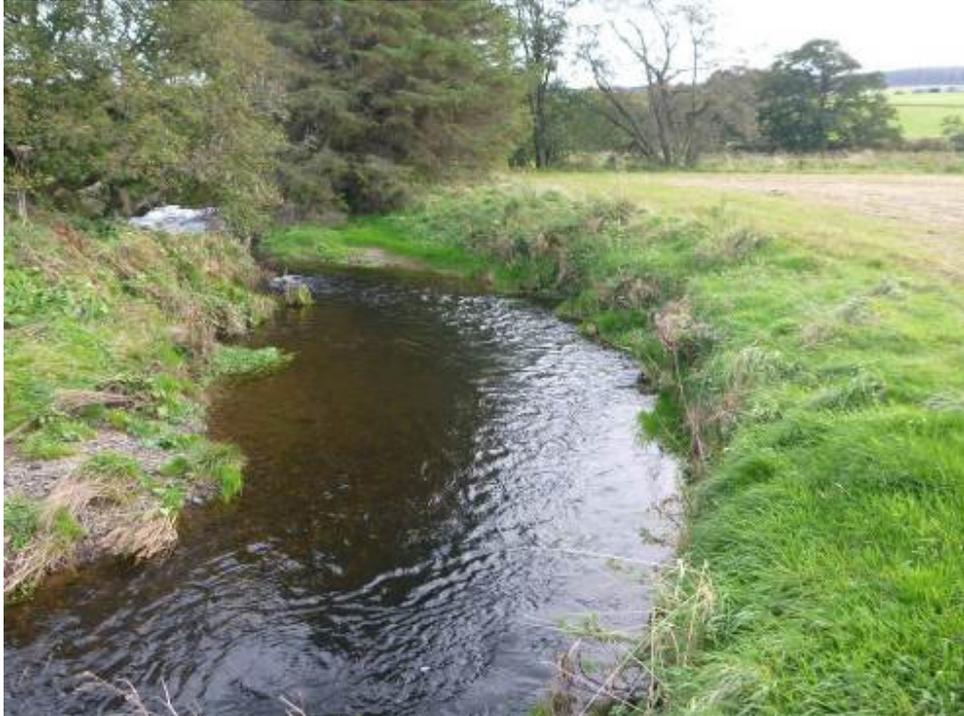
Downstream of the Bridge of Maisley, land use alongside the river appears to be predominantly grassland, with the occasional arable field. The river has a meandering plan form and the banks have moderate tree cover, with some lengths fenced off from livestock (Photos 35, 37). No areas of severely accelerated bank erosion were observed, although there are some areas suitable for brushwood revetment and fencing, such as Photo 34 (these would be a lower priority than on the section upstream of Bridge of Maisley). In-stream habitat is good, with a pool-riffle sequence, although low and submerged cover is lacking in some areas (Photo 36).

**Photo 36 Good in-stream habitat although low bankside cover is lacking in places**

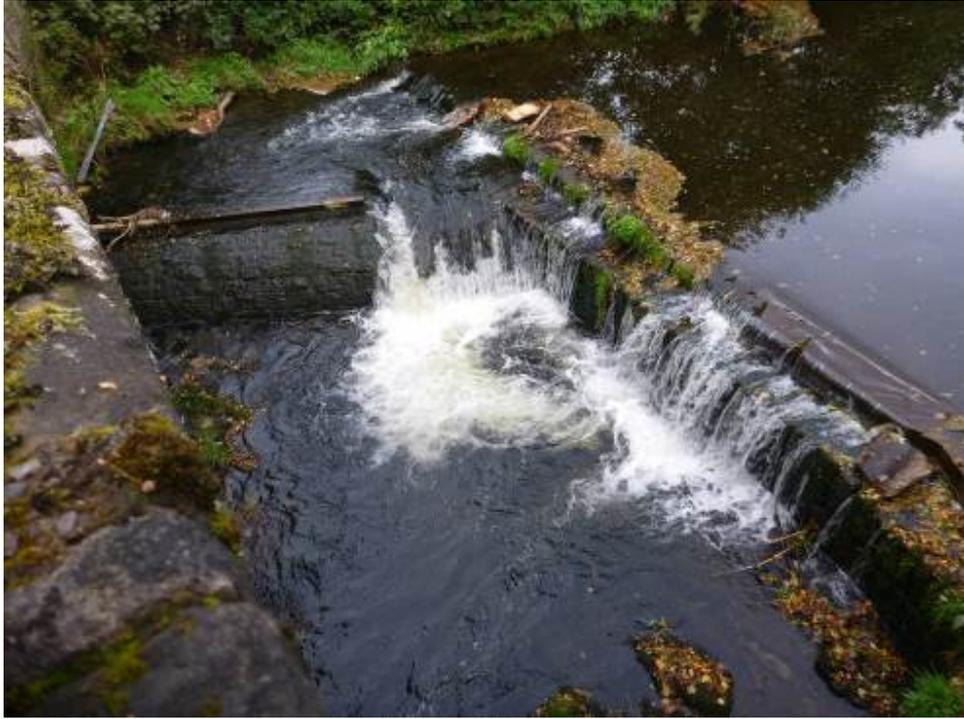
The section of river from Braehead (NJ422495) downstream into Keith was not inspected. In Keith itself, barriers to migration such as the one in Photo 37 are a problem for fish migration. Upstream movements of adult salmonids accessing spawning habitat and downstream movements of juveniles (smolt migration) are the most commonly considered fish migrations, but movements of “non-migratory” trout of all sizes, along with other non-salmonid species, needs to be considered ([www.wildtrout.org/content/about-trout-challenges#weirs](http://www.wildtrout.org/content/about-trout-challenges#weirs)). DBIT have installed an easement on the weir in Photo 37 consisting of wooden baulks to concentrate the flow in one area; this will assist adult salmon and sea trout moving upstream, but the barrier remains a problem for smaller adult trout and delayed downstream movements of smolts. The latter has been implicated as a significant cause of smolt mortality on the River Tweed, depending upon water levels at the time of migration (Gauld *et al.*, 2013).

**Photo 38 Weir in Keith at a distillery abstraction point. DBIT have made an easement here, but obstruction to free fish passage is still a significant issue at such structures.**
