River Itchen – Kanara Fishery

**An Advisory Visit by Nick Lawrence on behalf of the Wild Trout Trust
April 2016**

This report is the output of a site meeting and walk-over survey of the Kanara Fishery on the Itchen at Brambridge in Hampshire.

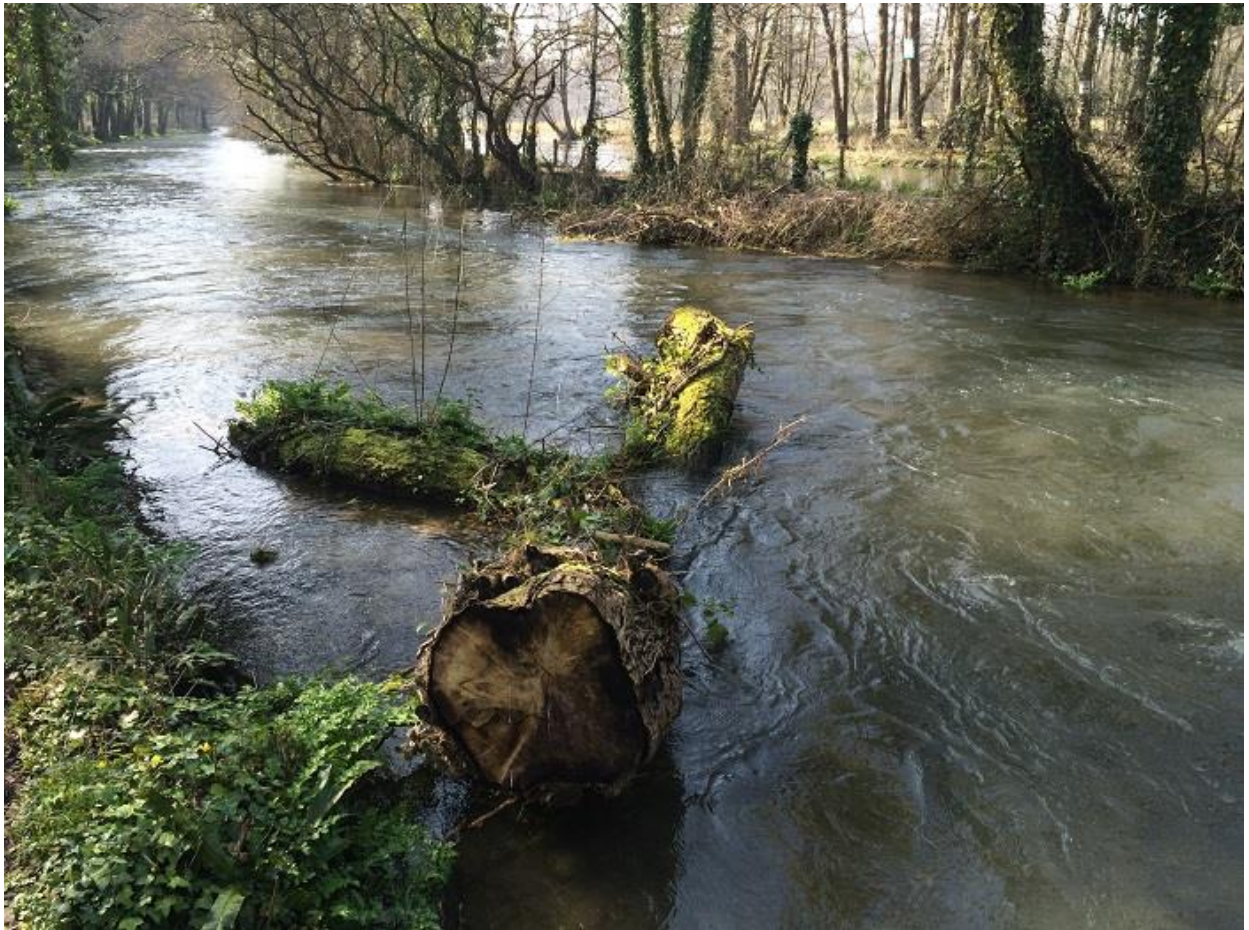
Just below the largest summer weir is a fantastic example of what to do when a tree falls in the river (cover photo). The tree couldn't be left where it fell because of flooding and eroding the footpath, so the butt section was severed and left where it fell, creating a natural scour off the end of the log and kicking the flow towards the LB. Just downstream all the brush was placed in the water on the RB in a mattress-style deflector, kicking the flow back across and creating a natural chicane. This habitat is ideal for all year classes of wild trout and is a great way of easily creating natural pool and riffles without the use of big summer weirs.

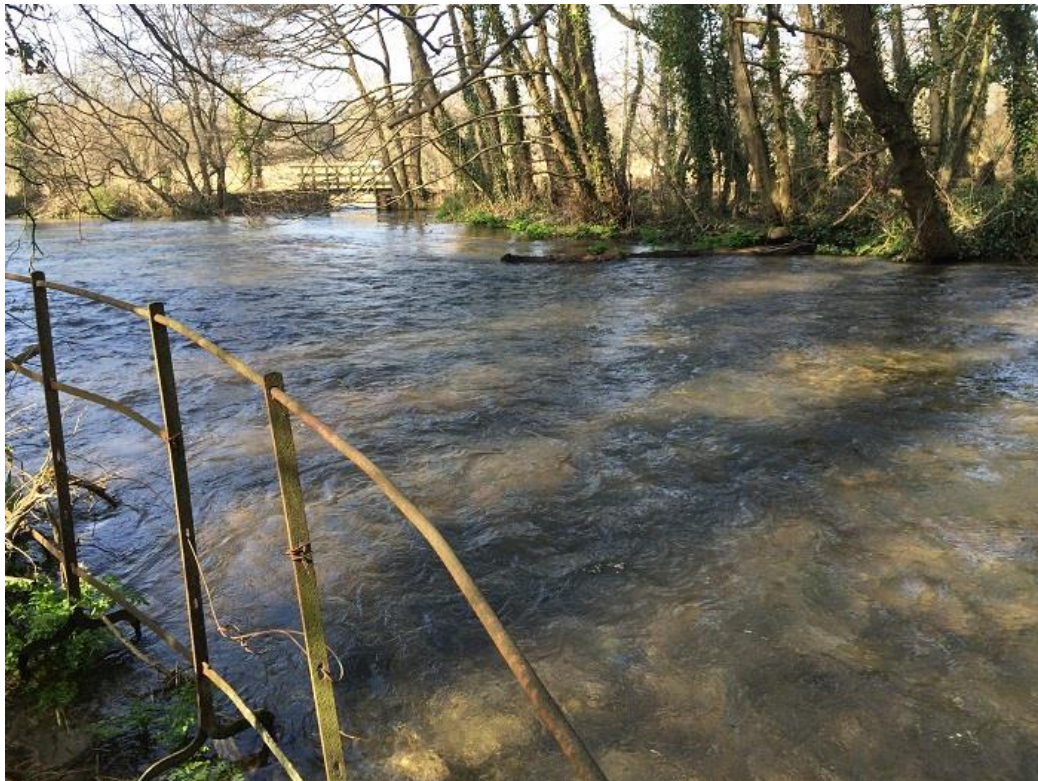
The top section below Kiln Lane is heavily shaded by woodland and is uniform in channel width and depth. There is no defined pool riffle sequence along this section. A fallen tree that has been left on the RB is providing valuable gravel sorting which will be a good area for salmonid spawning (Photo 1). This area could easily be improved with the addition of whole trees to bolster the existing natural woody material on the RB.

Photo 1. View from the bridge at Kiln Lane, a fallen tree on RB deflecting flow to provide valuable variation in habitat.

In the background of photo 1 you can see one of three inlets to this channel from the Itchen Navigation canal.

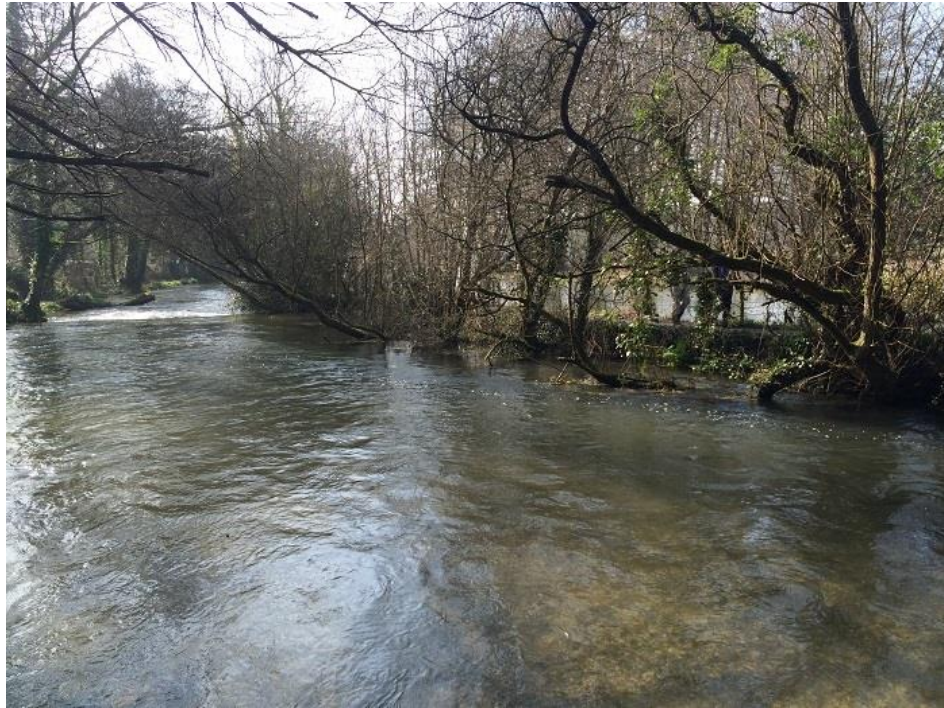
Below this area, the river narrows and has a nice scrubby margin on the RB (Photo 2); this area is prime wild trout habitat, with plenty of cover for small fish and a good scour promoted by the tree roots to create a lovely run. Kanara runs mostly through woodland, therefore there is a slight issue with shading, which possibly results in very little light actually hitting the water when the trees are in leaf. This could be improved by 'hinging' some willows into the channel to add habitat, thus improving the light situation at the same time. Weed growth was poor through this section and a little light could give it a kick start. NB Light touch here is key; some willows must be kept as low cover.

Photo 2. Nice pacey reach with good cut under RB. Some of the willows could be hinged to increase habitat as well as lighting the channel to improve weed growth.

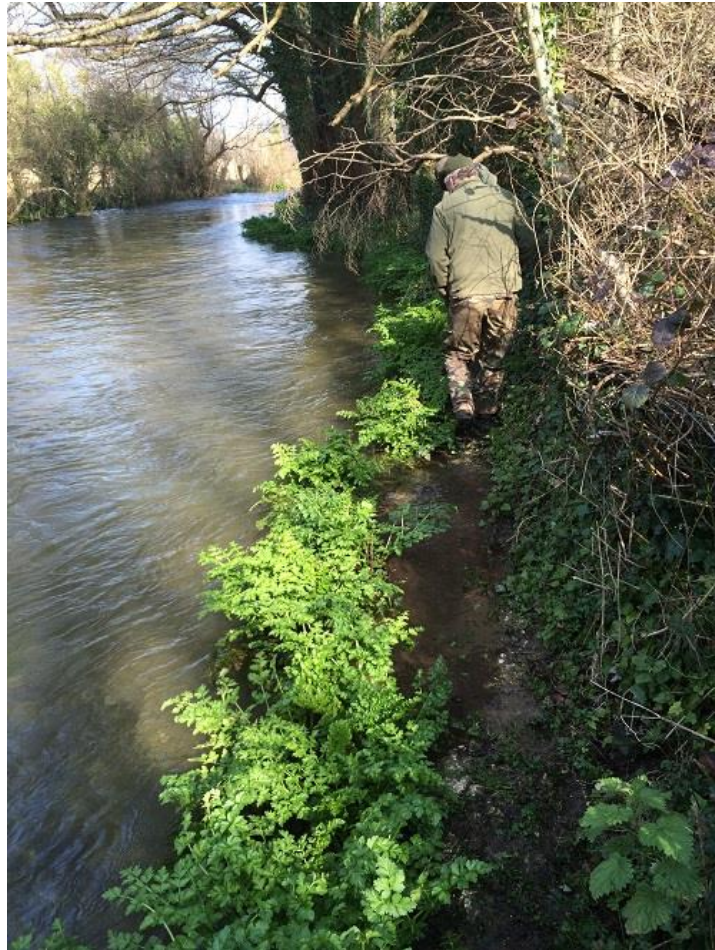
The LB in comparison has some serious issues. The LB is used as the path for anglers and is suffering badly from erosion. It is heavily shaded which means that not much grows under it and it has little to no marginal fringe apart from Hemlock Water Dropwort (*Oenanthe crocata*). If nothing is done about this, then it could become a serious access problem. Note the very narrow path in Photo 3. One of the main issues is there are no reed beds to buffer the flows, which means bare earth is exposed, causing serious bank erosion.

Photo 3. Very narrow eroded LB, possible regrading/ rebuilding project or some coarse woody material to protect it and try to establish more marginal plants.

The easiest and cheapest fix would be to install coarse woody material or faggot bundles backfilled with brushwood to protect the exposed bank, collect silt and try to establish a marginal reed bed to buffer the flows. This could be combined with strategic narrowing where the channel is overwide to keep the water energy in the channel. Coppicing of willow or hinging willows opposite these areas would be needed to encourage some extra light, helping to establish the fringe.

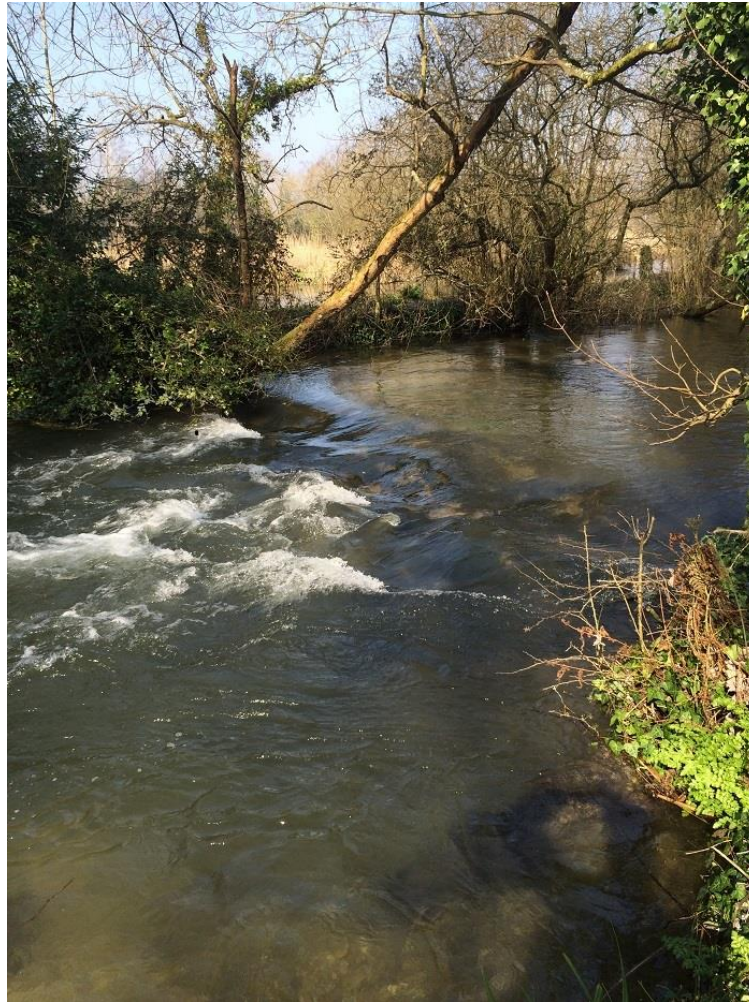
There were noticeably 3-4 summer weirs that were obviously installed some 20+ years ago (photo 4). They would have been used to hold up summer levels for stocked fish. These may not individually be impacting on fish passage but they may have a cumulative effect.

The main issue with these structures is the interruption of gravel movement. These structures could also be partially responsible for the bank erosion on the LB. This is because when the river comes up it is forced to find a new path, forcing flow towards the banks. Particularly on chalkstreams, where flows are generally more stable, such summer weirs suppress the natural geomorphology and reduce the abundance or magnitude of pool and riffle sequences. As mentioned, these were put in to hold up summer water levels and this is when the damage is done. The river needs to be 'free' so that natural pools have a chance to develop and provide depth and flow during dry weather. Holding up water levels suppresses natural river process, resulting in long sections of featureless glide habitat.

Photo 4. One of the summer weirs, note the smooth glide above it and erosion below in the bottom right of picture.

- **The summer weirs should be removed. This will allow the river to be 'free flowing' and may help with the erosion on the LB.**
- **Continue to employ light touch management, e.g. leave fallen trees in the river if they are not impounding the river or causing excessive bank erosion. If a fallen tree does fall in a place where it might cause a problem, adjust it into a more favourable position and secure it with posts and wire to retain the ecological (and fishery) benefit.**

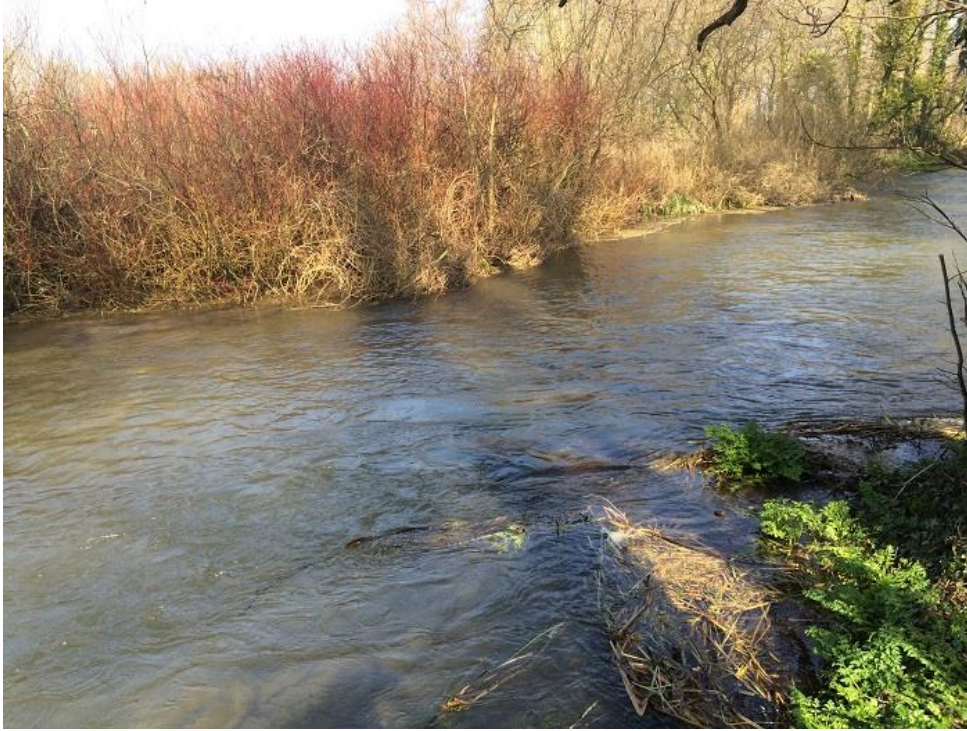
Between these summer weirs, there is some fantastic habitat, most notably the naturally occurring alder roots on the LB and scrubby dogwood and willows on the RB. If the summer weirs were removed, then these habitat features would be accentuated even more (photo 5).

Photo 5. Alder roots producing a good scour and a lovely scrubby margin of dogwood creating a nice natural pinch.

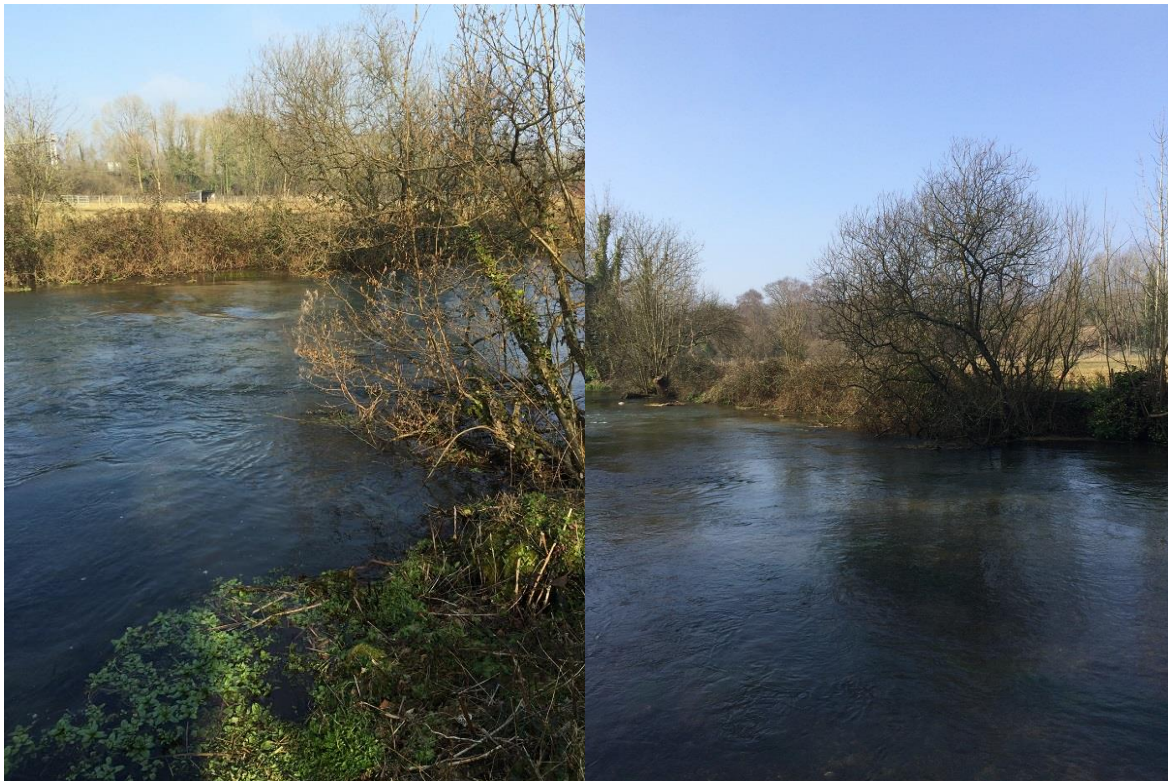
Photo 6. Rare low cover from LB, a superb slack area downstream of it. Photo 7. Slightly upstream of Photo 6, a goat willow is a likely candidate for a hinge cut.

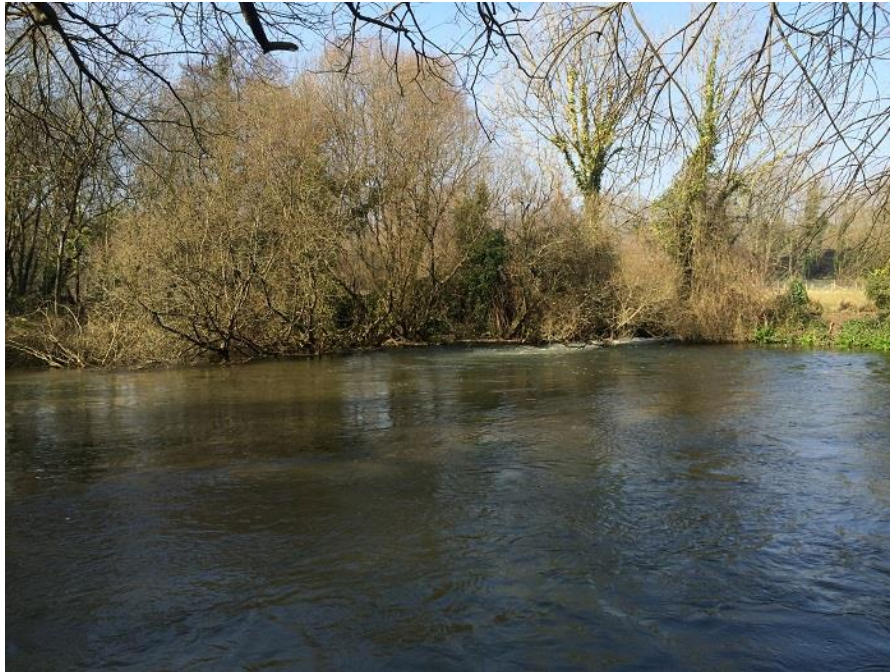
Downstream of photos 6 and 7 the river changes mainly due to more flow joining this reach from a set of side hatches from the Itchen Navigation Canal (Photo 8). From this point, the channel becomes much wider although further downstream of here it narrows again adjacent to woodland and tree roots, scouring very deep holes in the process. Often, salmon *Salmo salar* are spotted in these areas.

Photo 8. The tumbling bay in the middle of the fishery, an important nursery area for fish. Note great habitat under the scrubby bushes on RB and the shallow gravel bank perfect for small fish.

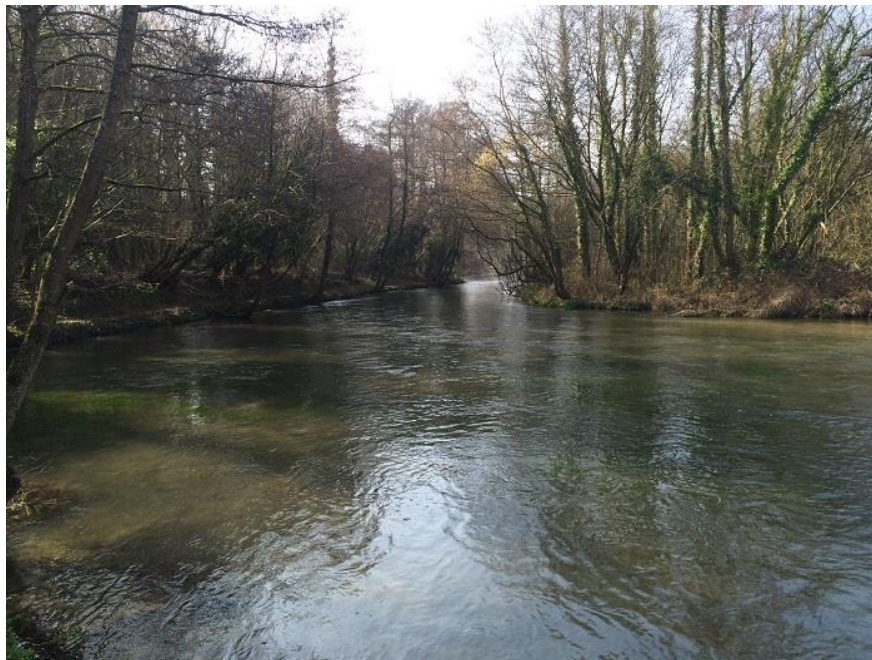
Photo 9. Looking downstream of tumbling bay, very wide but then narrows up in the wooded area.

There was very little wood actually in the water despite being a heavily wooded area. Presumably this is down to management practices although hinging some

likely looking willows was discussed on the visit. The area shown in Photo 9 could do with some large woody material, the width of the channel would allow fairly bold habitat installation.

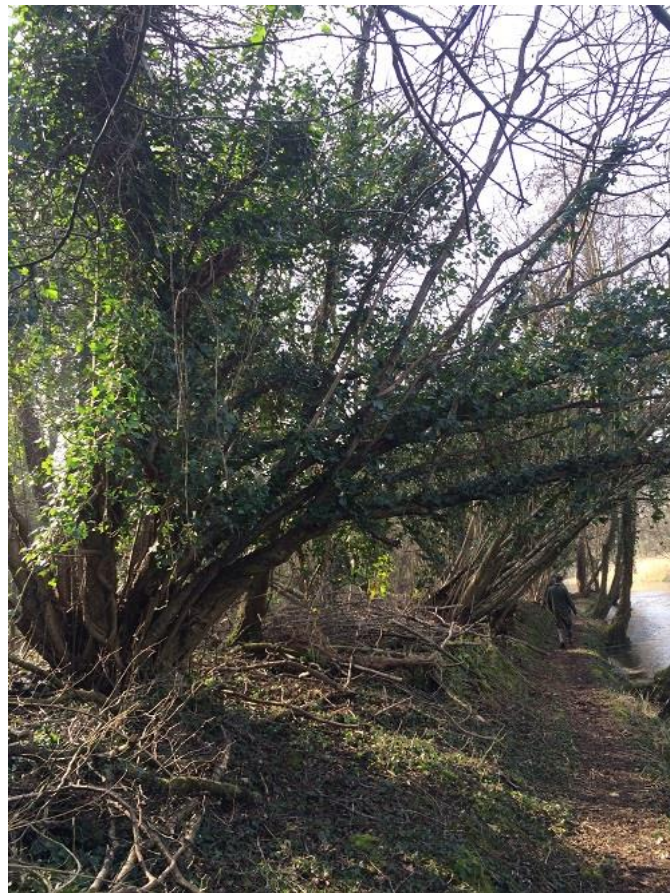
The hazel coppice in the wooded section is long overdue, it has a heavy lean on some of it and should be coppiced before it is lost, giving rise to material to use in the river. This should then be done on a rotation basis. Information on coppicing can be found on the WTT website.

This hazel coppice is shading the river and with mature trees all around, it will do the river no harm at all to receive some much needed light.

Photo 10. Hazel coppice on LB shading channel and about to go sideways.

The lower end of the fishery (photo 10) is in need of some coppicing. There are some very old stands of hazel that are long overdue a coppice; if it's not done, soon some of the stands will go sideways and could be lost. Coppicing on a 10-year rotation would be a sound approach, with the coppiced material used for the erosion protection upstream.

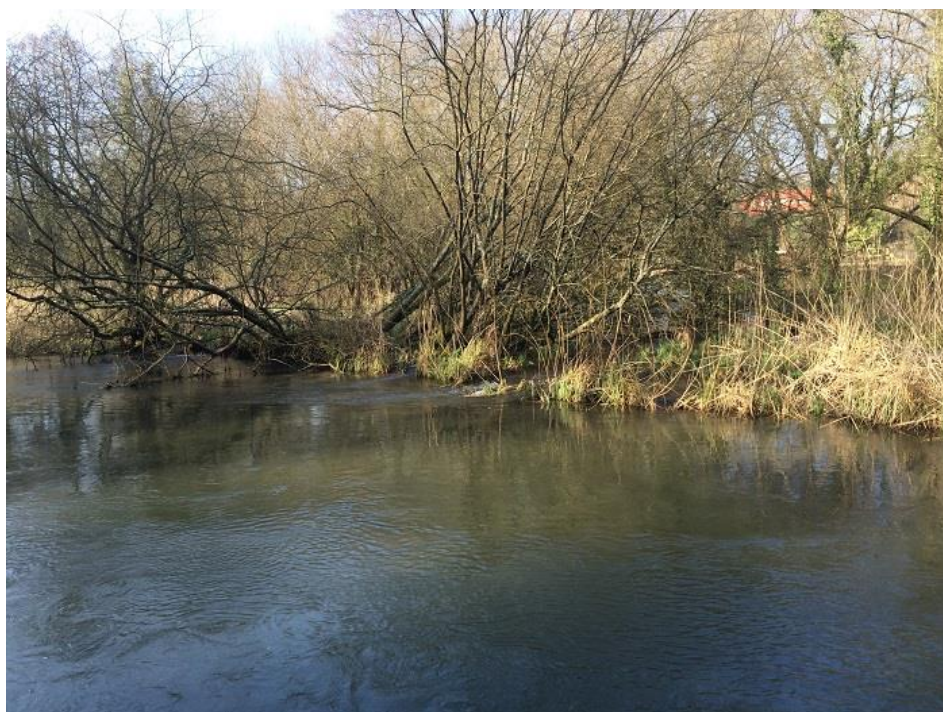
The third inlet enters this reach from the Navigation Canal on the RB of photo 11. This is particularly interesting as it has recently occurred. The perched bank that separates the Navigation Canal and Kanara became breached in the winter of 2013. It was repaired by the Environment Agency, leaving a constant flow of water between the two channels. This section seems the most diverse on the whole reach with a breach in the perched bank running through a heavily wooded section.

Photo 11. Breach from perched bank on Navigation Canal can be seen flowing through woodland into Kanara: wonderful habitat.

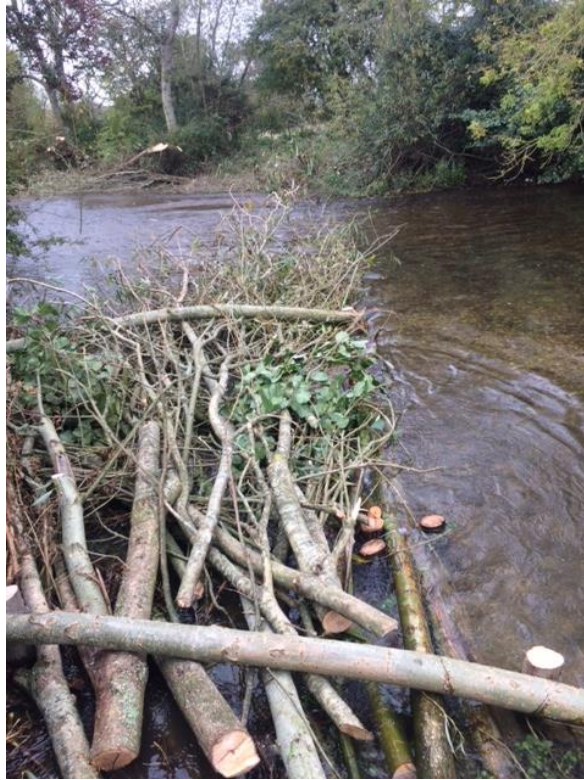
Photo 12. Brushwood mattress constructed with coppiced willow.

- **Encourage some coppicing practices especially in the shaded areas, this could weed growth and help manage the coppice as well as providing valuable material for river restoration/ erosion protection. In these eroded areas if some structures like photo 12**

were installed then these would protect the bank as well as helping to establish better marginal growth.

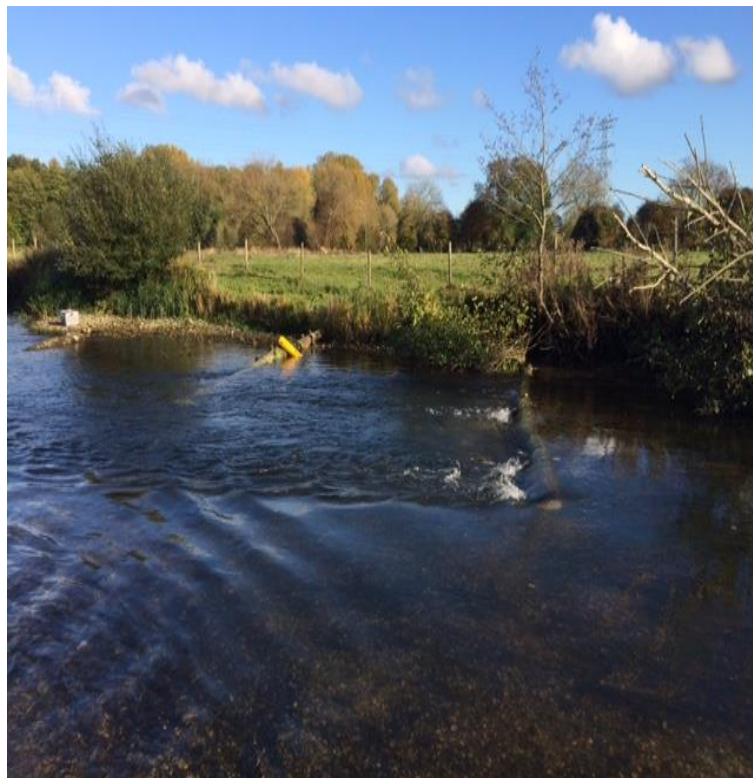
Photo 13. Log deflector.

- **Explore possibilities of adding large woody material, tree limbs or whole trees, (big and bold) in the upper and middle section to encourage variation in flow and depth. Approximately 6-10 structures could change this reach and drastically improve it. When building these the general rule is no more than a third of the channel in size. Photos 12, 13 and 14 show some examples of the type of structures that could be installed.**

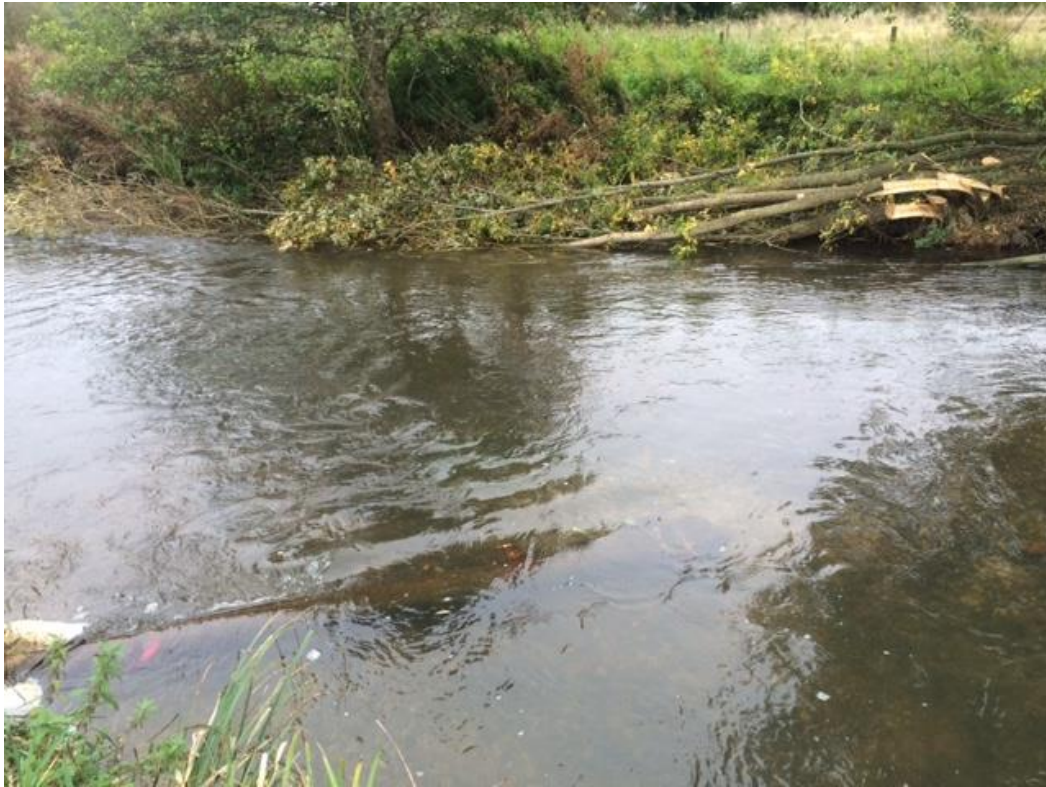
Photo 14. Log deflector combined with folded willow.
