Advisory Visit

R. Wharfe, Kilnsey Angling Club

19/02/2018

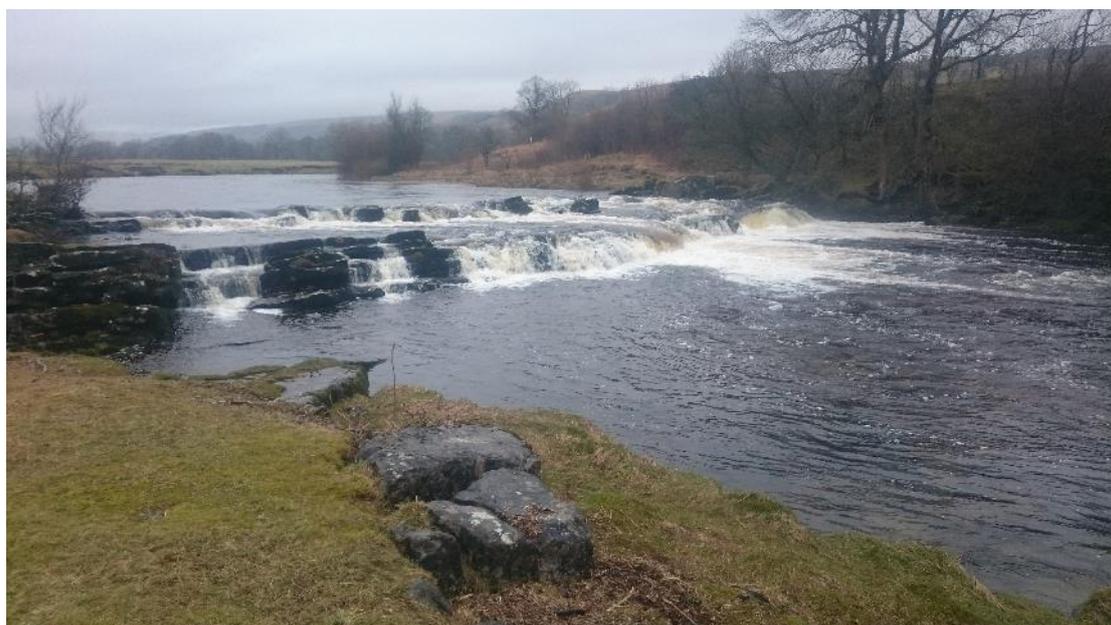
The walkover commenced on the lowest beat at Mill Scar Lash falls (Fig 2), a natural bed-rock feature which is almost certainly a barrier to grayling but less of an issue to the more powerful swimming trout. A brief discussion was had about historic records of grayling being caught on the Arncliffe beats of the Skirfare; these are almost certainly fish that were translocated above these falls and those at Linton.

Fig 2. Mill Scar Lash falls on the White Beck Down beat are likely to be a barrier to grayling but less of a challenge to wild brown trout.

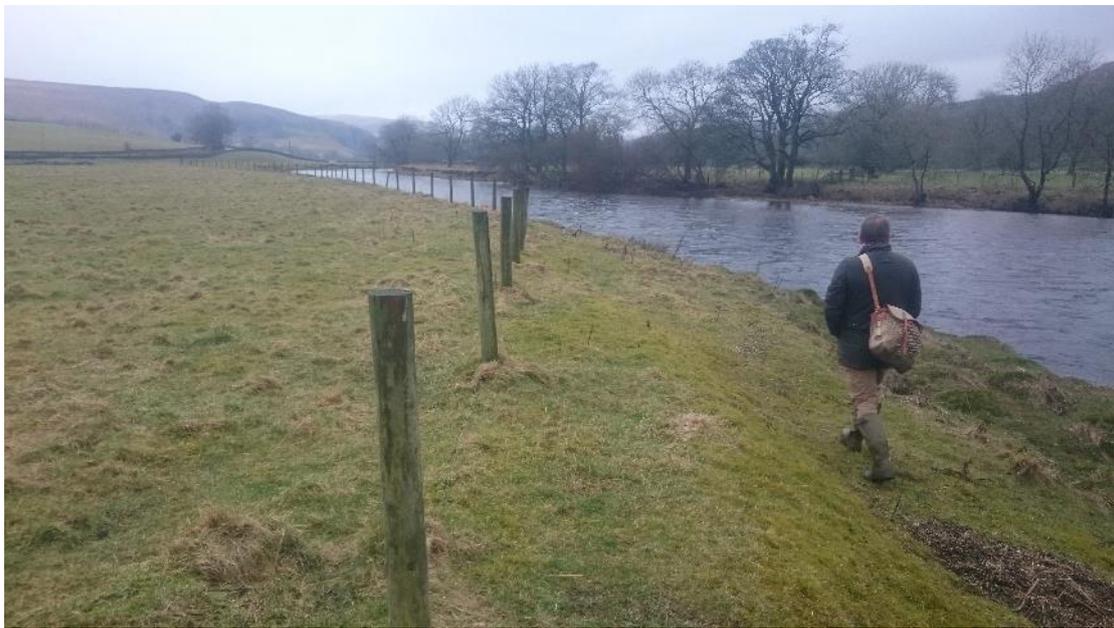
The field on the RB, immediately u/s of the falls is large and almost entirely devoid of diverse vegetation and tree cover at the bank edge because of livestock access. The posts and bottom wire of an incomplete fence were evident for much of the field length, and these were in good condition (Fig 3). If extended and completed, the fence would provide a considerable buffer zone which would regenerate quickly and could be augmented with some judicious planting of native tree species to complement those found locally. A more diverse riparian vegetation promotes faunal diversity. It also provides protection / cover where the 'shaggy' fringe trails from the bank into the water, which is used by fry and smaller individuals, as well as increasing resilience to spate erosion. The wooded sections on the LB (fenced) appeared to be in good condition, containing a variety of native tree species of mixed ages.

Fig 3. The first long field on the RB above Mill Scar Lash was devoid of tree cover and diverse bankside vegetation. Finishing the incomplete fence-line should be explored.

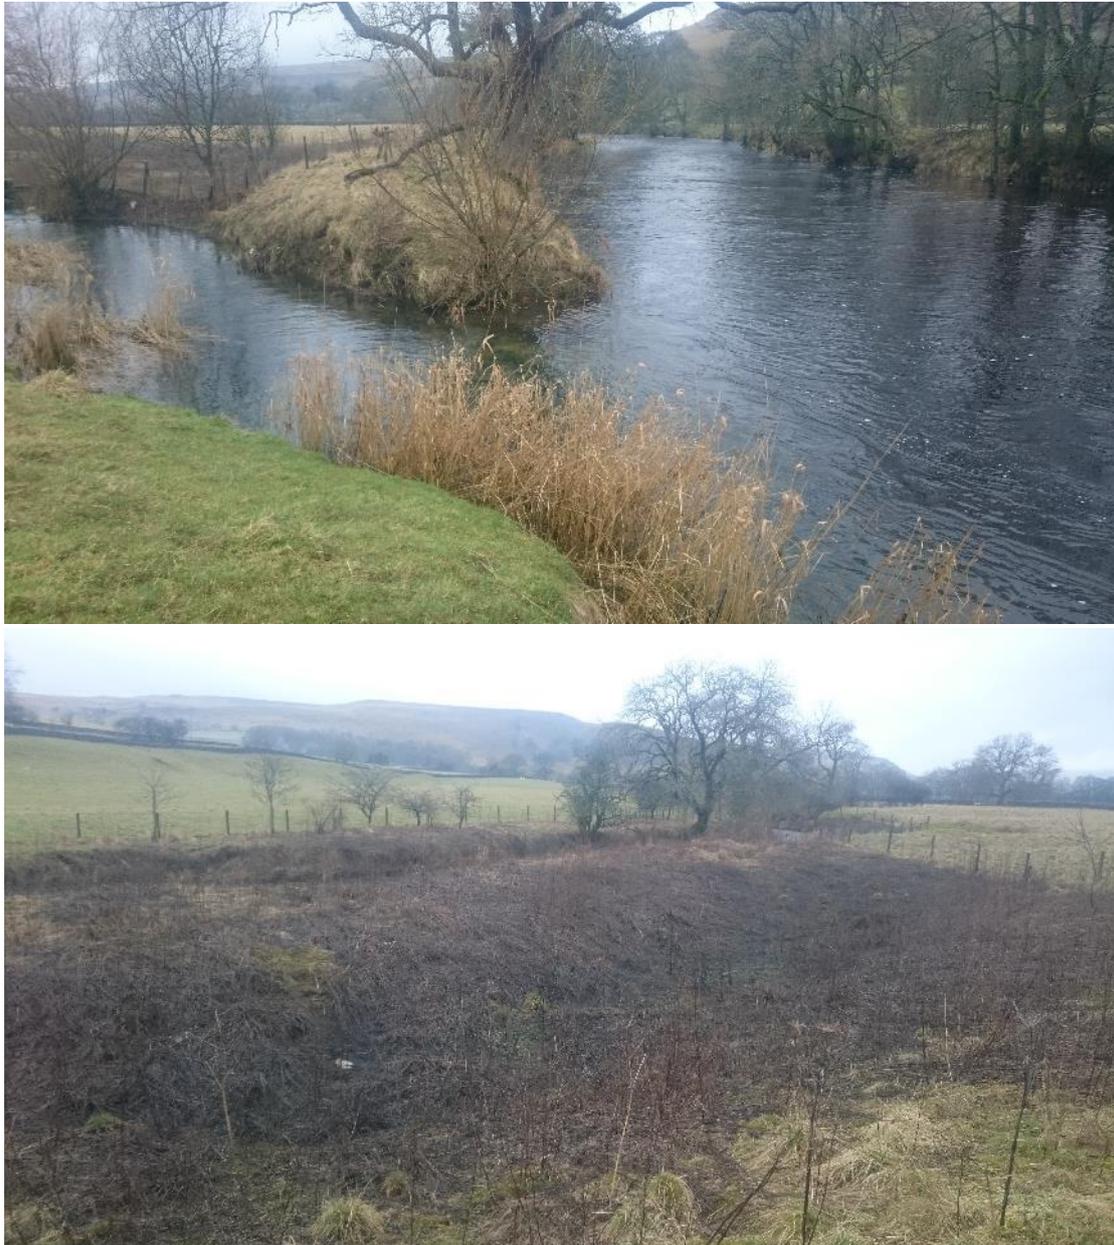
The confluence of White Beck was clear, providing good depth of water for fish to move in or out for spawning, feeding, or refuge (Fig 4). This limestone-spring fed stream is valuable for all three aspects – see Becks section. A triangle of land immediately u/s of the confluence which is already fenced should be considered for tree planting to promote low cover and extra security for fish moving through the confluence.

Fig 4. Upper: the confluence of White Beck and the Wharfe (RB) – access is good and the water quality appears reasonable from this limestone spring, but sediment quality could be improved; see Becks section. Lower: the LB of White Beck immediately u/s of the confluence is fenced off and could be planted up with native trees.

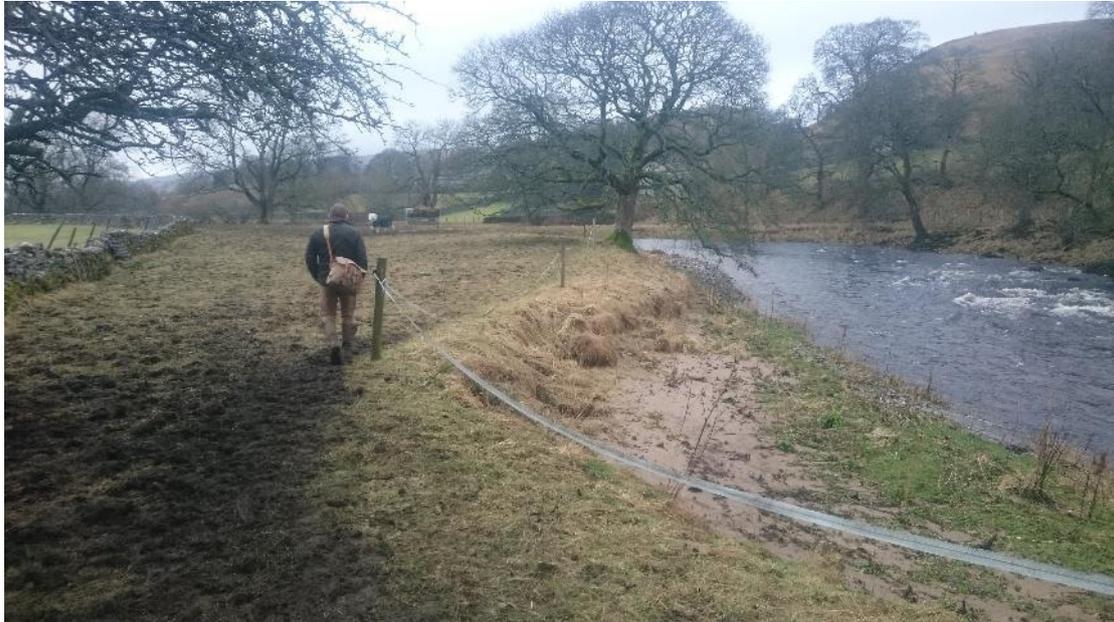
Fig 5. A small parcel of land, apparently occupied by a single horse, that was severely poached. An attempt had been made at electric fencing to protect the river bank but was not maintained. The bank was degraded as a consequence, contributing fine sediment pollution to the river.

Bank degradation from livestock poaching, trampling and grazing can be quite severe even at very low stock density, as exemplified by the small field containing a single horse (Fig 5). Denudation of the bank at the very water's edge will exacerbate erosion and promote fine sediment ingress which can degrade gravel habitat elsewhere.

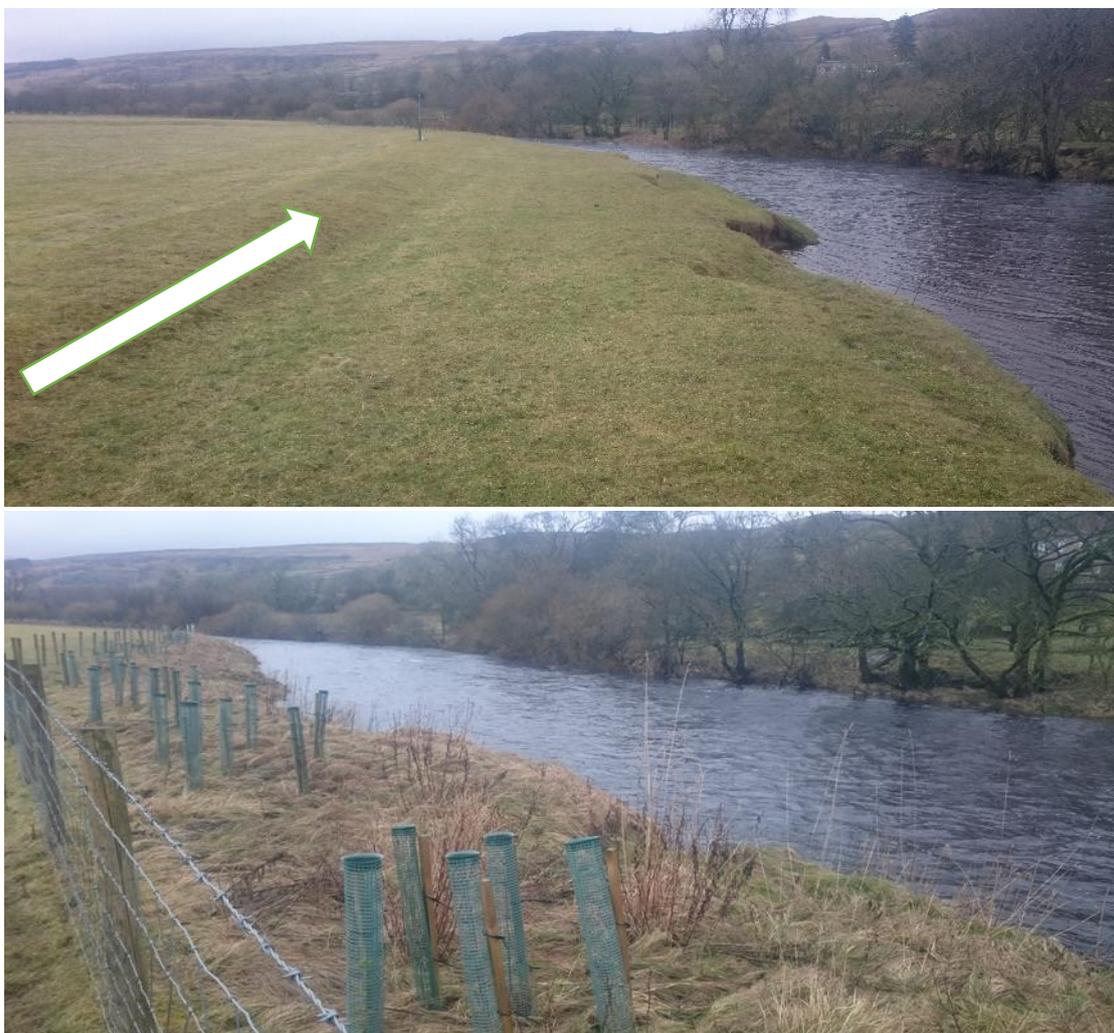
The impact of livestock grazing and poaching was also clear u/s of Conisstone Bridge; compare the vegetative structure of the two banks in Fig 6, and note the erosion 'scallop' developing on the RB despite it being on the inside of the bend and hence, theoretically, a deposition zone. Regular intensive grazing reduces plant diversity to short-sward grasses that are capable of withstanding such disturbance. However, those grasses invest the majority of their growth in replacing shoot material and little into root depth. Hence, banks that are heavily grazed to the very water's edge are susceptible to 'block failure'. Lateral erosion at the toe of the bank undermines the soil above, and without any root material to bind it together, blocks collapse into the river leaving further exposed material behind, introducing fine sediment, and causing over-widening of the river.

The first of several areas of buffer-fencing and tree planting was encountered at the u/s end of the same field. The difference in vegetation structure was apparent, even in mid winter (Fig 6).

Fig 6. Upper: unfettered livestock access on the RB immediately u/s of Conistone Bridge leaves only short sward grass at the bank edge with little root matrix to resist erosion (note erosion scallops forming). The white arrow demotes position of the shallow flood bund / levee. Lower: further u/s on the same field, a buffer strip has been fenced off and planted with small cospes of trees. Compare the vegetation in the two panels.

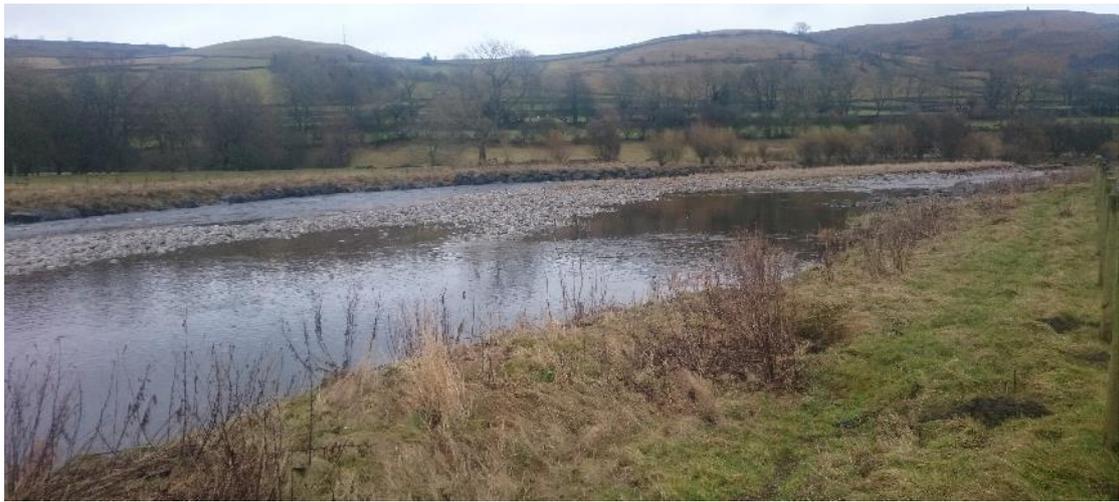
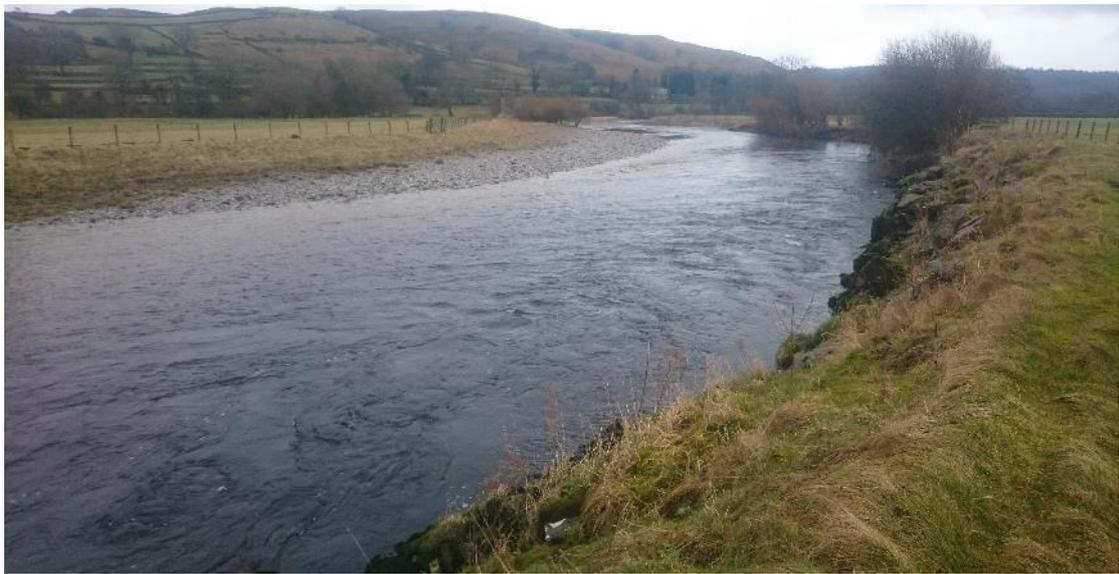
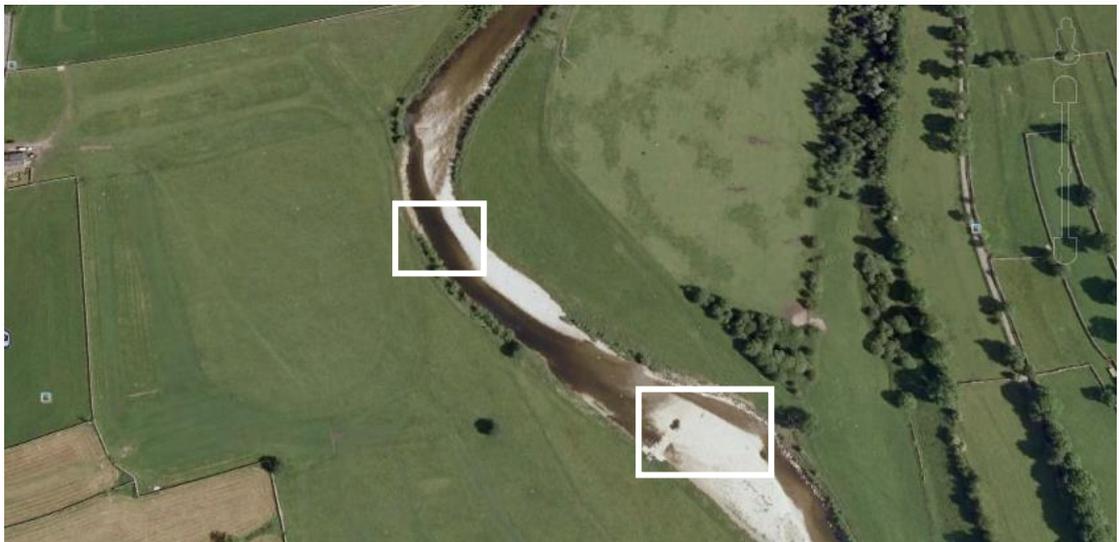
The consequences of hard-engineering to protect a bank and 'steer' the river are evident in Fig 7. Substantial rock armouring has been used to stop the river meandering toward the right-hand side of the valley floor, and instead, it is swept in a smooth curve toward the left. Prevented from lateral movement, the river is scouring downward and creating a deep channel on the outside of the bend. Material arising or transported rapidly through that bend is then deposited immediately downstream as flow energy dissipates and has created a wide, braided (multichannel) section. Such deposition bars, which are regularly shifting in position and inundated by even relatively small increases in flow, are very important ephemeral habitats for invertebrates such as detritivorous beetles and predatory spiders and beetles living at the cusp of land and water; many of these will contribute to trout diet.

Fig 7. Upper: a dynamic zone of gravel, cobble and boulder deposition which has braided the channel. This zone has undoubtedly developed in response to the rock armouring of the RB on the bend immediately u/s (mid panel). Lower: from Google Earth, it is clear to see how the river is scouring deeply around the outside of the armoured bend and then depositing its load in a wider cross-section d/s. White squares mark sites of upper and mid panel images.

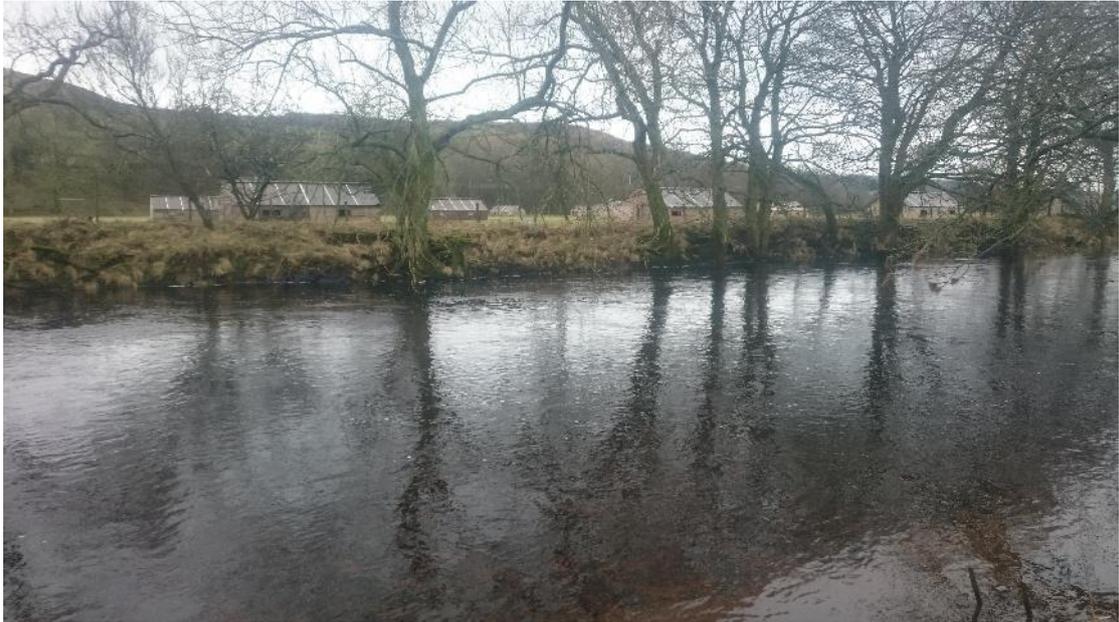
A mink was spotted on the LB where pheasant pens are located in the adjacent field (Fig 8). Such honey-pots tend to attract predators, and invasive species like mink can have detrimental impacts upon a fish population, so this area should be monitored and perhaps a trapping regime set up in collaboration with the gamekeeper.

Fig 8. A long glide towards the u/s end of Conistone / Byrom, typical when a river is straightened and constrained by bank reinforcement. Reasonable tree cover was evident, more consistent on the LB, but almost all trees were mature i.e there was a lack of diversity in age / canopy structure. Note the pheasant pens: a mink was spotted on this bank, probably drawn to the game rearing but no doubt taking fish too.

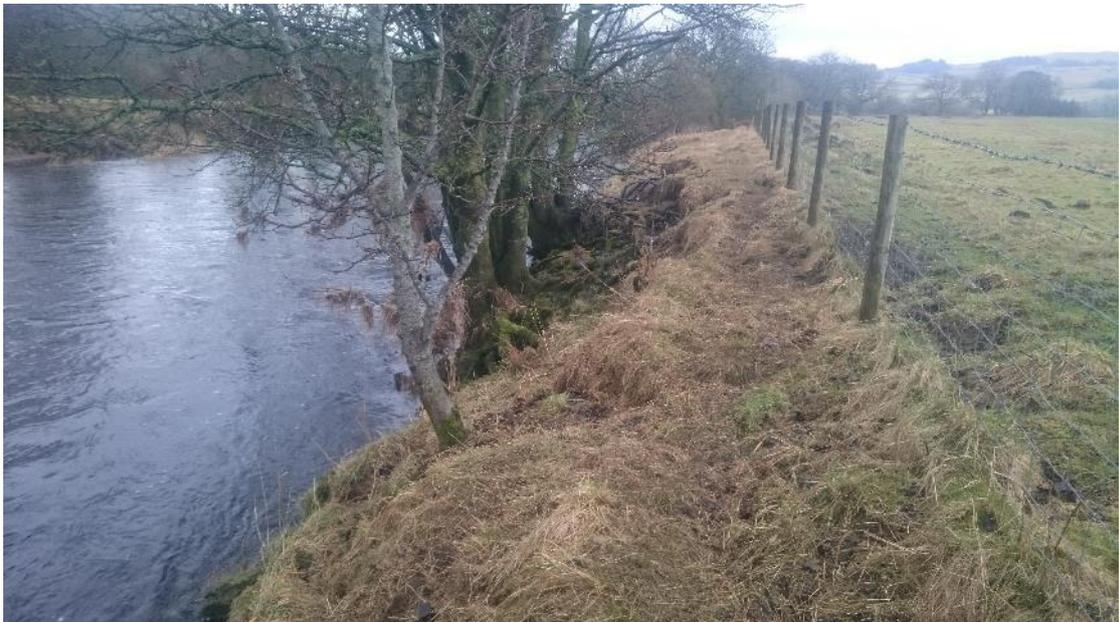
Long sections of the Wharfe are currently protected by buffer fencing, but small chinks in that armour, particularly at the head and tail of lengths, are readily exploited by livestock if the opportunity arises and degradation can be swift (Fig 9 & 11). It is advisable for the condition of fencing to be monitored and maintained on a regular basis.

Fig 9. Although this bank had a sturdy livestock exclusion fence affording some development of buffer strip vegetation, the post & rail at the head of it, i.e. perpendicular to the river and down to the water, had been damaged in a spate. Sheep had gained access and degraded the quality of the riparian zone.

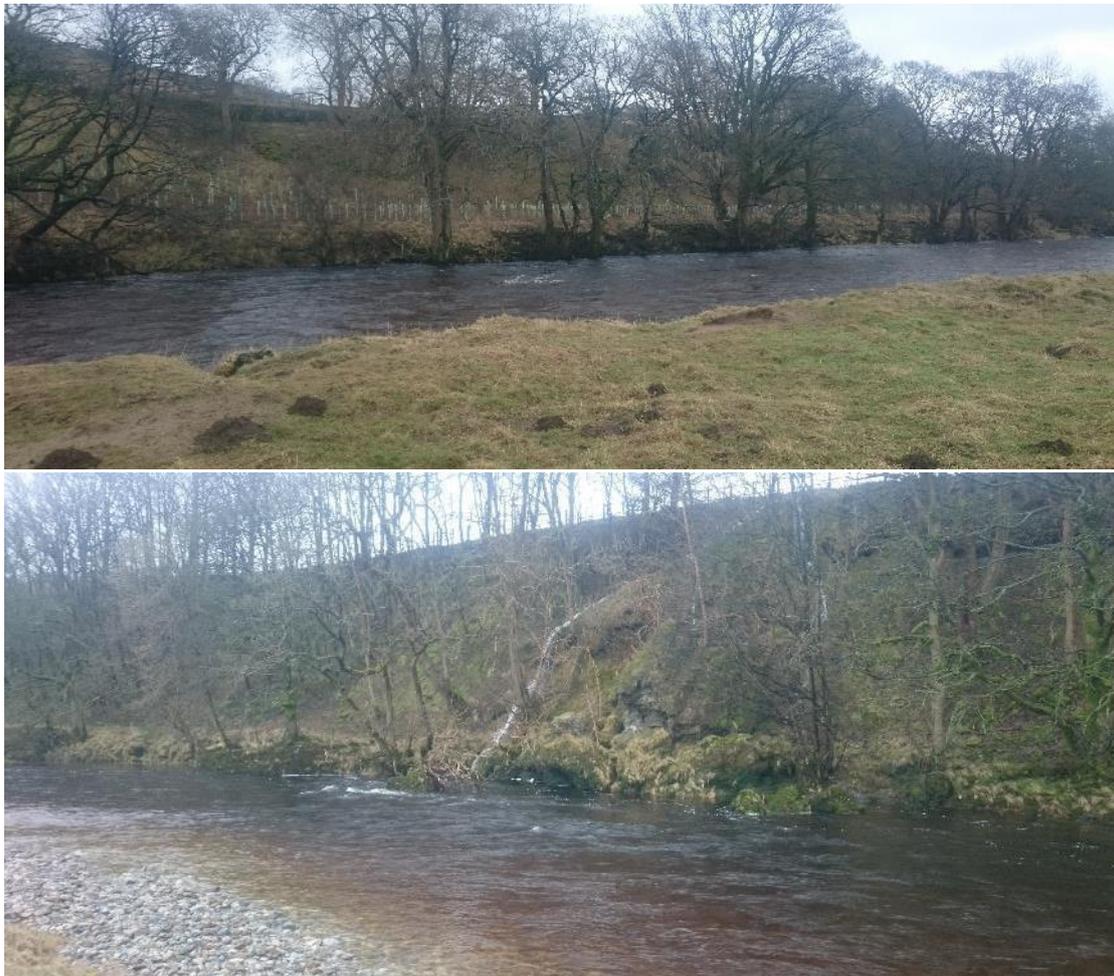
There has been extensive tree planting around Throstle Nest on the LB and the habitat quality will only improve further because of it (Fig 10; see also Fig 14). Around the Tufa Rock, the Wharfe is pressed hard against a natural outcrop of rock and the channel is more physically diverse as a consequence. The ideal would be natural woodland (of diverse age / canopy height) on both banks, but for the majority of the Kilnsey lower beats, at least one bank is almost always wooded to offset a grazed bank opposite. Ash (*Fraxinus excelsior*) becomes more prevalent further u/s and especially on the valley sides; the threat of ash dieback caused by an Ascomycete fungus is a considerable worry for the future of this landscape. Hence, any tree planting should consider future proofing for the potential loss of ash.

Fig 10. The wooded LB below Throstle Nest and the Tufa Rock. This is one of the few areas in the lower beats where the river butts up to the steeper side of the valley. Arguably, it has been pushed there by channel realignment and stone bank revetment to maximise farming land on the floodplain to the west (RB). However, it should be noted that the natural vegetation here is apparently resilient to spate flow despite it being on the outside of the bend. Gaps in the wood have been recently planted.

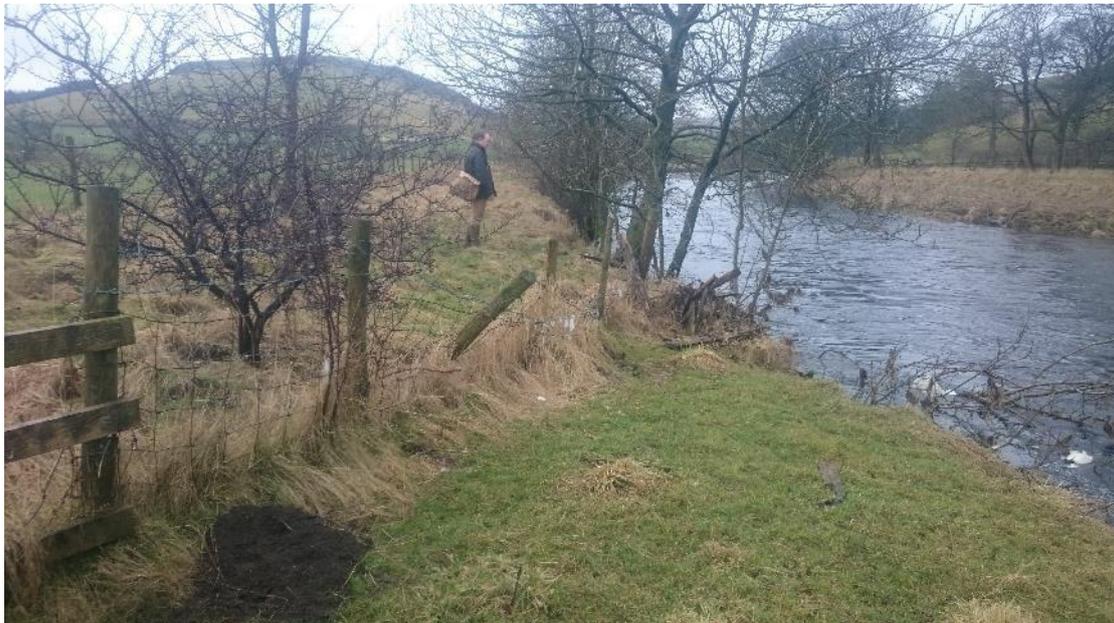
At Throstle Nest Dub, there is another very short section of dilapidated fence which has allowed livestock to access an otherwise well-protected bank (Fig 11).

Fig 11. Another small chink in the armour. This one very short section of dilapidated fence (RB; Throstle Nest Dub) has allowed sheep access into the otherwise well-protected riparian zone beyond.

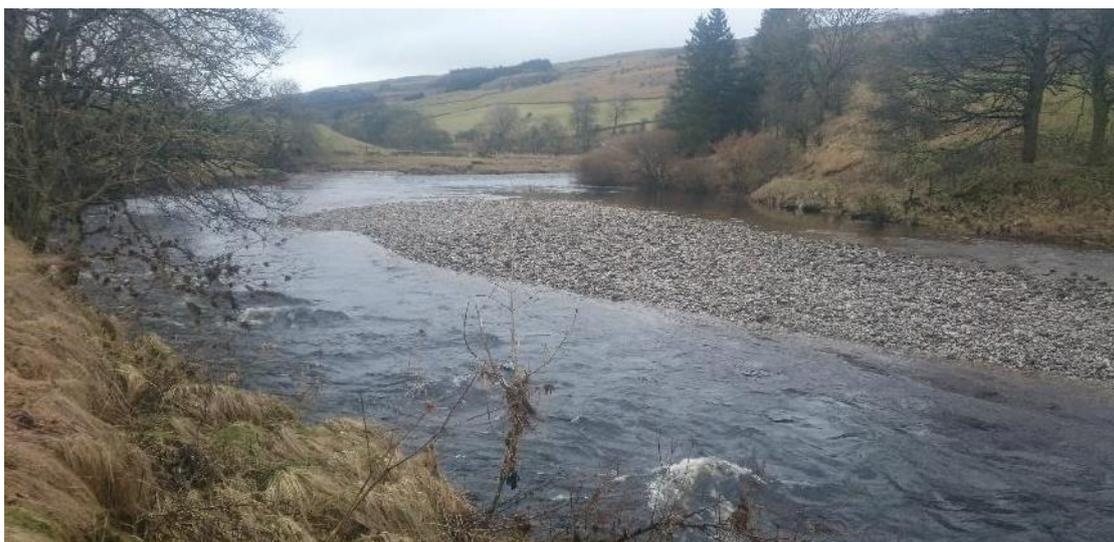
Downstream of Watersmeet, the confluence of the Wharfe and the Skirfare, there is a large deposition bar of cobbles and gravel which has braided the channel (Fig 12). This is an entirely natural and ephemeral feature which will wax and wane in response to spate flows removing and replacing that material from either or both of the rivers. Braiding diversifies the channel(s) habitats and provides a mosaic of depths and flow speeds which will suit different life-stages of trout. Amerdale Dub itself will provide excellent, deep holding habitat for trout when moving in and out of the Skirfare. The Skirfare is discussed in Section 3.3.

Fig 12. The deposition bar formed below the Amerdale Dub and Watersmeet (confluence of the Skirfare and the Wharfe) creating a fantastic braiding and diversification of flows / habitat.

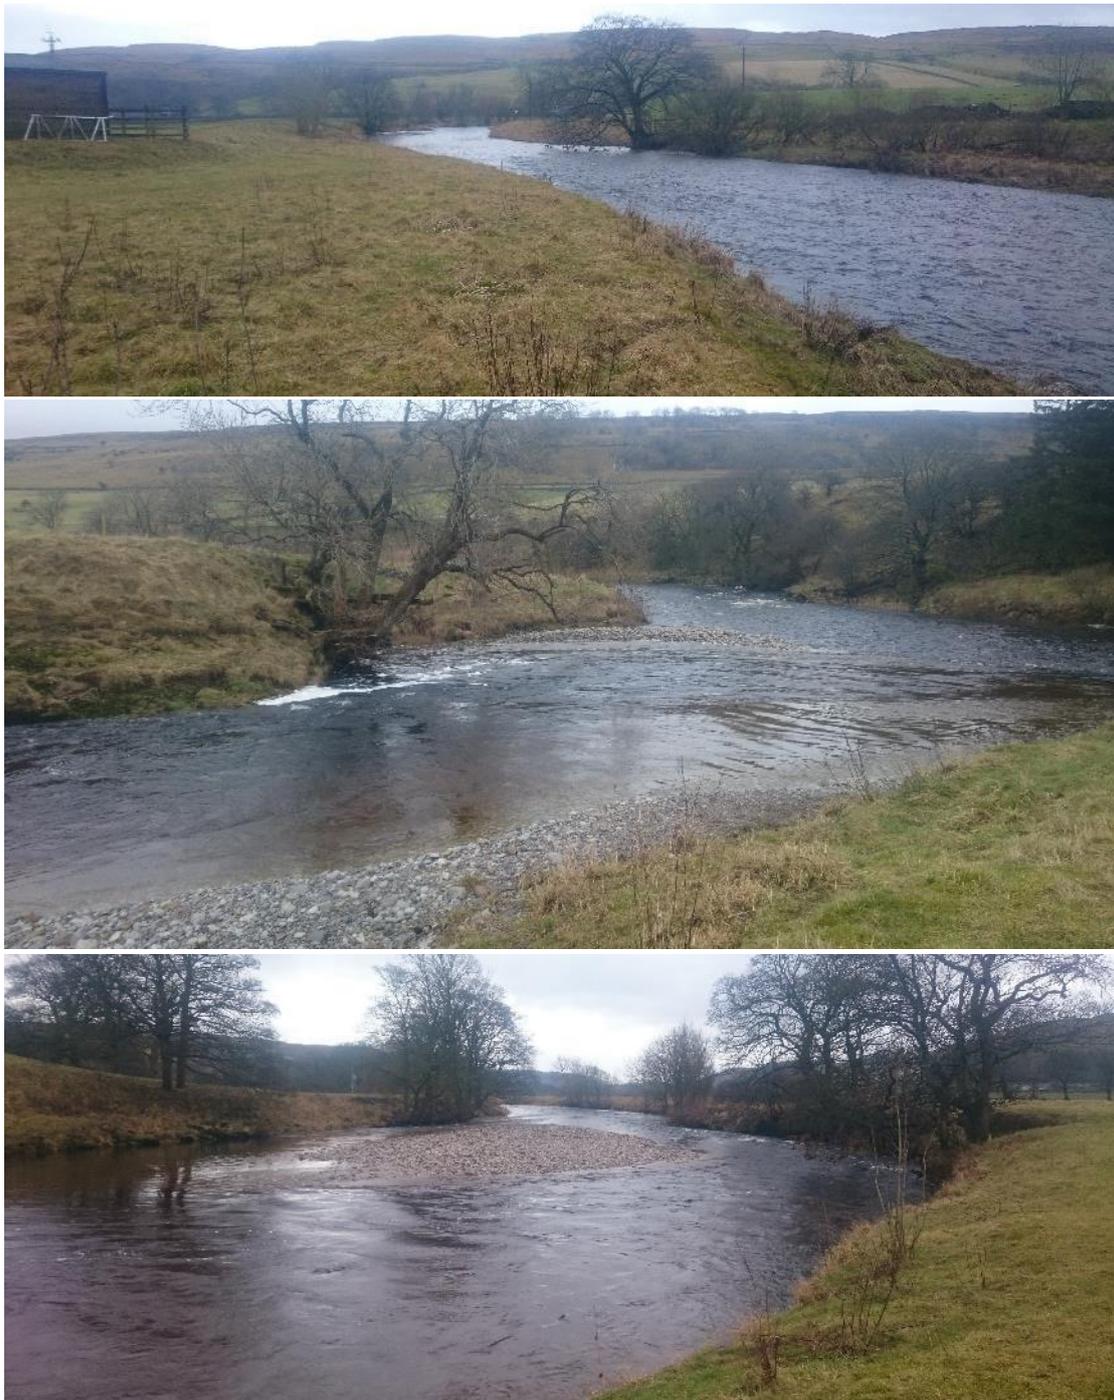
Fig 13. Views at Watersmeet. Upper: looking u/s on the Skirfare demonstrating a lack of cover on both banks, despite the LB being buffer-fenced. Mid: the confluence of the Skirfare (from left of image) and the Wharfe, with a deep holding pool immediately into the Skirfare (underneath the foam). Lower: looking d/s at the deposition bar below Amerdale Dub (see Fig 12).

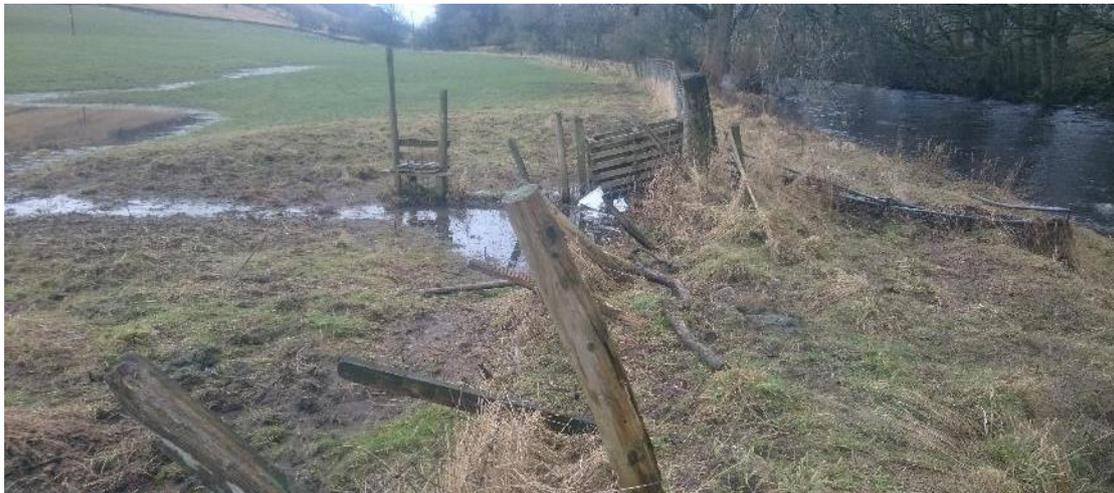
Fig 15. Poor maintenance of fencing on the RB, d/s from Mile House Dub. Again, a relatively short section has fallen into disrepair but the damage to the bankside from livestock entering through this gap is disproportionately extensive.

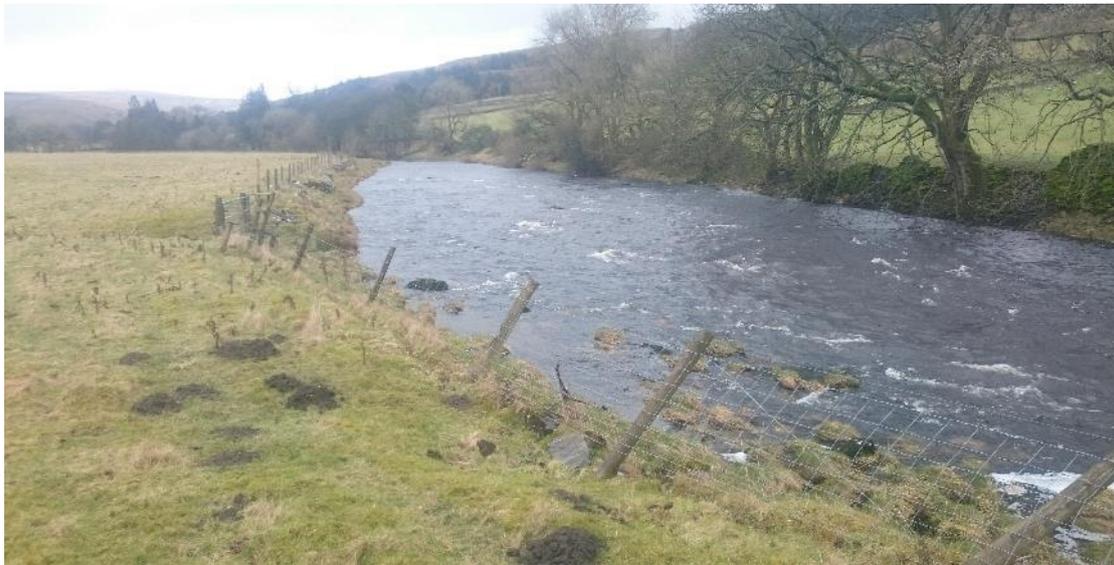
side to accommodate a field on the right, which has a degrading fence-line that should be repaired asap (Fig 17).

Fig 17. The fence-line on the RB immediately above Mile House Dub could also do with some TLC to retain its efficiency. The river is pinned against the left-hand side of the valley (right of image) by stone embankment to maximise use of the narrow floodplain for farming. The result is a straighter channel of steeper gradient and almost continuous riffle.

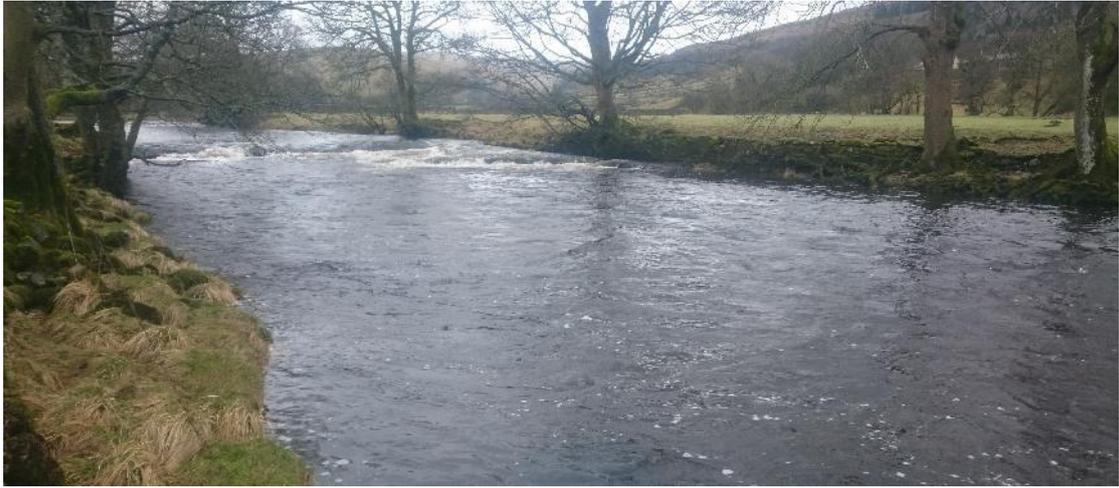
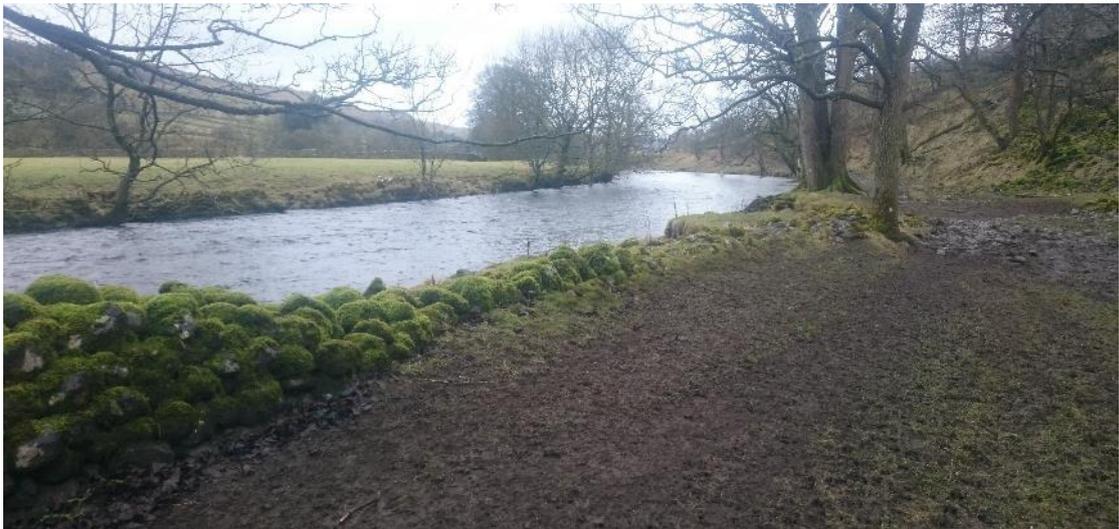
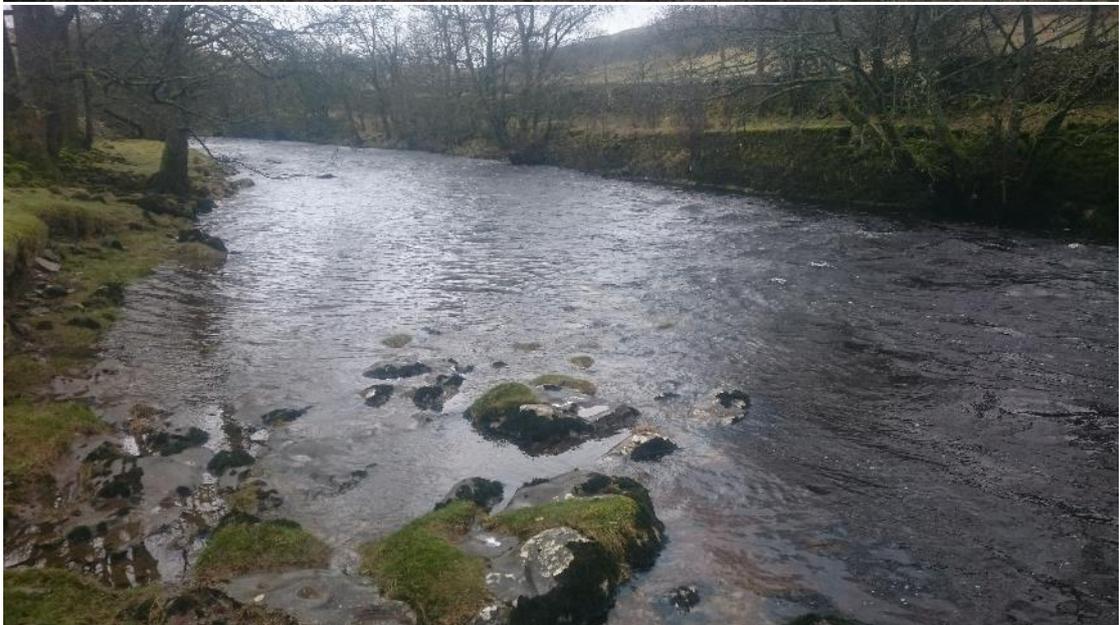
Fig 19. From Black Keld towards the stepping stones and Kettlewell Bridge, there is more evidence of stone revetment or walling of the banks, although the valley is narrower here too so it would not be expected to meander as such. Bedrock outcrops diversify channel form (lower panel). A public footpath and farm access track is a focal point for trampling and erosion (mid panel) although, it appears that little, if any fine sediment can enter the river here except under high flow.

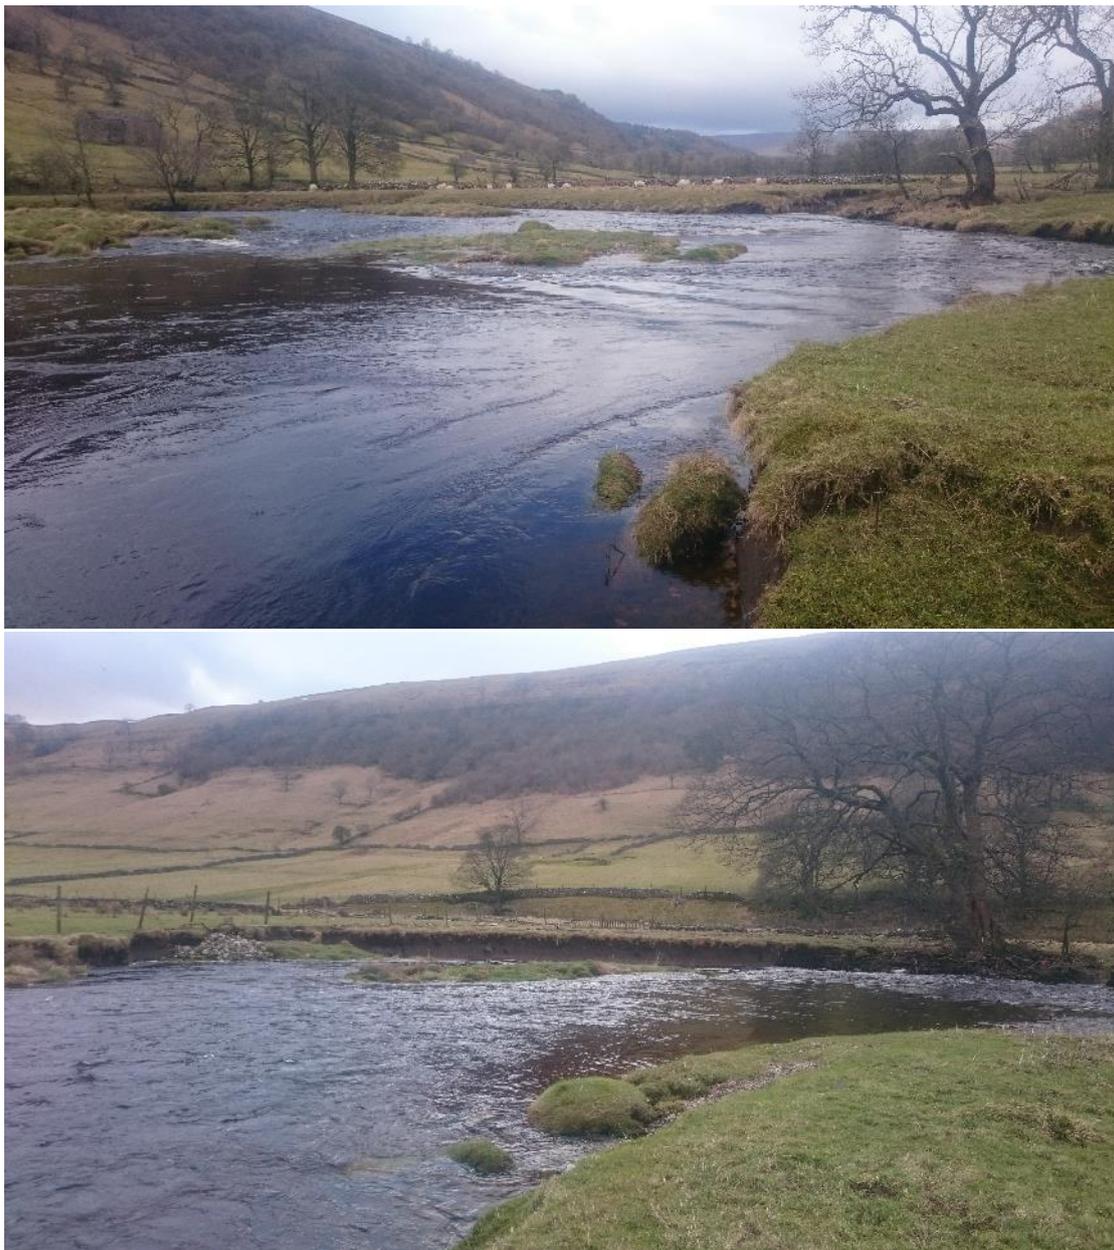
Fig 22. Images from around the meander bend highlighted in Fig 21, and which sits approximately halfway along Starbotton Down beat. This a highly active zone of erosion but also of deposition. As a consequence, there is great diversity in channel cross-section depth (and even some braiding caused by deposition bars instream), as well as longitudinally which has allowed the natural development of pool-riffle-glide sequences. Note at this point how well-connected the river is with its floodplain; i.e. little difference between bank top height and water surface.

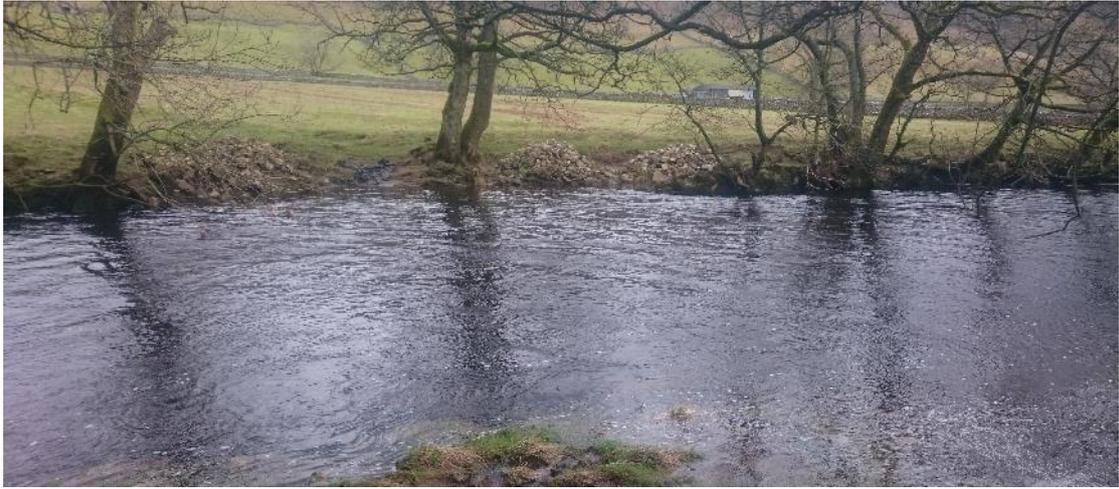
Below Starbotton footbridge, the river is once again constrained between straightening walls, and while an avenue of mature trees (mostly alder) lines the river bank, unfettered access by sheep in some reaches is causing erosion around their roots (Fig 24). Without exclusion fencing, there will be no self-set regeneration of trees to replace the mature specimens as they inevitably start to die off or are lost to spates. One land owner has placed piles of cobbles (probably sequestered from the river without consent) in several developing erosion scallops. The unconsolidated material is more likely to exacerbate the problem during the next spate as the cobbles are moved against the softer bank soils.

Fig 24. Upstream towards Starbotton, the river is once again entrained within stone banking. Where erosion scallops have formed by livestock accessing the water from the LB, small piles of cobbles have been dumped which are only likely to exacerbate the situation.

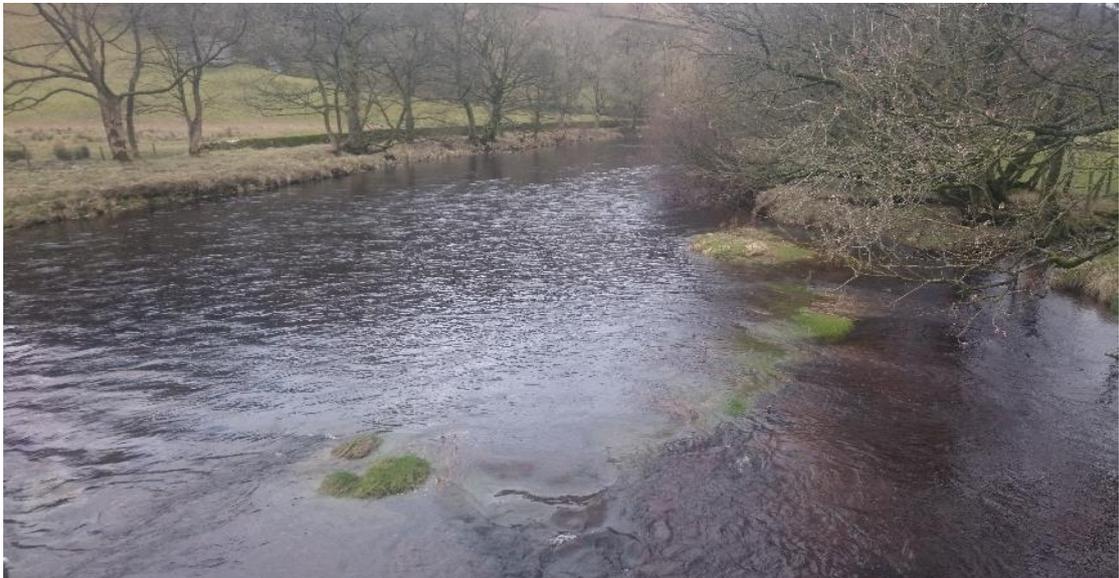
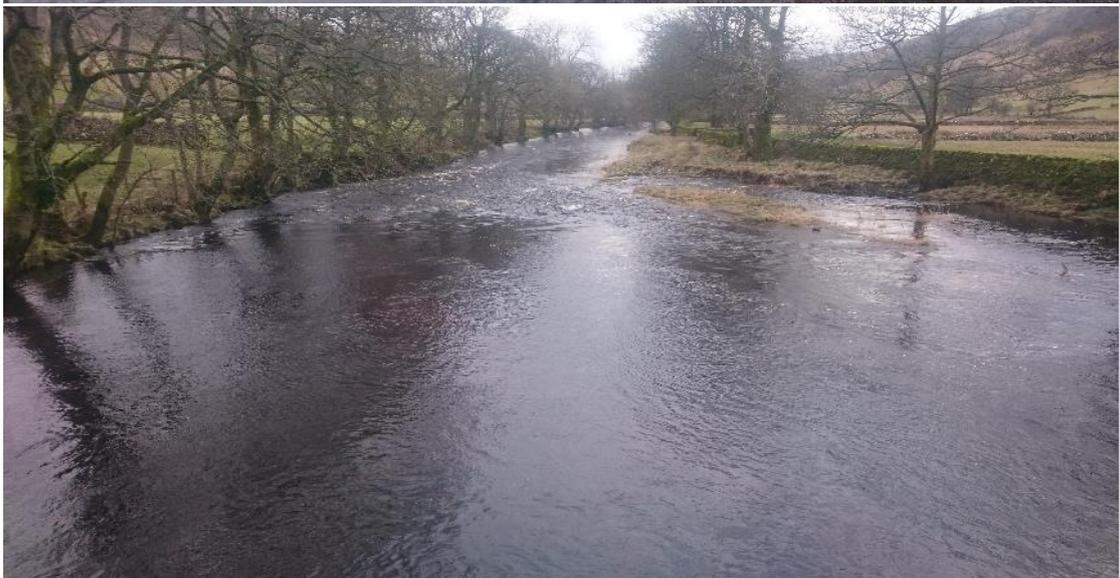
Artificial widening of the channel to form an historic ford (now the Starbotton footbridge) has reduced flow energy and caused deposition bars to form u/s and d/s of the bridge infrastructure (Fig 25). The localised diversification of flow paths has afforded sediment sorting and potentially created some spawning habitat.

Fig 25. Looking u/s (upper) and d/s (lower) from Starbotton footbridge exemplifying: a) how the river has been straightened; and b) how the infrastructure associated with the bridge and formerly the ford has caused erosion and over-widening of the channel at this point.
