Advisory Visit

R. Wharfe, Kilnsey Angling Club

19/02/2018

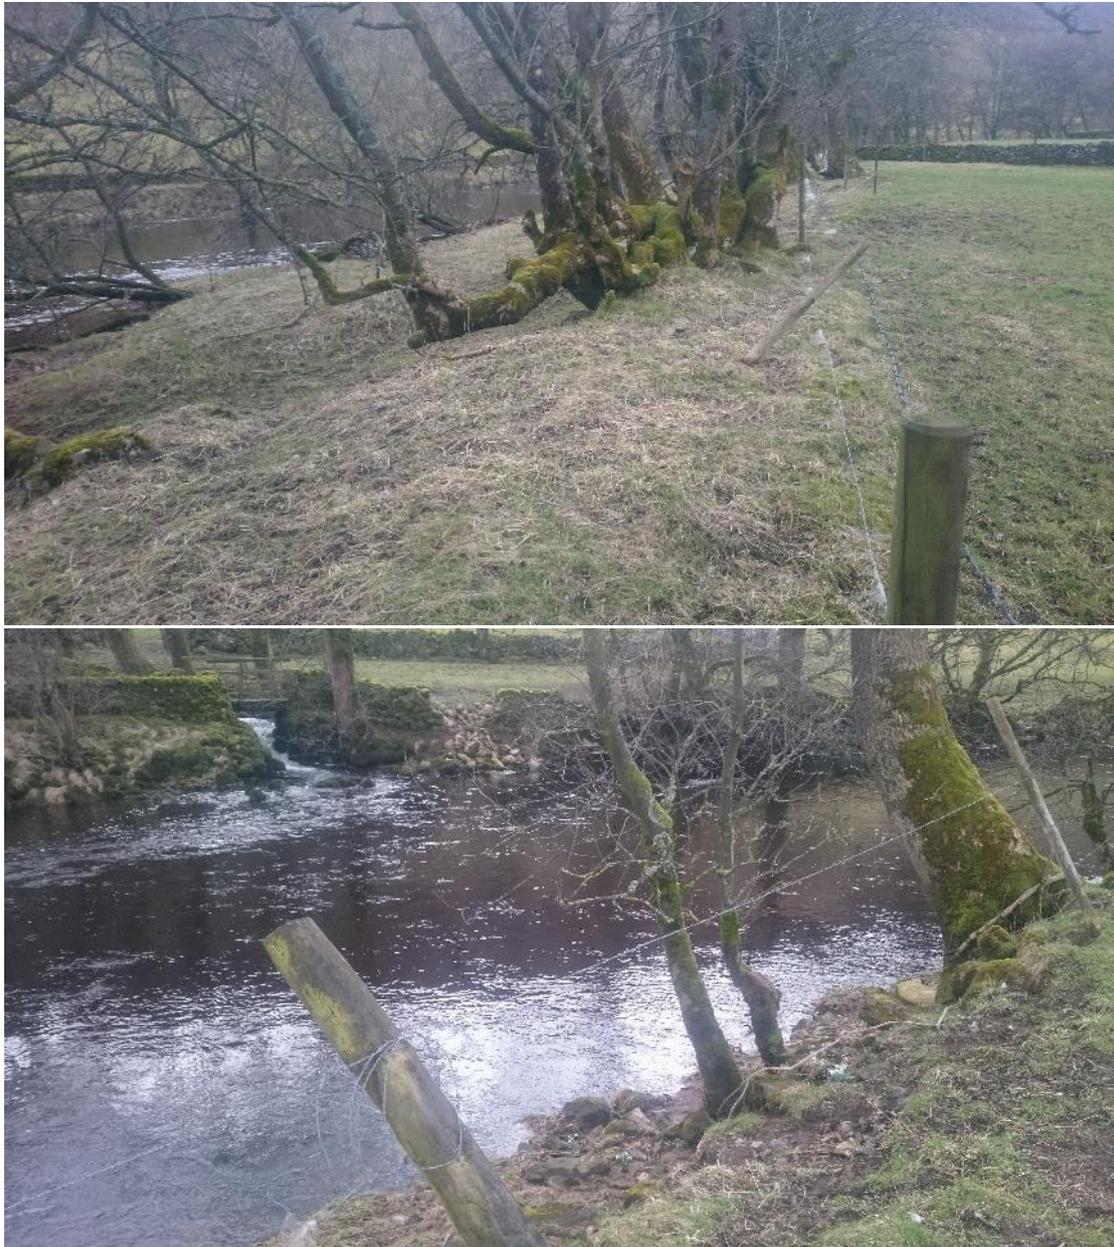
Fig 26. Upstream from Starbotton footbridge, fencing on the LB is only single or double strand and in a sorry state of repair in places, allowing sheep to degrade the bankside vegetation and prevent the establishment of self-set trees. Foss Gill enters on the RB but is unlikely to be of much use as a spawning tributary because of the gradient.

Upstream of the footbridge (Fig 26), it is clear that sheep have been grazing the riparian vegetation, so the dilapidated single or double-strand fencing should be replaced by 'flood-resistant' 7-strand with tensioners if possible.

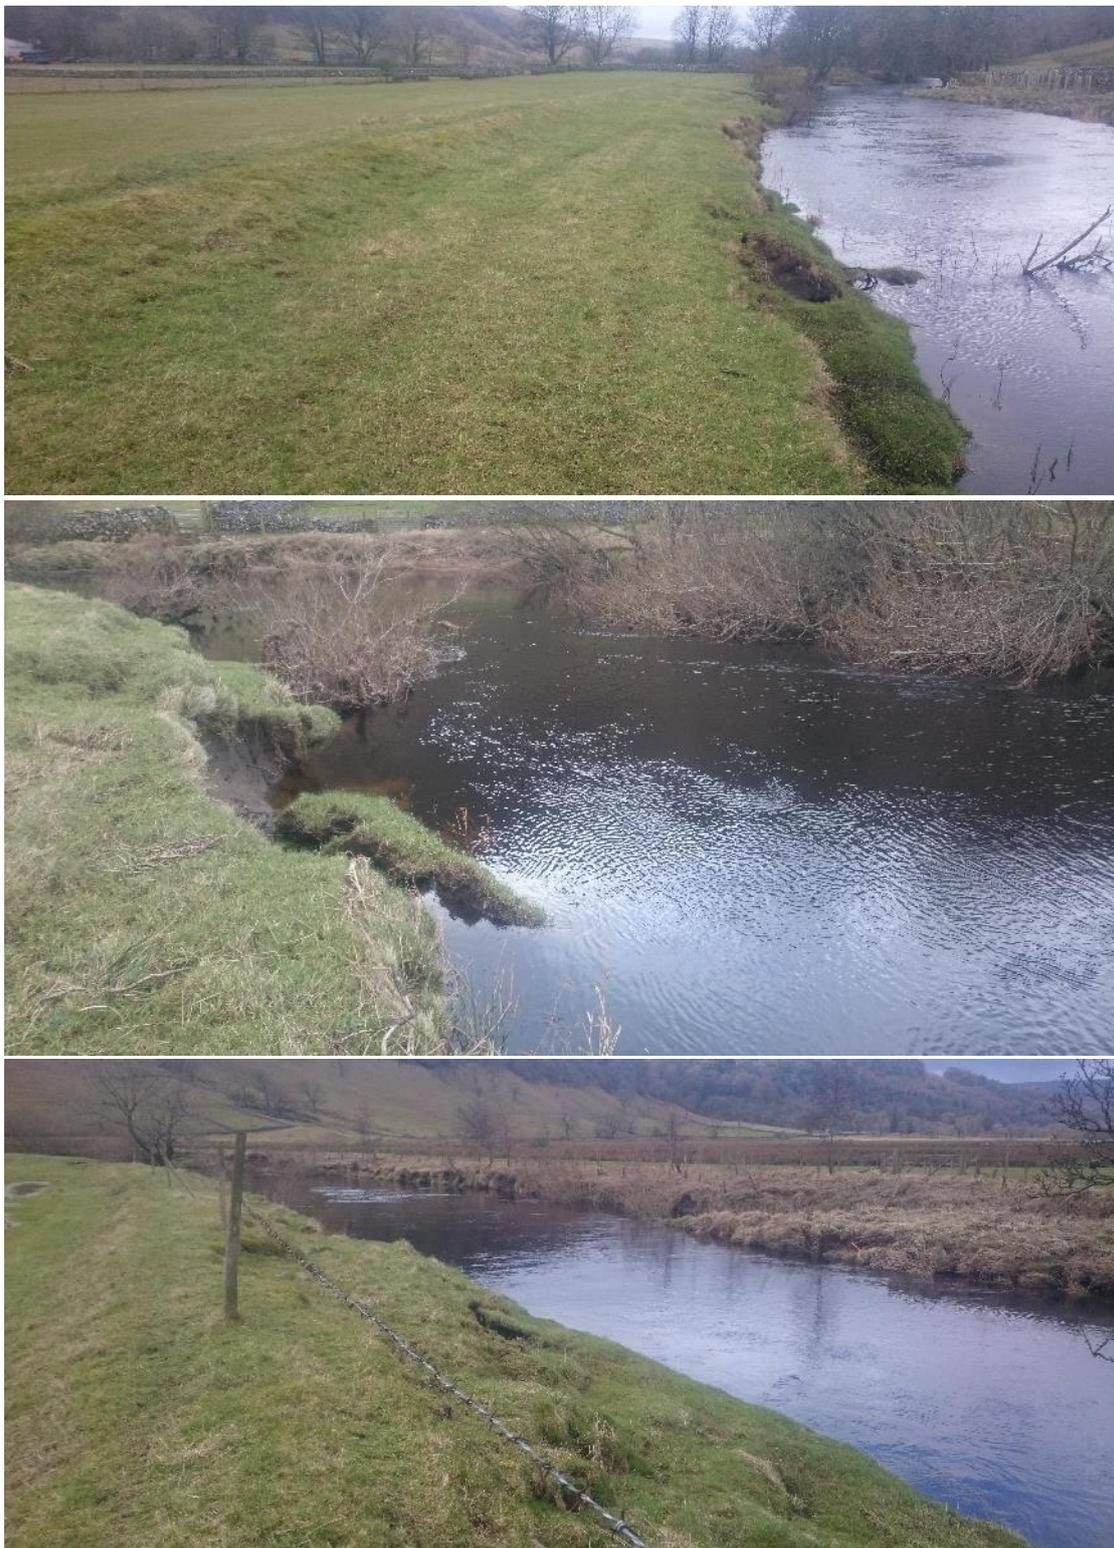
Fig 28. Above Starbotton stepping stones, the Wharfe is once more tightly constrained by stone revetment along a straightened channel and disconnected from its floodplain by bunds / levees. There is no protection from livestock on the LB (compare vegetation in lower panel). Block failure and slumping of the bank is occurring in many places as a consequence (particularly evident in mid panel).

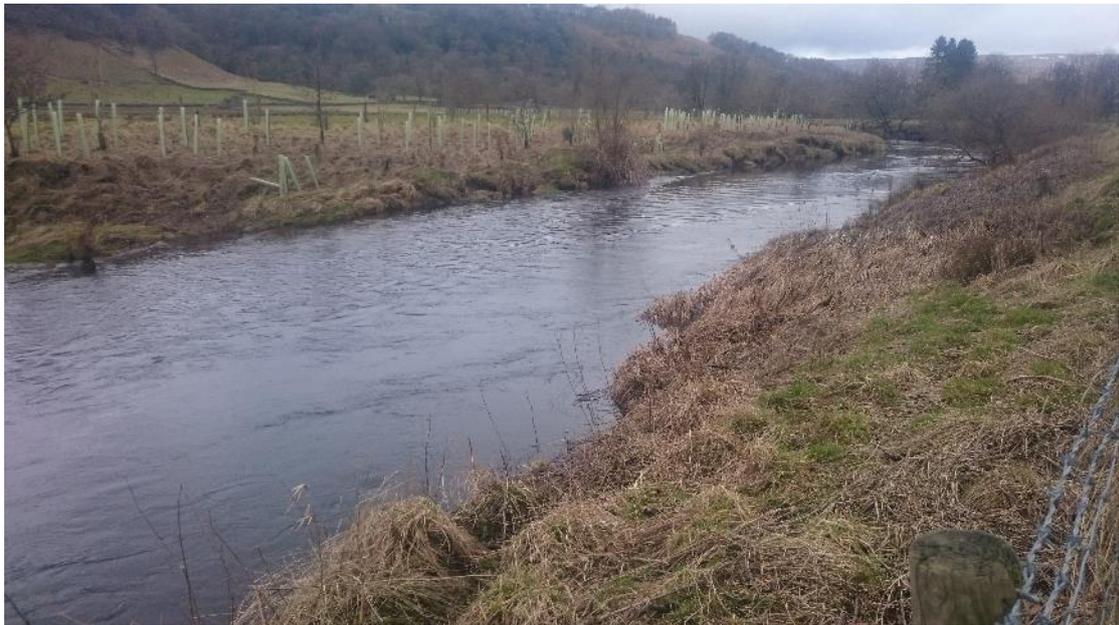
Fig 29. Planting is evident on the RB along many stretches but despite adequate livestock fencing and space, there was none on the LB.

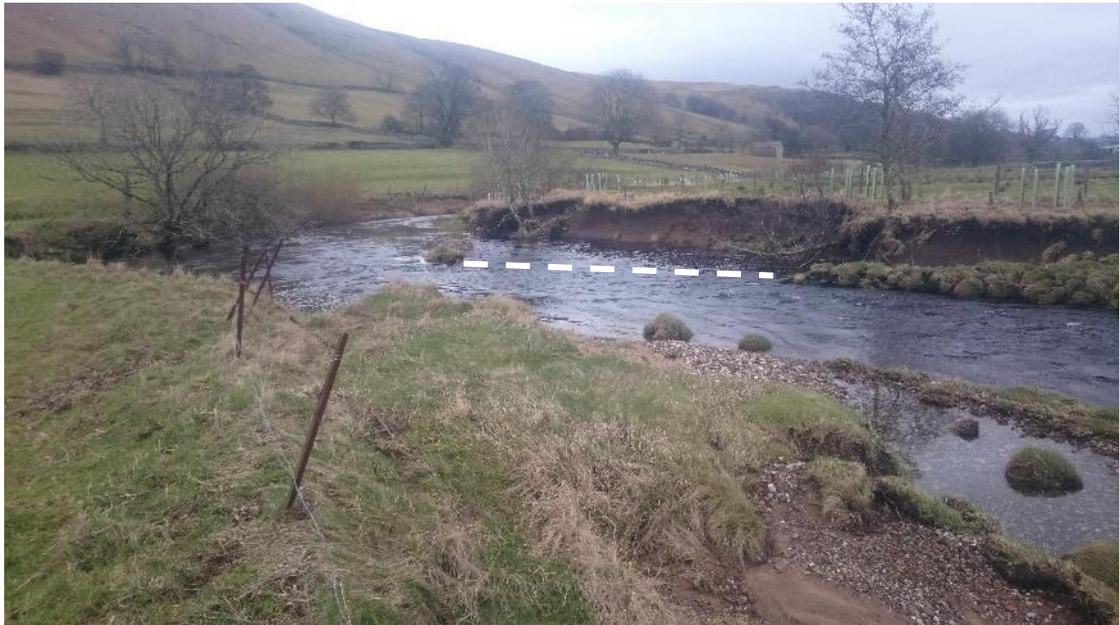
Fig 30. The white dotted line indicates the curve of the stone revetment which used to force the river through a U-bend and push it back to the left (eastern) side of the valley. This has been breached and the river is now evidently trying to cut a new course under spate flow through a stand of recent planting which has little chance of resisting the power of the Wharfe.

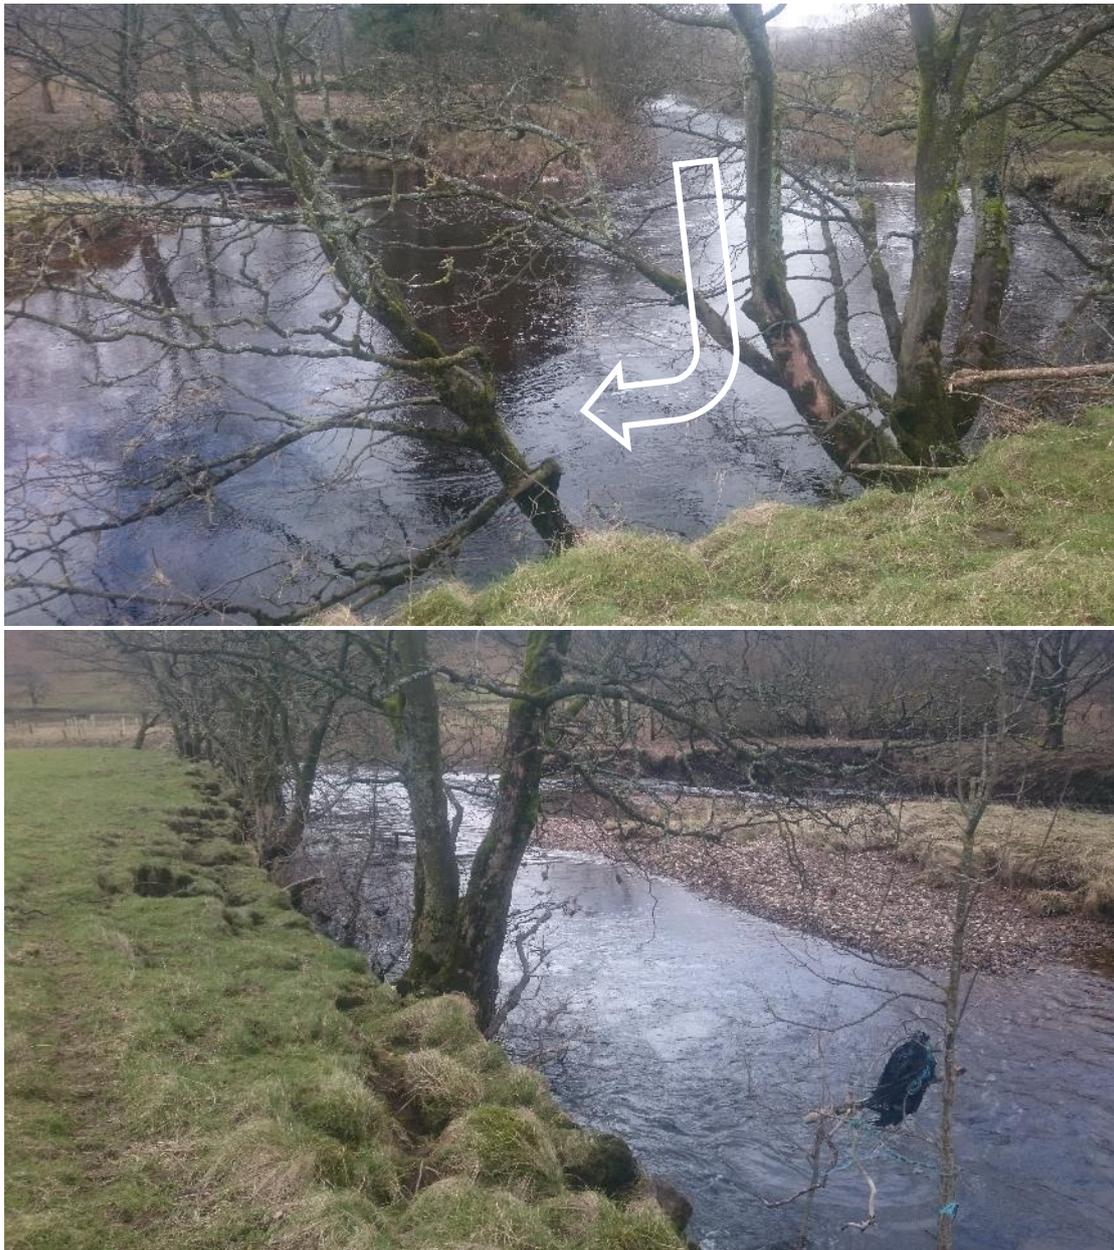
Fig 31. At the juncture between Buckden and Starbotton beats, the Wharfe has been perched to the east side of the valley for ~250m and maintained in a relatively narrow and very straight channel (evident in upper panel, top right), before being forced abruptly right (white arrow) and then into the U-bend described in Fig 30. The stone banking is evident along the LB (lower panel) to withstand the force of water under spate flow. Note the deposition bar (lower panel).

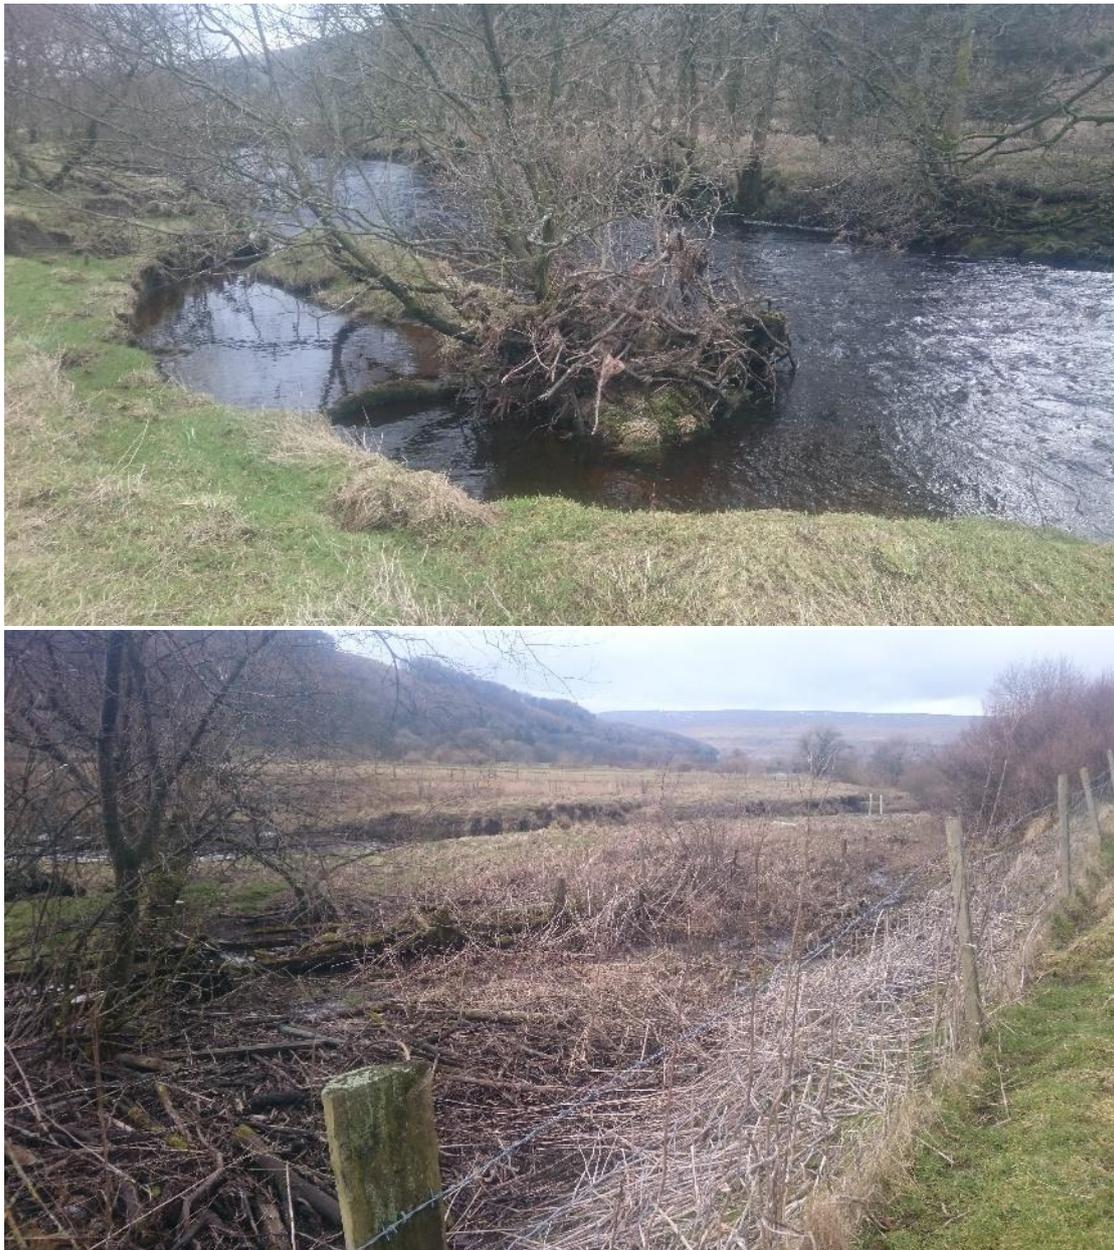
Fig 32. Scrubby willows along the LB provide some much-needed low cover and protection during spate flows on the most d/s straightened section of Buckden Down. Upper: the stone bank revetment has been breached here and scour behind the willow has resulted in a useful backwater refuge area for fry. Lower: a fenced section of bank where the few willows to left of image are trapping a considerable amount of flood debris. This area could be further planted with willow whips.

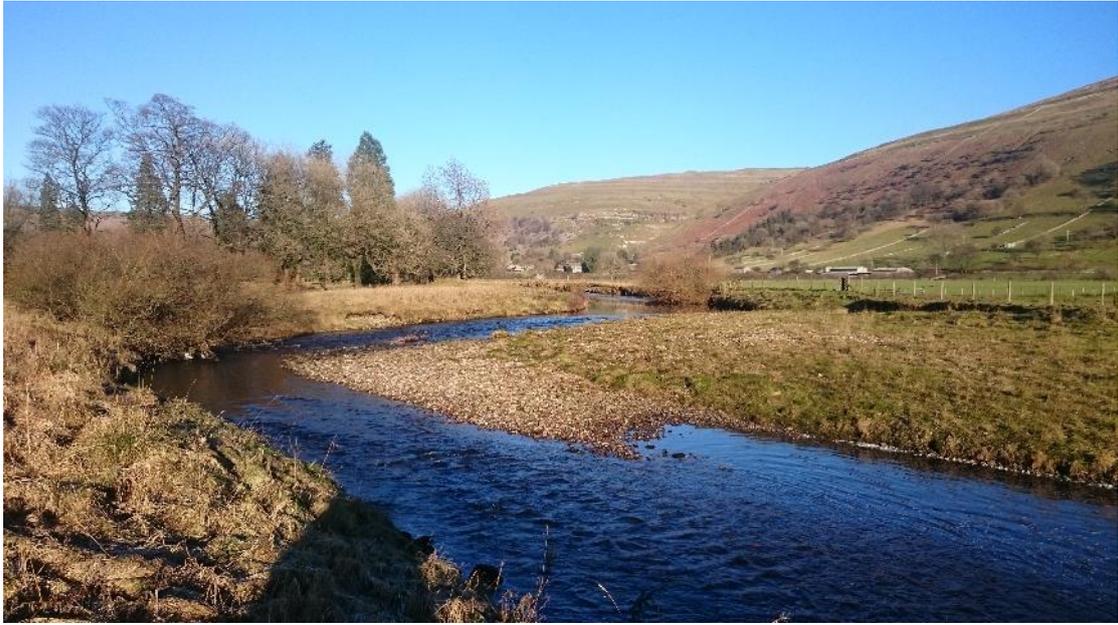
Fig 35. Meander d/s of another artificially straightened section parallel to some exotic conifers to the south of Buckden. Judicious planting could be undertaken within the buffer strip.

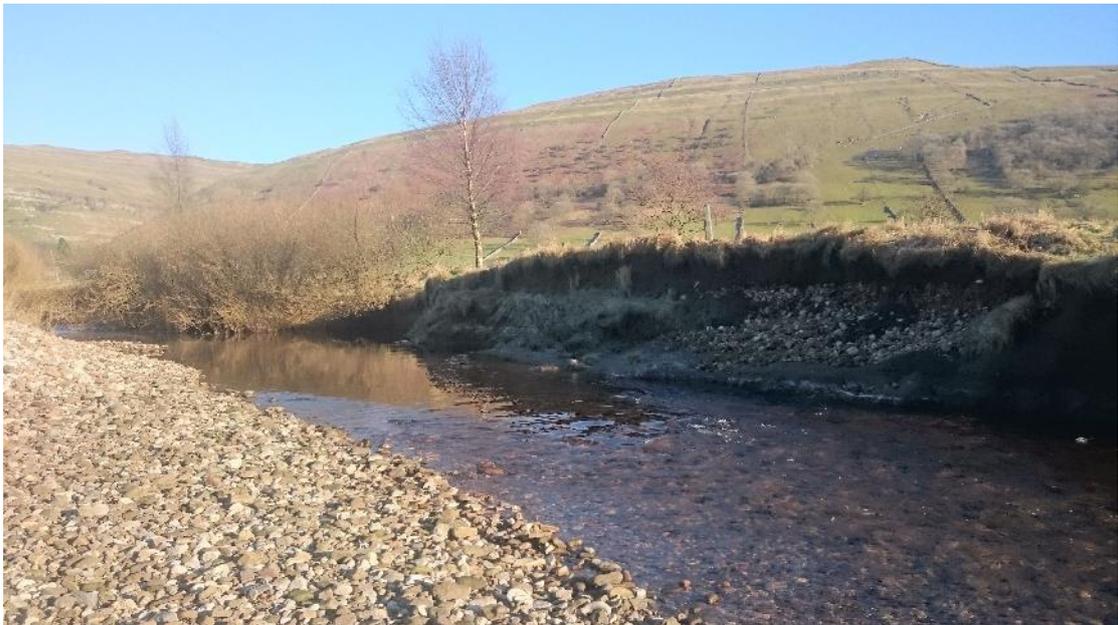
Fig 36. Marked scouring of the LB in response to the river depositing a substantial amount of bedload at the end of another artificially straightened run (towards the top end of Buckden Down).

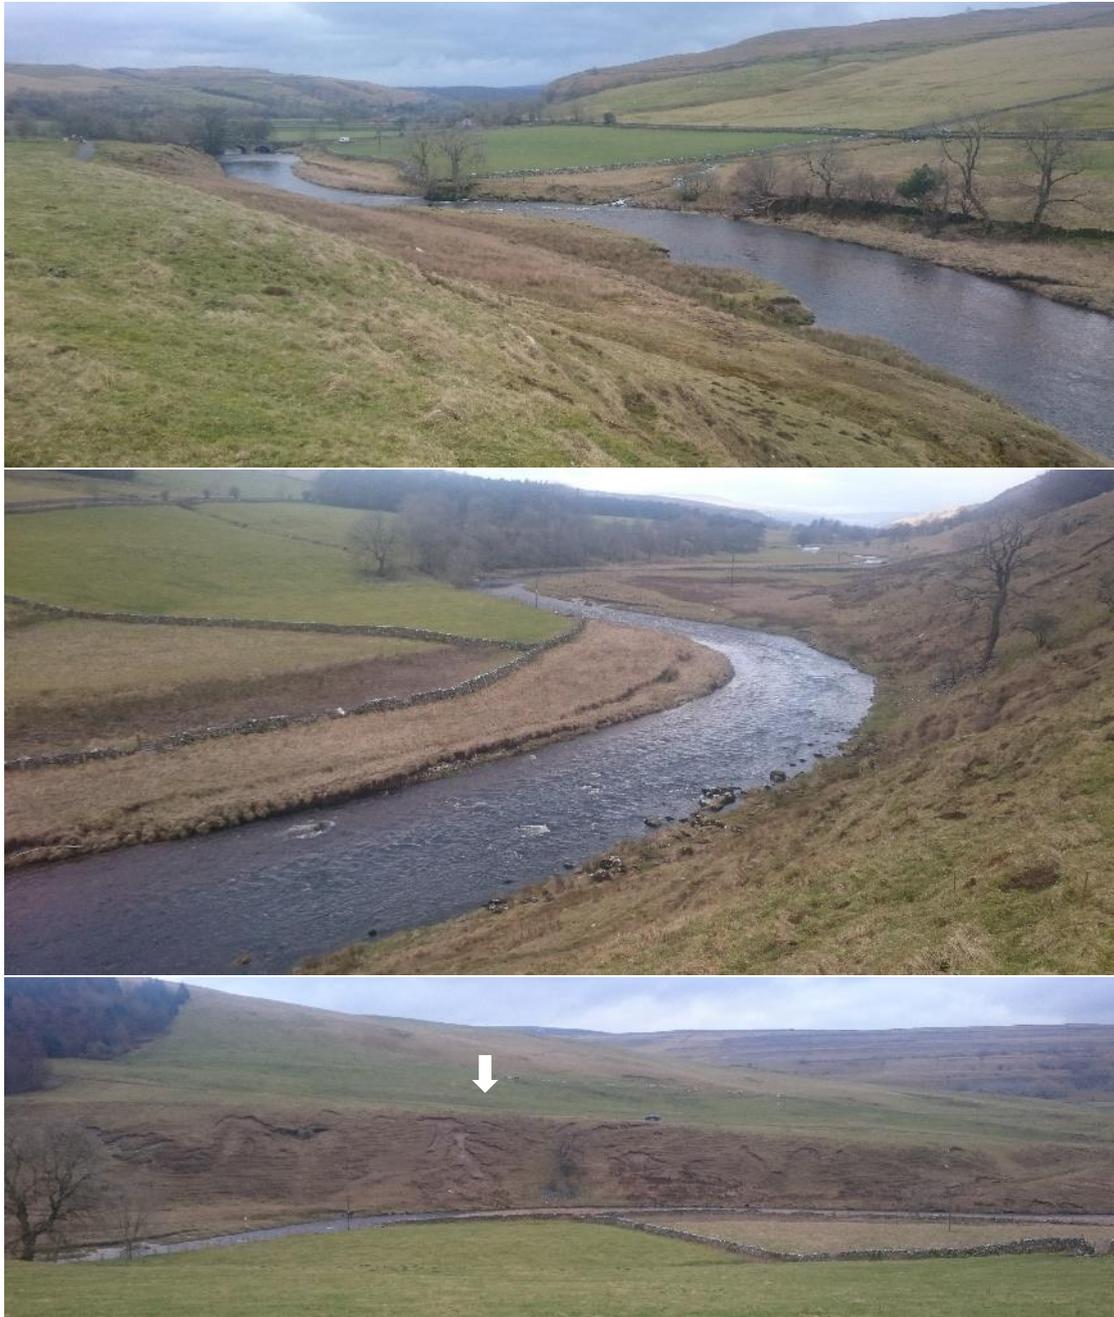
The Skirfare was observed at Watersmeet, and then at a few strategic points from a drive to Arncliffe and back. The lack of tree cover was noted in the upper panel of Fig 13 (at the confluence) and again exemplified on the lower reaches in Fig 37. An engineered channel cross-section, over-capacity to cope with spate flow and maintained by bank revetment means that the proportions of the river barely change, even around the bends (Fig 37). As a consequence, the flow

Fig 37. Views of the lower Skirfare from High Wind Bank: upper – looking d/s; mid – looking u/s. These images exemplify the lack of variability in channel cross-section, and an almost continual riffle habitat typical of a realigned, over-capacity channel. Lower – taken from the opposite side of the valley looking back to the point (white arrow) where the upper & mid images were taken. Note the scarring and slippage caused / exacerbated by sheep grazing on steep banks.

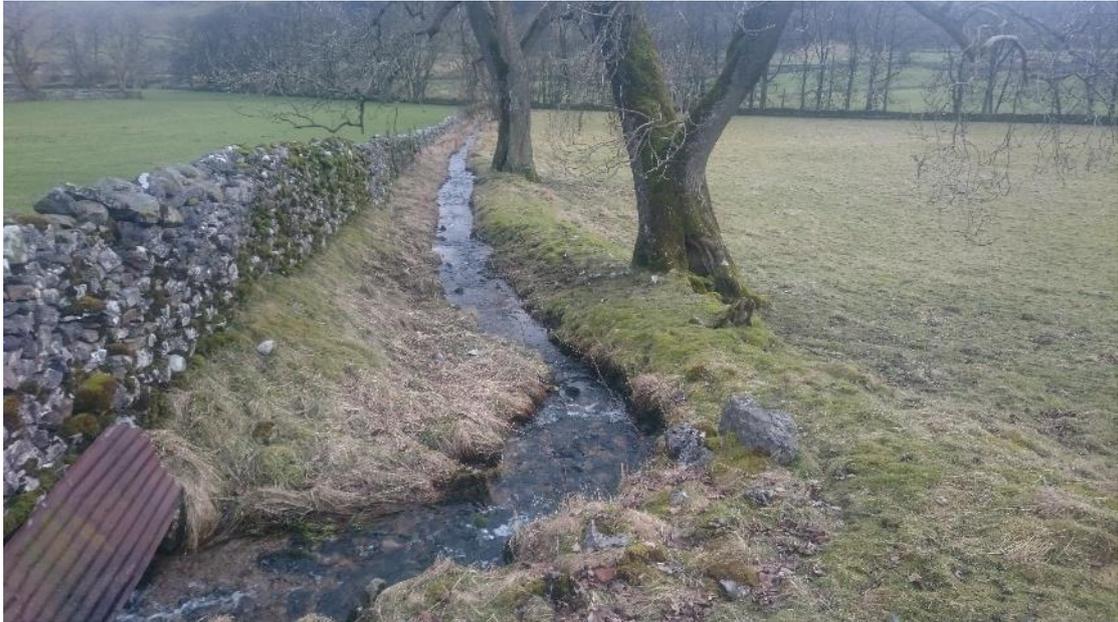
It is little wonder that the flow regime of the Skirfare (and Wharfe) is so flashy when one observes that most tributaries have been straightened to varying degrees. An extreme example was found u/s of Hawkswick (Fig 39); water will be conveyed very rapidly along this overly straight and steepened watercourse into the Skirfare, and it will probably flush out small gravels each time, leaving only cobbles (i.e. no use for spawning).

Fig 39. A typical small tributary which has been degraded to a ditch, 'perched' in a raised embankment and forced down the side of the field.

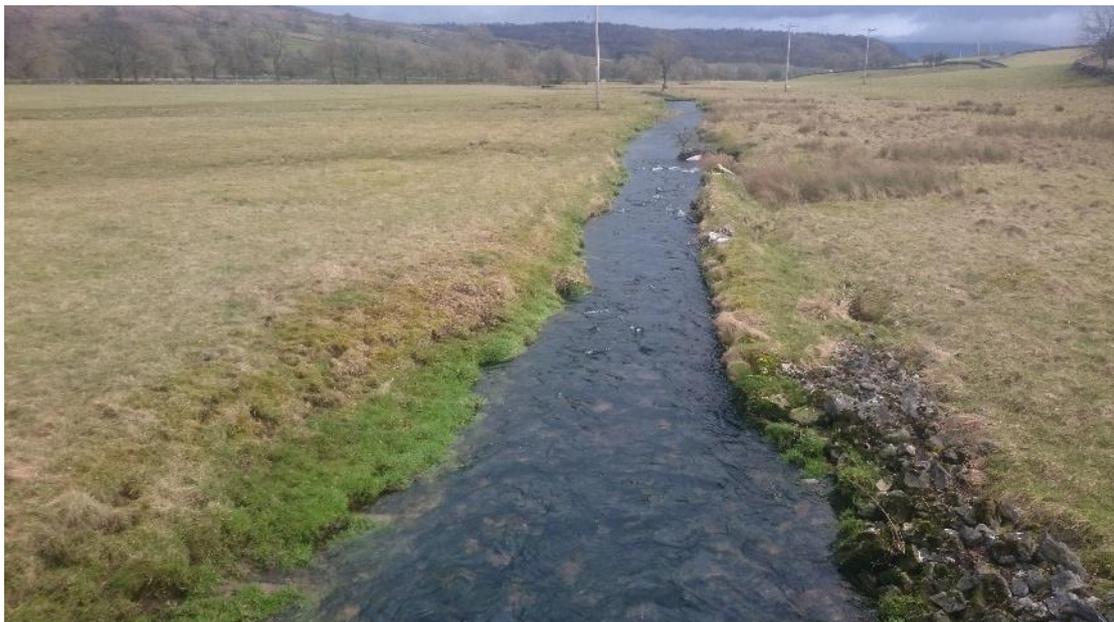
White Beck was observed at the confluence with the Wharfe (see Fig 4), from the road bridge to Conistone (Figs 41 & 42) and next to Kilnsey fishing lakes. Water clarity and submerged macrophyte growth was as expected from a limestone spring source, but algal growth on the substrate hinted at excessive nutrient enrichment. That growth would be exacerbated by the light climate; there is almost no tree cover for the majority of its length, and it has been straightened and embanked through the field to the Wharfe (Fig 41). From a cursory stone turn, macroinvertebrate life was diverse. This has great potential as a spawning and juvenile nursery beck if it can be protected. The one fly in the ointment might be escapement of overly large stocked fish from the fishery lakes which will cause detriment to wild fish in many ways.

Fig 41. White Beck, a potentially glorious limestone stream that has been bunded and straightened into a field drain, whereas it should be wending its way to the Wharfe across the floodplain watermeadow. If nothing else, it is crying out for livestock fencing to allow a natural riparian fringe to develop which will provide shade and cover for fish in this shallow, clear watercourse.

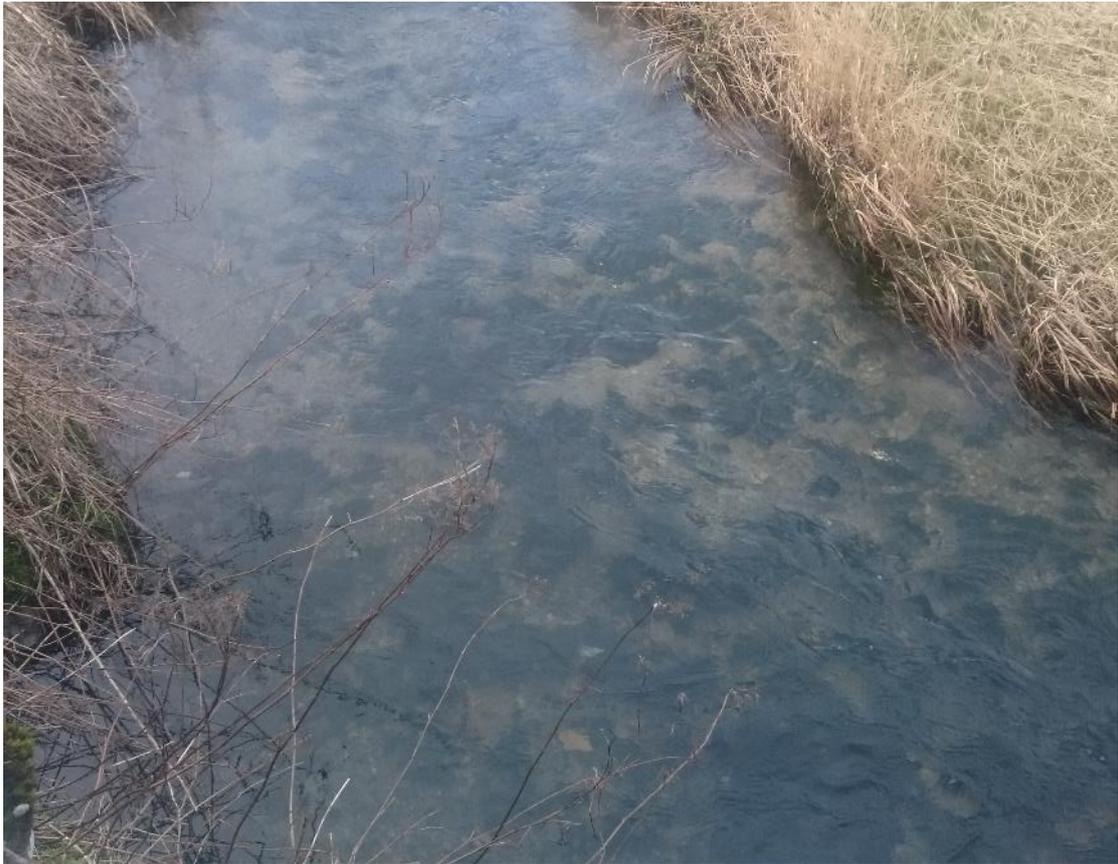
Fig 42. Looking upstream on White Beck from the Conistone bridge. The substrate is typical of a limestone river with good potential for macrophyte growth, but the gravels and cobbles are currently unsorted because of straightening of the channel.

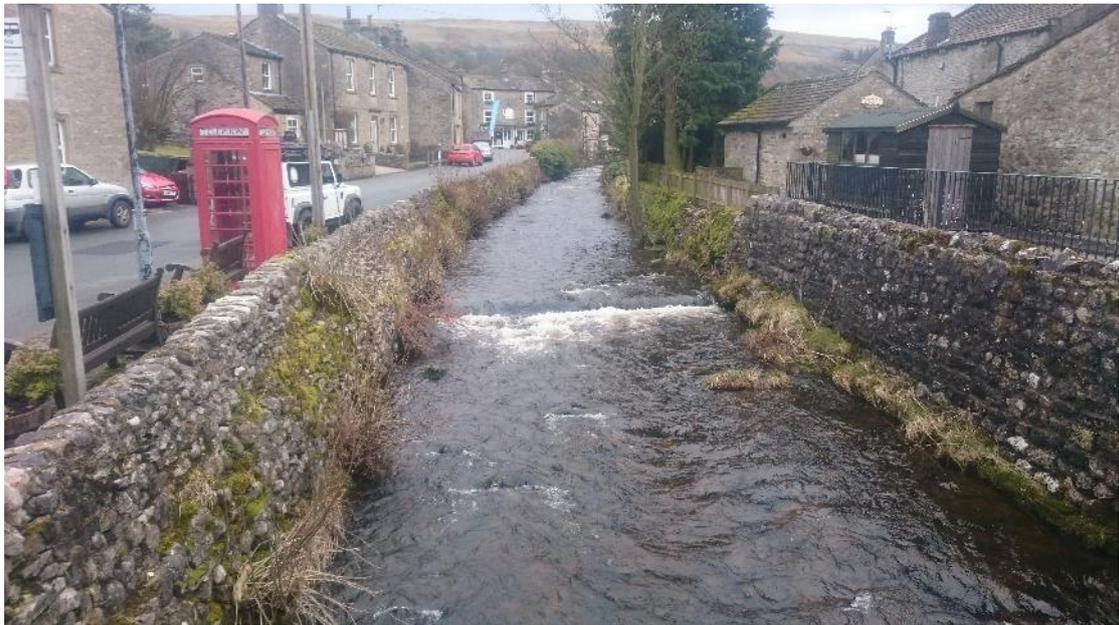
Fig 43. Straightened, walled and weir'd. Dowber Gill Beck lower reaches in Kettlewell.

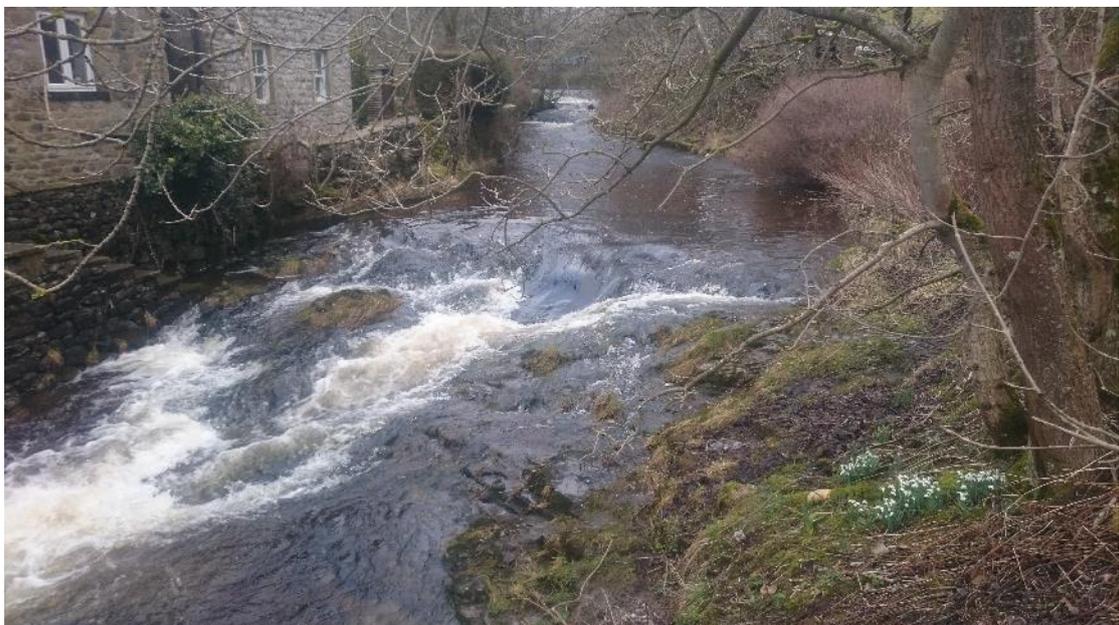
Fig 44. Some of the natural bed-rock falls towards the top end of Kettlewell on Dowber Gill Beck which probably limit the upstream passage of trout.

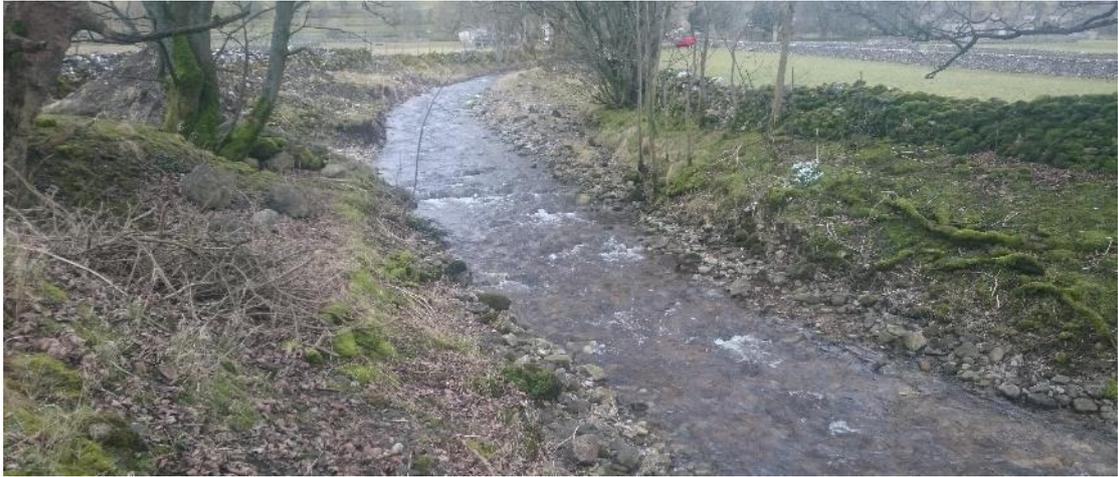
Fig 45. Cam Gill Beck below Starbotton village. The channel has been realigned and dredged; spoil is evident on the RB (left of image).
