Walkover Assessment

Lumley Park Burn – Source to Herrington Burn

River Wear, Co Durham

Date – 18/02/15

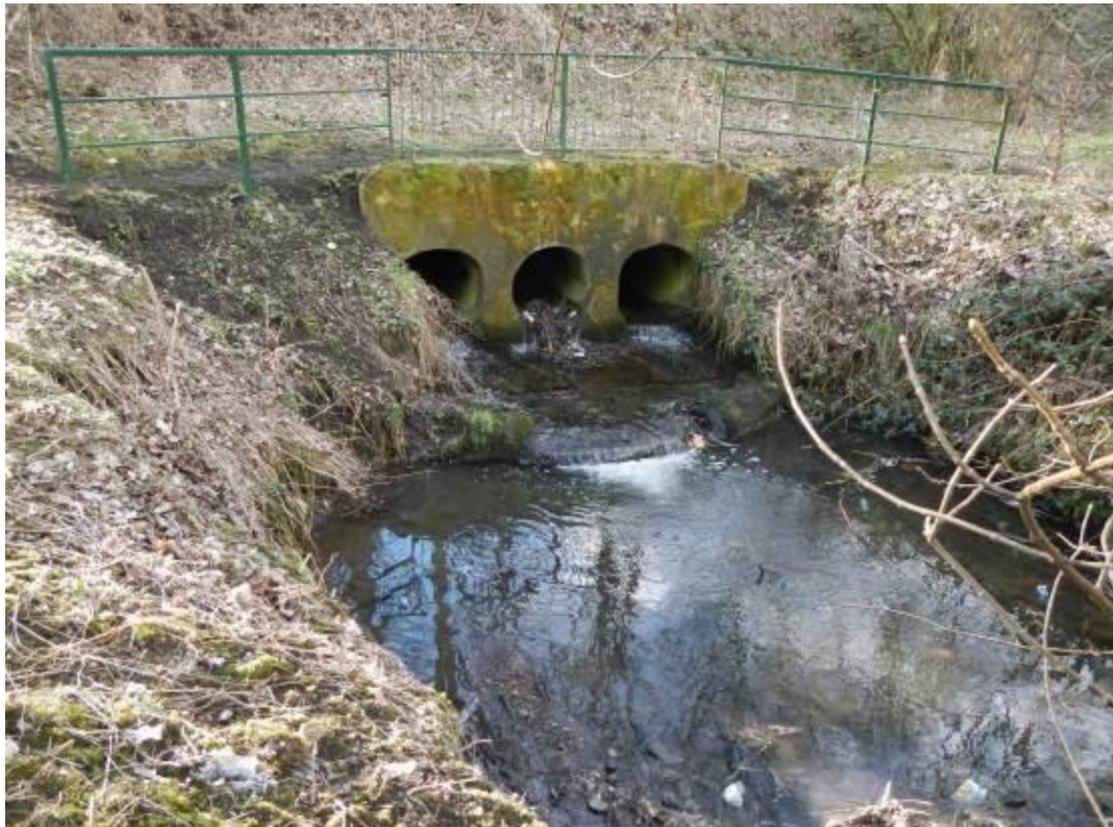
At the upstream end of Hetton Park a pipe culvert prevents further upstream fish access on the Hetton Burn (Photo. 1). The pipes are narrow, long and gradually increase in gradient. Even when water depths are sufficient, velocities within the pipes will be in excess of salmonid swimming capabilities. In addition, a step at the end of the culvert and stepped apron also inhibit access to the pipes.

Photograph 1. Upstream limit of fish access on the Hetton Burn.

While improvements to fish passage at the three-pipe culvert at the upstream limit of the section walked (upstream end of Hetton Park) are infeasible, easing fish passage over the steps and shallow aprons at the CSOs further downstream in Hetton Park ((Photo. 3 - NZ3506447852) & (Photo. 6 NZ3495648198)) would be worthwhile. This should ideally be undertaken by infilling the scour pool on the downstream side with a rock ramp type easement and some kind of baulk to increase water depth over the apron (Photo. 6); however, owing to the relatively short section of available habitat upstream, it may be that simply increasing depth over the aprons and focussing flow with a baulk (possibly with the inclusion of an adherent nappe on the step) would be a better use of funding.

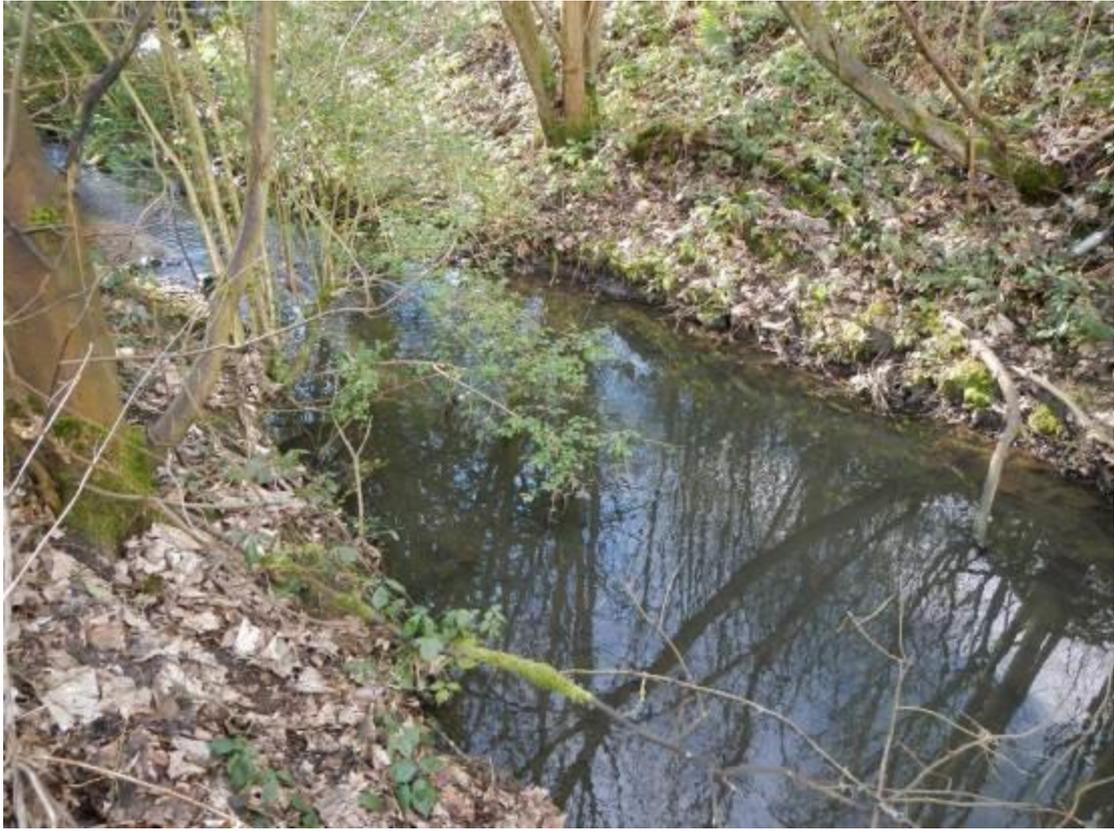
Even here, at the upstream limit on the walkover, the Burn shows signs of excess sedimentation, and a sewage-like odour emanates from the notably grey water. Reasonably high quality, low-level cover and structure are available in areas, within and along the watercourse (Photo. 2) but, in places, shading limits the growth of herbaceous vegetation and understory and the banks are relatively bare. Increasing and retaining overhanging/trailing shrubs and LWD within the channel would be greatly beneficial. Not far downstream a CSO with a concrete apron poses another obstacle to fish passage, due to a step and shallow water (Photo. 3).

Photograph 2. Low cover and structure along a deeper pool. Note the distinctively grey tint to the water.

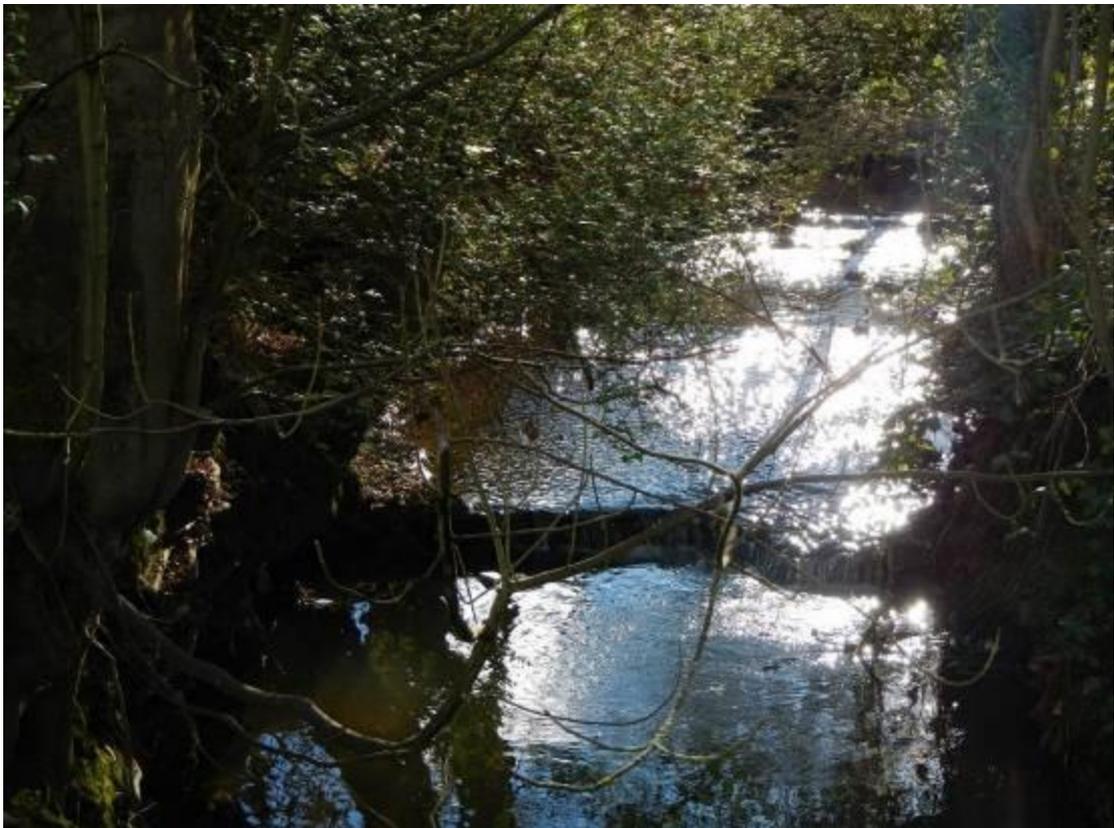
Photograph 3. Vertical step and shallow water across the apron of a CSO limit fish passage.

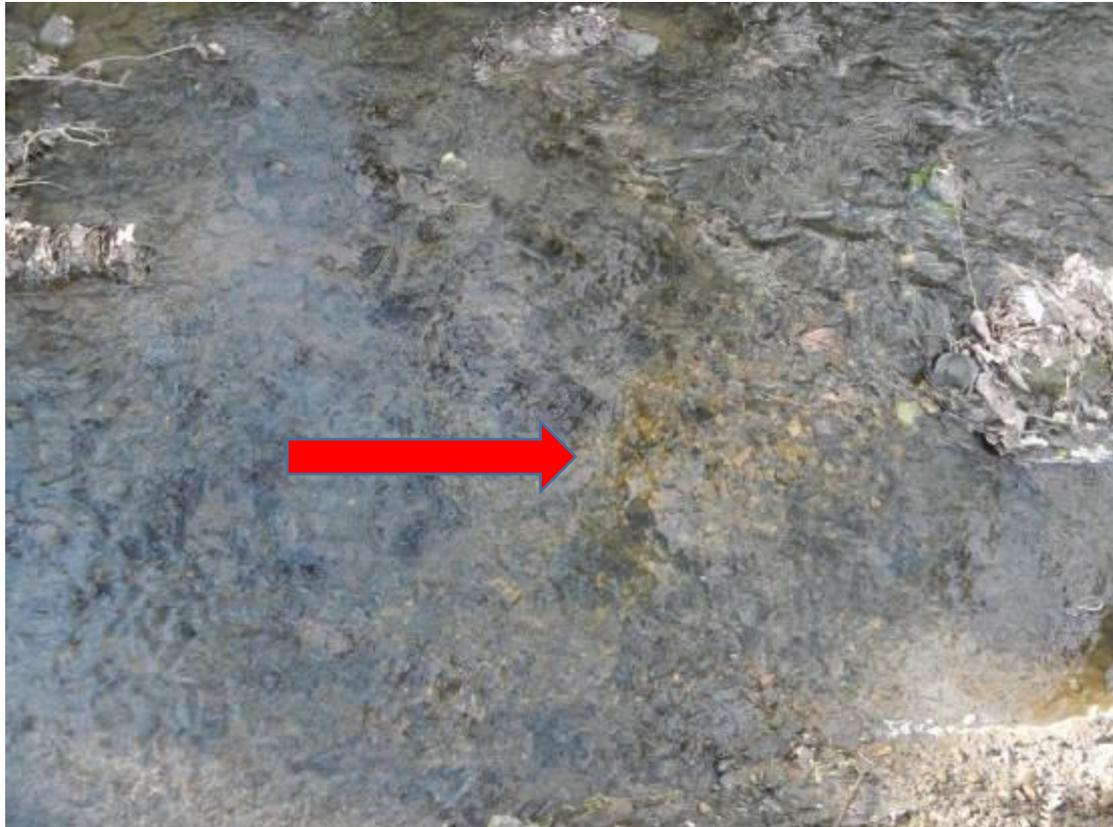
Even within the park, signs of salmonid spawning were present on any suitable substrate (Photo. 4), although the grey coating on the rocks signifies fine sediment that coats the bed and infiltrates the gravel. Fine sediment reduces through-flow of water within the gravel, smothering the eggs and reducing egg survival rates.

Photograph 4. Small salmonid redd (red arrow) on the first suitable sized substrate. Grey sediment coating on the bed is likely to reduce egg survival rates.

The issue of fine sediment entering the Burn from upstream should be addressed separately, but increasing the level of structure within the channel accentuates scour and deposition processes and helps to sort and maintain high quality silt-free substrate.

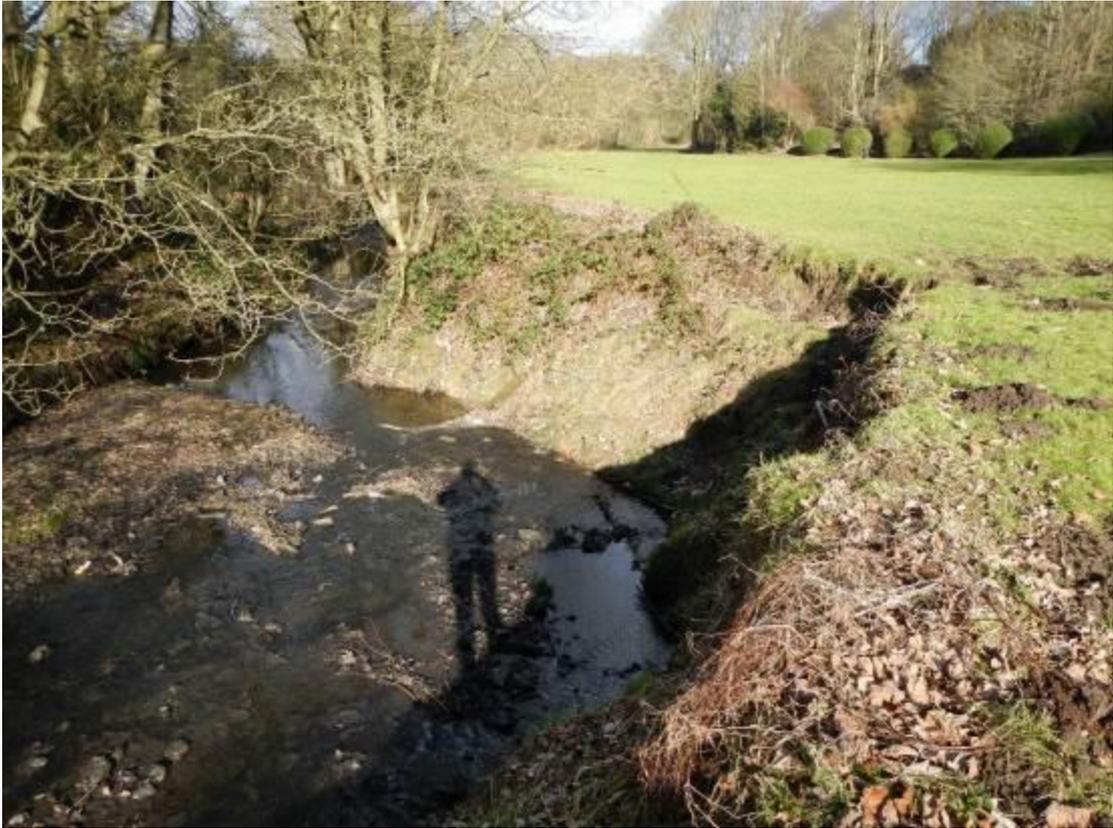
An area of erosion has led to bank slumping and loss of land (Photo. 5). Mowing up to the edge of the bank limits vegetation growth and increases erosion by reducing root structure in the bank which also inhibits re-grading (similar to grazing). Allowing a buffer to increase vegetation cover and trees in this area should reduce erosion rates. Further downstream, another CSO poses a similar problem to the first, with the step and shallow apron posing an issue for fish passage (Photo. 6). Several redds were observed in the short distance downstream of the structure, likely signifying that it is an obstacle, but also that the localised scour has cleaned and sorted the gravels to a favourable state for spawning.

Photograph 5. Area of erosion that could be addressed by increased vegetation.

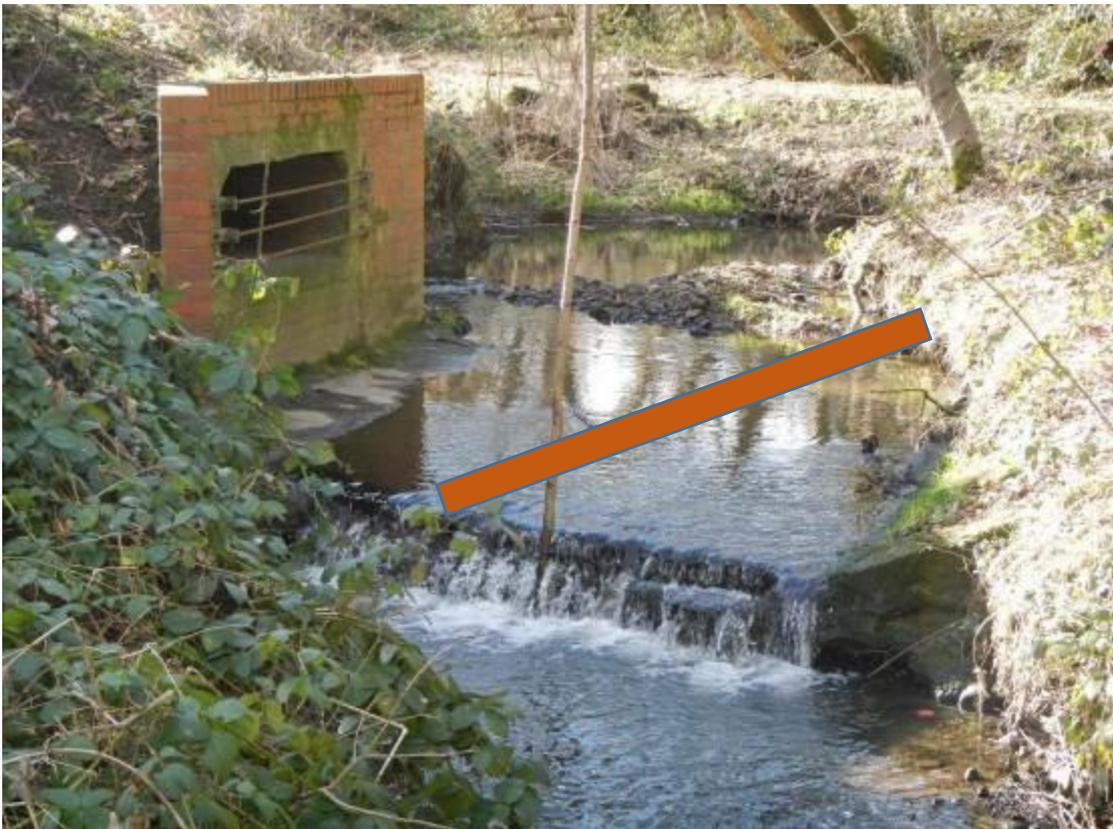
Photograph 6. Another CSO poses an obstacle to fish passage. The brown line represents a possible baulk-style easement that could be employed.

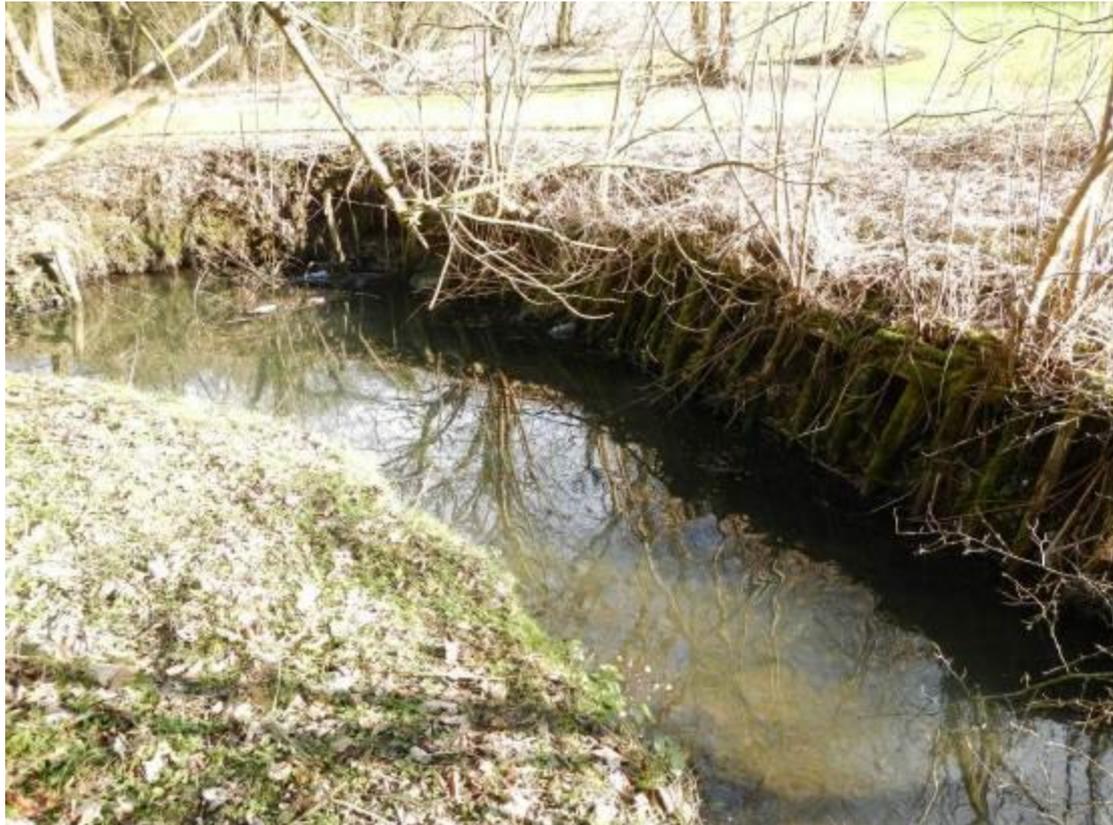
Around the entrance to the wood in Hetton Park is a sharp bend showing previous signs of erosion, with willow spiling employed to address the issue (Photo. 7). The work appeared to have worked to an extent, with erosion reduced on all but the lower end. As with many attempts at willow spiling, however, some of the cross pieces have failed to take, leaving the bank exposed. Bank protection could be significantly improved by cutting some of the willow re-growth into short sections and planting them into the bare earth. This would also promote low cover along the bank.

Photograph 7. Willow spiling to protect the outside bend.

In the two areas previous willow spiling work is now at a stage that would benefit from maintenance (Photos. 7 & 20). In these cases,

weaving some of the willow back into the structure and laying some branches into the channel would be beneficial.

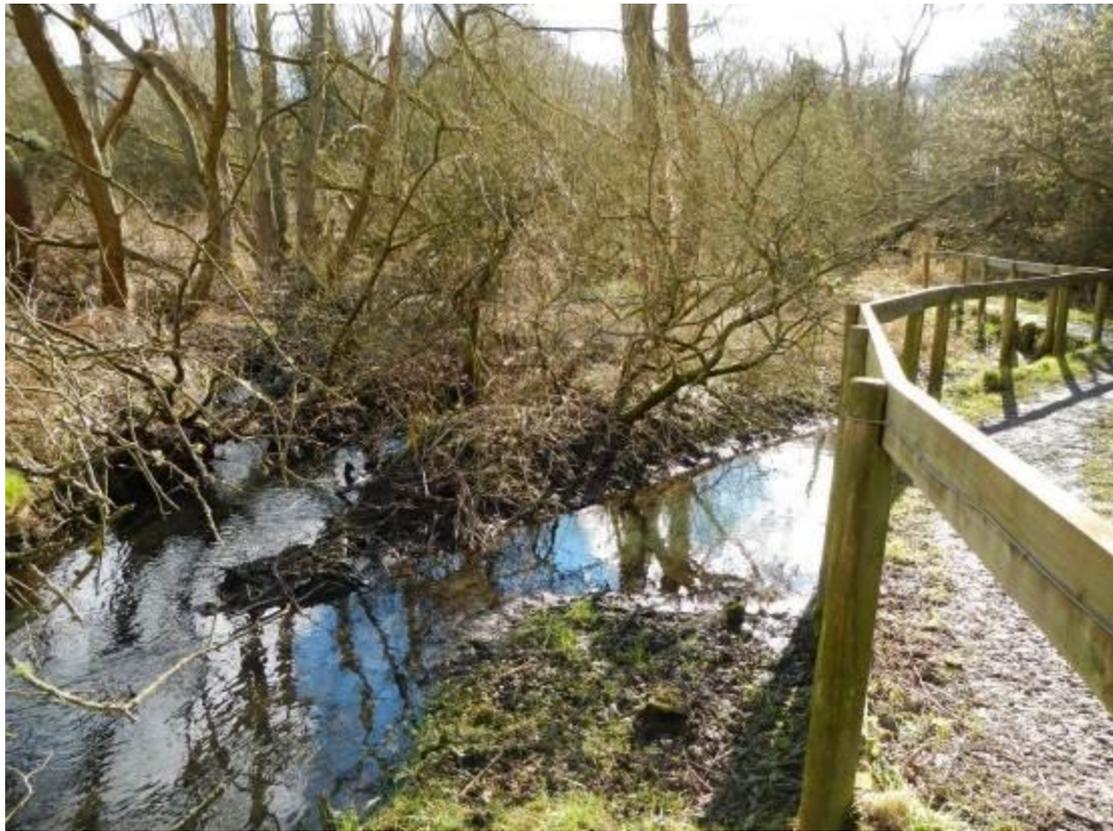
Also within the wood, signs of channel realignment are evident as a paleo-channel runs alongside a straight section of current channel, the latter flowing under the footpath bridge and re-joining the paleo-channel alongside the path (Photo. 10).

Photograph 10. Looking upstream, the straightened, current channel (left) and the paleo-channel (right).

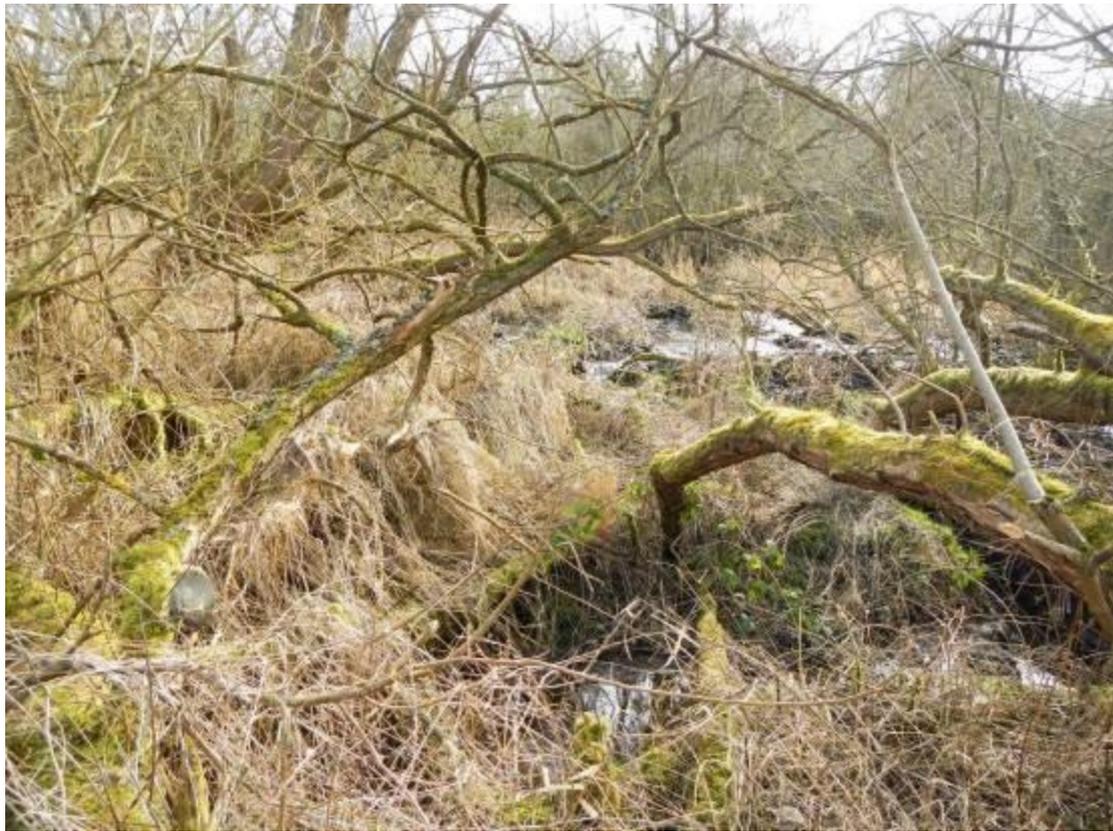
Photograph 11. Areas of the wood are so choked with willow and sediment deposition that there is no formal channel.

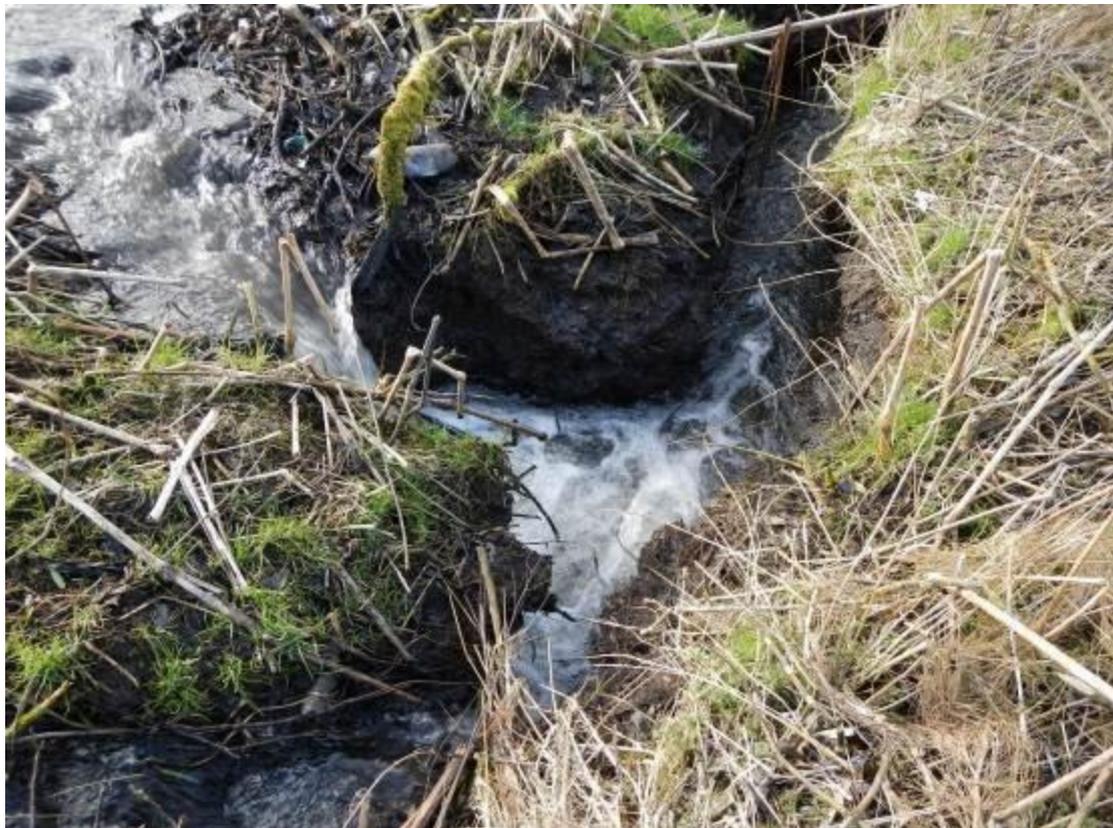
In this area, high flows have also forced localised downward scour, leading to the channel becoming significantly incised within a very narrow (c.300mm x 600mm) channel, which starts as a vertical step into the clay and humus (Photo. 12). The step poses an obstacle to fish passage in low-medium flows, but being a relatively natural feature (although possibly influenced by other interventions in the area) the decision of whether to ease the obstacle is somewhat complex. In addition, it may be that future erosion will begin to relieve the obstruction.

Photograph 12. In contrast to Photo 11, bed erosion in this area has led to a narrow channel incising c.600mm into the clay and humus and creating an obstacle to fish passage.

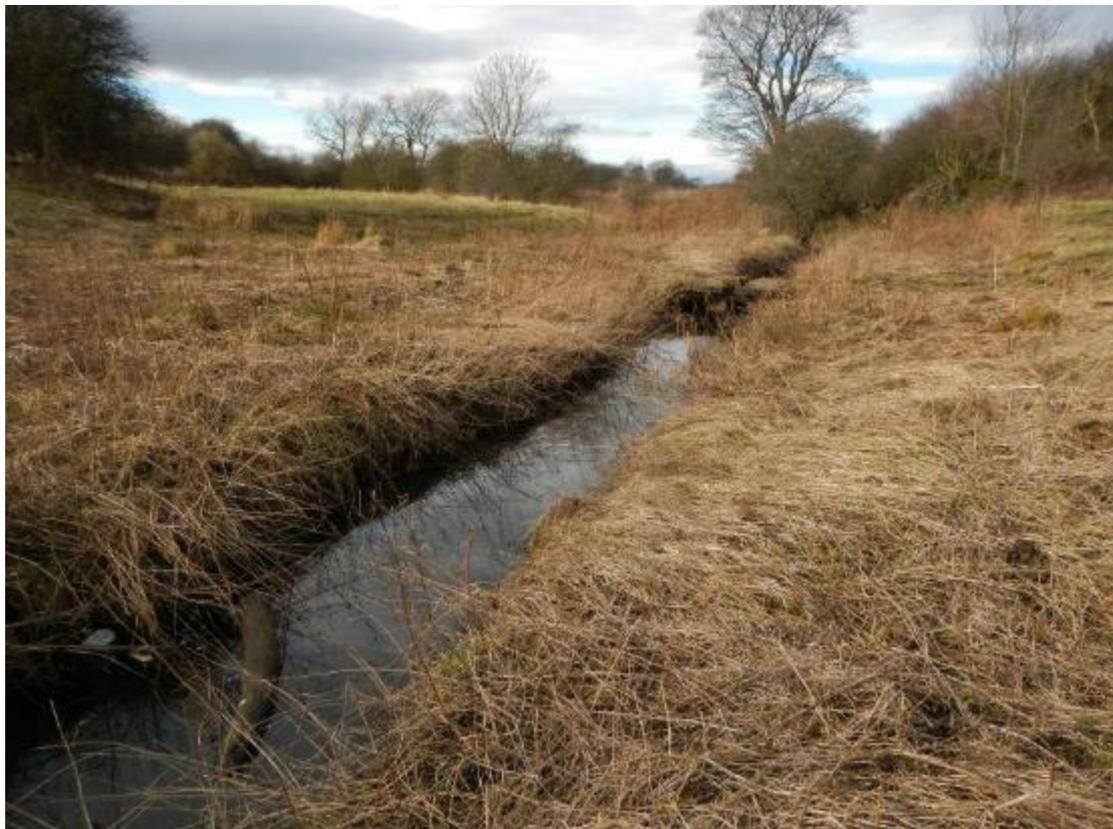
Downstream of the wood, land use reverts to grazing for one field, and the straight, over-capacity channel is testament to previous land drainage and dredging activity (Photo. 13). Grazing pressure is noted here but does not appear to be having an impact on all bank sections. However, significant sediment input is evident via the Rough Dene Burn, which forms one of the field boundaries, and suggests that livestock are poaching the banks on that tributary (photo. 14).

Photograph 13. Straightened, over-capacity channel.

Table 3. Locations in which fencing should be undertaken	
Location	NGR
Around Photos. 13 & 14	NZ3457448611
Throughout the horse grazed fields (Photos. 29-32 & 34)	NZ3325749399 - NZ3291150306

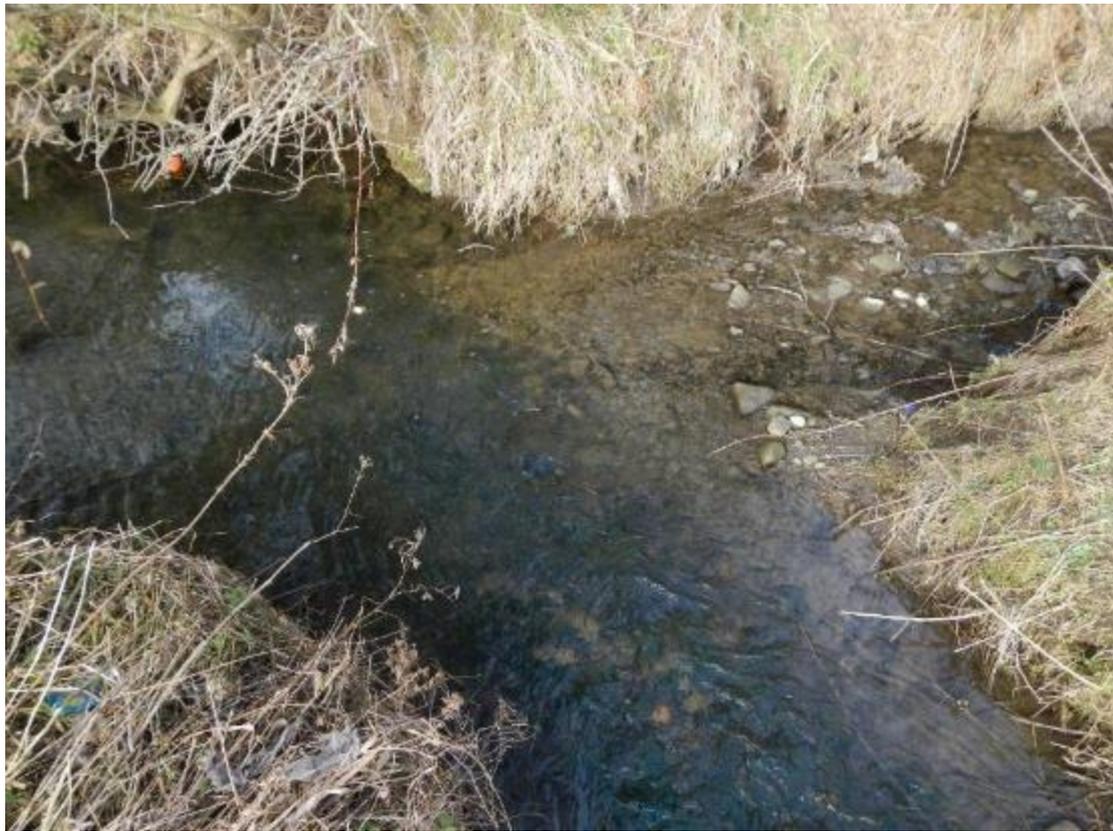
Photograph 14. Rough Dene Burn (right) supplying additional sediment.

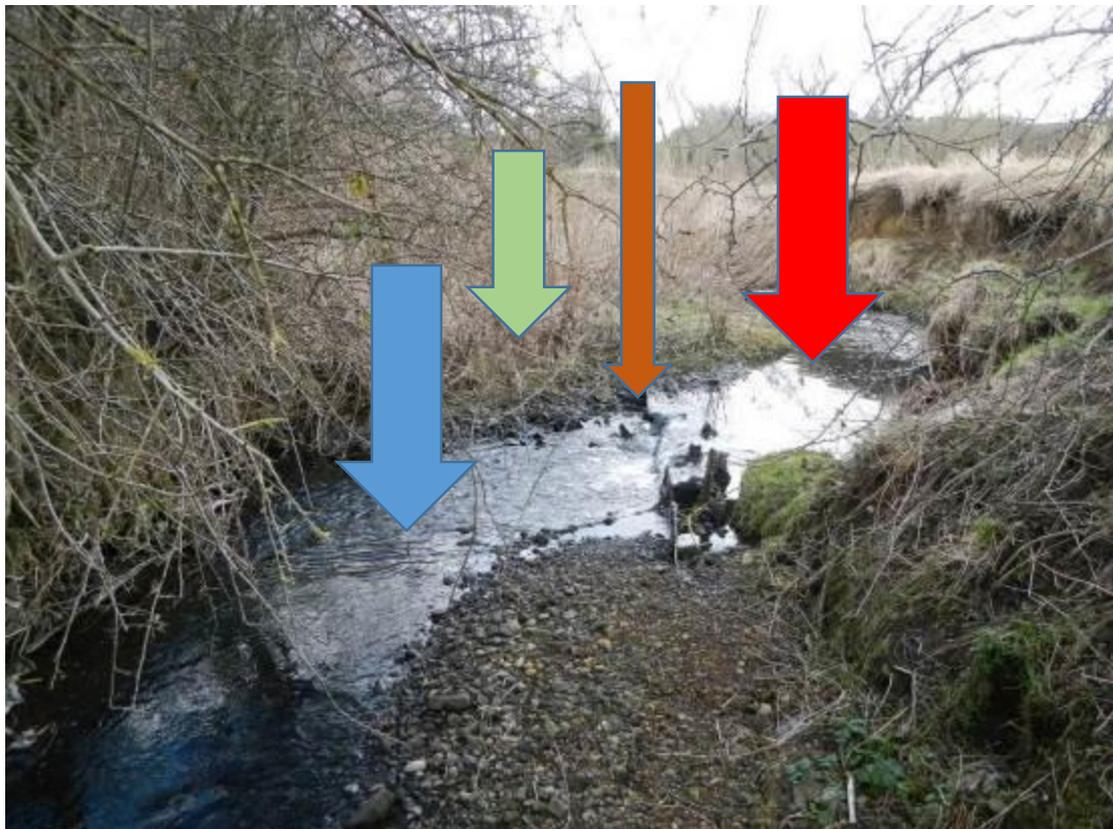
Downstream of Rough Dene Burn signs of past shutter-board bank protection is evident, as is the capacity of a constrained channel to break out given time (Photo. 15). Flows have worked behind the boards, which have then greatly exacerbated bank erosion.

Photograph 15. Looking upstream – the line of original channel (blue), line of failed shutter-board bank protection (Brown) and line of newly eroded channel behind originally

protected bank line. The green arrow represents a vegetated gravel bar formed by natural deposition.

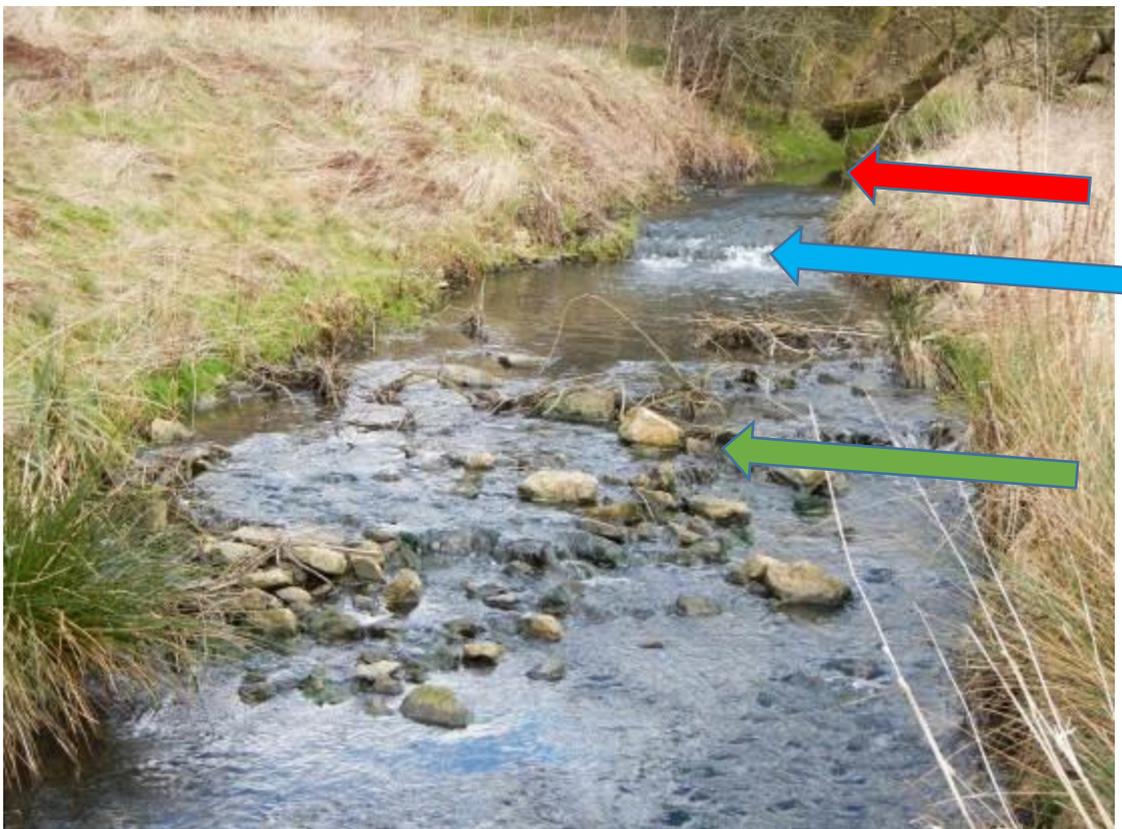
Following the short section of woodland, the Burn flows through a more open area, where a gas pipe crossing has resulted in the bed being raised through armoring to protect the pipe (Photo 18). It would be hoped that modern pipe crossings would be sunk well below the bed to avoid this issue. At least the work has incorporated three sympathetic bed-checks to maintain the bed level downstream. This has prevented the raised area from becoming significantly perched and reduced the obstacle created to fish passage (likely as an unintended positive consequence of protecting the pipe, rather than in consideration of fish passage). The crossing still poses an obstacle.

Photograph 18. Gas pipe crossing (red) armouring (blue) and one of three bed-checks (green) to prevent the pipe and armouring becoming perched.

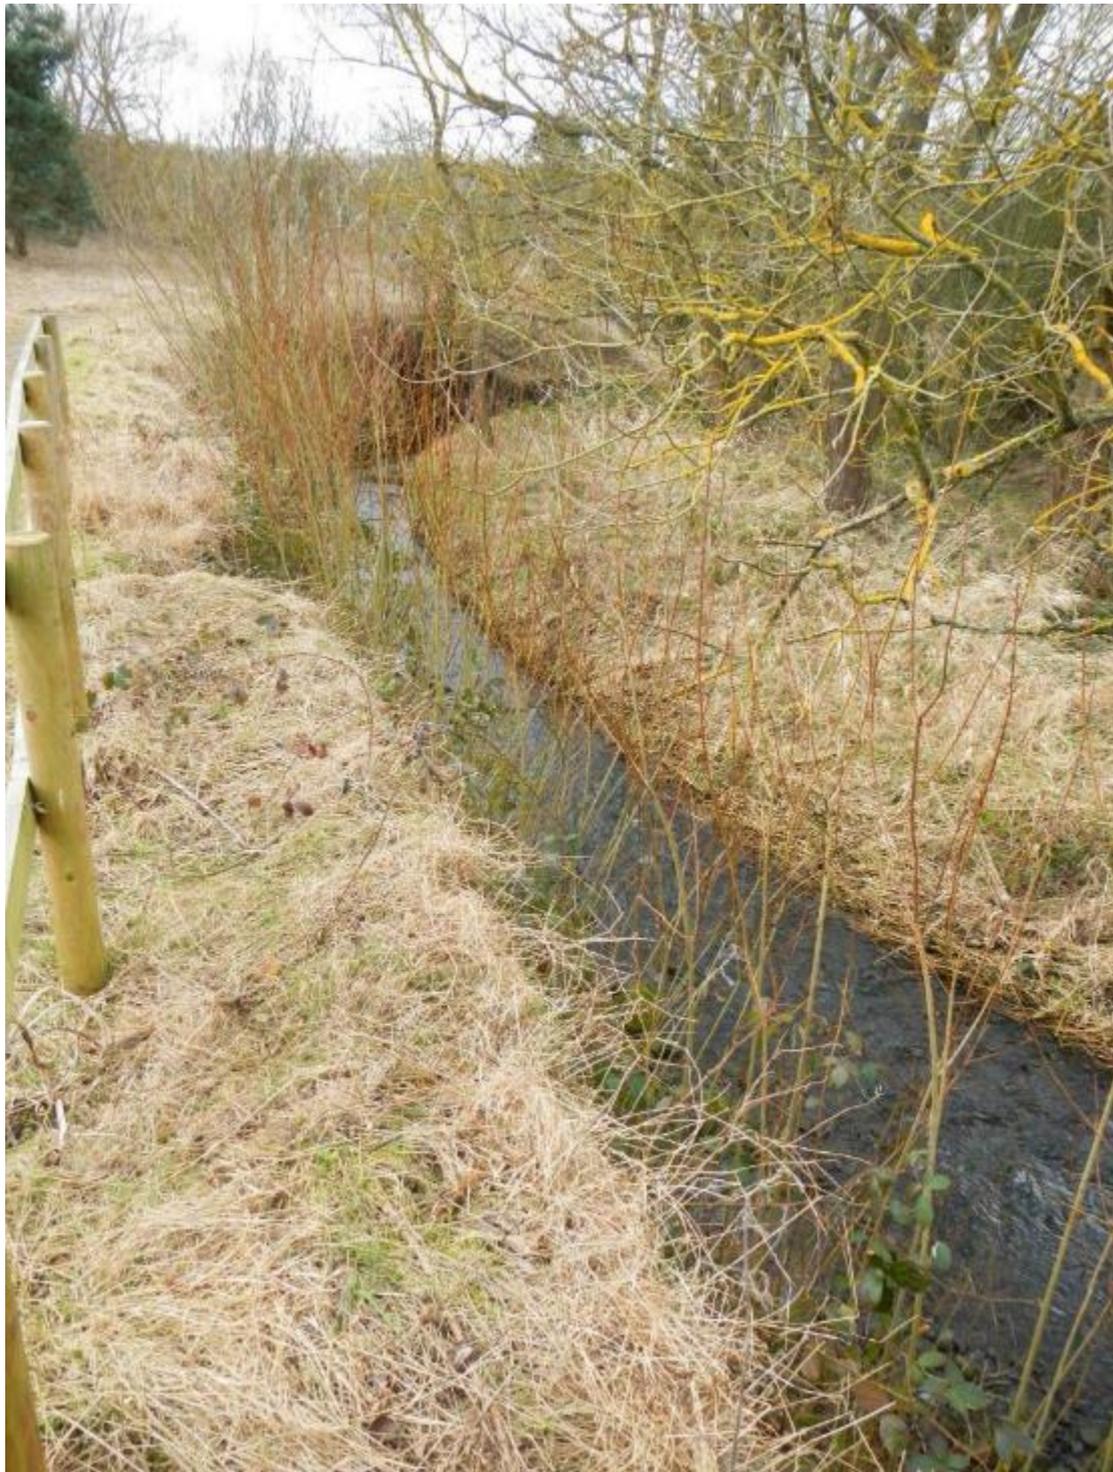
On a large area of bank erosion downstream without any tree protection which was threatening the footpath, two tiers of willow spiling have been installed, successfully halting the erosion (Photo. 20). The spiling installed is now at a stage requiring maintenance and the vertical shoots/branches should be treated in one of three ways. They could be laid down along the bank and into the channel to diffuse flows acting upon the bank; they could be woven back into the structure where possible, or they could be cut into short sections and re-planted into any bare areas of bank. A combination of all three options may give the best overall benefit.

Photograph 20. Effective use of willow spiling.

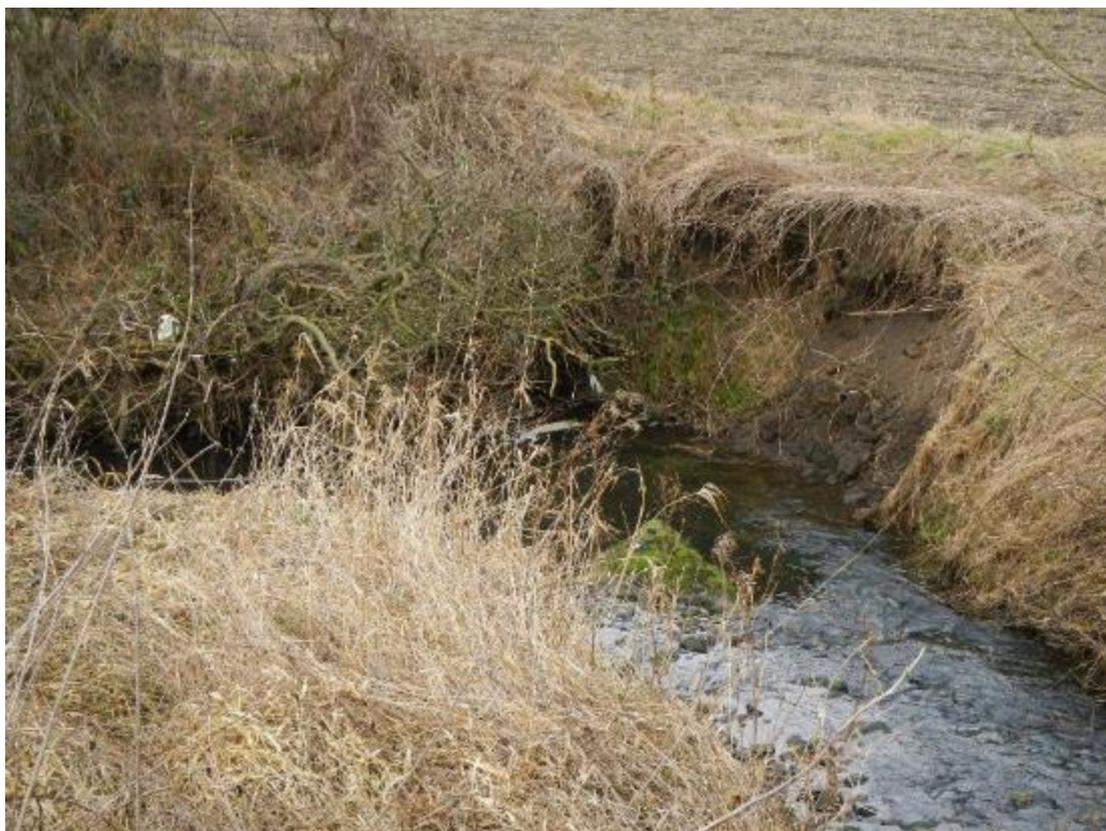
Another smaller area of bank erosion could also be addressed with the use of willow. Planting of willow whips in these exposed areas would increase structure in the bank (particularly as the willow takes root) thereby stabilising the bank and greatly inhibiting erosion (Photo. 21).

Photograph 21. Bank erosion that could be addressed with planting of willow whips.

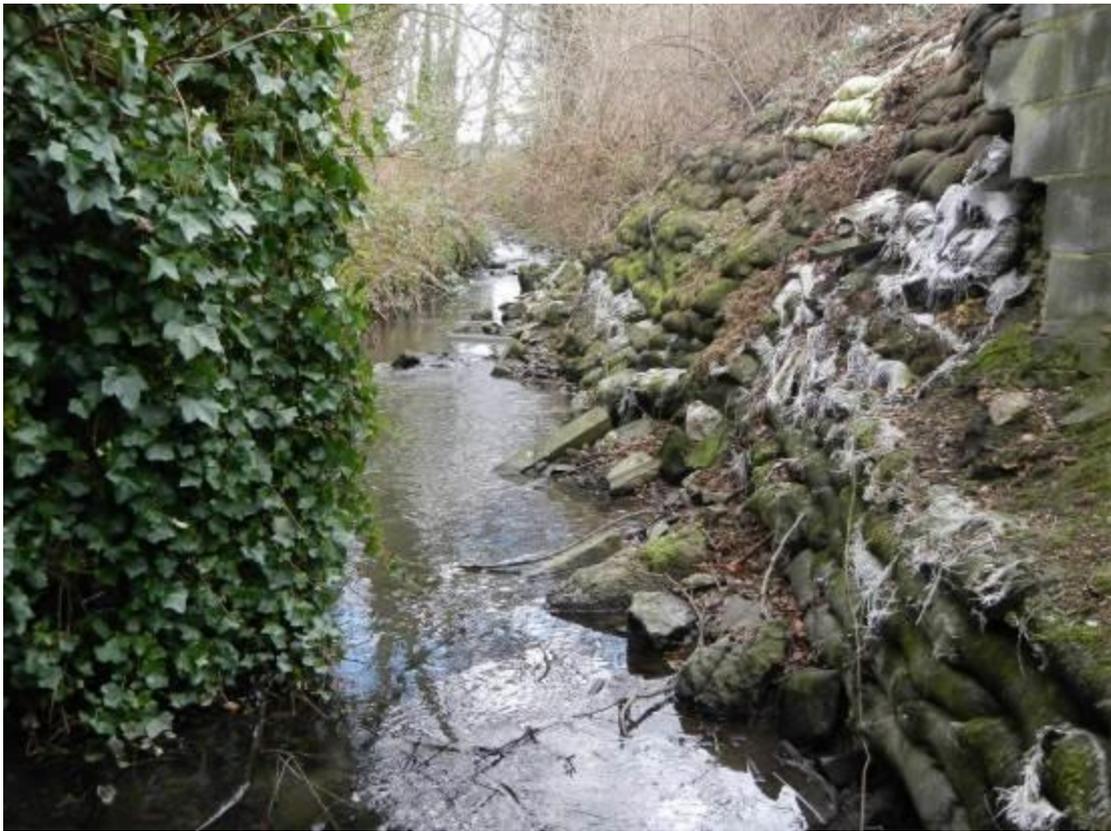
At the downstream end of this section the Burn enters another wooded section, with many houses backing onto the Burn. Through this section some reasonable habitat prevails; however, the area is a perfect example of how bank revetment and land boundaries are maintained out of public sight, and without consent (Photos. 22 & 23). Use of the Burn for garden waste disposal was also commonplace, with crass cuttings, leaves and tree prunings simply thrown down the bank (Photo 22).

Photograph 22. Inappropriate use of concrete filled bags as bank protection. A likely cause of one/some of the numerous fish-kills on the Burn.

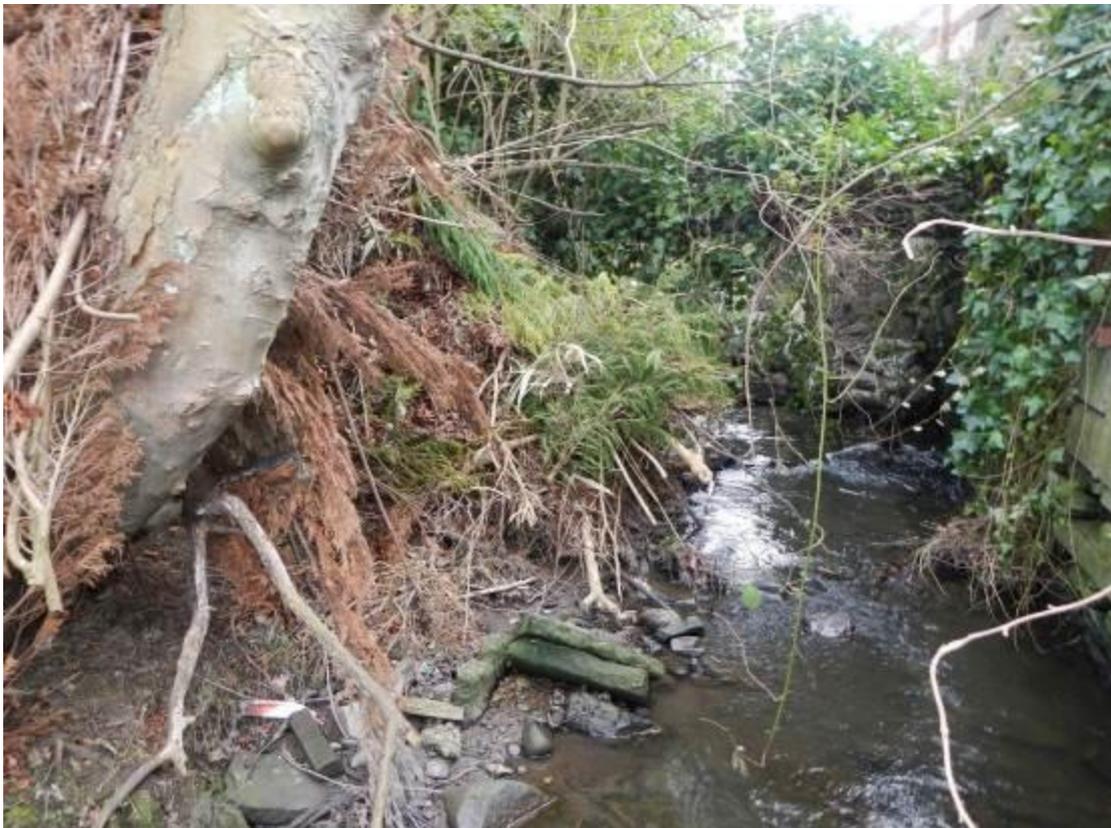
Photograph 23. Garden waste (left of shot) simply thrown down the bank.

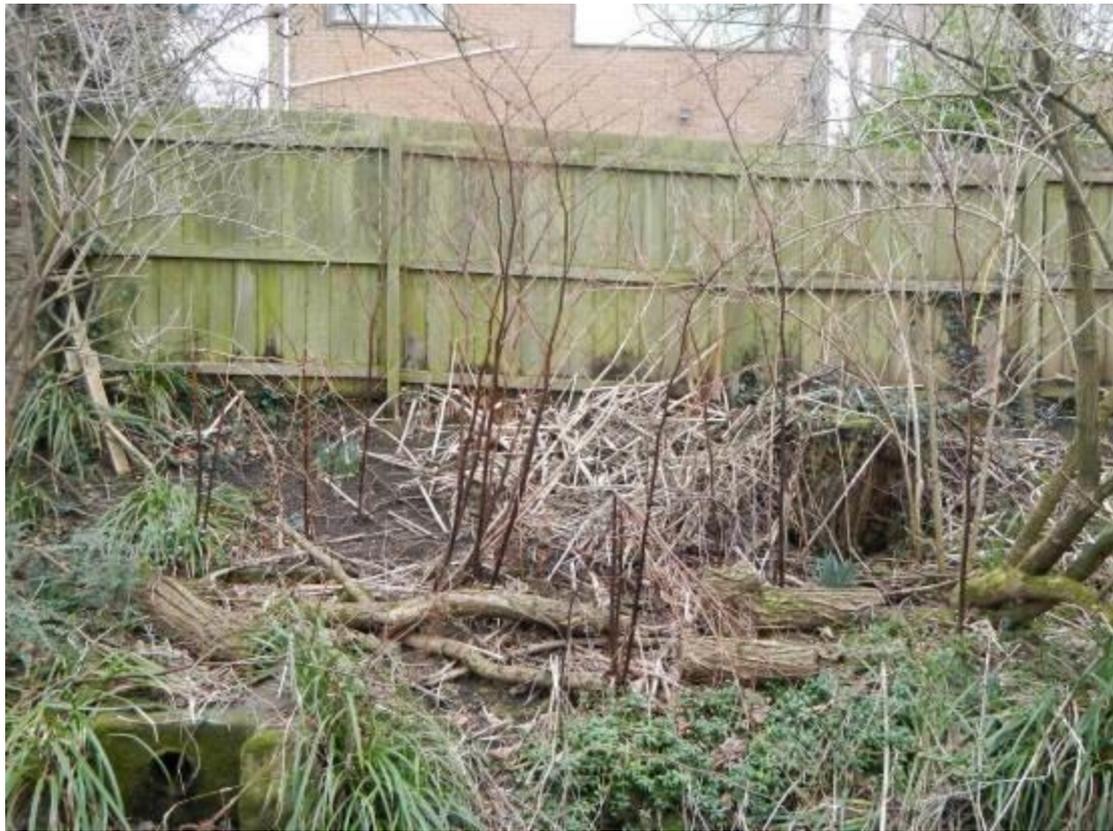
Alongside the gardens is also the first point during the walkover that Japanese Knotweed (*Fallopia japonica*) was observed (Photo 24). This should be treated with herbicide (by a trained and permitted individual) as a matter of high importance to prevent its spread downstream.

Photograph 24. First sighting of Japanese Knotweed

Japanese knotweed was observed at the following locations and should be treated with herbicide, by licensed personnel to prevent it spreading.

Location	NGR
Alongside the gardens downstream of the Hetton Bogs SSSI (Photo. 24)	NZ3391148726
40m upstream of the Moors Burn – Herrington Burn confluence	NZ 31994 50803

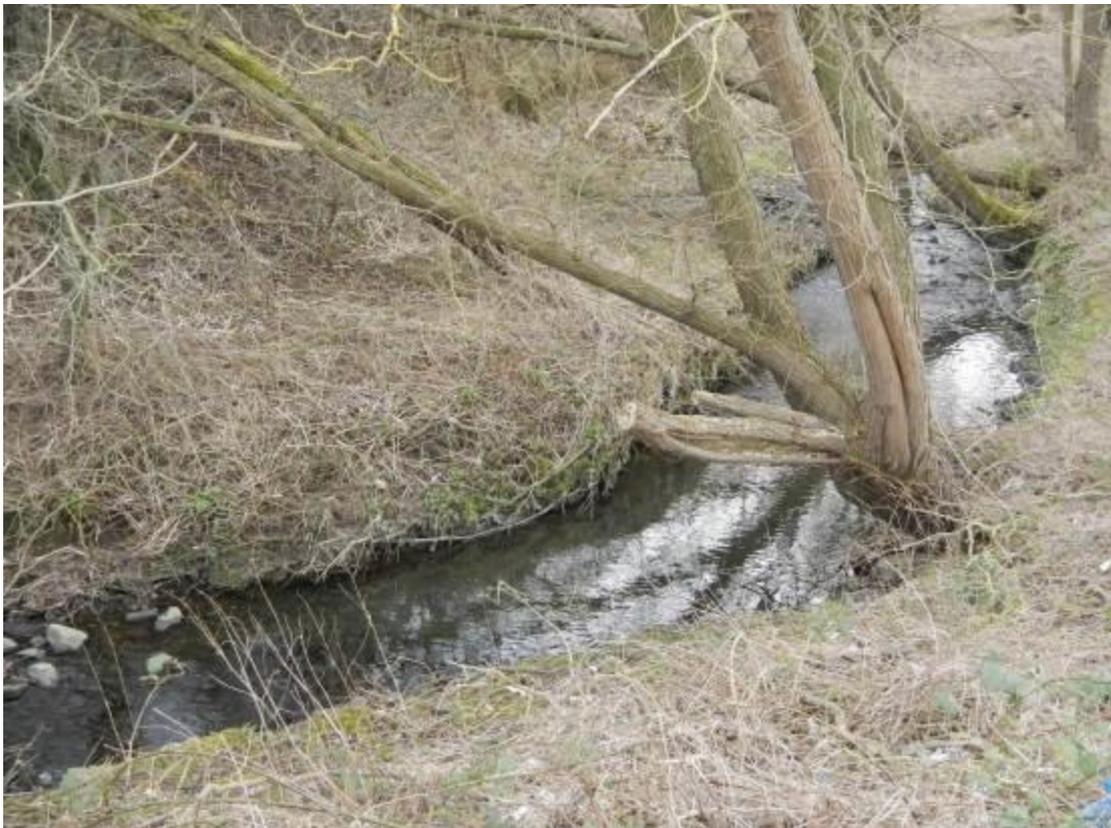
Proceeding downstream, the Burn flows alongside an industrial area and down through Gilpin Wood. There are numerous signs of past tree/channel maintenance in the form of cut stumps and branches (Photo 26). This is likely to have been undertaken by the Environment Agency to reduce perceived flood risk. However, as much of the land in the area is open, at least on one bank, and culverts (Photo. 26) are likely to form the major bottlenecks to any flow; it may be that a more pragmatic approach will prevail in future and beneficial overhanging branches and LWD can be left untouched.

Photograph 26. Cut branches – signs of past channel maintenance.
