Walkover Assessment

Lumley Park Burn – Source to Herrington Burn

River Wear, Co Durham

Date – 18/02/15

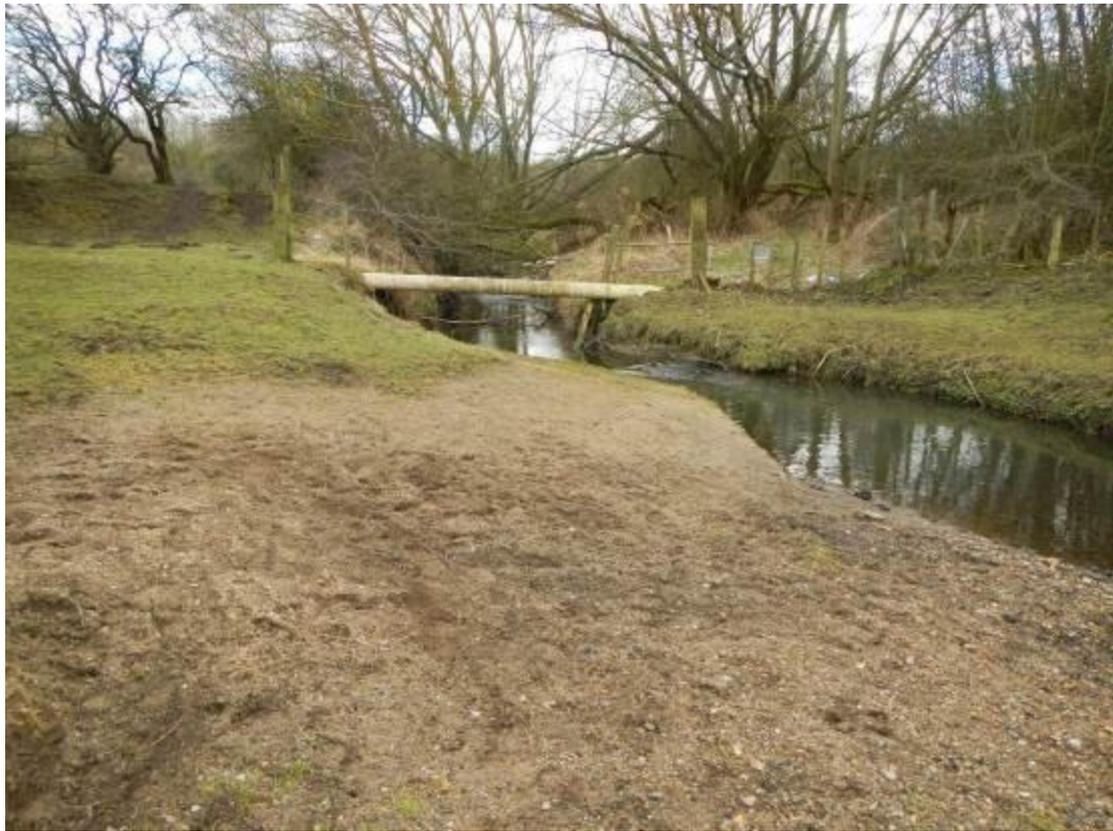
From the downstream limit of the wood (NZ 33249 49396), habitat quality becomes severely degraded by the impact of very intensive horse grazing through uncontrolled access to the Burn for the following 540m downstream to the A1052 (Photos. 29-32). This is undoubtedly one of the most serious areas of impact on the whole waterbody. Habitat is greatly suffering from a significant input of sediment, through erosion and poaching, and through intensive grazing of bankside trees and vegetation, leaving little or no cover.

Photograph 29. Serious habitat degradation through grazing (foreground). A stark contrast to the relatively high quality habitat in the fenced woodland upstream (background).

Table 3. Locations in which fencing should be undertaken	
Location	NGR
Around Photos. 13 & 14	NZ3457448611
Throughout the horse grazed fields (Photos. 29-32 & 34)	NZ3325749399 - NZ3291150306

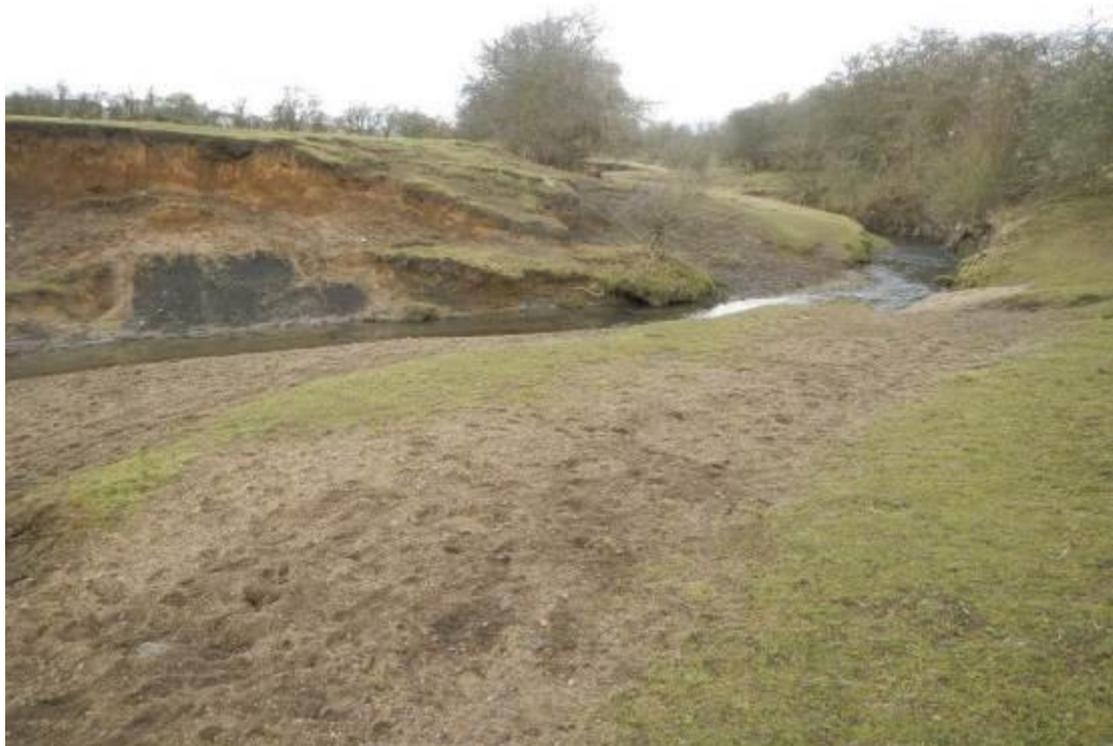
Photograph 30. Severe bank erosion through grazing and livestock (horse) poaching. All vegetation is also grazed almost to death.

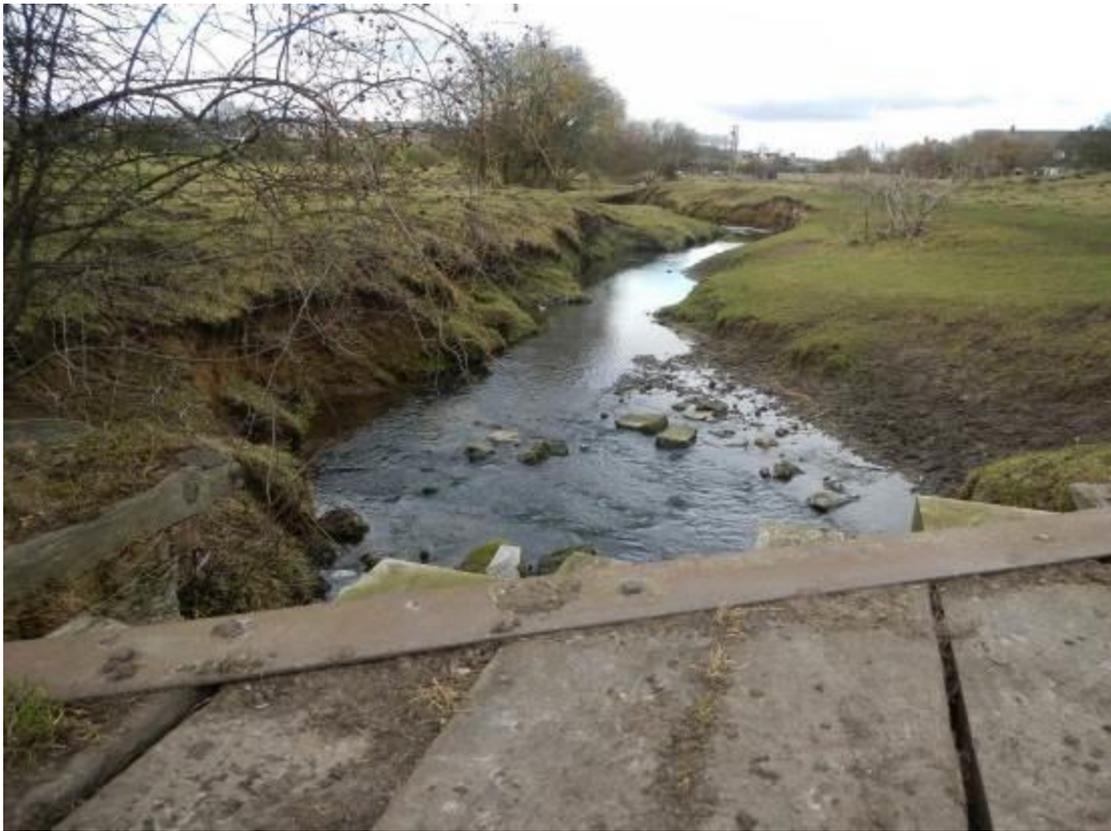
The presence of a railway sleeper bridge approximately half way through the fields would provide stock and human access even if the watercourse were buffer-fenced. The addition of another small access bridge may also be required across the small tributary that joins the Burn in Photo. 32. There may also be issues of deliberate vandalism of any fencing that is installed, to allow grazing of the buffered areas that become established. Much of the grazing already occurring in this area appears to be unconsented.

Photograph 31. Sleeper bridge over the Burn that could facilitate buffer fencing of the watercourse. Note again the serious lack of bankside vegetation.

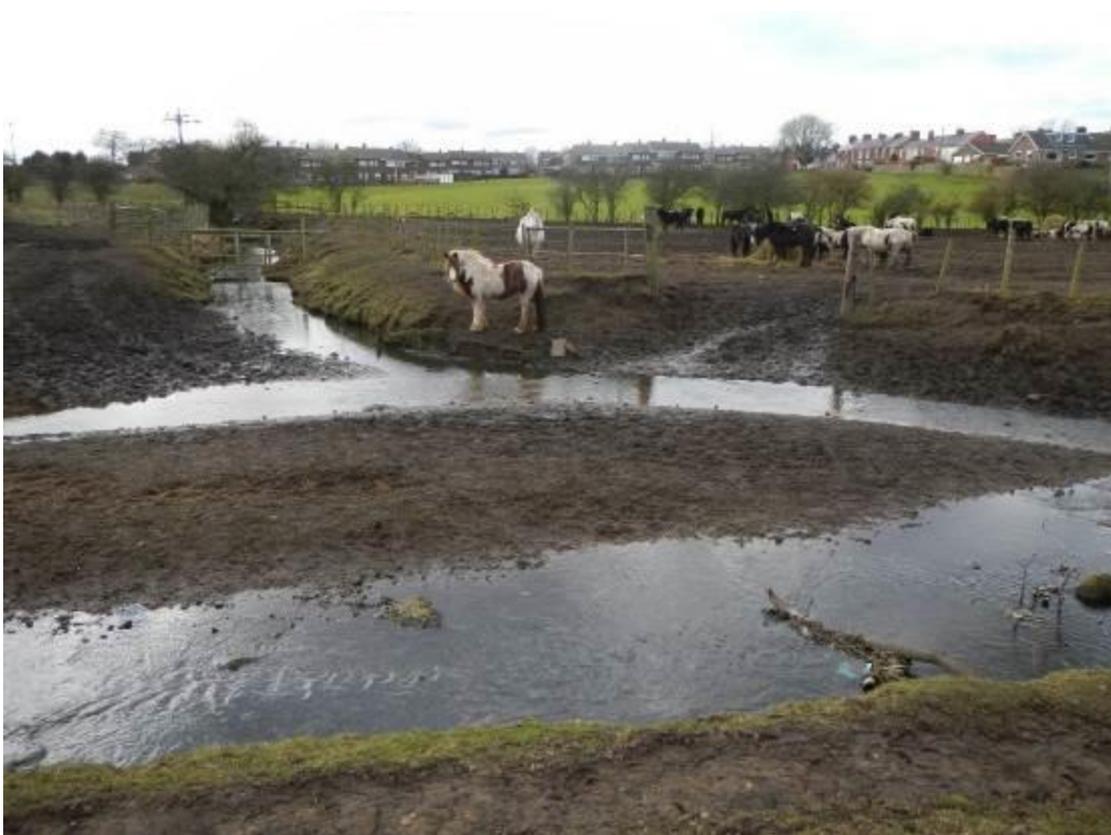
Photograph 32. Significant bank erosion and sedimentation of the watercourse through horse poaching and major overgrazing.

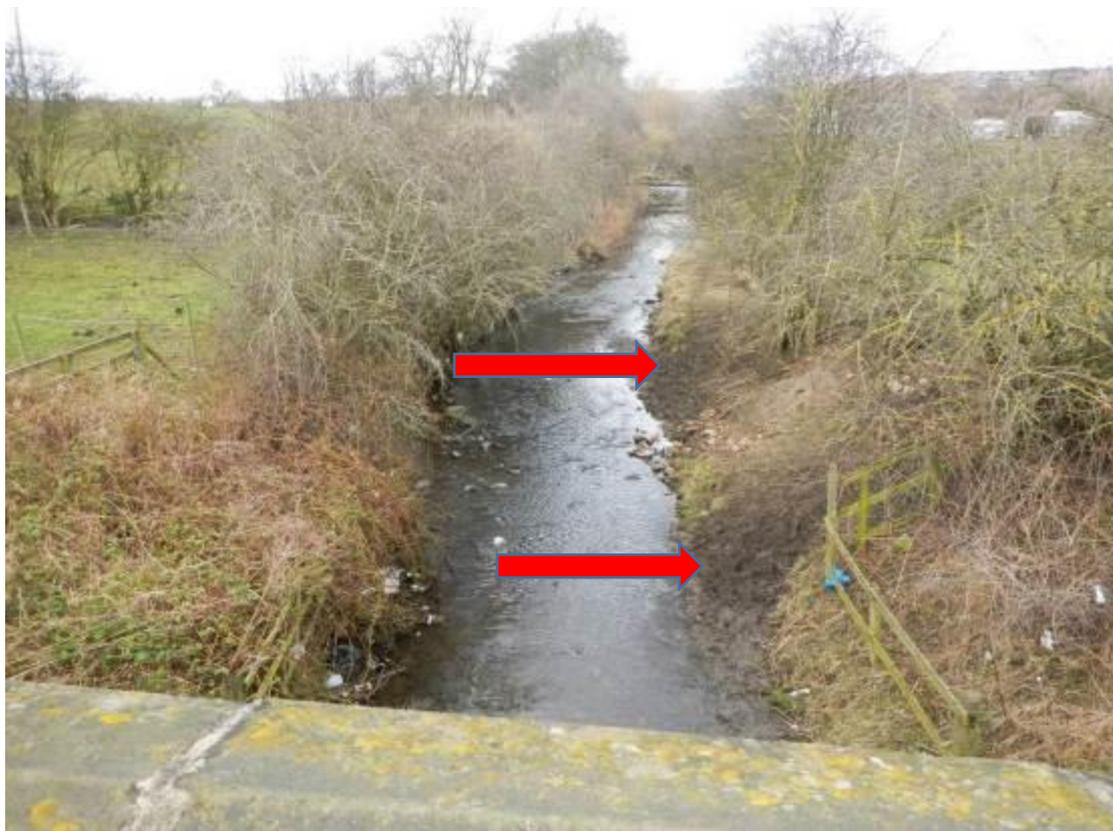
Downstream of the A1052, a short section of the Burn has some degree of fencing, although the protection afforded is minimal as obvious signs of formal access points and livestock grazing/poaching are present, with the fencing in some areas seemingly used as the boundary for an additional grazing unit (Photo. 33). Further downstream, unrestricted stock access to the watercourse resumes and no bankside vegetation remains (Photo. 34).

Photograph 33. Fenced section of watercourse D/S A1052. Livestock grazing and poaching is almost as heavy within the fencing as outside it (red arrows).

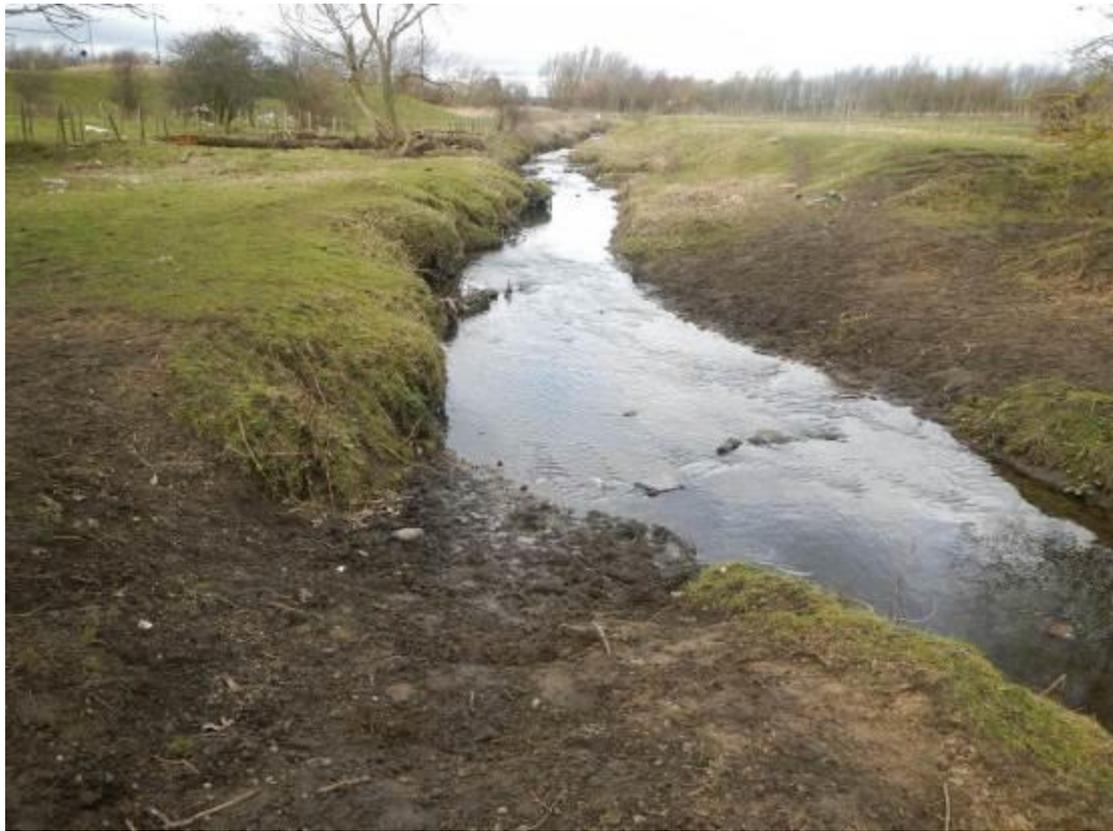
Photograph 34. Uninterrupted horse grazing for the riverbank D/S of the fenced section.

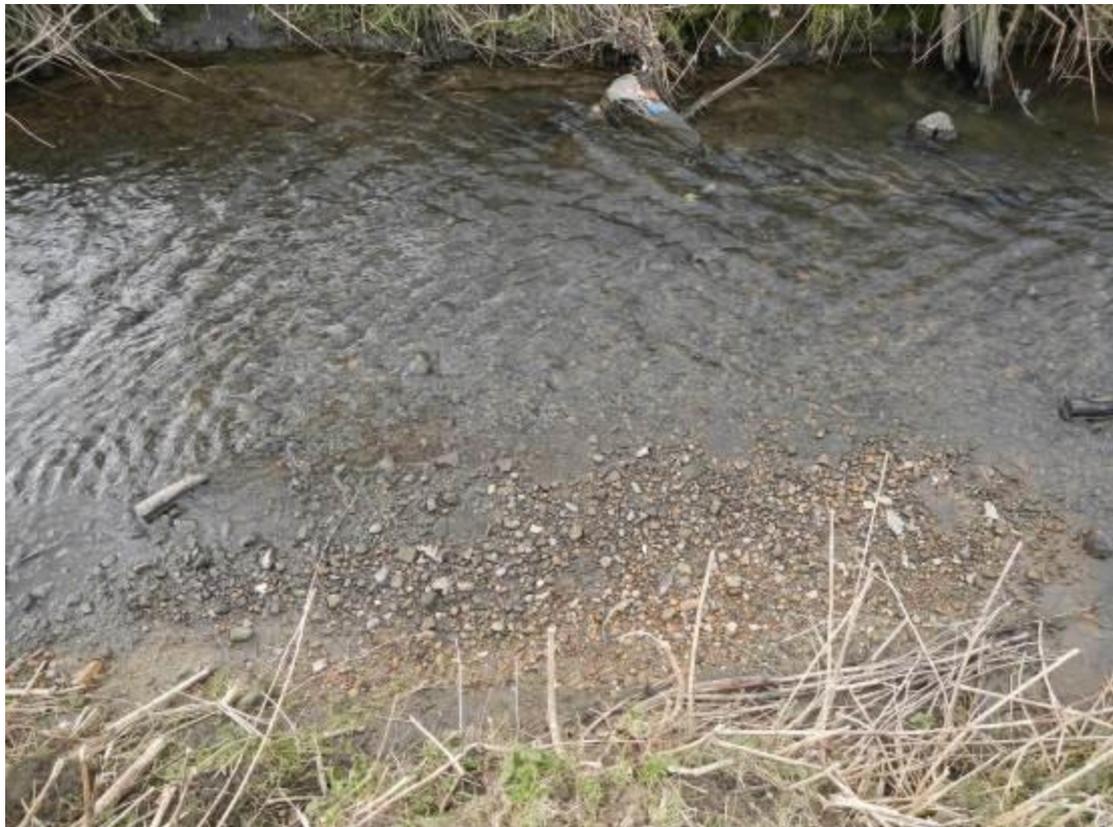
Unexpectedly, gravels of a suitable size for salmonid spawning are present, although they are significantly impacted by the mass sedimentation supplied from upstream to the extent that salmonids are unlikely to attempt to use them (Photo. 35).

Photograph 35. Gravel is present in the grazed area but is so compromised by sedimentation from upstream that it is unlikely to be used by salmonids for spawning.

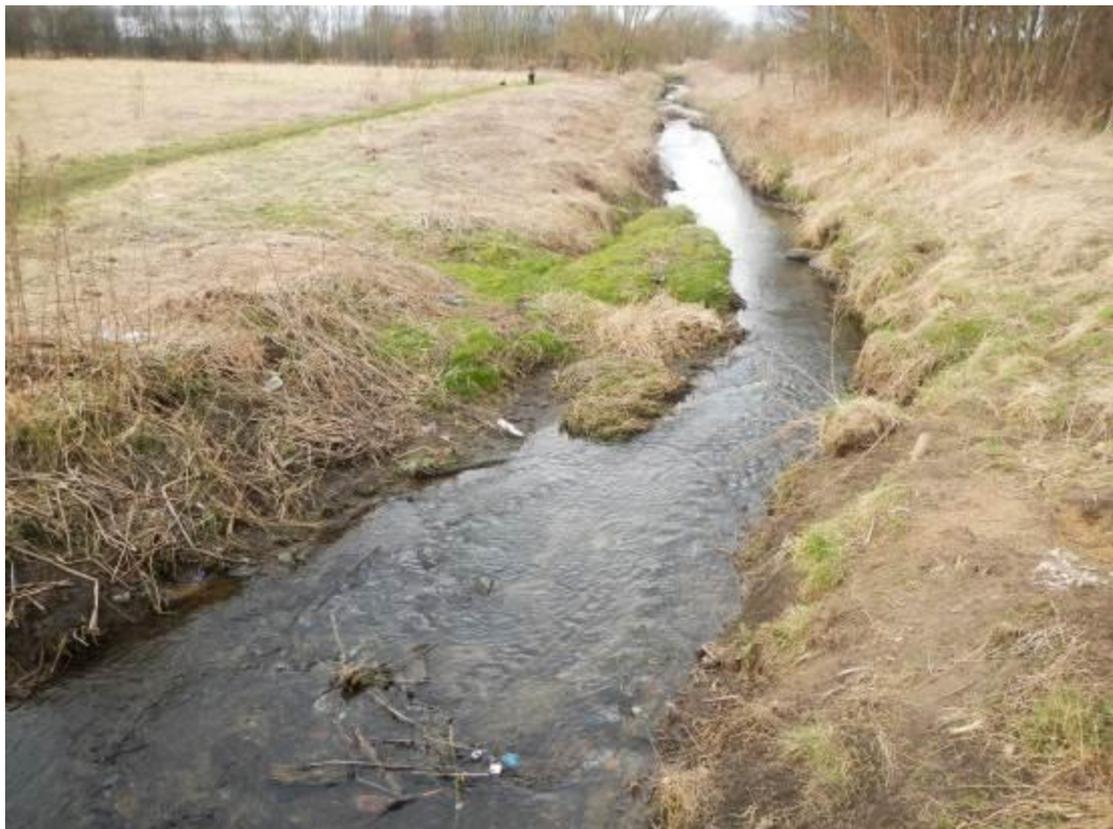
Downstream of the grazed areas, some semblance of bankside vegetation resumes, albeit along a realigned section of the Burn, with a significant lack of habitat variability. Some areas of sediment deposition add a little variation to the channel, but at present are far from sufficient to provide valuable habitat (Photo. 36). If funding were available, the large areas of open, unimproved grassland and alder carr along this reach could be incorporated in a restoration project to re-meander the channel; the enhancement to both habitat quality and aesthetics of the area should outweigh any inconvenience through altering access routes.

Photograph 36. Straightened section of Burn with very poor habitat, although a few natural depositional features are becoming established. This section could possibly be re-meandered if funding were available.

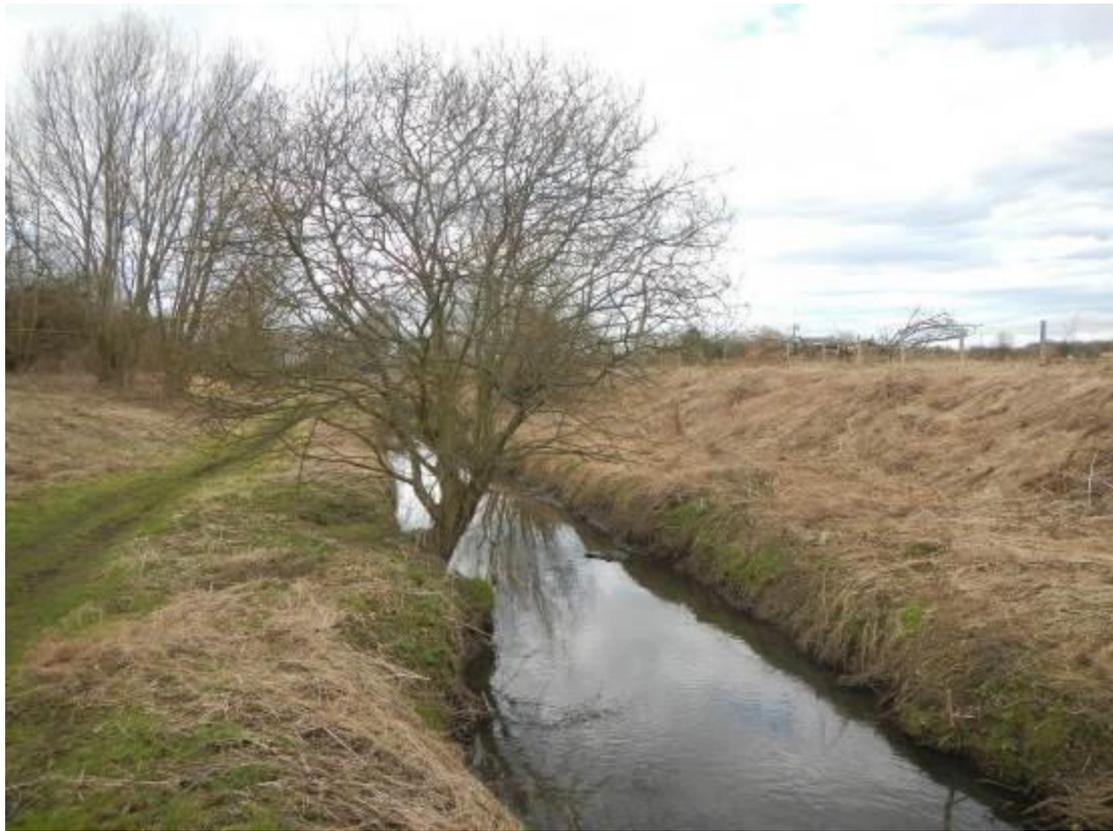
Photograph 37. Uniform, low quality habitat that could be enhanced by planting and laying.

If money is not available in the short-term for a full channel restoration, there are certainly improvements that could be initiated. Habitat along the open banks would greatly benefit from the planting of trees, and existing trees (Photo. 37) could be laid down into the channel to increase structure in the channel, kick-start erosional and depositional processes, and thereby enhance channel morphology. In a similar way, live willow branches and LWD could be installed within the channel. The minimal infrastructure in the immediate area of the channel limits potential flood risk.

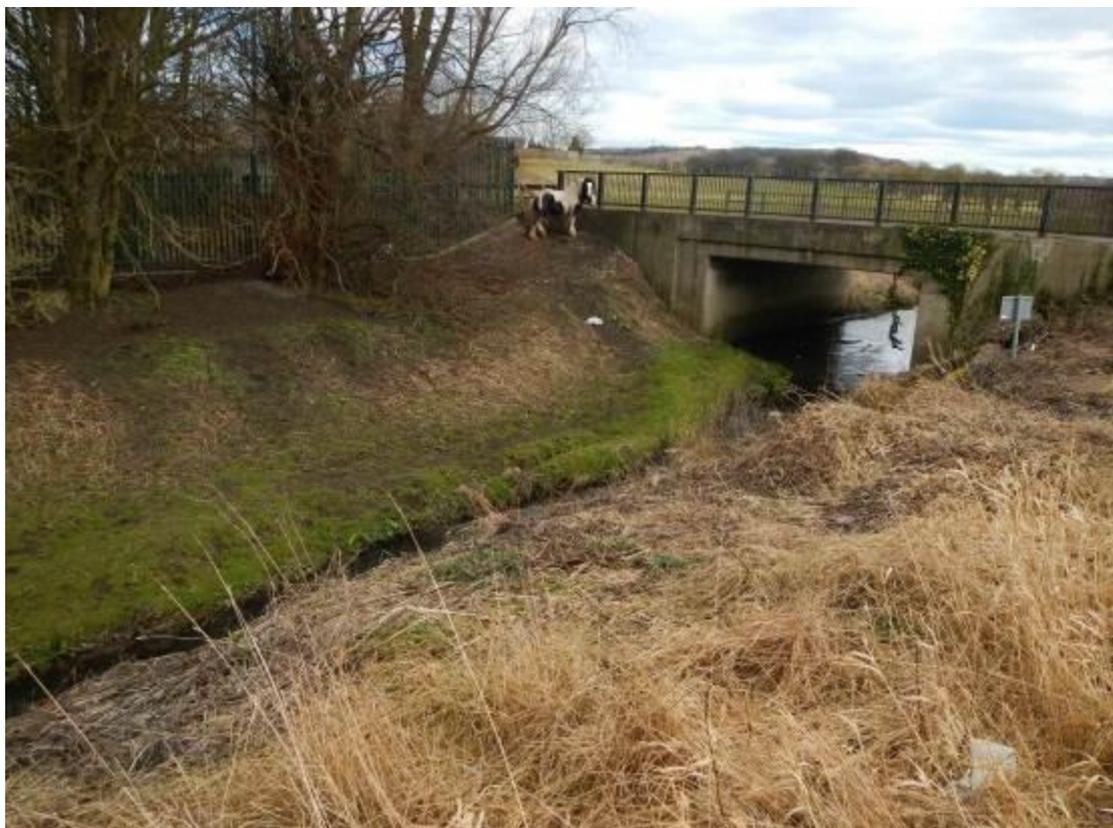
Photograph 39. Unconsented horse grazing on the RB continues for the rest of the waterbody.

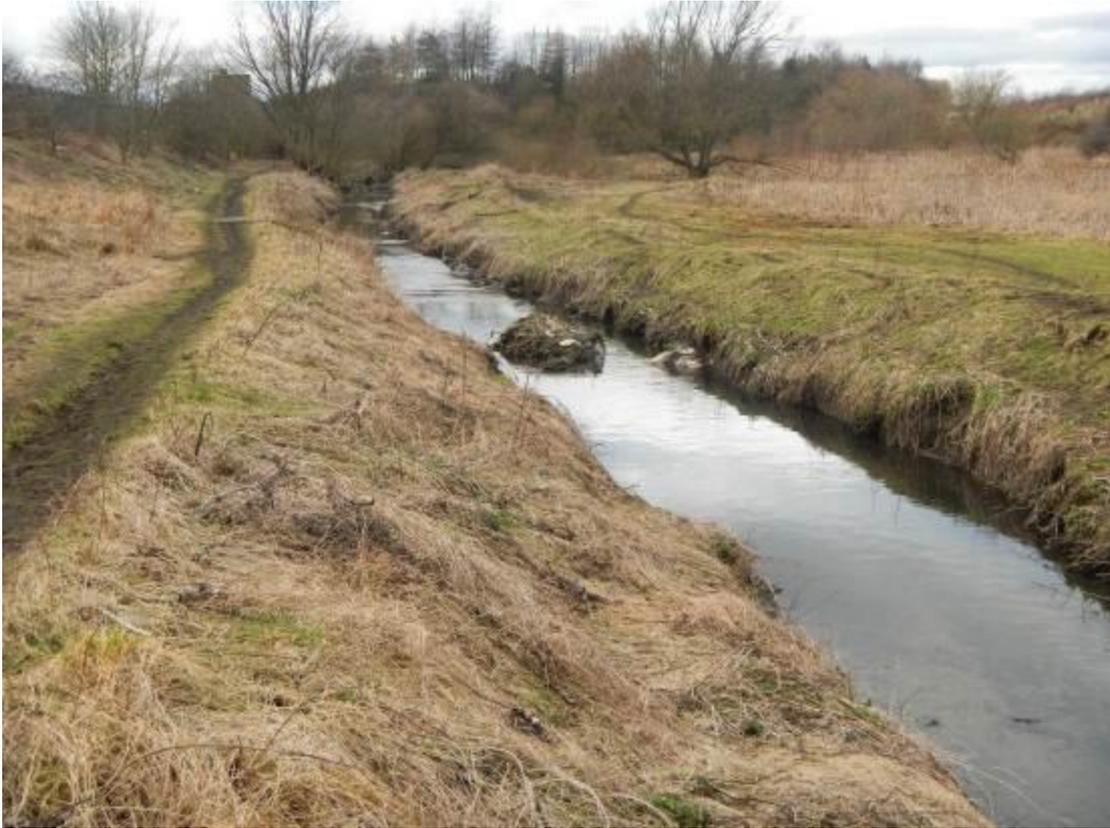
In the lower 350m of the waterbody, there is again potential for a more significant channel restoration project (Photo. 40). In addition to the minor habitat improvements, there is scope for re-meandering of the straightened channel into an area of wetland along the RB. This could reinstate all of the lacking habitat features, at least in that short length. Alternatively, a less beneficial, but worthwhile project could be to, at the very least, lower the RB to allow high flows to enter the wetland area and provide a more natural flow regime within the currently embanked reach.

Photograph 40. Straightened section that would benefit from planting and in-channel structures, including laying willows (background). There may be the possibility of a re-meandering or bank lowering project on the RB to even greater effect.

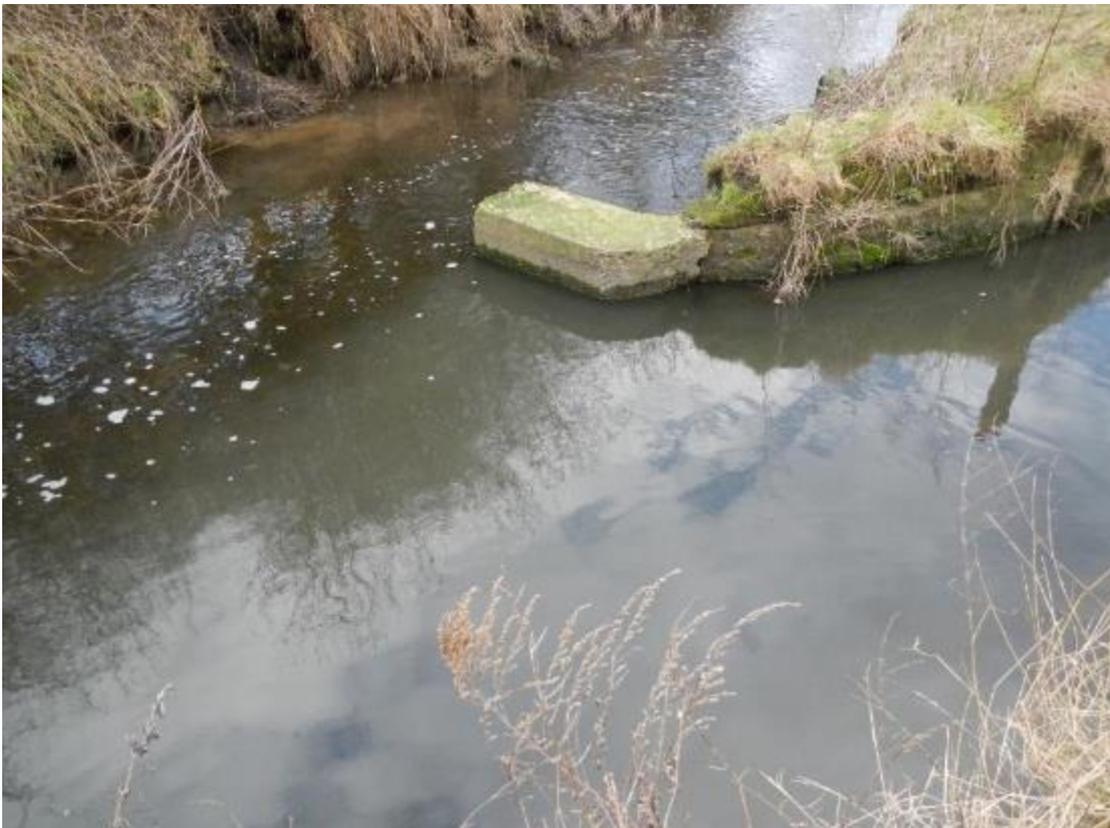
At the confluence of the Herrington and Moors Burns, turbidity in the Moors Burn was considerably greater. This demonstrates the impact that sedimentation occurring on the Moors Burn is having upon waterbodies downstream (Photo. 41).

Photograph 41. The Moors Burn (foreground) carrying notably more suspended sediment than the Herrington Burn.
