Advisory Visit

River Lagan, Dromore, Co. Down

July 2011

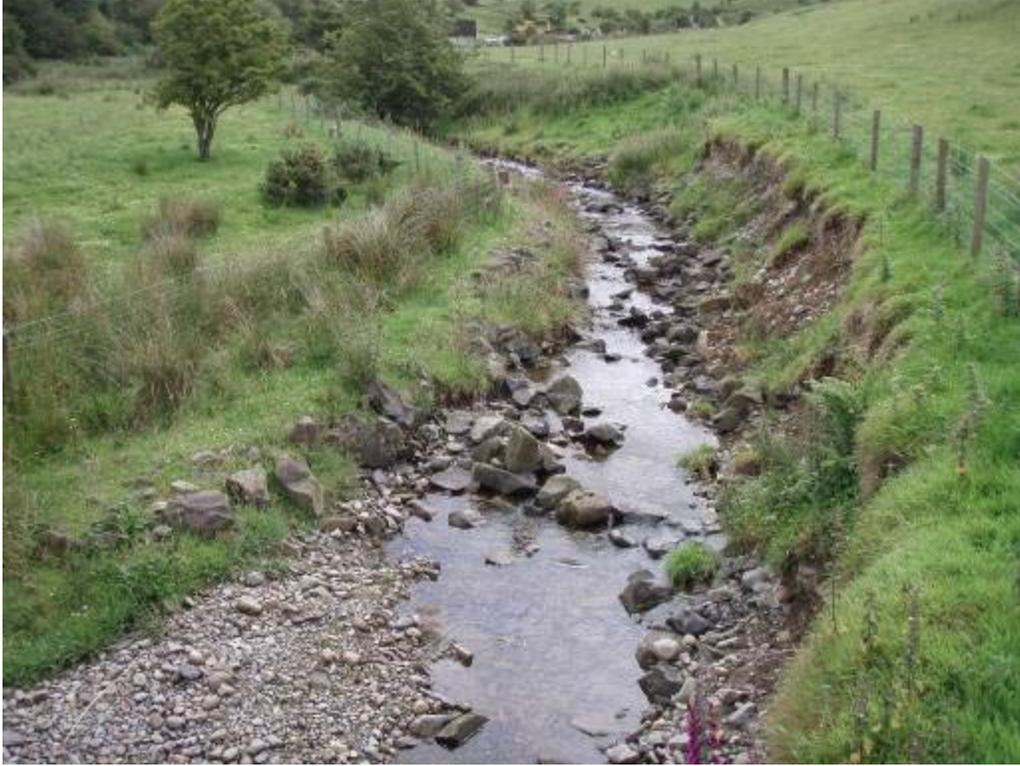
Photo 1

The upper reaches of the river were inspected briefly from the road bridge (Grid Reference NW 39314 02822). The river here was very open with overgrazed banks and little cover from riparian vegetation. Fencing and /or a reduction in grazing pressure is needed to improve the riparian zone. Some fencing had recently been completed just upstream of the road bridge (Photos 1, 2).

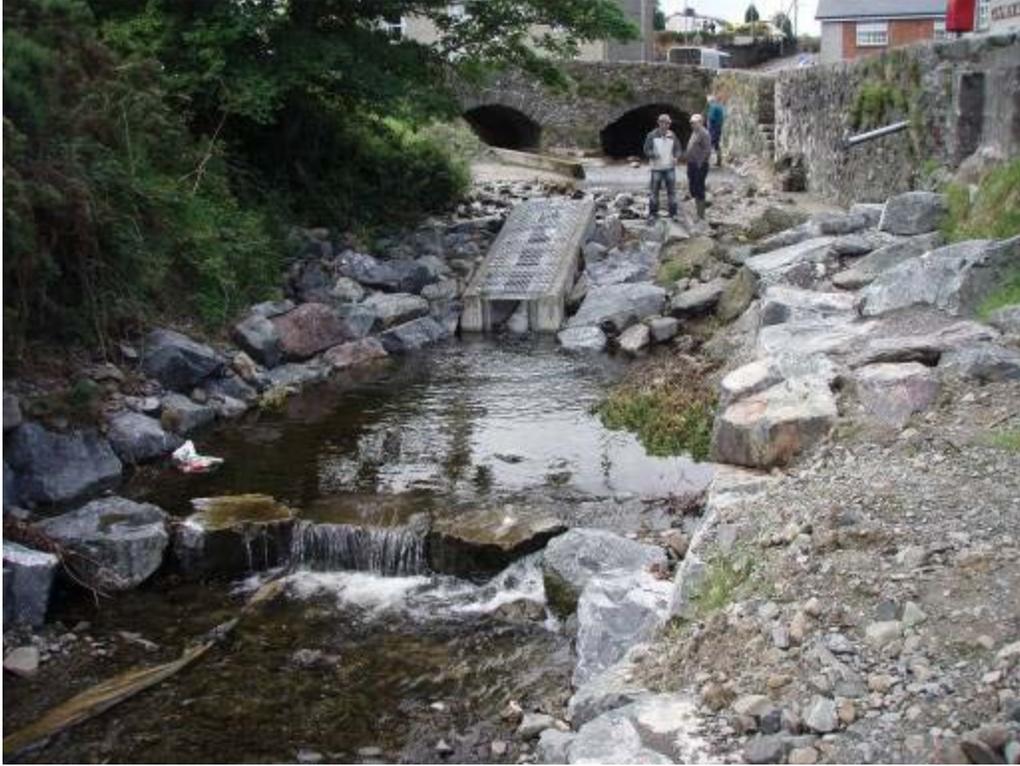
Photo 3

At the next road bridge downstream (NW 38703 03794) there was a recently constructed fish pass just downstream of the bridge culvert. The pass was constructed to improve fish access across a known obstruction and also included works to shore up the left bank downstream of the bridge which was becoming undermined, threatening a property. The works were part-funded by DADAC and carried out by the Rivers Agency with design input by Robert Rosell (pers. comm.). The pass is a baffled, Denil-type and the downstream water levels have been raised by the installation of a rock weir (Photo 3).

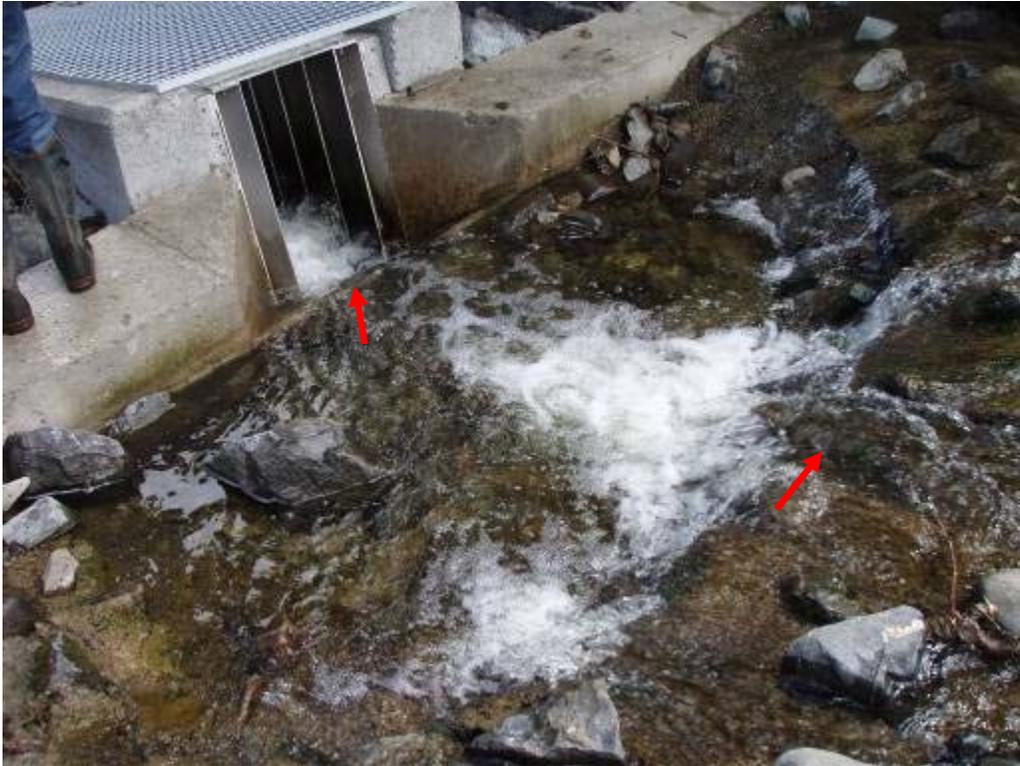
Upstream of the Denil pass there remain some challenges for fish passage and some opportunities for improvement. At the time of the visit (low flow) there was a lip at the upstream end of the Denil (Photo 4) which is not ideal; this will be drowned out at higher flows but removing it would increase the window of opportunity for fish migration. Upstream of this point, mass concrete studded with rocks was present, up to the base of the bridge culvert; a low-flow channel was present within the mass concrete, but it was quite shallow and a lip was present at the downstream end, again limiting the range of flows when fish passage is possible (Photos 4, 5).

Photo 4 Lip at the upstream end of the Denil pass and at the edge of the mass concrete.

The site of the Denil fish pass described above could be improved further by removing the lip at the exit of the Denil pass and improving the low-flow channel through the mass concrete (Photo 4). The main improvement however would be to modify the road bridge culvert by fitting low baffles to the concrete surface. These could be made of a variety of materials, but wooden or pre-cast concrete posts thru-bolted to the culvert base would suffice.

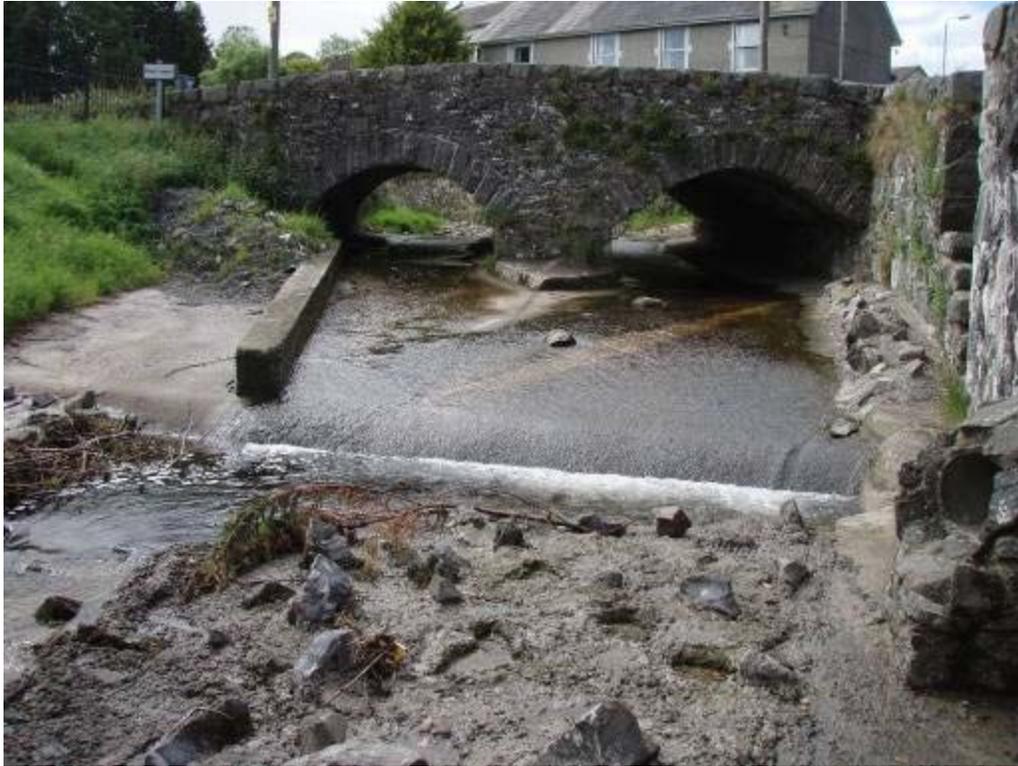
The bridge culvert (Photo 5) remains an obstruction to fish passage because of the shallow skim of water over smooth concrete. High flows are necessary to achieve the depth at which fish could pass, at which point the water velocities over the smooth concrete are likely to become an impediment. It is understood that this problem was not tackled during the fish pass construction project because of the issue of liability for the integrity of the bridge structure if the culvert base was altered. This is a pity, because a very simple solution is possible which would pose minimal risk to the bridge structure. Low baffles bolted (or cast) onto the concrete base to concentrate and slow flows would solve the problem (see Recommendations section).

Photo 5 The bridge culvert remains a challenge for migrating fish

The aim should be to concentrate low to medium flows through one arch of the bridge by constructing a low fillet across the entrance to the other arch; this would overtop in flood flows. The fillet could be wedge-shaped (pointing upstream) to allow trash to wash over the top in high water. Photo 24

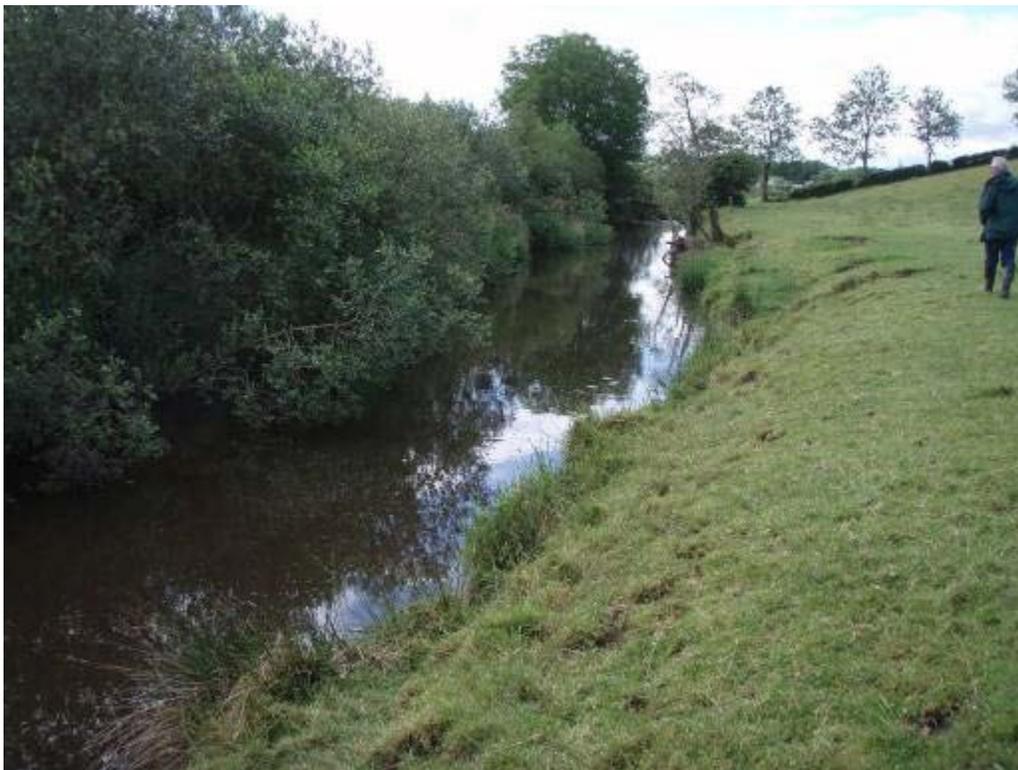
The left bank upstream of the bridge, in contrast to the right bank, is grazed pasture and has a poor quality riparian zone (Photo 6). The banks are steep, possibly because of previous land drainage works, and there is little vegetation present other than grass. The grazed banks do however provide easy access for angling. Some temporary (electric) fencing could be utilised here to reduce grazing pressure on a marginal strip and encourage better riparian habitat; allowing grazing for short periods would keep vegetation in check and maintain angling access.

Photo 6 Contrast between the grazed and ungrazed banks upstream of Black Bog Road

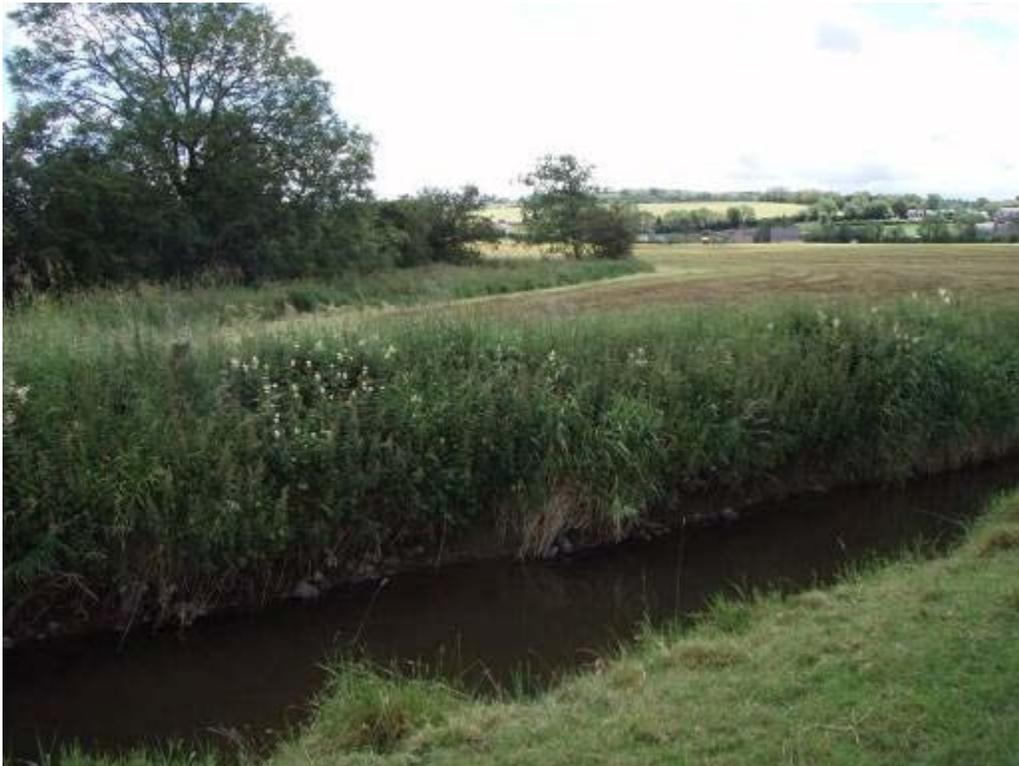
The Lagan upstream of the Little Lagan has a steeper gradient than downstream and is noted as being a prolific area for the production of juvenile trout. Land use alongside the river here was silage production and slurry spreading following the first cut was taking place (Photo 8).

Photo 8 Land use at the Lagan / Little Lagan confluence

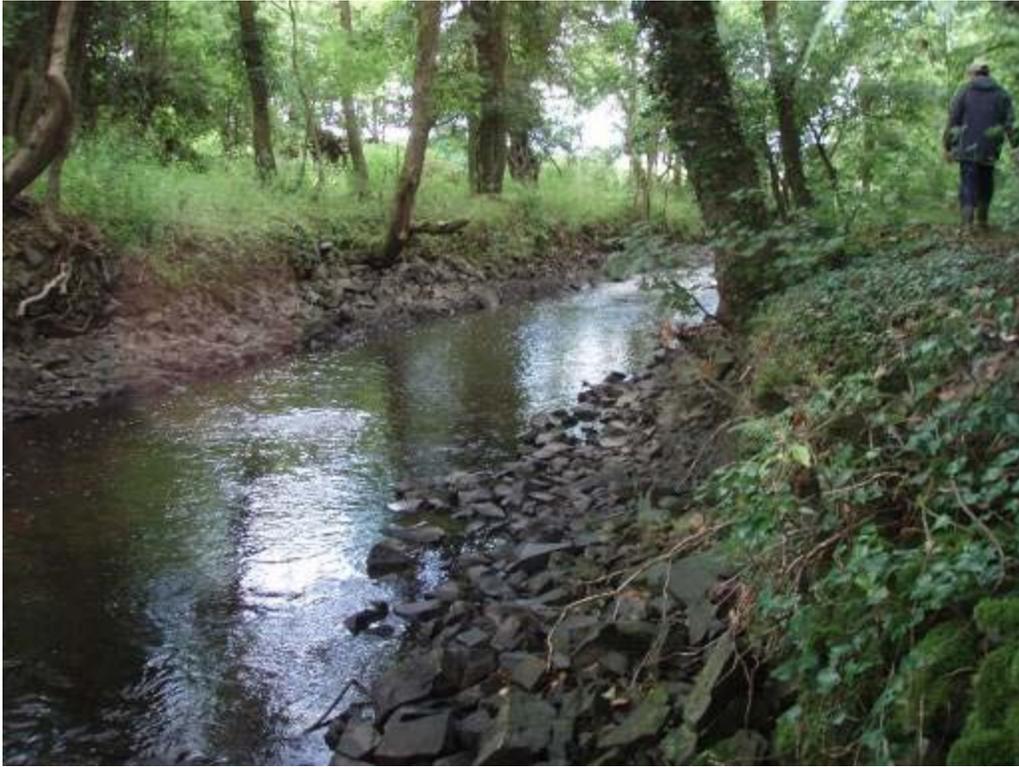
Downstream of Black Bog Road bridge the river occupies what appears to be an engineered channel with a trapezoidal cross-section, a large spoil bank on the left bank and the water level low in the channel (Photo 9). These appear to be the remnants of an impoundment and old mill race (behind the LHB spoil bank). The impounding weir has recently been bypassed; a meander has been cut off and the river diverted into a short section of new channel (Photo 10). This was done in order to reduce flooding of land adjacent to the now dry meander and has effectively removed the impounding effect of the weir.

Photo 9 Downstream of Black Bog Road. Lowered water levels following bypassing of the weir (below).

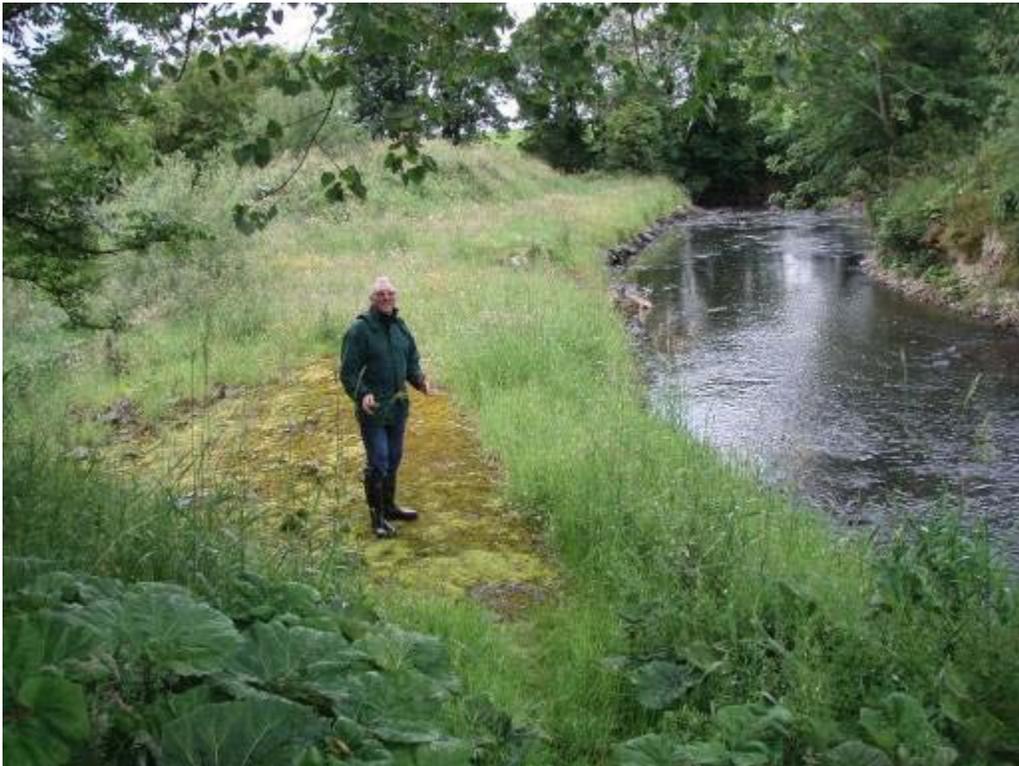
Photo 10 Former weir. Flow previously spilled over the concrete sill and away to the left of the picture, following a meander which rejoined the river in the background. The visible (wet) channel is the new cut.

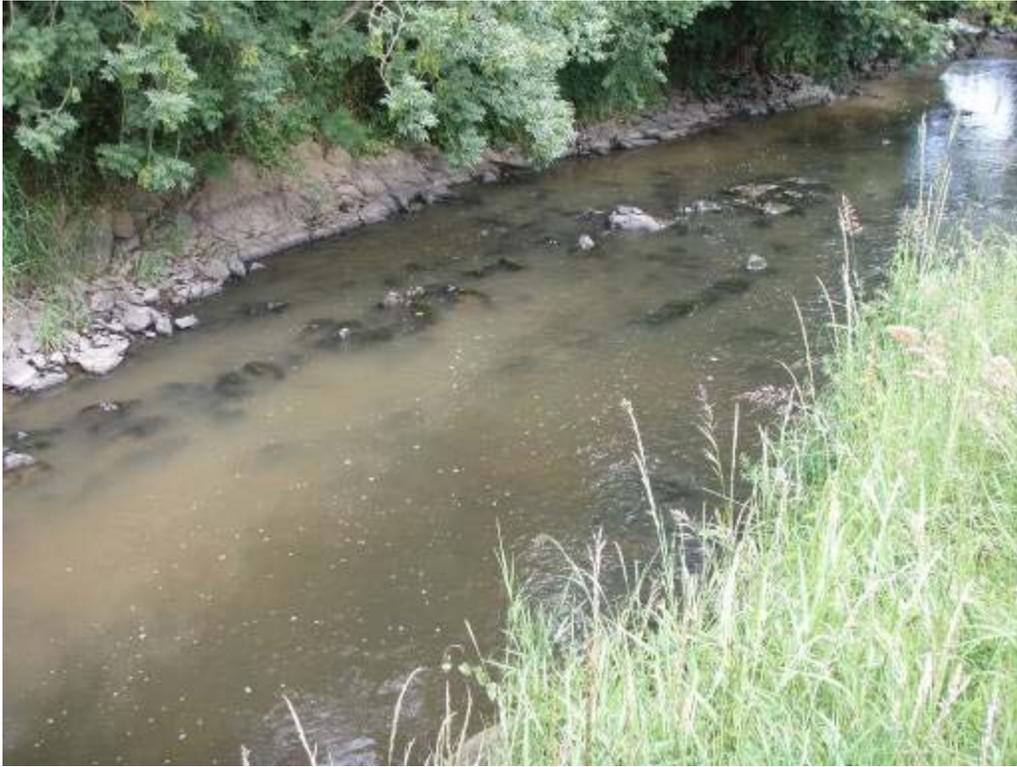
On the right bank of the river here (NW 35469 08014) there was a discharge to the river from a quarry. The discharge was discoloured and carrying

suspended solids which were visibly affecting the watercourse for approximately 40 metres downstream (Photo 11). The input of sediment from quarry drainage and also from the washing down of roads (which sluices fine sediment into surface drains and hence the river) in the vicinity of the quarry continues to be a cause for concern to DADAC. Fine sediment clogs gravels and impacts upon the survival of trout and salmon eggs and upon invertebrate communities.

Photo 11 Discolouration resulting from the discharge of quarry drainage to the river

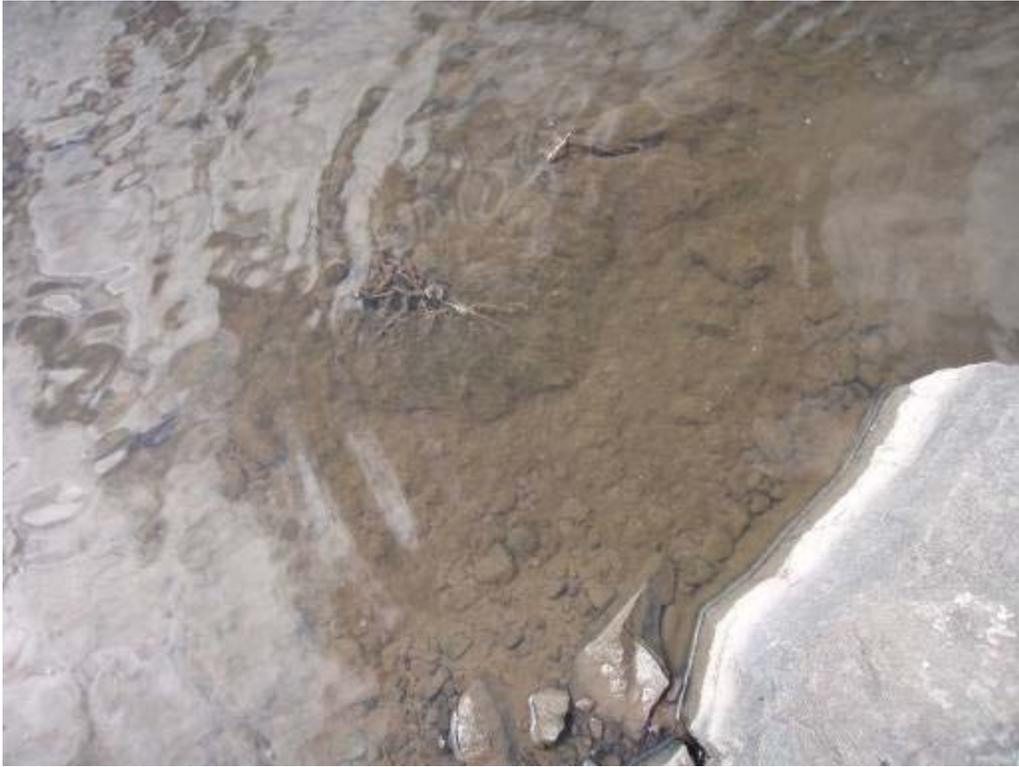
The river bed is covered with a film of algae which has trapped very fine sediment which is released in clouds, discolouring the water when disturbed (Photo 12). Stone turning revealed olive nymphs (Baetidae), blackfly larvae (*Simulium* sp.), shrimp (*Gammarus pulex*) and freshwater limpet – all moderately tolerant of organic enrichment. The presence of algae and the composition of the invertebrate fauna strongly suggest that nutrient enrichment is a problem in this catchment, probably originating from agriculture and domestic effluents. It is recommended that a detailed analysis of nutrients and sediments is carried out to determine which sources are the major contributors, so efforts to tackle them can be effectively targeted.

Photo 12 Diatomaceous algae and fine sediment coating the river bed

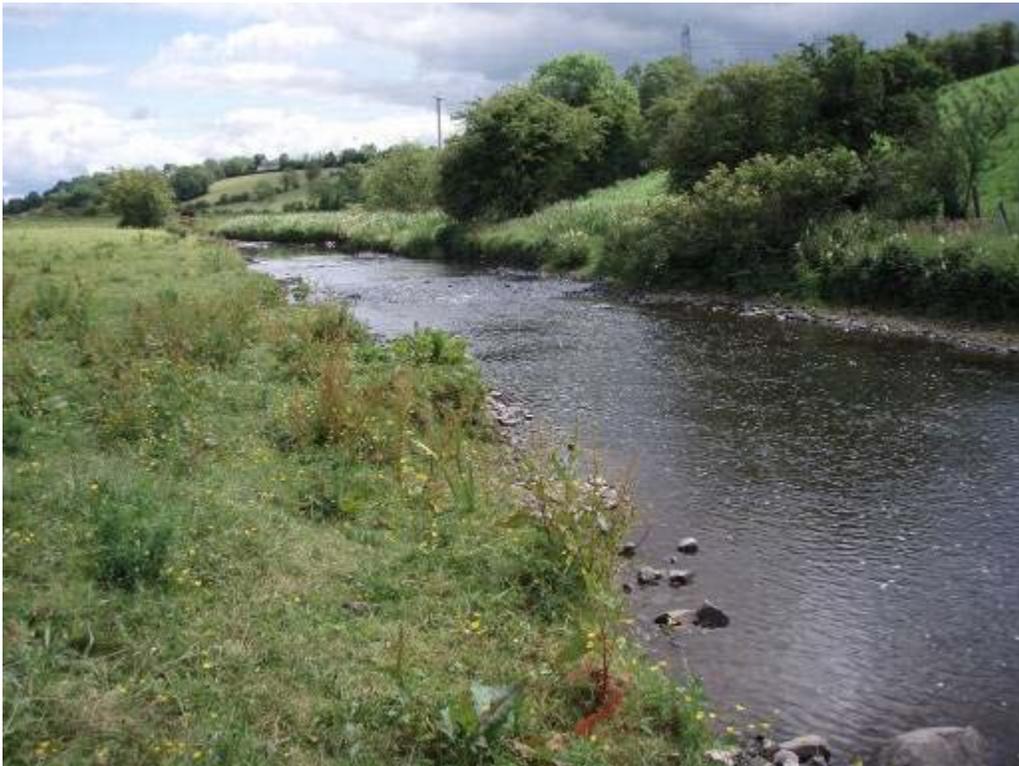
The lower end of this section of river is grazed by horses which have access to the river and there is a poor riparian zone (Photo 13). By contrast,

Photo 13 Grazed section of river

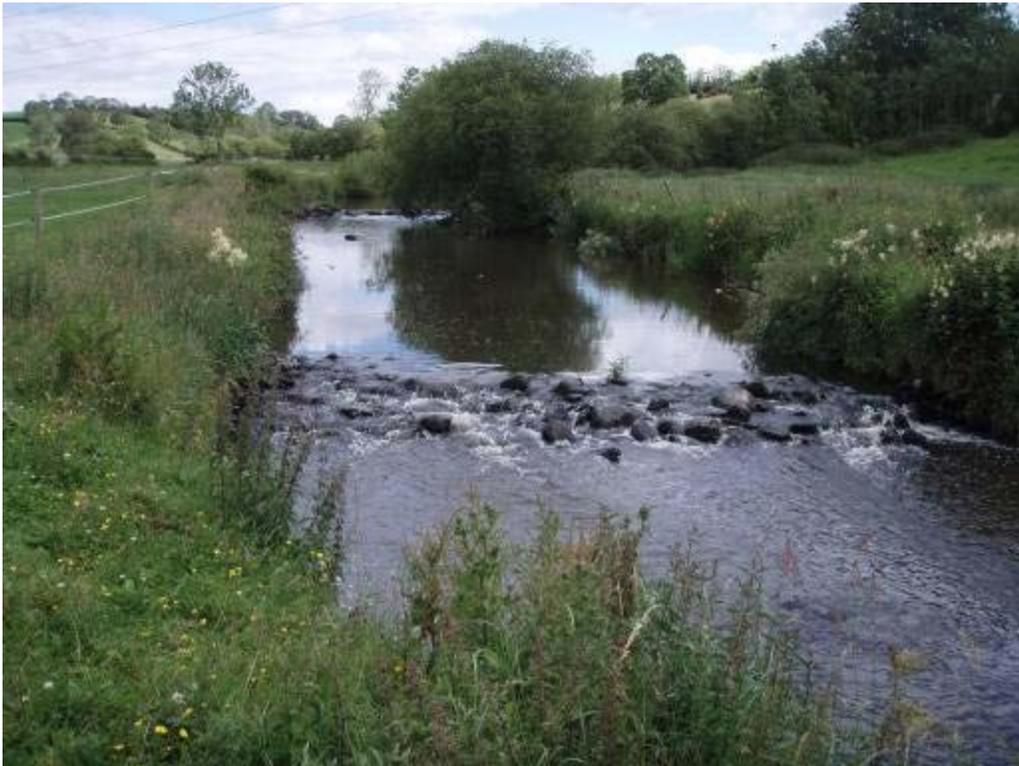
further upstream, electric fencing is present and the margins are well-vegetated with long grass, meadowsweet and some low willow trees (Photo 14). Some low stone weirs have been installed and at the head of the section some in river works have been completed by DADAC to relieve overgrazing and protect the banks; an island has been created and some very nice habitat has resulted with a good variety of depth, flow velocity and well-sorted bed substrate.

Photo 14 Better riparian vegetation behind the electric fence

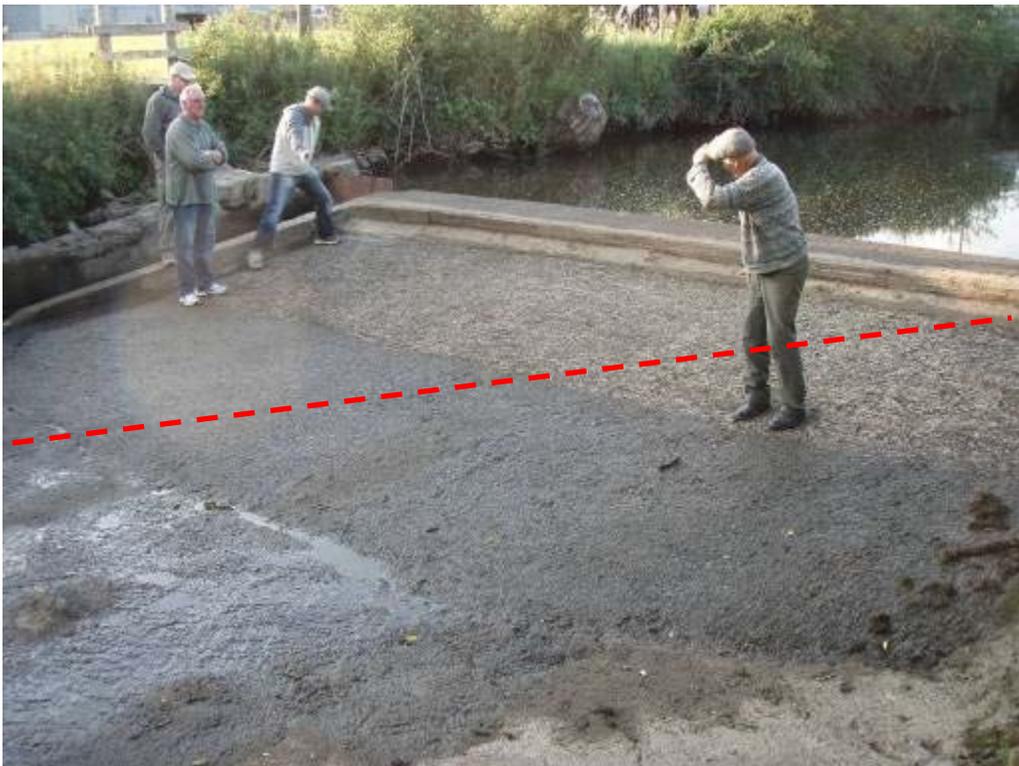
Downstream of Blacks' a visit was made to an impounding structure across the river that supplied water to a flax mill museum. Fish have been observed struggling to ascend the the weir and sluice in the autumn, getting stuck below the lip along the crest of the weir. Advice was provided to the weir owner on how to construct a simple easement to allow fish to cross the weir (Photo 15).

Photo 15 Flax mill weir. Install a baulk (of similar dimensions to the lip on the weir crest) along the line indicated to concentrate flows on the weir face. Notch the crest of the weir at the head of the baulk.

Advice has already been provided separately for improving fish passage at the weir near the flax mill downstream of Blacks (Photo 15). Either a baulk or low-cost baffle easement were suggested and details can be found in the Environment Agency (England and Wales) Fish Pass Manual (pages 144 and 151).

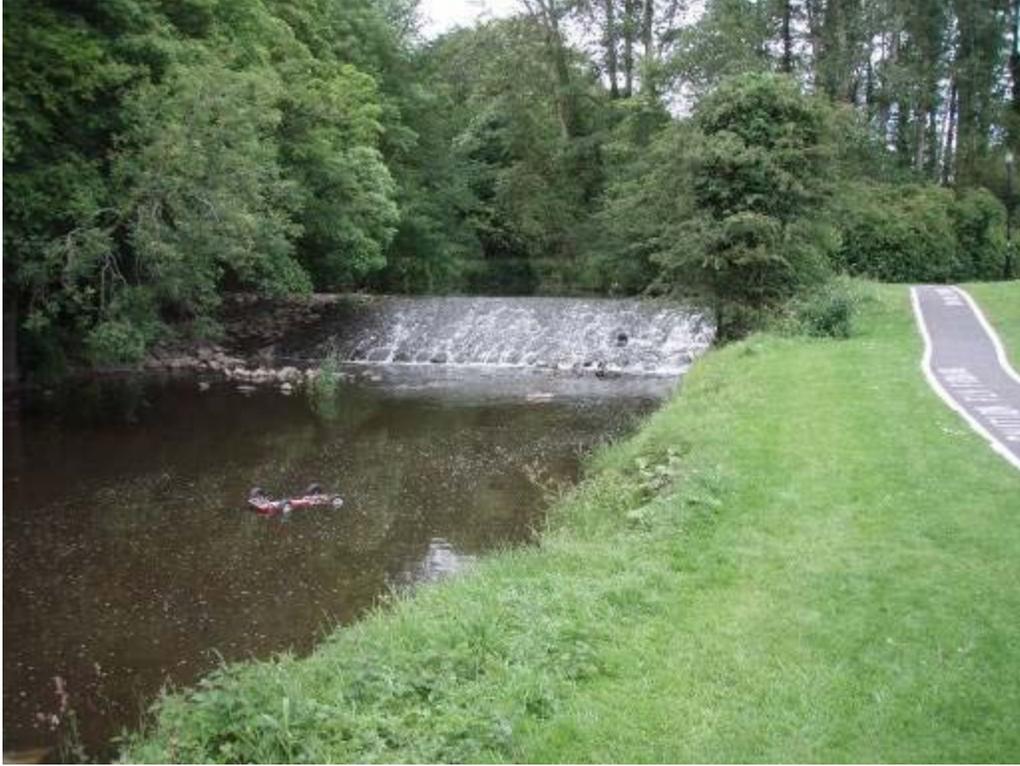
In Dromore the river flows through a public park where it is impounded by a large weir with a head difference of approximately 2 metres (NW 30421 09959). The weir is a redundant structure with the former leat upstream now blocked off. This is a substantial barrier to fish migration, although it is reported that bigger fish (including salmon) have been observed crossing the structure in high water by swimming over the right hand side of the weir which has a rough, rocky surface.

Photo 16 Weir in the park in Dromore

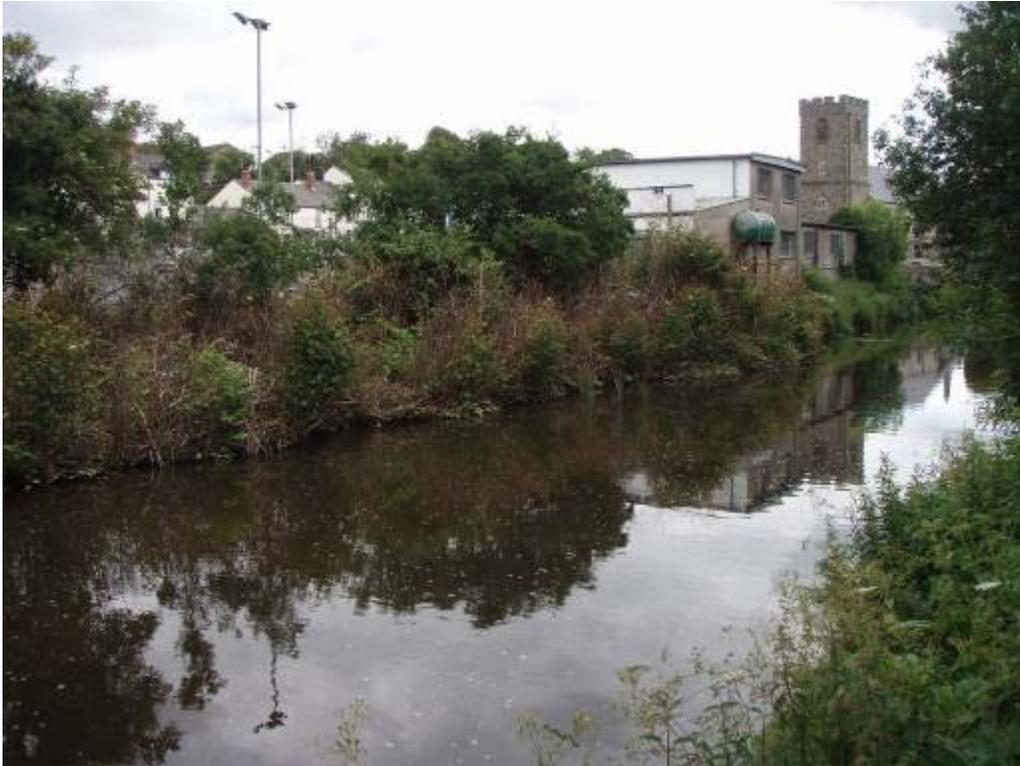
The deep, slow section upstream of the weir extends upstream into Dromore. There are substantial stands of Japanese knotweed here, particularly along the right bank. This is an invasive non-native plant and gives cause for concern because of its proximity to buildings and a car park. The plant is extremely persistent and has the ability to spread underground via runners then grow up through hard surfaces like tarmac and concrete. Further information on the plant and appropriate control methods can be found at www.doeni.gov.uk/niea/japanese_knotweed-commonly_asked_questions_2.pdf.

Photo 17 Impounded section upstream of the weir with stands of Japanese knotweed

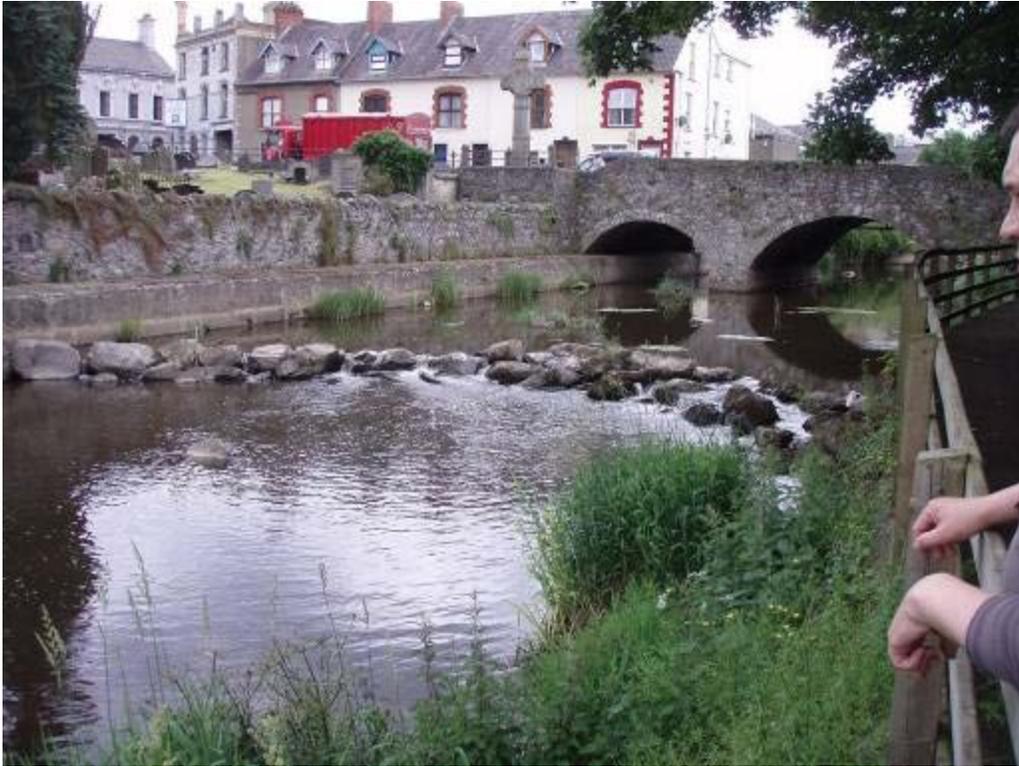
Photo 18 Boulder weir installed by DADAC to maintain water depths

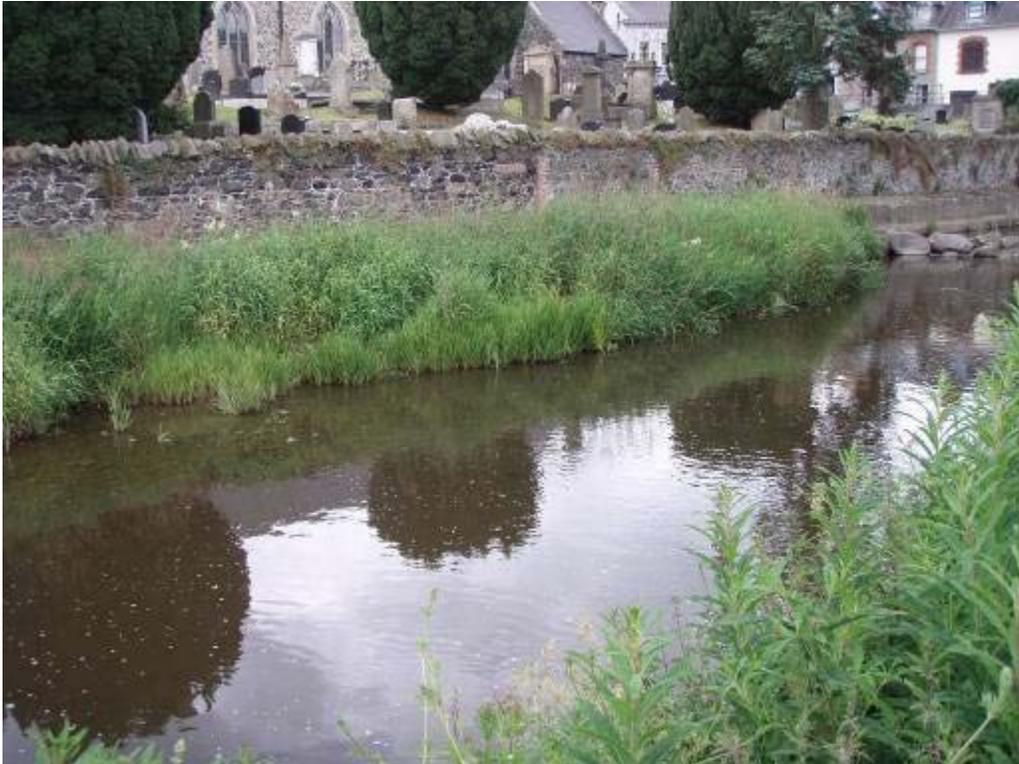
Photo 19 Vegetated berm

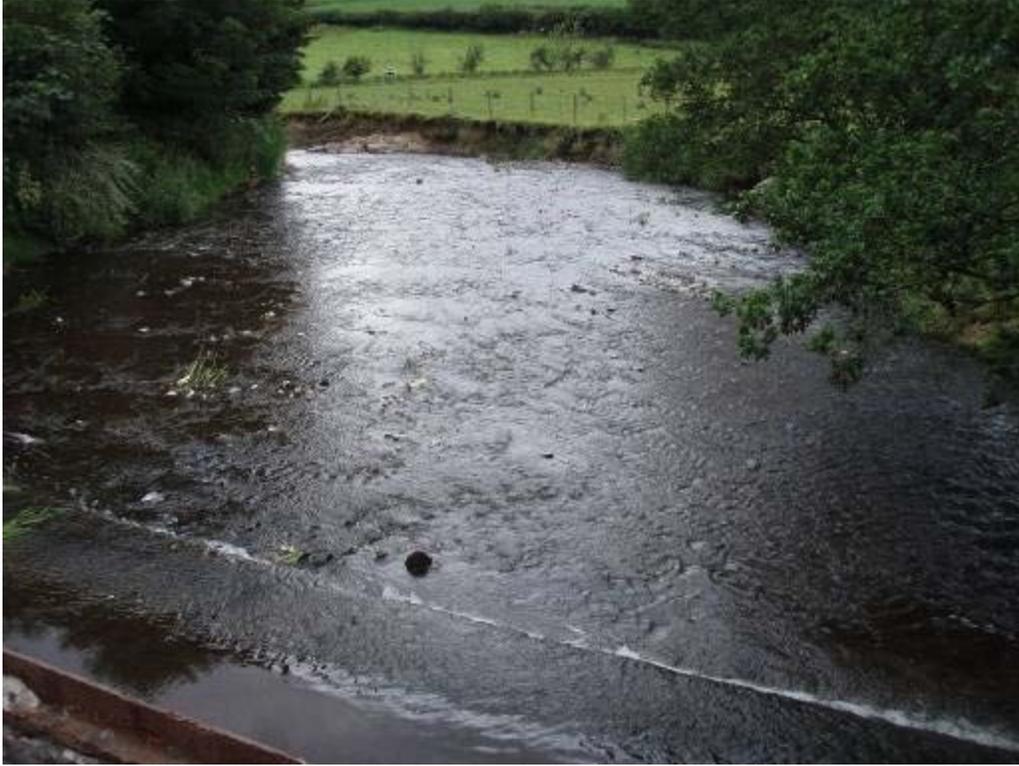
Just downstream of the bridge to the Angling First site, a large gravel shoal had been recently removed from the river by the Rivers Agency for flood defence purposes (Photo 20). The rationale for its removal is debatable given the control on flow at this point exerted by the aperture of the bridge culvert itself.

Photo 20 Site of gravel shoal removal

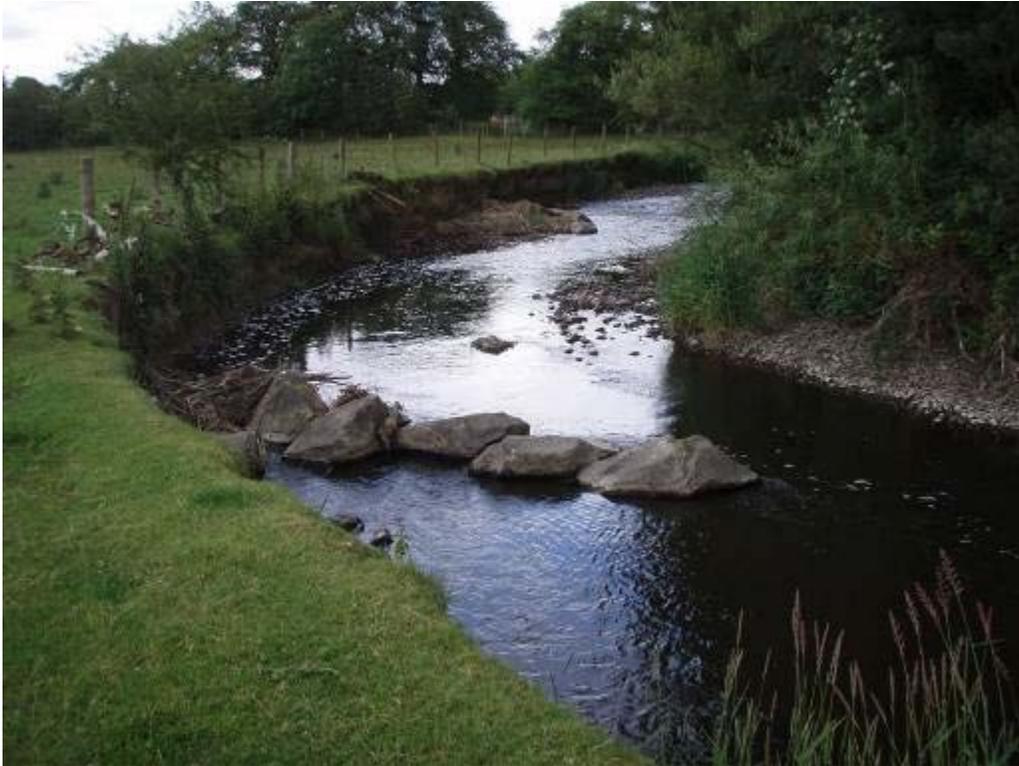
Just downstream the right bank is experiencing accelerated rates of erosion because of grazing pressure on the adjacent land (Photo 22). Two stone flow deflectors have been placed against the right bank here and these are pointing downstream; as such they will overtop and exacerbate erosion on the left bank in this location (Photo 21). It is recommended that these are removed and soft revetment and a wide fenced margin is installed.

Photo 21 Downstream-pointing flow deflectors tend to cause adjacent bank erosion in high flows

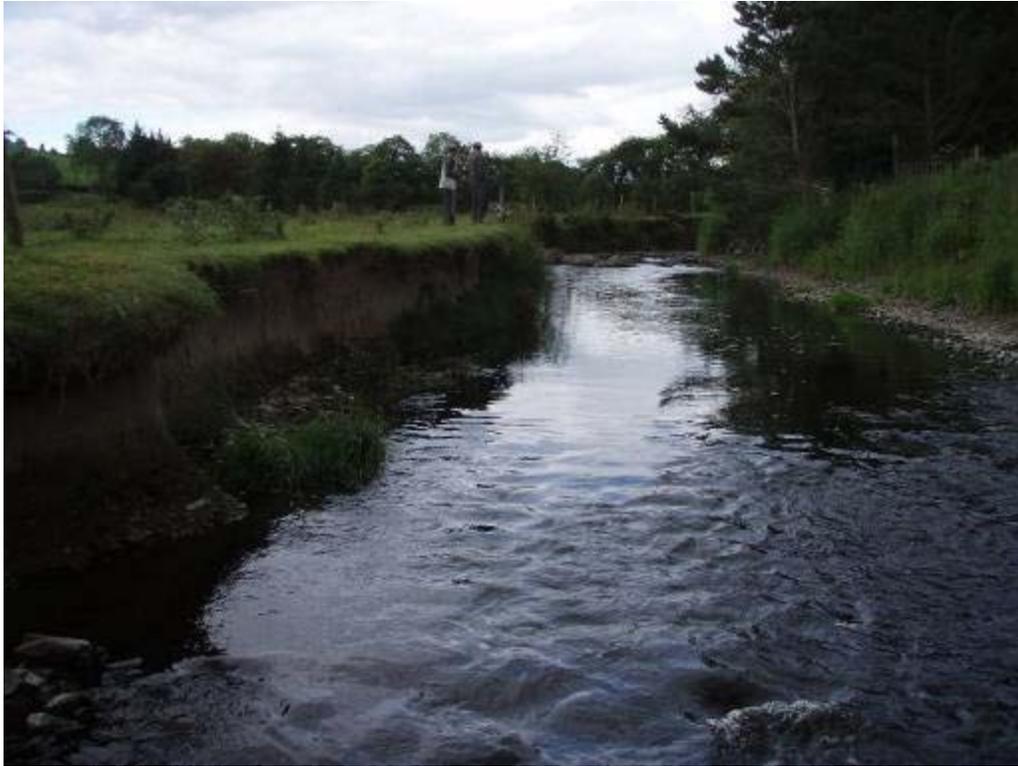
Photo 22 Accelerated rates of bank erosion

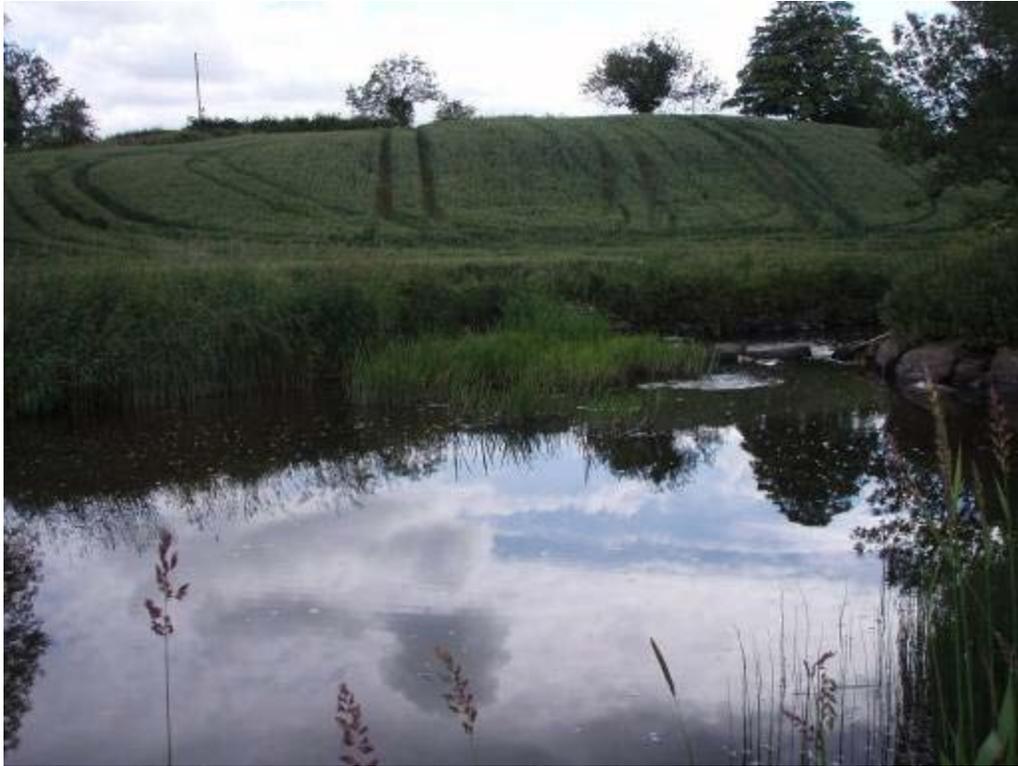
Photo 23 Agriculture on a slope immediately adjacent to the Lagan with little to buffer the river from effects of fertilisers or sprays.

Practical measures which reduce the impacts of diffuse pollution from agriculture include the establishment of a vegetated buffer strip (as wide as possible – at least 3 metres and better if 5 - 10 metres) alongside watercourses. This will help to slow the rate at which dissolved nutrients enter the stream over fields, as long as the buffers are not bypassed by ditches or drains. Including access gates for seasonal grazing by livestock is ideal for achieving a diversity of plants and animals within the buffer strip and maintaining access.

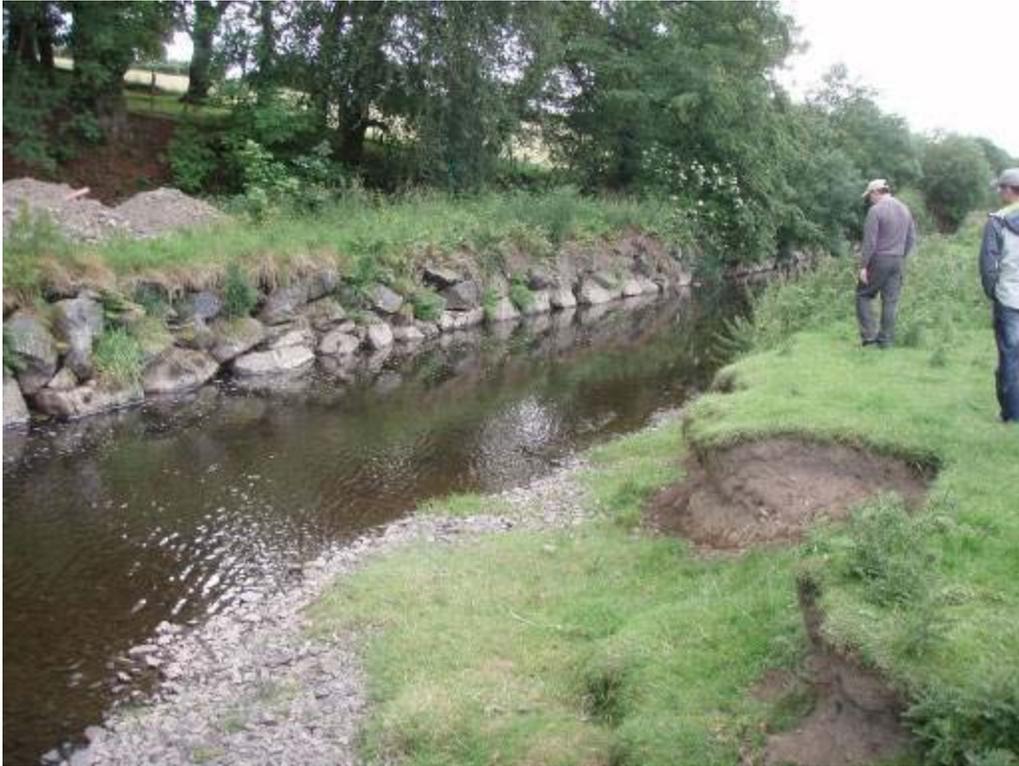
A number of areas along the river have structures made of block stone, including low weirs (Photo 14), flow deflectors (Photo 21) and bank re-inforcement (Photo 26). Whilst stone is the right choice in some circumstances, the use of softer materials such as brushwood, Christmas trees and root wads can achieve similar aims and also provide much better in-stream habitat. The WTT's Upland Rivers Habitat Manual provides detailed guidance on these techniques and can be downloaded from the publications section at www.wildtrout.org.

Photo 26 Stone bank revetment

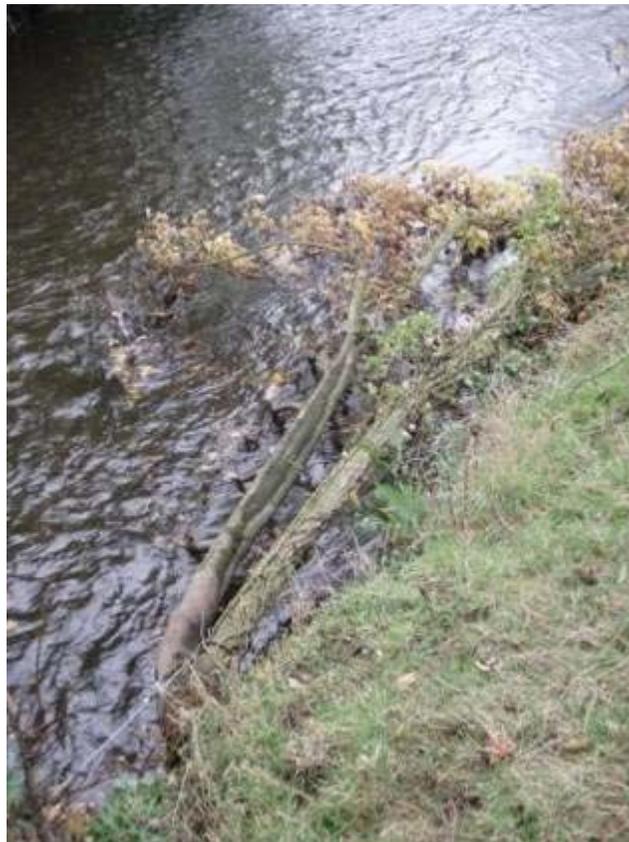
Photo 28 Tree anchored to its stump providing good in-stream habitat

There are opportunities for further in-stream enhancements on the Little Lagan (vortex weirs and gravel introduction), and on the section of the Lagan downstream of Black Bog Road where water levels have been lowered by the weir bypass; large woody debris introduction could take place here (Photo 28).
