**Advisory Visit**

**Lea Brook, Derbyshire**

**July 2017**

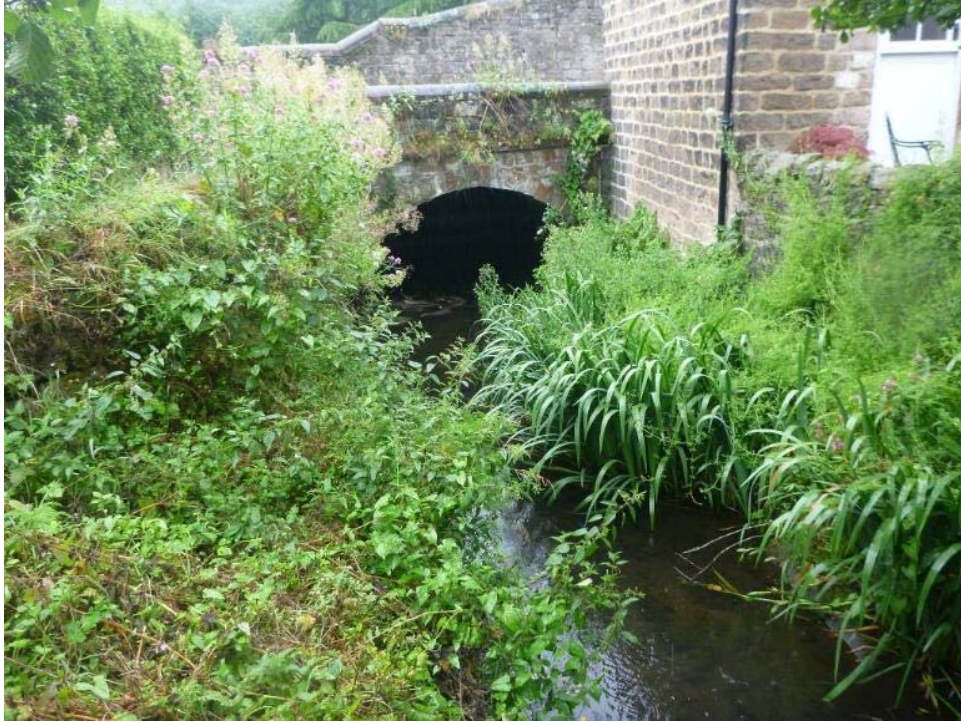
Upstream of the bridge, the gradient of the stream is less than the norm for a short distance because of impoundment by the invert of the bridge culvert; plants favouring slower-flowing water (rushes) are present in the margins here (Photo 1). The brook is bordered on the right bank by the gardens of residential properties and on the left by a sewage pumping station building and a field (Photo 2). The bank alongside the pumping station had been recently mown right to the edge of the brook (Photo 3); leaving a marginal fringe of shaggy vegetation is recommended to provide low cover over the water for trout.

**Photo 1 Bridge at the downstream end of the section.**

The brook flows through a bridge culvert under a track to some cottages at the downstream boundary, then on to join the River Derwent. Downstream of the bridge was not inspected during this visit. Future inspection to check on access for fish from the Derwent is recommended.

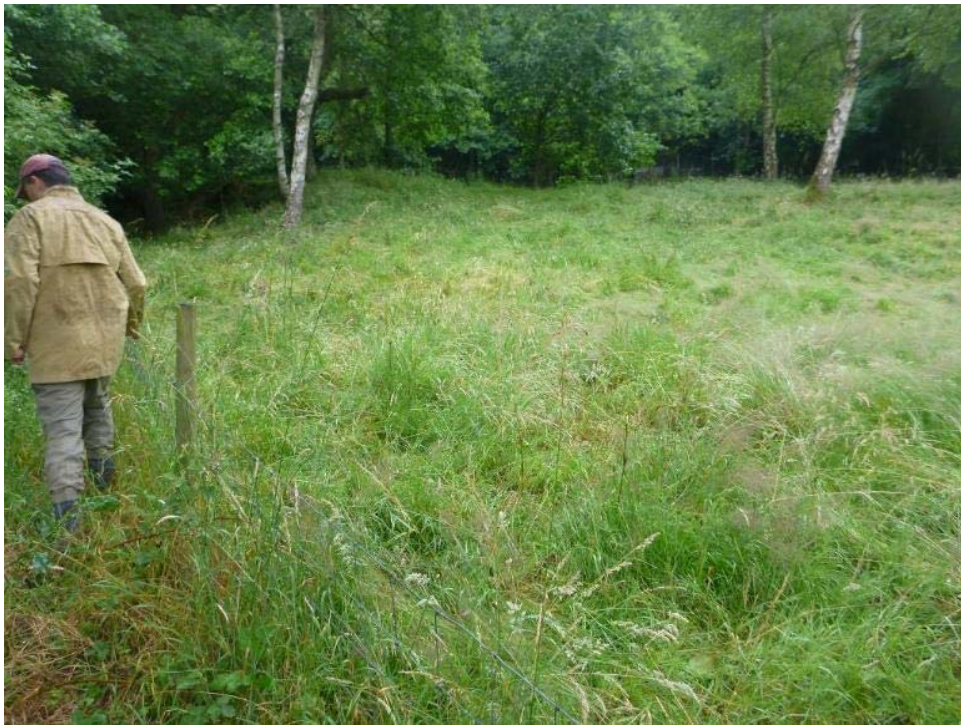
**Photo 2 Left bank land use is very low intensity, good news for the brook.**

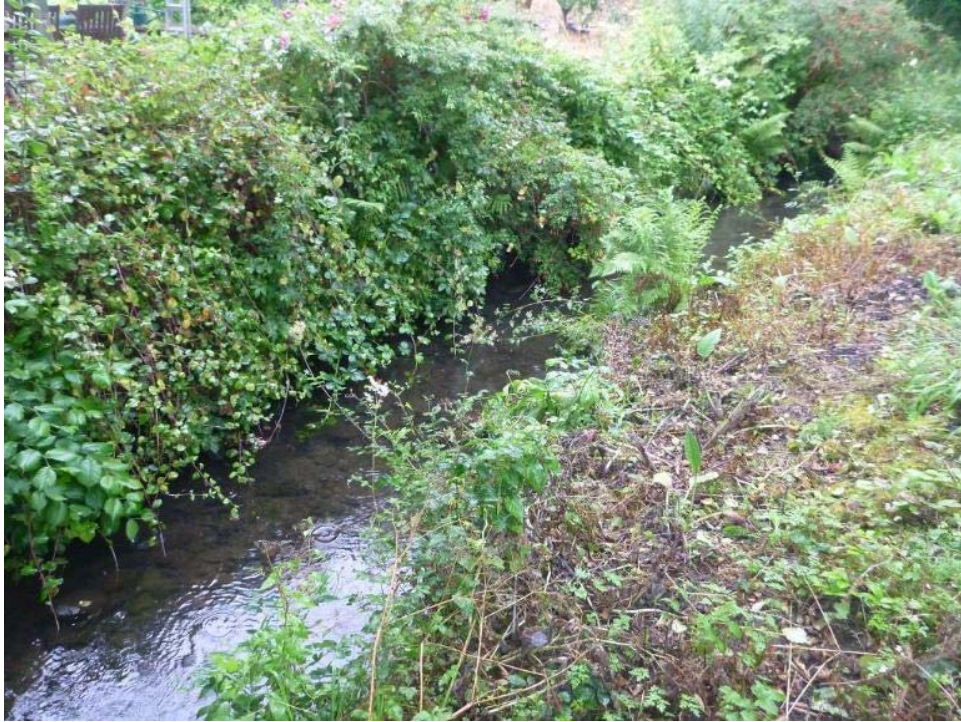
**Photo 3 Mowing close to the river, alongside the sewage pumping station. Leaving a larger marginal fringe of vegetation next to the brook is recommended.**

- Leave a fringe of vegetation around 1 metre wide alongside the brook next to the sewage pumping station when mowing.
- Leave large woody material in place within the river channel.

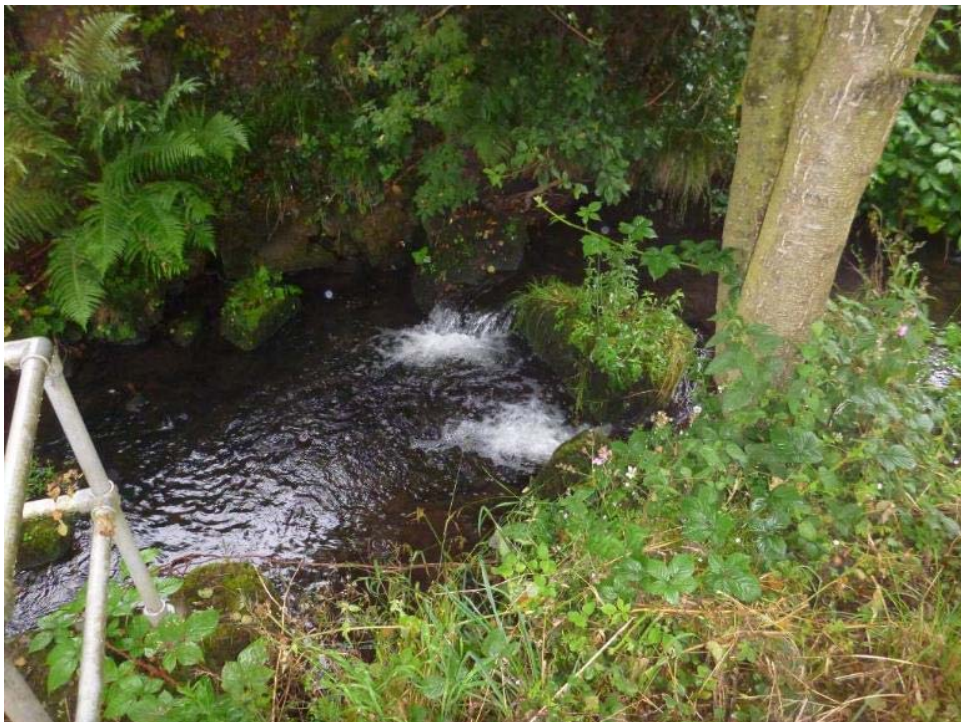
**Photo 4 Boulders just upstream of the pumping station and bridge. These appear to have been deliberately positioned, possibly to provide bed grade control. They have created a nice scour pool downstream in an otherwise relatively uniform and modified section. They do not impede fish movement.**

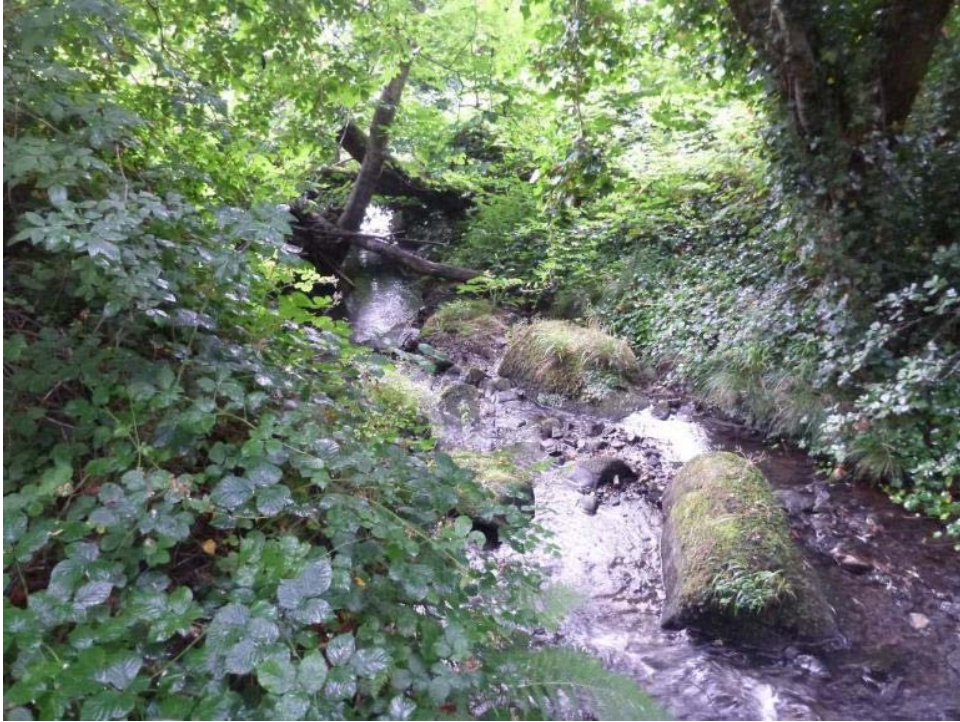
**Photo 5 Good in-stream habitat: pool, riffle/cascade and large woody material.**

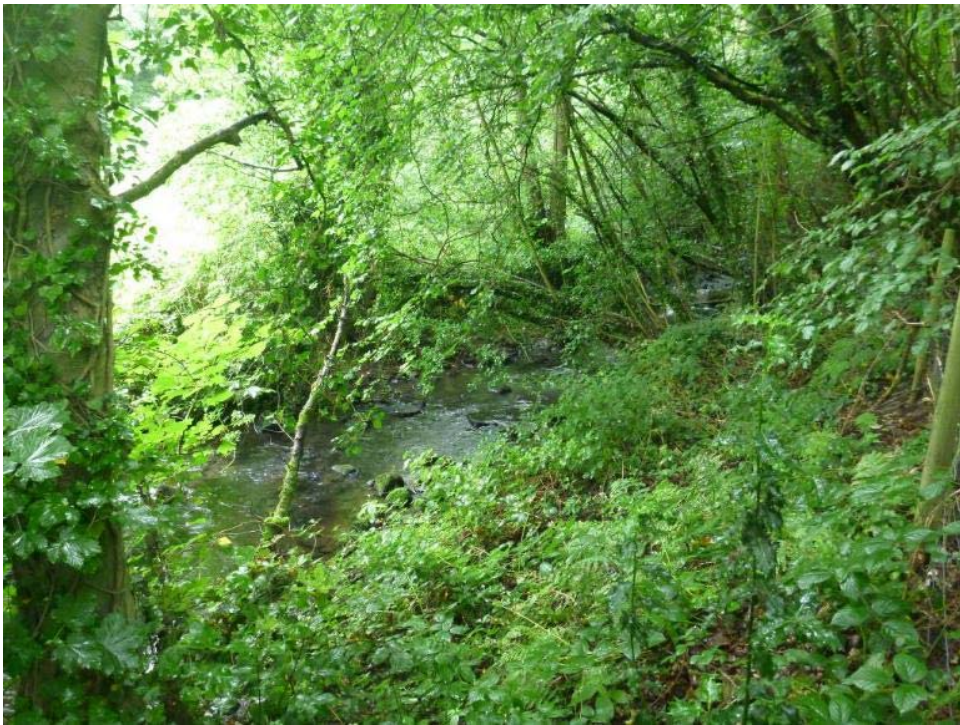
**Photo 6 The brook is well-shaded, helping to moderate water temperature. Small watercourses are vulnerable to high water temperatures in the summer and trout's upper lethal limit is quickly reached above 20 degrees Celsius.**

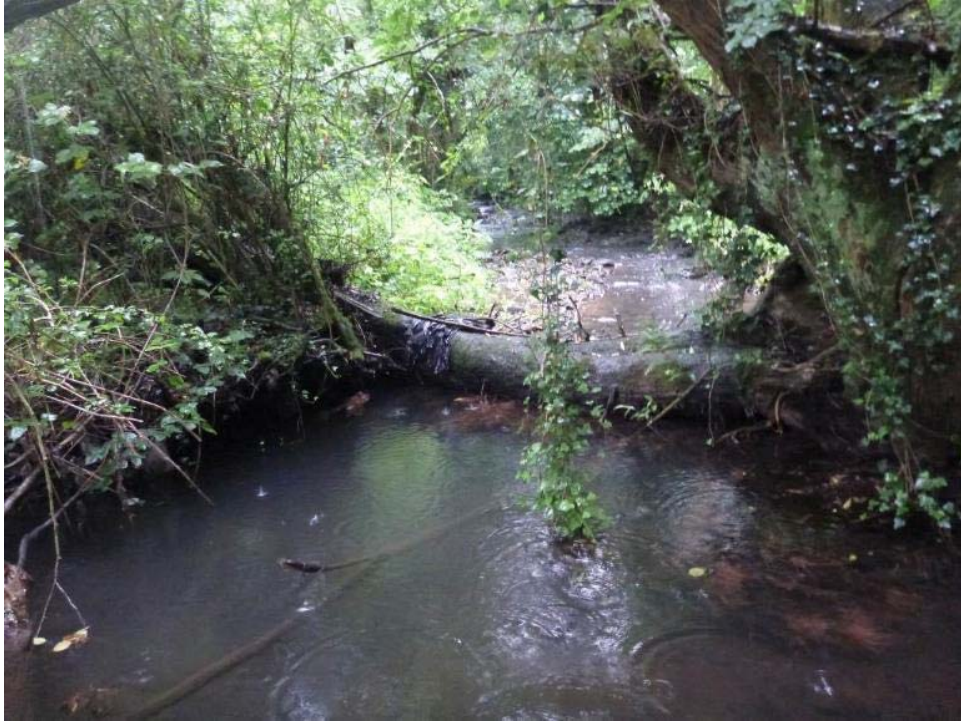
pockets in faster water suitable for trout spawning. This section is also well-shaded by mature trees and large woody material is present in several places, contributing to good in-stream habitat (for example creating scour pools, Photo 7).

**Photo 7 Stable large woody material which has helped to create a deeper scour pool – valuable habitat for larger fish.**

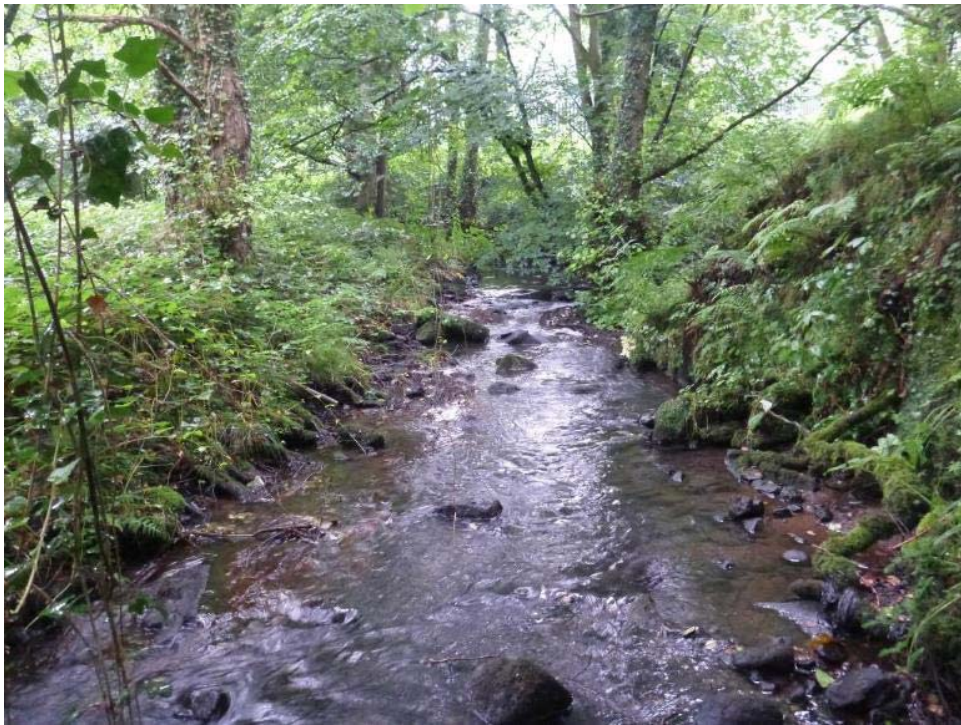
Towards the road, there is evidence that brook channel has been modified in the distant past. Some parts of the channel appear to have been straightened and widened resulting in a predominance of shallow water and a lack of pools (Photo 8). There is also a bund present on the left bank at the edge of the field and some sections of the left bank have been walled. In these areas there is an opportunity to introduce large woody material to mimic the natural features mentioned above.

**Photo 8 Wide shallow straight section lacking in pools, probably resulting from historic channel engineering. Introducing large woody material here to mimic effects similar to Photo 7 would improve in-stream habitat.**

- Place and secure large woody structures in straighter shallow sections downstream of the road to encourage pool formation (Photo 20)
- Label surface water drains for pollution prevention.

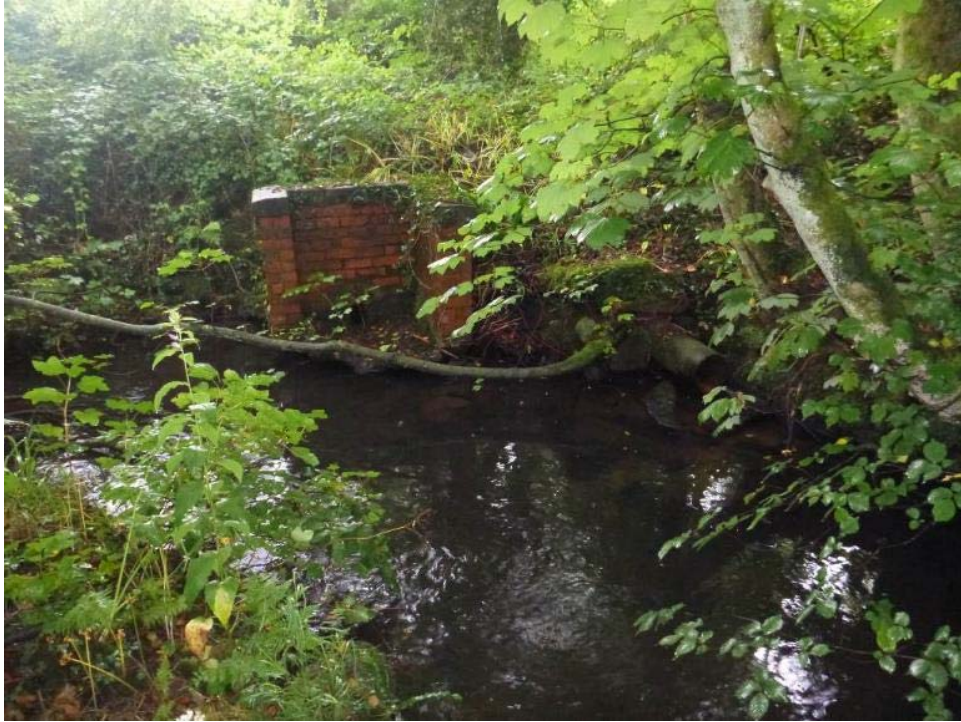
Surface water drains enter the brook (Photo 9) possibly draining the car park area for the factory. At the source end of such drains, raising awareness that they discharge into the brook can help prevent inadvertent pollution.

**Photo 9 Headwall from a surface water drain. Clear demarcation of these at their source can assist in pollution prevention (for example by preventing spills being flushed down).**

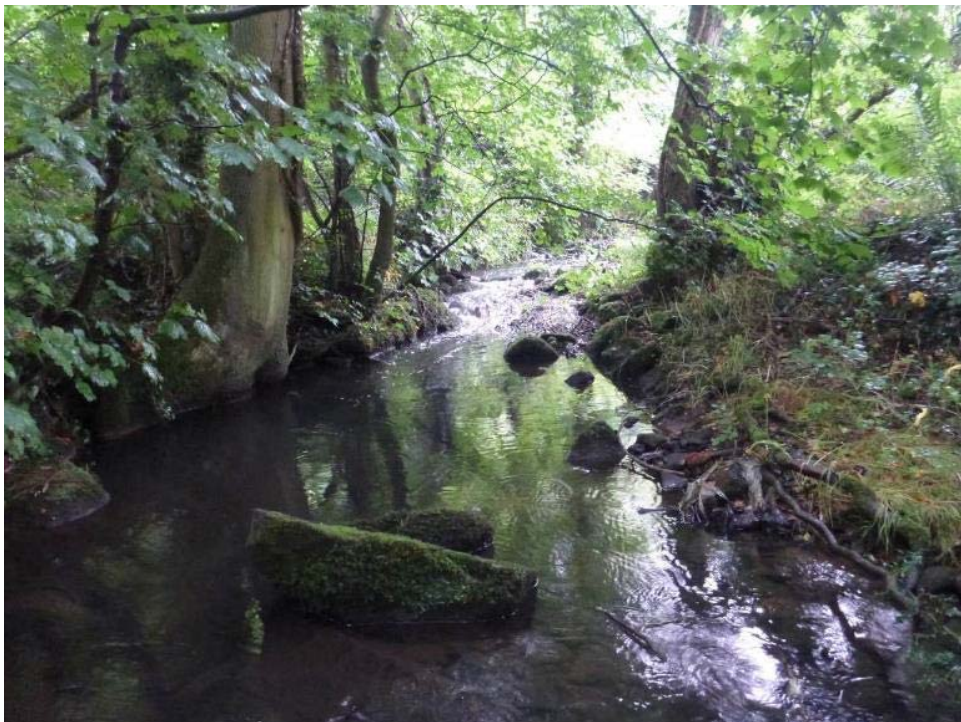
**Photo 10 Further good pool habitat, formed where a pinch point between two areas of high bank stability (tree roots) are fluming the water and scouring the river bed.**

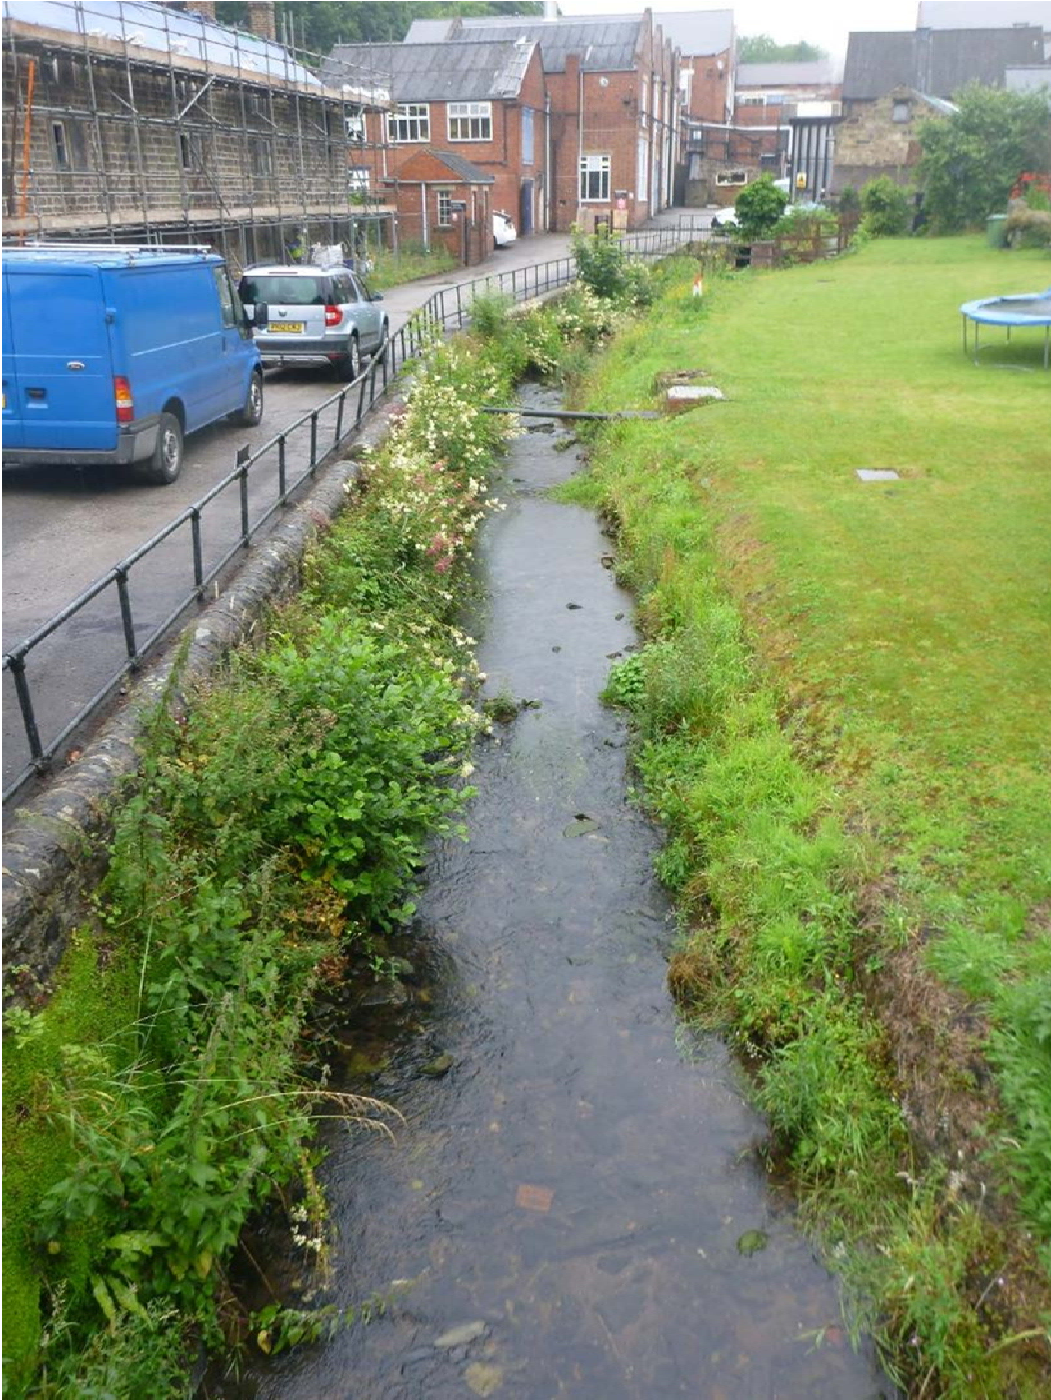
Upstream of the road, the brook flows through the John Smedley factory site. There is a section bordered by the factory entrance road (right bank) and a garden area on the left bank (Photo 11). Both banks comprise stone walls, but despite this there is a nice fringe of marginal vegetation (particularly on the right bank) and a stand of water crowfoot (*Ranunculus* sp.) is present mid-stream. The shaggy vegetation, which includes meadow-sweet and self-seeded alder and sycamore saplings, provides good marginal cover over an otherwise uniformly shallow section. Trout have been observed here and the marginal cover is likely to be an important factor contributing to their presence. Maintenance of this vegetation should be carried out sensitively to preserve the overhanging cover and shade throughout the year (for example rotational 'coppicing' of the saplings, rather than cutting all in one year).

The uniformly shallow nature of this section limits its trout holding capacity. It may be possible to create some depth variation here by installing features similar to that in Photo 4. Creative placement of boulders using a machine with a grab attachment would be relatively easy from the road side. Alternatively, more engineered structures such as vortex 'weirs' or cross-vanes (see Recommendations) designed to scour pools downstream (not impound water upstream) could be installed. Care would be needed to avoid underground services which are evidently present in this section. There could be synergies between this work and the planned installation of an industrial gas supply to the factory. A recent project on the Porter Brook in central Sheffield involving WTT Urban Project Officer, Dr Paul Gaskell may also provide ideas and inspiration for this section:  
[www.youtube.com/watch?v=XgcTleRj4WY](http://www.youtube.com/watch?v=XgcTleRj4WY) .

**Photo 11 View upstream from the road into the factory site.**

- Create some deeper pool areas in the reach immediately downstream of the factory (Photo 11) by placing boulders or building structures designed to scour the river bed (Photos 21 and 22).

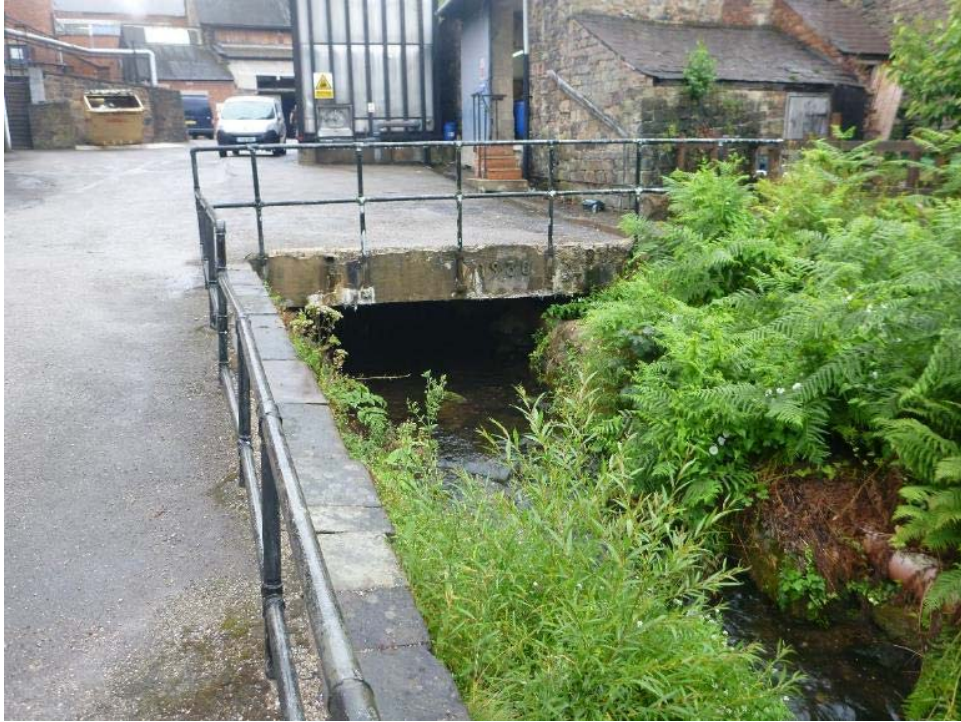
The brook flows in a culvert beneath the factory for approximately 160 metres (Photos 12 and 13). De-culverting is the ideal scenario for the brook, but far more easily said than done in the middle of a working factory which has grown and evolved over more than two centuries. Opportunities to 'daylight' sections of the brook may arise with ongoing development of the site. Historic maps ([www.old-maps.co.uk](http://www.old-maps.co.uk)) indicate the brook course was open through the factory site in 1880 but was culverted by the time of the 1899 map. The course of the brook is marked throughout the factory site as part of numerous measures implemented to minimise the risk of pollution of the brook from the yarn and fabric dyeing process.

**Photo 12** Downstream end of the factory culvert. The gradual transition from light to dark provided by the vegetation is better than an abrupt change in encouraging fish to pass into the culvert.

- Check the factory culvert for fish passability. Seek to daylight sections of the channel, taking any opportunities as they present themselves.
- Improve fish passage at the twin pipe culvert by raising downstream water levels and roughening the surface of the invert.

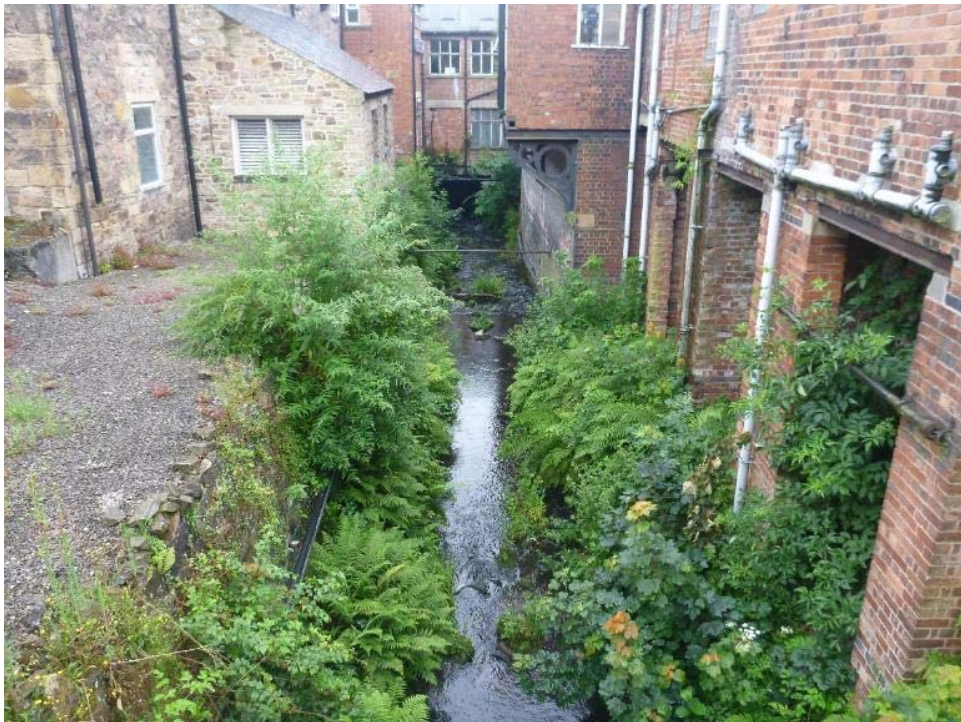
**Photo 13** The upstream end of the factory culvert. The same comments as above apply. Also, the natural bed is far better than a smooth artificial surface (like concrete), assuming this extends the full length of the culvert.

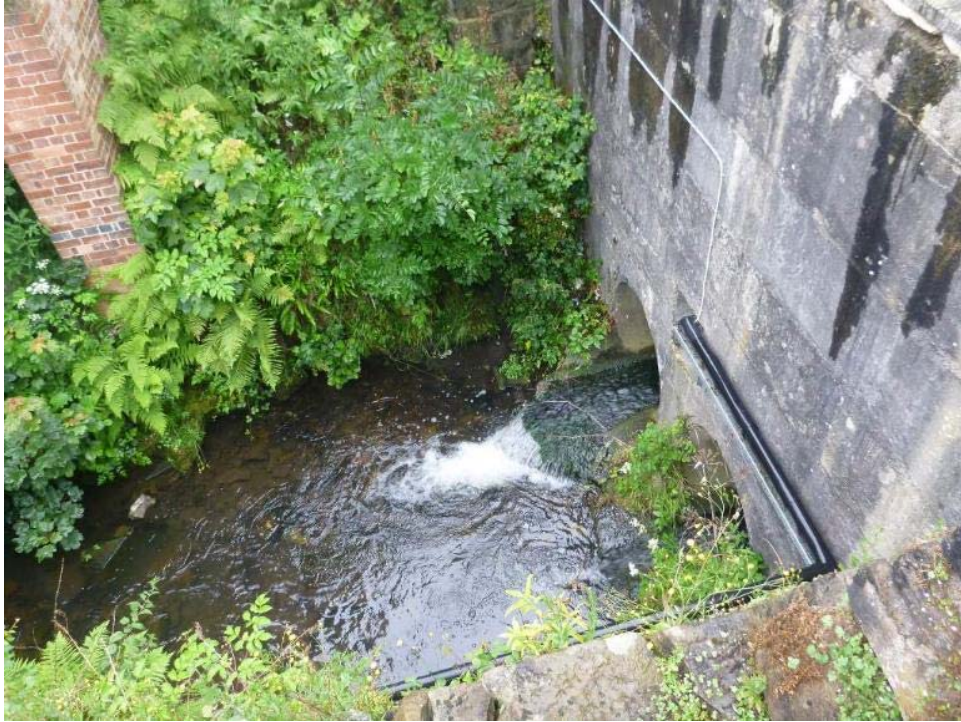
Upstream of the culvert, the brook flows beneath a bridge with a twin pipe culvert which is perched at the downstream end (Photo 14). This represents a barrier to fish migration and illustrates the potential problems that may exist within the long culvert under the factory. The drop at the downstream end of the pipes and the shallow, fast flow over the smooth concrete invert lessen the chance of fish successfully crossing this structure. Potential improvements to overcome this can be found via the above link.

**Photo 14** Above the main culvert under the factory, the brook is crossed by a bridge with a twin pipe culvert. The downstream end is perched above bed level. Along with the thin skim of water over the concrete bed of the pipe, this creates an obstacle to fish passage.

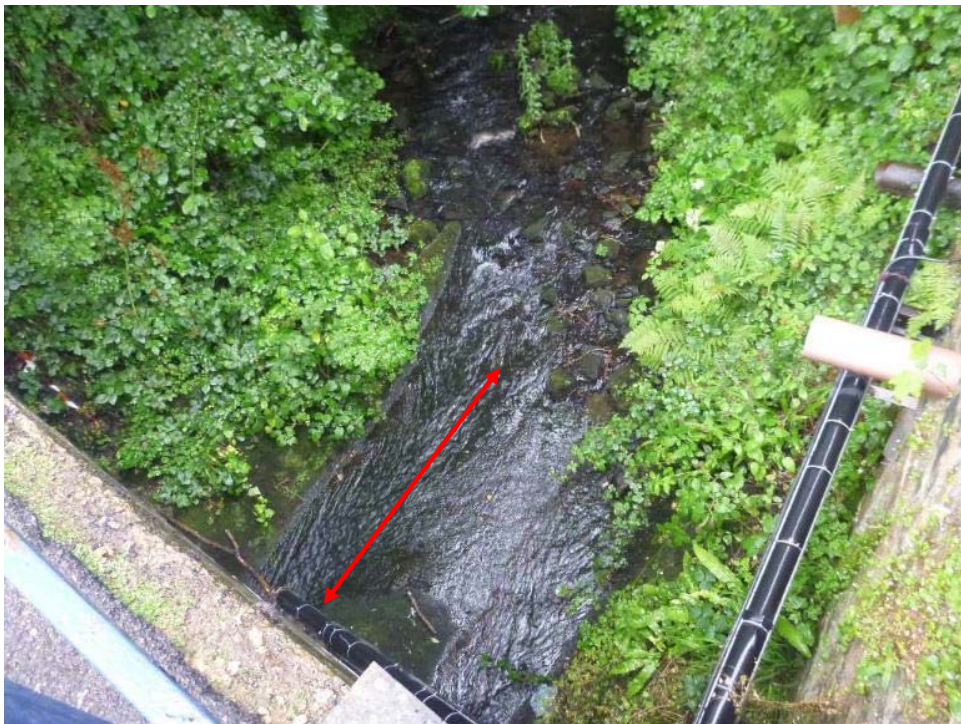
**Photo 15** Upstream end of twin pipe culvert, showing extent of concrete base and shallow, fast water.

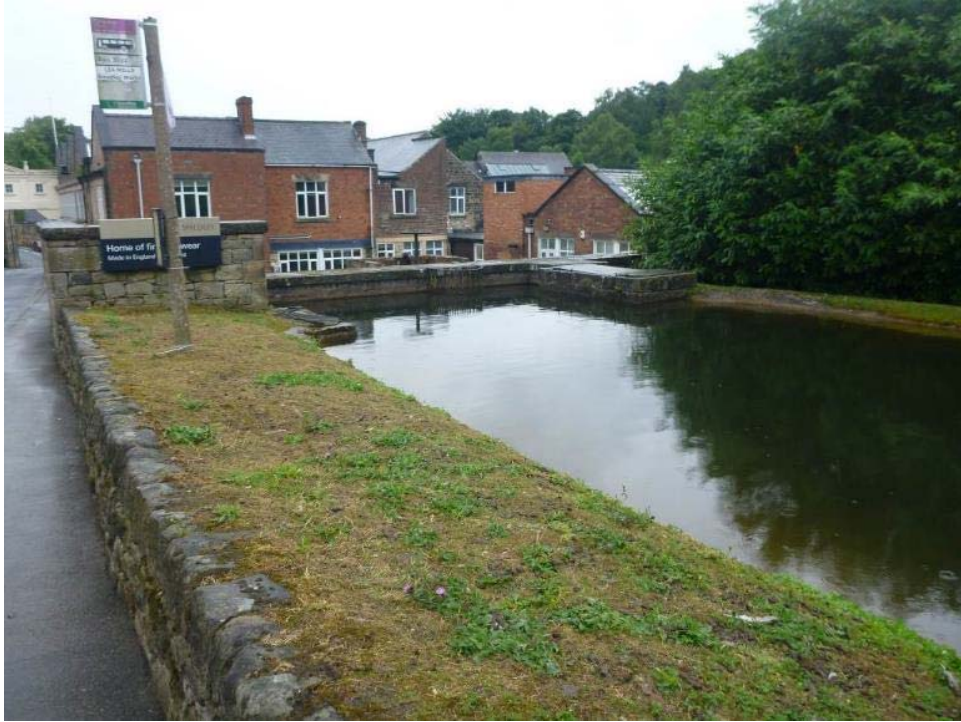
**Photo 16 Reservoir located upstream of the factory which supplies water to the factory sprinkler system. The reservoir is topped up by a feed from the brook.**

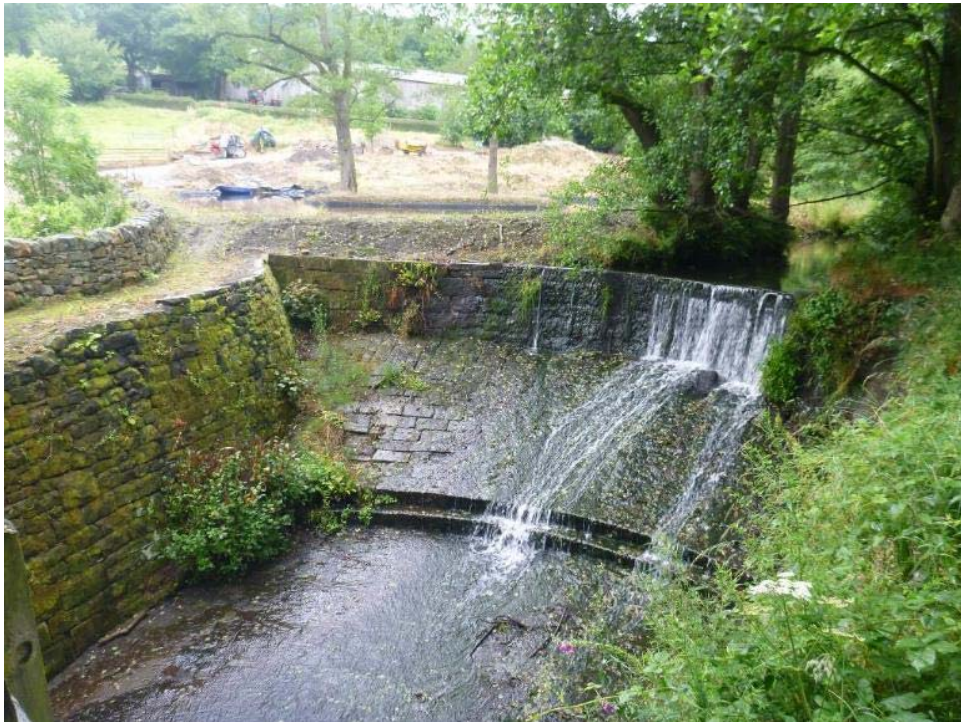
**Photo 17 Large weir located on the brook upstream of the reservoir. The conduit channel to the reservoir leaves the brook on the LH bank (not visible, right of shot). A recently created pond is visible in the background on the site of a former mill pond.**

The weir is a major detrimental impact upon the brook habitat. It is a total barrier to fish movement and a significant impoundment which interrupts natural sediment transport. The latter means over time there is a net loss of smaller sediment particles downstream of the weir (including gravel suitable for trout spawning). The weir appears to be a long-standing structure, possibly dating back to the construction of the factory. Maps from the late 1800s show an additional mill pond located upstream of the weir, indicating the full width of the valley was dammed (Figure 2); this is evident looking at the present land levels around the houses to the west of the footbridge, above which a pond has recently been created (separate from the brook course).

The prospect for improved fish passage and brook habitat through removal or lowering of the weir or installation of a fish pass seem remote given the likely costs.

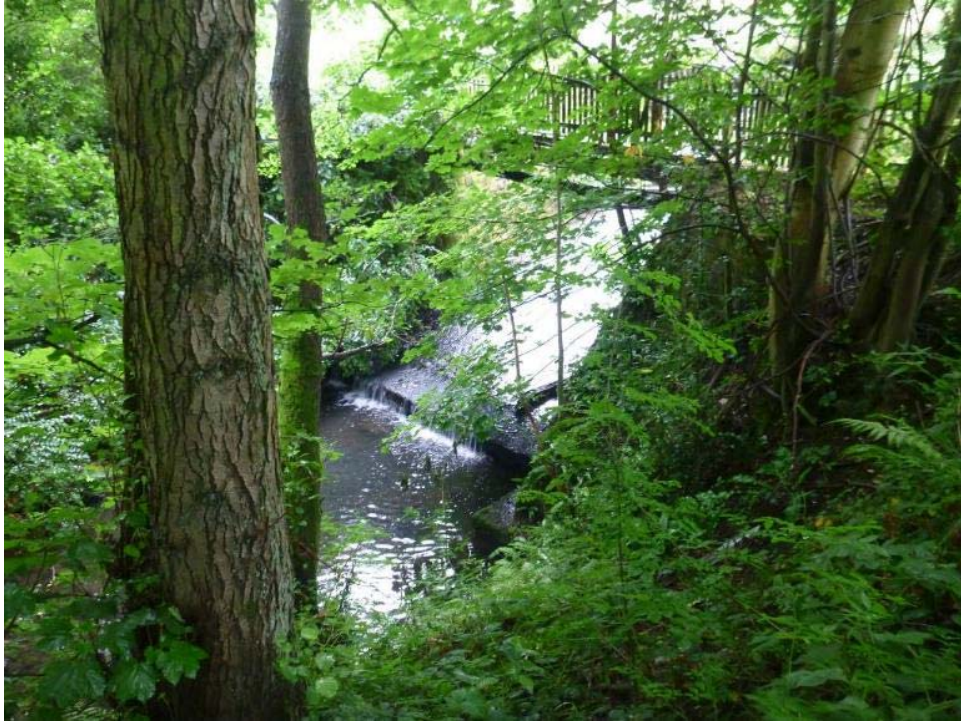
**Photo 18** The downstream lip of the spillway of the above weir, beneath the footbridge. A trout was observed in the pool downstream but fish will not be able to ascend the weir structure in any flows, fragmenting the habitat of the brook.

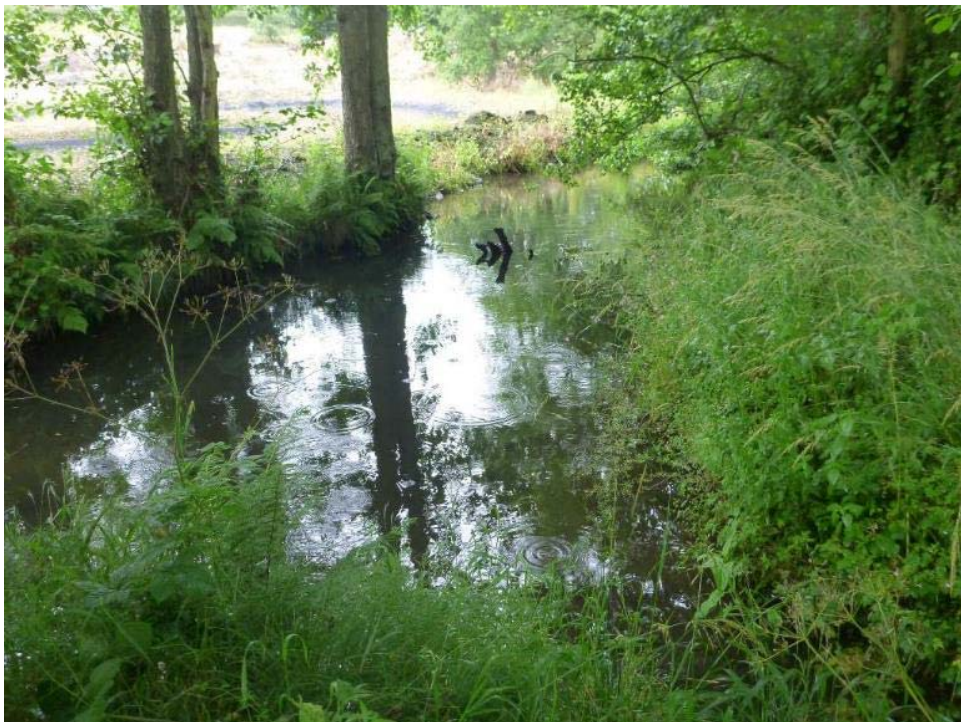
**Photo 19** Impounded section of brook, upstream of the above weir.
