Advisory Visit

River Leadon, Gloucestershire

October 2009

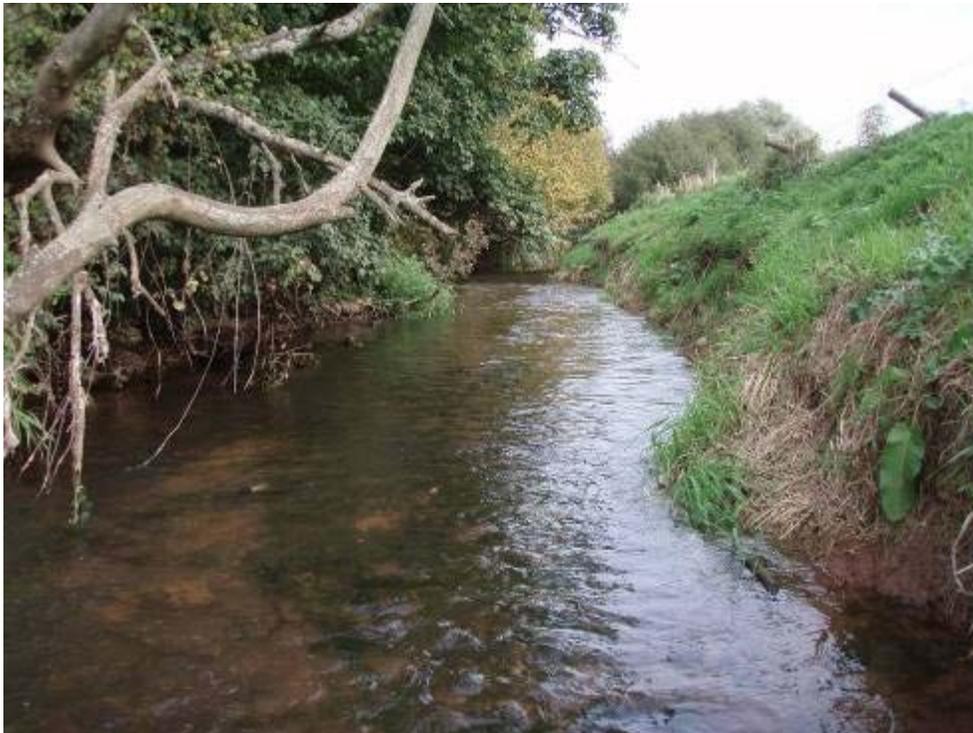
Upstream from the mill (National Grid Reference SO 7695 2700) and road bridge, the river lies within a channel which has been straightened and deepened for land drainage / flood defence, giving a trapezoidal cross-sectional profile (Photos 1 and 2). The river bed is comprised of hard, red clay with thin deposits of sand and fine gravel in places; this suggests retention of bed load material is poor, probably due to the straight and deep nature of the channel, combined with a flashy runoff regime.

Photo 1 Upstream from the mill at Upleadon

- The weirs on the Durbridge section should be removed to reduce the impoundment of water within this section, and gravel introduced to provide spawning areas. This should be done in conjunction with channel narrowing and LWD introduction, planned by the EA.
- Ideally, on the lower section of river (Upleadon), bank re-profiling should be carried out to create a two-stage channel. A low berm could be created alongside the river, allowing variation in width and depth of the low-flow channel, yet retaining flood-flow capacity.

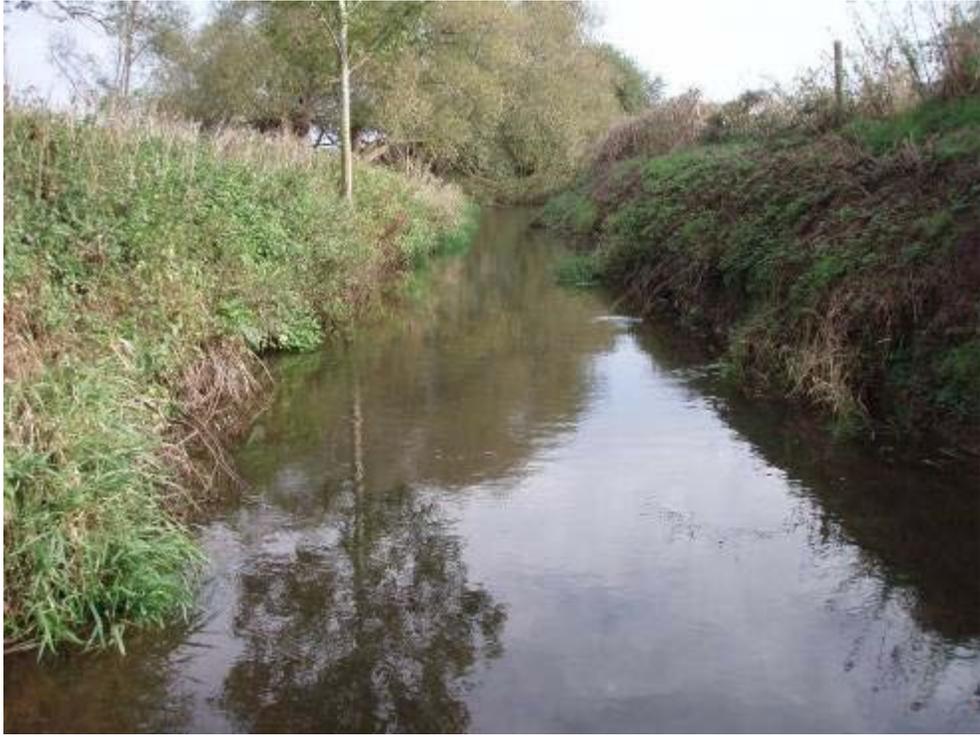
Photo 2 As above – a straightened, trapezoidal channel with steep banks and little variation in channel dimensions

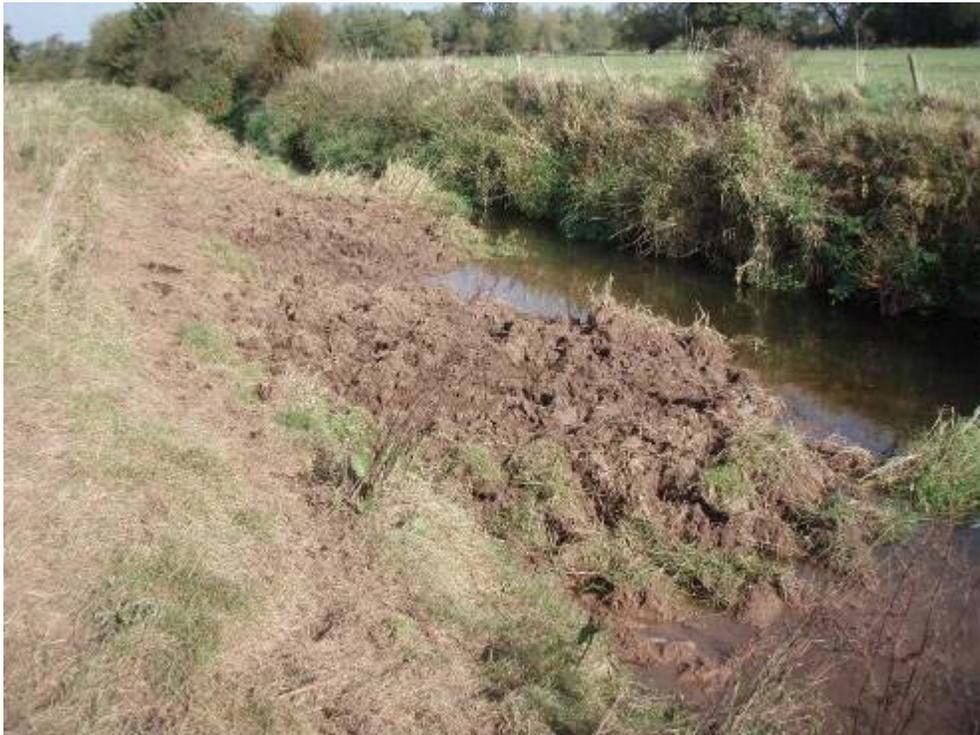
Bankside trees and bushes are present, mostly on the LHB through this section; these include field maple, hawthorn, willow, alder, blackthorn and elder. The RHB has unfettered stock access, and although the steep banks limit access, there are some areas of severe bank poaching by cattle (Photo 3). By contrast there is a well designed and constructed cattle drink on the LHB (Photo 4).

Photo 3 Severe bank poaching by cattle

Cattle should be fenced out of the river on the RHB and formal cattle drinking areas created, like the one on the LHB.

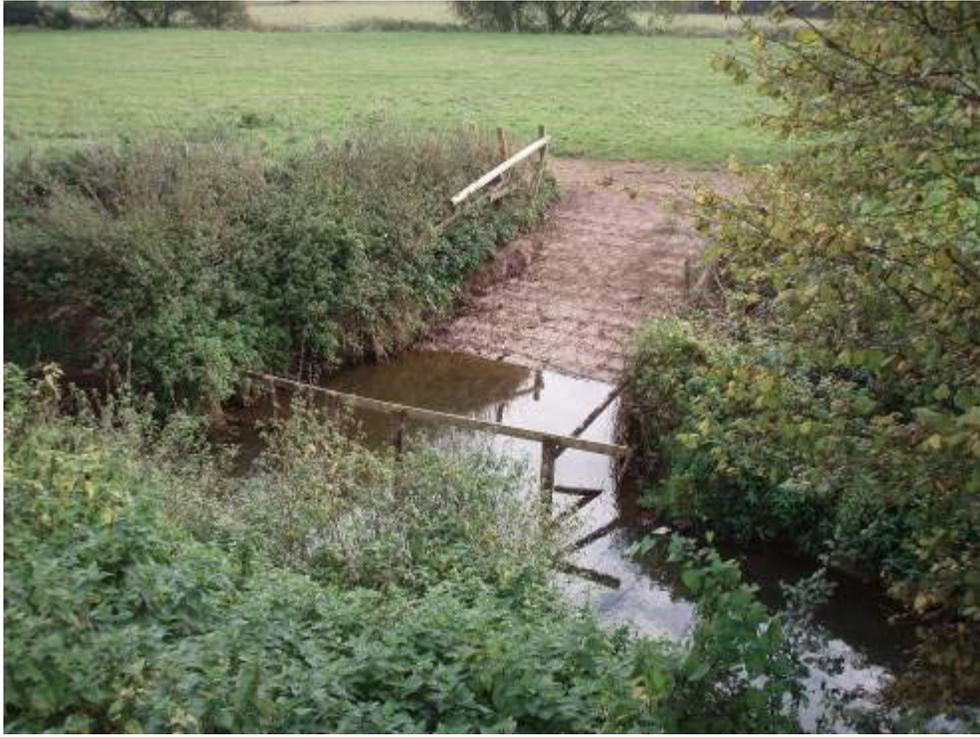
Photo 4 More formalised stock watering area on the LHB; the ramp is reinforced with concrete sleepers.

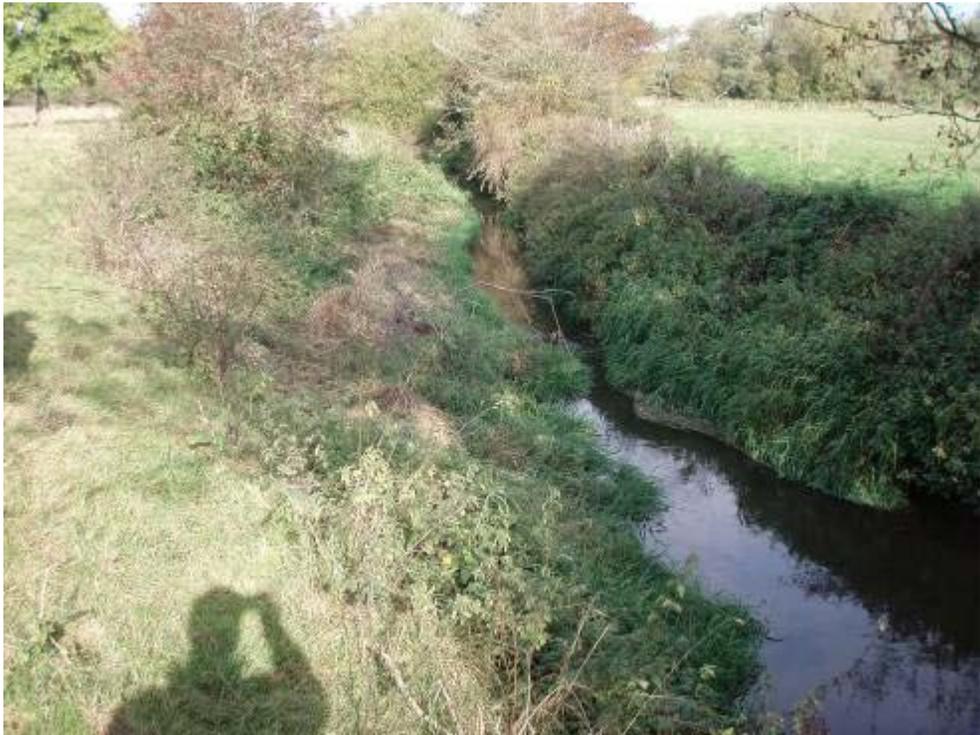
With progress upstream (second field above the mill), the channel becomes more meandering and narrower and deeper (Photo 5). Although the influence of land drainage works is still very much apparent, the river has a much more variable depth profile, although shallow riffle areas are lacking.

Photo 5 Better habitat where the river has built up some marginal vegetated berms, narrowing and deepening the channel.

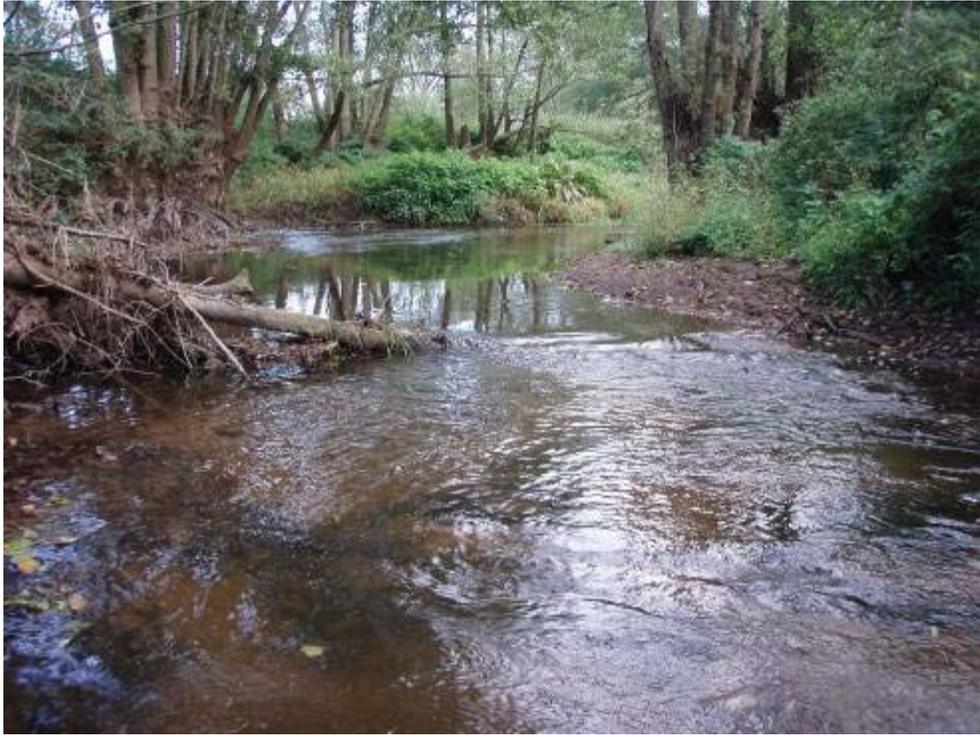
There is a short section of excellent habitat alongside the farm, with a varied depth profile, pool-and-riffle sequence and good cover in the form of submerged alder roots (Photo 6). The river is lined with mature alder trees, most of which are multi-stemmed indicating they have been previously coppiced; some showed signs of the fungal alder disease *Phytophthora* (Photo 9).

Photo 6 Good habitat near Durbridge Farm – pool-and-riffle, depth variation, LWD and submerged alder roots

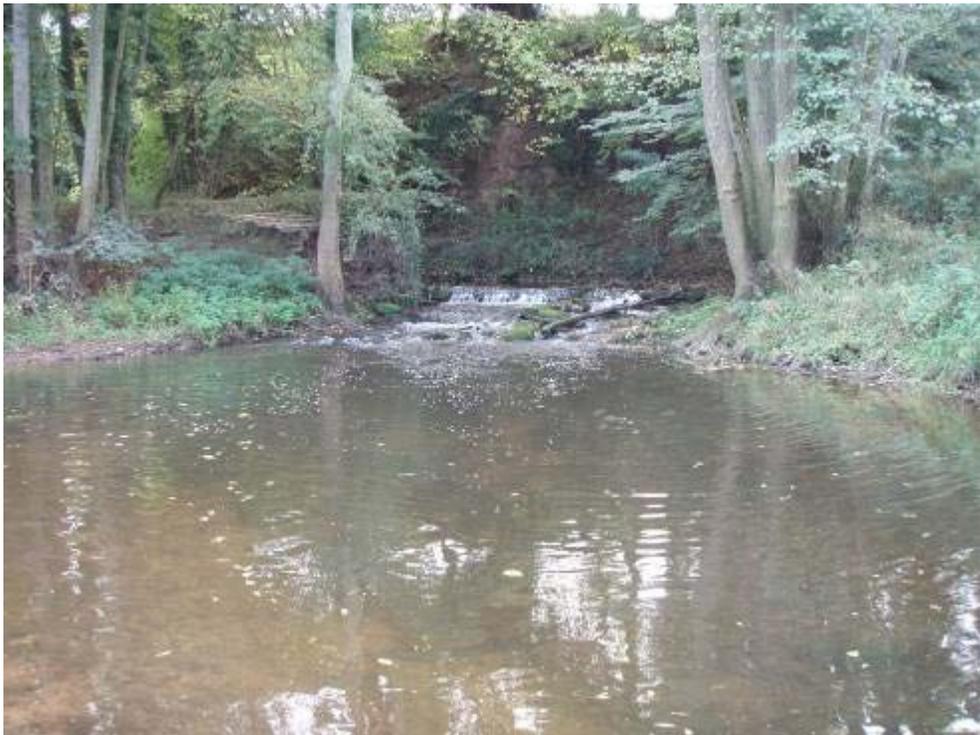
Just upstream of the farm is the remains of an old weir which formerly diverted water to the mill at the farm (Photo 7). The mill building is still present, along with a metal water wheel which is thought to have been in use up to around the 1940s. Up until about 20 years ago, the weir had wooden boards which raised the crest and impounded a considerable depth of water.

Despite the lowering of the weir, the river upstream still has the characteristics of an impounded channel. The river is slow-flowing, wide and has a silty bed; it is relatively shallow (knee depth) and there is little depth variation. The channel is shaded by mature alders along most of its length.

Photo 7 Old weir structure above Durbridge Mill

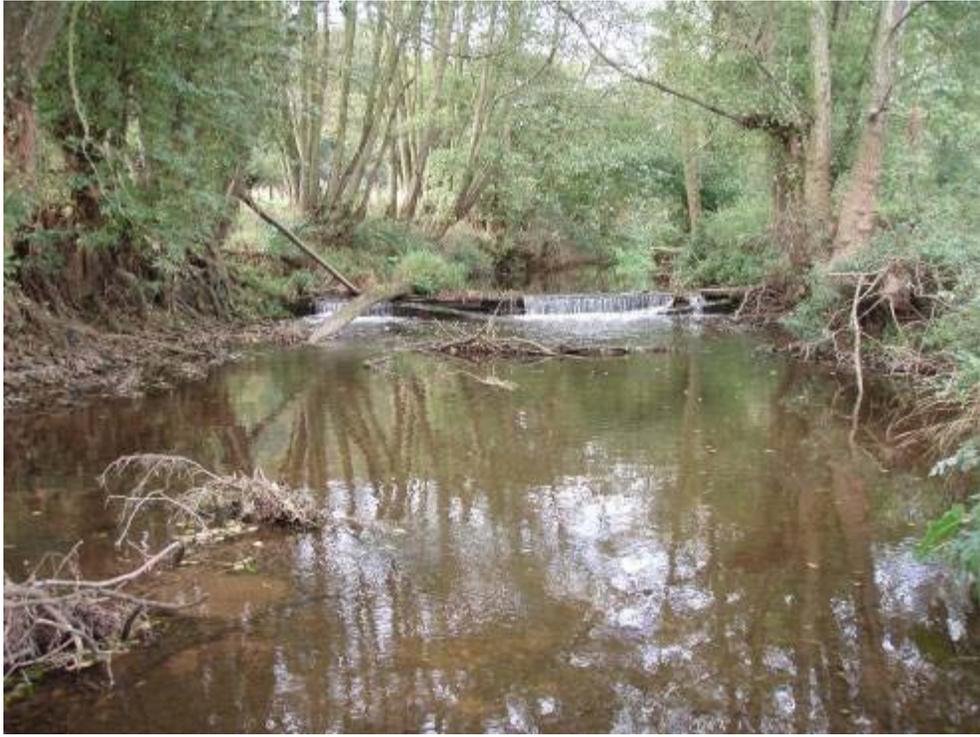
There is another weir on this section and the channel upstream continues with the impounded characteristics described above. Long-standing members of the club report catching good-sized (1½ - 2lb) trout from this impounded section in the 1950/60s, but a marked deterioration in stocks since that time.

Photo 8 Another weir further upstream, and typically poor habitat in this reach – wide, shallow, silty and heavily shaded.

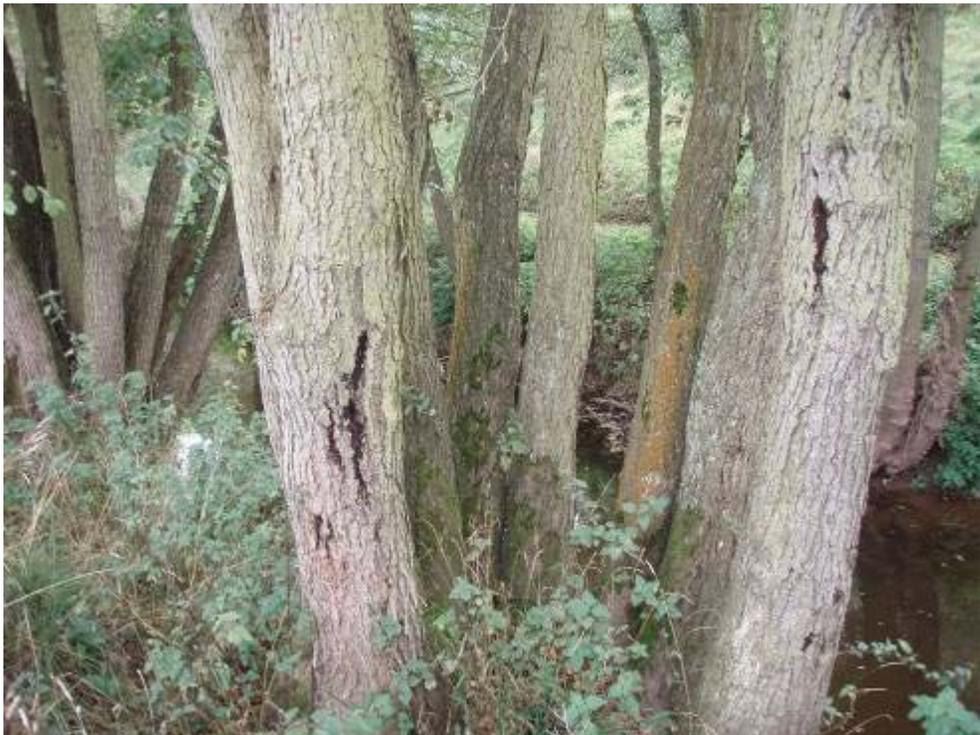
Photo 9 Tarry spots - signs of *Phytophthora* disease on alders

- The dense stands of alder along the banks of the Durbridge section should be managed by rotational coppicing, as described in the *Wild Trout Survival Guide*. The aim should be to produce a mixture of trees at different stages of re-growth, giving a mixture of light and shade and cover. The coppicing should be carefully planned to minimise environmental impact, and a good practice guide is included in Appendix 1.

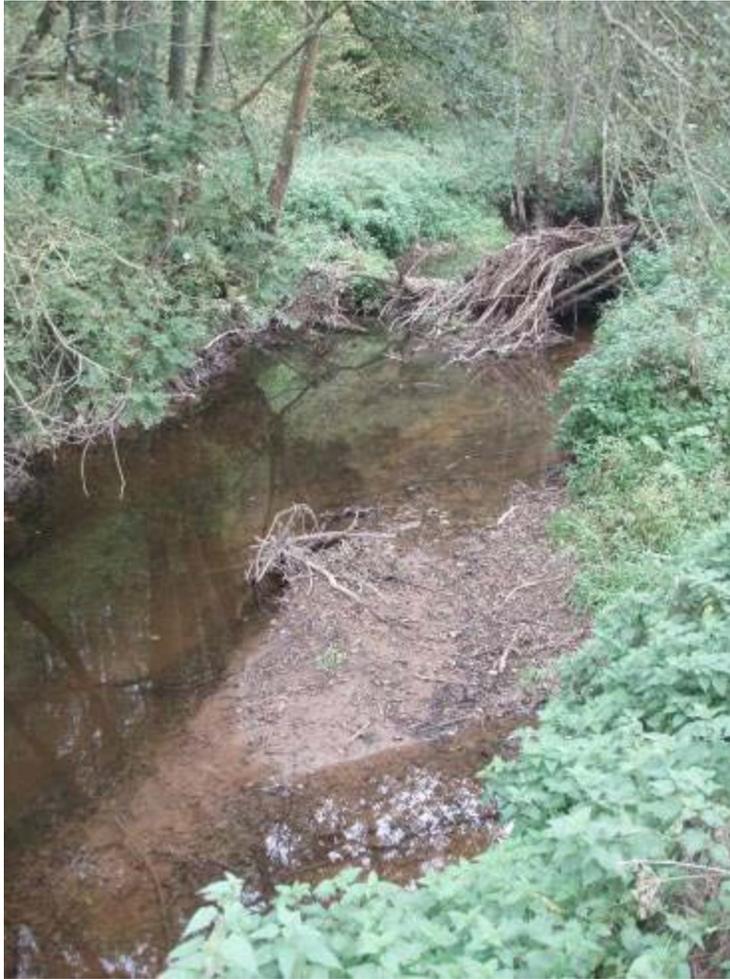
Photo 10 Below the farm, a good example of LWD and its effects on the channel – scour and deposition, creating depth variation

Downstream of the farm there are some good examples of LWD and its effects in promoting localised scour, deposition and hence depth variation. The presence of LWD has been shown to be extremely important in several respects:

- The club should adopt a policy of retaining LWD in the river channel wherever possible. To achieve this liaison with landowners and the Environment Agency internal workforce may be required. The West Country Rivers Trust provides a useful guide to the management of natural LWD:
