Walkover Assessment
Light Water
(Tributary of the River Eamont)
Cumbria
24/07/2018

Undertaken by Gareth Pedley

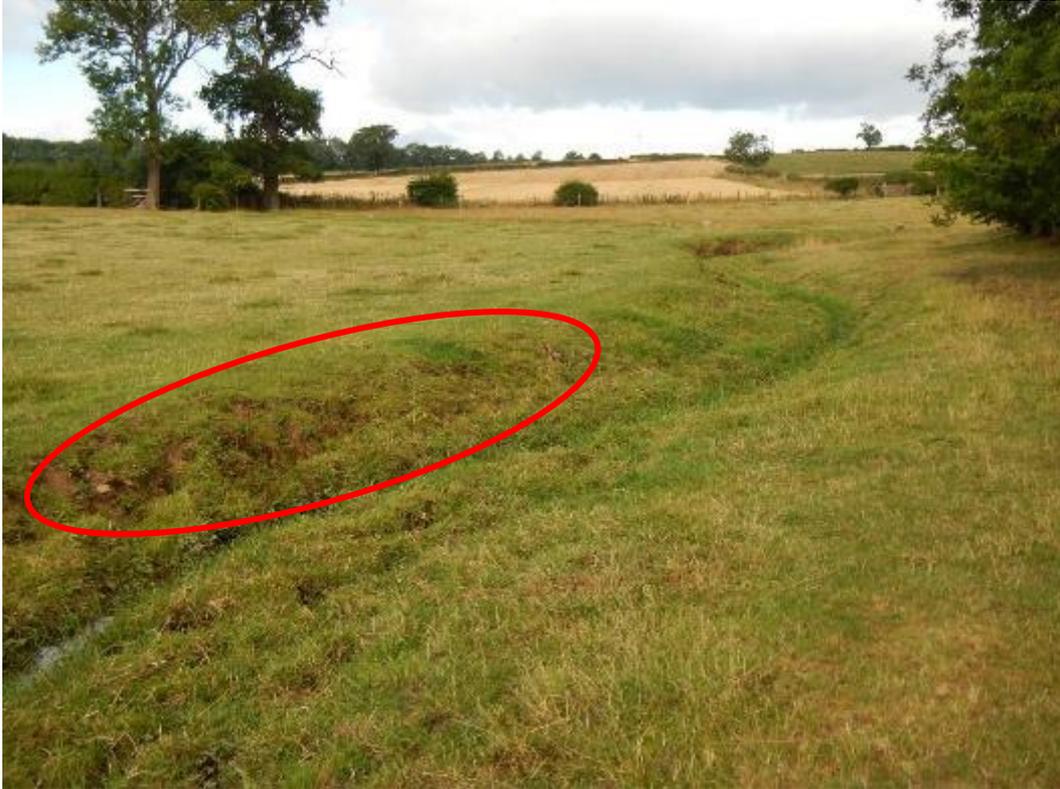
Photo DSCN33346. At the u/s limit of this walkover, Light Water emerges alongside an arable field. The watercourse then flows through pasture where grazing is sufficiently intense to prevent the growth of anything other than grasses (NY 54381 26624 - NY 54600 26626). Cattle access is trampling the banks into the watercourse (red ellipse) and will undoubtedly increase fine sediment input, particularly in wet conditions; this will also increase the requirement for periodic dredging.

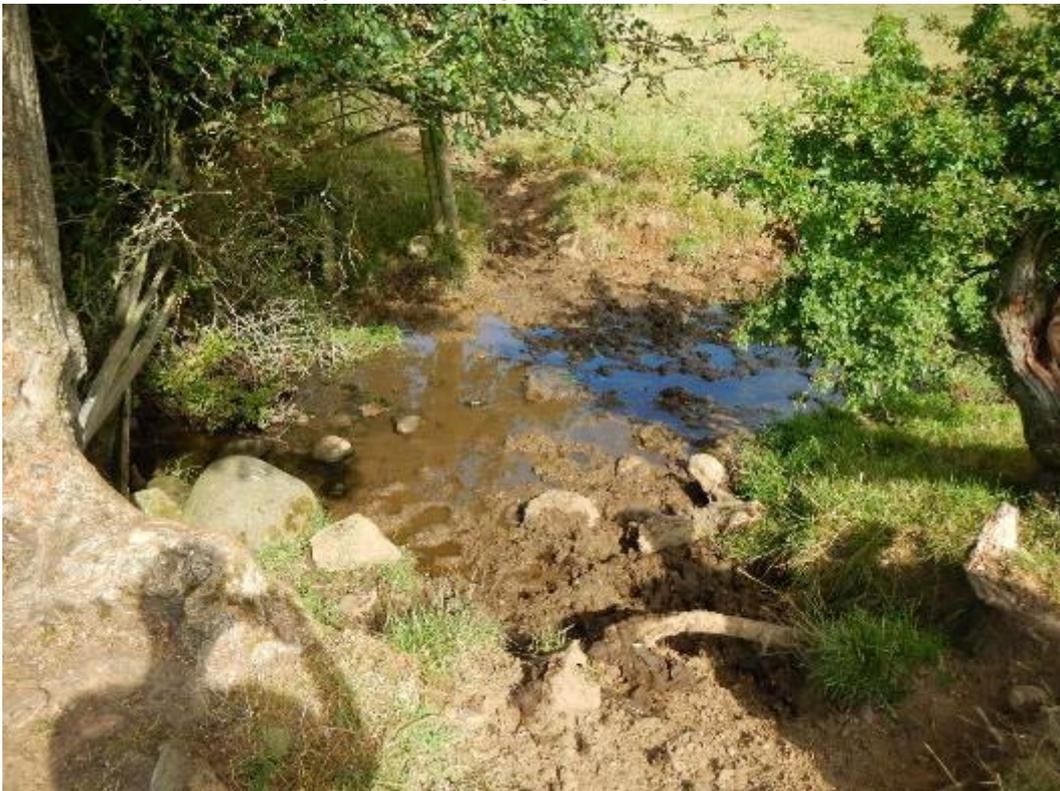
Photo DSCN33347. In areas where livestock poaching is focussed, the impact of increased fine sediment input is particularly apparent and installing buffer fencing would clearly be beneficial.

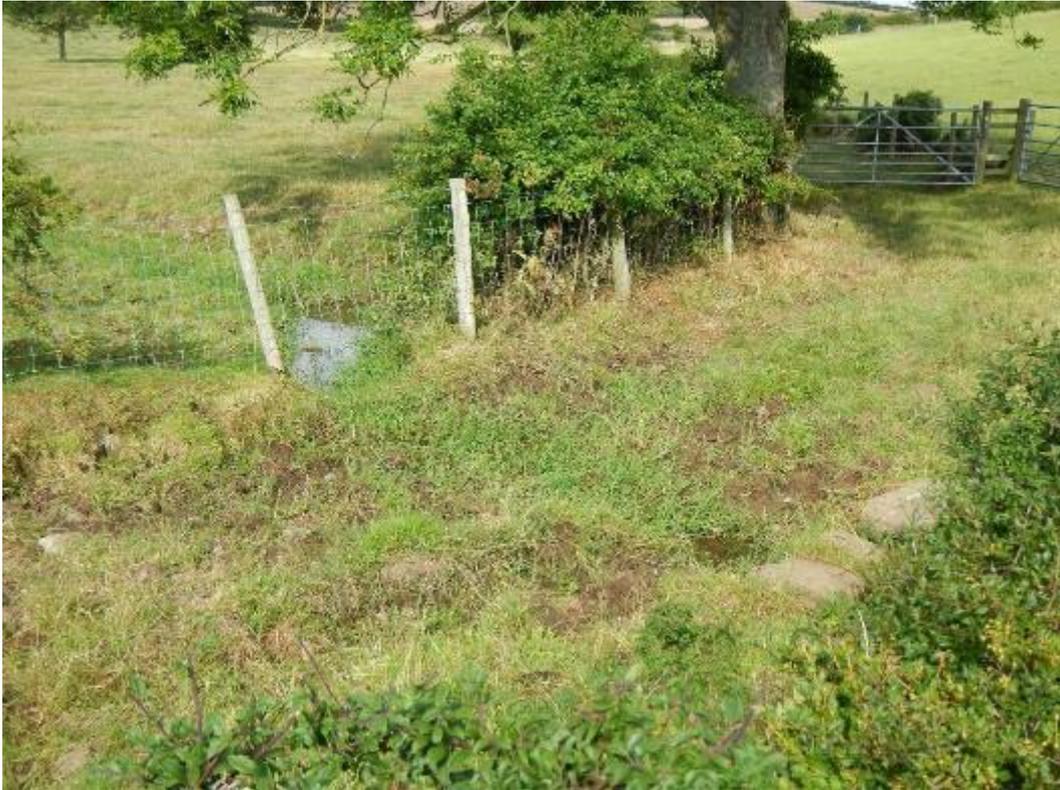
Photo DSCN3344. A track crossing between fields creates a focus point for poaching of the watercourse (NY 54605 26628). This could easily be rectified with an appropriately sized, partially sunken pipe culvert to carry the watercourse. There are unlikely to be any fish in this area of the Light Water but an appropriately sunken pipe would create no access issues anyway.

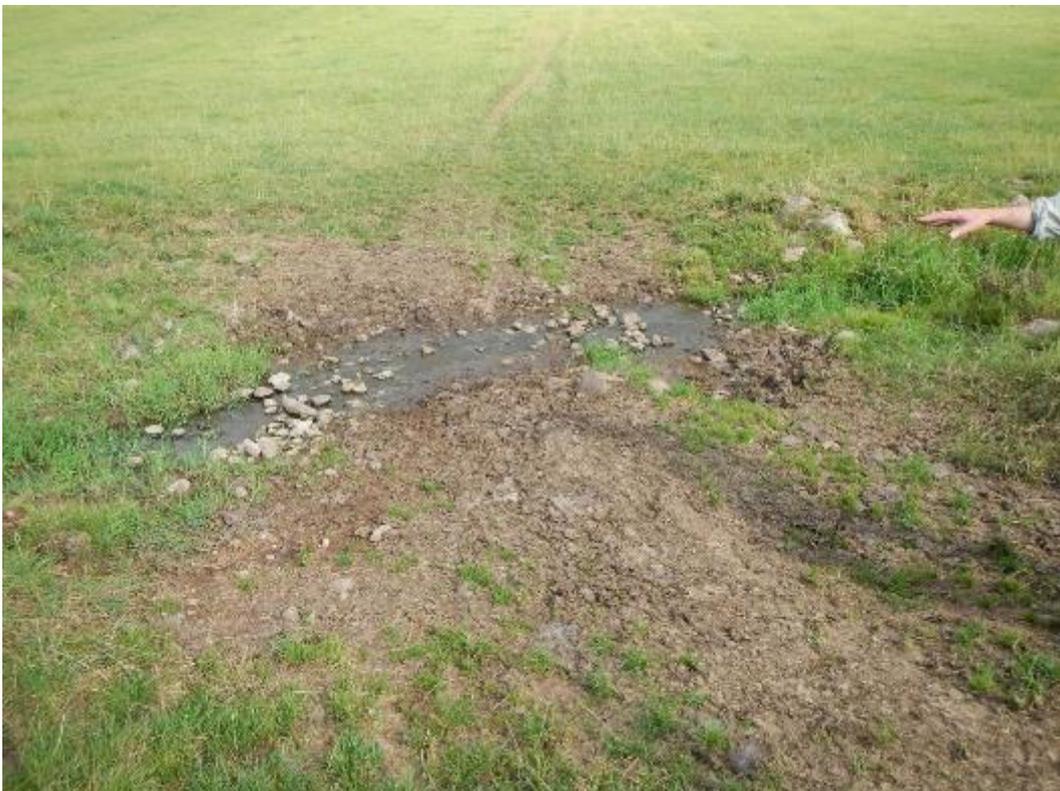
Photo DSCN3342. The next two fields (NY 54606 26631 - NY 54809 26652) appear to be mowed for fodder then grazed. This reduces the time that livestock are within the field but trampling of the banks into the watercourse will be elevating fine sediment input and obvious impacts were noted. The watercourse would benefit from buffer fencing in both fields, combined with a formal pipe culvert crossings to reduce the silt issue.

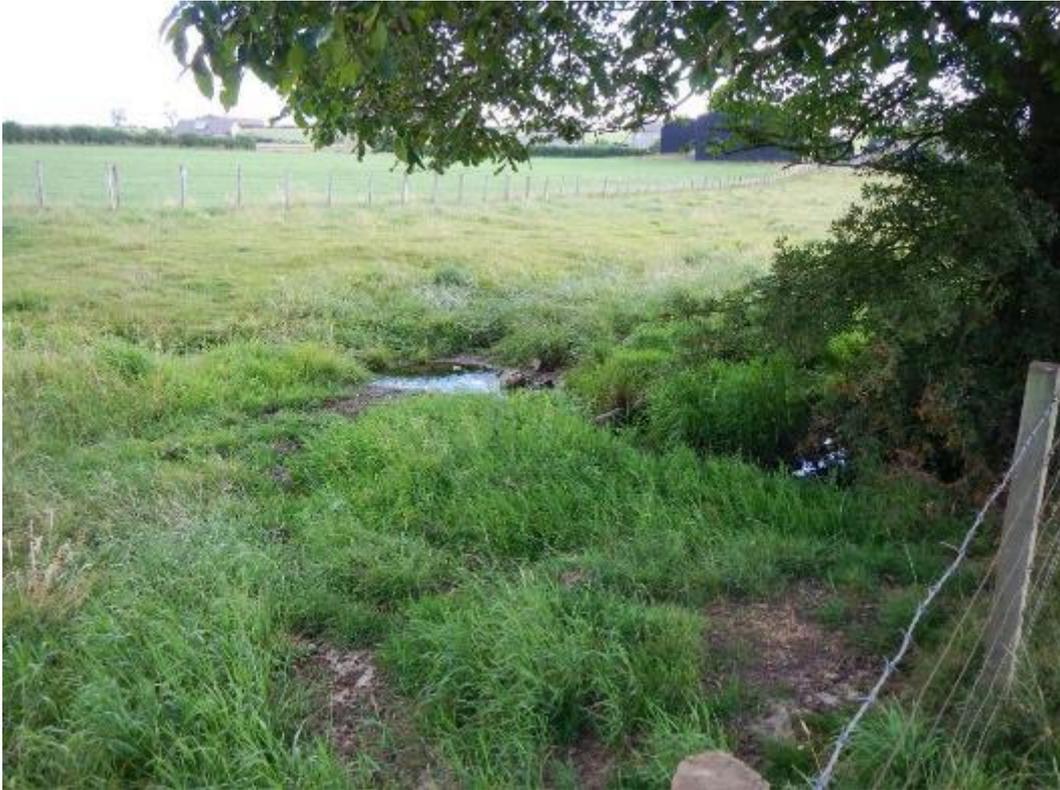
Photo DSCN3339. The next field d/s appears to be more lightly grazed but trampling of the banks at localised areas is inputting fine sediment (NY 54809 26652 - NY 54928 26696).

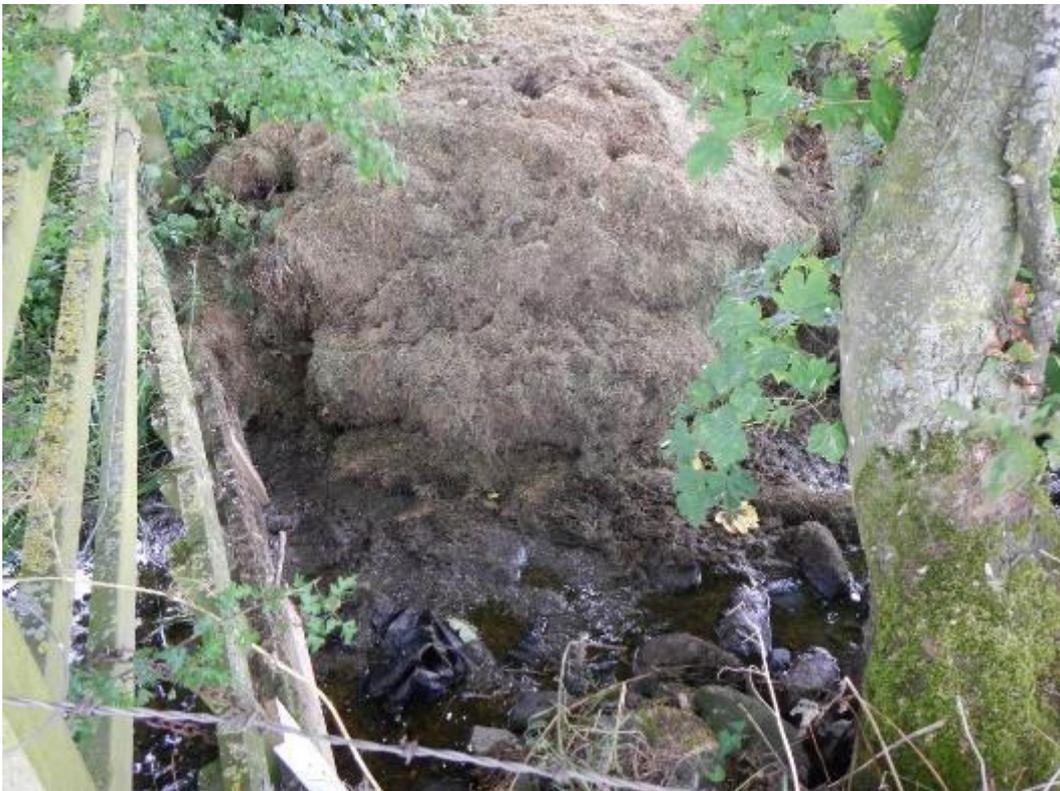
Photo DSCN3355. In the next field the watercourse is adjoined by grazing and a short section of gardens (NY 54928 26696 - NY 54965 26687). The grazing is leading to the same bank poaching problems but the gardens present an additional issue. As all too often occurs, the watercourse is being used for disposal of garden waste. This is pollution and will be creating a high nutrient input to the watercourse. Garden waste should always be composted well away from any watercourse to prevent such issues, and nutrient leaching.

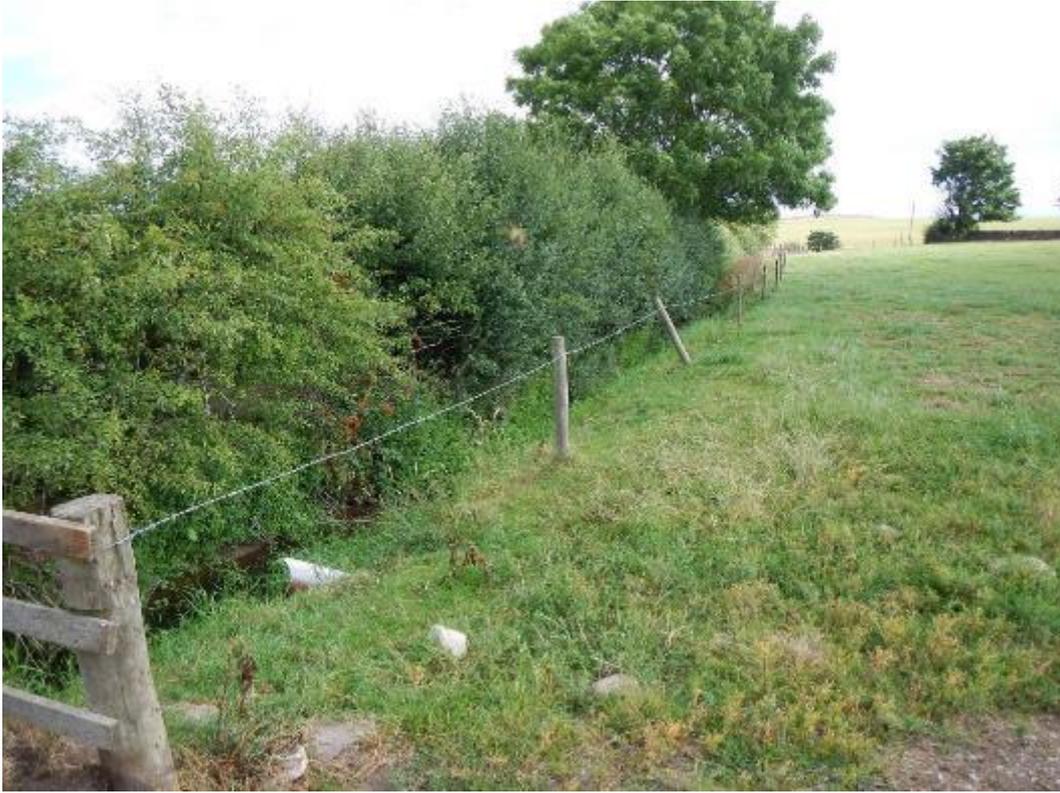
Photo DSCN33351. A small ephemeral tributary/ditch joins the Light Water in this area and while it is buffer fenced (protecting the banks) a very high nutrient discharge into the ditch was observed (Photo DSCN33352).

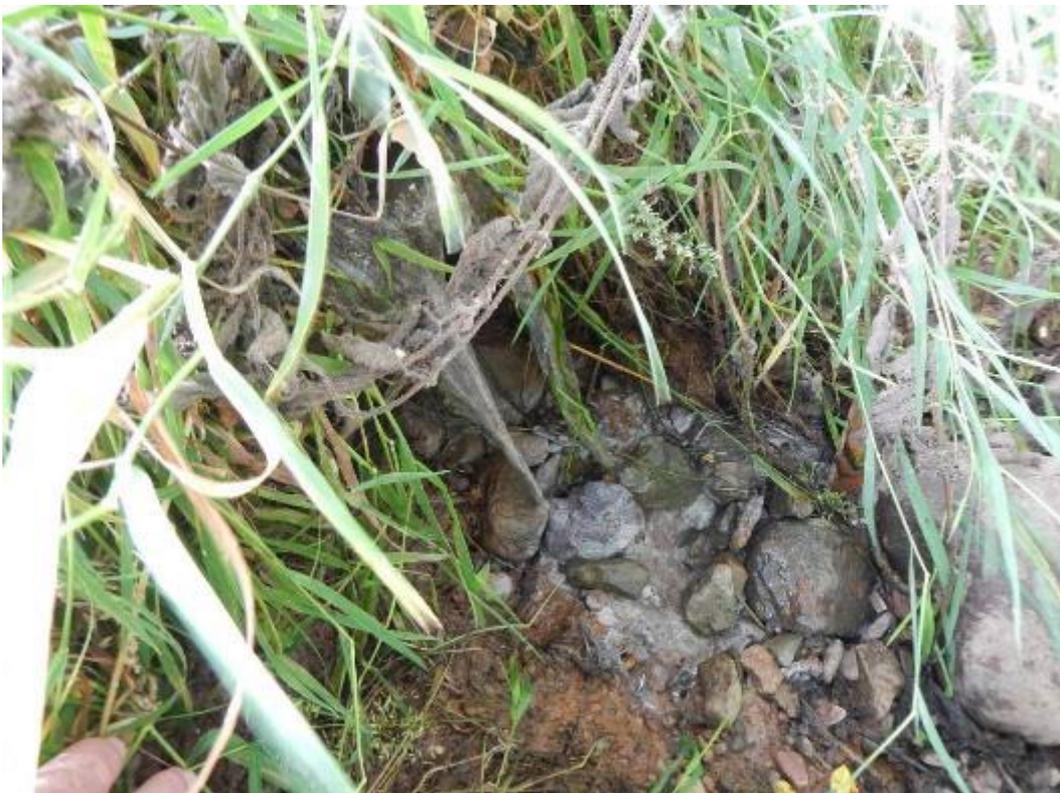
Photo DSCN33352. A strong sewage odour was associated with a discharge (NY 54926 26610), suggesting it is emanating from a poorly maintained septic tank. Grey sewage fungus growing around the discharge confirms this as pollution.

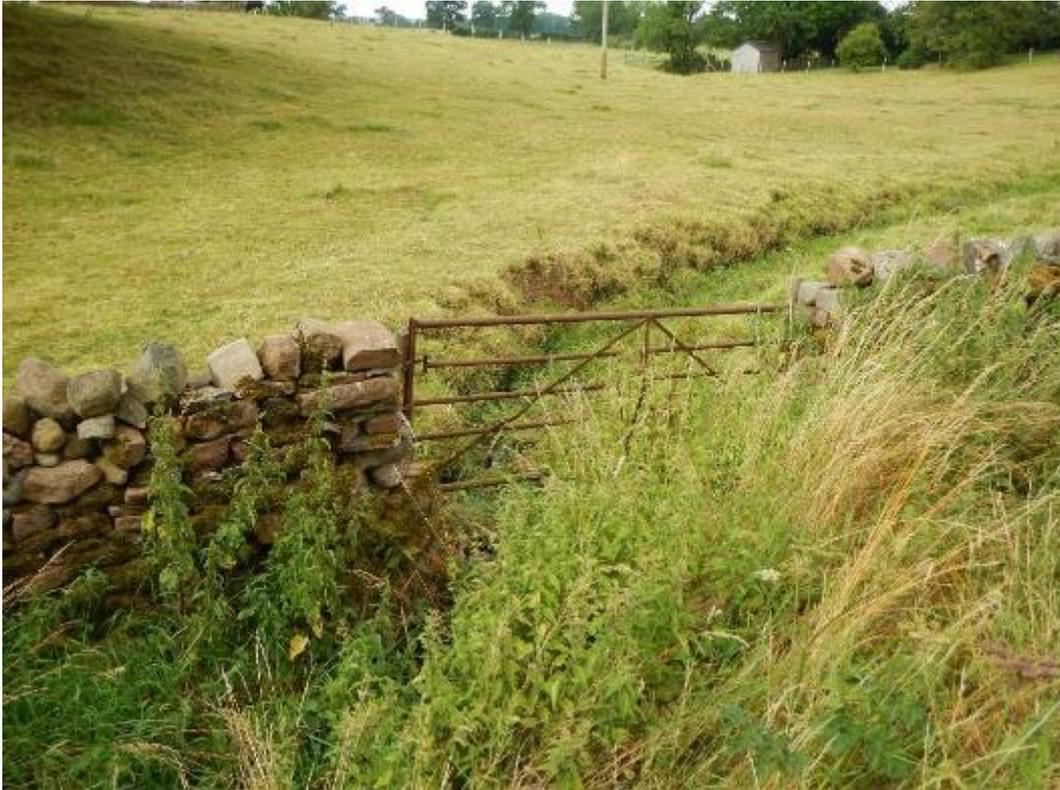
Photo DSCN3360. The bank poaching/trampling issues are clearly evident in the field u/s of Weatheriggs Road, when comparing the recently dredged channel of the 2010 picture (Goggle Maps) with the choked channel on day of the walkover. Another high nutrient discharge was also observed within the field at NY 55010 26718, which again appeared to be from a poorly maintained septic tank.

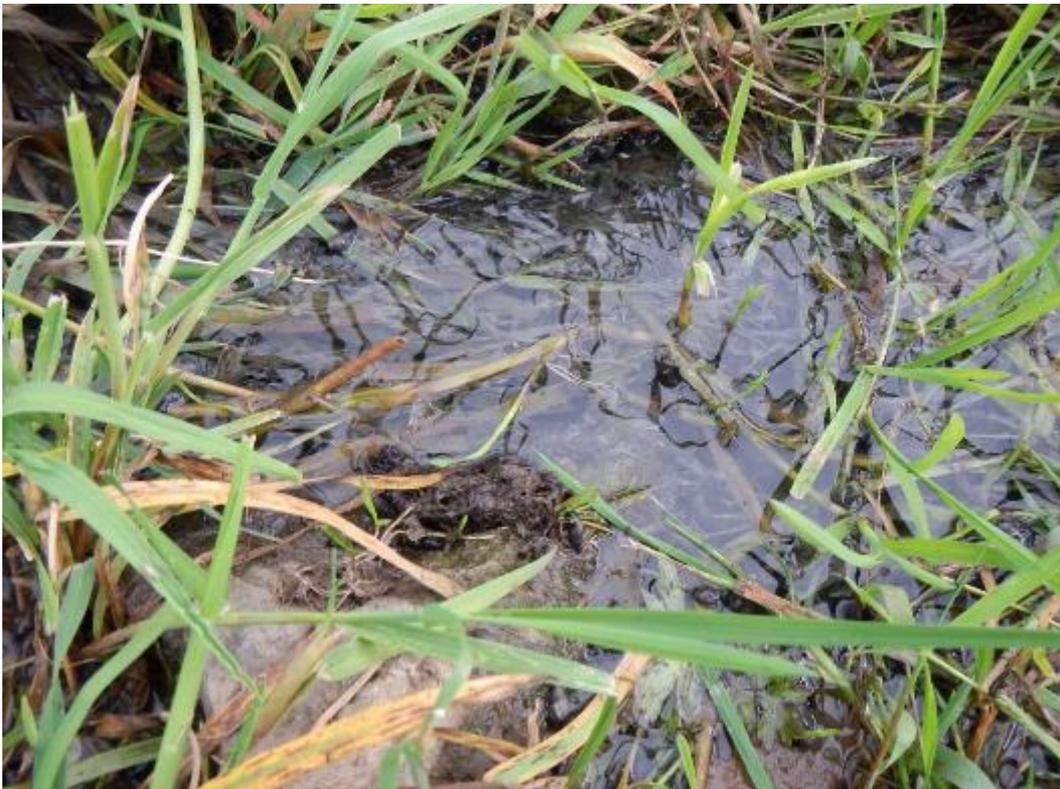
Photo DSCN3358. Another high nutrient discharge was also observed within the field at NY 55010 26718, which again appeared to be from a poorly maintained septic tank.

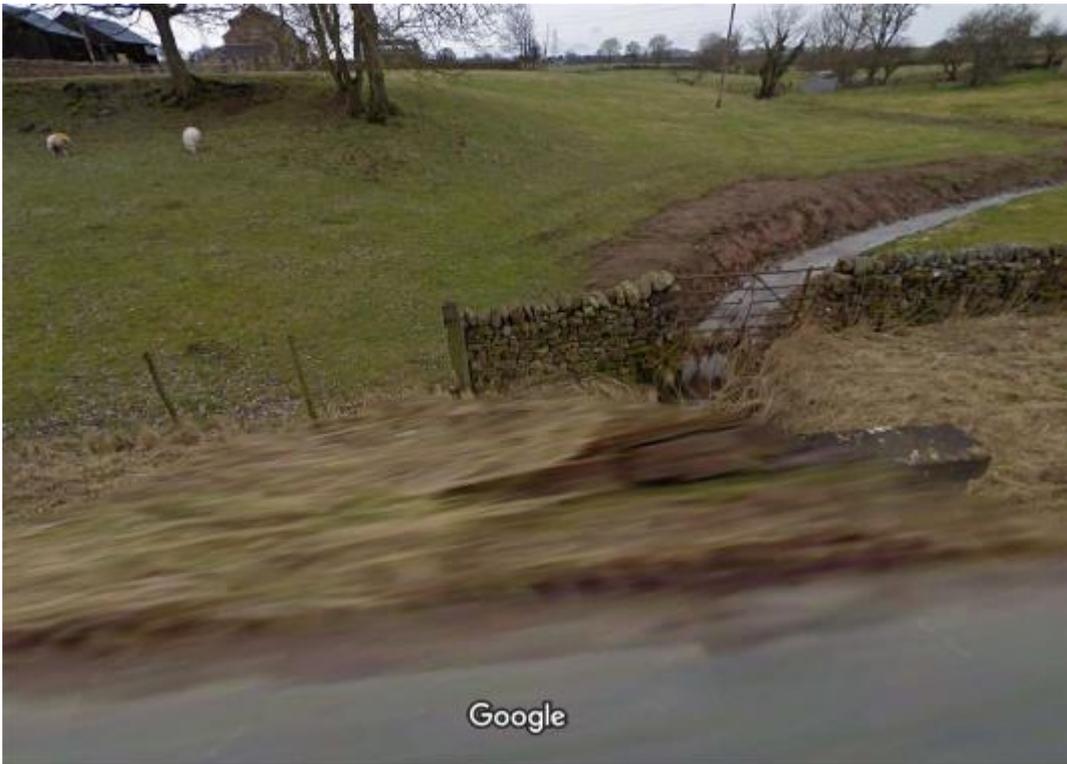
Photo Google. Uniformly dredged, over-capacity channel u/s of Weatheriggs Road (2010). Over-capacity channels result in increased sediment deposition, with additional bank poaching/trampling this leads to choking of the channel. It would be far better to exclude livestock from the watercourse and allow a, self-cleansing channel to develop.

Dredging of the watercourse in the fields u/s of Weatheriggs Road is likely to be an ongoing maintenance burden upon the landowners/tenants. This issue could be greatly reduced by the buffer fencing/livestock exclusion measures suggested. This would clearly require negotiation with the landowners/tenants but could bring about significant improvements for land management and water quality.

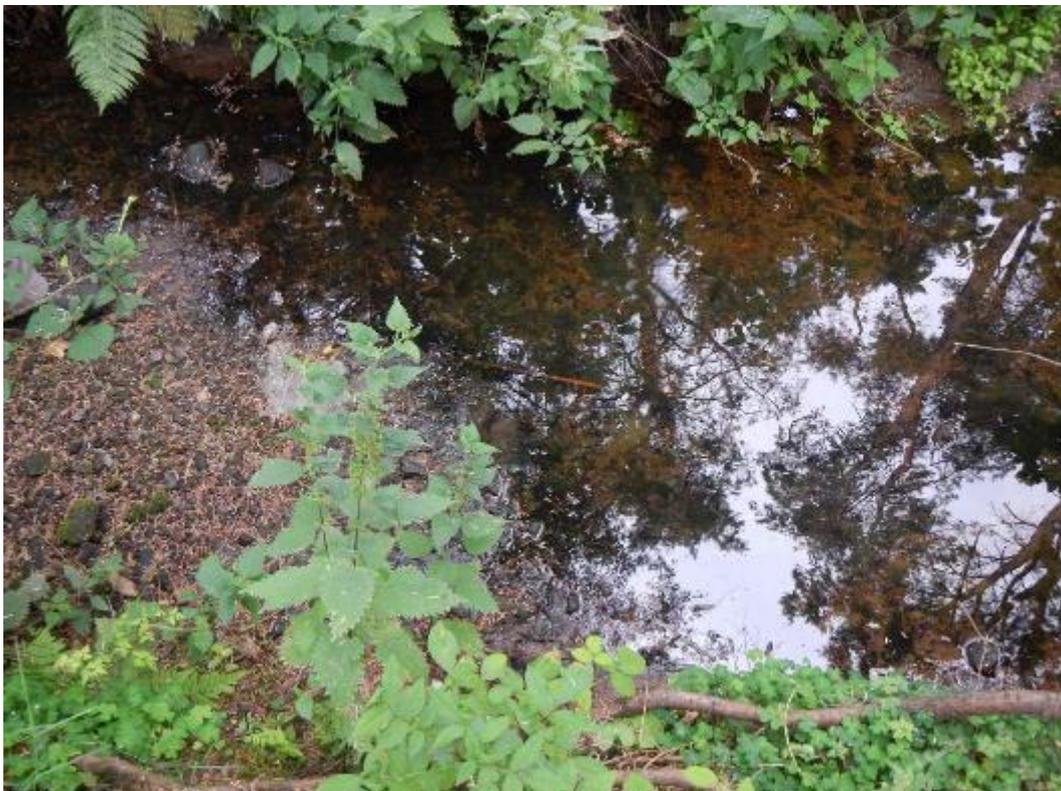
Photo DSCN33366. Light Water flows through a recently thinned conifer plantation d/s of Weatheriggs Road (NY 55058 26704 - NY 55482 26811). Although likely dredged in the past, this section of watercourse retains a more natural bed composition and could provide good quality invertebrate habitat. However, the sedimentation and high nutrient inputs u/s are likely to limit its current potential. Correspondingly, only freshwater lice and snails were observed, both being particularly tolerant to poor water quality.

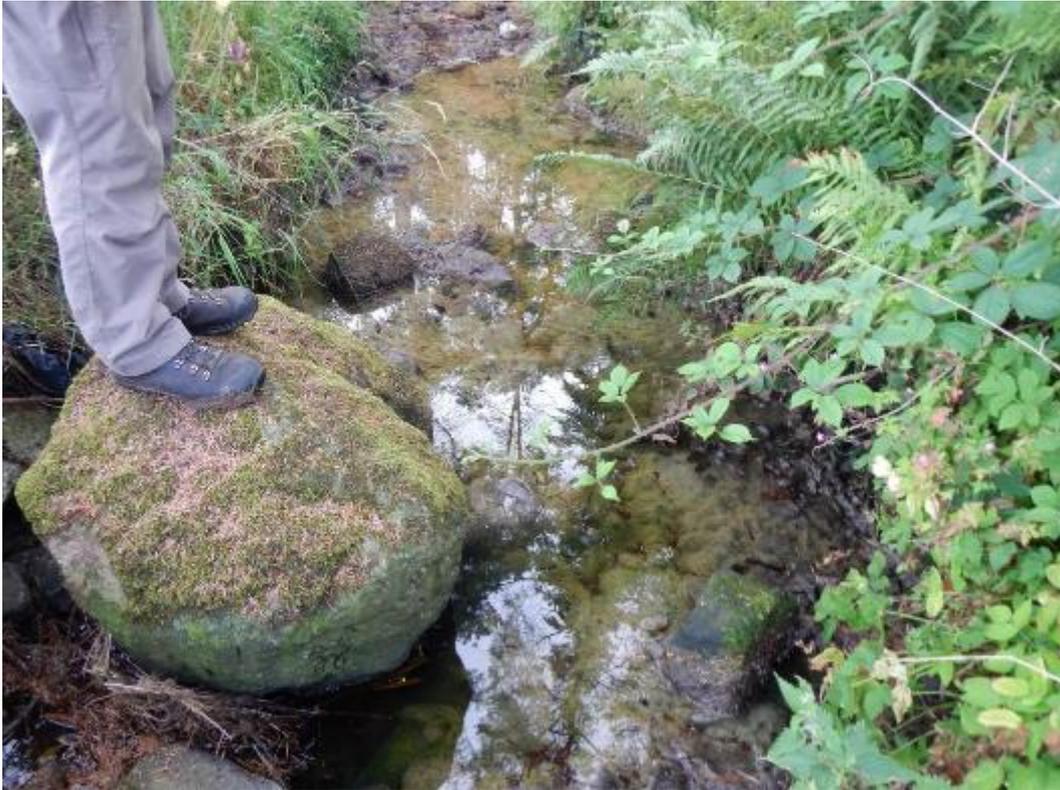
Photo DSCN3373. In areas where light penetration to the watercourse is good, excess algal growth was observed, again highlighting the issues of fine sediment and nutrient inputs u/s.

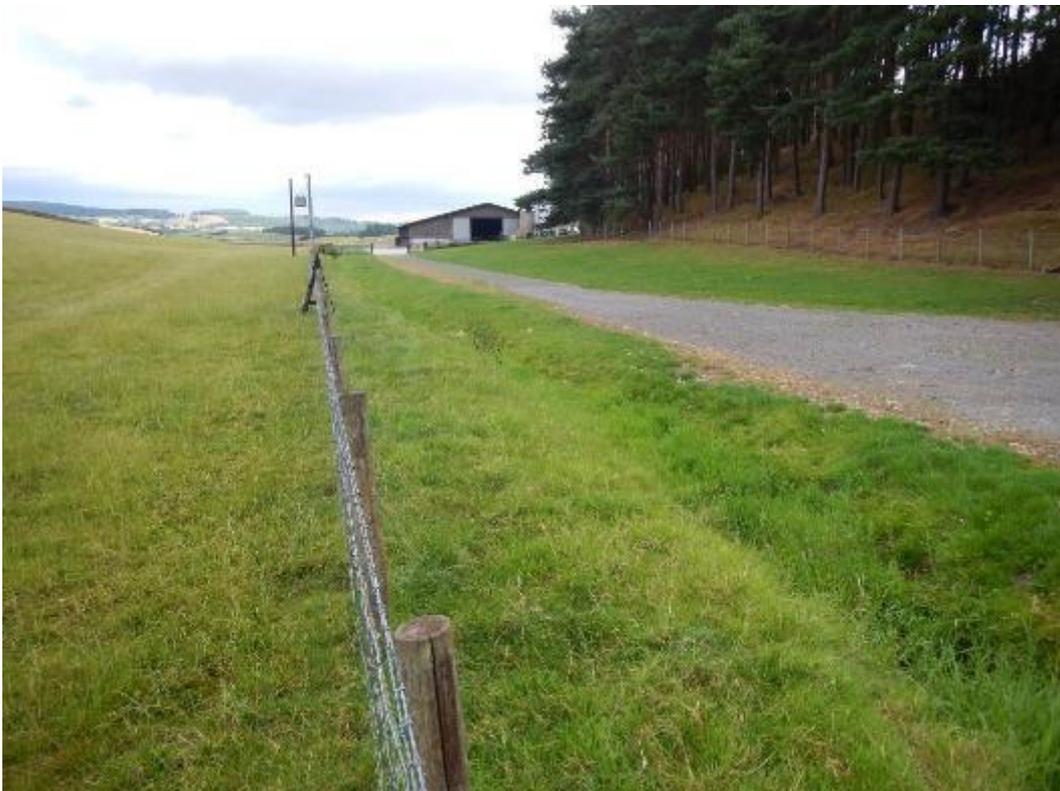
Photo DSCN3379. D/s of the plantation a small tributary (dry at the time of the walkover) joins Light Water before continuing alongside an area of livestock pens and sheds. The watercourse is buffered from the adjacent LB grazing on but lightly grazed on the RB. At the time of the walkover the watercourse was carrying very little flow, and was completely dry in places.

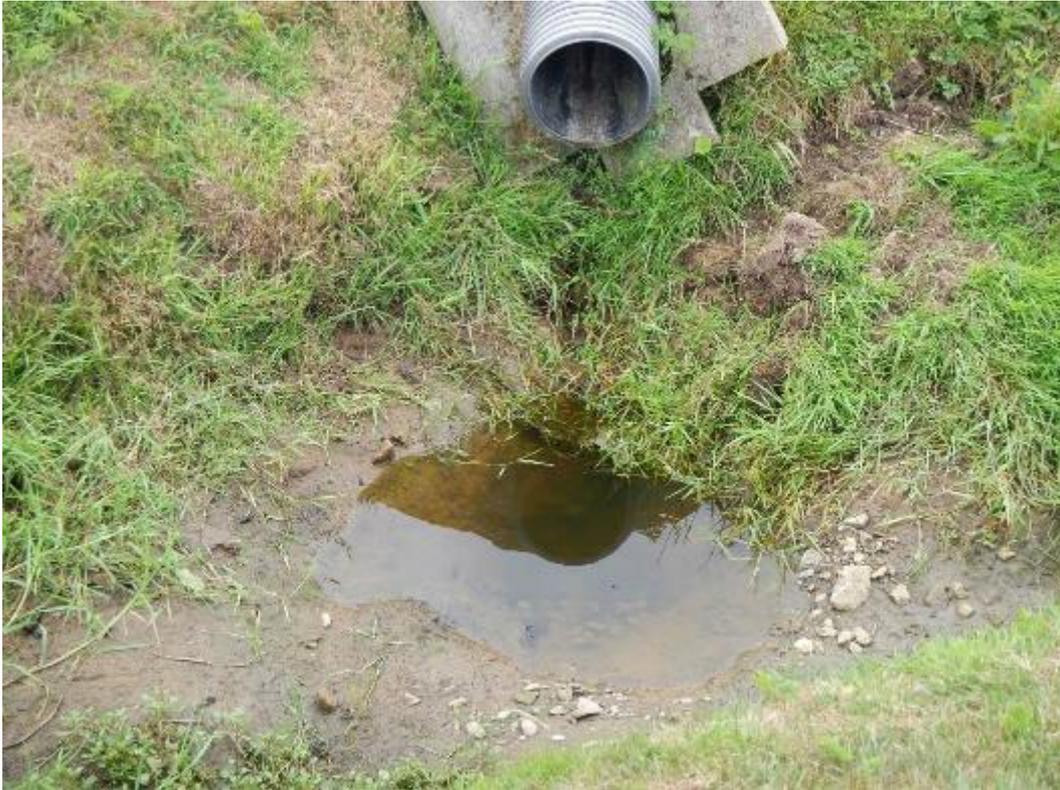
Photo DSCN3384. A pipe near the infrastructure (NY 55414 27073) appears to be supplying elevated nutrient water (possibly silage or slurry liquor) to the watercourse, as evident by the discoloured pool immediately d/s. However, the absence of sewage fungus suggests that it is either a relatively low nutrient or an intermittent discharge.

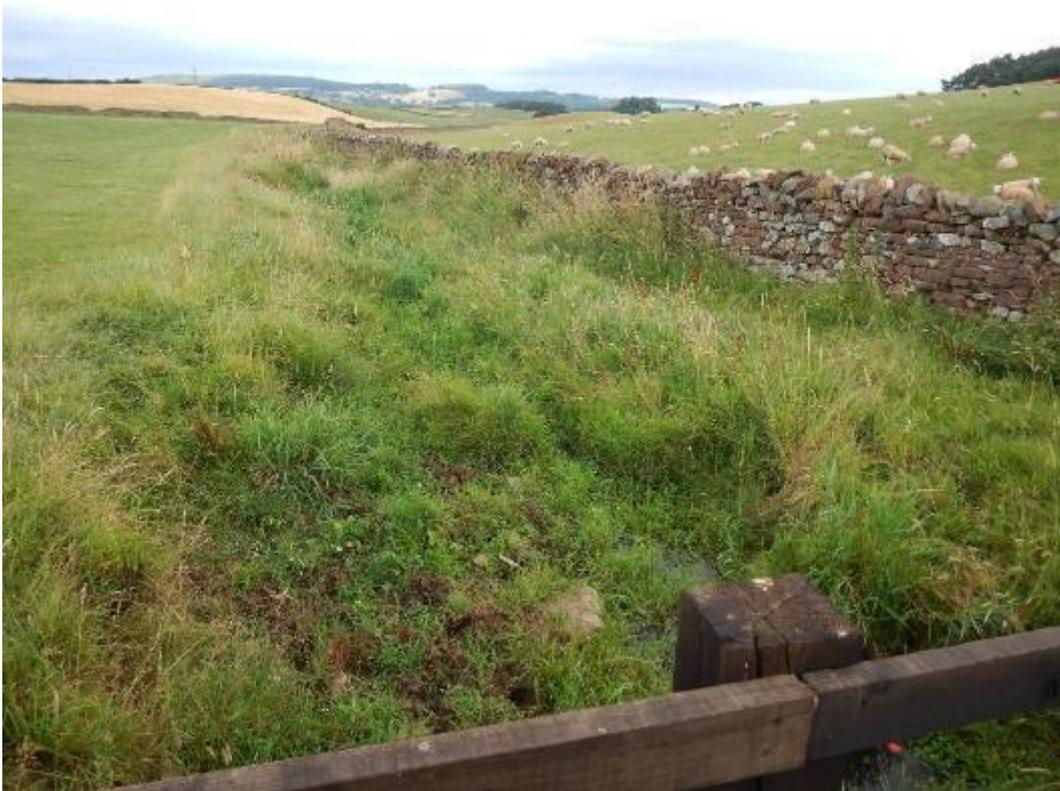
Photo DSCN33385. The next field d/s is grazed from the LB, which allows access to both banks (NY 55404 27104 - NY 55339 27221). As the damage appears to be predominantly by cattle, a basic breast-wire fence could protect the channel here.

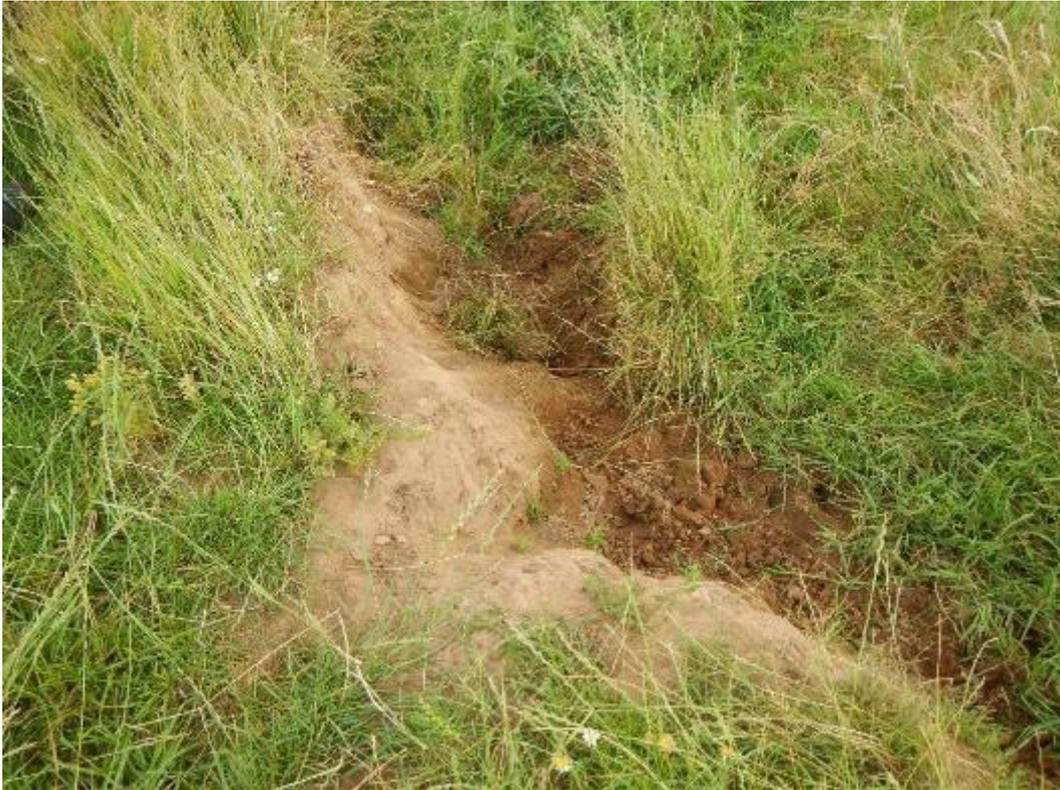
Photo DSCN33387. Although the watercourse was largely dry, it is clear to see that the scarring of the banks and poaching will create a notable source of fine sediment in higher flows. It should also be remembered that the very dry conditions in summer 2018 have led to many other, usually perennial watercourses drying up.

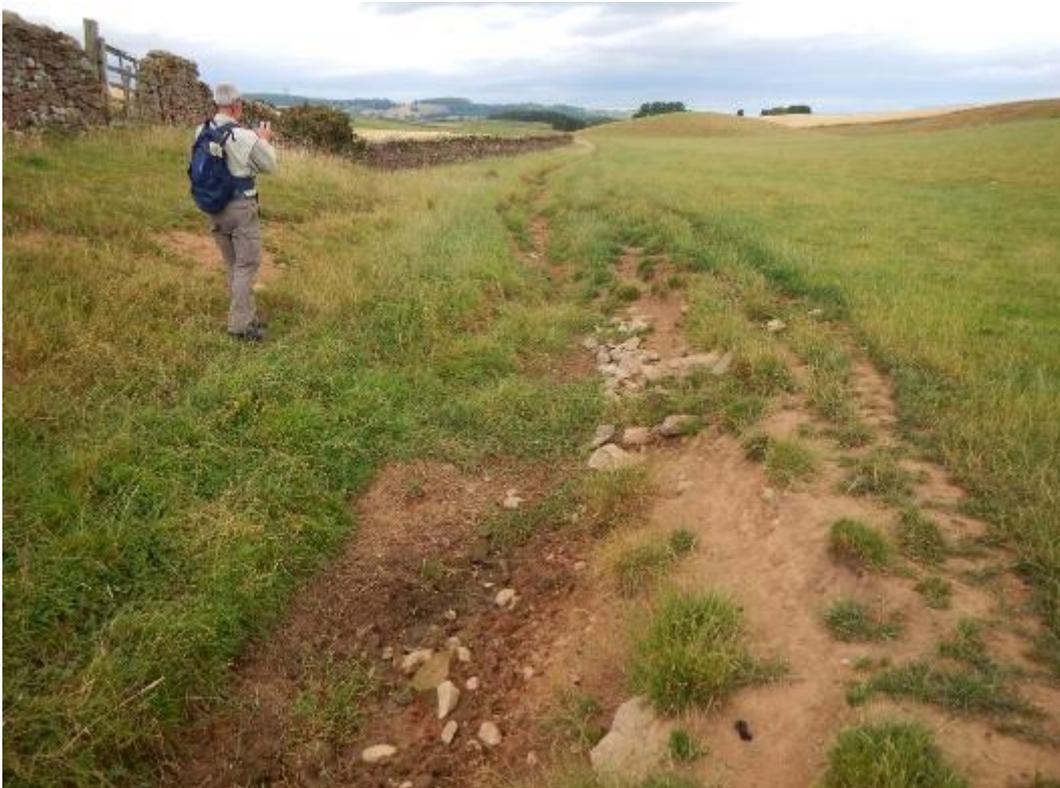
Photo DSCN3391. Higher density sheep grazing in the next field d/s is creating similar issues and ideally requires a stock-netting fence (NY 55339 27221 - NY 55315 27631). The wall along the LB would mean that only one fence would be required to exclude livestock.

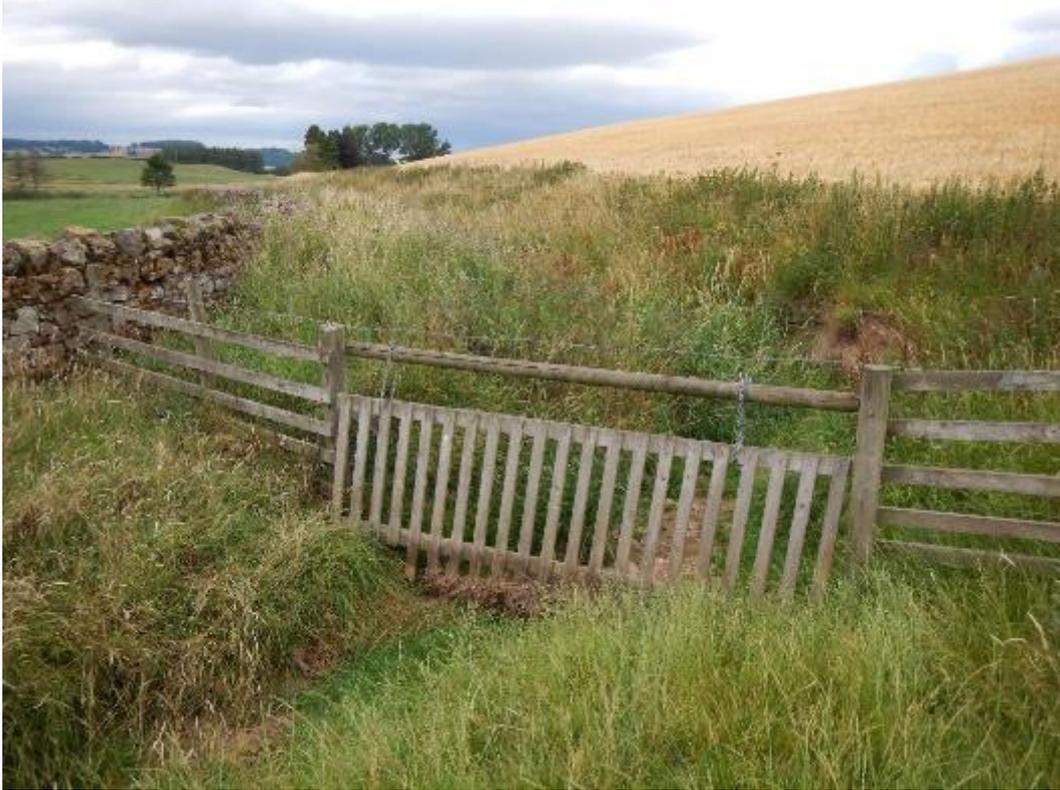
Photo DSCN3391. The next field d/s is used for arable production and is adequately buffered (NY 55315 27631 - NY 55284 27727), with the channel still protected by the wall on the LB.

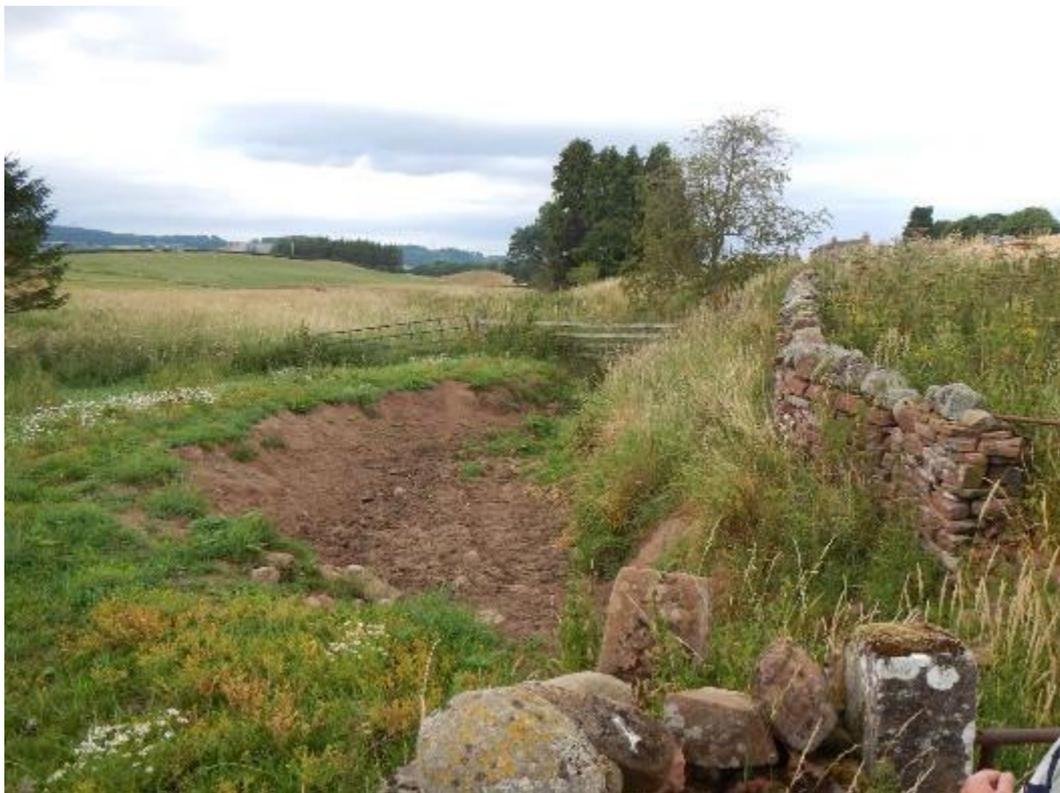
Photo DSCN3394. A short section of un-buffered channel in the corner of the next field d/s creates a disproportionate fine sediment impact through significant scarring and poaching (NY 55280 27735).

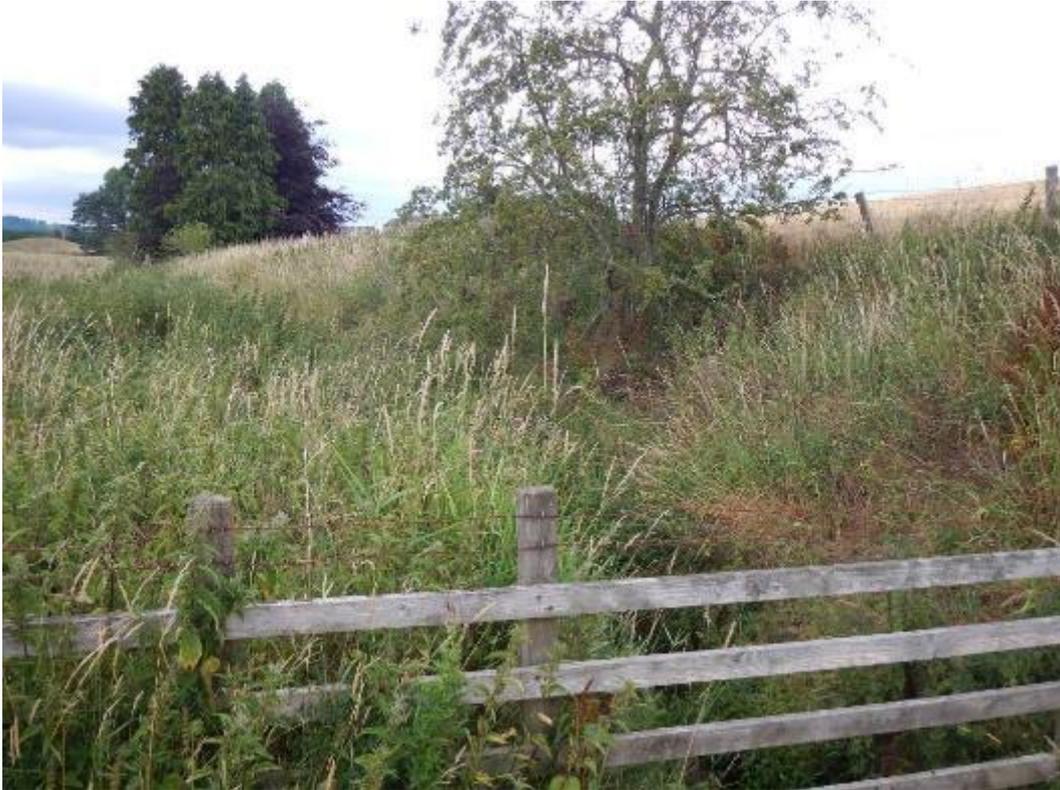
Photo DSCN3395. An area of rough vegetation d/s is out of production and it appears that there may be springs or field drains discharging within that area.

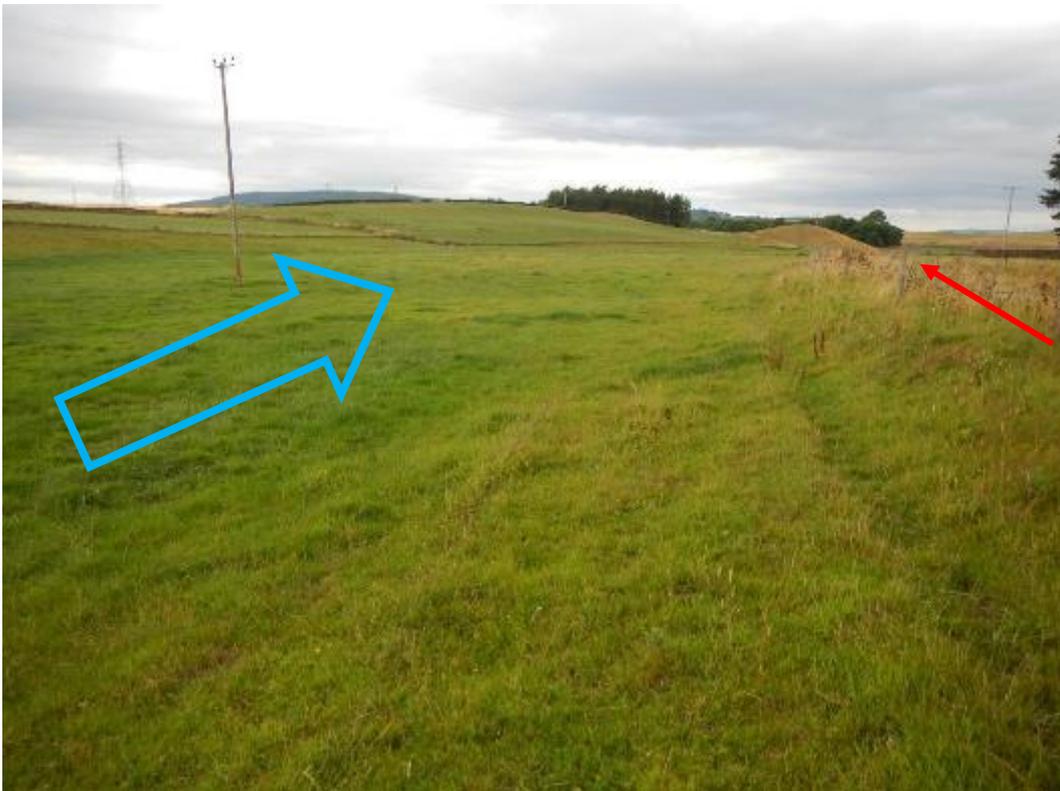
Photo DSCN3399. For two fields d/s of the wet area (NY 55266 27803 - NY 55206 28408), a dry channel follows a raised, embanked course on the RB slope (red arrow). Such realignment invariably results in a poorly drained valley bottom. It is suspected that the primary Light Water flow remained in the valley bottom at the time of the walkover, within the boggy ground and possibly sub-surface field drains (blue arrow). The ideal solution here would be to reinstate the original surface watercourse in the bottom of the valley.

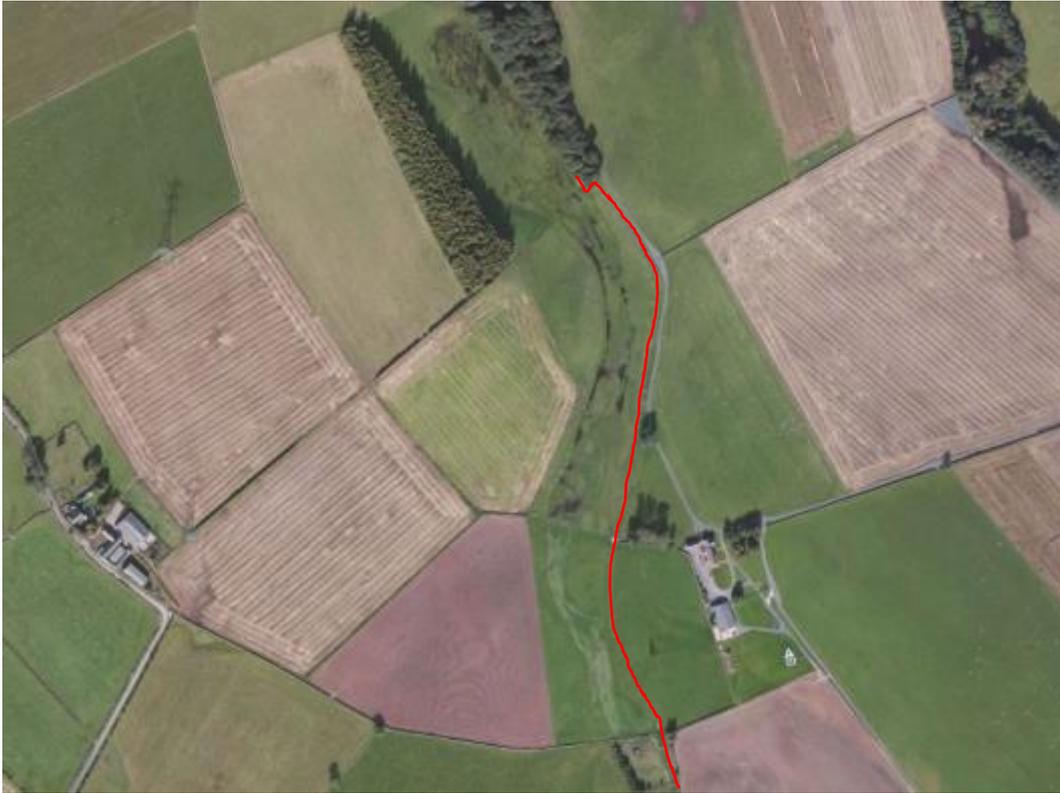
Photo DSCN3399. Aerial imagery (Bing Maps), taken following wet conditions, shows the Light Water's old course and likely primary flow course, where surface water is visible (centre of shot – to the left of the red line). This further supports the case of a river restoration project there. The current surface channel roughly follows the red line.

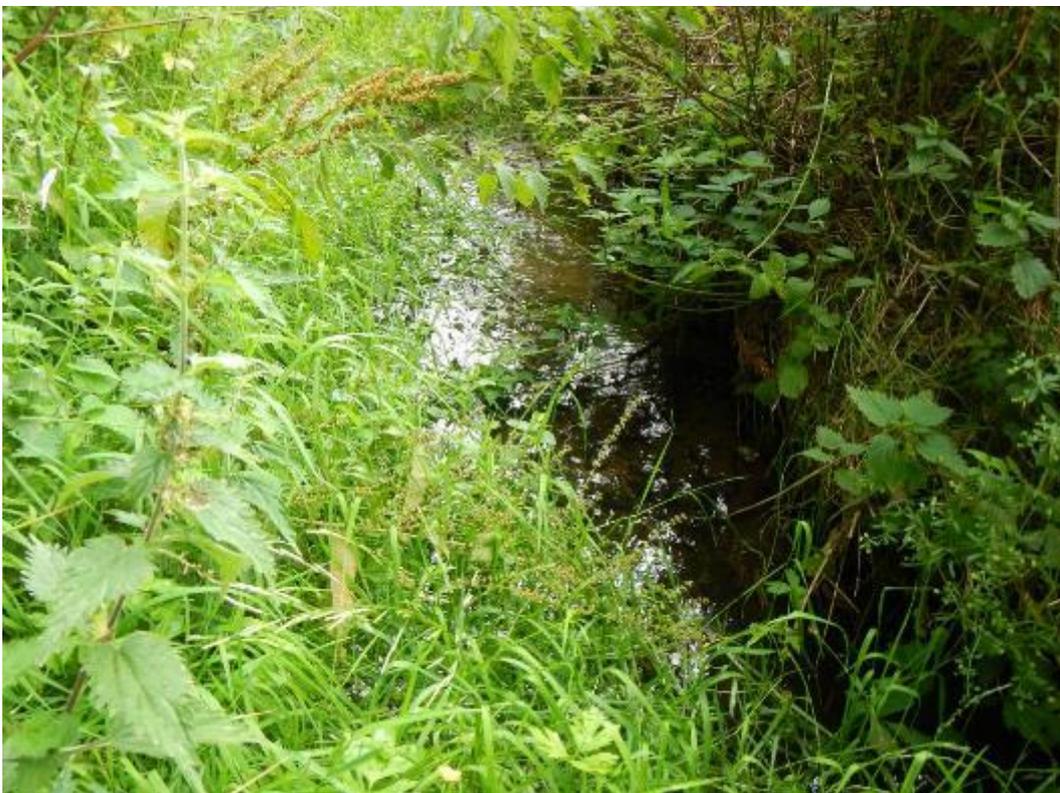
Photo DSCN3410. Within the wood, although remaining straightened, the Light Water channel returns closer to the valley bottom and the flow increases significantly (NY 55206 28408 - NY 54971 28757). This may support the theory that much of the flow u/s is being carried sub-surface in pipes in the low point of the valley and that they discharge to the Light Water's surface channel when it returns near the valley bottom.
