Walkover Assessment
Light Water
(Tributary of the River Eamont)
Cumbria
24/07/2018

Undertaken by Gareth Pedley

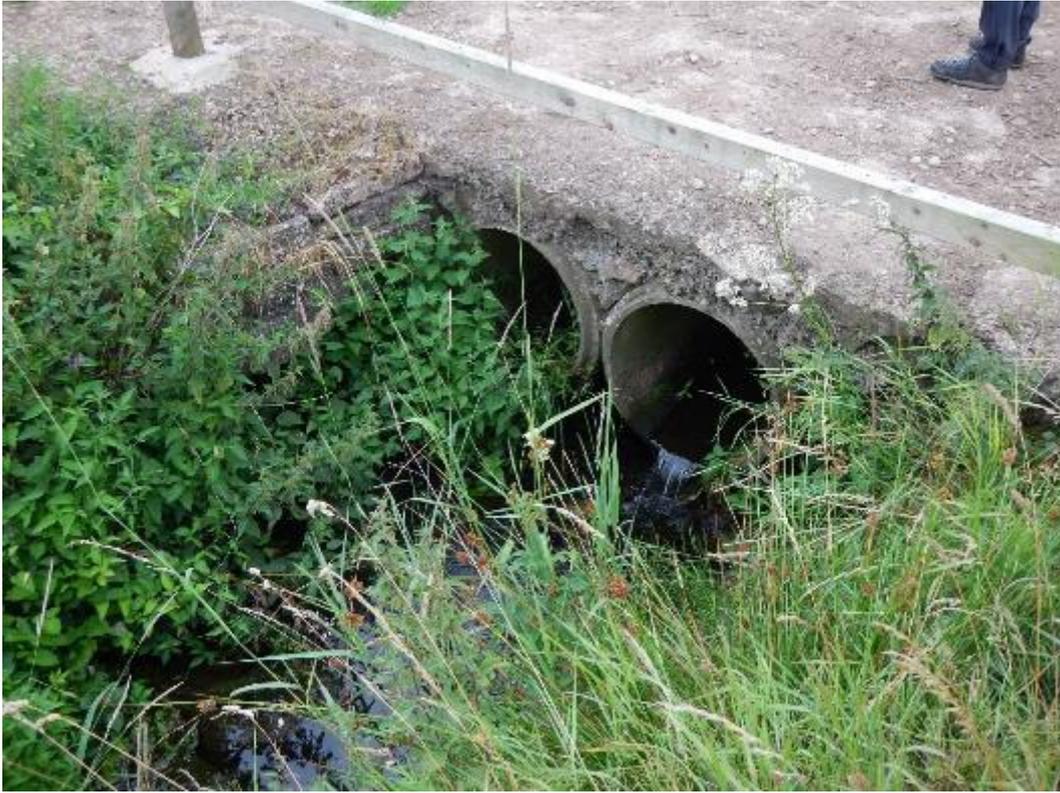
Photo DSCN3420. A perched culvert at NY 54962 28792 creates an obstruction for fish but the severe habitat degradation of the Light Water u/s of here means that it is unlikely to be a major issue until the u/s habitat issues can be addressed. Improved invertebrate assemblages were observed from around this area.

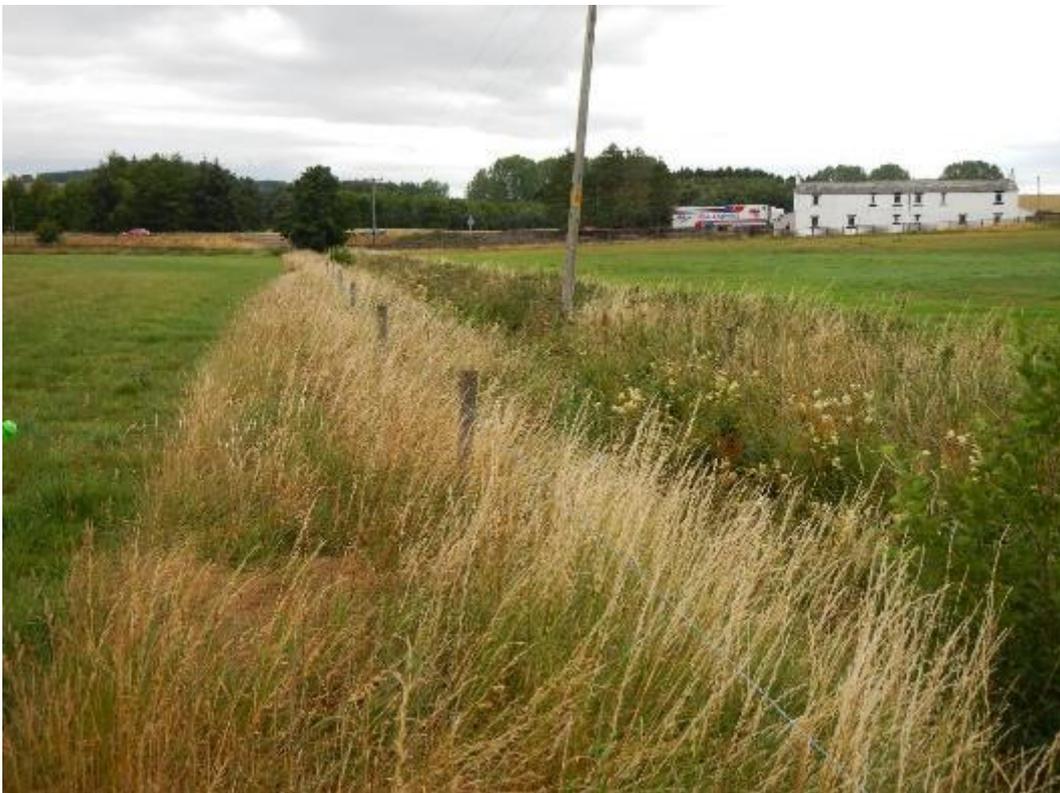
Photo DSCN3422. The field u/s of the A66 is buffered with a single breast-wire, which appears to be adequately protecting the watercourse but the straightened degraded channel would benefit from restoration to a more naturally sinuous course (NY 54971 28759 - NY 54922 28955).

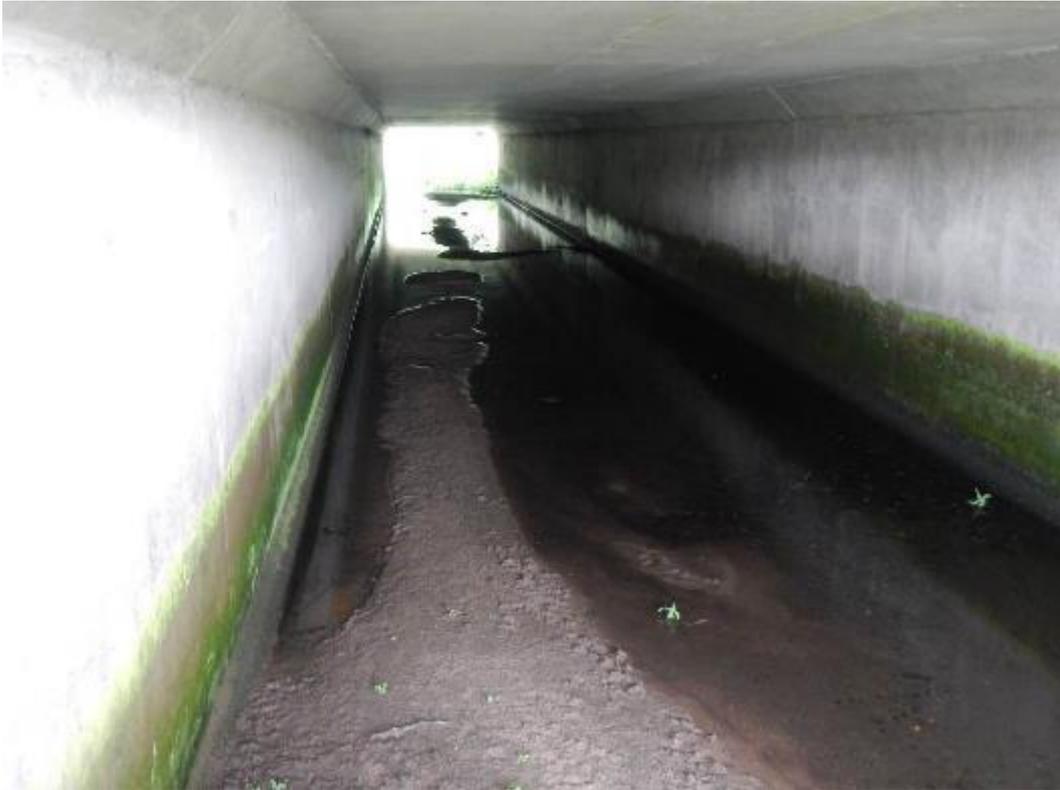
Photo DSCN3. The A66 road culvert (NY 54914 28972) is over-capacity for the size of the watercourse and, correspondingly, high volumes of the fine sediment supplied from u/s are deposited there. This creates an additional issue as that material will lie there, unconsolidated (in the absence of light and vegetation growth), only to be remobilised at higher flows. Mink and otter tracks were observed within the silt.

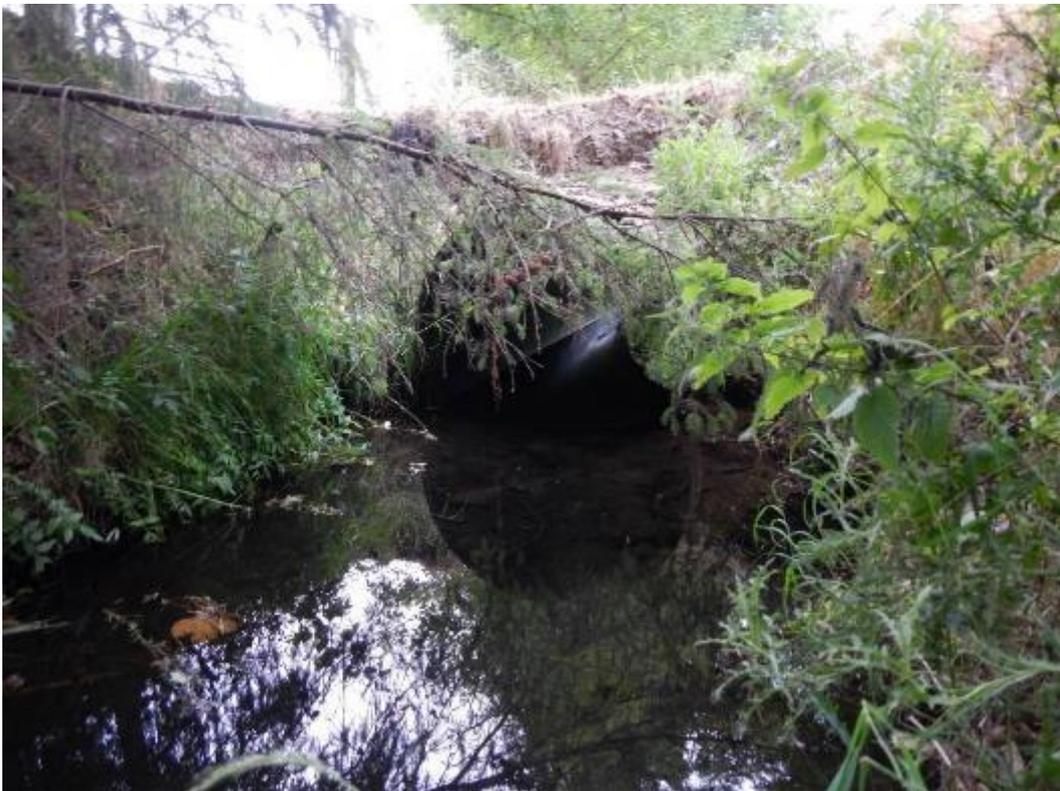
Photo DSCN33429. Another small culvert just d/s of the A66 (NY 54884 29006) is partially sunken below the bed level and poses no issues for sediment and fish movement.

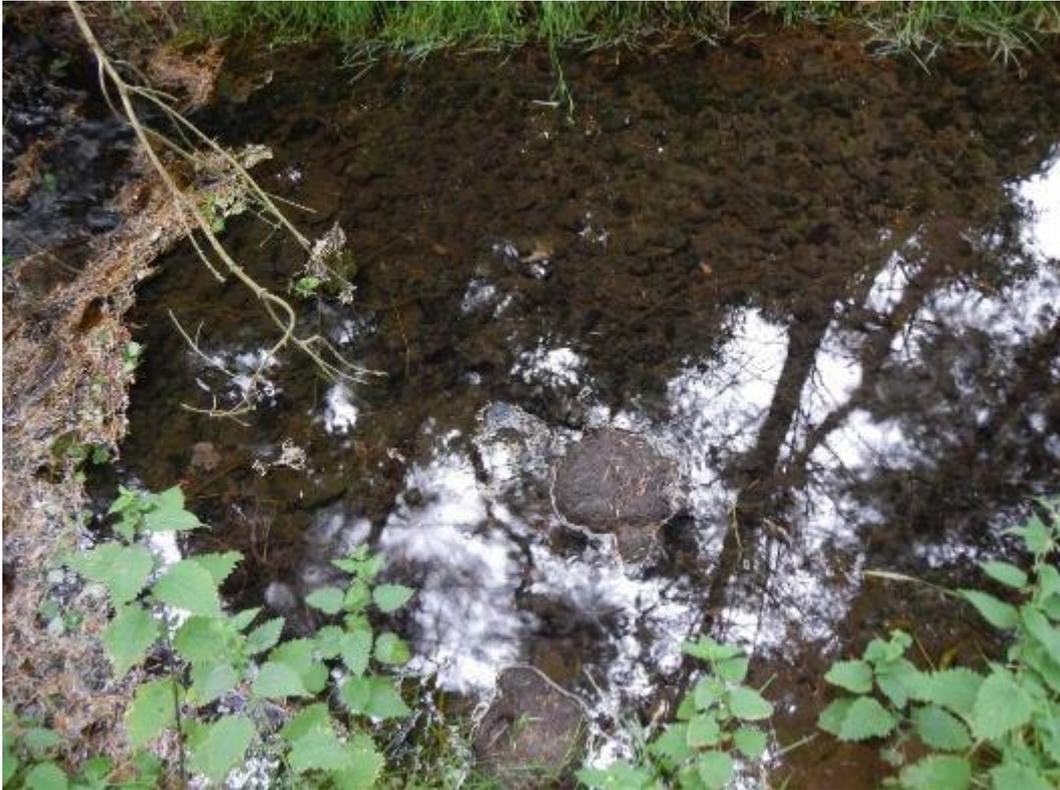
Photo DSCN3430. The potential quality of salmonid spawning substrate improves in the lesser-dredged section d/s of the A66; however, the fine sediment component resulting from inputs u/s greatly limits that potential.

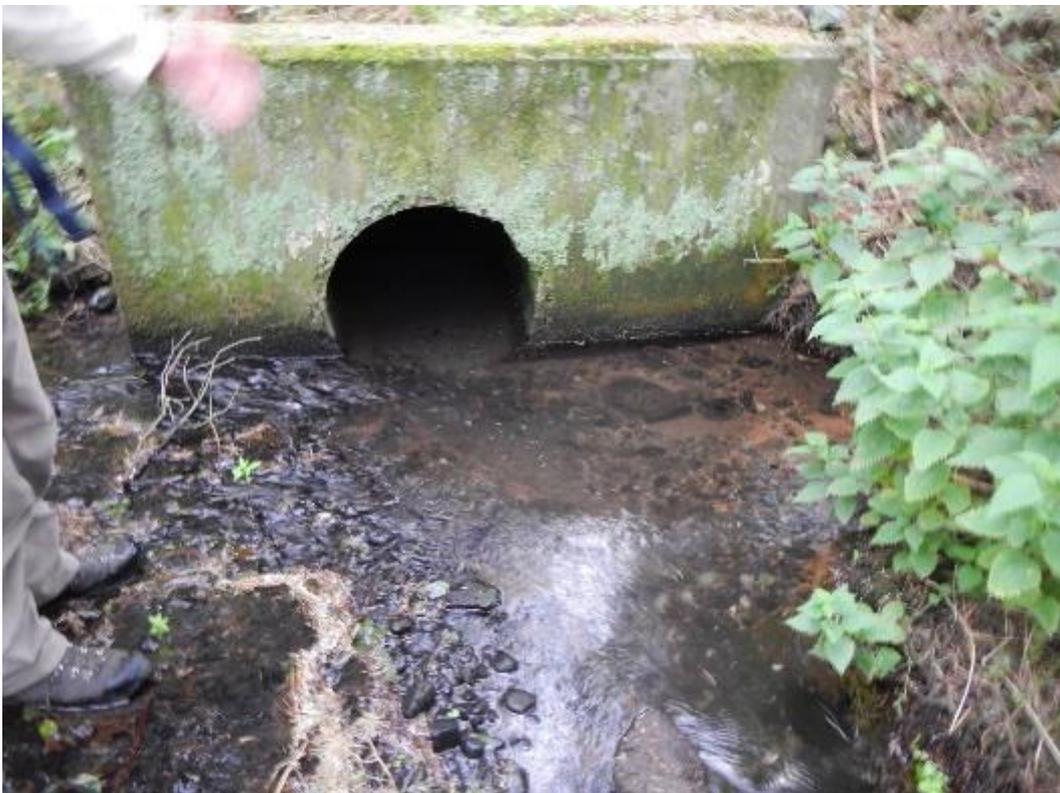
Photo DSCN3431. Although not flowing at the time, the bed of a culvert which joins the Light Water at NY 54873 29043 was covered with silt, potentially suggesting it to be another fine sediment source (although it could just be backed up out of the main channel). Further investigation of the potential source of the culvert would be beneficial.

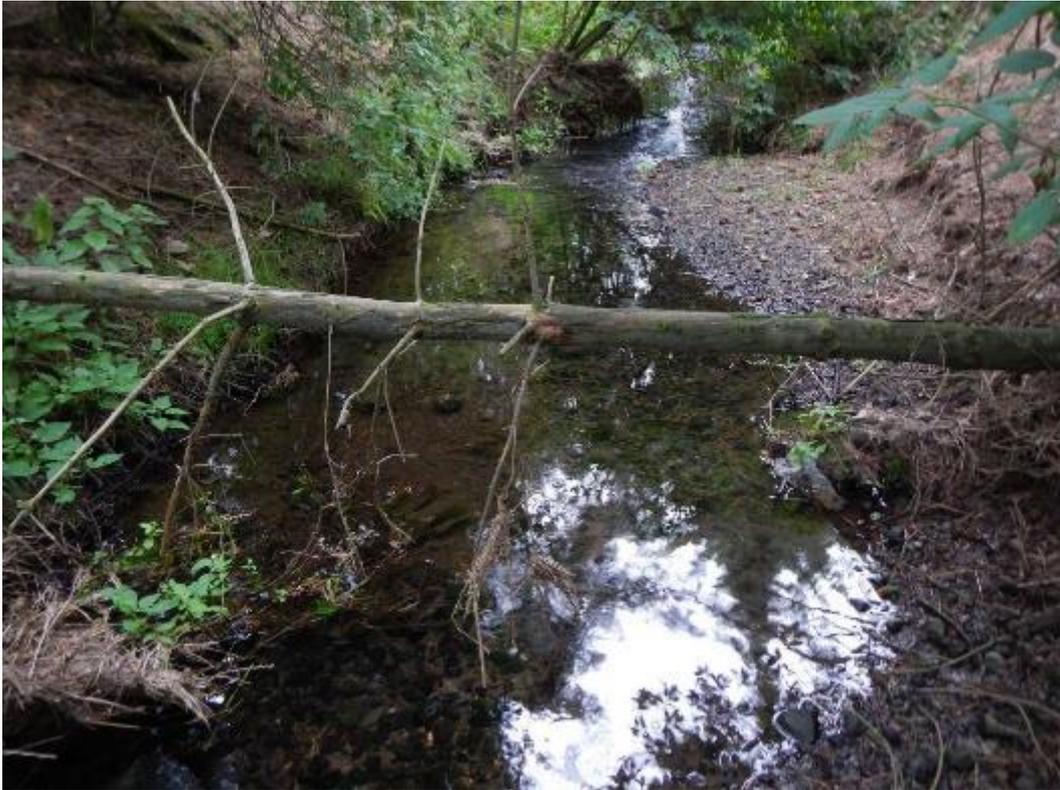
Photo DSCN3435. The channel in the wood d/s of the A66 is quite incised (possibly naturally) and has clearly also been dredged and realigned in the past. However, erosion and depositional features are beginning to reinstate a crude pool and riffle sequence in some places. A high volume of fine material was observed within the gravels, which were often very soft underfoot as a consequence.

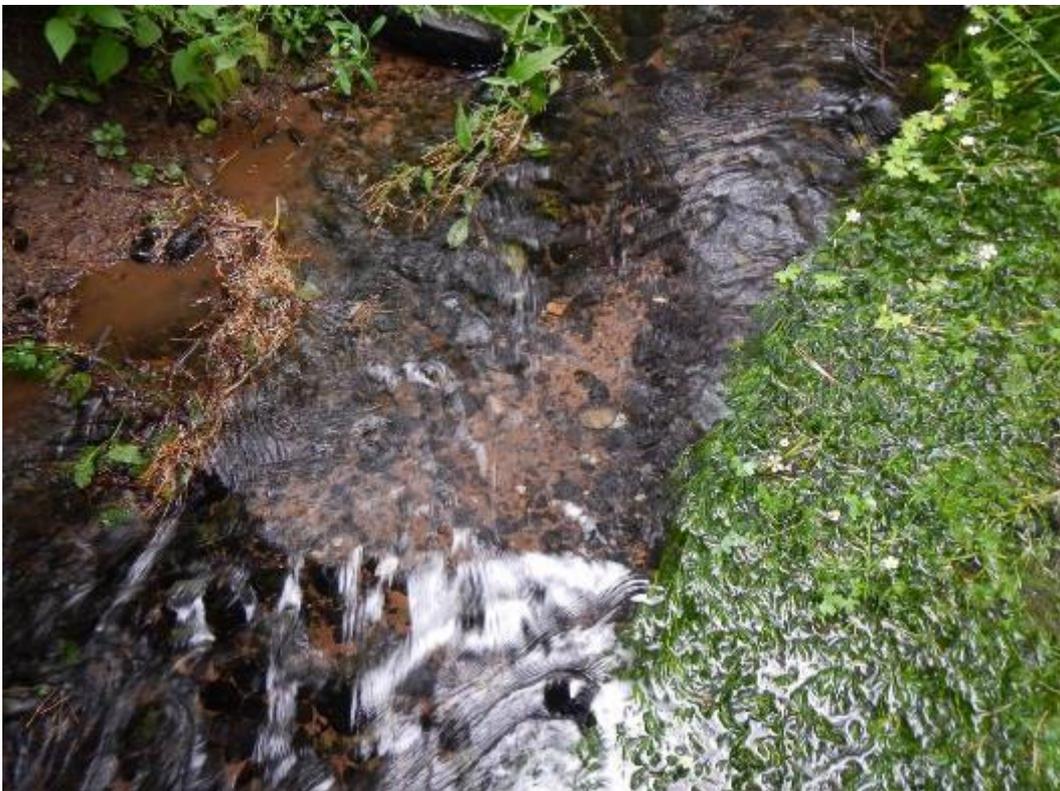
Photo DSCN33434. Disturbing the bed revealed a very high portion of sand and smaller particles beneath the surface gravel. This renders the substrate of significantly degraded potential as fish spawning and invertebrate habitat. Ranunculus was also noted from around this area.

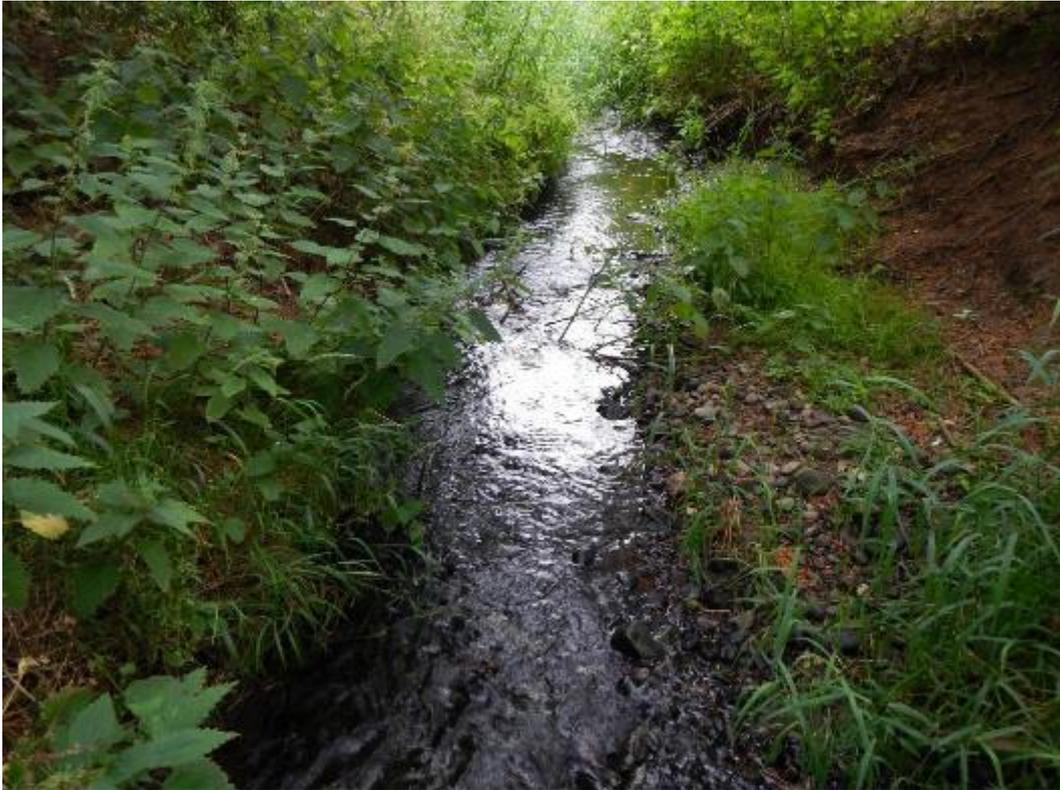
Photo DSCN33438. In the less dredged and over-capacity sections, some reasonably good quality juvenile salmonid habitat was observed. Salmonid recruitment and invertebrate populations are likely to remain impoverished due to the fine sediment issues.

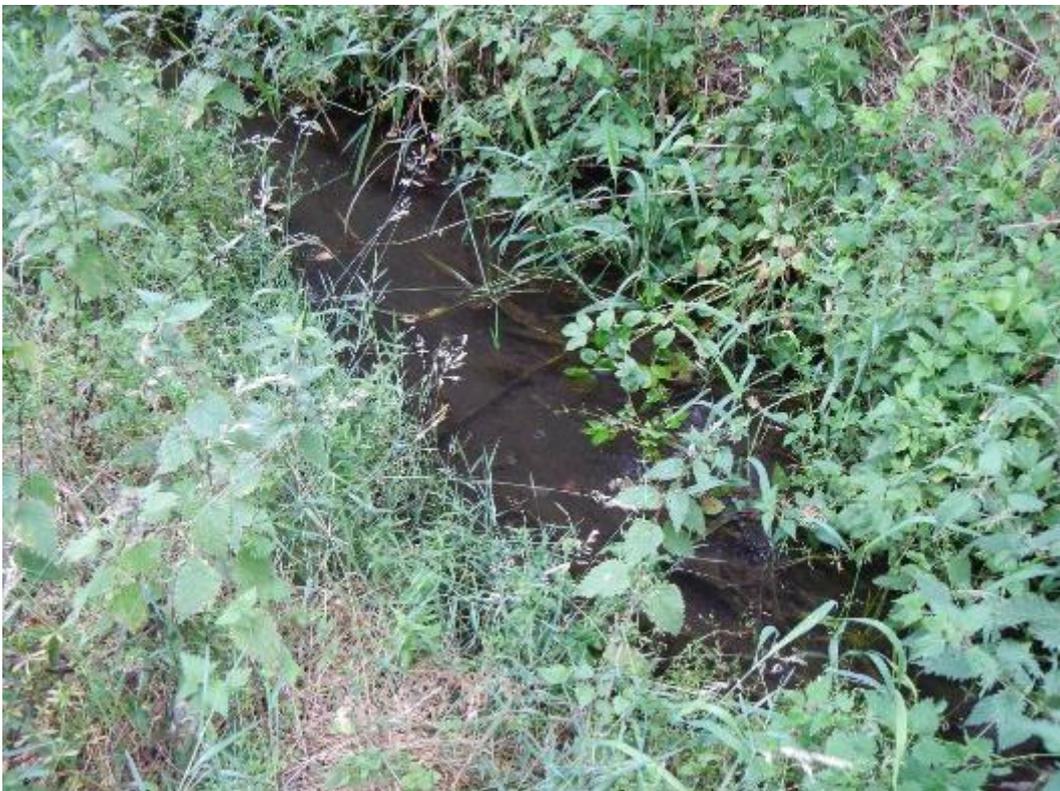
Photo DSCN33442. The more heavily dredged/not yet recovered sections are, however, particularly poor quality habitat for all riverine species.

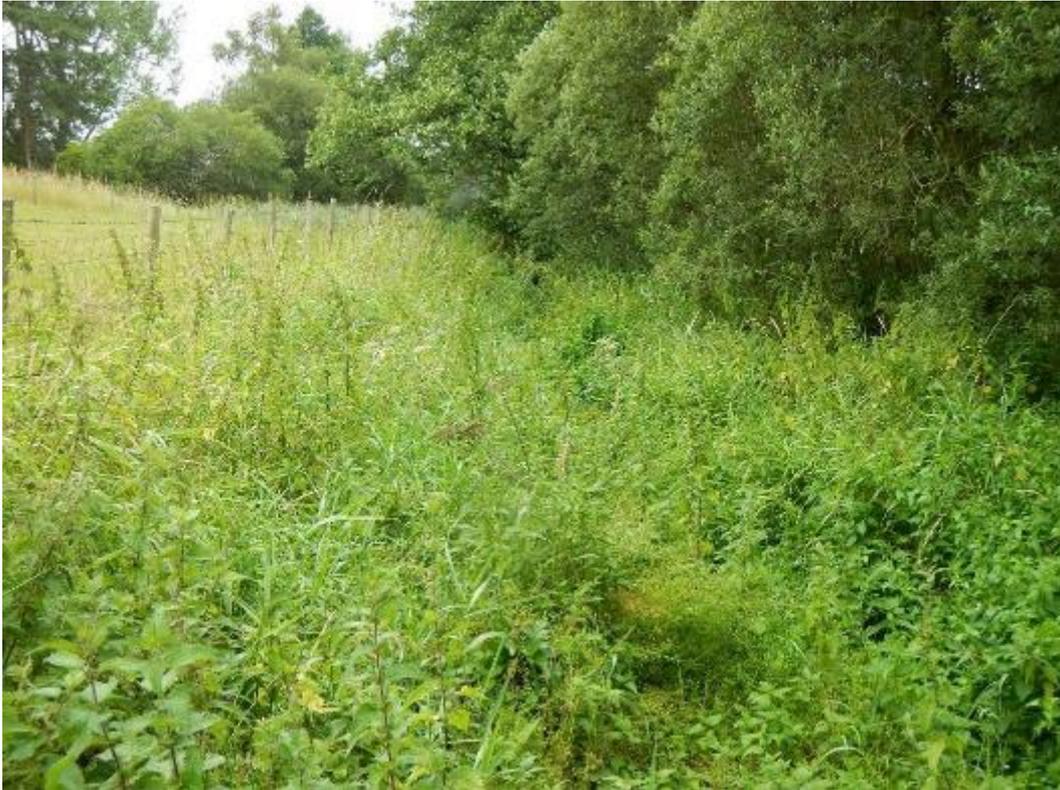
Photo DSCN3445. D/s of the initial incised section, a wider area of plantation/wet woodland may present an opportunity for major channel restoration/realignment (NY 54884 29075 - NY 55004 29301).

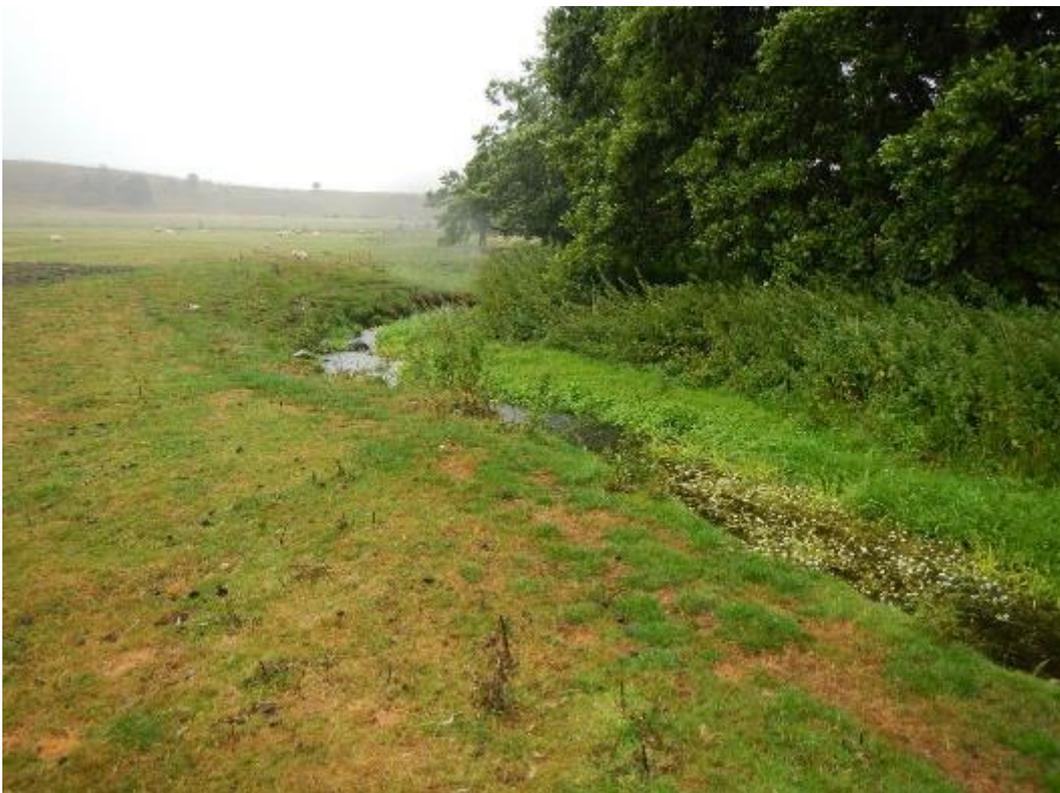
Photo DSCN3456. The potential for restoration continues d/s through a heavily sheep grazed field to the confluence with the Eamont (NY 55004 29301 - NY 55451 29347). The grazing/land use in the lower field may make such a scheme a harder sell to the landowner/tenant, but the significant potential for improvement remains. Even installing buffer fencing here would be an improvement but the potential for a wider reaching scheme should be ascertained first.

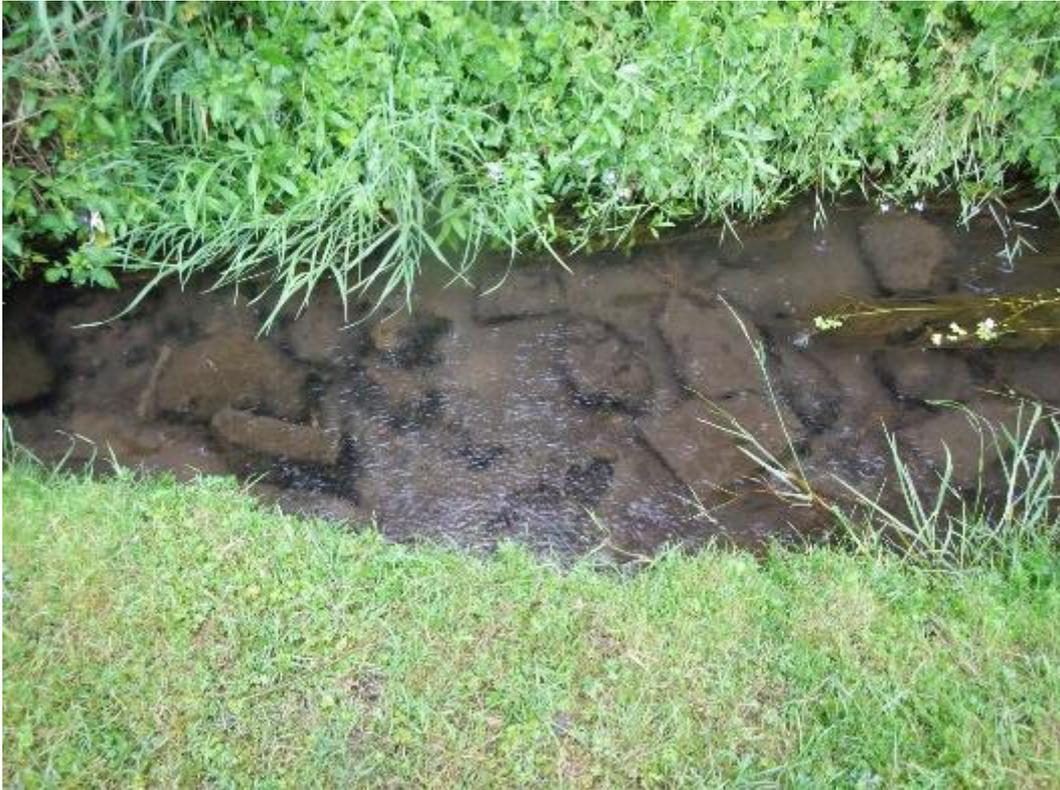
Photo DSCN3453. In the slower reaches of this section, the cumulative fine sediment issues and smothering of the bed and vegetation is very apparent, as is the high clarity, and likely quality of the water when not directly receiving fine sediment. Several factors including the flora and fauna of the Light Water and tufa, observed on areas of the substrate suggest that the water is relatively alkaline, strongly suggesting an influence of limestone geology in the catchment.

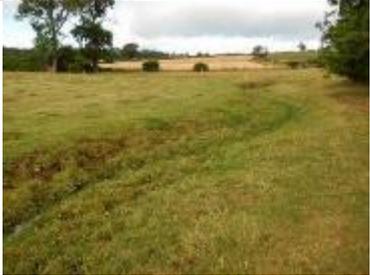
Issue	Photo (If required)	Priority (1-3)	Location	Proposed action
Livestock access and poaching of the watercourse (both banks).

2	NY 54381 26624 - NY 54600 26626	Breast Wire buffer fencing. Would also require a sunken pipe culvert to maintain grazing access.
Livestock access and poaching of the watercourse (both banks).

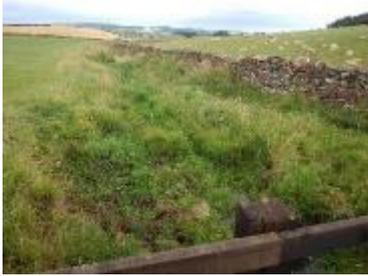
<p>Livestock access and poaching of the watercourse (both banks).</p>

<p>2</p>	<p>NY 55404 27104 - NY 55339 27221</p>	<p>Breast Wire buffer fencing of the LB would exclude cattle from both banks owing to wall along LB top.</p>
<p>Sheep access, erosion/scarring and poaching of the watercourse (both banks).</p>

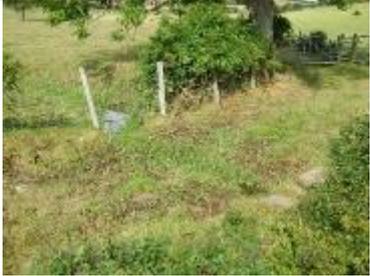
Issue	Photo (If required)	Priority (1-3)	Location	Proposed action
Poached watercourse crossing.

2	NY 54605 26628	Sunken pipe culvert to maintain grazing access.
Disposal of garden waste in watercourse and nutrient leaching.

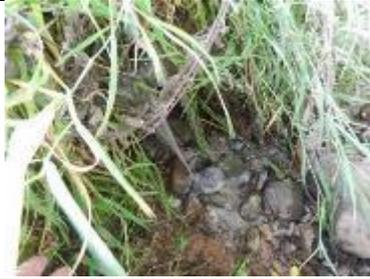
<p>Pollution of the watercourse/suspected septic tank discharge.</p>

<p>1</p>	<p>NY 54926 26610</p>	<p>Initially, inform the residents of the adjacent buildings of the issue so they can rectify it.</p> <p>If no action taken report as pollution to the Environment Agency.</p>
<p>Pollution of the watercourse / suspected septic tank discharge.</p>

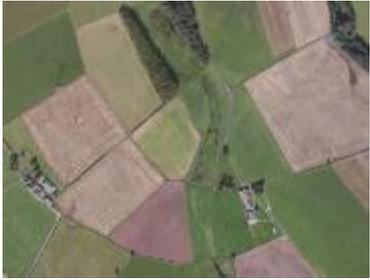
Issue	Photo (If required)	Priority (1-3)	Location	Proposed action
Major realignment of the surface channel and suspected culverting/piping of the watercourse in the valley bottom.

2	NY 55266 27803 - NY 55206 28408	<p>Possibility of channel restoration to improve land drainage and habitat quality in low-lying fields.</p> <p>The exact value dependent upon how much flow is actually available (further investigation required).</p>
Channel straightening alongside woodland in the valley bottom.

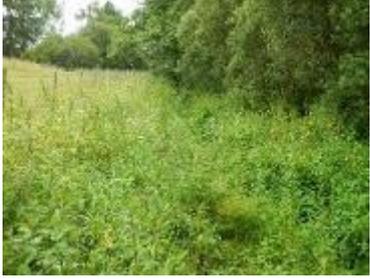
<p>Channel straightening.</p>

<p>1</p>	<p>NY 54884 29075 - NY 55004 29301</p>	<p>Possible channel restoration to improve habitat quality. This is a higher priority than other sections u/s as, combined with addressing the fine sediment issues u/s and at least fencing of the section d/s to the Eamont, it could deliver significant improvements.</p>
<p>Channel straightening.</p>
