River Lod – Lurgashall Mill Pond

A Project Proposal by the Wild Trout Trust – May 2014

1. Introduction

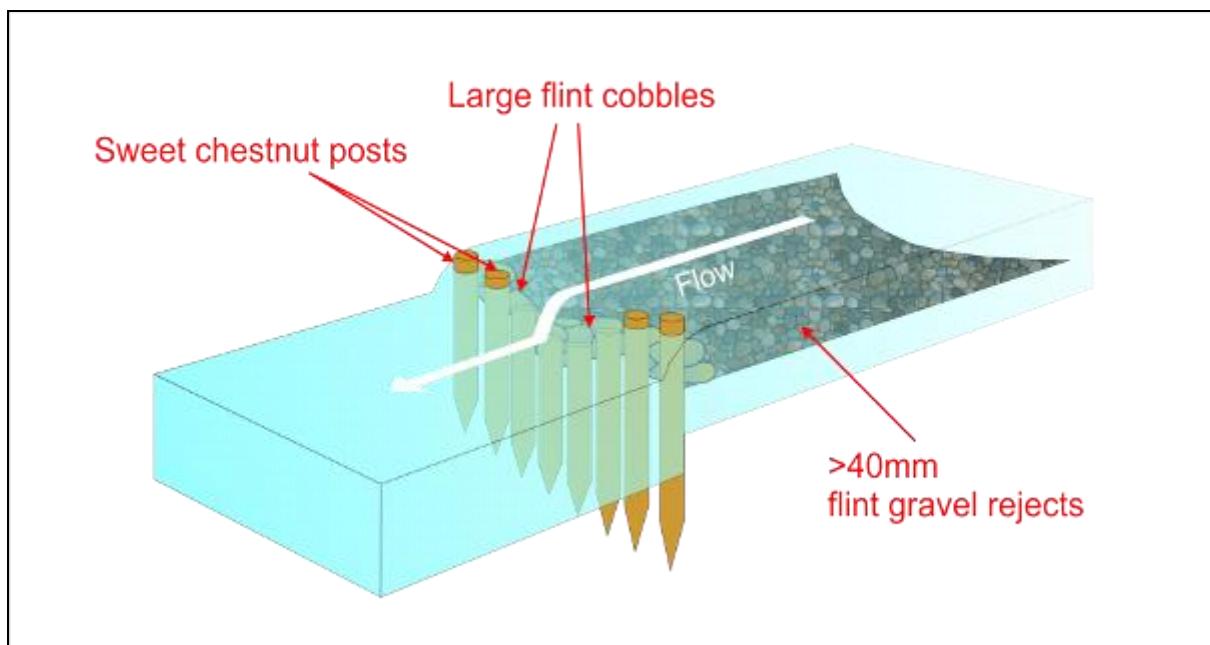
Drawing 1. Small level check weirs can be created with imported stone or vertically driven posts backfilled with cobble and gravels.

The current head-loss difference between downstream and upstream water levels could be gradually reduced, facilitating a natural channel recovery. If this were not possible because some of the dam structure is required for access, the head differential could be managed by creating a series of low steps in the new river bed using either blockstone or vertical wooden piles backfilled with imported cobbles and gravel (drawing 1).

These low "check-weirs" could be located both below and above the existing dam to reconnect the two levels. Each step should be sufficiently spaced to ensure stability and would need to be at least 30m apart longitudinally. The banks and margins of any newly created naturalistic channel lying within the confines of the old lake bed will initially need to be formed with an excavator and the soft banks defended with biodegradable soil saver and then planted.

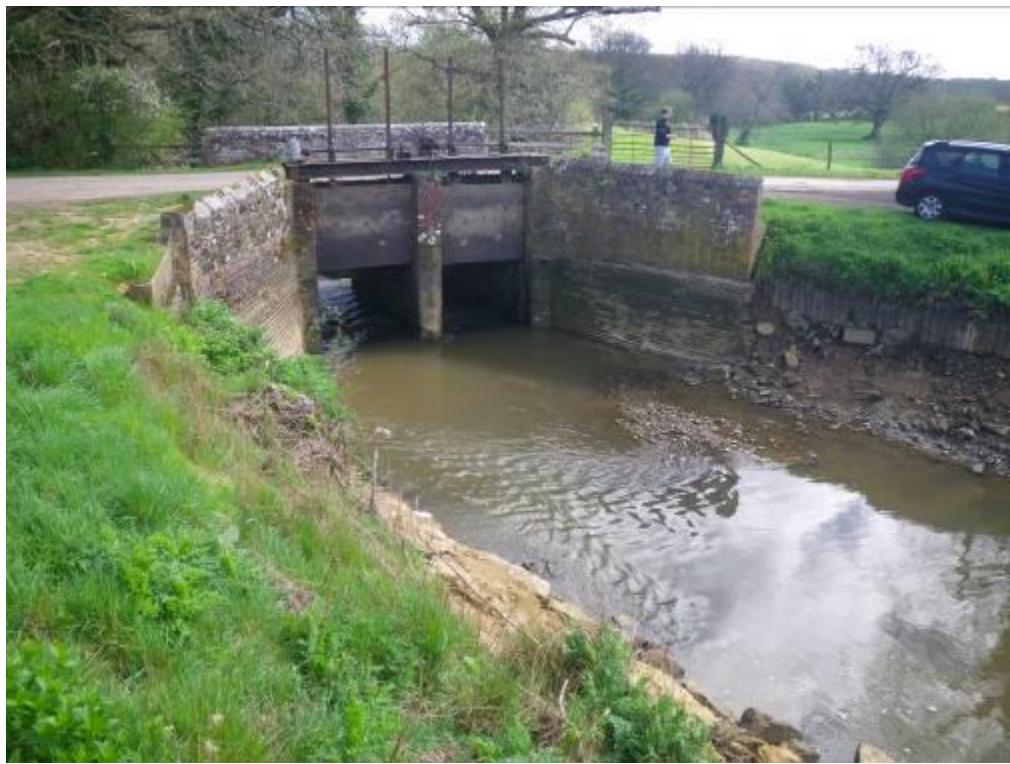
The main outfall (Photo 1) from the Mill Pond is intact but finding an effective solution for reducing the head differential at this particular location, as well as improving fish connectivity would be expensive and difficult, especially given the need to repair the centre of the dam and provide a sustainable solution for the site as a whole.

Photo 1. Existing pond outlet. If the river channel were to be restored, the hatches could be removed and this channel left as an emergency spillway with no operational requirement or maintenance liabilities.

This main exit route could be utilised as a channel for emergency flood capacity, or possibly used to accommodate a smaller proportion of the flow via a restored but smaller off-line pond (option 3.2) created in the northeast corner of the existing Mill Pond (See sketch 1 on pg 13). This could be the best option if a pond at the site is considered as an essential component of a restoration plan. An inlet taking a small sweetening flow into any newly constructed pond could be taken off from a constructed main channel near to the top end of the existing Mill Pond. The pond carrier would feed into the new small pond with the current hatches forming the outlet structure. The new main channel should meander down through the existing pond bed to exit through the site where the current spillway is located.

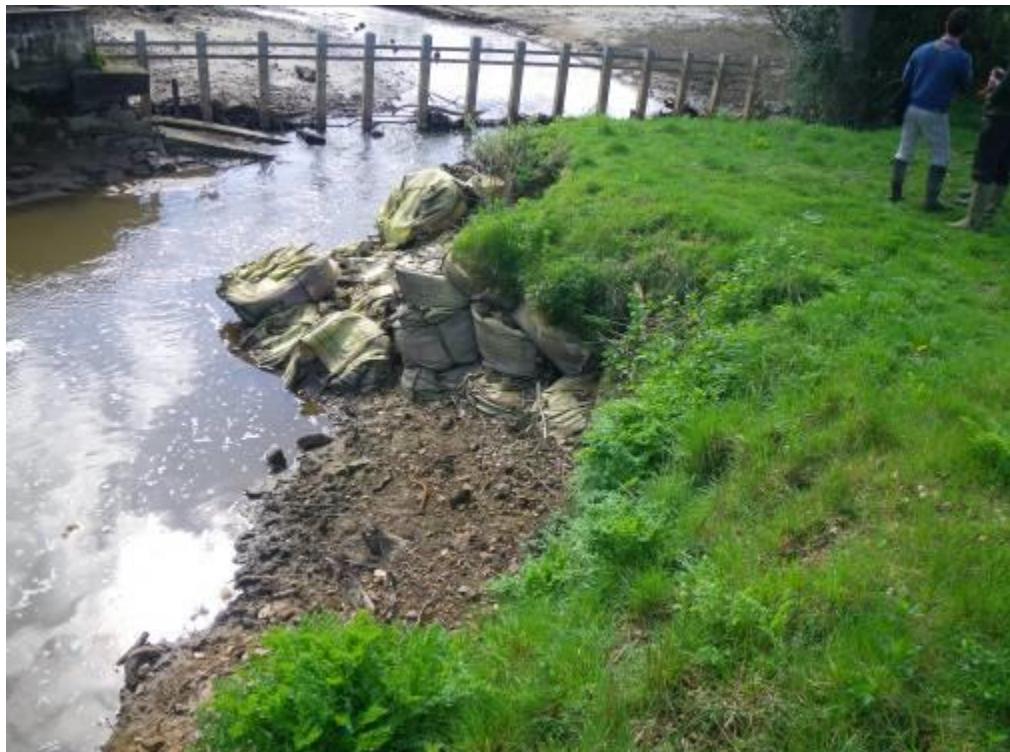
Photo 2. The trash screen/walkway should be removed, as should the temporary bank repairs. This area of bank will naturally recover.

If no pond is required then the hatch gates and winding gear on the existing outlet should be removed, as should the vertical piles (photo 2). If the gates were completely removed there may well be sufficient capacity without the need to accommodate additional flow on the old spillway.

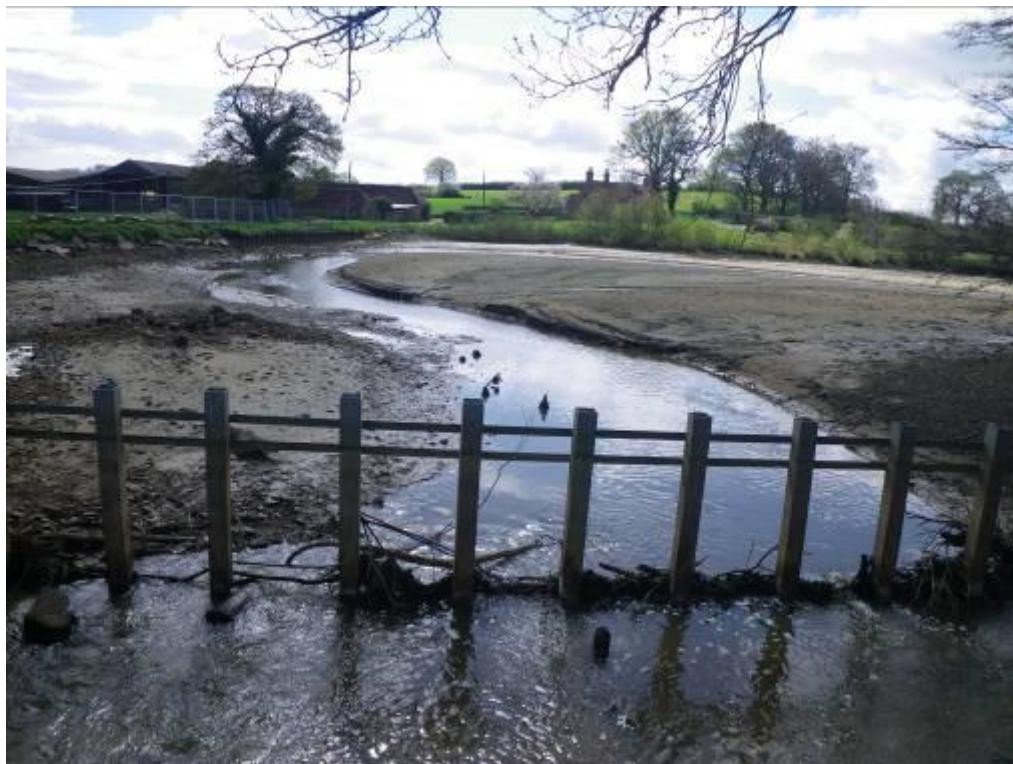
Photo 3 View of the drained down Mill Pond with huge quantities of settled sand. This area could be either a "green swale" or alternatively a small "off-line" pond but would still provide additional capacity during a large flood.

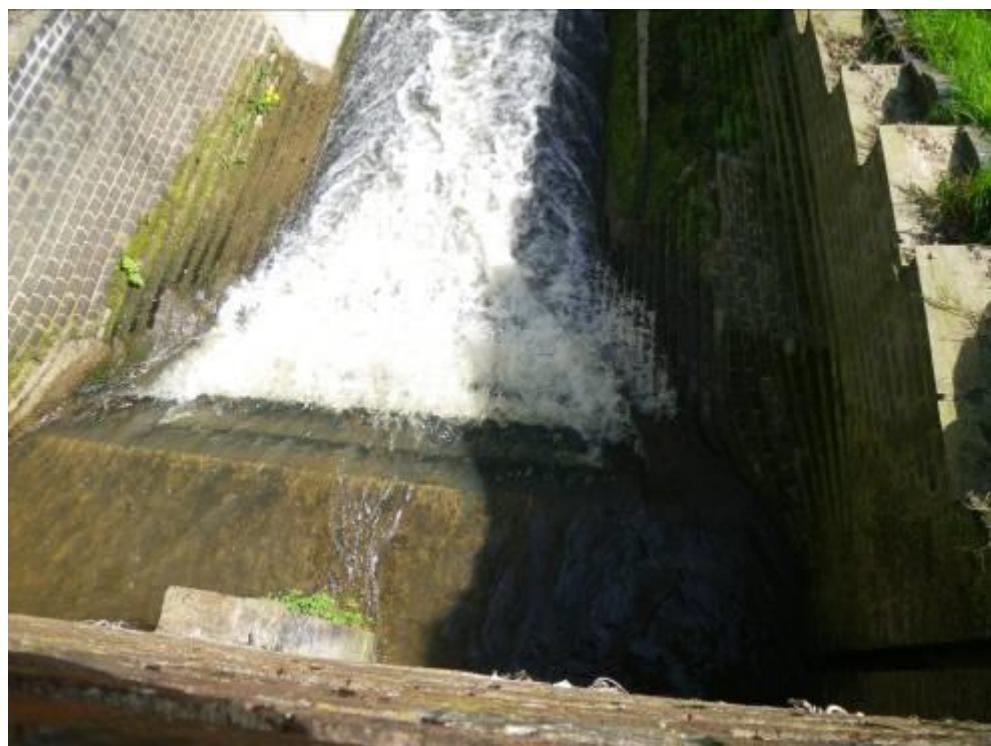
Photo 4. Existing outlet structure. No options for fish passage at this location.

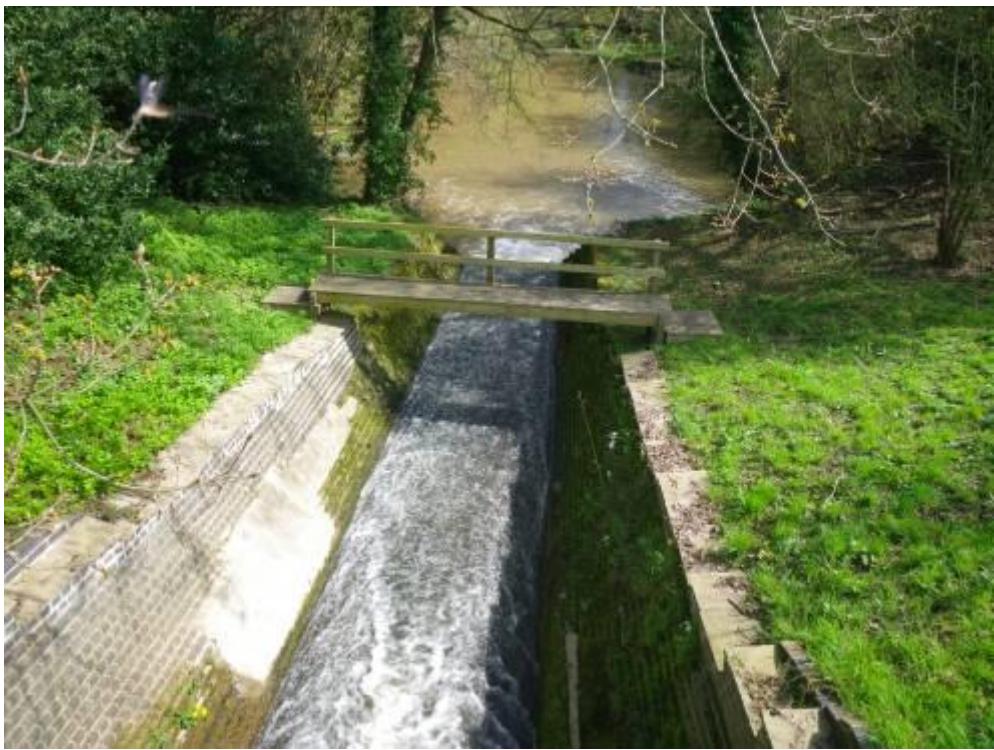
Photo 5. Downstream end of existing outlet – a high velocity chute.

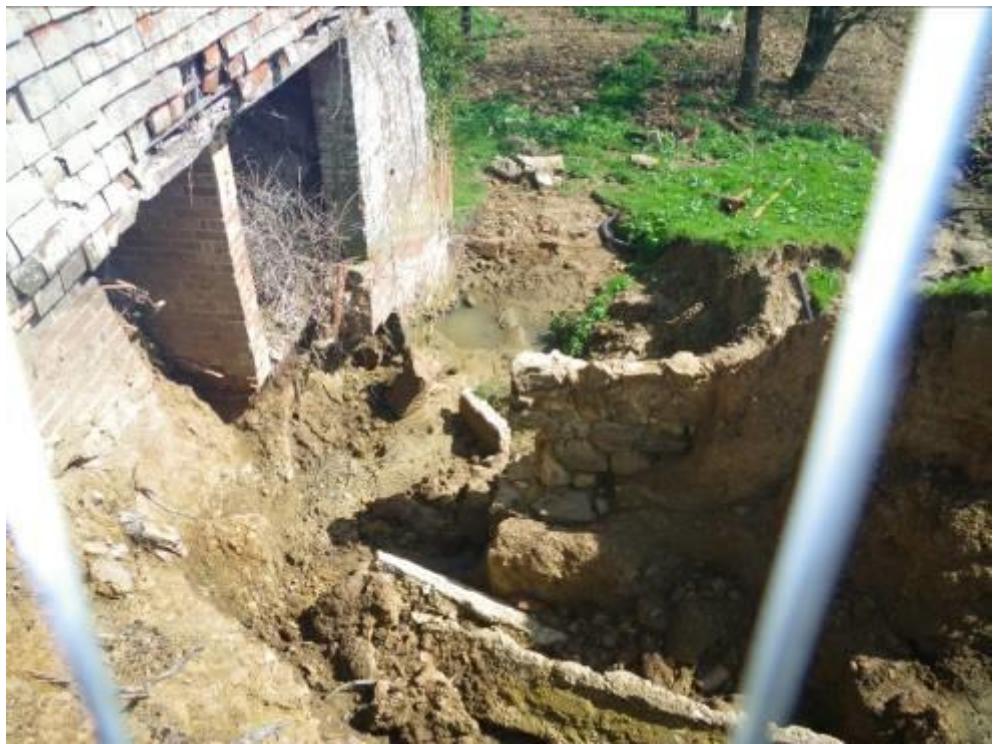
The central part of the dam and associated spillway are in poor condition and of a flawed design (photos 6-10). Breaking out the existing culverts, concrete and block work spillway could provide a route for a modified main channel with a clear span bridge for access.

Photo 6. Damage to the downstream face of the dam.

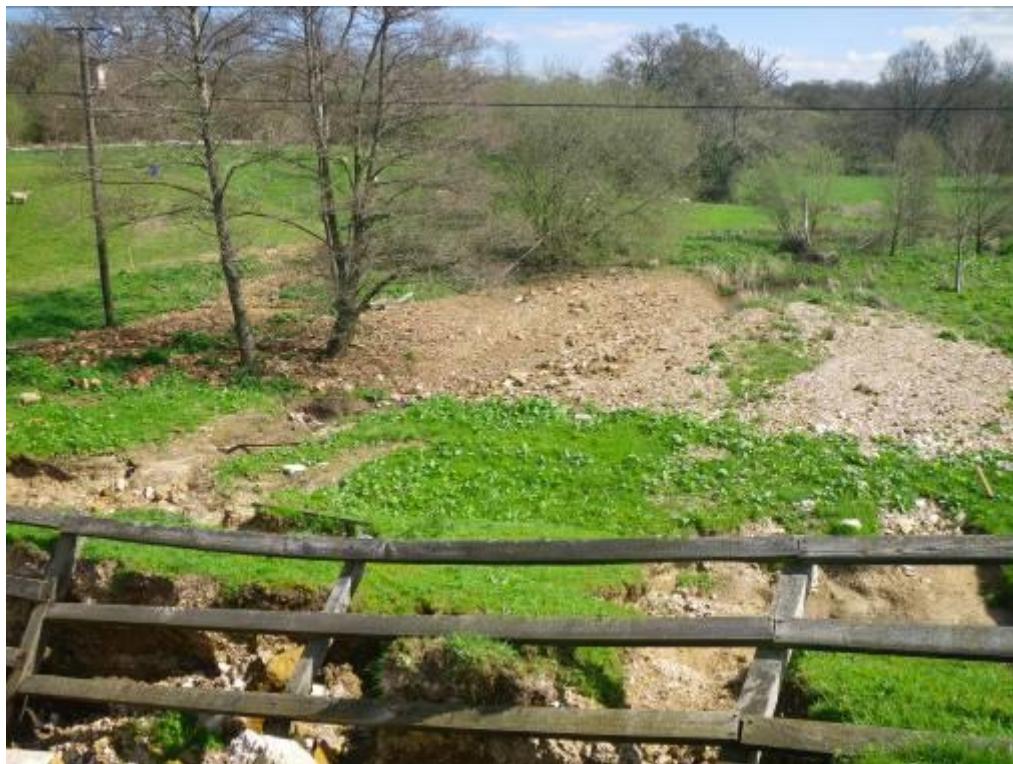
Photo 7. Spoil blown out from the dam structure.

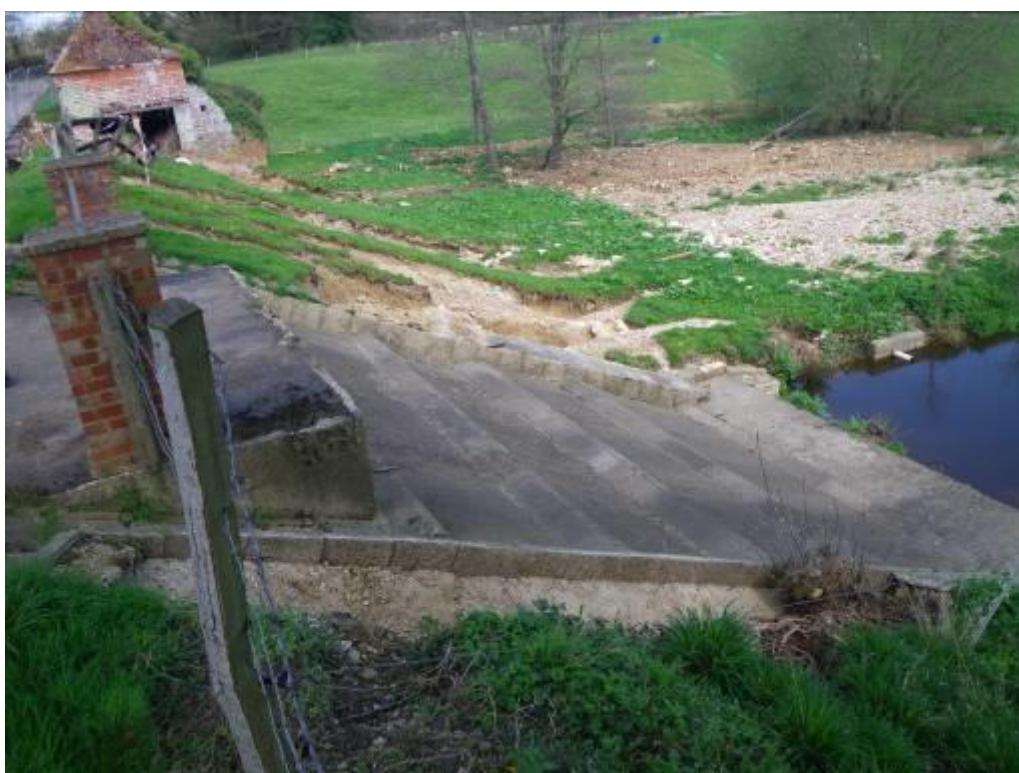
Photo 8 High level spillway outlet. This could be broken out to create the new route for a naturalistic river channel.

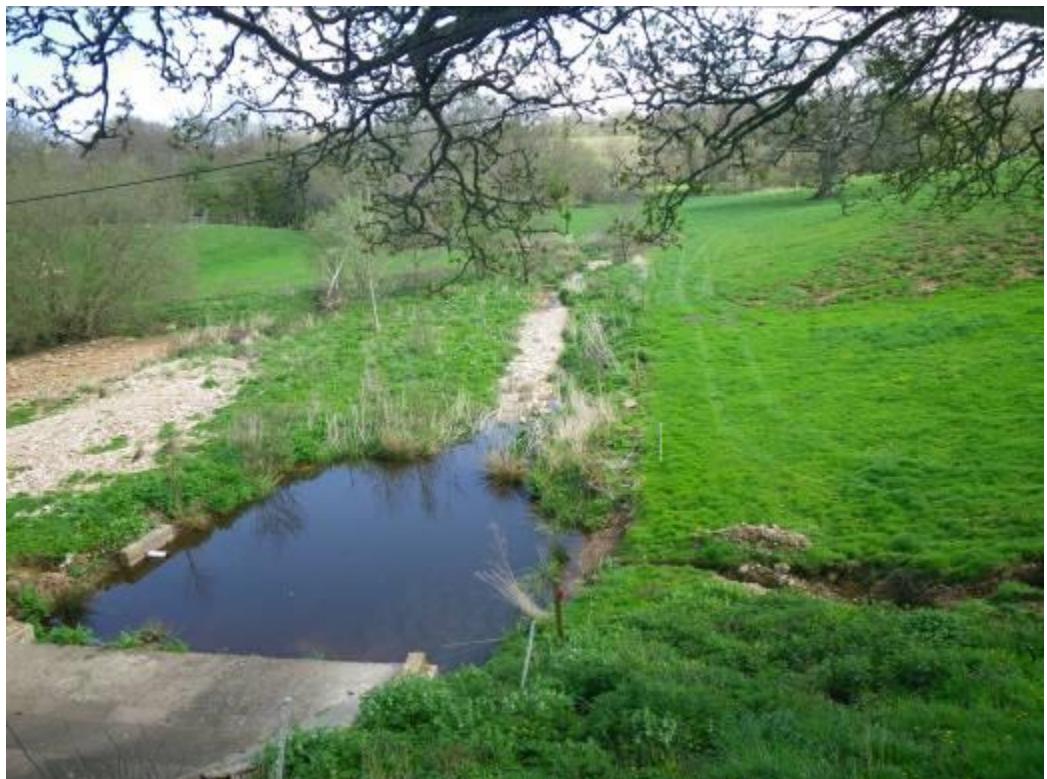
Photo 9. Spillway channel. Potentially the route for a new main channel.

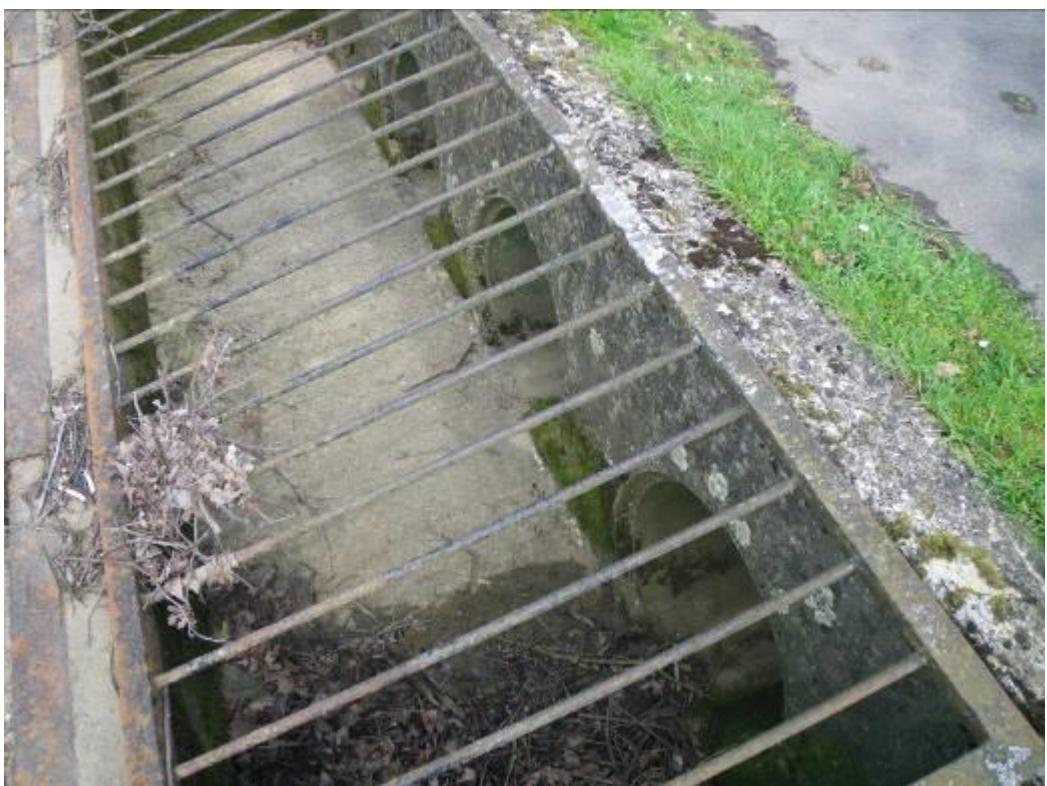
Photo 10. The inlet side of the spillway.

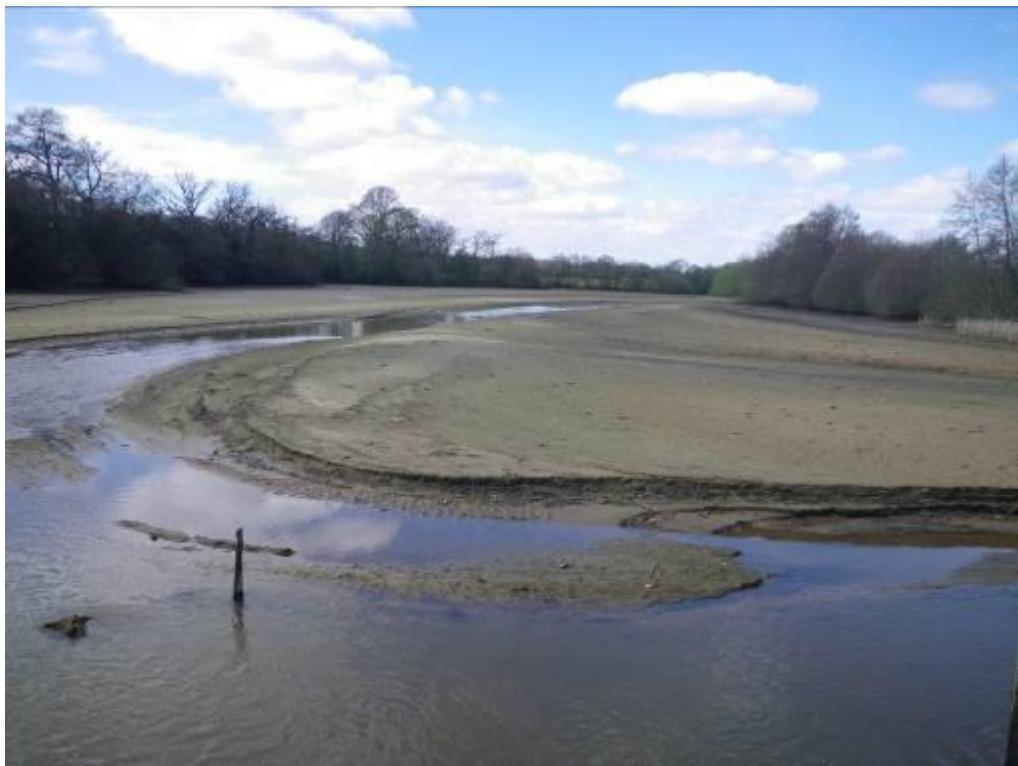
Photo 12. View upstream from the spillway. A new river channel with small managed "steps" in the bed to overcome the existing head differential could be created both downstream and within the bed of the old mill pond. Soft river margins would have to be defended with biodegradable geotextile and planted. The area to the right above could be raised to separate the channel from an excavated off-line pond if this is deemed an essential element of the project.
