Lyme Brook and Causley Brook: Opportunities to Improve Habitat & Connectivity

Report and Proposal by the Wild Trout Trust – 17/02/2016

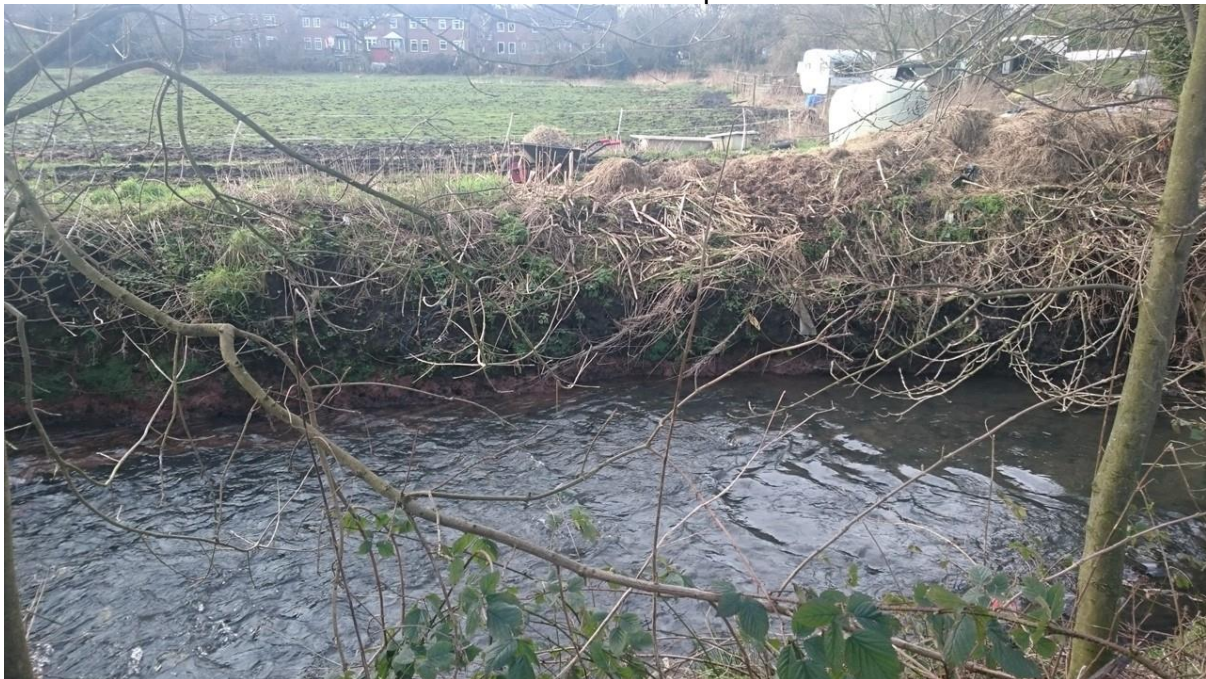
Just downstream of the weir at National Grid Reference (NGR) SJ 85789 44139 the adjoining land features a small vegetated buffer strip on the RB. However, poor siting of silage for animal feed (Fig. 1) will result in polluting inputs of nutrients. Repositioning this away from the bank-top such that runoff from rainfall does not enter the Brook will solve this pollution issue.

Figure 1: Poor siting of silage along the bank top in this photo (middle and right of frame on far bank) is causing inputs of polluting nutrients during rainfall events at SJ 85789 44139.

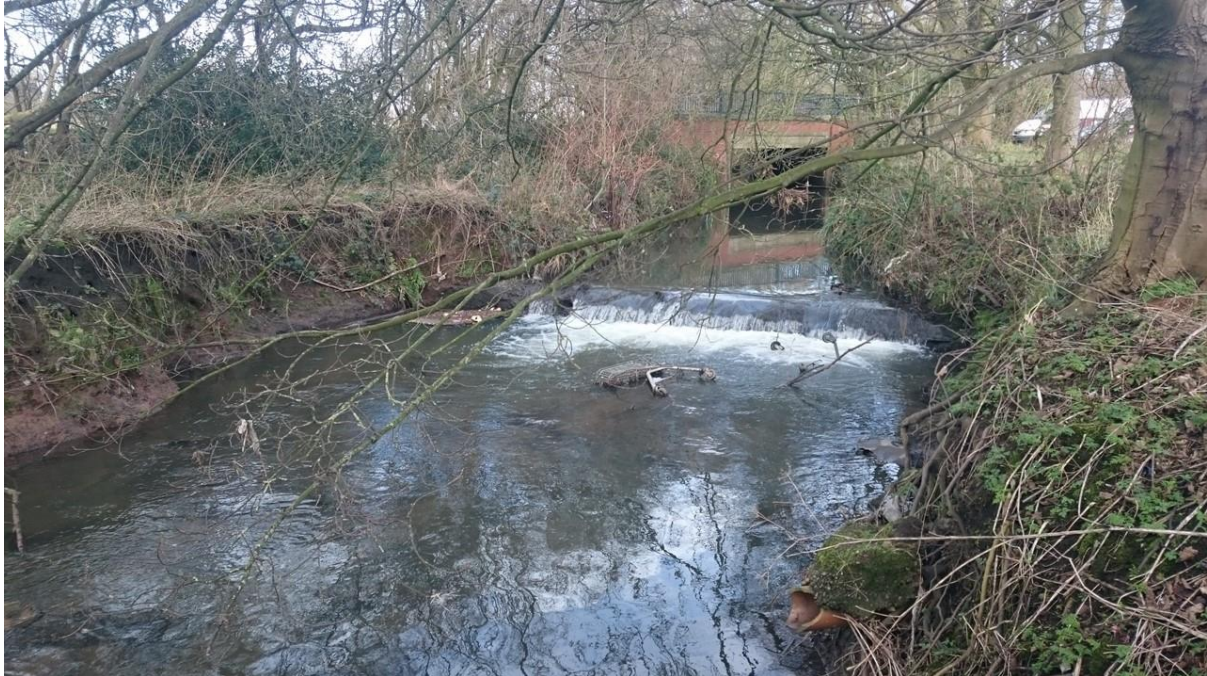
Just upstream of the location shown in Fig. 1 is a significant weir (Fig. 2). This structure is sited at SJ 85779 44170 and is reported to be associated with underground sewer services. Clarification is, therefore, required as to the depth of the sewer beneath the weir before appropriate measures can be suggested. By far the most desirable option would be a complete removal of the impounding structure that is currently responsible for the following impacts:

- Impoundment and associated habitat degradation upstream of Clayton Lane as far as SJ 85761 44468

- Barrier to longitudinal migration in both upstream and downstream directions
- Potentially undesirable bank erosion where the weir joins the banks at a perpendicular angle (there may not be a “do nothing” option if this erosion is likely to compromise adjacent infrastructure – including the sewer).

Figure 2: The white water (entrained air) below the weir combines with the height of the weir crest to make this a more significant barrier to migration than most observers appreciate. The impounding effect extends far upstream of the road-bridge (Clayton Lane) visible in the background. The erosion (particularly on the RB which is pictured on the LEFT of this photo) is caused by the construction of the weir at right-angles to the original river banks and the soft nature of those banks.

Removal would be a comparatively simple process if the sewer is well below the existing bed-level of the river. Conversely, if the existing structure actually houses the sewer pipe itself – then removal becomes more complicated.

In that instance, it may be possible to construct a boulder, rubble and gravel “mat” downstream of the weir that sufficiently raises the downstream water-level as to mitigate the barrier effect of the weir (Section 3 “Recommendations”). *Note that such an option does not improve the degraded, impounded habitat upstream of the weir.*

It may be possible/desirable to incorporate some retaining structures (such as sleepers) that would help to consolidate the gravel riffle component of the boulder/gravel mat. This option would also depend upon suitable access for the delivery and unloading/positioning in the channel of large quantities of stone and gravel (as well as sleepers if required).

Hydrological calculations would also be required to ascertain the volumes of substrate required to sufficiently raise the downstream water-level under a range of flow conditions. The WTT would seek external expert assistance in that eventuality.

There are significant opportunities for maximising the benefits of habitat works already completed directly upstream of this structure. First of all it is imperative to establish the depth and location of the sub-surface sewer. This critically influences the most appropriate course of action for habitat improvement. If it is found to be unaffected by the work required to completely remove the weir, then this is the best course of action to take. N.B. it would be prudent to have an assessment of the implications of increased flow velocities for the stability of the Clayton Lane road bridge.

It is stressed that this course of action (complete removal) is significantly more valuable and worthwhile compared to all options that result in the retention of the impounding impact upstream of the current structure.

As a secondary alternative (in the event that removal cannot be agreed), it may be possible to use the creation of greater habitat structural variety to reduce the barrier effect of the weir. A formal expert geomorphologist’s survey would be required to assess whether the longitudinal bed-slope would require only one – or more than one – downstream “rubble mat” feature (Figs. 8 and 9) to sufficiently raise the downstream water-level. Additionally, the impact that this may have on local flood risk should be taken into account – however, it is worth noting that the current weir height is deemed acceptable in terms of flood risk. Obviously, the aim of the rubble mat would be to reduce the differential between upstream and downstream water height – but not to exceed the level of the weir crest.

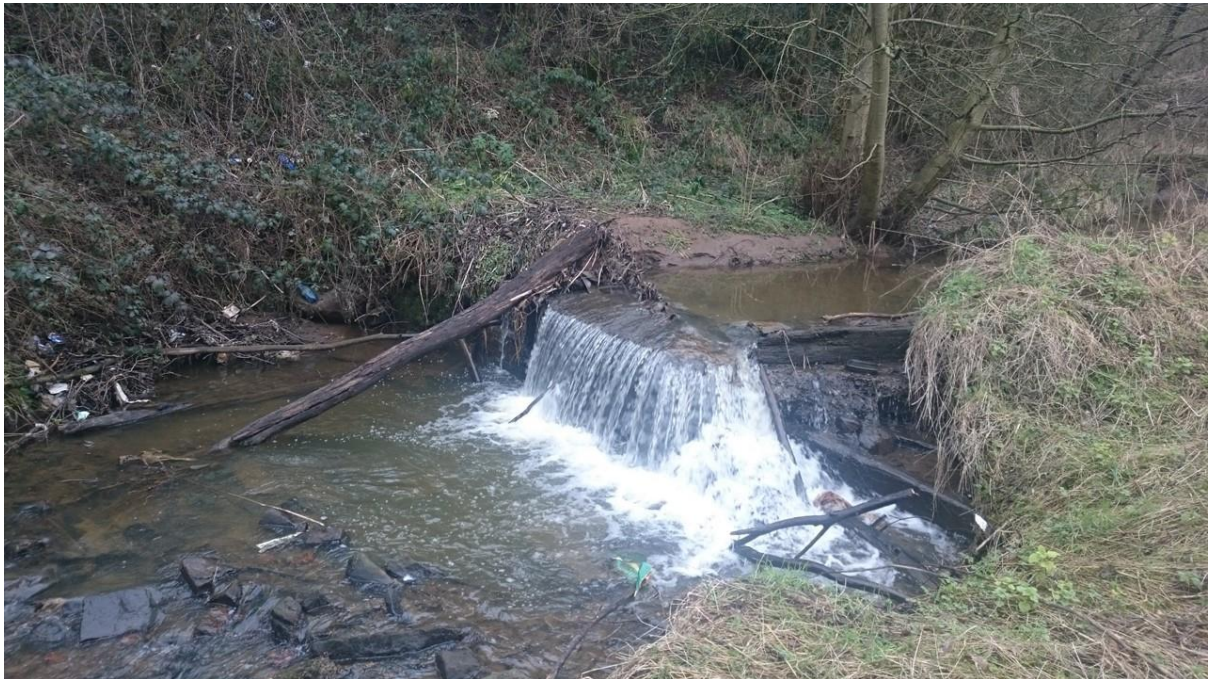
Figure 3: Causley Brook Weir 1 at SJ 85779 44170 – concrete and wood structure

A complete barrier to upstream fish passage (Fig.3) and also impounding a significant reach upstream (Fig. 4) with associated habitat degradation. The purpose of the weir is unclear (there was no discernible diversion or abstraction of water upstream of the structure). The higher quality habitat below the weir, with much greater variety (Fig. 5), is readily obvious.

The tree-root stabilisation of the RB upstream of the weir and the general lack of infrastructure surrounding the impounded reach on either bank reduces risks associated with weir removal. The rebalancing of longitudinal bed-slope and natural channel width is unlikely to disrupt any of the upstream land-use. Pending suitable kit access (either small 360 digger or even pneumatic drill and generator), this is a good candidate for removal – especially given its concrete construction/low heritage value.

Some intervention is recommended for Causley Brook Weir 1 (Fig. 6) to effect its complete removal. There would be no need to transport the arising material off-site as it could be distributed within the upstream and downstream channel to create valuable structural variety.

The apparent low-risk nature of the surrounding land-use associated with the upstream reach would seem to make this an ideal candidate for removal. It may be advisable to have an Environment Agency geomorphologist walk over the site and simply estimate the likely limits of channel response. Following permission from the landowner(s) of relevant reaches, this should enable the removal to go ahead without the need for extensive modelling.

There is an excellent opportunity to maximise the habitat benefits (and also regulate the degree of lateral response of the upstream channel) by undertaking grazing exclusion and tree planting on the LB. By producing this vegetated buffer strip, many benefits would be accrued:

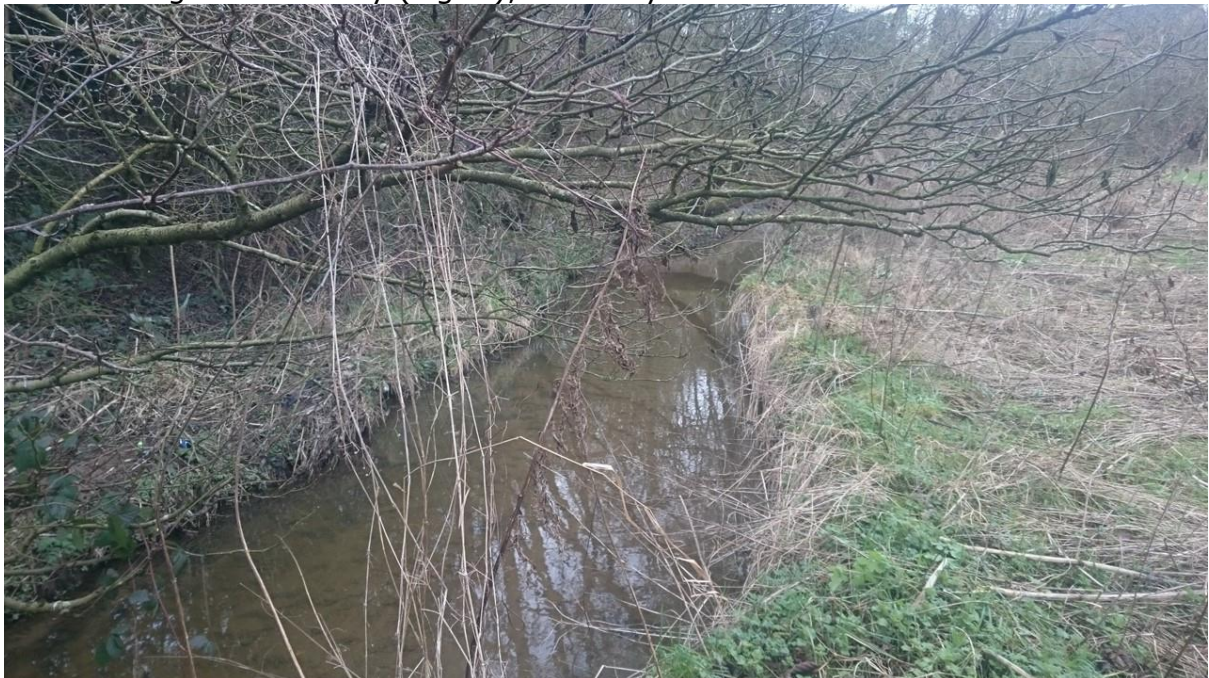
Figure 4: Impounded section upstream of weir pictured in Fig. 3

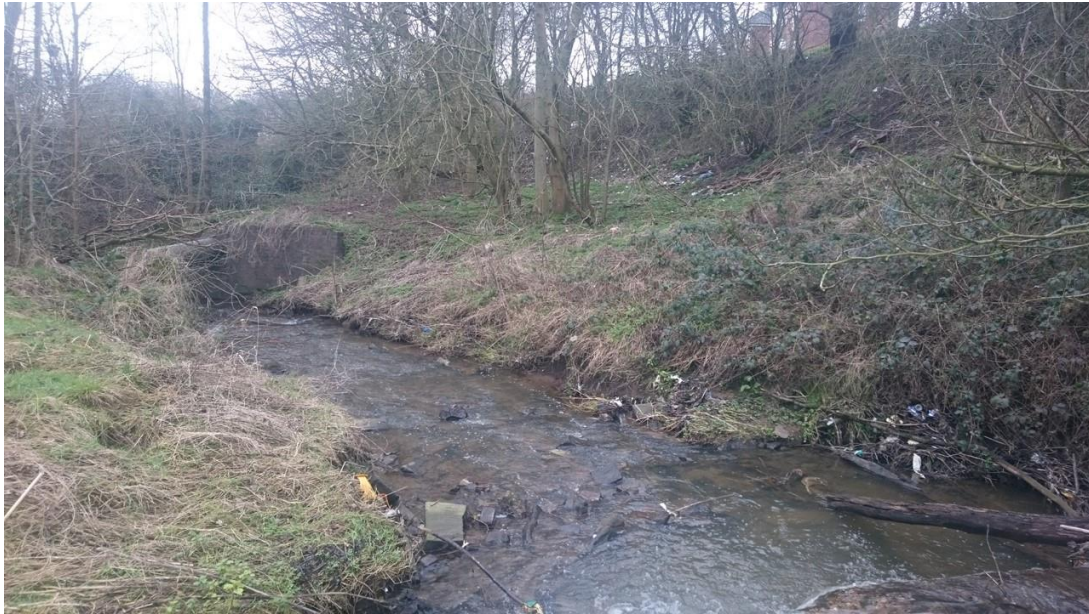
Figure 5: Un-impounded, varied habitat downstream of weir pictured in Fig. 3

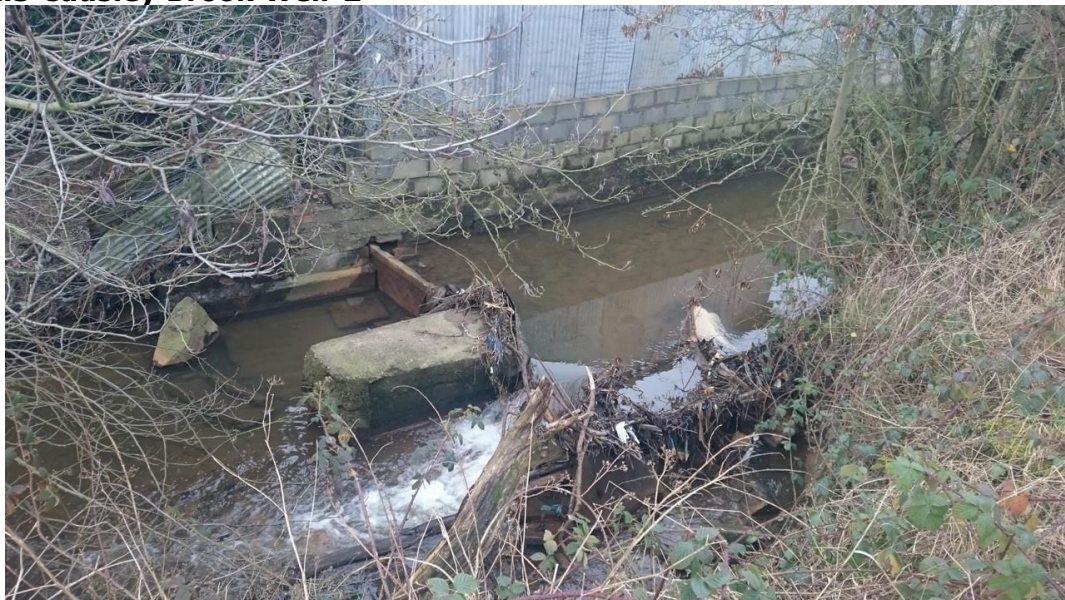
Figure 6: Causley Brook weir at SJ 90163 46891 – stonework and shuttering

This structure is having a similarly negative impact on both connectivity and upstream habitat quality as the structure in Fig. 3. However, the structure itself is naturally degrading and the brook is beginning to bypass it. This would seem to negate the costly exercises of either arranging removal or, alternatively, digging a bypass channel along the route indicated in Fig. 7.

The only scenario that such a bypass channel may be required is if property-owners on the RB directly upstream of the weir apply to reinstate the structure as a means of stabilising the retaining wall along that RB (see Fig. 6). In such a case, the cost and delivery of digging an appropriate bypass channel should be made a condition of consenting the completion of those works.

The first (and easiest) recommendation would be to allow the Causley Brook Weir 2 (Fig. 6) to continue to naturally degrade and be bypassed.

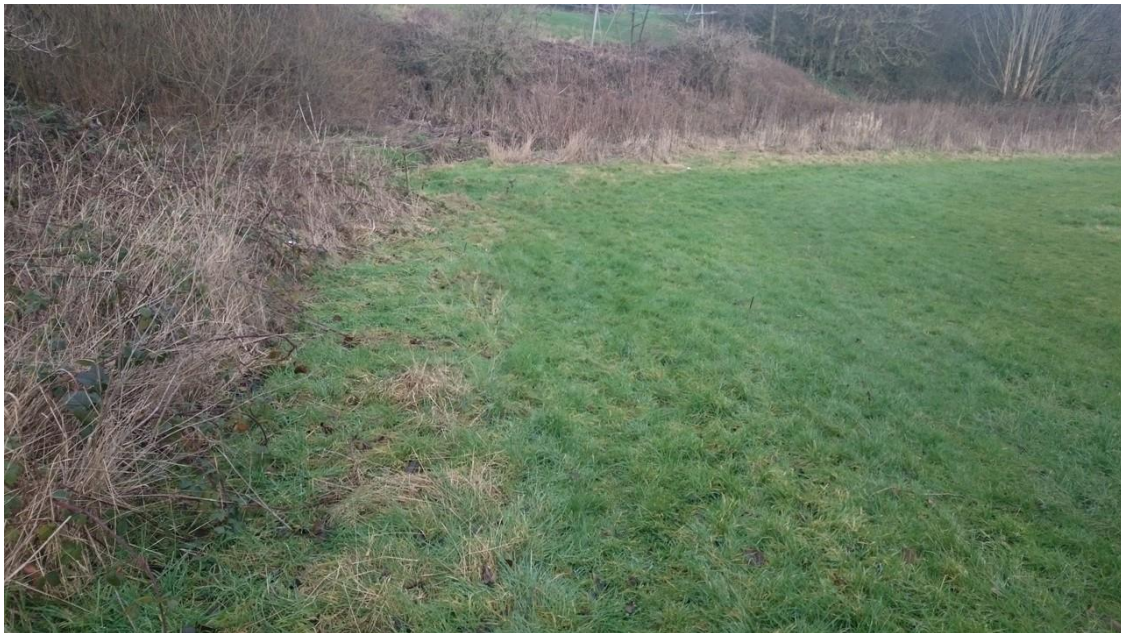
Figure 7: The brook is to the left of the frame in an incised channel. The bank-top line is indicated by the scrub vegetation. This is the LB and shows the scope for a bypass channel (if ever required). Some care would need to be taken due to the presence of the telegraph pole sited just out of the right of frame in the foreground of this picture.
