Advisory Visit

River Lymn, Lincolnshire

December 2015

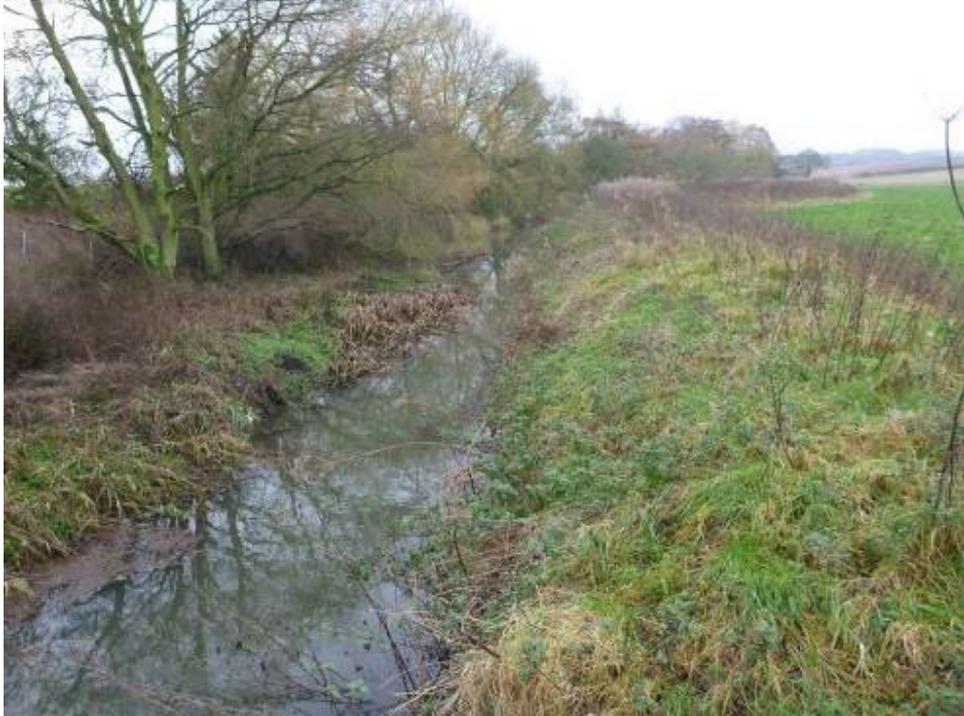
The riparian vegetation consists of trees, bushes and scrubby vegetation which provide good low cover over the river channel and some areas of woody debris within the channel; this provides good habitat and shelter for adult fish (Photo 2). Where there is less shading from bankside trees and bushes, emergent vegetation (such as beds of reedmace *Typha latifolia*) are present, narrowing the channel and providing a small amount of variation in current speed (Photo 1).

Photo 1 Downstream view towards Awardby Mill. The river is in a perched, embanked channel above the level of the field to the right which contained the original river course

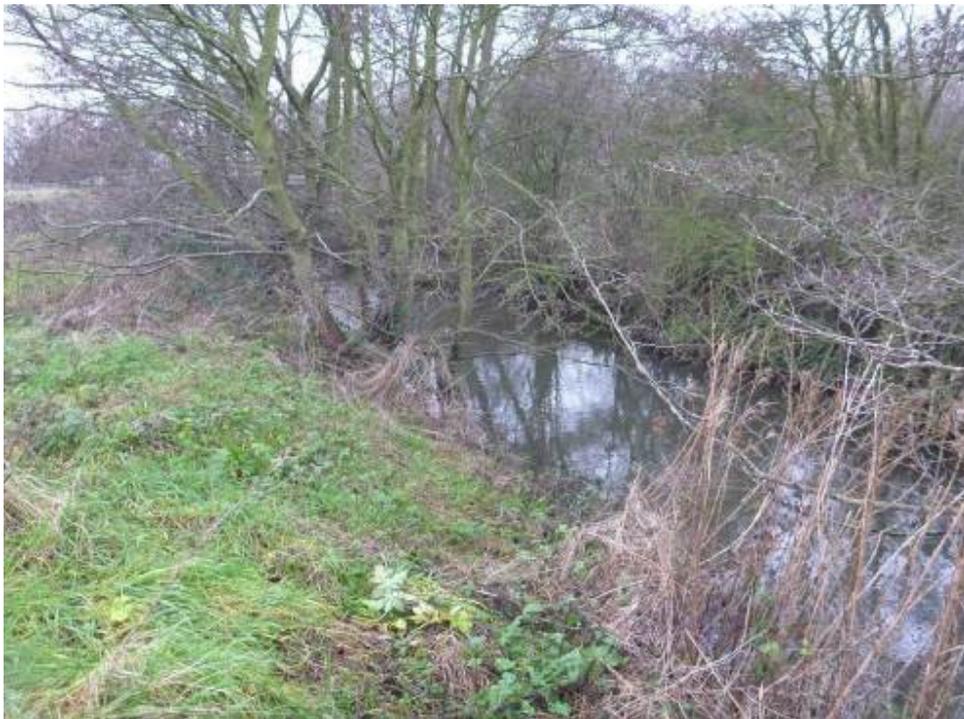
Photo 2 Downstream of Awardby Bridge, trees and bushes provide shading and low cover over the river channel.

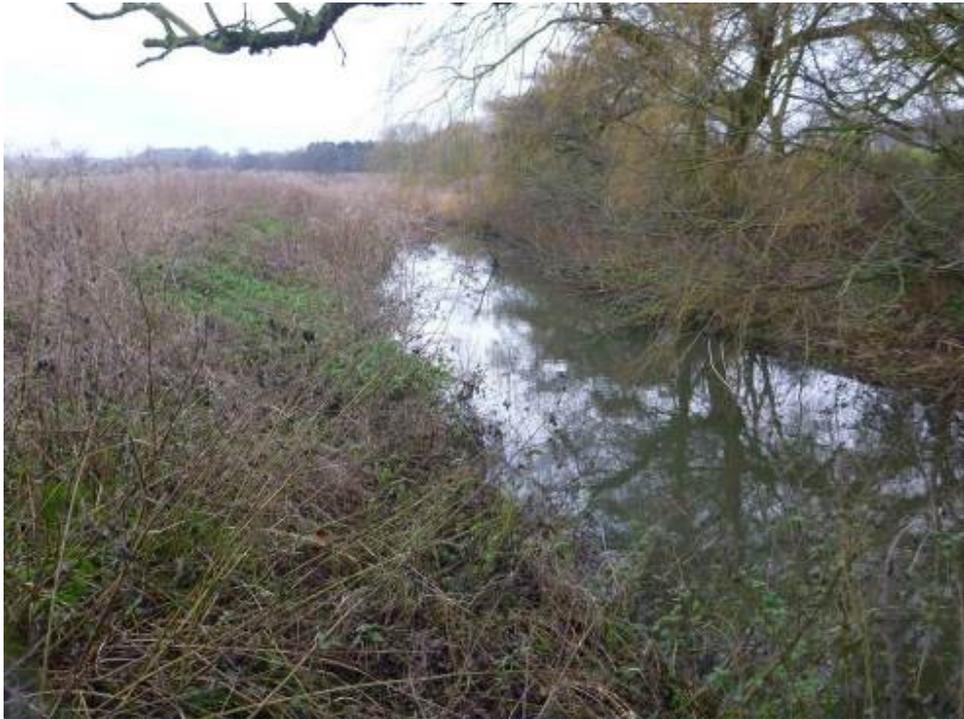
Between the A158 road and the mill, the river channel is straight and embanked. The artificial nature of the channel and the impoundment at the mill means the flow consists of a steady glide, lacking a natural pool-riffle sequence (Photo 3). The river bed consists of clay and fine sands; there is

Photo 3 Impounded river upstream of the mill (upstream view).

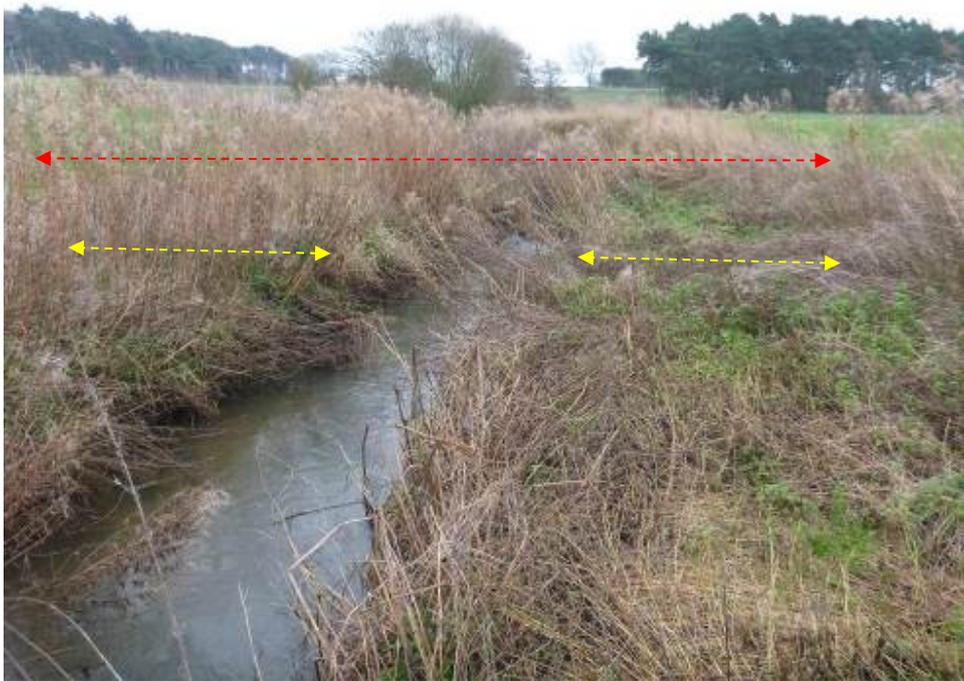
The river channel between the mill and Sausthorpe Bridge has been straightened and lowered in the past for land drainage purposes; it may have been realigned from its original course (see Figure 2, Section 3.2). This is reflected in the lack of meanders and the uniform, cross-sectional shape of the channel. The flow pattern is a uniform, swift glide with no pool-riffle sequence and a lack of depth variation. In the intervening years since the channel was engineered, the river has naturally narrowed its wetted width, forming berms (shelves) at a lower level within the over-widened channel. These berms represent a new, lower floodplain level established by the river, essentially creating a two-stage channel: dry weather flows are contained within the narrow channel, whereas elevated flows spill over the berms but are contained within the bank-full channel (Photo 6).

Photo 6 Typical section between Awardby Mill and Sausthorpe Bridge, showing lowered river bed, engineered channel width (red arrow) and berms resulting from river reinstating its natural width (yellow arrows).

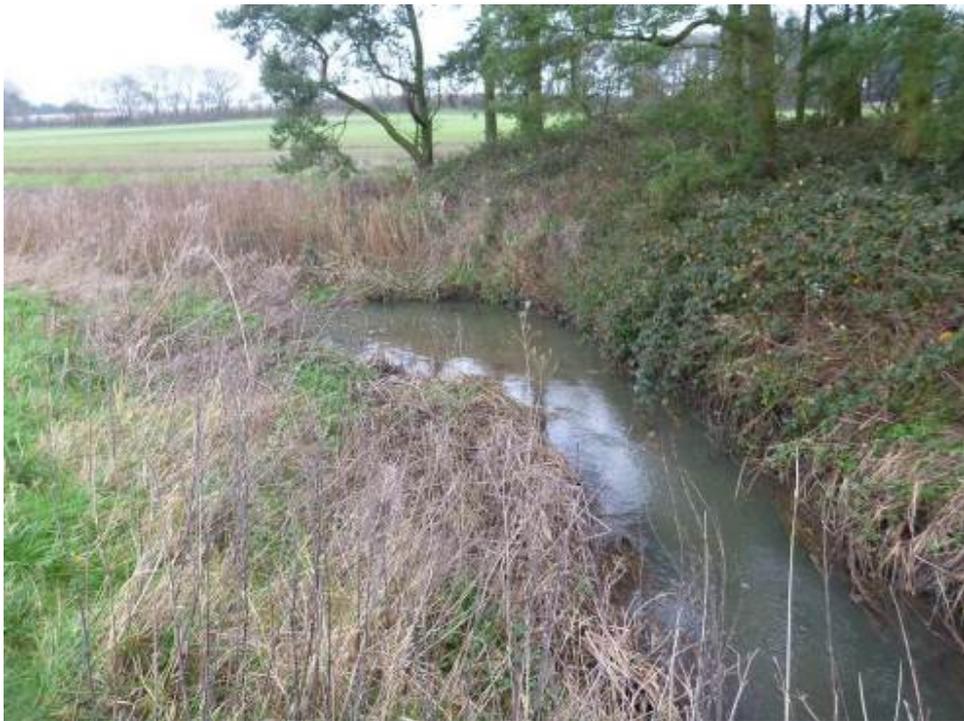
At the bend in the river at TF 37821 68775, a lateral scour pool has formed which provides some deeper water habitat suitable for adult fish (Photo 8). This illustrates how such habitat is dependent upon a meandering river course and how this is lacking throughout the rest of this reach.

Photo 8 A lateral scour pool providing some good adult fish habitat (TF 37821 68775).

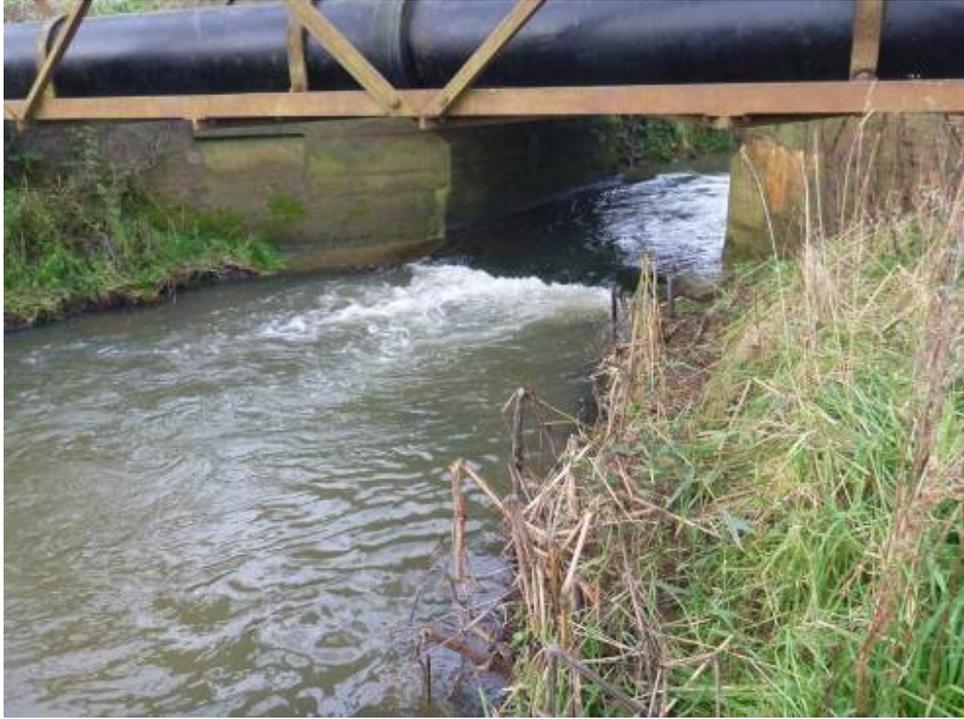
Photo 9 Sausthorpe Bridge culvert.

The bridge culvert has a small drop in level on the downstream side and shallow, fast-flowing water beneath the bridge (Photo 9). This may form a barrier to free migration of fish, particularly during periods of low flow, but was certainly passable by trout of all size ranges at the time of the visit.

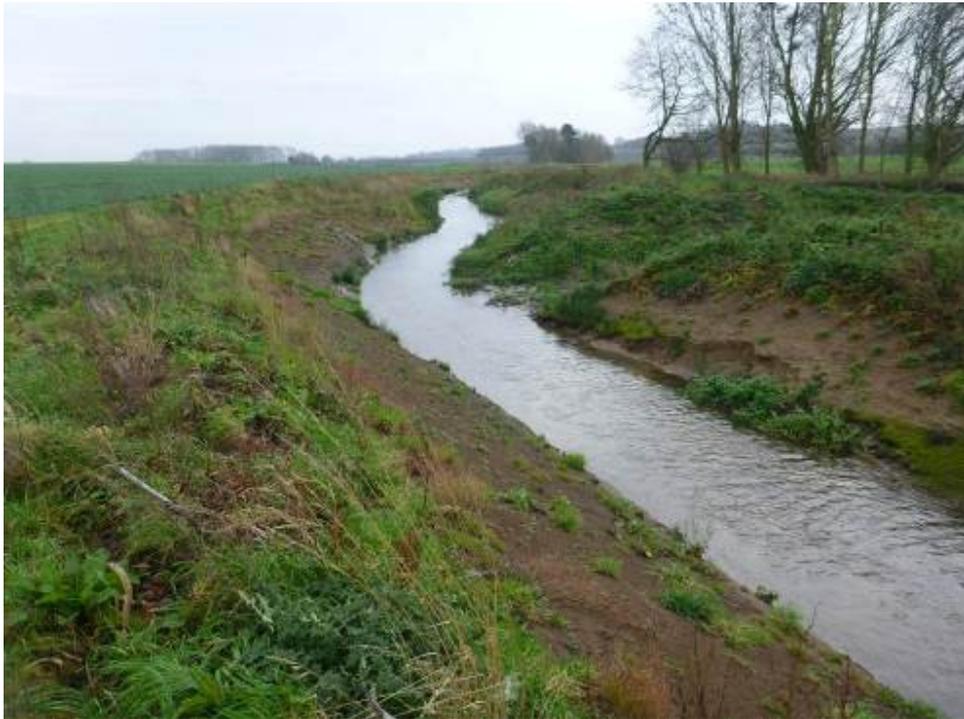
Photo 10 Recent river engineering downstream of Sausthorpe Bridge, including the cutting off of a meander (right of picture).

Downstream of the bridge, recent engineering of the river channel has been carried out. The channel has been widened, bankside trees and vegetation removed and the channel has been straightened, cutting off a meander loop on the RHB (Photos 10 – 12). These works have severely damaged in-stream habitat, leaving a uniformly shallow river, devoid of any cover for fish. The overwide channel promotes the deposition of fine sediment which tends to smother the areas of gravel that have started to appear (probably supplied from the tributary stream). The removal of meanders is very damaging to river habitat, because it removes lateral scour pools which form on the outside of bends (as in Photo 8); this removes vital deeper areas (which hold adult fish) and prevents them from re-establishing.

- Re-connecting and restoring the flow to the meanders cut off by the recent works
- Narrowing the low-flow channel by introducing low berms. These should be positioned on the inside of bends, or where the river is straight on alternate banks (Photo 52).

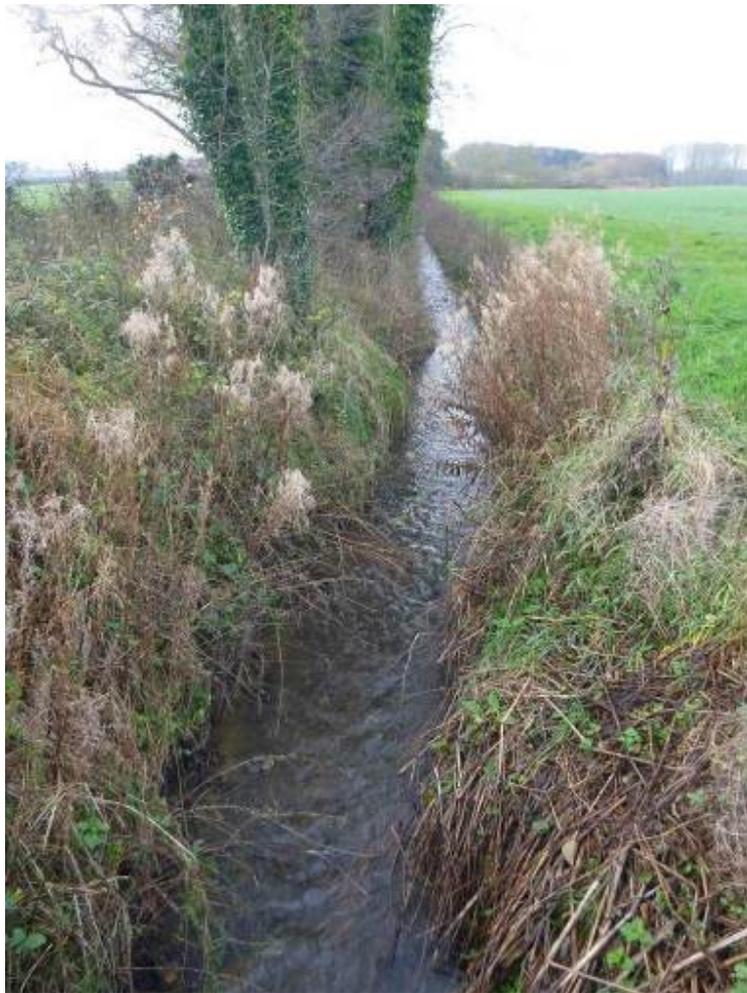
Photo 13

The section of stream alongside the road has a straight channel with fast-flowing, uniformly shallow (10 cm) water over a gravel substrate (Photo 13).

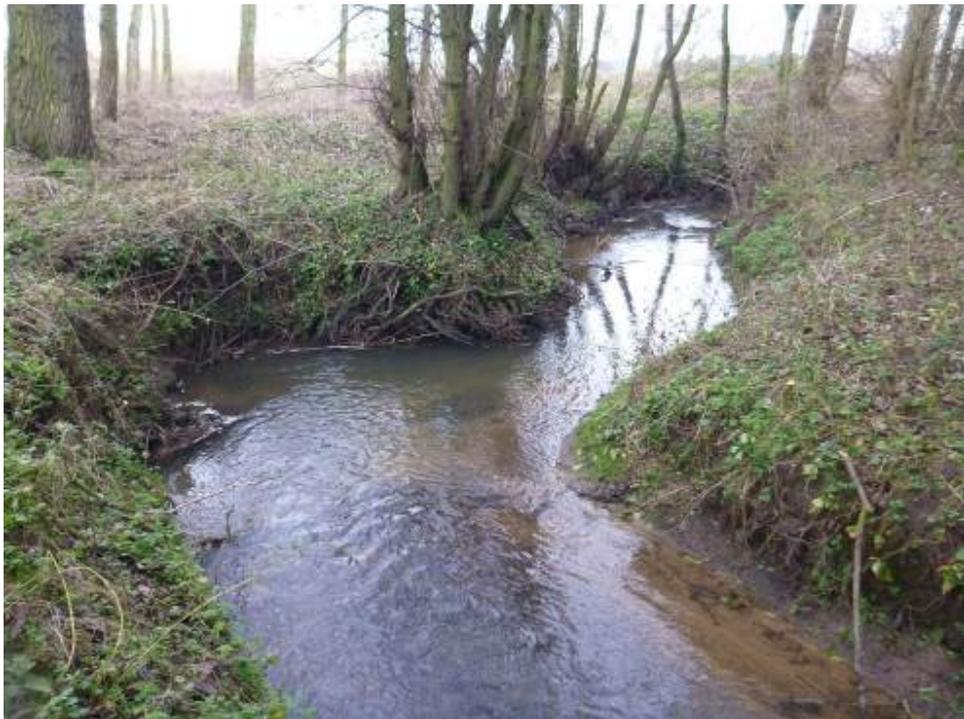
Photo 17 Good in-stream habitat (downstream view from same point as Photo 16). Note high levels of fine sediment.

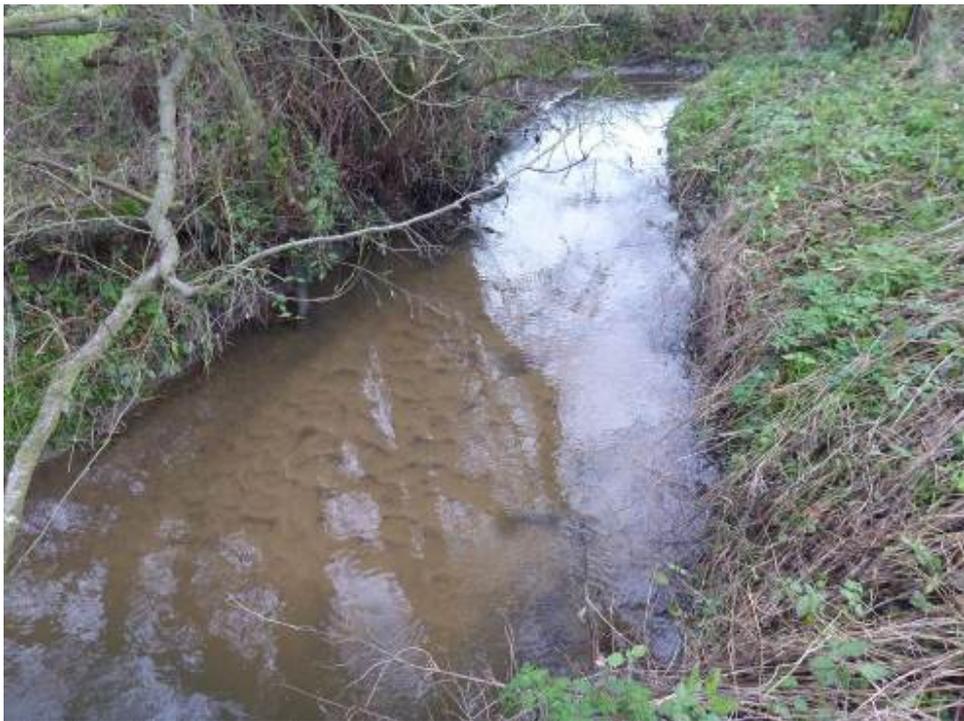
Photo 23 Large amounts of fine sediment on the bed indicate an excessive supply to the brook and give concern for the survival of trout eggs.

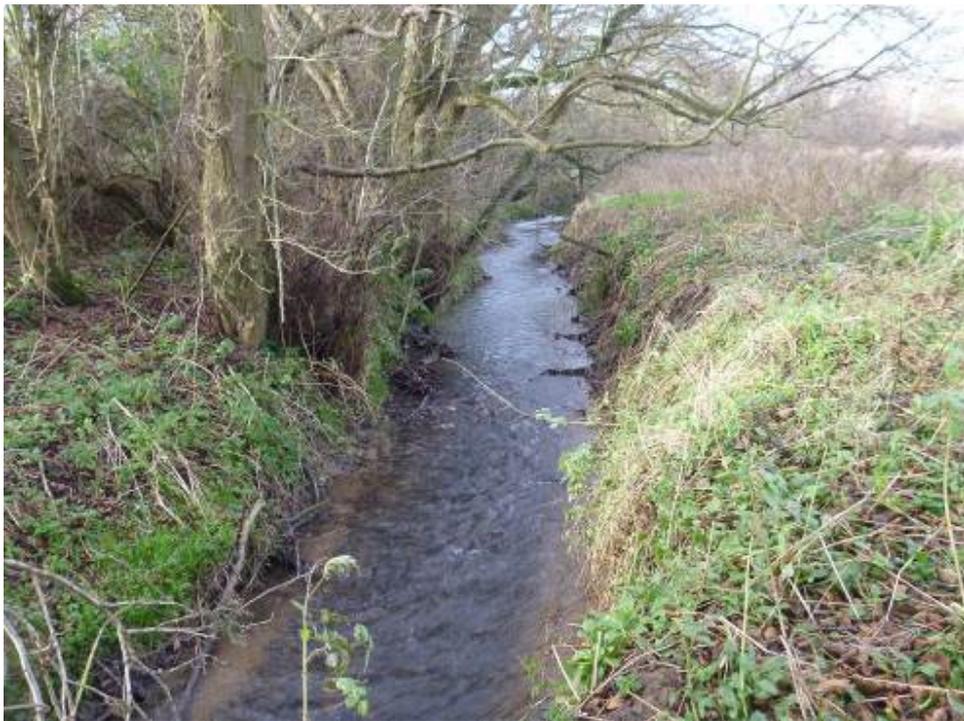
Photo 25 Straightening of the channel has occurred in the past upstream of Raithby Bridge, as indicated by the lack of meanders and pool habitat in some sections.

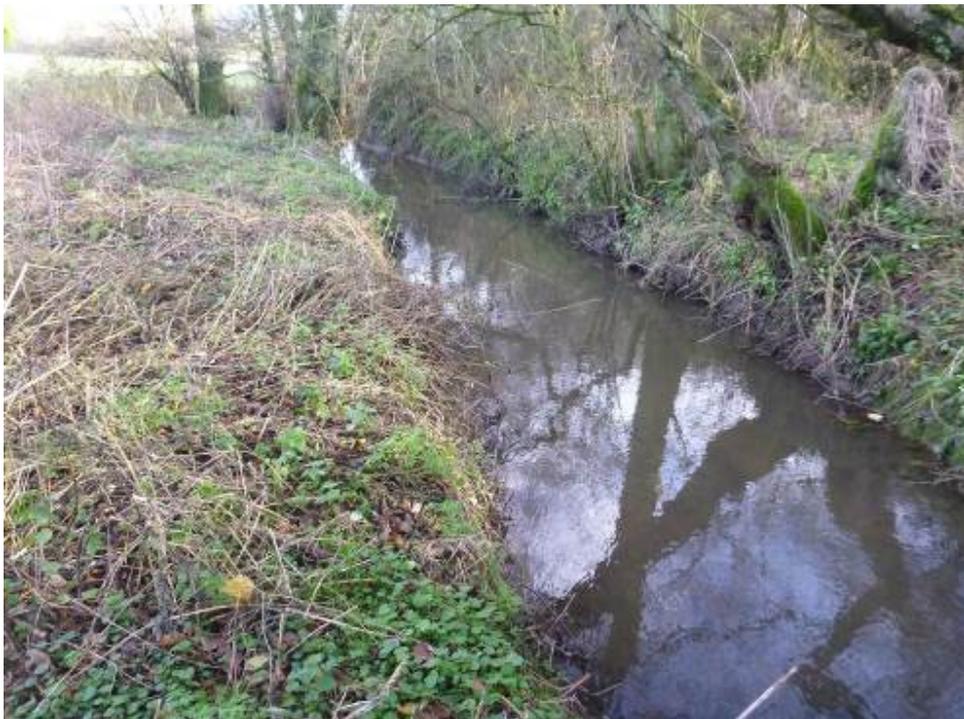
Photo 27 Some sections a little further upstream from the area in Photo 26 have been straightened and have much poorer habitat.

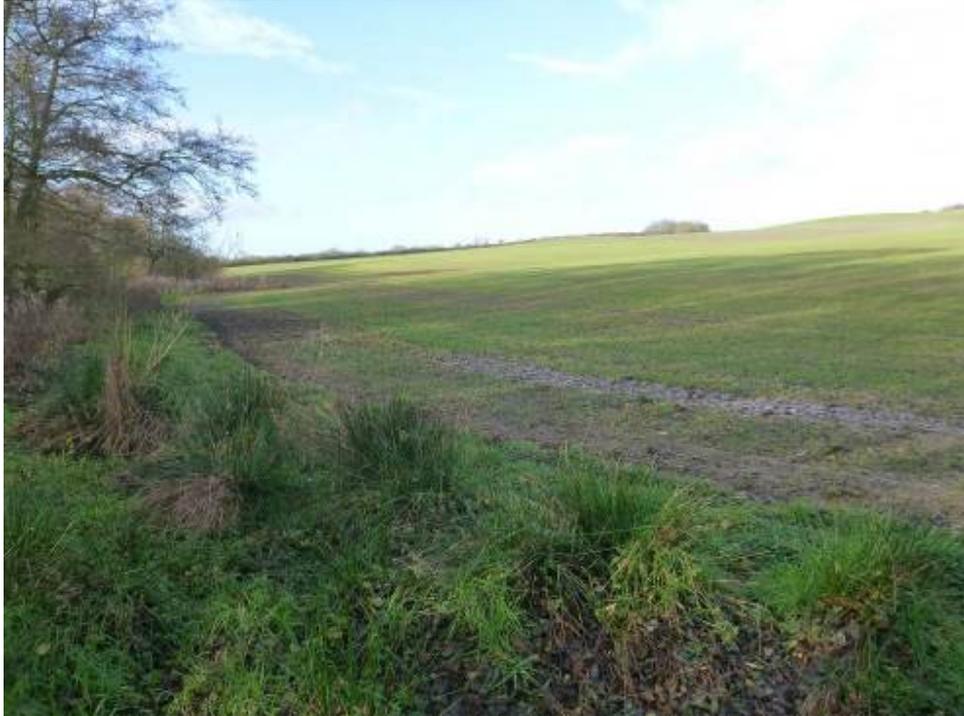
Photo 28 More intensive land use beyond the riparian zone of the brook. Although the brook is well buffered, fine sediment is reaching the watercourse via field drains (Photo 30).

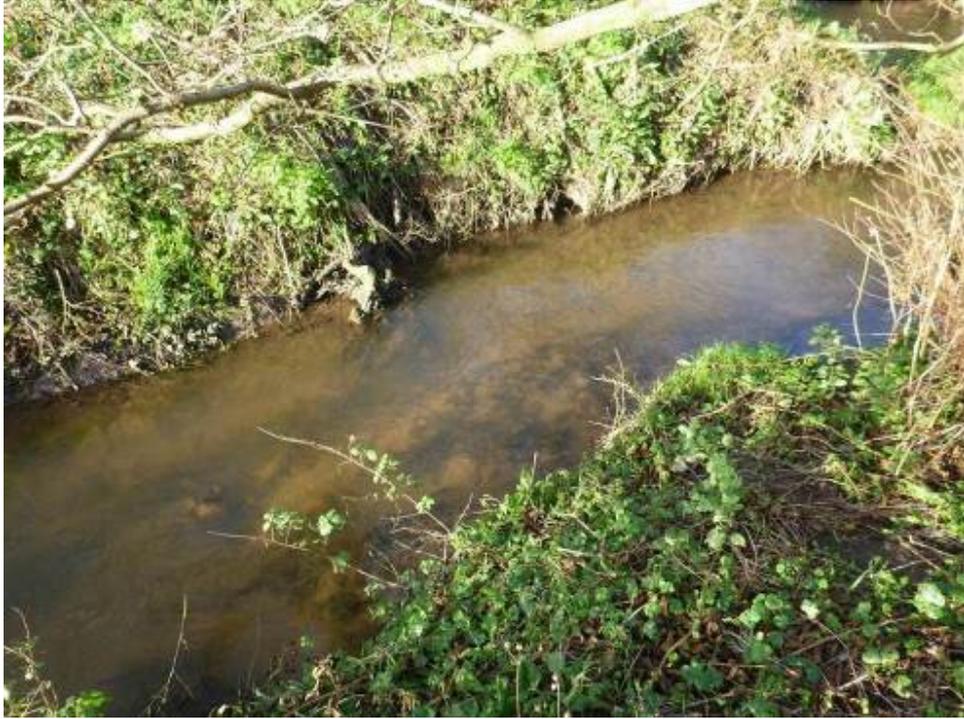
Photo 34 Large amounts of fine sediment dominate the bed of the brook.

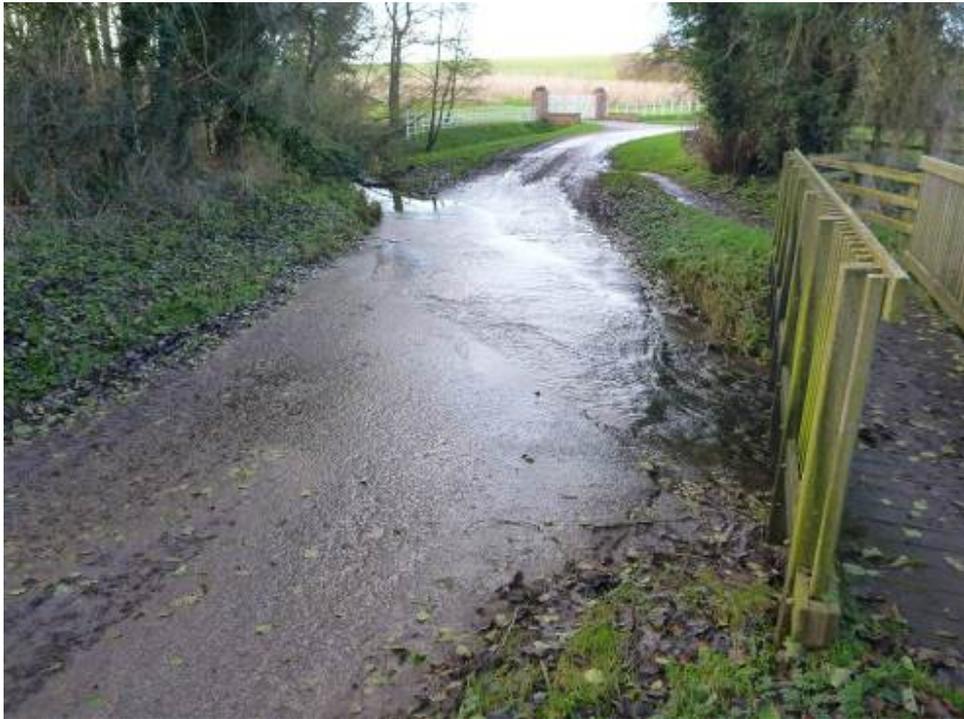
The ford at TF3456968880 near Hagworthingham (Photo 37) presents a barrier to free movement of fish. There is a drop of around 30cm at the downstream extent (under the footbridge), which is likely to be surmountable by trout (including juveniles) by leaping from the pool below. However, the extensive, very shallow section over the road is probably impassable at all but very high flows.

Photo 37 Ford at TF3456968880 near Hagworthingham.

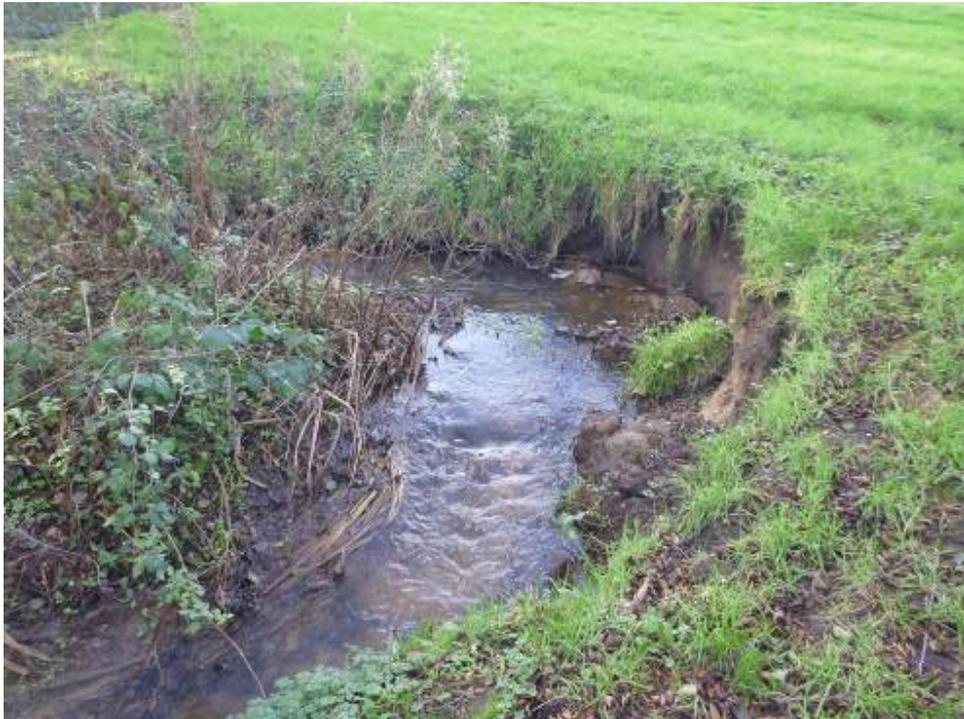
Photo 39 On the LHB, fewer trees means less bank stability, leading to increased rates of erosion and poorer pool habitat on the outside of meanders.

- The section of brook upstream from the ford near Hagworthingham lacks trees on the LHB and is experiencing accelerated bank erosion as described in section 3.2. These areas should be protected with brushwood revetment followed by native tree planting. This will increase bank stability and promote bed scour, increasing the depth of pools and providing much better trout habitat.

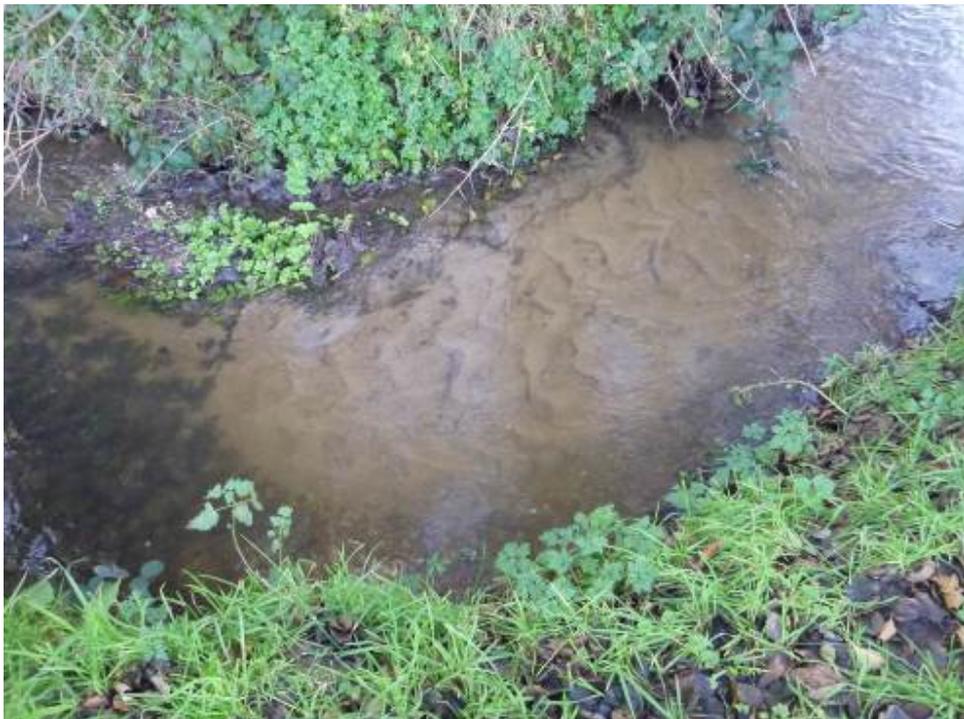
Large quantities of fine sediment are still evident in this section of the brook (Photo 41), although the sinuous plan-form and presence of in-channel woody debris promotes better sorting of the river bed substrate. Trout spawning activity was observed on areas of gravel, mainly associated with localised scour caused by woody debris (Photo 42). Undershot scour caused by water forced underneath fallen trunks spanning the channel seems particularly effective at creating depth and sorting sediments (Photo 43). Mimicking this effect in other areas with introduced structures is recommended.

Photo 41 Fine sediment is still evident in the upper reaches, although sediment is generally better sorted than on the section downstream of the ford. Areas of gravel are more abundant.

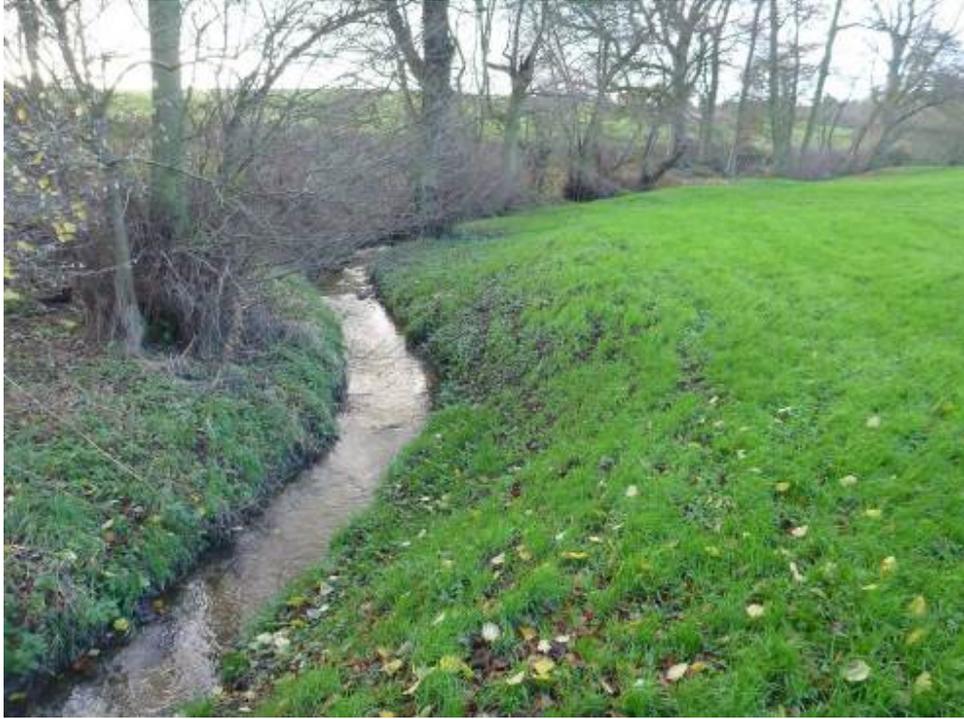
Photo 44 The channel straightness and bank profiles of some sections of the upper course suggest there has been some engineering of the brook in the past, leaving a dearth of pools and poorer in-stream habitat.

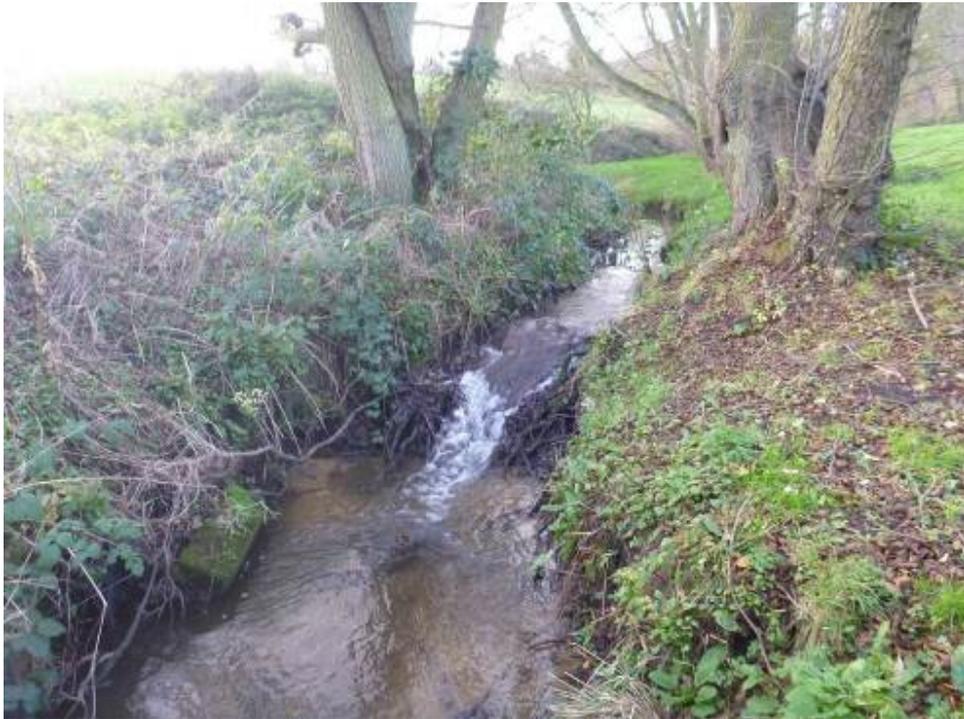
Photo 45 A number of tree-root “waterfalls” were observed. A natural feature, or indicative of past channel engineering?

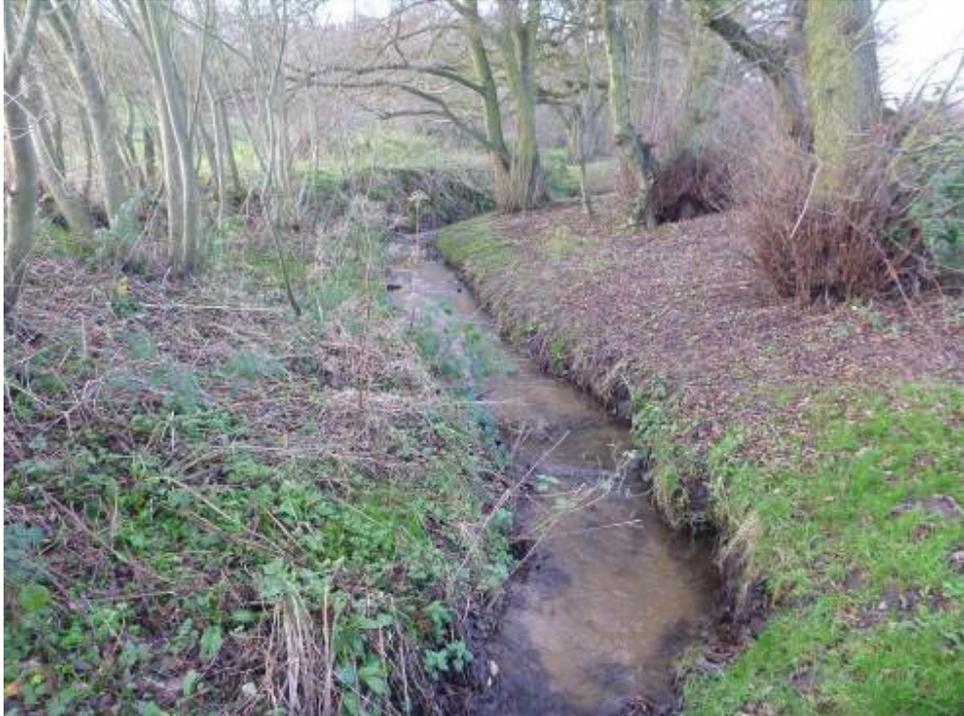
Photo 46 Another straight section, lacking depth variation and with a bed dominated by unsorted sediments. Installing woody debris in areas such as this would greatly improve in-stream habitat.

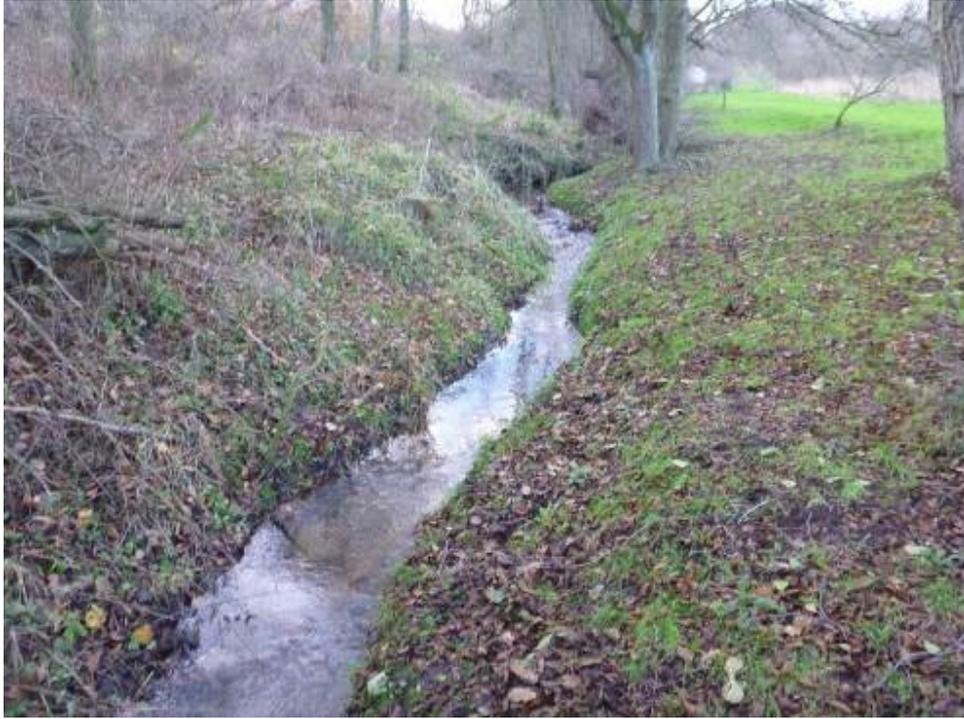
Photo 50 More typical habitat on the upper reaches, with very few pool areas.

(Photos 49, 50). Woody debris structures to promote bed scour and the development of a more sinuous course would be beneficial in this area.
