Advisory Visit

Rivers Meden and Maun, Thoresby Estate, Nottinghamshire

January 2018

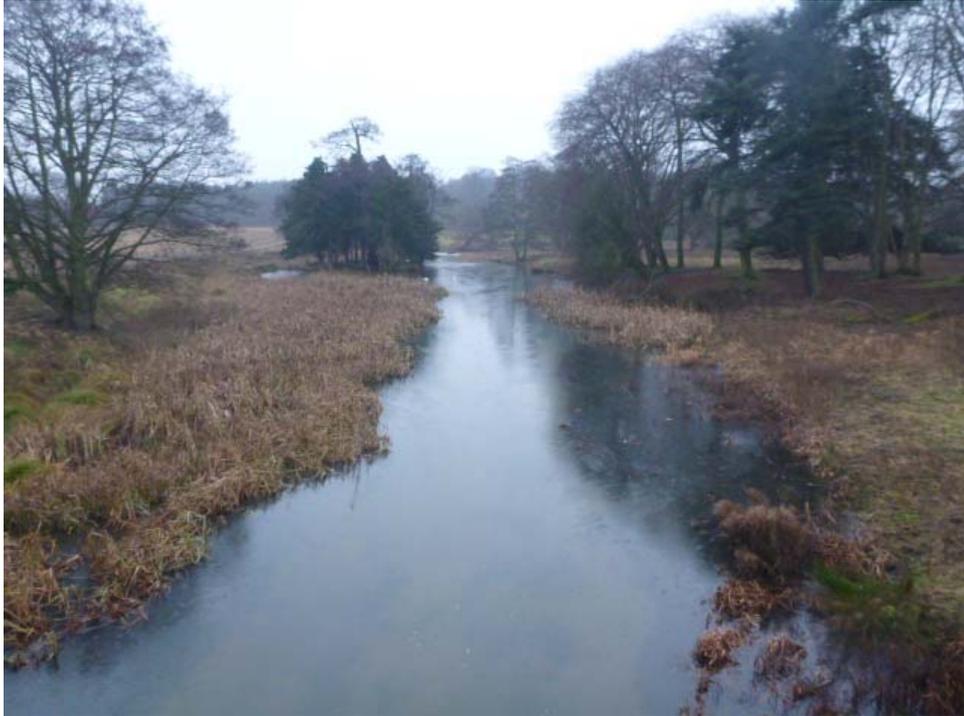
This reach of the River Meden is located downstream of Thoresby Lake, an ornamental, online lake. The 320-m section either side of Green Bridge (SK6404270867), adjacent to Thoresby Hall, has a widened channel forming an ornamental broadwater (Photo 1), bounded upstream and downstream by weirs. The channel has narrowed over time as emergent vegetation (reeds and rushes) have colonised the margins, trapping sediment which has gradually consolidated.

Photo 1 Looking upstream from Green Bridge towards Thoresby Lake. The river channel here has been historically modified into an ornamental broadwater. Note the extensive reed encroachment as the river narrows itself to more natural dimensions.

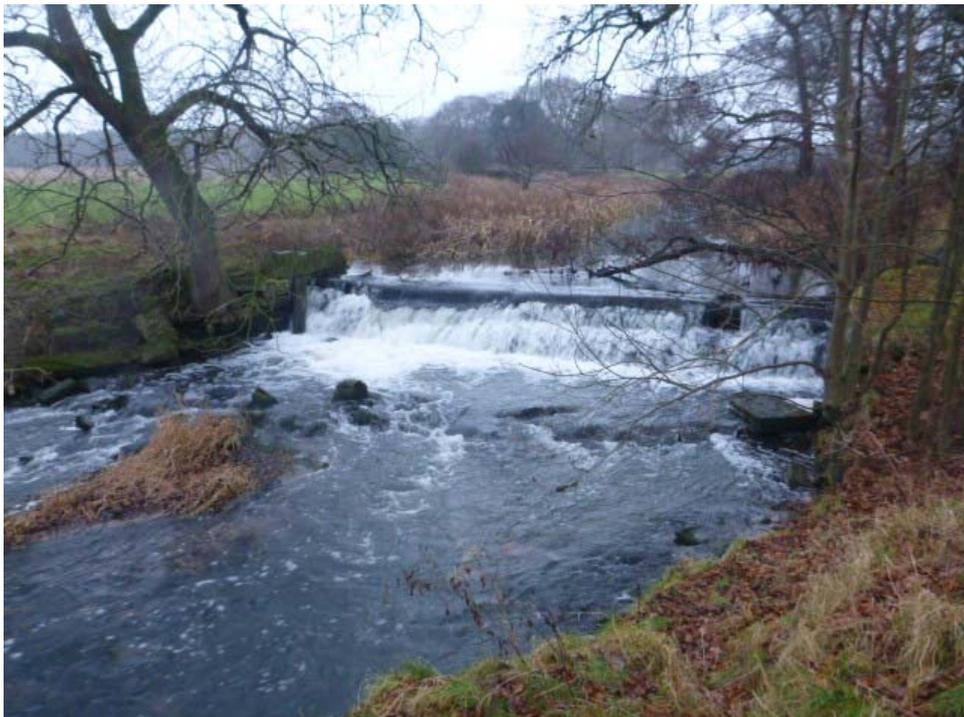
The water level is controlled on the Green Bridge section by a weir (Photo 2), which limits the value of the section for trout in two main ways:

- The impounding effect of the weir slows the flow upstream, promoting deposition of fine sediment on the river bed: not favourable habitat for trout or the majority of their food species.
- The weir is a considerable barrier to fish attempting to move upstream. This is particularly relevant here, because this location is isolated by Thoresby Lake from any suitable habitat for trout breeding and recruitment in the River Meden upstream.

Photo 2 The weir located at SK6409770982 approximately 130m downstream of Green Bridge which impounds flows and maintains water levels upstream.

The weir in Photo 2 has a level invert (crest) across the entire width of the brook, with a sharp downstream edge which causes two problems for fish passage:

- A shallow, even spread of water across the weir crest
- Water plumes to leave the face of the structure creating an air gap between the plume and the structure (Figure 1). This prevents fish from swimming up and through the plume, and causes them to have to jump. Fish are essentially designed to swim, and while they can clearly jump, especially salmonids, jumping fish is a sign that they are in difficulty.

The Green Bridge section could be improved by reducing the impounding effect of the weir. This could be achieved by removing the weir entirely, or lowering or notching the weir crest, or by creating a bypass channel around the weir, with the aim of speeding up the flow in the section upstream and improving fish passage across/around the weir. With increased flow speeds upstream, the channel could be narrowed using brushwood bundles to create a new bankline and back-filling behind. It would not be worth pursuing the channel narrowing unless the impounding effect of the weir could be reduced. Consultation with Historic England is recommended as a first step, given the location within a Registered Park and Garden (Thoresby Park) and the numerous Listed structures in the vicinity.

- Reduce the impounding effect and improve fish passage at the weir downstream of Green Bridge (Photo 2). Lower the weir crest and creating a notch with an 'adherent nappe' (to eliminate entrained air in the water flow), and carry out channel narrowing upstream.

See Appendix 1 for examples and descriptions. Consultation with Historic England regarding heritage aspects would be required.

- The weir crest should be lowered, reducing the height the fish have to traverse. This would also reduce the water level and speed up the flow upstream of the weir, giving more scope for habitat improvement.

- The weir crest could be made more varied with free gaps, notches, and lateral variations of the structure included in the works to ensure that a wide variety of flow and velocity conditions occur across the structure at any one flow condition. These heterogeneous conditions offer fish of different species, sizes, and abilities a better prospect of surmounting obstructions.

- A notch with an “adherent nappe” (i.e. excluding the air gap) could be created within the structure, which would allow the fish to use its burst speed to swim through, rather than jump. This is normally achieved by having sufficient thickness of cross-wall and providing a curved or 250 -300mm radiused profile (Figures A2 and A3). An alternative means of creating an adherent nappe can be to use a chamfered profile, which is sometimes easier to attain. Scaling up the profiles in these structures gives possible profiles for use in other thicknesses of cross-wall, for example that shown in Figure A4 below for a typically 300mm thick wall
Notches are effective in narrow crested, vertical weirs where the head difference between upstream and downstream water levels is $\leq 0.5\text{m}$ and there is a suitable depth of water below the weir - a depth of at least twice the head difference is required. Where the head difference is

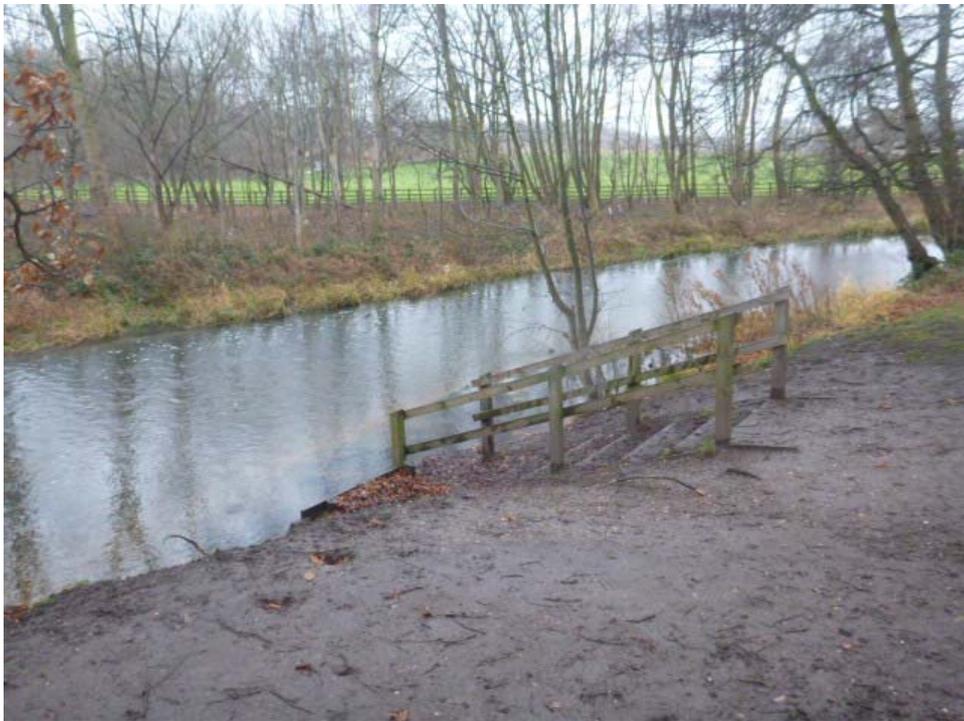
Photo 3 Access point for river study used by groups at the nearby Perlethorpe Environmental Education Centre (www.nottinghamshire.gov.uk/education/outdoor-and-environmental-education/outdoor-education/perlethorpe)

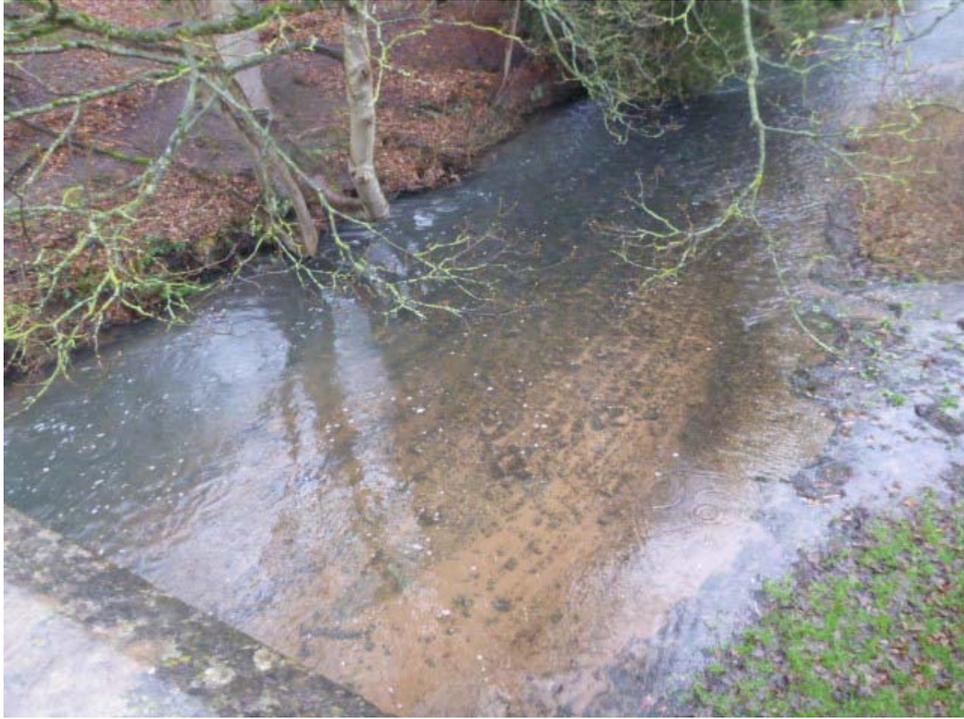
Photo 5 Downstream of footbridge showing fine sediment deposition where the channel is wider.

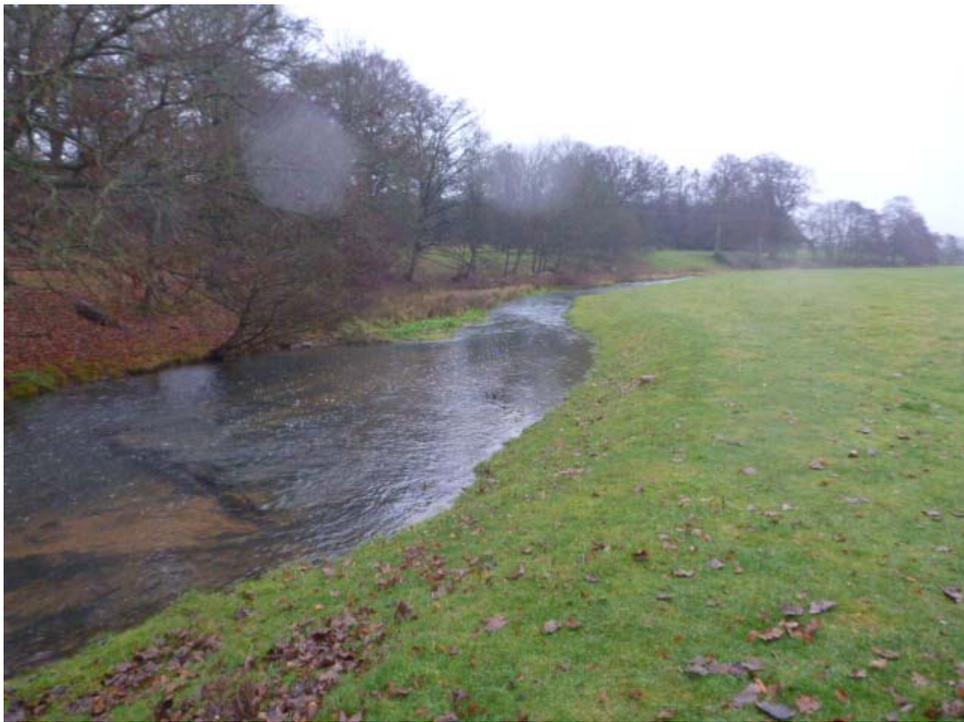
Photo 6 View downstream from the footbridge.

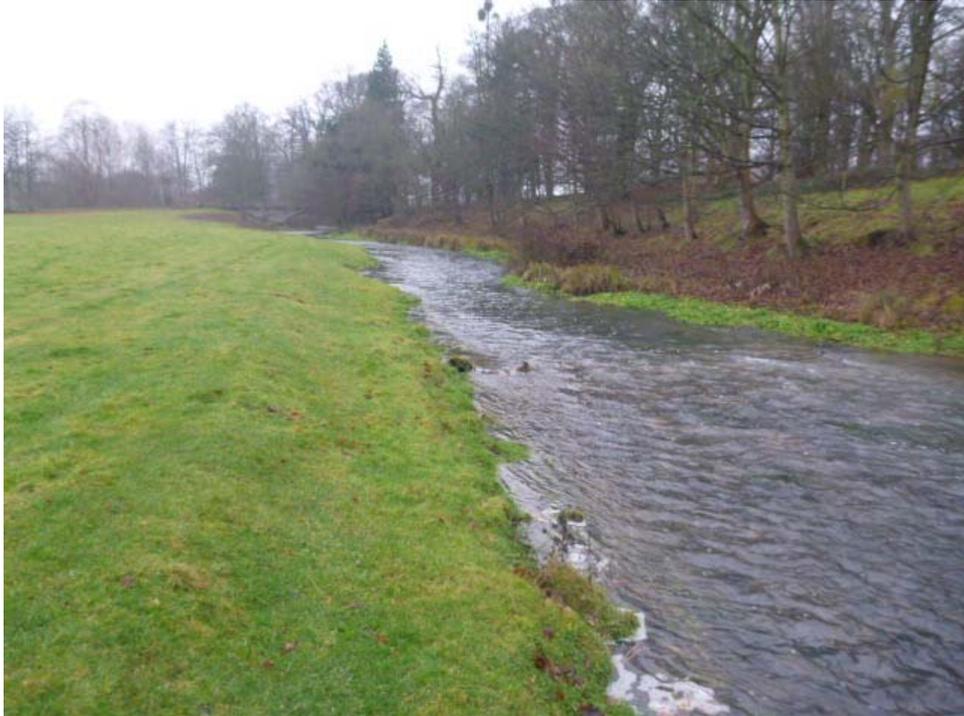
distance, and is lacking a natural pool-and-riffle sequence (Figure 2). This means the reach is comprised of mainly long, shallow, riffle-like habitat (Photo 7), with a short section of deeper glide (Photo 8). This type of habitat has some value for the juvenile stages of trout, but lacks deeper areas and areas of cover which fish beyond c. 6" (15 cm) could inhabit.

Photo 7 Downstream of the footbridge the river is un-impounded (free flowing), over a gravel bed. The right (near) bank is grazed, in contrast to the left (far) bank. The river channel is artificially straight and largely shallow.

Ideally, the planform of the river here should be changed to introduce some meanders and re-establish a pool-riffle sequence, providing depth variation and habitat niches for all trout life stages. This would require design input from a professional fluvial geomorphologist and earthworks to excavate new sections of channel and backfill some existing sections. An example of this type of project can be seen in Figure 3 (with more details at www.wildtrout.org/content/river-glaven). Early consultation with Historic England over heritage considerations and with the Estate over the land-take required is essential. The natural flood management aspects of such a project may be advantageous in the current climate of changing agri-environment subsidies.

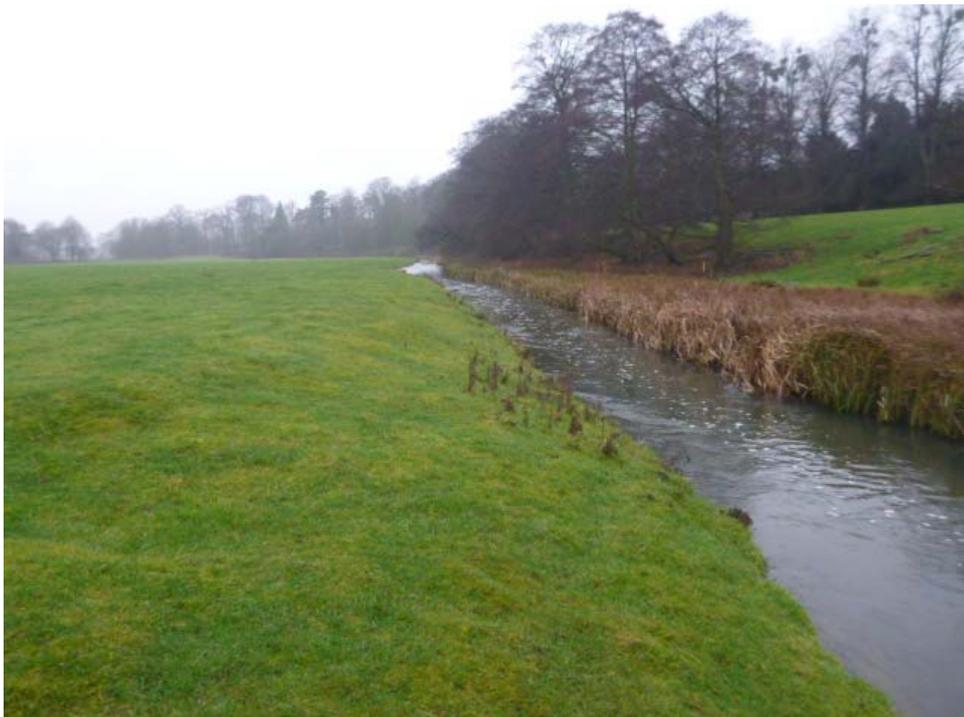
Photo 8 A short section downstream of the footbridge has narrowed and deepened as emergent vegetation has pinched the channel and trapped and consolidated sediment.

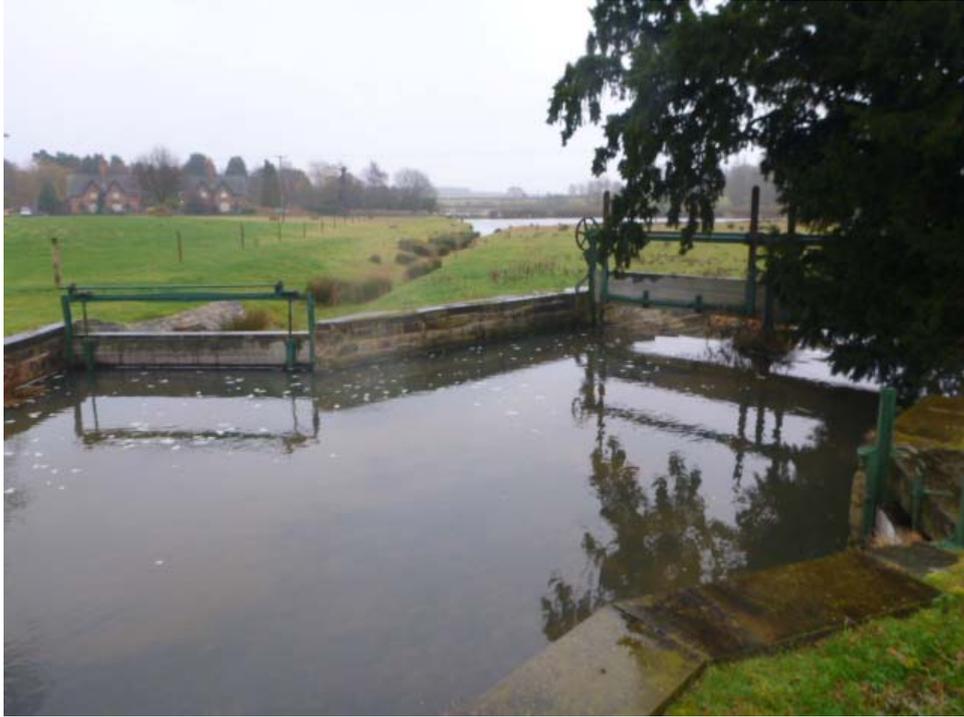
Near Thoresby Home Farm, there is a weir and sluice system in the river (Photos 9 and 10) where water is abstracted by the Estate for agricultural irrigation. There is apparently a system of water release from the lakes upstream to supplement flow during periods of abstraction. In the warmer months, an influx of lake water which is warmer and with lower levels of dissolved oxygen, could have potentially detrimental effects to the river ecology. This practice should be checked to ensure it does not limit the fishery potential of this reach.

One of the sluices is permanently shut, but formerly fed a water meadow system (now partly inundated because of mining subsidence). The weir is an impassable barrier for fish migration and the quality and resilience of the fishery in this part of the River Meden would be enhanced if fish passage was improved. There is potential to create a nature-like bypass channel around the weir on the left bank by modifying the existing channel feeding the former water meadow. Further investigation into the feasibility of this is recommended, including consideration of the heritage aspects, existing ground and water levels, and the quantity of flow that could be diverted without compromising the existing abstraction.

Photo 9 Weir, sluices and abstraction point where water is pumped for irrigation on Estate farmland (SK6463271236). The sluice on the left is permanently closed, having formerly supplied a water meadow system. The standing water in the background is pooled because of mining subsidence.

- Create a bypass channel around the weir/sluiice near Thoresby Home Farm to improve fish passage, by modifying the existing channel on the left bank feeding the former water meadow. Further investigation into the feasibility of this is recommended, including consideration of the heritage aspects, existing ground and water levels, and the quantity of flow that could be diverted without compromising the existing abstraction. An example of a bypass channel is shown in Appendix 1.
- Re-visit the Budby section and wade the river, making habitat and angling access improvements, such as 'hinging' small trees (Photo 17) and introducing flow deflectors.

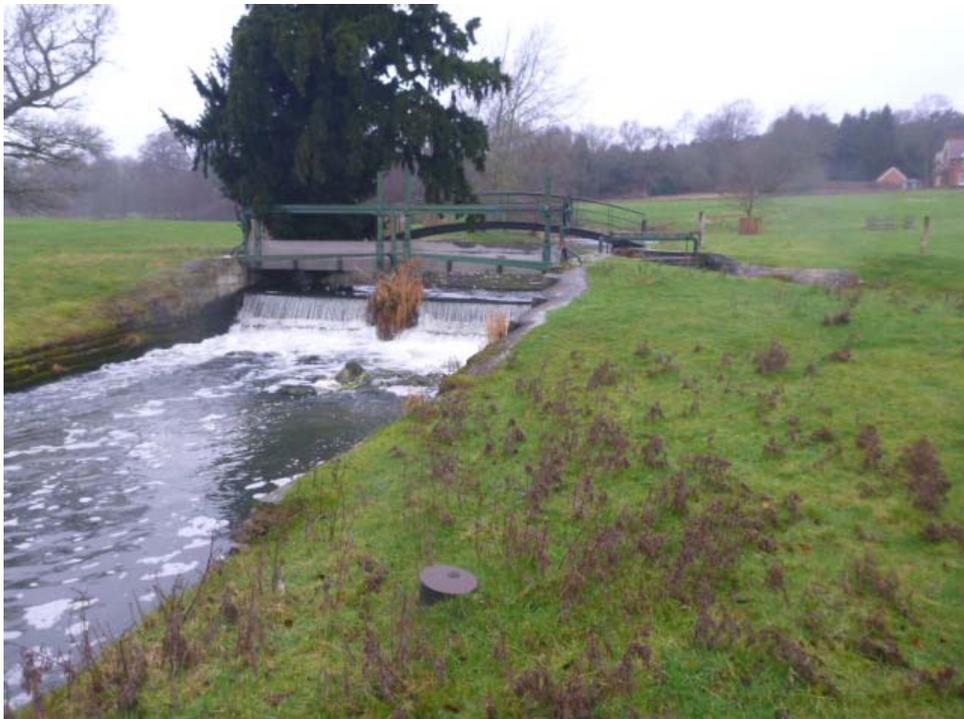
Photo 10 Upstream view of the weir at the abstraction point.

At the Thoresby Home Farm weir, a bypass channel could be constructed around the weir on the left bank, such as the one illustrated in Figure A5.

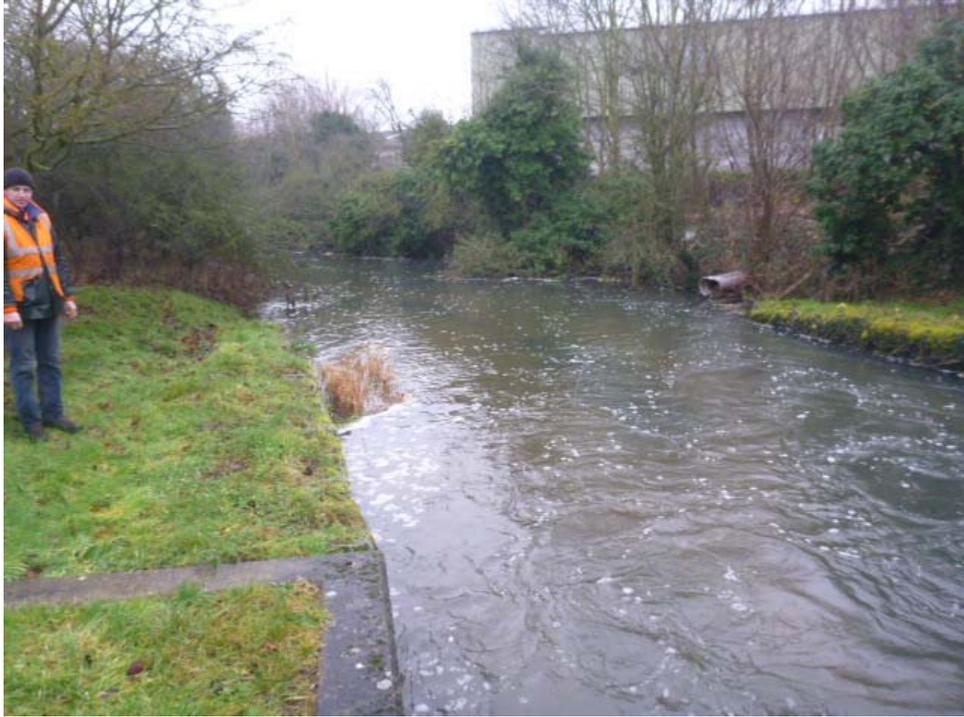
A short distance downstream of the weir is an Environment Agency flow gauging station (with a v-crump weir). This has also been affected by mining subsidence and it is understood that it is to be replaced with an open channel, Doppler effect ultrasonic flow gauge.

Photo 11 Downstream view from the EA flow gauging weir, a short distance downstream from Photo 10.

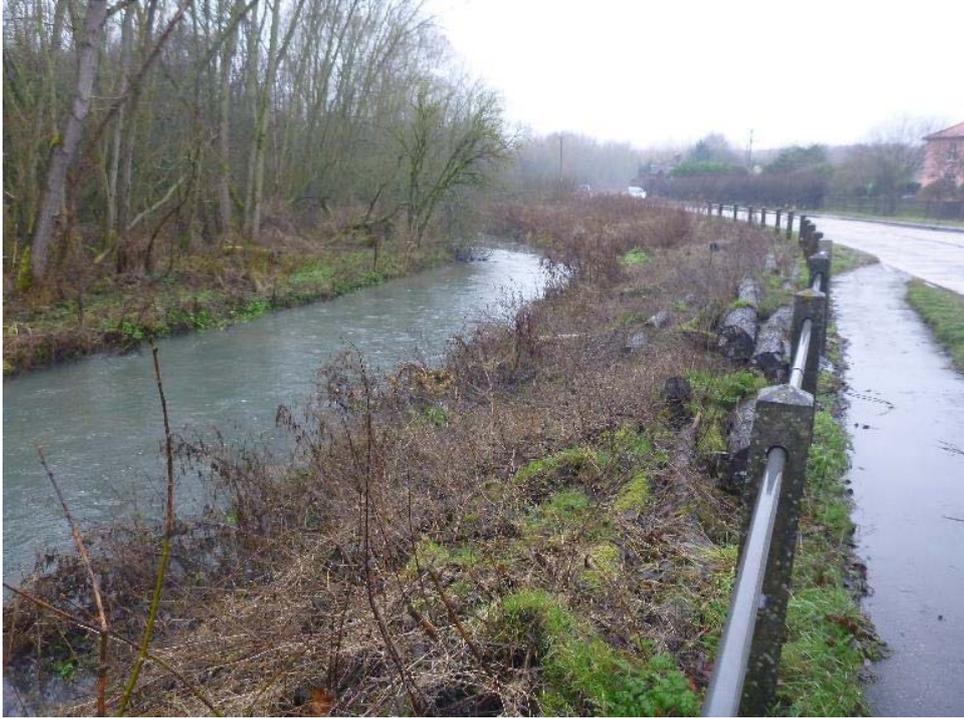
Photo 12 River Meden at Budby, alongside the road (SK6159670283).

A short section of the River Meden was inspected upstream of Thoresby Lake, alongside the road at Budby and into Budby Carr wood. This section is more natural in character (although its planform also indicates historic alteration and a pool-riffle sequence is generally lacking). The riparian land here (and for considerable lengths upstream) is woodland which is an excellent buffer for the river from more intensive forms of land use and provides abundant natural woody material in the channel. The woody material creates natural flow deflectors, scouring the river bed and providing depth variety and cover for fish. It is likely that this section of the Meden holds reasonable stocks of wild trout and could provide a resource for angling. Fly-fishing by wading the river between access/egress points would be possible and a wild, catch-and-release fishery could be sustained here. Further investigation during the spring is recommended, wading the channel to identify areas for habitat and access improvements. The plentiful riparian trees and in-house forestry expertise at Thoresby could facilitate the creation of habitat improvement features, along with WTT guidance.

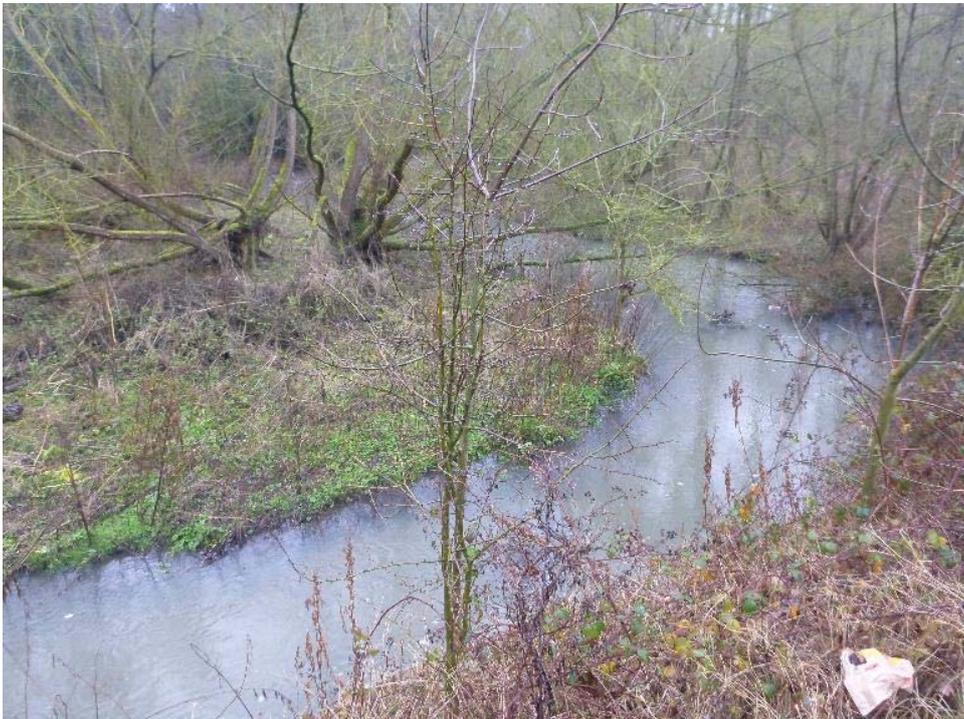
Photo 13 River Meden at Budby, upstream view away from the road (SK6148970466)

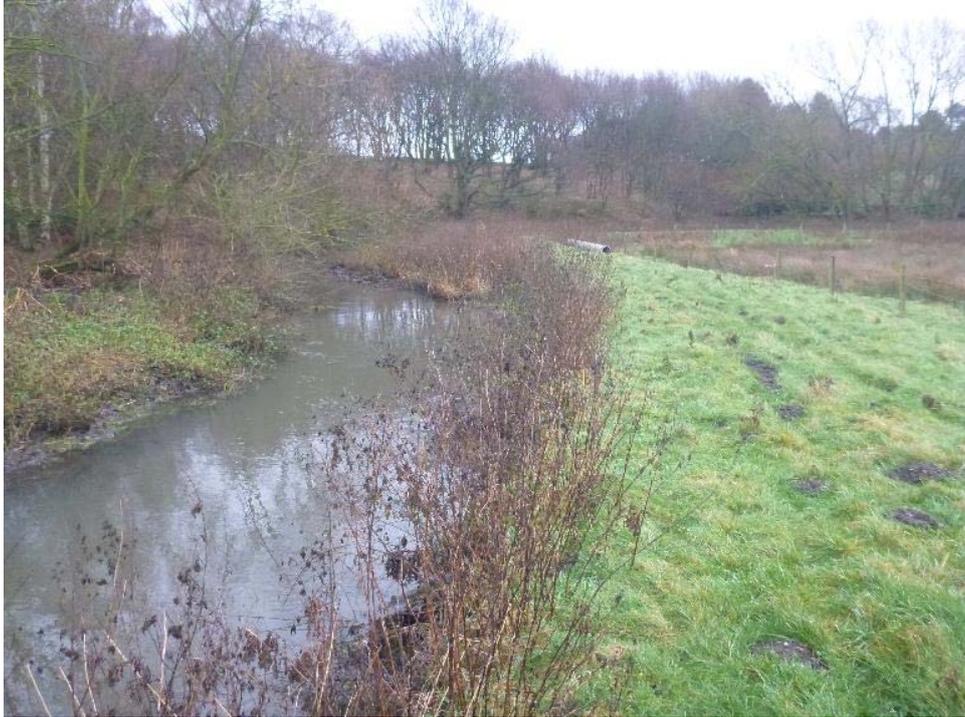
Photo 14 River Maun (Whitewater) SK6643070425

The section of the River Maun (Whitewater) upstream of Stan's Lake was inspected (Photo 14). Despite the meandering planform on the map, the in-stream habitat present here is disappointing. The river occupies a channel perched above the level of the adjacent land and is embanked along its left bank. The channel dimensions are uniform and there is no pool-riffle sequence. Riparian habitat is reasonably good, especially along the right bank (Walesby Scout Camp) which has trees, bushes and tall herbaceous vegetation. The left bank is grazed, but there are no serious issues with bank poaching or fine sediment ingress.

Trout are not known to be present in this section, although coarse fish including barbel are found throughout and upstream to Ollerton. Cormorants were observed feeding in the river, so in-stream cover is important to protect the fish stocks. There are some opportunities to enhance instream cover by hinging trees into the channel and introducing brushwood structures in the margins.

- Carry out similar tree hinging works on the Maun (Whitewater).
