Advisory Visit

Merritt's Brook, Birmingham

23/01/12

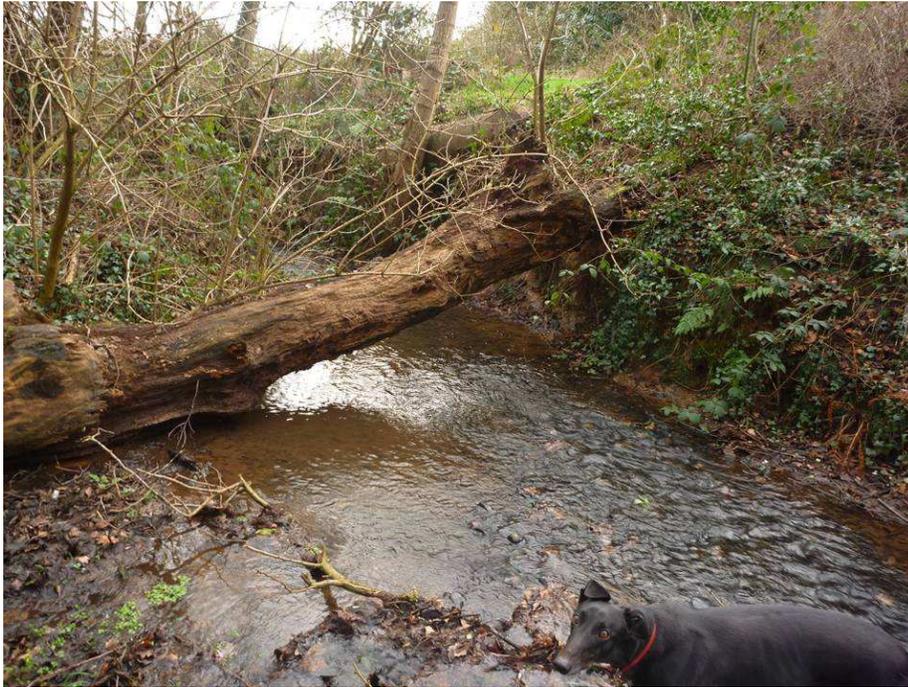
Starting at the upstream inspection limit around SP 00889 79931, the sandy nature of the substrate that is typical of this region is immediately apparent. Soft and highly erodible banks are, in this reach, quite well protected by marginal vegetation. Additionally, the presence of timber within the channel appears to be tolerated by those responsible for overseeing maintenance (Fig. 2). Allowing both lightly managed bank-side vegetation and natural deadfall of timber to occur are valuable means of promoting aquatic (as well as terrestrial) biodiversity. The bankside vegetation provides cover from predation, increases the variety of physical habitat and also helps to slow the rate of bank erosion that might otherwise occur at a rate that limited biodiversity. Fallen tree trunks, limbs and coarse brush all promote localised river bed scour. This process is especially valuable in the grading or “sorting” of gravels for fish spawning as well as often generating pool habitat for adult fish. Even so, the brook in these reaches has a very small rate of discharge – and consequently the potential for developing scour pool habitat capable of sustaining adult trout is quite limited (Fig. 3). In addition, the sheer amount

Figure 2: Fallen timber, well-vegetated banks and the presence of gravel. Good ingredients for trout spawning. However, abundant fine sediments may block the gaps in between gravel particles that would be necessary to generate good “within-gravel” flow of oxygenated water required for egg survival

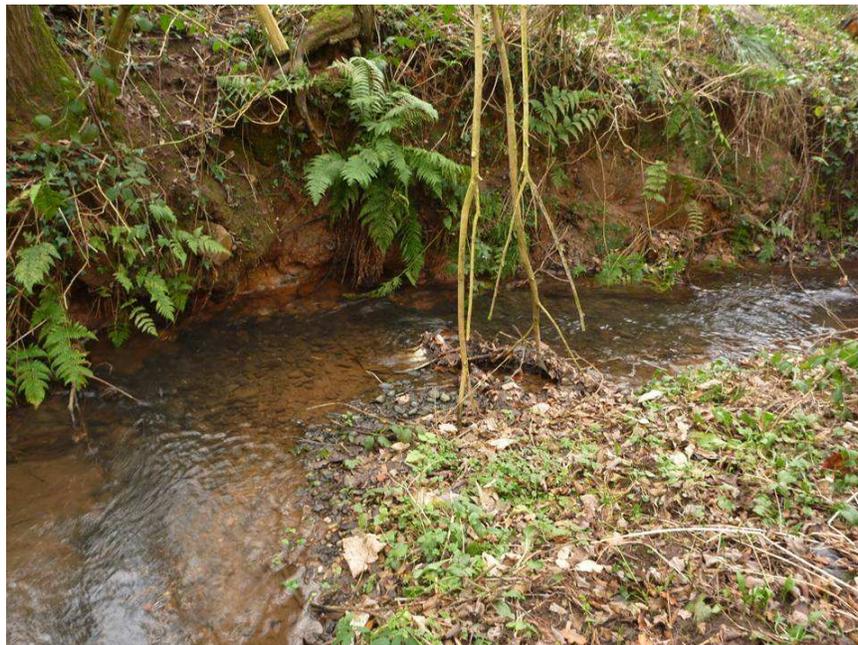
Figure 3: Channel width in the centre of the frame is less than 60 cm and the depth around 5 cm. This section has characteristics of a spawning tributary and juvenile nursery area rather than as a realistic year-round home for adult trout

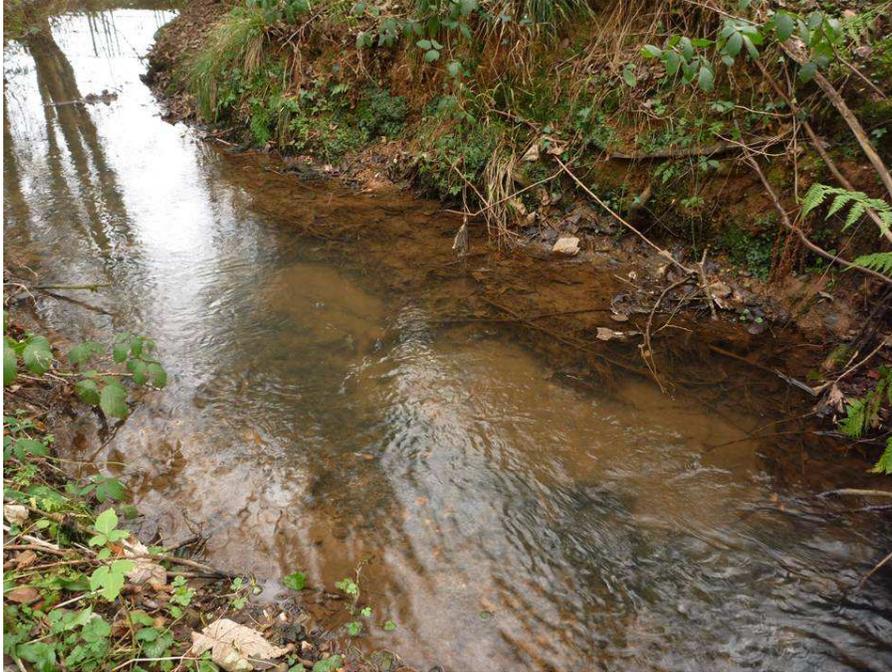
of fine/sandy substrate present in the stream bed will tend to limit the egg survival and hatching success for flow-loving species such as trout (Fig. 4).

Figure 4: Fine sand/silt substrate predominates

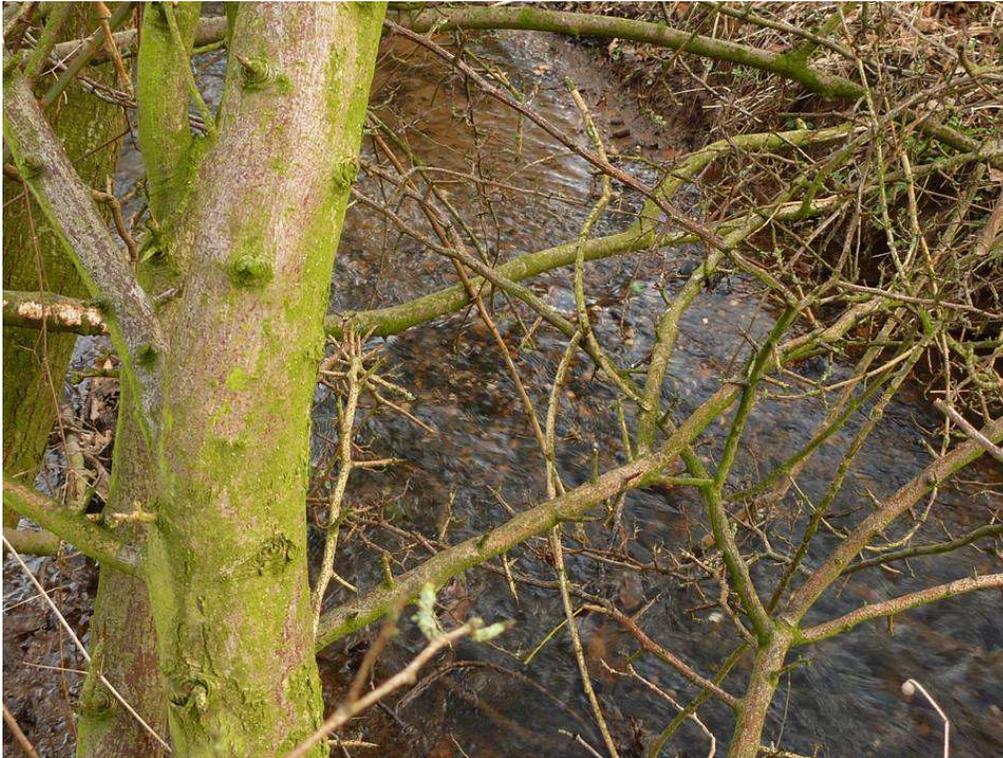
However, the potential for these upper reaches to be a vital resource within the lifecycle of wild trout populations was highlighted by examples of what may have been spawning attempts by gravel-spawning fish (i.e. trout in this instance). The area beneath the low overhanging branches (Fig. 5) shows a typical ramp or mound of gravel that is favoured by trout for their spawning attempts. The brighter patch of stones could indicate an area where trout have made attempts to cut a nest (called a "redd") using their tails. If areas with this appearance are discovered during autumn and winter, **do not disturb or examine them**. Even treading on or near the gravel mounds can kill the eggs within them – especially during their most delicate early stages soon after laying. Whether or not these areas were genuinely the result of wild trout breeding attempts, the physical conditions of suitable depth, flow, gravel sorting and low, overhanging branch cover for trout spawning all exist in the putative breeding locations. Consequently, it is worth exploring the potential to add to the two or three existing examples of such habitat via creation of several comparable locations in this upper section (i.e. upstream of SP00982 79894). Furthermore, due to the January date of the site assessment, it was not possible to judge how extensive any stands of annual invasive plant species (especially Himalayan balsam, *Impatiens glandulifera*) might be. This could, if allowed to dominate bankside vegetation, significantly increase the rate of fine sediment supply to the watercourse. More information on the biology and control of invasive

Figure 5: Although difficult to photograph, there were what appeared to be examples of trout redds in two separate locations in the visited reaches; this one (central frame) at SP00982 79894 and another a short distance downstream. Overhanging branches can be vital to determining whether adult trout feel sufficiently safe to make breeding attempts

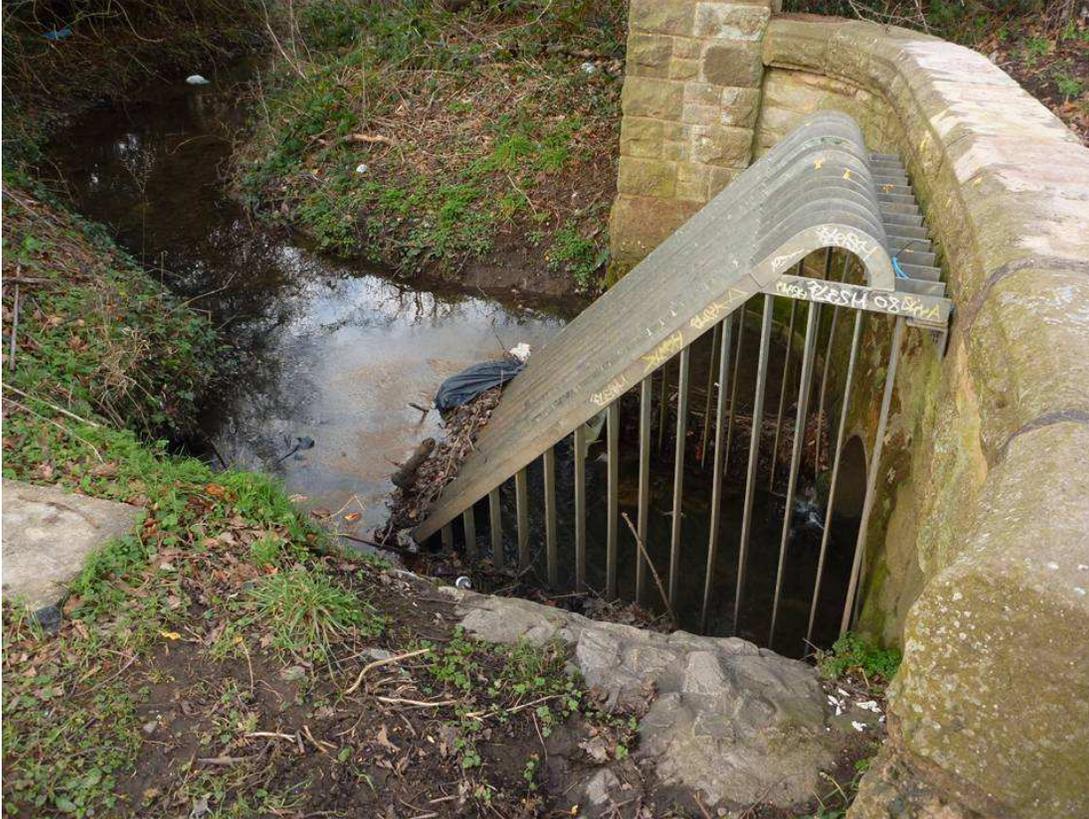
The culvert at SP 01039 79867 (Fig. 6) is a natural border that defines the upper reach described above and is a potentially significant barrier to migration of fish to and from the lower reaches. It is absolutely imperative that, if the potential for spawning and juvenile production is to be realised, the upper section is connected to the lower reaches by tackling this barrier. It is particularly important given the limited potential for the uppermost reach to support adult fish of a breeding age (in other words, all breeding fish must migrate into and out of this reach during a short, seasonal window of opportunity). Simply removing the trash screen (perhaps on a seasonal basis i.e. October to February inclusive) and committing a local community group to keeping the culvert clear of blockages would be extremely valuable. A more expensive alternative would be to investigate replacement of the culvert with an open channel crossed by a flat bridge (section 3: Recommendations).

Figure 6: Culvert with a trash screen that currently creates a serious barrier for fish wishing to migrate into or out of the upper section of Merritt's Brook

- Monitor and control (by hand pulling and composting *in-situ*) any infestations of Himalayan Balsam
- Investigate options with local council for seasonal or permanent removal of trash screen on the culvert at SP 01039 79867

- Alternatively explore potential to convert the short culverted section into an open channel crossed by a level bridge
- Co-ordinate efforts to secure investment in improvements to CSO discharges throughout the reach

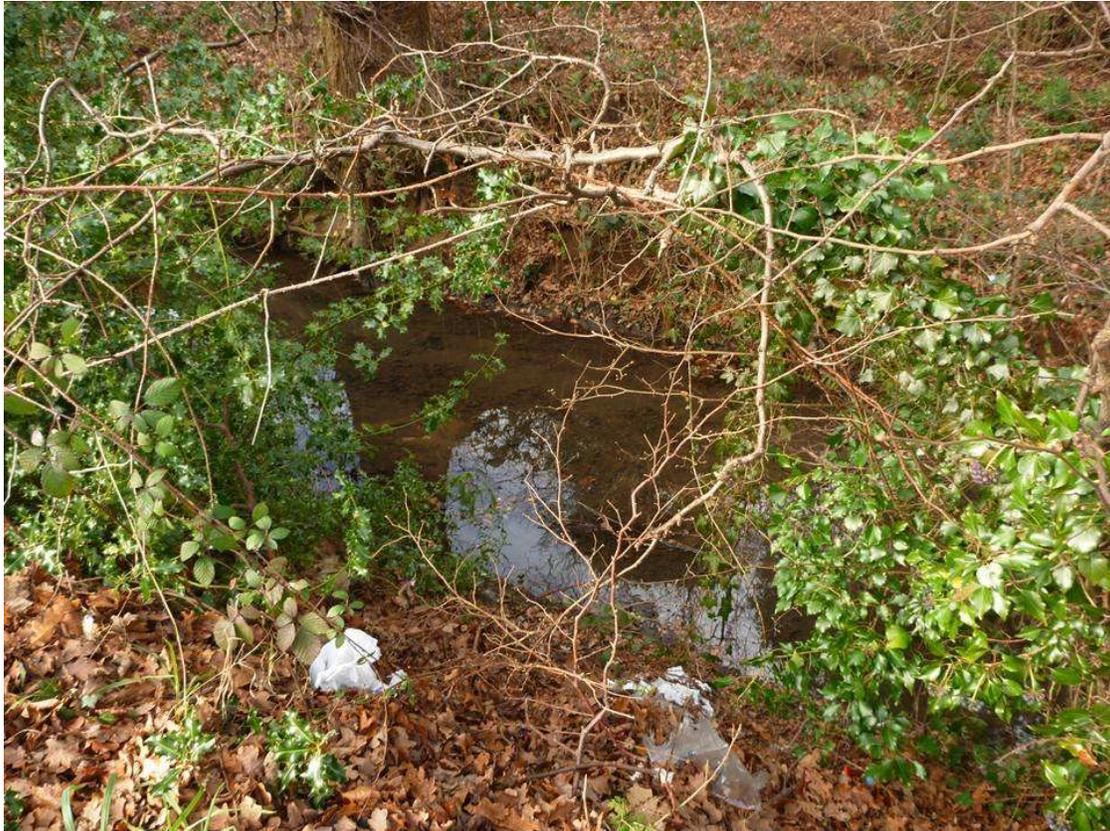
Downstream of the culvert, Merritt's Brook runs parallel to "Merritt's Brook Lane" on its RHB with quite dense tree canopy on both RHB and LHB (Fig. 7). The channel here is extensively straightened and there is limited opportunity for a variety in flow depth and velocity to develop. A combination of light coppicing to establish a more varied age/height structure in the woody canopy along with some quite simple in-stream modifications using material arising from such coppicing could be of great ecological value in this reach. The modifications (see section 3: Recommendations) would not be of sufficient magnitude to elevate flood risk. Similarly, the methods of anchoring any introduced material would be tried and tested to withstand much harsher conditions than those experienced in Merritt's Brook. Simple "pinning" of tree limbs to generate river-bed scour and sheltering cover from predation risk would have significant benefits to fish and invertebrate populations alike. The increased physical variation promoted by small amounts of canopy management would be of great benefit to terrestrial and aquatic flora and fauna.

Figure 7: Straight and a little uniformly shaded - a light touch combination of canopy management and adding in-stream structure would pay dividends here (NGR: SP 01180 80009)

- Combine the sensitive canopy opening at Merritt's Brook Lane section with "hingeing" or "pleaching" of saplings (or cabling of suitable-sized limbs of trees obtained during canopy work) to provide marginal cover and generate flow velocity and depth variety. Figure 15 gives an example.

- Some small in-stream log pinning could also be used to generate greater structural diversity in the channel alongside Merritt's Brook Lane (e.g. Figs. 16 and 17) – **N.B. it is imperative to collate information on underground services where any stakes or pins are proposed to be driven into the stream bed or surrounding banks**

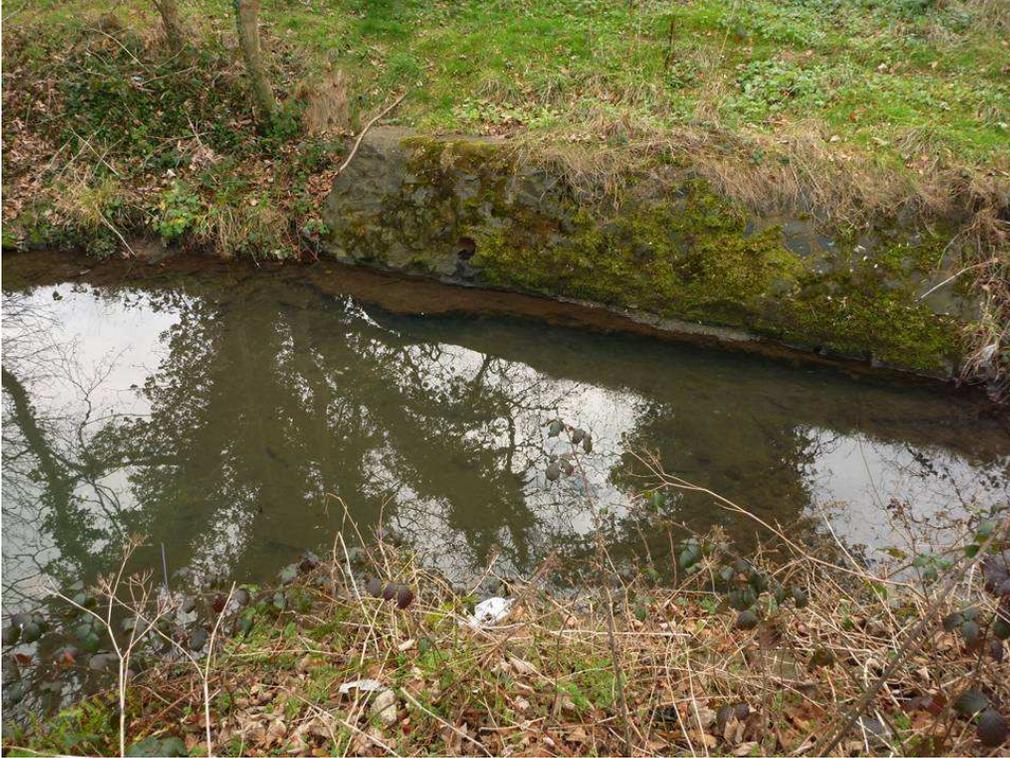
A little further downstream (SP 01333 80103), slow, uniform pool habitat with a conspicuous absence of cover was noted (Fig. 8). Many sections of this reach were also obviously affected by nutrient enrichment from either drainage ditches (e.g. ditch joining close to trash screen/culvert at SP 01039 79867) or Combined Sewer Outfalls (CSOs; Fig. 9). If ecological potential is to be improved within these reaches, it is imperative to reduce the influence of these enriching inputs. Opportunities to create reedbed/wetland treatment prior to effluent reaching the river, investment in sewer improvement (e.g. to increase storm water storage capacity) and vigilance for blockages and misconnection problems are all vital to achieving this. Judging by characteristic filamentous algae and bacterial "sewage fungus" growth, the apparent effects of each discharge point disappeared with downstream dilution. It must be noted, though, that any potential improvements in habitat will not translate into ecological benefits in those sections where water quality is too poor. However, there is no harm in pushing forward with both habitat and water quality improvements in parallel. This will minimise the duration that the water body is falling short of its ecological potential.

Figure 8: Open pool. The only structural value for fish is provided by the degrading concrete lintel at the base of the wall

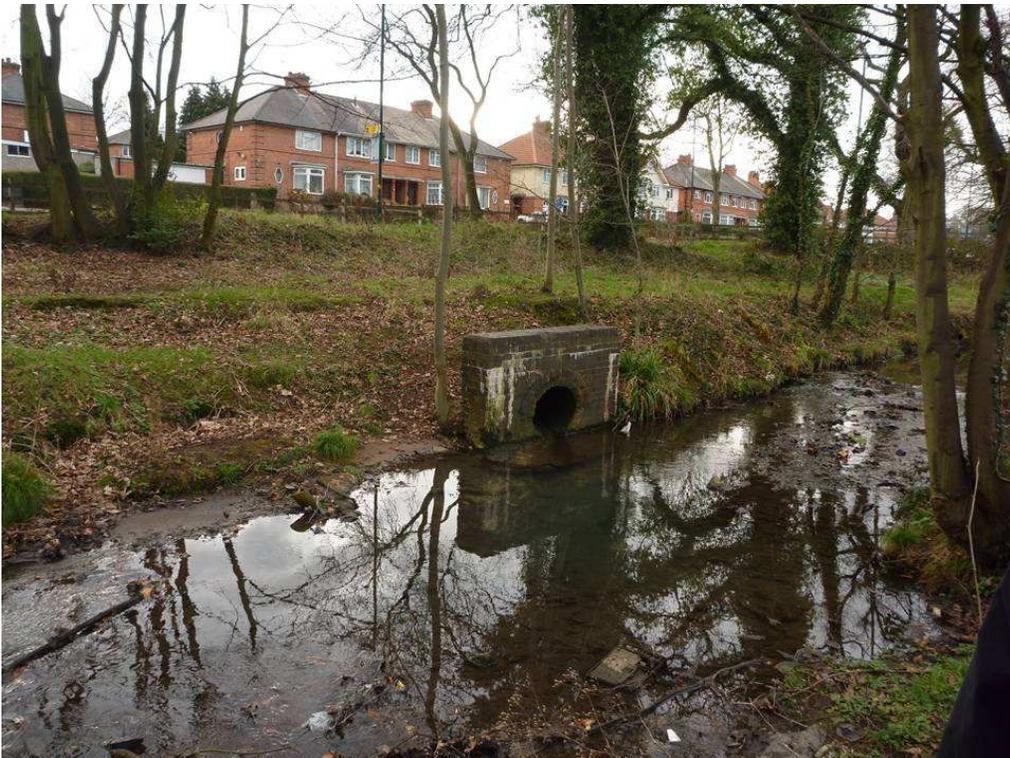
Figure 9: One of several Combined Sewer Outfalls (CSOs) in the reach. A programme to set back the discharge point further away from the river and promote wetland and reedbed development would be hugely beneficial

- Investigate and develop options to break out CSO pipework and generate localised wetland and reedbed as a means of intercepting runoff prior to entry into surface watercourse

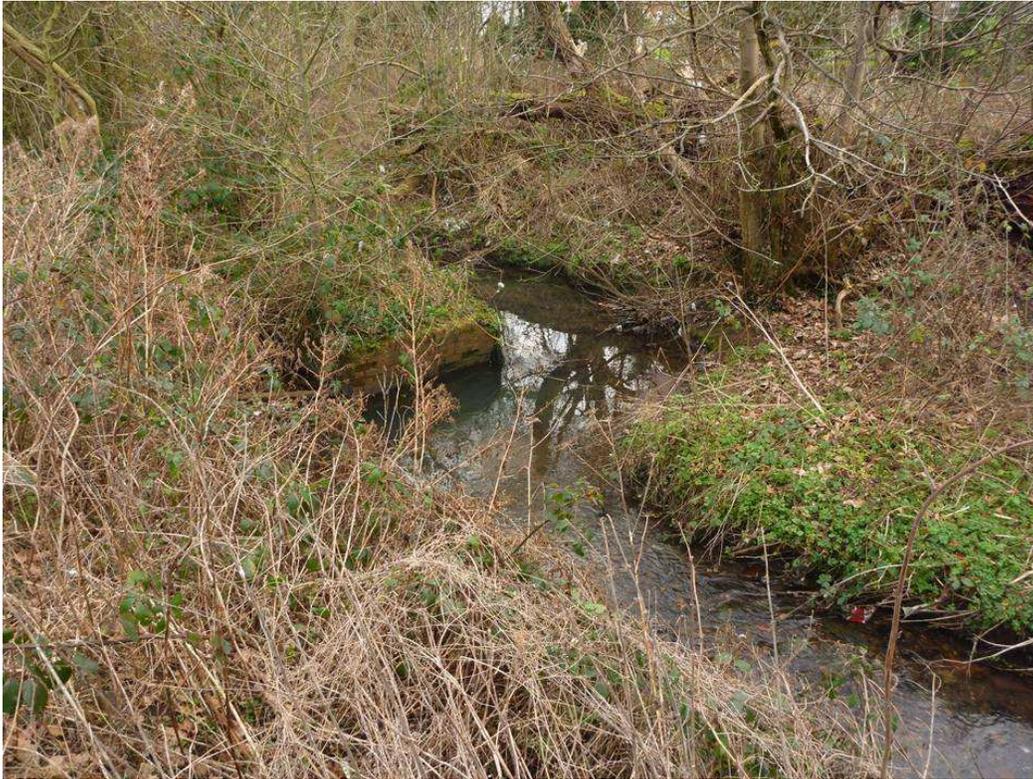
The section from Merritt's Hill and downstream to the lower limit of inspected habitat contains the highest value habitat that was assessed during the visit. A variety of riparian vegetation is evident and the stream is largely allowed to generate a meandering planform (Fig. 10).

Figure 10: Typical meander and riparian vegetation for the lower inspected reach

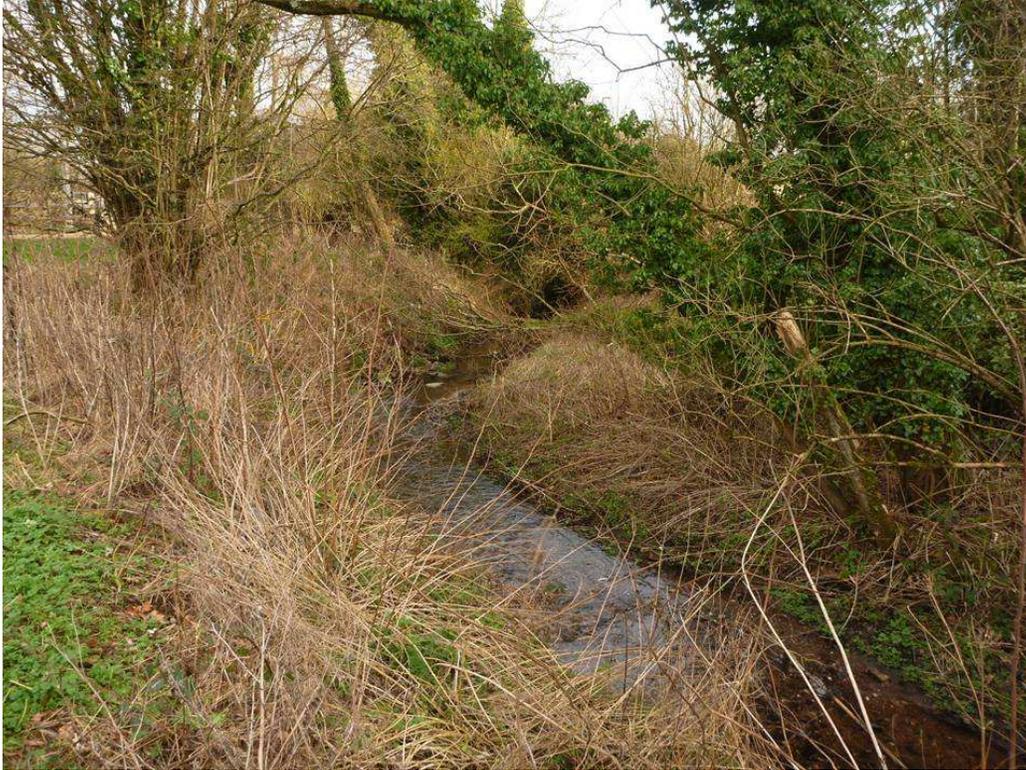
Consequently, the stream produces a variety of features that are favourable to a range of critical life stages of wild trout. These include shallow riffles with cover from predation that are favoured by juvenile fish (e.g. Fig. 10; lower right of frame and Fig. 11) as well as pool habitat for adult fish (e.g. Fig. 10: upper/central frame and Fig. 12). The naturally-occurring debris dams that have produced some excellent adult pool habitat with ample cover from predation are worthy of special attention (Fig.12). A simple regime of unsightly litter removal and periodic checks that the dams are passable to fish (and allow sufficient flow of water) at their base will maximise the value of these superb features. The small size of the channel and the nature of the debris mean that the maintenance of these structures is well within the capabilities of community groups. Some limited potential for spawning habitat exists already (Fig. 13). The potential for successful spawning would be dramatically increased by providing cover for adult fish and also promoting scour of the stream bed using installations of woody debris. Such

Figure 11: Perfect juvenile trout habitat

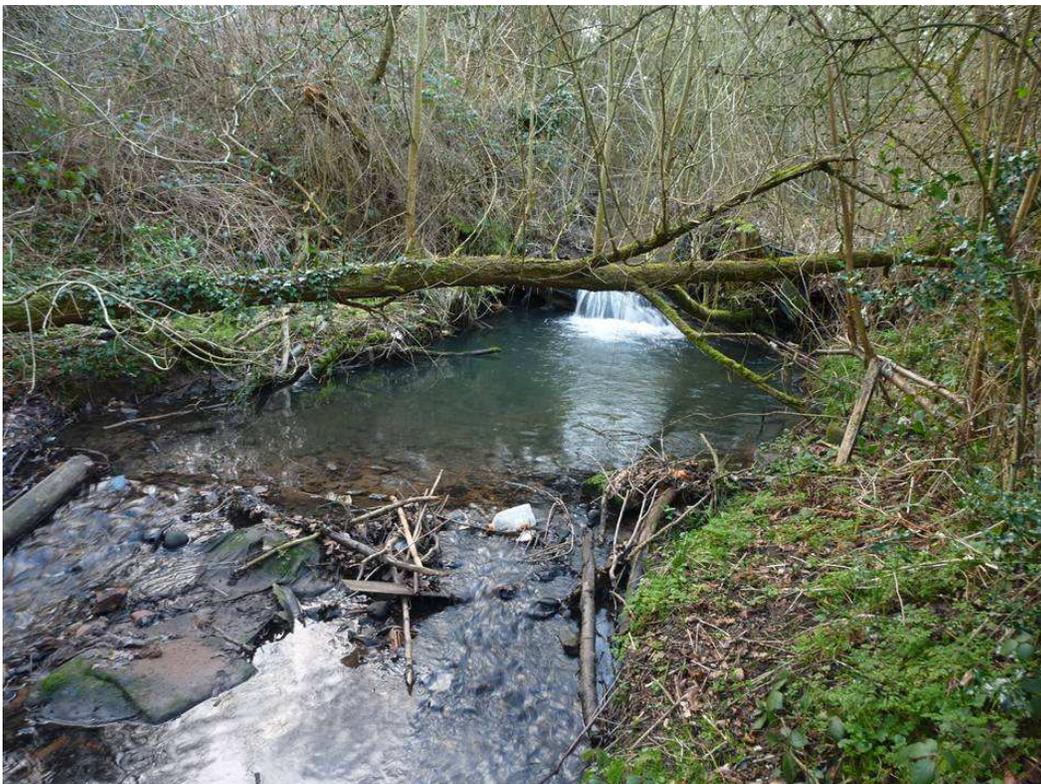
Figure 12: Perfect adult trout pool generated by scour caused by upstream debris dam (white water)

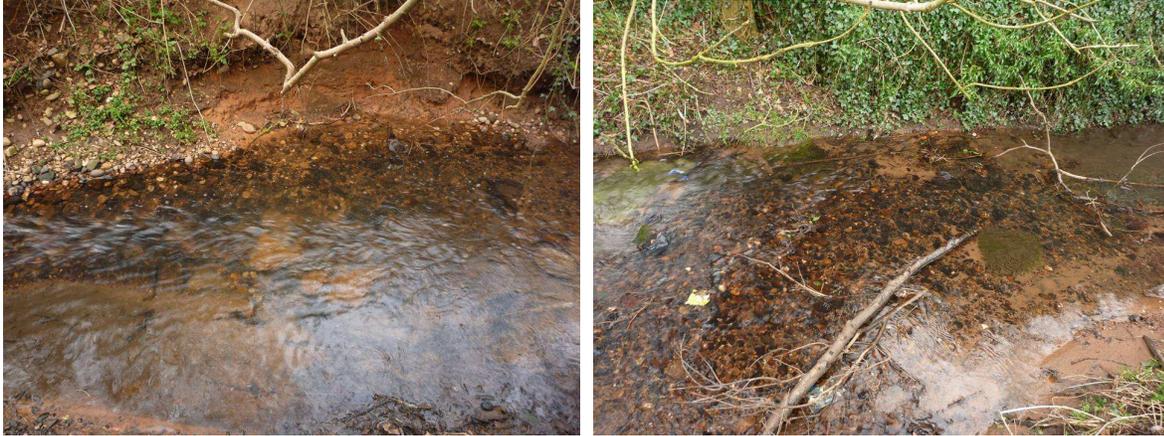
Figure 13: Limited, but not impossible, opportunities for trout spawning exist in the lower inspected reach. These would be greatly improved by provision of cover for adult fish and also promotion of localised bed scour to “grade” gravels and keep them free of fine sediment

localised bed-scour “sorts” or “grades” the gravel into favourable particle sizes for trout spawning – as well as blowing out fine sand and silt from the spaces between gravel particles. This ensures a much greater flow of oxygenated water over the eggs that are deposited within the gravels (and prevents eggs suffocating through lack of oxygen). Figure 14 shows one location that would benefit from the installation of mid-channel scouring structures (such as an upstream V placement of logs).

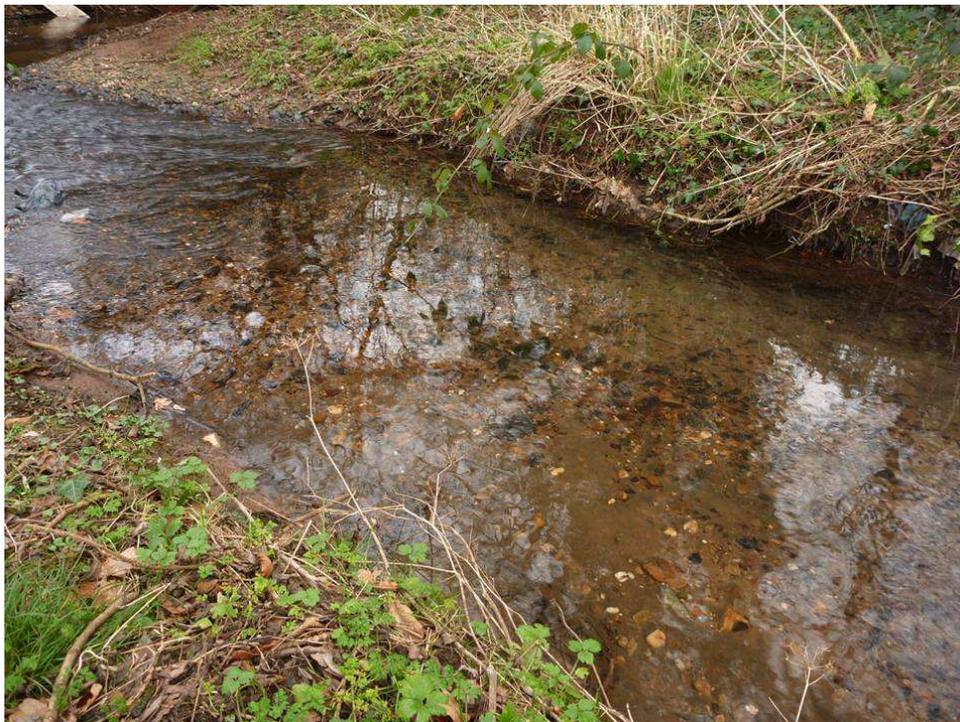
Figure 14: Candidate location for "upstream V" installation to blow out fine sand/silt, generate pool habitat and grade spawning gravels

- An upstream V (e.g. Fig. 18) could be considered at suitable locations within the lower visited reaches downstream of Merritt's Hill to promote pool formation and spawning gravel improvement
