Advisory Visit
Midhope (Pardovan) Burn
26/05/2015

1.0 Introduction

This report is the output of a site visit to the Midhope Burn, West Lothian, undertaken by Jon Grey & Gareth Pedley of the Wild Trout Trust. The visit was requested by Donald Noble of Hopetoun Estates prior to a funding bid for improving habitat for wild fish populations.

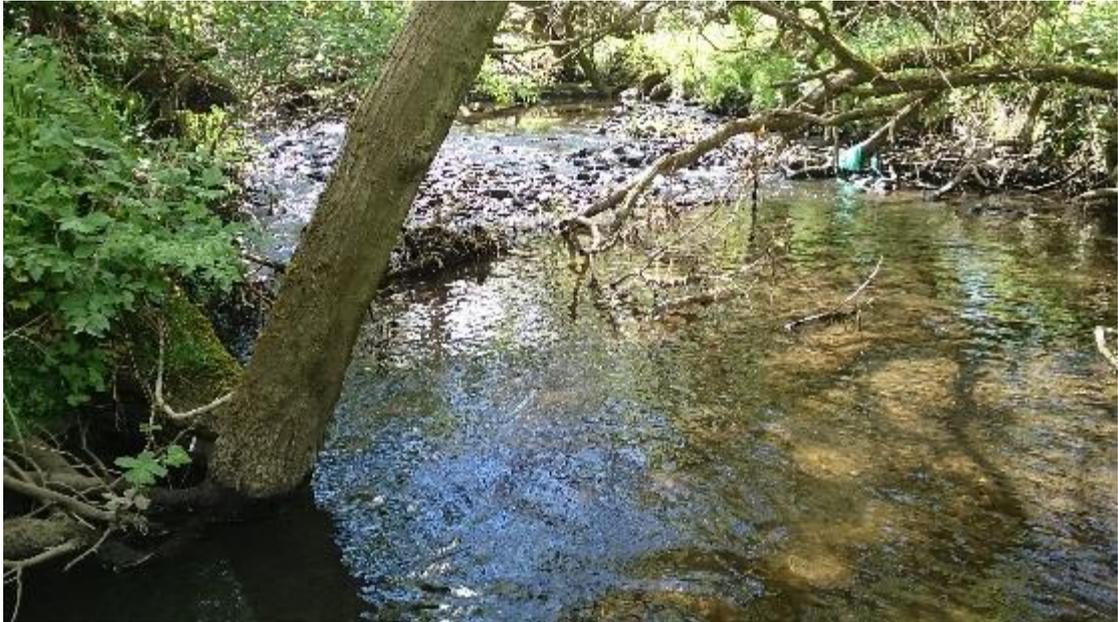
Fig 1. Midhope Burn just above the confluence with Errick Burn. Channel structure (riffles, pools) and cover from Large Woody Debris and riparian vegetation generally good.

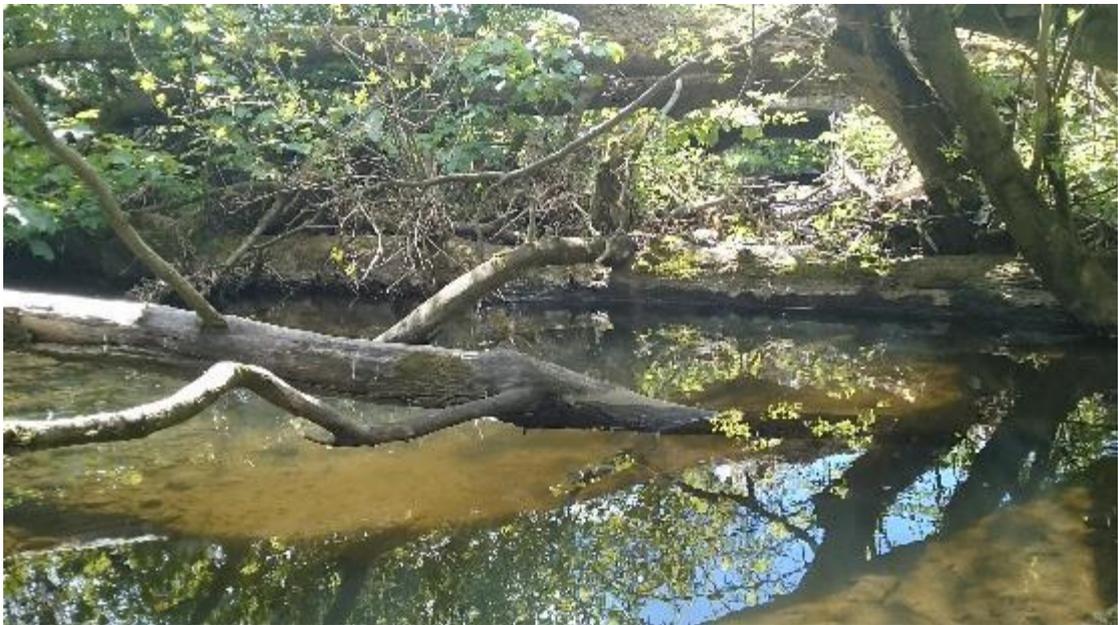
LWD introduces diversity in flow pattern and water depth arising from scour as the water is forced over, under, or around the woody obstruction. It also provides refuge for fish from spate flow and predators, as well as providing invertebrates with food and shelter. Despite the presence of LWD, fine sediments were apparent in all but the fastest flowing riffles (Fig 2).

Fig 2. Despite generally good habitat structure as depicted in Fig 1, fine sediments were obvious throughout, smothering the substrate.

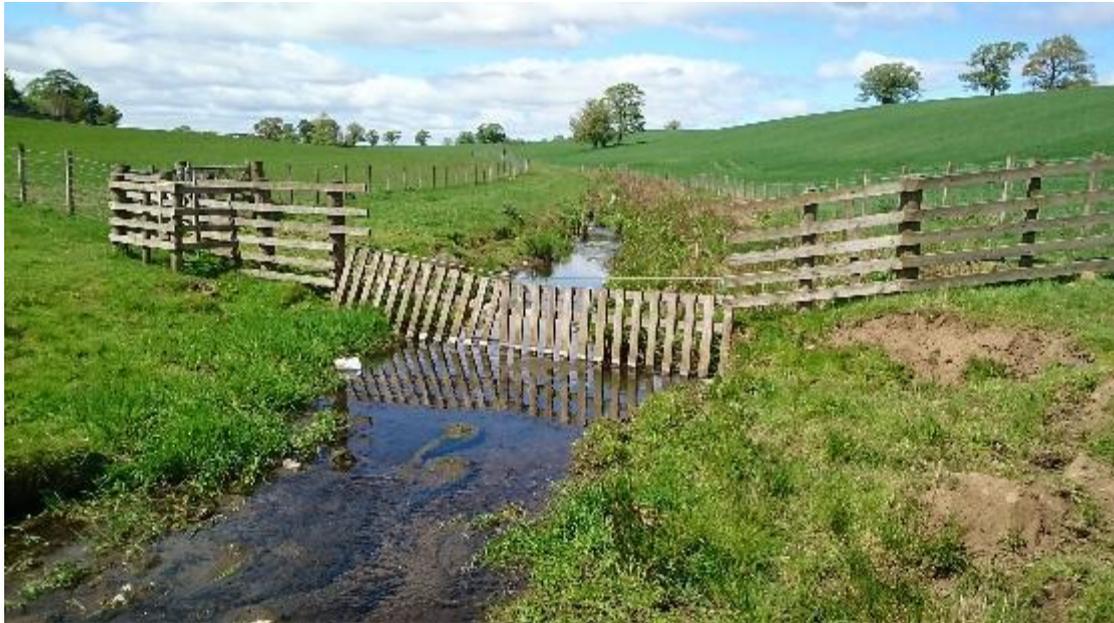
Errick Burn was followed u/s until just beyond the woodland edge. Here, it is bordered by arable fields, and although it has been fenced to enclose a buffer strip of several metres width on both banks, the lack of tree cover and nutrient loading has led to excessive growth of nuisance algae. It is also clearly a considerable

source of fine sediment to the Midhope Burn: u/s of the confluence, almost the entire bed was uniformly smothered in silt (Figs 3 & 4) suggesting possible issues before the fencing was erected and likely issues upstream (possibly field drains, surface runoff and unrestricted grazing).

Fig 3. Errick Burn 100m above the confluence with Midhope Burn. Buffer fencing allows natural vegetation to grow (especially on LB). However, there is no shade and silt and algae choke the channel in the foreground.

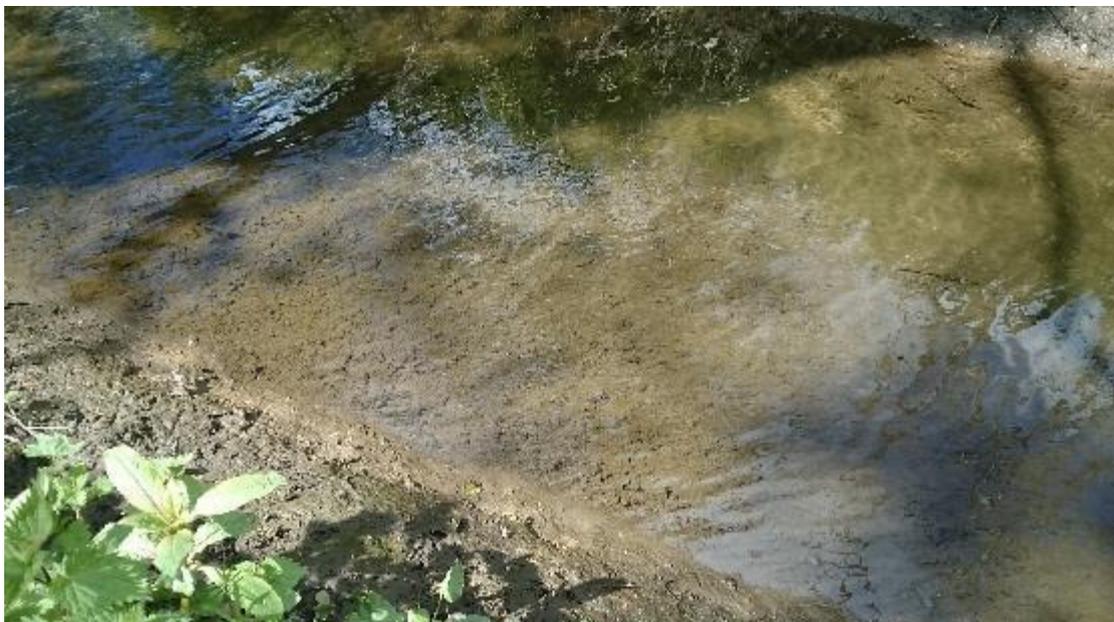
Fig 4. The bed of Errick Burn just above the confluence with Midhope Burn is a uniform layer of fine sediment. Note the Himalayan balsam in the foreground.

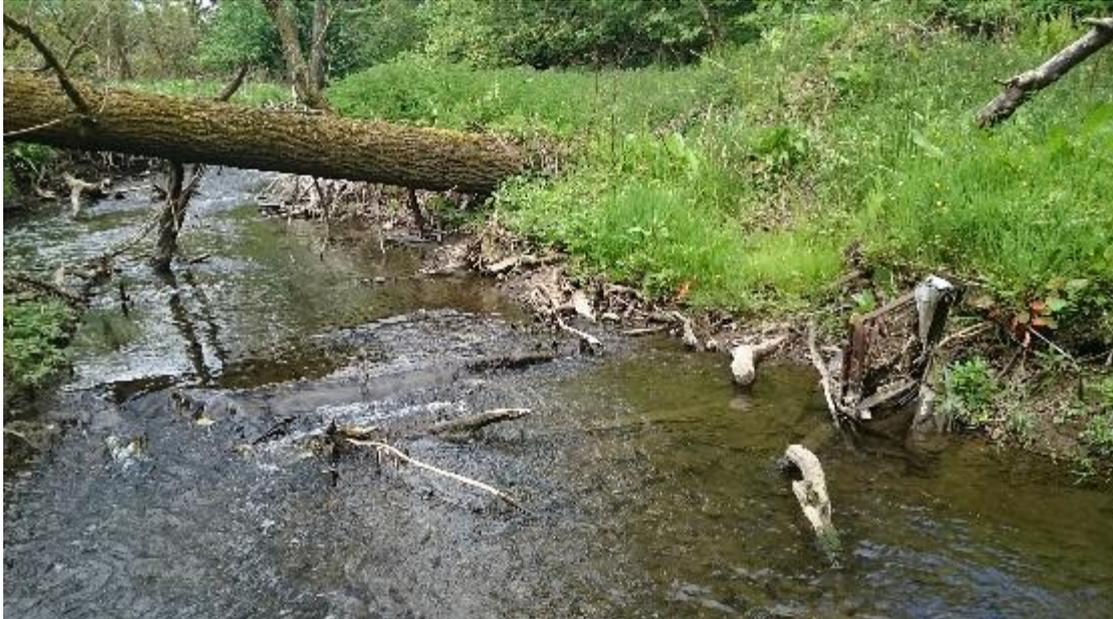
season. The reason for this landform became apparent at Binns Mill (NT0574077911). An historic mill pond has clearly filled in with tonnes of sediment over the years, and Midhope Burn is now cutting down through those sediments (as evidenced by the amount of woody debris laid down perpendicular to the current flow direction; Fig 5).

Fig 5. Midhope Burn, just above Binns Mill, where it appears to be cutting down through sediments deposited in an historic mill pool.

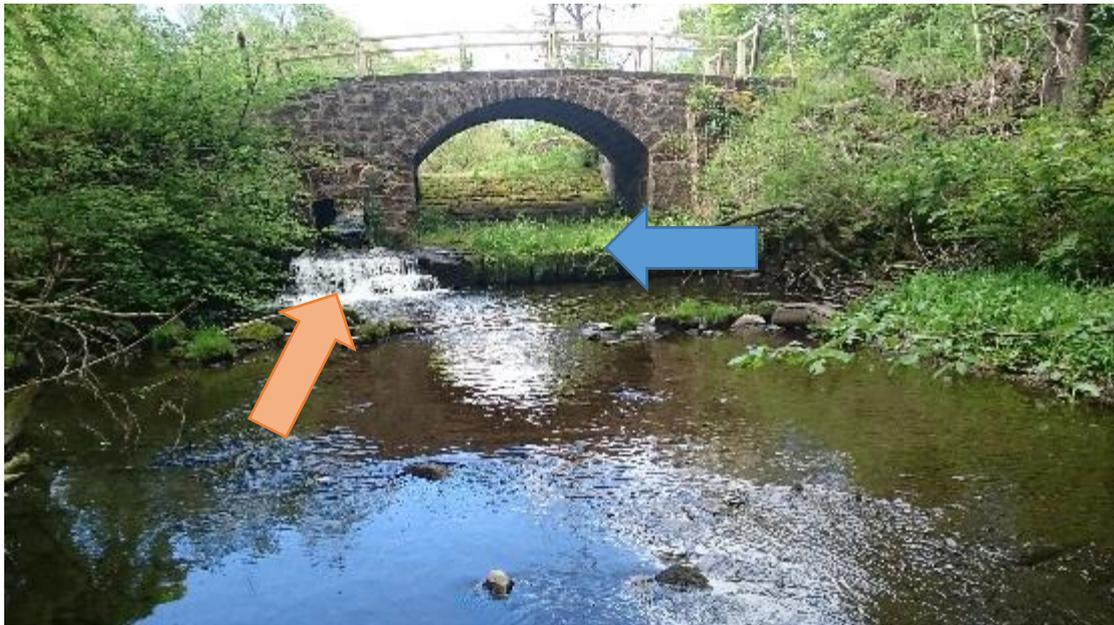
The barrier is a stone wall and bridged weir where, at low flow, the water is funnelled through a narrow sluice, with a board at the u/s end and a sill and two steps at the d/s end (Fig 6). A much wider spillway accommodates higher flows. At any flow regime, either structure is a considerable obstruction to fish passage, exacerbated by scour at the d/s side of the weir that has left it perched above the d/s water level. The bridge structure appears to have been maintained / repaired recently. The pool d/s is wide as a result of erosion, presumably during spate conditions, but allows space for remedial options for fish passage (see Recommendations).

Fig 6. The sluice (orange arrow) and bridged weir (blue arrow highlighting how the d/s side is now perched above the water level) on the site of the former Binns Mill. Both structures present serious challenges to fish passage.

The lowest major obstruction on the Midhope Burn was the sluice and weir combined beneath the old mill pool bridge at Binns Mill (Fig 6). The remaining weir appears to be purely aesthetic and could be partially or fully removed with little obvious consequence apart from redistribution of the accrued sediments in the mill pool to further downstream. It was noted that some renovation of the weir and bridge structure had occurred (possibly by the National Trust?) but the footpath leading over it was clearly not in regular use. The owner should be approached with regard to potential removal of these limiting structures.

Weir removal is likely to be costly (£5k-20k depending on contractor and how the process is managed), but funding *may* be available through the SEPA or the local Rivers Trust to assist, and it should be recognised that the structures are a long term liability that will degrade over time, potentially causing greater issues in the future.

If removal of the weir is not acceptable, work to ease fish passage should be undertaken. Since the mill pool has long since filled with accumulated silt, improvement could be made by removal of the sluice board on the u/s side, which would probably only result in the burn adjusting its bed by cutting slightly deeper into the accrued silt. This would preferably be done in conjunction with the installation of a rock ramp on the d/s side of the weir, to gradually bring the bed up to the level of the weir; however, this option is also likely to be quite costly. Alternatively, the sill on the d/s side should be baffled and the water level immediately below should be raised via a series of resting pools, which could quickly be achieved using some of the large stone already available in the current weir pool. It should be noted, however, that these options can never be as effective and beneficial as full removal.

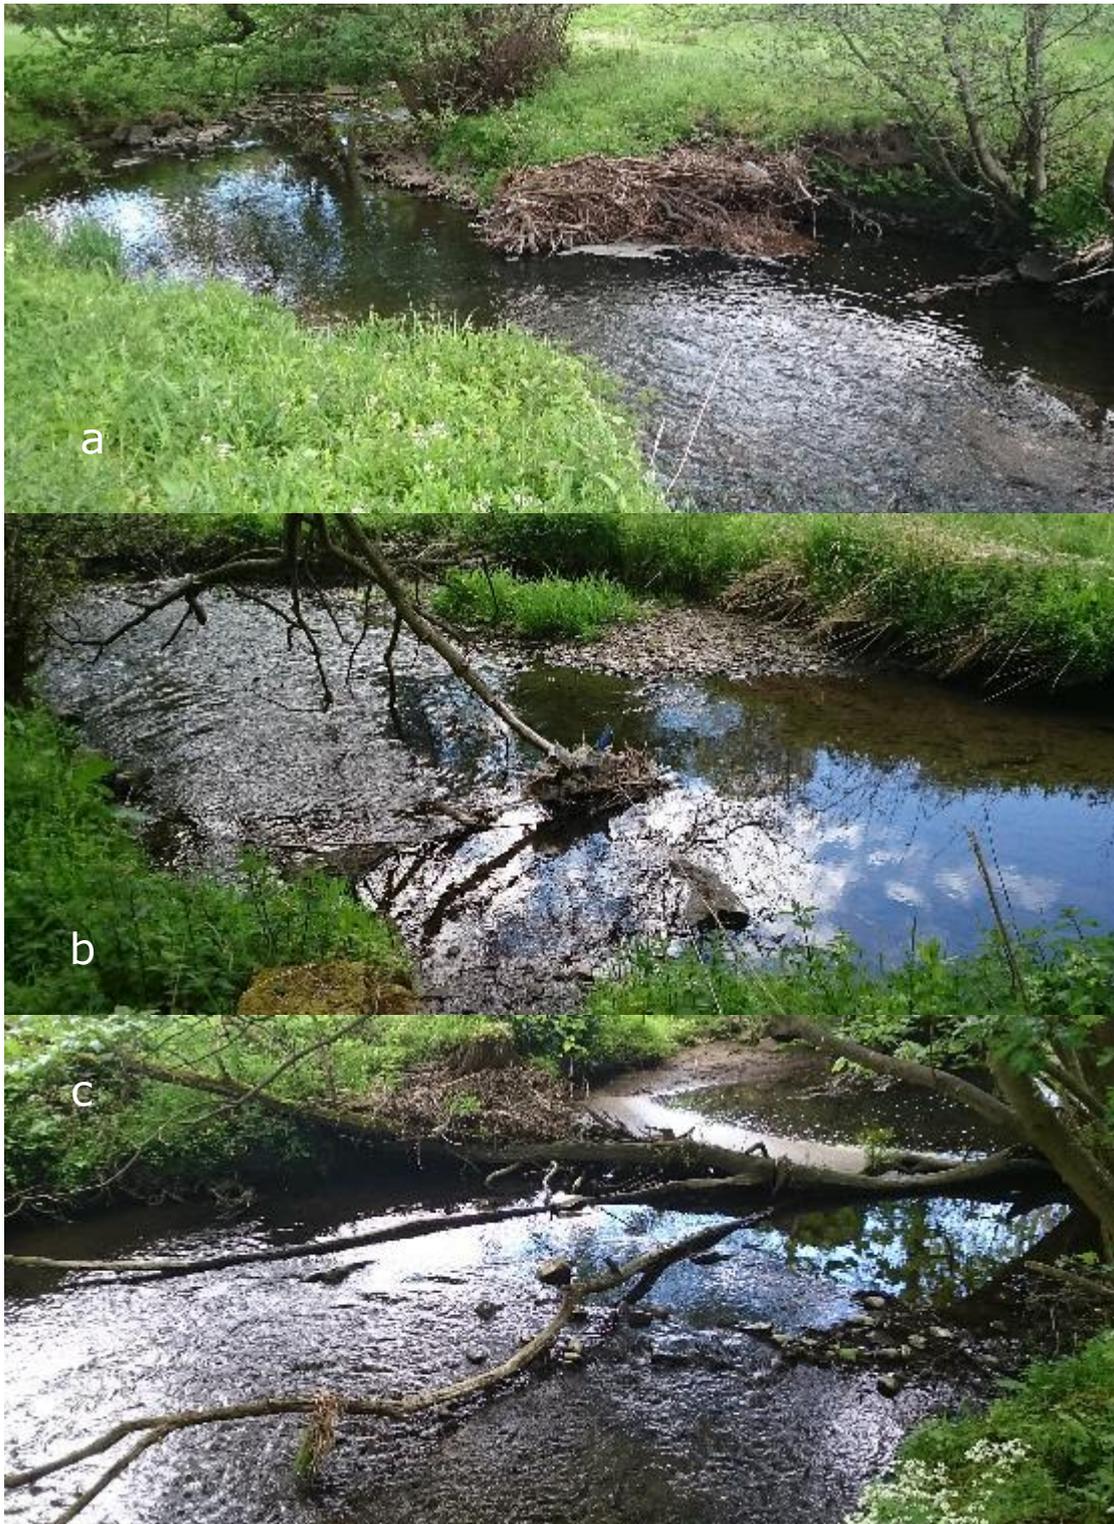
Fig 7a-c. Examples of trapped woody material creating good habitat features: (a) helping to maintain scour and create pool depth; (b) diversifying flow direction and trapping smaller debris material; and (c) creating a temporary log-jam and forming a pool.

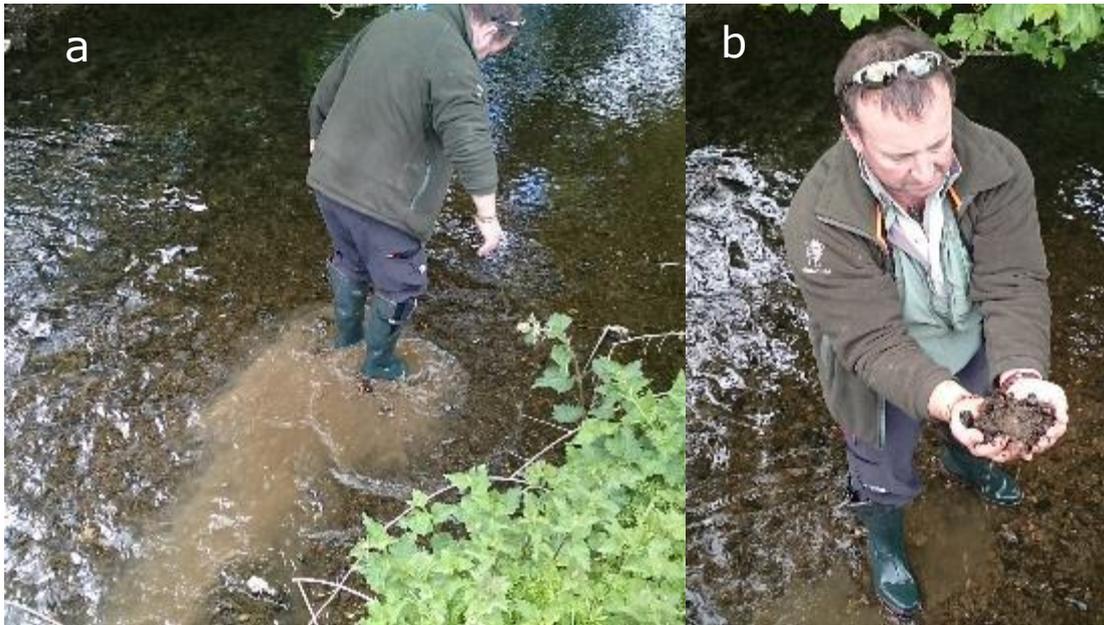
Again, despite all the natural features being in place, the gravels were choked or smothered with fine sediment (silts and sands) suggesting that the supply of these materials from u/s must be considerable and ongoing (Fig 8a,b).

Fig 8a,b. Minor disturbance of gravels revealed the extent of fine silt and sandy sediments.

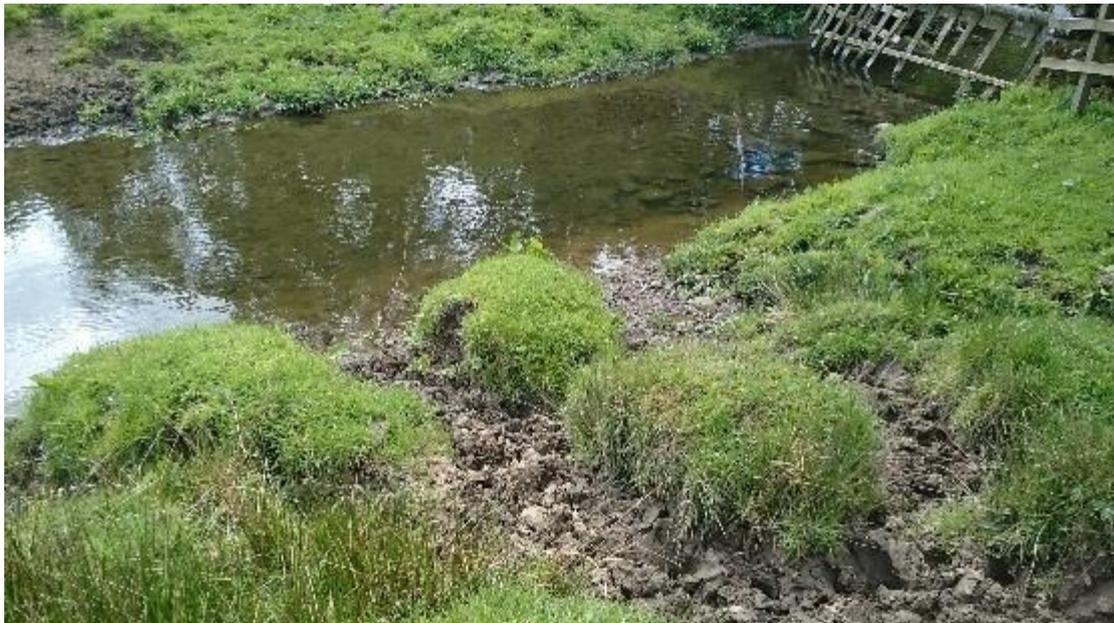
Below the conifer plantation, the valley broadens into what is known as Terrace Rigg. This whole section has been seriously degraded. Across the terrace, the burn has tended to meander naturally and there is clear evidence of oxbows. Livestock, currently cattle, have complete access to the burn throughout the terrace. As a consequence, the banks are in many cases poached where cattle have accessed the burn to drink. This erosion has several consequences. The channel is over-widened, and the additional input of soil is contributing to the sediment problems on the riverbed (Figs 9 & 10). The access points also become focal drains for surface runoff, 'guttering' fine sediment into the burn during heavy rains.

Fig 9. Cattle poaching of the banks at the u/s end of Terrace Rigg.

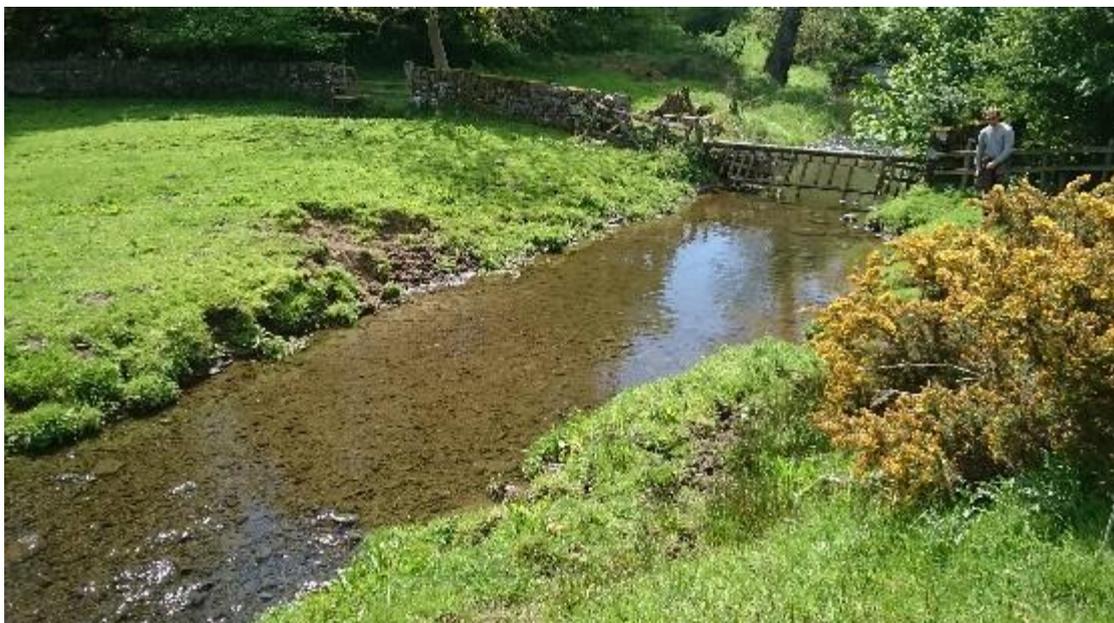
Fig 10. Over-widened, shallow, exposed and highly silted section of Midhope Burn as it enters Terrace Rigg. The erosion on the RB is from cattle poaching, visible in Fig 9.

Over-widening the channel means that it is also shallower, and the energy required to mobilise the extraneous fine sediment is dissipated so that the bed becomes smothered in silt and takes on a uniform character (Fig 11). This reduces the quality of habitat for invertebrates and potential spawning gravels are compromised as the reduced flow fails to actively sort bed materials and keep the spaces between the gravel free from fine sediments.

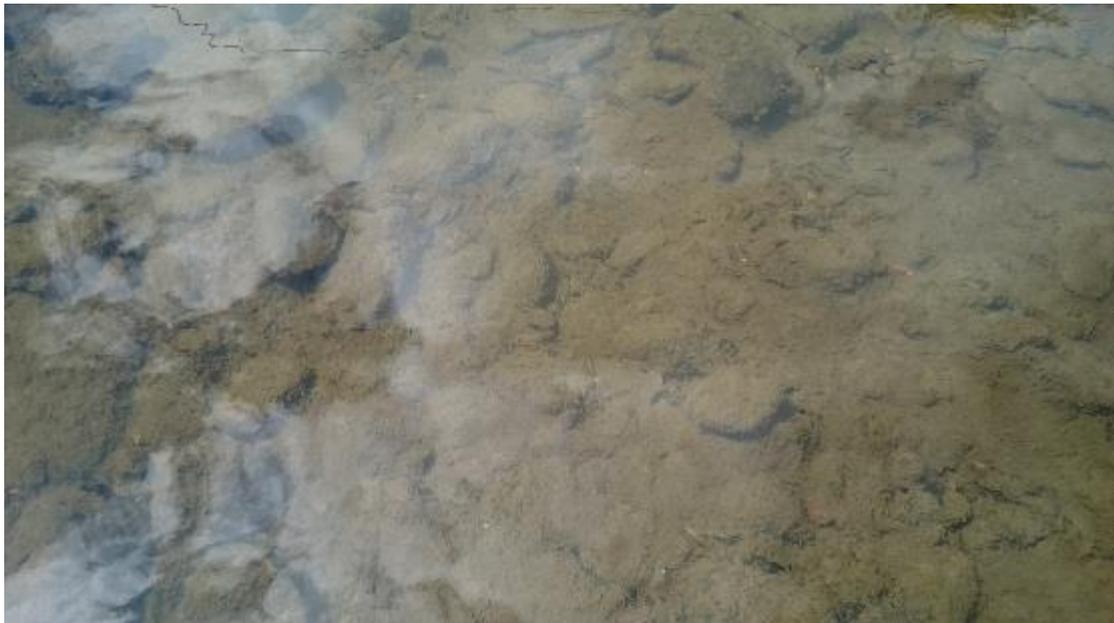
Fig 11. Heavy smothering of fine silt throughout the Terrace Rigg section of Midhope Burn.

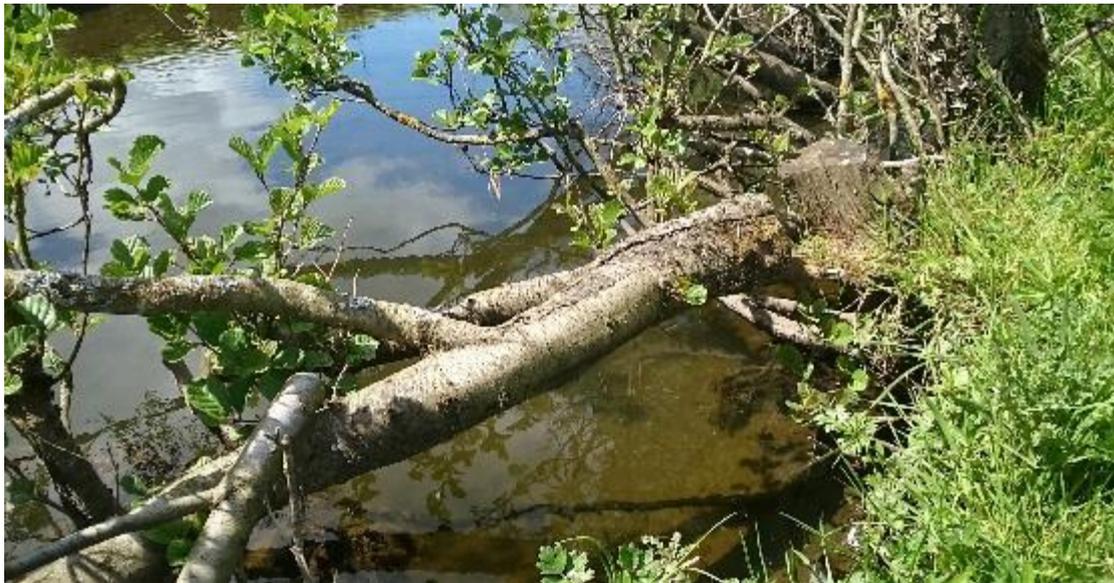
Fig 12. Evidence of previous tree management on Terrace Rigg: hinging of alder and laying the part-cut, living trunk parallel to the water surface and aligned to the flow.

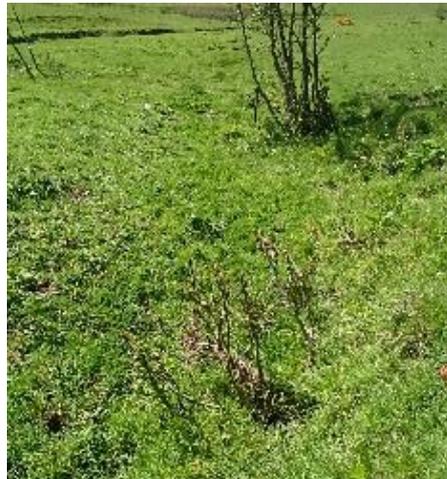
Fig 13. Browsing of self-set trees and inhibition of herbaceous vegetation along an old oxbow on Terrace Rigg demonstrates the capacity of livestock to significantly reduce riparian habitat quality.

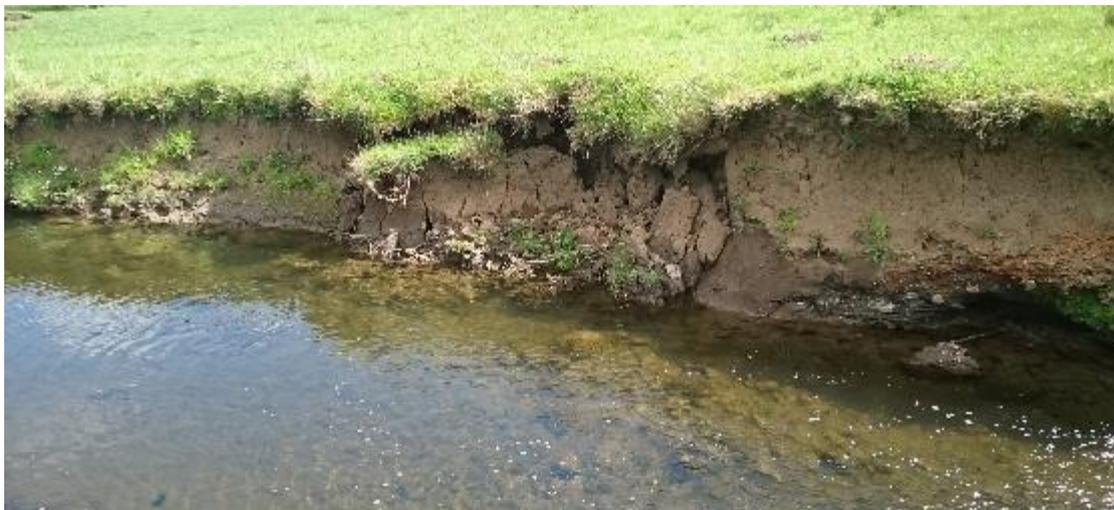
Fig 14. Erosion and block failure caused by livestock grazing and trampling. Heavily grazed grasses divert energy into replacing lost shoots rather than roots so there is less physical structure holding the soil together.

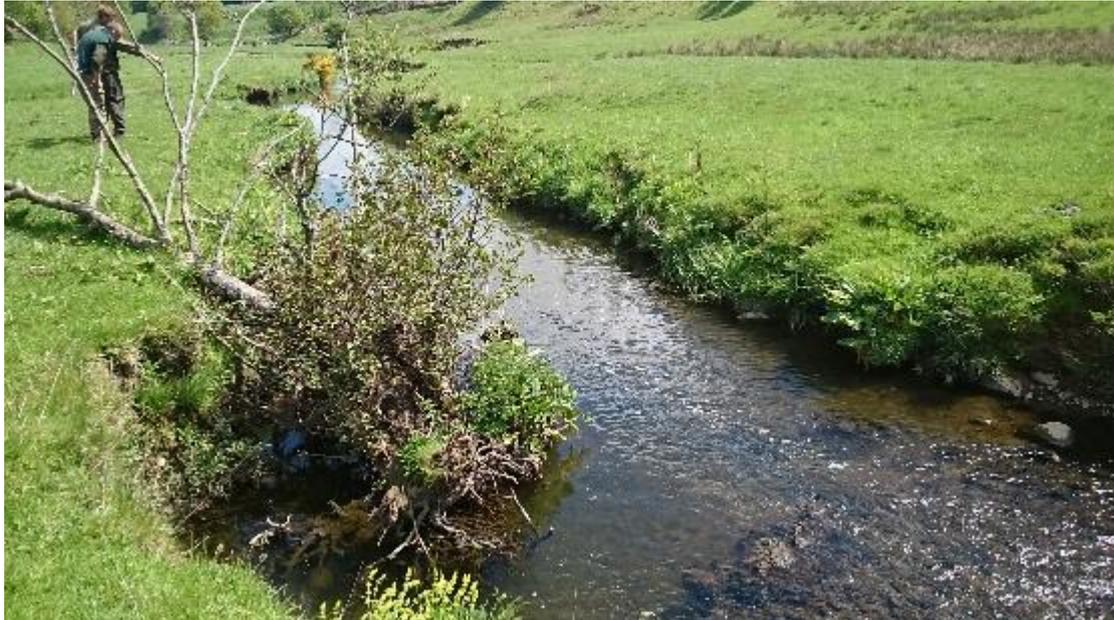
One or two of the few trees are in danger of being lost completely (Fig 15). Their root structure has been undermined by livestock access from the field side. Rather than removing these trees, they should ideally be secured *in situ* to provide the function of LWD.

Fig 15. One of the trees on Terrace Rigg in danger of being lost to a future spate. It is still alive and should be secured *in situ* as it provides valuable cover and flow diversion.

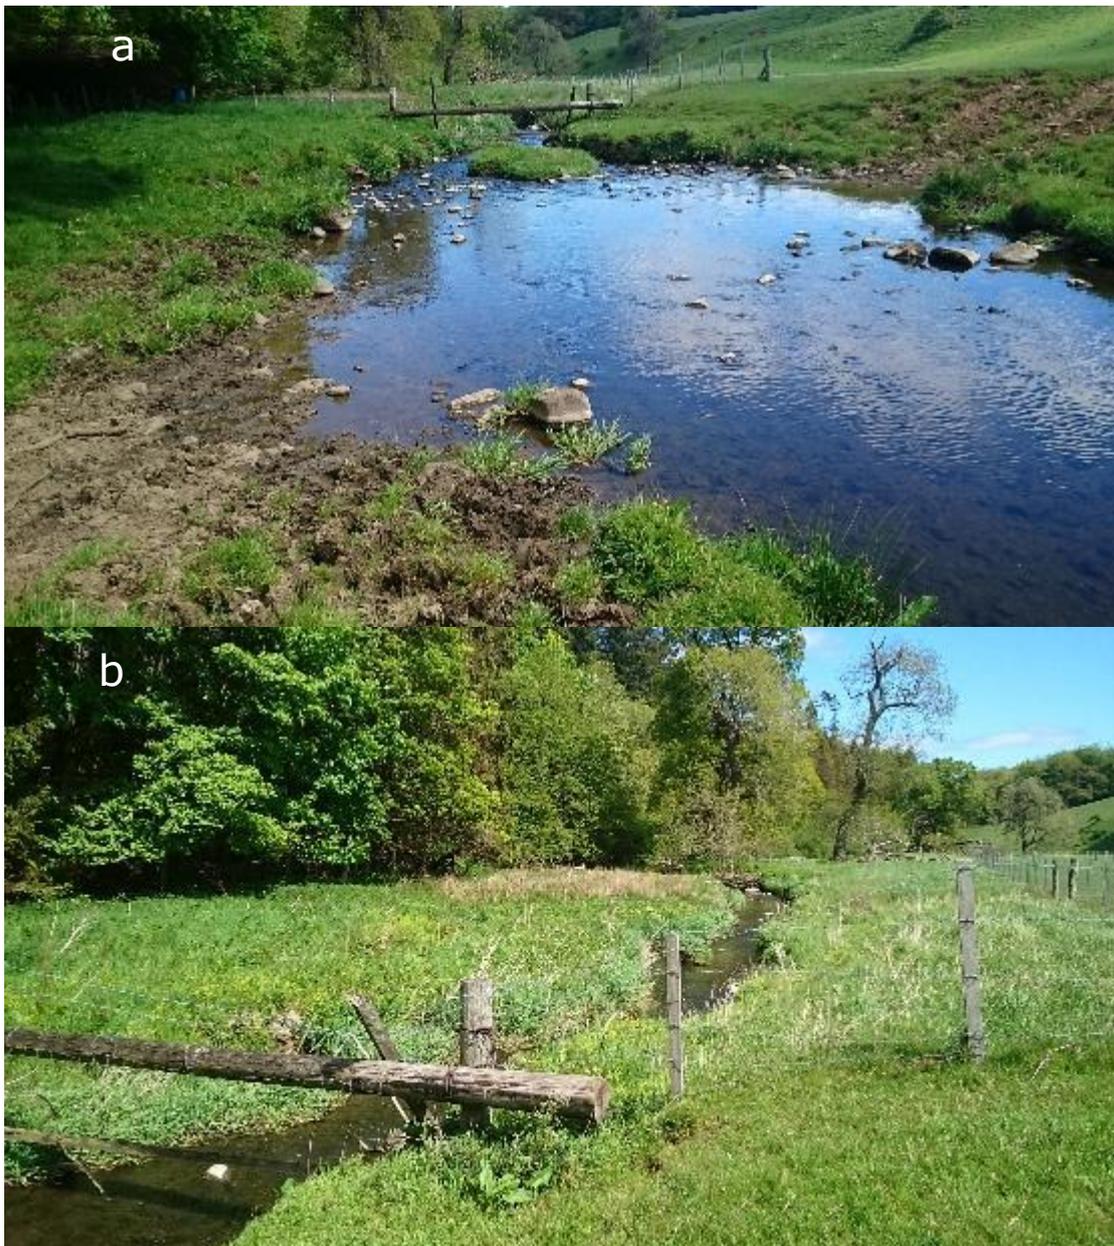
Fig 16. The 'watershed' point at the d/s end of Terrace Rigg: a) looking upstream from the stock exclusion fence the burn is over-wide, shallow, exposed and the riparian vegetation is depauperate; whereas in b) the burn has returned to its natural width and there is plenty of natural vegetation providing cover on the banks.

Fig 16a,b clearly demonstrate the difference livestock access makes to a watercourse. Just u/s of the buffer fencing (while accepting that the channel is stressed by both cattle poaching and its use as a ford for vehicles at this point), the channel is some four to five times the width, and consequently much shallower, than the more natural proportions seen d/s of the fencing. The difference in the diversity and depth of bankside vegetation, and its influence on the margins of the burn, is also readily appreciable in these two images. Several trout were immediately apparent in the first pool within the fenced section d/s of Terrace Rigg.

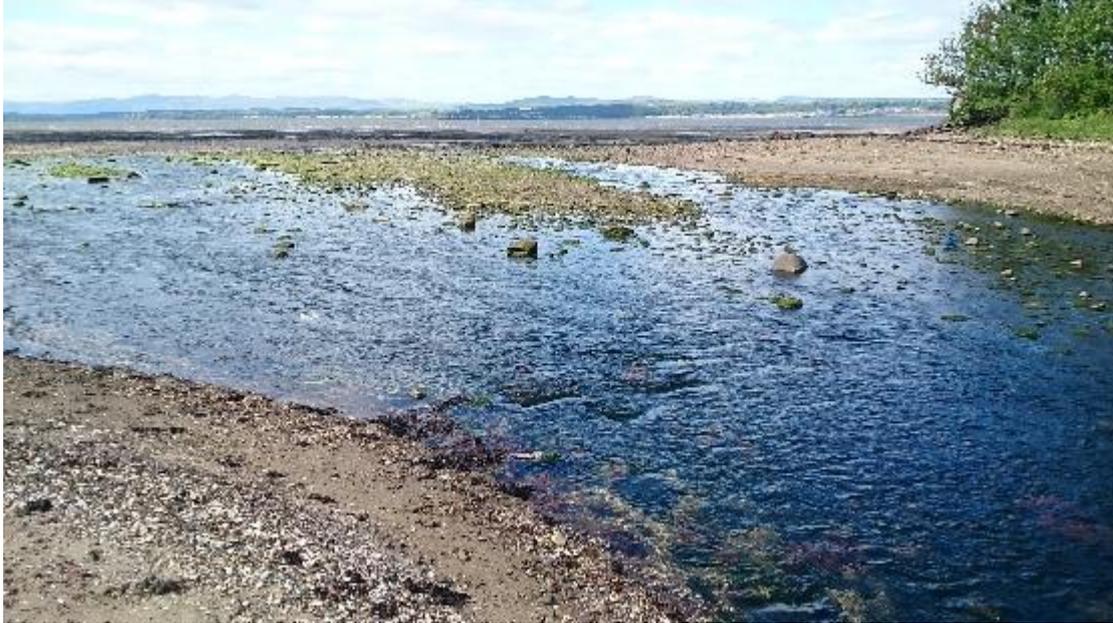
Access to Midhope Burn from the estuary is limited at low water by the local geomorphology i.e. a flat shingle beach over which the burn flows to reach the sea (Fig 21). However, as salmon have been observed in the burn in the past, they can clearly access it at high tide.

Fig 21. The mouth of Midhope Burn below Nethermill Bridge. Access at low water for migratory salmonids is challenging but sufficient water is clearly available at high tide.

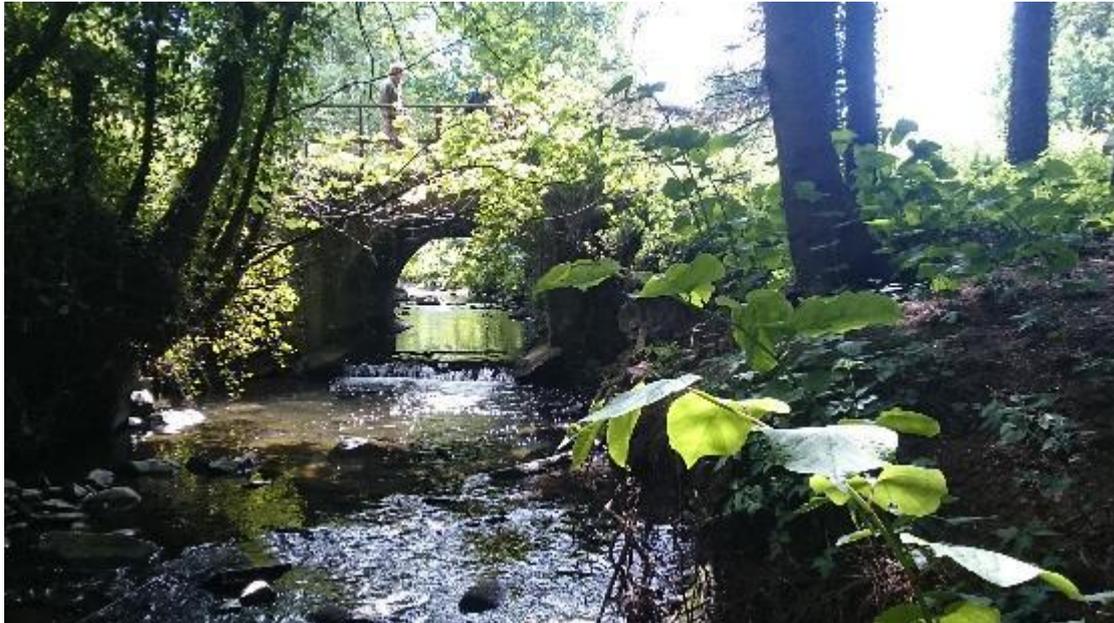
While not a major obstruction, the footings of the track bridge by the saw-mill (NT0741978589; Fig22) will pose an obstruction to fish movement under certain flows, particularly for juveniles. There was also evidence of Japanese knotweed (*Fallopia japonica*) here, particularly on the LB.

Fig 22. The track bridge at the saw-mill could become a bottleneck for juvenile movement under low flows. Note the Japanese knotweed on the true LB (right of shot).

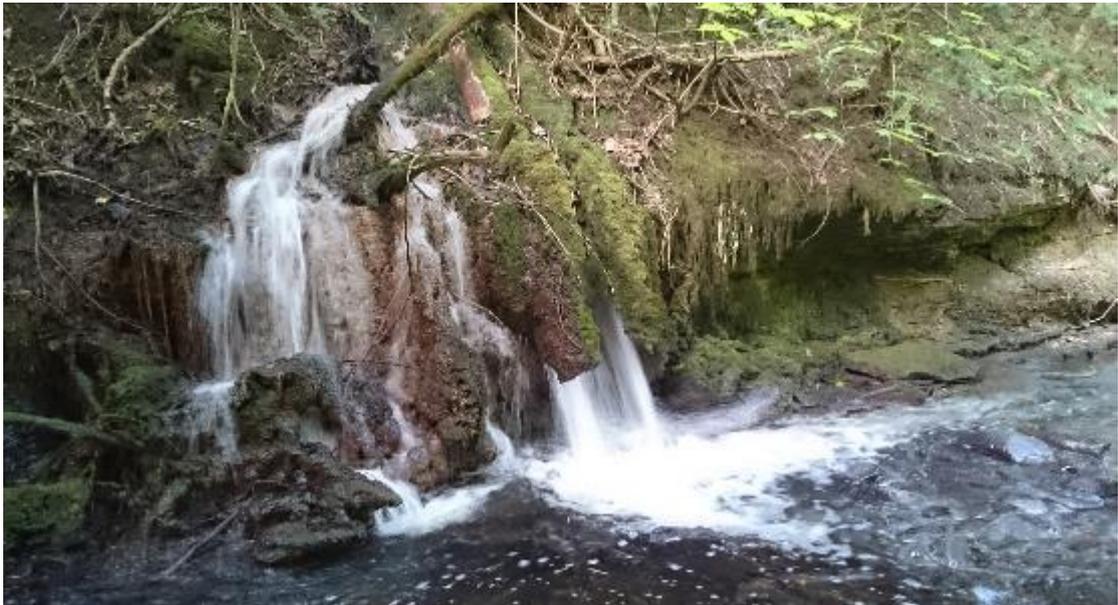
Two major point sources of pollution were noted: two pipes of 30cm diameter on the LB at NT0795279109 (Fig 23), and a smaller pipe on the RB ~30m d/s (Fig 24), discharging effluent. The former were discharging a considerable volume which seemed to be constant for the 5 minute period it was observed. Sewage fungus was evident across the full channel width within 20m of the pipes (Fig 25) and that, combined with the build-up of solids around the pipes (Fig 23), suggest that pollution has been ongoing for a long period.

Fig 23. Two large diameter pipes on the LB discharging effluent at considerable rate.

These should be investigated as a serious and significant pollution issue.

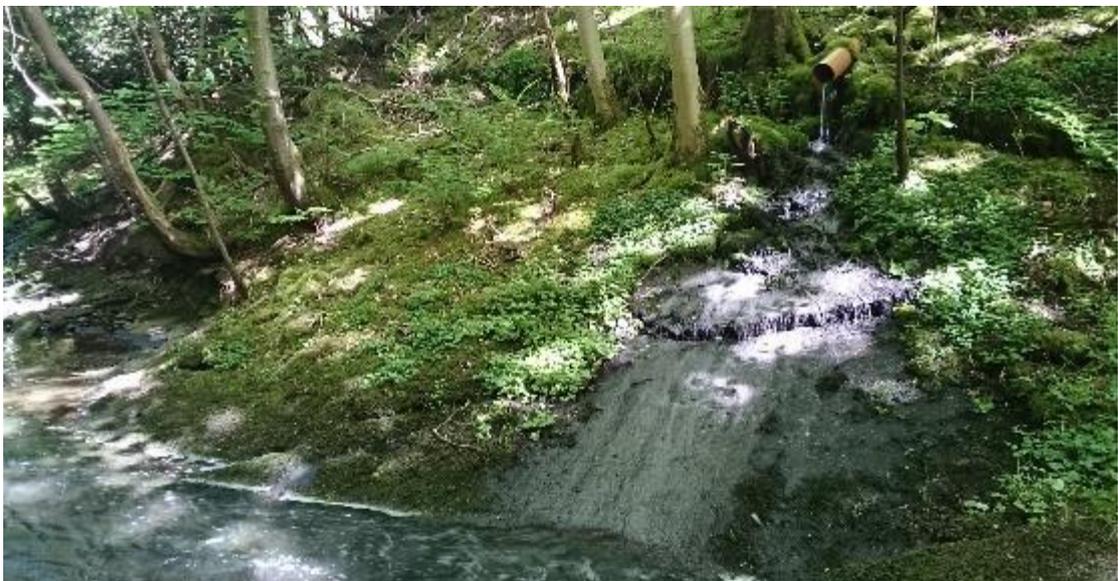
Fig 24. A smaller pipe on the RB also discharging effluent.

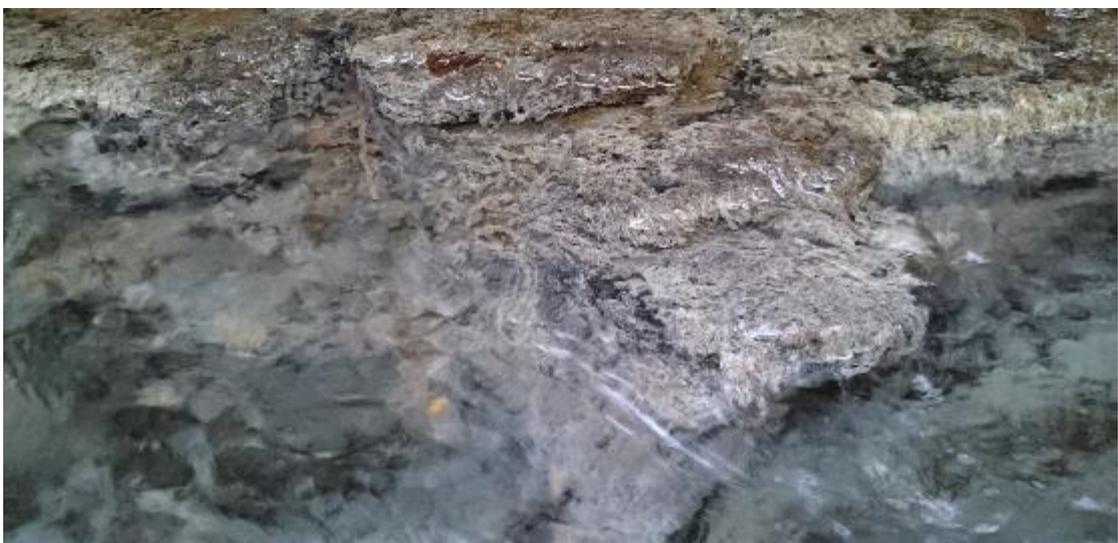
Fig 25. Sewage fungus was evident across the full width of the channel within 20m of the pipes discharging from the LB (Fig 23).

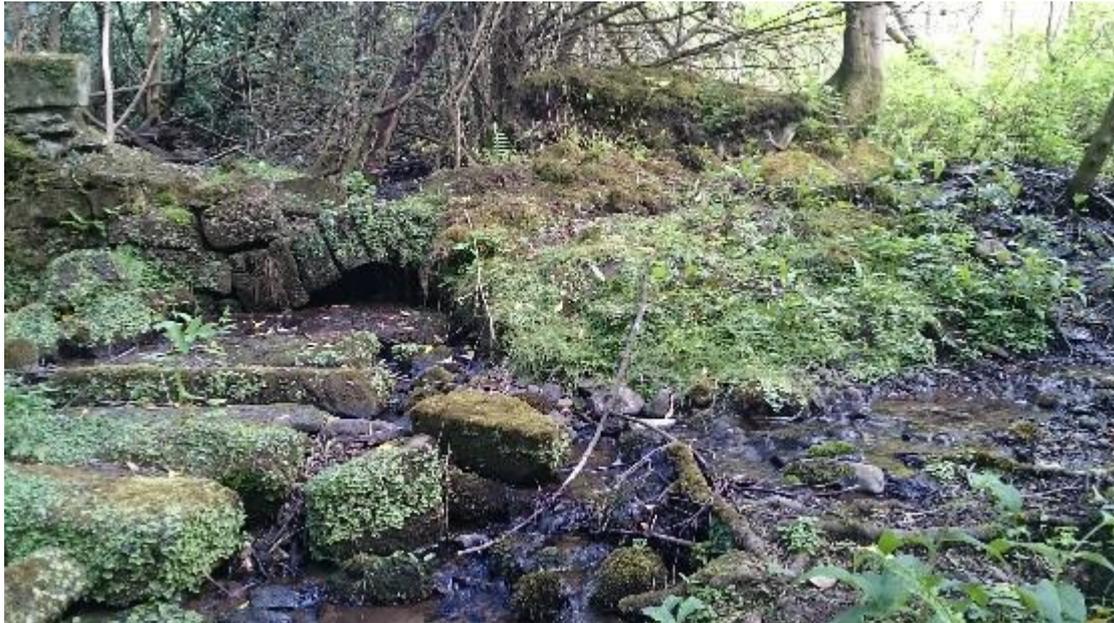
On the RB at NT0804379205, just u/s from Nethermill Bridge, a small tributary enters the burn. It is of a size and gradient, and contains suitable substrate that indicate it might be a useful as a spawning site. However, it is currently inaccessible for two reasons. Its confluence with the Midhope Burn appears to be hampered by a stone building and wall which are now dilapidated. Stone from these structures looks like it is blocking the original channel and the flow has become diverted and braided to such an extent that it is rarely more than a few centimetres deep (Fig 26).

Fig 26. A potential spawning tributary, the mouth of which has been obstructed and braided by stone from a dilapidated building.

Redefining the mouth of the potential spawning tributary just u/s of Nethermill Bridge on the RB (Fig 26) would be beneficial for resident and migratory spawners alike. The majority of the lower section of Midhope Burn is constrained within a steep valley and does not typically retain much gravel of a suitable size (10-40mm) for resident brown trout, whereas the small tributaries do. Hence, rehabilitation of this small tributary at the lower end of the system means residents need not travel so far upstream to locate suitable spawning habitat. To initiate this, the original channel should be located and any stone obstructions from the dilapidated building

removed. Channel modifications to accommodate the footpath alongside the main burn should also be checked so that the confluence is unobstructed. To make this work worthwhile, the issue of fish passage at the culvert under the footpath (already mentioned above) needs addressing too.

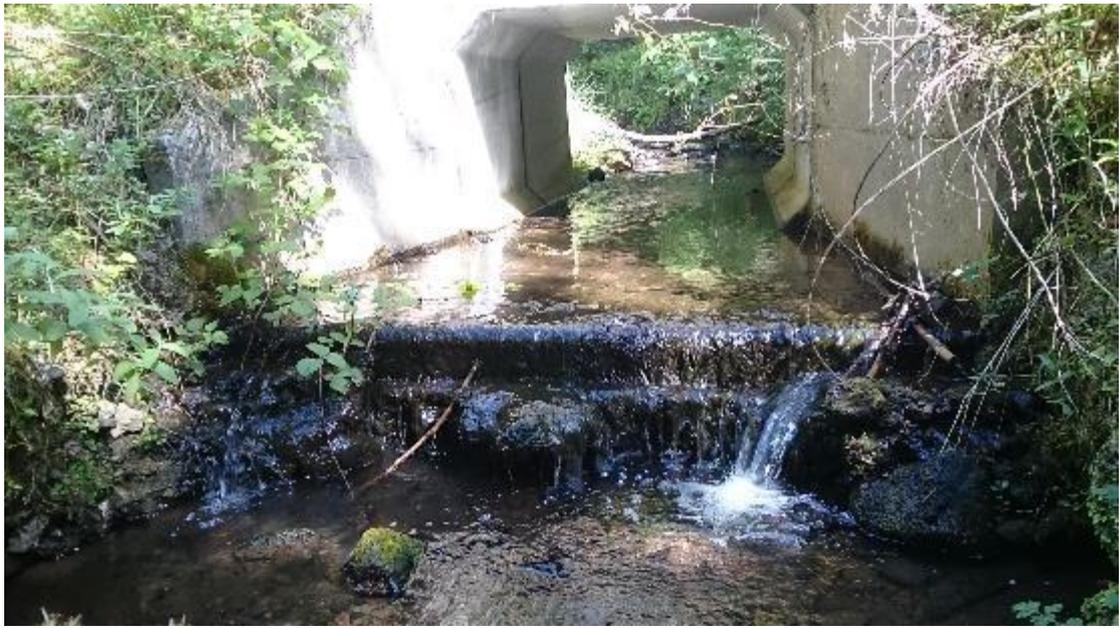
The tributary was traced on the u/s side of the building for a distance of ~40m where the second obstruction was found; a culvert under a footpath (Fig 27). The step on the d/s side was not large but the depth of water maintained within the culvert would have been impassable by all but the smallest of fish (which would be unlikely to overcome the step in the first place).

Fig 27. The culvert running under a foot path on the potential spawning tributary close to the mouth of Midhope Burn.

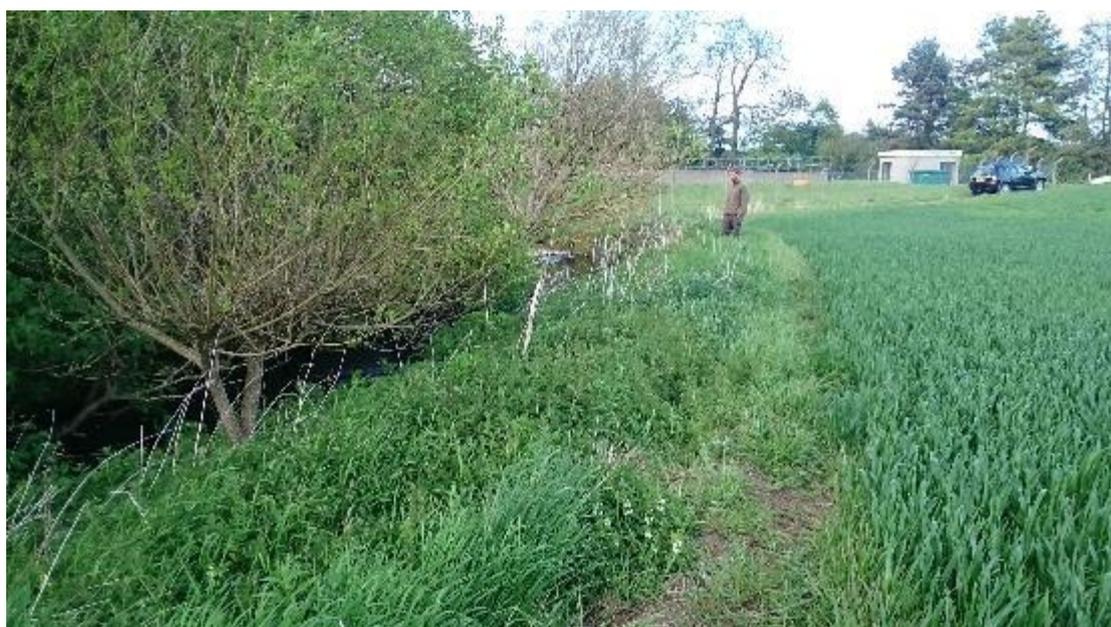
Fig 28. Arable fields border the Midhope Burn u/s of Philpstoun STW (in the background). There is a buffer strip, and the burn is well fringed by willow, but the low point of the field (behind the figure) should be checked for overland flow run-off.

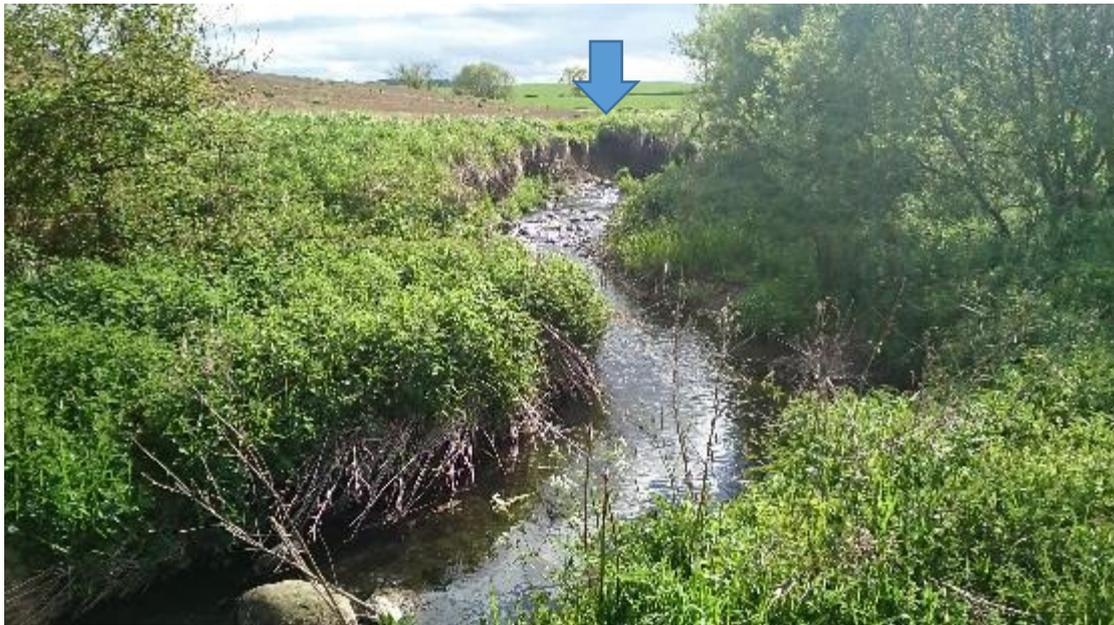
Immediately u/s of the aquaduct, there were ploughed fields on both banks, and while a narrow buffer strip was in place (Fig 30), it had clearly been breached in at least one location, apparently intentionally to remove standing water accumulating in the field at the lowest point (Fig 31). Fine silt was immediately apparent d/s of the breach and throughout this section of the burn.

The natural vegetation within the buffer strip provides bank stability but only where the strip is of adequate width (>2m). Bank failure was evident where the strip was observed to be narrowest (~1m). This was on the outside of a bend and so it is feasible that the river had eroded and hence reduced the width of the buffer strip at that point. However, it would appear prudent to adjust the ploughing of that particular field edge, and hence reinstate a wider buffer strip, as the weight of machinery might soon cause catastrophic bank failure, and / or the slope of the field at that point will soon lead to runoff breaching the buffer (see arrow in Fig 30).

Fig 30. The Midhope Burn winding between arable fields south of Philpstoun. While a buffer strip and reasonable riparian vegetation was evident, in several places it had been breached (see Fig 31) or the strip had been compromised (blue arrow).
