Advisory Visit
Midhope (Pardovan) Burn
26/05/2015

1.0 Introduction

This report is the output of a site visit to the Midhope Burn, West Lothian, undertaken by Jon Grey & Gareth Pedley of the Wild Trout Trust. The visit was requested by Donald Noble of Hopetoun Estates prior to a funding bid for improving habitat for wild fish populations.

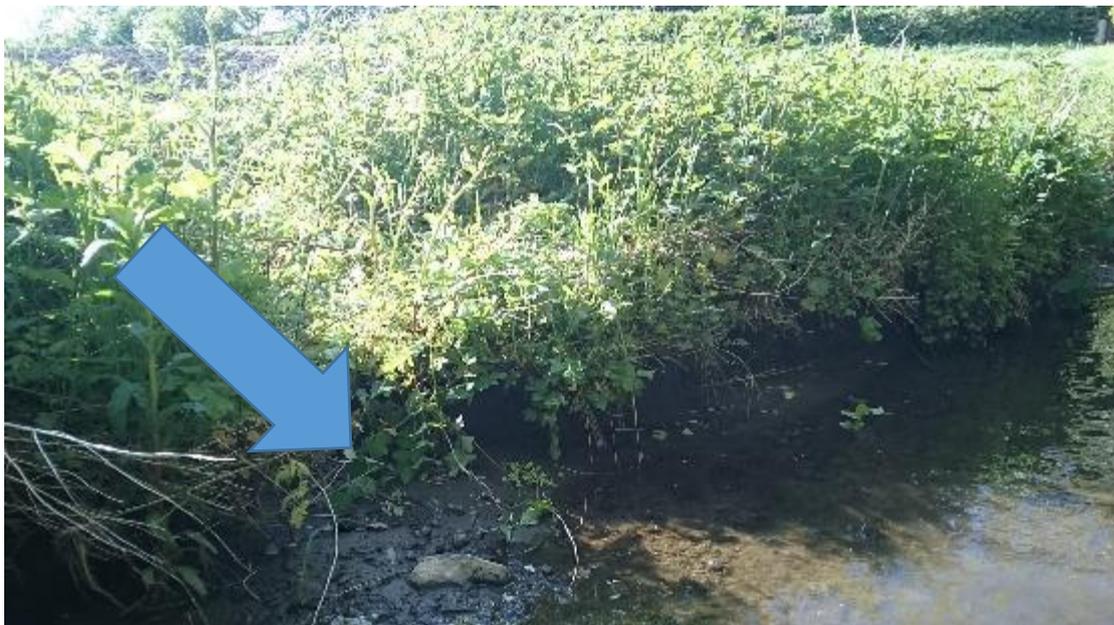
Fig 31. An erosional channel (above the blue arrow) leading from ploughed fields directly across the buffer strip into the Midhope Burn. Silt depositions (at the point of the arrow) indicate overland flow is a source of agricultural fine sediment and nutrients to the burn.

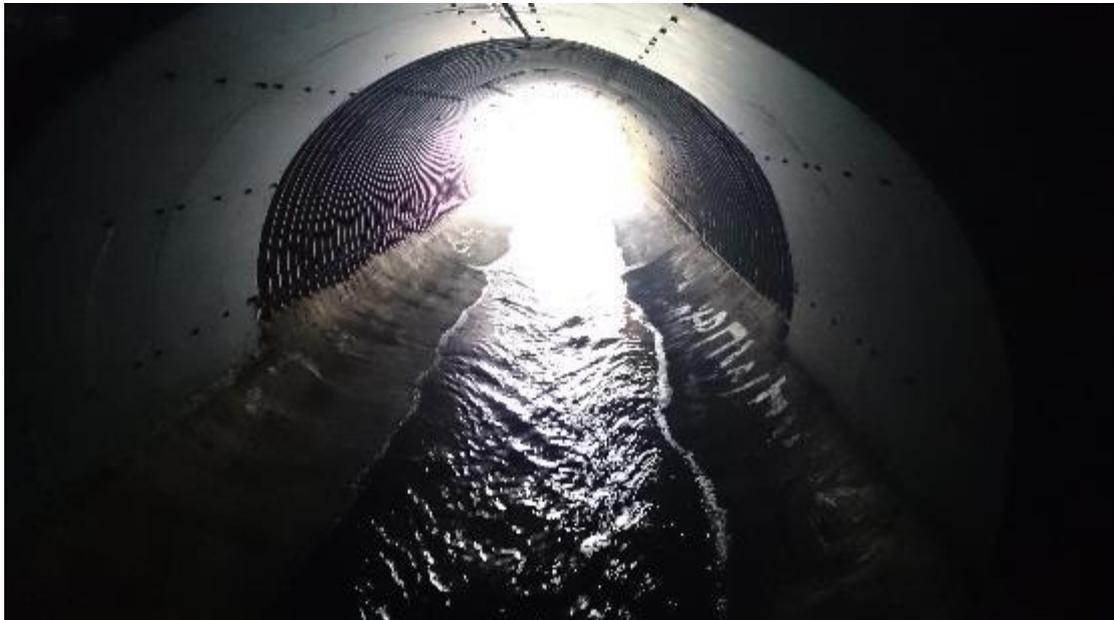
At NT0438576105, d/s of the B9080 (Bridgend), the burn was again well protected with a wooded riparian strip on the LB and an adequate herbaceous buffer strip provided by stock fencing to exclude sheep grazing on the RB. The piped culvert under the B9080 at this point is long and shallow and a significant obstruction to fish passage (Fig 32). It has not been installed in an environmentally sensitive manner; the groundworks should be over-capacity to allow installation with at least 1/3 of the pipe below the bed level, to reduce unwanted bed scour at the mouth (which can leave the pipes perched), and to allow formation of a more natural bed within the culvert.

Fig 32. The piped culvert under the B9080 at Bridgend contains insufficient depth of water for fish passage at base-flow.

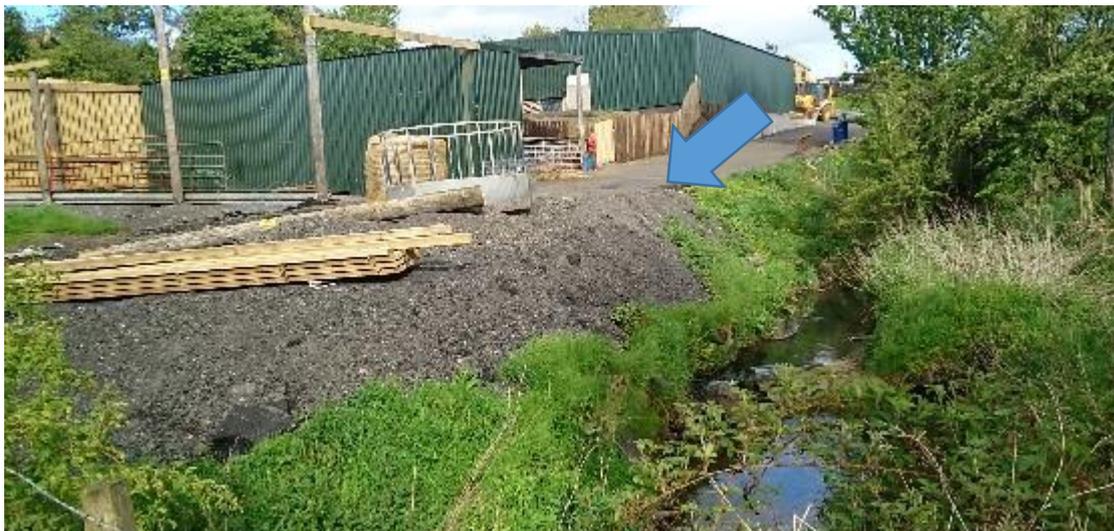
On the RB at Bridgend (NT0420075961), there was recent evidence of dumping of material (soil, tarmac, concrete) to 'create' land, which is sloughing into the burn (Fig 33). In addition to the impact of the material, it may also be leaching hydrocarbons and other noxious compounds into the watercourse. This is probably in breach of SEPA regulations and should be brought to their attention. That material also appears to be the source of the Himalayan balsam that was observed throughout the d/s section, as none was found u/s.

The same property should be checked for adequate drainage from all the farm outbuildings that looked like they held livestock. The slope of the land would lead any waste from those buildings directly into the burn over the unconsolidated material mentioned above (see Fig 33).

Fig 33. Unconsolidated material (tarmac, concrete etc) sloughing into the Midhope Burn from a property in Bridgend. There is apparently nothing to stop waste from the outbuildings being washed directly into the burn (see arrow).

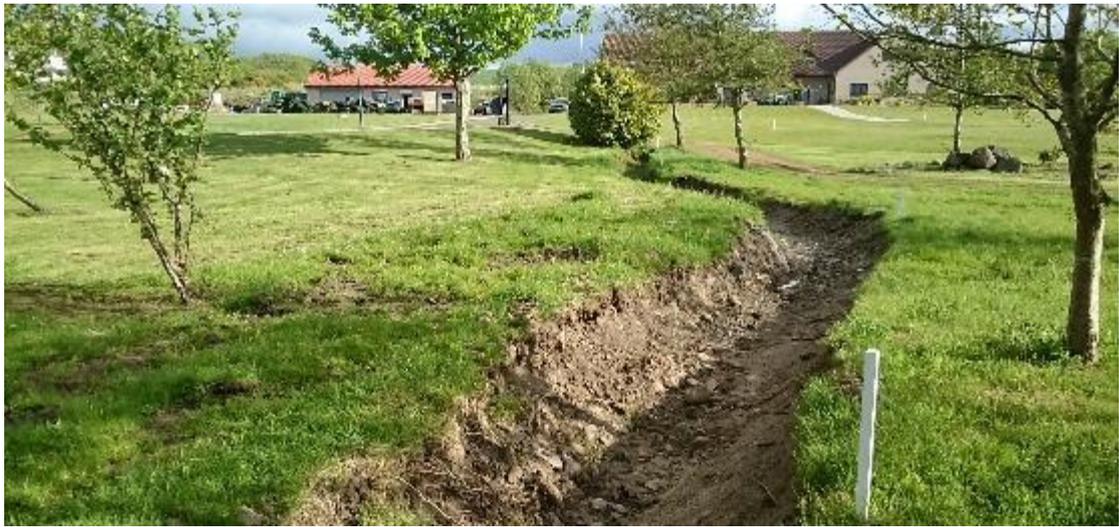
The most u/s point visited was Bridgend Golf Club, which is very likely to have been an historic source of sediment to the burn during construction, and its current drainage system should be inspected. The newly dug channel in Fig 34 is a significant erosion risk and further sediment source. The burn was sluggish at this point and provided little habitat of a suitable quality for salmonids.

Fig 34. A potential sediment source to the Midhope Burn from drains at Bridgend Golf Club, the most upstream site visited.
