**River Mimram, Tewin, near Welwyn Garden City,  
Hertfordshire**

**An Advisory Visit by the Wild Trout Trust October 2015**

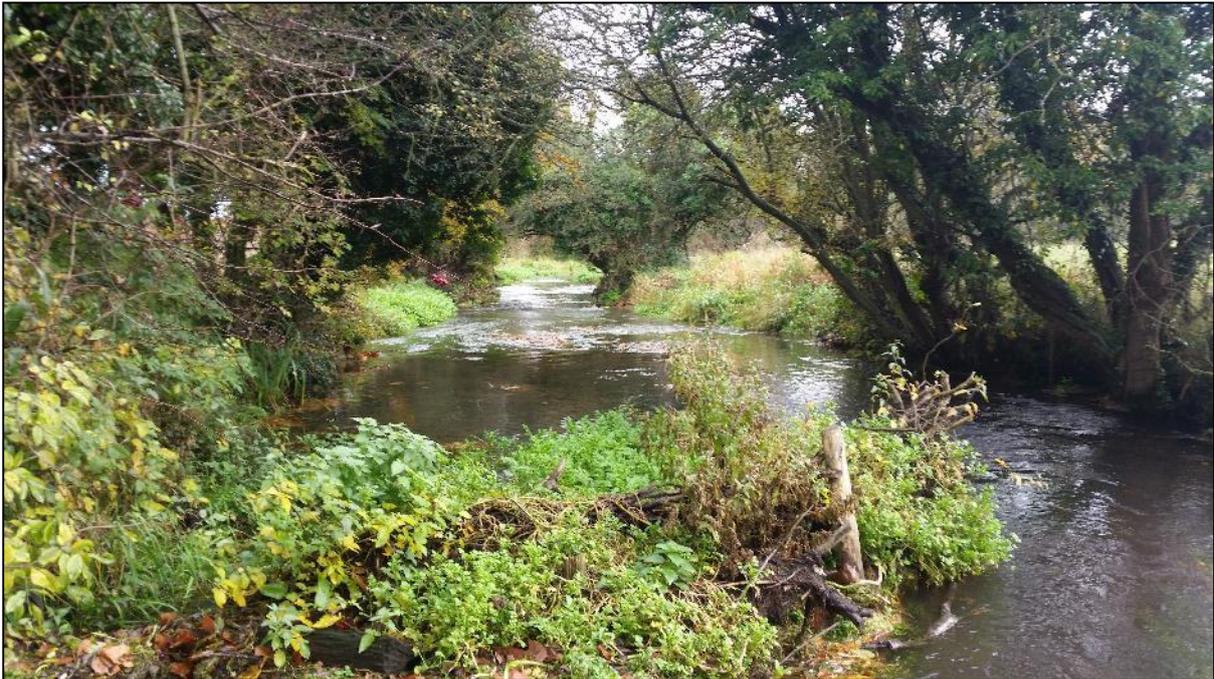
Figure 2: A hawthorn limb secured to the bed provides excellent cover and deflects flow

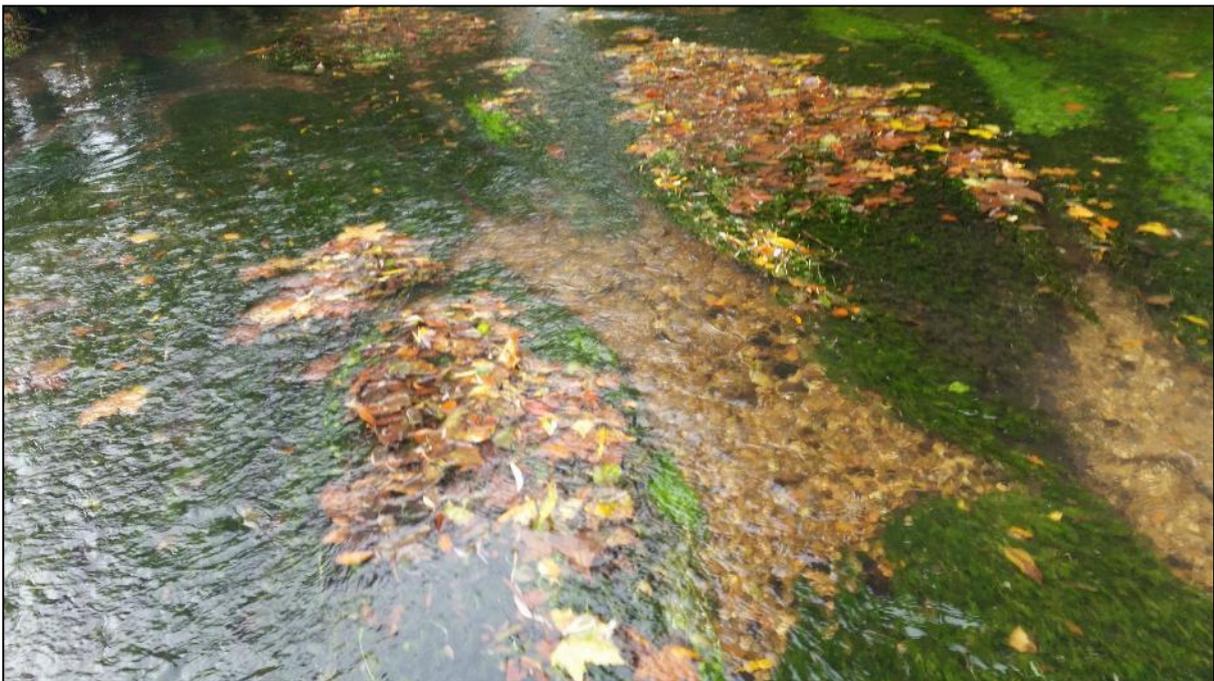
Figure 3: Gravel scoured out from the pool is well-sorted and relatively free from fine sediment

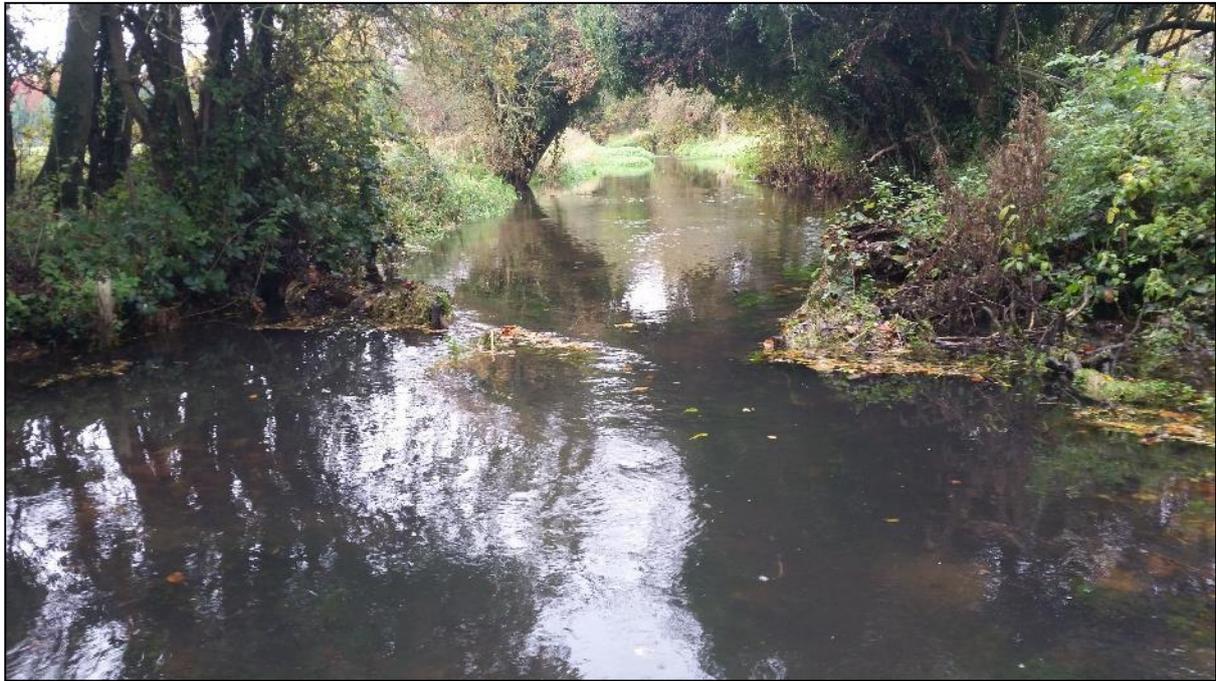
Apart from the hawthorn limb and a pinch-point created by a pair of flow deflectors constructed from wooden planks and stakes (Figure 4), the channel is overly uniform in width throughout the upper reach. The pinch point could be improved by replacing the planks with logs (sourced from nearby trees) set well below water level towards the centre of the channel, sloping up to above water level at the banks. In addition to the accelerated flow through the pinch point, this technique ensures a portion of the flow is forced over the submerged logs in all flow conditions, maximising the scouring effect. The introduction of untreated dead wood would also make the pinch a valuable habitat feature in itself, providing food

Figure 4: Opposing flow deflectors create a pinch in the channel.

and habitat for freshwater invertebrates, whilst retaining the beneficial flow deflection produced by the present arrangement.

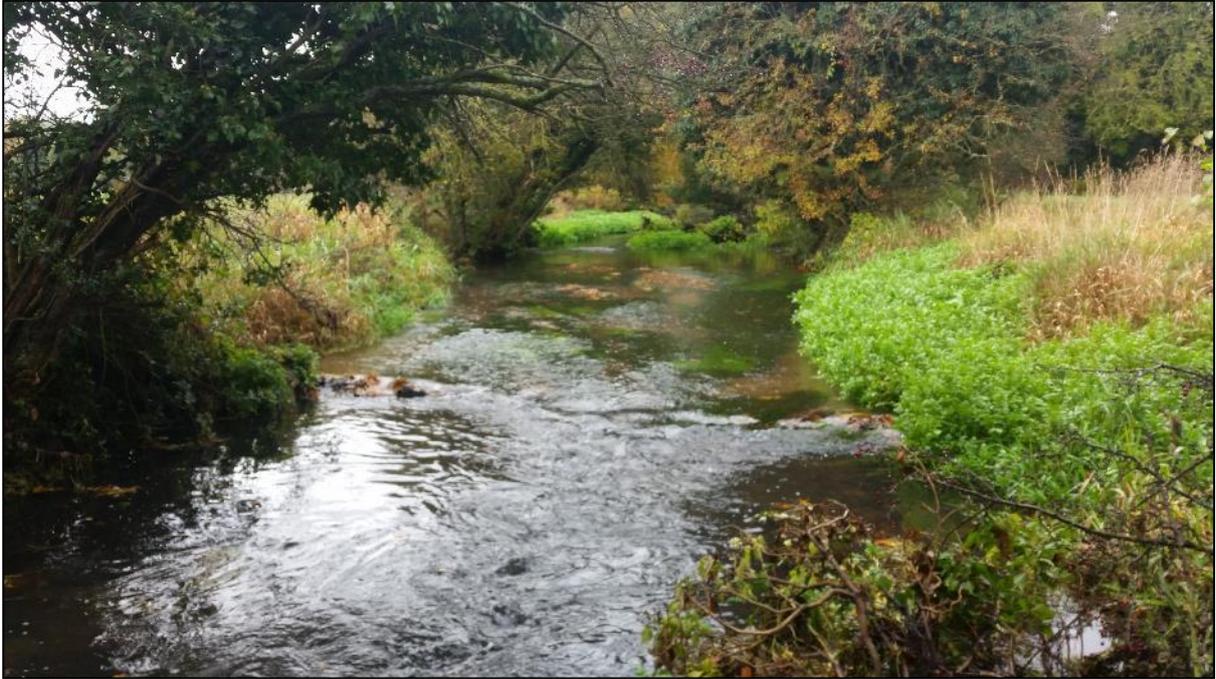
Figure 5: One of the low-level stonework structures

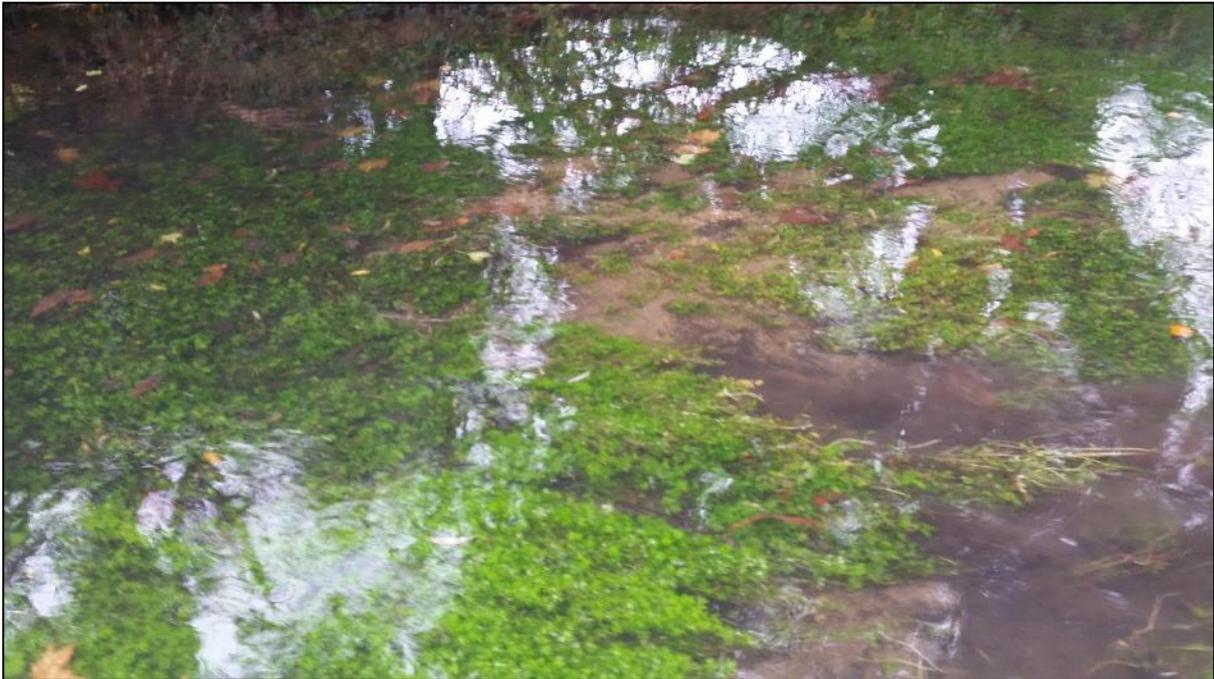
An increase in flow diversity in the upper reach could help to better distribute fine sandy sediment. Water flowing through a brushwood berm is slowed, allowing fine sediment to drop out of suspension. Conversely, water flowing around the structure is accelerated, scouring away fine sediment. Thoughtful positioning of such features could help to manage sections where fine sediment is uniformly deposited over the bed (Figure 8).

Figure 8: A thick deposit of fine, sandy sediment blankets the bed in a section of the upper reach

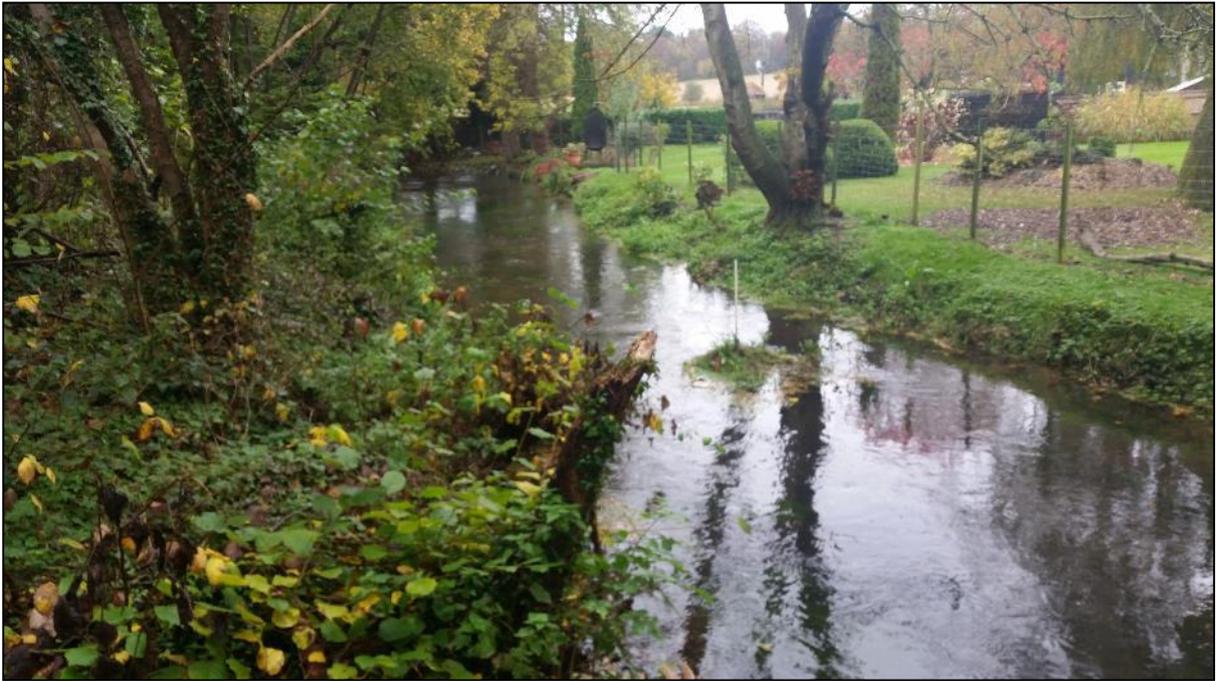
At top of the middle reach the channel is relatively narrow and free-flowing (un-impounded), allowing for a good diversity of habitat (Figure 9). However, habitat quality degrades as the flow becomes more laminar and sluggish upstream of another cobble and block stone structure (Figure 10). The impounding effect of this feature is more pronounced than the structures in the upper reach and it is essentially acting as a 'summer weir'. Many such structures have been installed in rivers throughout the UK by fishery managers attempting to mitigate against low water levels. Whilst this may seem like an intuitive solution, the act of holding up water levels actually reduces a river's resilience to low flow events by impeding the morphological processes that would otherwise contribute to the development a more natural and drought-resilient channel profile.

Figure 9: At the top of the Middle Reach the channel is narrow and the river flows freely.

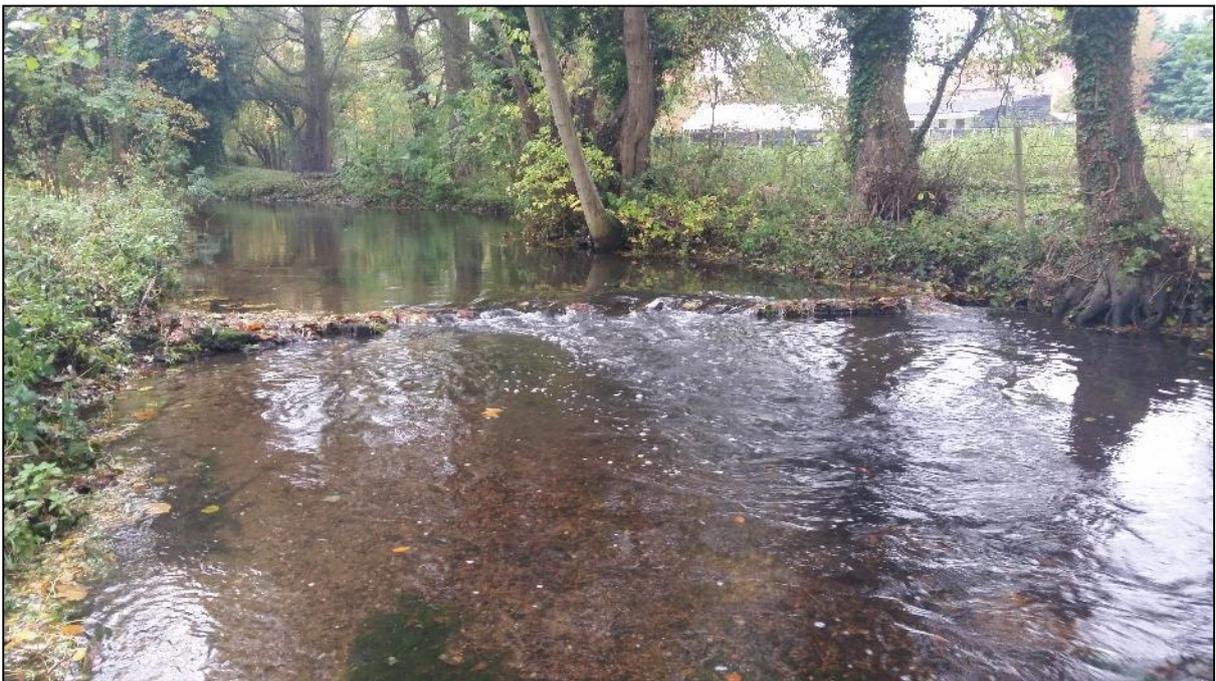
Impoundments also cause uniform slowing of flows upstream, causing deposition of sediment over the bed. Over time, this will cause an evening out of the channel topography above the weir, resulting in reduced habitat diversity. Many clubs are reluctant to remove summer weirs, expressing concerns over the loss of water depth or favoured fishing spots. However, it is often the weir pool below the structure that provides the good fishing and replacing the weir with flow deflectors that retain scour through the existing pool should ensure that favoured fishing spots continue to provide good angling without impounding flow.

Figure 10: Flow is impounded by another stone structure. Whilst there is good scouring flow below the structure, this is at the expense of flow diversity upstream (note the uniform laminar flows upstream of the structure).

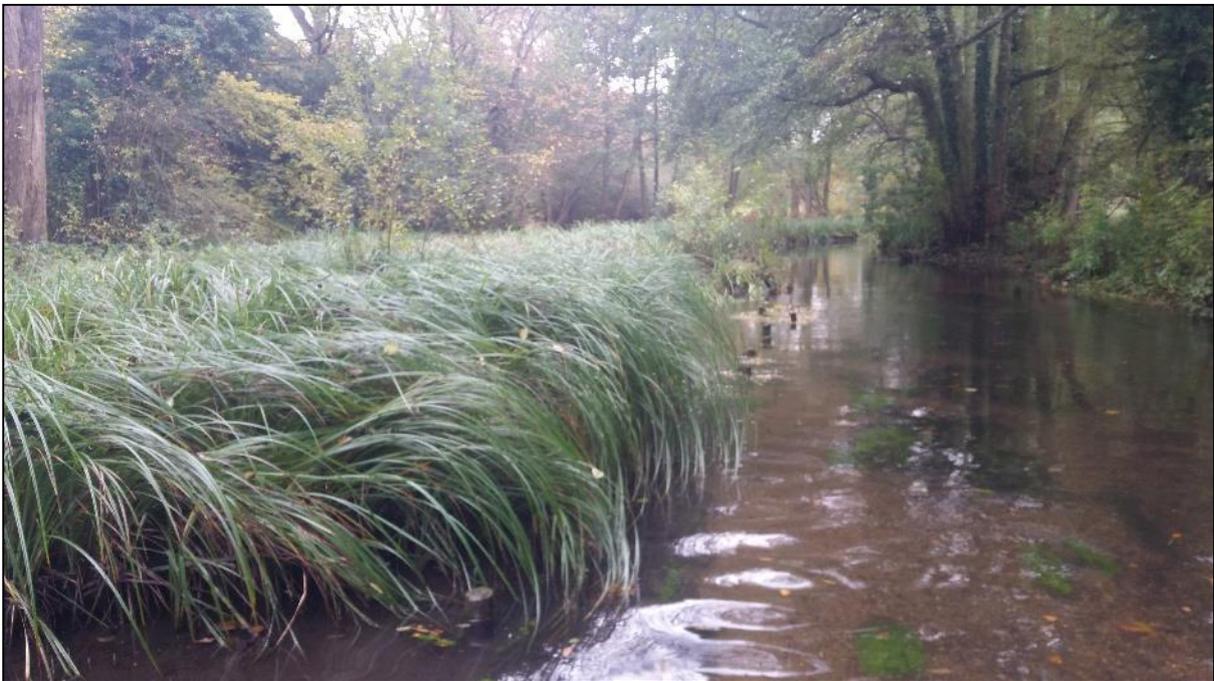
Downstream, the river becomes uniformly over-wide and over-shaded. A project was undertaken in 1996 to narrow this over-wide channel (Figure 11). Whilst the project appears to have been relatively successful, the dense tree cover over the reach is putting the long-term integrity of the project at risk.

Figure 11: The 1996 narrowing project has been relatively successful but is at risk from over-shading from bankside trees

Patches of the berm are no longer vegetated and, in some places, new faggots have been added by the club in attempt to patch up sections where the original brushwood has rotted away. One berm, on the RB towards the downstream extent of the shaded reach is barely vegetated (Figure 12). Additional brushwood or planting here will have limited success unless tree works are undertaken to allow more sunlight onto the bed and bank.

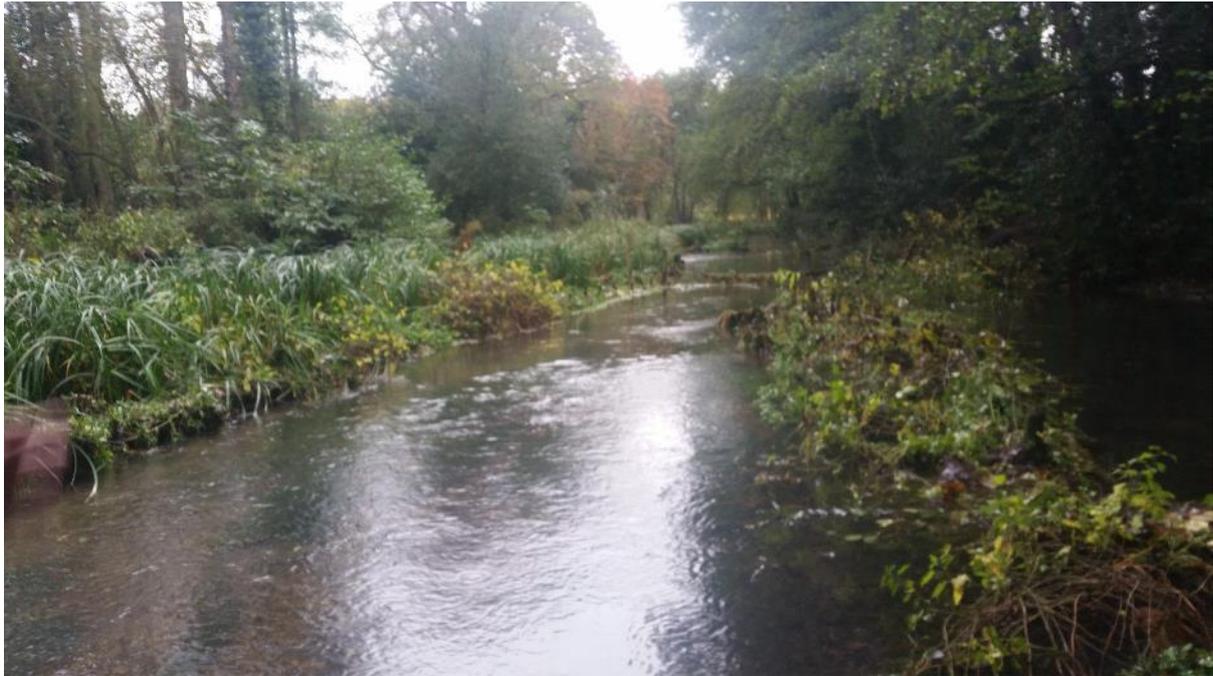
Figure 12: A berm on the LB (right of picture) is particularly over-shaded and barely vegetated

Tree works to allow a greater diversity of light into the channel would greatly enhance this section of the club's water. Woody material arising from tree works should be used to patch up the berms where required and also to introduce greater variation in flow speeds and channel widths. From a fishery perspective, this would increase the number of good holding lies and feeding runs, making for a more interesting, and potentially more productive angling experience. From a biodiversity perspective a greater diversity of physical characteristics (flows, depths etc.) will provide a greater diversity of habitat niches, which should result in improved populations of freshwater plants and invertebrates.

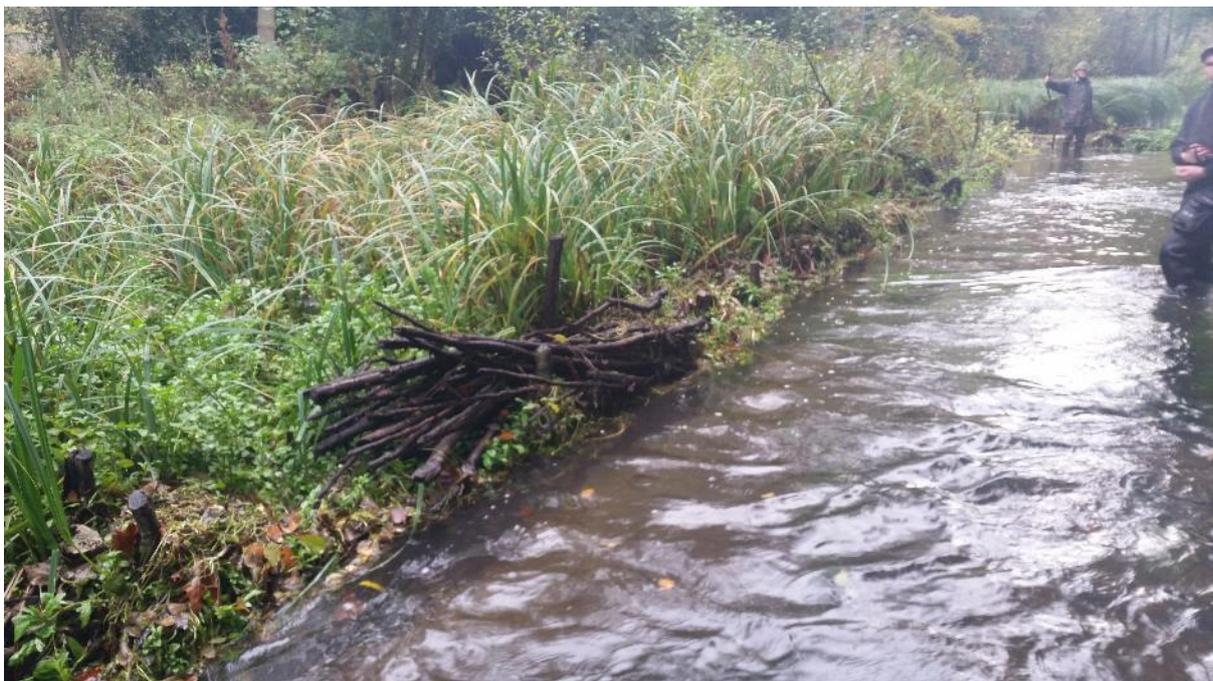
Whilst the 1996 project has helped to narrow the channel, the habitat remains relatively uniform. This is owing, in places, to the edge of the vegetated brushwood berm being overly-straight (Figure 13), resulting in relatively uniform channel width and flow conditions.

Figure 13: In places, the existing berm presents an overly-straight bank edge, reducing channel diversity

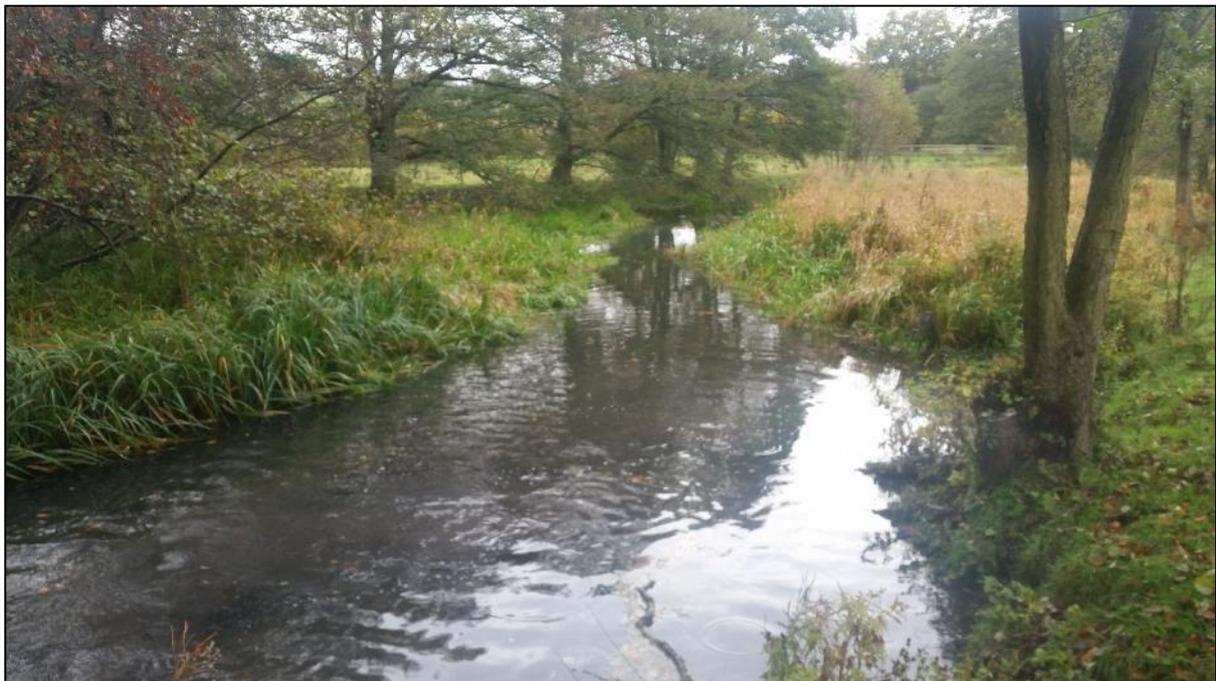
Figure 14: A downstream view from the top of the reach restored in 2000

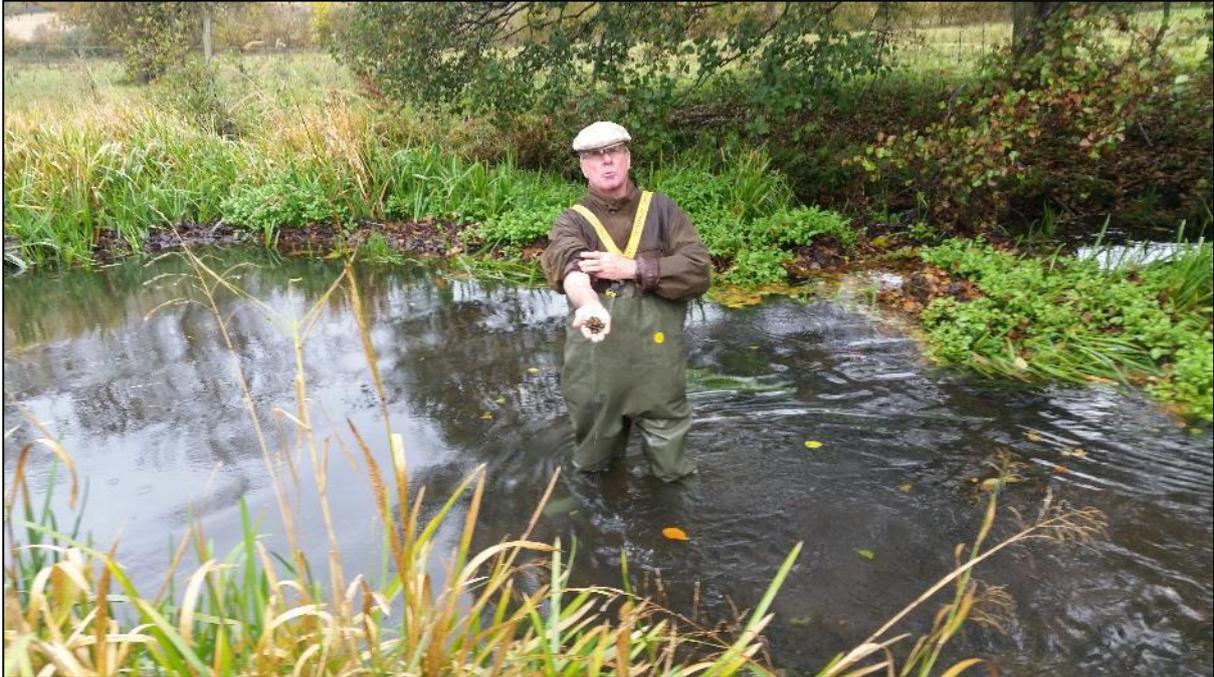
The channel was not uniformly narrowed and a good diversity of channel widths is present. The imported gravel appears to have remained relatively free from fine sediment infiltration (Figure 15) and redds have been observed most winters. The dense and 'shaggy' marginal vegetation also provides good refuge habitat for juvenile trout.

Figure 15: Chris Mungovan demonstrates the relatively good condition of the gravel imported as part of the 2000 restoration project

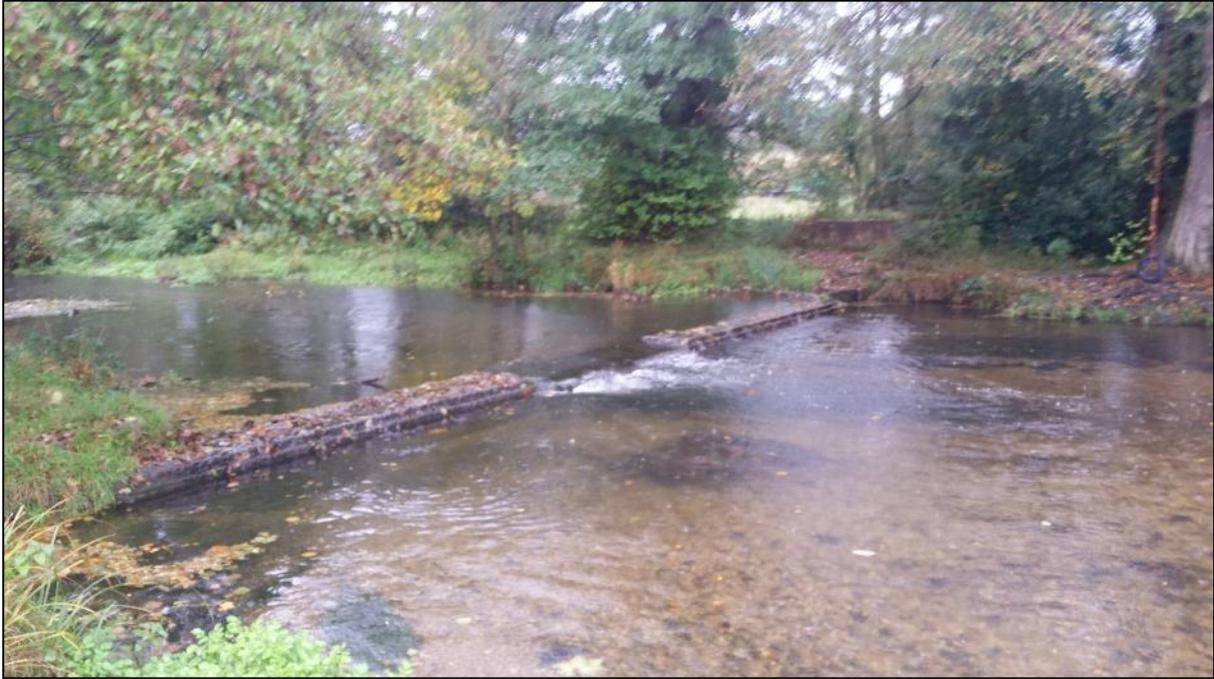
The weir (Figure 16) was originally installed to hold up a head of water which was pumped to a nearby mill. This purpose is now redundant but the weir arguably also helps to protect the footings of an ornamental bridge situated at the downstream extent of the restored reach (Figure 17). However, a number of ecologically appropriate and cost-effective soft-engineering solutions are available to protect the bridge footings in the absence of the impoundment. These options are explored further in the *Recommendations* section.

Figure 16: The weir at the top of the bottom of the middle reach limits habitat quality upstream

Although the weir is not necessarily a barrier to trout migration, it remains a significant obstacle for juvenile trout and smaller fish species. Whilst it is commonly believed such structures help to protect fish during low flow events by retaining sufficient depth, it is often during low flow events that weirs are at their most damaging. During low flows, obstacles that may be perfectly passable under other flow conditions can become barriers to fish passage. This can prevent fish from easily moving out of low flow environments and accessing deeper pool habitat. The slowing of flow during such events can also lead to spikes in temperature, putting undue stress on fish and other temperature-sensitive

The weir is a key limiting factor presently preventing this reach from reaching its full potential as a healthy chalk stream ecosystem capable of supporting a vibrant wild trout population. Therefore, removing the weir or at least lowering a significant portion of it to bed level should be considered a priority action for the

middle reach. With the impoundment removed, or its effect significantly reduced, a more natural morphology could be reinstated via the installation of some occasional woody habitat features in the form of secured log deflectors or tree limbs.

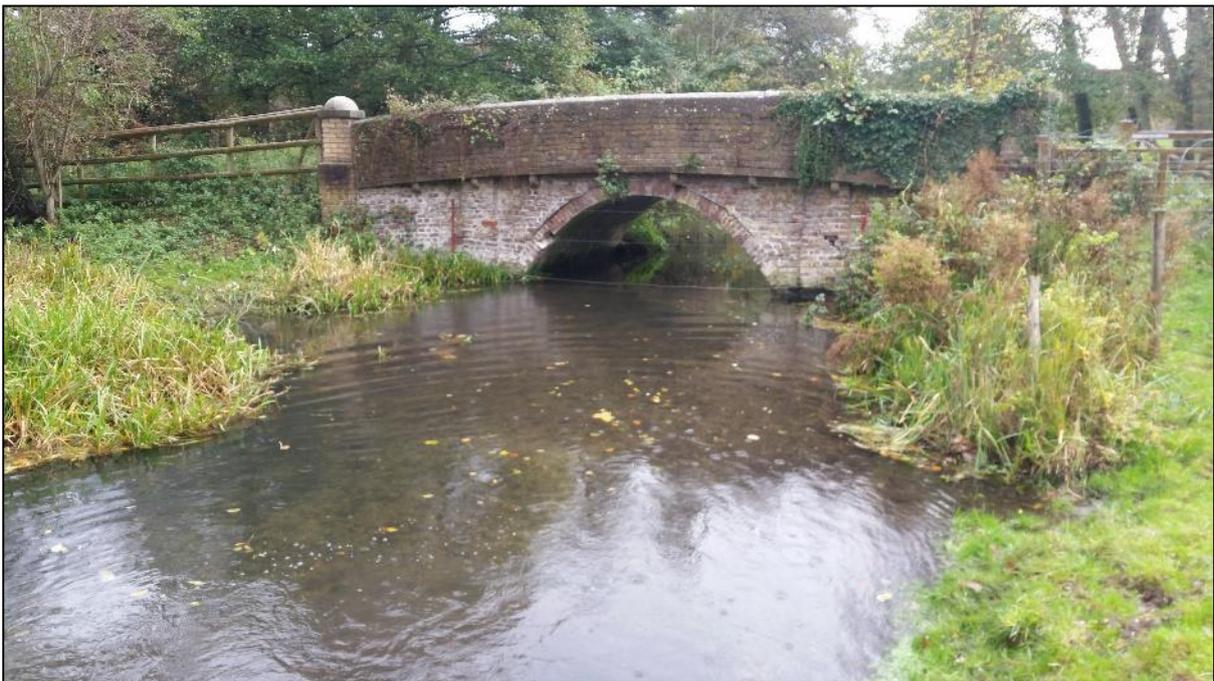
Figure 17: A view of the ornamental bridge from upstream

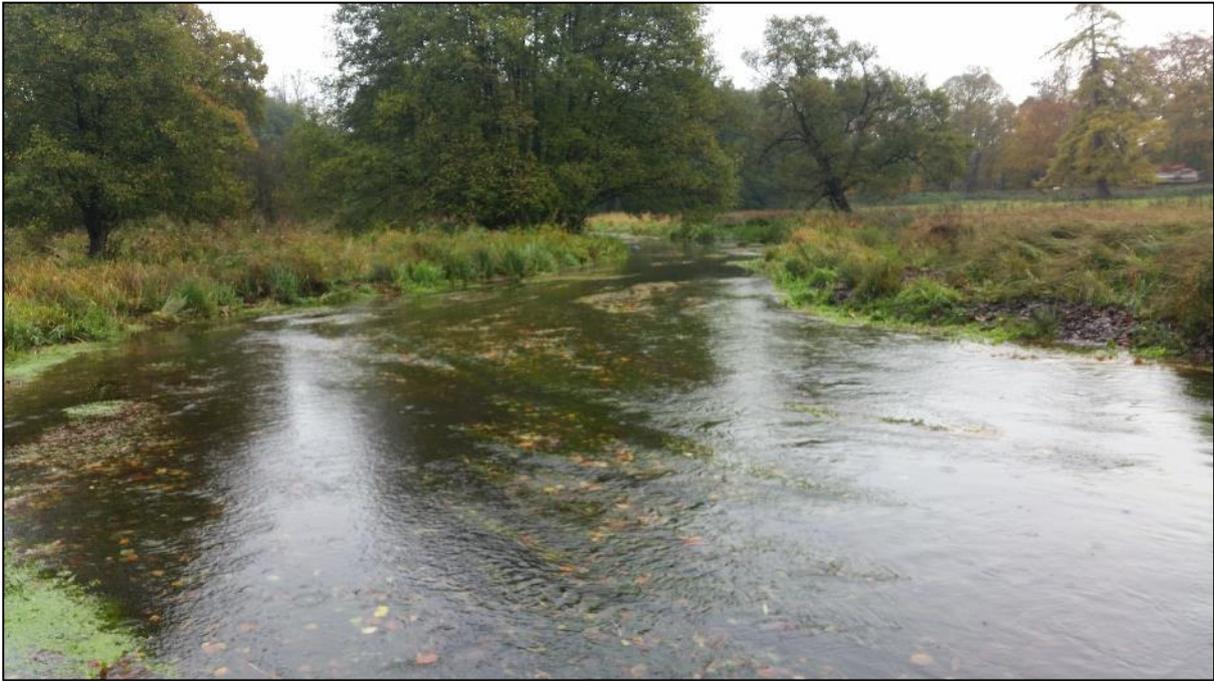
The lower reach was, until a few years ago, heavily grazed by cattle. This resulted in heavy bank poaching, causing a widening of the channel and depletion of marginal habitat (Pers comm. Chris Mungovan). Since the grazing ceased, a wide and biodiverse margin has recovered, naturally narrowing the channel and providing excellent habitat for invertebrates and juvenile fish as well as waterfowl and mammals (Figure 20).

Figure 20: Marginal vegetation has recovered since the cessation of grazing in the adjacent fields.

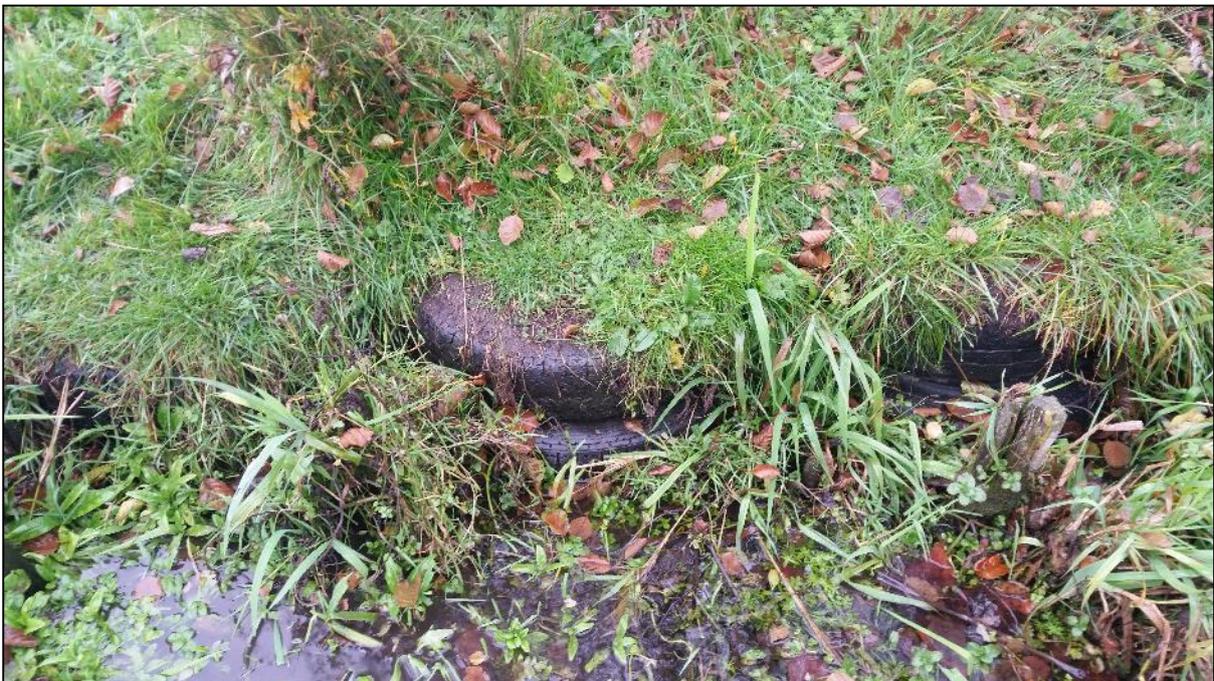
Whilst the majority of the riverbanks provide good habitat, examples of historic, less appropriate bank stabilisation works were observed in places (Figures 21 and 22). Balancing good habitat with safe, easy and cost-effective angler access is a common challenge facing many wild trout fisheries. However, there are a range of techniques available that will provide good angler access whilst also having a degree of habitat value (see *Recommendations*).

Figure 21: A bank revetment constructed using recycled car tyres has no habitat value and detracts from the overall aesthetics of the club's water

5. The recycled car tyre revetment should be removed and replaced by a more appropriate structure. For example, logs secured to the bed and back-filled with flint gravel rejects. If the cost and/or logistics of importing gravel make this option unfeasible, another option could be to backfill with brushwood until dense-enough to walk on and secure with cross-braces cut from straight branches. Translocated marginal turfs could be planted over the structure and within a season it should be established enough to withstand being walked on (Figure 32).

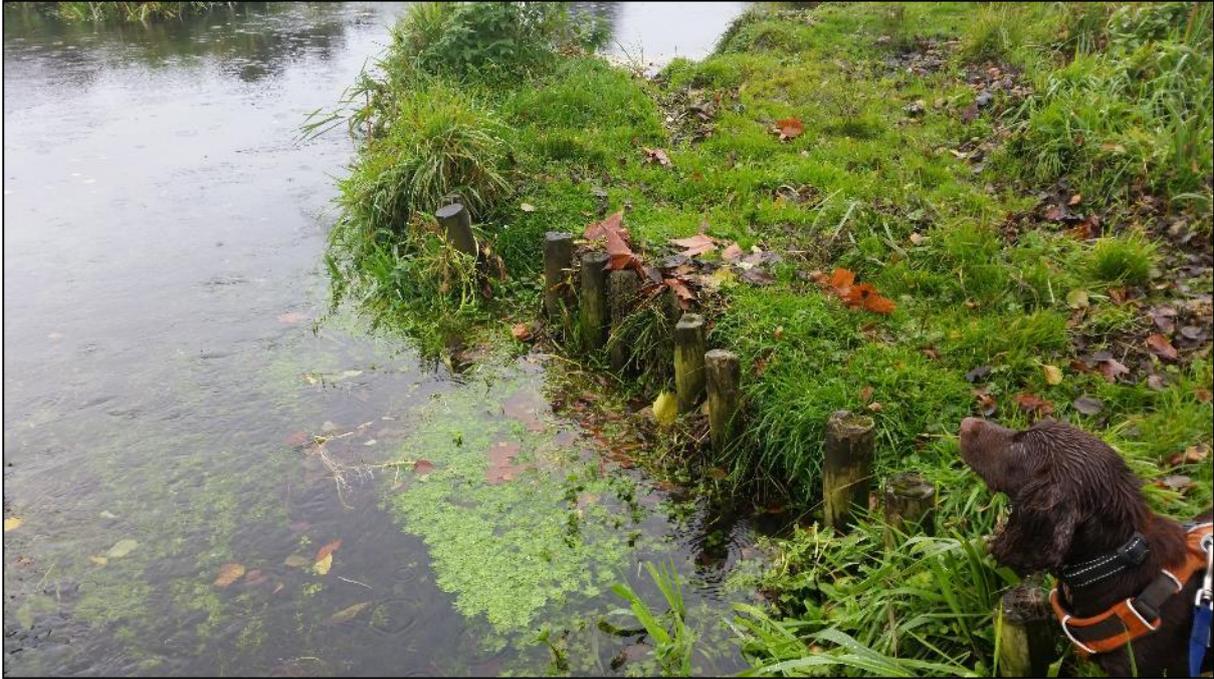
Figure 22: A revetment of untreated wooden stakes is less incongruous but inhibits the growth of marginal plants and ultimately fails as a long term solution

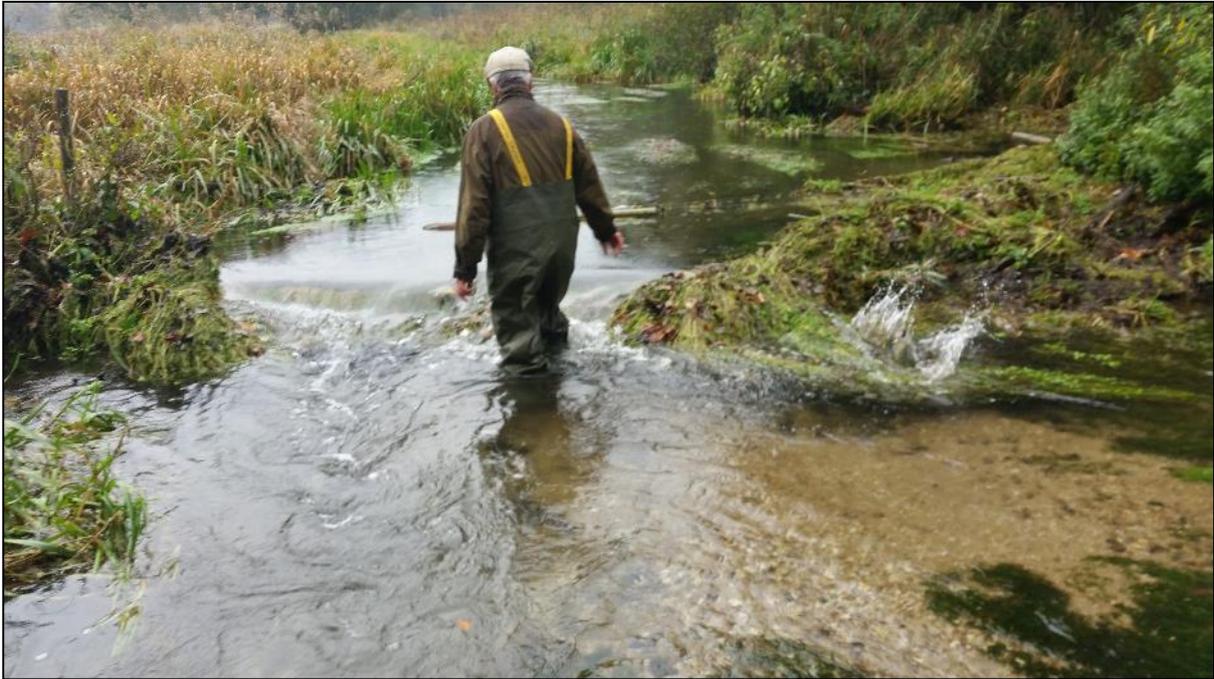
At the bottom of the reach, the remains of an old grid work 'fish stop' structure, previously used to retain stocked fish during the fishing season, is redundant and marked for complete removal by the club. This structure impounds flow and is a potential obstacle to free fish passage (especially if a significant volume of weed becomes trapped against the grid work). The removal of this structure will be an important step towards a more natural wild fishery.

Figure 23: Chris Mungovan points out the remains of the old fish stop towards the bottom of the lower reach

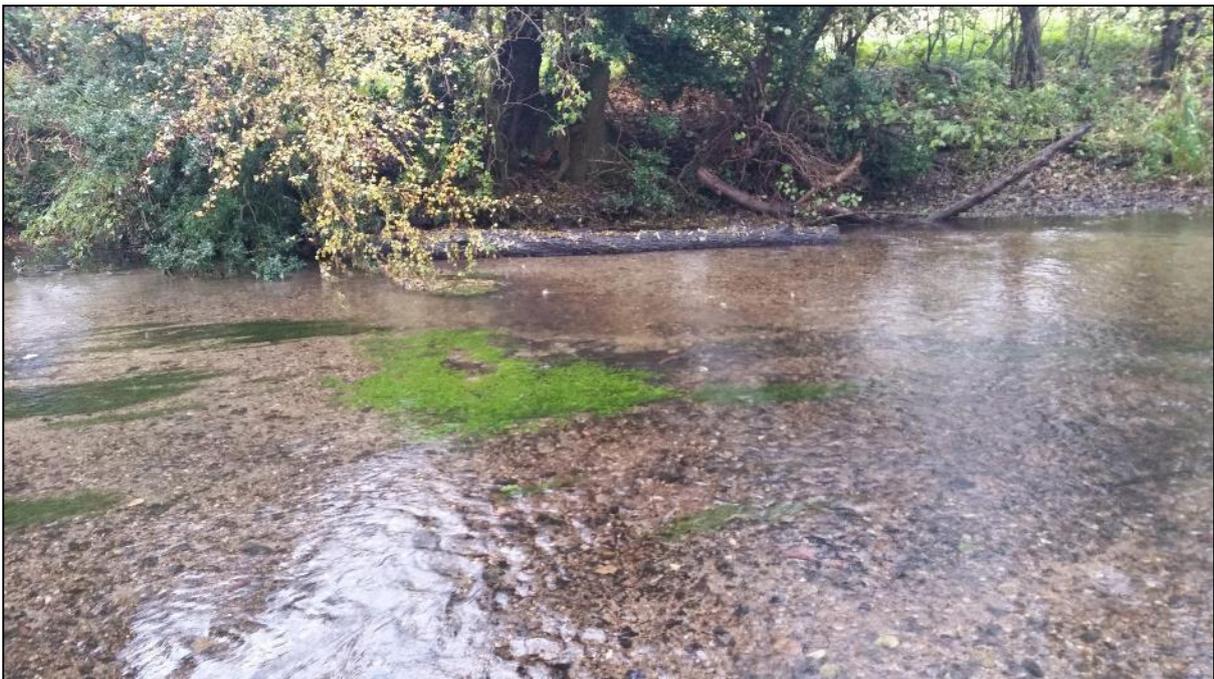
Between the old fish stop and the B1000 road bridge downstream, the channel becomes abruptly wide and shallow (Figure 24).

Figure 24: Some additional light and structure could make this shallow and wide section more resilient to low flow events

Whilst sections of wide and shallow river can be valuable, and often rare habitats in themselves, the lack of any in-stream structure and paucity of weed could potentially make this section impassable to fish during periods of low flow. Allowing a little more light into the river here and adding one or two flow-deflecting woody habitat features could help make this section more physically diverse and resilient to low flow events.
