Monks Brook

A Project Proposal by the Wild Trout Trust - February 2015

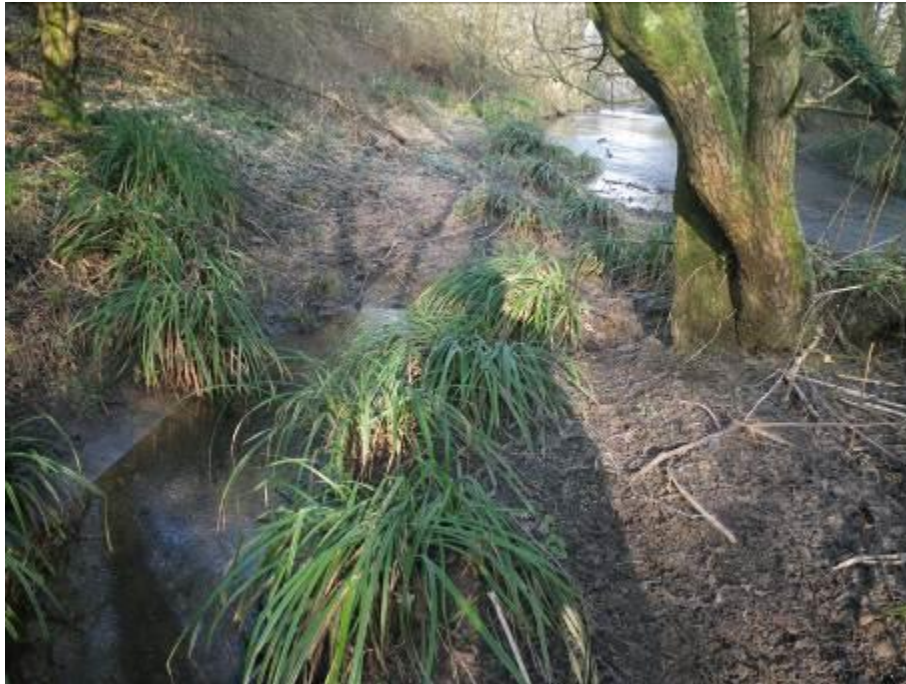
In most places, the channel width appears to be excessively wide for the given average flow discharge. Much of the channel is heavily shaded by mature crack willow trees, *Salix fragilis*. The excessive, high level shading and hard nature of the bank and bed has made the establishment of both in-channel submerged and marginal emergent plants difficult. That said, in some places clumps of sedge, *Carex* sp. and even some mature trees have established on deposited bed sediments, providing some valuable habitat (photo 1).

Photo 1. Sedge and even the odd shallow rooted tree have established on deposited river bed material. Note the exposed concrete bank on the left hand side of the photo.

Where bed material has accreted in front of the defended banks, there is no benefit to be derived from ripping out habitat that works reasonably well. Where the concrete bank is exposed adjacent to the RB this should be left in situ and the channel narrowed in front of the exposed concrete to create a new toe to the bank. The concrete lining to the bed immediately adjacent to the RB should also be left to a distance of at least 1m from the toe of the existing concrete batter. The remaining concrete bed and any exposed sections of concrete making up the LB could be broken out with hydraulic pecker and excavator. If the concrete material can be broken up into rubble sized pieces on site then the majority of it can probably be reused within the existing channel. If the underlying substrate is gravel rich, as suspected, this can be redistributed with a tracked excavator, on top of the berms made from the broken out rubble. It will be important to ensure that any concrete rubble that is recycled is adequately buried below natural river gravels.

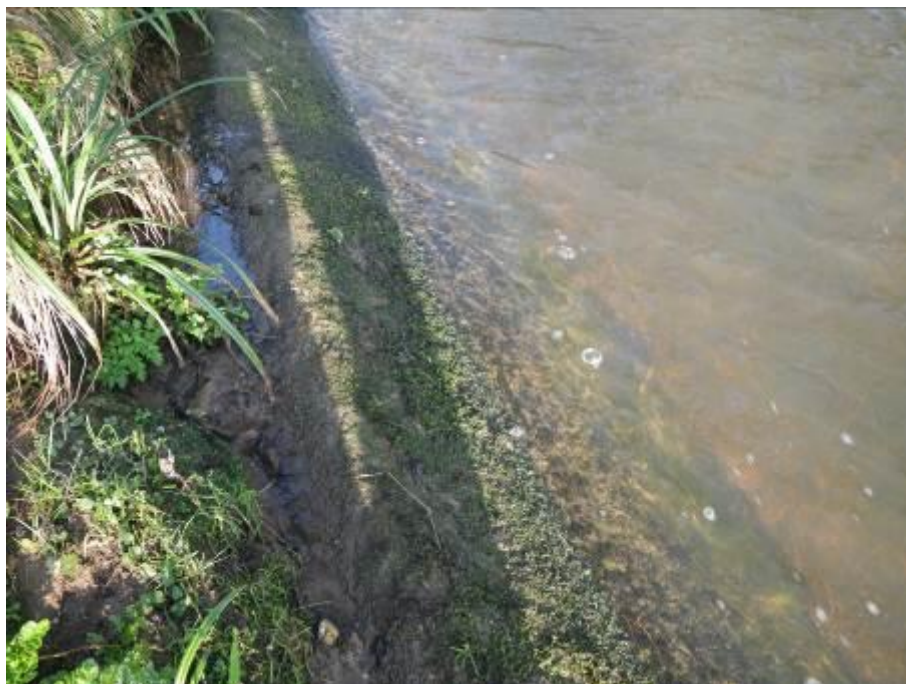
Photo 2. Battered concrete margin limiting the establishment of a natural river bank

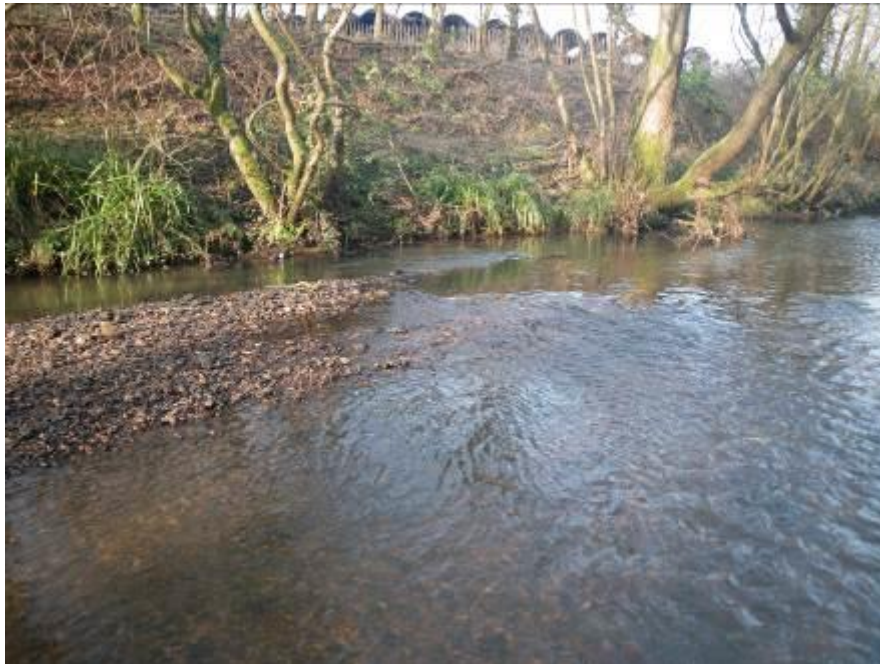
In some areas, significant quantities of deposited gravels and fine sediments have enabled natural margins to establish and in-channel gravel bars to form (photo 3), providing some valuable habitat for invertebrates and very small fish.

Photo 3. A natural river margin and a deposited gravel bar provide some useful habitat on top of the bed and bank armouring.

A small trout redd was observed in this location but spawning opportunities here are very limited due to the thin and poorly sorted nature of the river bed gravels, overlying what is probably a concrete base.

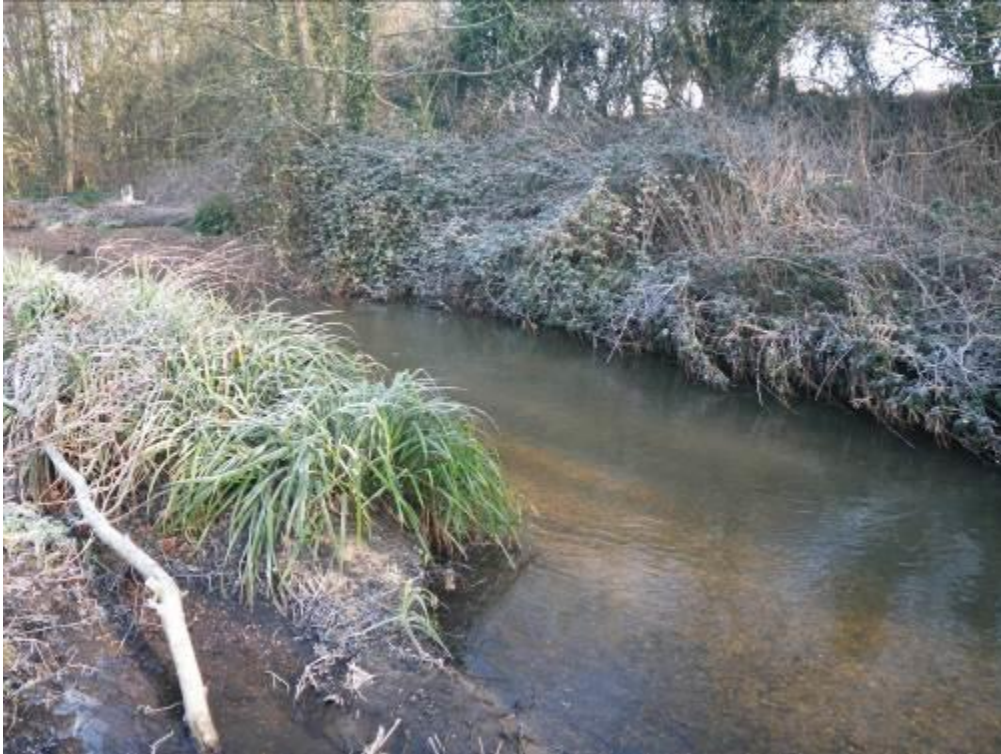
Downstream of the culvert, the channel has narrowed via deposited sediments and some cover for fish is available via trailing scrubby terrestrial plants such as bramble (photo 4).

Photo 4. Bank sediments have been stabilized with the establishment of sedge beds. The overhanging bramble does provide a modicum of cover for fish seeking refuge during migration.

Removing the existing bed and bank armouring from the reach below the modified culvert to the M27 is not recommended due to the flow energy that is likely to be generated by the new culvert; this represents an unnecessary risk. Currently, this section provides at least some refuge for migrating fish and any enhancements here should be restricted to the installation of one or two low, short stub groynes to provide refuge in high flow conditions. These stub groynes

could be constructed from large sections of tree trunk cabled to anchoring points and bolted into the concrete.

These low stub groynes should be set in at right angles to the bank and protrude out into the channel by approximately 2 to 3m, set in at a height to overtop during heavy flow conditions.

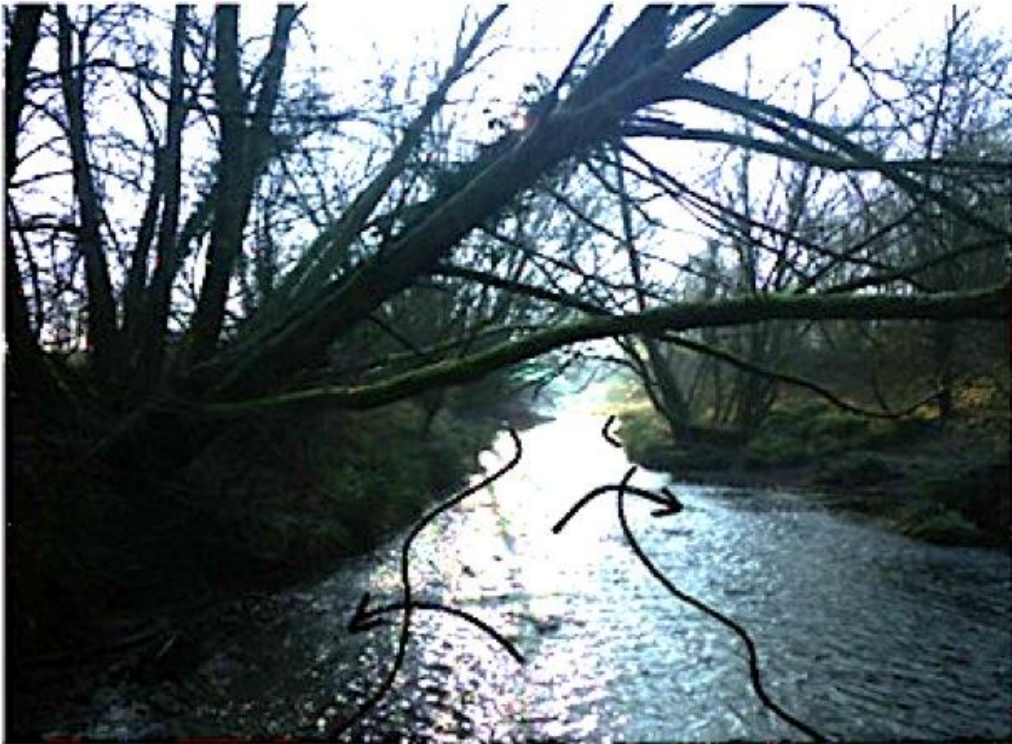
Photo 5. An impression of how the low marginal shelves could be created from material broken out from the armoured river bed and top dressed with river gravels.

The objective will be to create some sinuosity within the existing channel width by bouncing the flow off low marginal berms or shelves located adjacent to opposing banks. Photo 5 is a view from upstream looking down towards the culvert and depicts an impression of where the berms could be located to promote flow sinuosity and increased depth within the channel. Some tree work prior to any in-channel work will be required to provide safe working access.

Over the full 500m of channel up to 10 pool-and-run features could be created, transforming habitat quality for fish both in terms of adult holding but also for spawning.
