River Monnow, Walterstone, Herefordshire

An Advisory Visit by the Wild Trout Trust, May 2014

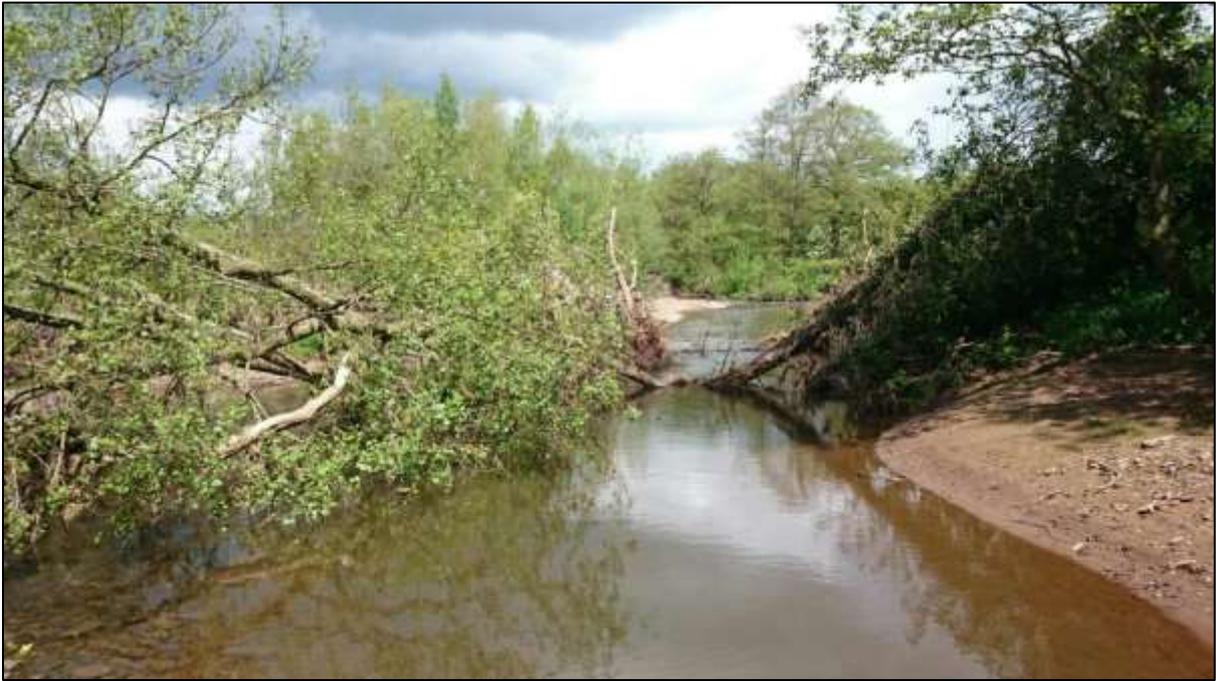
At the upstream extent of the reach, a large tree had fallen into the river during a heavy spate (Figure 2). The response of the river's morphology to the tree is a good indication of the forces acting within the river during high flows. A deep pool had been scoured under the tree and material scoured out from the pool was deposited a short distance downstream to form a number of gravel and cobble shoals and point bars (Figure 3). The redistribution of bed material caused by the undershot scour had introduced a diverse range of habitat features. Within a distance of approximately 50m, deep pool, shallow riffle/glide, slack backwater and fast run habitats were all observed. There was also an abundance of cover habitat in the form of tree roots and woody debris. High-flow channels (dry on the day of the visit) were also observed indicating that the diversity of habitat most-likely increases during periods of higher water levels as the river swells and occupies additional channels.

Figure 2: A large tree fallen into the river at the upstream boundary of the water

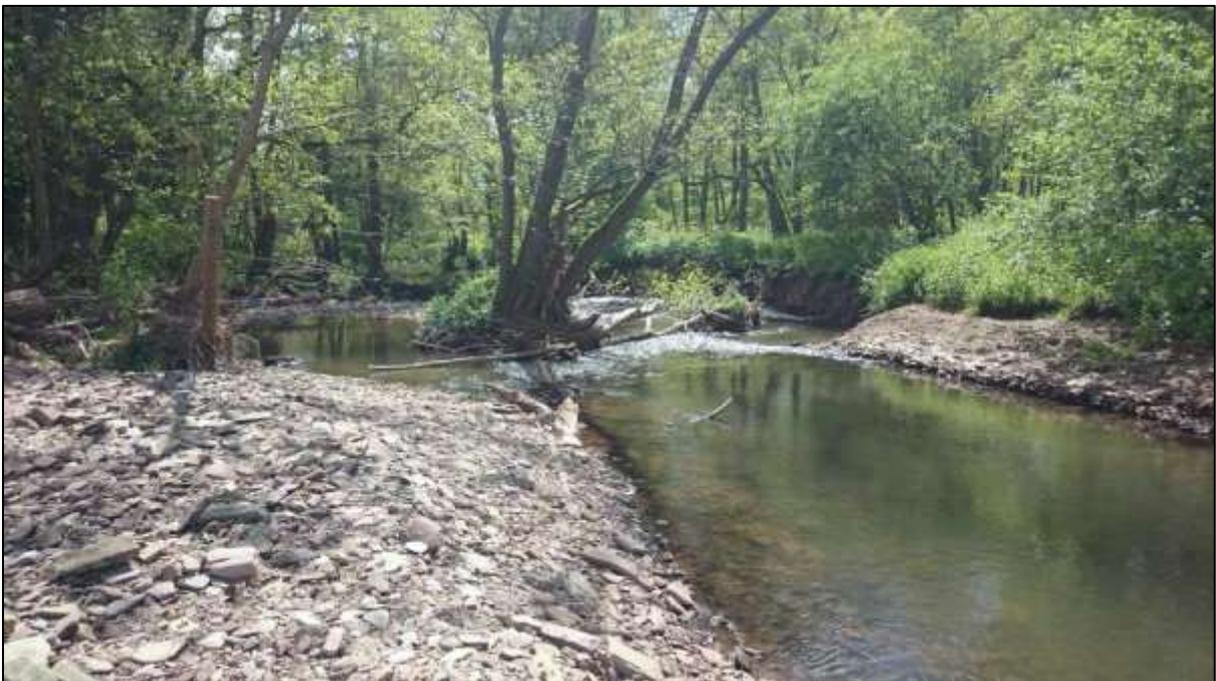
Figure 3: Material scoured from the bed has been deposited to create a range of physical features

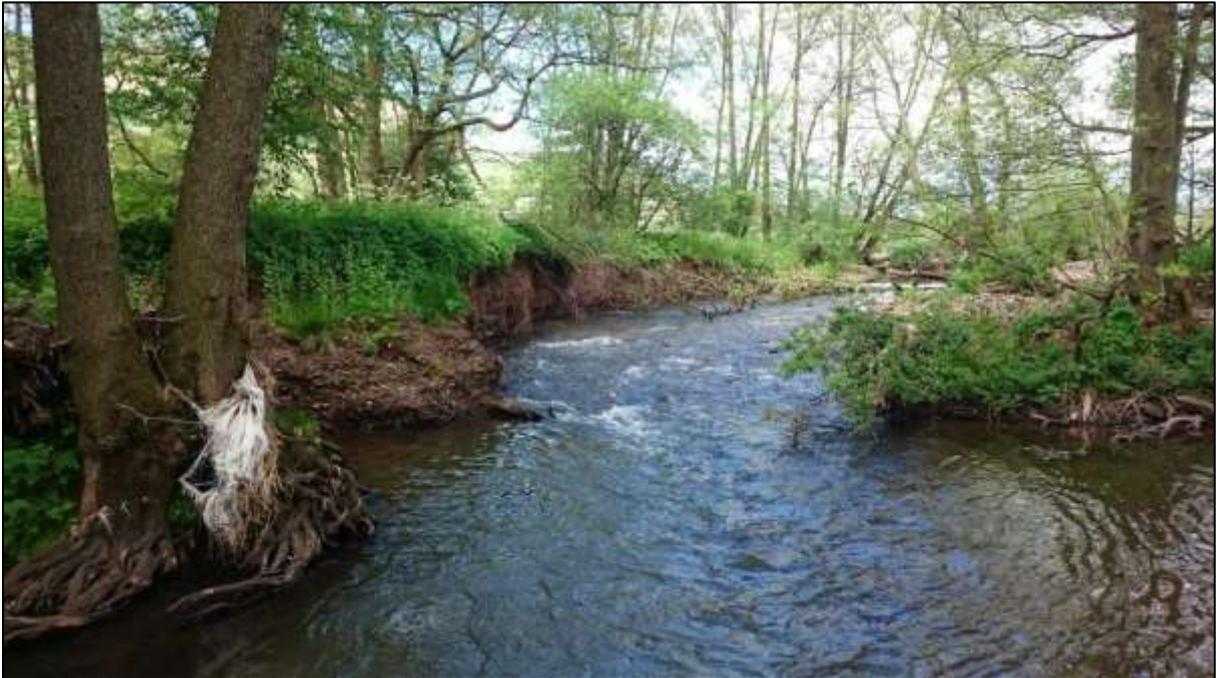
river. A rich seam of gravel can be seen in Figure 4 suggesting that some bank erosion is probably beneficial at this upstream section of the water. However it is worth noting that the overlying soils of the Monnow valley can be particularly friable and where a natural gravel seam is not present banks can be particularly soft and vulnerable.

Figure 4: A rich gravel seam in the eroding bank will introduce as steady supply of gravel into the river Downstream of this reach the river is shaped by the natural bedrock of the valley (Figure 5). The stepped formation of the bedrock creates some small pools and good 'pocket water' habitat. The roots of bankside trees, unable to penetrate the hard bedrock, have grown out laterally into the river (Figure 6). This provides excellent refuge habitat for trout – especially juveniles.

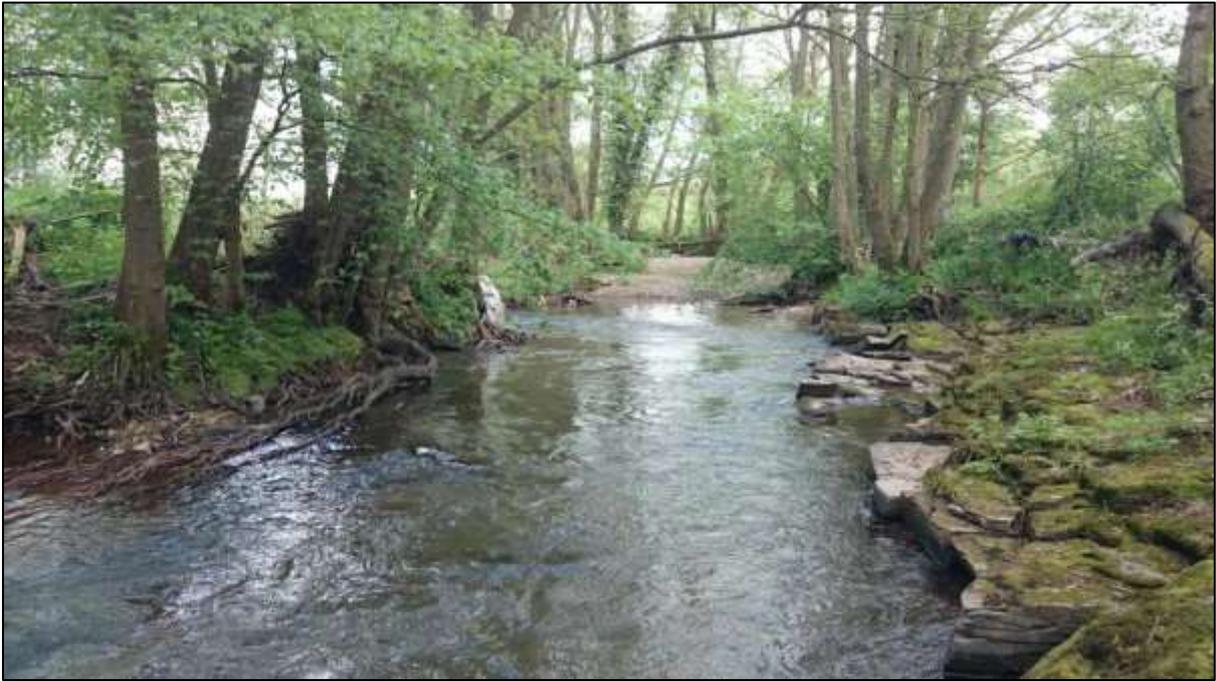
Figure 5: The stepped formation of the valley bedrock helps to provide a diverse habitat

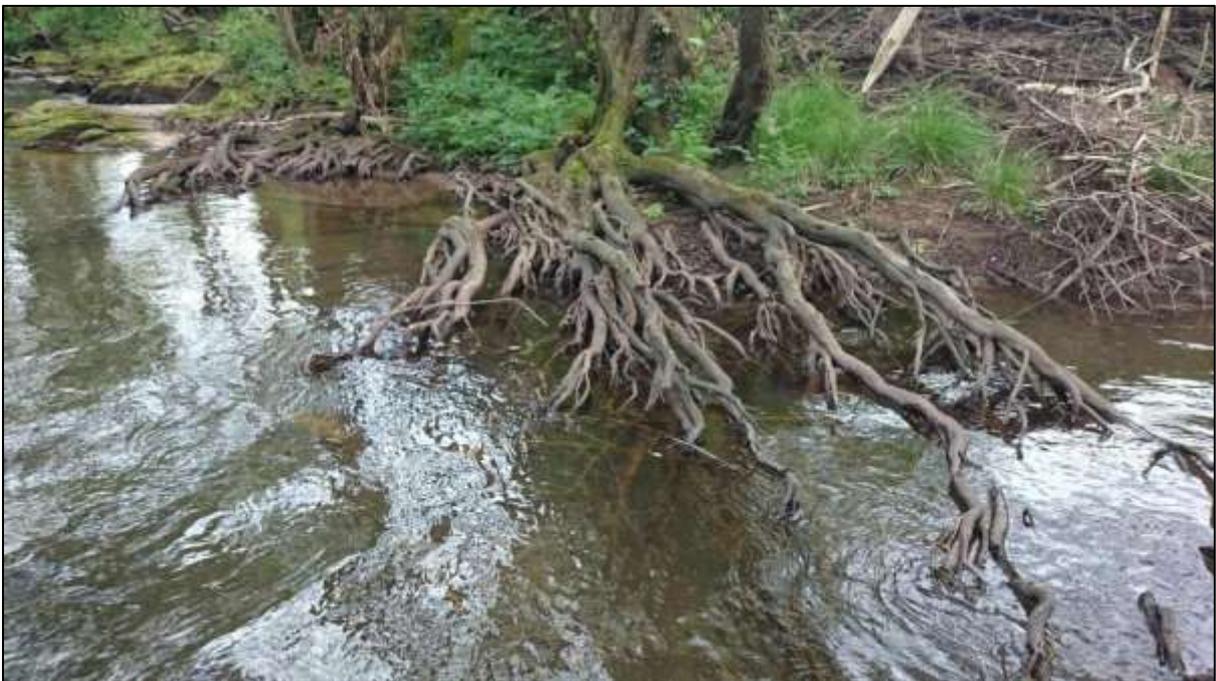
Figure 6: Tree roots forced to grow out over the bedrock provide excellent cover and refuge habitat

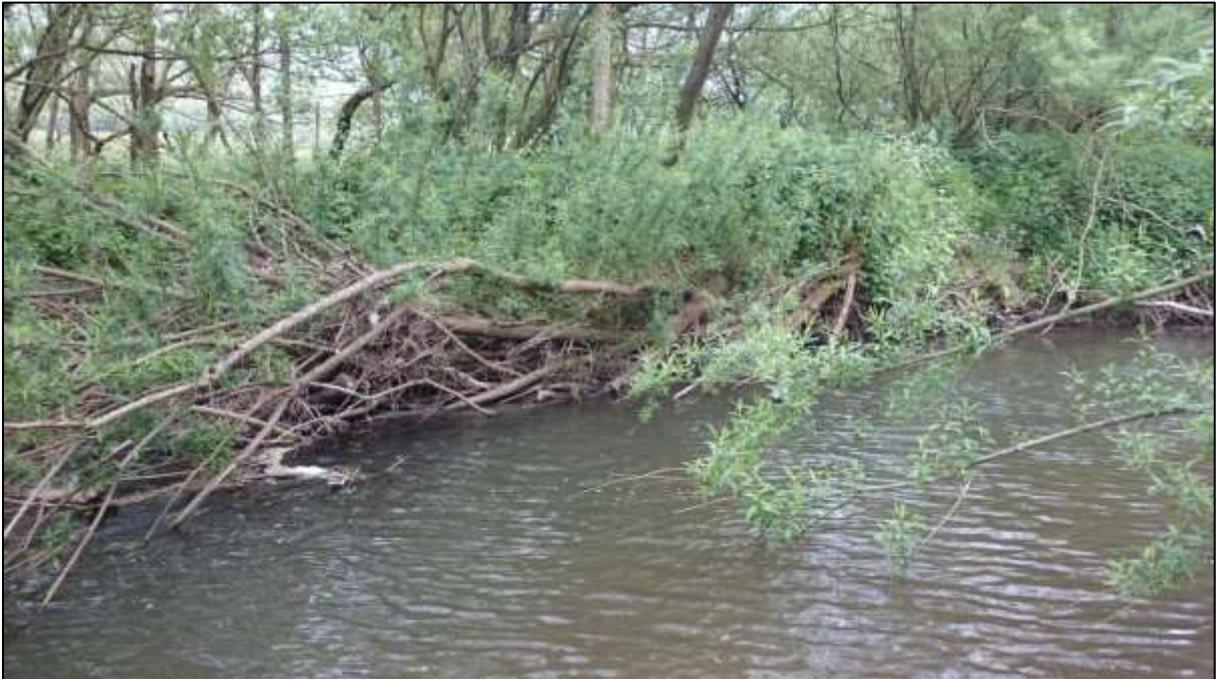
Marginal cover is abundant as the river flows around an island at SO 3315 2411. Low overhanging branches and small, partially fallen bankside willows (*Salix spp.*) provide good shelter from high flows. In high-energy rivers, sheltered pockets of slack water in the lee of tree roots or fallen limbs (Figure 7) provide a vital refuge where fish can rest out of the strong currents and until flows lessen. They also provide excellent holding habitat in normal flows and increase the carrying capacity of the river.

Figure 7: A partially fallen willow provides an excellent refuge during spate flows

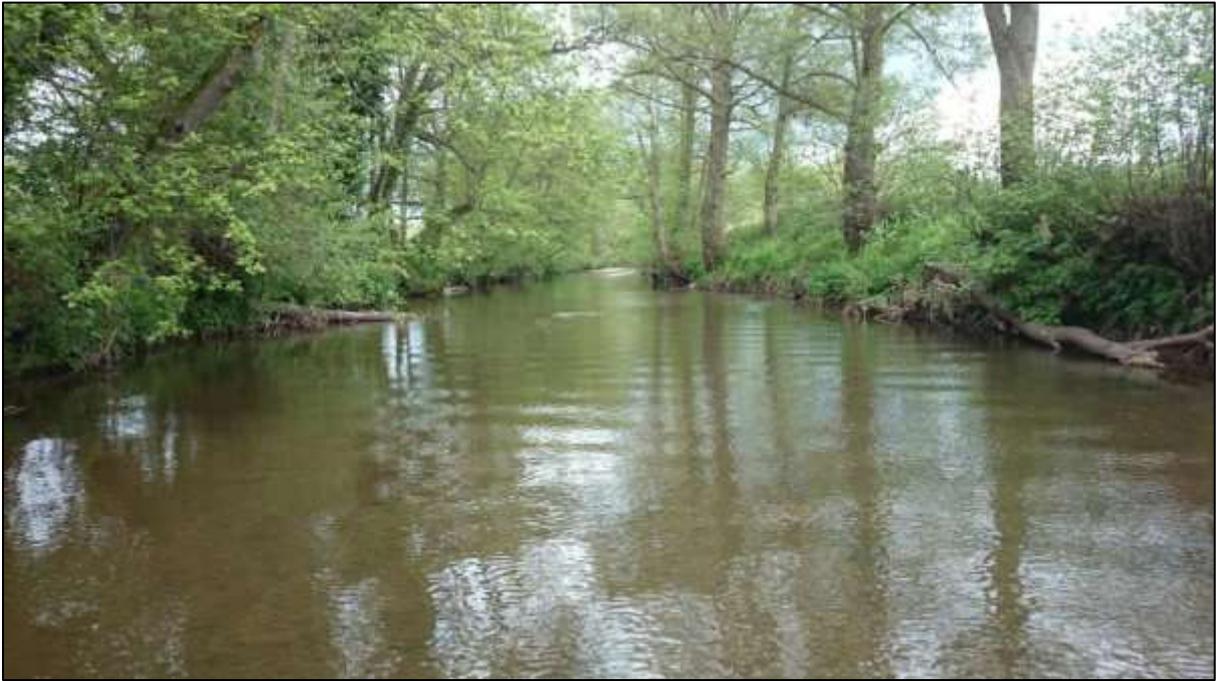
At SO 33148 23995 the character of the river abruptly changes. Upstream the river is morphologically active and physically diverse with a range of flow patterns, whilst downstream habitat diversity significantly reduces and the river exhibits a uniform cross-section with laminar flows (Figure 8). For approximately 200m the river has been significantly straightened. The extent of the artificial straightening of the channel is highlighted by the difference between the shape of the official border between England and Wales (which historically followed the river) and the path of the river at present (Figure 9).

Figure 8: The straightened reach has uniform depth and width and laminar flows

A study of old maps (www.old-maps.co.uk) shows that the channel modifications were undertaken pre-1900. The modification may have been for land drainage or milling, or possibly even to protect the road to the west. Whatever the purpose of the modification, the outcome has been a significant reduction in habitat diversity as the straight and uniformly wide channel evenly distributes bed material transported from upstream.

4. Capitalise on opportunities to introduce further flow diversity and cover habitat to the straightened reach by hinging or felling bankside limbs into the river and securing with **both** steel reinforcing bars and braided steel cables attached to the bank.

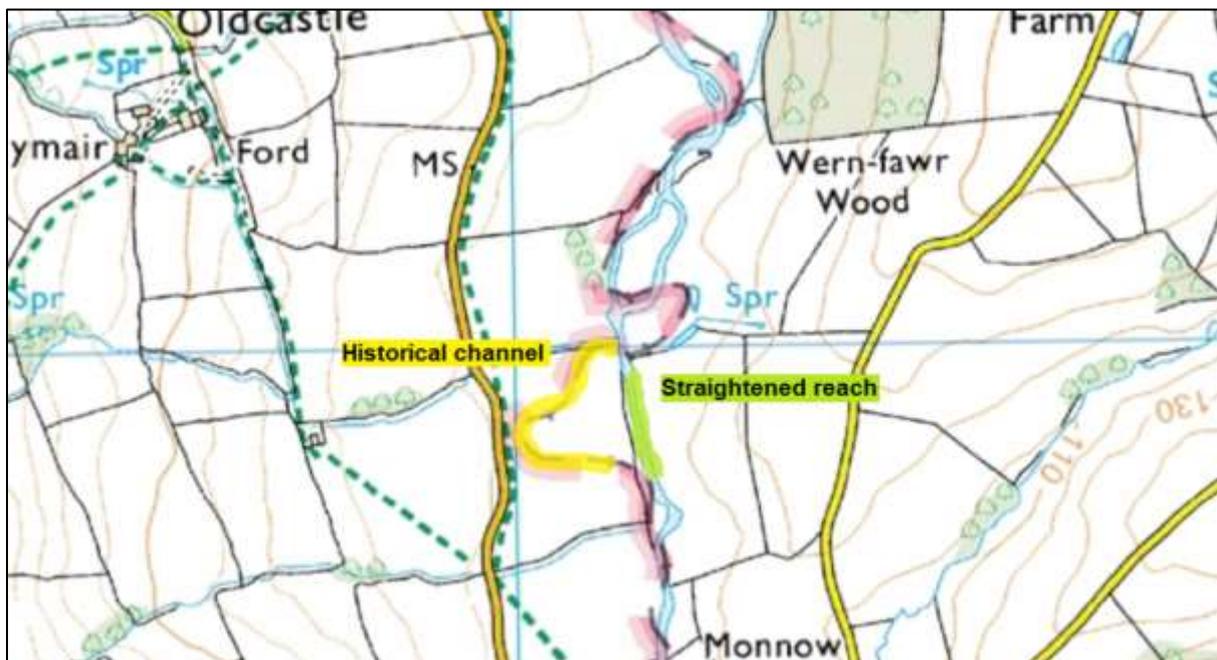
Figure 9: The England-Wales border shows the historic course of the river and the extent of artificial straightening

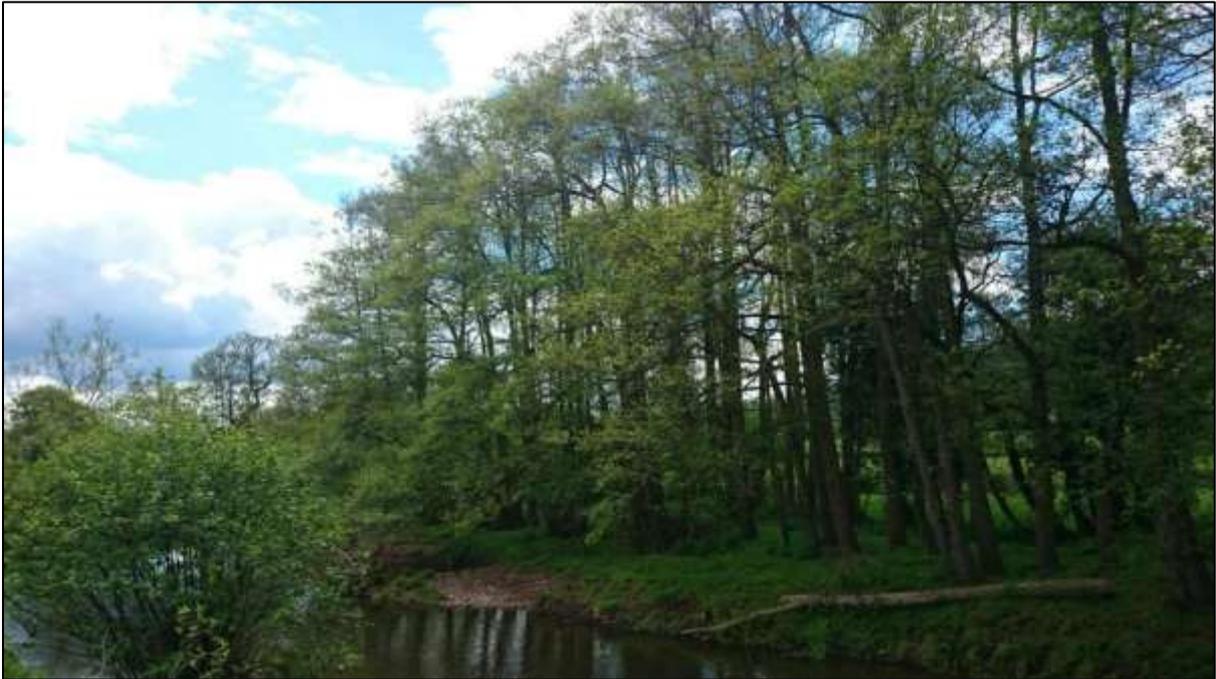
Light conditions within the straightened reach are also relatively uniform as a both banks are densely wooded with alder (*Alnus glutinosa*). The uniform height of the alders (Figure 10) suggest they may have colonised (or perhaps been planted to reinforce the banks) at the same time. The result is that the trees cast uniform shade over the river, further contributing towards the homogenous conditions in the reach. There is also a risk that they will start to fall at approximately the same time in the future.

Figure 10: The uniform height of the tree canopy casts uniform shade over the river

2. Introduce a greater diversity of light by implementing a 5-10 year rotation of tree works. Tree limbs and brushwood arising from these works could be used for bank protection or habitat enhancement structures
<http://www.wildtrout.org/content/how-videos#tree>

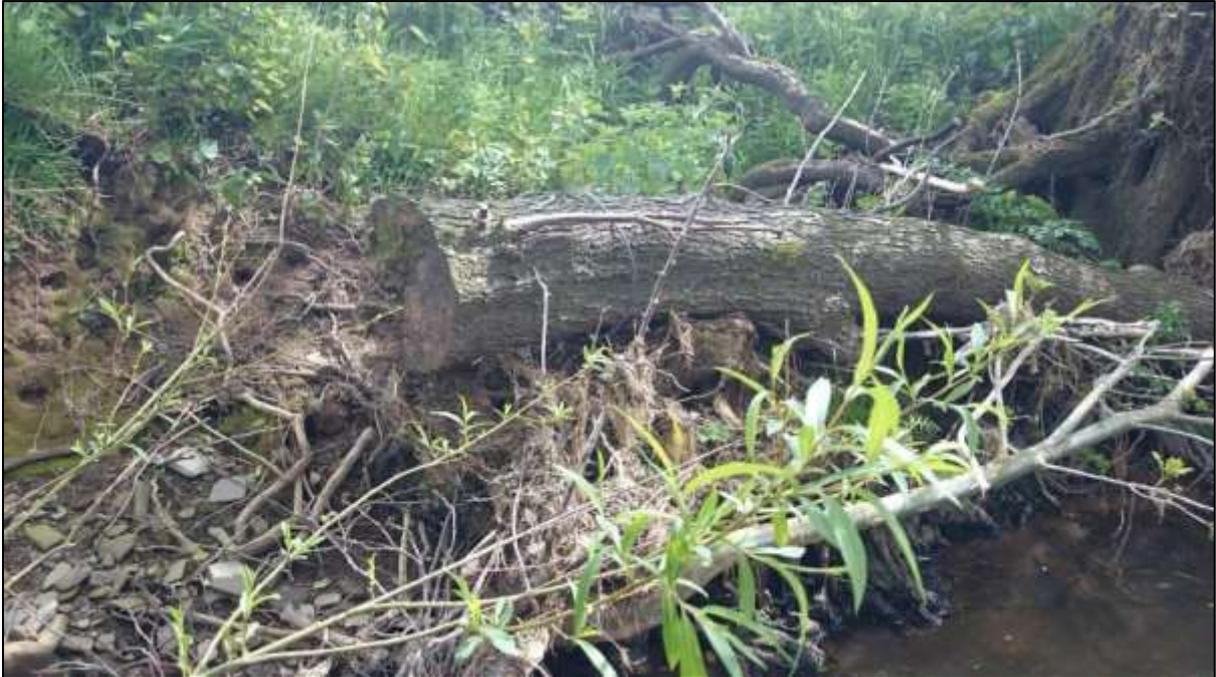
Figure 11: A felled alder secured with rebar and braided steel cable

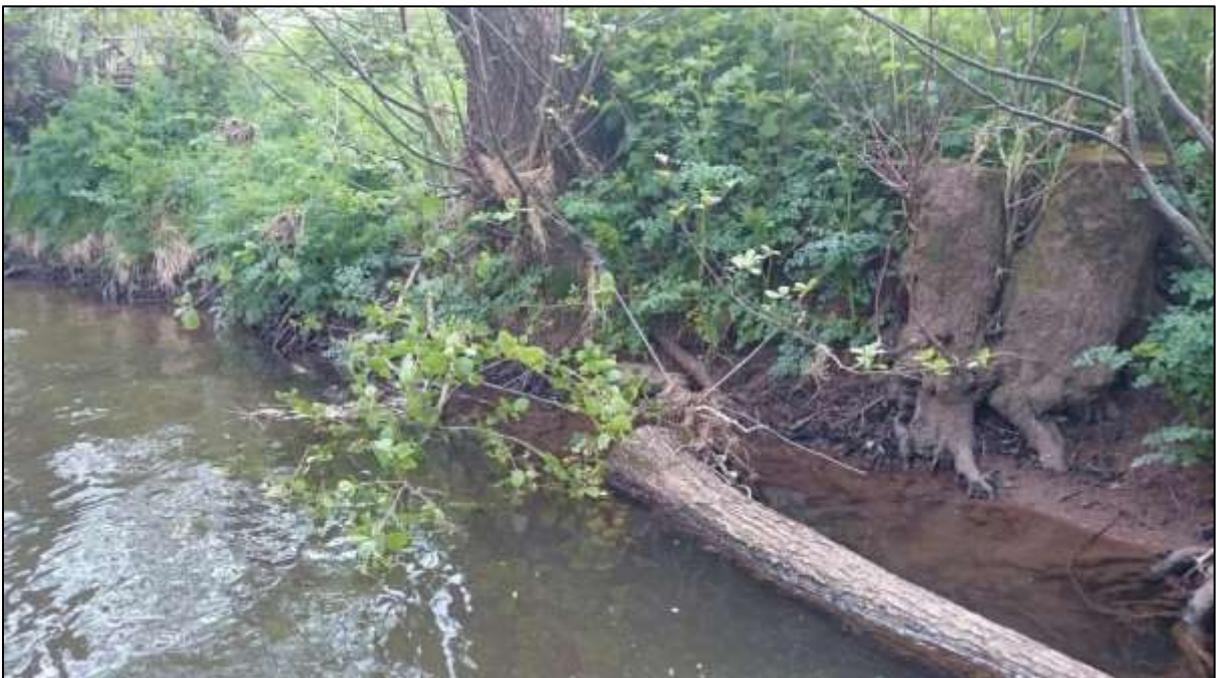
Figure 12: A felled alder cabled back to its stump

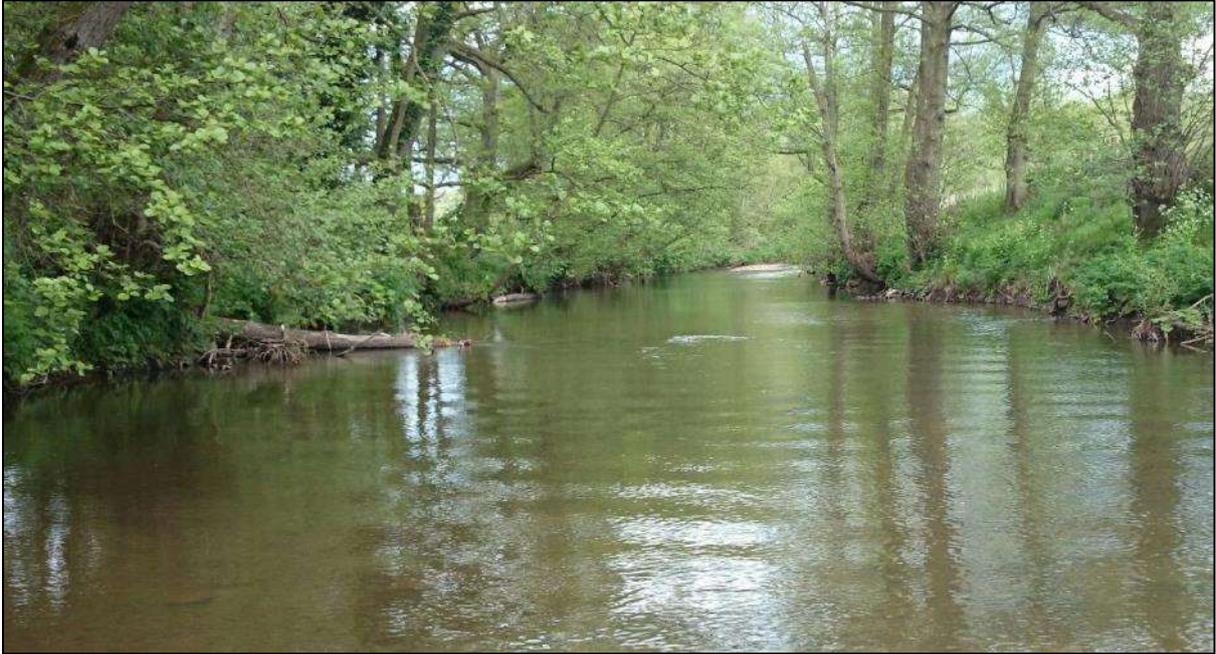
erosion and also provide some good marginal refuge habitat. One feature observed had been secured perpendicular to the bank (Figure 13). This feature is acting as flow deflector which has caused a small pool to be scoured in the bed. In the otherwise very uniform reach, this structure introduces some much-needed diversity.

Figure 13: An alder trunk secured perpendicular to the bank introduces some localised diversity

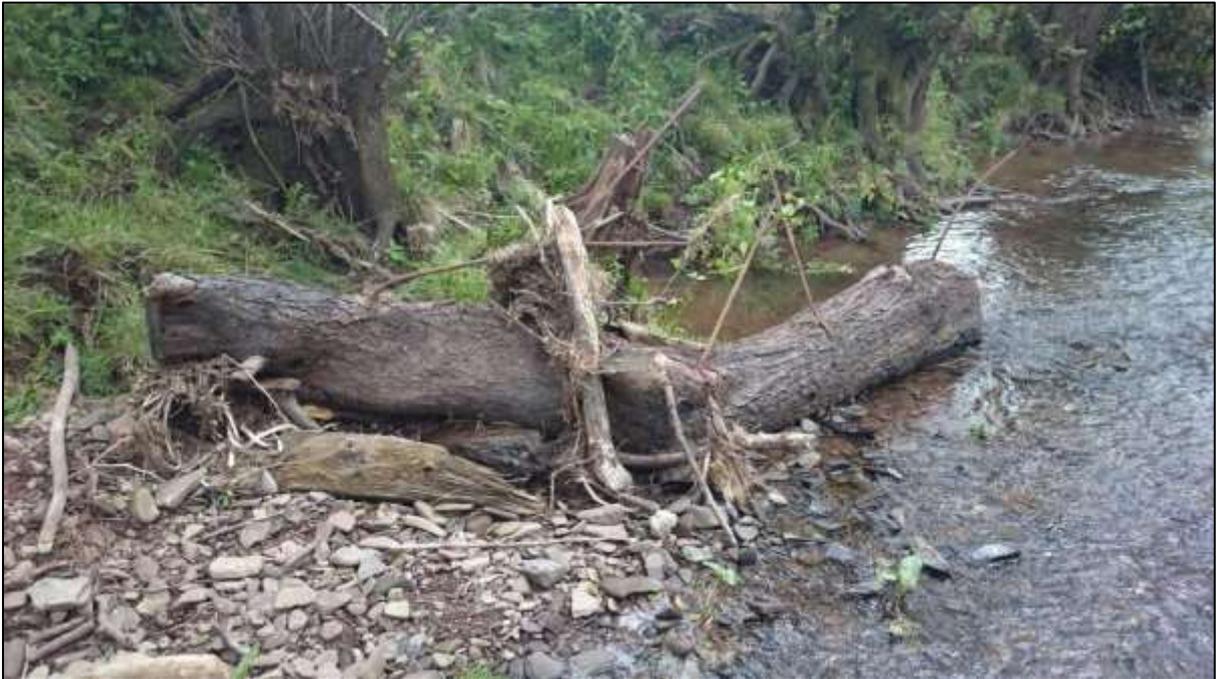
The habitat enhancements have mostly withstood the powerful spates of the Monnow. However, a large piece of LWD was spotted which had once been secured with at least five rebars. It had been torn from the bed during high flows and transported downstream (Figure 14). This emphasises the power of the force acting on such structures during big spates.

Figure 14: An LWD habitat feature has been torn from the bed despite being secured with at least five steel reinforcing bars

The fact that a piece of LWD meticulously anchored to the bed but *not* the bank was moved, and that LWD features attached to a well rooted stump (either by hinging or with cables) are still present, indicates that hinging and cabling (in combination with securing to the bed) are potentially the best practice techniques for this section of river.

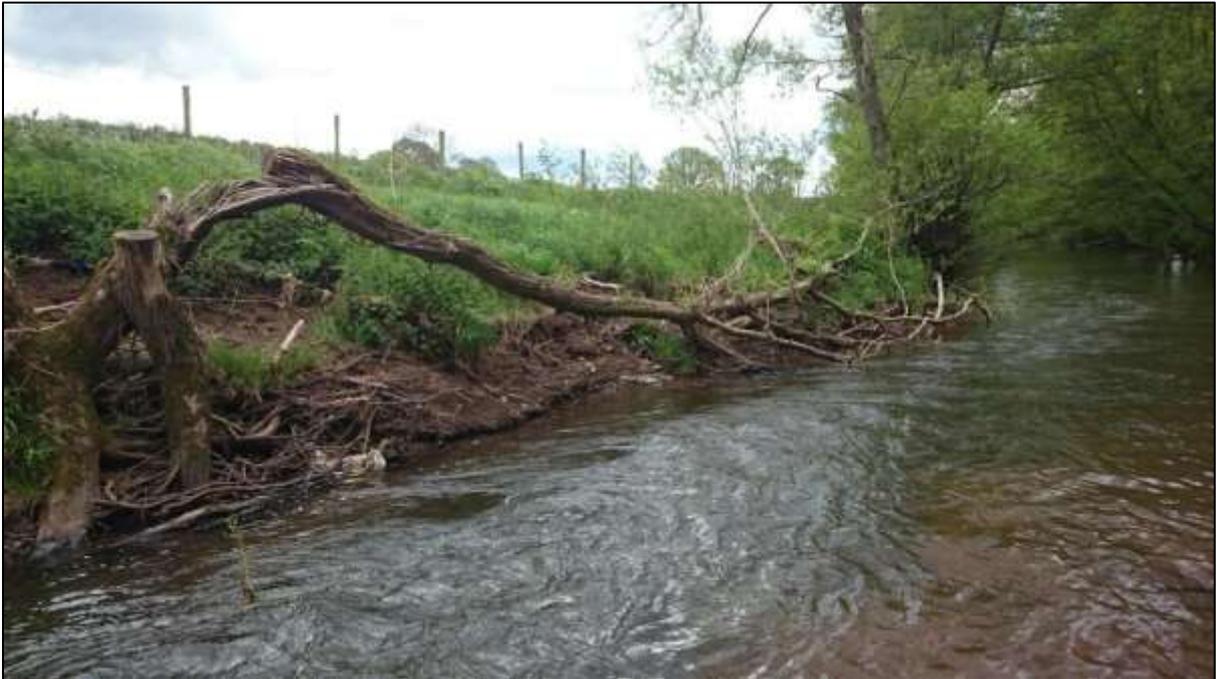
Another technique that has been used on the reach is 'hinging' of live willow (*Salix* spp.) trees (Figure 15). Instead of felling the tree completely, a cut is made approximately $\frac{3}{4}$ of the way through in combination with a vertical cut which allows the willow to be dropped into the river whilst remaining attached to its stump and roots. Willow is a robust genus of tree which (provided it has access to plenty of water) will normally survive the procedure and continue to grow.

Figure 15: A hinged willow provides some cover habitat and flow deflection

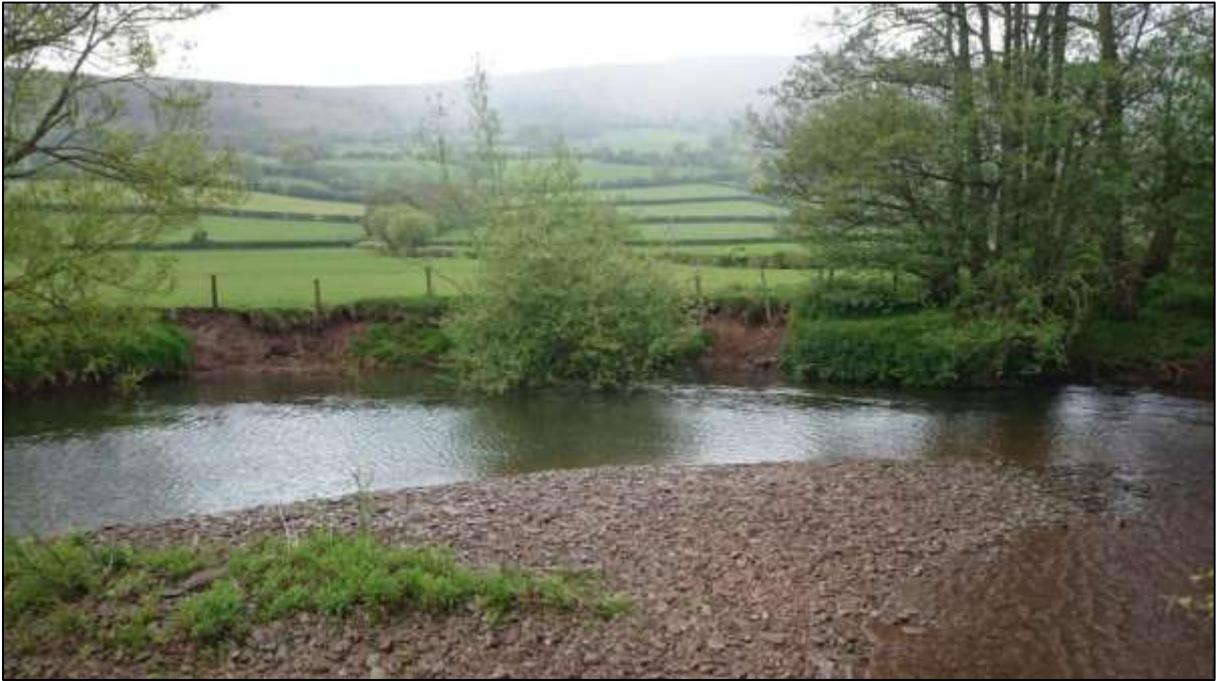
The LB is stock fenced throughout and there is a wide buffer strip between grazing land and the top of bank for most of the reach. However, the RB is not entirely fenced and much of the fencing present has been installed very close to or at the top of the bank. As a result the RB is generally steeper and less well vegetated, making it vulnerable to excessive erosion and less likely to be retained to form a re-graded bank if it does slump (Figure 16). Of even greater concern is that cattle from RB can access and cross the river and damage the LB (Figure 16).

Figure 16: A fence line too close to the river allows grazing and soil compaction to weaken the top of the bank leading to erosion and block failure.

1. Engage with land owners/tenant farmers on the Right Bank and explore options to improve land management regarding the river. Ideally, the bank should be stock-fenced at least 3 metres back from the top of the bank with gated access so that cattle can graze the buffer once or twice a year to manage bankside vegetation and retain biodiversity.
(https://www.youtube.com/watch?v=00tcTY_UEk4)

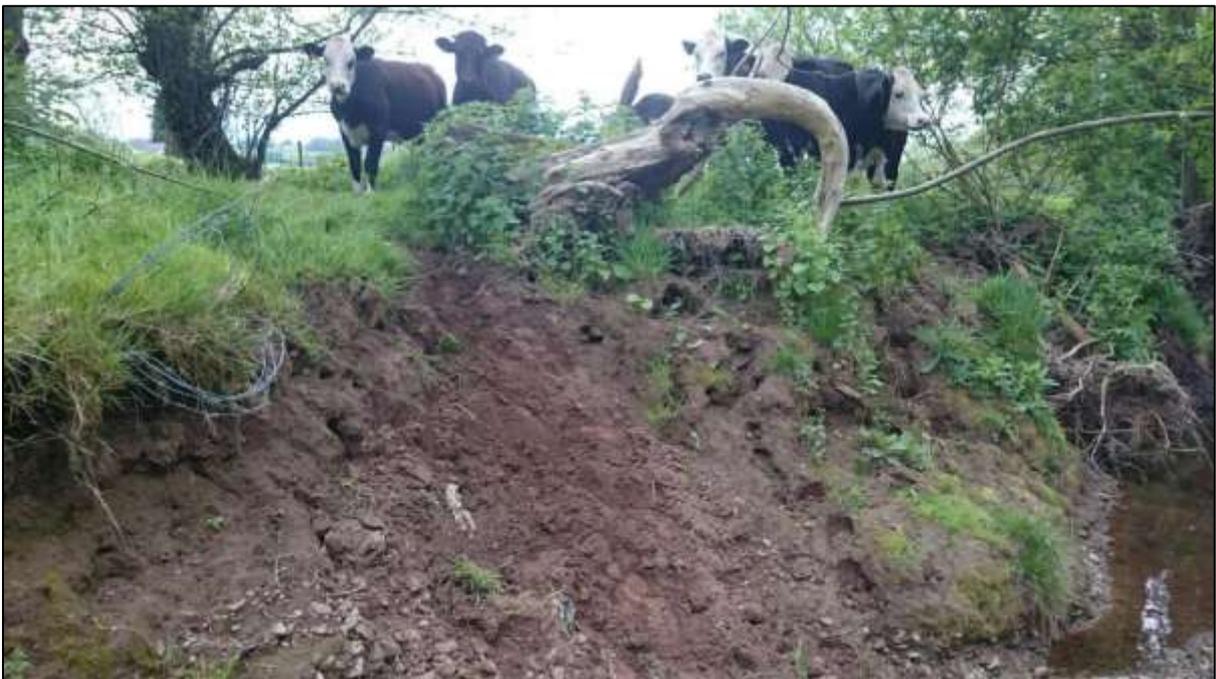
Figure 17: The impacts of the cattle that cross the river are concentrated between the top of bank and the LB fence line causing severe erosion in places.

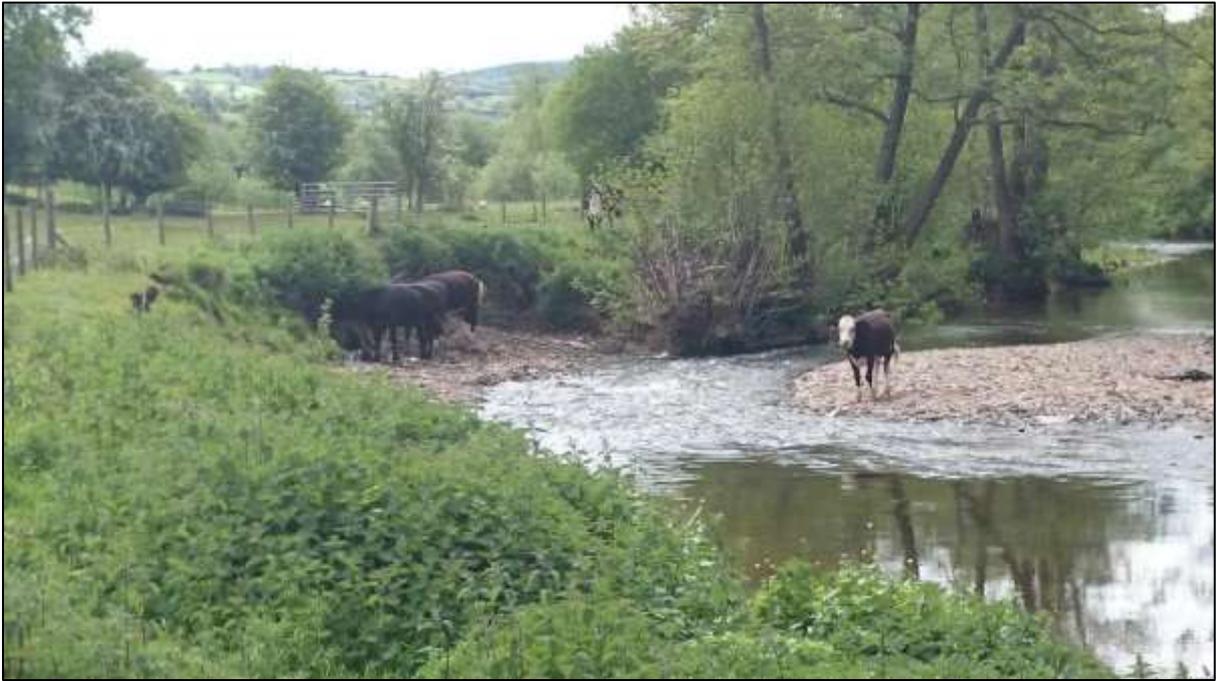
At SO 33198 23671 the LB is severely eroded and beginning to cut behind a stand of alder. The cattle accessing the river are significantly exacerbating the problem (as shown in Figure 18). The root cause of the erosion is probably the energised flows which have also caused the development of a point bar mid channel (also Figure 18).

Figure 18: Cattle trampling and grazing the bank are exacerbating the problem but a mid-channel point bar (right of image) is the main cause of the erosion

The point bar is situated on the riffle downstream of the first deep pool at the downstream extent of the straightened reach. It is reasonable to infer that material is deposited here as a result of increased flow speeds through the straightened reach scouring out the pool. Straightening rivers also shortens them which in-turn increases the bed gradient. The steeper gradient in combination with a lack of in-channel friction (normally provided by an uneven bed and natural woody debris) results in fast, energised flows.

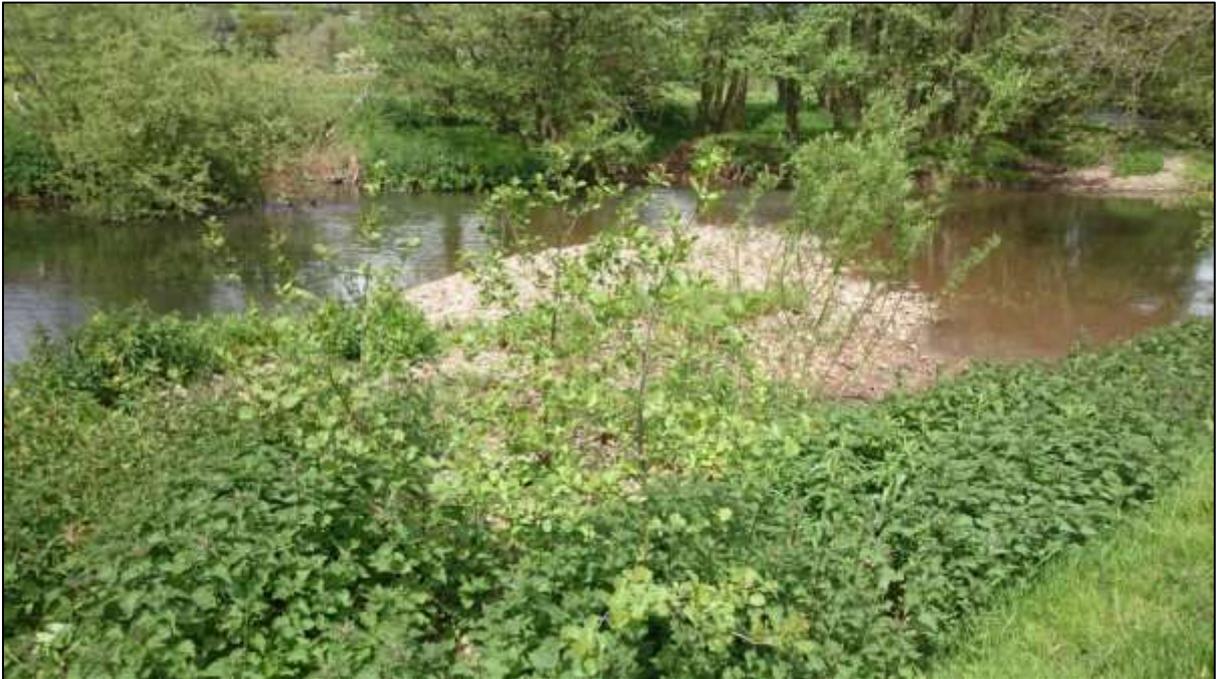
A short distance upstream the bank is well-protected by new growth sprouting from hinged willows and some young alder saplings growing on the lower bank (Figure 19). Tree roots and branches help to locally slow flows during spates, reducing erosion and even creating areas of deposition. This principle can be used to help protect the bank. This is explored further in the *Recommendations* section.

Figure 19: Willow and alder saplings help protect the bank upstream

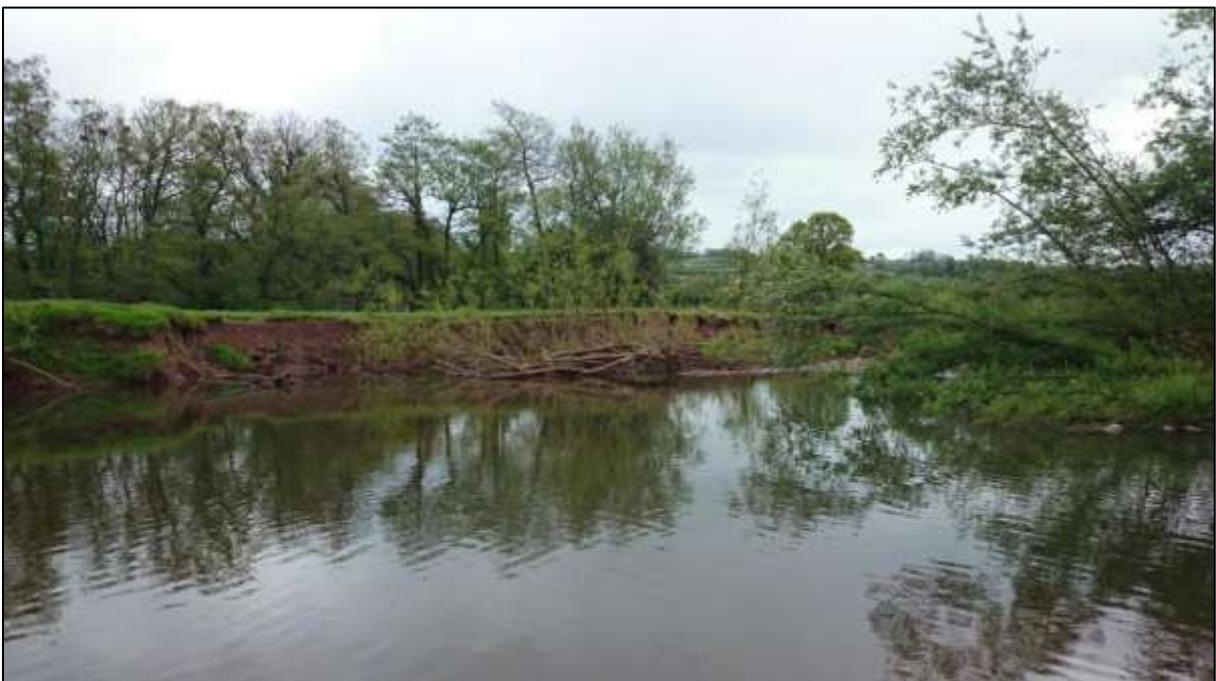
At SO 33156 23482 the river bends sharply to the left. A deep pool has been scoured on the outside of the meander and the arising bed material deposited into a long riffle immediately downstream. At the tail end of the riffle the river turns through a series of sharp meanders. Despite numerous willows helping to hold the bank together (Figures 20 and 21), the forces acting against the banks during high flows have caused substantial erosion.

Figure 20: Despite numerous willows, the banks within the sharply meandering reach are heavily eroded.

3. In areas where excessive erosion is deemed to be a problem, brushwood won from on-site tree works could be used in combination with live willow to stabilise the bank (see example Figures 19 and 20). Densely-packed brushwood is very effective at absorbing energy from the flow and locally slowing water velocity, this in turn encourages deposition of sediment. Live willow 'whips' (thin, straight sections) and live willow stakes driven into the bank will, if successfully planted, continue to grow and strengthen with time. Willow whips and stakes can probably be won from existing bankside willows.

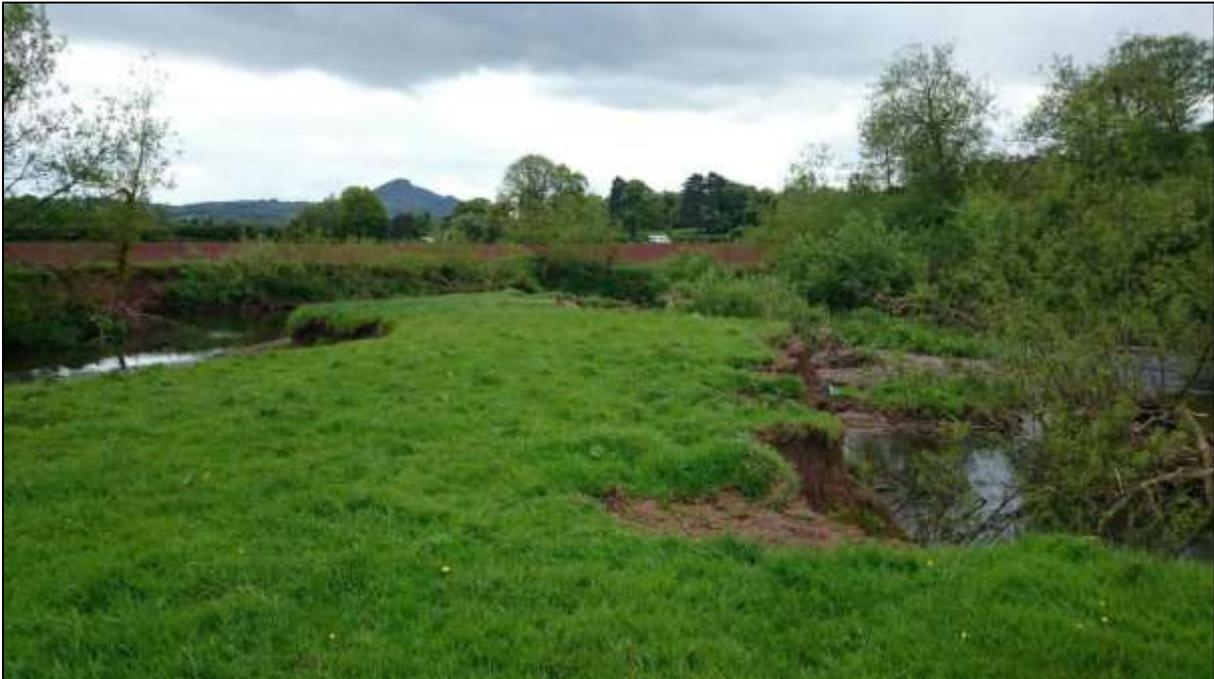
Figure 21: The tight meanders have almost cut-off an outcrop

The tight meanders are probably the result of the river adjusting to the increased gradient of the river locally brought about by the river being straightened. As well as being straightened upstream, it is quite possible that the river was straightened downstream to facilitate the operation of the old corn mill and to protect the road bridge.

In the future, the growing meanders either side of the narrow strip of land shown in Figure 21 will probably intersect and cut-off a meander loop, effectively creating an island. Whilst actions can be taken to delay this event, the benefit of retaining access to such a small outcrop of land is unlikely to equate to the cost of protecting it. So long as no properties or infrastructure are threatened by the

On the RB on the outside of the meander shown in Figure 21, the field is used for intensive arable agriculture and in wet weather this is likely to be a point source of fine sediment into the river. Whilst the present rate of bank erosion in this reach constitutes a source of excess fine sediment into the watercourse, the ploughed field represents an additional source of sediment loading from the floodplain. This is highly likely to be a source of excess nutrients, potentially fuelling in-channel algal growth and impacting on trout spawning success. .

erosion, the best option may be to allow the river to naturally adjust and keep an eye on how the river changes as a result.

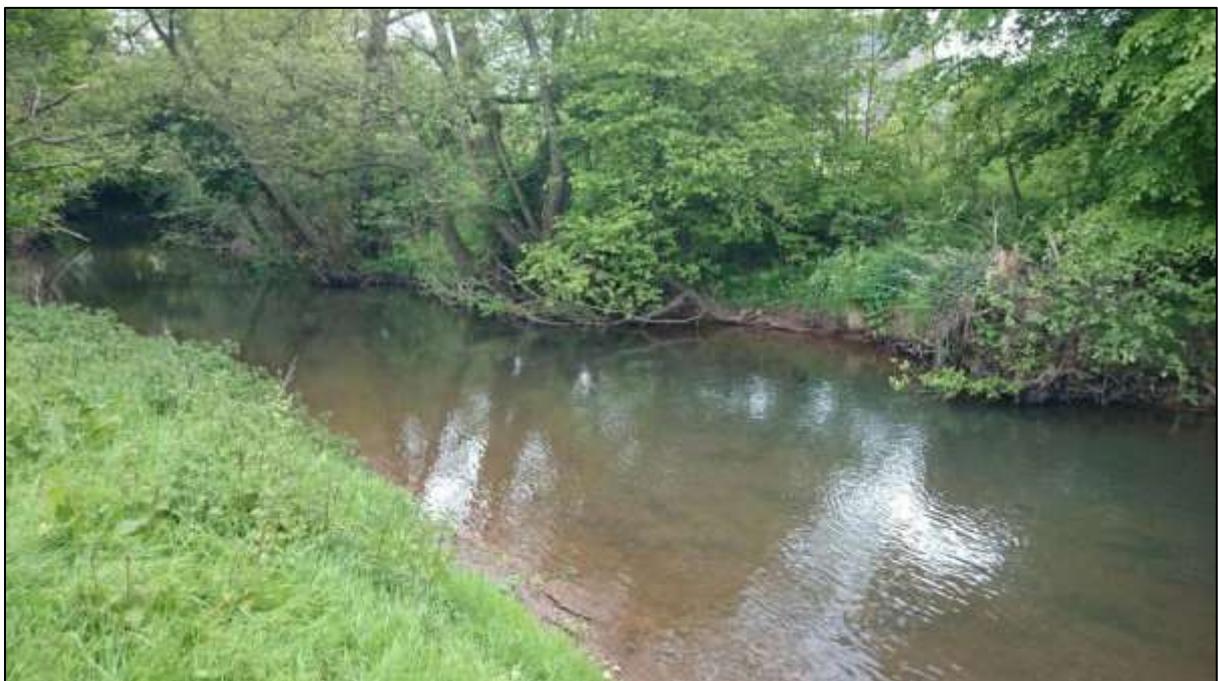
Downstream of the meandering reach, the river becomes straighter and flows become once again uniform and laminar towards the road bridge and the downstream boundary of the ownership. Despite this there is a good variation in depth and an abundance of overhead cover and refuge habitat (Figure 22).

Figure 22: Despite the river becoming straightened again towards the road bridge, good depth variation and an abundance of cover habitat has been retained

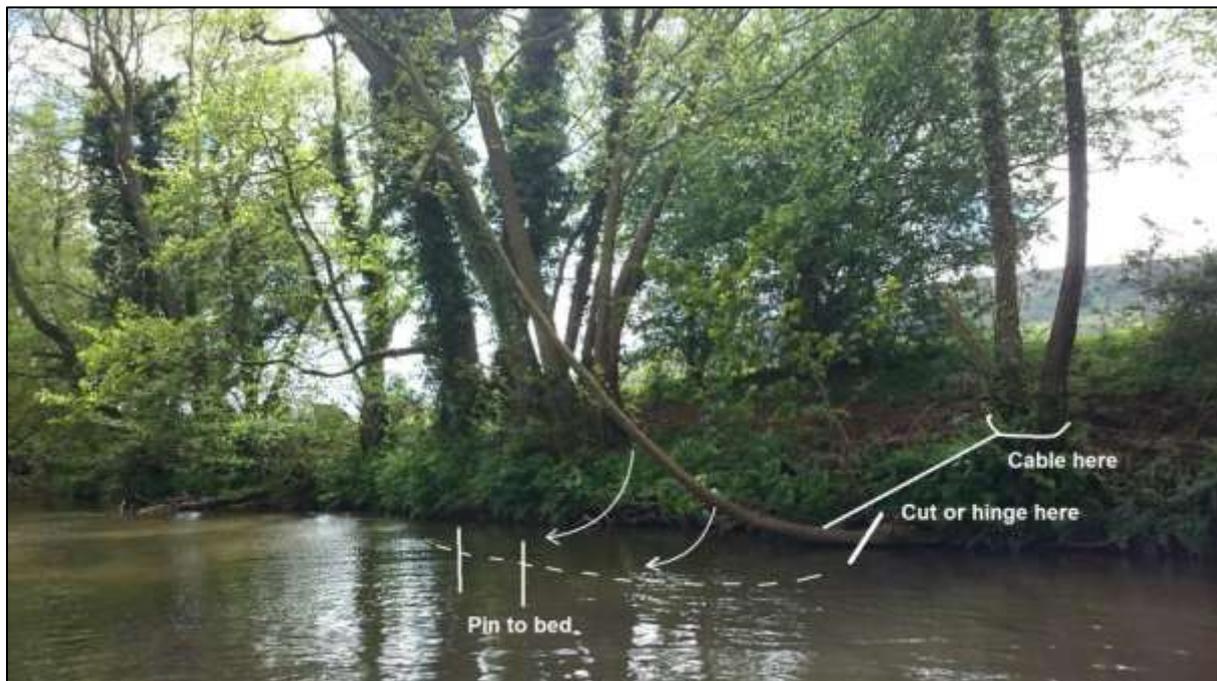
Figure 25: An example of an opportunity to introduce additional woody debris cover habitat
