**Walkover Habitat Survey**  
**Nettleham Beck, Lincolnshire**  
**November 2016**

This report is the output of a site visit undertaken by Tim Jacklin of the Wild Trout Trust to the Nettleham Beck, approximately 5km north east of Lincoln, on 28<sup>th</sup> and 29<sup>th</sup> November, 2016. Comments in this report are based on observations on the day of the site visit and discussions with Marie Taylor (Lincolnshire Rivers Trust) and David Hutchinson (Environment Agency).

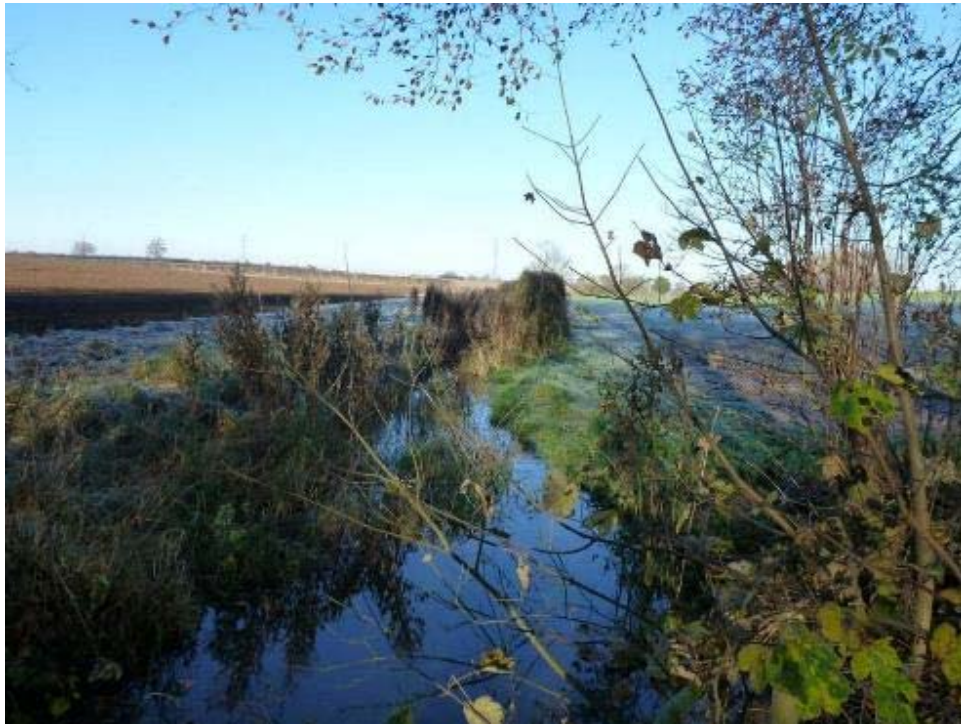
**Photo 1 View upstream towards spring source of the Beck, on land owned by University of Lincoln and tenanted for agriculture.**

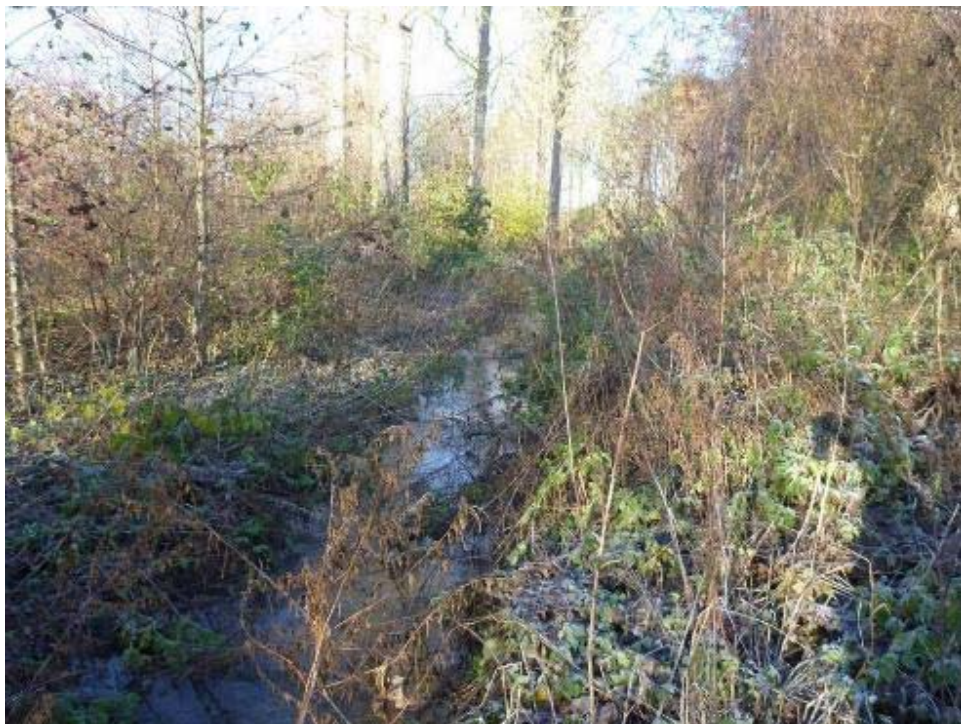
The beck rises above the Riseholme Campus and flows through agricultural land before entering a woodland area, then two online lakes (Photos 1 – 5). The channel through the woods is artificially straight but connected to its floodplain and there may be opportunity here to create wet woodland habitat as part of the stewardship scheme which is in existence.

**Photo 2 Woodland area upstream of Riseholme lakes. Straight channel but good connectivity to floodplain.**

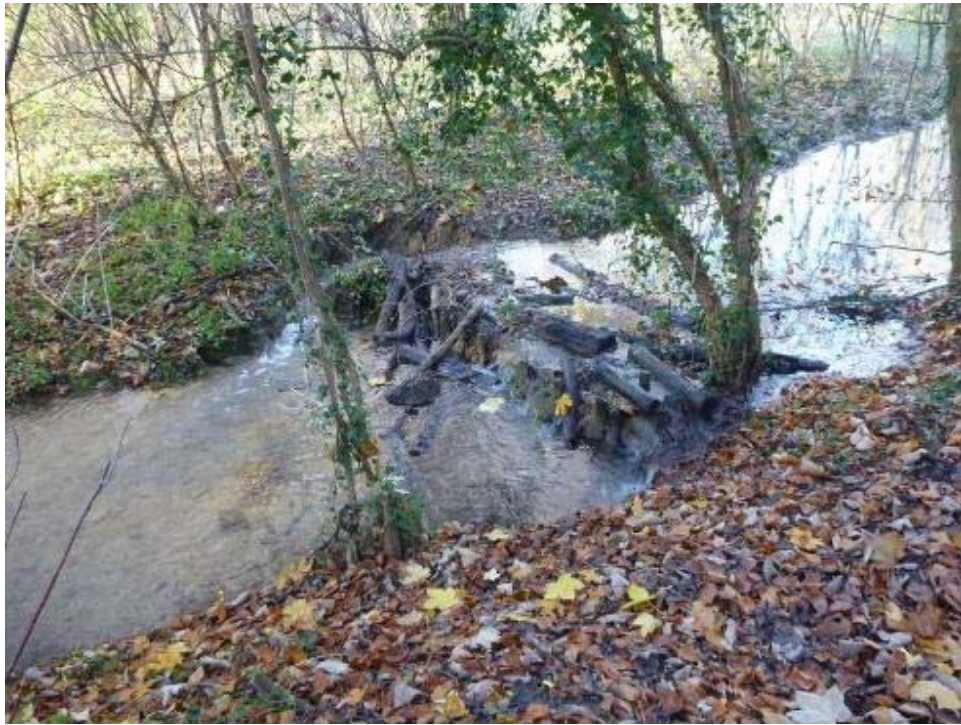
**Photo 3 As above, impoundment.**

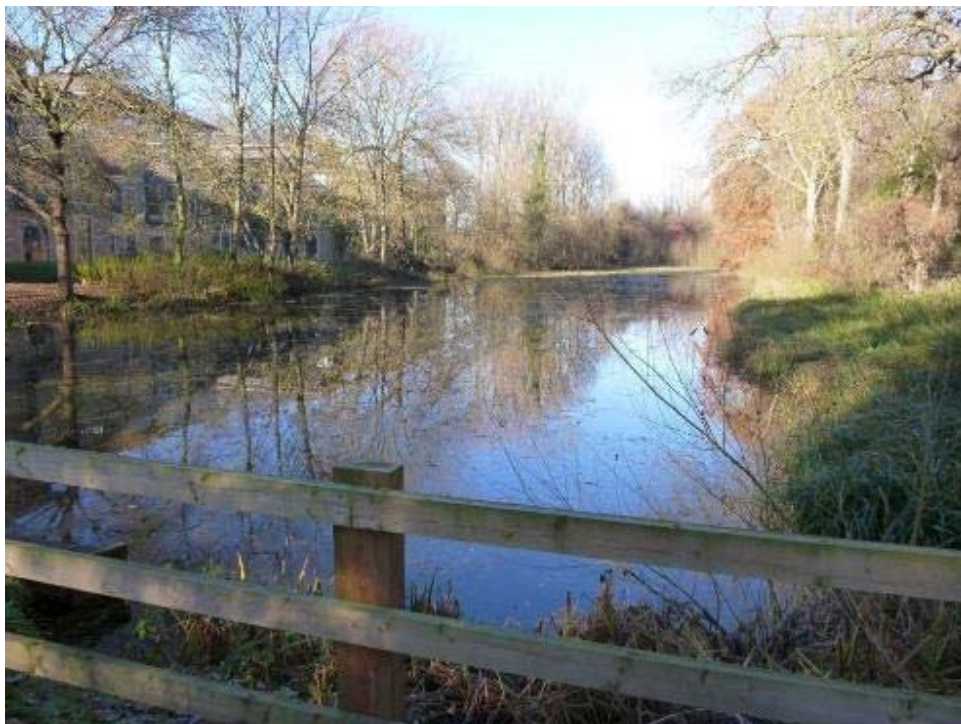
The upper lake appears heavily sedimented with abundant aquatic vegetation. This is an inevitable consequence of an online lake and periodic maintenance to remove sediment is required to prevent habitat succession to wetland and ultimately terrestrial habitat. The upper lake currently acts as a sediment trap for the lower lake. Diverting the beck around the lakes would greatly reduce the rate of sedimentation, but it is a project beyond the scope of the current Limestone Becks initiative.

**Photo 4 Upper lake, Riseholme campus**

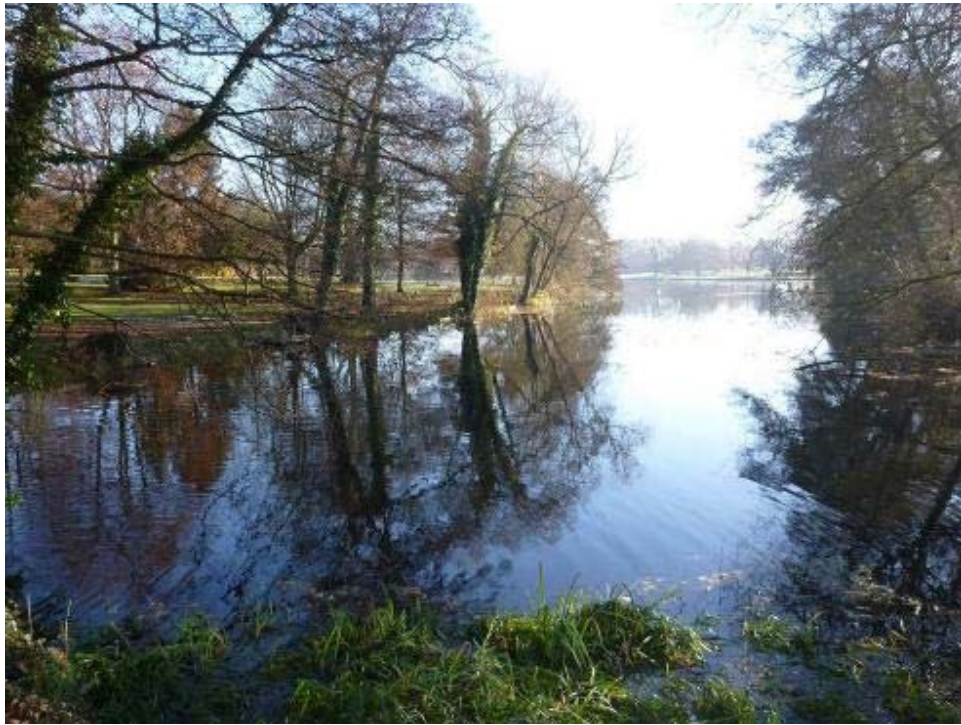
**Photo 5 Lower lake, Riseholme campus**

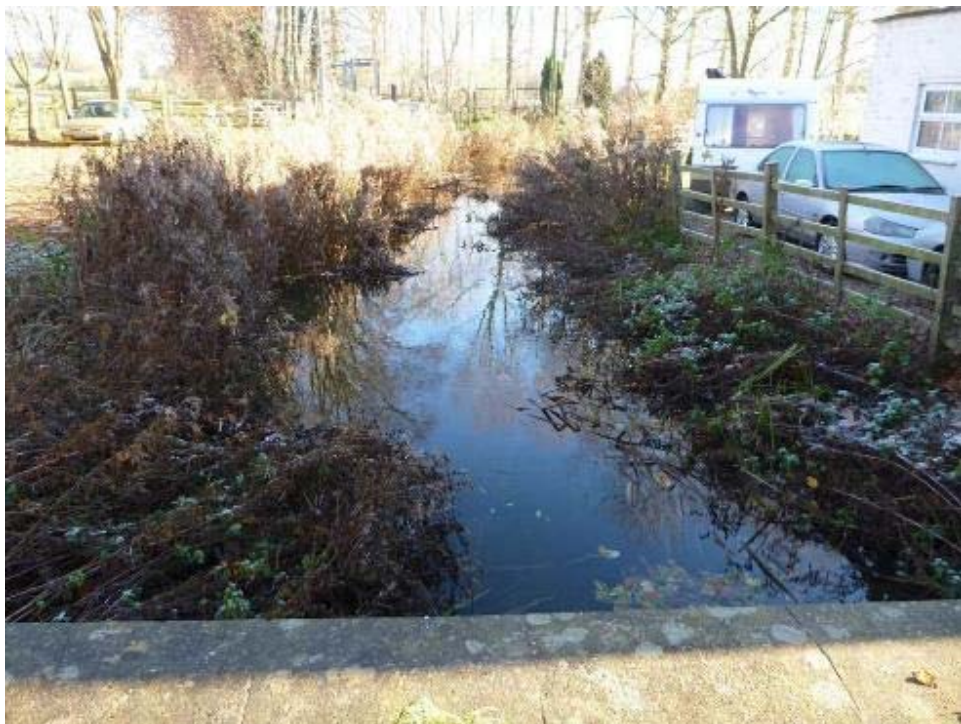
Downstream of the large lake, the beck is impounded by a weir above the former fish farm site (Photos 6 – 9), then there is a 200-m section down to a lower impoundment (former sluice). The beck between these impoundments is over-wide, silty and choked with aquatic vegetation. This section has potential for tree thinning and channel narrowing; removal or lowering of the impoundments is also possible.

**Photo 6 Impounded section upstream of former fish farm weir, Riseholme campus**

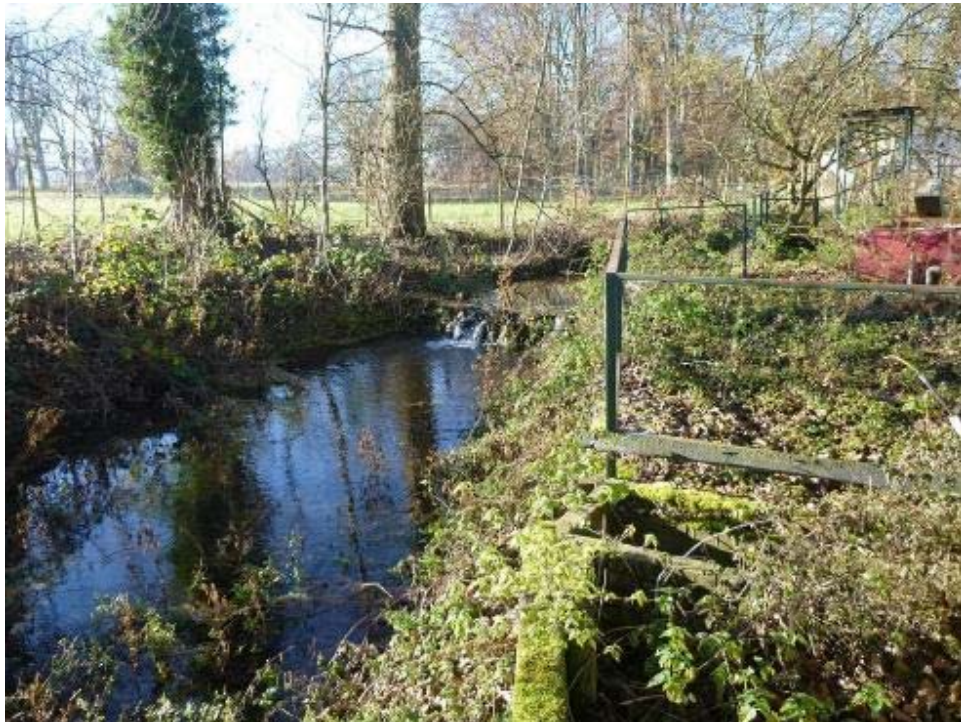
**Photo 7 Former fish farm weir, Riseholme campus**

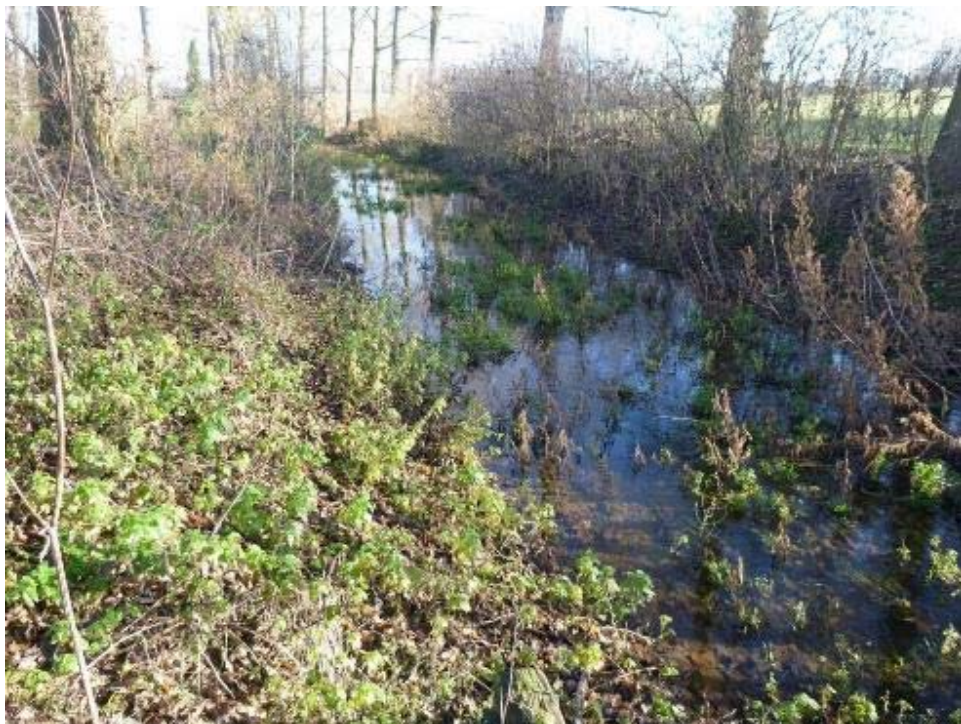
**Photo 8 Alongside former fish farm, Riseholme campus**

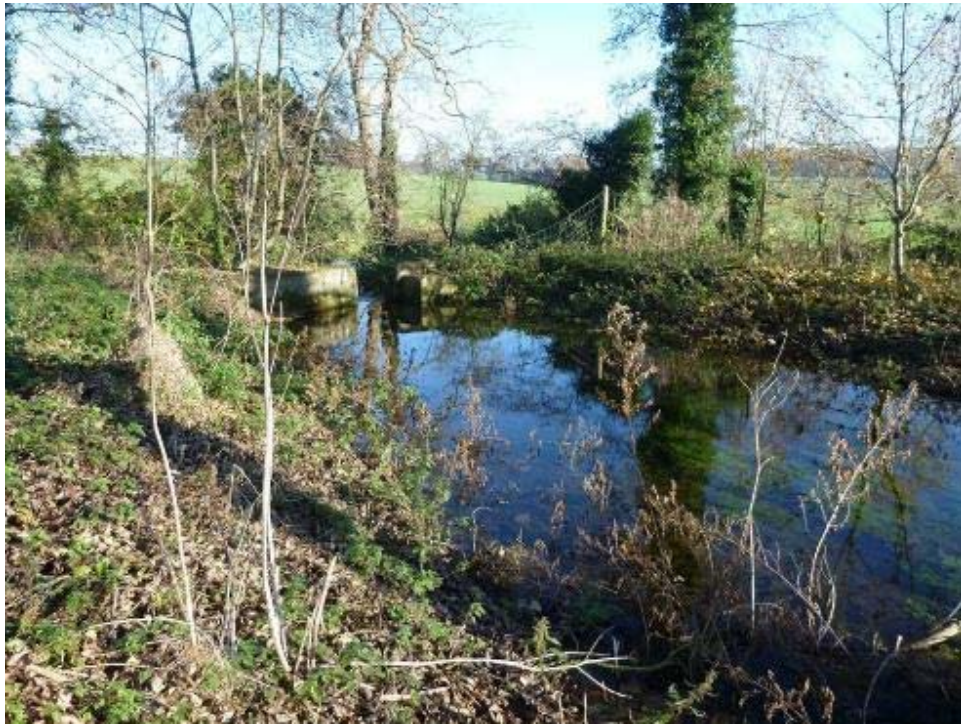
**Photo 9 Sluice structure (boards removed) at downstream end of former fish farm site.**

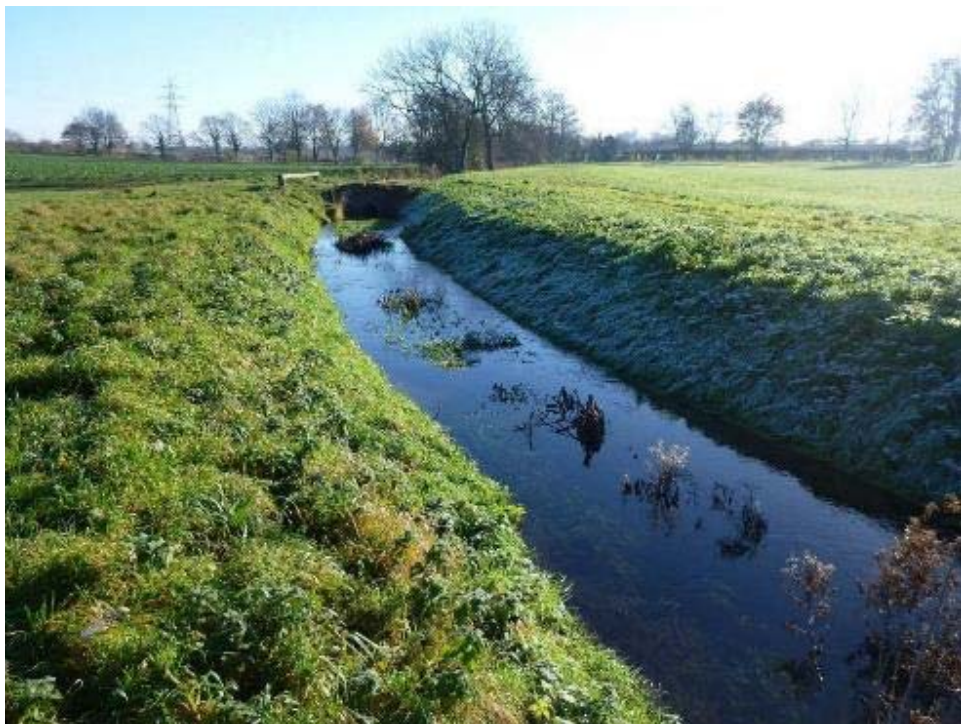
Between Riseholme Campus and Riseholme Road, the beck runs through agricultural land and is maintained for land drainage (Photo 10). Creating a two-stage channel may be possible here. Liaison with the body currently maintaining the channel is essential. Downstream of Riseholme Road, there is an 820-m section to the A46, which is also maintained for land drainage and is straight, incised and very open and has a perched culvert under a farm track (Photos 11 – 12). There is possibly opportunity here for naturalising the beck by re-meandering; this would be dependent on the availability of land and agri-environment incentives going forward.

**Photo 10 Between former fish farm and Riseholme Road**

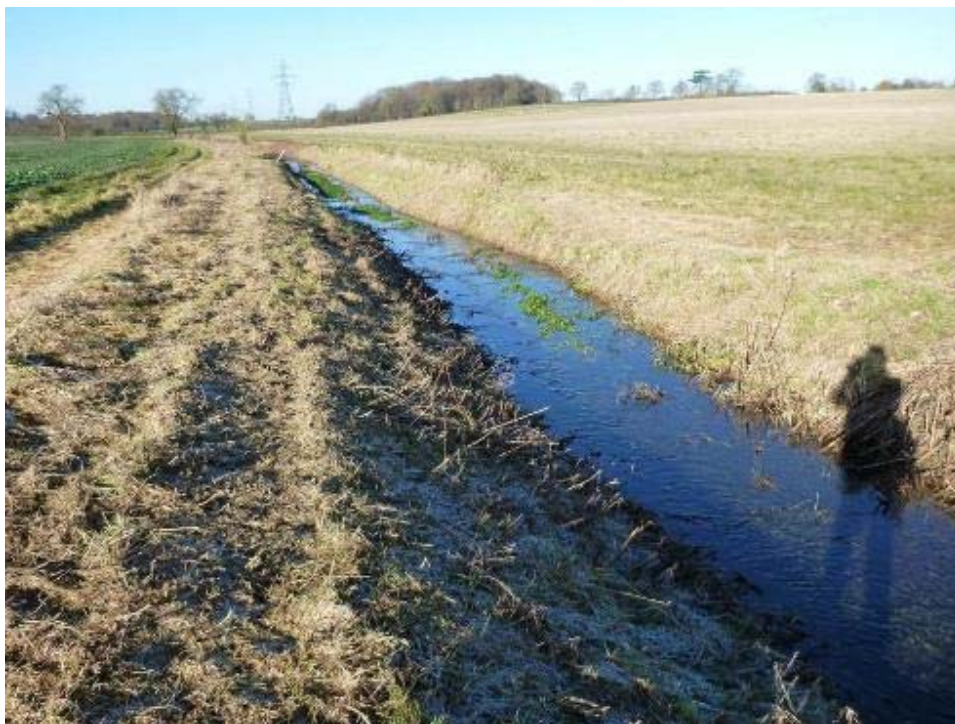
**Photo 11** Downstream of Riseholme Road towards A46. A straightened channel maintained for land drainage.

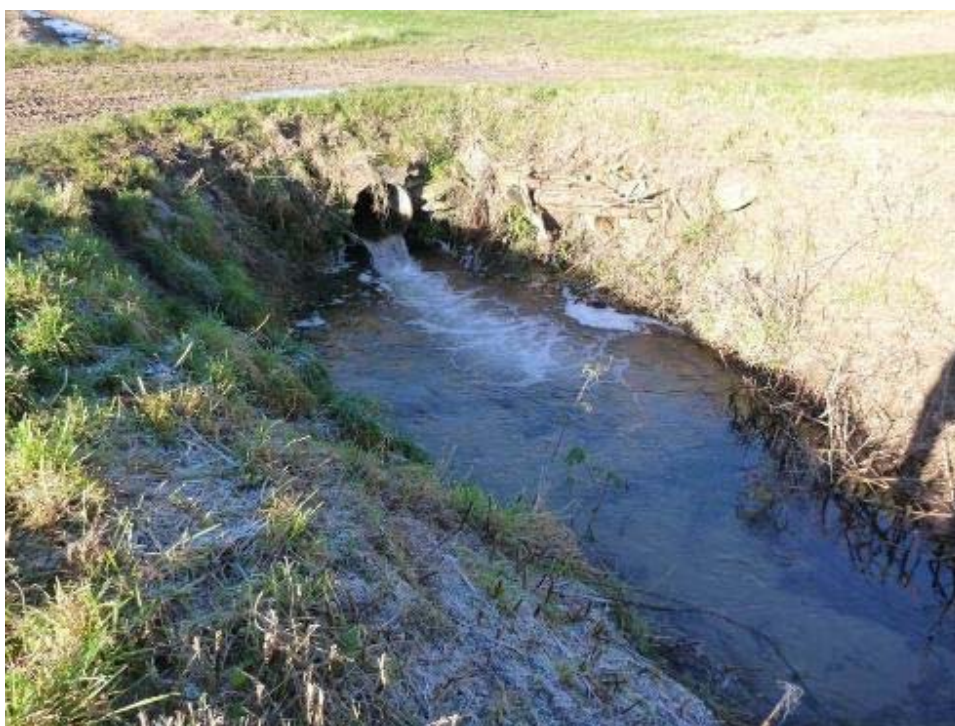
**Photo 12** A perched culvert on the reach downstream of Riseholme Road towards A46, which presents a barrier to free fish movement. Ideally this should be replaced with a much larger pipe/box culvert set well below river bed level to ensure continuity of the natural river bed.

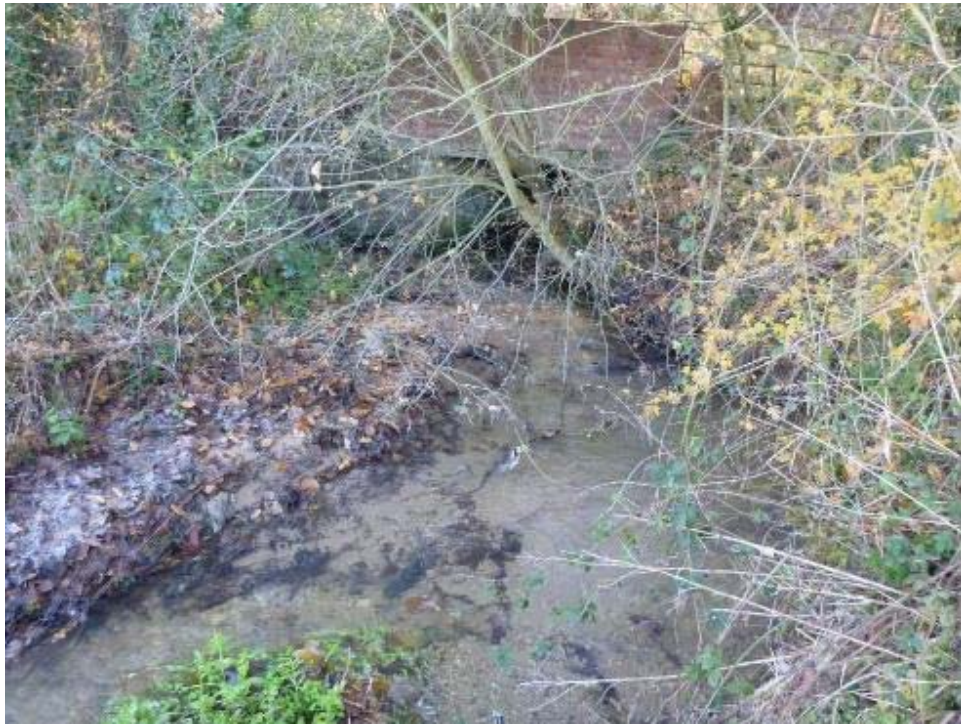
**Photo 13 Downstream end of culvert under A46 and confluence of the Roaring Meg tributary**

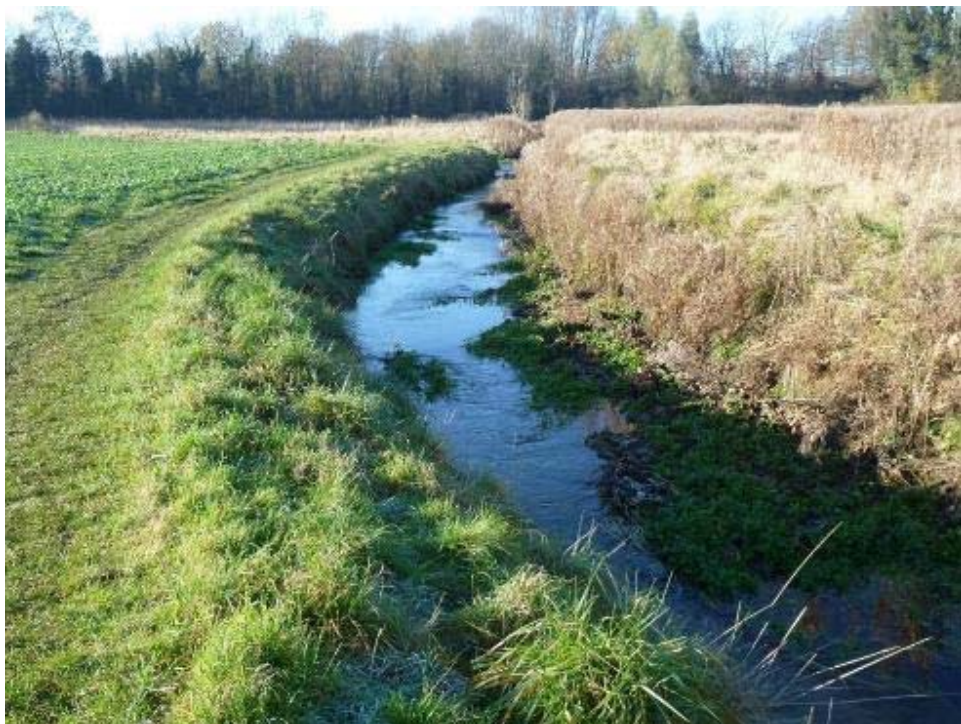
**Photo 14 Downstream of A46, upstream view. A permanent spring joins the Beck here on the true RHB, left of picture. The Beck has been less intensively maintained here and is recovering some sinuosity, through formation of low berms.**

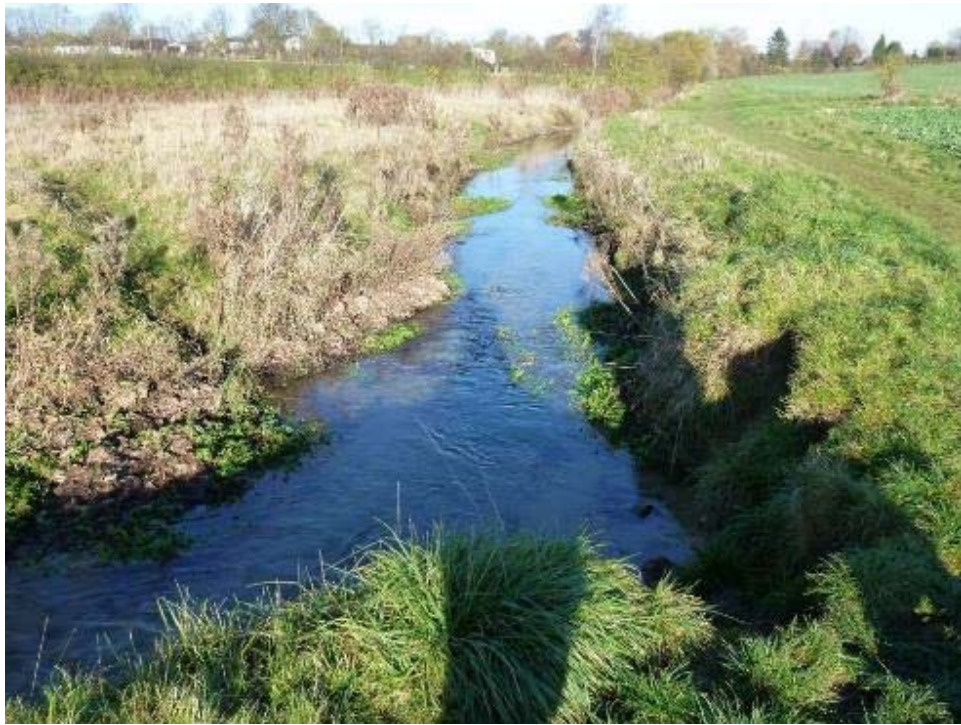
**Photo 15** As above, downstream view. Land on the left bank here does not appear to be used for agriculture, so there may be potential for creating meanders there.

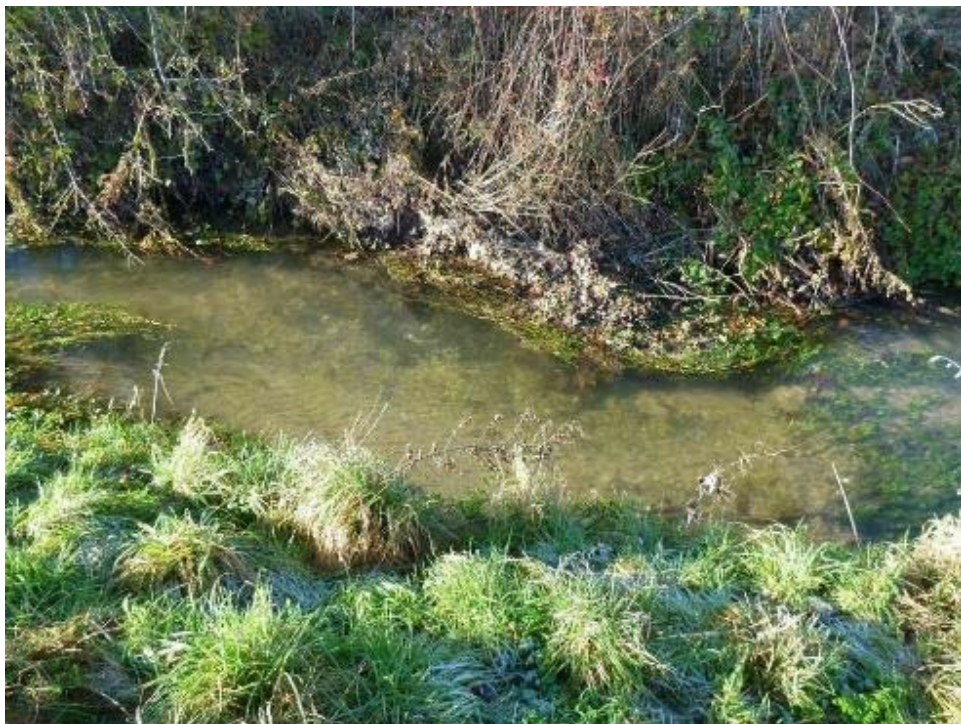
**Photo 16** Some reasonable instream habitat is present in the reach downstream of the A46, with bed scour, depth variety and sorting of substrate. This is a product of the lighter maintenance of this reach.

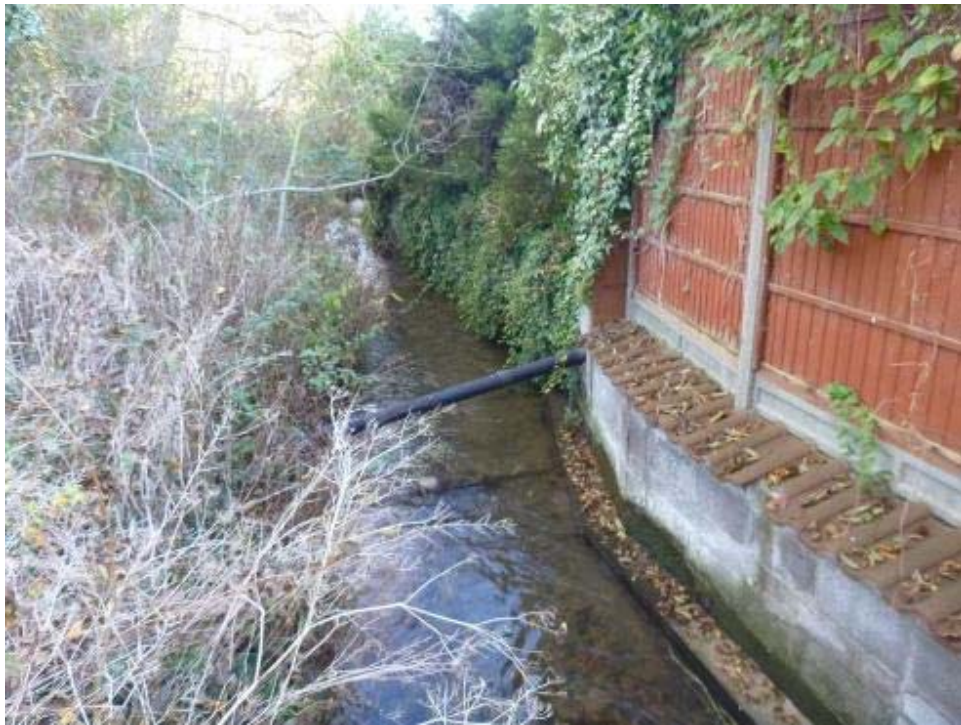
**Photo 17 Upstream of the former water mill, the channel is narrower, deeper and steeper gradient.**

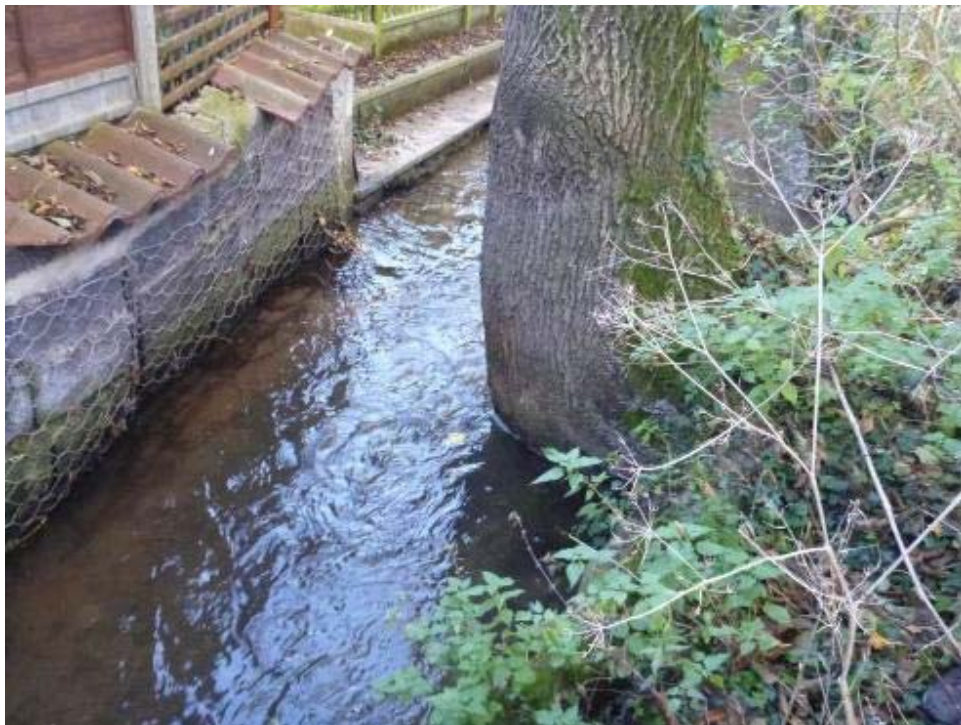
**Photo 18 A rare deeper area formed by bed scour between the bole of the tree and the hard bank revetment. This gives an indication of the degree of channel narrowing necessary to create deeper water features.**

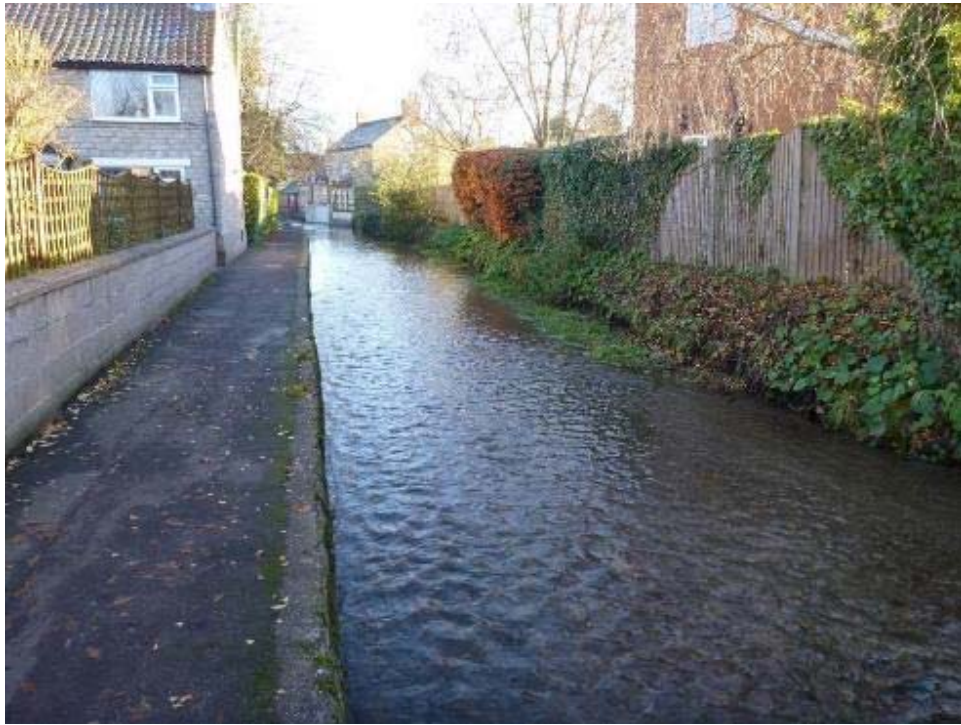
**Photo 19** Downstream of water mill and ford in Nettleham. The channel is maintained artificially wide to increase conveyance of higher flows. The natural tendency of the river is to narrow itself; note the vegetated berms which have formed on the far bank.

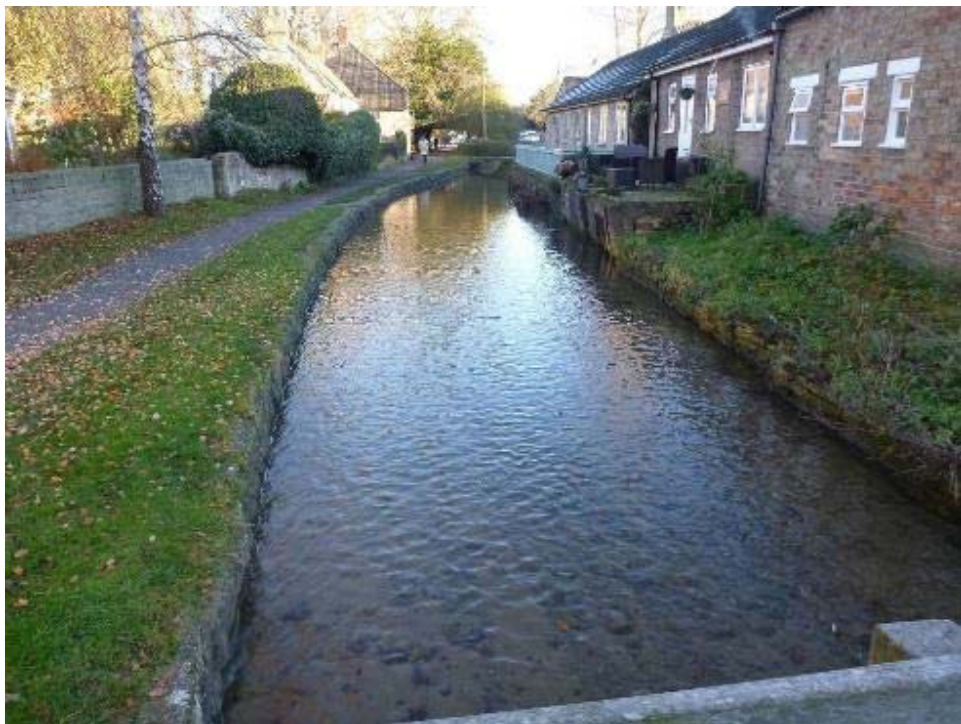
**Photo 20** Wide channel within Nettleham.

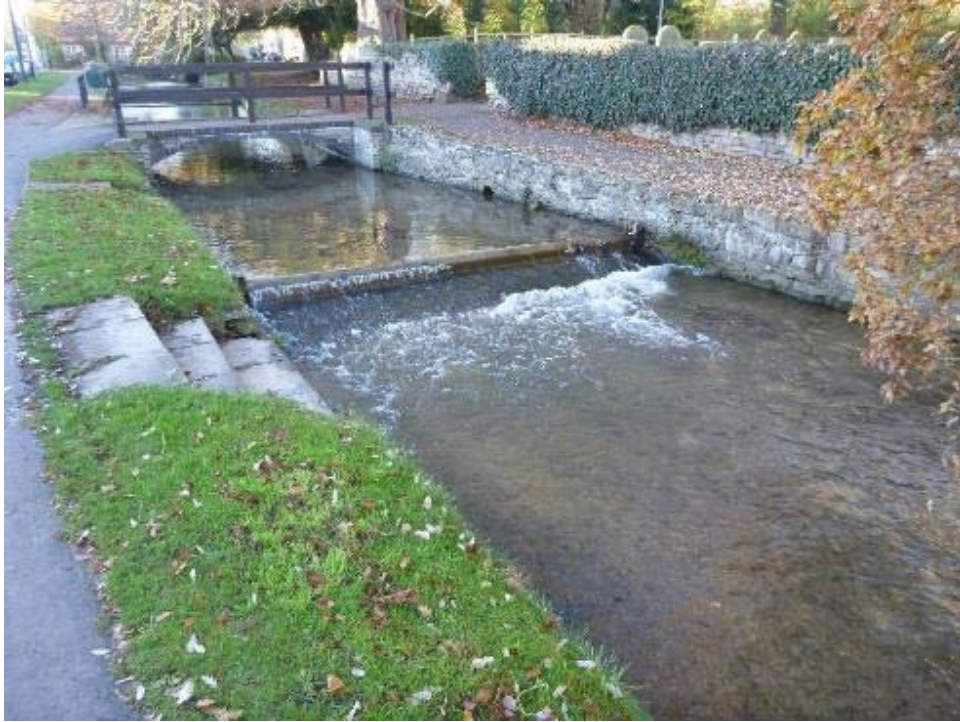
**Photo 21** One of a series of low weirs in Nettleham, designed to retain water levels in the over-wide channel at times of low flow.

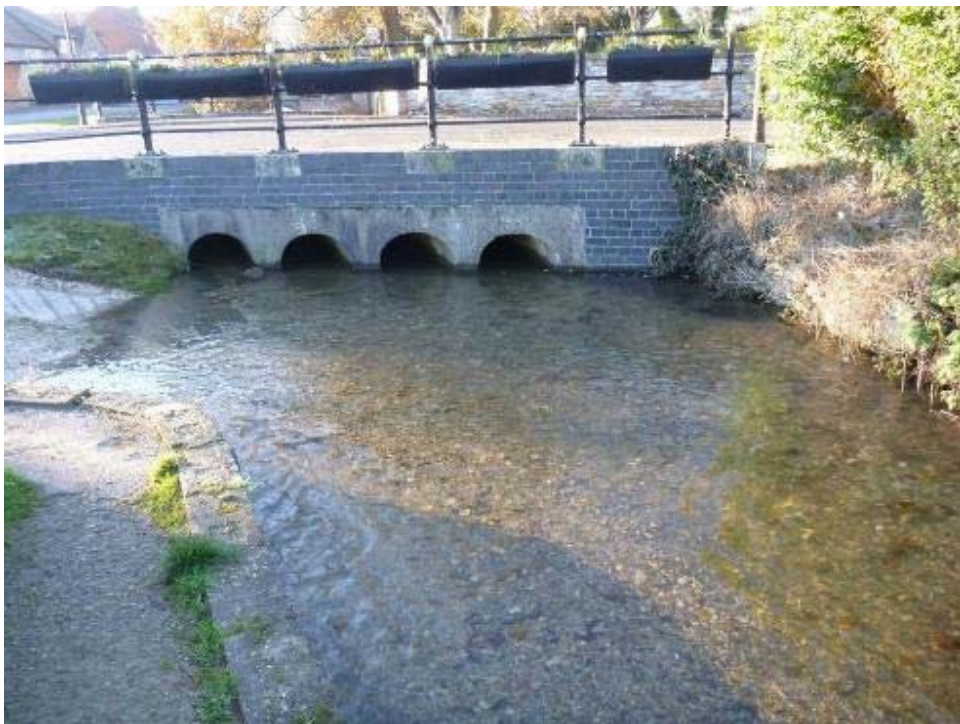
Limited capacity bridge culverts can be more significant bottlenecks on conveyance than channel capacity (Photos 22 and 25). The Faber Maunsell report into the June 2007 flood in the village noted, 'It is also considered that the lack of capacity of various culverts along the Nettleham Beck may also have been a contributing factor.'

**Photo 22** Narrow bridge culverts can act as a pinch point and back up water at times of higher flow, potentially increasing flood risk.

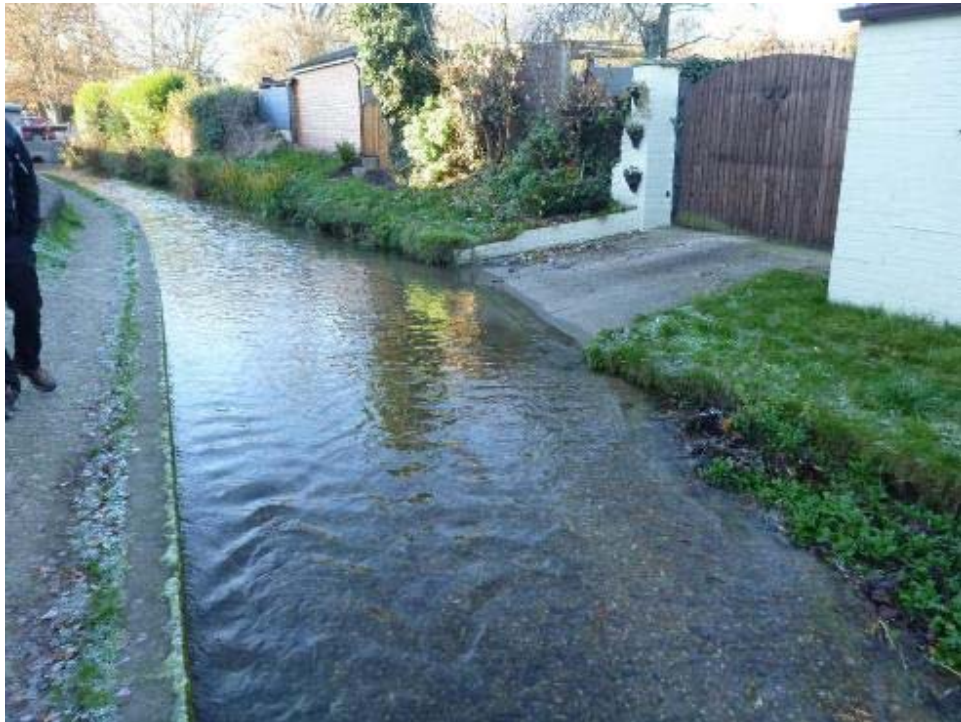
**Photo 23** At this point, the beck is a vehicular access route to a residential property.

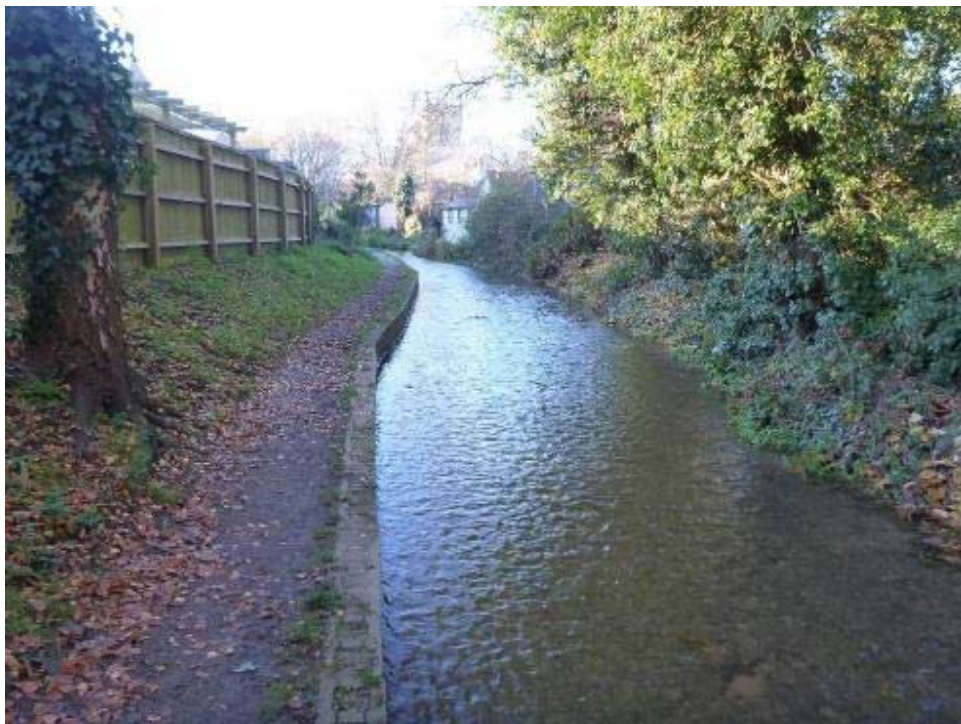
**Photo 24** Wide and shallow reach downstream from the Church towards the Co-op.

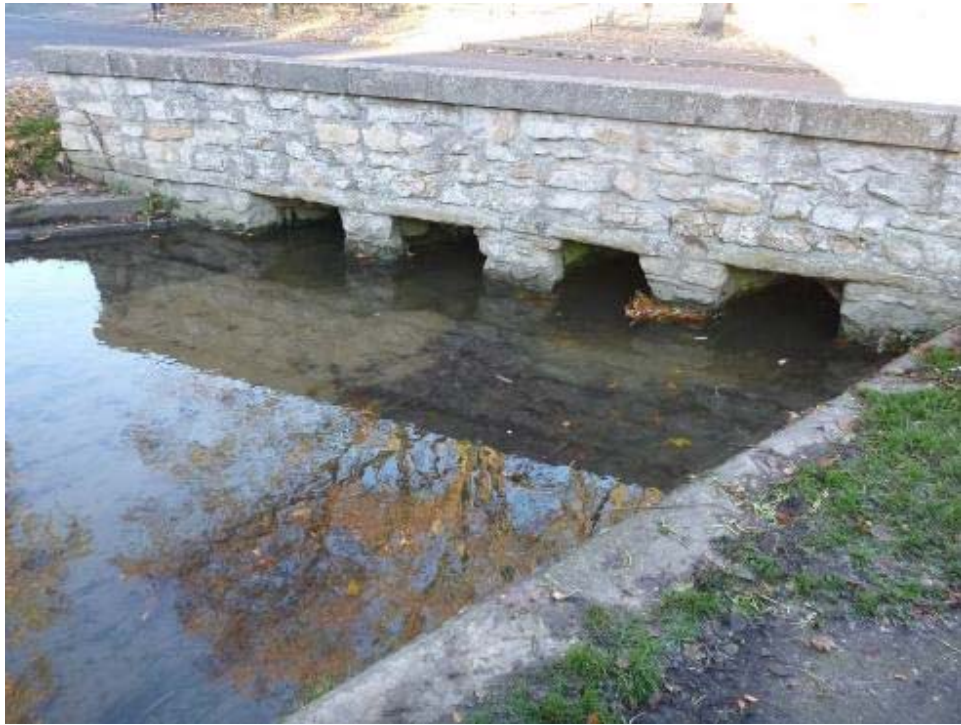
**Photo 25 Another small capacity culvert.**

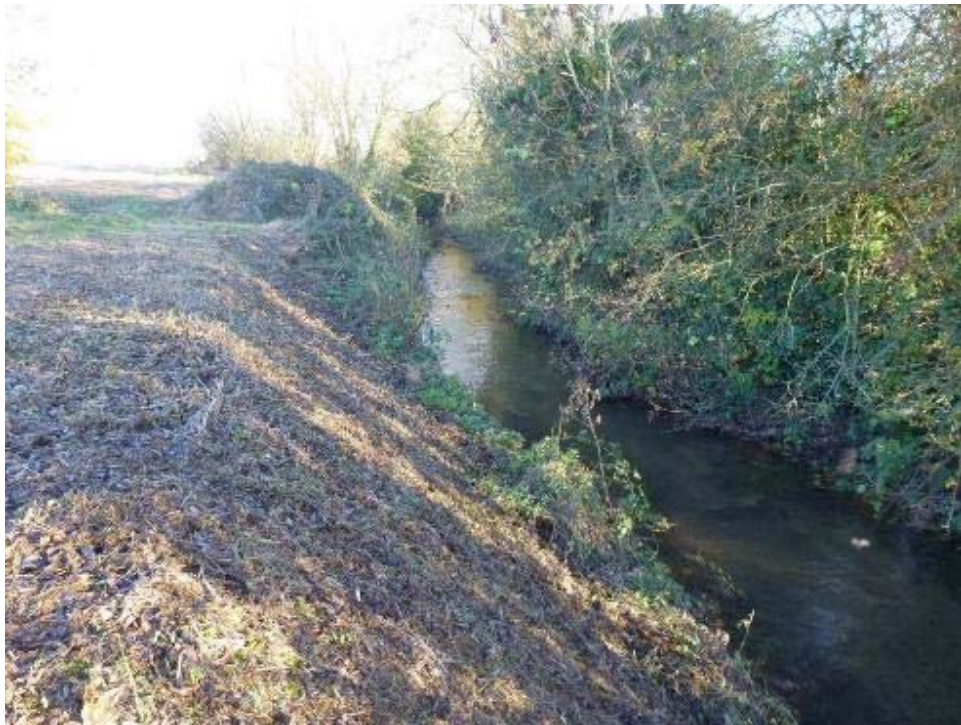
Below Nettleham village down to the sewage treatment works (TF 01865 75846), the beck is straightened and maintained for drainage and has very poor in-stream habitat (Photo 26). It is evident from aerial photography and observations on the ground that the original beck channel ran through the land on the right bank (Photos 27 – 28) in a meandering course. The land on the right bank is clearly lower lying than the existing beck channel and was waterlogged at the time of the visit.

**Photo 26 Straightened channel downstream of Nettleham with poor habitat value.**

There is good potential in this area for a river re-naturalisation project, creating a new channel approximately along its historic course using the principles of natural river geomorphology; this concept is illustrated in Figure 1. A number of similar projects have been carried out elsewhere and further examples are provided in Appendix 1. The advantages of such a project in this location include:

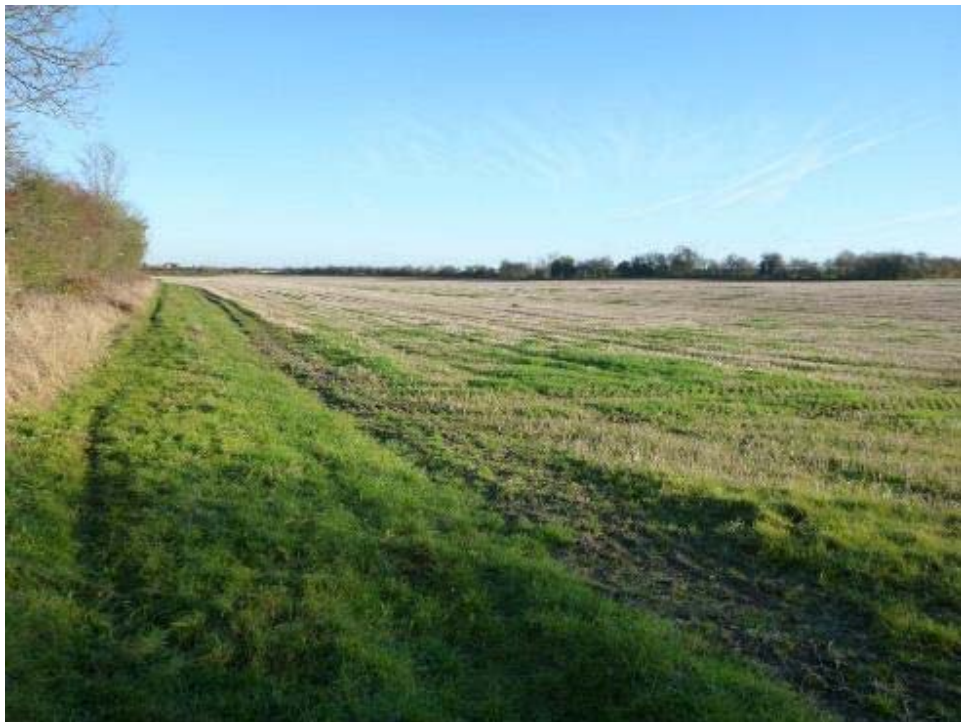
**Photo 27 Low-lying field on the right bank upstream of the sewage works which contained the historic beck channel.**

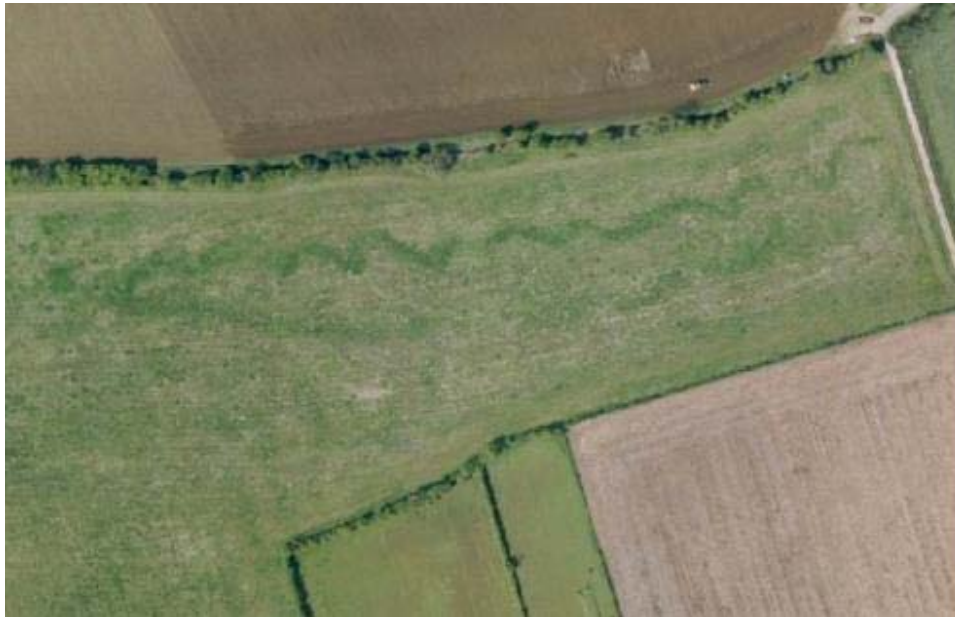
**Photo 28** Aerial view of the field in Photo 27. The existing beck course follows the hedge line across the top of the frame. A historic meandering course of the beck can be seen in the field, marked by darker vegetation.

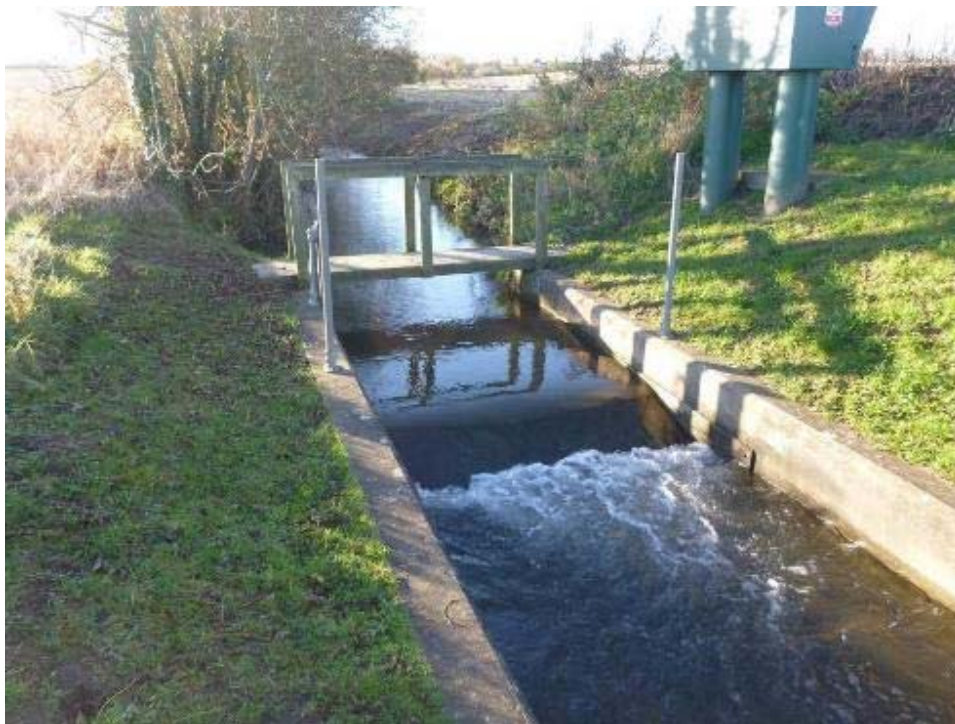
**Photo 29** EA Flow gauging weir.

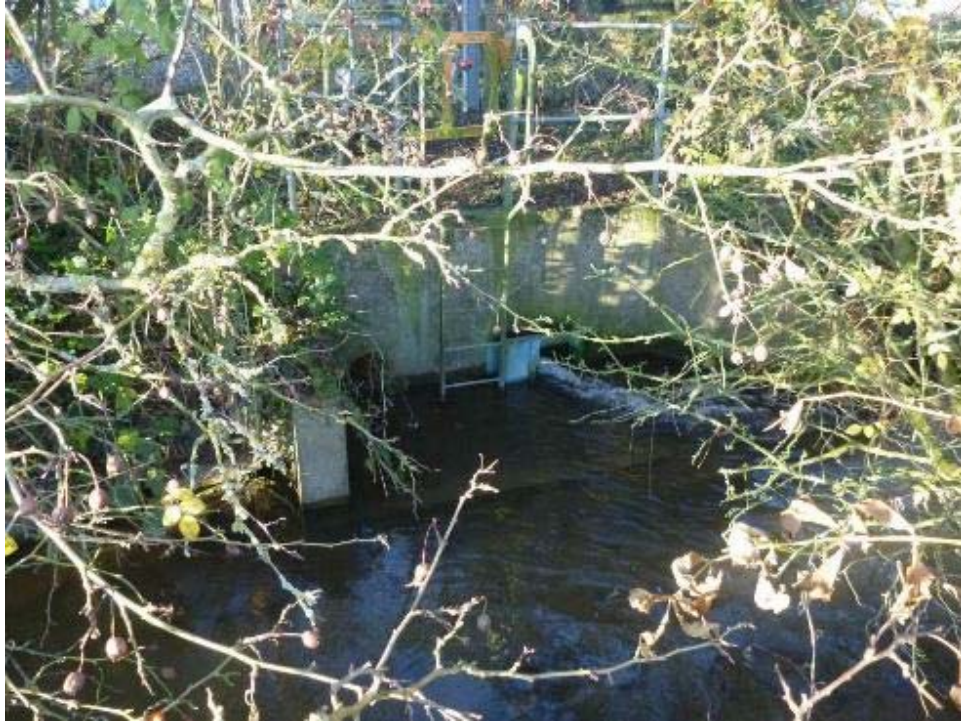
**Photo 30 Sewage works discharge point.**
