**Walkover Habitat Survey**  
**Nettleham Beck, Lincolnshire**  
**November 2016**

This report is the output of a site visit undertaken by Tim Jacklin of the Wild Trout Trust to the Nettleham Beck, approximately 5km north east of Lincoln, on 28<sup>th</sup> and 29<sup>th</sup> November, 2016. Comments in this report are based on observations on the day of the site visit and discussions with Marie Taylor (Lincolnshire Rivers Trust) and David Hutchinson (Environment Agency).

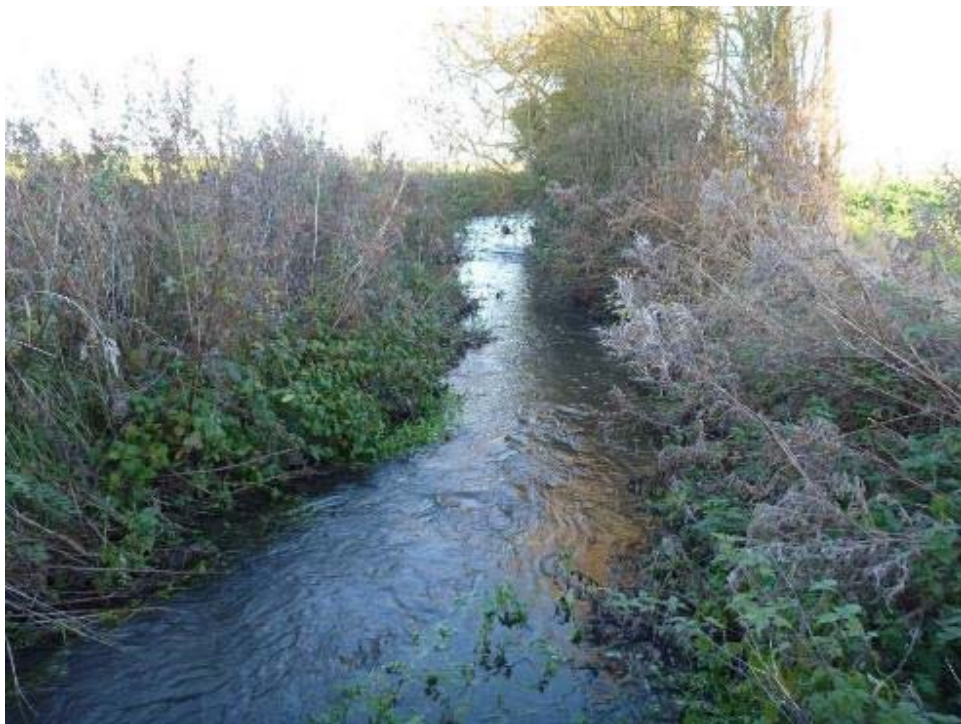
**Photo 31 Channel downstream of the sewage works.**

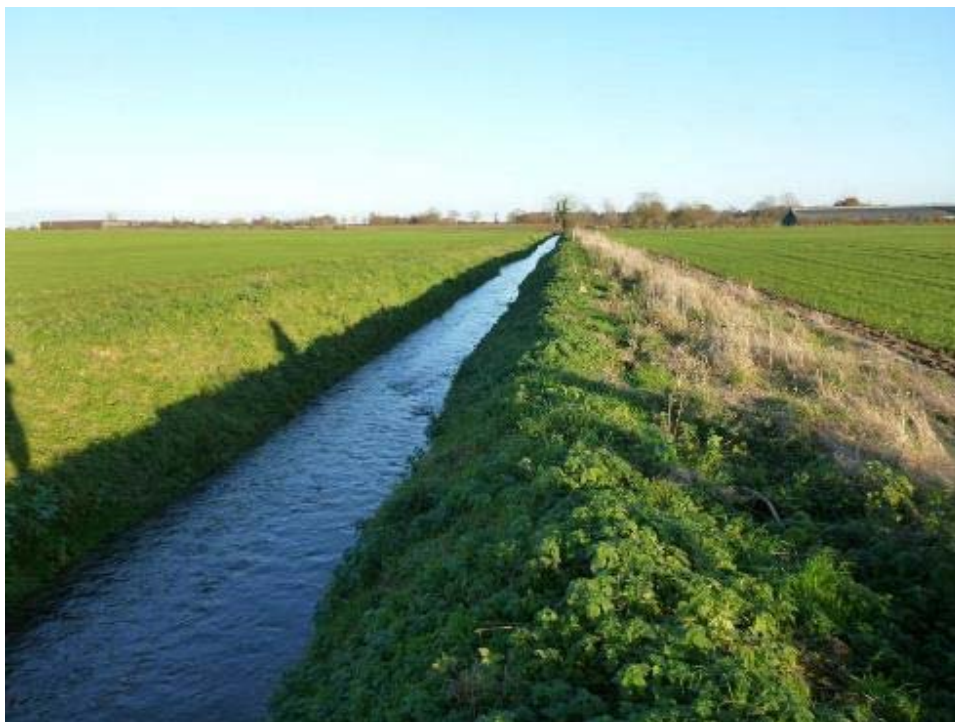
**Photo 32 Channel downstream of the sewage works, IDB maintained section. Specialised low weir structures spaced at the correct intervals could provide much needed deeper pool habitat along straight sections like this. The aim would be to promote bed scour downstream of the structure, not impoundment upstream.**

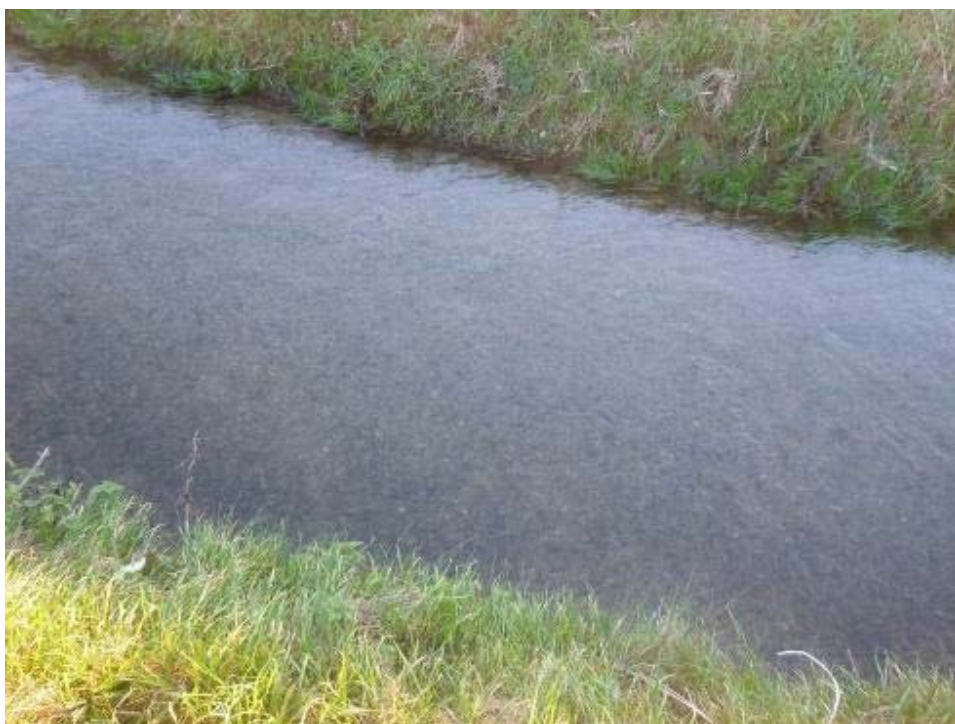
**Photo 33 Uniform and shallow – very poor habitat.**

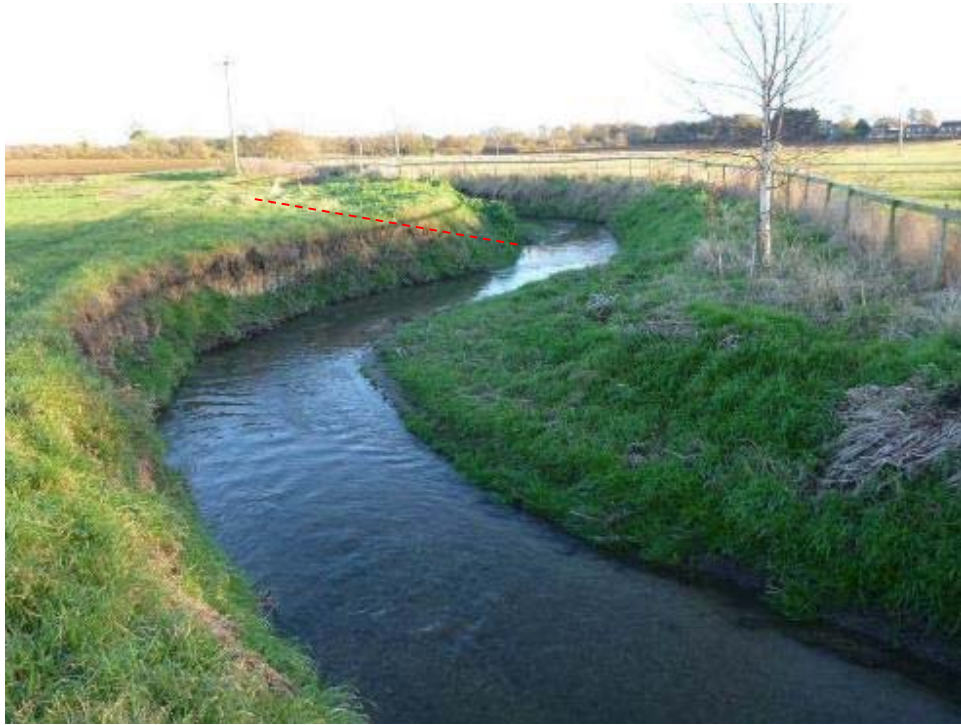
**Photo 34** More sinuous reach upstream of Sudbrooke Road with a nice shallow gradient on the bank on the inside of the bend.  
Bank reprofiling to achieve similar on other bends (e.g. red dashed line) would promote good instream habitat.

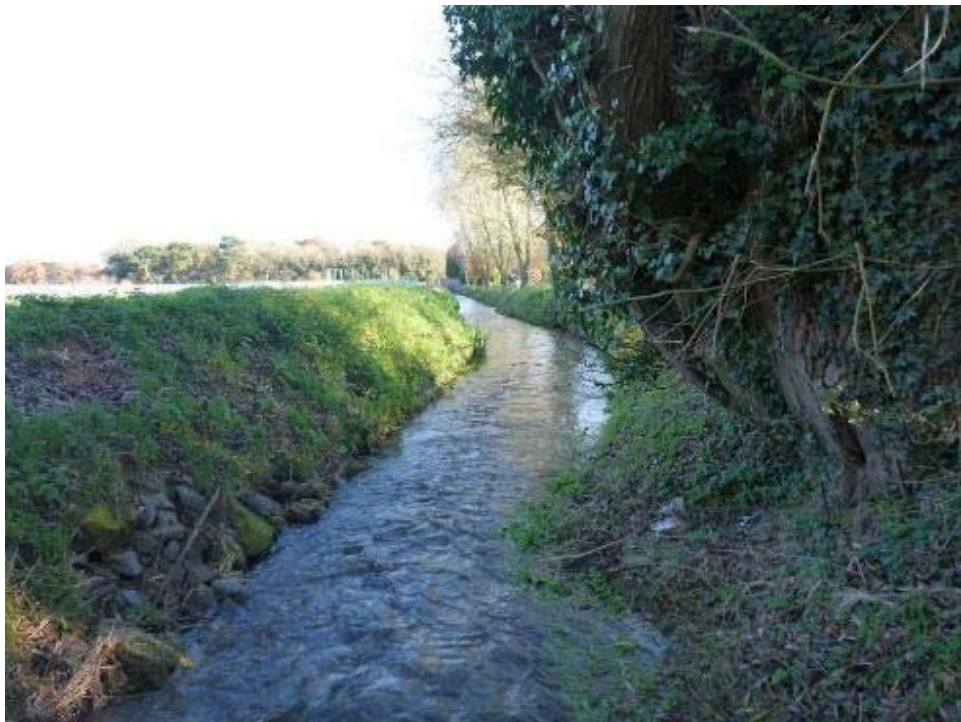
**Photo 35** Section downstream of Sudbrooke Road, alongside Poachers Lane.

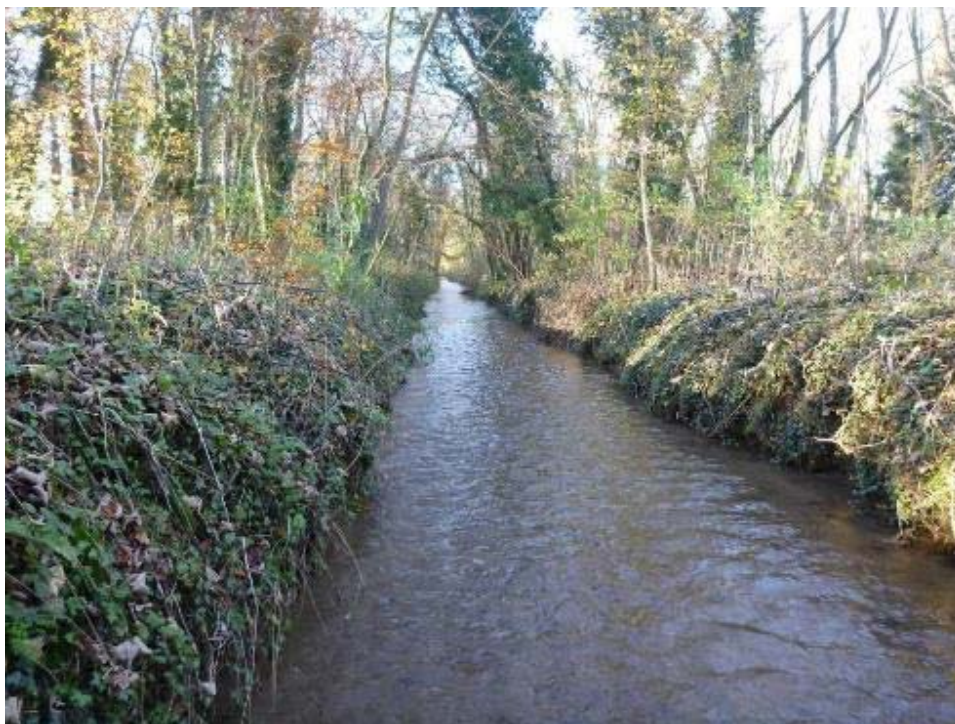
**Photo 36 Straightened section within Ten Acre Covert, with very uniform, poor in-stream habitat.**

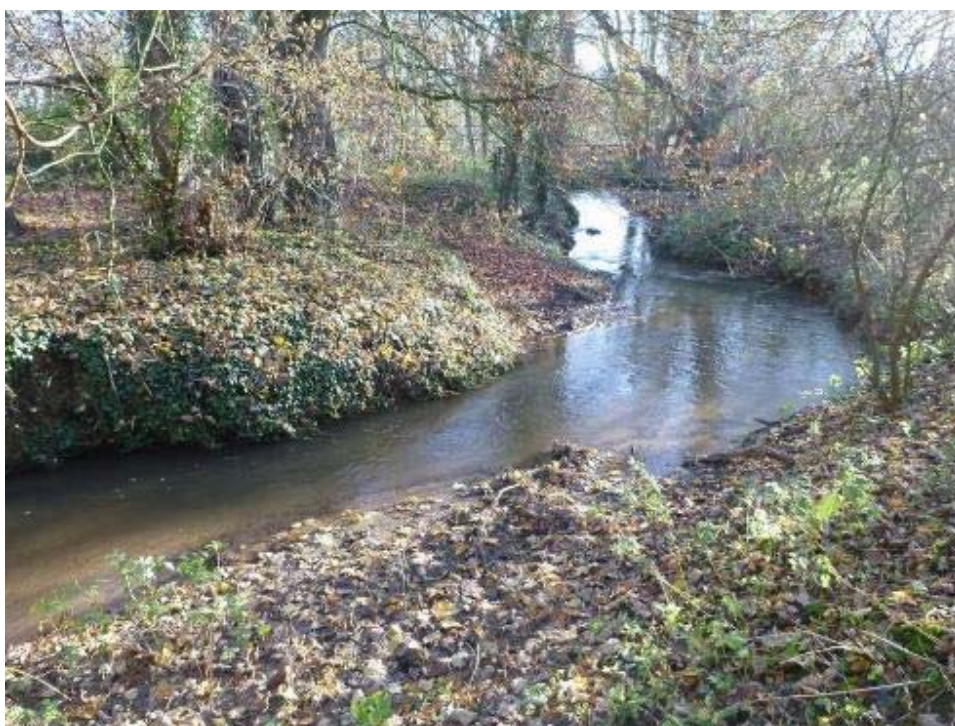
**Photo 37 More meandering section downstream of culvert under track leading off West Drive. Some good in-stream habitat here with meanders, lateral scour pools and riffles.**

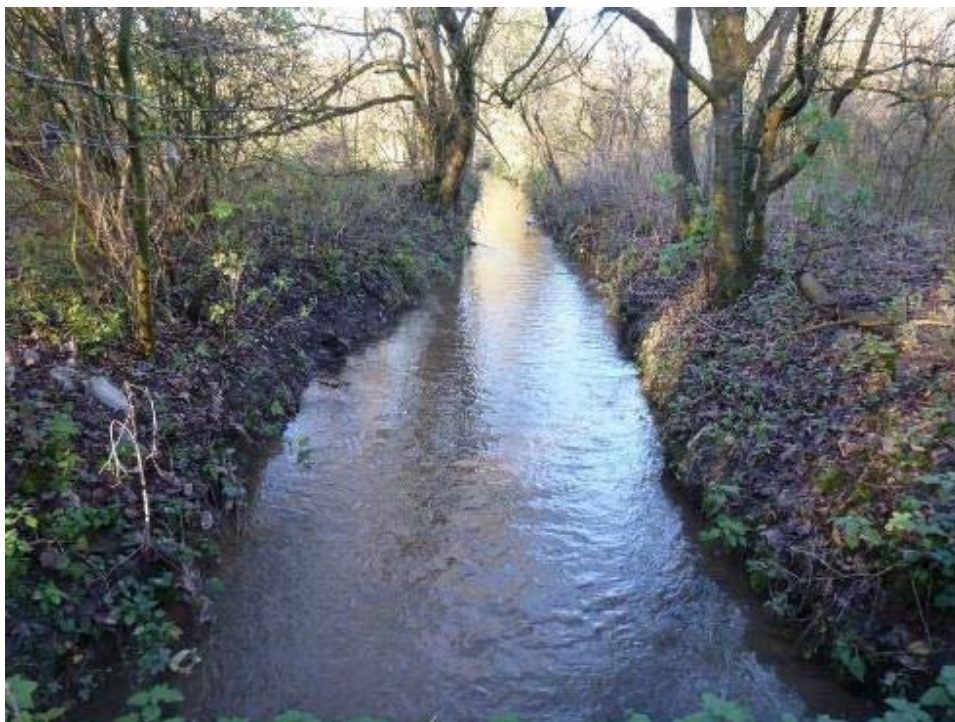
**Photo 38 Straightened, poor habitat section within woodland, approximately TF040758.**
