**Advisory Visit**

**River Onny, Shropshire**

**November 2017**

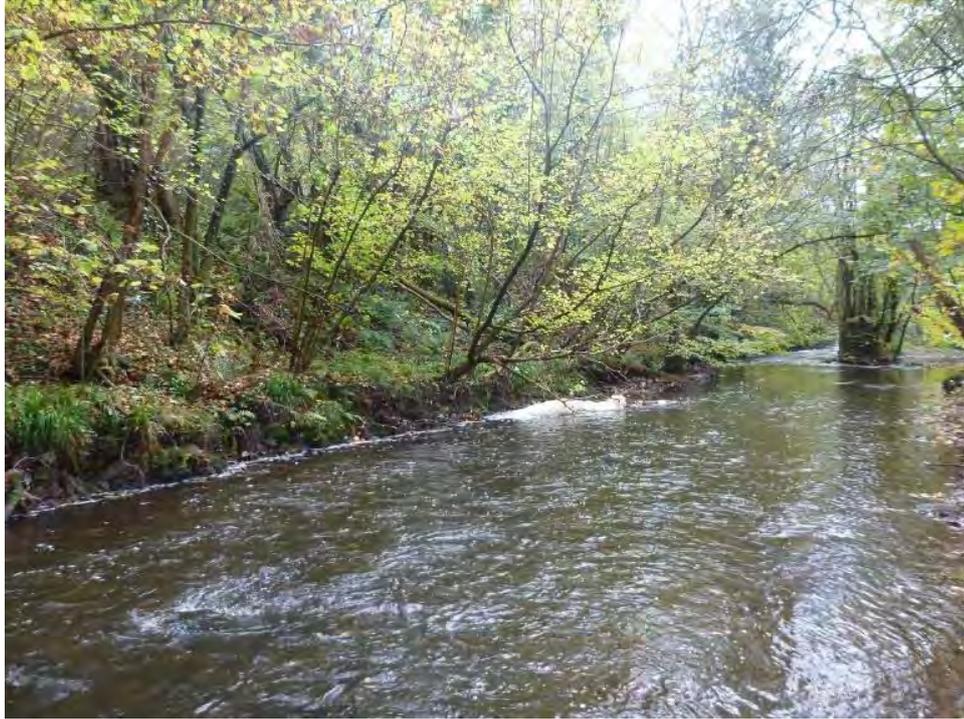
*Photo 1 Downstream view of the section downstream of the road bridge, with the former railway bridge buttress visible mid-channel in the background. There are numerous opportunities for hinging smaller trees on the left bank.*

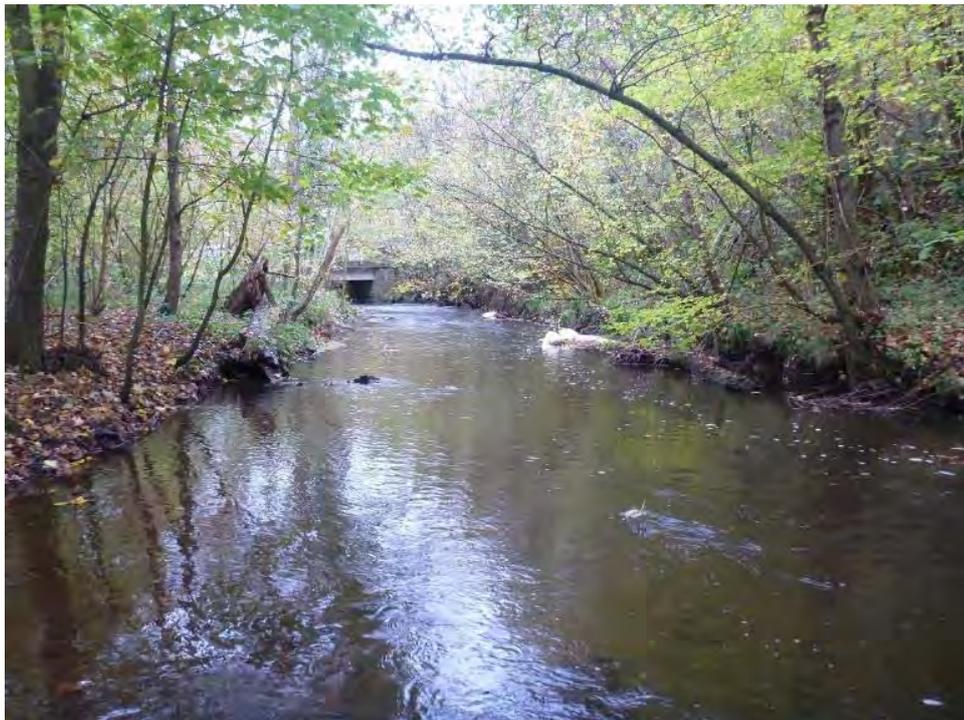
*Photo 2 Upstream view of the section downstream of the road bridge. Large woody material present here should be retained.*

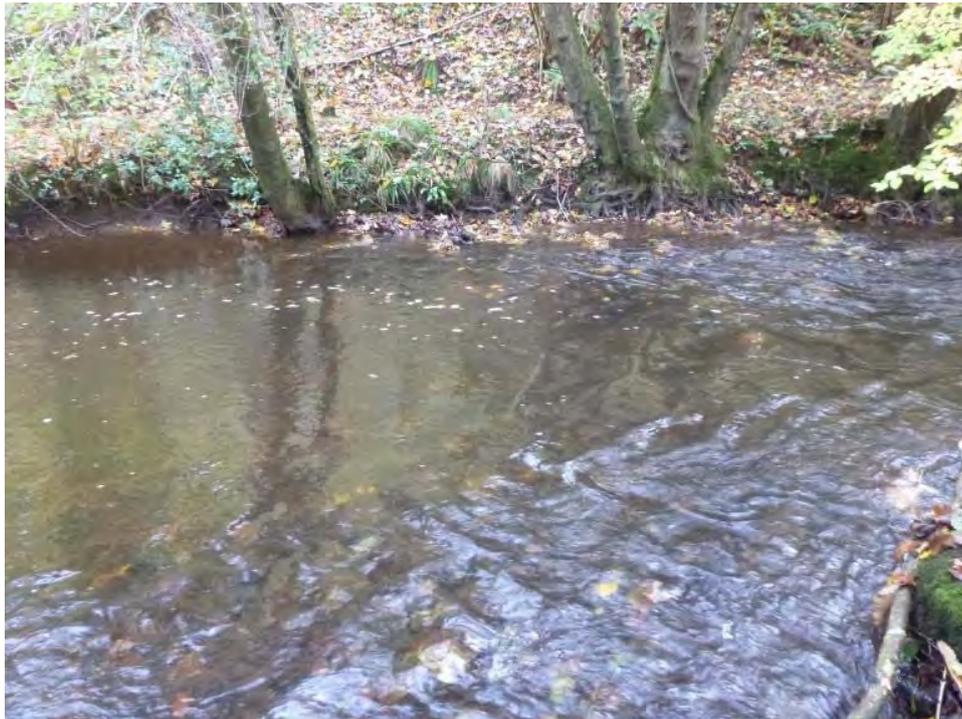
*Photo 3 Area where it is likely trout and salmon may spawn, on gravel substrate at the tail of a pool/glide where the flow is speeding up and breaking into a riffle.*

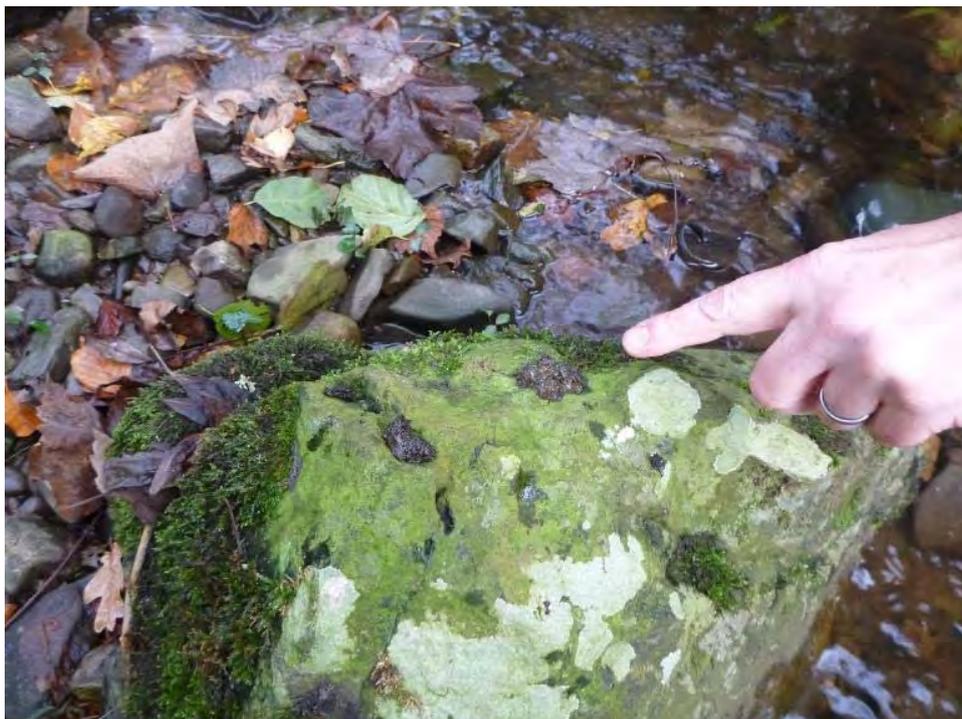
*Photo 4 Numerous signs of otter activity were found during the visit including fresh spraint...*

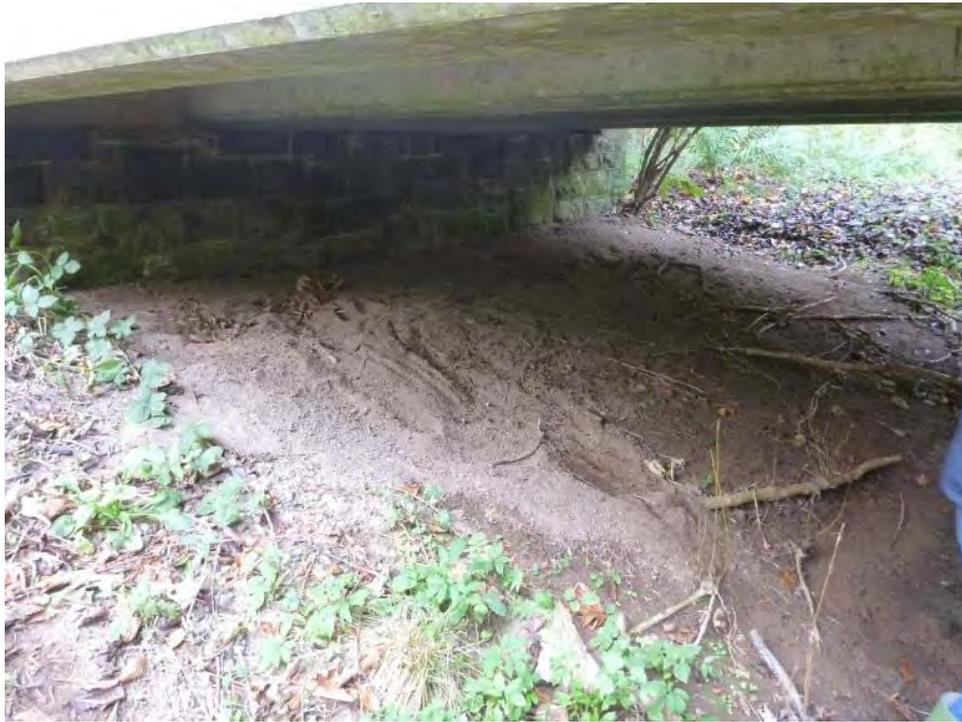
*Photo 5...footprints, rolling and sliding activity in riverside sand....*

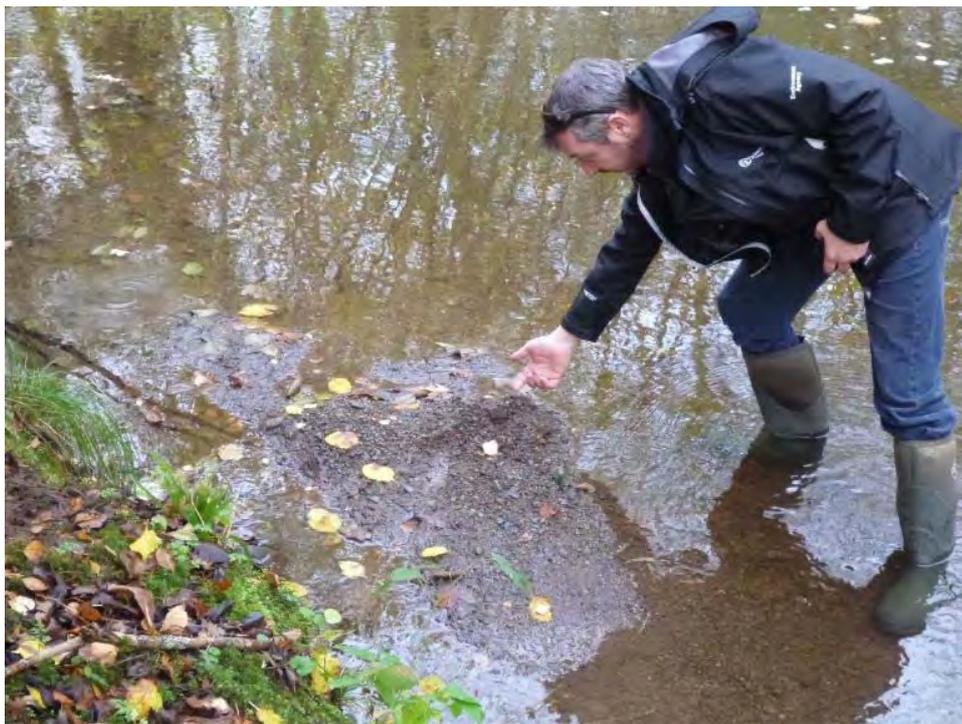
*Photo 6...and mounding of sand to form a sprainting point.*

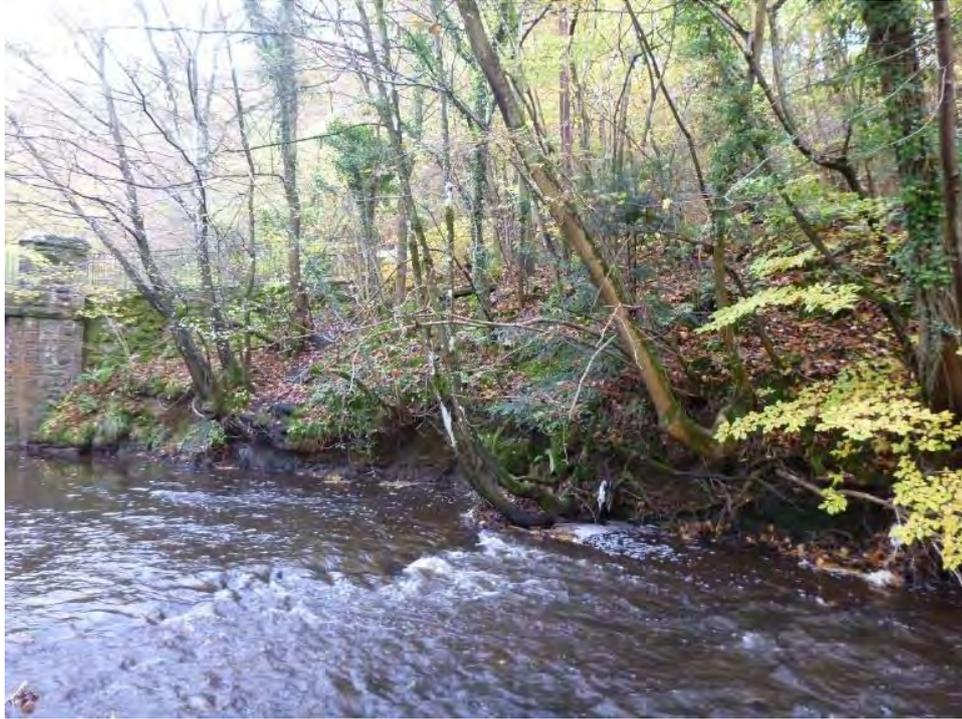
*Photo 7 Steep section of left bank immediately downstream of the bridge. Assessing the stability of the trees here and selectively coppicing could preserve the root structure and bank stability, preventing the need for less sensitive bank protection in the event of trees toppling.*

- Assess the trees on the left bank for risk of toppling and damaging the bank alongside the road. Make a plan for staggered coppicing over a few years to reduce this risk and the need for invasive bank repairs. Likewise, repair presently small areas of damage to bank revetments to prevent more extensive problems and interventions.
- Hinge smaller trees into the river margins to create cover for fish (Photos 17 and 18).

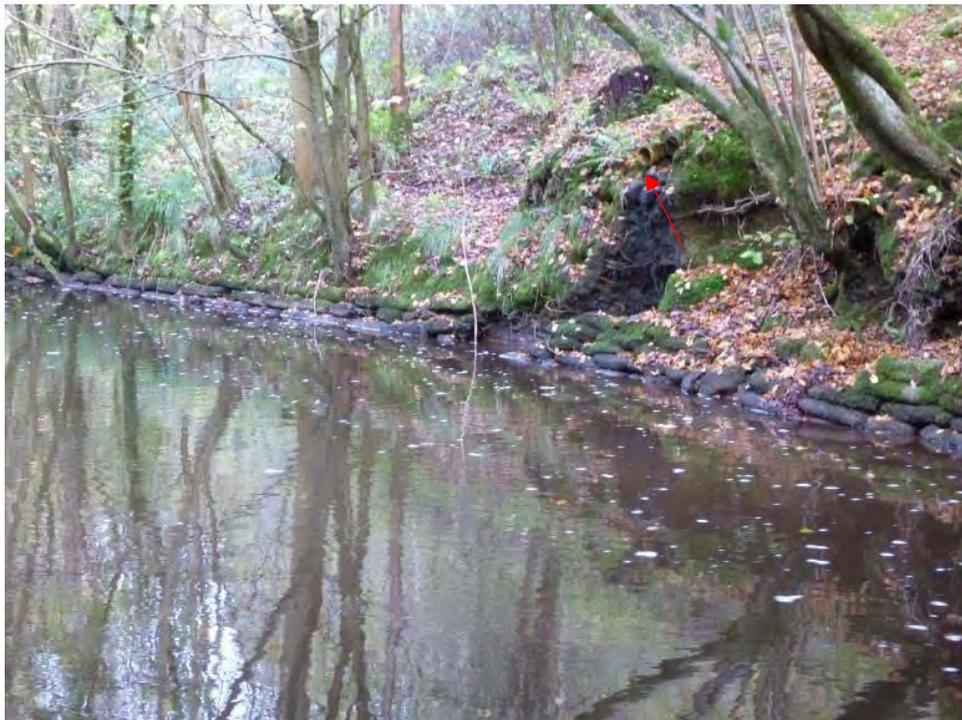
The A489 road runs close to the left bank of the river on either side of the minor road bridge in the middle of the reach inspected. There is a steep drop down from the road to the river in places and the toe of the bank has been reinforced with gabion baskets (downstream of the bridge) and concrete sandbags (upstream of the bridge). The growth of trees in and around these reinforcements suggest they were constructed around 20 years ago (Photos 7 – 9). There are few intact gabions left below the bridge, but trees root systems are now providing bank stability. The concrete sandbags are largely intact, except for a section where discharge from a surface water road drain set at a high level has scalloped behind the sandbags and created a weak spot for high river flows to erode (Photo 8).

*Photo 8 Repair of the bank protection failure caused by the outfall from the drain (arrow) upstream of the bridge could also prevent the need for more extensive works. Likewise, assessment and staggered coppicing of the trees (as per Photo 7). Hinging smaller trees to lay parallel to the bank would also improve low cover and fish holding capacity alongside the hard revetment.*

The deeds of the property include a clause allowing the local highways department to maintain the bank reinforcements; inevitably, when this occurs there will be disturbance and damage to the existing riparian habitat and loss of trees. Early intervention to manage existing trees and repair the gap in the sandbags could delay or prevent the need for major works, thus protecting habitats. Installation of a solid apron beneath the drainage pipe to withstand and dissipate the force of the falling water could also be incorporated.

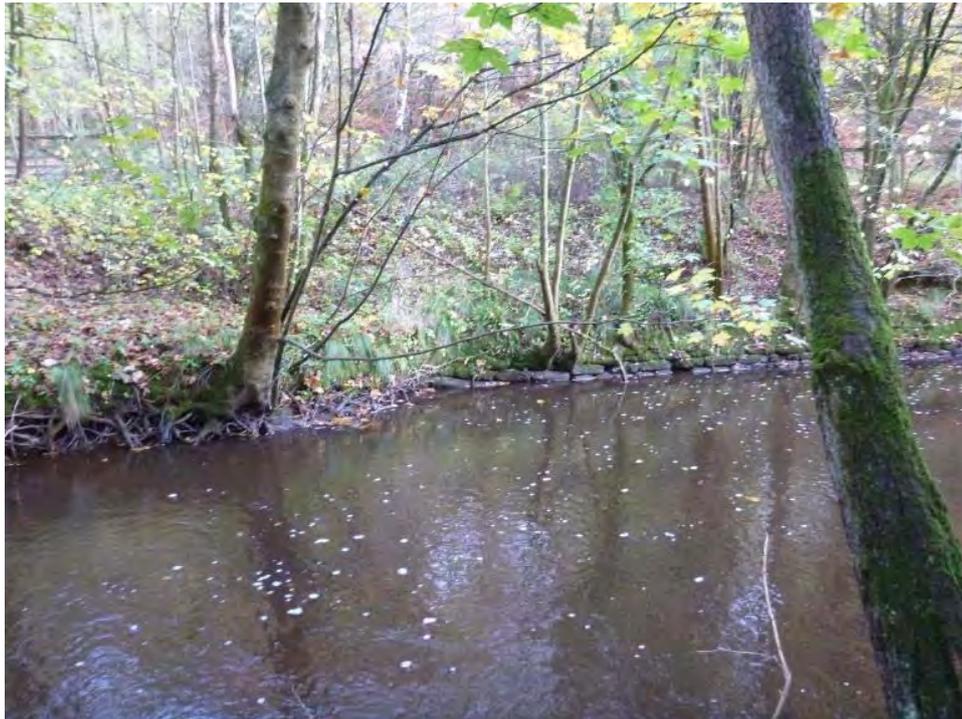
*Photo 9 Tree root systems provide good bank stability and much better habitat (cover) compared with the hard bank revetment. Preserve the root systems by coppicing the tree if it looks in danger of falling.*

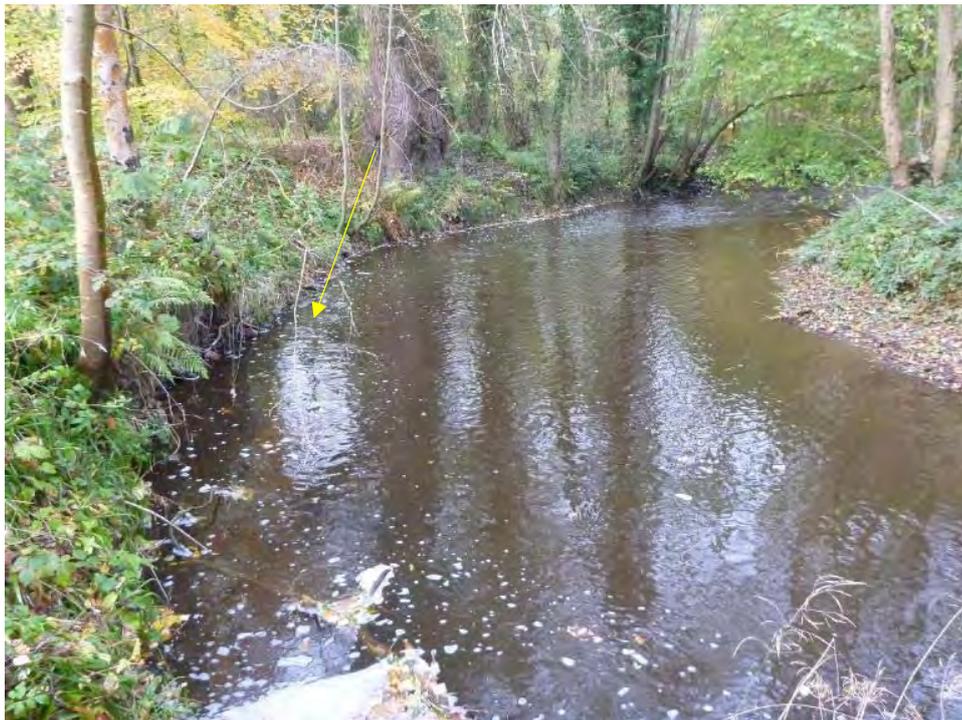
*Photo 10 A bend in the channel illustrates the point in the text about pool formation and a more natural river cross-sectional profile, with deep water on the outside and a point bar ("beach") on the inside. With good bankside cover (including some tree hinging - arrow), the outside of the bend is a classic fish holding spot.*

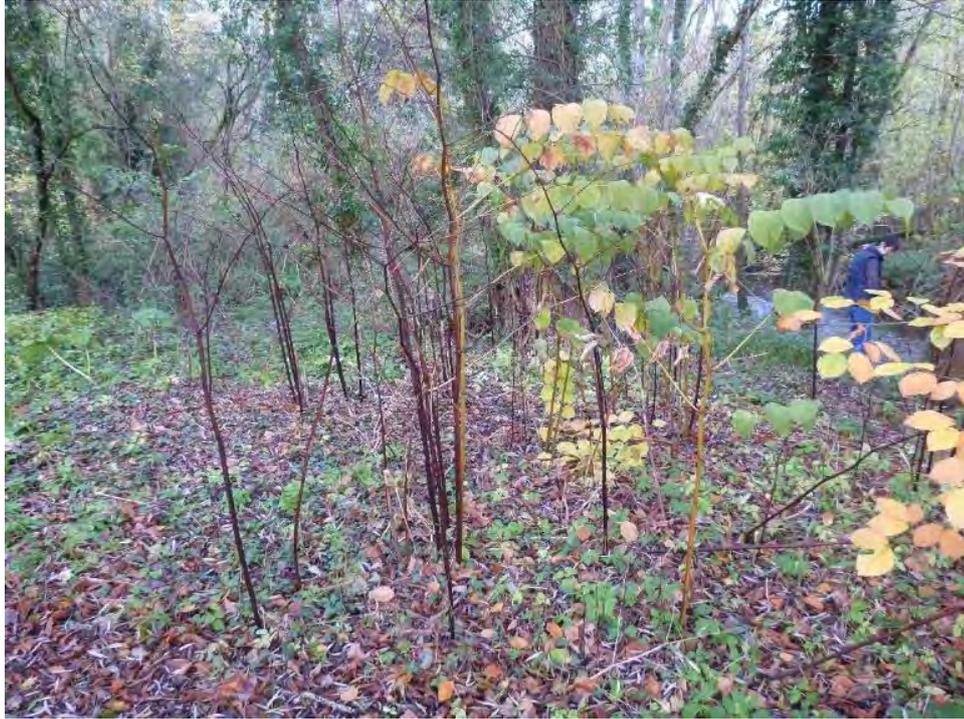
Upstream of the bridge there is a small stand of the non-native, invasive plant species Japanese knotweed on the right bank. The landowners are aware of this and have had it treated with herbicide; this should be

continued until it is eradicated. The landowners are also aware of the undesirability of Himalayan balsam, another non-native invasive, and have been pulling this by hand.

*Photo 11 A stand of Japanese knotweed – highly undesirable and invasive. The landowners are aware and have treated this stand. This should be continued until eradicated.*

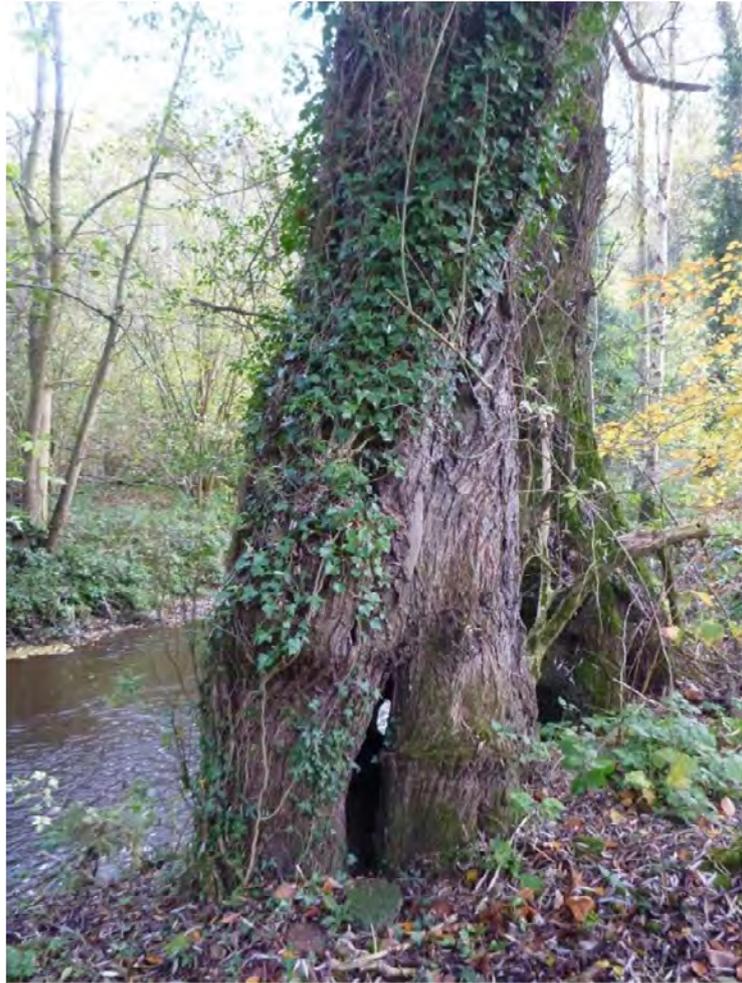
*Photo 12 Veteran trees such as this, with crevices and extensive ivy cover, are very valuable wildlife habitats (particularly for bats) and should be preserved. Equally, standing dead wood should be retained as habitat for invertebrates, woodpeckers, etc.*

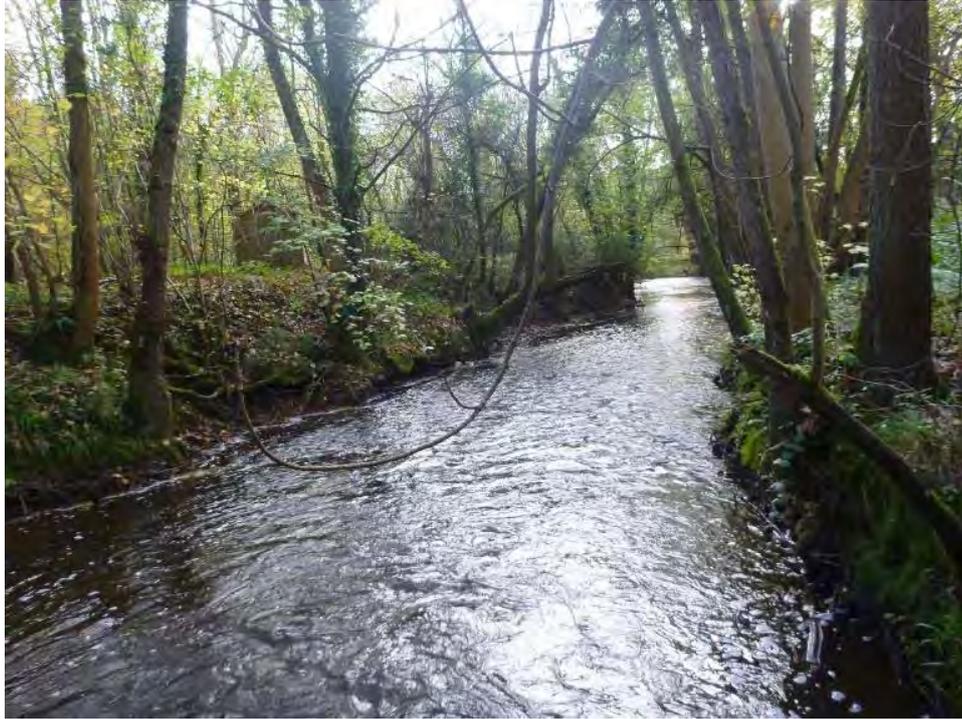
*Photo 13 The sections of river with more dense stands of trees of a similar size and age could benefit from light rotational coppicing top promote re-growth of varying size and maturity.*

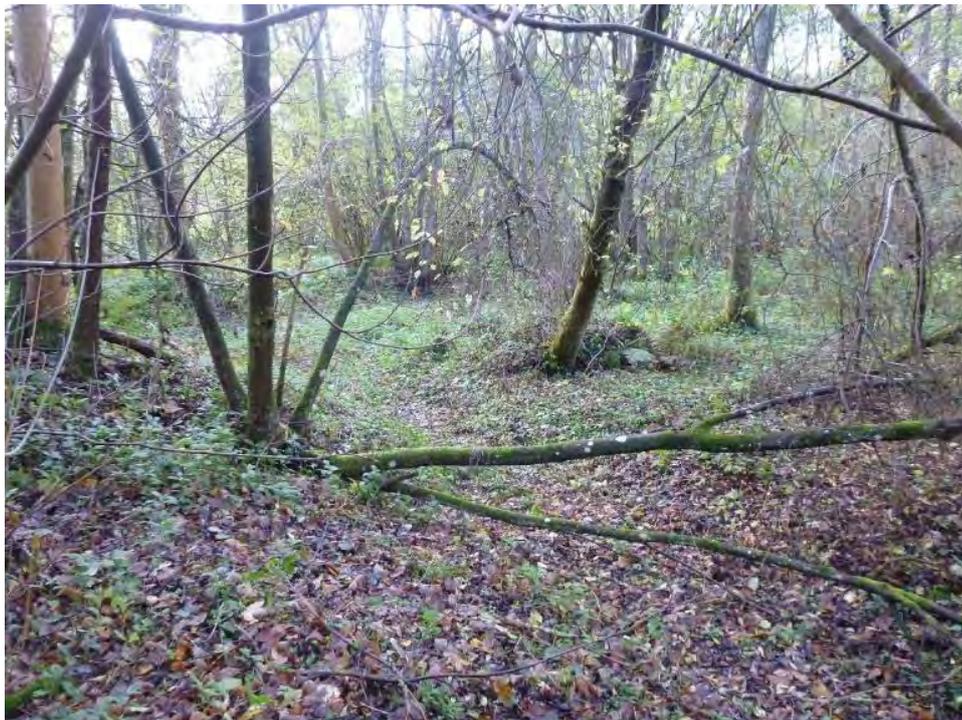
At the upstream extent of the reach, there is a dry channel on the left bank that could be the remains of a former meander in the river. At the end of it nearest the river, it appears that an earth bund has been removed in order to drain the former channel (and presumably the adjacent low-lying field). There are drainage pipes on the bank here that could have been set at a high level within the bund to retain water levels in the former meander and create wet woodland. The adjacent field is evidently still wet (from the *Juncus* rushes present), so it may be worth liaising with the owner/user of the field to see if the bund and pipes could be reinstated to restore the wet woodland habitat.

*Photo 14 Possibly the former course of the river cut off by channel straightening at the upstream end of the reach, right bank.*

- Contact Severn Rivers Trust and join the Riverfly Partnership invertebrate monitoring scheme.
- Keep an eye out for spawning trout and salmon and report to Chris Bainger at the Environment Agency.
- Have a regard for maintaining shading of the channel during any woodland maintenance works. Undertake any coppicing on a rotational basis, allowing trees to re-grow at different rates / sizes. See the code of practice for coppicing in the appendix.
- Investigate the possibility of re-instating the wet woodland in the former channel.

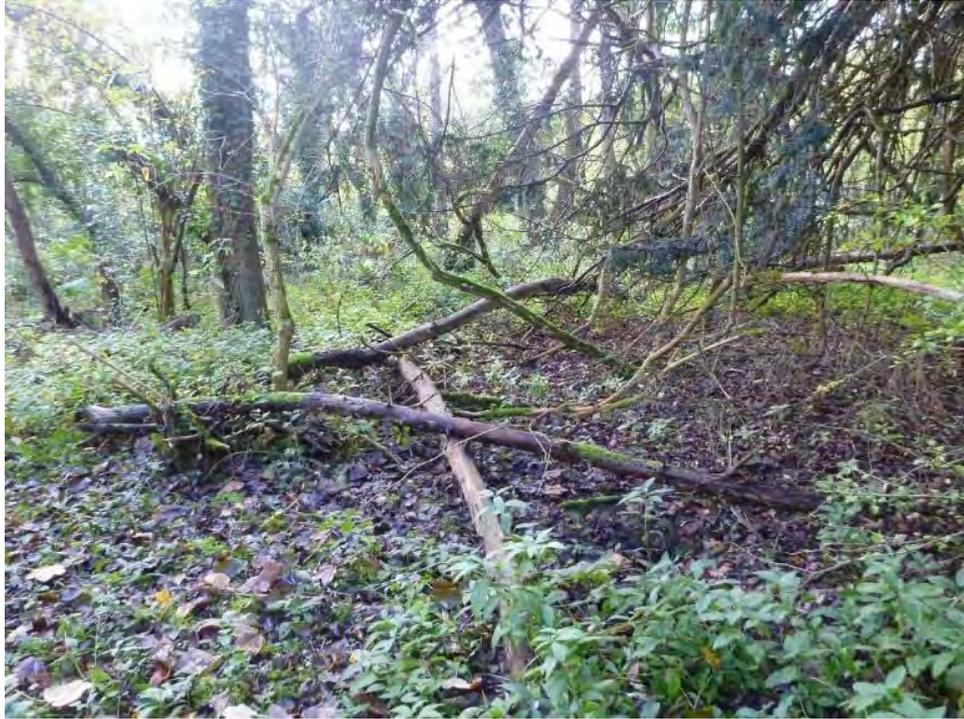
*Photo 15 The woodland on the right bank has some good examples of veteran trees (including some fine yews) and lots of fallen dead wood. Biodiversity interest is high here.*

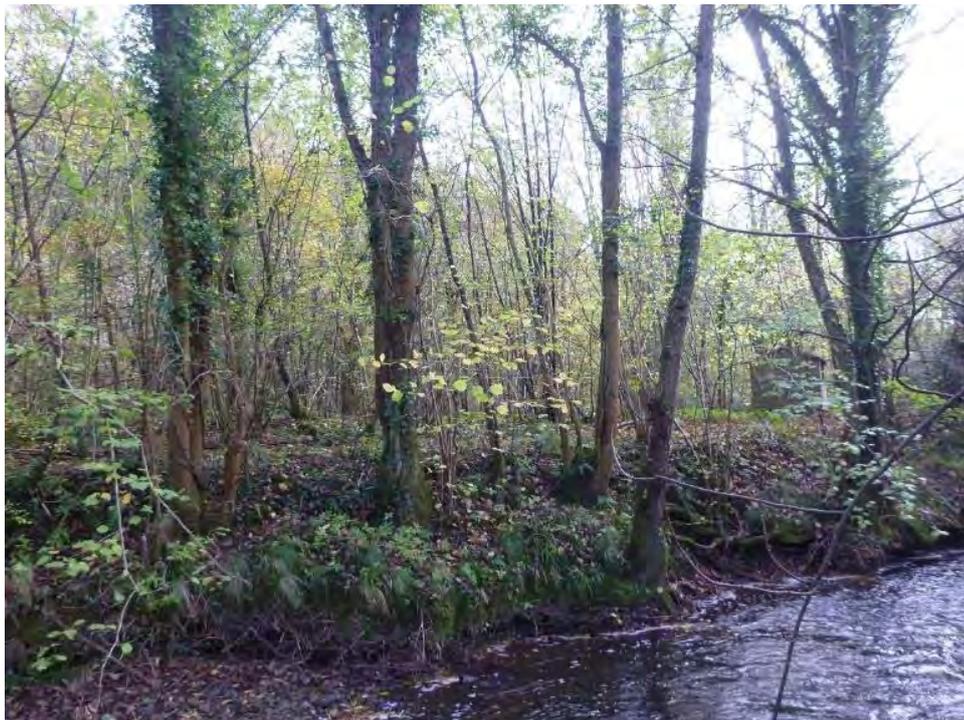
*Photo 16 On the left bank, the woodland appears to have been more recently managed as a coppice. Advice from experts such as the local wildlife trust and Woodland Trust should be sought for the best way to manage the woods on both banks.*
